Crosswalk at 39th Ave SW and SW Oregon St

Intersection of 39th Ave SW and SW Oregon St

Seattle Department of Transportation (SDOT) Review

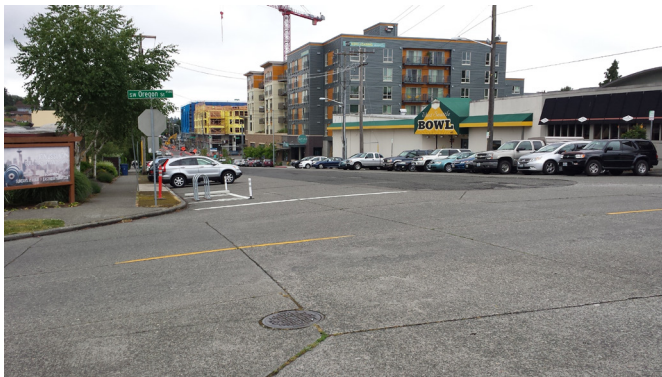
Looking south from the NE corner of SW Oregon St and 39th Ave SW

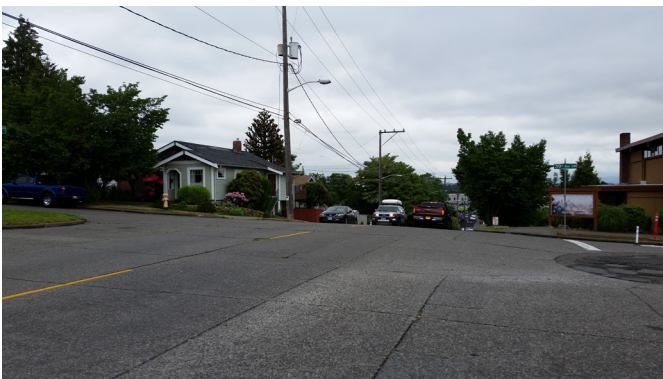
Looking east from the southeast corner of SW Oregon St and 39th Ave SW

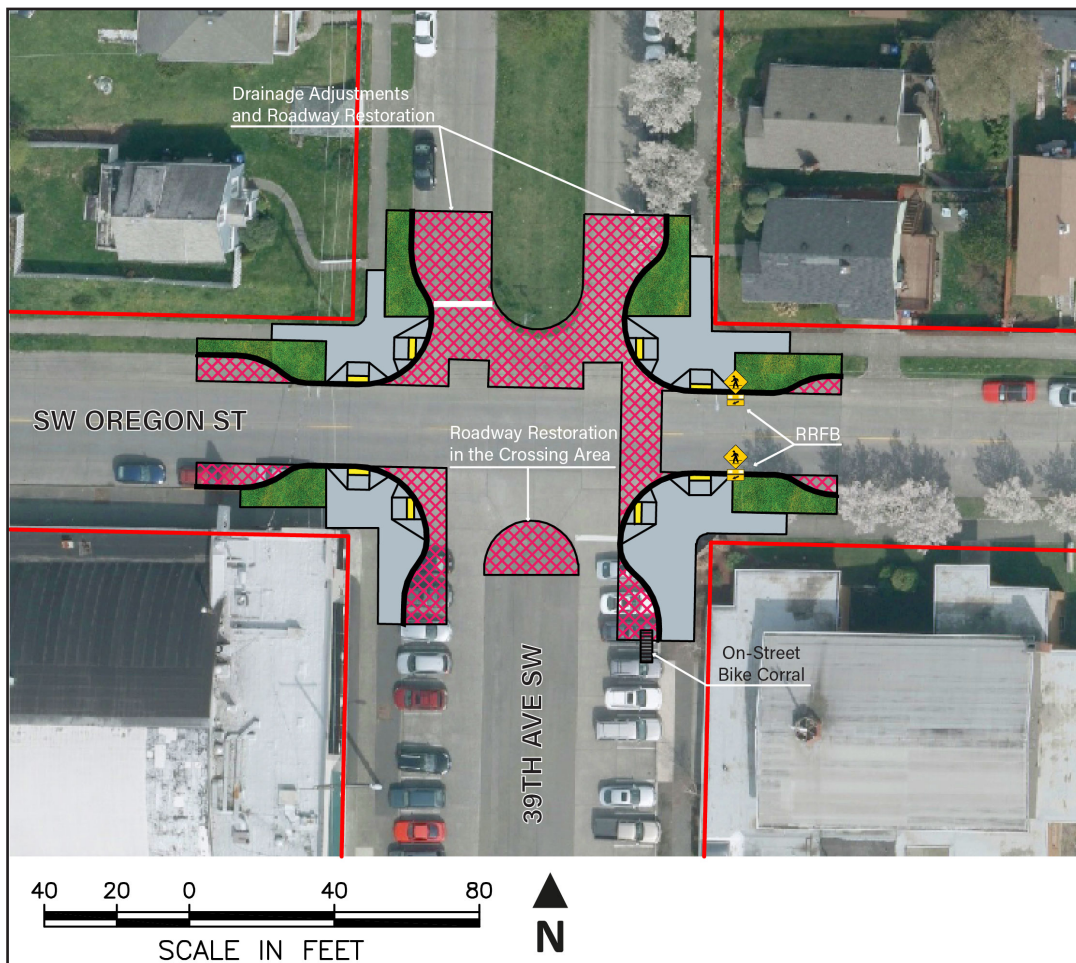
This conceptual design proposes curb bulbs on all corners to increase pedestrian visibility and ensure that people driving aren't parking too close to the intersection. One marked crosswalk can be added on the east leg of the intersection. This crosswalk will include a set of pedestrian-activated Rectangular Rapid Flash Beacons (RRFBs). Construction of curb bulbs will require relocating several drainage inlets and a bike corral on the southeast corner of the intersection. The cost estimate includes street repair after the new drainage is installed.

- Re-grading may be necessary to ensure new curb ramps are ADA compliant on the east side of the intersection

- There will be a perceived loss of parking with the installation of curb bulbs, however these parking spots were in fact too close to the intersection to be legal
- Drainage will need to be reconfigured on the north side of the intersection
- The existing bike corral on the southeast corner of the intersection will need to be relocated further south with the construction of the curb bulb at this corner
