## **Phase 2B**

# **Terminal Level Overview**

**9. 24. 2012**

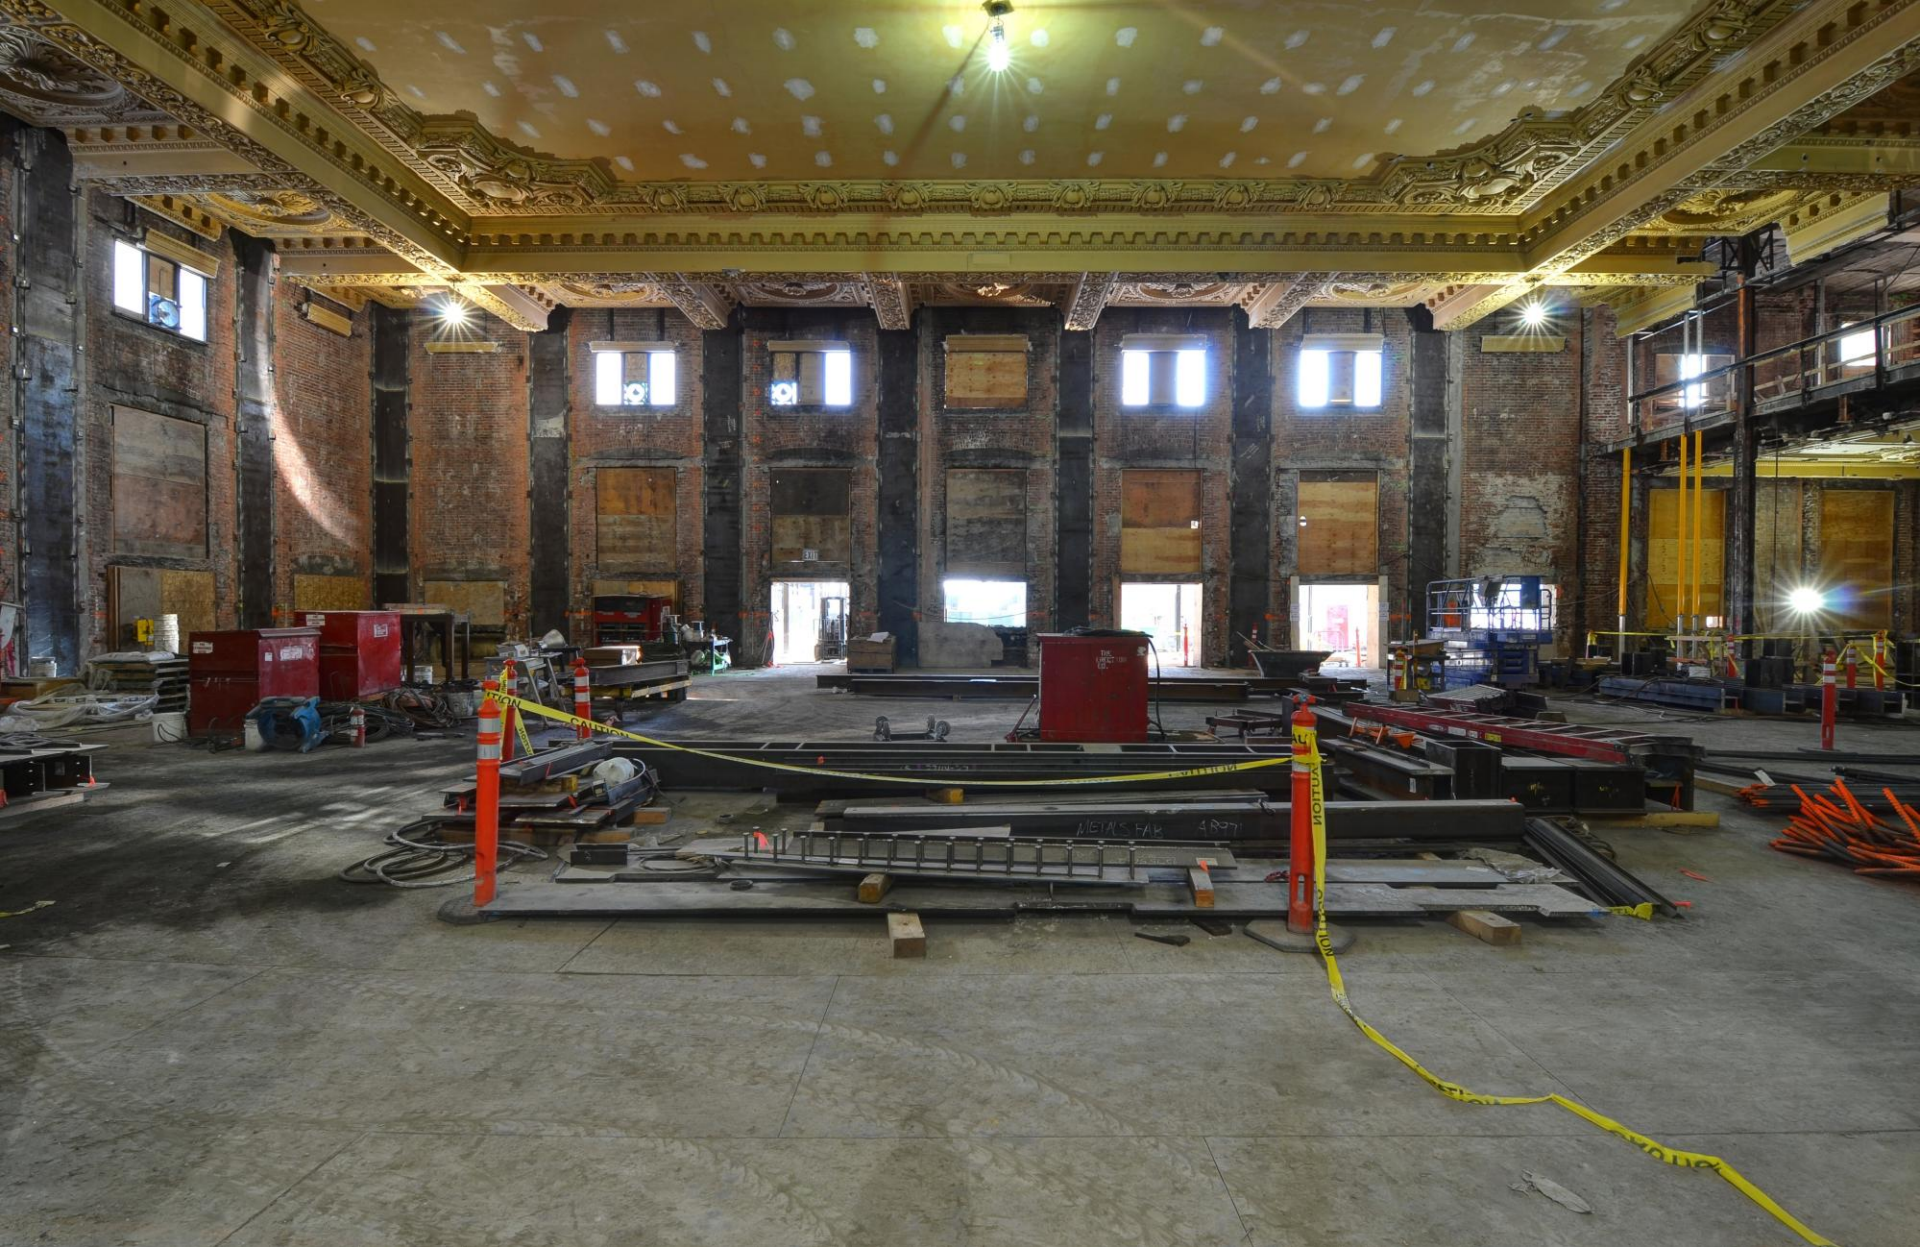
Plywood protects the terrazzo floor during construction. Major seismic upgrades are currently taking place in this area. These upgrades includes: all new perimeter columns, grade beams and reinforced interior columns.

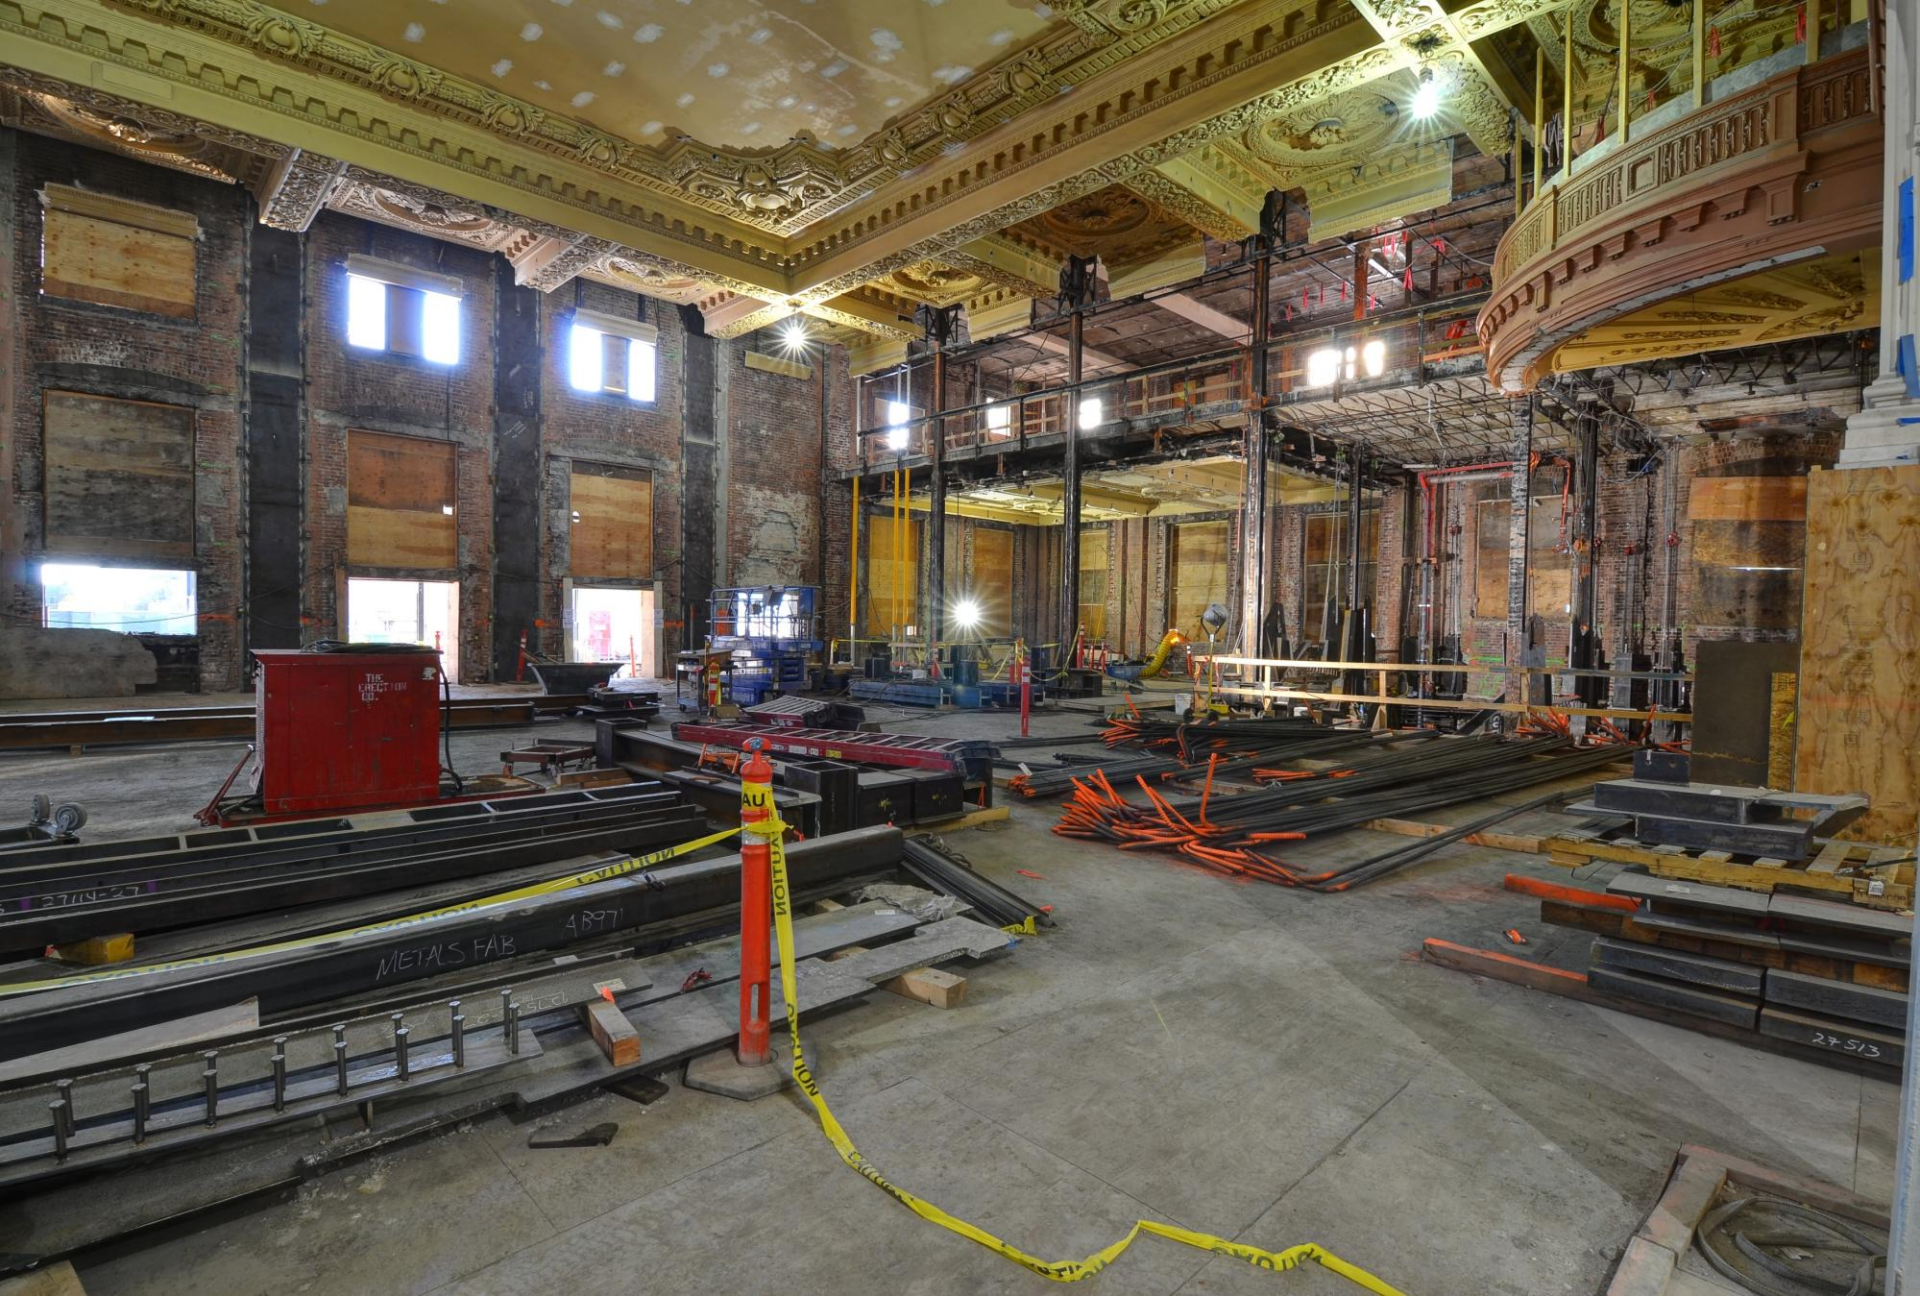
Looking northwest from the main waiting room. Top left: Large sheets of metal enclosed newly installed columns to support the building's vertical and shear stress.

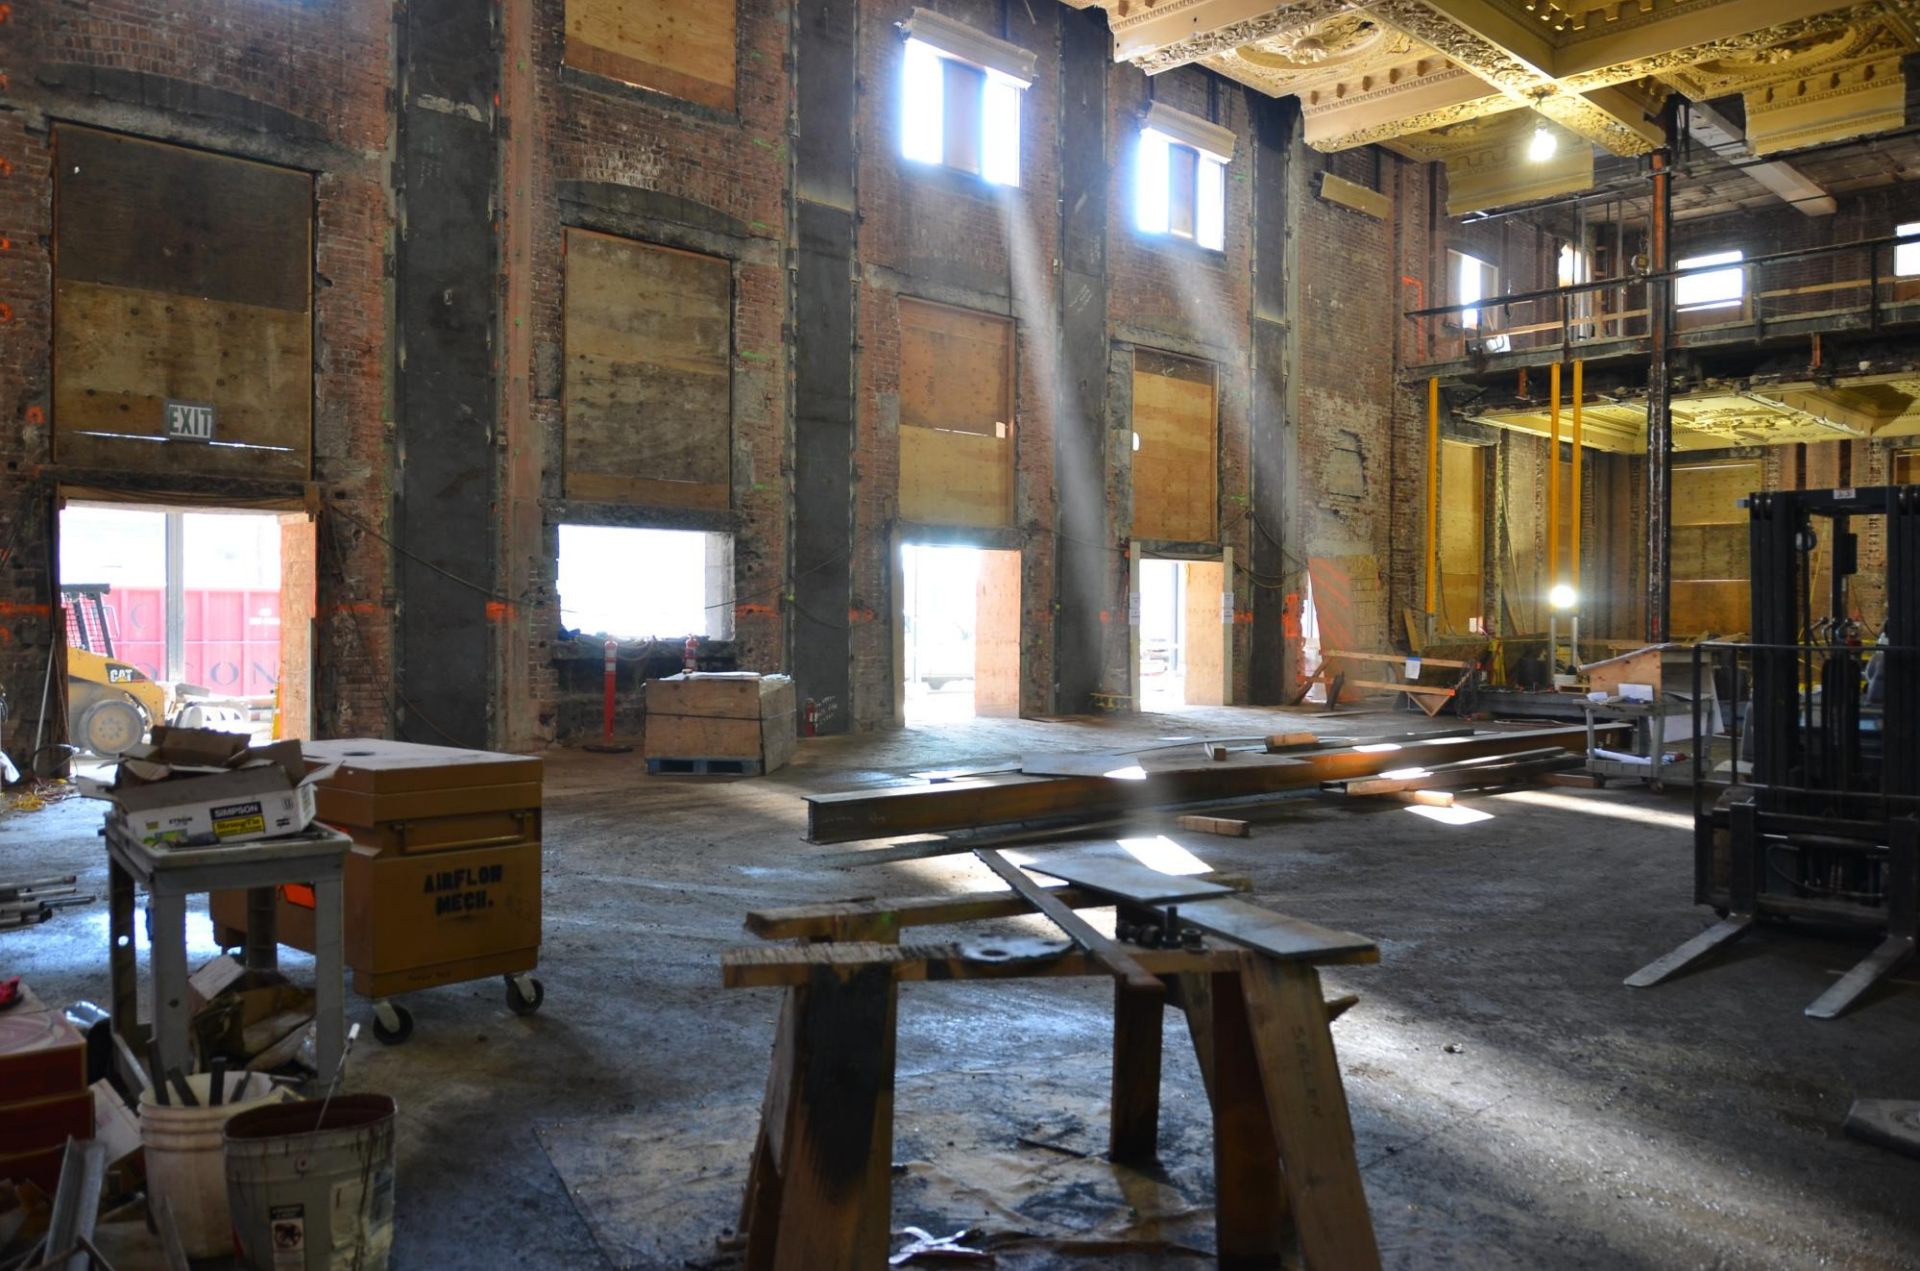
Sunlight streams through the temporary plexiglass windows from level 2 of the building. Damages to the ornamental plaster are being repaired. A separate slide show will show the work in detail.

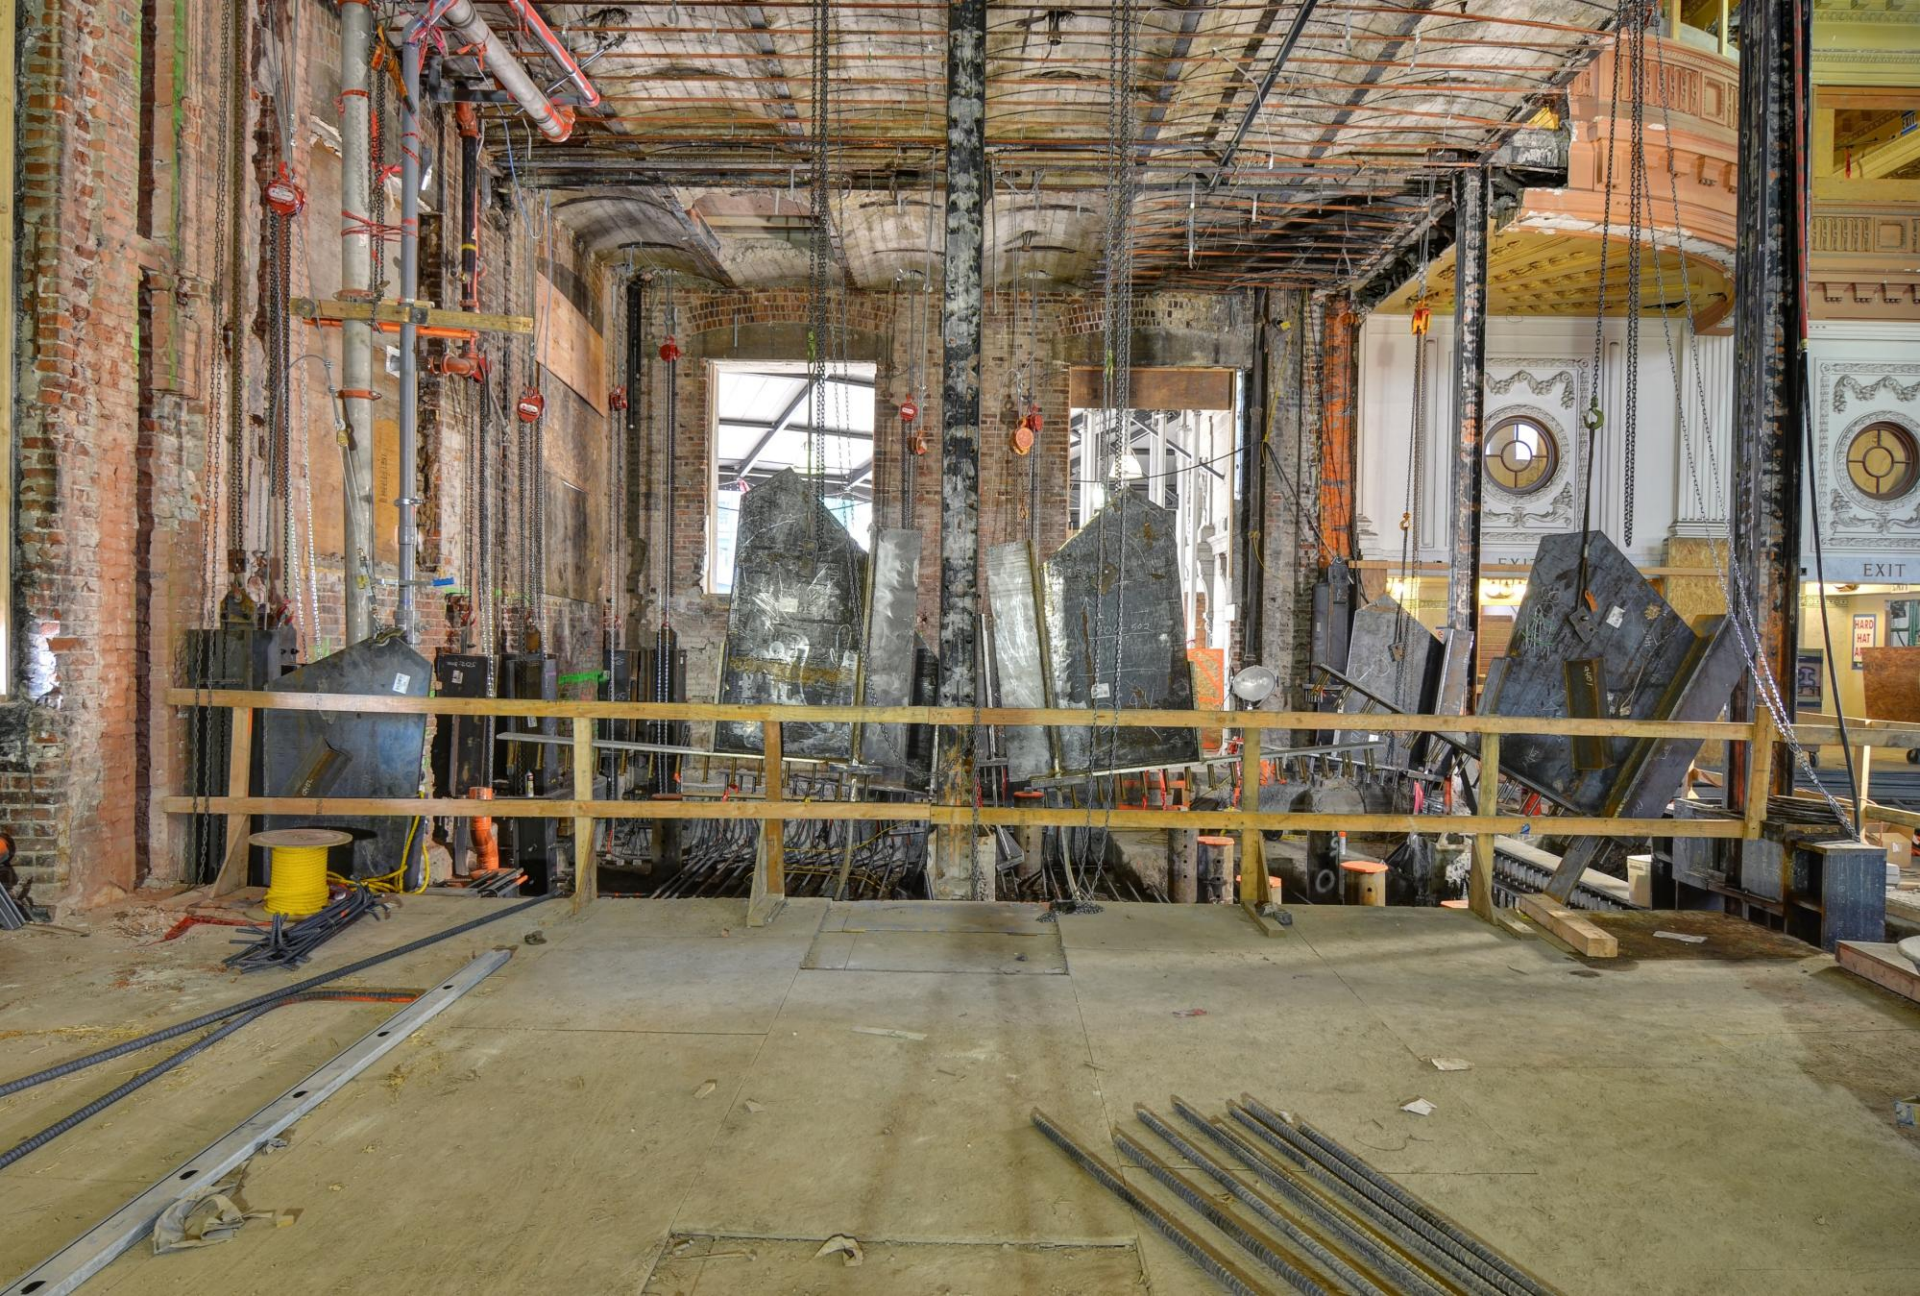
A collection of new steel pieces which will be installed as part of the seismic upgrade.

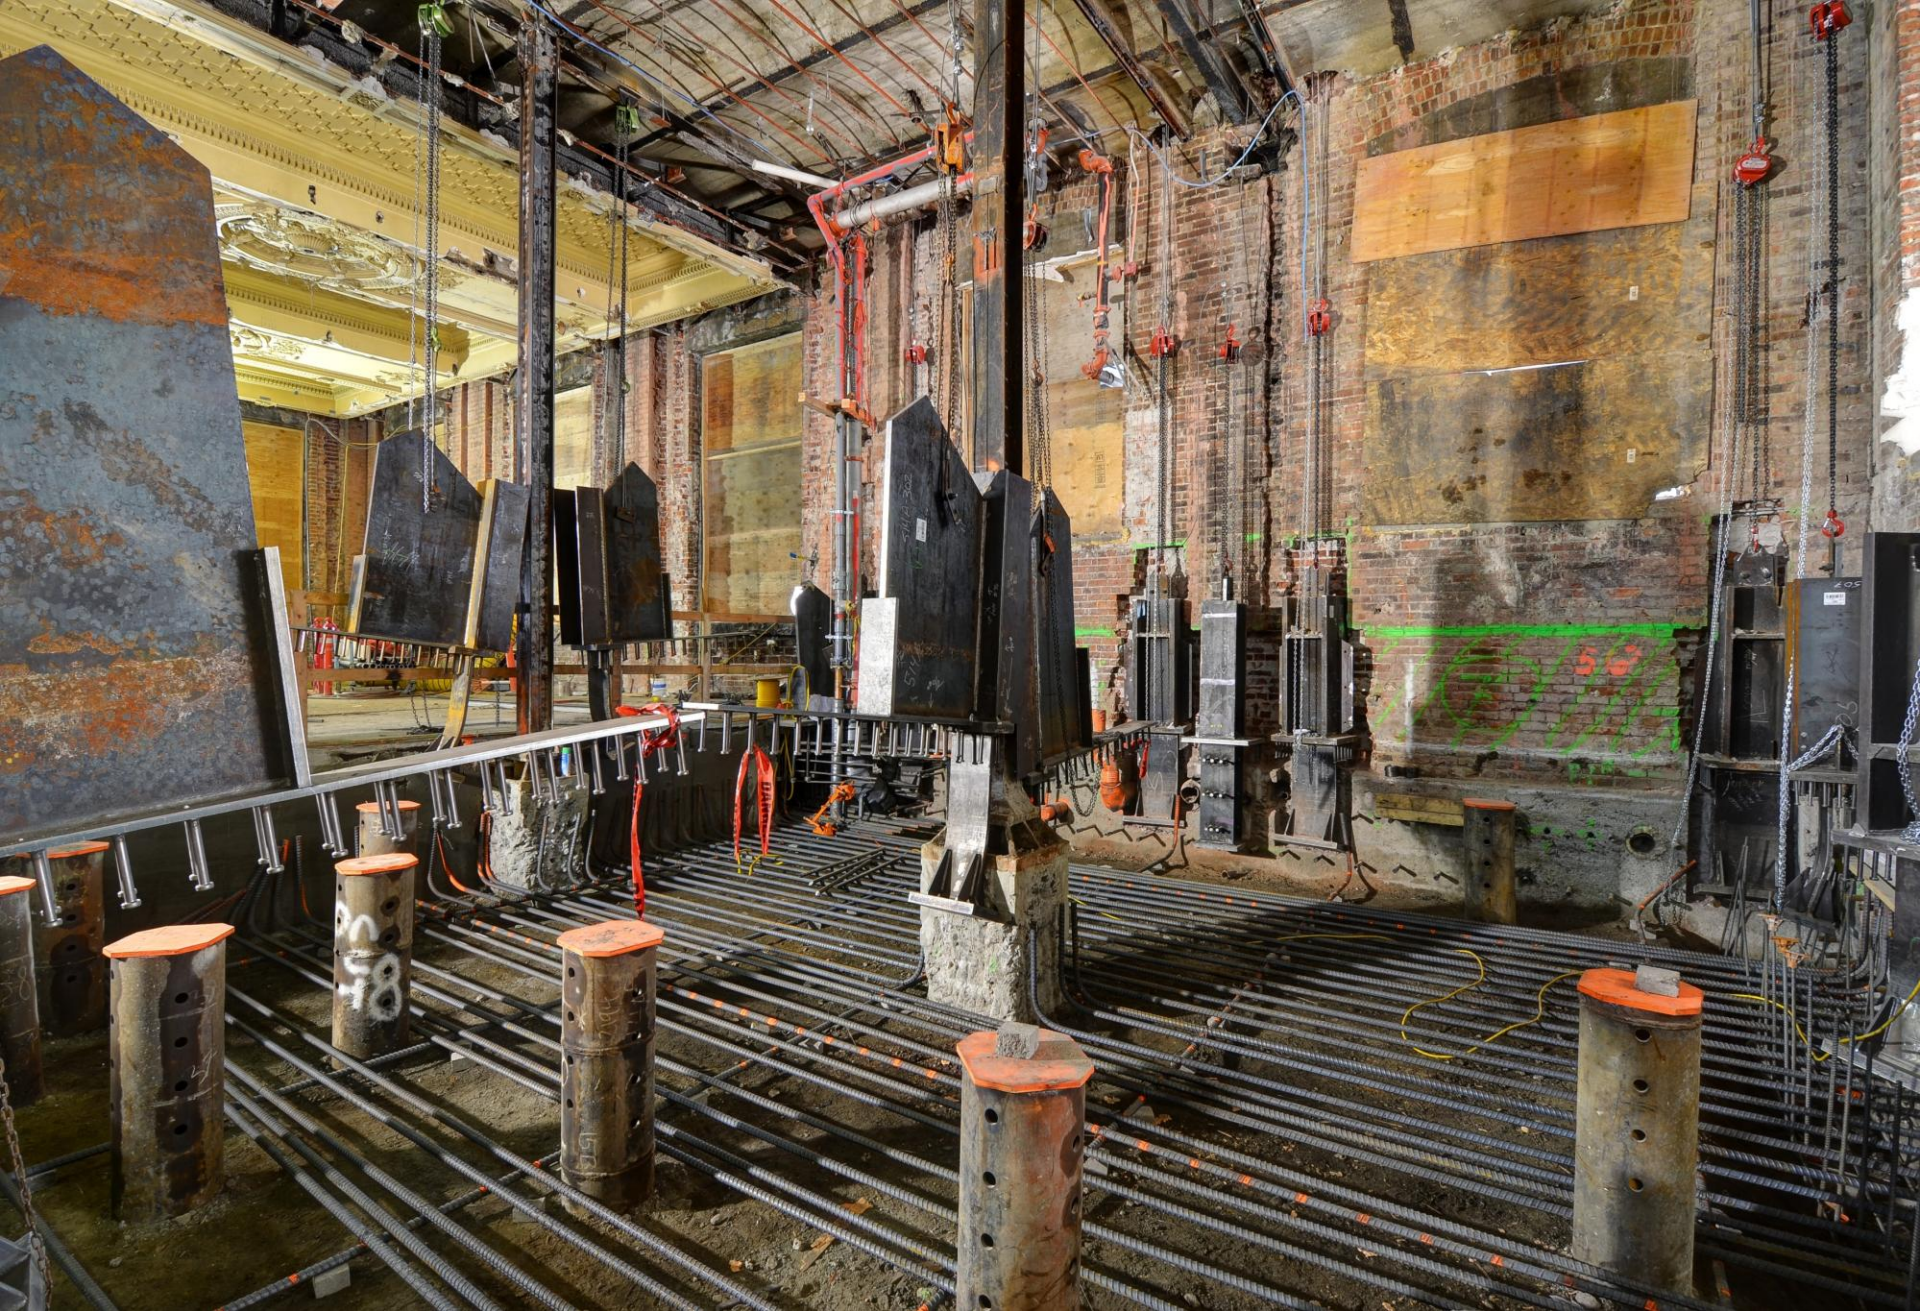
This area will have new deep pile foundation, columns, grade beam, along with new plumbing.

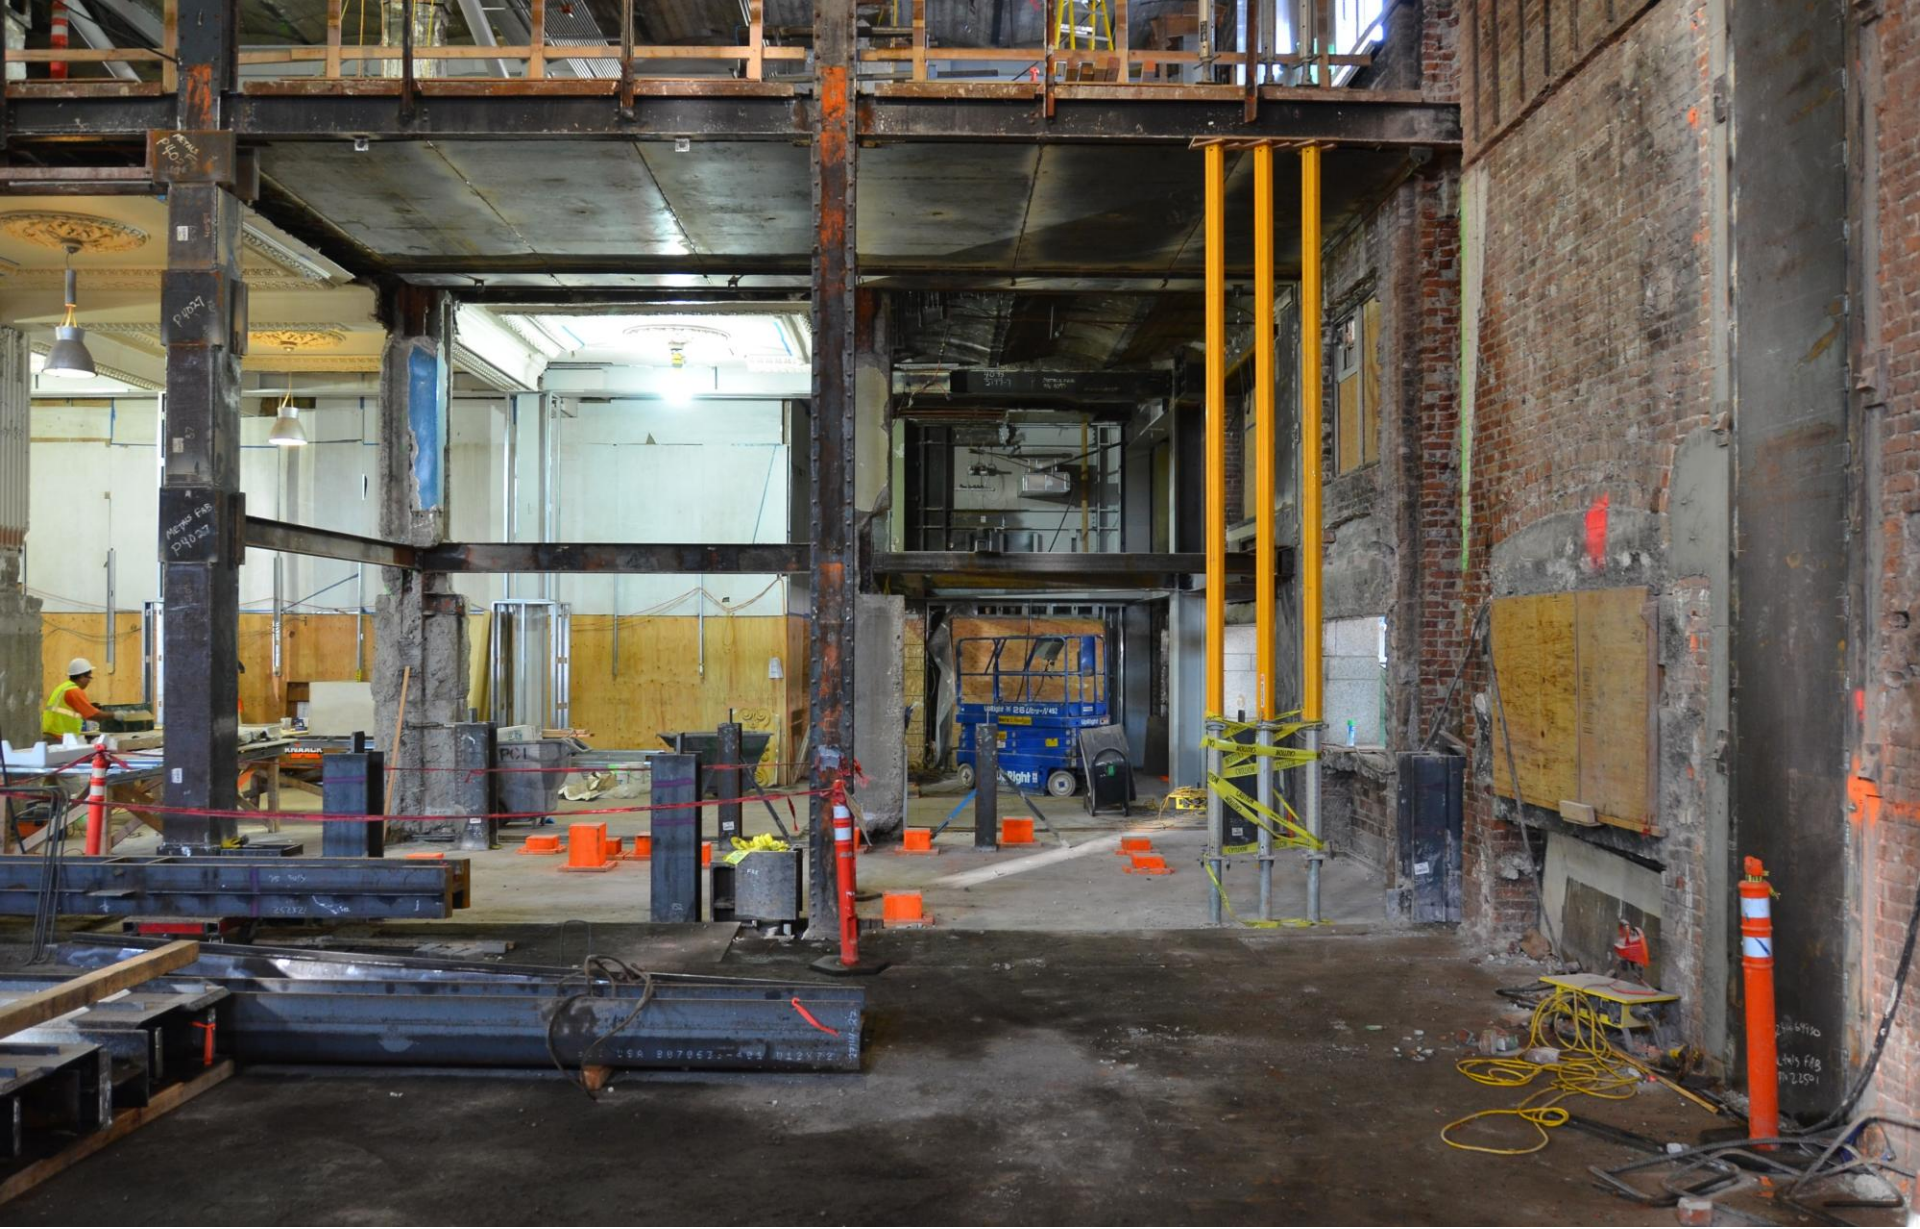
New steel framing at previous Amtrak lunch room provide additional structural load capacity. New concrete slabs, deep pile foundation, grade beam, and new utility lines were also installed.

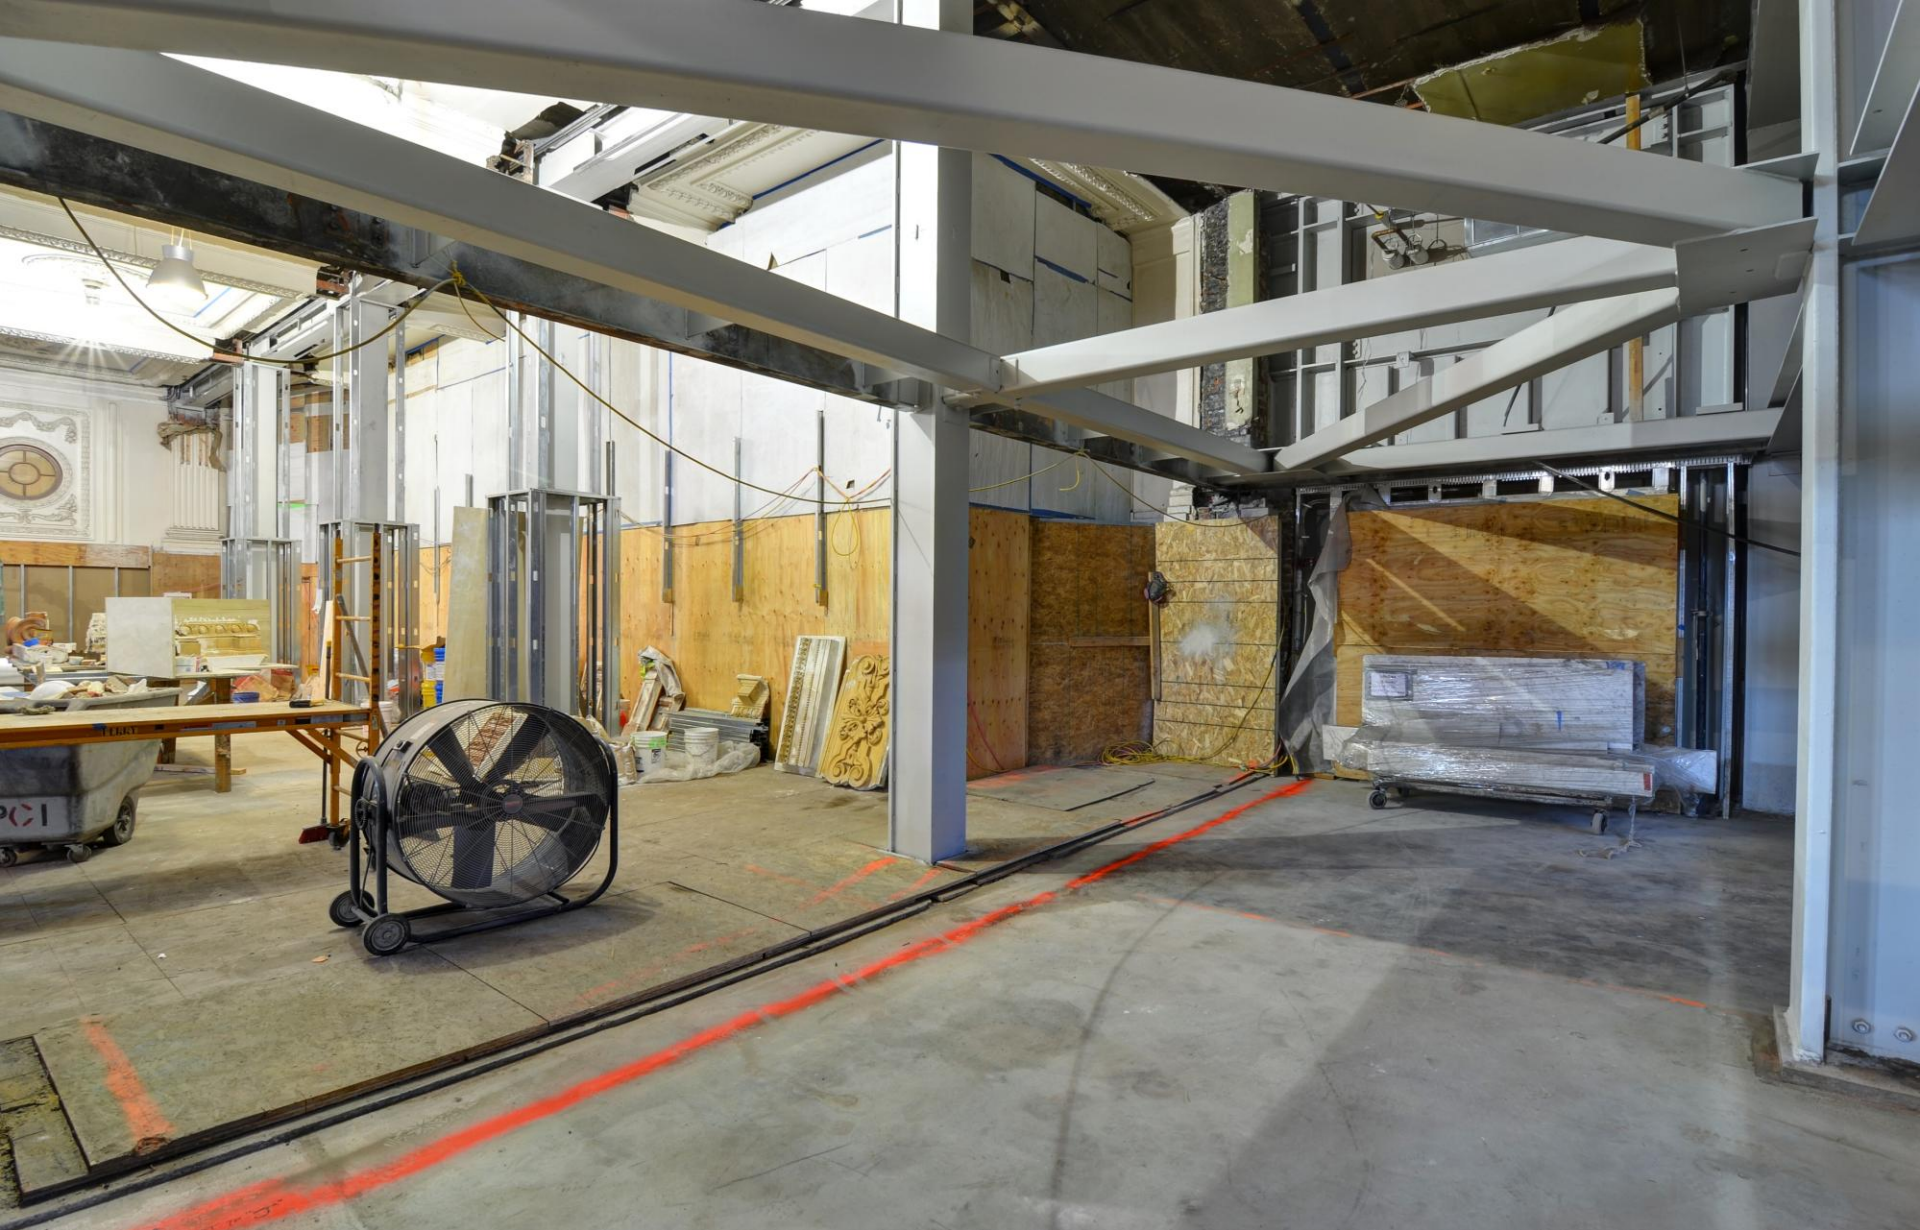
The original electrical room was located in the middle of the building along the east side wall shown here. The new electrical and mechanical control room is now located under the plaza adjacent to the tunnel beneath.

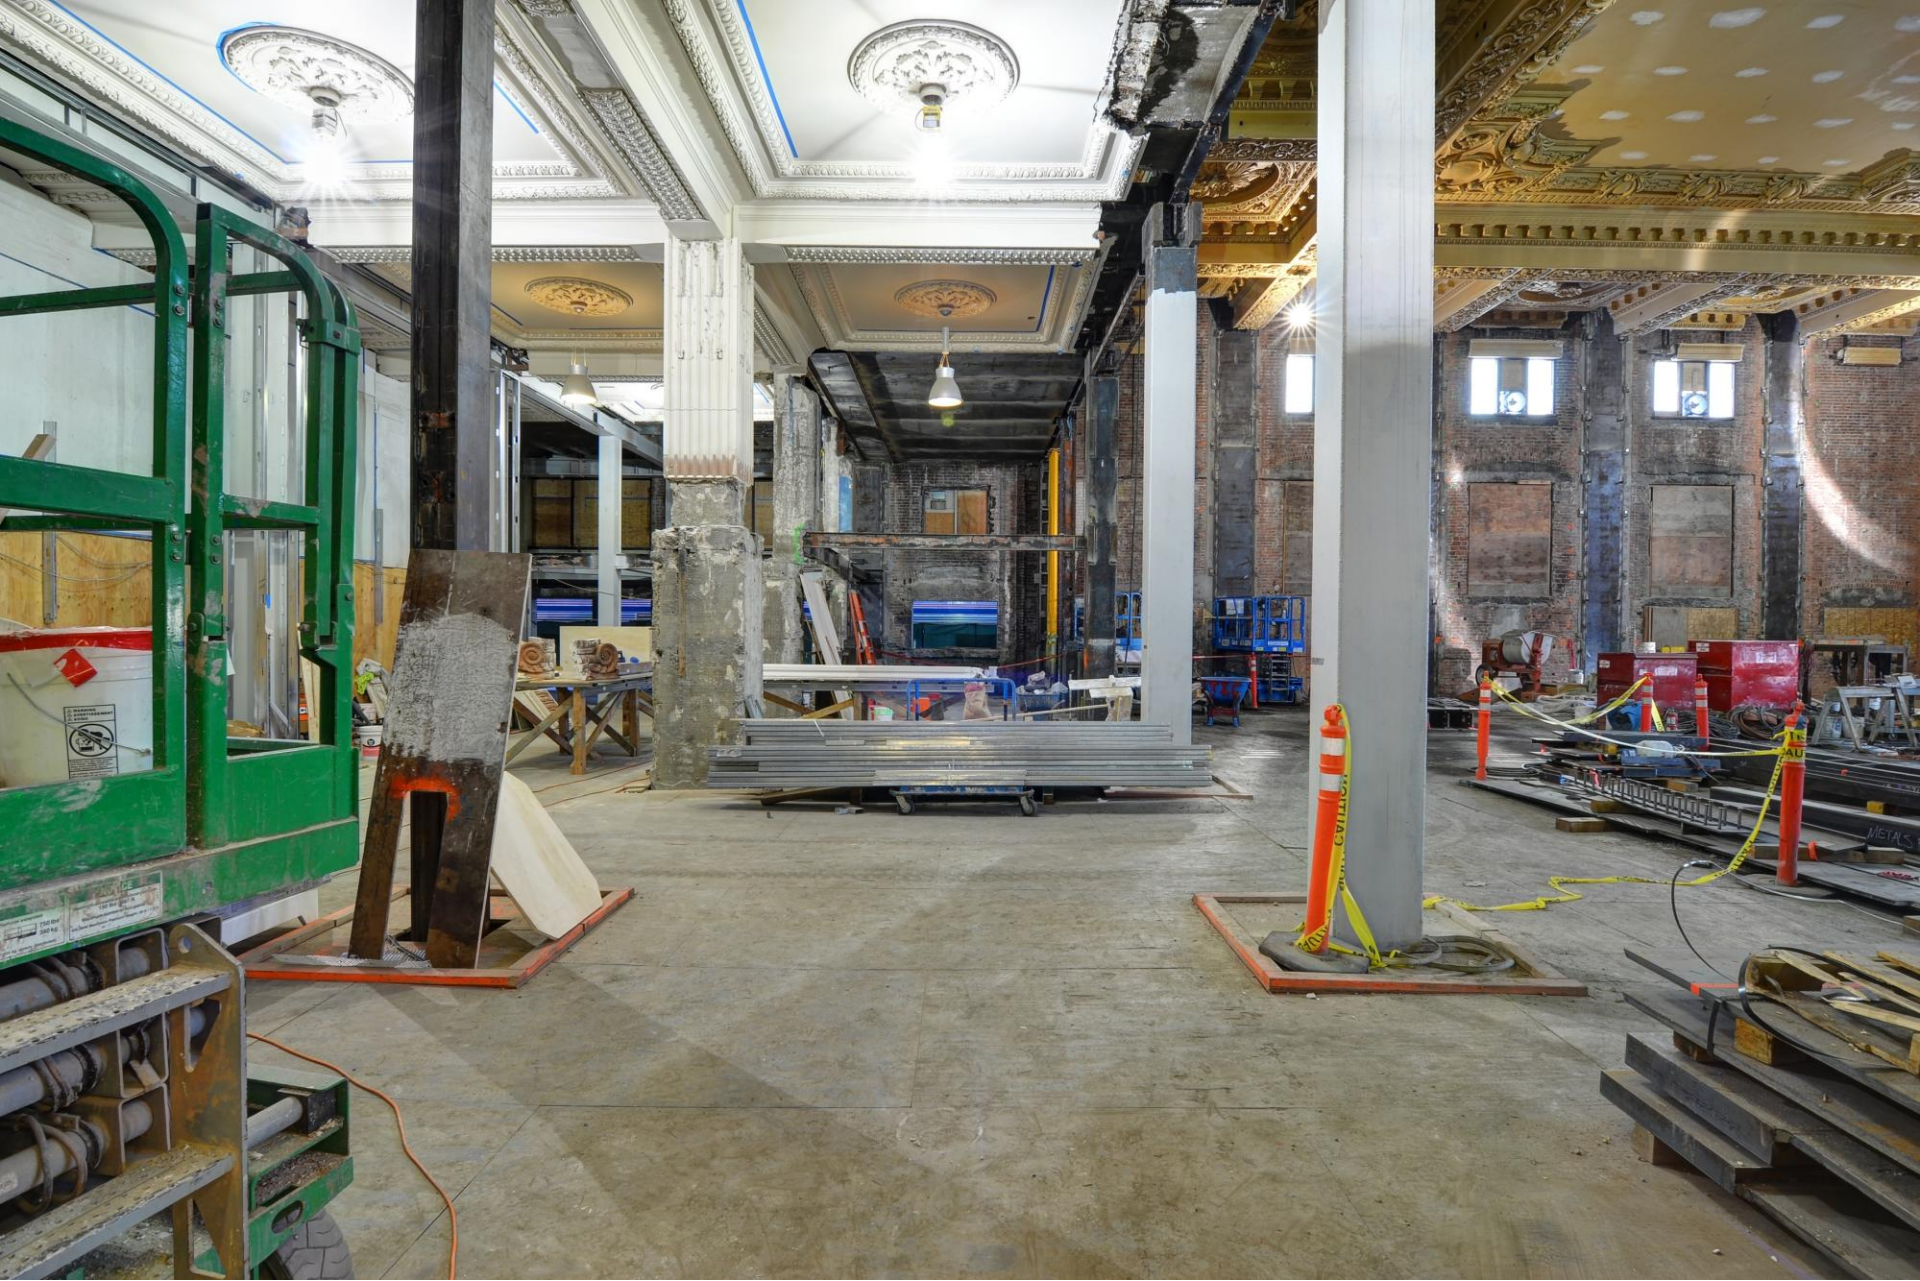
These interior columns have been retrofitted. Ornamental plaster will wrap the upper part of the columns and marble panels will cover the lower parts of the columns.

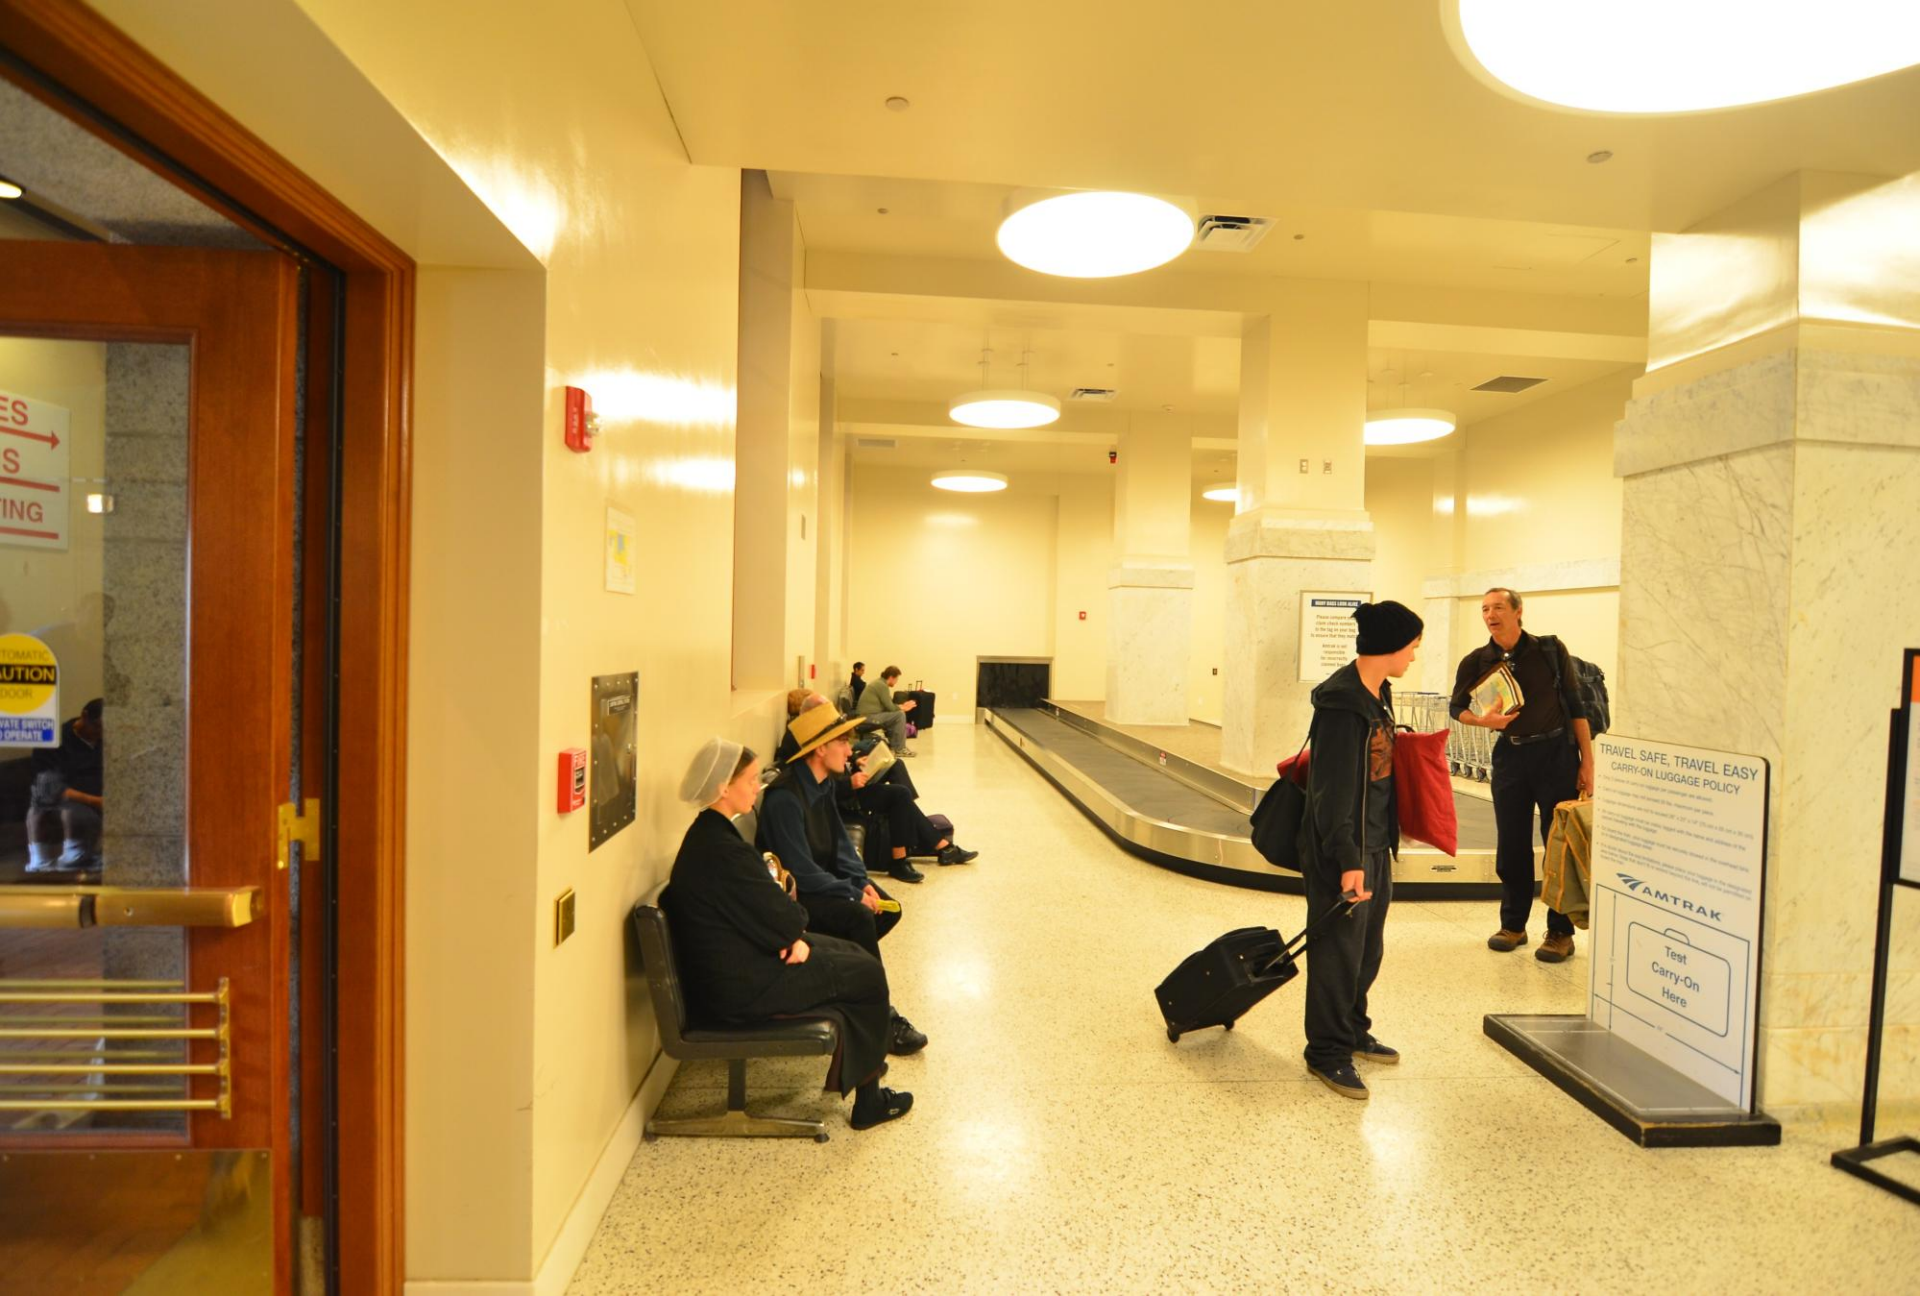
Previous Amtrak warehouse is now the new baggage claim room. New terrazzo floor, restored marble wrap columns, and refurbished windows grace the new space.
