## **Phase 2B**

# **Terminal Level Overview**

**9. 24. 2012**

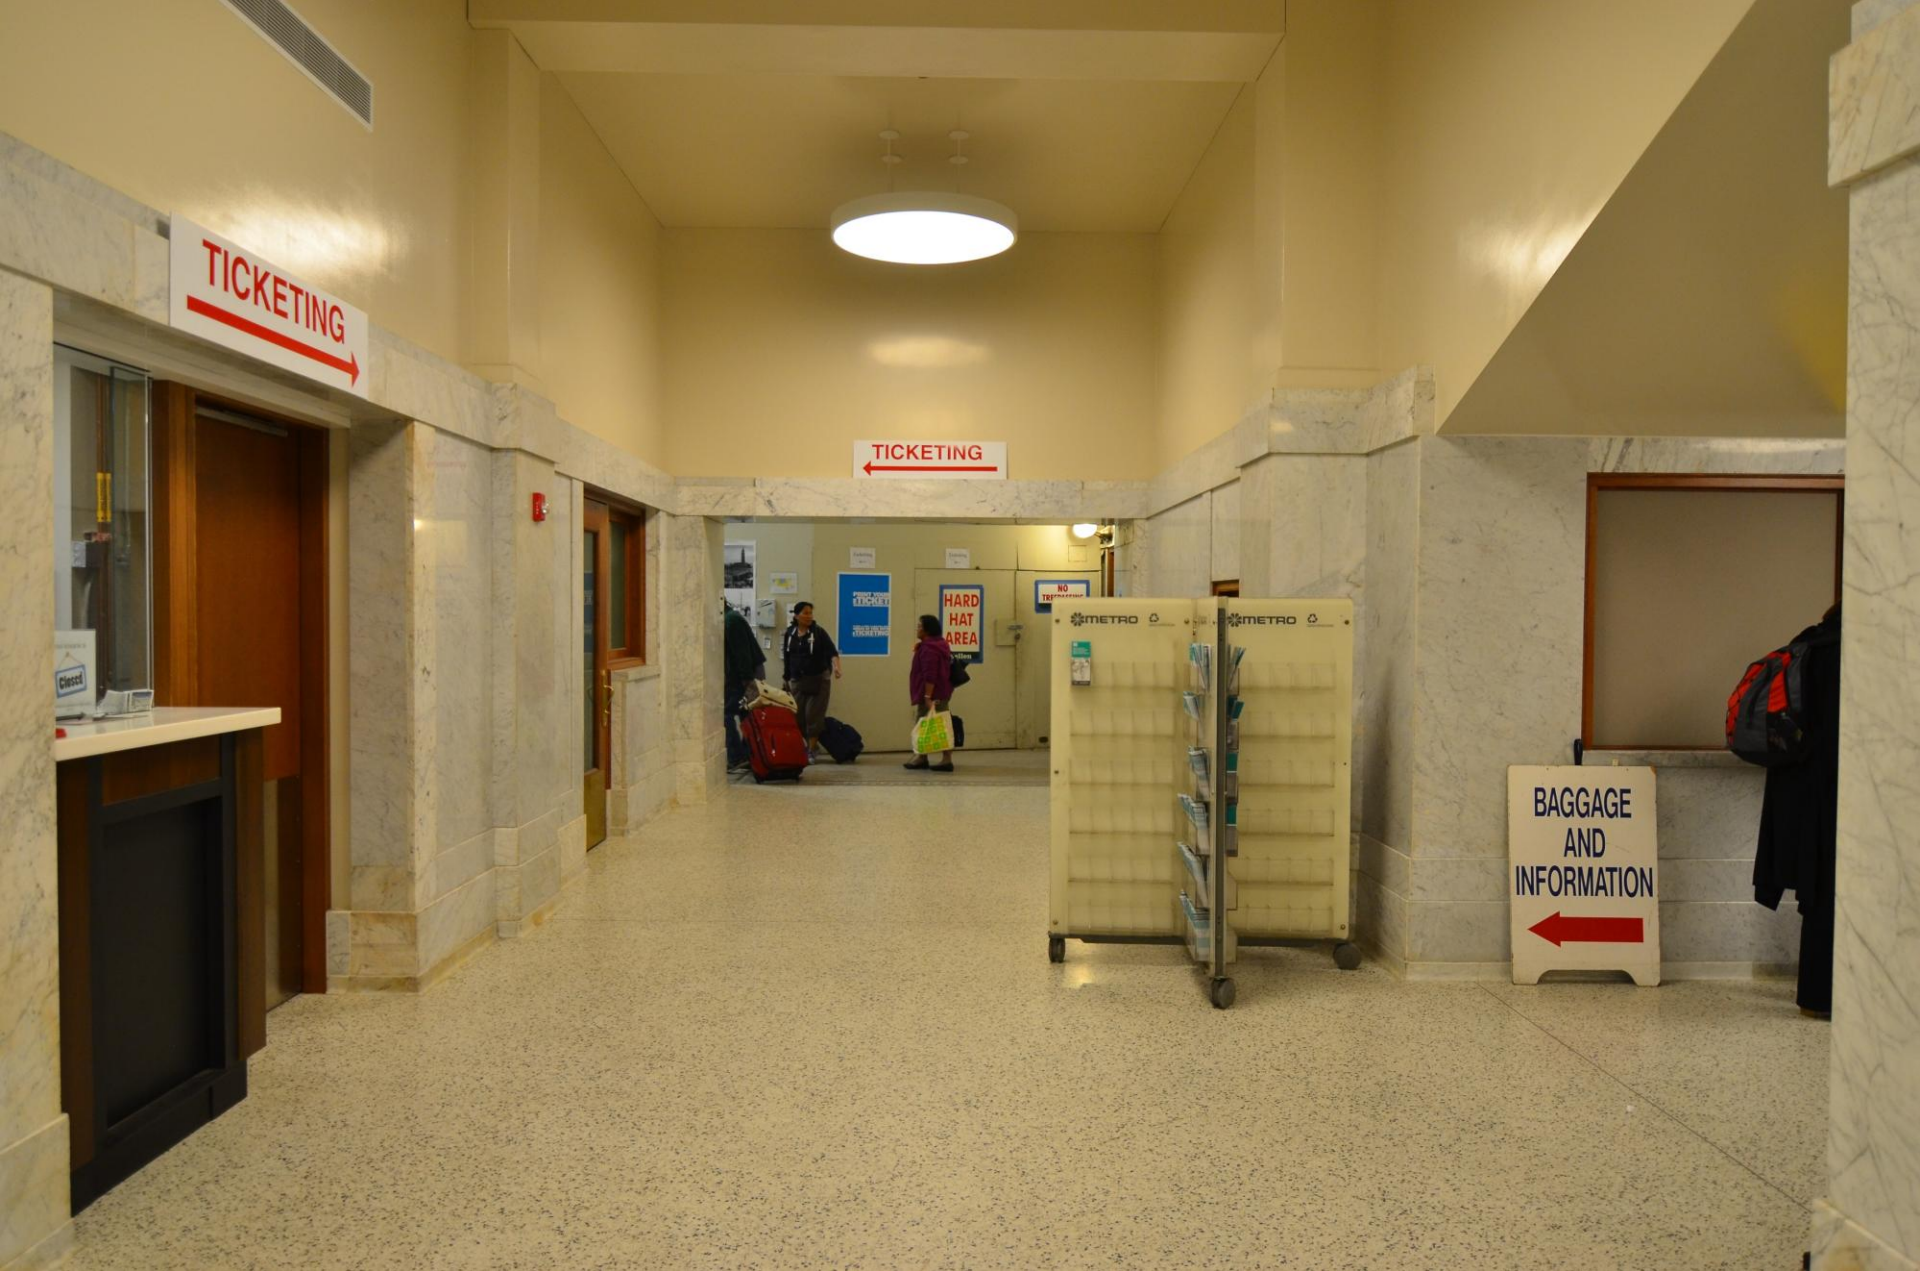
Travelers navigate the new space with the help of new signs. Stains in the original marble panels add character to the 106 year old station.
