MEMORANDUM

Madison Corridor BRT Study – Existing Conditions Memo #4: Traffic and Safety

Prepared For: City of Seattle

Date: December 12, 2014

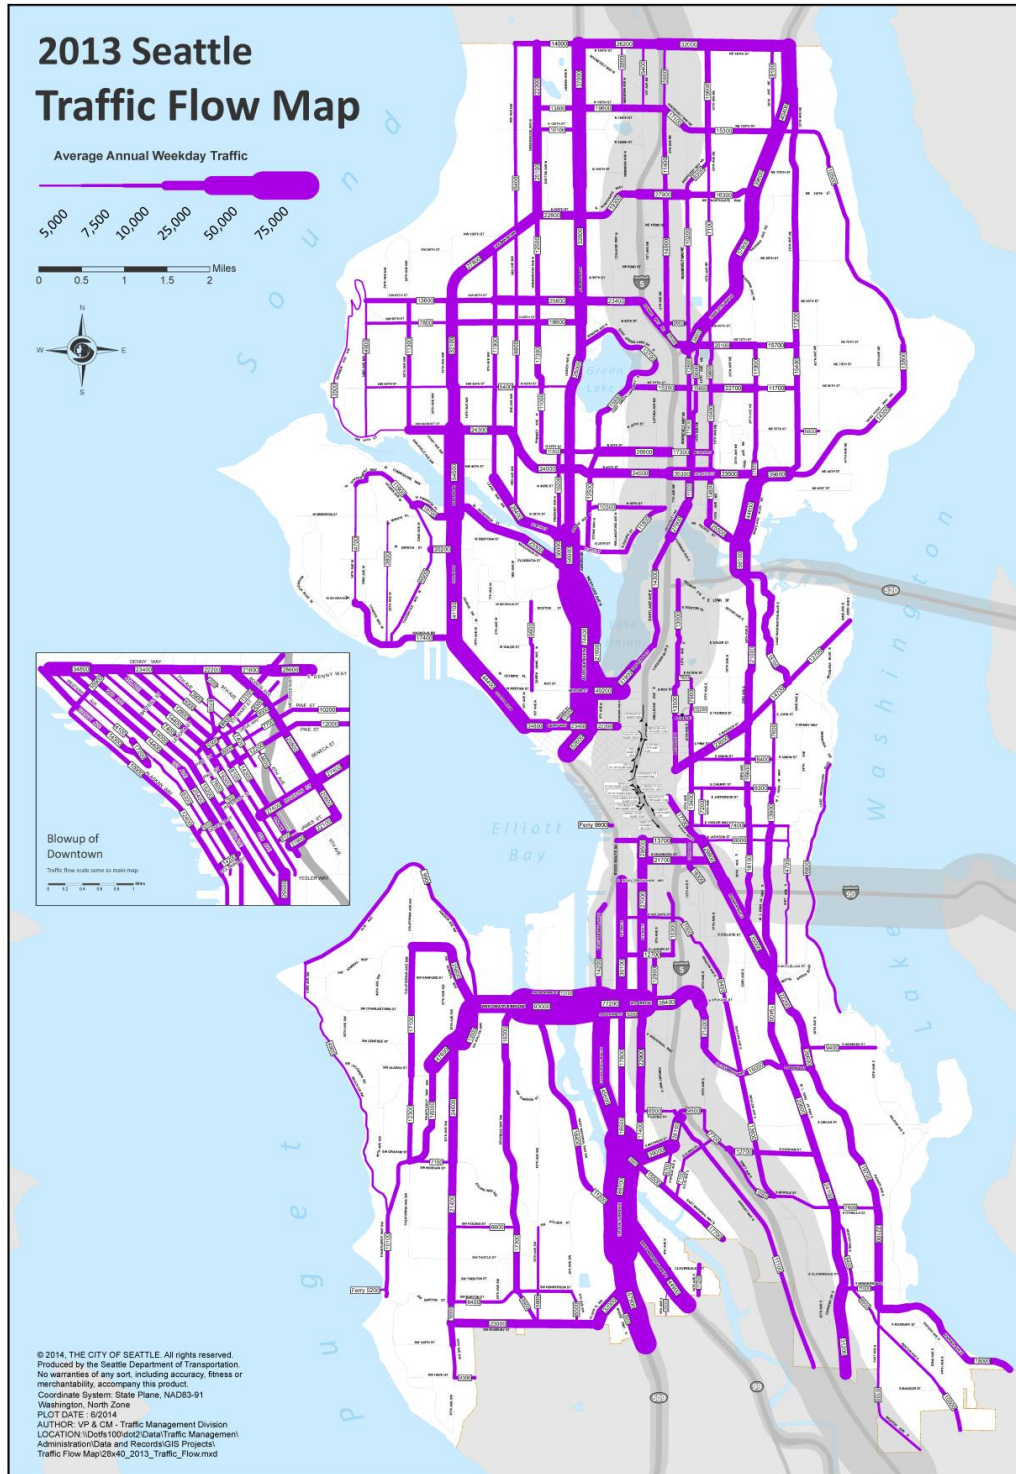
Figure 1-1 2013 Seattle Traffic Map

Madison Street is one of few east-west arterials in Central and East Seattle. Figure 1-1 shows citywide traffic volumes in 2013. Between 5th Avenue downtown and Broadway, Annual Average Daily Traffic (AADT) on Madison Street is approximately 27,400 vehicles. Between Broadway and 23rd Avenue volumes decline to 23,600, and even further to 14,700 between 23rd Avenue and Lake Washington Boulevard. East of Lake Washington Boulevard, AADT is 12,700 vehicles.

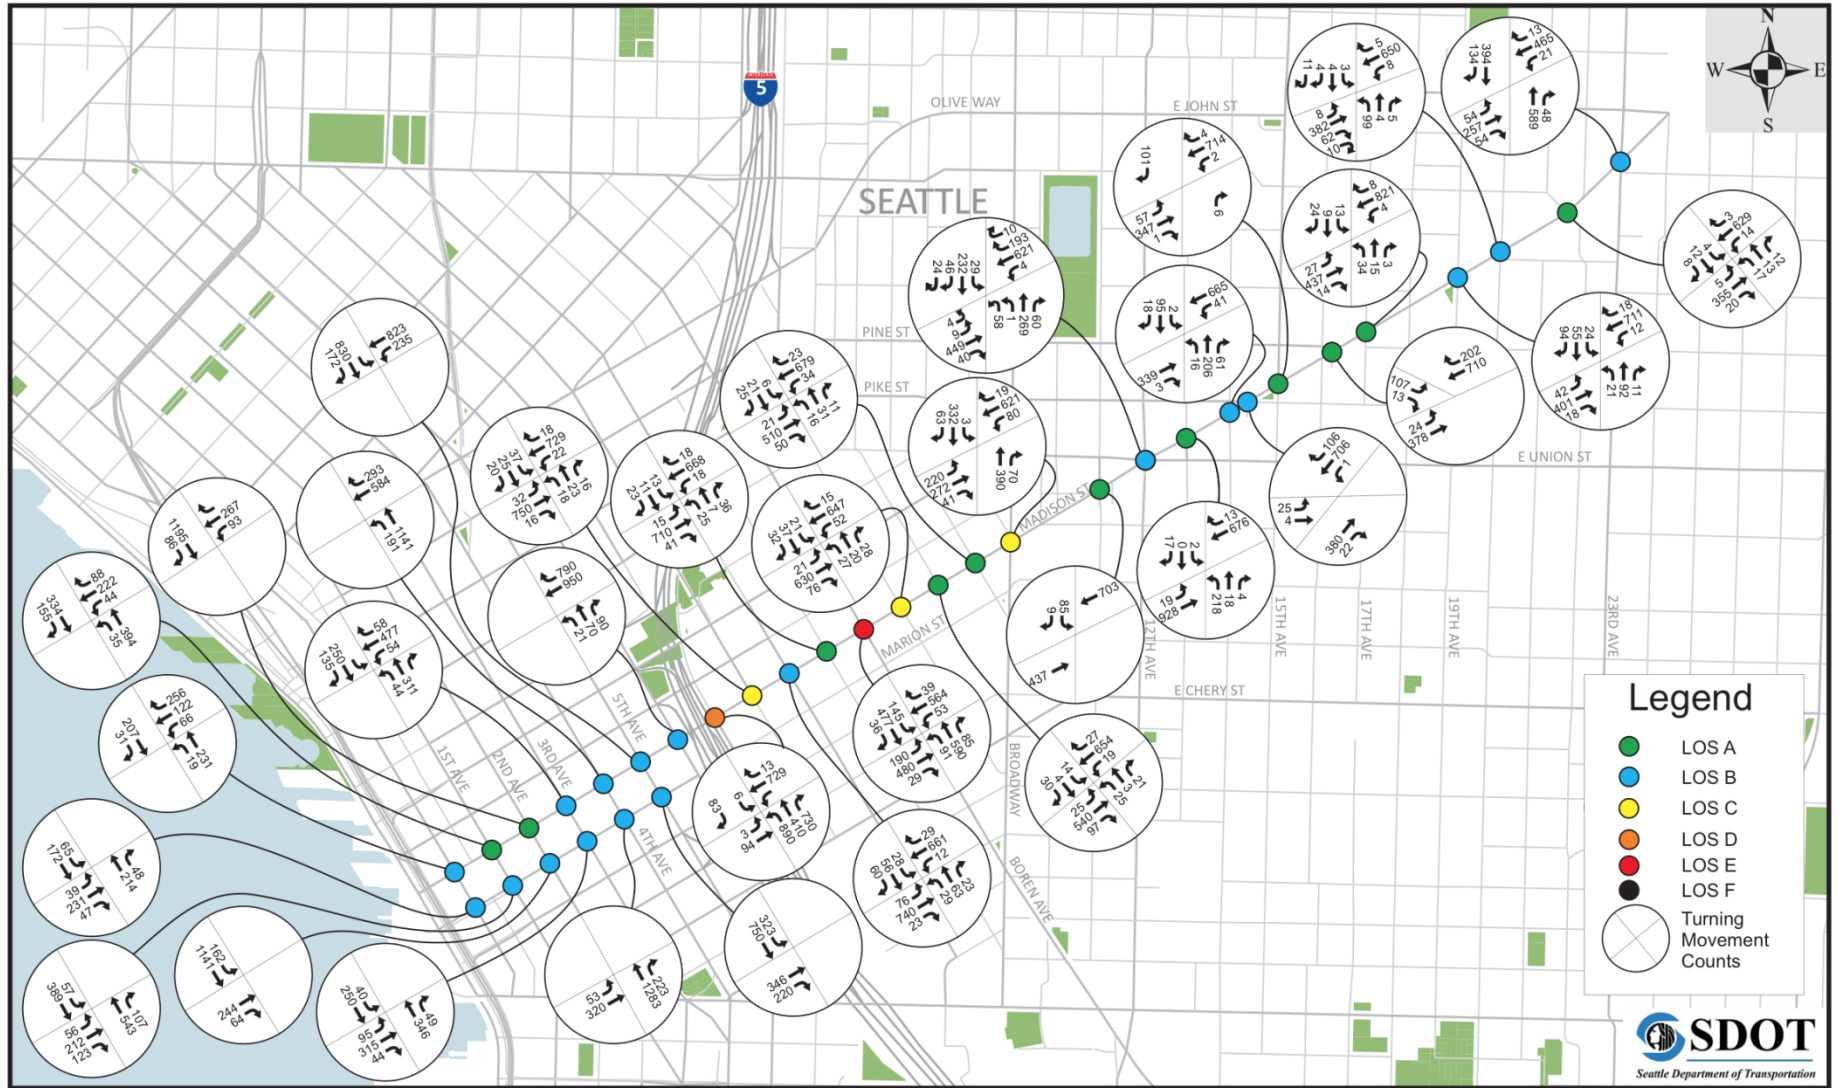
Figure 1-2 AM Peak Hour LOS and Turning Movements

Intersection Levels of Service (LOS) and turning volumes are shown in Figure 1-2 and Figure 1-3. In the morning peak period, all intersections east of 12th Avenue and west of I-5 operate at LOS A or B. LOS is lower at intersections approaching I-5 from the east, likely due to I-5-bound traffic. Only one intersection – Madison and Boren – operates at LOS E. In the afternoon peak period, several intersections along the corridor operate at LOS C, and the intersections of Madison and Broadway and Fifth and Marion operate at LOS D.

*data compiled from three Synchro models 2006,2007 and 2009

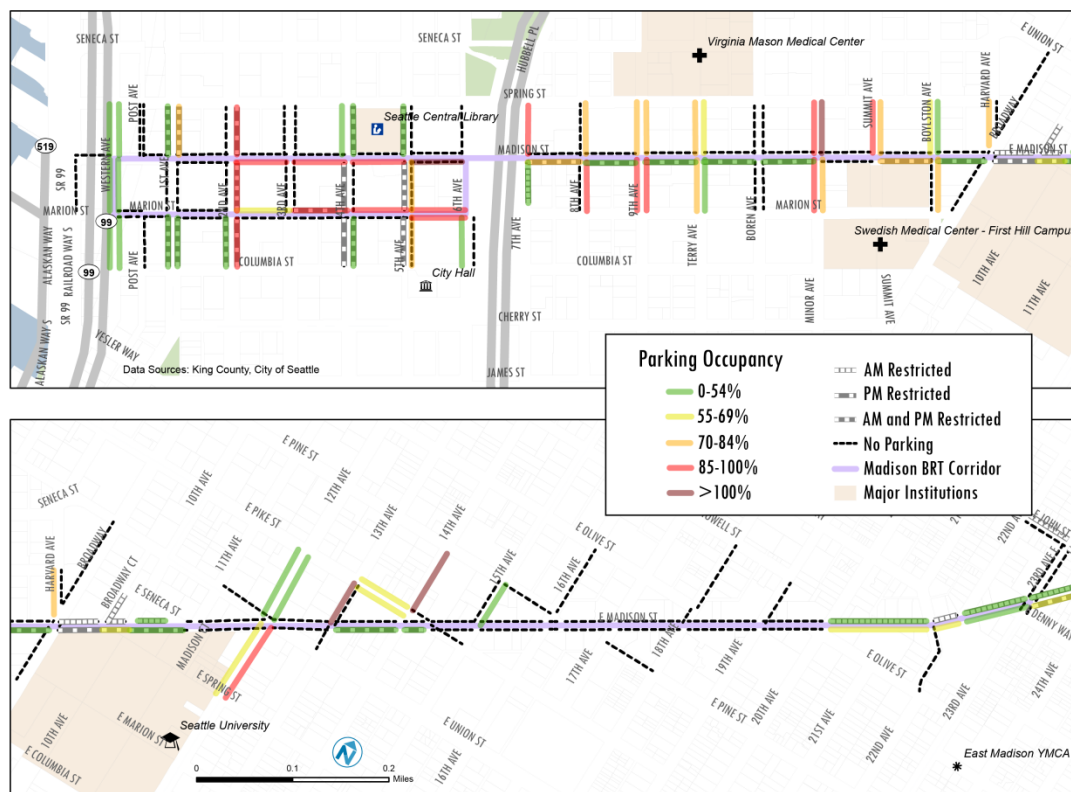
Figure 2-1 Morning Parking Occupancy (8-10 AM)

Parking occupancy data for different time periods are shown in Figure 2-1, 2-2, and 2-3. Data provided by SDOT were used for paid parking spaces on Madison Street and intersecting blocks. For unpaid areas on Madison itself, additional data were collected on a recent (October) weekday every two hours from 8 a.m. to 7 p.m.

Throughout the corridor, average all-day occupancy is 62 percent, well below the city's target of 70 to 85 percent occupancy. Observed occupancy is lowest in the morning peak period (56 percent) and afternoon peak period (62 percent) and highest during the midday (72 percent). These figures likely overstate availability, however, as this analysis does not account for peak-period restrictions on some spaces; instead, supply is assumed to remain constant throughout the day. In reality there are various parking restrictions on Madison, particularly between 3 and 7 p.m. when parking on the south side of the street is prohibited.

Parking utilization is mixed throughout the corridor, with heavily-used spaces Downtown on Madison and Marion streets from Second to Sixth Avenues and in First Hill on many of Madison's cross streets. In the eastern segment of the corridor, parking occupancy is high near the intersection of Madison Street and 12th Avenue. During the midday period, several blocks in these areas are above 100 percent of official capacity (this may indicate illegal parking, or simply smaller vehicles requiring less space than is assumed for each parking space on blockfaces where spaces are not defined). Parking utilization is moderate east of 20th Avenue and in Downtown Seattle near the waterfront.
