Colman Park Vista Project

May 10, 2017

COLMAN VISTA RESTORATION

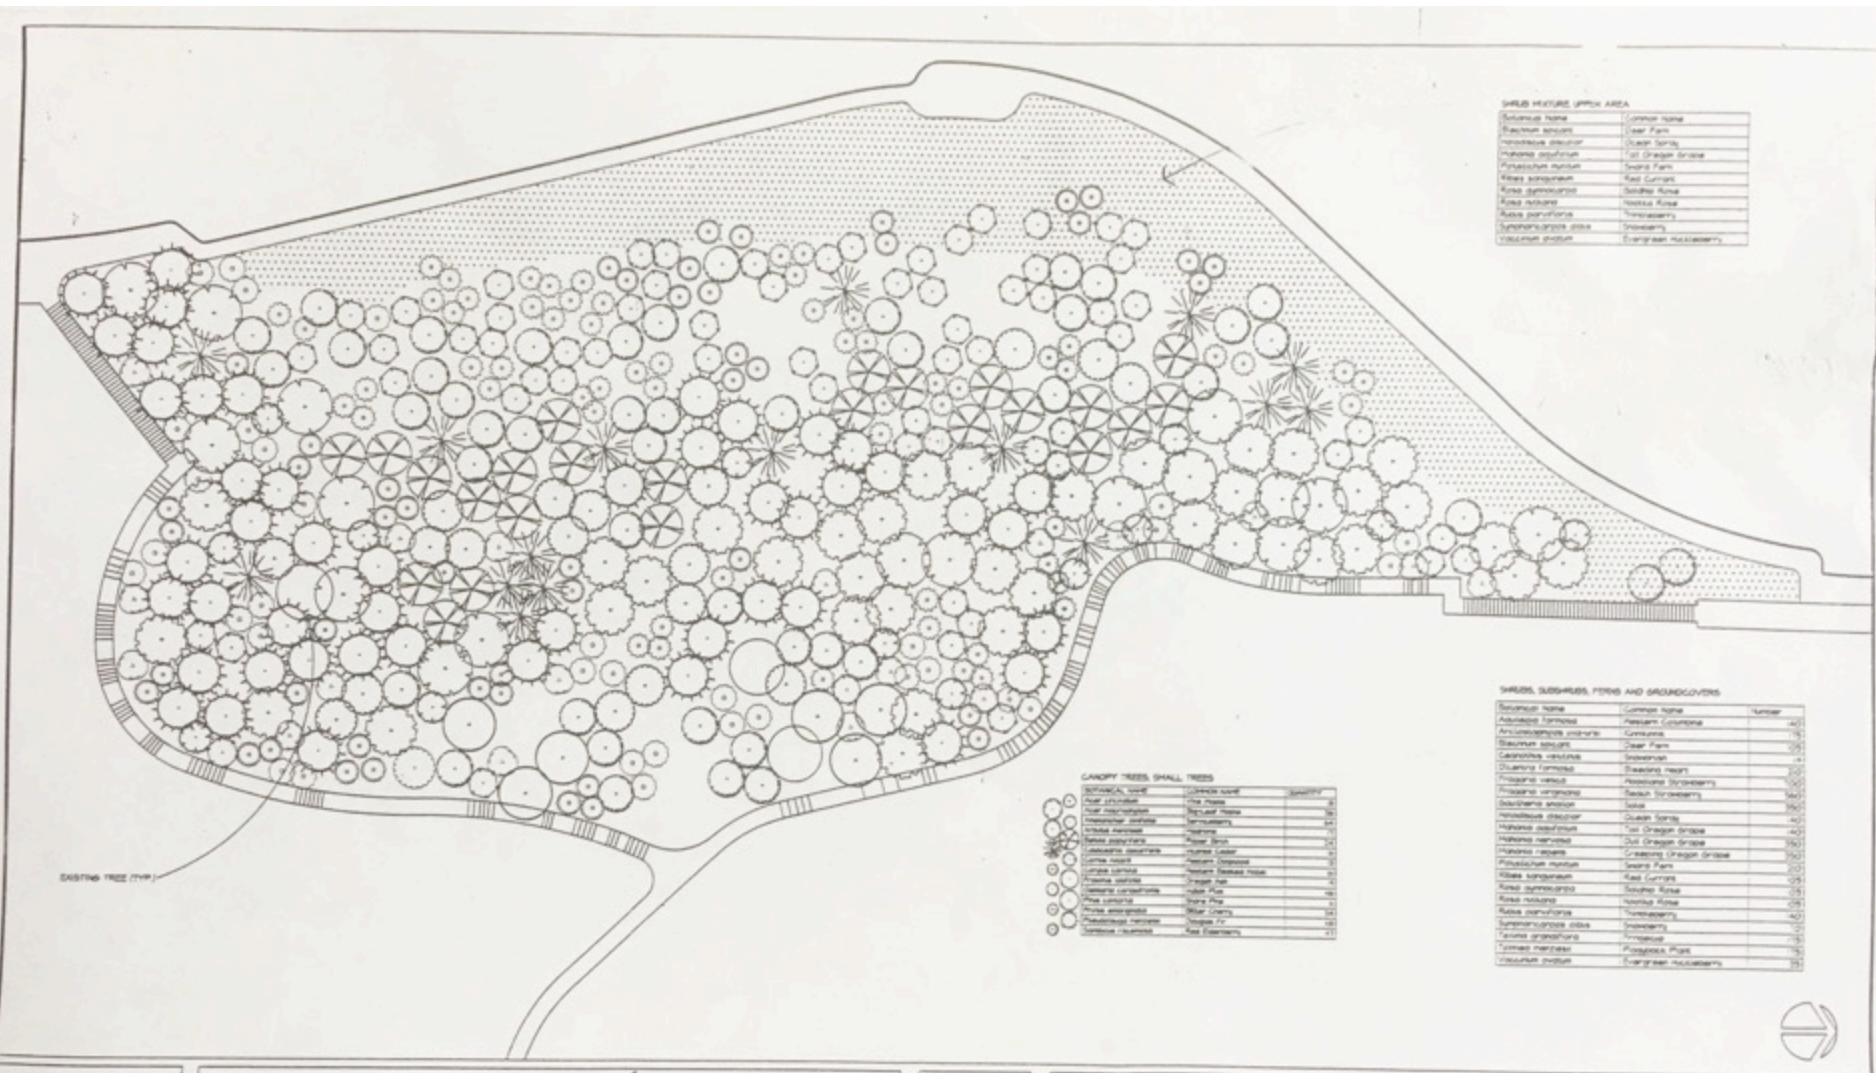
L1.1
of X Sheets

UPPER COLMAN PARK
SEATTLE, WA

NOTE:
THIS PLAN IS SCHEMATIC ONLY.
IT DOES NOT TAKE INTO
CONSIDERATION EXISTING
VEGETATION.

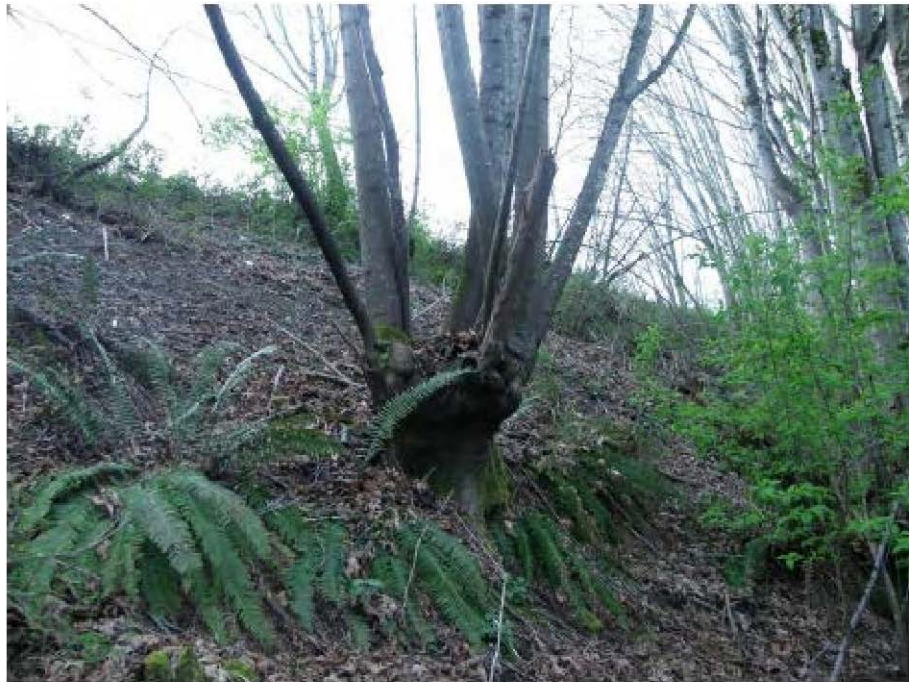
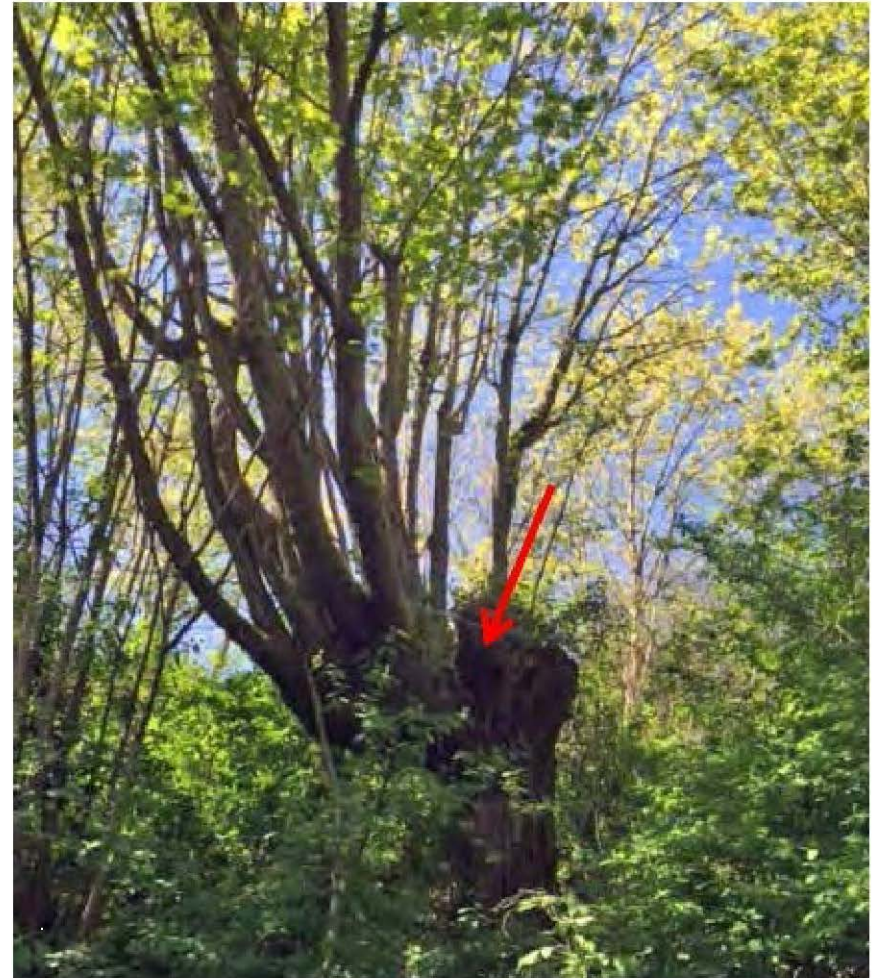
Stump sprout trees are unsustainable over long-term

- Poor forest structure
- “Stump sprout” architecture is inherently weak
- Basal trunk decay observed

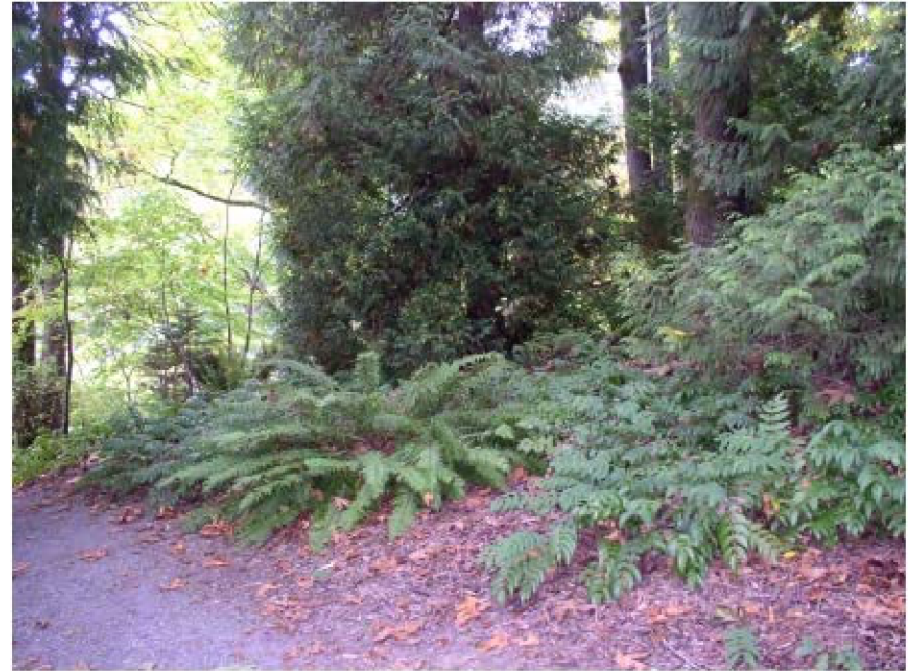
Example of trail edge with low growing vegetation, Washington Park Arboretum. Photo courtesy of Chris Pfeiffer.

Low-growing vegetation next to trails

- Reduced maintenance requirements

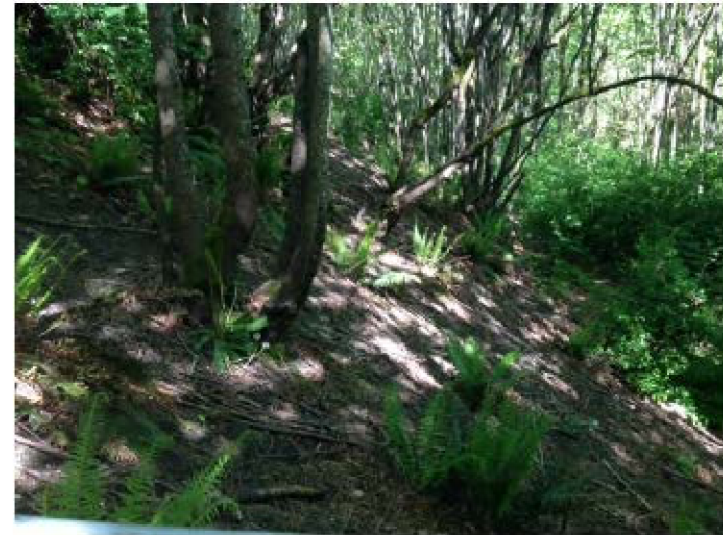
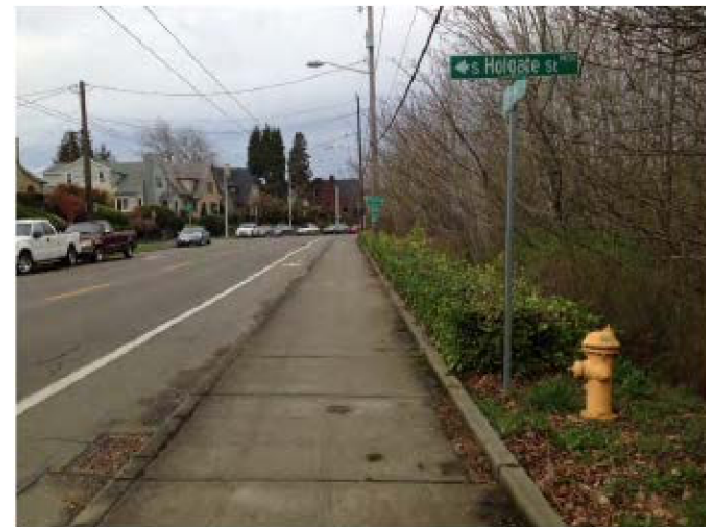
Overall Stability

- No recent activity
- No significant settlement, tilting, or cracking of road and sidewalk

Stormwater Management

- Curbs prevent direct runoff from road or sidewalk
- No daylighting pipes observed

Stability

- No evidence of significant erosion
- No evidence of recent sloughing
- No evidence of recent slumping

Tree Removal Considerations

- Overall stable soil conditions
- Existing deciduous trees provide shallow soil support
- Removal feasible if shallow root network is restored

Hillslope Restoration

- Slope disturbance should be minimized during all work
- Bare/Disturbed areas should be protected with matting, wattles
- Slope should be replanted with groundcover immediately
