## Request for Clean Water Act Section 401 Water Quality Certification Washington State Department of Ecology

The current license for the Newhalem Creek Hydroelectric Project (FERC No. 2705) expires on January 31, 2027. As noted above, repair and maintenance costs make it impractical to continue to operate the project and City Light has decided not to seek a new license but rather surrender the license for the Newhalem Creek Hydroelectric Project and proposes to decommission it as described herein.

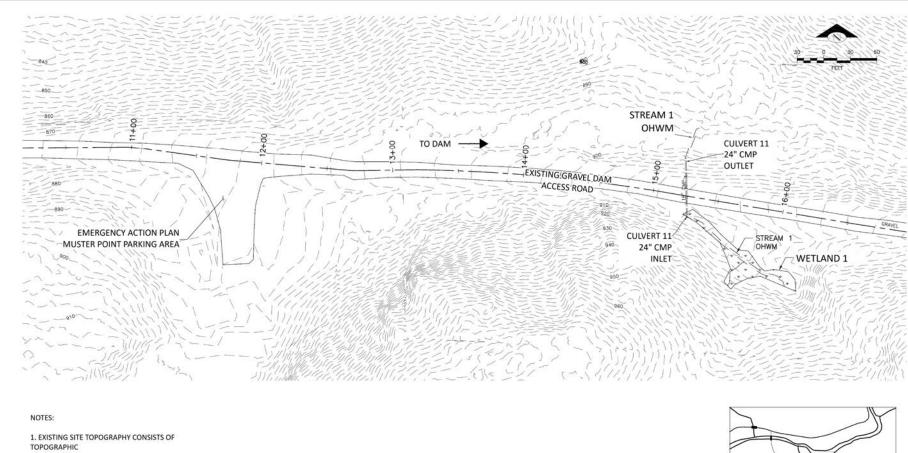
#### **CULVERT 11 EXISTING CONDITIONS**

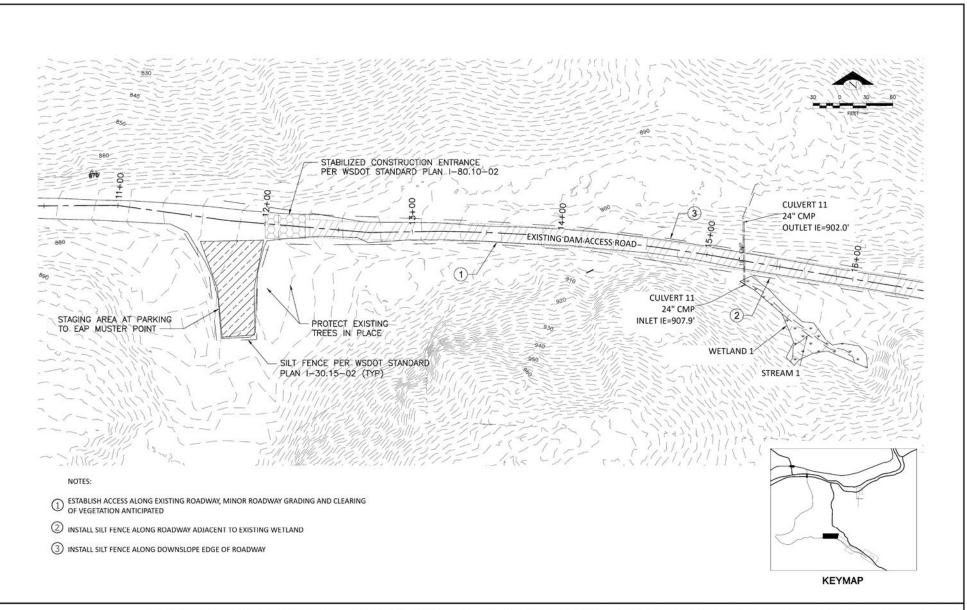
#### **CULVERT 11 REMOVAL AND CHANNEL RESTORATION: CONSTRUCTION ACCESS AND STAGING**

CULVERT 11 REMOVAL AND STREAM GRADING SHALL BE PERFORMED FOLLOWING THE
COMPLETION OF ALL

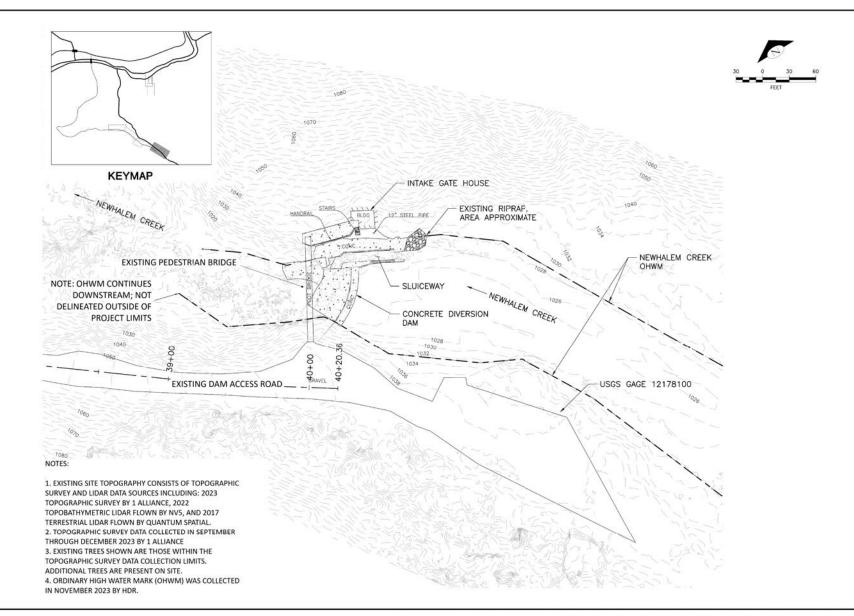
#### **NEWHALEM DAM AND HEADWORKS EXISTING SITE PLAN**

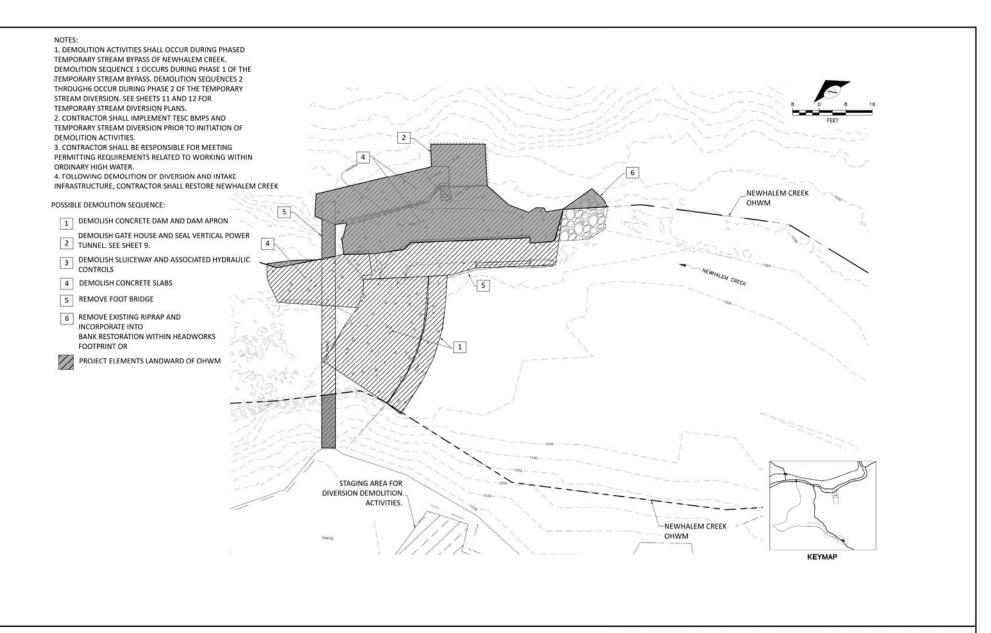
### **NEWHALEM DAM AND HEADWORKS DEMOLITION PLAN**

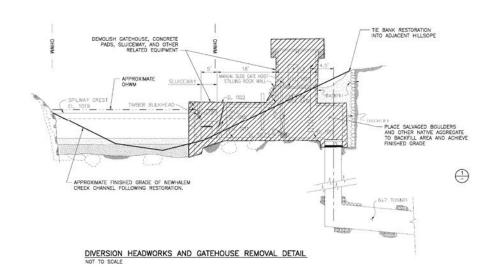
SLUICEWAY REMOVAL DETAIL

- DIVERSION DAM, HEADWORKS, AND INTAKE GATE HOUSE DETAILS TAKEN FROM FERC NO. 2705 EXHIBIT F, SEPTEMBER 1992.
- ELEVATIONS SHOWN ON REFERENCE DRAWINGS ARE IN LOCAL PROJECT VERTICAL DATUM AND DO NOT CORRESPOND WITH ELEVATIONS SHOWN ON REMAINDER OF PLAN
- SETI. ANY MATER MARK SHOWN ON REFERENCE DRAWNGS IS APPROXIMATE. CONTRACTOR SHALL HAUL AND DISPOSE OF ALL CONCRETE, REBAR, METAL AND ASSOCIATED DEBRIS OFF SITE TO A LEGALLY DESIGNATED DISPOSAL LOCATION.

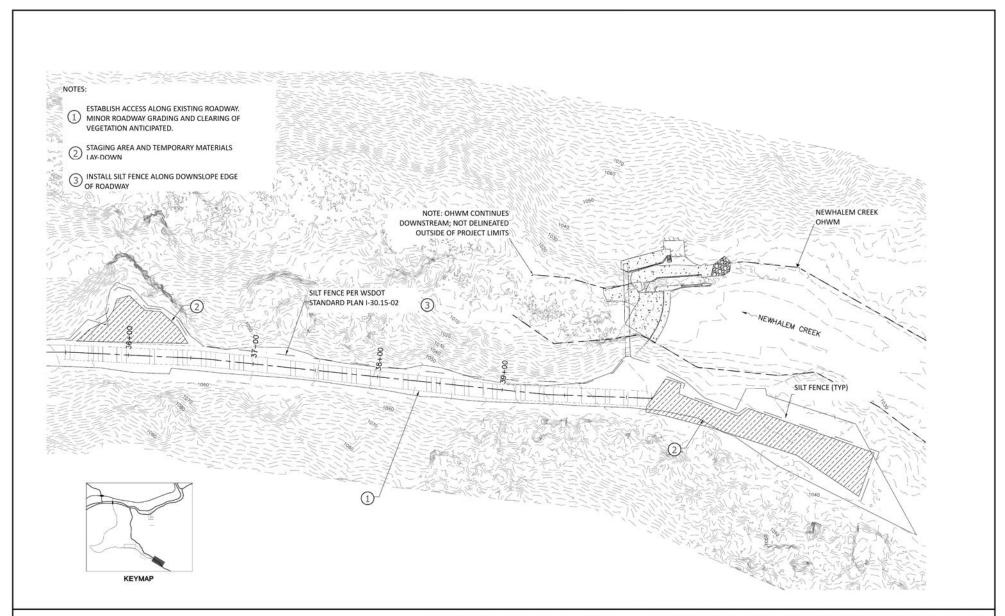
## **NEWHALEM DAM AND HEADWORKS ACCESS AND STAGING PLAN**

ANTICIPATED TEMPORARY STREAM DIVERSION SEQUENCING AND DAM CREST AND APRON REMOVAL - PHASE 1

- PREPARE SLUICEWAY FOR TEMPORARY STREAM DIVERSION.
   OPEN SLIDE GATE, BLOCK TIMBER WEIR AND BULKHEAD
- 2 ESTABLISH EQUIPMENT ACCESS TO CHANNEL THROUGH EXISTING MAINTENANCE POINT
- 3 INSTALL COFFER DAM CONSISTING OF SUPERSACKS FILLED WITH NATIVE STREAMBED MATERIAL
- 4 DEMOLISH DIVERSION DAM CREST AND APRON

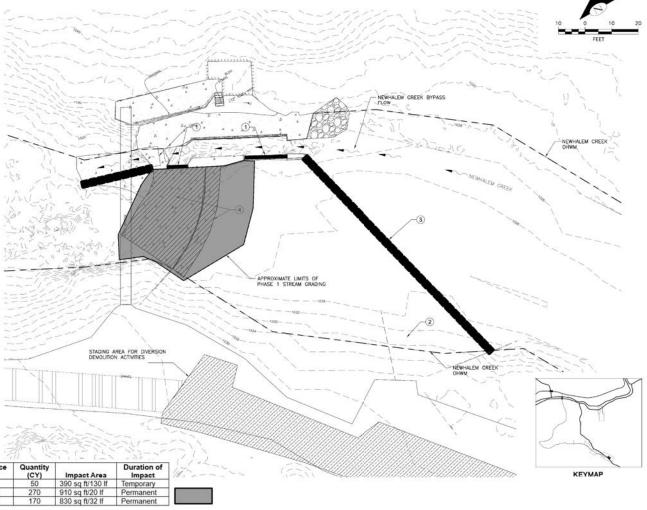
Activity	Name	(CY)	Impact Area	Impact
Fill: Cofferdam placement	Newhalem Creek	50	390 sq ft/130 lf	Temporary
Remove concrete dam	Newhalem Creek	270	910 sq ft/20 lf	Permanent
Remove concrete dam apron	Newhalem Creek	170	830 sq ft/32 lf	Permanent

#### **NEWHALEM DAM DECOMMISSIONING - PHASE 1**

Figure 2. Phase 1 Temporary Stream Bypass and Cofferdam Placement

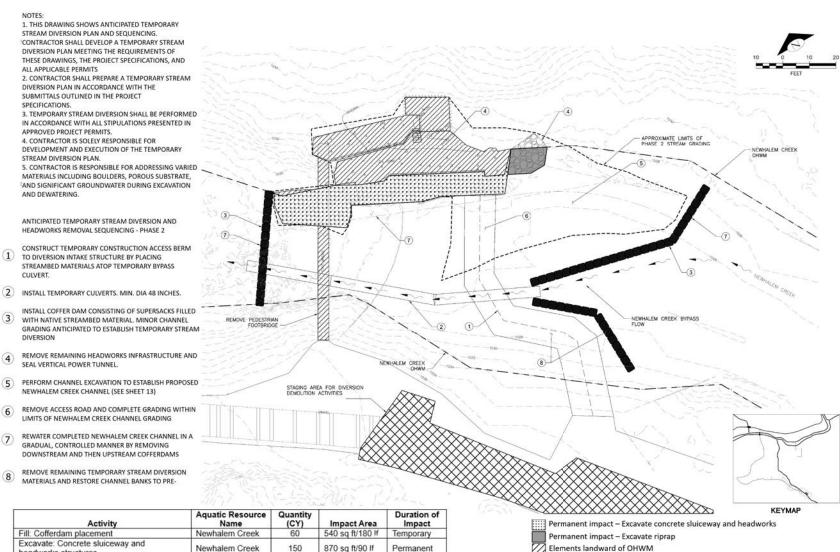
Activity	Aquatic Resource Name	Quantity (CY)	Impact Area	Duration of Impact
Fill: Cofferdam placement	Newhalem Creek	60	540 sq ft/180 lf	Temporary
Excavate: Concrete sluiceway and headworks structures	Newhalem Creek	150	870 sq ft/90 If	Permanent
Excavate: Riprap	Newhalem Creek	20	170 sq ft/20 lf	Permanent

## **NEWHALEM DAM DECOMMISSIONING - PHASE 2**

Figure 3. Newhalem Dam Decommissioning Phase 2

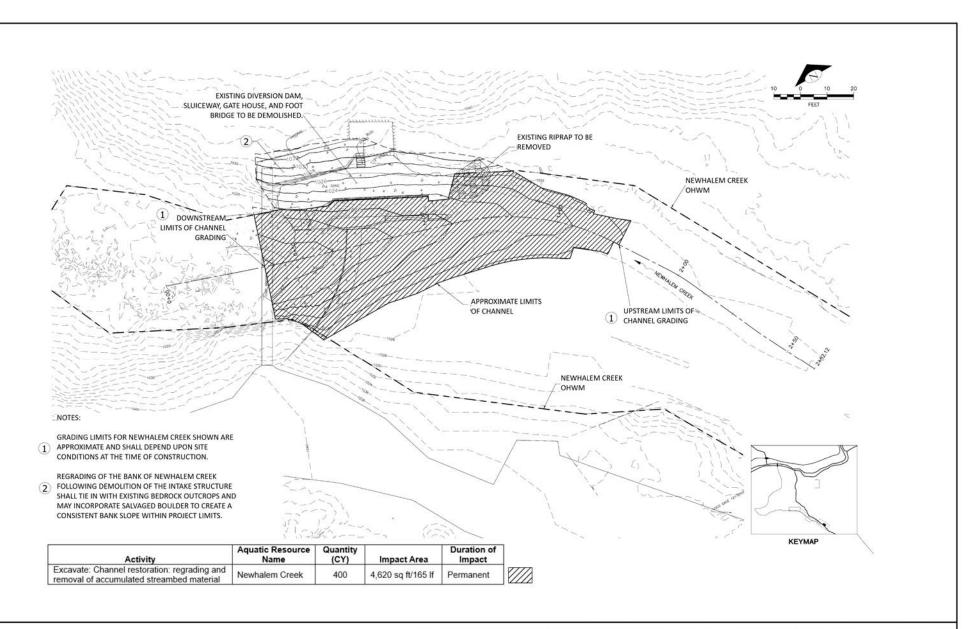
#### **NEWHALEM CREEK CHANNEL RESTORATION PLAN - PHASE 2**

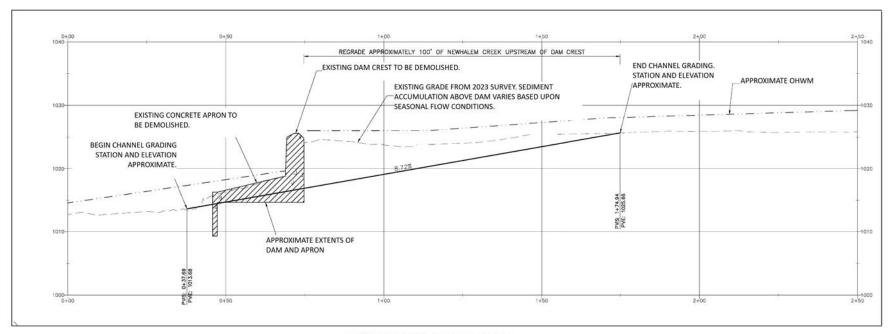
NEWHALEM CREEK CHANNEL PROFILE

SCALE: HORIZ 1" = 10' VERT 1" = 5'

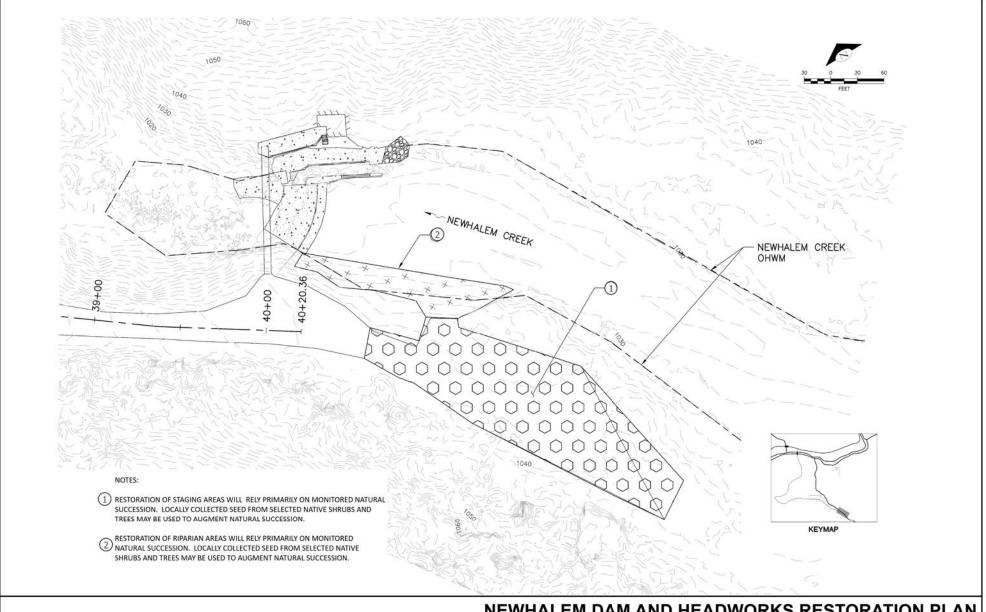
## **NEWHALEM DAM AND HEADWORKS RESTORATION PLAN**

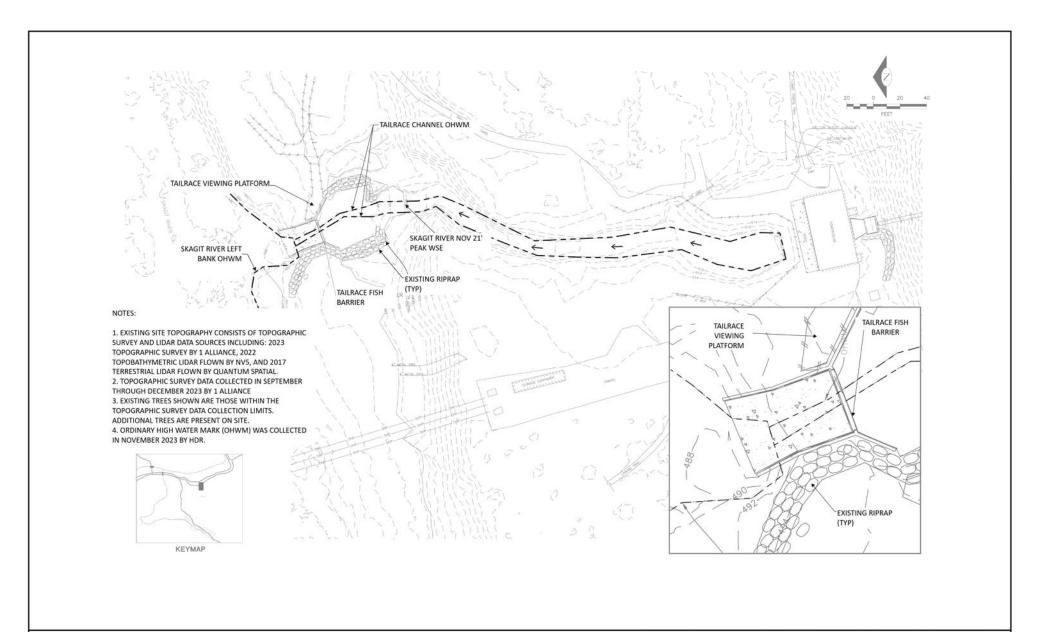
#### **NEWHALEM POWERHOUSE TAILRACE EXISTING SITE PLAN**

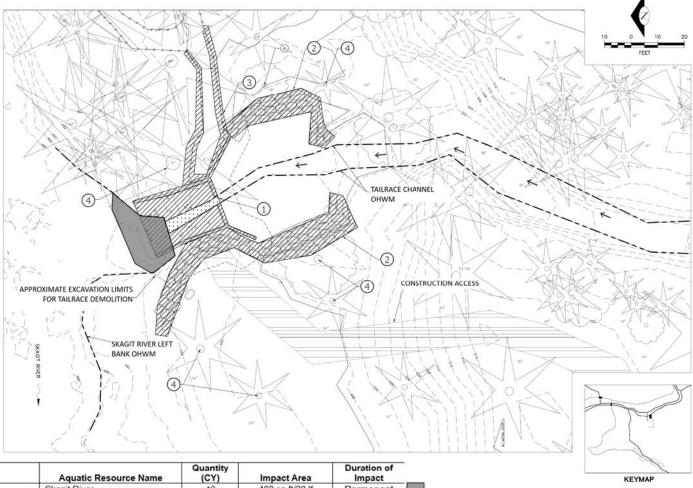
- DEMOLISH AND REMOVE CONCRETE TAILRACE BARRIER
- REMOVE AND DISPOSE OF EXISTING RIPRAP OFF SITE. ALL RIPRAP TO BE REMOVED IS LANDWARD OF OHWM
- DEMOLISH EXISTING WOOD FENCE
- (4) PROTECT EXISTING TREE IN

Activity	Aquatic Resource Name	Quantity (CY)	Impact Area	Duration of Impact
Excavate: Concrete tailrace barrier	Skagit River	40	400 sq ft/20 If	Permanent
Excavate: Concrete tailrace barrier	Newhalem Powerhouse Tailrace	10	110 sq ft/30 If	Permanent ::::

#### **NEWHALEM POWERHOUSE TAILRACE BARRIER DEMOLITION PLAN**

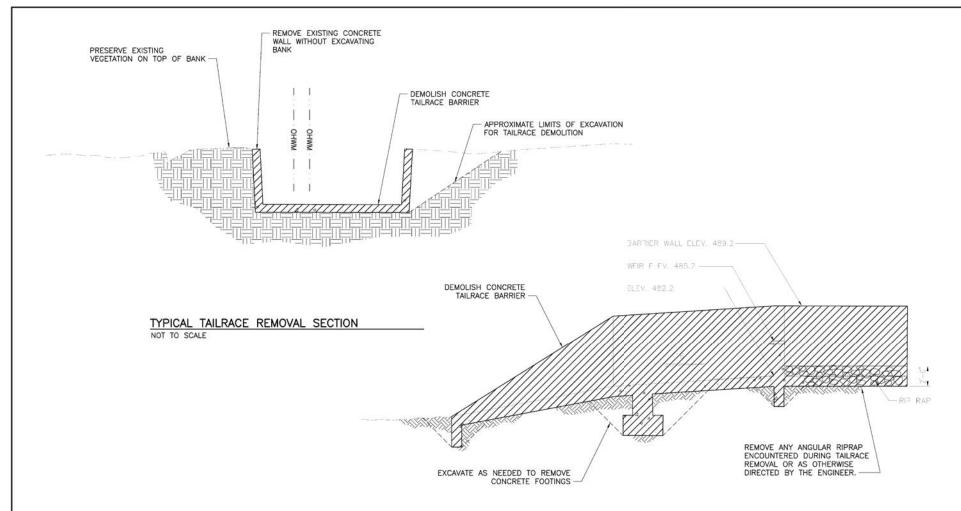
1. CONCRETE TAILRACE BARRIER DETAIL TAKEN FROM FERC NO. 2705 EXHIBIT F, SEPTEMBER 1992. FULL EXHIBIT INCLUDED IN REFERENCE DRAWINGS.

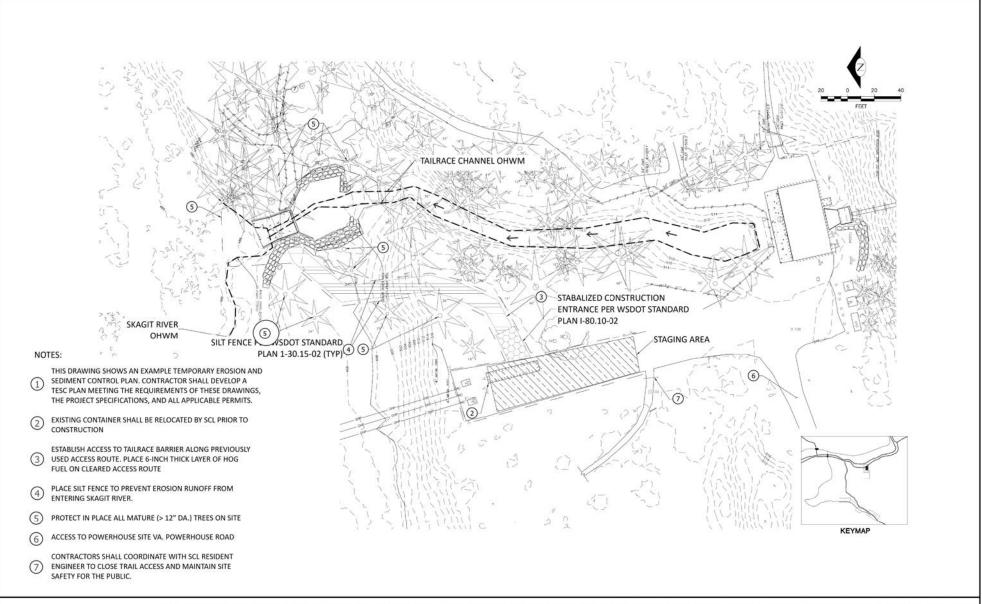
#### NEWHALEM POWERHOUSE TAILRACE BARRIER CONSTRUCTION ACCESS AND STAGING PLAN

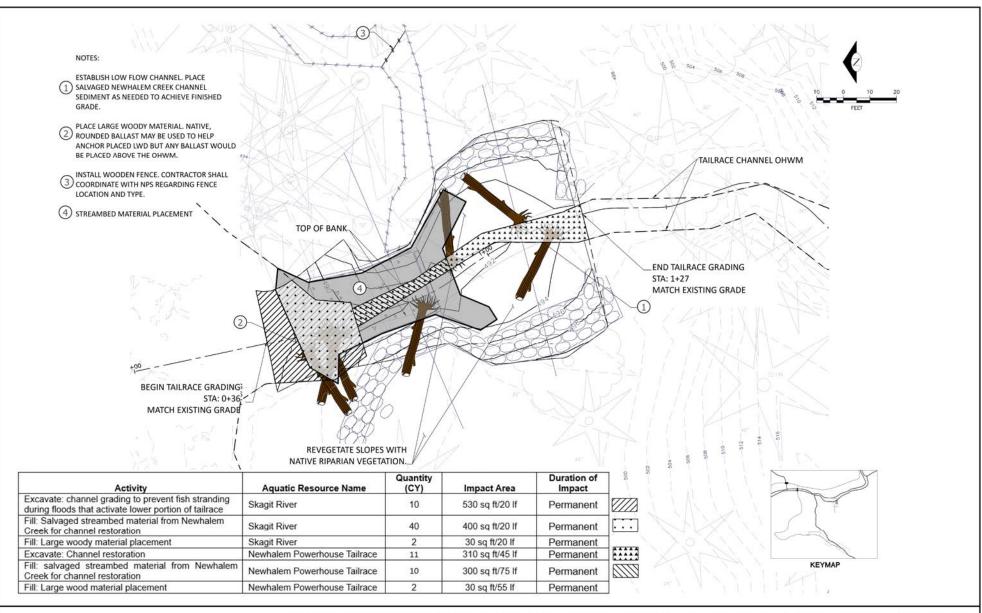
#### NEWHALEM POWERHOUSE TAILRACE BARRIER CHANNEL RESTORATION PLAN

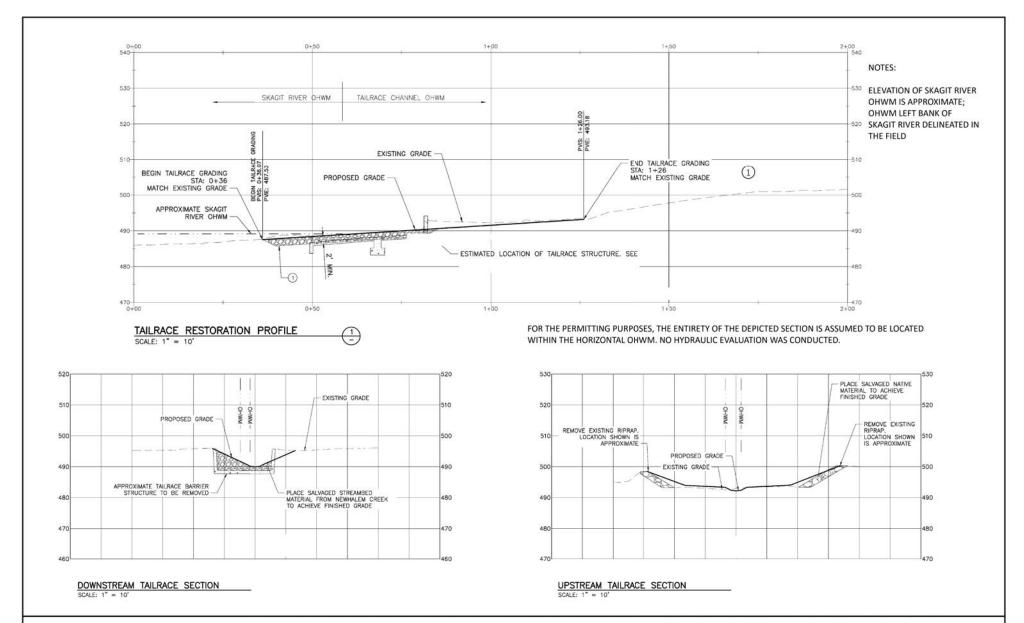
#### **NEWHALEM POWERHOUSE TAILRACE BARRIER RESTORATION PROFILE AND SECTIONS**

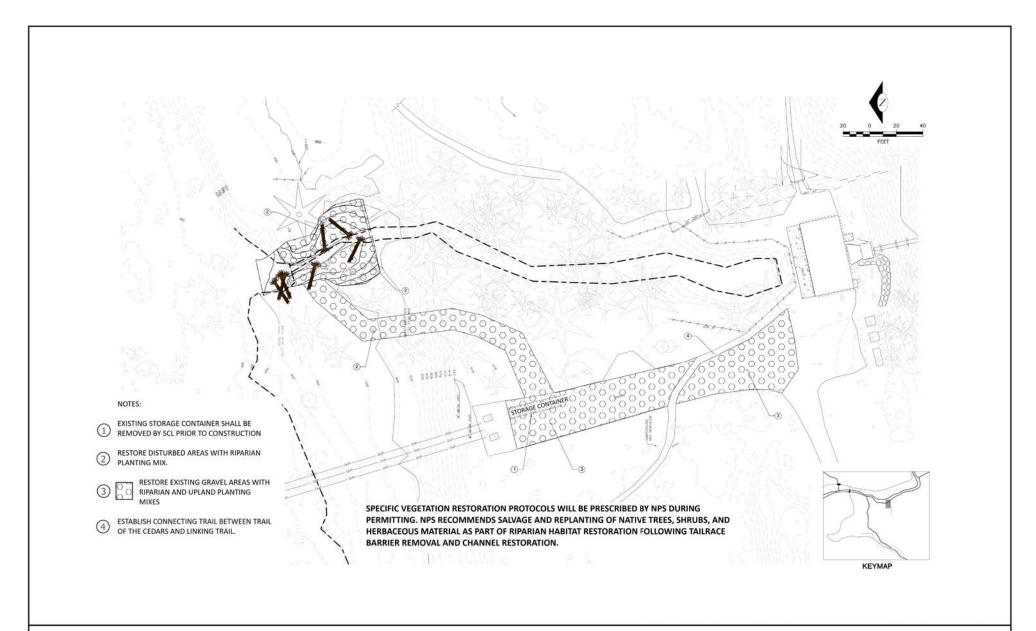
#### **NEWHALEM POWERHOUSE TAILRACE BARRIER RESTORATION PLAN**

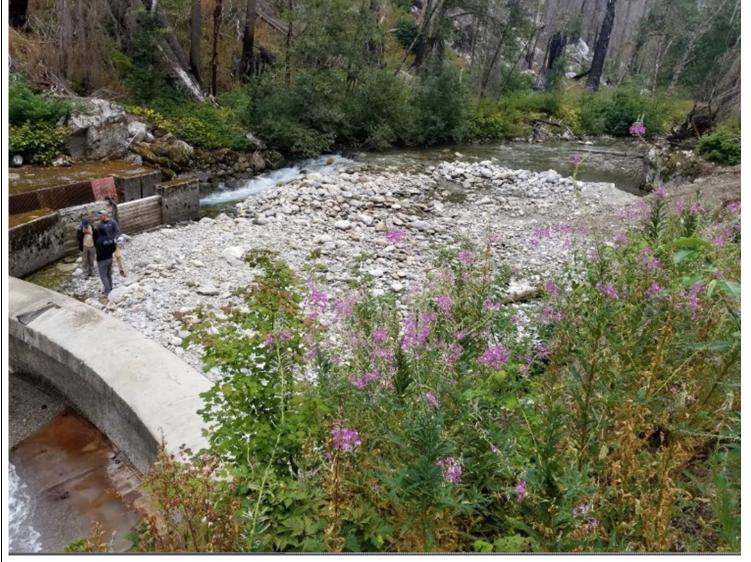
Newhalem Dam, August, showing low flow conditions, looking upstream. Creek flows along right bank into sluiceway; left bank "in the dry."

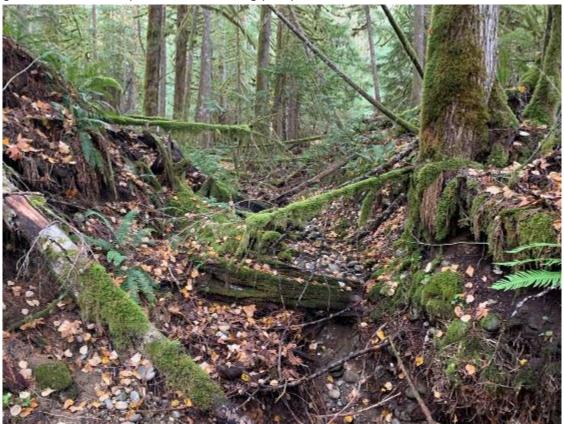
Tailrace (Type F stream), facing upstream (south). Aside from the pool near the powerhouse, no surface flow was observed in the tailrace during the field investigation in November 2023.

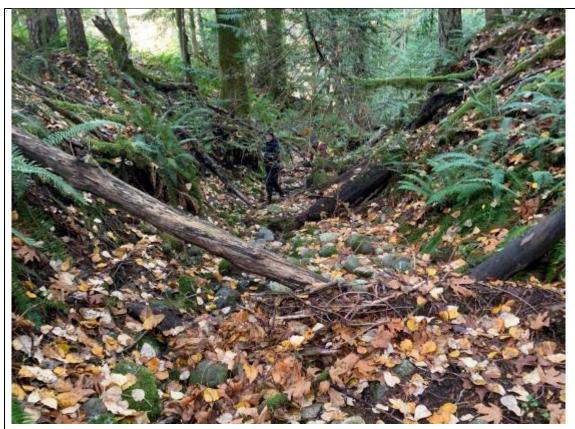
Tailrace, facing downstream (north). Aside from the pool near the powerhouse, no surface flow was observed in the tailrace during the field investigation in November 2023.

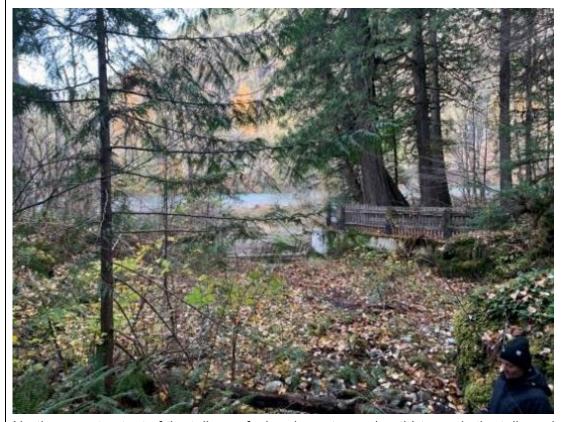
Northernmost extent of the tailrace, facing downstream (north) towards the tailrace barrier with the Skagit River visible in the background. In the portion of the tailrace pictured above, the tailrace channel narrows to approximately 4 to 6 feet wide and disperses into a relatively flat, rocky area (pictured below).

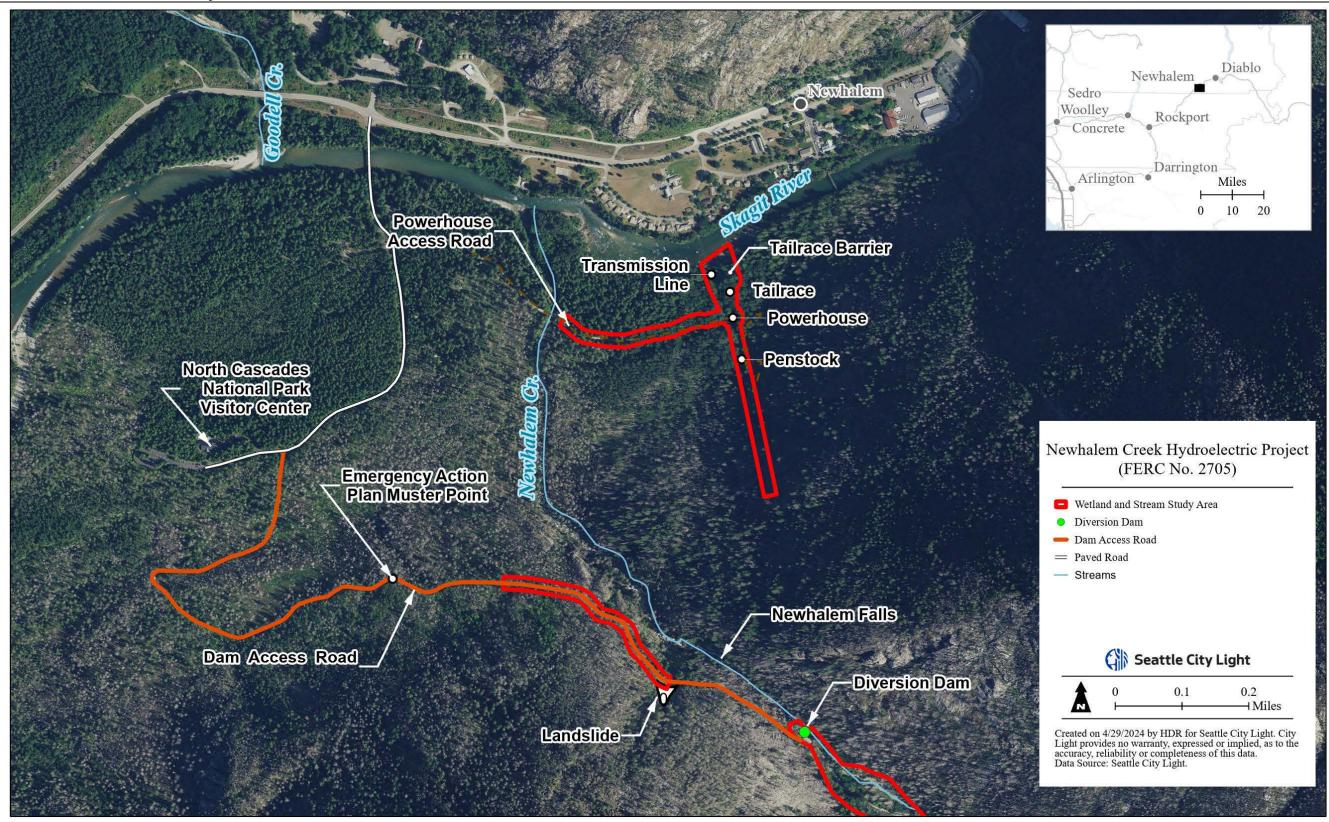
Figure 1-1. Project vicinity and prominent features of the Project.

The Project is located south of State Route 20 and the Skagit River, just downstream of the Gorge Powerhouse (Figure 1-1) on NPS-managed land within the RLNRA. The Project powerhouse is reached via a road that traverses NPS's Newhalem Creek Campground and provides access to Newhalem Creek and several hiking trails.

- 5. According to the Whatcom County Shoreline Management Program, the Skagit River is considered a shoreline of statewide significance (i.e., a Type S stream) upstream of the Whatcom-Skagit County line to the point where the mean annual flow is measured at 1,000 cfs or more, approximately, at the confluence of Newhalem Creek (WCC 23.40.020[B][2]). Therefore, because the portion of the Skagit River in the study area is upstream of the confluence with Newhalem Creek (see Figure 1-1), the Skagit River is considered a Type F stream for the purposes of this study.

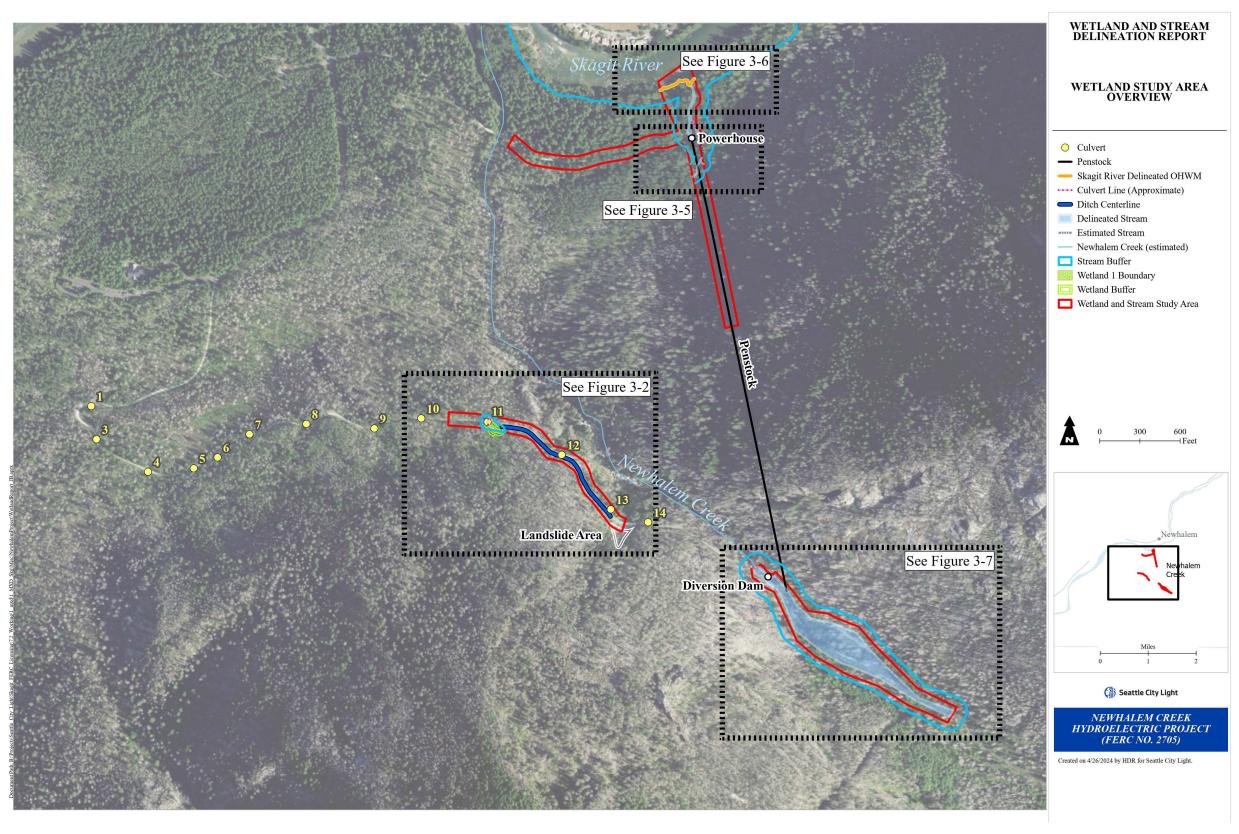
Figure 3-1. Overview of existing wetlands and streams within the study area.

A total of eight streams (Stream 1 through Stream 5, Newhalem Creek, the tailrace, and the Skagit River) were identified in the study area. Stream 1 and Stream 2 are located adjacent to the gravel dam access road in the southern portion of the study area; Stream 3, Stream 4, Stream 5, the tailrace, and the Skagit River are located in the northern portion of the study area near the penstock and the powerhouse (Figure 3-1). As noted previously, a 0.35-mile section of Newhalem Creek was also delineated as part of the field investigation near Newhalem Dam (Figure 3-1). A summary of streams delineated in the study area is provided in Table 3-2 and photos of the streams and surrounding areas are in Appendix D. A detailed description of each identified stream is provided below.

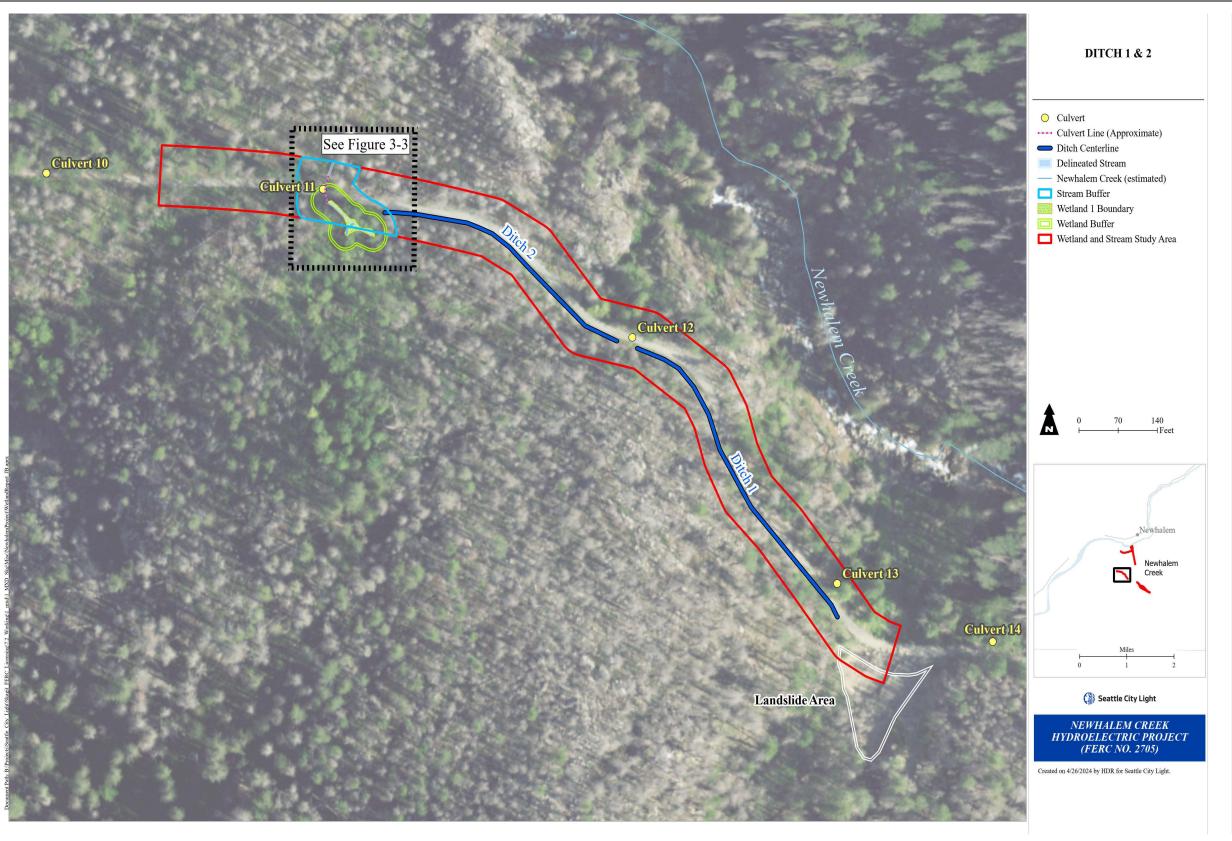
Figure 3-2. Existing wetlands, ditches, and streams along the dam access road.

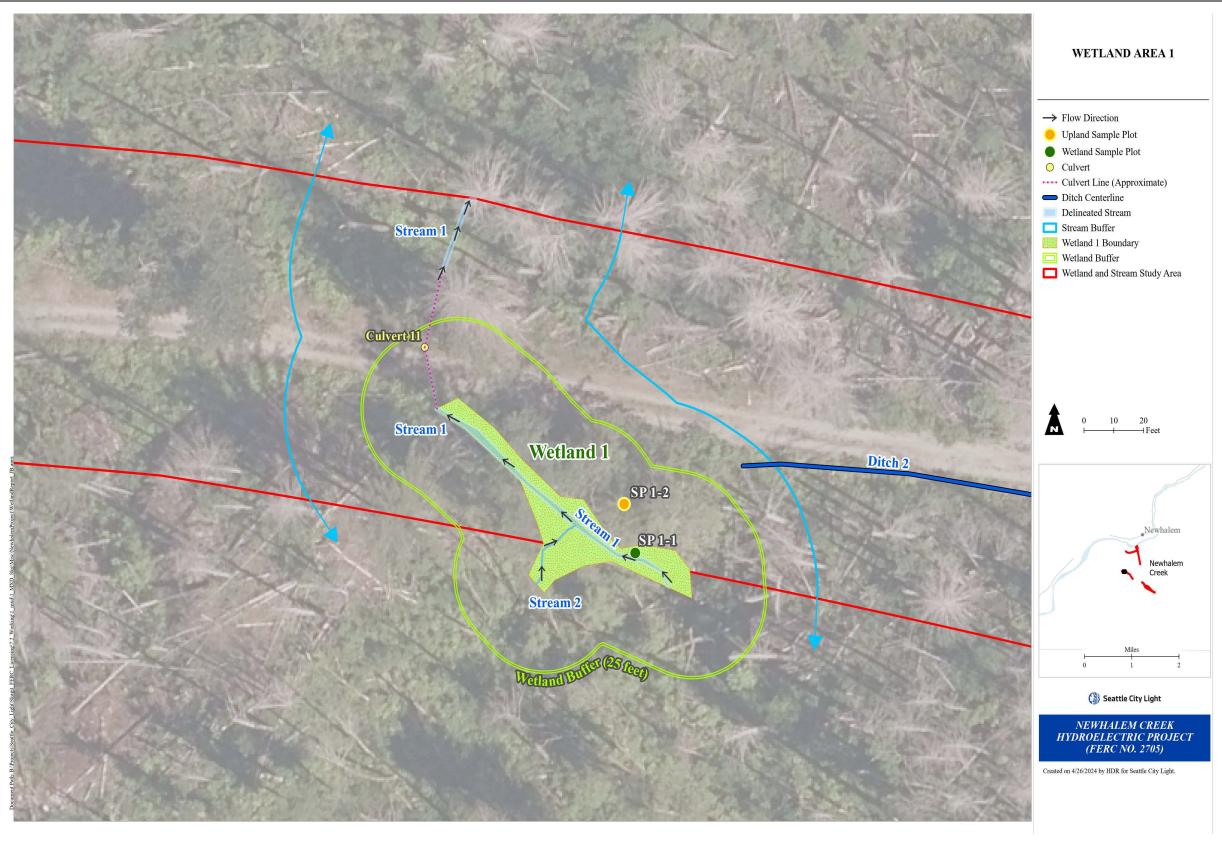
Figure 3-3. Wetland 1, Stream 1, and Stream 2 along dam access road.

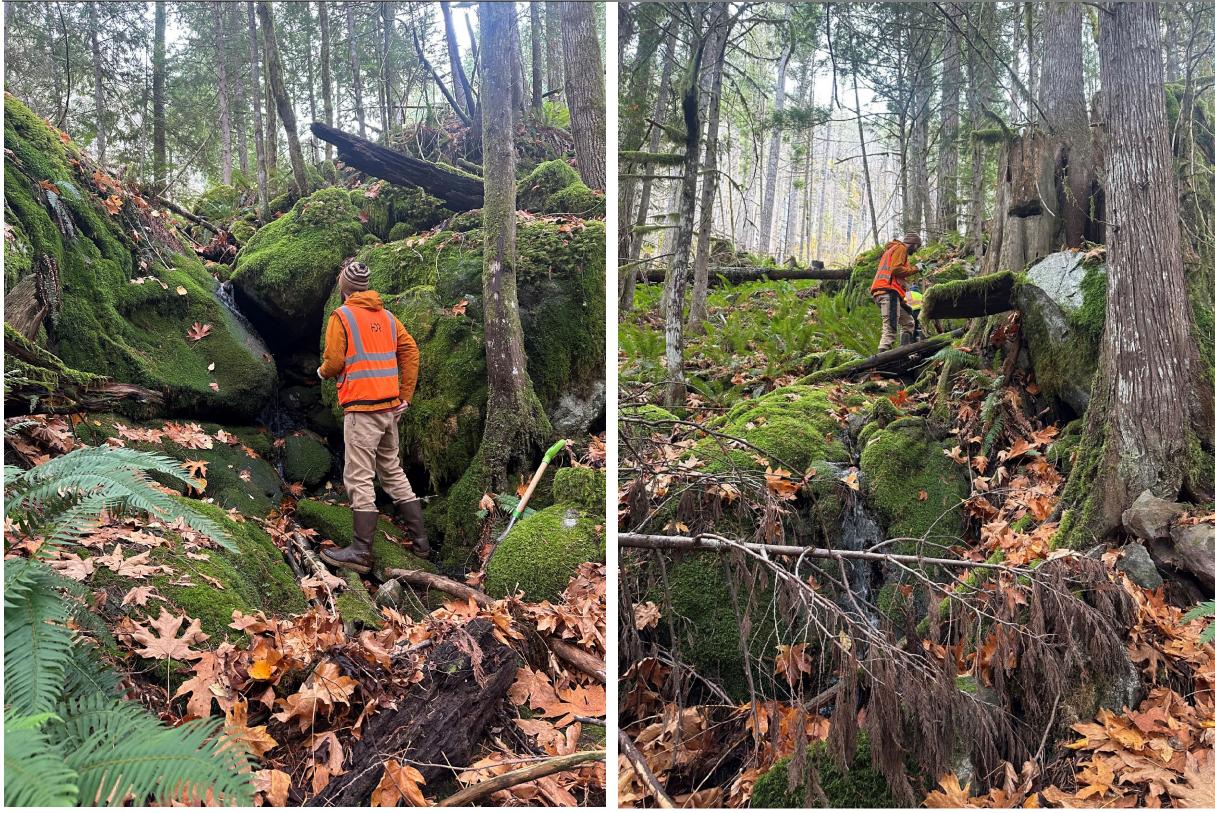
Figure 3-4. Photos of rocky waterfall feature in Stream 4

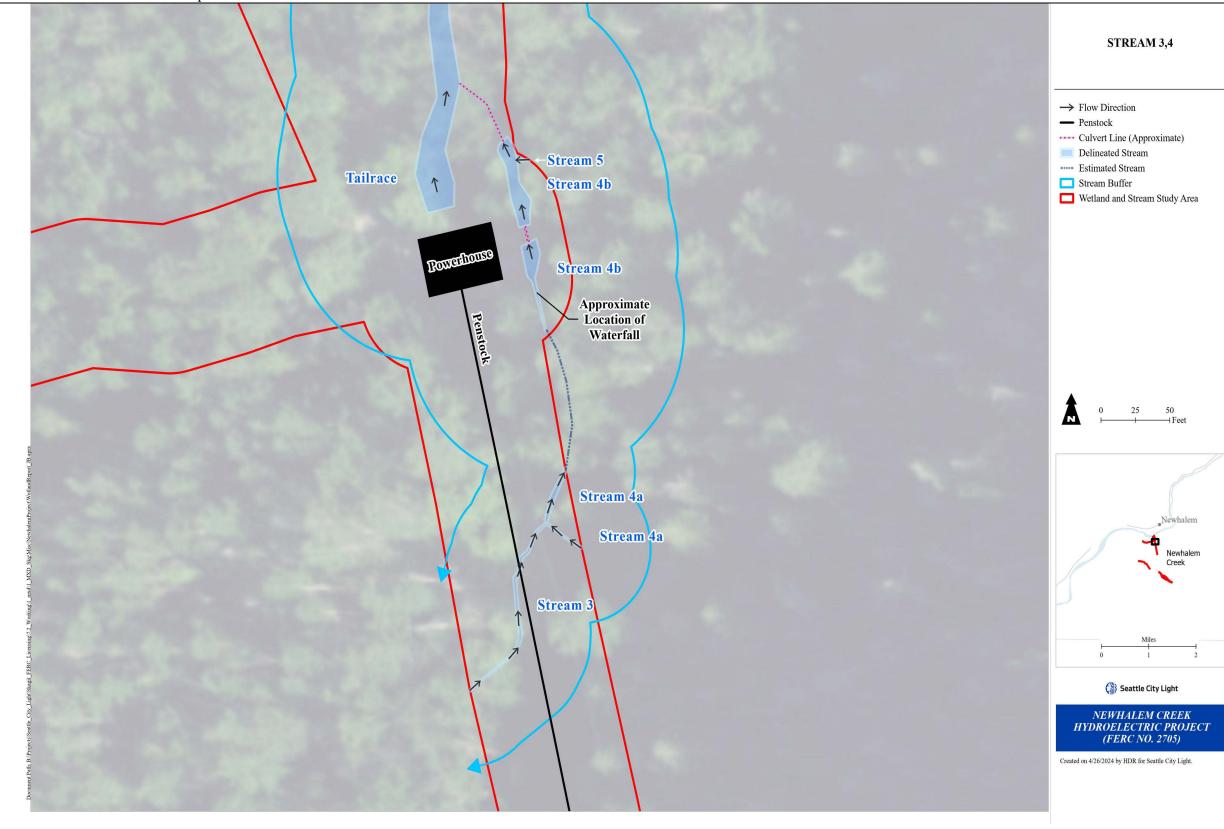
Figure 3-5. Stream 3 and Stream 4 in the study area.

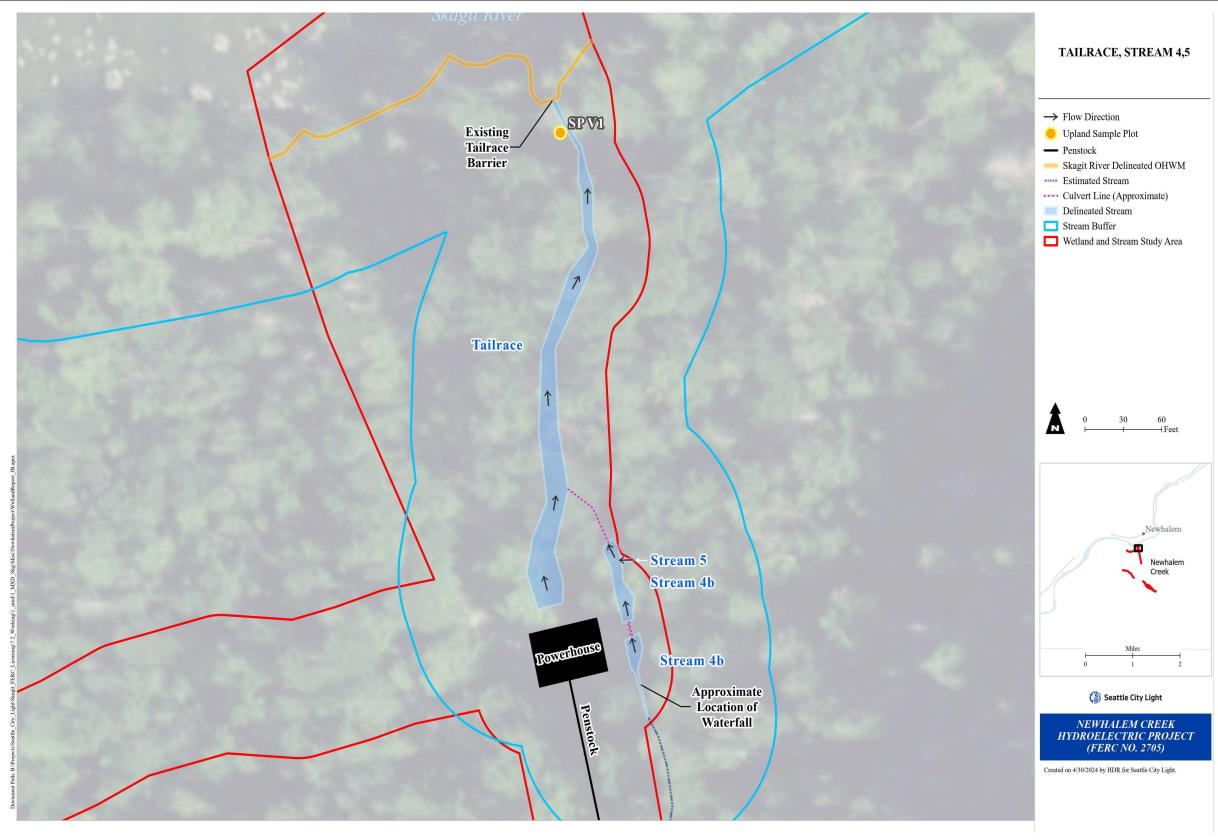
Figure 3-6. Tailrace, Stream 4, and Stream 5 in the study area.

Stream 5 is located in the northern portion of the study area and flows west into Stream 4 just east of the tailrace (Figure 3-5, Figure 3-6). Within the study area, Stream 5 is approximately 1 to 1.5 feet wide and has an approximately 5 percent slope. No flow was observed in Stream 5 during the field investigation in November 2023 (see Appendix D, Photo 31). Within the study area, the stream substrate varies and consists of gravel and small cobbles near the confluence with Stream 4 and silt/sand and gravel near the eastern edge of the study area. Similar to Stream 4, vegetation near Stream 5 consists of a mature forested canopy dominated by big leaf maple and black cottonwood and an open understory vegetated with scattered sword fern. Stream 5 is too narrow to meet the physical criteria of a fish-bearing stream and is therefore typed as a non-fish bearing seasonal waterbody (Type Ns). Stream 5 is not mapped on the Forest Practices Application Mapping Tool (DNR 2023).

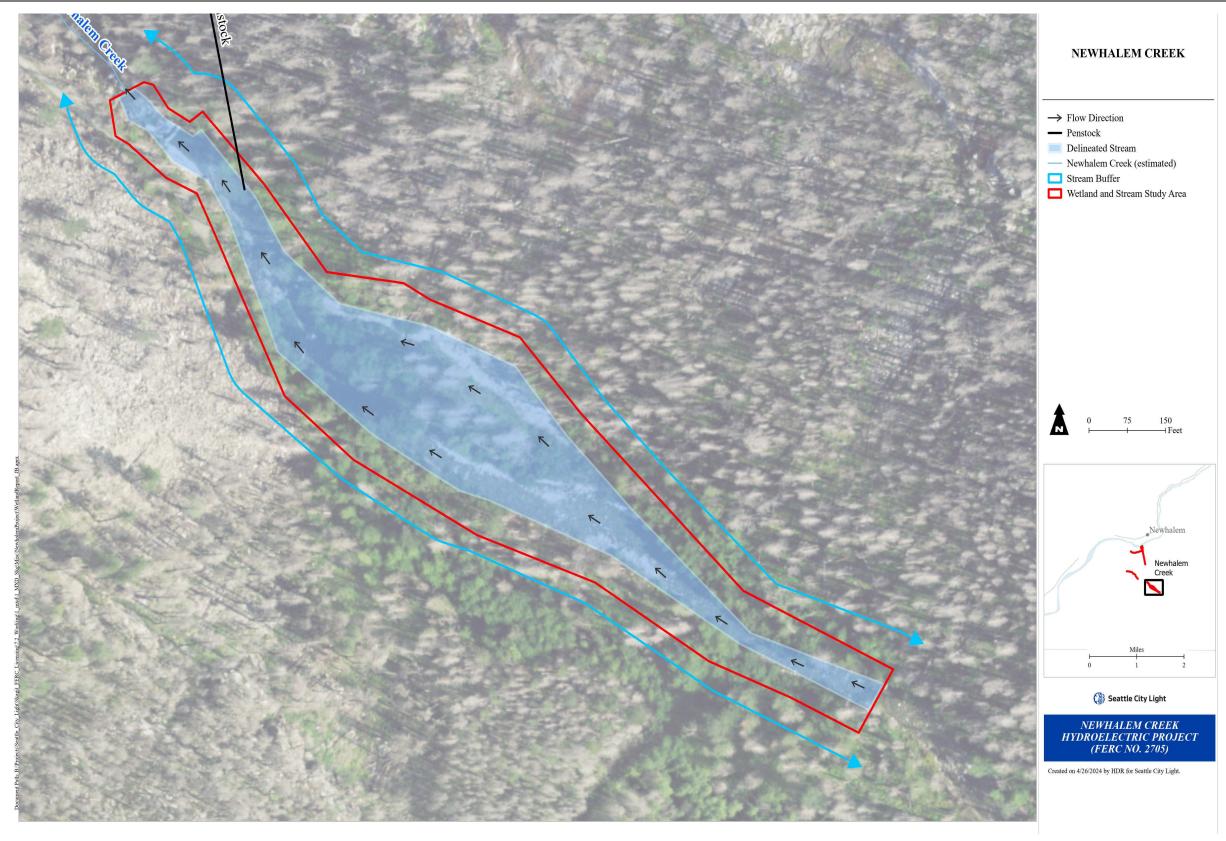
Figure 3-7. Delineated portion of Newhalem Creek.

Although the Forest Practices Application Mapping Tool (DNR 2023) includes Newhalem Creek as a Type S water, the Whatcom County Shoreline Management Program does not include Newhalem Creek in the list of designated shorelines of statewide significance in unincorporated Whatcom County (WCC 23.40.020[B]). Therefore, Newhalem Creek is considered a Type F stream for the purposes of this study due to documented fish use, physical criteria, and a direct surface water connection to the Skagit River.

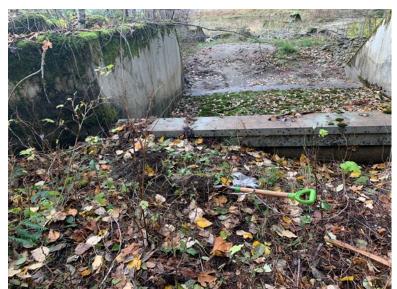
**Caption:** Surrounding vegetation and tailrace barrier at sample plot SP V1.

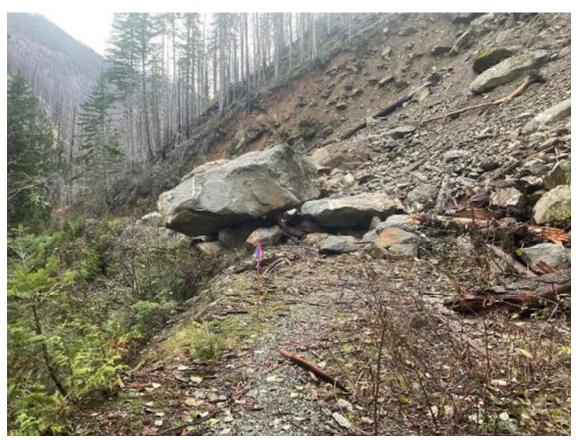
Photo 1: Landslide on dam access road as of November 2023. Photo taken facing SW from dam access road.

The Newhalem Creek diversion structure, located at creek mile (CM) 1.0 just above a 167-foot waterfall (Newhalem Falls, CM 0.8), is run-of-the-river and impounds very little water (approximately 0.1 acre/0.6 acre-feet). Access to the dam is via a 1.4-mile-long gravel section of a former logging road, starting near the parking lot of NOCA Visitor Center, and continuing past the dam along the Newhalem Creek drainage as an unmaintained gravel trail. The upper portion of the gravel dam access road is closed to public access due to a landslide (see Appendix D, Photo 1).

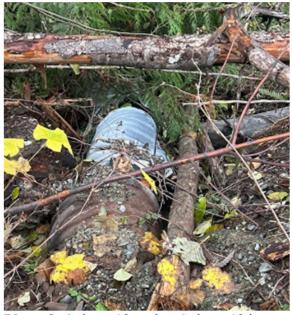
**Photo 2**: Culvert 13 outlet. Culvert 13 is a perched culvert located underneath the dam access road just downslope of the landslide area. The inlet to Culvert 13 appears to be buried and was not visible during the site investigation in November 2023.

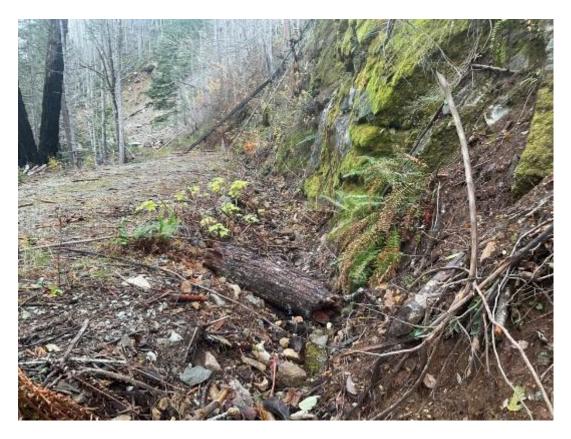
**Photo 3**: Ditch 1, an excavated feature located downslope from the landslide area and adjacent to the dam access road between Culvert 13 and Culvert 12. Photo taken facing SE toward Culvert 13 and the landslide area.

Ditch 1 is an excavated roadside feature that conveys stormwater northwest along the dam access road, extending approximately from the landslide area to Culvert 12 (Figure 3-2). The bed and right bank of the ditch are primarily comprised of quarry spalls overlain by a thick layer of soil, and the left bank is comprised of eroded soils (Appendix D, Photo 3 and 4). Ditch 1 does not contain wetland vegetation and no flow was observed during the site visit in November 2023. Prior to discharging to Culvert 12, the last 15 feet of Ditch 1 contains some expressed groundwater that flows through the culvert and is discharged to the top of a cliff on the other side of the dam access road (Appendix D, Photo 5 and 6). Immediately after the cliff and outside of the study area, the conveyed flow transitions subsurface and lacks a downstream connection to Newhalem Creek. Ditch 1 is not considered a stream and does not provide fish habitat.

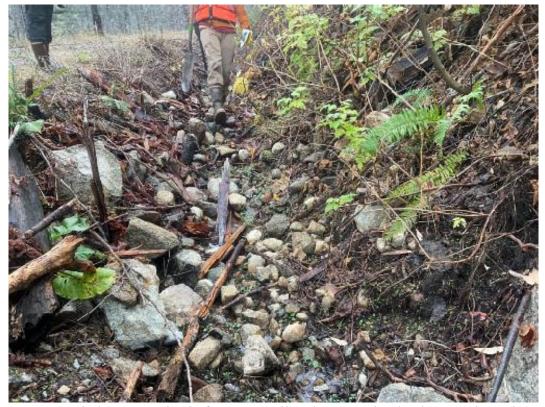
Photo 4: Ditch 1, comprised of quarry spall and scattered upland vegetation. Photo taken facing SE.

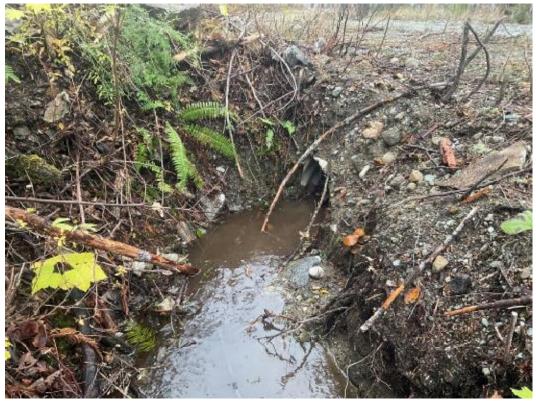
Photo 5: Culvert 12 inlet, containing expressed groundwater and hillside seeps conveyed in Ditch 1.

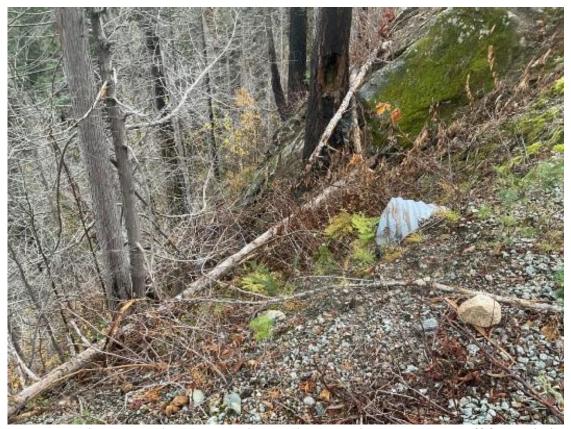
**Photo 6:** Culvert 12 outlet. Expressed groundwater and stormwater runoff from Ditch 1 flows through Culvert 12 and is discharged to the top of a steep slope/cliff. Immediately after the cliff and outside of the study area, the conveyed flow goes subsurface and lacks a downstream connection to Newhalem Creek.
