## Request for Clean Water Act Section 401 Water Quality Certification Washington State Department of Ecology

The current license for the Newhalem Creek Hydroelectric Project (FERC No. 2705) expires on January 31, 2027. As noted above, repair and maintenance costs make it impractical to continue to operate the project and City Light has decided not to seek a new license but rather surrender the license for the Newhalem Creek Hydroelectric Project and proposes to decommission it as described herein.

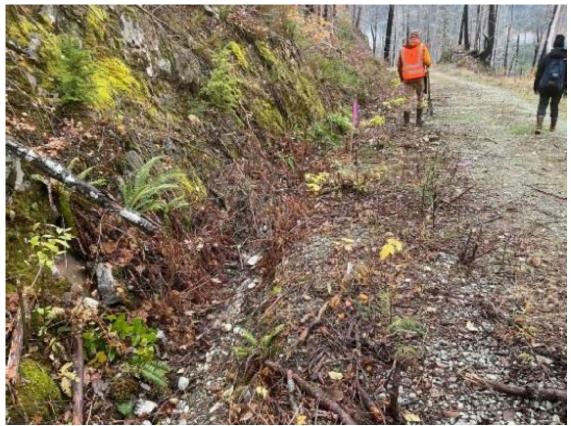
**Photo 7:** Ditch 2, located approximately 10 feet west of Culvert 12. Ditch 2 is an excavated roadside feature that conveys stormwater northwest along the dam access road. The bed and bank of the ditch are comprised of quarry spall and gravel, with scattered upland vegetation.

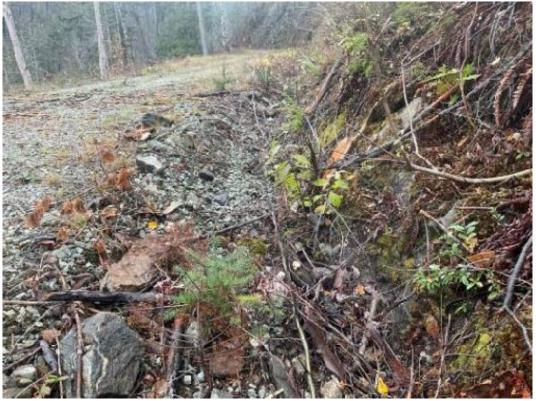
**Photo 8**: Ditch 2. Photo taken facing east along dam access road near the location where Ditch 2 disperses into uplands.

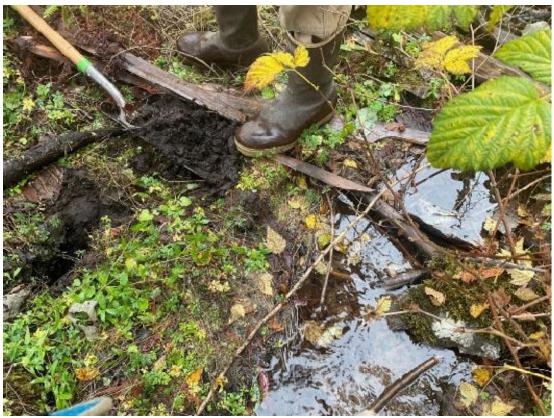
**Photo 9**: Wetland 1, with Stream 1 visible at the bottom of the photo. Photo taken facing southwest near sample plot SP 1-1.

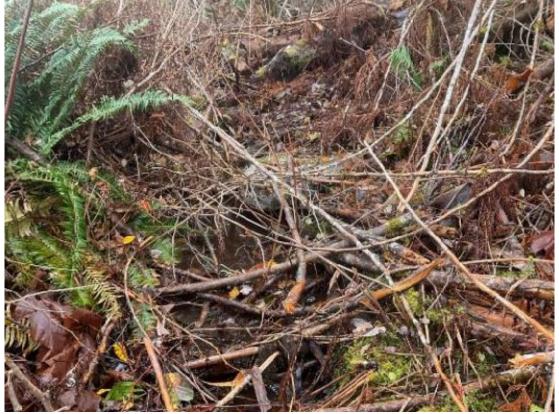
**Photo 10**: Sampled soils and wetland vegetation near sample plot SP 1-1 in Wetland 1. Stream 1 also included in photo.

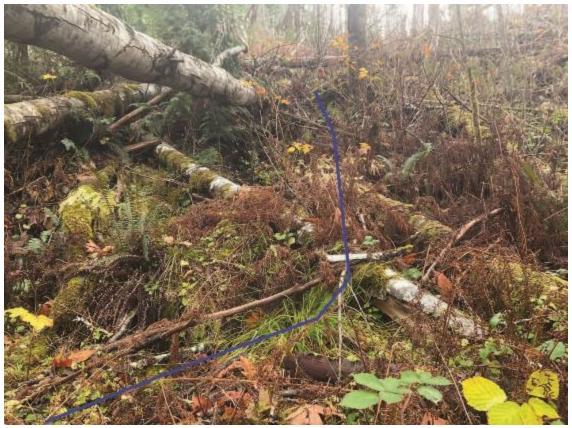
Photo 11: Stream 1 (Type Np) in Wetland 1, upstream of confluence with Stream 2.

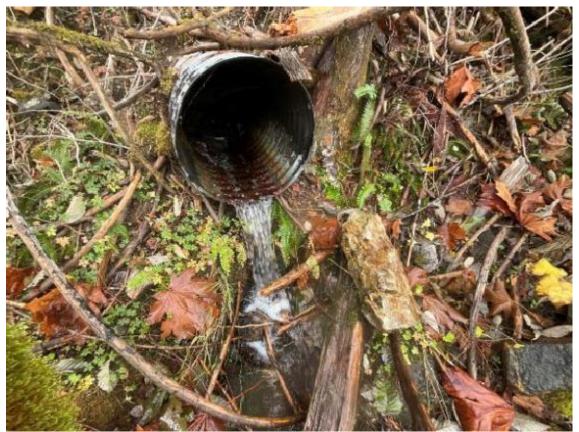
**Photo 13**: Culvert 11 inlet, located on the boundary of Wetland 1. Culvert 11 conveys Stream 1 under the dam access road.

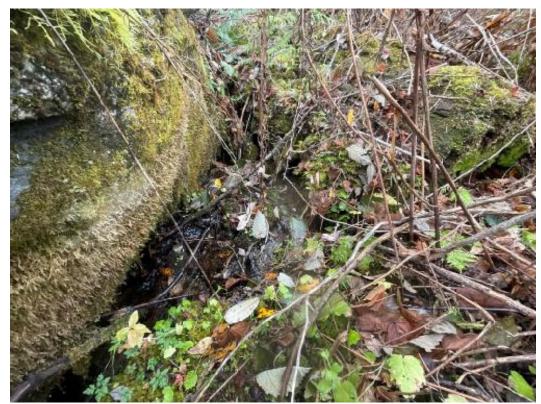
**Photo 14**: Culvert 11 outlet, located on the north side of the dam access road. Water conveyed through the culvert discharges onto large boulders and drops approximately 6 feet below the culvert.

Following decommissioning of all Project elements at the diversion dam and associated headworks, the existing dam access road will be converted to road storage. Existing culverts along the road will be removed and natural drainage patterns will be reestablished. One of the culverts (Culvert 11) along the road conveys flow from a natural stream and slope wetland. As discussed in the Project wetland and stream report (HDR 2024), Stream 1, a non-fish-bearing perennial stream, flows through Culvert 11 and discharges over a 6-foot drop onto boulders. From there, it has a steep slope (15 to 20 percent) for approximately 20 feet, and then flows down a nearly 100 percent slope into Newhalem Creek on the (north) side of the existing dam access road (See Photo 1, Appendix A). At the time of the November 2023 field survey, Stream 1 had less than 1 cubic foot per second (cfs) of flow. Given site conditions, it is not possible to monitor turbidity at the point of compliance 100 feet downstream of the culvert removal location per WAC 173-201A-200. However, considering the low amount of flow, nature of work, lack of fine materials in the boulder-dominated narrow stream, and proposed construction BMPs, it is likely the water quality criterion for turbidity will be met. Additionally, it is unlikely any turbid water would reach Newhalem Creek, which is approximately 400 feet downstream. Visual monitoring for downstream turbidity and sheen will occur during culvert removal at Stream 1.

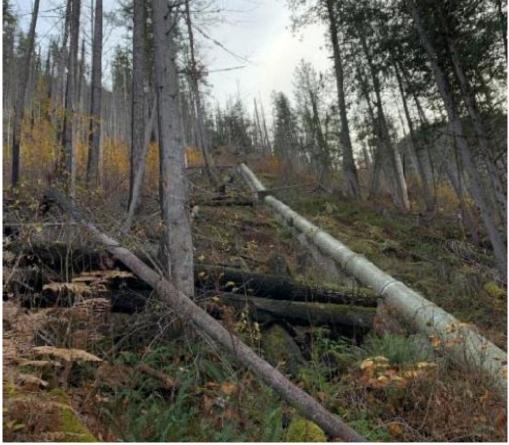
**Photo 16**: Overview photo of the northern portion of the study area along the penstock. Photo taken facing north towards the powerhouse. No wetlands were identified in the northern portion of the study area near the penstock.

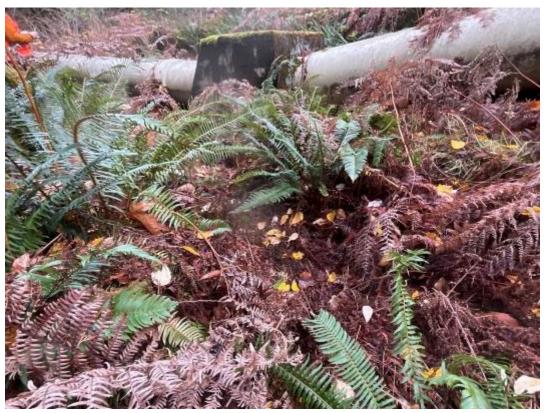
**Photo 17**: Overview photo of the northern portion of the study area along the penstock. Photo taken facing SW towards the penstock.

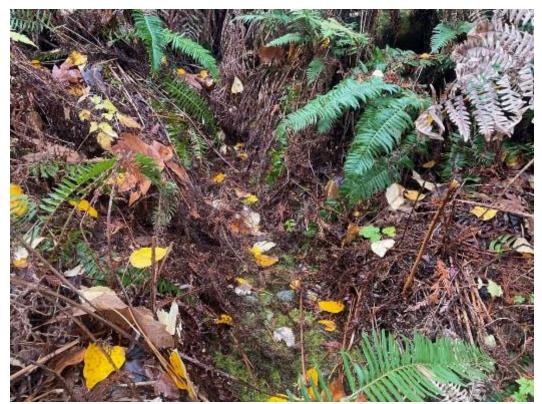
**Photo 18**: Stream 3 in the study area (Type Ns), just upstream of where the stream crosses under the penstock. Stream 3 lacked flow during the field investigation in November 2023. Photo taken facing NE.

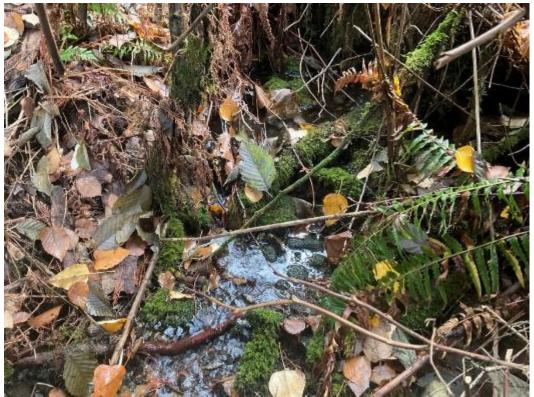
**Photo 19**: Bed and bank of Stream 3 in the study area, upstream of the confluence with Stream 4a. Stream 3 has a bankfull width of approximately 1-1.5 feet in the study area and lacked flow during the field investigation in November 2023.

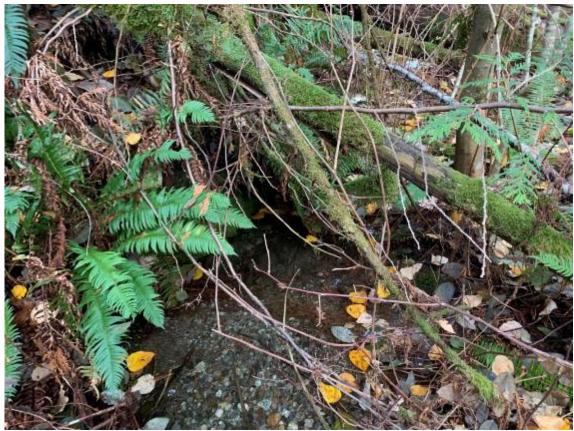
**Photo 20**: Stream 4a in the study area (approximately 1.5 feet wide; Type Ns), upstream of the confluence with Stream 3.

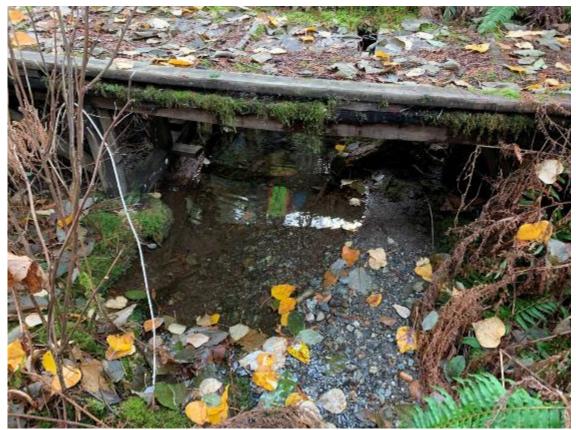
Photo 21: Stream 4a in the study area, downstream of the confluence with Stream 3.

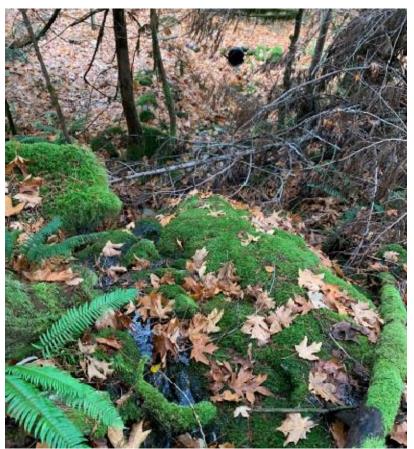
**Photo 23**: Stream 4a just prior to reentering the study area near the powerhouse. Photo taken facing downstream (north) towards the top of the rocky waterfall feature pictured in Photos 24 and 25 below.

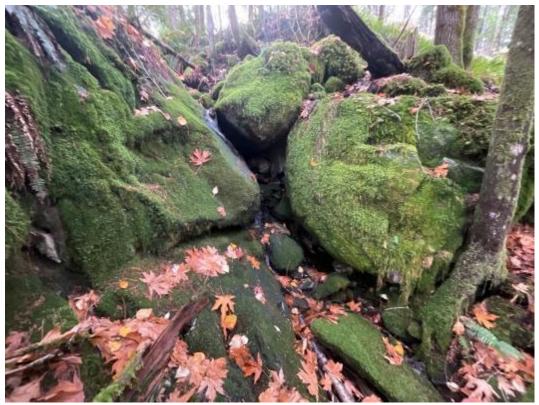
**Photo 24**: Top of the rocky waterfall feature within Stream 4 as it re-enters the study area, with some visible surface flow. Photo taken facing downstream (north) towards Stream 4b and the culvert pictured in Photo 26 below. Stream 4a is the portion of Stream 4 located upstream of the rocky waterfall feature (Type Ns) and Stream 4b is the portion of Stream 4 located downstream (Type F).

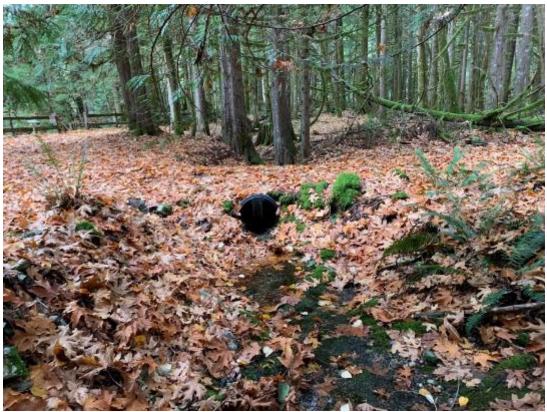
**Photo 25**: Stream 4 after reentering the study area near the powerhouse, facing upstream. Stream 4 flows through a rocky waterfall feature (pictured above) before forming a defined, flattened channel (i.e., Stream 4b) just east of the powerhouse (see Photo 26, below). As noted above, Stream 4a is the portion of Stream 4 located upstream of the rocky waterfall feature (Type Ns) and Stream 4b is the portion of Stream 4 located downstream (Type F).

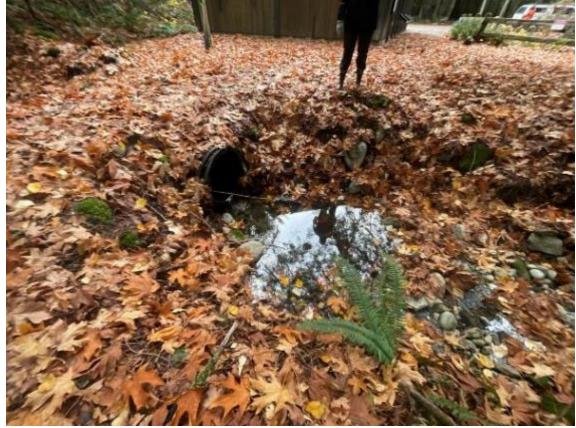
**Photo 26**: Stream 4b, just east of the powerhouse. Photo taken facing north (downstream) towards culvert that conveys Stream 4b under a trail.

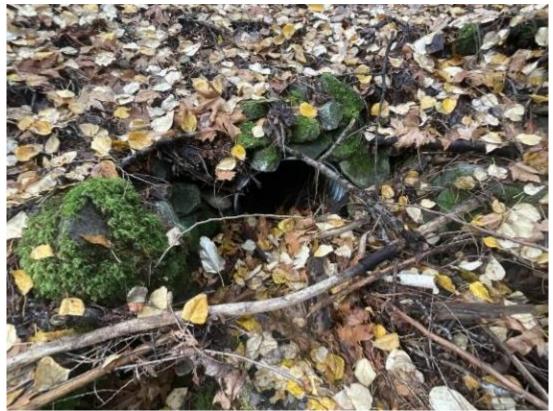
**Photo 29**: Inlet of culvert that conveys Stream 4b into the tailrace. No flow was observed in this portion of Stream 4b during the field investigation in November 2023.

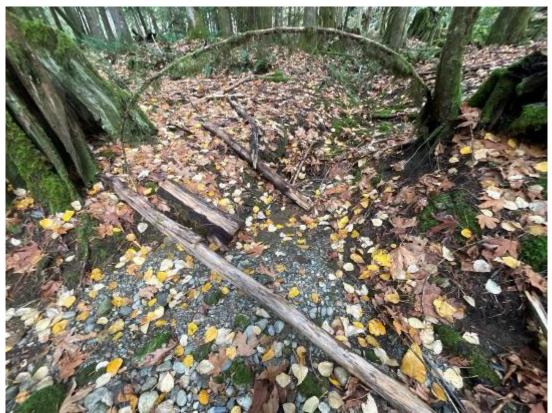
**Photo 30**: Confluence of Stream 4b and Stream 5. Photo taken facing upstream (east) in Stream 5, with Stream 4b visible in lower lefthand corner of photo. No flow was observed in this portion of Stream 4b, nor Stream 5, during the field investigation in November 2023. Stream 5 flows into Stream 4b approximately 18 feet upstream of the culvert pictured in Photo 29 above.

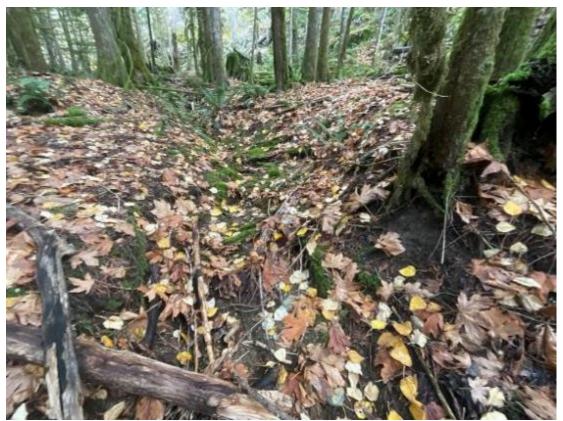
**Photo 31**: Stream 5 (Type Ns stream), facing upstream (east) towards edge of study area. No flow was observed in Stream 5 during the field investigation in November 2023.

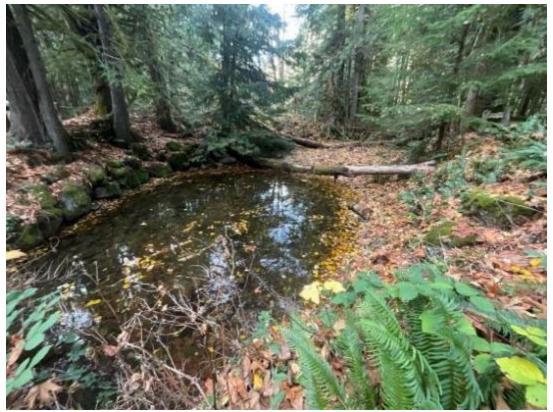
**Photo 32**: Large pool in the tailrace, just north of the powerhouse. Photo taken facing north. Aside from the pool shown above, no surface flow was observed in the tailrace during the field investigation in November 2023.

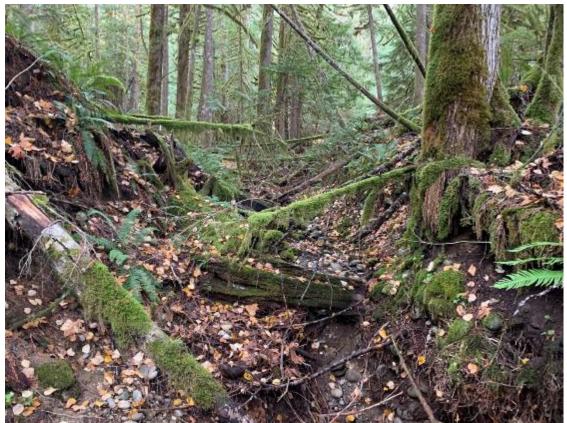
**Photo 33:** Tailrace (Type F stream), facing upstream (south). Aside from the pool near the powerhouse, no surface flow was observed in the tailrace during the field investigation in November 2023.

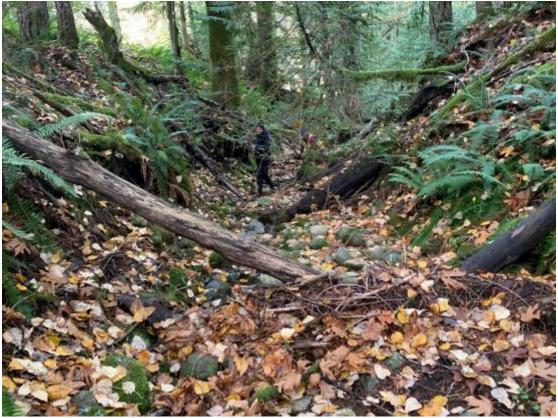
**Photo 34:** Tailrace, facing downstream (north). Aside from the pool near the powerhouse, no surface flow was observed in the tailrace during the field investigation in November 2023.

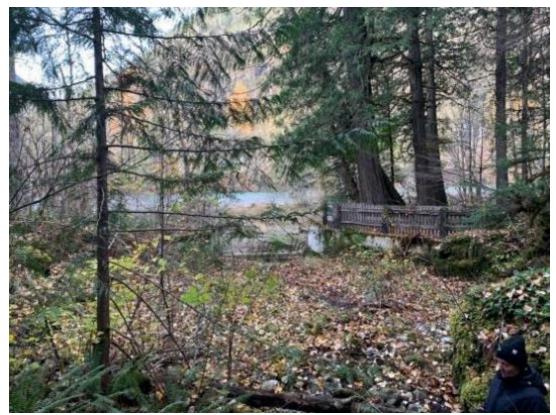
**Photo 35:** Northernmost extent of the tailrace, facing downstream (north) towards the tailrace barrier with the Skagit River visible in the background. In the portion of the tailrace pictured above, the tailrace channel narrows to approximately 4 to 6 feet wide and disperses into a relatively flat, rocky area (pictured in Photo 36, below).

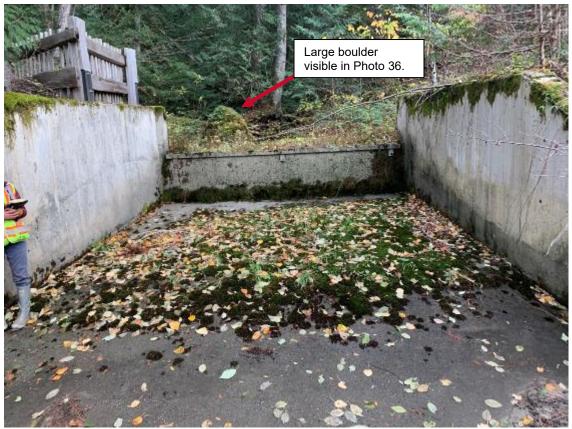
**Photo 36:** Flat, rocky portion of the tailrace, just upstream of the tailrace barrier. Photo taken facing upstream (south). Sample plot SP V1 is located in this area and confirmed that the area is non-wetland.

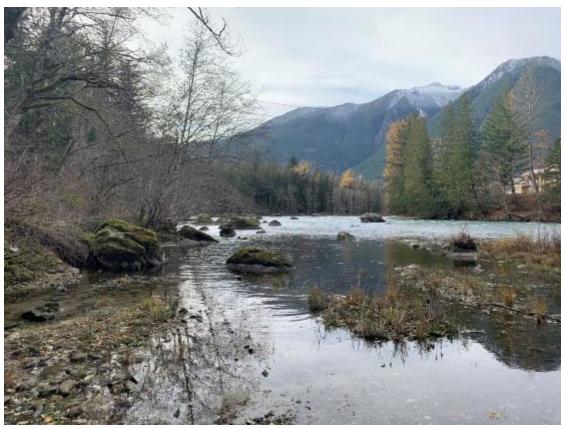
**Photo 37:** Tailrace barrier. Photo taken facing upstream (south) into the tailrace from the left bank of the Skagit River.

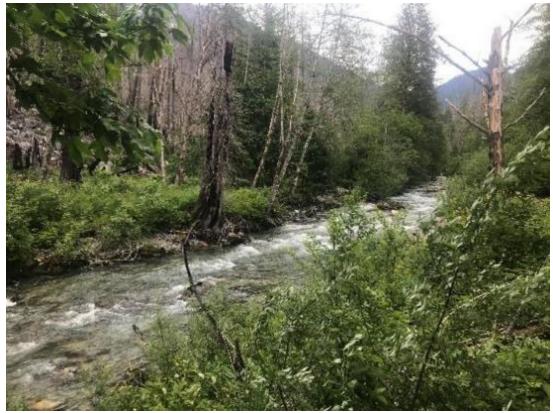
**Photo 38:** Skagit River in the study area (Type F stream). Photo taken facing downstream (west) along the left bank of the Skagit River.

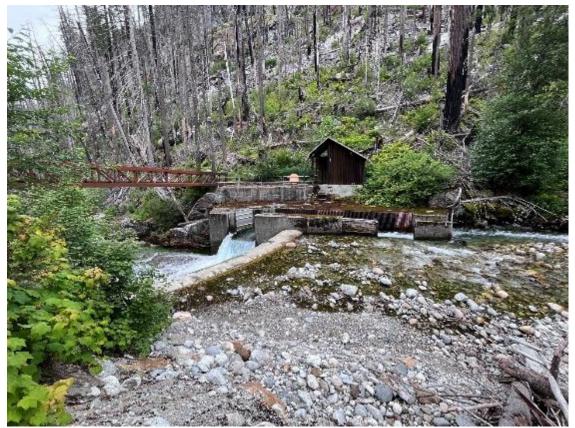
**Photo 39:** Delineated segment of Newhalem Creek (Type F stream) upstream of the diversion dam. Project archive photo from June 2021 taken from the left bank, facing upstream (northeast). The outlet of the side channel located along the right bank of Newhalem Creek is visible near the center of the photo.

A 0.35-mile section of Newhalem Creek, extending approximately 100 feet downstream and 1,750 feet upstream of Newhalem Dam, was delineated in July 2023 as part of the field investigation (Figure 3-7). The delineated reach did not extend further downstream due to near vertical slopes adjacent to Newhalem Creek and resulting access issues. The delineated reach of Newhalem Creek has a bankfull width that ranges from approximately 30 to 90 feet. Approximately 550 feet upstream of the diversion dam, Newhalem Creek has a side channel along the right bank that flows for approximately 500 feet before rejoining the main channel (see Appendix D, Photo 39).

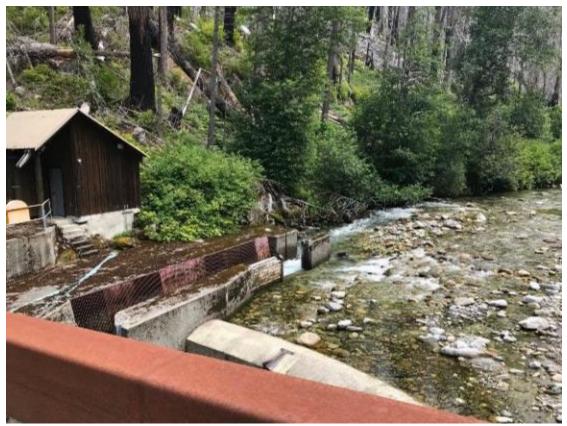
**Photo 40**: Delineated segment of Newhalem Creek. Photo taken in July 2023 from the left bank, just upstream of the diversion dam and facing north towards the dam and gatehouse.

Stream substrate in this reach of Newhalem Creek is generally coarse and includes boulders, cobbles, and gravels with little fine sediment (see Appendix D, Photo 40 and 41). The banks of the creek immediately upstream and downstream of the diversion structure are generally steep and composed of bedrock (see Appendix D, Photo 42 and 43). Streambank vegetation through the delineated reach of Newhalem Creek primarily consists of salmonberry, vine maple (*Acer circinatum*), red alder, willows (*Salix* spp.), and devil's club. Outside of the immediate riparian corridor, much of the surrounding forest near the site of the diversion dam burned during the Goodell Fire in August 2015 (see Appendix D, Photo 44 and 45).

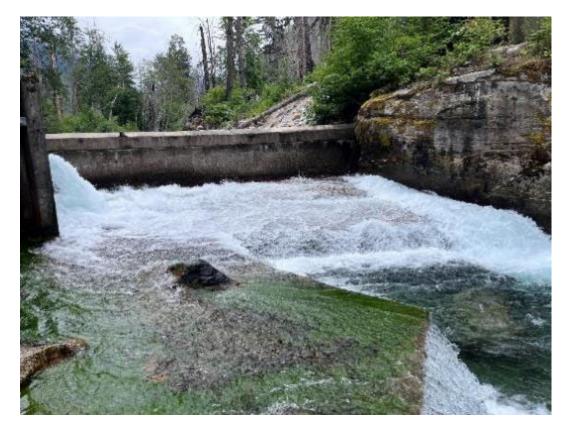
**Photo 41:** Delineated segment of Newhalem Creek. Photo taken in July 2023 from the footbridge, facing upstream (northeast) towards the gatehouse and sluiceway.

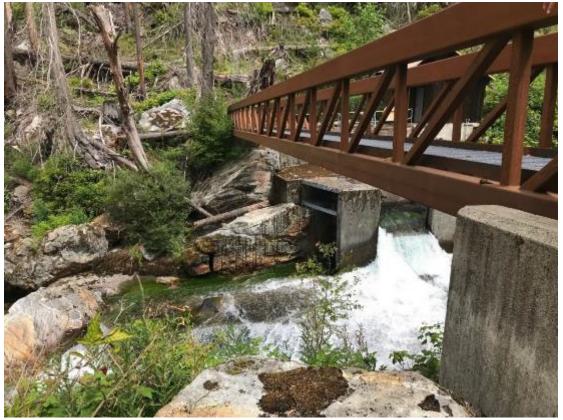
**Photo 42:** Concrete apron in Newhalem Creek, just downstream of the diversion dam. Photo taken in July 2023, facing upstream towards the dam.

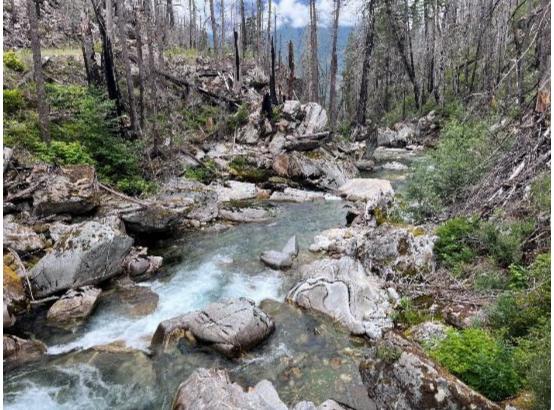
**Photo 43:** Newhalem Creek, just downstream of the diversion dam and the footbridge. Photo taken in July 2023, facing northeast.

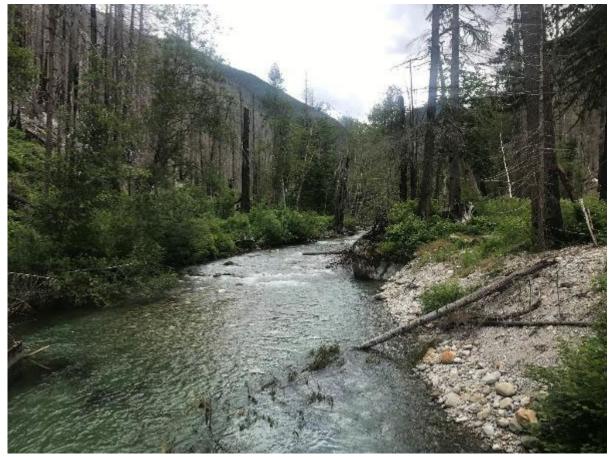
**Photo 44:** Newhalem Creek and surrounding forest burned during the Goodell Fire in 2015. Photo taken from the footbridge at the diversion dam site, facing downstream, in July 2023.

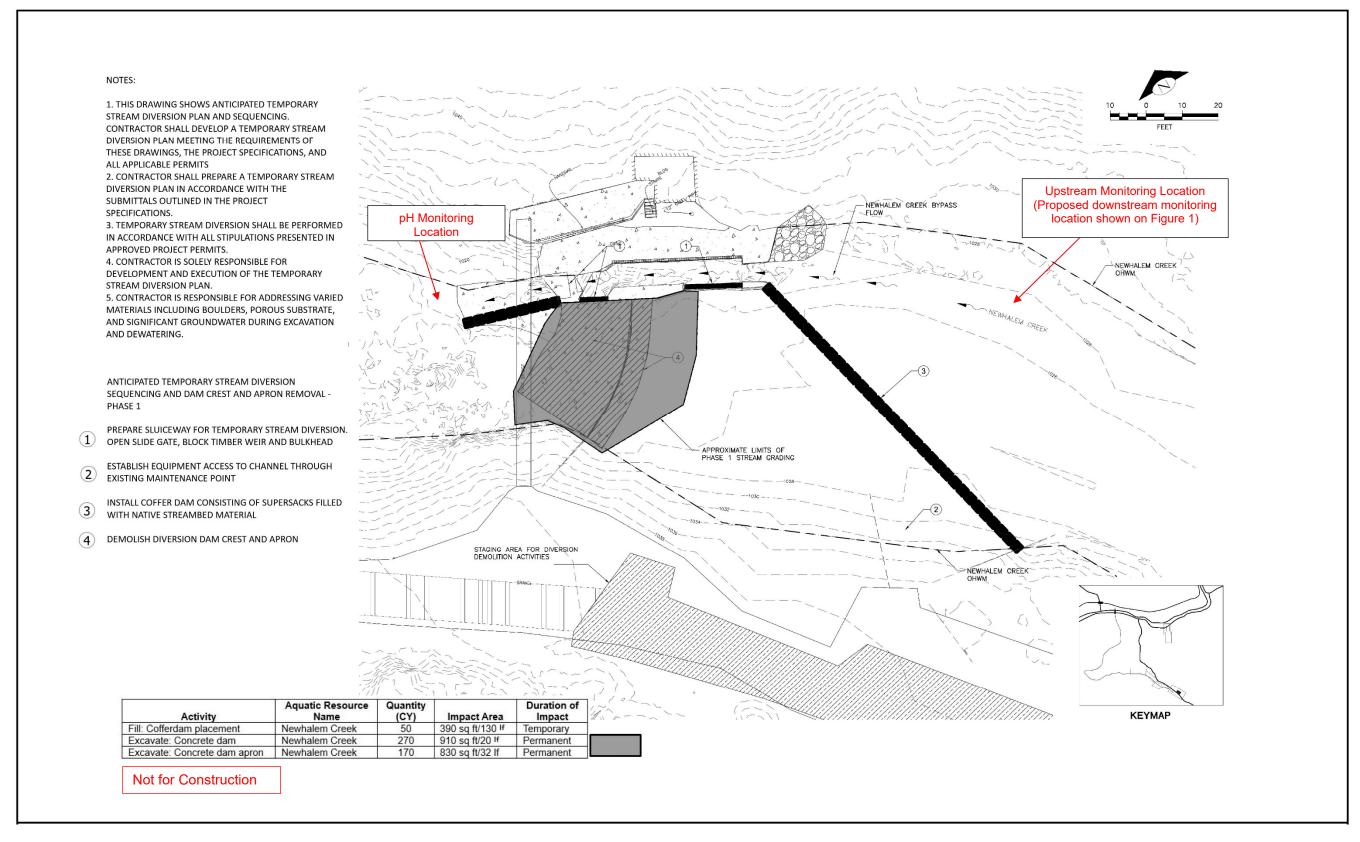
Figure 2. Phase 1 Temporary Stream Bypass and Cofferdam Placement

During the first phase of dam infrastructure decommissioning, the selected contractor will fill supersacks with native creek sand, gravel, and cobble sourced from material along the left bank to form a temporary cofferdam upstream of the diversion dam. The temporary diversion dam will divert water into the sluiceway and dewater the work area around the dam. During low-flow periods in summer and early fall, including the proposed work window, Newhalem Creek naturally flows along the right bank into the sluiceway/intake structure, and the left side of the channel is typically dry (see Photo 6 in Appendix A). This condition will allow for use of an excavator to fill supersacks with streambed gravels "in the dry" from the dewatered left-side of the channel. In the unlikely event that any flow is present along the left bank at the start of the work window, an excavator positioned from the bank will push accumulated gravel materials to form an earthen bridge to reach the accumulated gravel bar. Once the work area is isolated, the contractor will remove the diversion dam crest and apron by breaking apart the concrete with an excavator, jack hammer, and/or non-explosive cracking agent and hauling the demolished materials off site (Figure 2).

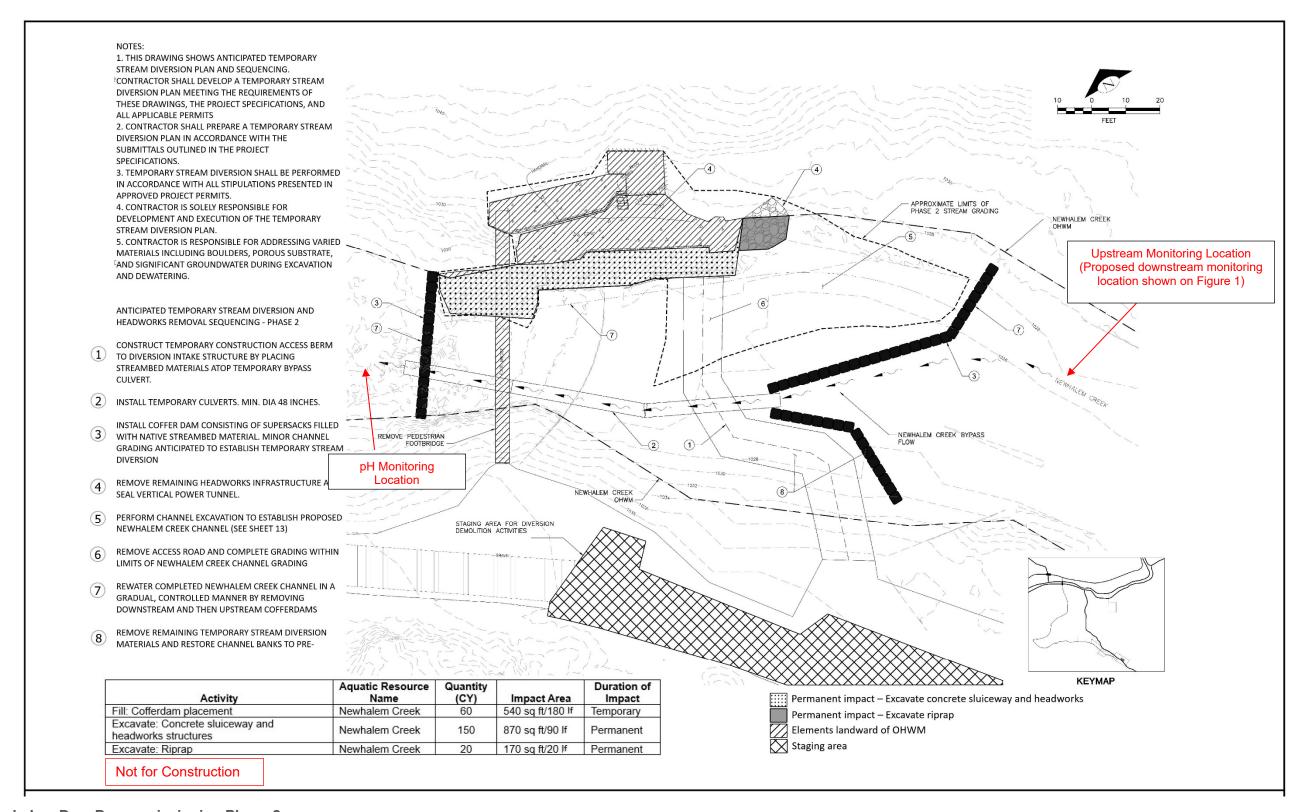
Figure 3. Newhalem Dam Decommissioning Phase 2

Figure 3 and Figure 4 show the stream bypass, cofferdam placement, and decommissioning activities proposed as part of Phase 2.

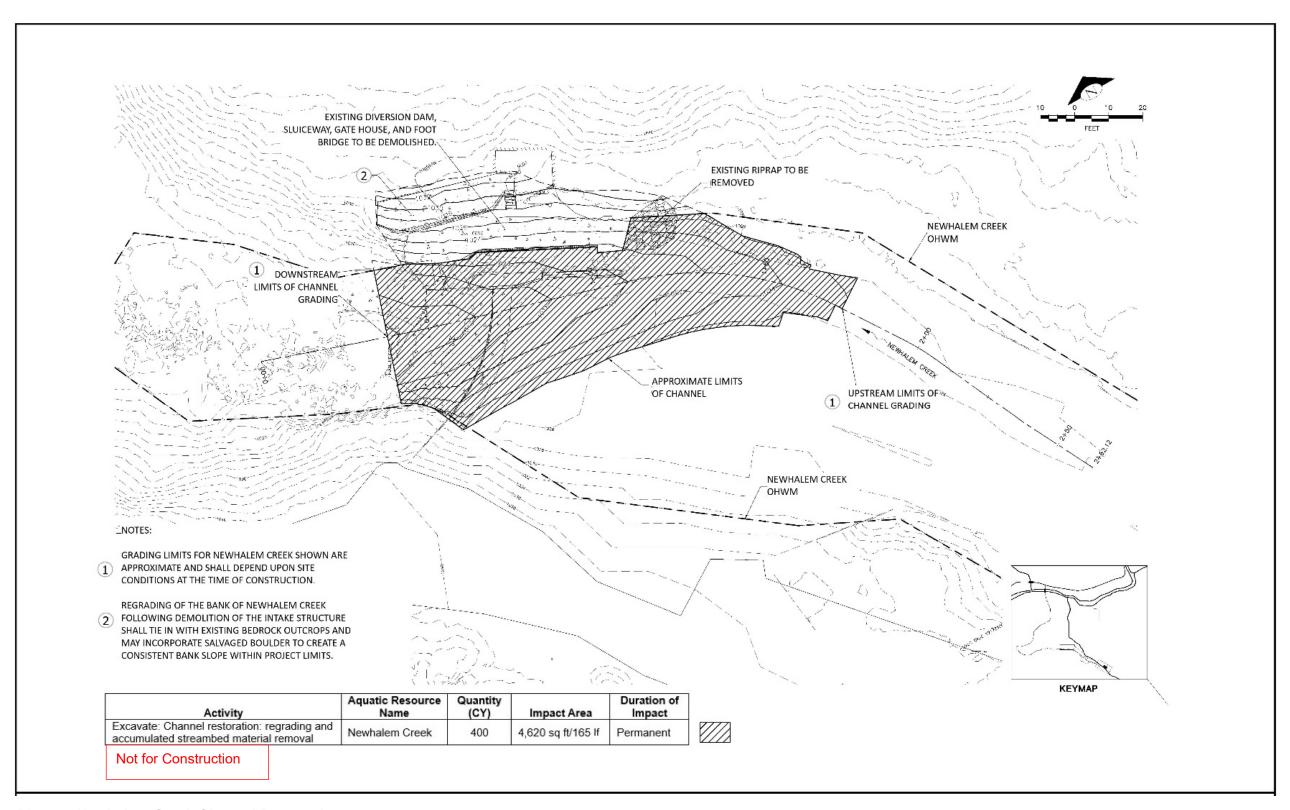
Figure 4. Phase 2 Newhalem Creek Channel Restoration

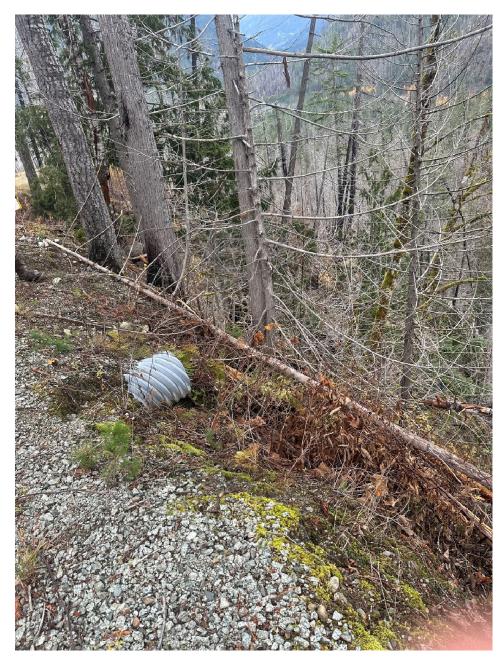
Photo 1. Culvert 11 outlet. Stream 1 flows through Culvert 11 and immediately discharges over a 6-foot drop onto boulders. From there, it has a steep slope (15 to 20 percent) for approximately 20 feet, and then flows over a near vertical drop to Newhalem Creek.

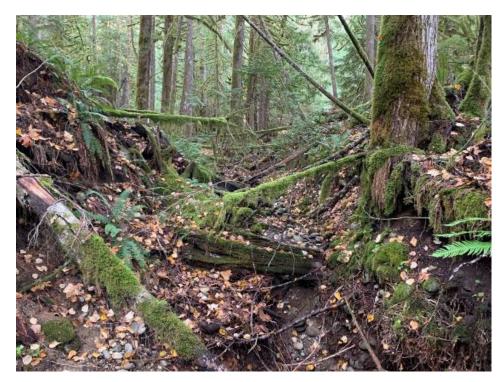
Photo 2. Tailrace, facing upstream (south). Aside from the pool near the powerhouse, no surface flow was observed in the tailrace during the field investigation in November 2023.

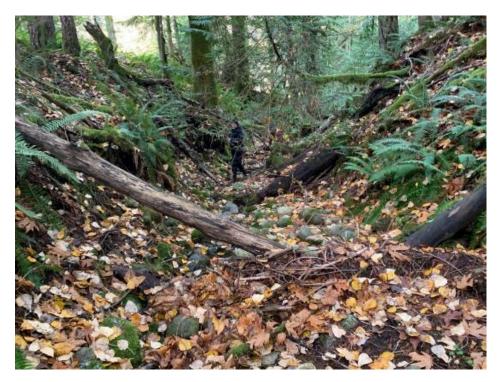
Photo 3. Tailrace, facing downstream (north). Aside from the pool near the powerhouse, no surface flow was observed in the tailrace during the field investigation in November 2023.

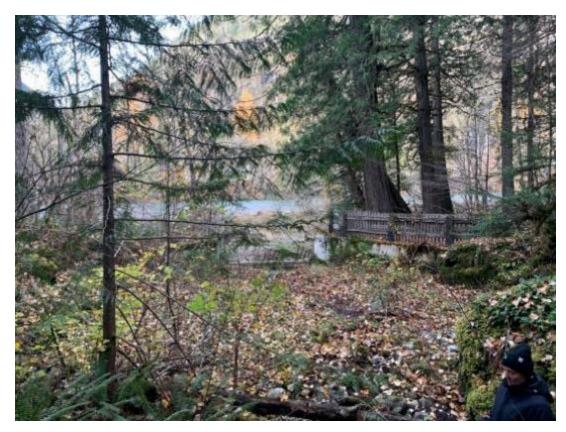
Photo 4. Northernmost extent of the tailrace, facing downstream (north) towards the tailrace barrier with the Skagit River visible in the background. In the portion of the tailrace pictured above, the tailrace channel narrows to approximately 4 to 6 feet wide and disperses into a relatively flat, rocky area.

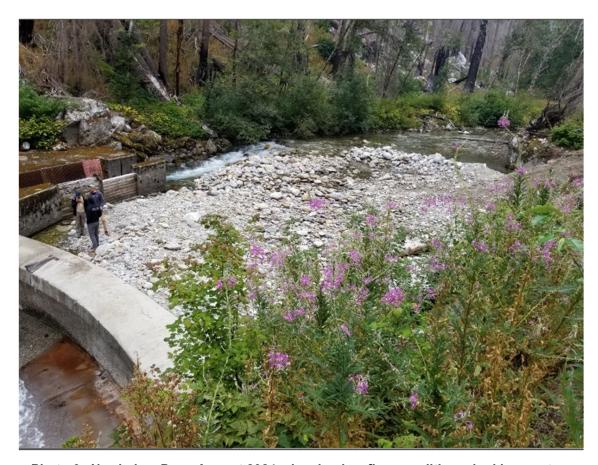
Photo 6. Newhalem Dam, August 2024, showing low flow conditions, looking upstream.

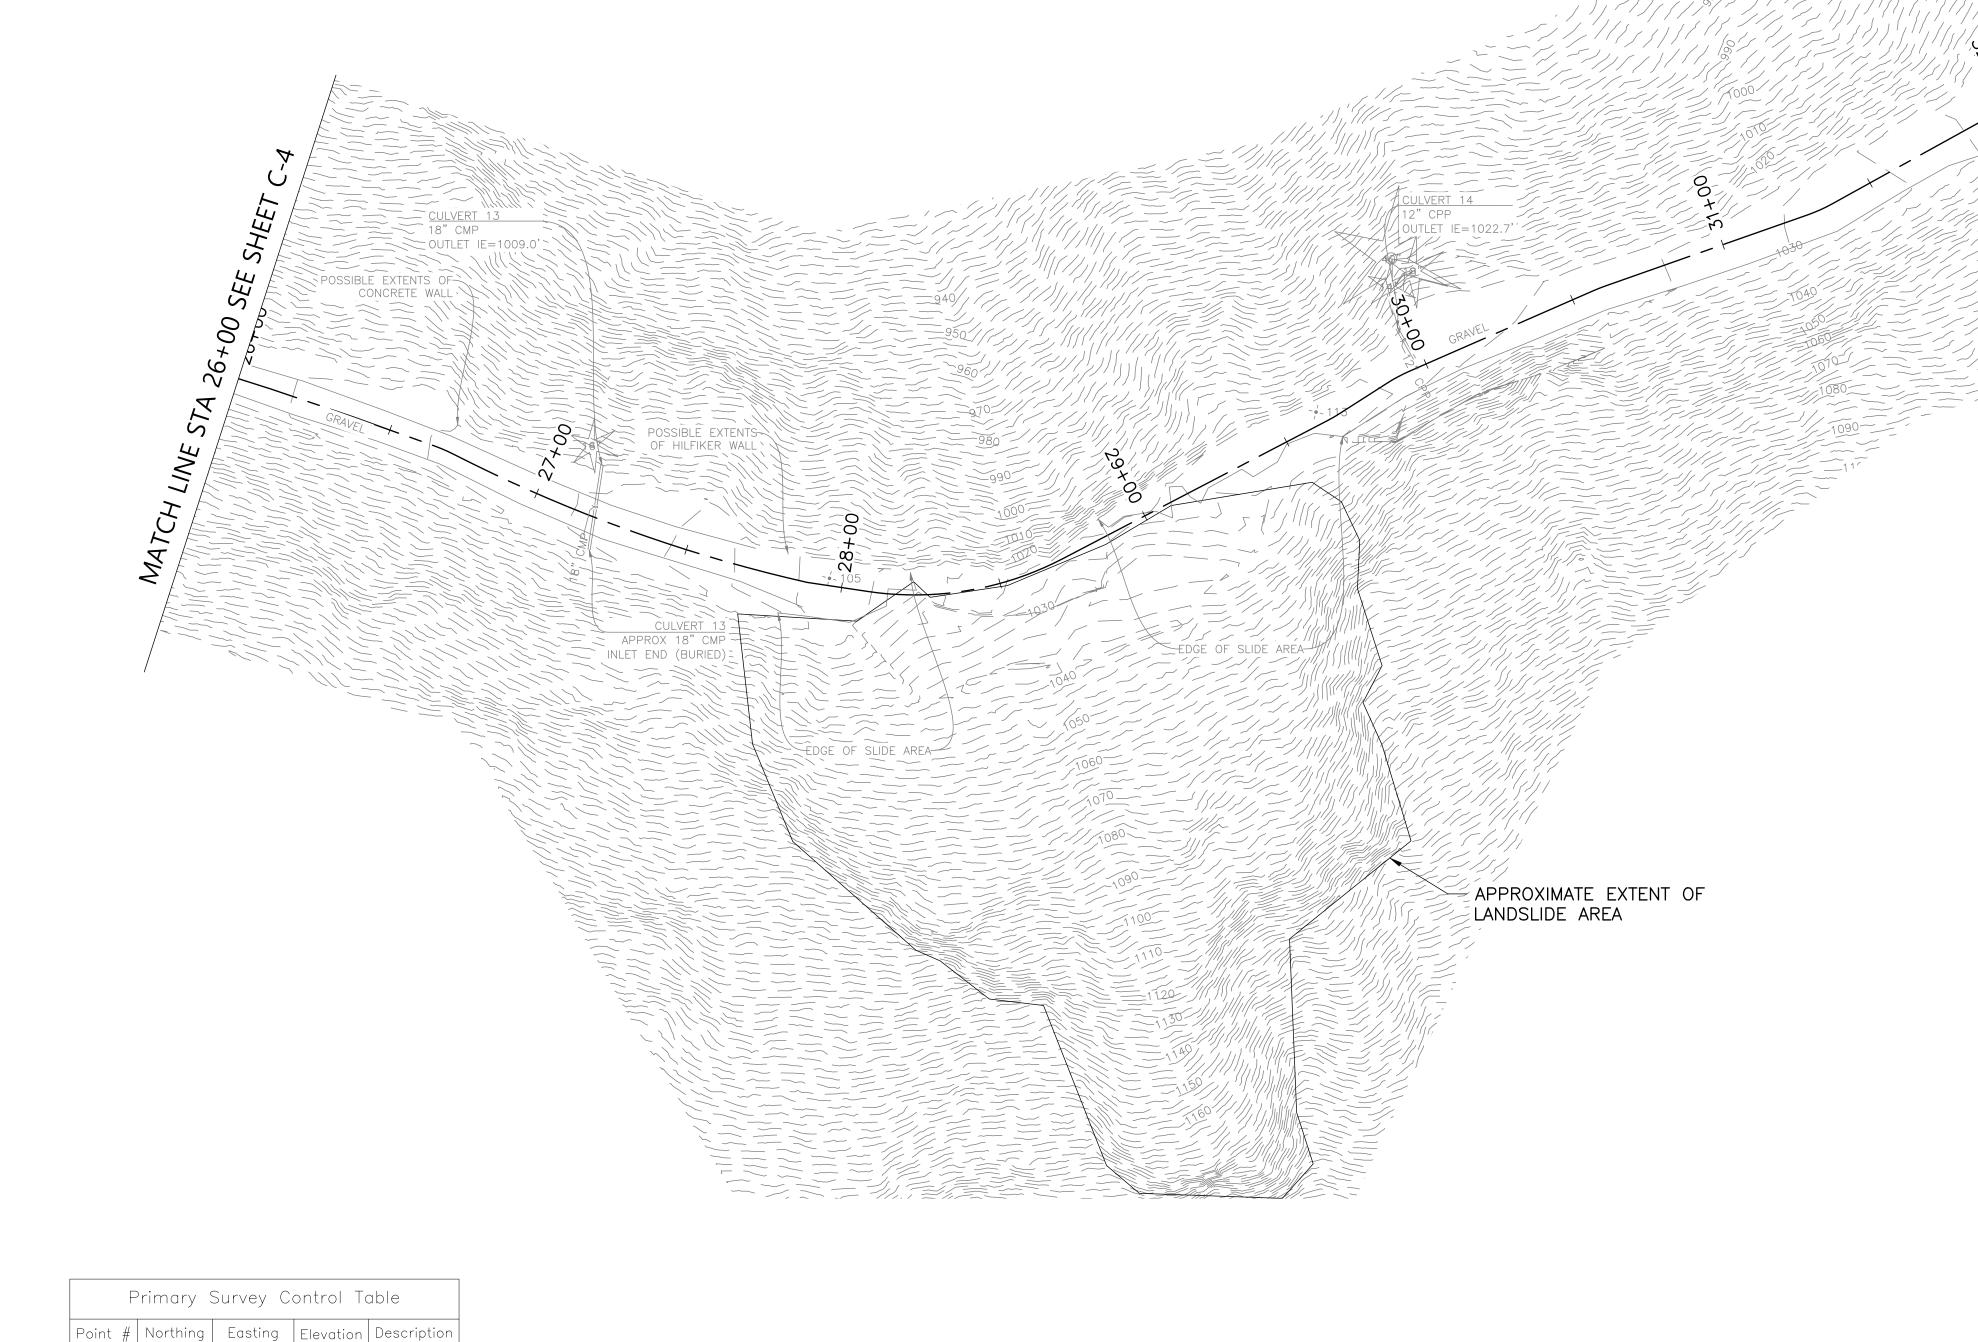
- 1. EXISTING SITE TOPOGRAPHY CONSISTS OF TOPOGRAPHIC SURVEY AND LIDAR DATA SOURCES INCLUDING: 2023 TOPOGRAPHIC SURVEY BY 1 ALLIANCE, 2022 TOPOBATHYMETRIC LIDAR FLOWN BY NV5, AND 2017 TERRESTRIAL LIDAR FLOWN BY QUANTUM SPATIAL.
- 2. TOPOGRAPHIC SURVEY DATA COLLECTED IN SEPTEMBER THROUGH DECEMBER 2023 BY 1 ALLIANCE.
- 3. APPROXIMATE LIMITS OF LANDSLIDE AREA BASED UPON INTERPRETATION OF 2022 LIDAR DATA.

In the upper portion of the project area, access to the dam would need to be re-established, requiring some repairs to Newhalem Creek Road between Station 12+00 and Station 40+20 (30% Design Plan Sheets C-3 to C-6). A landslide that currently blocks the road at Station 29+00 would require repairs to improve slope stability and the roadbed structure for safety and short-term access through the landslide area (Sheet C-18). Work in the landslide area may include the following:

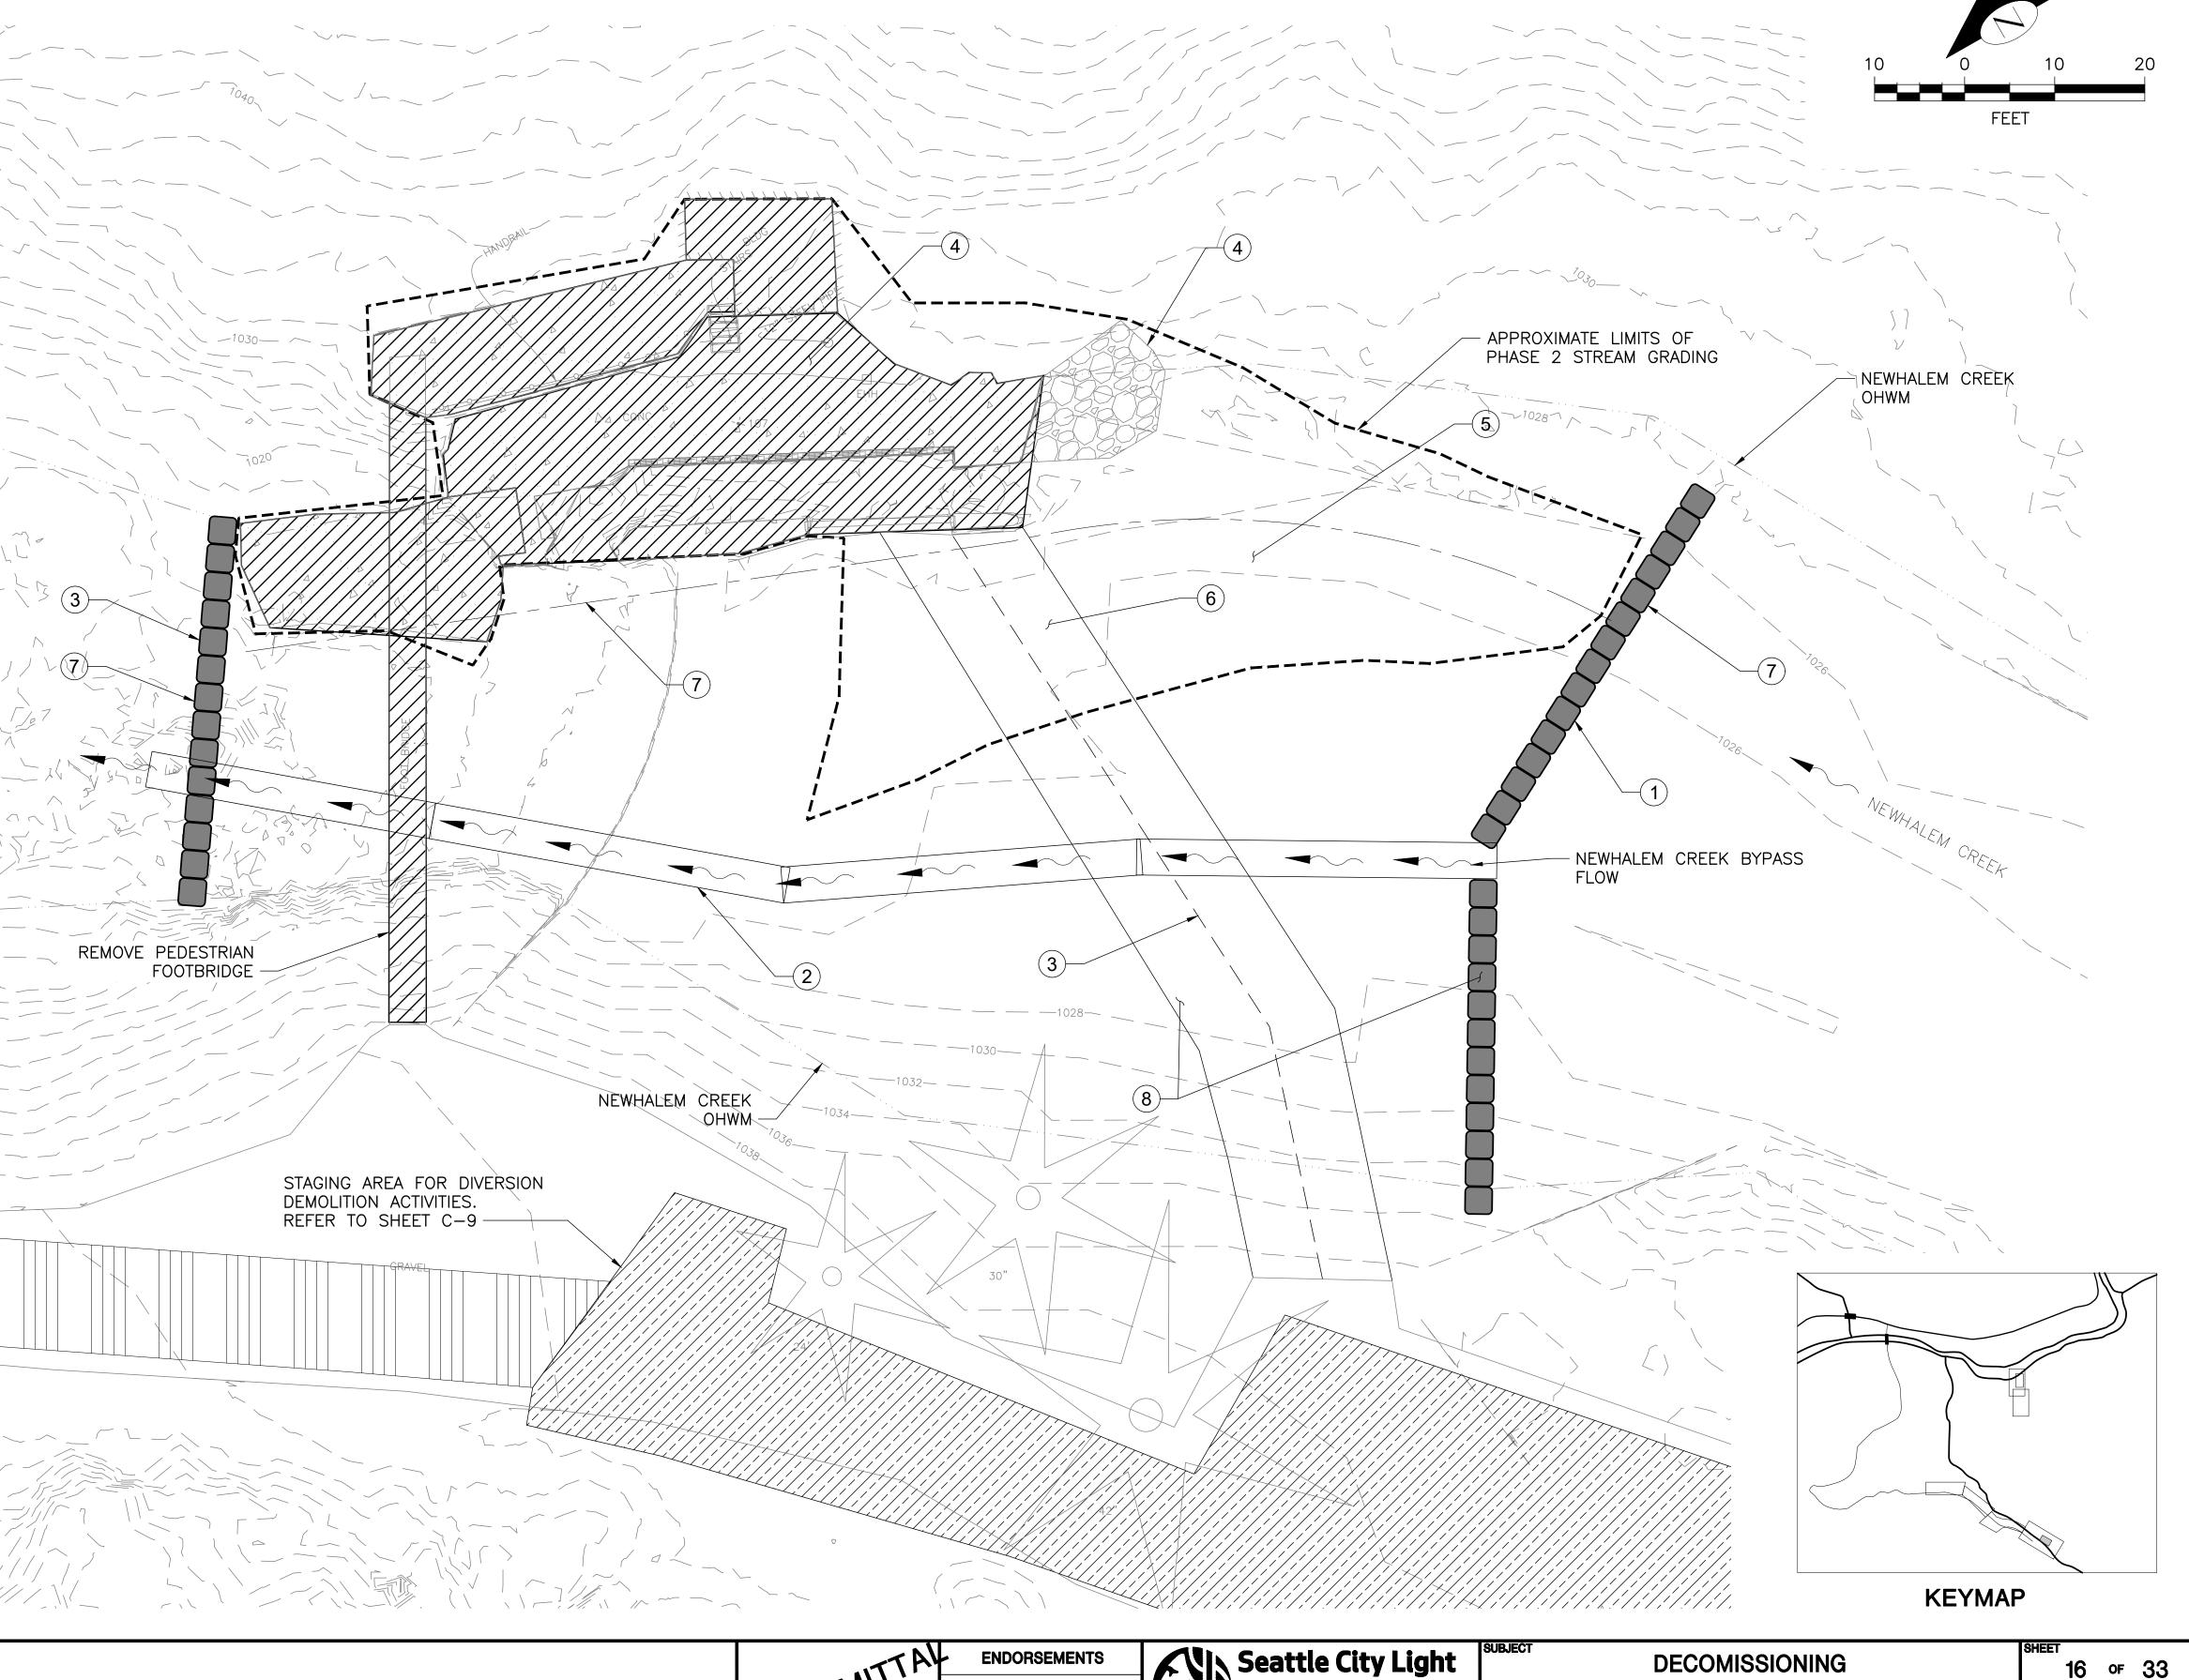
EXAMPLE TEMPORARY STREAM DIVERSION SEQUENCING - PHASE 2

- INSTALL COFFER DAM CONSISTING OF SUPERSACKS FILLED WITH NATIVE STREAMBED MATERIAL. MINOR CHANNEL GRADING ANTICIPATED TO ESTABLISH TEMPORARY STREAM DIVERSION.
- INSTALL TEMPORARY CULVERTS, MIN. DIA 48 INCHES.
- 3 CONSTRUCT ACCESS ROAD TO DIVERSION INTAKE STRUCTURE
- REMOVE REMAINING HEADWORKS INFRASTURUCTURE AND SEAL VERTICAL POWER TUNNEL. REFER TO SHEETS C-7 AND C-8.
- 5 PERFORM CHANNEL EXCAVATION TO ESTABLISH PROPOSED NEWHALEM CREEK CHANNEL.
- 6 REMOVE ACCESS ROAD AND COMPLETE GRADING WITHIN LIMITS OF NEWHALEM CREEK CHANNEL GRADING
- REWATER COMPLETED NEWHALEM CREEK CHANNEL IN A GRADUAL, CONTROLLED MANNER BY REMOVING DOWNSTREAM AND THEN UPSTREAM COFFERDAMS
- REMOVE REMAINING TEMPORARY STREAM DIVERSION MATERIALS AND RESTORE CHANNEL BANKS TO PRE-CONSTRUCTION GRADE.

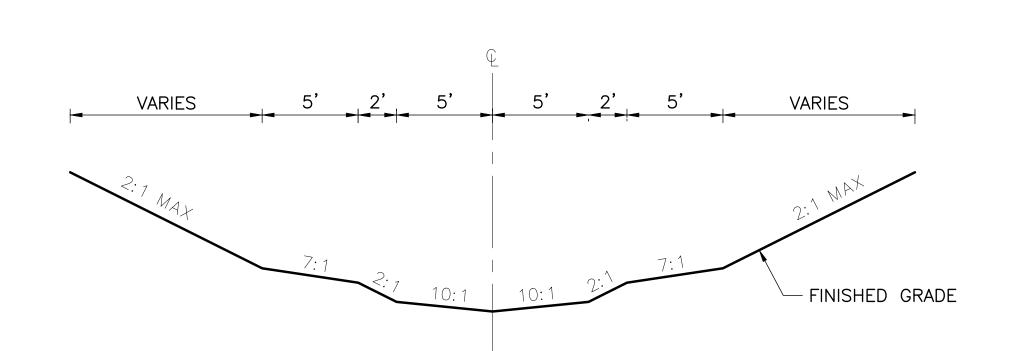
NEWHALEM CREEK TYPICAL CHANNEL SECTION 1
SCALE: 1"=5"

1. ELEVATION OF OHWM ACROSS CHANNEL APPROXIMATE; OHWM ALONG RIGHT AND LEFT BANKS DELINEATED IN THE FIELD.
