## Request for Clean Water Act Section 401 Water Quality Certification Washington State Department of Ecology

The current license for the Newhalem Creek Hydroelectric Project (FERC No. 2705) expires on January 31, 2027. As noted above, repair and maintenance costs make it impractical to continue to operate the project and City Light has decided not to seek a new license but rather surrender the license for the Newhalem Creek Hydroelectric Project and proposes to decommission it as described herein.

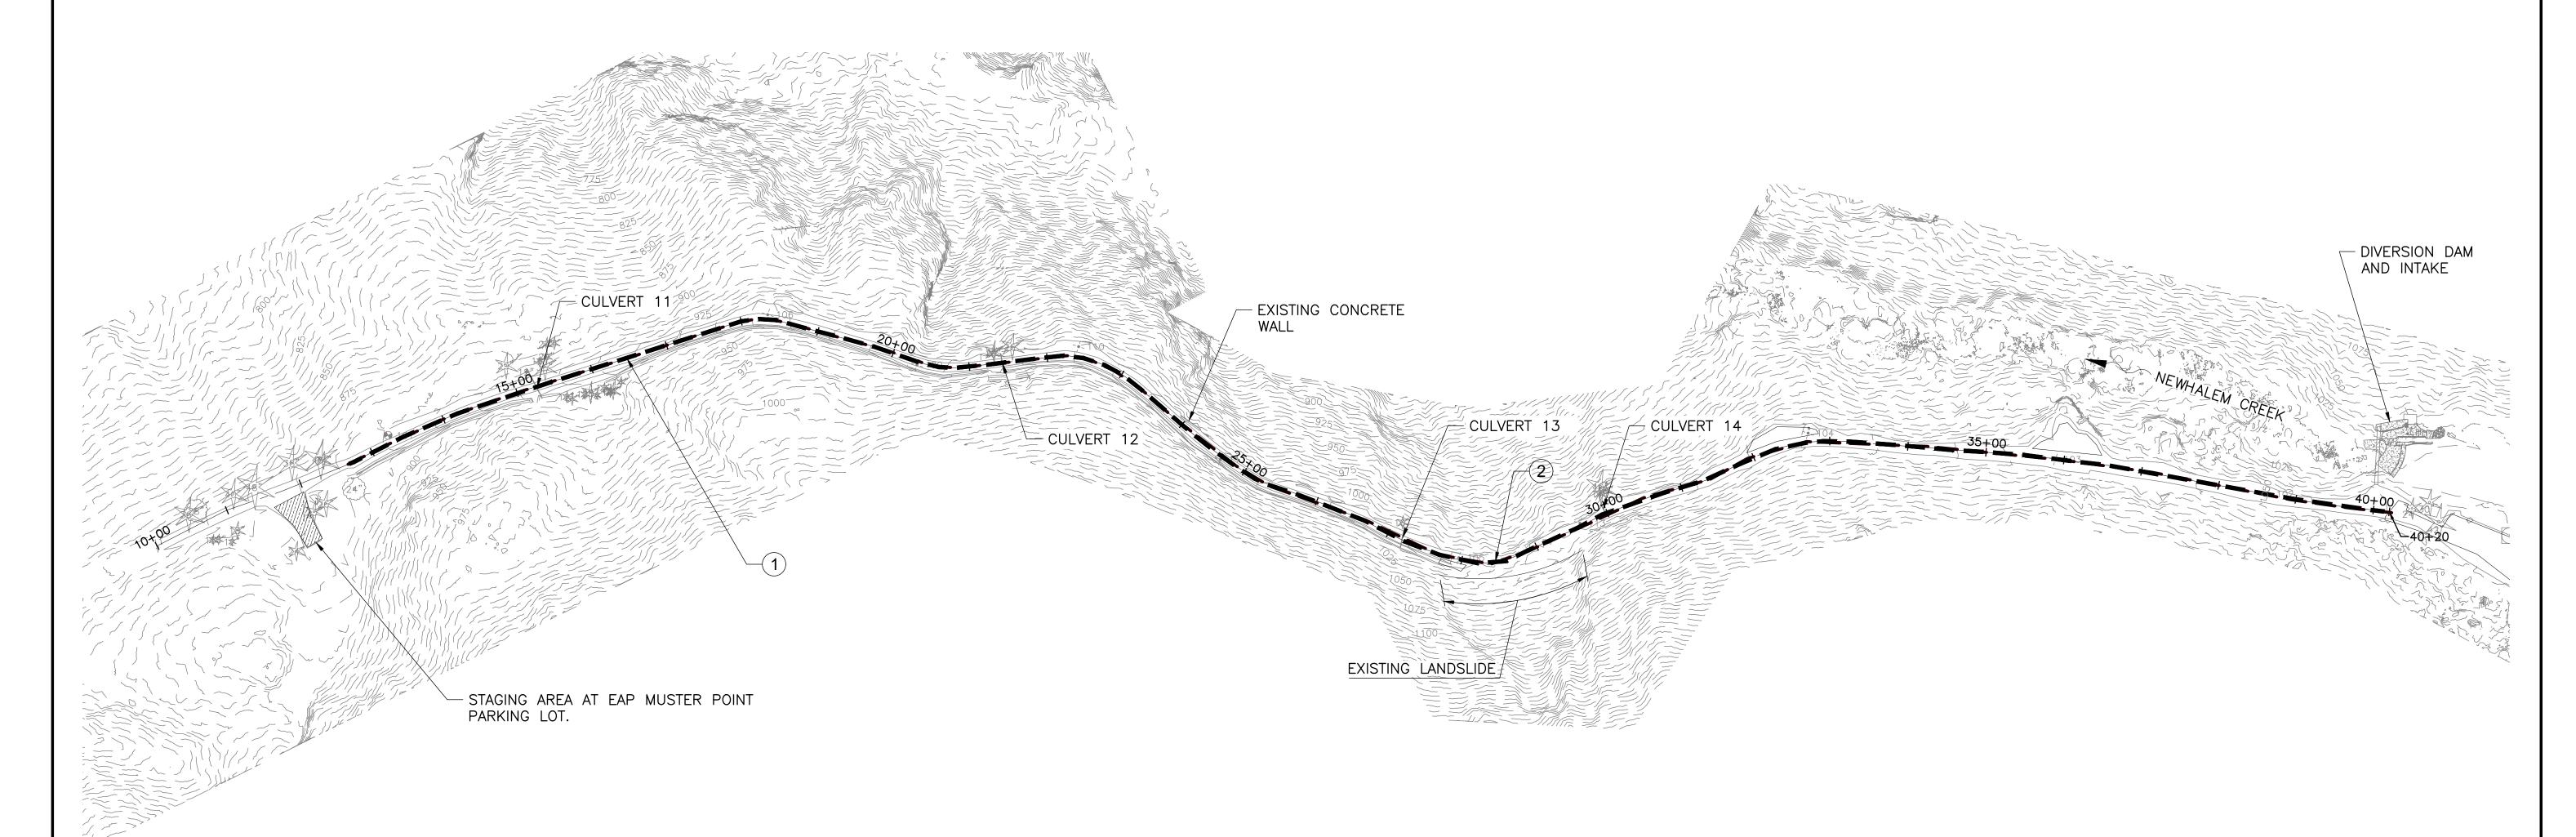
EXISTING	EXISTING ACCESS ROAD FEATURES				
STATION	FEATURE				
15+25.5	CULVERT 11: 24-INCH CMP				
21+42.3	CUVLERT 12: 18-INCH CMP				
26+30.9	BEGINNING OF CONCRETE WALL				
26+68.7	END OF CONCRETE WALL				
27+19.4	CULVERT 13: 18-INCH CMP				
27+82.2	BEGINNING OF LANDSLIDE				
29+66.2	END OF LANDSLIDE				
30+00	CULVERT 14: 12-INCH CPP				
40+00	DIVERSION DAM AND INTAKE

- 1 ESTABLISH ACCESS ALONG EXISTING ROADWAY, MINOR ROADWAY GRADING AND CLEARING OF VEGETATION ANTICIPATED.
- 2 CONTRACTOR SHALL CLEAR EXISTING LANDSLIDE DEBRIS TO ESTABLISH SAFE ACCESS TO DIVERSION DAM SITE. SEE DETAILS ON SHEET C-21.

In the upper portion of the project area, access to the dam would need to be re-established, requiring some repairs to Newhalem Creek Road between Station 12+00 and Station 40+20 (30% Design Plan Sheets C-3 to C-6). A landslide that currently blocks the road at Station 29+00 would require repairs to improve slope stability and the roadbed structure for safety and short-term access through the landslide area (Sheet C-18). Work in the landslide area may include the following:

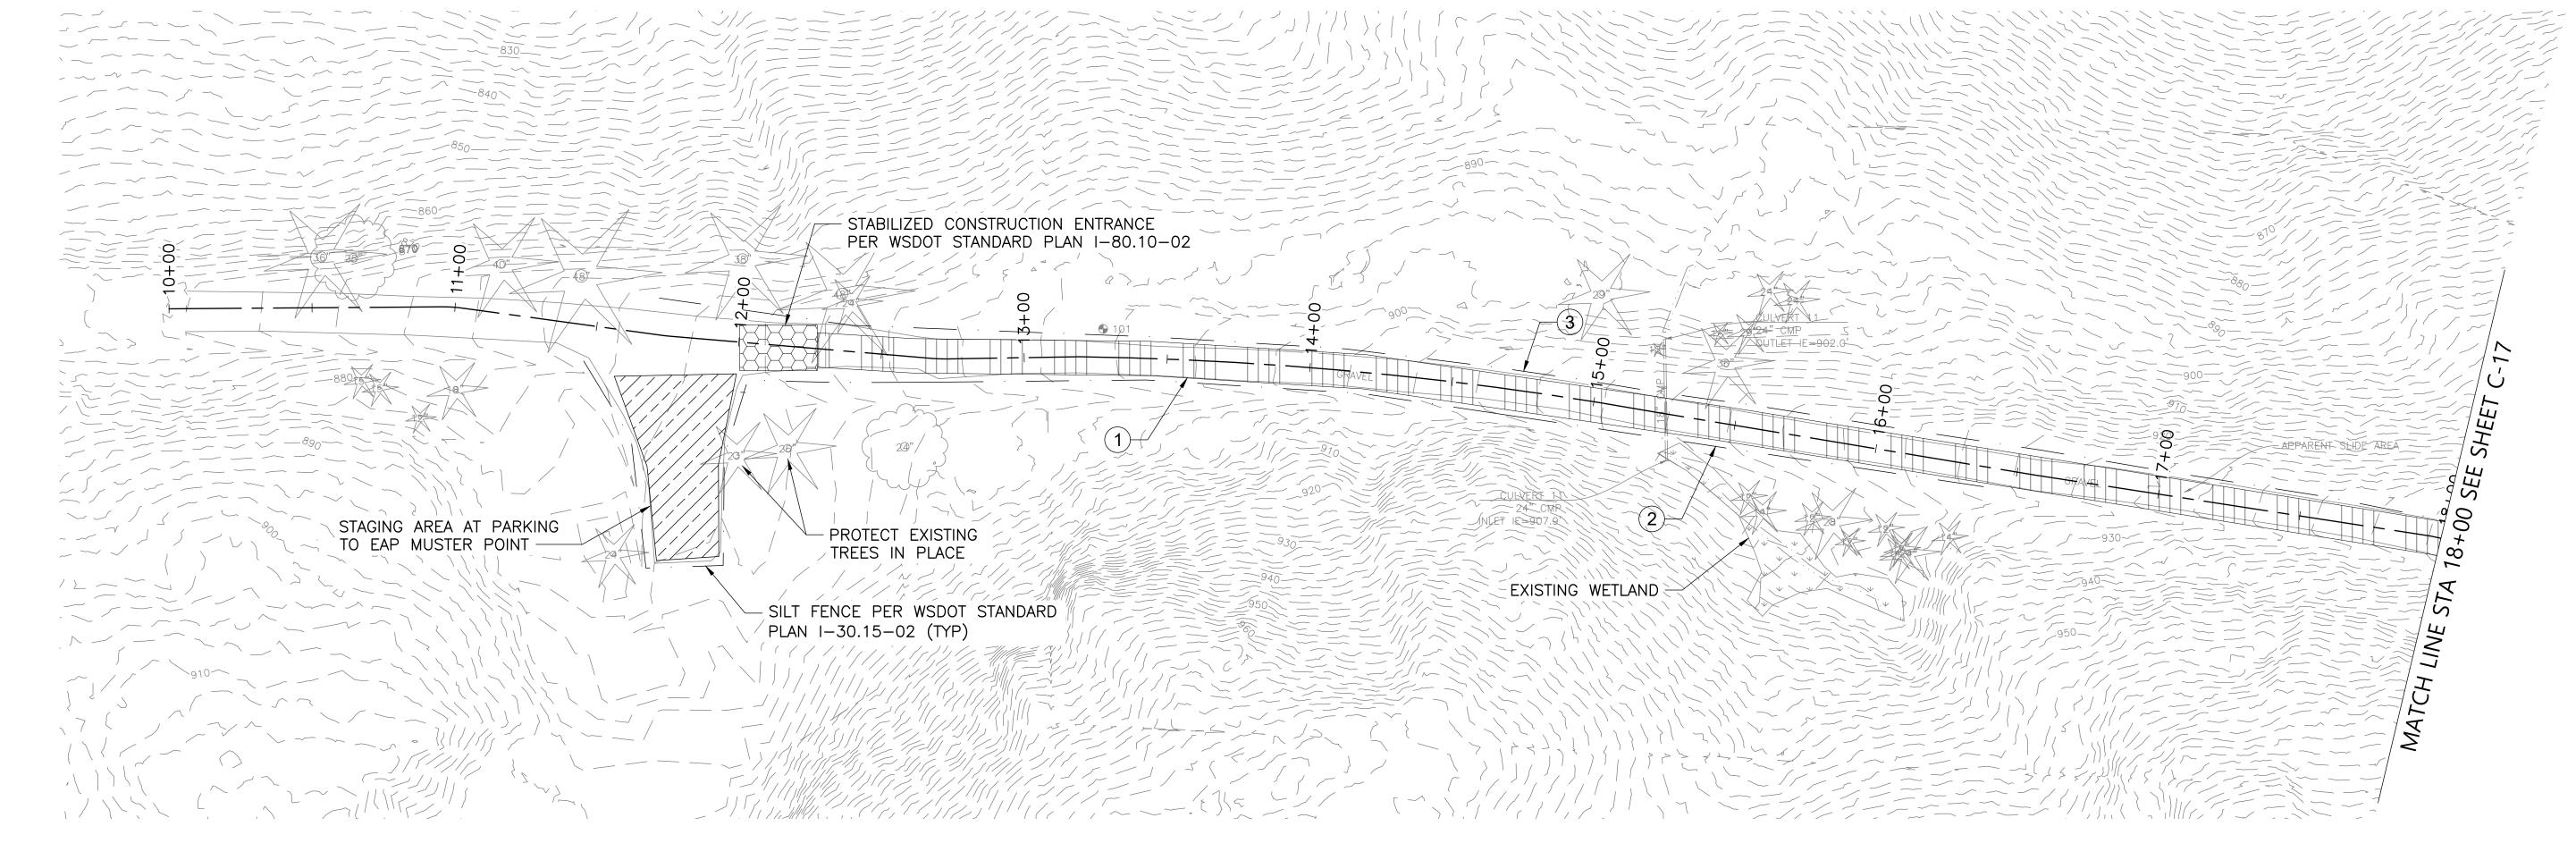
- 1 ESTABLISH ACCESS ALONG EXISTING ROADWAY, MINOR ROADWAY GRADING AND CLEARING OF VEGETATION ANTICIPATED.
- 2 INSTALL SILT FENCE ALONG ROADWAY ADJACENT TO EXISTING WETLAND.
- (3) INSTALL SILT FENCE ALONG DOWNSLOPE EDGE OF ROADWAY.

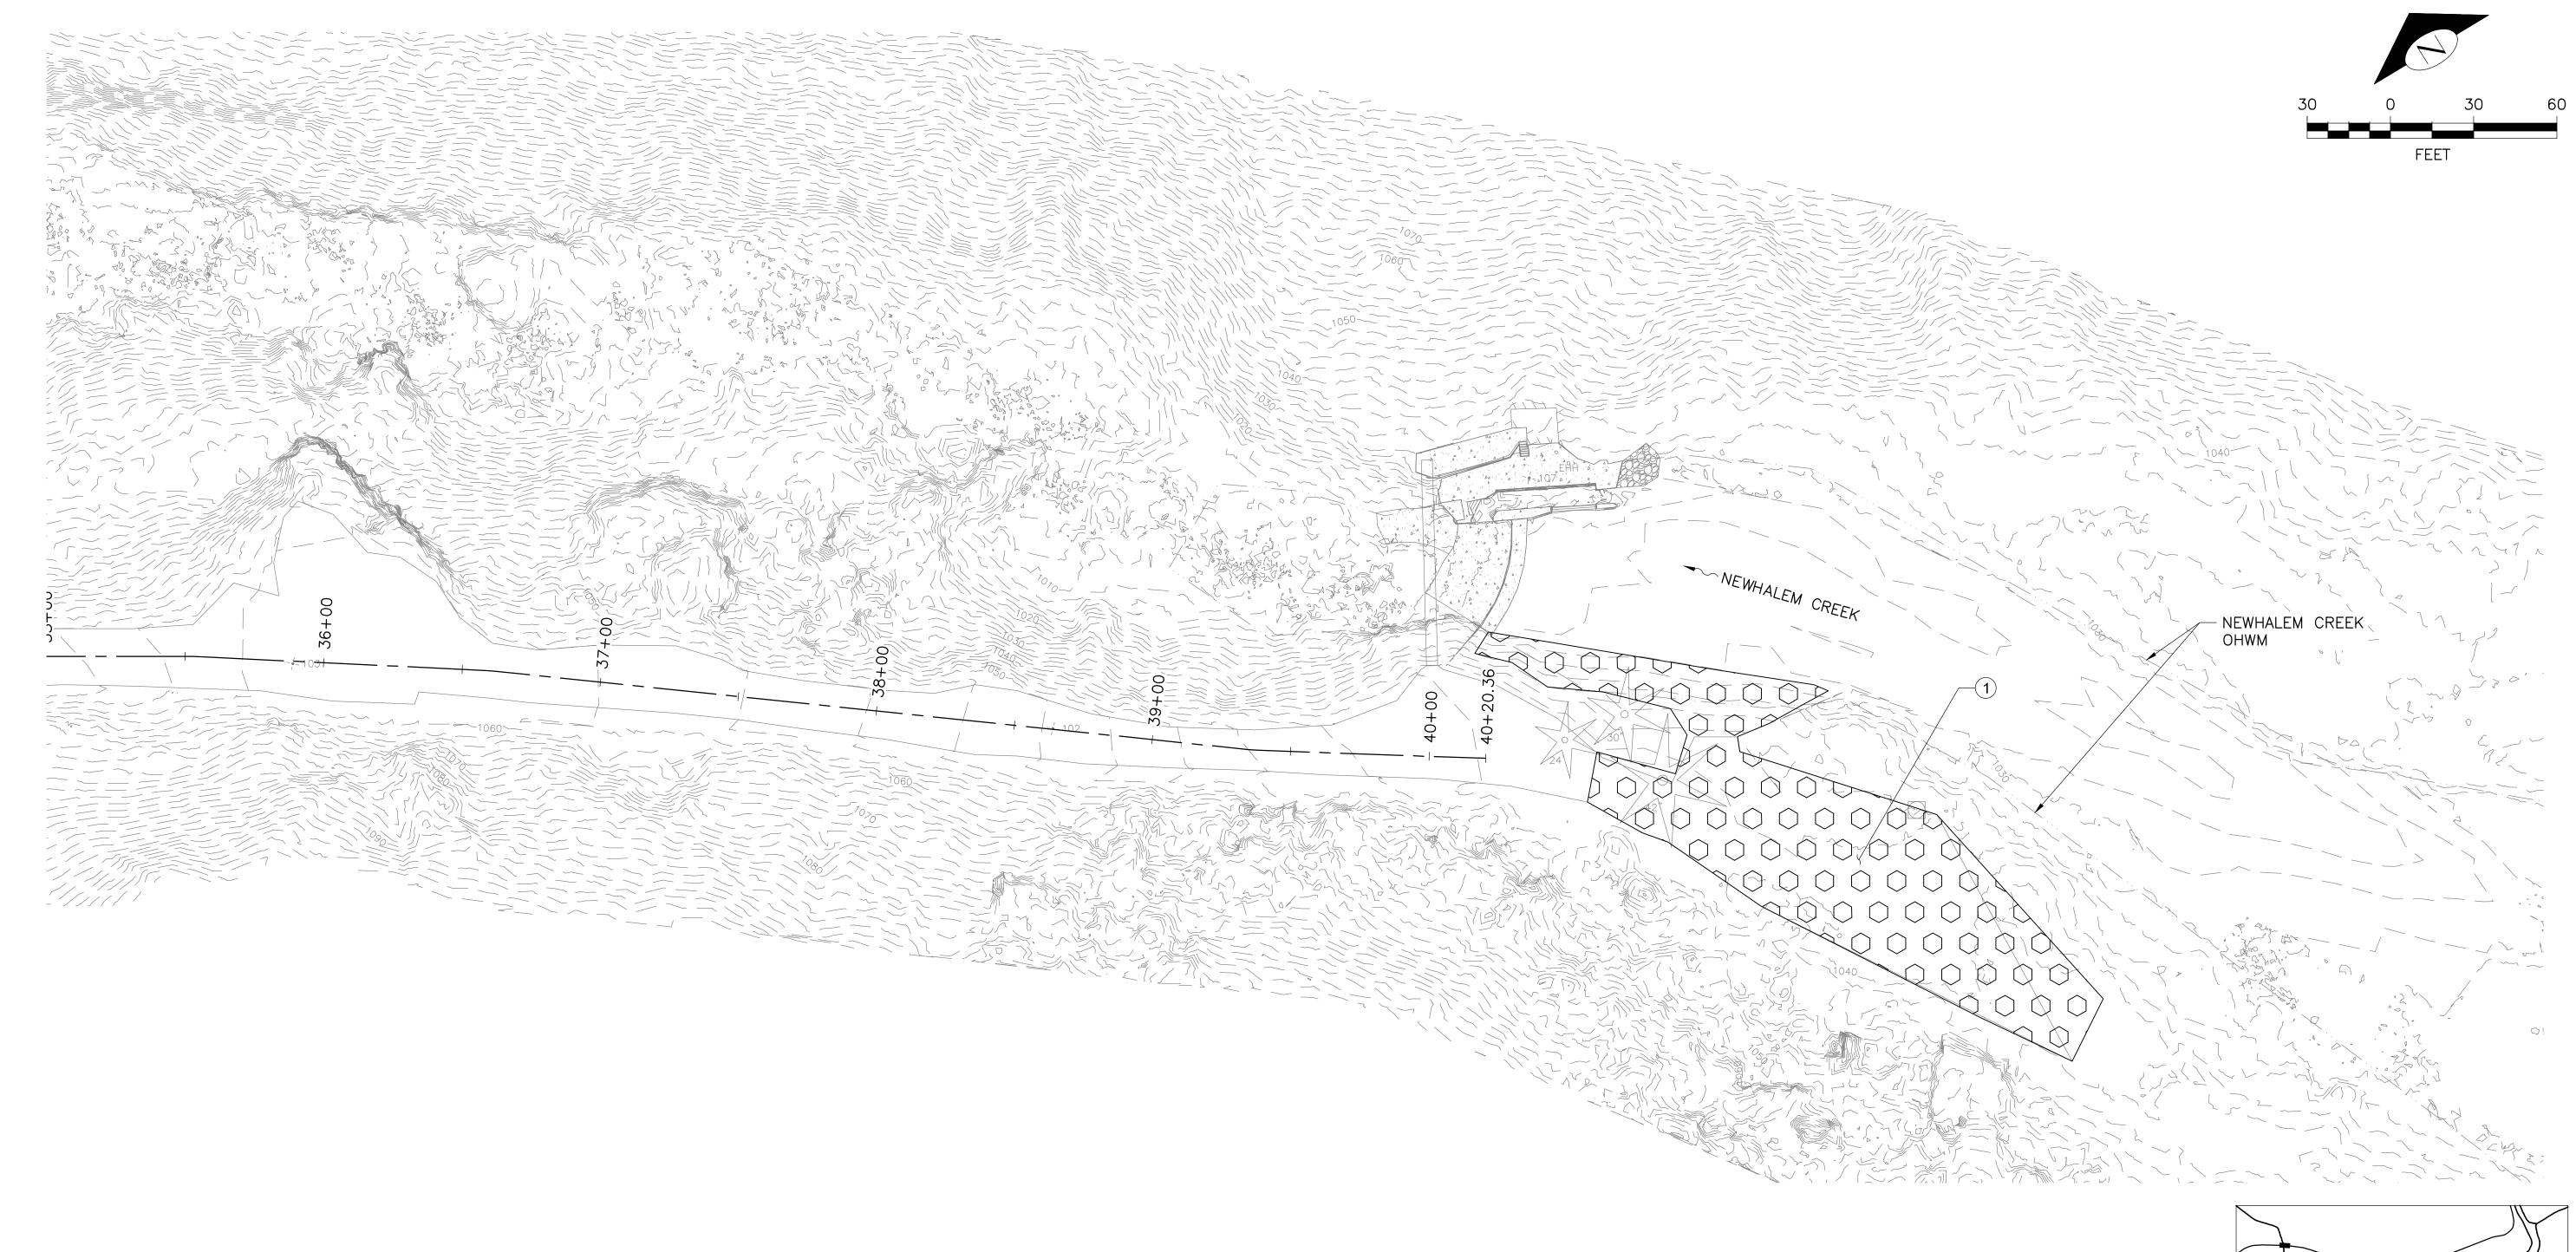
- 1. ROUGHEN AND LOOSEN WITH AN EXCAVATOR TO CREATE MICROTOPOGRAPHY THAT WILL FACILITATE NATURAL REGENERATION OF NATIVE RIPARIAN FOREST VEGETATION THROUGH MONITORED NATURAL SUCCESSION.
- 2. MONITOR NATURAL SUCCESSION PROCESSES AND CONSIDER COLLECTING AND SOWING SEED OF SELECTED NATIVE TREES AND SHRUBS TO AUGMENT NATURAL SUCCESSION PROCESSES.
- 3. A RESTORATION AND INVASIVE SPECIES MANAGEMENT PLAN IS BEING DEVELOPED IN COLLABORATION WITH THE NPS, TRIBES, NATURAL RESOURCE MANAGEMENT AGENCIES AND OTHER INTERVENORS.

After the headworks are removed, the gravel staging area would be restored by roughening and loosening with an excavator to create a pit and mound topography like that found in natural mature forests in the Pacific Northwest. This roughening and loosening method (Polster 2013) is commonly used on heavily disturbed industrial sites and has been used effectively by City Light and other restoration practitioners to facilitate natural succession and regeneration of desirable native forest types on earthen dams, mine sites, and abandoned roads. Restoration of native forest vegetation types will rely primarily on natural succession processes such as transport of native plant seed by hydrochory (water), wind, and animal dispersal mechanisms. Natural succession of native riparian and upland forest types found in adjacent undisturbed areas will be monitored and invasive species controlled as documented in a restoration and invasive species management plan being developed in collaboration with the NPS, Tribes, natural resource management agencies and other intervenors.

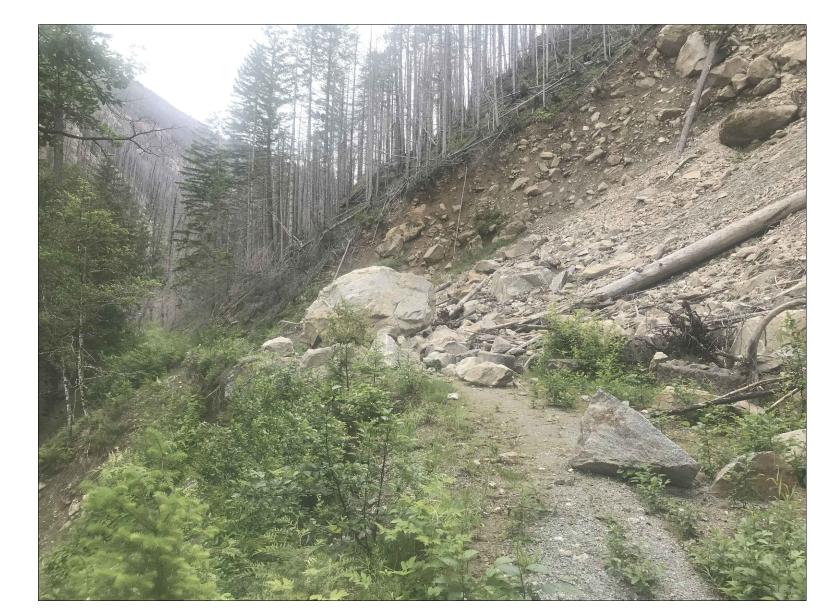
TYPICAL LANDSLIDE DEBRIS

- 1. CONTRACTOR SHALL BE SOLELY RESPONSIBLE FOR SITE SAFETY IN ESTABLISHING AND MAINTAINING A SAFE WORK AREA DURING MOBILIZATION, CONSTRUCTION ACTIVITIES AND
- 2. PRIOR TO CONSTRUCTION ACTIVITIES, CONTRACTOR WILL SUBMIT A TEMPORARY ROCKFALL PROTECTION PLAN TO ESTABLISH SAFE ACCESS THROUGH THE LANDSLIDE AREA FOR THE
- DURATION OF CONSTRUCTION FOR APPROVAL BY THE ENGINEER.

3. SCALING OF LARGE LANDSLIDE BOULDERS ON THE EXISTING HILLSLOPE SHALL BE ANTICIPATED BY THE CONTRACTOR.

4 ESTABLISH A CLEAR AREA FOR CONSTRUCTION TRAFFIC. WORK SHALL REQUIRE RELOCATION OF 10-FOOT DIAMETER BOULDERS. CONTRACTOR MAY USE NON-EXPLOSIVE CRACKING METHODS TO REDUCE BOULDER SIZE.

- Clearing material from the roadway, including using a non-explosive cracking agent to break apart the largest boulders.
- Using some or all the cleared material to construct a protective berm as a barrier between the road and the slope above the road.
- Scaling the slope above the road to remove hazard rocks, which may involve the use of small explosives. A few scaled rocks may pass over the road and reach Newhalem Creek.

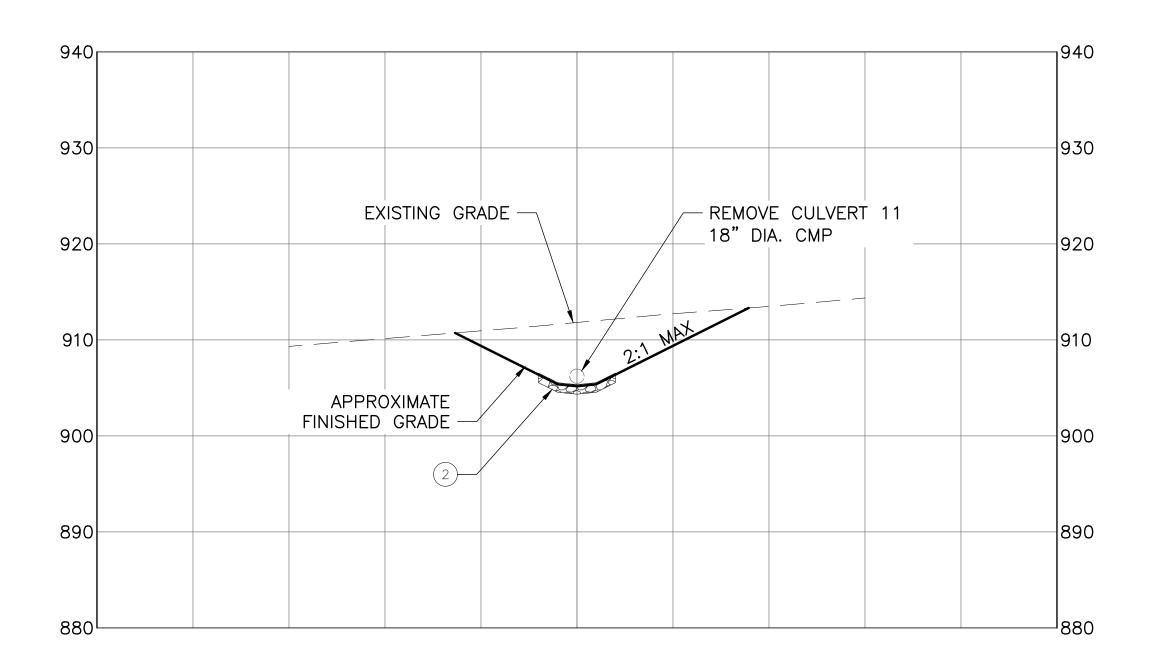
CULVERT 11 REMOVAL TYPICAL SECTION (A) SCALE: 1" = 10'

- 1. CULVERT 11 REMOVAL AND STREAM GRADING SHALL BE PERFORMED FOLLOWING THE COMPLETION OF ALL DECOMMISSIONING, SPOILS REMOVAL, AND RESTORATION ACTIVITIES AT THE DIVERSION DAM SITE.
- (2) PLACE SALVAGED STREAMBED MATERIAL FROM NEWHALEM CREEK TO ACHIEVE FINISHED GRADE.
- (3) INSTALL PUMPED TEMPORARY STREAM DIVERSION.

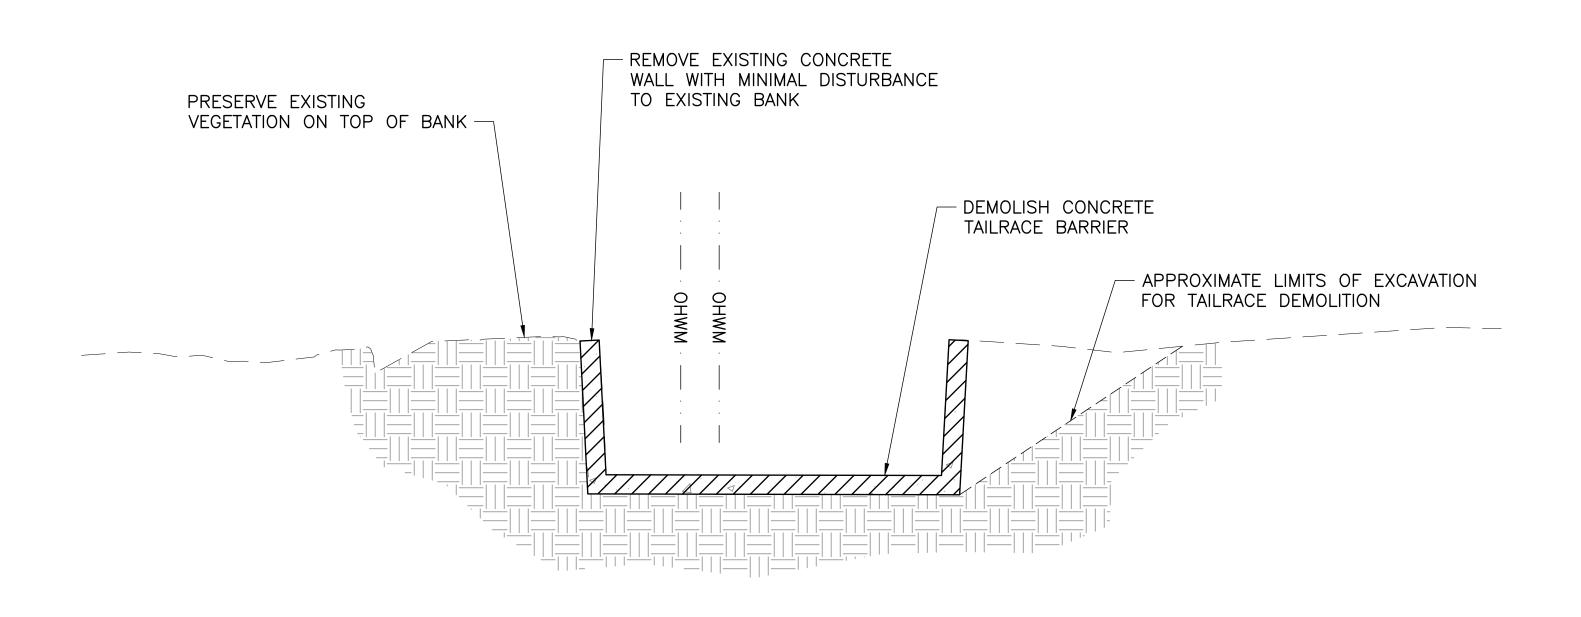
BARRIER WALL ELEV. 489.2—— WEIR ELEV. 485.2 ——— DEMOLISH CONCRETE ELEV. 482.2 — TAILRACE BARRIER - RIP RAP REMOVE ANY ANGULAR RIPRAP ENCOUNTERED DURING TAILRACE REMOVAL OR AS OTHERWISE EXCAVATE AS NEEDED TO REMOVE CONCRETE FOOTINGS DIRECTED BY THE ENGINEER. —

SECTION SHOWN IS LOCATED COMPLETELY WITHIN OHWM.

Tailrace Creek downstream of the powerhouse would be retained because it is part of the existing intermittent stream. However, the concrete tailrace fish barrier and apron would be demolished using an excavator-mounted jackhammer, possibly assisted by a non-explosive cracking agent, concrete saw, and/or waterjet cutter. The tailrace barrier consists of approximately 99 CY of reinforced concrete. City Light would develop BMPs to ensure that concrete dust is controlled. Dump trucks would transport the concrete debris and rebar to an appropriate disposal site or recycling facility. Additionally, the riprap associated with the tailrace barrier would be removed, as would the concrete viewing platform. The approximate 60-ft-long spur trail from the Trail of the Cedars would be restored and the tailrace fish barrier site would be regraded and restored to provide for high-flow fish refugia (see submitted 30% design plan Sheets C-26 to C-28). The temporary access route used to install the tailrace barrier is still evident and would be restablished (see submitted 30% design plan Sheet C-25). Re-establishment of this temporary access minimizes the number of trees and other riparian vegetation that would need to be removed. A thick layer of hog fuel or wood chip mulch is proposed to be used to preserve the
