# Prefontaine Fountain

## 90% Design Presentation

# PREFONTAINE FOUNTAIN & SURROUNDING OPEN SPACE REHABILITATION

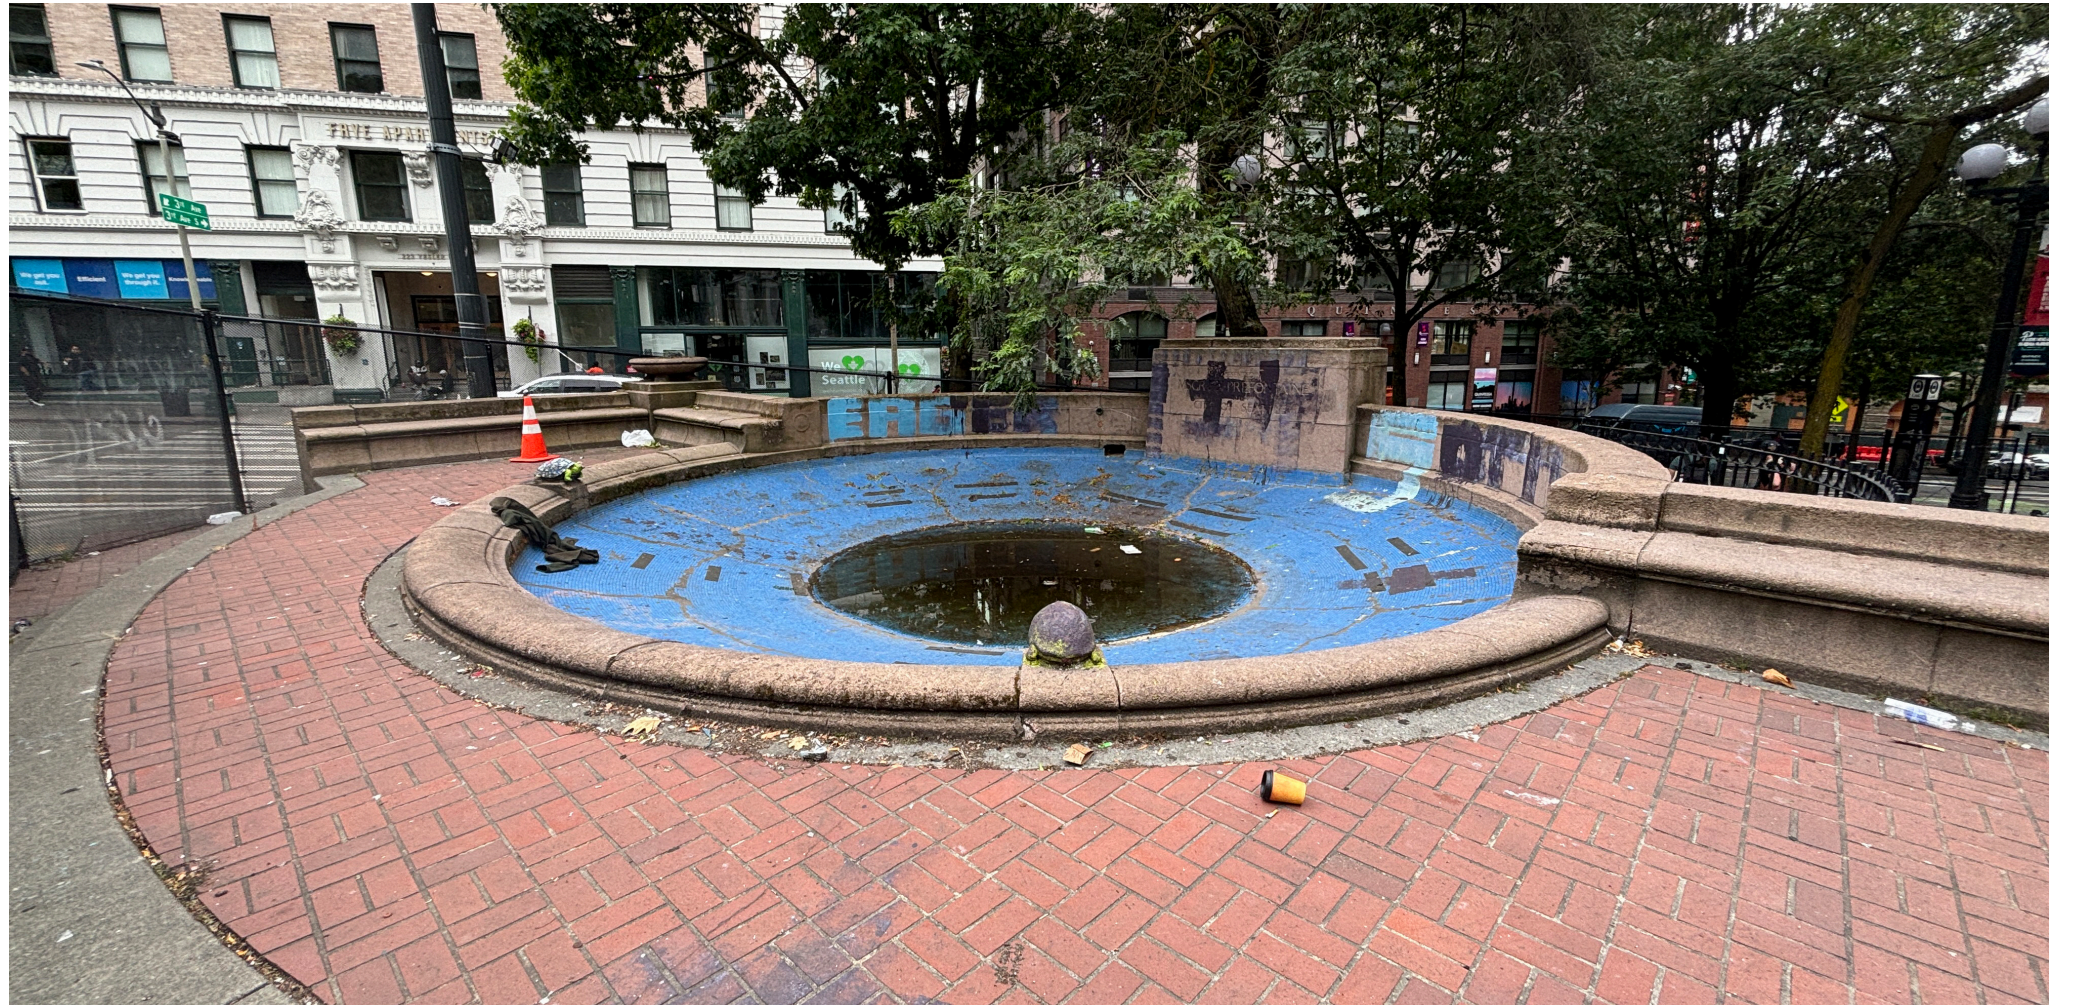
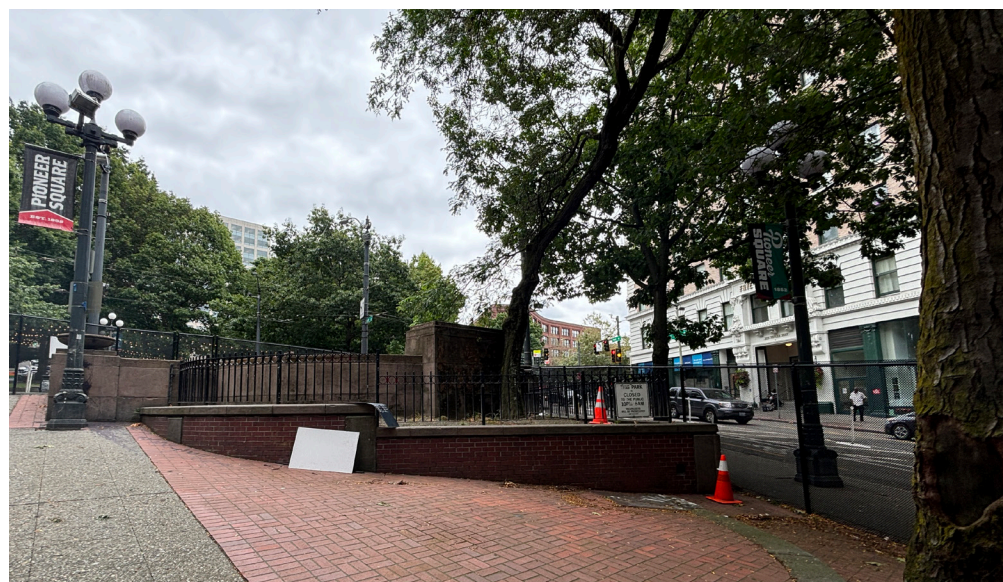
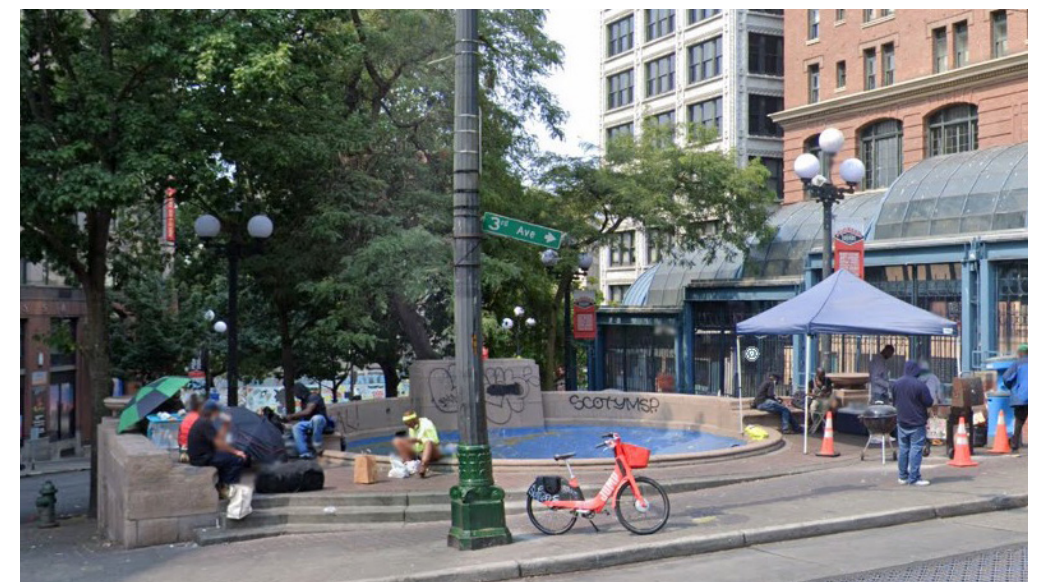
2. Wall heights in combination with street slopes create hiding spots and lack of visibility.
3. Fountain bowl feature encourages garbage accumulation.
4. Fountain in its current position is most susceptible for vandalism and vagrancy.

5. Existing structure blocks access through the site, causing users to avoid the area.
6. Re-establish community investment in the space.
7. Original turtles are broken and are not suitable vandal-resistant elements.
8. Opportunity for new commemorative plaque.
9. Three trees internal to the Prefontaine Place property are in poor health condition and must be removed. Opportunity for one new tree(TBD). Street trees to remain.

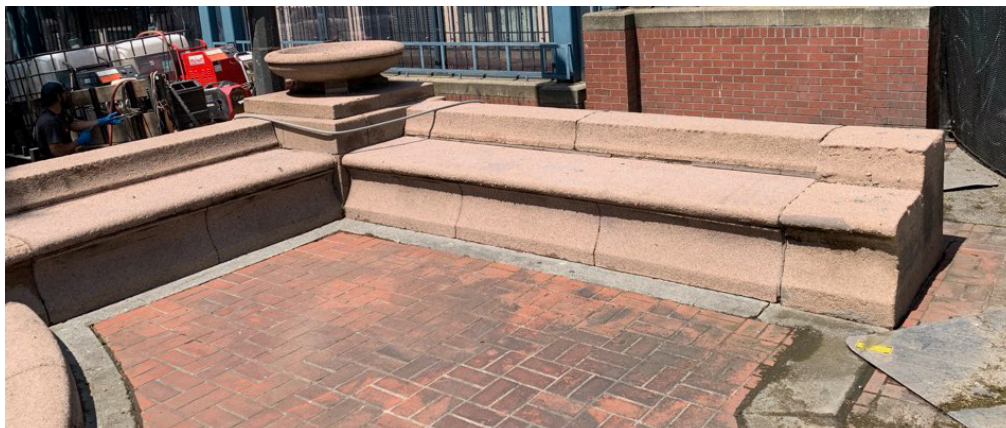
Fountain cleaning and evaluation has been completed to identify where the cast stone is in need of repairs. At this time, no pieces needing in kind replacement have been identified.

- Routing out 100% of the mortar joints on the pre-cast fountain to a depth of 3/4 of an inch.
- Flushing joints with water to remove all dust and debris.
- Tuck point 100% of mortar joints using Type N mortar. Mortar color, texture and tooling to match existing.
- Route out cracks in the pre-cast fountain to a width and depth of 1/4 inch minimum; install new patch.
- Square cut the perimeter of any spalls to a depth of 1/4 inch minimum and prep surface per Cathedral Stone Jahn repair mortar specification; install new patch.
- Lightly clean new tuck pointing using Prosoco Safety Klean.

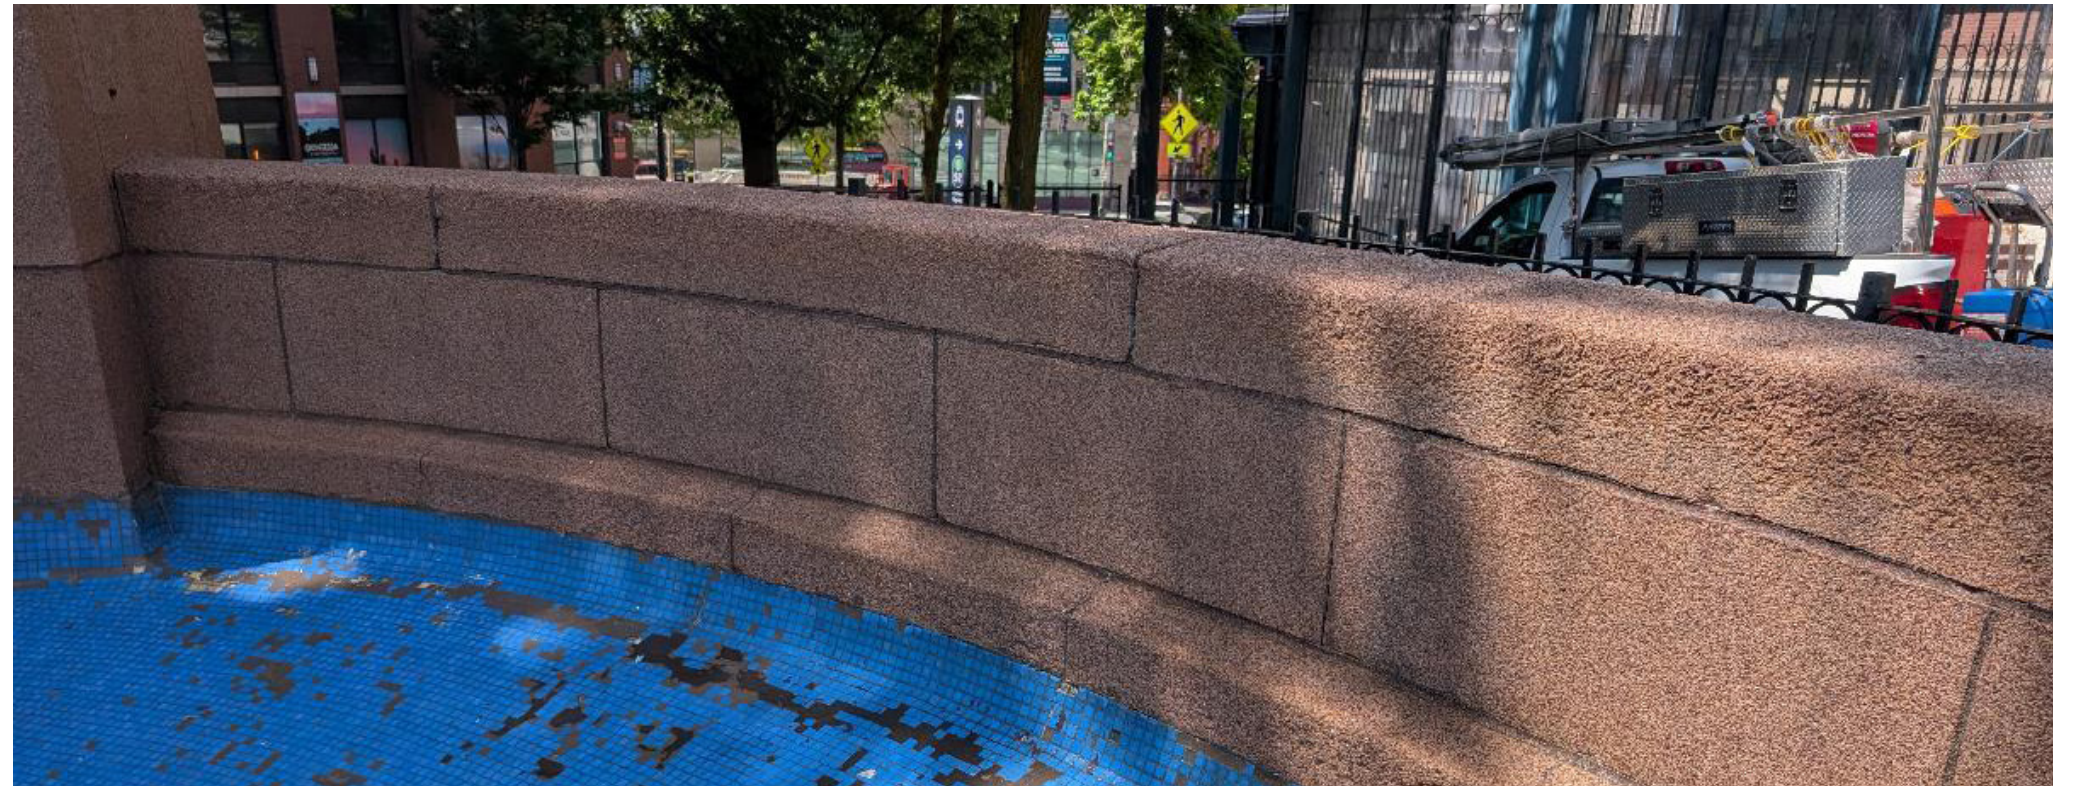
Cleaned Fountain Back Wing Wall - North of Monument

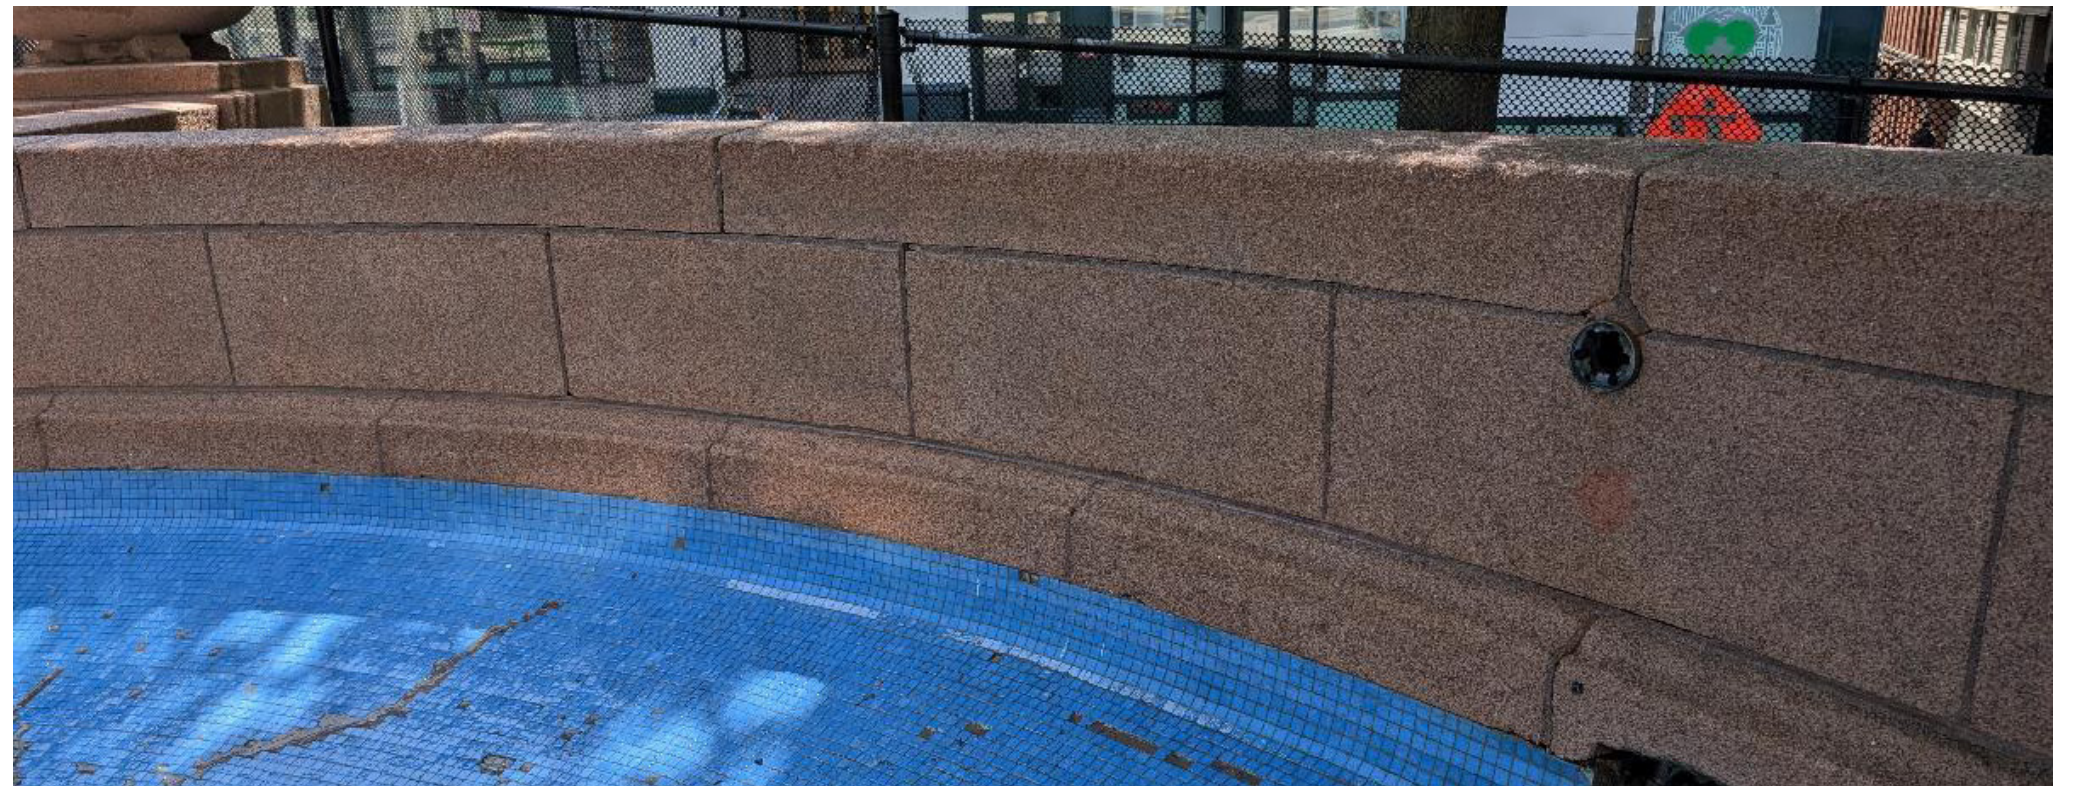
Cleaned Fountain Back Wing Wall - South of Monument

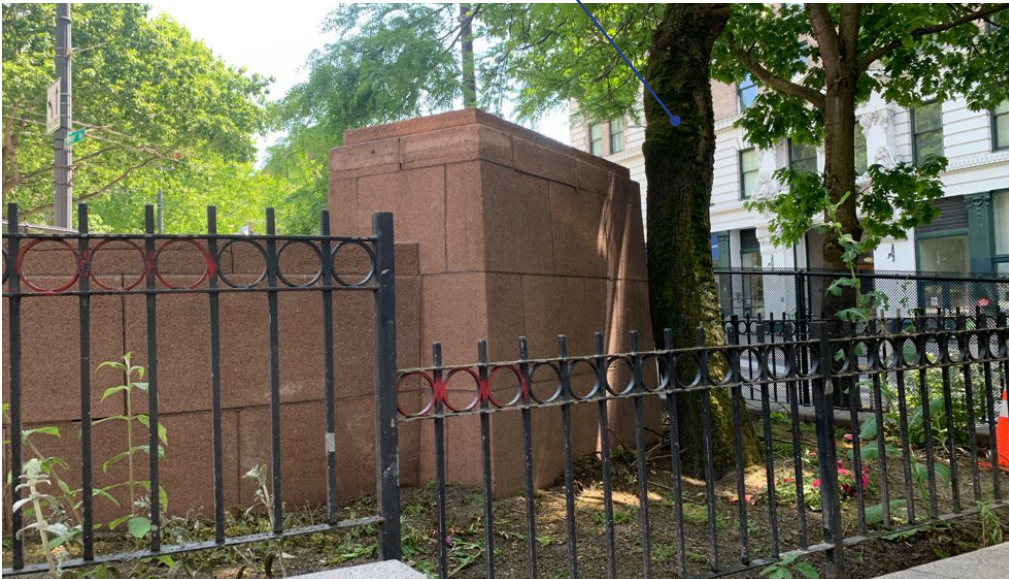
Also completed has been the removal of the center tree in the existing brick planter, which was coming into contact with the stone monument and causing stress to the structure.

Tree at back of monument that has been removed.

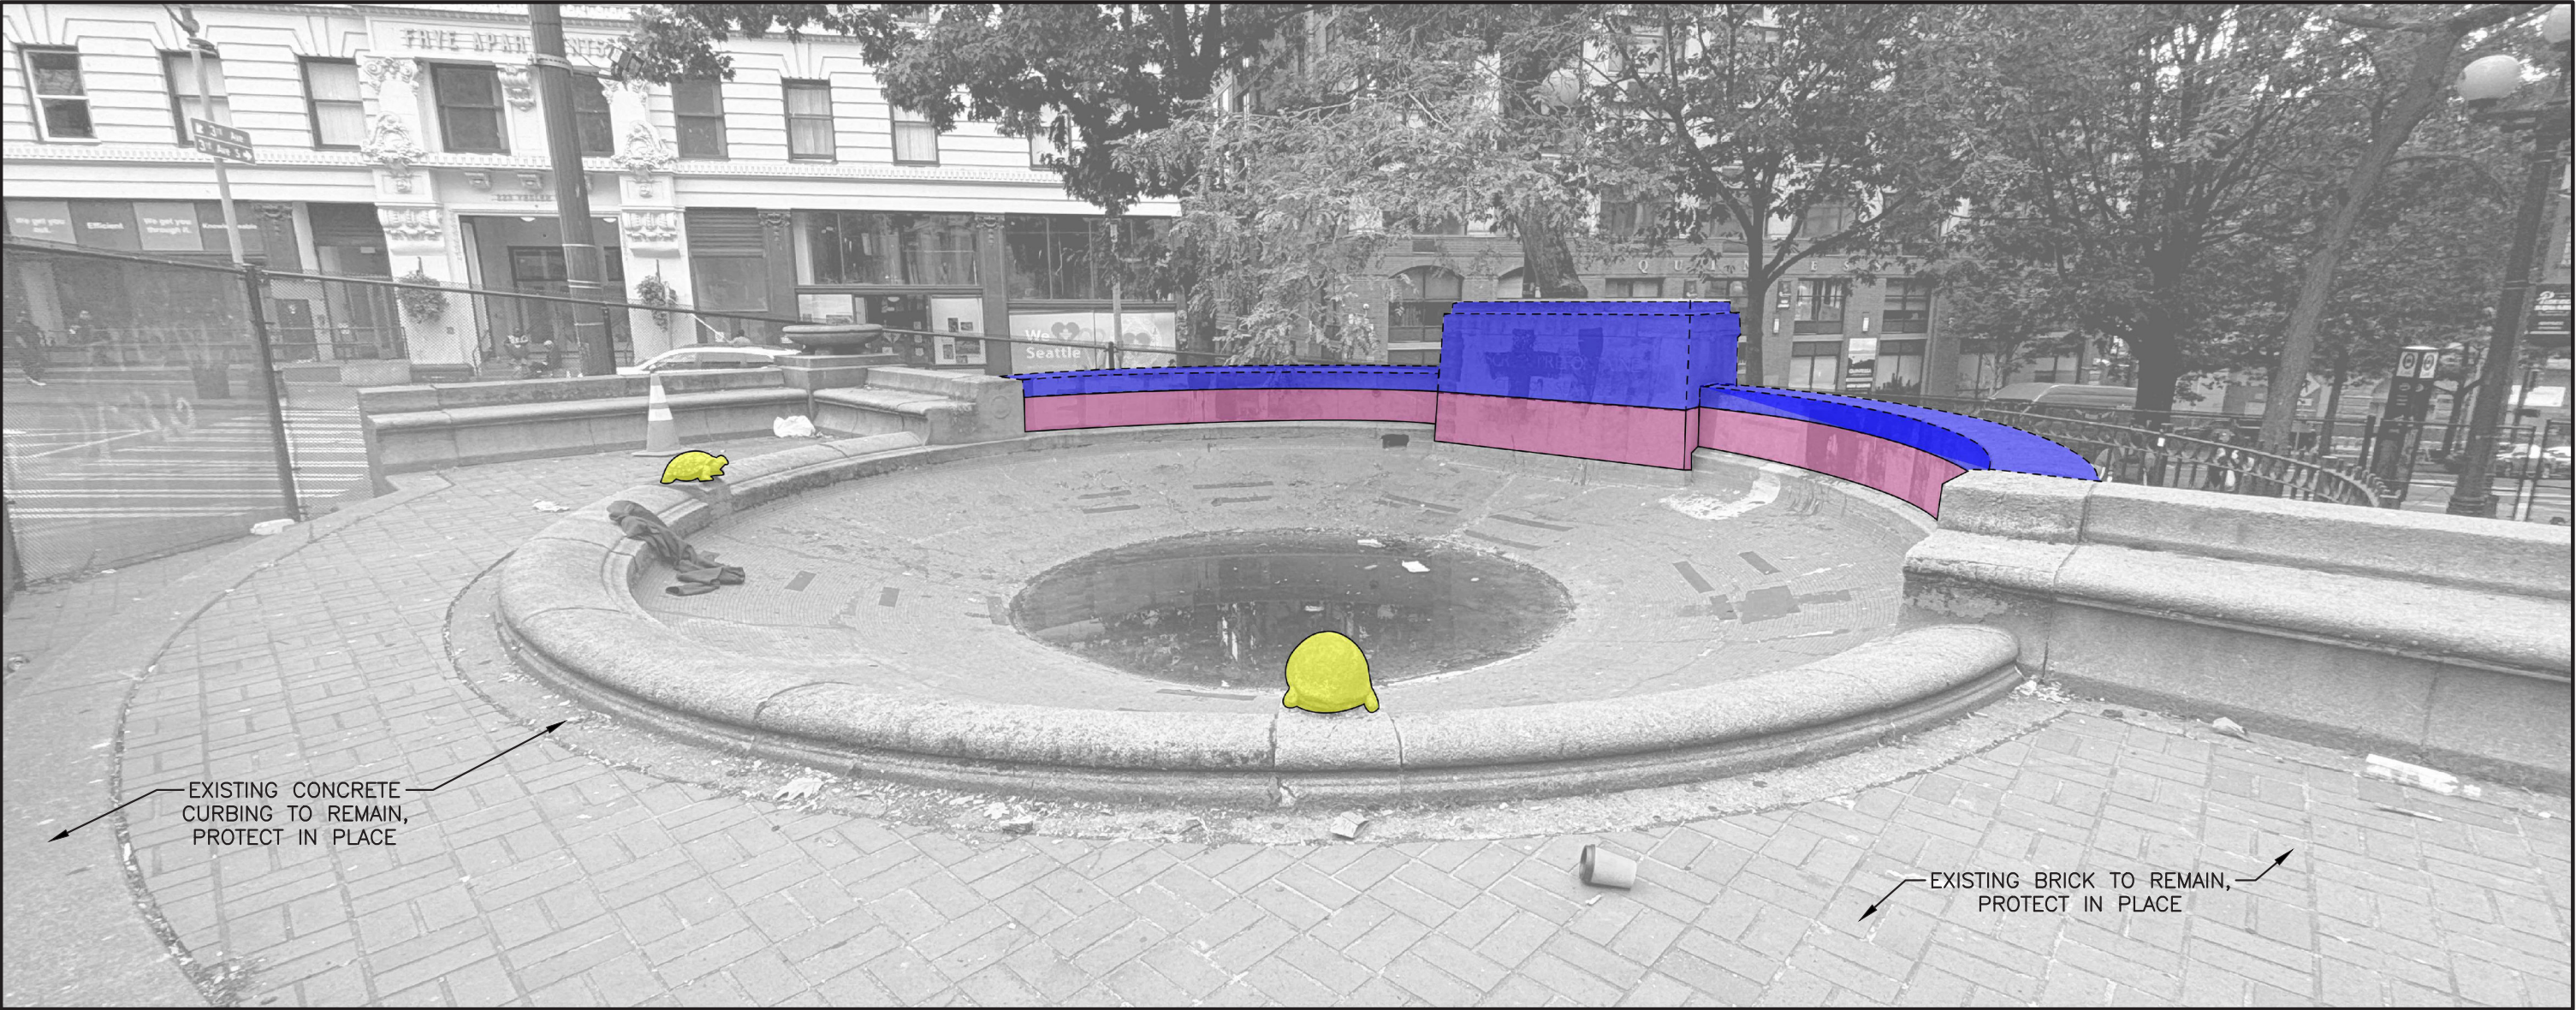
01 EXISTING FOUNTAIN SELECTIVE DEMOLITION DIAGRAM  
SCALE: NTS

- 1. EXISTING STONE WALL COURSE IN PINK TO BE REMOVED AND DISPOSED OF.
- 2. EXISTING STONE TURTLE ELEMENTS TO BE REMOVED AND SALVAGED, SEE DETAIL 02/L-002.
- 3. EXISTING STONE CAP IN BLUE TO BE REMOVED AND SALVAGED (OR RE-INSTALLED AS REQUIRED), AND RESET, SEE DETAIL 03/L-002.
- 4. ALL EXISTING STONE STRUCTURE NOT IDENTIFIED FOR REMOVAL TO BE PROTECTED IN PLACE.
- 5. ALL FOUNDATIONS/FOOTINGS TO BE PROTECTED IN PLACE.

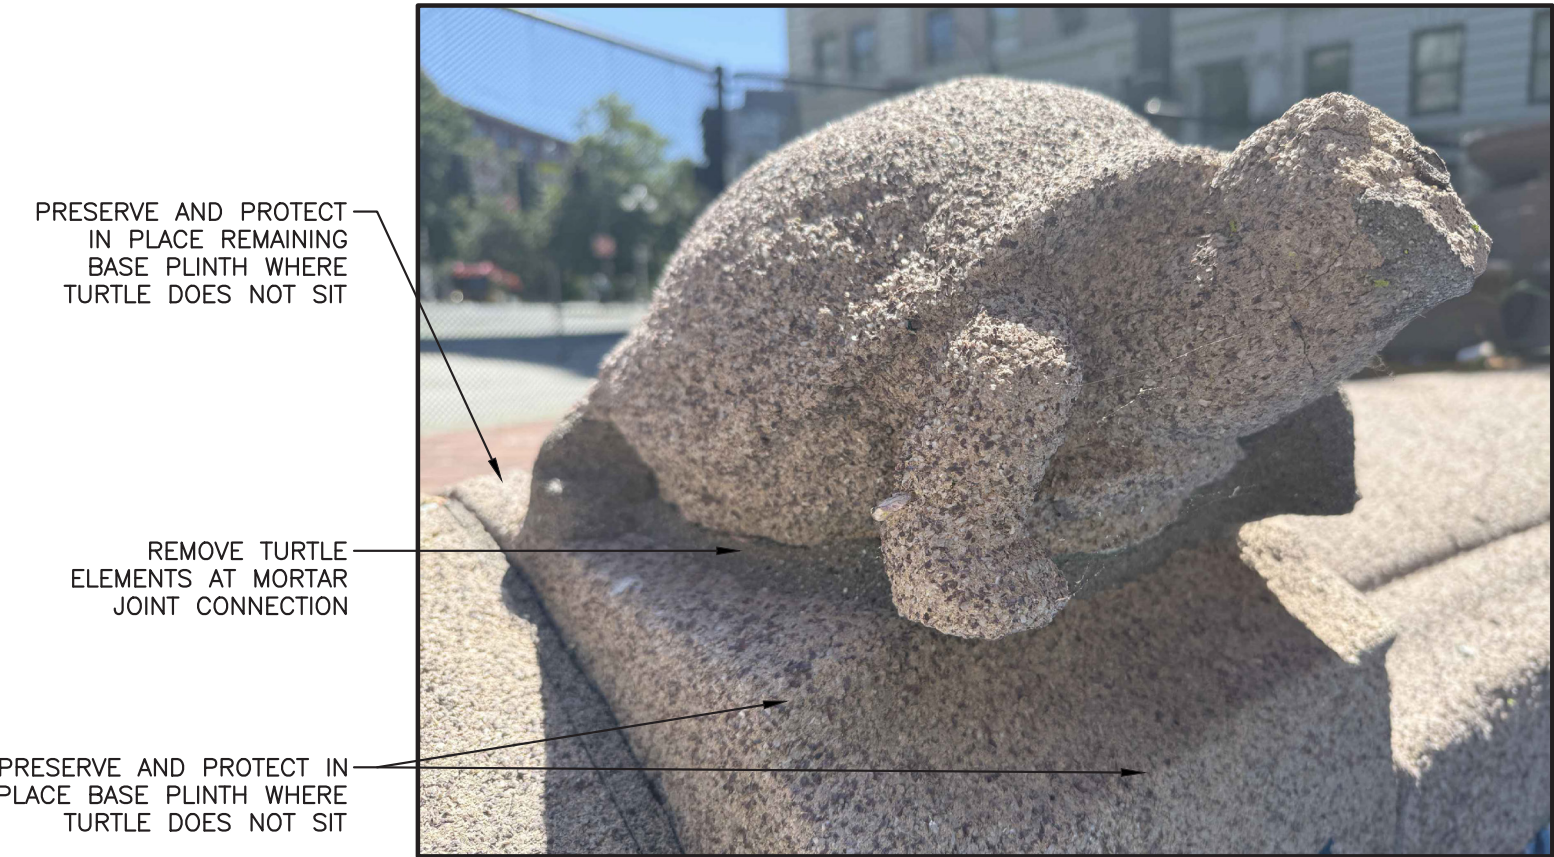
02 EXISTING TURTLE ELEMENT REMOVAL AND SALVAGE

- NOTES:
- 1. TURTLE TO BE REMOVED AND RETURNED TO ORIGINAL DONOR.
  - 2. SEPARATE FROM BASE AT MORTAR JOINT. AVOID DAMAGING BOTH BASE AND TURTLE.
  - 3. CUT AND CAP EXISTING FOUNTAIN PLUMBING WITHIN TURTLE BASE PLINTH.

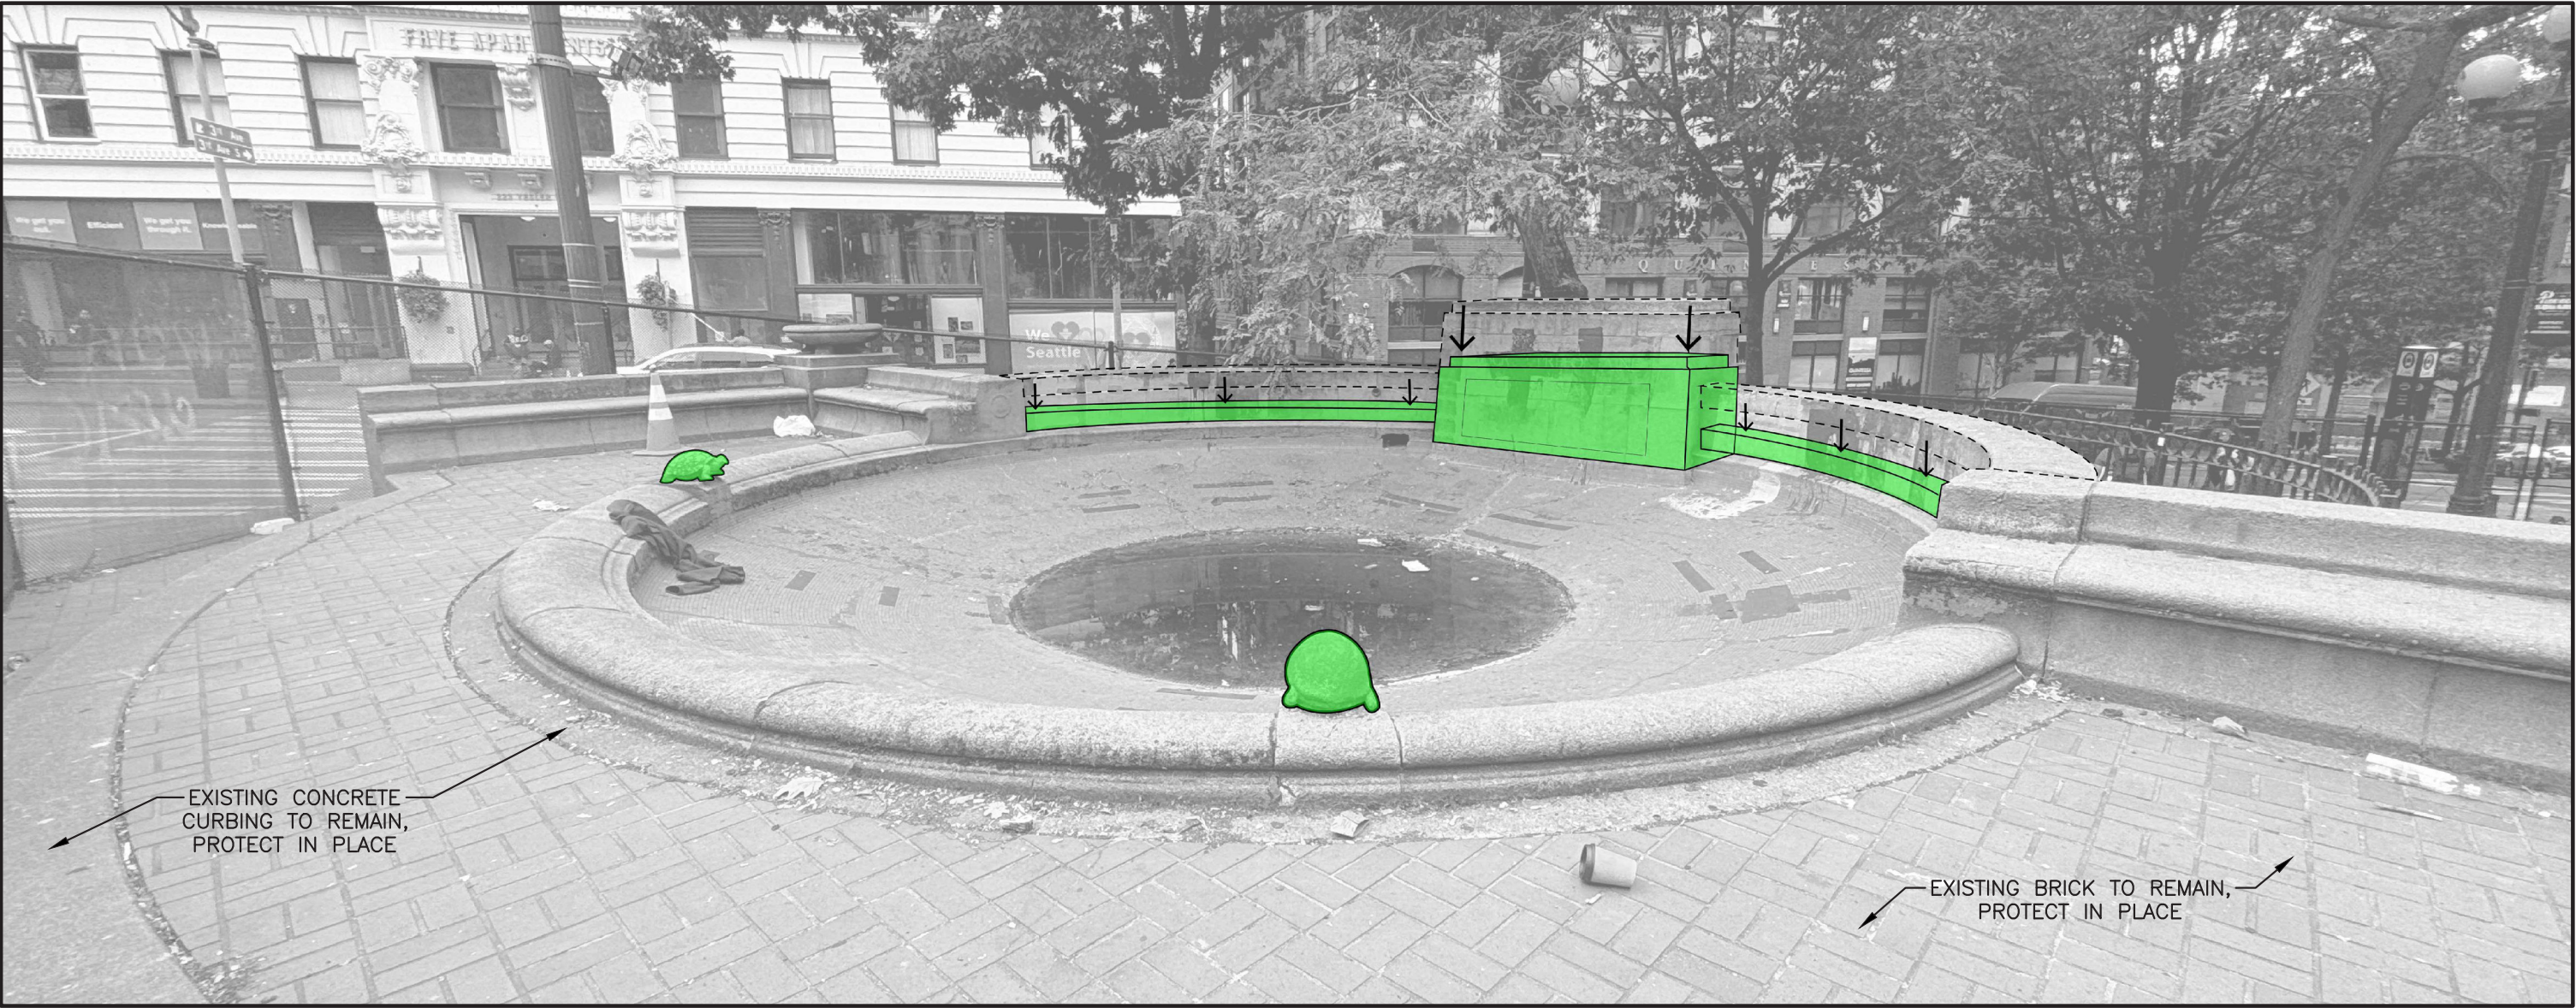
03 EXISTING FOUNTAIN SELECTIVE STONE RESTORATION DIAGRAM  
SCALE: NTS

- NOTES:
- 1. RESTORE REMOVED CAST STONE WALL CAPS AND MONUMENT AT LOWERED LOCATIONS SHOWN IN GREEN.
  - 2. CONTRACTOR TO CONFIRM ALL LOCATION, HEIGHTS AND CONDITION OF STONE WITH ENGINEER PRIOR TO RE-SETTING WALL ELEMENTS.
  - 3. NEW TURTLE SCULPTURES SHOWN TO BE LOCATED IN PLACE OF REMOVED TURTLES ELEMENTS, AS SHOWN IN GREEN.
- FABRICATOR TO FINALIZE AND COORDINATE TURTLE SCULPTURE ATTACHMENT AND INSTALL.

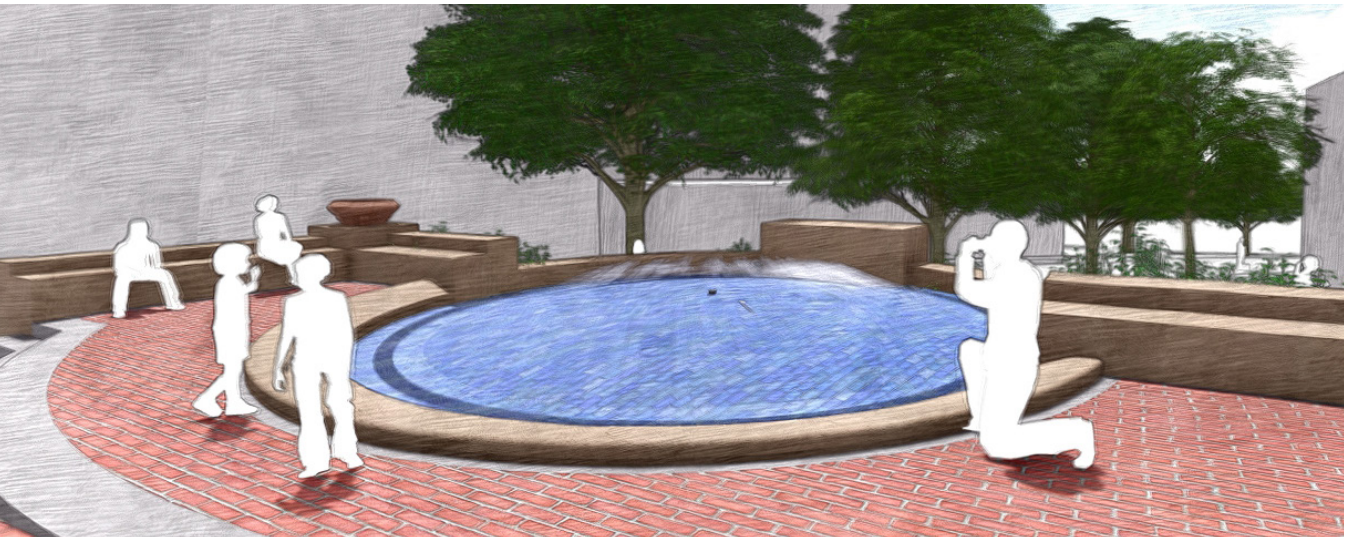
FOUNTAIN BOWL IMPROVEMENT DETAILS (pg. 13)

Detailing of the fountain bowl has been finalized into an inverted dome shape, improving safety concerns over the depth of the bowl. Connecting the dome to a tiled, perimeter gutter allows for more curvature, discouraging vagrant activity interaction and preventing water accumulation with an improved drainage capability.

Where the bowl is able to remain intact, it is proposed to be lined with a protective felt/slip joint, and then filled with a lightweight control density fill (CDX) to level out the working surface. Then, the inverted dome with be cast above, prior to tiling.

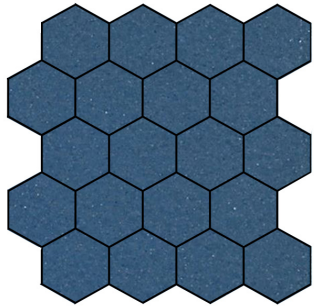
COLOR: GALAXY  
MATERIAL: COLORBODY PORCELAIN  
CHIP SIZE: 2"  
SHAPE: HEXAGON MOSAIC

- Notes:
- Colorbody Porcelain utilizes color throughout the entire tile body to help disguise chips.
  - Hexagon shape allows for larger chip size more proportional with the overall scale of the fountain.

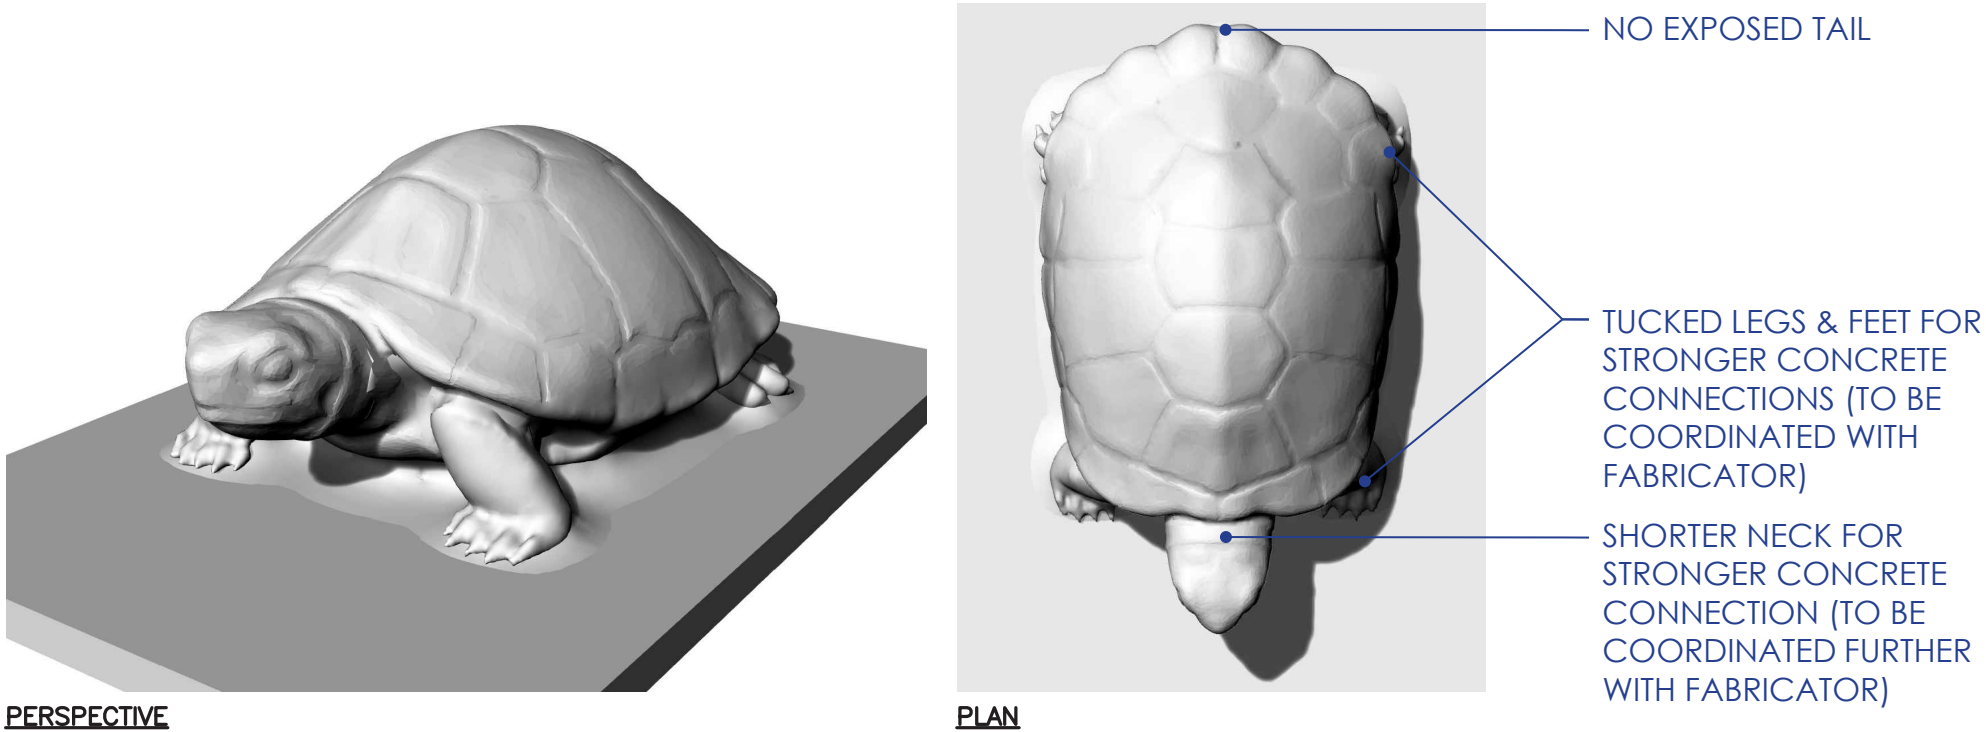
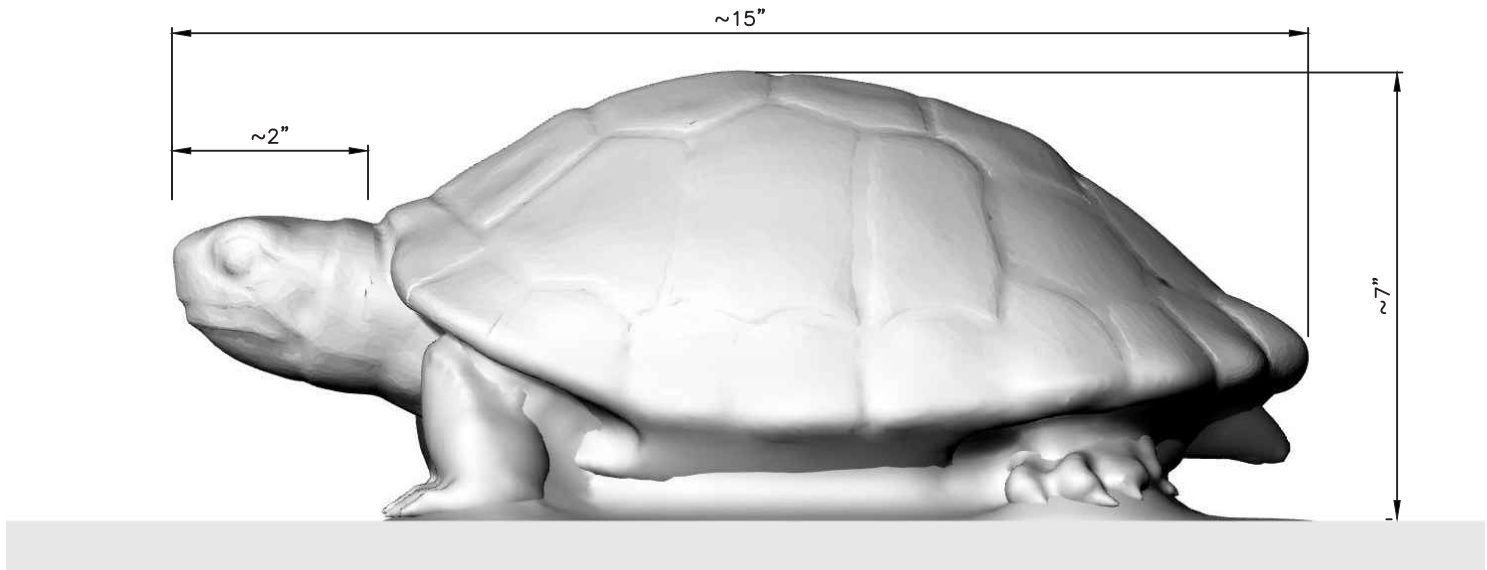
These high level renderings show the form the new turtles are taking, with fabrication constraints in mind. The turtles form is intended to emulate the Pacific Northwest’s native pond turtle.

The pieces will be fabricated from reinforced, high strength precast concrete, color-matched to the existing fountain’s precast stone color as close as possible for seamless integration. Further modifications to ensure detail and constructibility will continue to evolve as the fabrication vendor progresses development and creation.

- 1. IMAGES AND DIMENSIONS SHOWN FOR REFERENCE ONLY. FINAL CONCEPT AND SIZE TO BE CONFIRMED WITH ENGINEER PRIOR TO FABRICATION.
- 2. CONTRACTOR TO COORDINATE FABRICATION AND INSTALL OF NEW TURTLE ELEMENTS WITH FABRICATOR.
- 3. TURTLES TO BE FIBER REINFORCED CONCRETE, PER FABRICATOR RECOMMENDATION. TURTLES TO MATCH EXISTING CAST STONE COLOR OF FOUNTAIN STRUCTURE TO REMAIN. CONTRACTOR TO COORDINATE SAMPLES TO BE CONFIRMED WITH THE ENGINEER.

Coordination is underway to create the turtle sculptures that will be located where the existing turtles are to be salvaged and returned to the original donor.

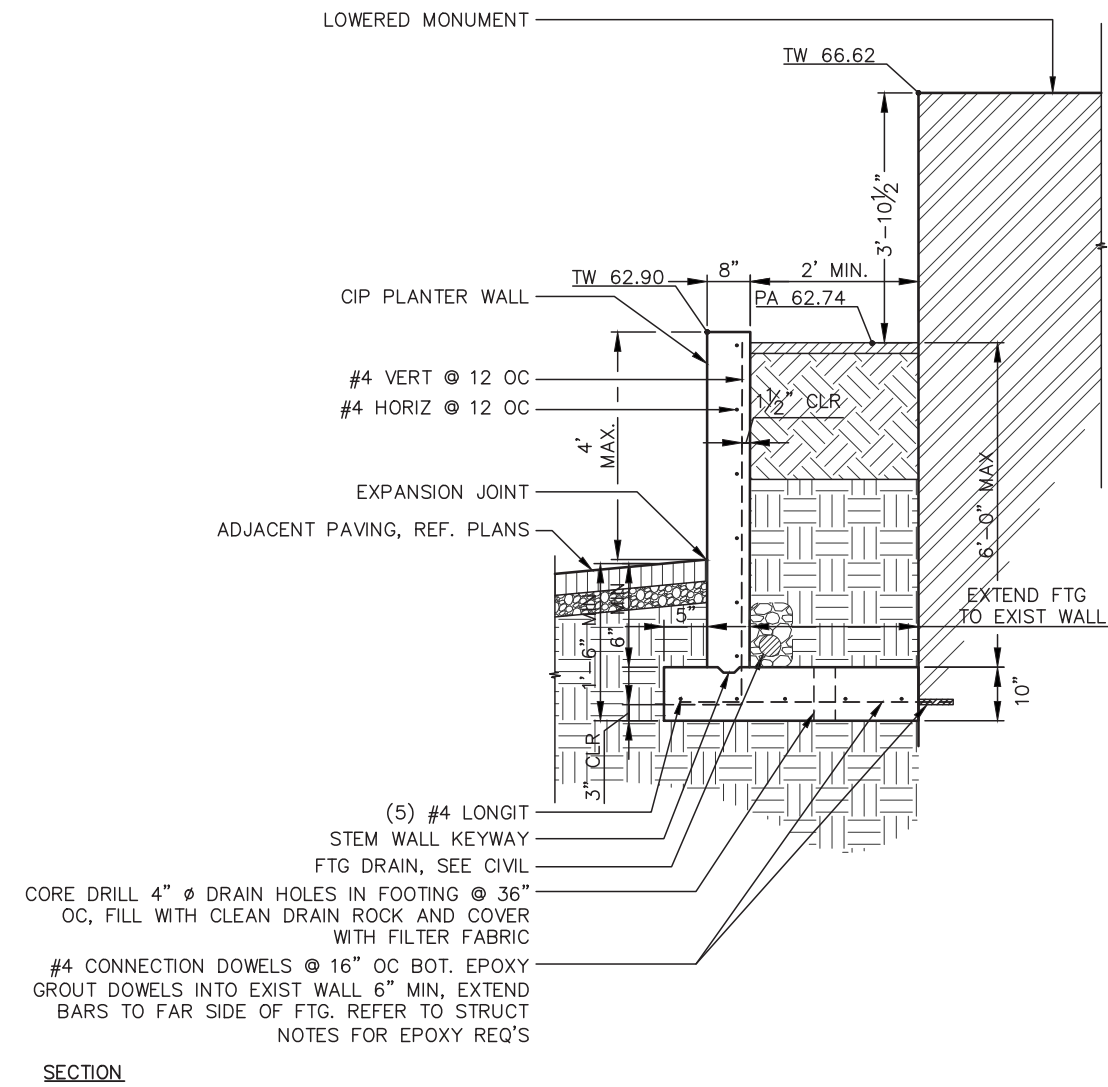
02 LOWER TIER CIP WALL AT MONUMENT  
SCALE: 1/2" = 1'-0"

The details shown here are representing the walls that will come near or into contact with the existing fountain structure. Pinning will be required for the upper tier walls to establish a structural connection. The lower tier planter wall footing will require field investigation to confirm how deep the existing monument structure foundation goes. If the footing comes into conflict, pinning will be required.

The planter walls proposed will require careful excavation to ensure there is no risk to compromising the existing fountain structure during construction.
