Subject: RE: Asking your approval for vault hatch with grating in Pioneer Sq Preservation Dist, SCL Network Distribution

ADDRESSES WHY SCL WILL REPLACE THE SOLID HATCH, AND REPLACE IT WITH THE GRATING, FOR VAULT 022V004 AT 117 S MAIN STREET, PIONEER SQUARE

LETTER RESPONDING TO PIONEER SQUARE PRESERVATION BOARD JULY 7TH, 2023 CORRECTION NOTICE PSB 185/23

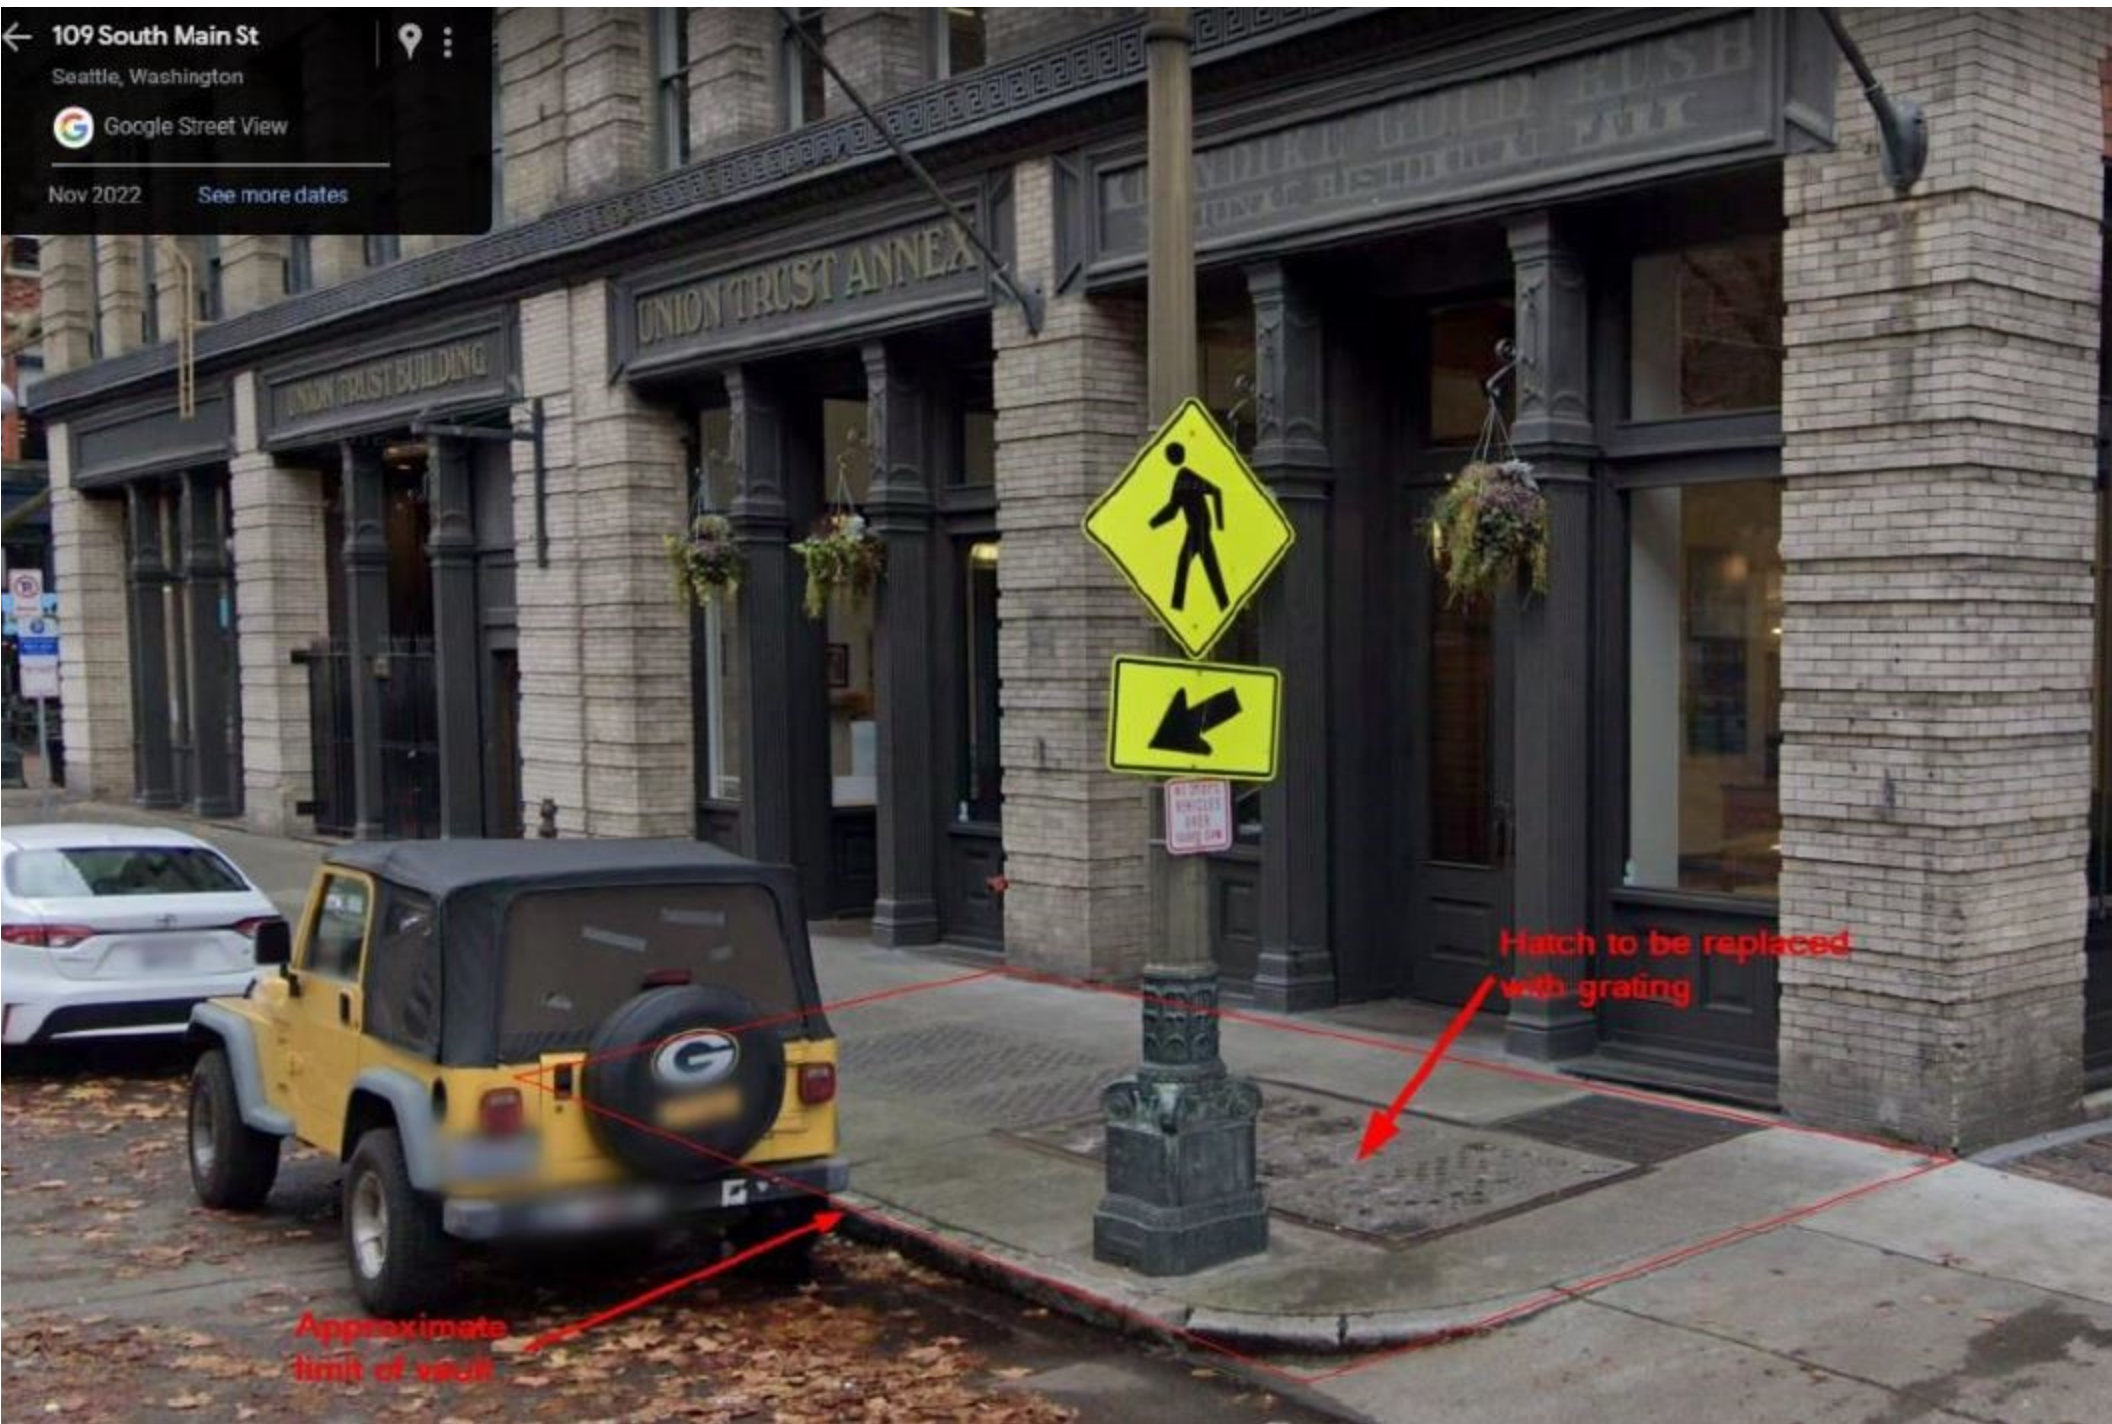
Approximate
limit of view

Hatch to be replaced
with grating

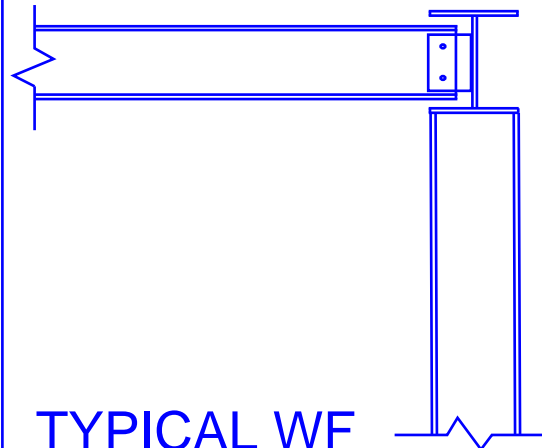
TYPICAL WF
CONNECTION DETAIL

EXISTING BEAM
TO FRAME INTO
NEW BEAM.

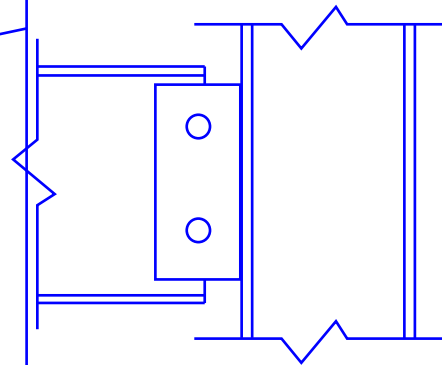
CONNECTION DETAIL

TYPICAL WF TO HSS

BASE PLATE
CONNECTION OF
HSS TO SLAB, TYP.

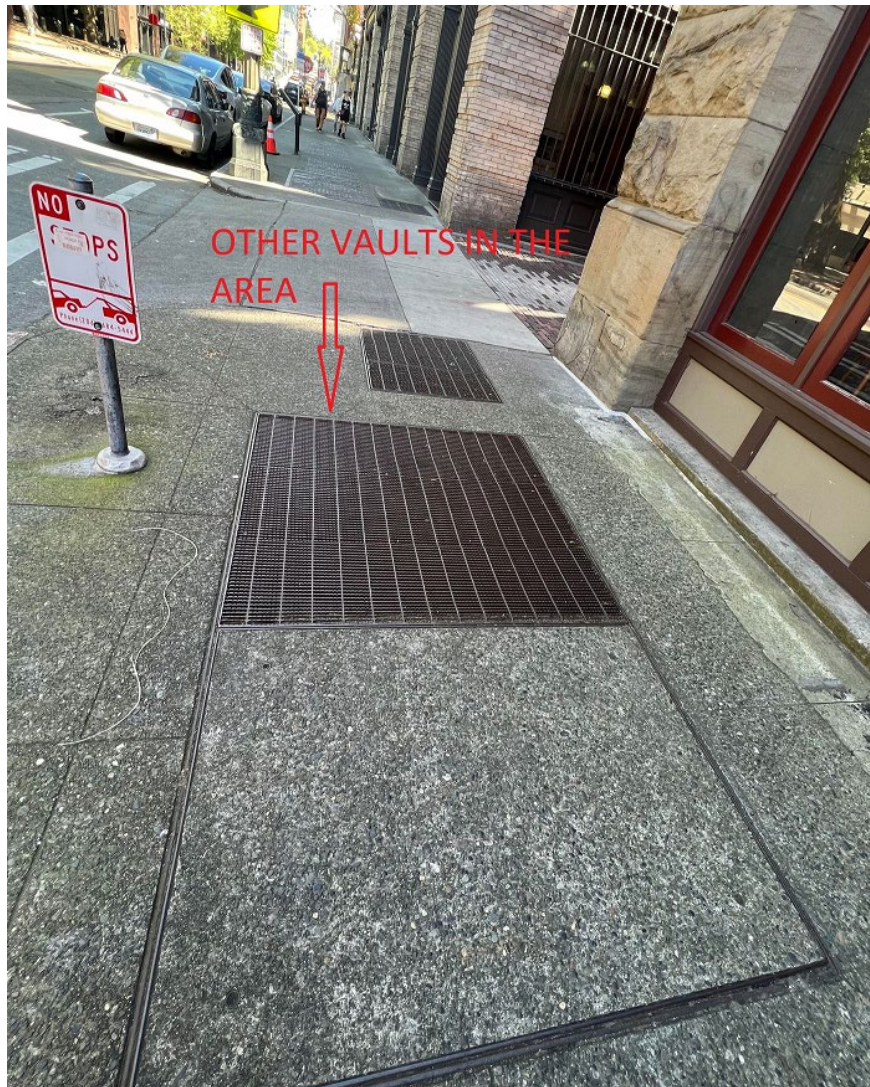
Seattle City Light needs to move an electrical transformer into our Network Vault 22V004 on the south side of S. Main Street just east of the 1st Ave Alley. The vault is an areaway vault, and the structure supporting the vault ceiling (which is also the sidewalk) is in poor condition, so we are in the permit process with SDOT to reinforce the ceiling of the vault / sidewalk. No changes will be made to the surface of the sidewalk. However, the solid rectangular hatch (see image below) is in poor condition and appears to be rusted into the surrounding frame. We will need to demolish this solid hatch (break it up into pieces) in order to remove it so that the reinforcing work can be done, and need to replace the solid hatch with a metal grating in order to provide adequate ventilation for the transformer that we will be installing in the vault. Transformers by design generate heat and must have proper air ventilation.

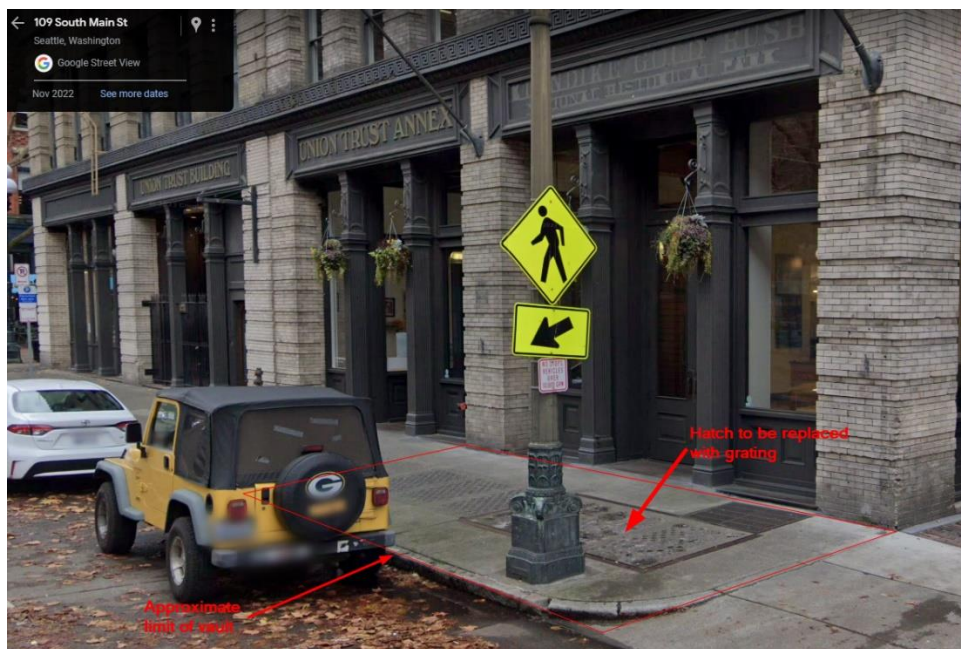
SCL Network Engineering is in the Utility Major Permit (UMP) process with SDOT to reinforce the ceiling of the vault / sidewalk. No changes will be made to the surface of the sidewalk. However, the solid rectangular hatch (see images below) is in poor condition and appears to be rusted into the surrounding frame. We will need to demolish this solid hatch (break it up into pieces) in order to remove it so that the reinforcing work can be done. The solid hatch will be replaced with grating hatch for the necessary air circulation. The main issue with the Department of Neighborhood is the replacement of solid hatch.

If the hatch can't be opened, the vault loses its functionality, because the equipment needs to be got in and out through the rectangular opening. Right now, the hatch is rusted into the surrounding frame, the only way to open is to demolish this solid hatch by breaking it up into pieces.

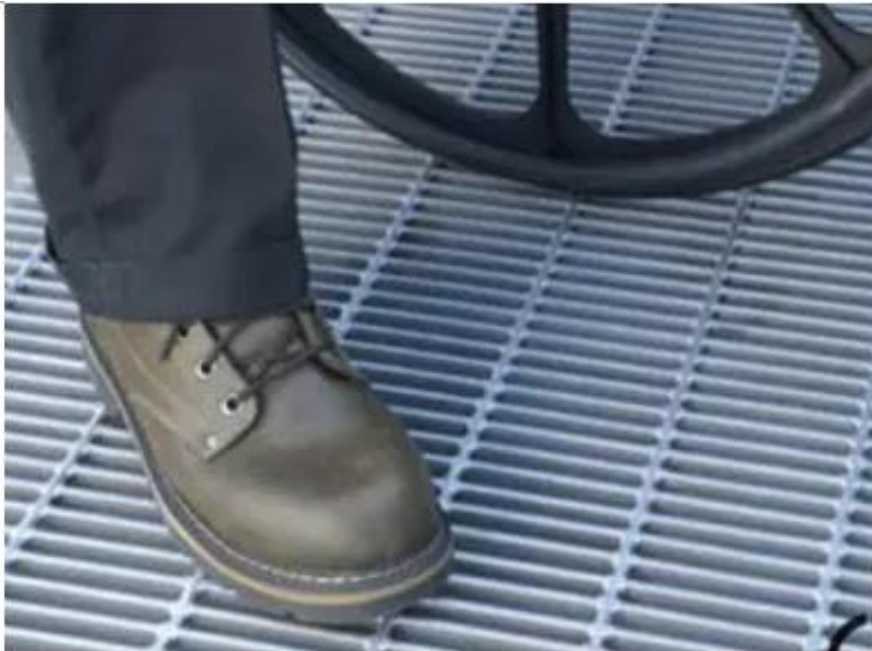
Grating vault hatch

Currently customer in 200 1st Ave South is expanding, the indoor electrical vault must be modified. The expansion requires larger and more reliable electrical service. To accommodate their electrical needs, and being requested by the customer, the existing transformer must be relocated to the nearest vault to provide the same electrical service to the nearby business. Vault 022V004 is the only vault that transformer can move to and meet the service requirement. To accommodate the relocated transformer, grating hatch is needed, to increase the airflow thus maintaining the operable temperature inside the vault 022V004. As Department of Neighborhood has noticed, there is a grating cover next to the rectangular hatch, but it's too small to provide the air circulation for the transformer cooling.

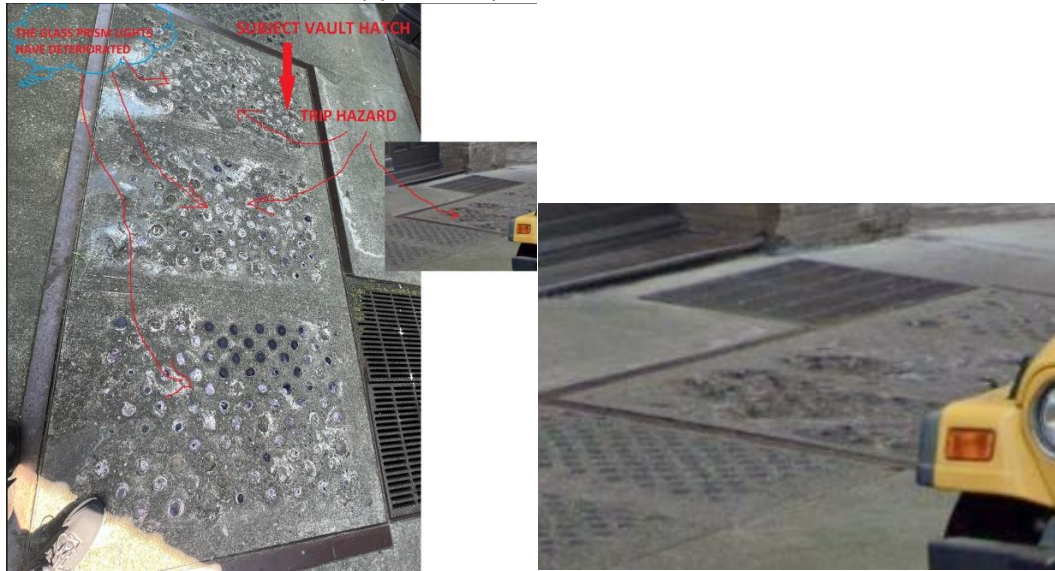
- a. The structure supporting the vault ceiling is in poor condition, so we are in the permit process with SDOT to reinforce the ceiling of the vault / sidewalk.
- b. Where Glass Prism Lights have been chipped off, it left the damaged and corroded concrete surface, that may pose a trip hazard.

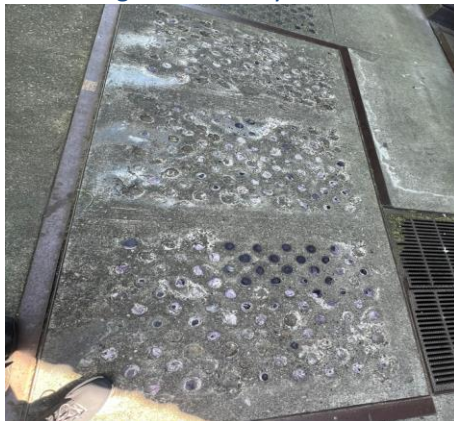
- a. Almost all Glass Prism Lights on this vault hatch have been chipped off and left sizable holes. It no longer shows any historical value or visual appealing anymore.

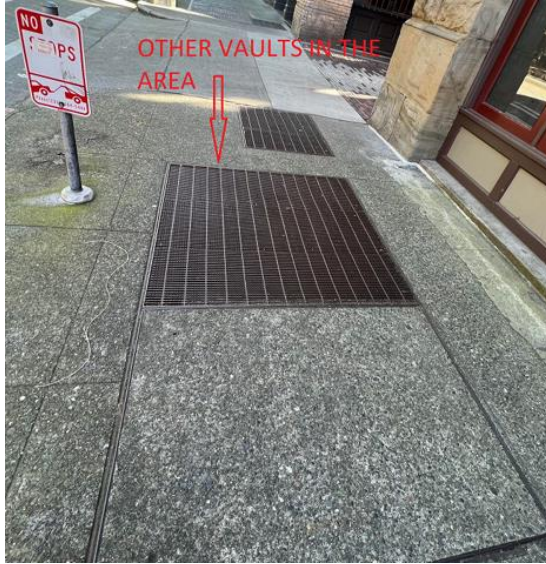
- b. All electrical vaults in the area have grating for hatches, it's been the standard in the vicinity.
