ASUW Shell House

SEATTLE LANDMARKS PRESERVATION BOARD
Certificate of Approval Presentation, September 2025

ASUW Shell House Certificate of Approval Presentation

Existing Window Survey

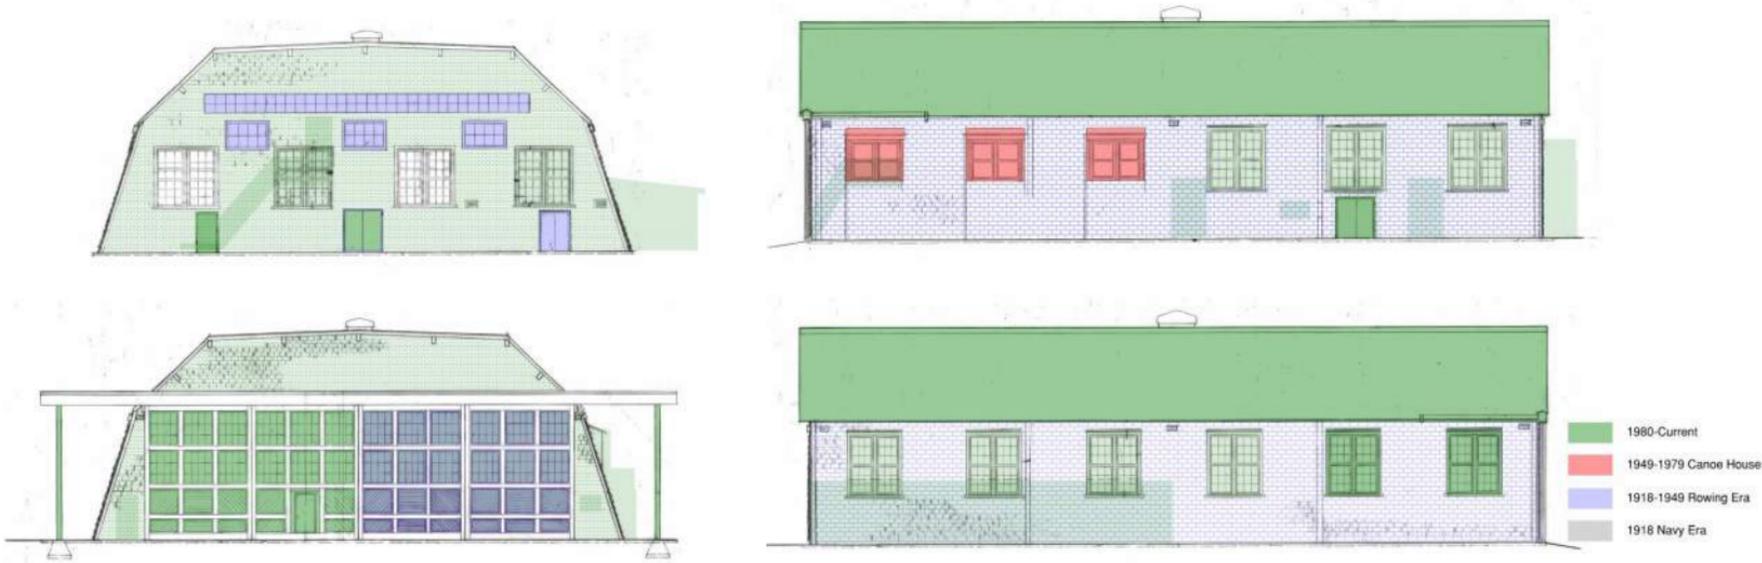
HANGAR DOOR CHANGES IN 1980

NORTH AND SOUTH
FACADES SHINGLED

GLASS REMOVED,
SOME REPLACED

ALL DOORS
REMOVED FROM
TRACKS, (1) DOOR
COMPLETELY
REPLACED, OTHER
(3) REBUILT

RESTORED AND
REBUILT DOORS
REPLACED AND
ULTIMATELY PINNED
IN CLOSED POSITION

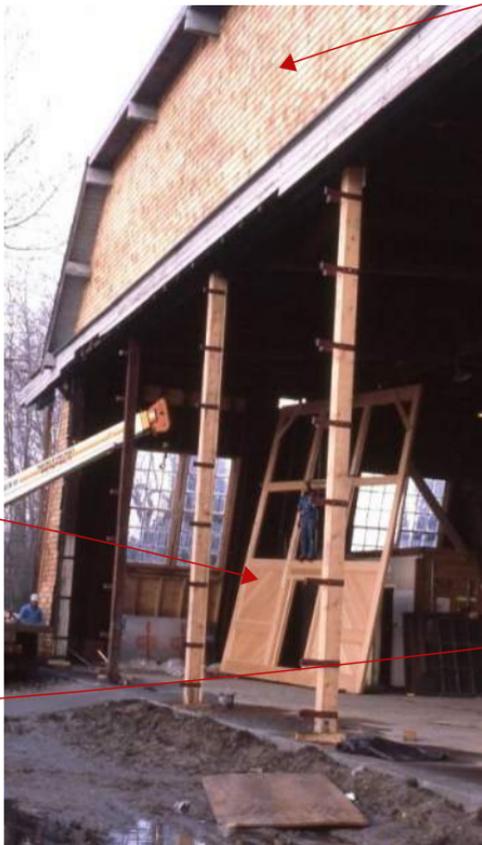
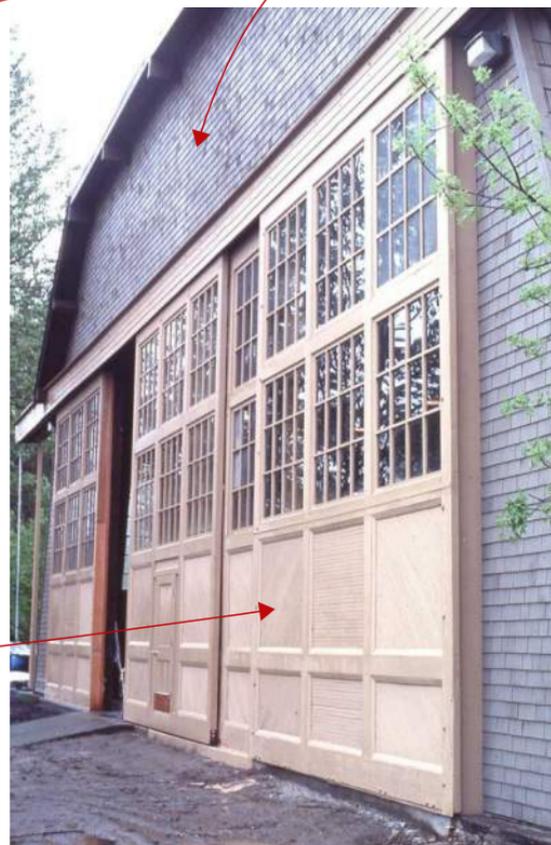
WINDOW AND DOOR ASSESSMENT

Door A		
Description- Hangar door. Approximately 18'-0" x 22'-0". Door area is divided into twelve subsections of glazed lights and wood slat infill.		
Repair Code		Exterior Condition Notes
Paint Condition	3	Significant exposed wood with raised grain and peeling paint. Full paint removal likely needed. (Photo 2)
Operability Ease	3	Currently inoperable. Needs a full overhaul of the tracks and hardware to restore operability.
Alignment	3	Door is bowed and visibly misaligned. Non-original brackets have been added for stiffness. Infill panels are misaligned. (Photo 3)
Glass Condition	1	Heavily soiled.
Weather Stripping	3	Currently no weatherstripping at perimeters, joints are open.
Sill Condition	3	Dry rot along sill, horizontal wood is split. (Photo 4)
J1 Condition	2	Jamb largely intact. Dry rot at base. Casing trim warped.
J2 Condition	2	Misaligned, bowing.
V1 Condition	2	Split wood at ends. Raised grain, weathered and exposed. Suspected dry rot near base of G5.

V2 Condition	2	Split wood at ends. Raised grain, weathered and exposed. Suspected dry rot near base of G5.
H1 Condition	1	
H2 Condition	2	Raised grain, weathered and exposed.
H3 Condition	3	Dry rot present. (Photo 5)
H4 Condition	2	Raised grain, weathered and exposed.
G1 Condition	3	Damaged perimeter trim, 1 cracked muntin
G2 Condition	3	Replace perimeter trim
G3 Condition	3	Replace perimeter trim
G4 Condition	3	Misaligned with H2, Replace perimeter trim, Bottom Rail is split
G5 Condition	3	Misaligned with H2, Replace perimeter trim, 1 split muntin
G6 Condition	1

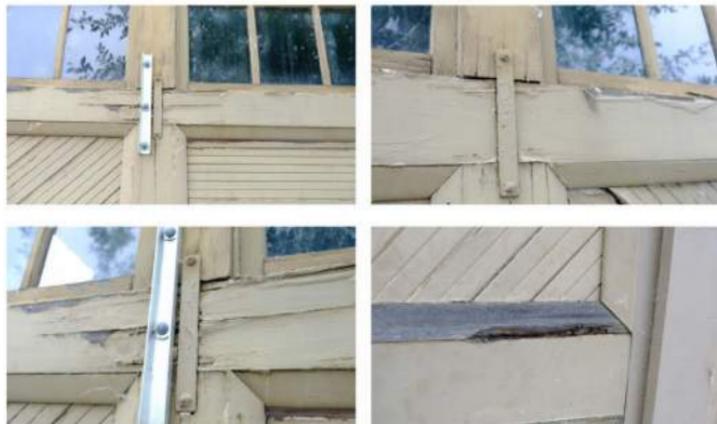
North Elevation Windows

Window Type	Era of construction	Materials	Operation	Width	Height	Condition
A	1980s	wood frame, single glazed, true divided lite	fixed	4'-3"	10'-3"	Poor, due to 17° slope installation. Significant wood rot, exposed wood w/ raised grain, glazing putty loss.
B	1980s	wood frame, single glazed, true divided lite	single hung	3'-10"	5'-2"	Needs repair or replacement.
C	1918	wood frame, single glazed, true divided lite	double hung	4'-3"	10'-2"	Needs full rehabilitation
D	1980s	wood frame, single glazed, true divided lite	single hung	4'-3"	10'-2"	Needs full rehabilitation
E	1920s	wood frame, single glazed, true divided lite	fixed	6'-4"	6'-6"	Needs full rehabilitation
F	1920s	wood frame, single glazed, true divided lite	fixed	56'-0"	4'-2"	Needs full rehabilitation
G	1980s	wood frame, single glazed, true divided lite	sliding hangar doors	35'-5"	22'-0"	Poor, due to south-facing water side exposure. Significant wood rot, splits, exposed wood w/ raised grain.

Project: ASUW Shell House
Date: 6/7/2024
From: Brad Carmichael, PE, BEMP, CPHC - 4EA Building Science
To: Mithun
RE: North Window Condition Assessment

The purpose of this report is to assess and document the condition of the existing windows in order to help establish a scope for restoration and repair and aid discussion with landmarks.

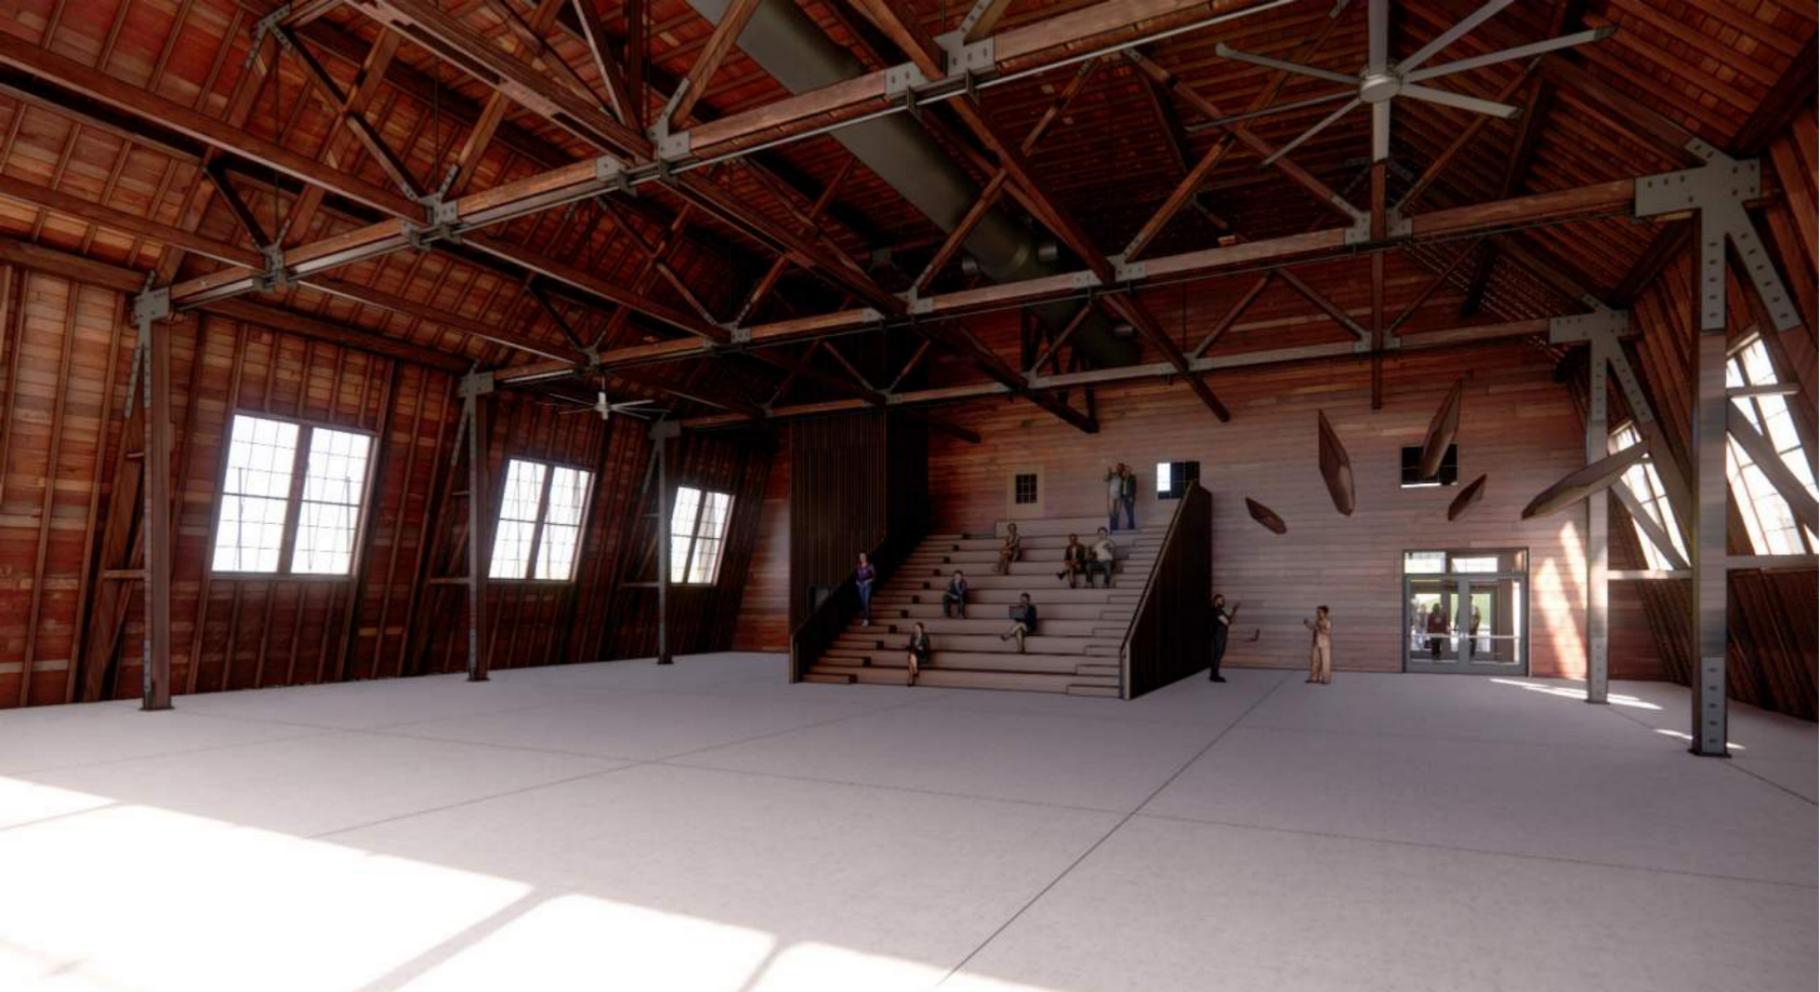
Preserving Historic Surfaces

EXISTING FINISHES

REMOVE AND REINSTALL WALL LINENING TO MATCH EXISTING CONDITIONS. THE

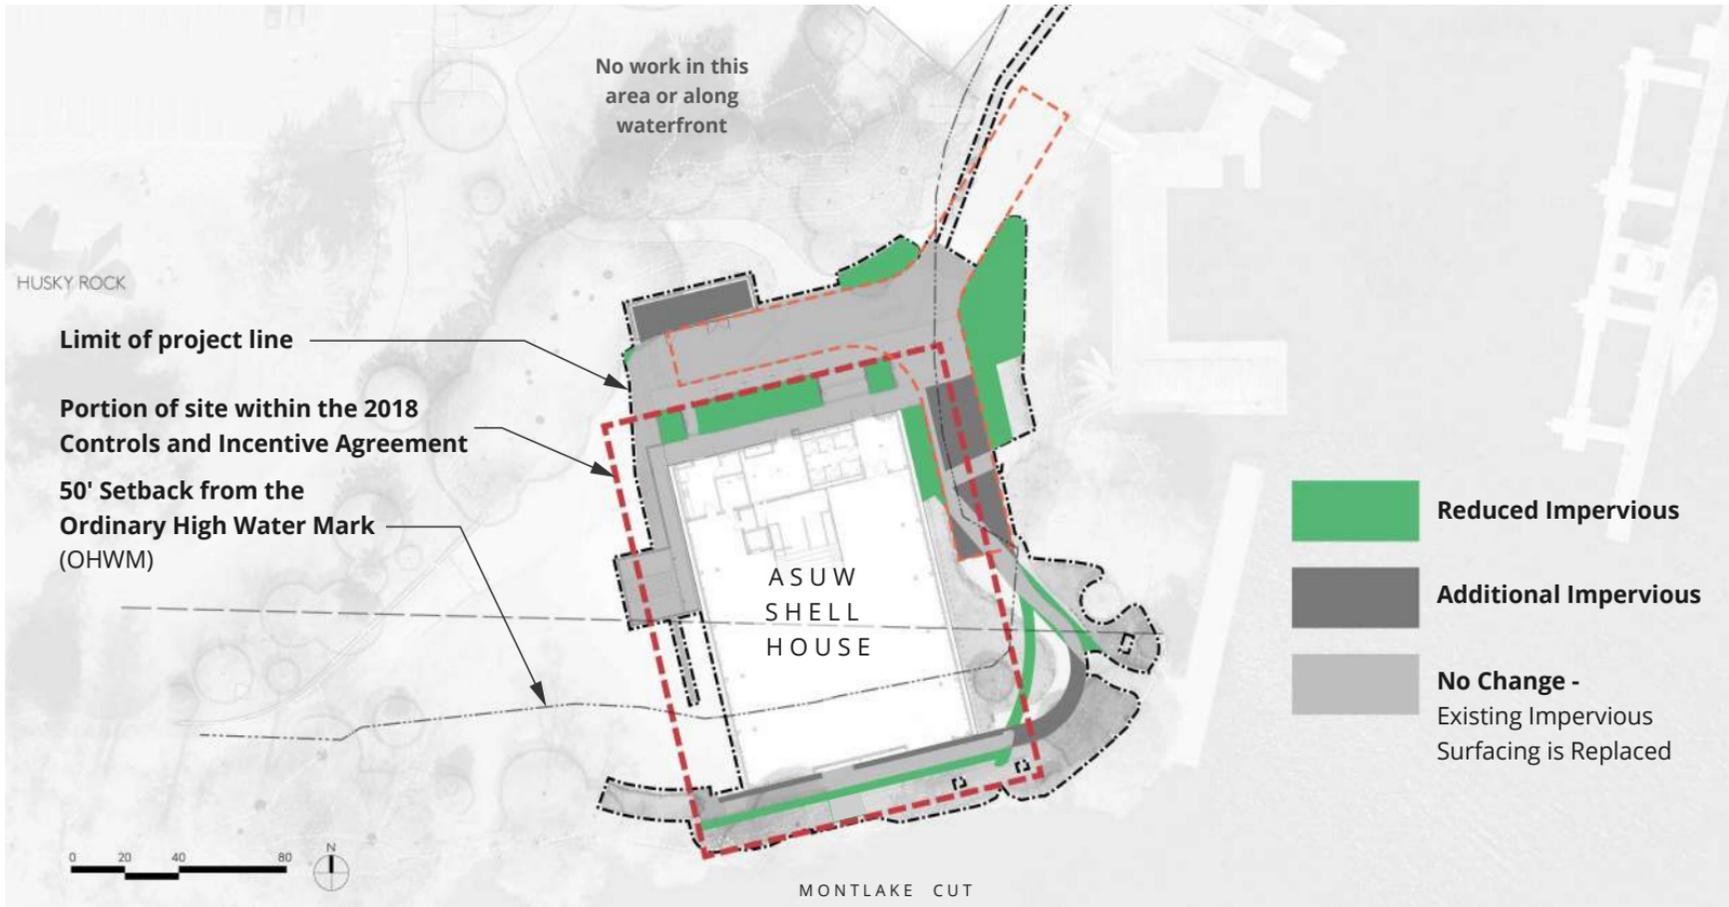
Overall Site Plan - Proposed Permeable Areas Diagram (within proposed Limit of Work)

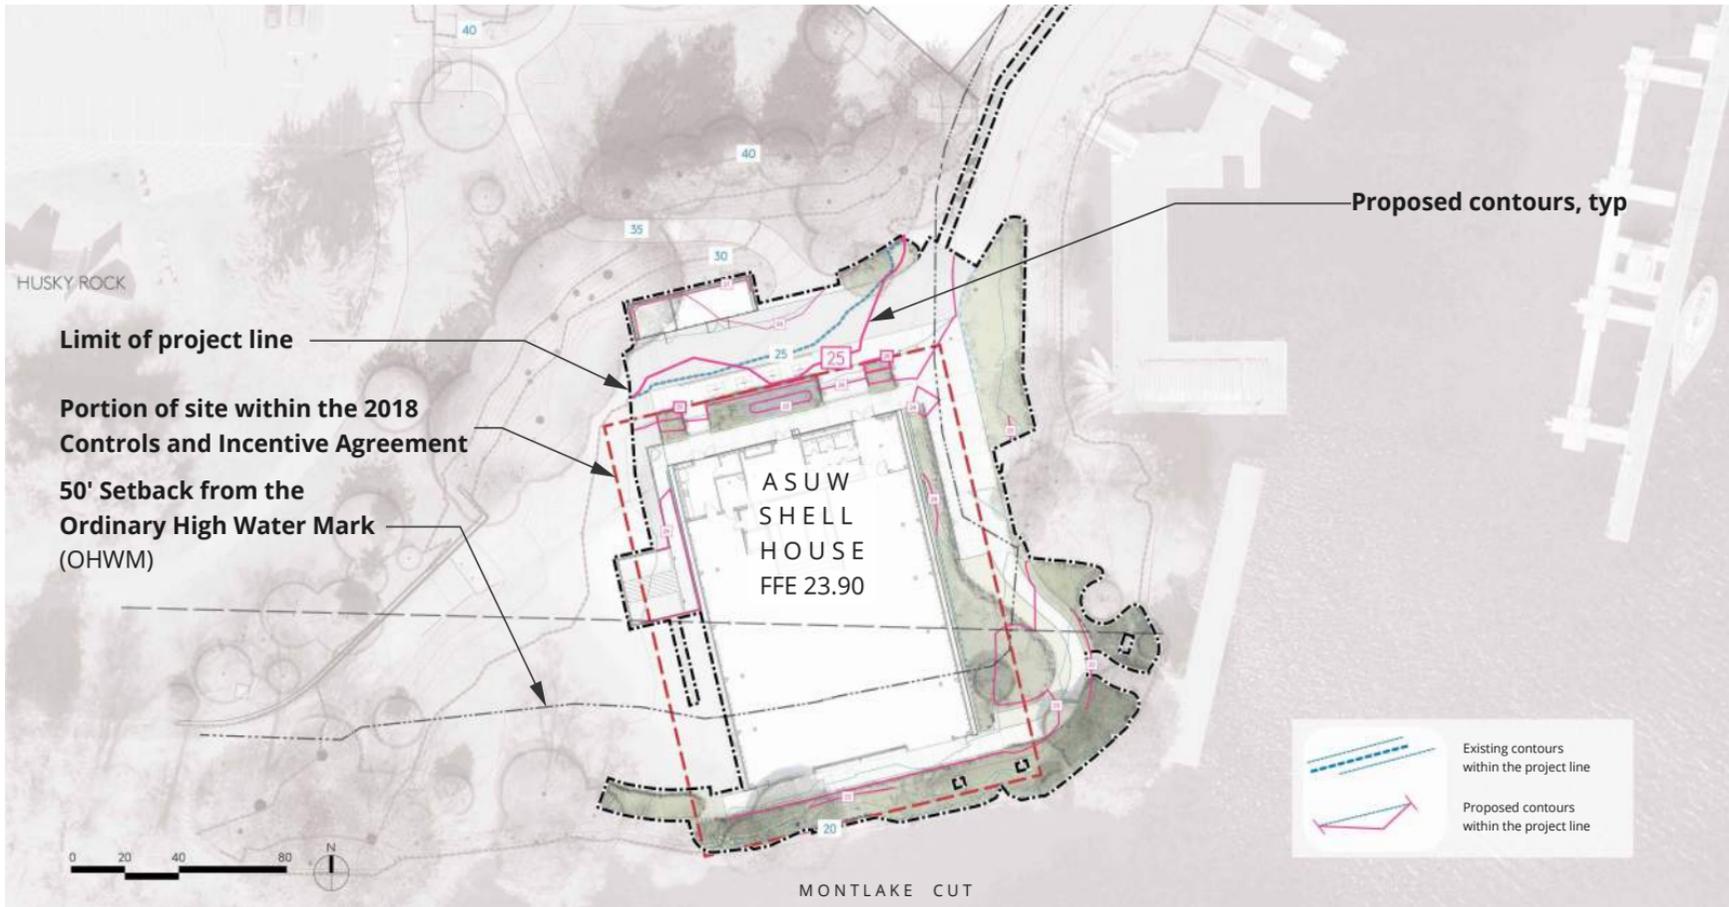
Overall Site Plan - Proposed Grading

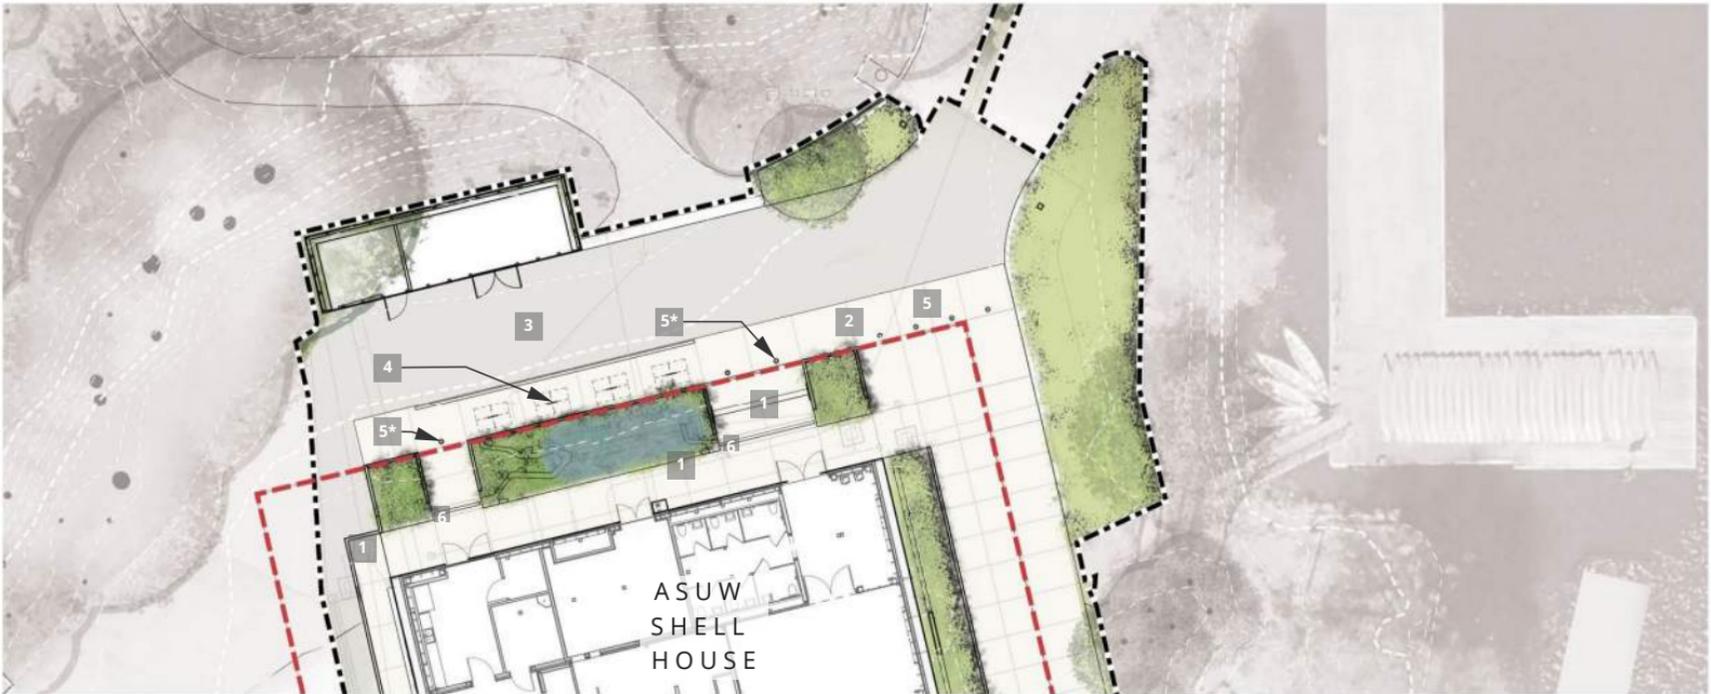
North Side - Plan Enlargement

1 Pedestrian Concrete
 CAST-IN-PLACE
 LIGHT BROOMED FINISH
 AS SHOWN

2 Vehicular Concrete
 CAST-IN-PLACE
 LIGHT BROOMED FINISH

4 Bike Racks
 Stainless Steel
 Sportsworks,
 TOFINO No-Scratch

5 Bollards
 Stainless Steel,
 #4 Brushed Finish
 External locking mechanism, typ
 * internal locking mechanism

6 Trench Drain Cover
 Gray Iron
 Raw
 Urban Accessories,
 JAMISON

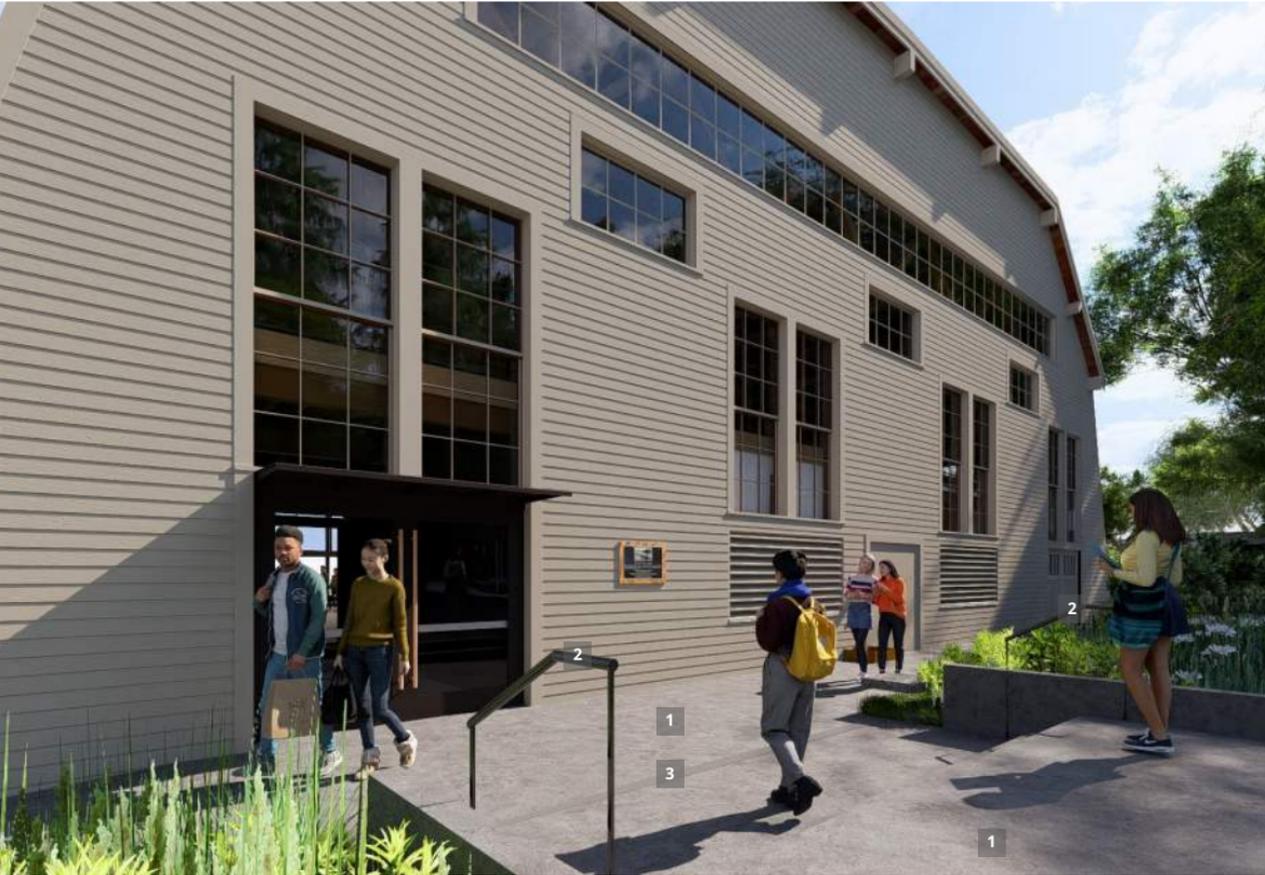
North Side - Proposed Material Palette

Pedestrian Concrete
CAST-IN-PLACE
LIGHT BROOMED FINISH
ACCESSIBLE PATH

Handrails
Stainless Steel
180-Grit Polished Finish
ENTRY STAIR

Bike Racks
Stainless Steel
Sportsworks, TOFINO No-Scratch
At Drive Aisle

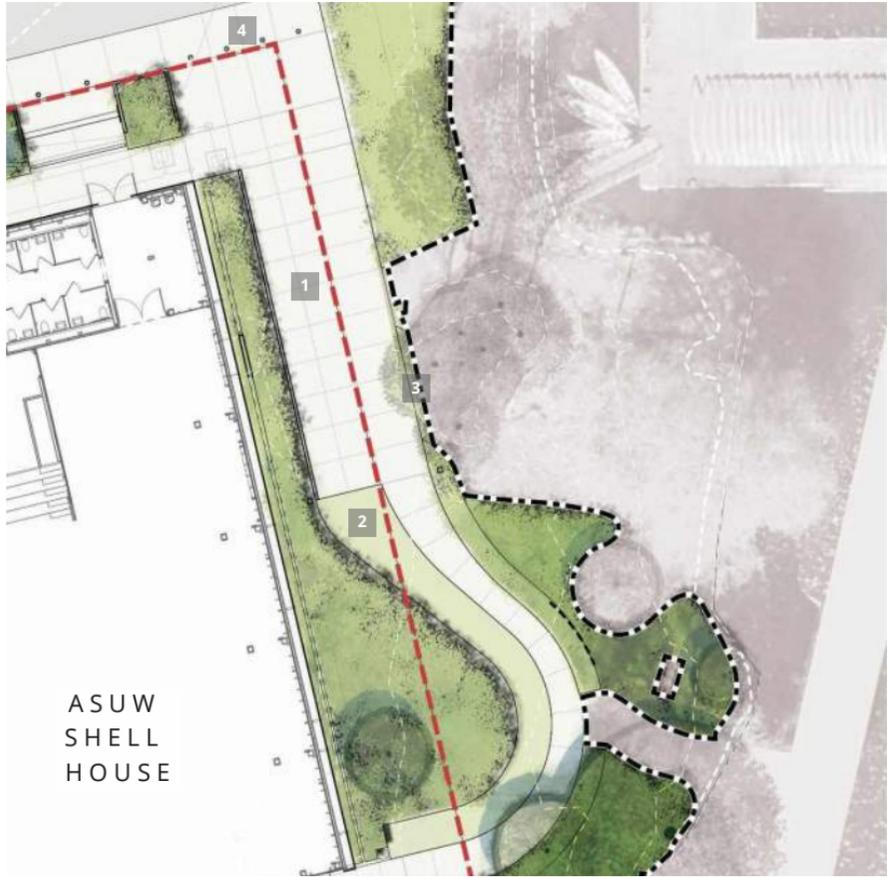
East Side - Enlargement + Proposed Material Palette

Vehicular Concrete
CAST-IN-PLACE
LIGHT BROOMED FINISH
FIRE ACCESS TURNAROUND

Bollards
Stainless Steel,
#4 Brushed Finish
External locking mechanism, typ

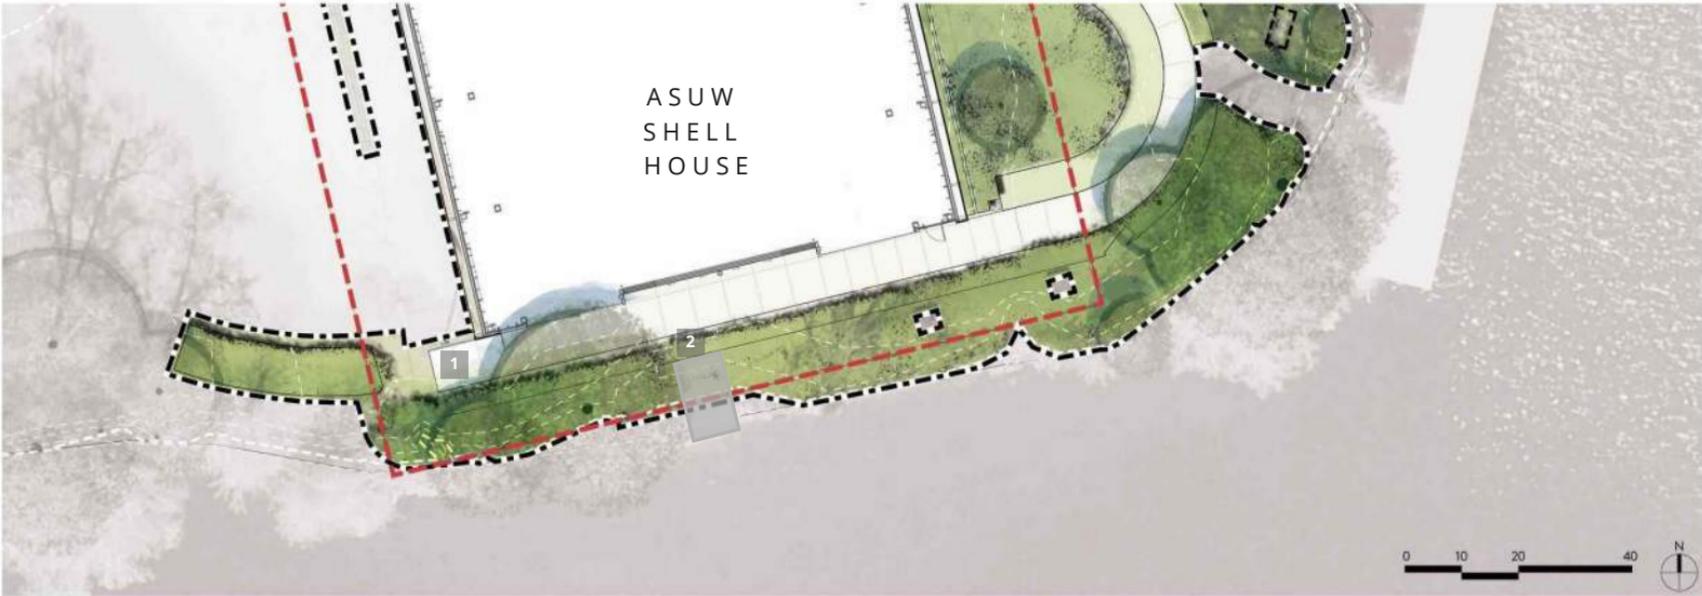
South Side - Enlargement + Proposed Material Palette

Gravel Filter Strip
COBBLE AND GRAVEL FILTER
STRIP BELOW CONCRETE
WALK

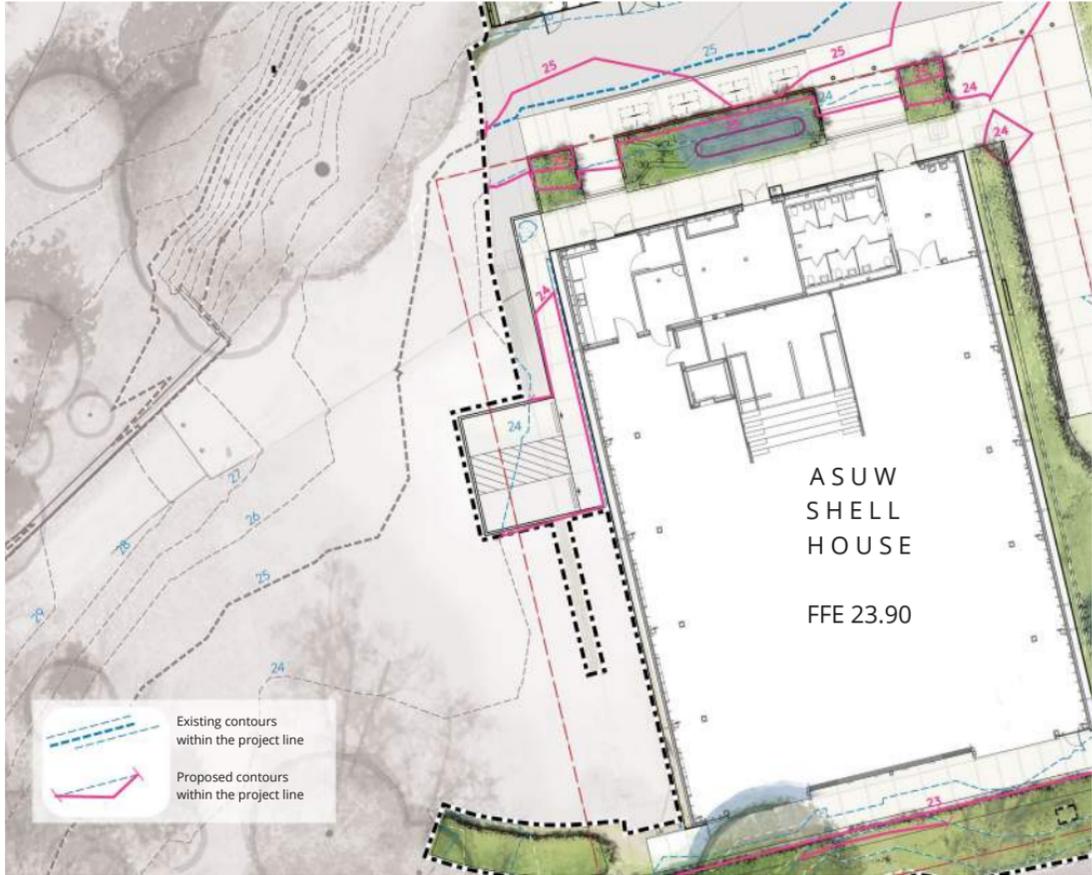
** GRAVEL PAVE/PERMEABLE GRAVEL NEED NOT BE USED AS PREVIOUSLY SPECULATED. STRATEGY OF FILLING GRAVEL TO MEET PERMEABLE PARKING SPACES ALLOWS FOR NON PERMEABLE MATERIAL. (BECAUSE WE ARE NOT CUTTING.)

Proposed Accessible Parking

- MAJORITY OF WEST LOT IS MAINTAINED FOR EVENTS
- REGRADING IS MINIMIZED
- OPTIMUM STORMWATER APPROACH
- AFFORDABLE

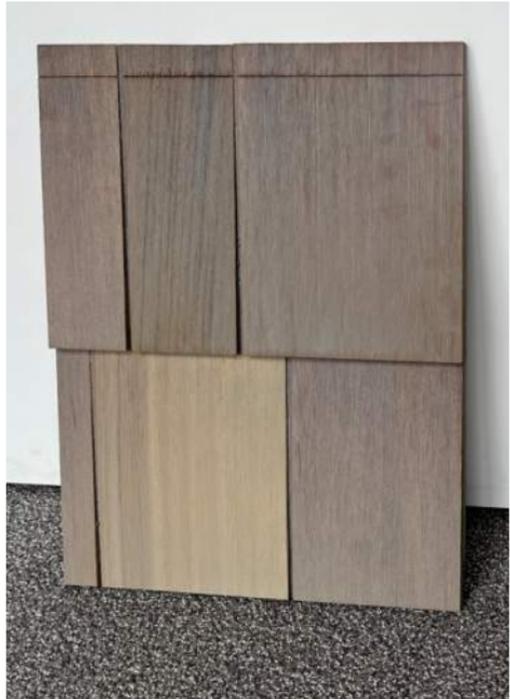
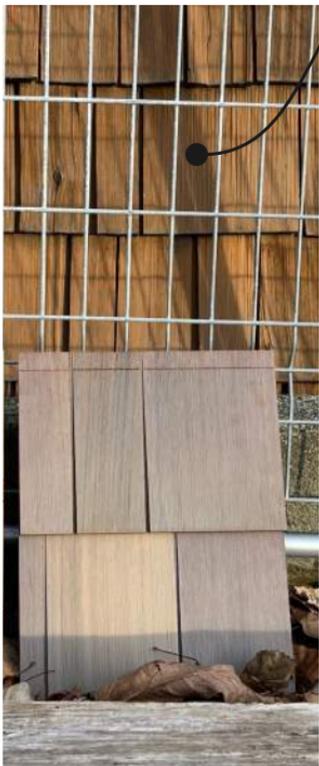
CEDAR SHINGLE PANEL

BASIS-OF-DESIGN: SHAKERTOWN CRAFTSMAN CEDAR SHINGLE PANEL, 7" EXPOSURE WITH VERTICAL KEYWAY; EVEN BUTT.

EXISTING SIDING HAS AN STAGGERED BUTT, KEYWAY AND IS APPROXIMATELY 9" EXPOSURE

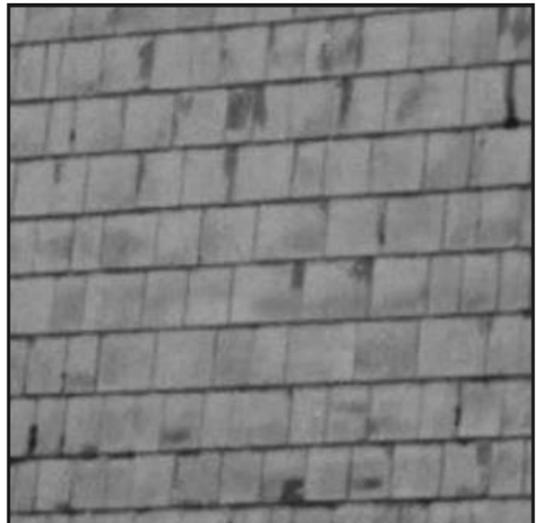
PRE-1980 RENOVATION SHINGLE SIDING APPEARS TO BE AN EVEN BUTT WITH KEYWAY SIMILAR TO PROPOSED NEW SIDING.

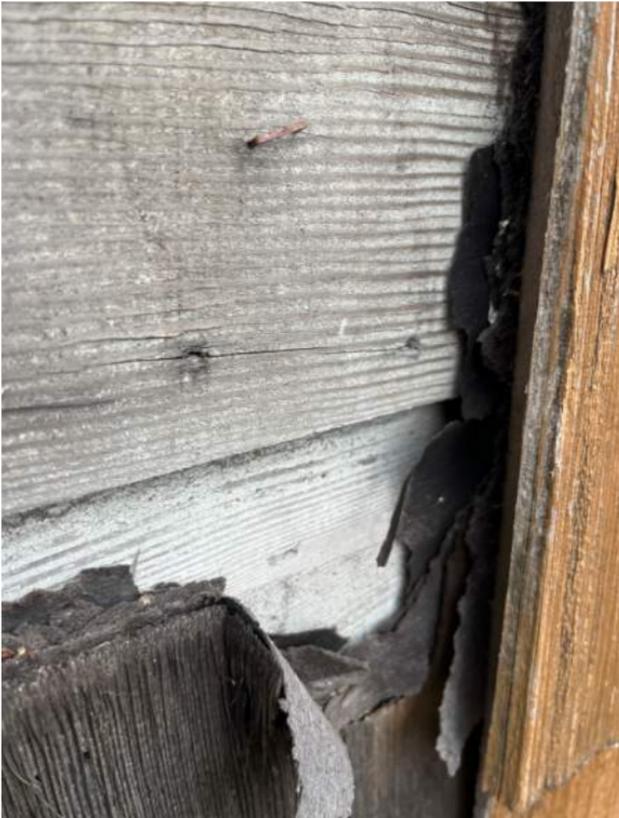
Materials - Horizontal Wall Siding (North and South Facades)

EXISTING ORIGINAL HORIZONTAL SIDING UNDER 1980-ERA SHINGLES

← **PROPOSED HORIZONTAL DROP SIDING PROFILE**
TO MATCH THE EXISTING ORIGINAL PROFILE AS
VERIFIED ON SITE

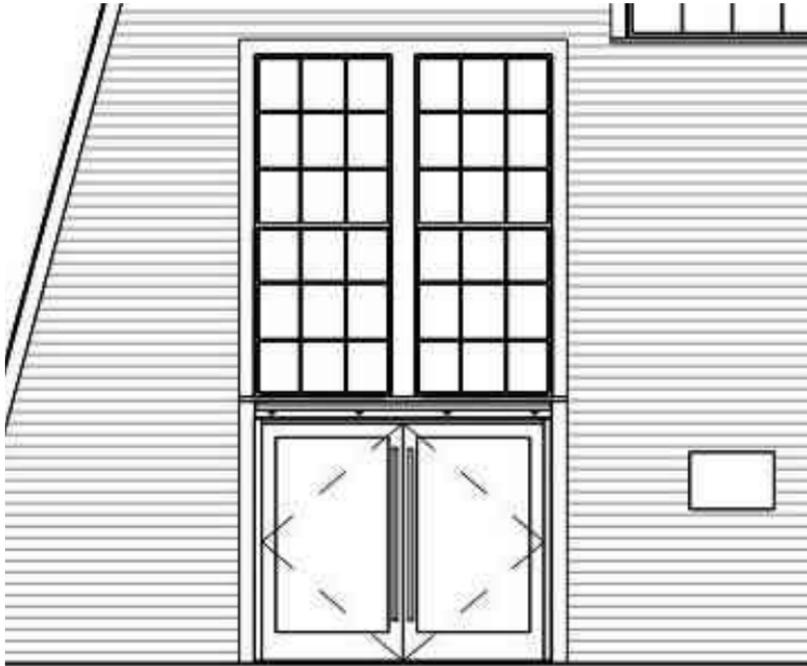
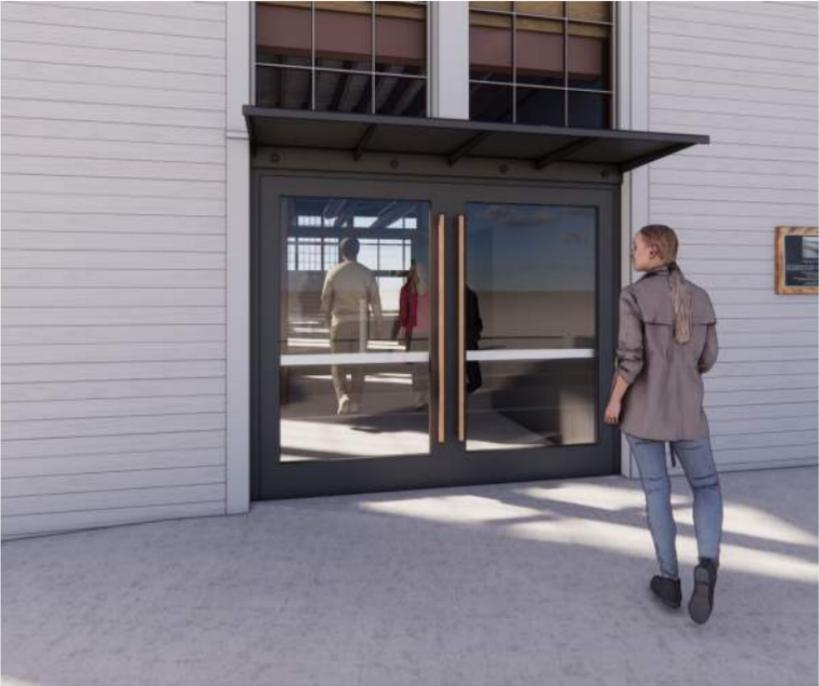
North Entry

- Doors occupy full width of opening per NPS direction (no sidelites)
- Historic windows to remain in current position
- Lighting integrated into canopy to avoid added fixtures on wall

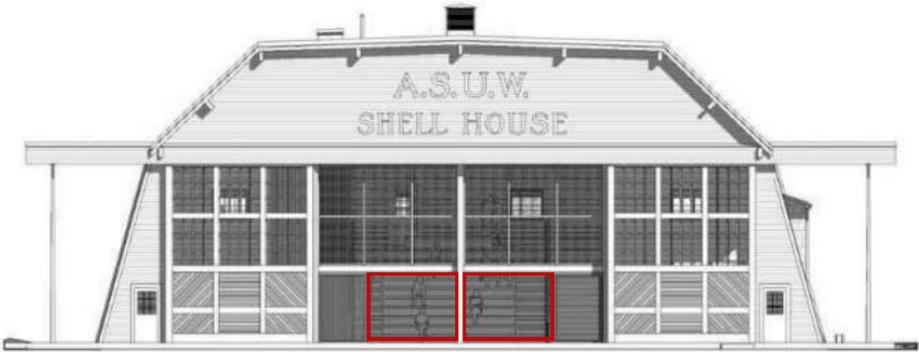
GLAZING OPEN

Sliding glass doors and hangar doors open;
visual and physical connection to the exterior in fair
weather.

Hangar Doors Open, Glass Sliding Doors Open

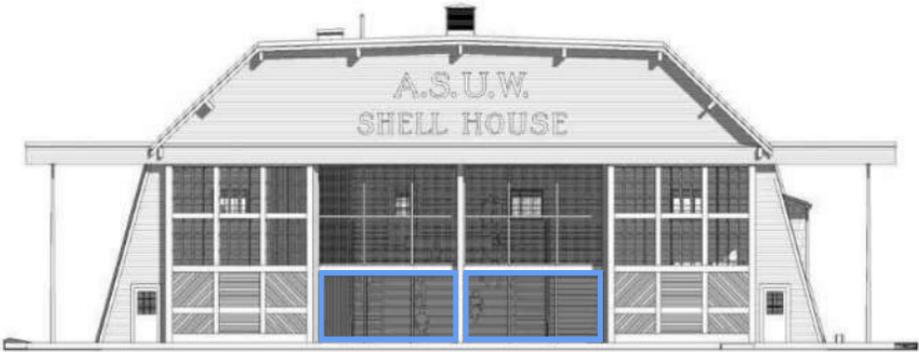
GLAZING CLOSED

Sliding glass doors closed, hangar doors open;
visual connection to the exterior in all weather.

Hangar Doors Open, Glass Sliding Doors Closed

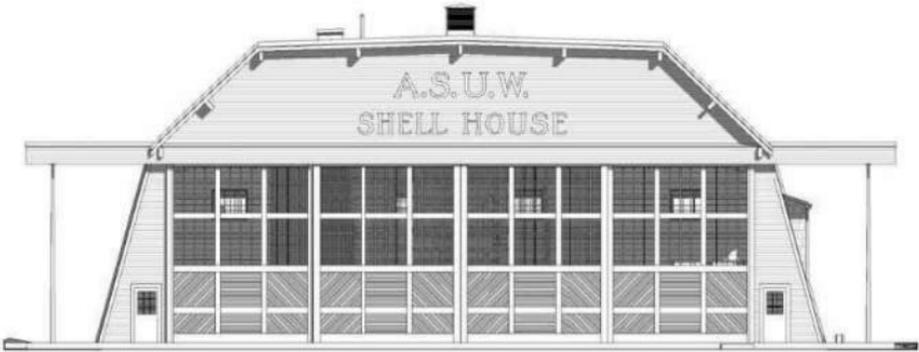
Hangar Doors Closed, Glass Sliding Doors Closed

Sliding glass doors and hangar doors closed;
no connection to the exterior.

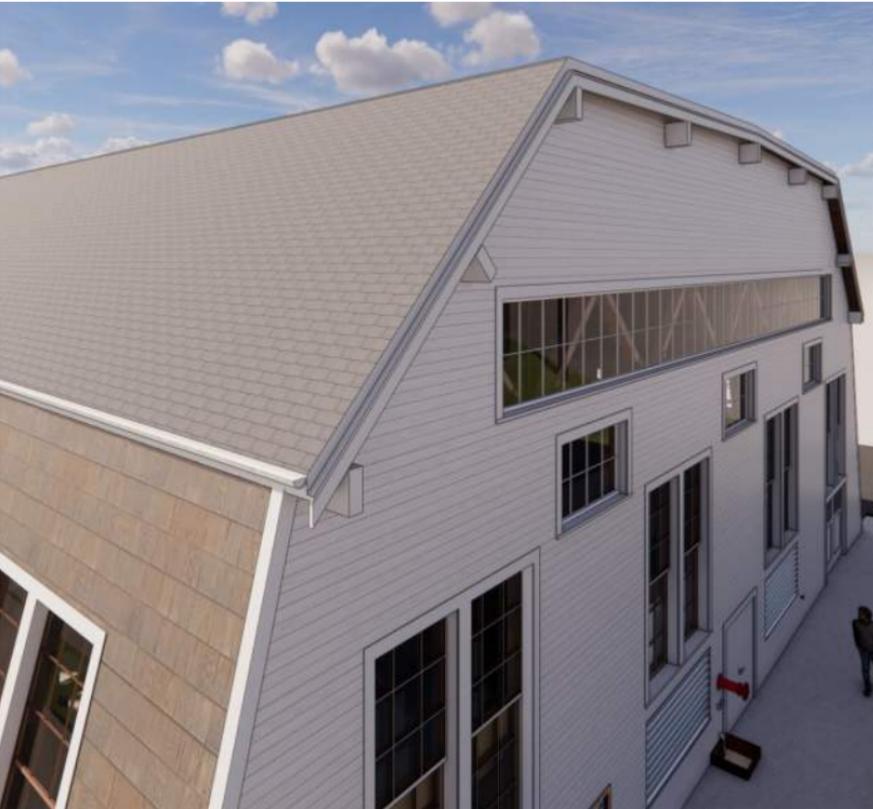
Roof Edge - Step and Taper (Previous)

The new insulation layer is stepped back from the edge of the roof to allow the historic fascia dimensions to read prominently. The thicker upper roof insulation is tapered to meet the lower roof thickness at the north and south facades.

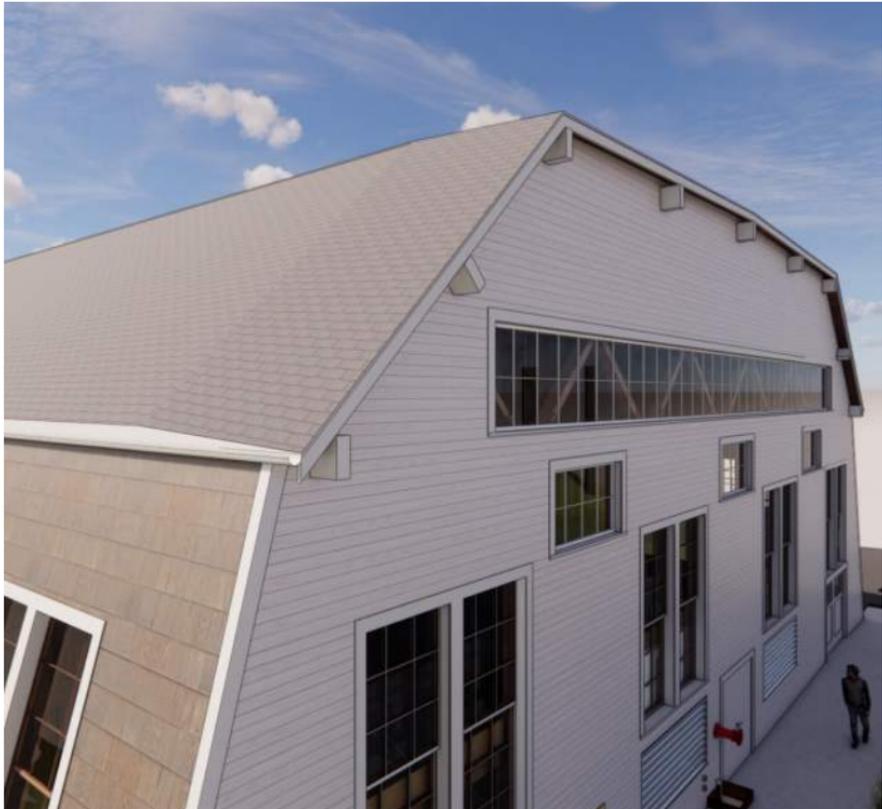
Roof Edge - Long Taper (NPS Direction)

The new insulation layer is tapered to the rake edge of the roof. Taper starts 8'-0" from the edge of roof and gradually reduces to zero.

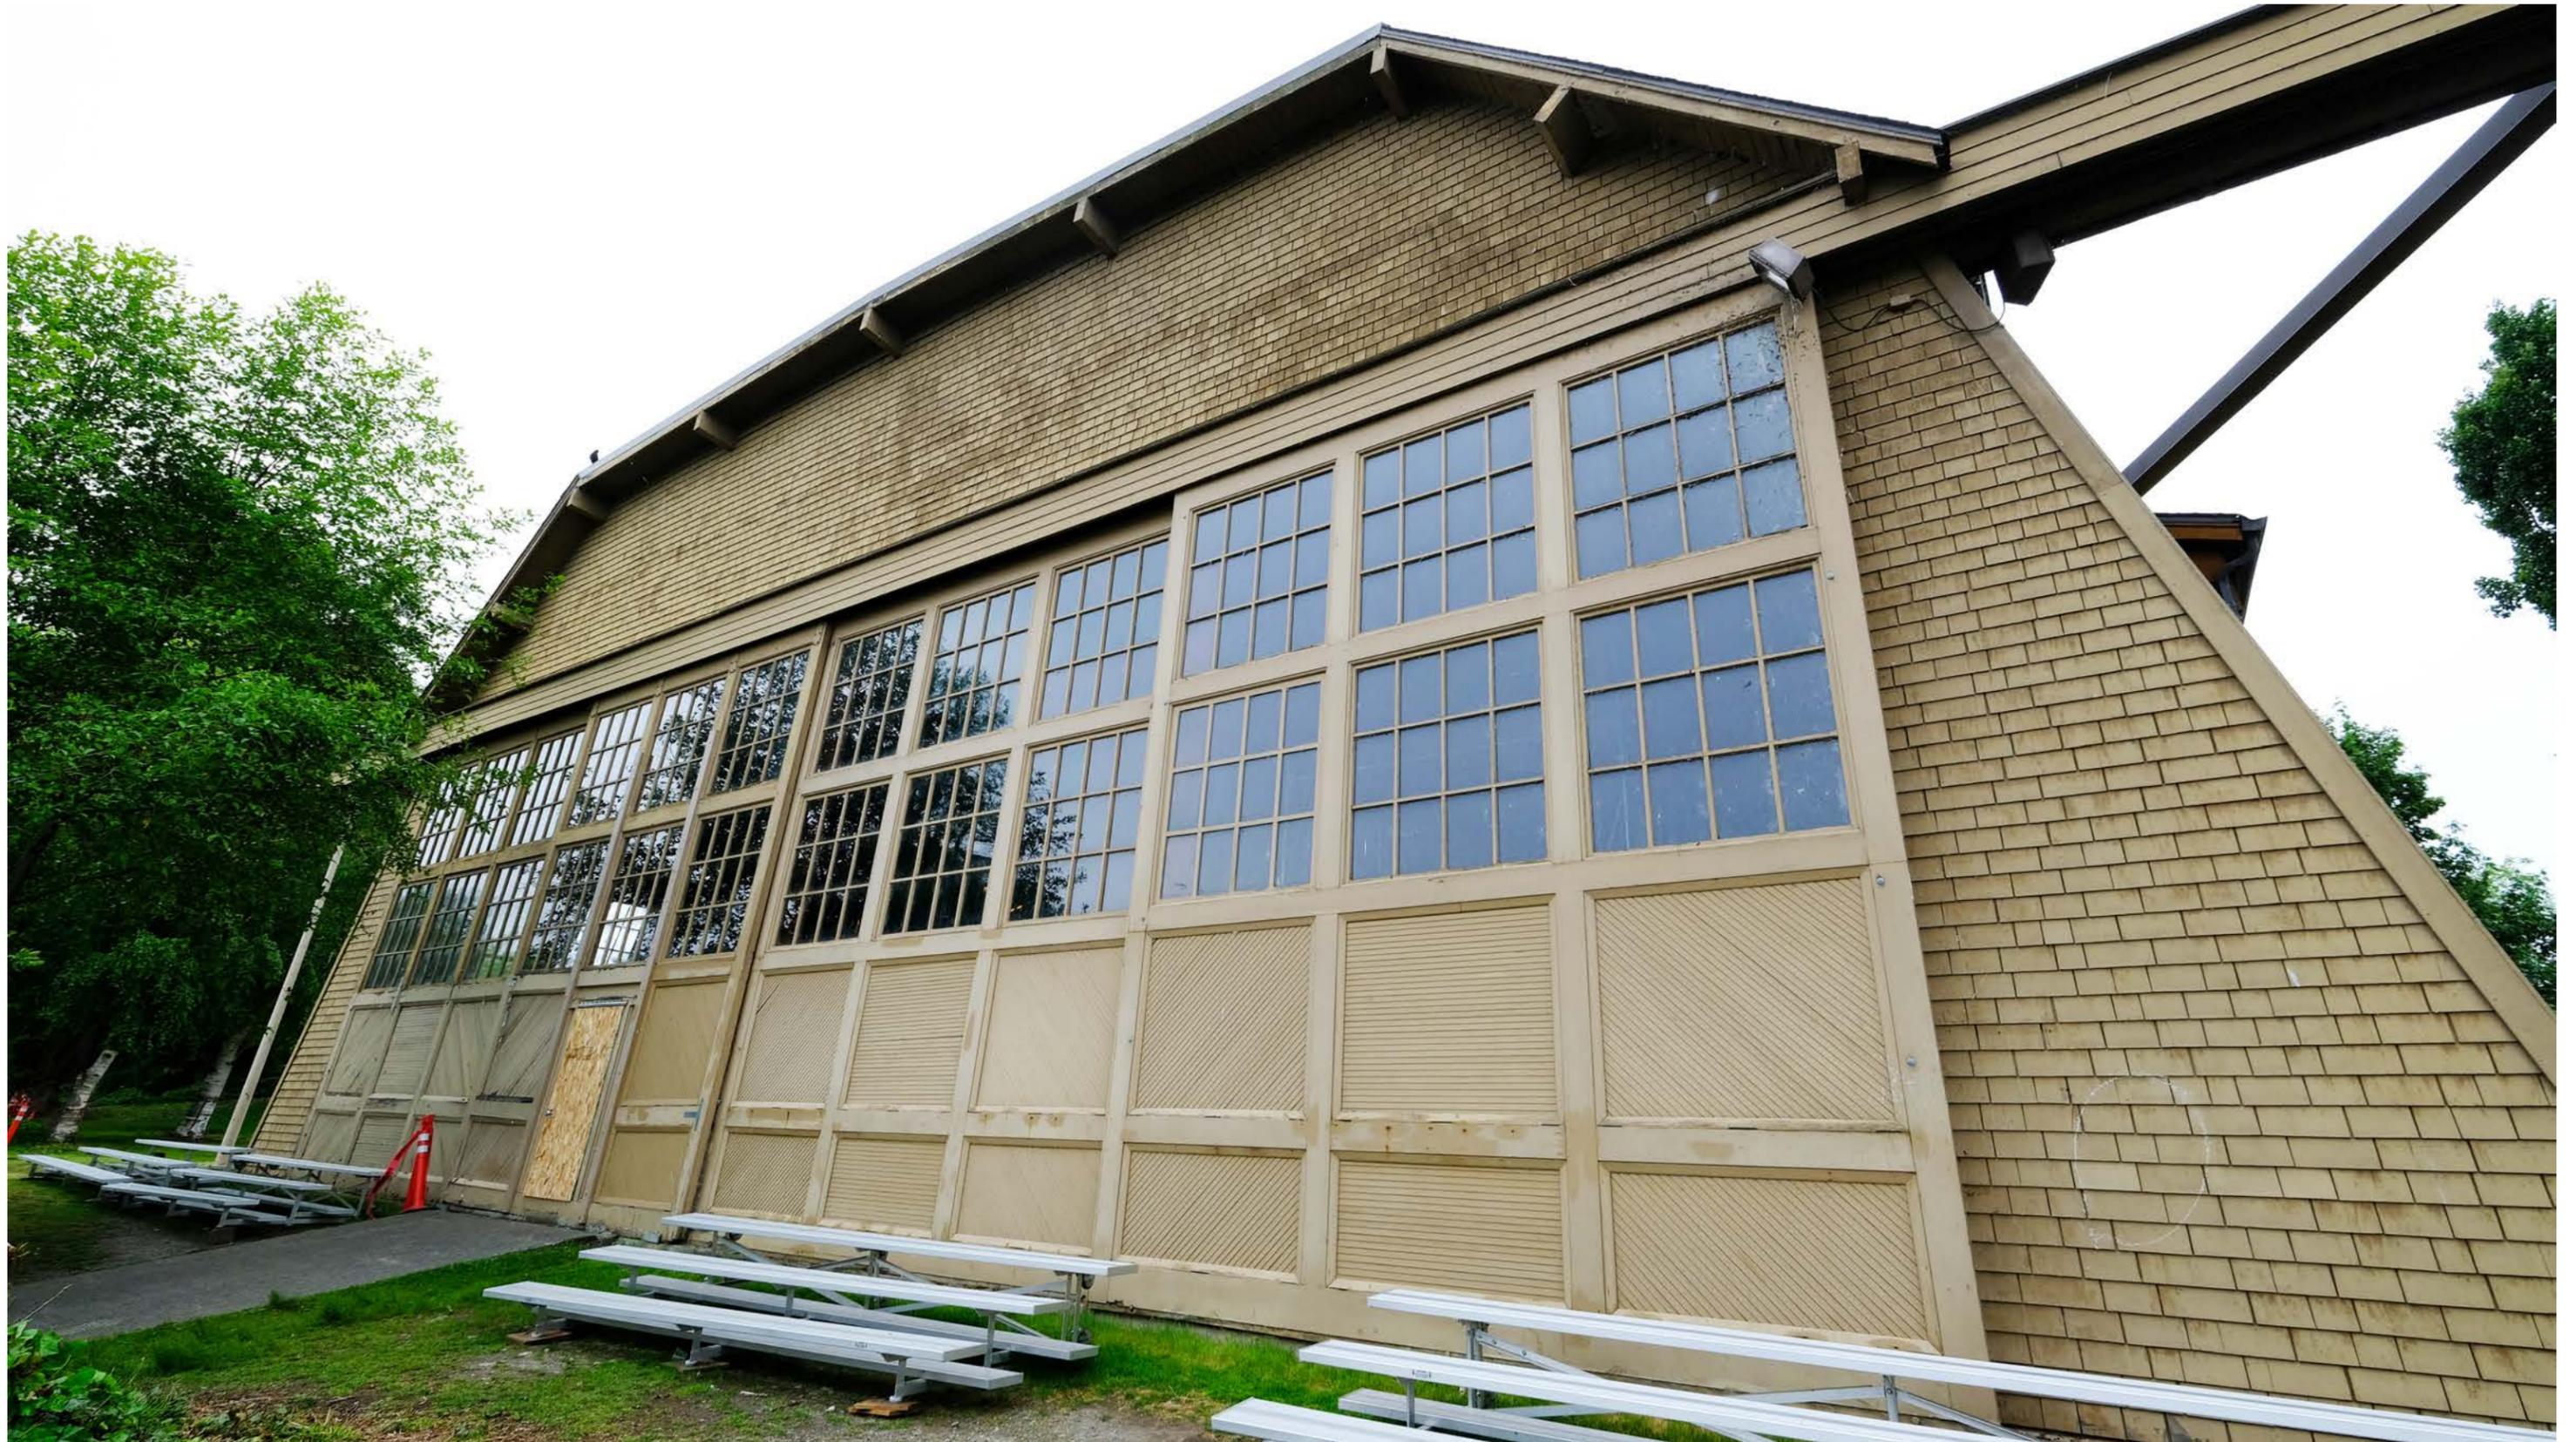
South Elevation Hangar Doors
