ASUW Shell House

SEATTLE LANDMARKS PRESERVATION BOARD
Certificate of Approval Presentation, September 2025

ASUW Shell House Certificate of Approval Presentation

Existing Window Survey

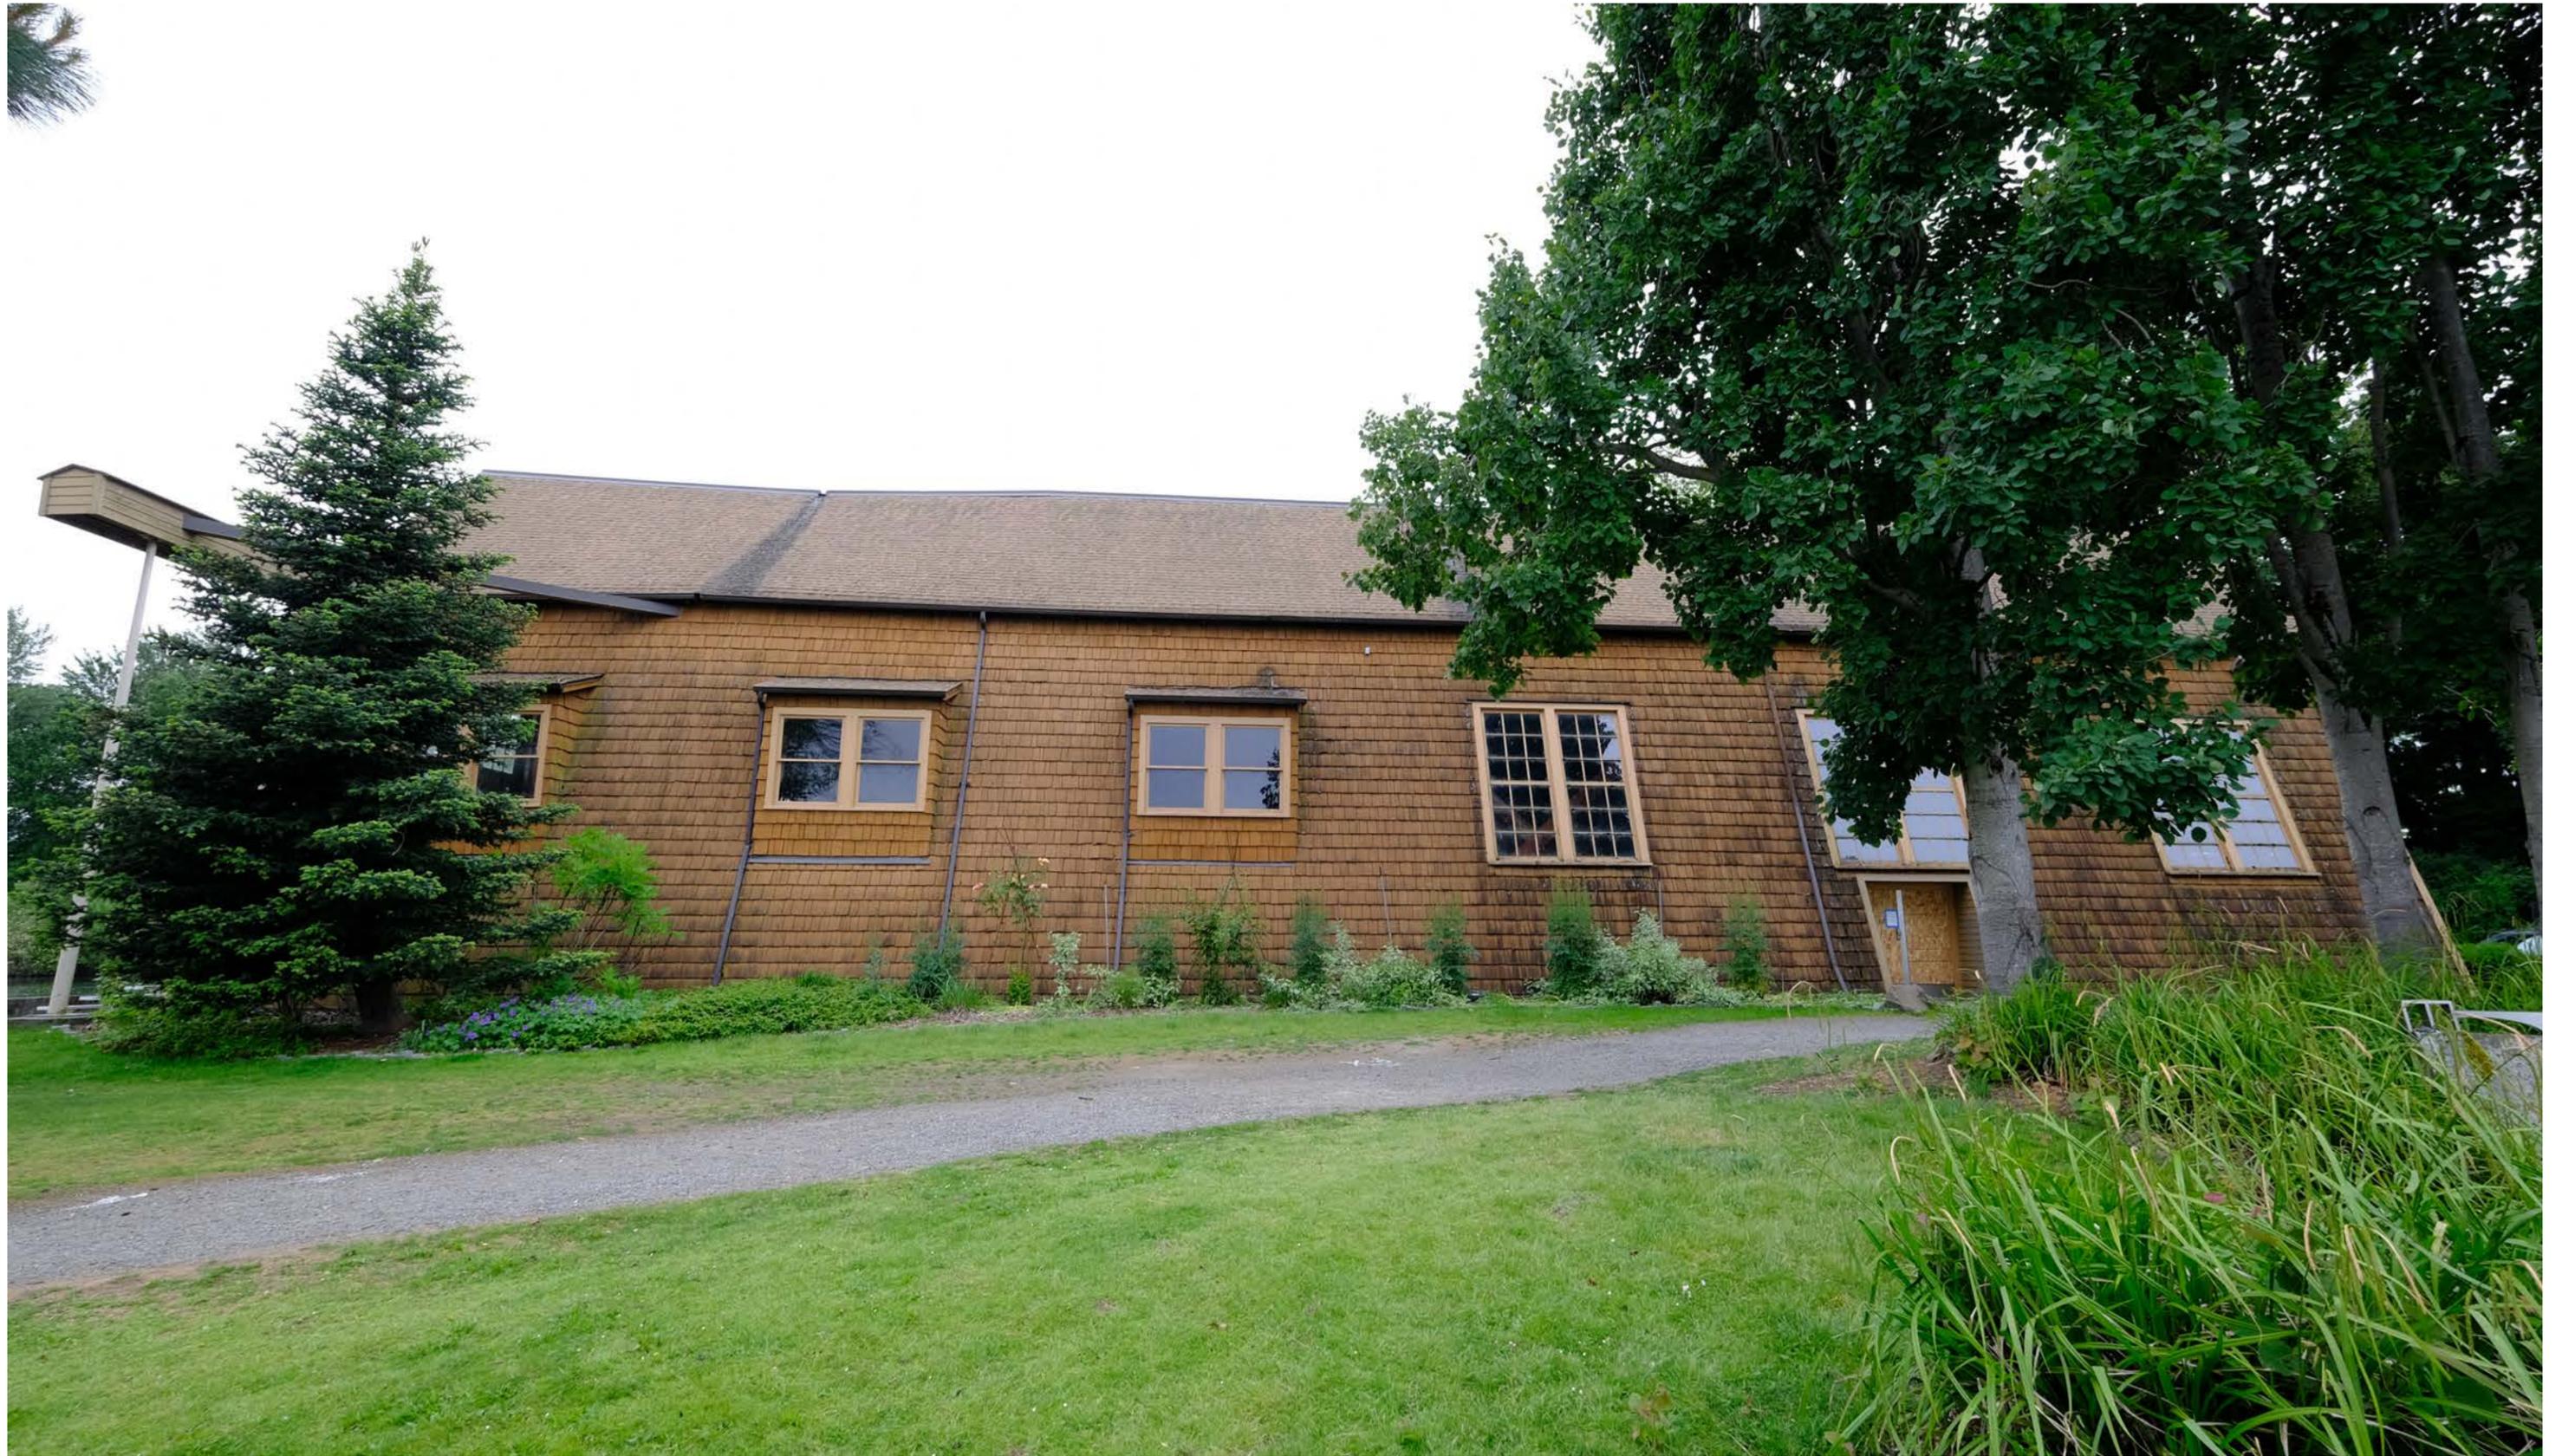
East Elevation Windows

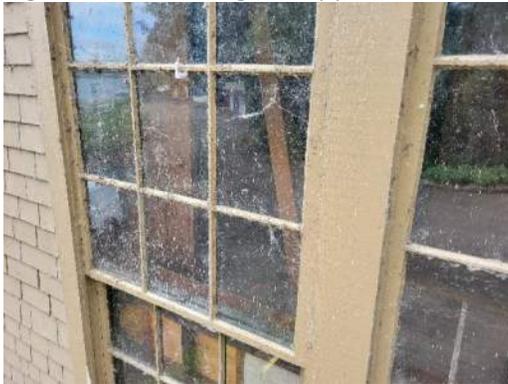
Figure 2 - xC1 Glass soiling

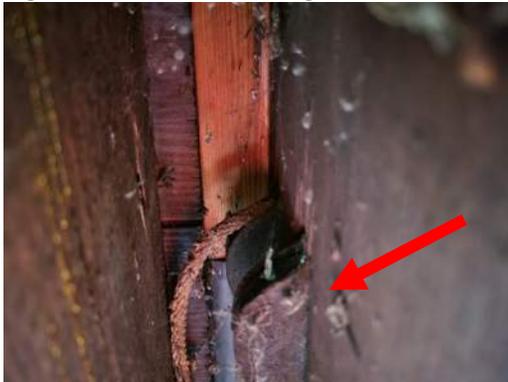
Figure 3 - xC1 Pulley

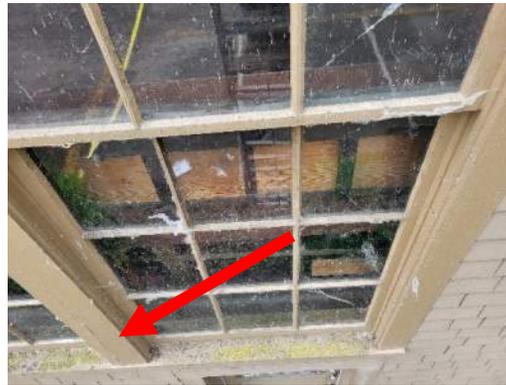
Figure 4 - xC2 with Split Trim

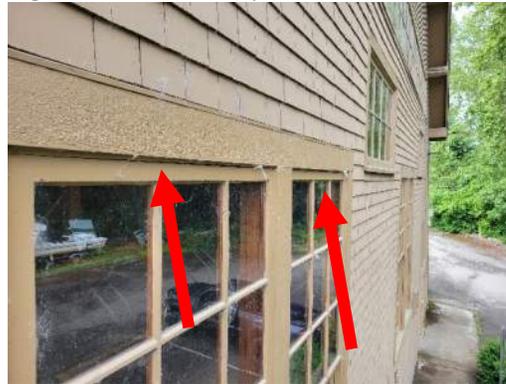
Figure 5 - xD1 & xD2 Misalignment at fixed upper sash.

Window xD1			
Description- 1980's replacement wood window. Approximately 4'-6" x 10'-0". Window shares a rough opening with xD2. Windows are fixed in place currently but have tracks to potentially operate as single hung windows.			
Repair Code	Exterior Condition Notes		Interior Condition Notes
Paint Condition	1		Interior wood is unpainted, staining and soiling present.
Operability Ease	3	Currently inoperable.	
Alignment	2	Misaligned gap between top rail and head. May need sash removal for realignment, or infill. (Figure 5)	
Glass Condition	1	Heavily soiled – including paint splatter that may be difficult to remove.	
Weather Stripping	NA		
Sill Condition	1		Interior of sill not accessible for review.
Jamb Condition	1		
Head Condition	1		
Top Rail	2	Misaligned gap between top rail and head. May need sash removal for realignment, or infill. (Figure 5)	
Meeting Rails	1		
Bottom Rail	1		
Stiles	1		
Muntins	1

Window xD2			
Description- 1980's replacement wood window. Approximately 4'-6" x 10'-0". Window shares a rough opening with xD1. Windows are fixed in place currently but have tracks to potentially operate as single hung windows.			
Repair Code	Exterior Condition Notes		Interior Condition Notes
Paint Condition	1		Interior wood is unpainted, staining and soiling present.
Operability Ease	3	Currently inoperable.	
Alignment	2	Misaligned gap between top rail and head. May need sash removal for realignment, or infill. (Figure 5)	
Glass Condition	1	Heavily soiled – including paint splatter that may be difficult to remove.	
Weather Stripping	NA		
Sill Condition	1		Interior of sill not accessible for review.
Jamb Condition	1		
Head Condition	1		
Top Rail	2	Misaligned gap between top rail and head. May need sash removal for realignment, or infill. (Figure 5)	
Meeting Rails	1		
Bottom Rail	1		
Stiles	1		
Muntins	1

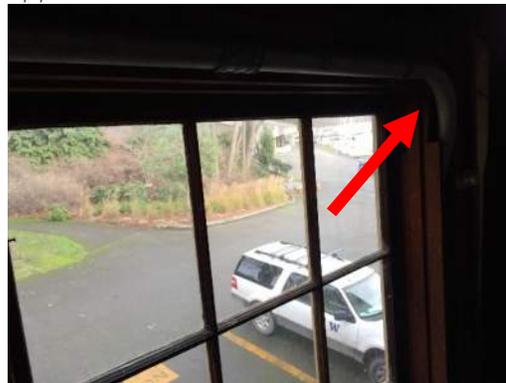
Figure 6 - Cut out at top corner frame for conduit clearance.

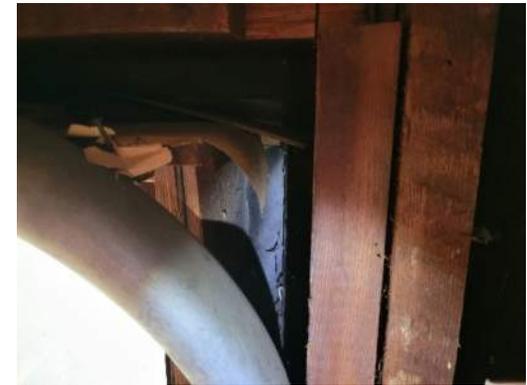
Figure 7 - xC3 Close up of cut frame at conduit.

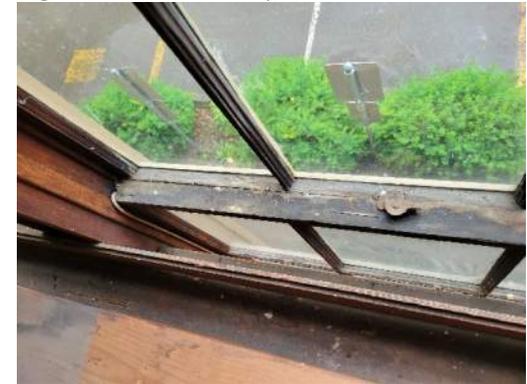
Figure 8 - xC3 hardware & meeting stile

Muntins	1		Three muntin bars are damaged at interior and will require wood repair or replacement.
Hardware	1		Hardware is corroded and missing pieces. (Figure 8)
Balancing	1		New sash cord, and weights needed. Pulley could be refinished or replaced. (Figure 8)
Rough Opening	2	Face sealed. No building paper or sheathing @ trim between xC1 and xC2.	
Attachment	2		Attachment to surrounding structure is unclear. May require supplemental attachment clips during construction for securement. Review once exposed during construction.

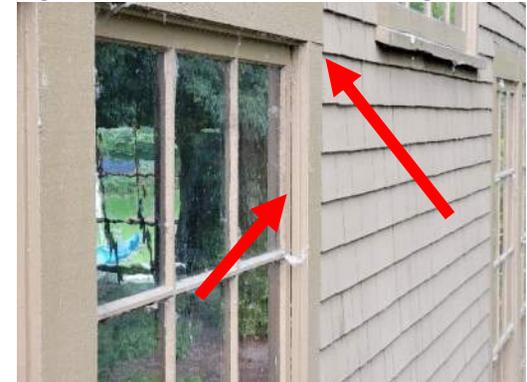
Figure 9 - xC4 minor misalignment at jamb

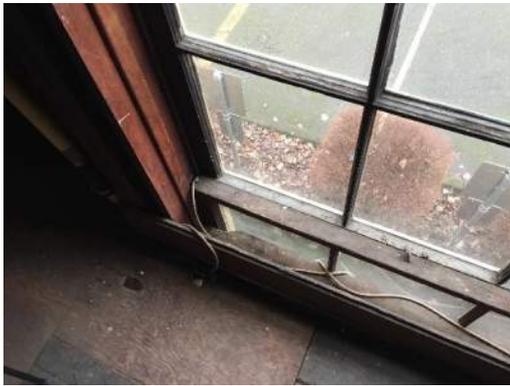
Figure 10- xC4 hardware & meeting stile

Window xC4			
Description- Original double hung wood window. Approximately 4'-6" x 10'-0". Window shares a rough opening with xC3.			
Repair Code	Exterior Condition Notes		Interior Condition Notes
Paint Condition	1		Interior wood is unpainted, staining and soiling present.
Operability Ease	2		Not currently operable. Sashes should be removed in order to restore operability.
Alignment	2	Far right (west) jamb has some noticeable misalgnment.	
Glass Condition	1	Heavily soiled – including paint splatter that may be difficult to remove. Some glass appears original.	
Weather Stripping	1	New weather stripping needed.	
Sill Condition	1		Interior of sill not accessible for review.
Jamb Condition	2	Far right (west) jamb has some potential misalgnment. (Figure 9)	
Head Condition	2		Head was cut for conduit clearance.
Top Rail	2		
Meeting Rails	1		
Bottom Rail	1		
Stiles	2		
Muntins	1		
Hardware	1		Hardware is missing pieces. (Figure 10)

Balancing	1		New sash cord, and weights needed. Pulley could be refinished or replaced. (Figure 10)
Rough Opening	2	Face sealed. No building paper or sheathing @ trim between xC1 and xC2.	
Attachment	2		Attachment to surrounding structure is unclear. May require supplemental attachment clips during construction for securement. Review once exposed during construction.

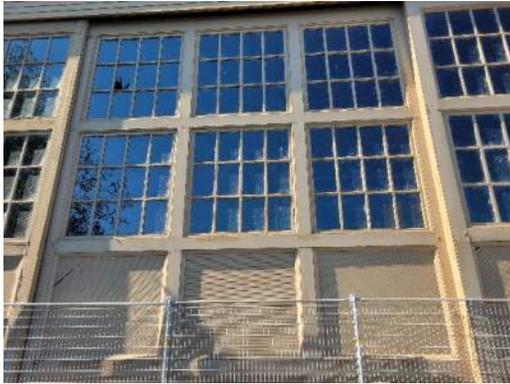
Photo 1 – Overall Door Photo

4EA visually reviewed the hangar doors to document the condition. (Photo 1) The intent of this review is to establish a baseline recommended restoration scope, and identify conditions where restoration beyond the baseline scope should be allowed for.

- Wood components should be cleaned, have damaged or loose paint and putty removed, including abatement of any hazardous materials. Provide sealant or epoxy application to gaps and joints. Refinish the wood, apply wood preservation treatment, several coats of boiled linseed oil, and paint wood.
- Targeted repair and stabilization of wood should be performed on as-needed basis– see the following tables for unit survey identifying the expected extent of targeted repairs.
- Glass panes should be removed and numbered. Any original glass to be salvaged should be removed and cleaned. We assume non-original windows would receive new glass.
- Hangar doors should have new perimeter gaskets or be sealed for weather tightness, new connection

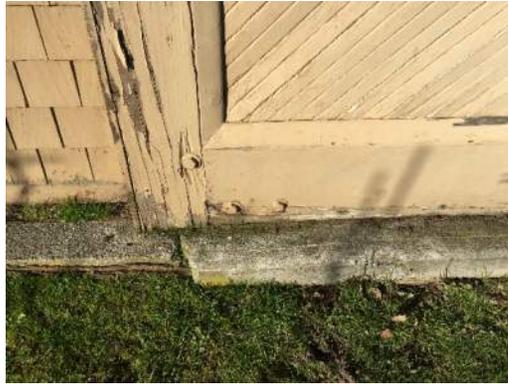
Photo 4 – Dry rot at Door A sill

Door A Currently in Door Position #1		
Description- Hangar door. Approximately 18'-0" x 22'-0". Door area is divided into twelve subsections of glazed lights and wood slat infill.		
Repair Code		Exterior Condition Notes
Paint Condition	3	Significant exposed wood with raised grain and peeling paint. Full paint removal likely needed. (Photo 2)
Operability Ease	3	Currently inoperable. Needs a full overhaul of the tracks and hardware to restore operability.
Alignment	3	Door is bowed and visibly misaligned. Non-original brackets have been added for stiffness. Infill panels are misaligned. (Photo 3)
Glass Condition	1	Heavily soiled.
Weather Stripping	3	Currently no weatherstripping at perimeters, joints are open.
Sill Condition	3	Dry rot along sill, horizontal wood is split. (Photo 4)
J1 Condition	2	Jamb largely intact. Dry rot at base. Casing trim warped.
J2 Condition	2	Misaligned, bowing.
V1 Condition	2	Split wood at ends. Raised grain, weathered and exposed. Suspected dry rot near base of G5.

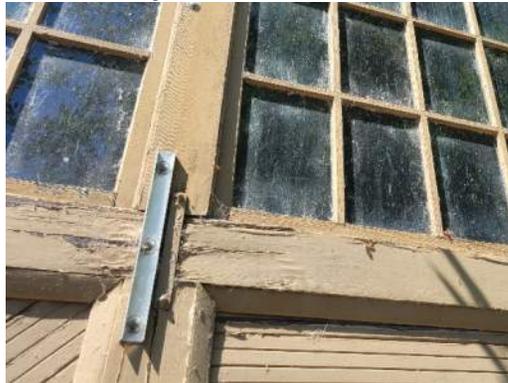
Photo 5 – Dry rot

V2 Condition	2	Split wood at ends. Raised grain, weathered and exposed. Suspected dry rot near base of G5.
H1 Condition	1	
H2 Condition	2	Raised grain, weathered and exposed.
H3 Condition	3	Dry rot present. (Photo 5)
H4 Condition	2	Raised grain, weathered and exposed.
G1 Condition	3	Damaged perimeter trim, 1 cracked muntin
G2 Condition	3	Replace perimeter trim
G3 Condition	3	Replace perimeter trim
G4 Condition	3	Misaligned with H2, Replace perimeter trim, Bottom Rail is split
G5 Condition	3	Misaligned with H2, Replace perimeter trim, 1 split muntin
G6 Condition	1

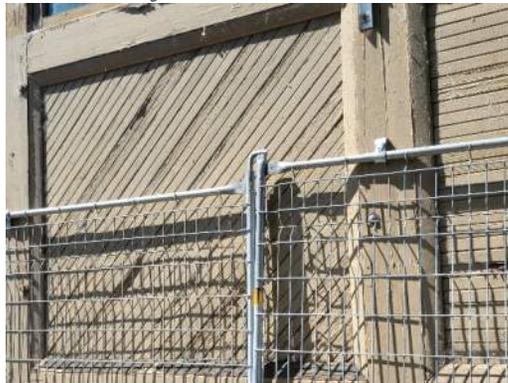
Photo 6 – Deteriorated Wood Infill

Door A Continued		
Repair Code		Exterior Condition Notes
W1 Condition	3	Wood infill slat replacement needed, gaps, open joints, damaged base trim. (Photo 6)
W2 Condition	3	Gaps and open joints in slats, damaged base trim.
W3 Condition	3	Wood infill slats are buckled
W4 Condition	3	Wood infill slats are missing
W5 Condition	2	Fill and seal gaps in slats
W6 Condition	3	Buckled slats, gaps in slats, split trims

- At wood slat infill panels (W1-W6), consider replacing the wood slats with a solid panel to allow for greater weather sealing.
- The interior surface of the hangar doors is not currently intended for exterior exposure. Should the doors be relocated such that the interior surface be exposed to prolonged weather, we recommend that the wood be sealed and painted for such exposure, and that weeps be added to bottom trims at minimum. Further work would be needed to refine this scope.

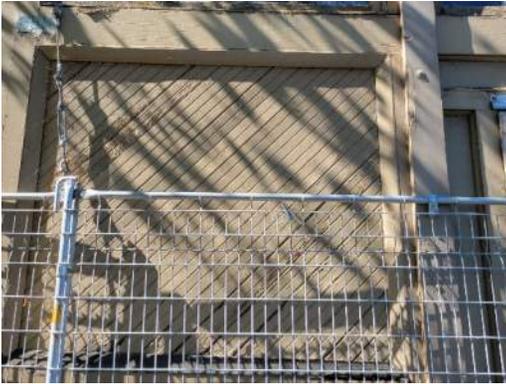
Photo 30 – Wood Panel

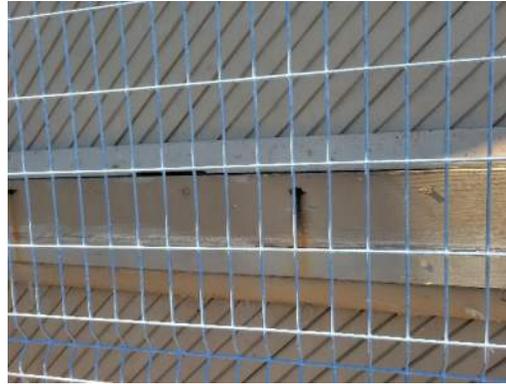
Photo 13 – Corroded fasteners

Door C Currently in Door Position #3		
Description- Hangar door. Approximately 18'-0" x 22'-0". Door area is divided into twelve subsections of glazed lights and wood slat infill.		
Repair Code		Exterior Condition Notes
Paint Condition	2	Spot paint removals needed, paint may not need full removal.
Operability Ease	3	Currently inoperable. Sits fully on ground. Needs a full overhaul of the tracks and hardware to restore operability.
Alignment	2	Misalignment at jamb with Door B, but that may be largely due to Door B.
Glass Condition	3	1 broken pan, 2 heavily scratched panes. (Photo 11)
Weather Stripping	3	Currently no weatherstripping at perimeters, joints are open.
Sill Condition	2	Non-matching treated wood has been added along sill, may need alternate material or replacement. (Photo 12)
J1 Condition	1	
J2 Condition	1	
V1 Condition	1	
V2 Condition	1	
H1 Condition	1	
H2 Condition	1	
H3 Condition	1	
H4 Condition	2	Corroded and popped fasteners. (Photo 13)

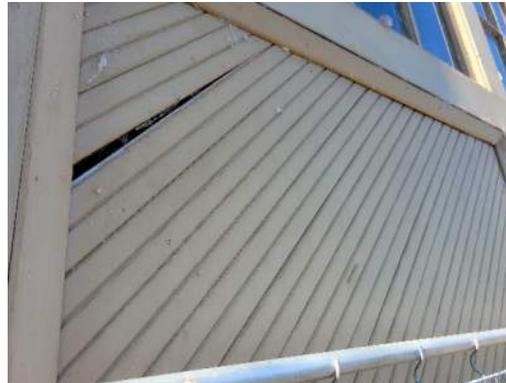
Photo 14 – Damaged infill panel

Door C Continued		
Repair Code		Exterior Condition Notes
W1 Condition	3	Buckled slats, gaps, trim rot. (Photo 14)
W2 Condition	3	Buckled slats, gaps, trim rot.
W3 Condition	1	
W4 Condition	2	Buckled bottom trim
W5 Condition	1	
W6 Condition	2	Fix/replace bottom trim

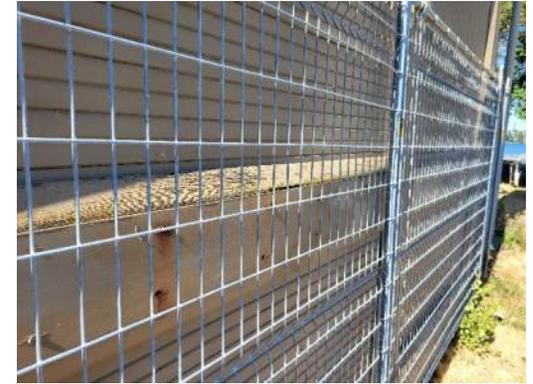
Photo 16 – Corroded fasteners

Door D Currently in Door Position #4		
Description- Hangar door. Approximately 18'-0" x 22'-0". Door area is divided into twelve subsections of glazed lights and wood slat infill.		
Repair Code		Exterior Condition Notes
Paint Condition	2	Spot paint removals needed, paint may not need full removal.
Operability Ease	3	Currently inoperable. Sits fully on ground. Needs a full overhaul of the tracks and hardware to restore operability.
Alignment	1	
Glass Condition	1	
Weather Stripping	3	Currently no weatherstripping at perimeters, joints are open.
Sill Condition	2	Non-matching treated wood has been added along sill, may need alternate material or replacement. Some dry rot rear J1 (Photo 15)
J1 Condition	1	
J2 Condition	1	
V1 Condition	1	
V2 Condition	1	
H1 Condition	1	
H2 Condition	1	
H3 Condition	2	Dry rot present below G5
H4 Condition	2	Corroded and popped fasteners. (Photo 16)
G1 Condition	1	
G2 Condition	1

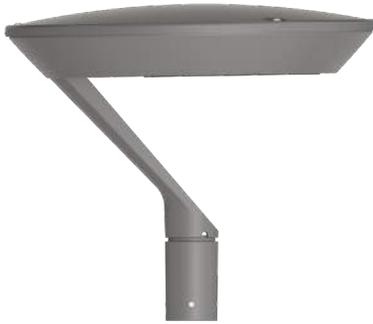
XP1/XP2

KEY FEATURES:

- Dust Protection - IP66
- IES Classification Type I, II, III, IV
- Optical System - Removable
- Controls - Fix / 0-10 / DALI
- Voltage 110V - 277V (347V and 480V optional)
- SPD - 10kV - 10kA
- CRI - >70
- CCT - 3000K / 4000K
- Switch Off Connector
- Operating Temp: -40°F (-40°C) to 104°F (40°C)
- Lifetime - L90B10 > 100 000 h

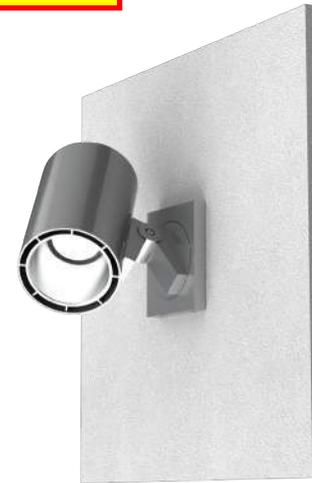
4"

High Center Beam Wall Mount Tilt & Rotate Cylinder

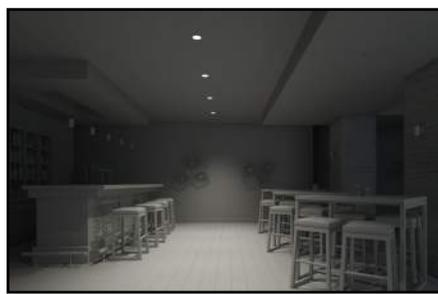
Coordinated Apertures | Multiple Layers of Light

General Illumination Layer | EVO

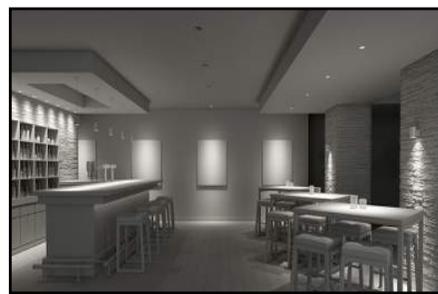
High Center Beam Layer | Incito

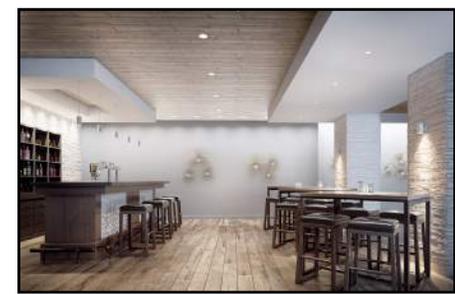
EVO + Incito — Multiple Layers of Light

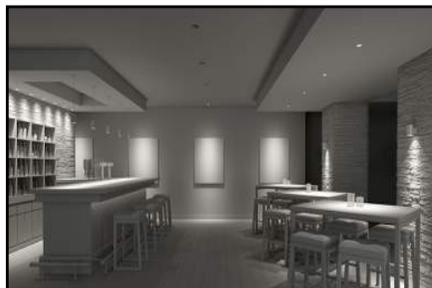
General Illumination Layer | EVO
