Gas Works Park - Cracking Tower Work/Repairs

Gas Works Park Cracking Towers Tower Photographs

GAS WORKS PARK "CRACKING TOWERS": EMERGENCY SELECTIVE DECONSTRUCTION

SELECTIVE REMOVAL OF PIPING, CATWALKS, LADDERS AND SUPPORT SYSTEMS FROM TOWER STRUCTURES LOCATED WITHIN GAS WORKS PARK.
EMERGENCY SECURITY LIGHTING SYSTEMS.

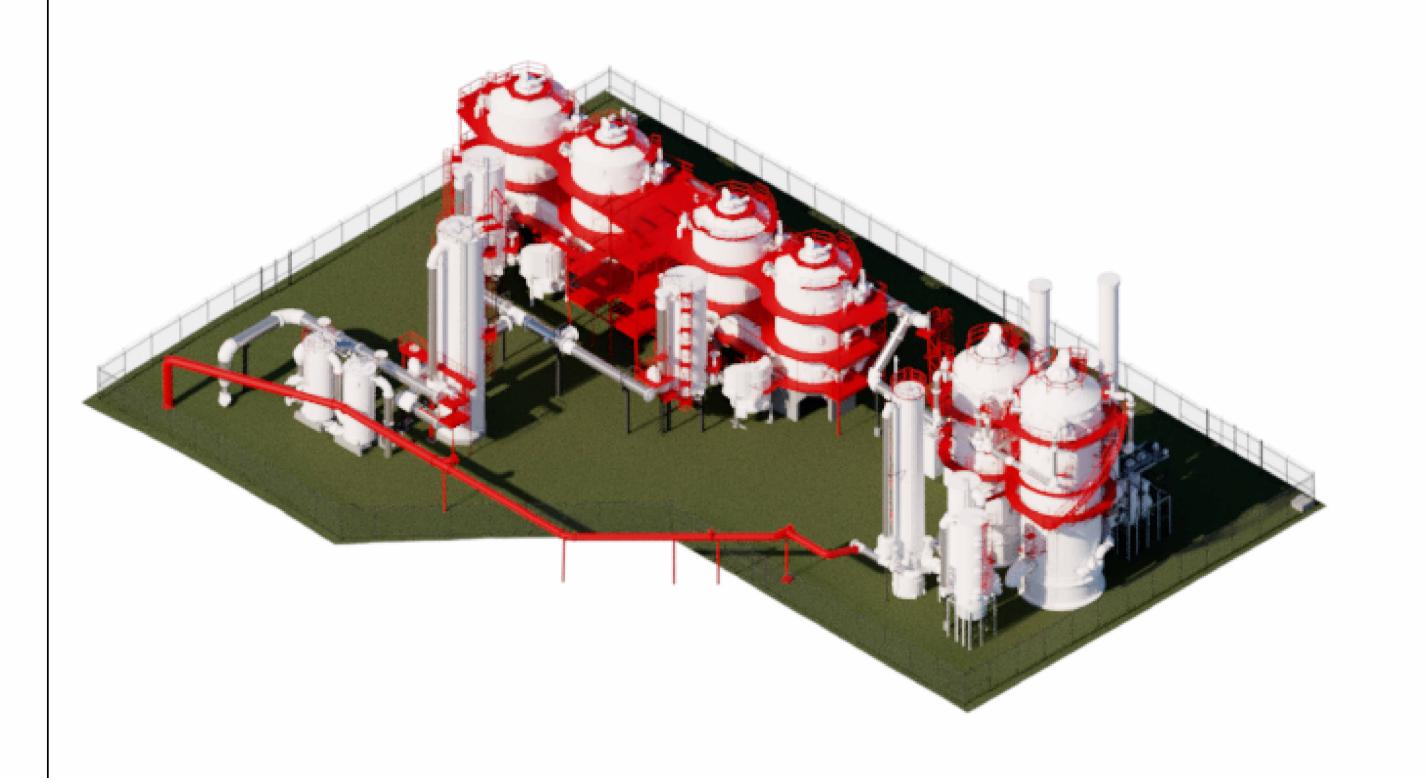
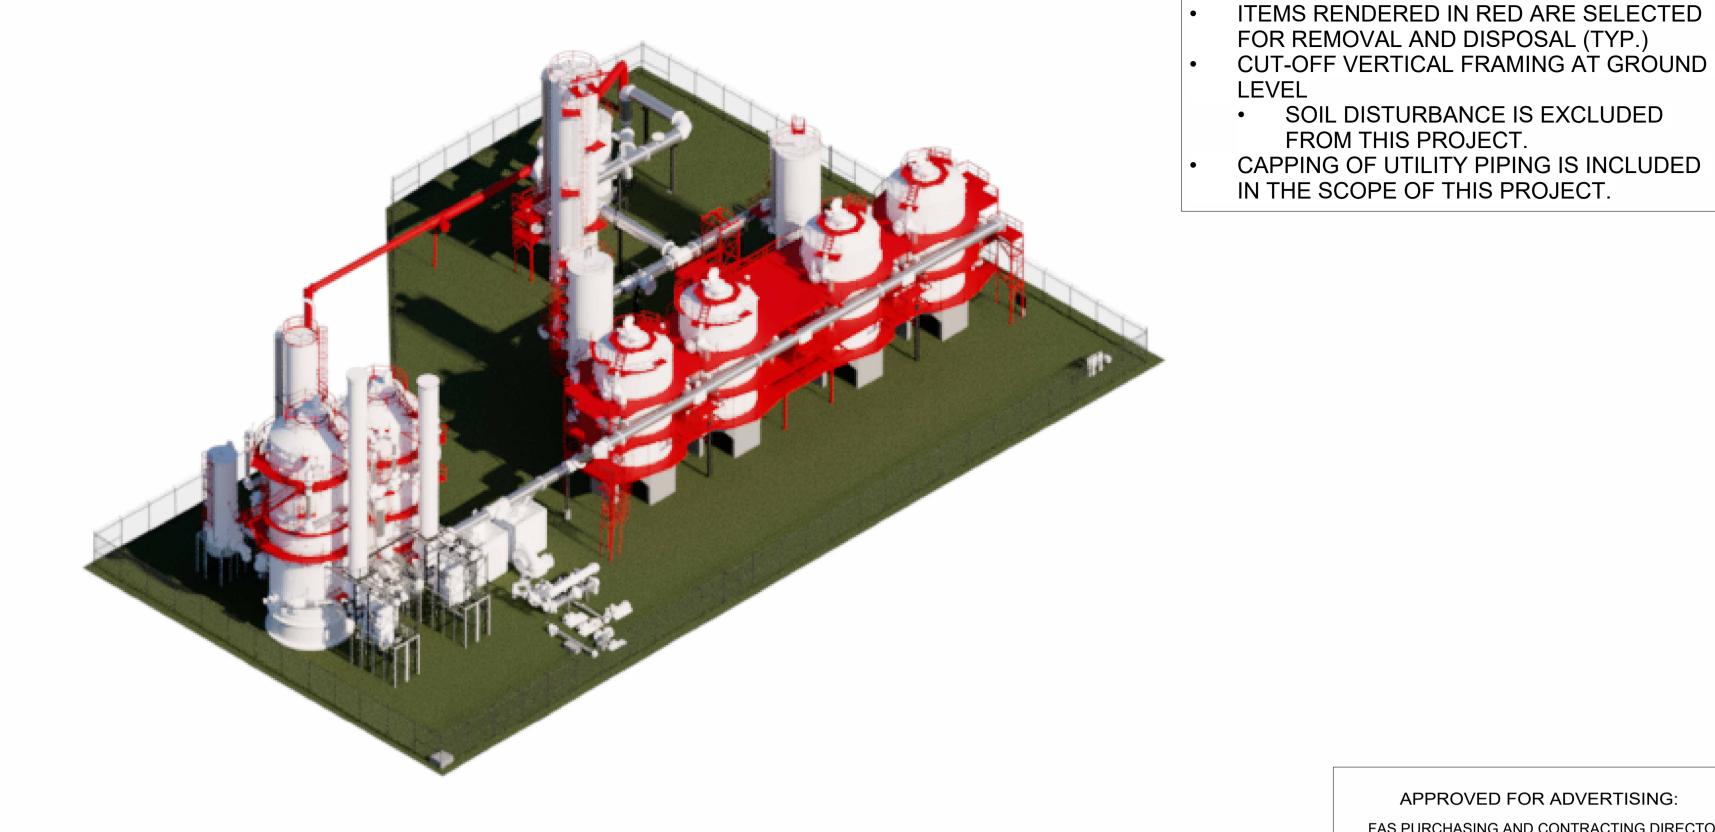
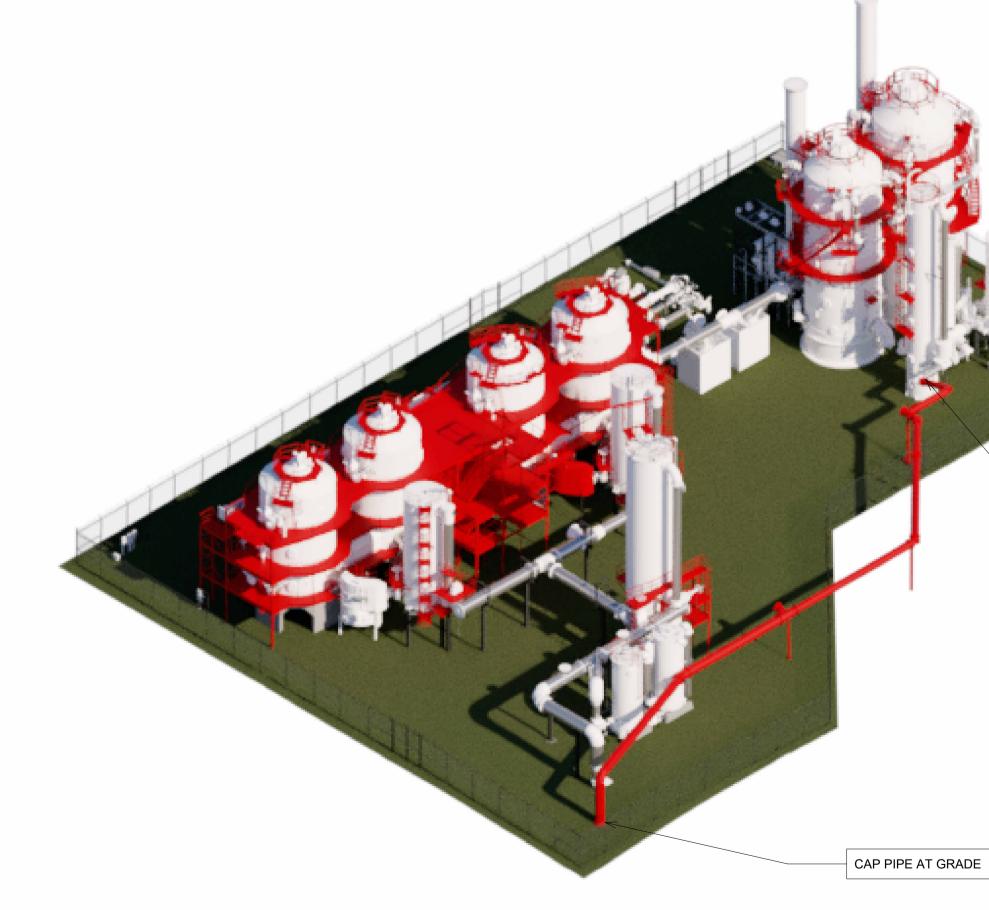
D1.01 ORDINANCE NO. CONTRACT NO.

2 SE PERSPECTIVE NTS

4 NW PERSPECTIVE NTS

3 NE PERSPECTIVE NTS

1 SW PERSPECTIVE NTS

CAP PIPE AT INDICATED
POSITION AND RETAIN
VERTICAL SECTION AS SHOWN
ON SHEET D1.02

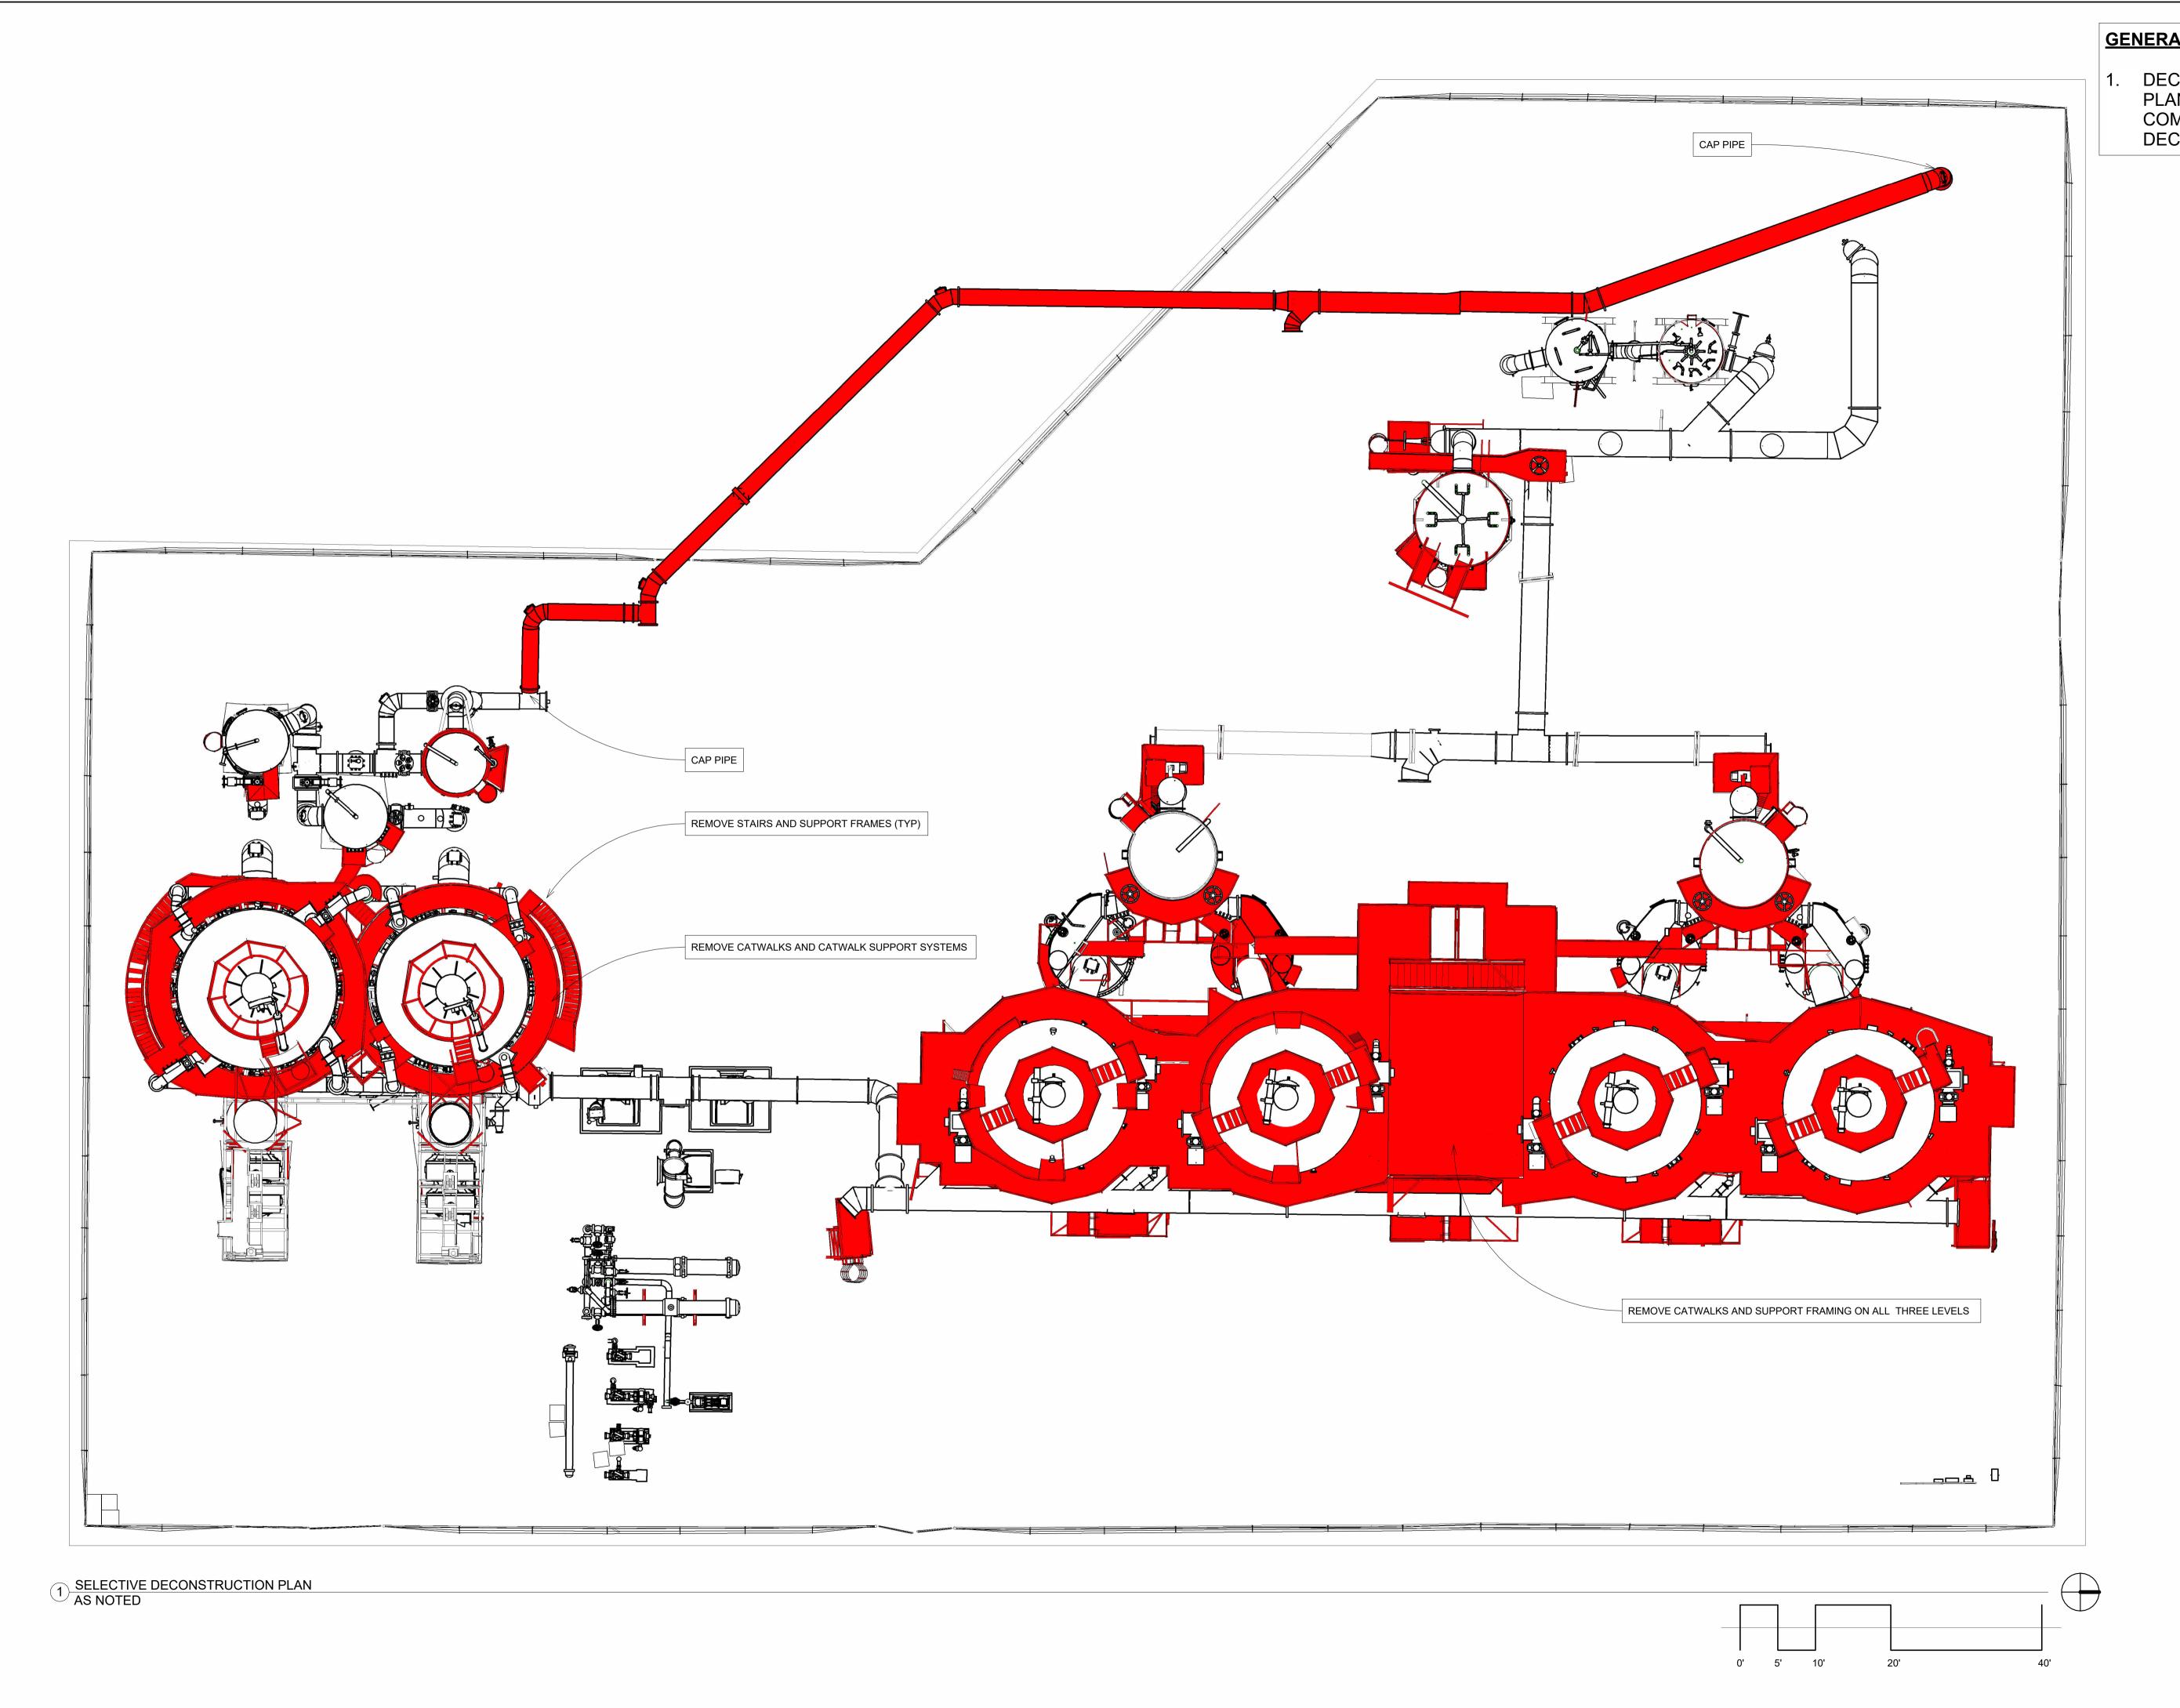
D1.02 ORDINANCE NO. CONTRACT NO.

SELECTIVE DECONSTRUCTION PLAN

- DEMOLISH (E) PIPING
- 2. DEMOLISH (E) RAILING
- DEMOLISH (E) CATWALKS
- 4. DEMOLISH (E) CATWALK SUPPORT STRUCTURE
- 5. DEMOLISH (E) LADDER ASSEMBLY AND SUPPORT SYSTEM
- 6. DEMOLISH (E) PIPE SUPPORTS CUT OFF FLUSH WITH GRADE

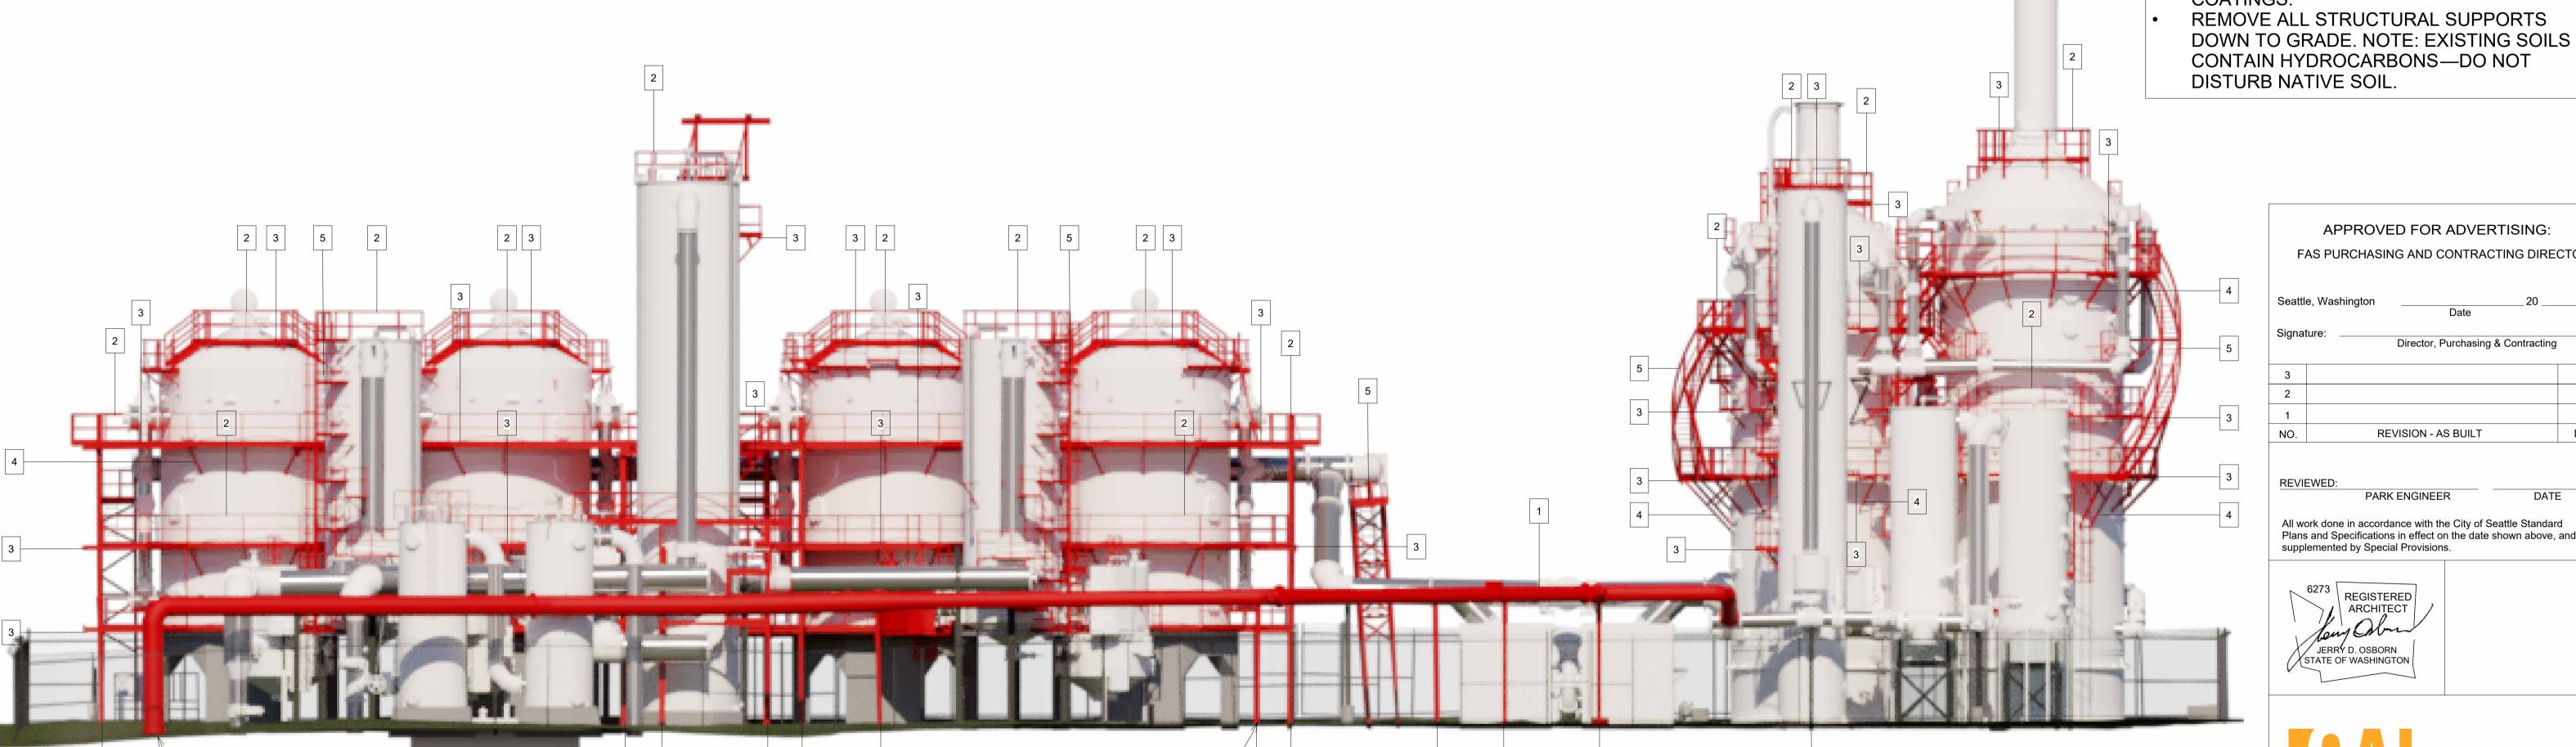
D1.03 ORDINANCE NO. CONTRACT NO.

CAP ALL STRUCTURAL SUPPORTS AT GRADE (TYP.)

WEST DECONSTRUCTION ELEVATION ^¹∕ AS NOTED

CAP PIPE AT GRADE

- DEMOLISH (E) PIPING
- 2. DEMOLISH (E) RAILING
- DEMOLISH (E) CATWALKS
- 4. DEMOLISH (E) CATWALK SUPPORT STRUCTURE
- 5. DEMOLISH (E) LADDER ASSEMBLY AND SUPPORT SYSTEM
- 6. DEMOLISH (E) PIPE SUPPORTS CUT OFF FLUSH WITH GRADE

- REMOVE ALL ELEMENTS INDICATED IN
- APPLY "CORROSIONX HD" CORROSION-INHIBITING COATING (OR APPROVED EQUIVALENT) TO ALL EXPOSED STEEL THAT HAS BÉEN CUT OR TORCHED.
- CAP EXISTING PIPE AT CUT/TORCH LOCATIONS USING A 1/2" STEEL PLATE, FIELD-WELDED TO THE PIPE END. PAINT THE CAP AND WELDS WITH THE SPECIFIED CORROSION-INHIBITING COATING.
- SCOPE INCLUDES REMOVAL OF CATWALKS, LADDERS, AND ASSOCIATED SUPPORT FRAMING. REVIEW IN-FIELD CONDITIONS WHERE PIPING SYSTEMS NOT SCHEDULED FOR REMOVAL MAY BE SUPPORTED BY CATWALK STRUCTURES.
- REFER TO HAZMAT SURVEY FOR WORKER SAFETY AND DISPOSAL PROCEDURES RELATED TO LEAD-CONTAINING
- REMOVE ALL STRUCTURAL SUPPORTS DOWN TO GRADE. NOTE: EXISTING SOILS CONTAIN HYDROCARBONS—DO NOT

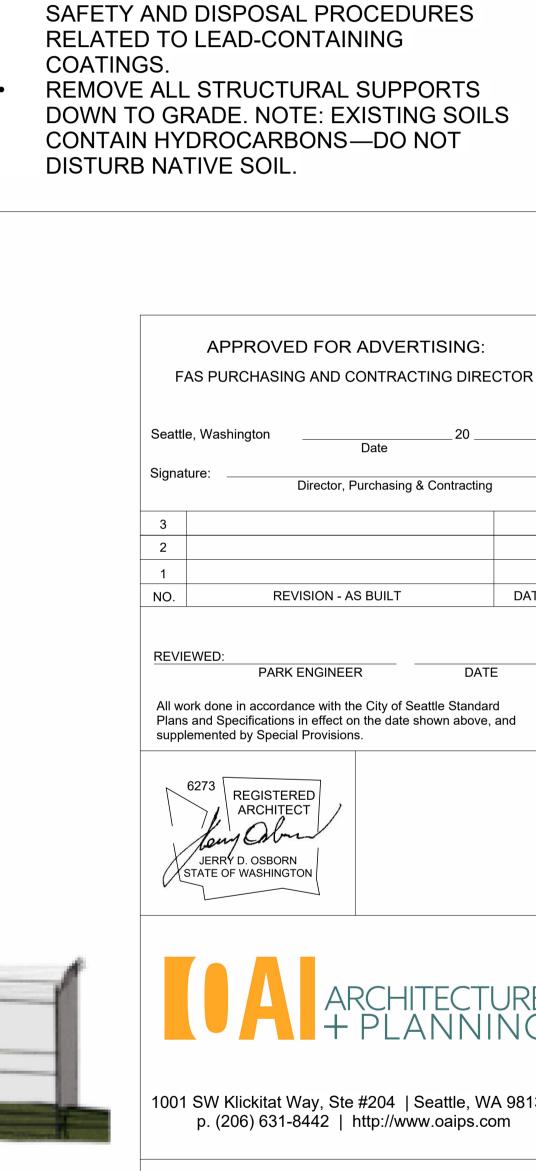
D1.04 ORDINANCE NO. CONTRACT NO.

5 CAP PIPE

NORTH DECONSTRUCTION ELEVATION

- 1. DEMOLISH (E) PIPING
- 2. DEMOLISH (E) RAILING
- B. DEMOLISH (E) CATWALKS
- 4. DEMOLISH (E) CATWALK SUPPORT STRUCTURE
- 5. DEMOLISH (E) LADDER ASSEMBLY AND SUPPORT SYSTEM
- 6. DEMOLISH (E) PIPE SUPPORTS CUT OFF FLUSH WITH GRADE

- REMOVE ALL ELEMENTS INDICATED IN RED.
- APPLY "CORROSIONX HD" CORROSION-INHIBITING COATING (OR APPROVED EQUIVALENT) TO ALL EXPOSED STEEL THAT HAS BEEN CUT OR TORCHED.
- CAP EXISTING PIPE AT CUT/TORCH LOCATIONS USING A 1/2" STEEL PLATE, FIELD-WELDED TO THE PIPE END. PAINT THE CAP AND WELDS WITH THE SPECIFIED CORROSION-INHIBITING COATING.
- SCOPE INCLUDES REMOVAL OF
 CATWALKS, LADDERS, AND ASSOCIATED
 SUPPORT FRAMING. REVIEW IN-FIELD
 CONDITIONS WHERE PIPING SYSTEMS NOT
 SCHEDULED FOR REMOVAL MAY BE
 SUPPORTED BY CATWALK STRUCTURES.
- REFER TO HAZMAT SURVEY FOR WORKER SAFETY AND DISPOSAL PROCEDURES RELATED TO LEAD-CONTAINING COATINGS.
- REMOVE ALL STRUCTURAL SUPPORTS DOWN TO GRADE. NOTE: EXISTING SOILS CONTAIN HYDROCARBONS—DO NOT DISTURB NATIVE SOIL.

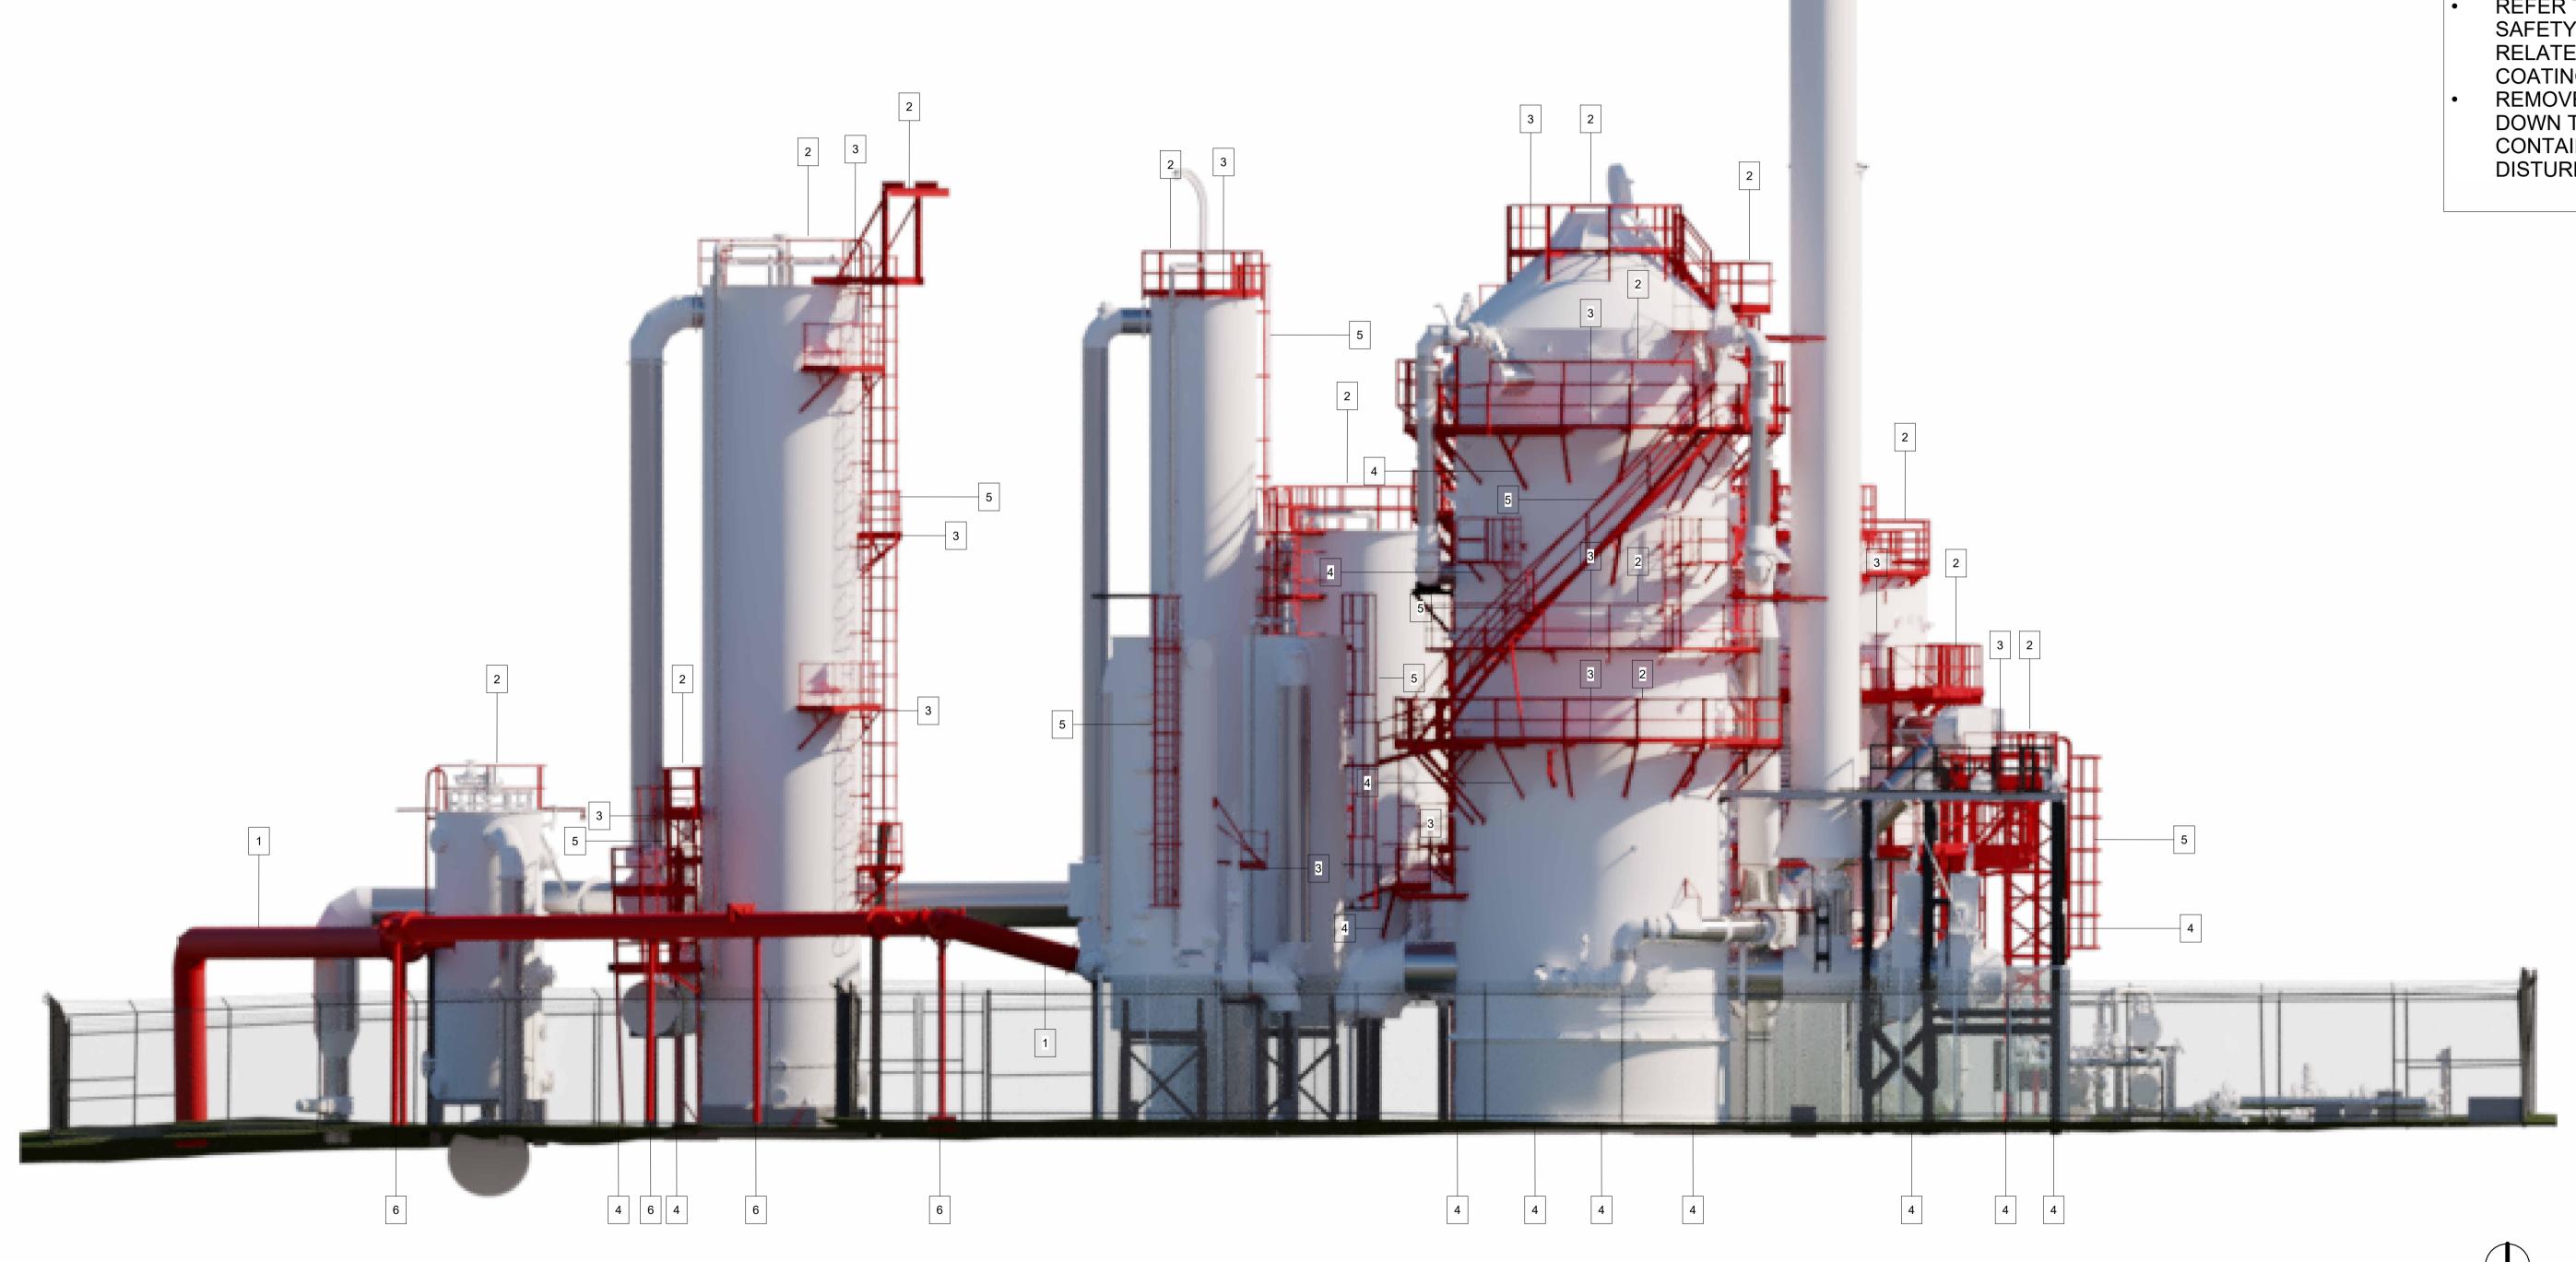
D1.05

2 SOUTH DECONSTRUCTION ELEVATION AS NOTED

- DEMOLISH (E) PIPING
- 2. DEMOLISH (E) RAILING
- DEMOLISH (E) CATWALKS
- 4. DEMOLISH (E) CATWALK SUPPORT STRUCTURE
- 5. DEMOLISH (E) LADDER ASSEMBLY AND SUPPORT SYSTEM
- 6. DEMOLISH (E) PIPE SUPPORTS CUT OFF FLUSH WITH GRADE

- REMOVE ALL ELEMENTS INDICATED IN RED.
- APPLY "CORROSIONX HD" CORROSION-INHIBITING COATING (OR APPROVED EQUIVALENT) TO ALL EXPOSED STEEL THAT HAS BÉEN CUT OR TORCHED.
- CAP EXISTING PIPE AT CUT/TORCH LOCATIONS USING A 1/2" STEEL PLATE, FIELD-WELDED TO THE PIPE END. PAINT THE CAP AND WELDS WITH THE SPECIFIED CORROSION-INHIBITING COATING.
- SCOPE INCLUDES REMOVAL OF CATWALKS, LADDERS, AND ASSOCIATED SUPPORT FRAMING. REVIEW IN-FIELD CONDITIONS WHERE PIPING SYSTEMS NOT SCHEDULED FOR REMOVAL MAY BE SUPPORTED BY CATWALK STRUCTURES.
- REFER TO HAZMAT SURVEY FOR WORKER SAFETY AND DISPOSAL PROCEDURES RELATED TO LEAD-CONTAINING COATINGS.
- REMOVE ALL STRUCTURAL SUPPORTS DOWN TO GRADE. NOTE: EXISTING SOILS CONTAIN HYDROCARBONS—DO NOT DISTURB NATIVE SOIL.

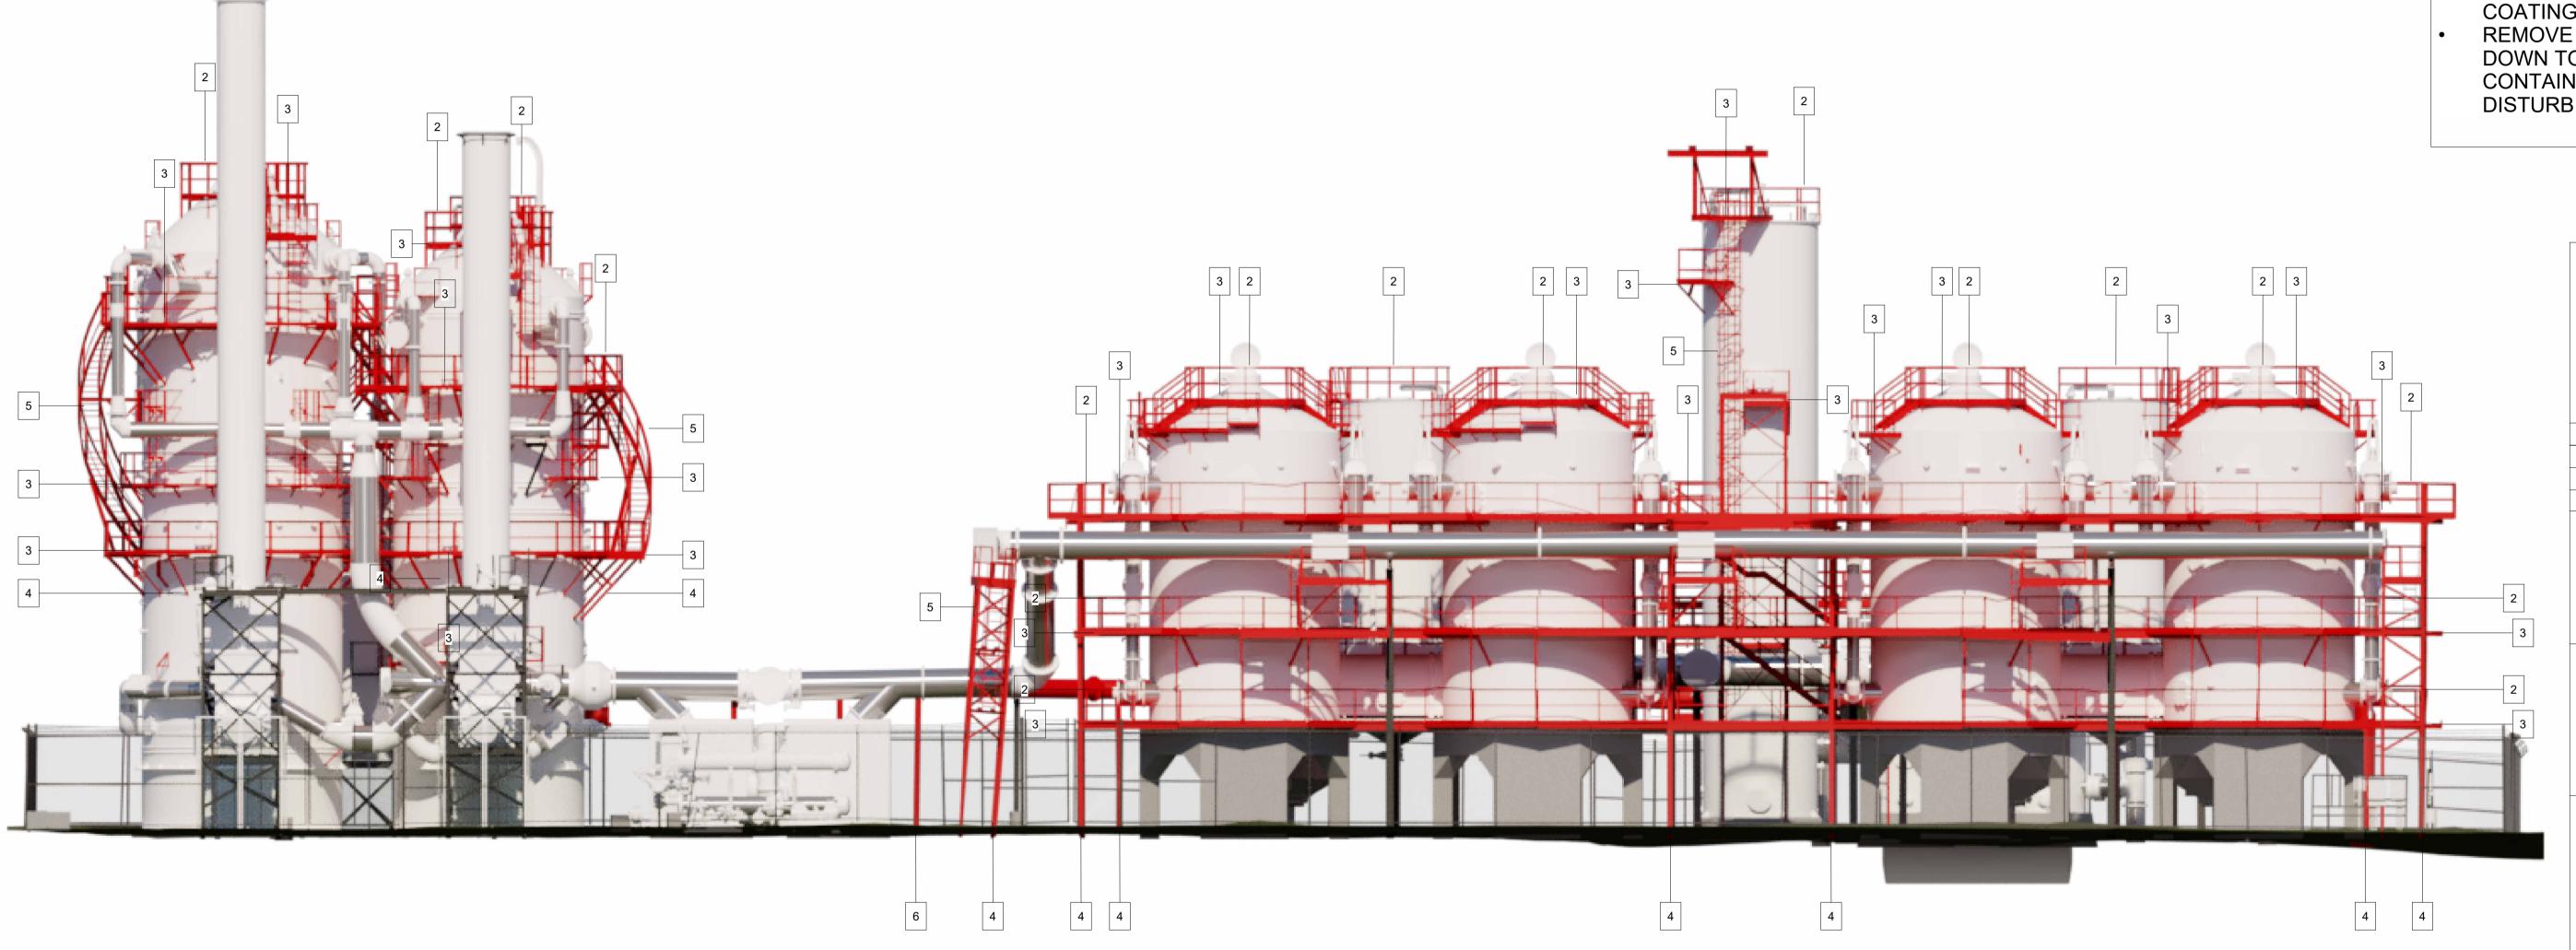
D1.06 ORDINANCE NO.

2 EAST ELEVATION AS NOTED

EAST DECONSTRUCTION ELEVATION

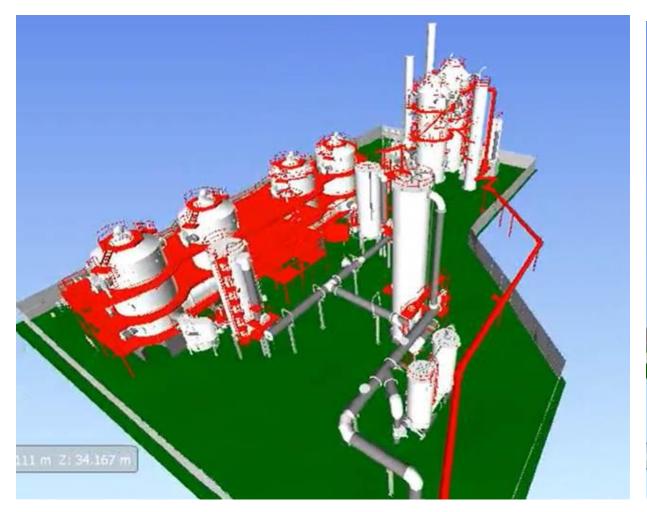
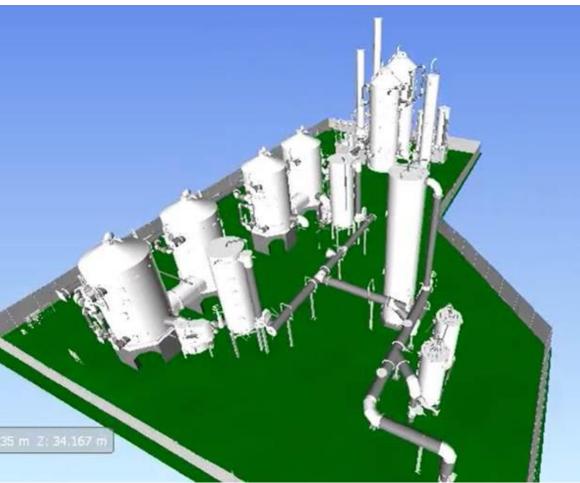
Looking Southeast (before and after)

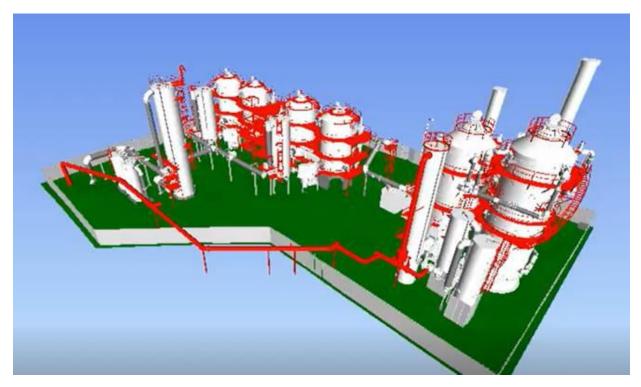
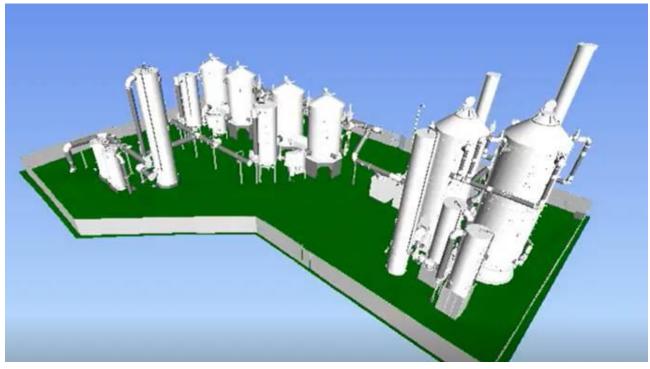
Looking Northeast (before and after)

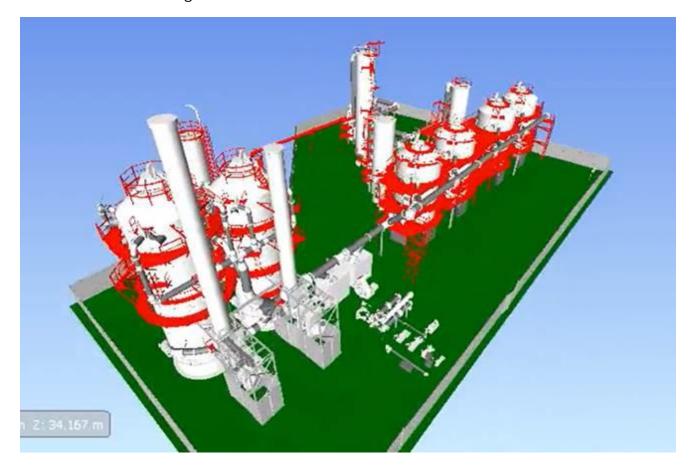
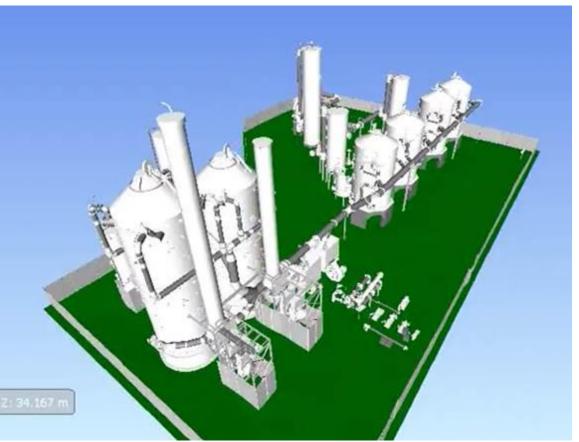
Looking Northwest (before and after)

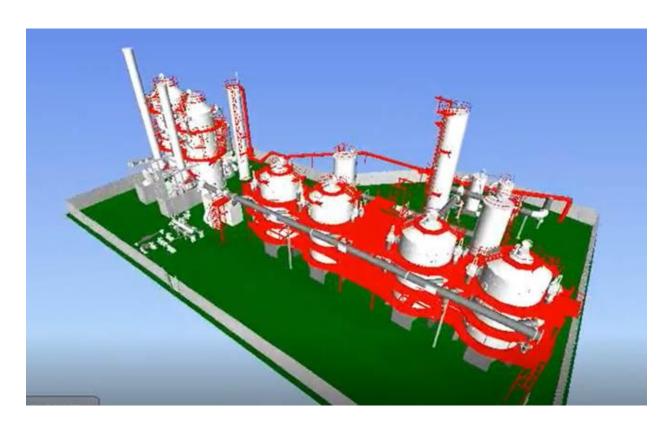
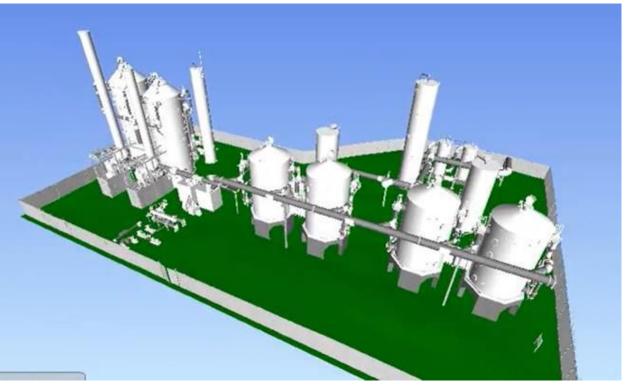
Looking Southwest (before and after)
