# GREEN LAKE COMMUNITY CENTER & POOL LANDMARKS ARC MEETING 2

July 31, 2026

# CONTEXT: EVANS POOL BUILDING, LANDMARKED ON NOVEMBER 24, 2021

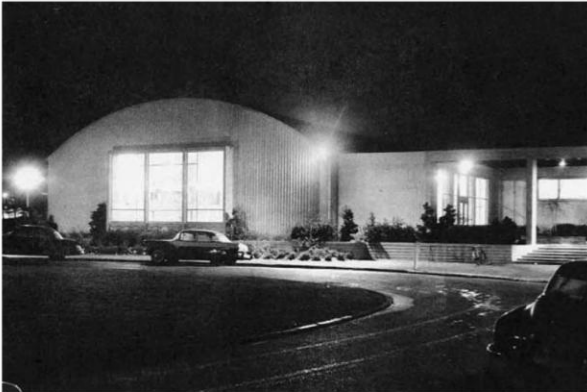
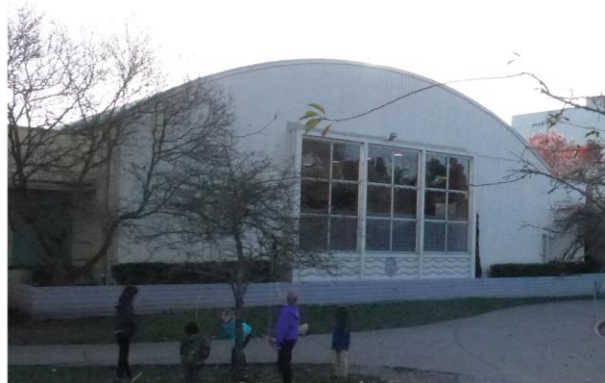
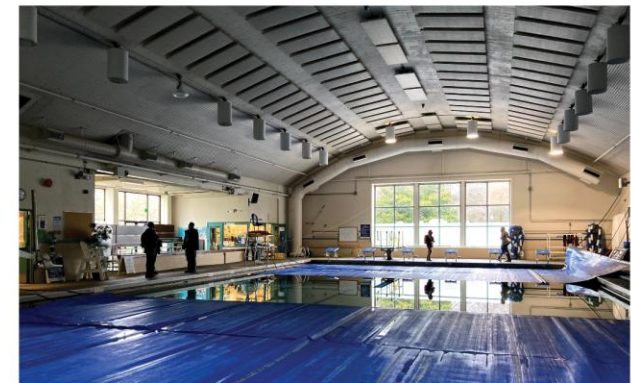
# EVANS POOL SUMMARY OF CHANGES OVER TIME

1954-1955

Evans pool addition construction

1972-1973

Pool renovation

1981-1982

Re-roof replacement

Barrier free facility ramp addition

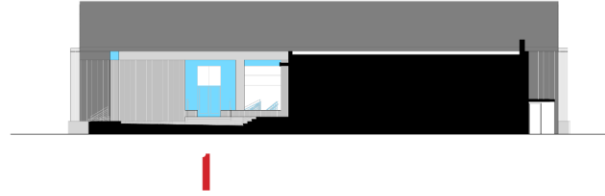
# EVANS POOL SUMMARY OF CHANGES OVER TIME

HIGHLIGHTED AREAS  
INDICATE AREA OF  
CHANGES SINCE EVANS  
POOL ADDITION

1. Courtyard changed for barrier free access
2. Exterior windows boarded
3. Exterior windows changed
4. Exterior doors changed

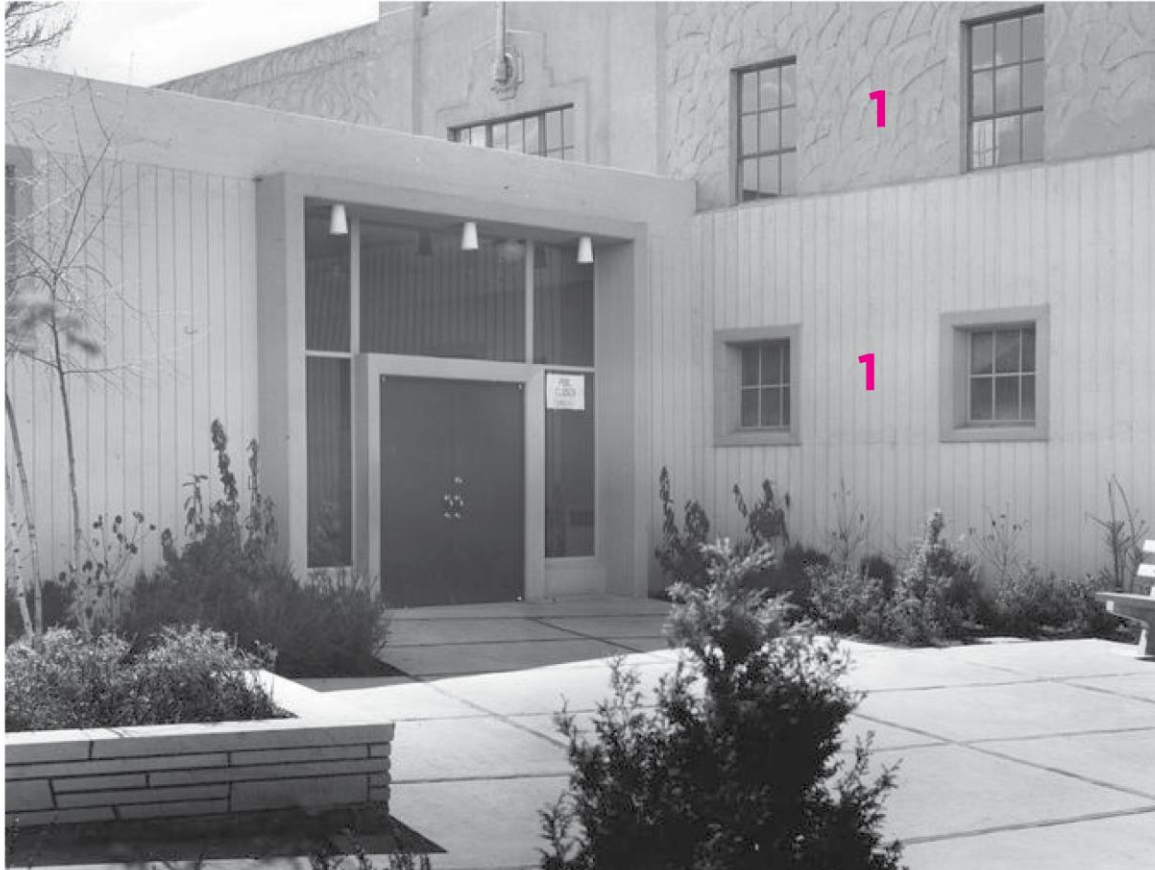
# WEST COURTYARD WALL

1. WHAT IS APPROACH TO LANDMARKED WALL ONCE FIELDHOUSE IS REMOVED?

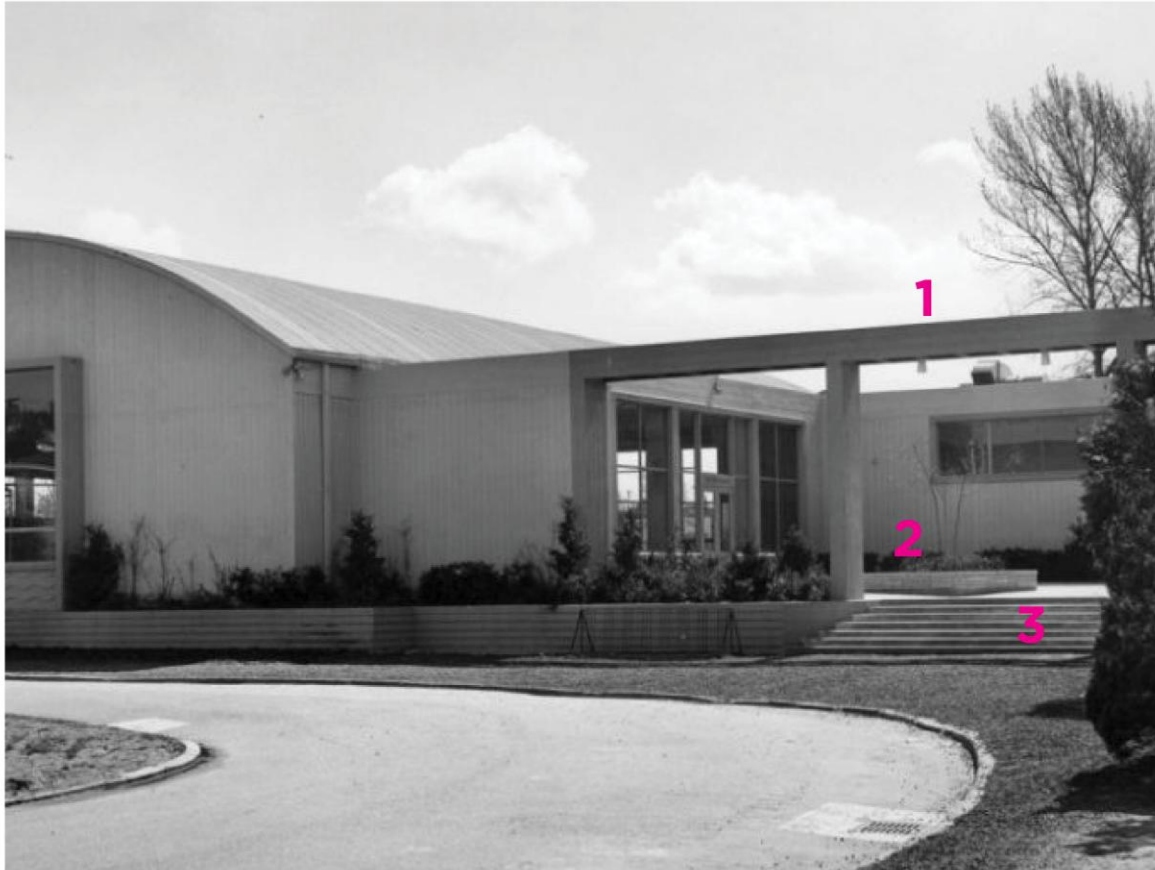
# COURTYARD DESIGN

1. DESIRE TO RESTORE THE ORIGINAL COLUMN AND BEAM FRAME ELEMENT TO THE ENTRY COURTYARD
2. ADDRESS OVERGROWN STATE OF LANDSCAPING IN COURTYARD TO GIVE ROOM FOR GATHERING AND HIGHLIGHT THE BUILDING
3. BRING BACK THE MORE GENEROUS ENTRY STAIR

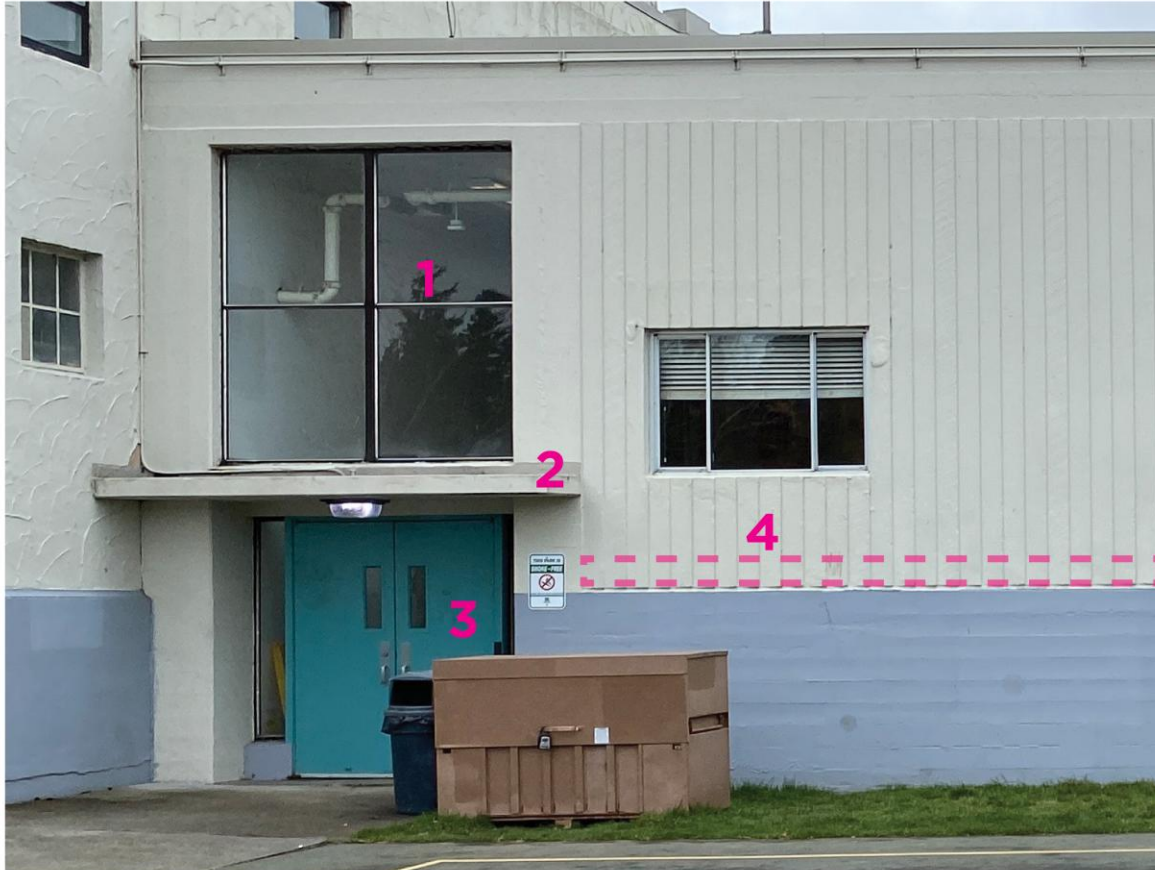
# SOUTH ENTRANCE

- 1. EXISTING WINDOW ABOVE SOUTH ENTRY STAIR
- 2. EXISTING CONCRETE CANOPY OVER SOUTH ENTRY.
- 3. EXISTING ENTRY AT SOUTH SIDE OF BUILDING
- 4. APPROXIMATE LOCATION OF INTERIOR FLOOR LINE

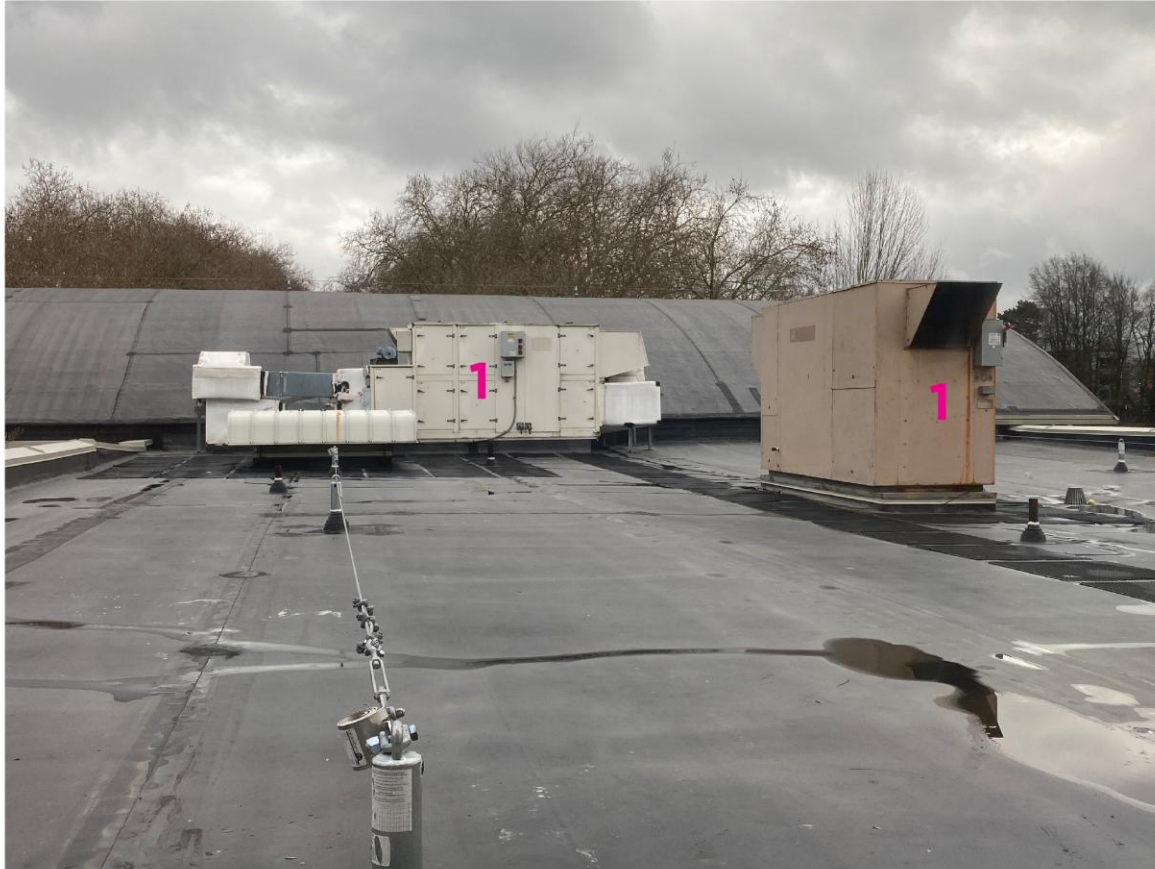
# ROOFTOP EQUIPMENT

1. OUTDATED EQUIPMENT NEEDS REPLACEMENT. NEW EQUIPMENT WILL BE LARGER
