## **Parsons-Harvard Mansion / aka Bellemont – 2706 Harvard Avenue E**

### **Proposed Selective Removal and Replacement**

## Historic Preservation Certificate of Approval DONH-COA-02282

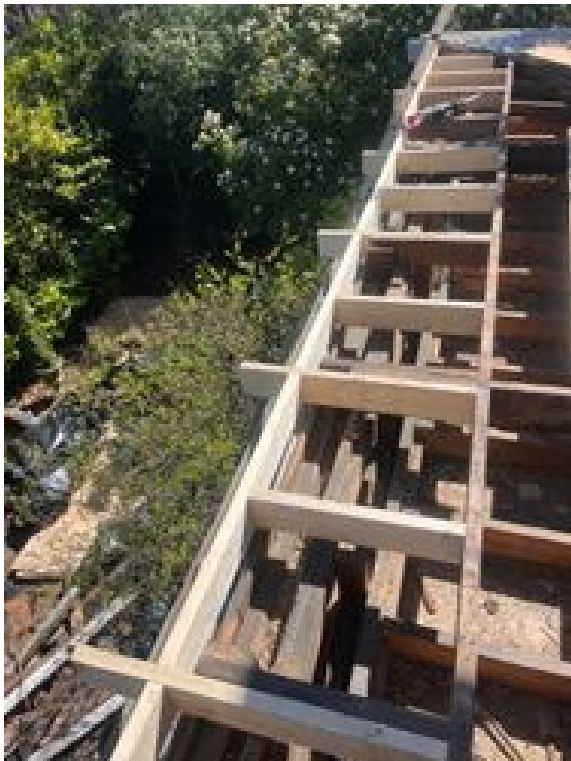
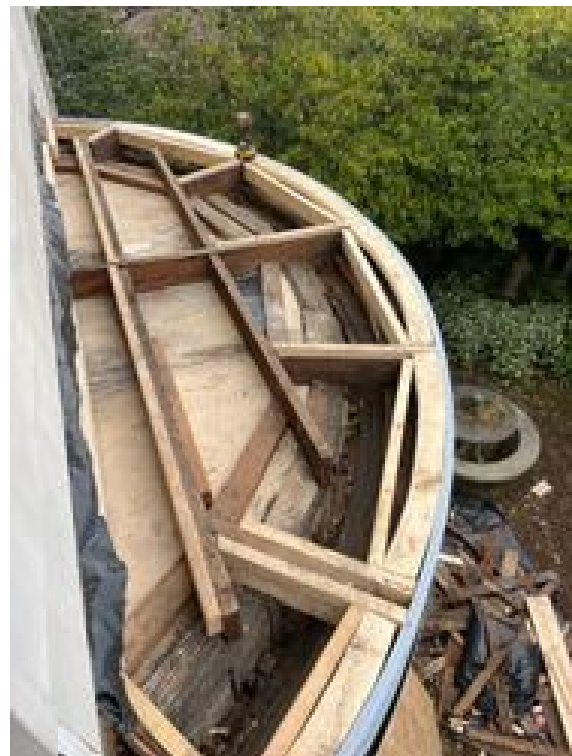
Reframing the roof of the lower porches in process

Deteriorated second floor decking at wrap-around porch was removed. New roof decking was laid on wrap-around porch, with torched down membrane roofing, similar to original.

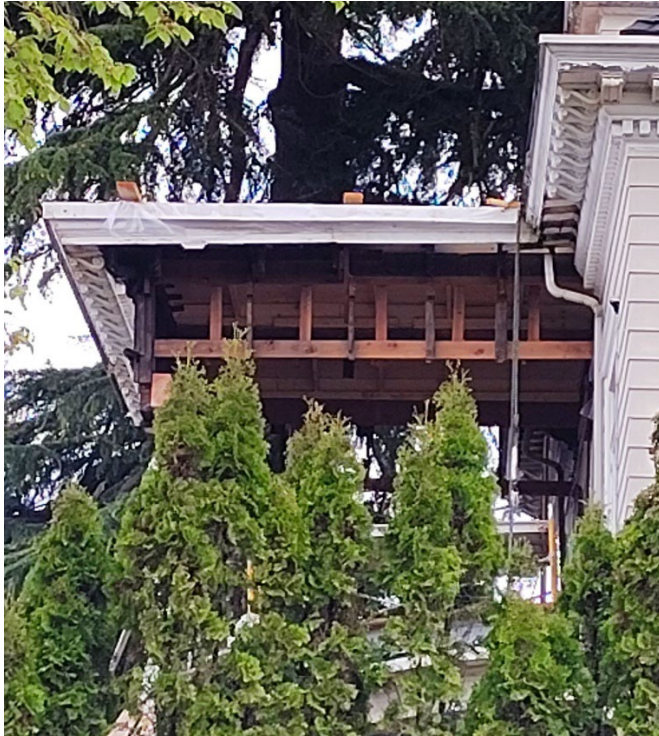
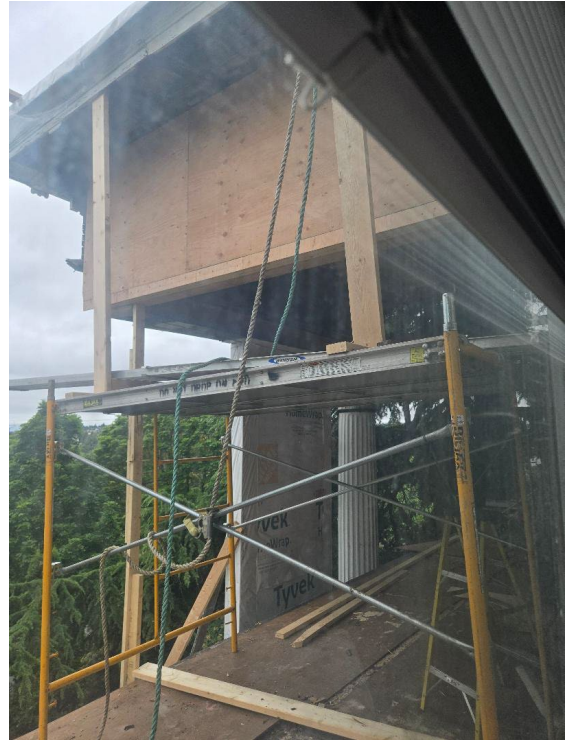
Reframing and sheathing the portico/belvedere in process

Deteriorated materials on Belvedere/Portico porch were removed due to rot. Elements of the portico porch /belvedere roof are being reframed and rebuilt in wood to match the original wood details as well as at the main roof, including: railings, cornice, frieze, beam fascia/trim; missing modillions, dentils, and moldings.

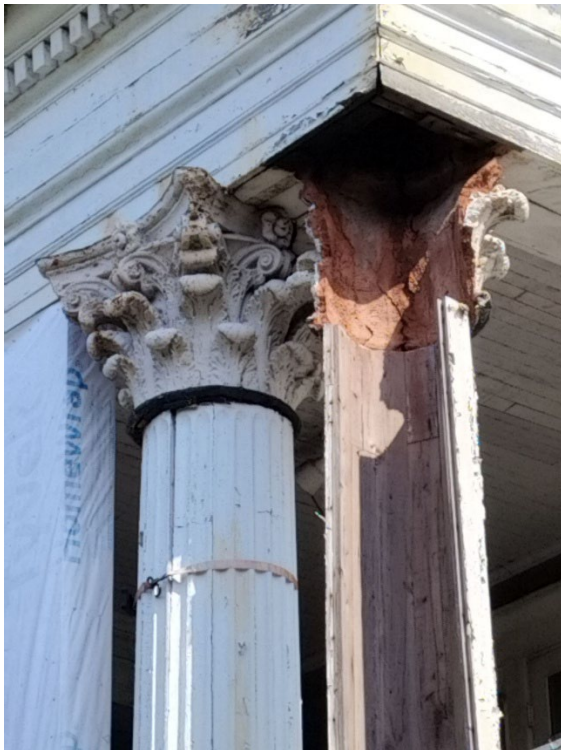
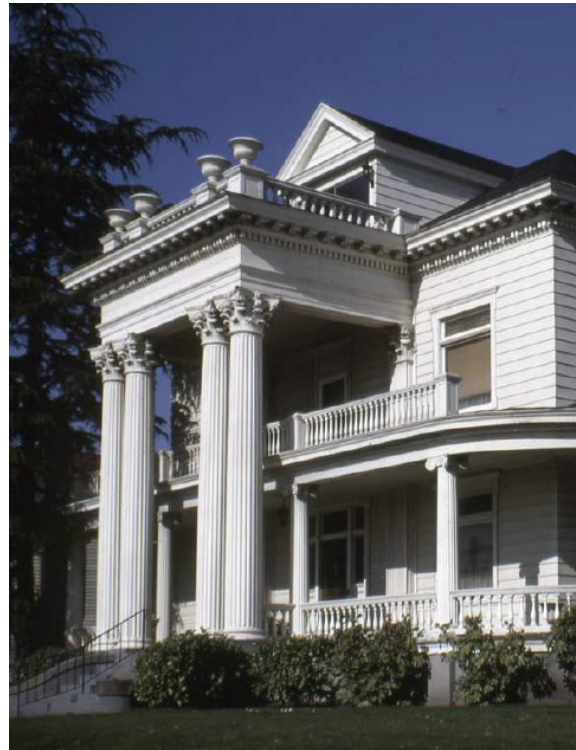
Following total collapse of one column and imminent threat of others following same path, given decay found, wood columns and terra cotta capitals were removed. The Belvedere/Portico roof is currently supported by steel scaffolding. Once column remains standing for reference. Proposed replacement of four rotted wood columns with reinforced fiberglass columns. The

Wood and terra cotta column falling apart, other one strapped (left); older photo (right)

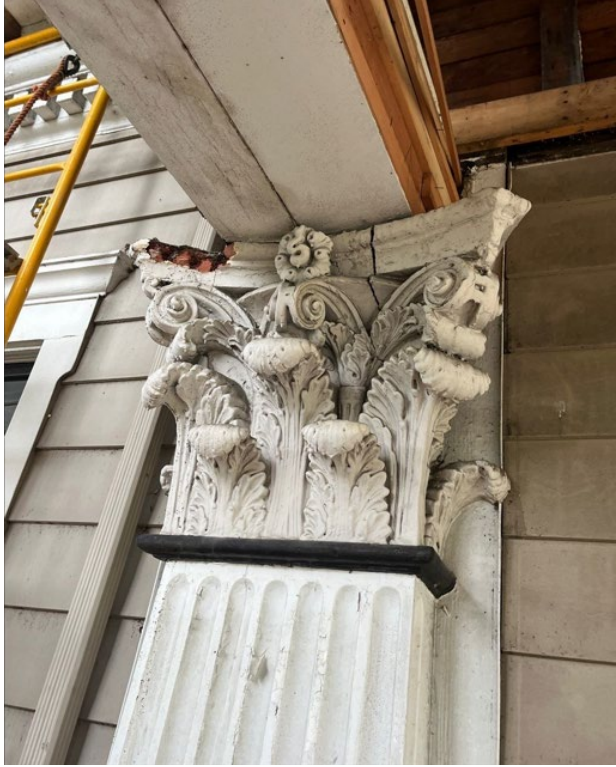
Existing wood pilaster and terra cotta capital at 2<sup>nd</sup> floor (left); proposed 2<sup>nd</sup> floor pilaster not to scale (right); contractor will field verify all existing conditions and dimensions

same materials are proposed to replace the four wood pilasters that rotted from water damage when the porches deteriorated.

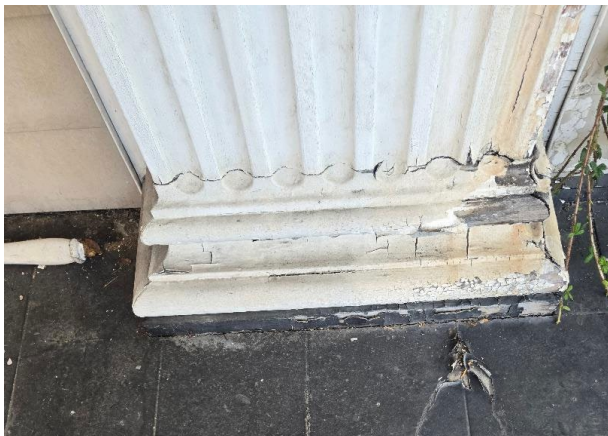
Existing wood pilaster base and fluted shaft at 1<sup>st</sup> floor – no capital (left) after removal; contractor will field verify all all existing conditions and dimensions

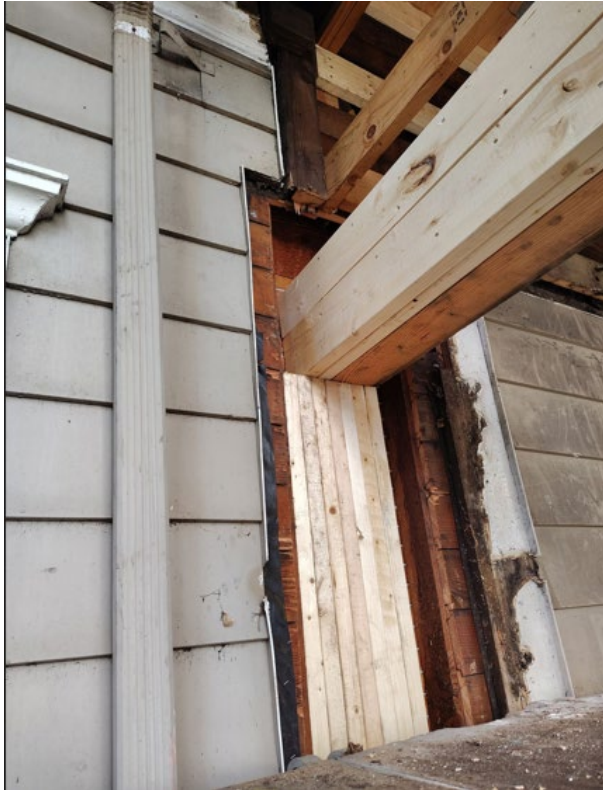
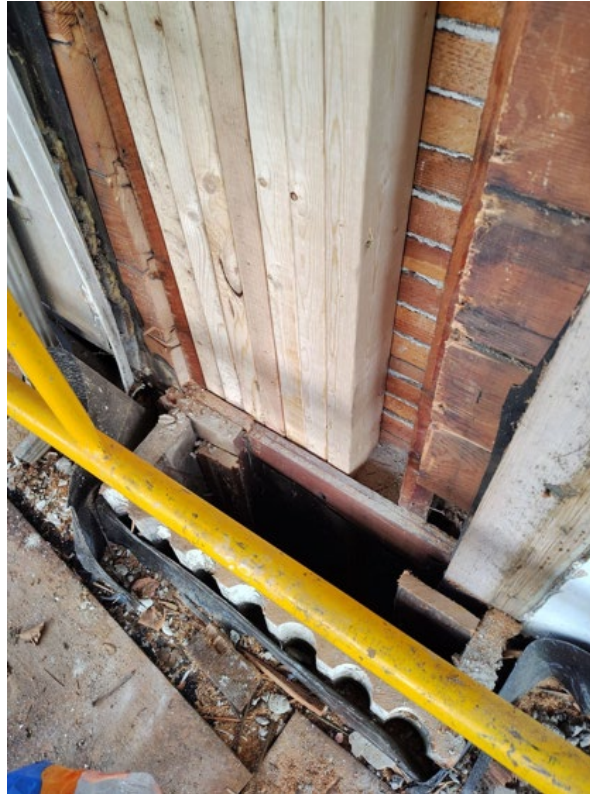
Following pilaster removal to build new structural supports and address water infiltration

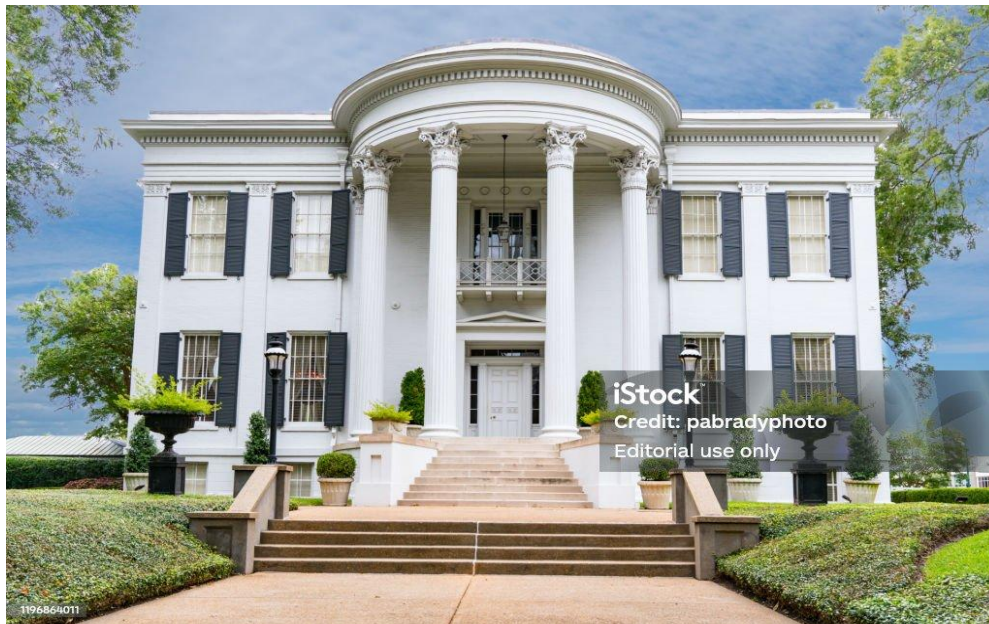
#### 1. The Governor's Mansion – Jackson, Mississippi

Pacific Columns provided large, fluted load-bearing FRP columns for restoration work on the Greek Revival portico.

- Original wood columns had severe rot and insect damage.

- FRP replacements provided dimensional stability and long-term durability.
- Full-height Corinthian FRP columns replicate original 1842 profiles.
- Semi-circular portico similar in scale to Bellamont's Belvedere.
- High moisture exposure and repeated repainting cycles made wood unsustainable.
- FRP selected to preserve historic form while eliminating structural failure risk.

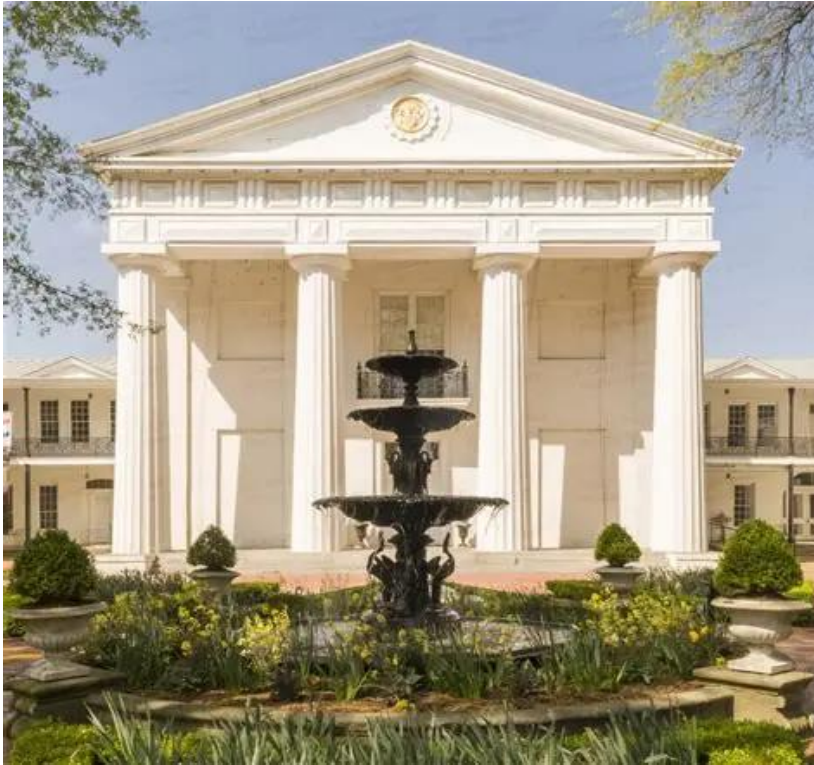
## 2. The Old State House – Little Rock, Arkansas

Pacific Columns replaced four large deteriorated exterior columns on monumental Greek Revival portico with structural fiberglass units.

- High-exposure façade with repeated paint failure cycles
- Wood columns deteriorated due to moisture and insects.
- Demonstrates FRP acceptance in a high-scrutiny historic landmark.

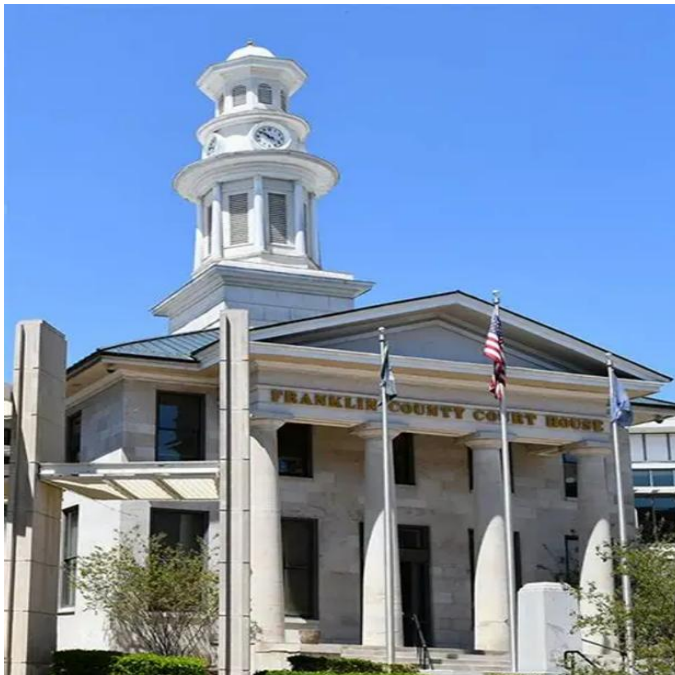
## 3. Historic Courthouse Renovation – Franklin County, Kentucky

Pacific Columns provided tapered, fluted FRP columns needed to support the portico roof load.

- FRP selected to avoid future rot and reduce maintenance.
- Demonstrates FRP suitability for load-bearing historic column systems.

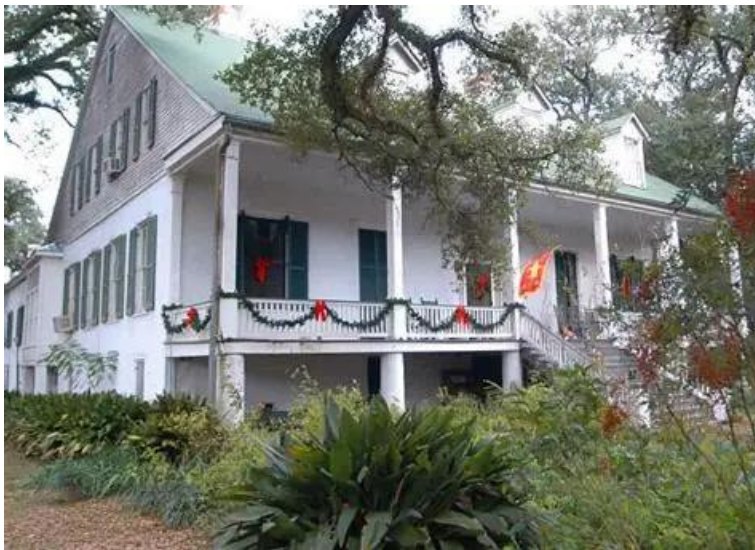
#### 4. The Magnolia Plantation (Multiple Structures) – Louisiana

Pacific Columns used FRP for several outbuildings and porches during restoration.

- High humidity and termite exposure made wood impractical.
- FRP matched original profiles while providing superior environmental resilience.
- 
- While Magnolia's columns are simpler than Bellamont's Corinthian capitals, the restoration context supports FRP as a preservation-appropriate material for moisture-exposed column systems.

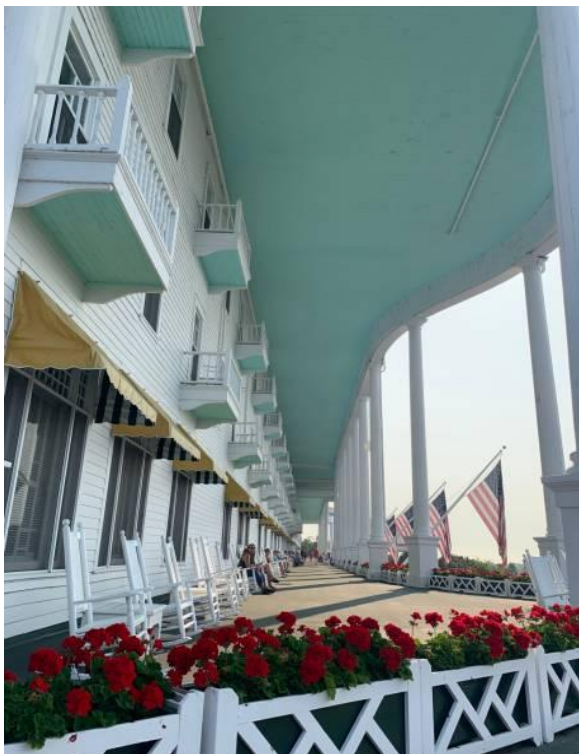
#### 5. The Grand Hotel – Mackinac Island, Michigan

Pacific Columns supplied oversized FRP columns for veranda and façade restoration.

The Grand Hotel's veranda restoration shows how large-scale, high-visibility column systems require durable materials and precise replication. FRP is widely used in similar veranda restorations to maintain historic appearance while ensuring long-term stability.

- Columns needed to withstand extreme seasonal weather.
- FRP was chosen for strength, longevity, and ability to mimic historic wood detailing.

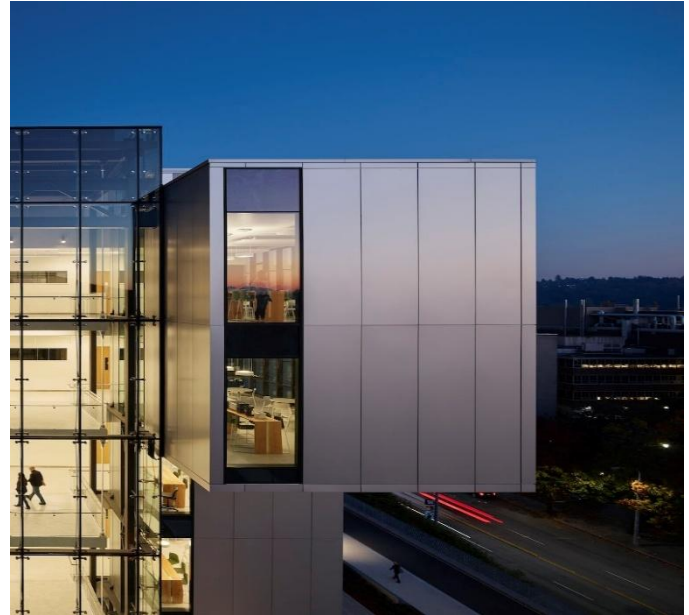
GFRC/fiberglass composite cladding on UW campus building
