SEATTLE PUBLIC LIBRARY UNIVERSITY BRANCH RENOVATION

BUILDING HISTORY + EXISTING CONDITIONS

ENERGY AND EGRESS CODE
ENERGY CODE COMPONENT REQUIREMENTS

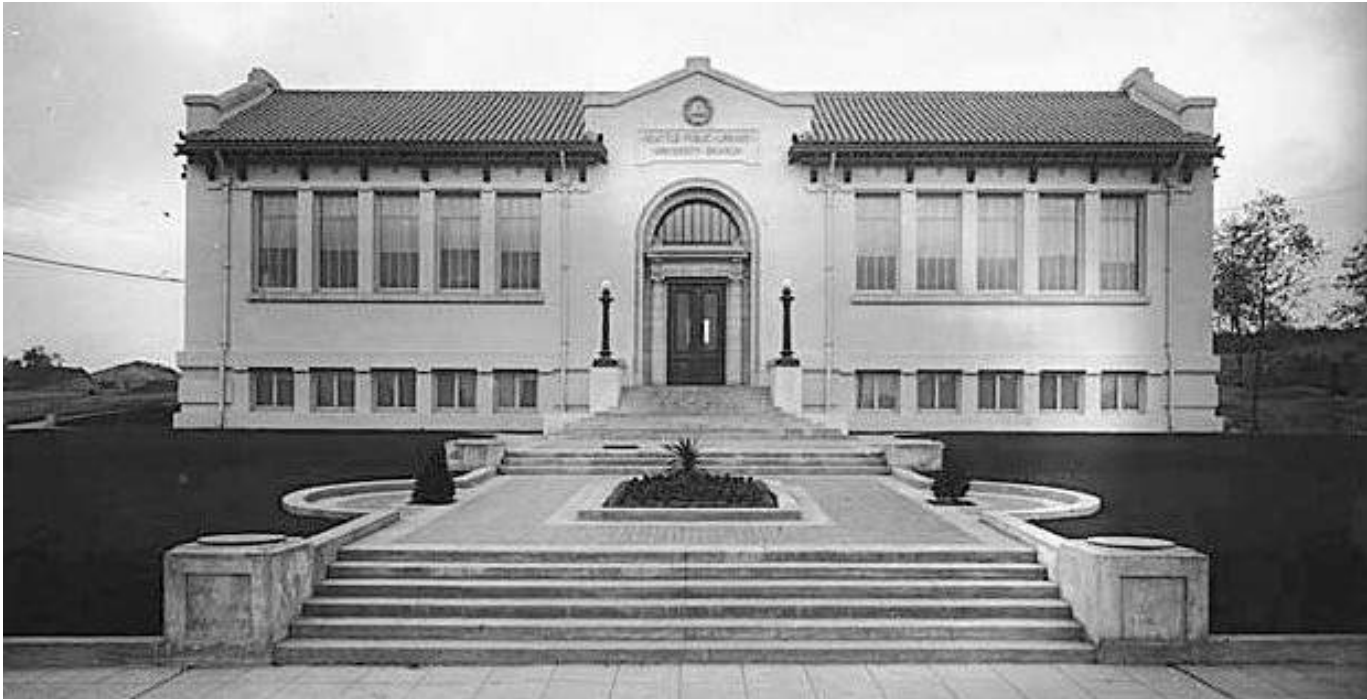
UNIVERSITY BRANCH 1910

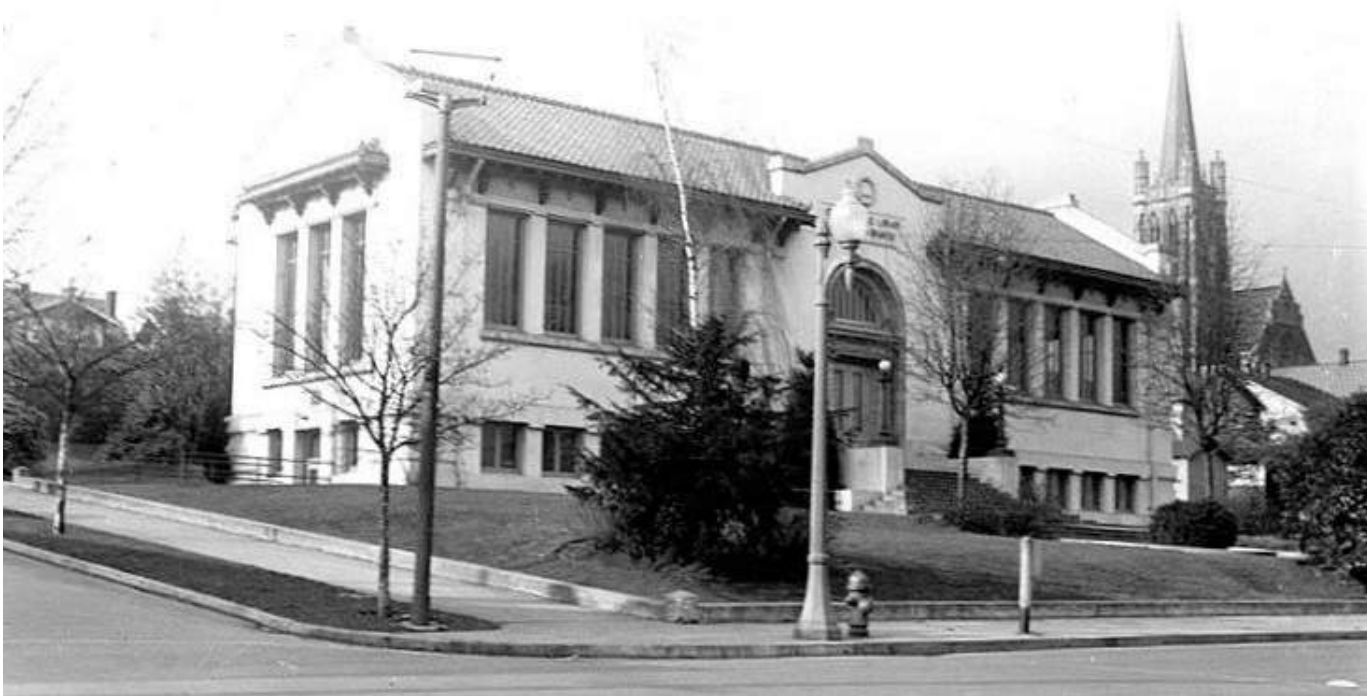
UNIVERSITY BRANCH 1931

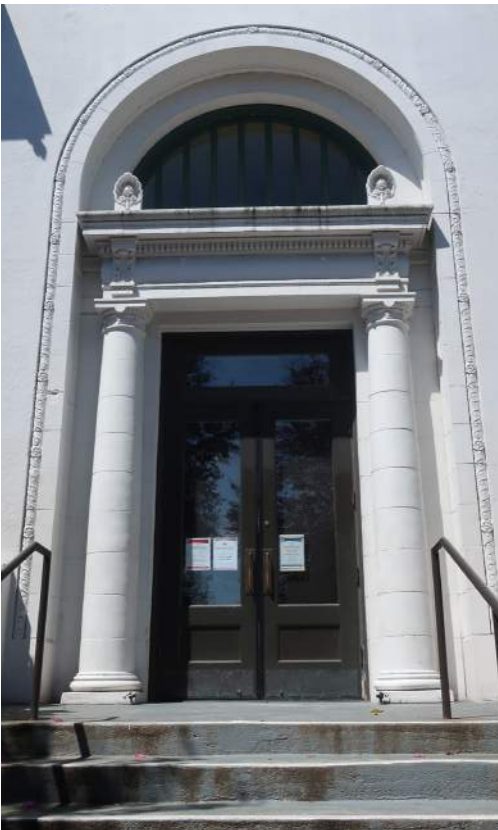
EAST DOOR EXTERIOR

The existing configuration of the east entry door, stair, and lower level access door have a number of conditions that are not code compliant for the proposed main & lower level egress plan:

- The symmetrical main east entry door leafs do not meet the minimum 32" clear width for egress (30-3/4").
- The existing door to the lower level does not swing in the direction of travel for lower level egress.
- The position of the existing door to the lower level does not permit 12" extension for lower level egress stair handrail.
- The existing landing stair handrails do not meet the minimum 12" extension beyond end of stair.
- An additional handrail is required to prevent original door from protruding into defined main level egress path.

- Retain the existing east entry door width to preserve east facade symmetry & detailing.
- Install new landing stair handrails; extend to the maximum extent feasible without obstructing lower level egress (10.5")
- Preserve the existing location of the lower level door; reverse swing and inset door as required to not obstruct main level egress path.
- Install new wood handrail at lower level stair. Extend handrail to the maximum extent feasible (7-1/2").

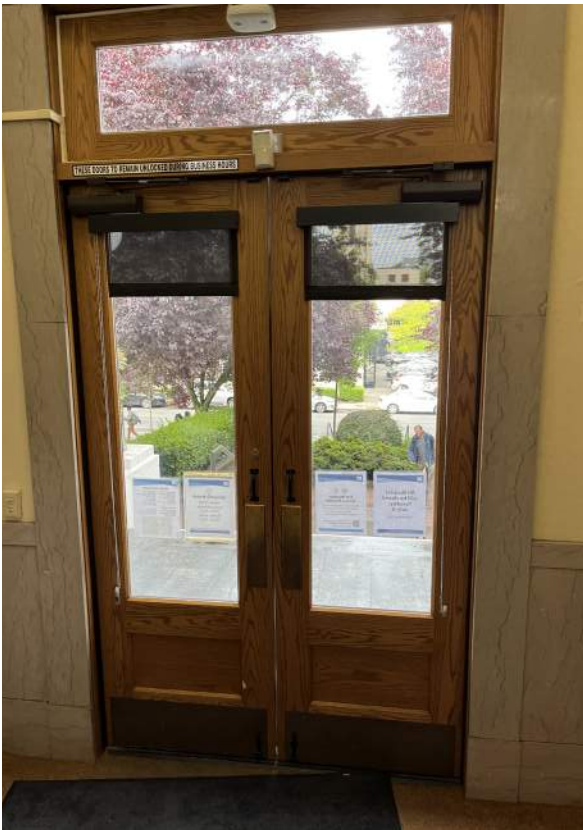
EAST DOOR INTERIOR

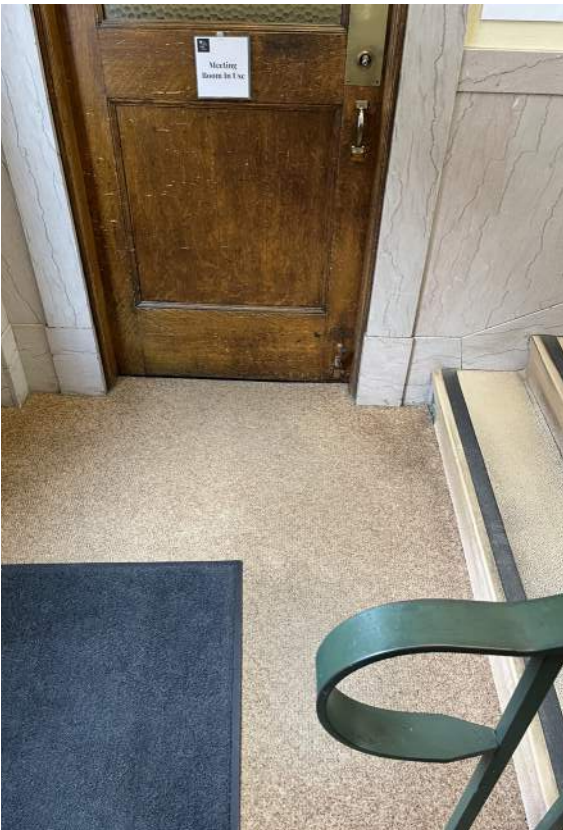
LOWER LEVEL DOOR, STAIR, & RAIL

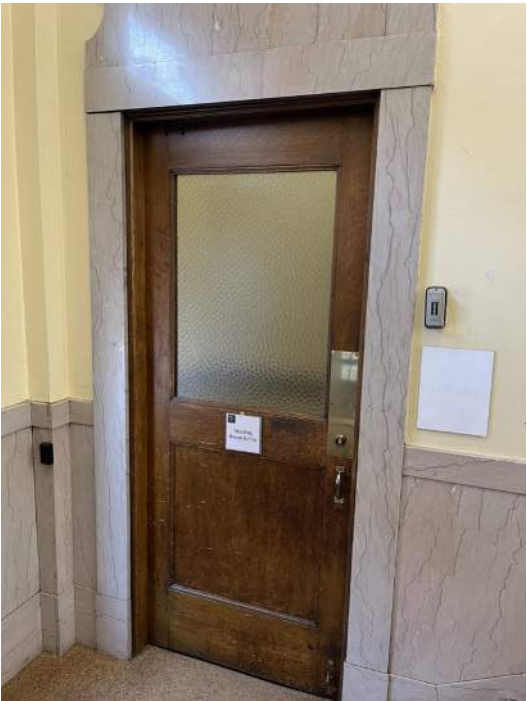
LOWER LEVEL DOOR

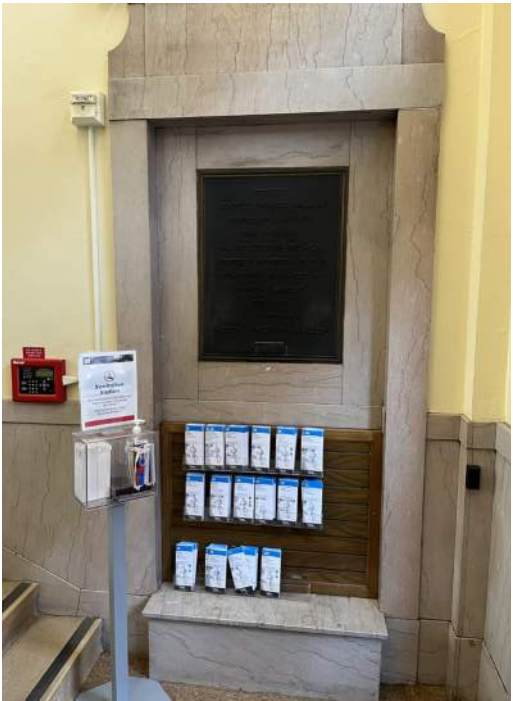
MIRRORED INSET

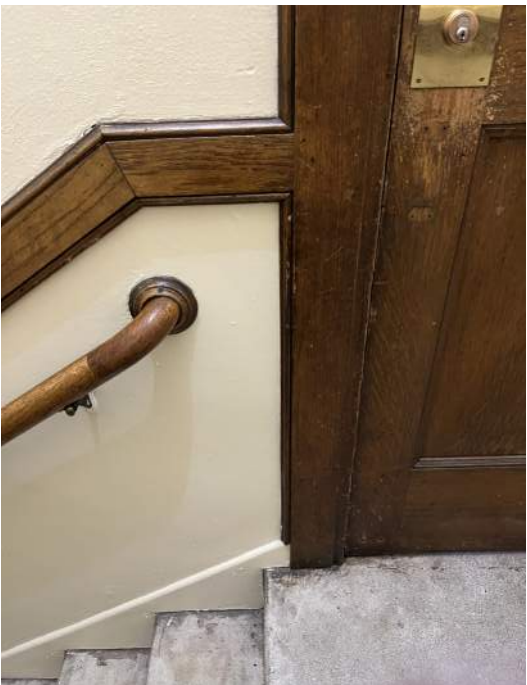
EXISTING HANDRAIL
(LOWER LEVEL SIDE)

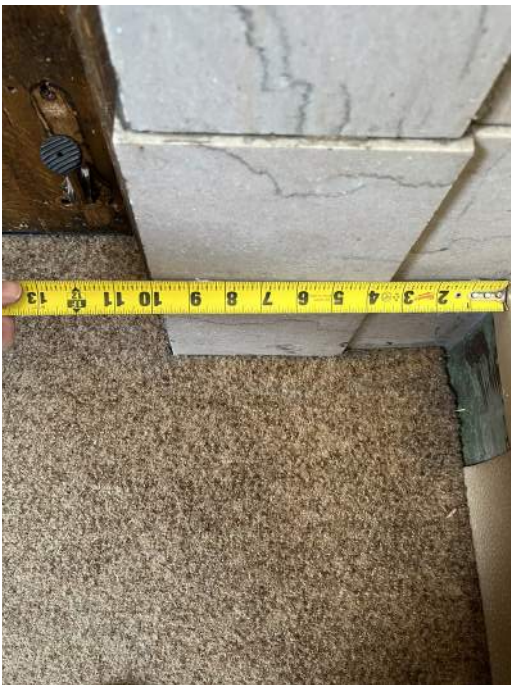
EXISTING DOOR & STAIR
(MAIN LEVEL SIDE)

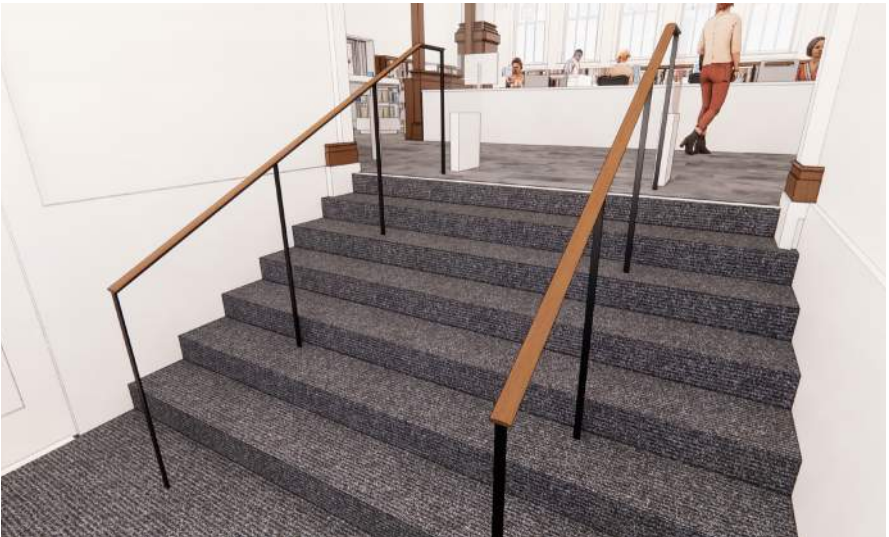
ENTRY W/ PROPOSED (2) HANDRAILS AND WALK-OFF MAT

"Section 306.1 Landmarks (exception):

Where approved by the code official, compliance with this code is not required where preservation of historic elements precludes complete compliance and a reasonable degree of safety to the public and the occupants of the building is provided."

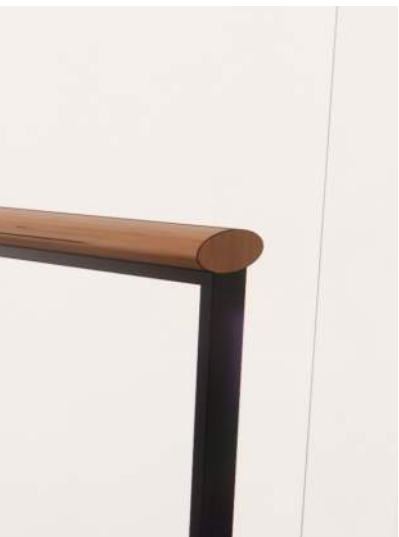
PROPOSED WOOD HANDRAIL PROFILE

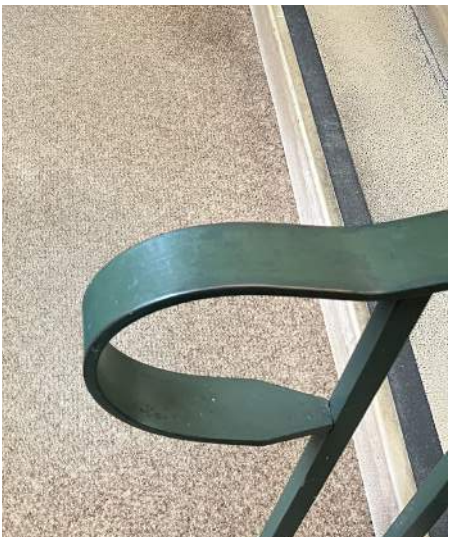
EXISTING NON-ORIGINAL METAL RAIL

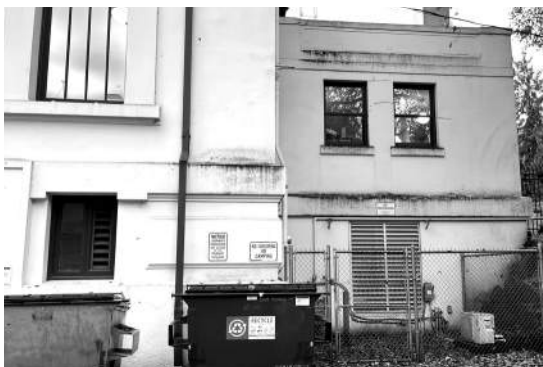
SALVAGE AND REINSTALL
TILE ROOF PARAPET
CAPS WITH EMBEDDED
ANCHORS, TYP

**INSTALL CONCRETE
SHEAR WALL;
REPLICATE ORIGINAL
BANDING,RELIEF, TILE.
3-PART STUCCO TO
ALIGN WITH (E) STUCCO**

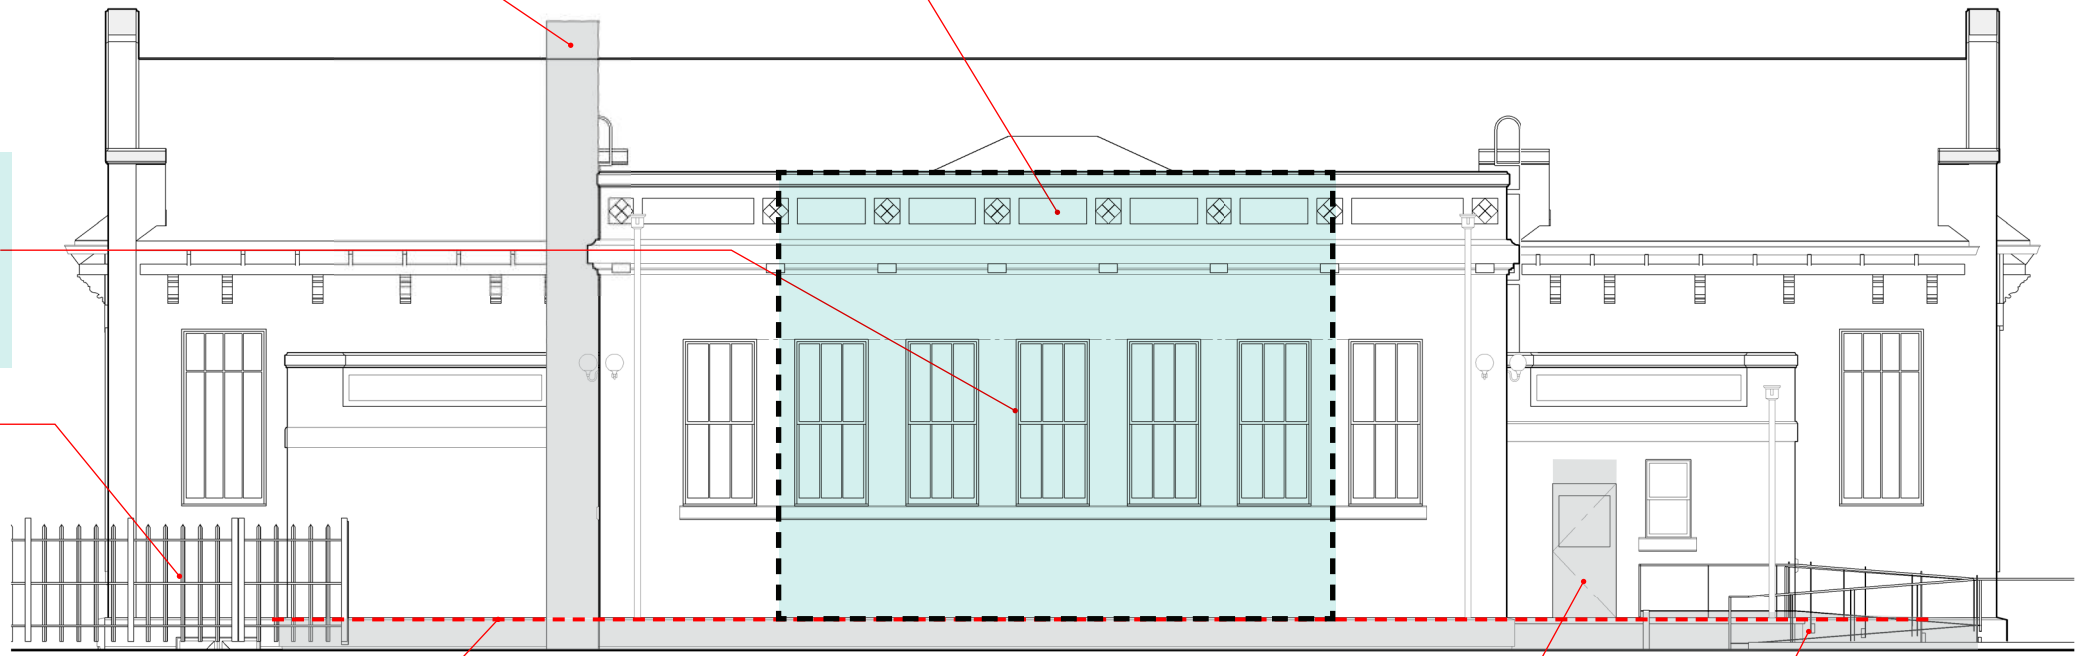
EXISTING WEST ELEVATION

DEMO EXTERIOR WALL;
INSTALL CONCRETE
MOMENT FRAME

REMOVE CHIMNEY
(NOT ORIGINAL)

SALVAGE (5) EXISTING
WINDOW FRAMES AND
SASHES FOR REINSTALL

REMOVE FENCE

RAISED PARKING
LEVEL (RED DASHED)

REMOVE DOOR (NOT
ORIGINAL)

REMOVE
ACCESSIBLE RAMP

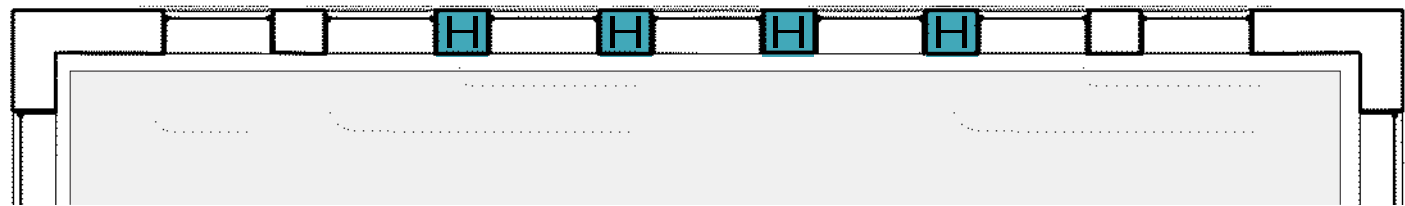
PROPOSED: CONCEALED MOMENT FRAME (STEEL AND/OR CONCRETE)

As part of substantial alteration requirements, the renovation includes **new shear element upgrades at the the west wing**. In order to minimize loss of existing shelving, maximize floor space, and preserve architeturar character, the design locates new structure **within the west wing wall within the exterior wall itself**.

SHKS pursued a number of structural and finish material options for the rebuild of the the wall, assessing factors such as constructablity, moisture infiltration and drainage, thermal expansion, and replication of original exterior details (see following slides).

- + NO REDUCTION TO PERIMETER SHELVING
- + LIMITED FOUNDATION WORK
- + CONCEALS FRAME (COLUMNS/BEAM)
- WALL DEMO/REBUILD
- SALVAGE/RESINTALL OF WINDOW

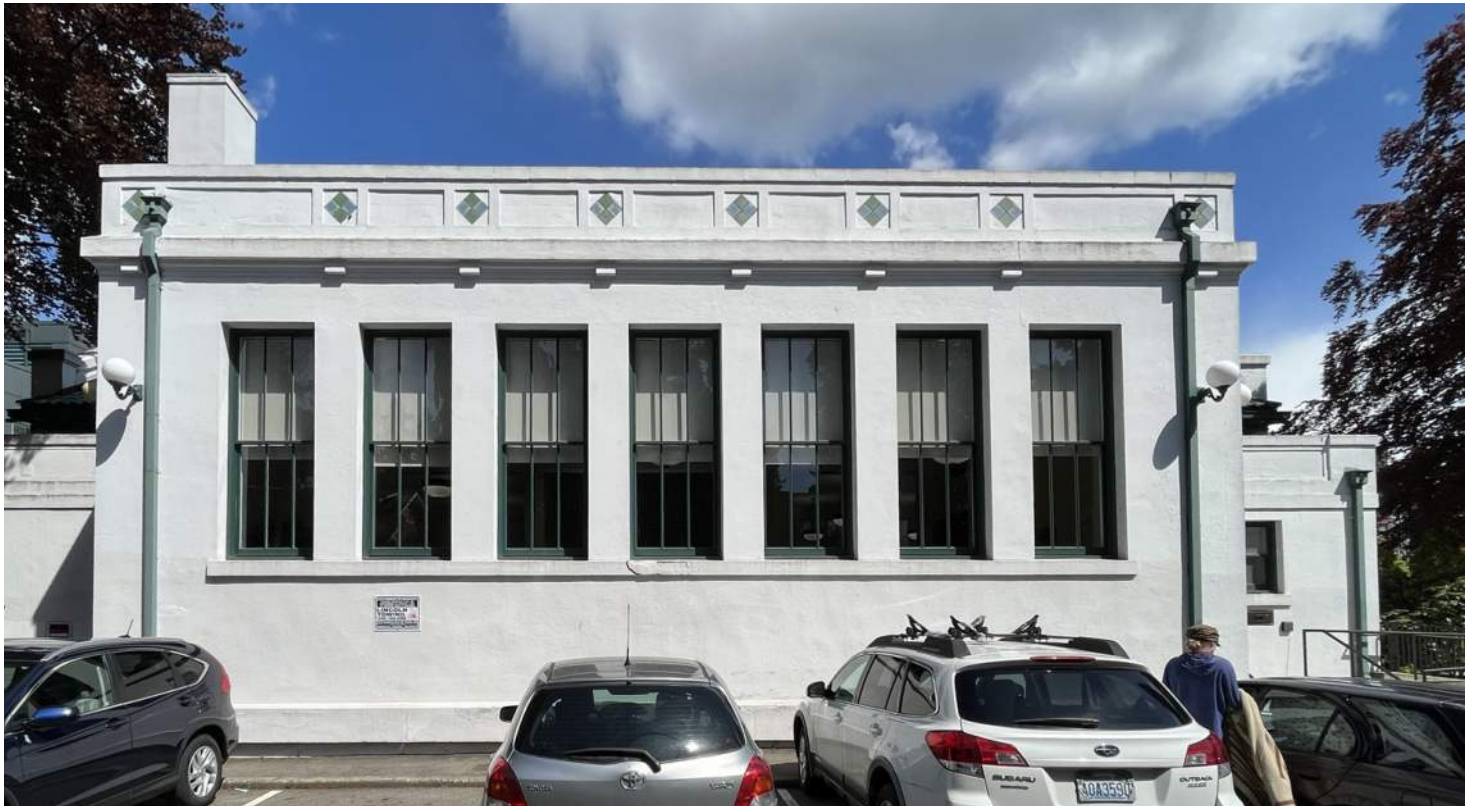
WEST ELEVATION W/ CONTROL JOINTS

At the previous Landmarks briefing on 07/26/23, SHKS proposed the use of an internal steel moment, metal framing and a composite panel assembly to rebuild exterior west wing walls.

A composite panel assembly would require control joints, a drainage plane, and weeps for the the assembly to be warrantable. **A masswall (stucco on concrete) avoids the use of control joints and restores the original unrelieved exterior finish.**

- CONTROL JOINTS FOR COMPOSITE PANEL SYSTEM (18' MAXIMUM)
- DRAINAGE FLASHING

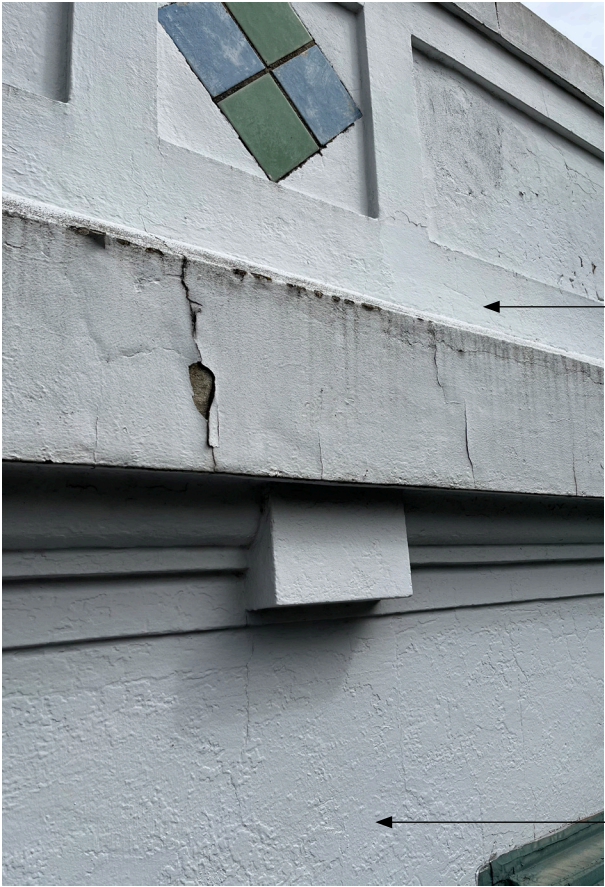
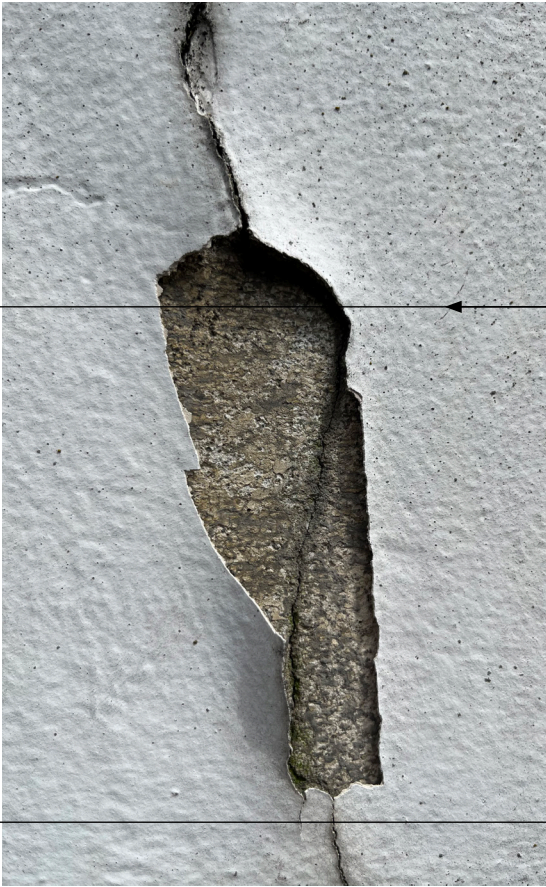
TYPICAL BANDING; PAINT OVER CEMENTITIOUS BLOCK

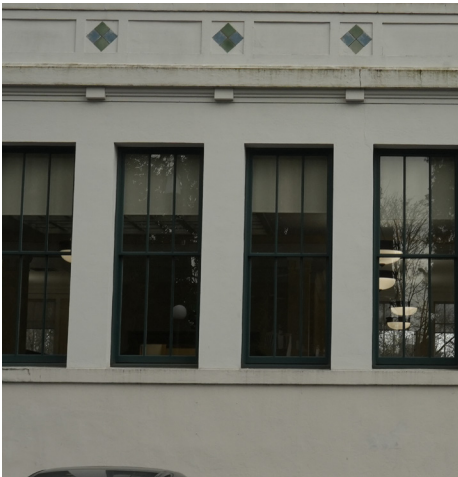
WEST ELEVATION; TILE, RELIEFS, AND BANDING

REINSTALL
TERRACOTTA
COPING CAP
REINSTALL TILES

Through-wall Coping Flashing
The existing coping caps were covered with liquid flashing during previous roofing and repair projects to limit costs. As a majority of coping caps are to be salvaged and reinstalled as part of the proposed wall rebuilds, the project is an advantageous time to install through-wall flashing to protect the wall assembly.

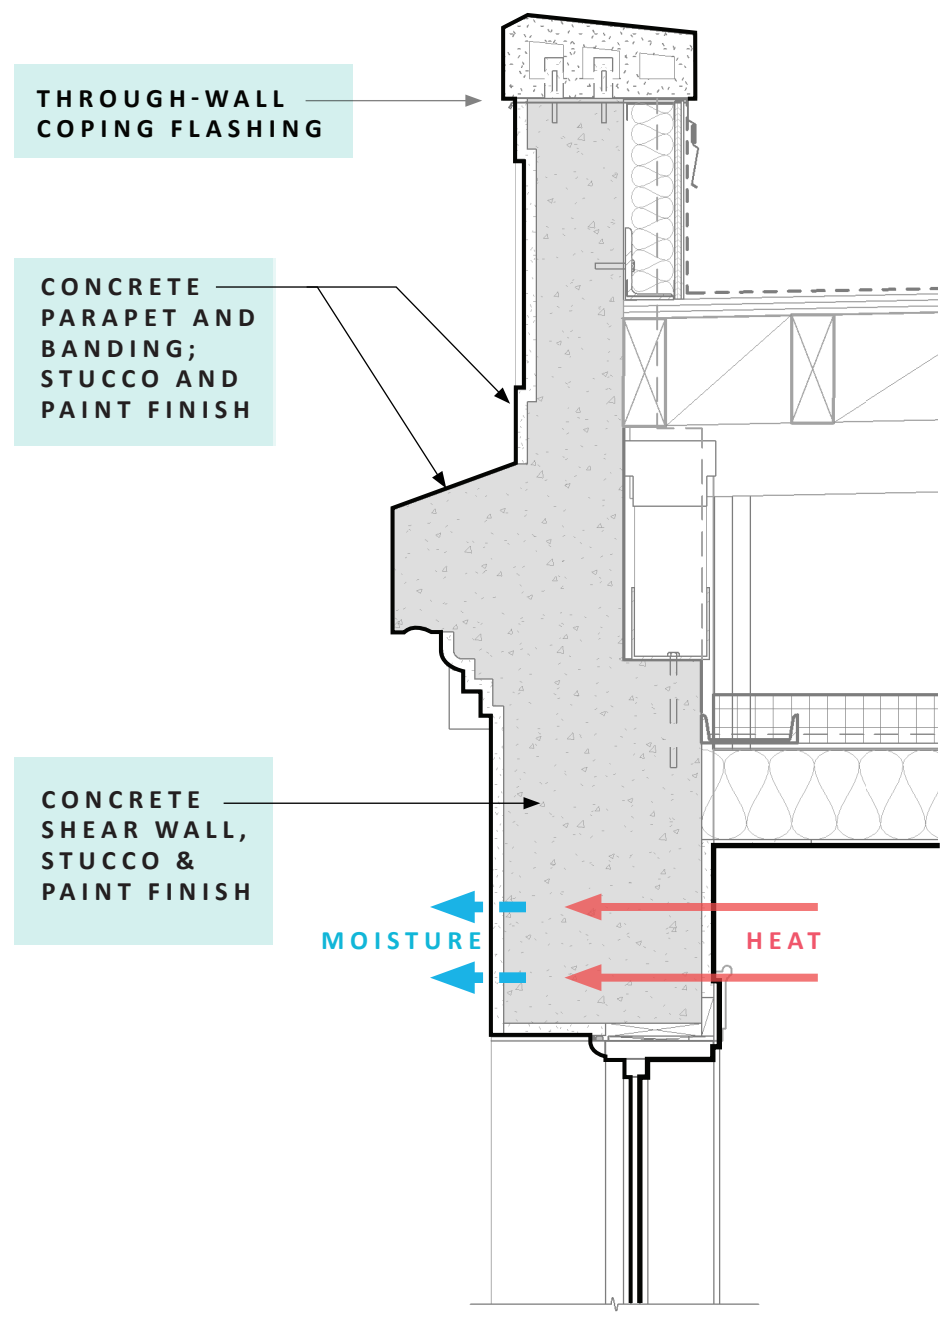
CURRENTLY PROPOSED:
CAST IN PLACE CONCRETE

- CAST-IN-PLACE CONCRETE**
- + MINIMIZE THERMAL DIFFERENTIAL
 - + MATCH EXISTING MOISTURE APPROACH
 - + OBVIATE THE NEED FOR CONTROL JOINTS
 - + MATCH STRUCTURAL BEHAVIOR
 - MINOR NEW/OLD STUCCO TRANSITION

SHKS Proposal:
Salvage and reinstall existing original terracotta coping caps with **anchor bolts and through wall flashing (west wing parapet only).**

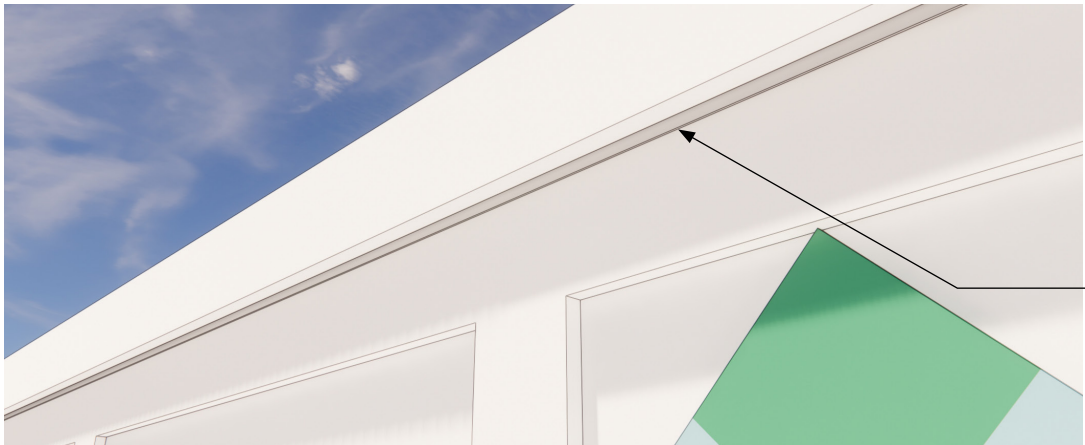
CLOSE-UP OF COPING FLASHING

THROUGH-WALL
FLASHING,
(1/2" DRIP EDGE,
BEAD-BLASTED
STAINLESS STEEL)

The existing coping caps are covered with liquid flashing from previous roofing and repair projects. A majority of west-wing coping caps are be salvaged and reinstalled as part of the proposed wall rebuilds; the project is an advantageous time to install through-wall flashing to protect the wall assembly.

Salvage and reinstall the existing original terracotta coping caps with **anchor bolts and through wall flashing (west wing parapet only)**. Exposed exterior drip edge to to be 1/2" bead blasted stainless steel.

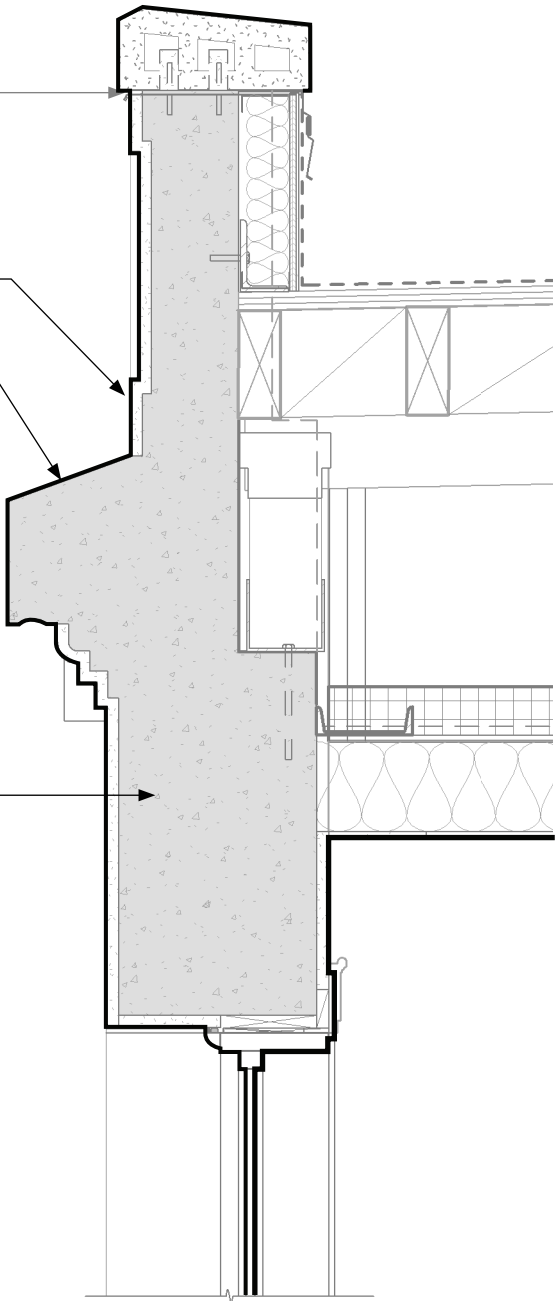
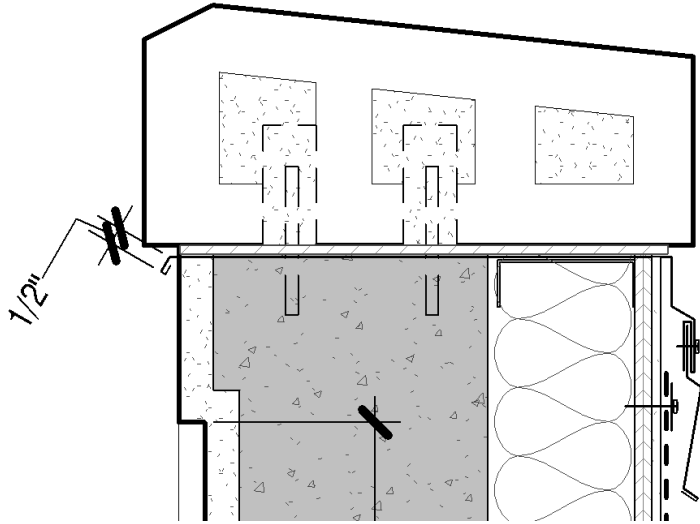
PARAPET SECTION DETAIL

THROUGH-WALL
FLASHING

CONCRETE
PARAPET AND
BANDING;
STUCCO AND
PAINT FINISH

CONCRETE
SHEAR WALL,
STUCCO &
PAINT FINISH

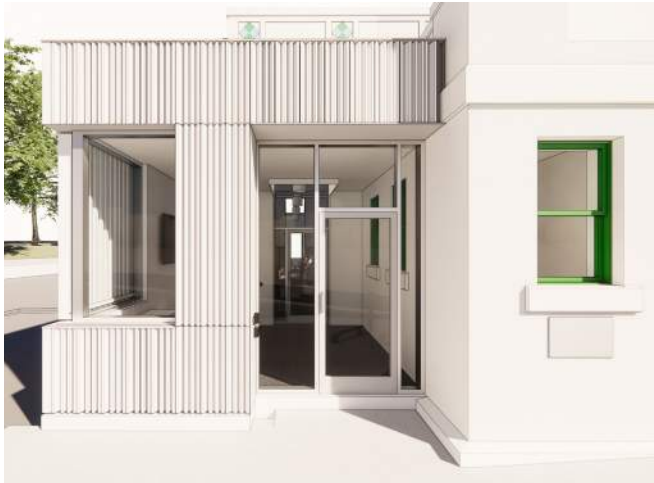
SOUTHWEST ADDITION

Clear anodized storefront at these openings, each denoting an interior/exterior transition, and/or a programmatic shift.

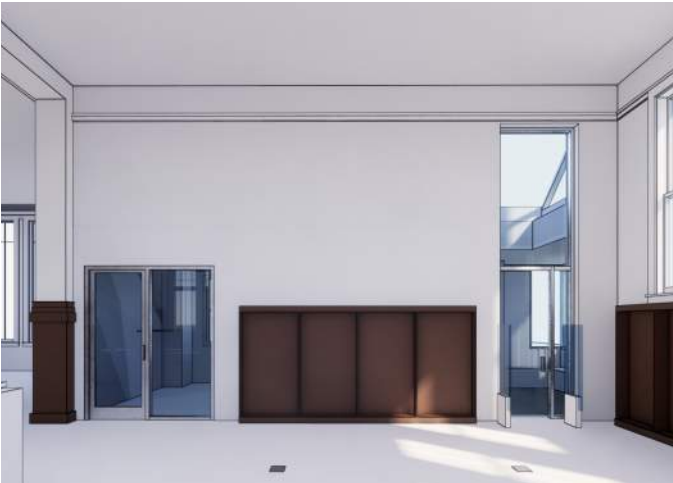
WEST WING OPENINGS

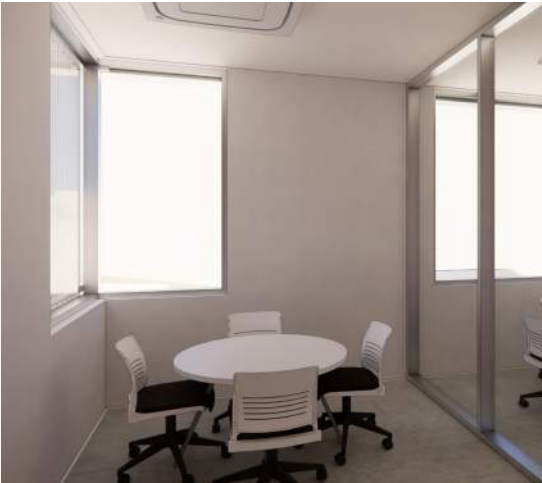
STUDY ROOM ADDITIONS

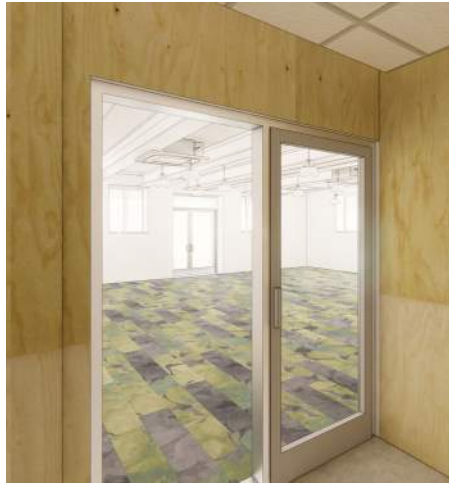
LOWER LEVEL MEETING

Relocation of the lower level meeting room requires modification or replacement of the existing original double door to meet egress requirements (min. (1) 3' wide leaf).

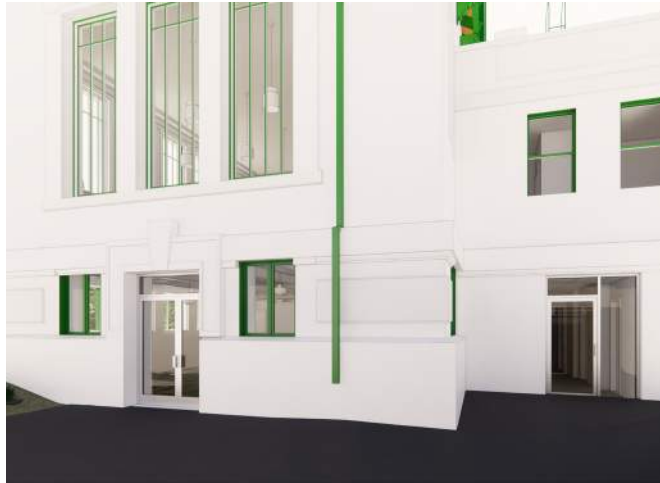
LOWER LEVEL ENTRIES

North Elevation Openings:

The lower level lobby will also have a new framed opening after removal of the existing non-original louver. Both openings are 8'-6"H, greater than the typical maximum for wood door manufacturers.

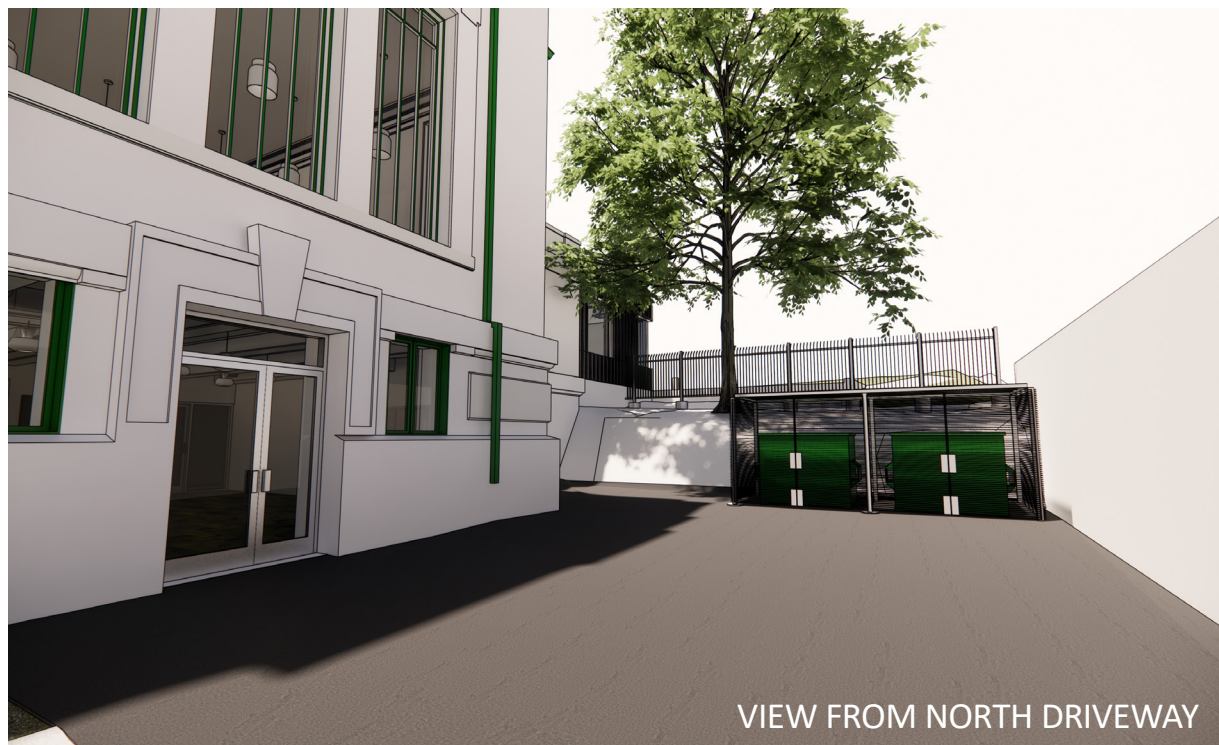
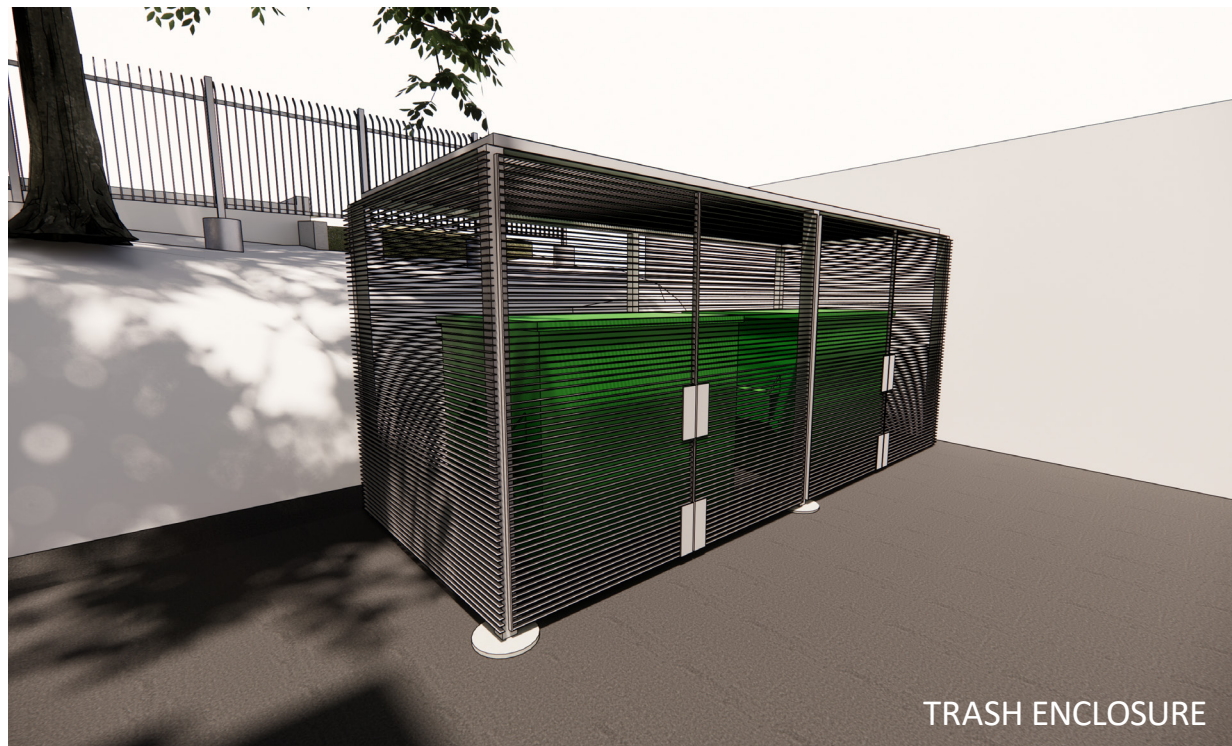
TRASH ENCLOSURE

Install a painted metal enclosure. Utilize **welded bar grating** for durability and visibility (sides and top). **Paint dark (black or dark bronze) to match existing metal site elements**, including the existing fence, handrails, and new steel retaining walls.

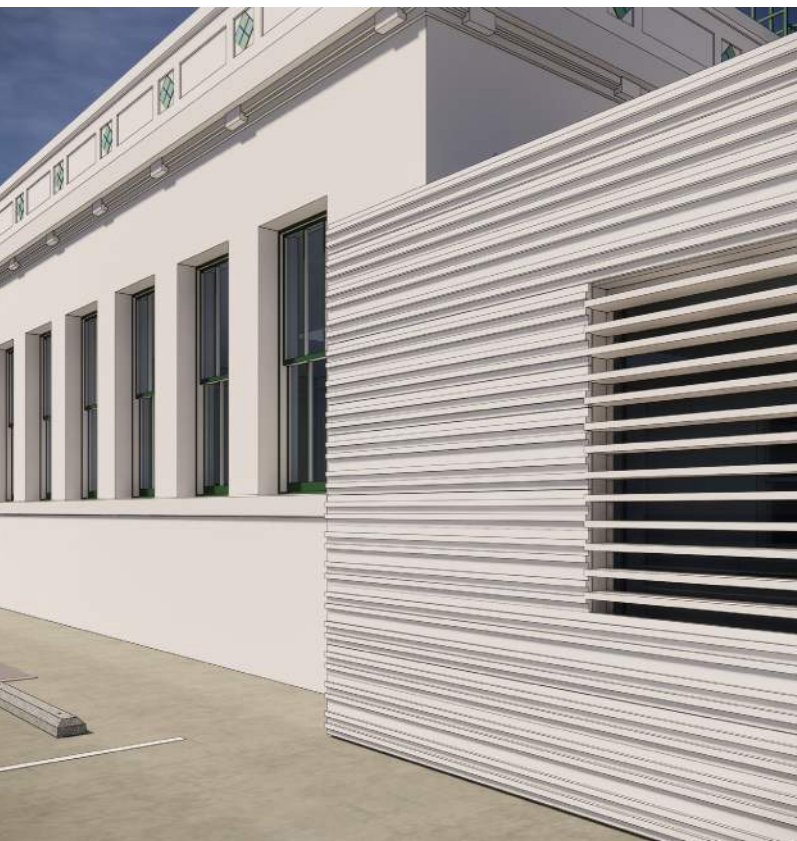
A horizontally oriented profile tests the hypothesis of vertical grain. Horizontal layouts contrast with the vertical grain of the existing building windows and mullions.

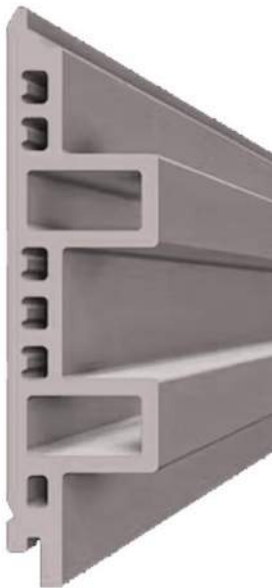
Slotted Flat Profiles

A shallow profile was studied to assess the value of depth. A lack of depth limits the potential shadow-play and results in a flatter texture that does not complement the existing stucco or terracotta detailing.

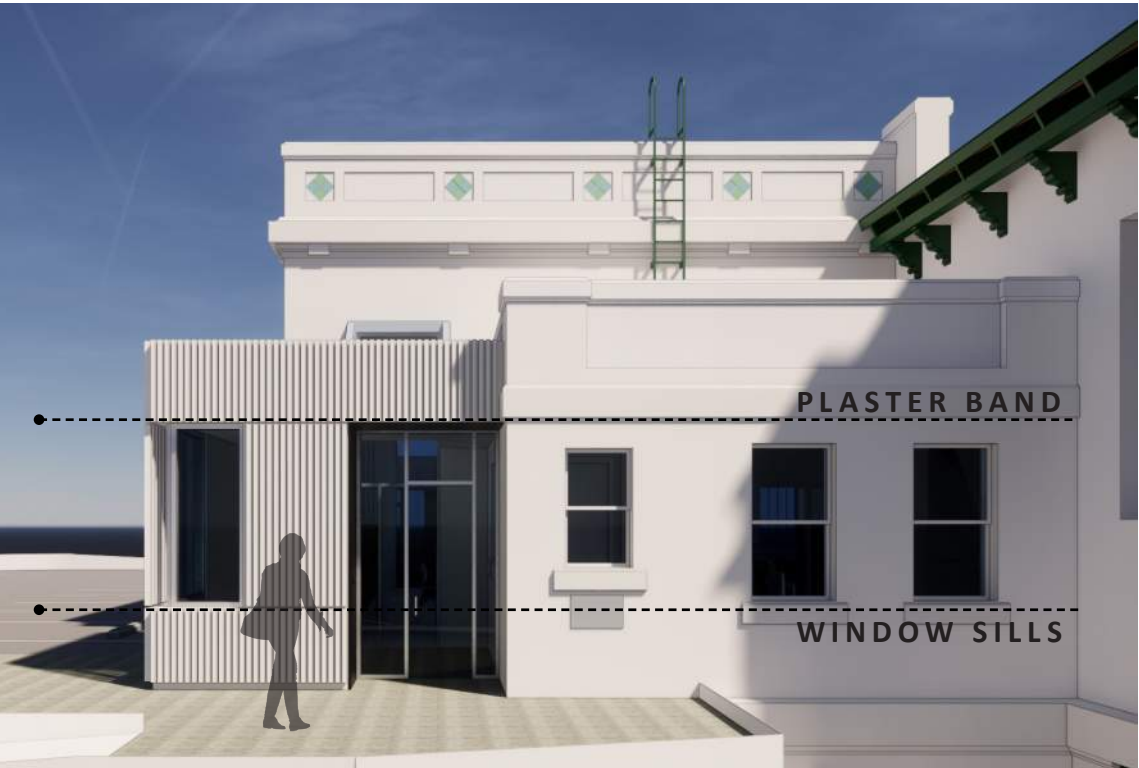
SOUTH ELEVATION

The proposed addition openings align with the adjacent service bay plaster band that delineates its roof plane, as well as its lower window sills. A roughly 1-2-1 proportion between roof, window, and foundation datums, which is shared with the adjacent west wing reading room.

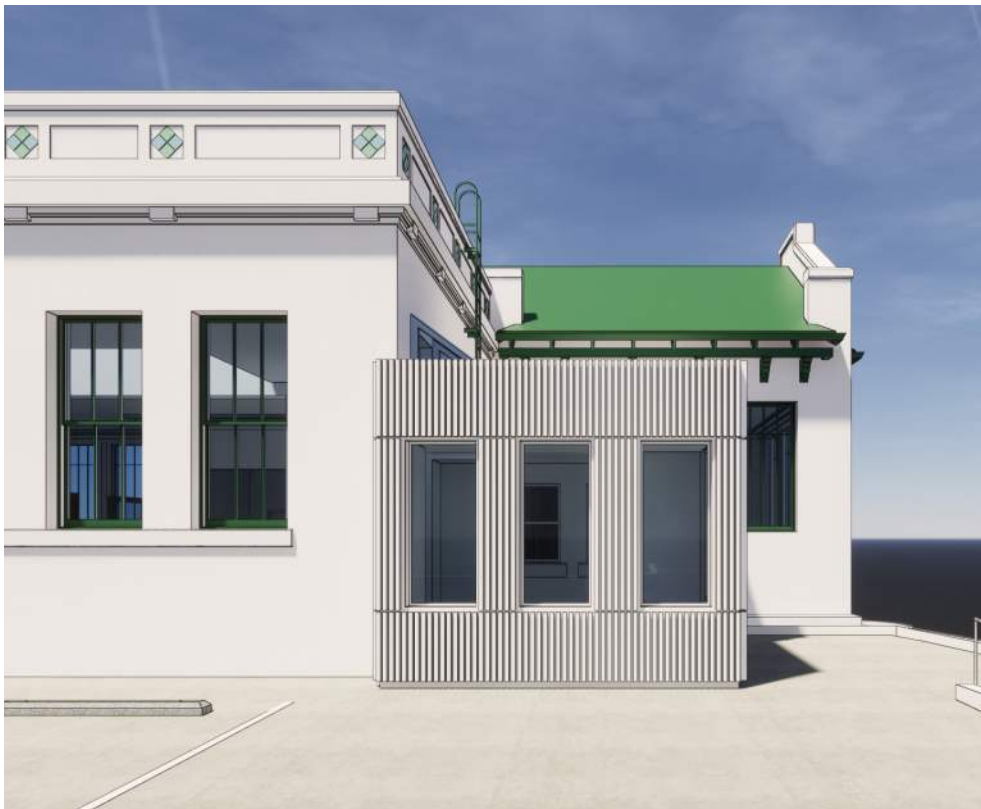
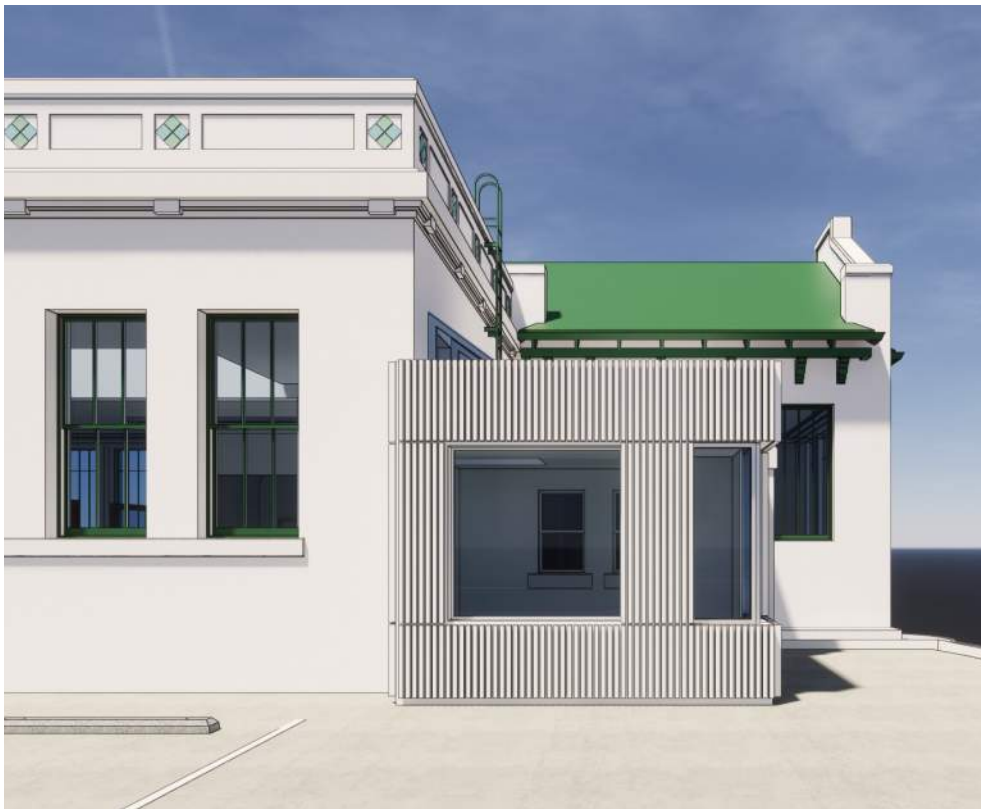
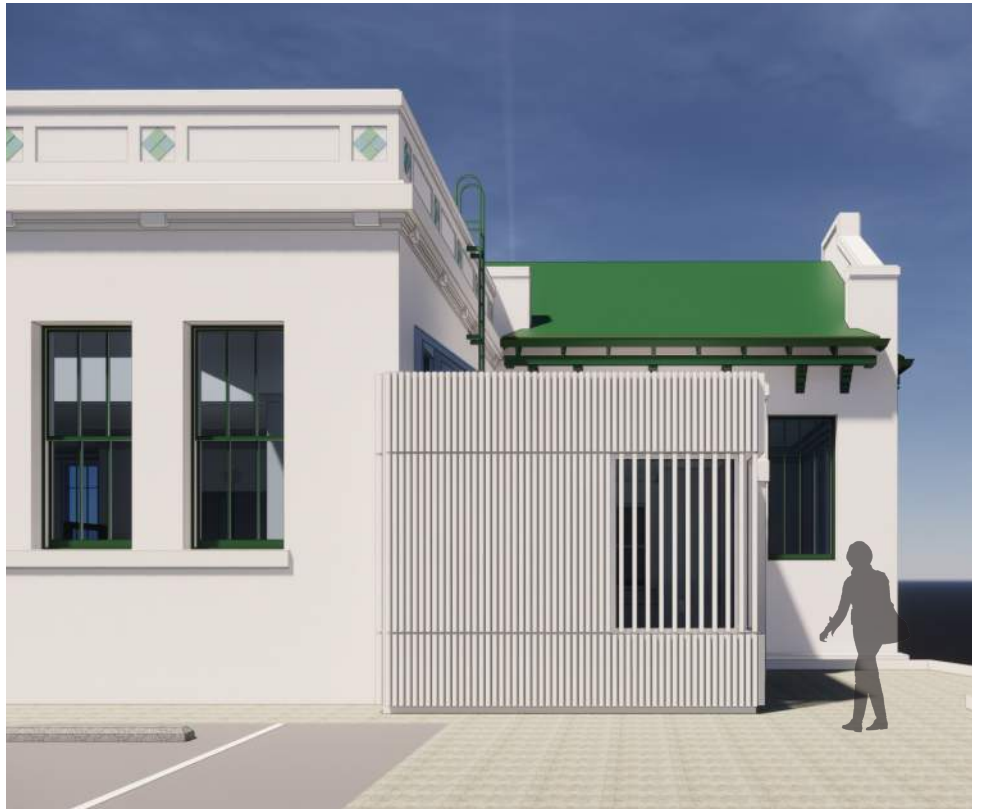
ADDITIONS DEVELOPMENT - OPENING LOGIC

Purely punched openings—especially vertical—imitate the existing windows. By contrast A carved corner window responds to and differentiates itself from the original building's in a method compatible with monolithic buildings (contemporary examples shown at right).

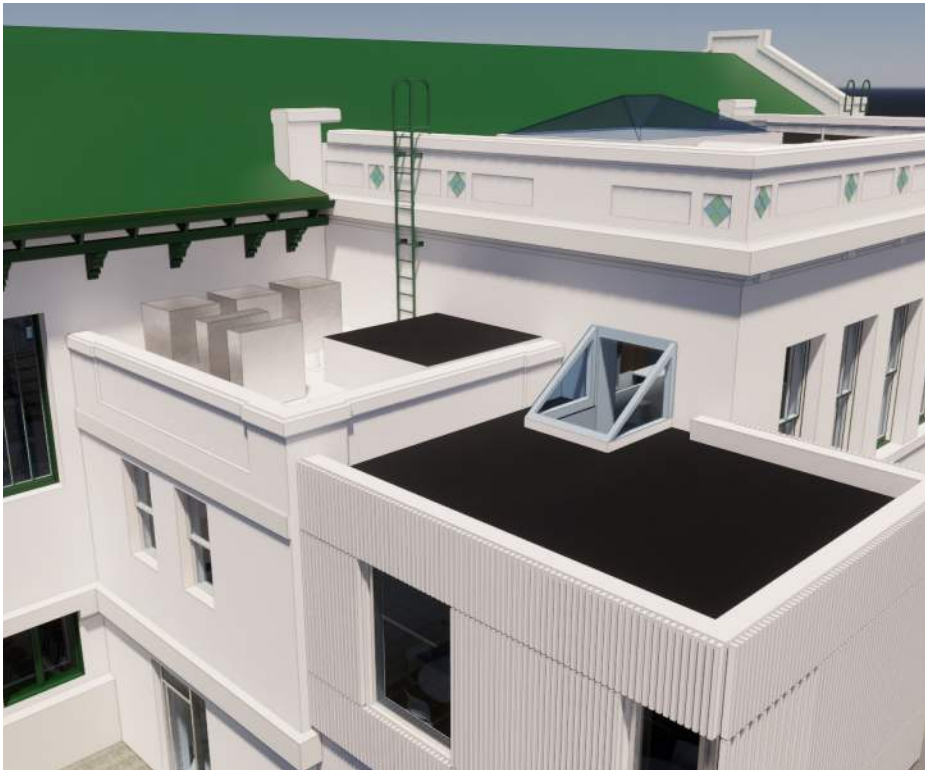
ROOFTOP ELEMENTS

Outdoors units for the new HVAC system are proposed to be located on the north service bay roof. The elevator overrun aligns with the parapet. These elements will not be visible from the parking lot, though the outdoor units will be visible from the higher elevation of 9th Avenue.

A solar panel array is proposed to be located on the west wing roof. The incidence angle will be set such that the panels will be fully concealed by the parapet when viewed from 9th Avenue.
