SEATTLE PUBLIC LIBRARY UNIVERSITY BRANCH RENOVATION

BUILDING HISTORY + EXISTING CONDITIONS

ENERGY AND EGRESS CODE
ENERGY CODE COMPONENT REQUIREMENTS

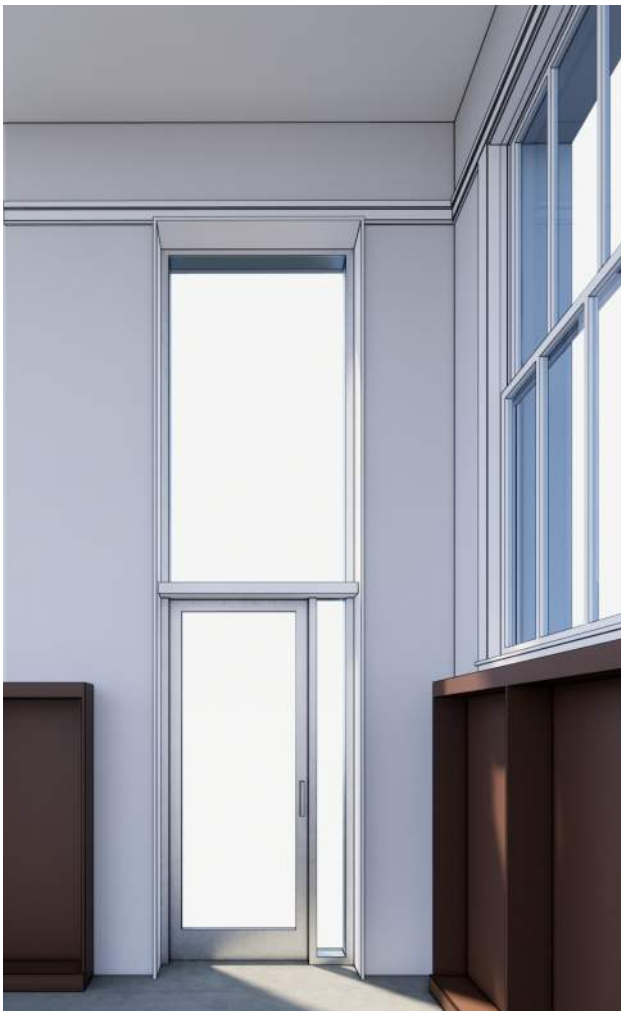
1: Window Removal

- Vertically flush opening
- Clear delineation of old & new openings
- Maximizes daylight & minimizes sticking

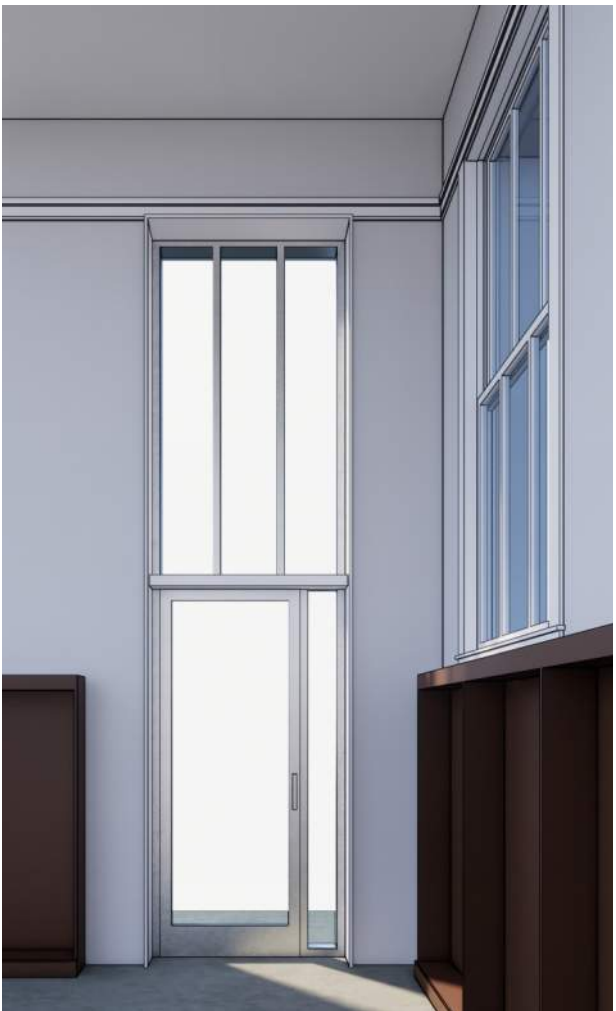
2: Window Removal w/Sticking

- Vertically flush opening
- Mimics original tripartite glazing
- Accessible door framing misaligned with sticking above

At the April 6th Landmarks Preservation Board Meeting, the board requested the development of alternate approaches to the SW entry opening treatment to assess the appropriateness of the proposal. SHKS developed a number of schemes with a range of approaches to window grain and retainage of the existing window.

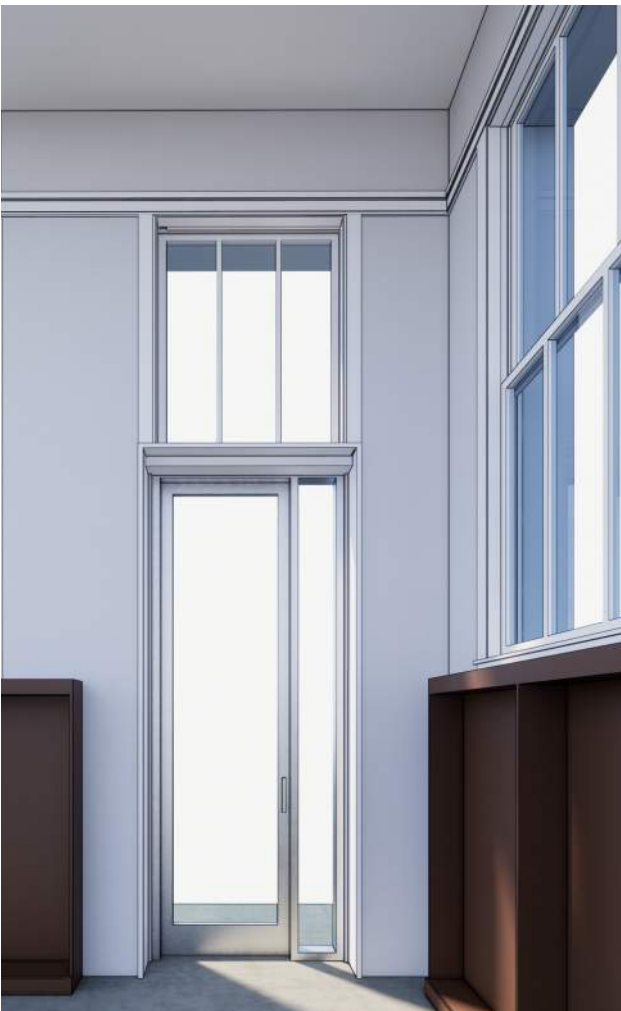
3: Retain Upper Sash

- Retains portion of original window
- Transom or tall door required to bridge gap
- Lintel delineates old & new openings

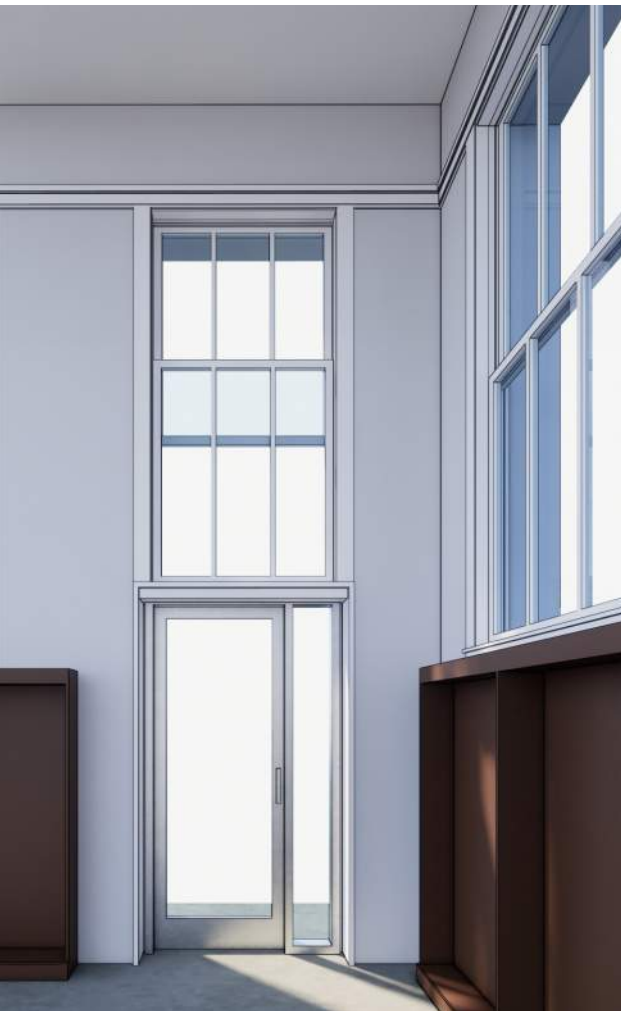
4: Retain Upper & Lower Sash

- Maximizes retainage of material
- Reflects original window operation
- Lintel delineates old & new openings

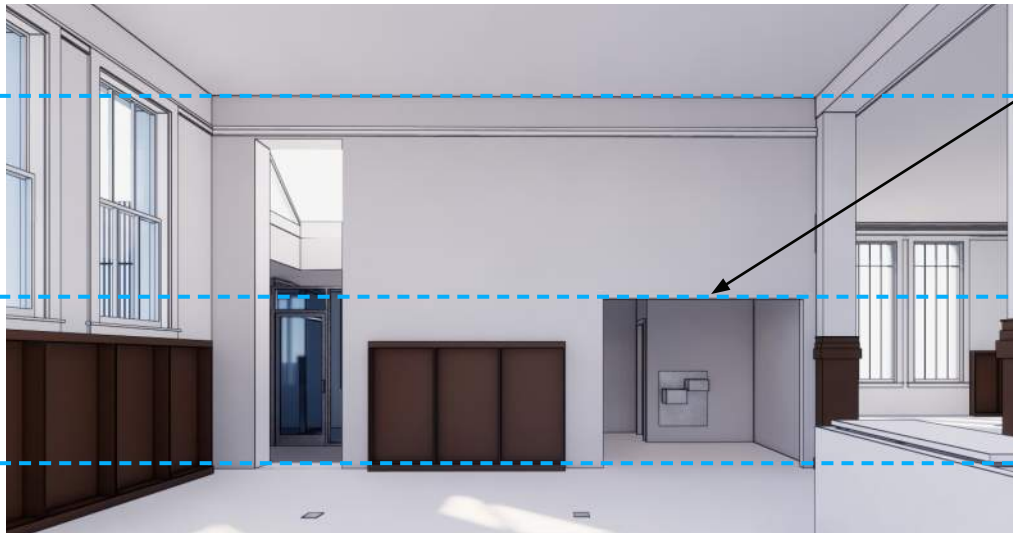
WEST WING NORTH - PROPOSED OPENING

It was since found that this solution is incompatible with SPL's operational requirements of sufficient visual access and circulation clearances into this elevator lobby. Due to this and the visual impacts of the proposed elevator shaft obscuring half of the glazing, SHKS is now proposing the removal of this partition, and installing a headwall to align the opening with the mirrored south wall openings.

- **ELEV LOBBY OPENING WITH WOOD TRIM**
- HEADWALL TO MATCH MIRRORED OPENINGS/DOORS
- **STAFF WORK ROOM DOOR & ACCESSIBLE ENTRY DOOR**
- HEIGHT TO MATCH MIRRORED ELEV LOBBY HEADWALL

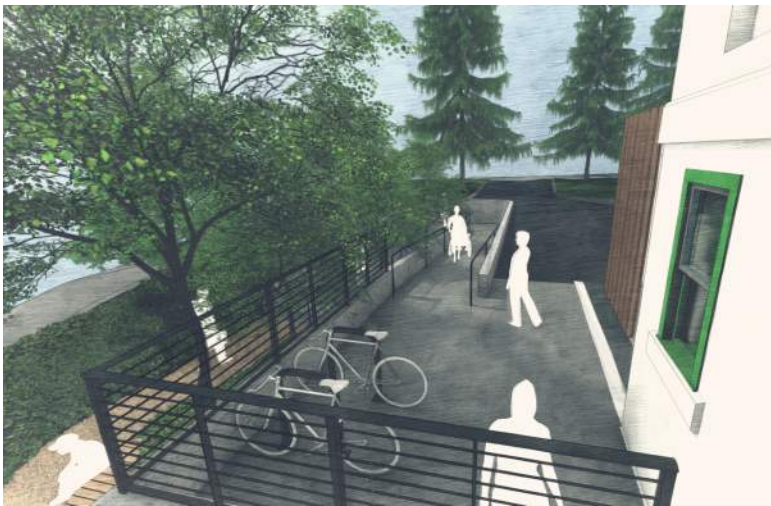
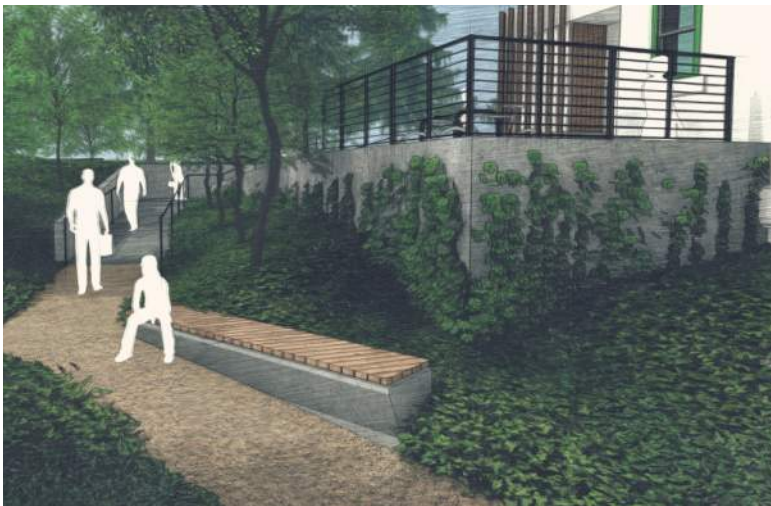
- Pathway trajectory minimizes impact on existing trees.
- Inviting and accessible sloped walk segment starting at mid-block sidewalk
- Terraced walls to reduce individual wall height and eliminate need for guardrail.
- Additional stepped walls to open up the space and make the pathway feel safer and less constrained.
- Harmonized relationship of upper plaza to architectural expansion.

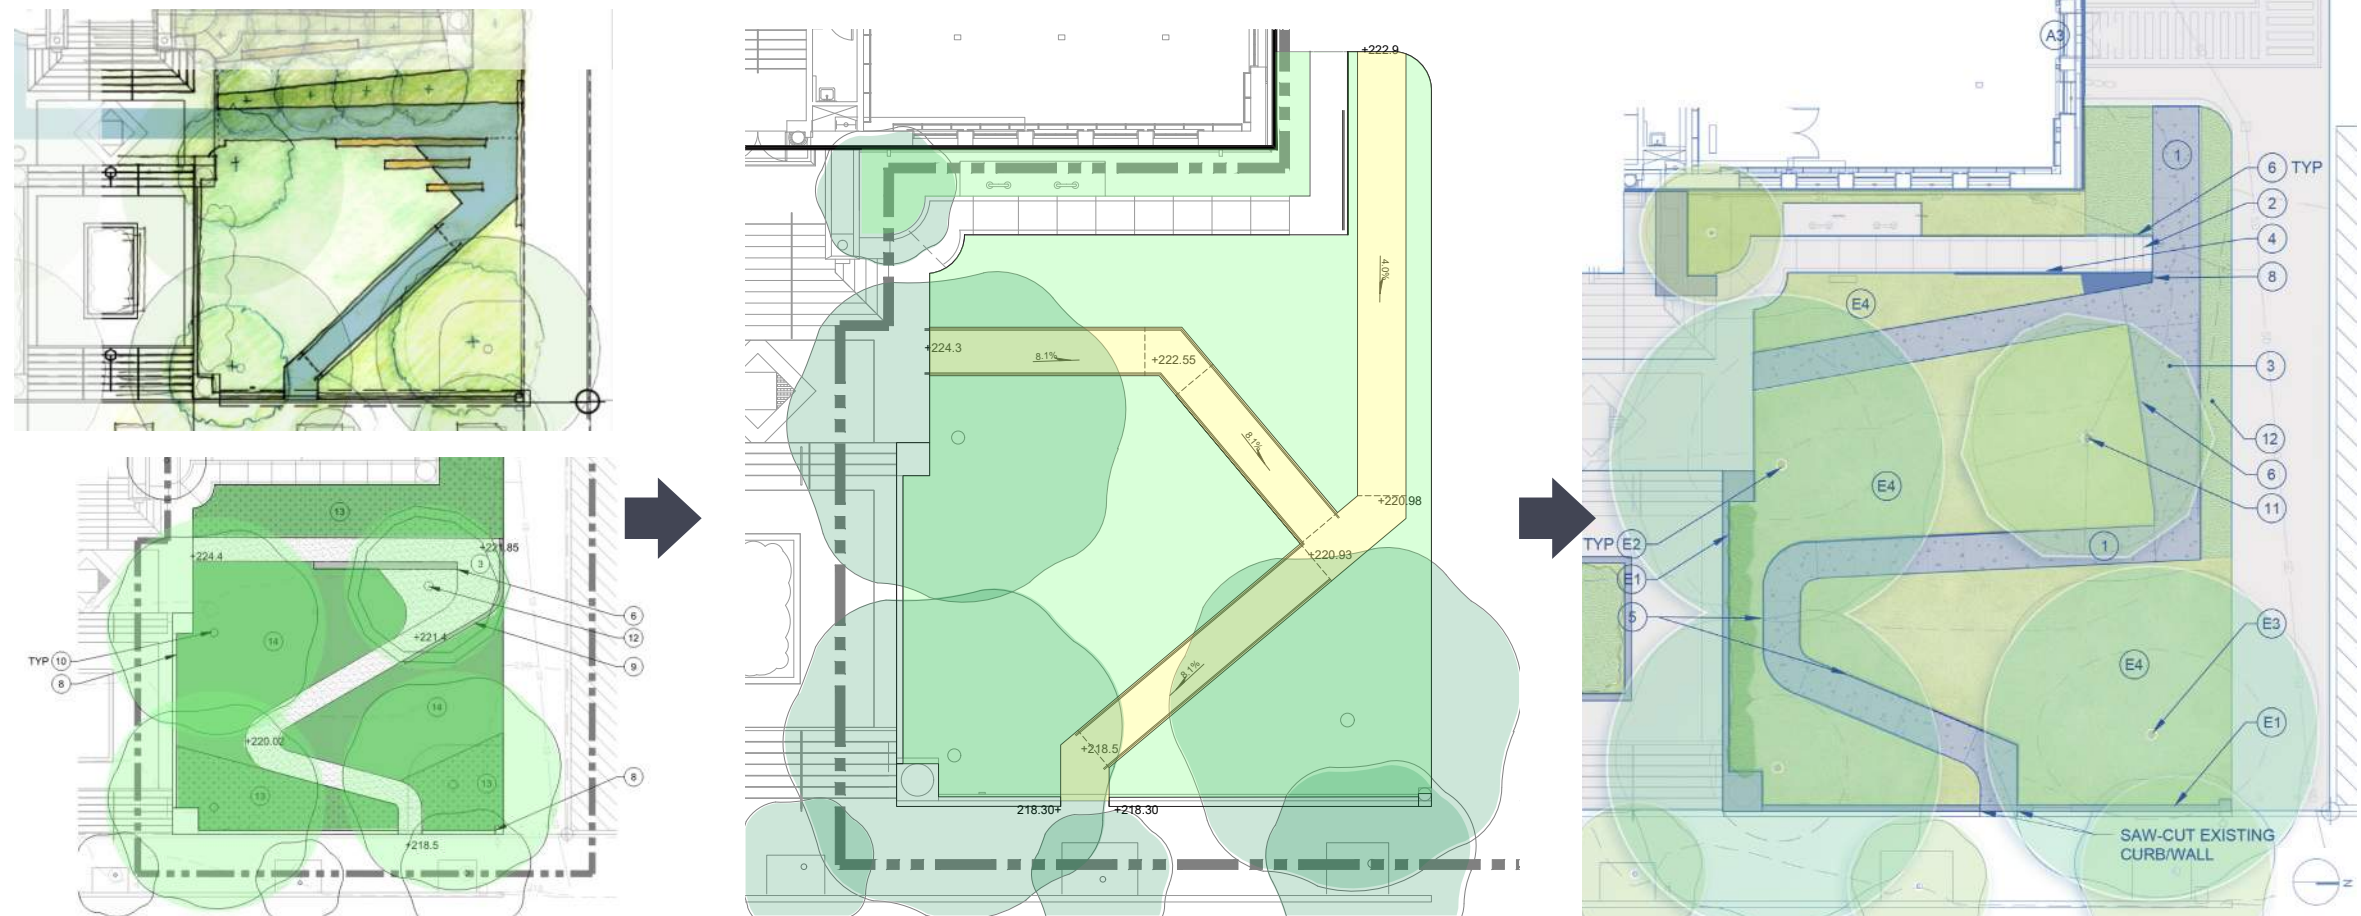
NE SITE AREA - ROOSEVELT WAY NE ACCESS - DESIGN EVOLUTION

CURRENT SCHEME ADVANTAGES:

- Pathway trajectory minimizes impact on existing trees.
- Ramp section with rails location minimizes impact on east elevation to maintain symmetry.
- Sloped walkways make up most of the grade change - gradual and easier to navigate.
- Stair relocation makes site navigation more intuitive.
- ADA access from street to both lower level entry and to south pathway ADA improvements, connecting entire site.

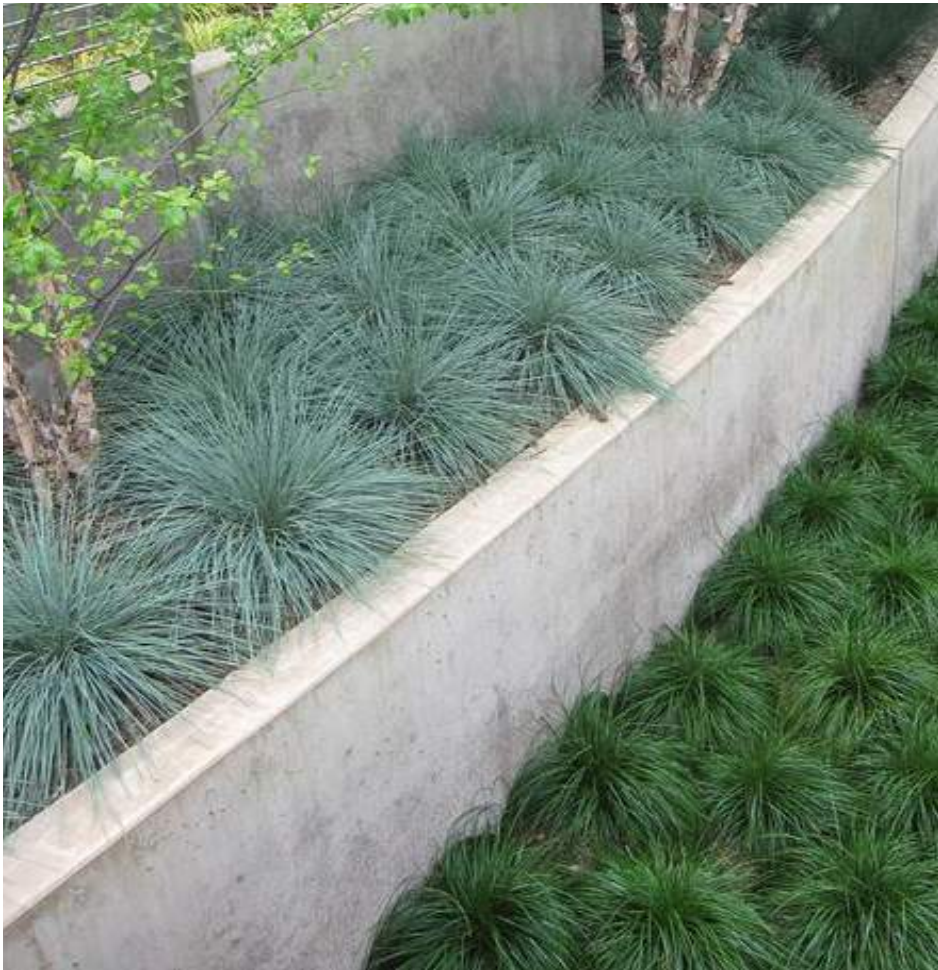
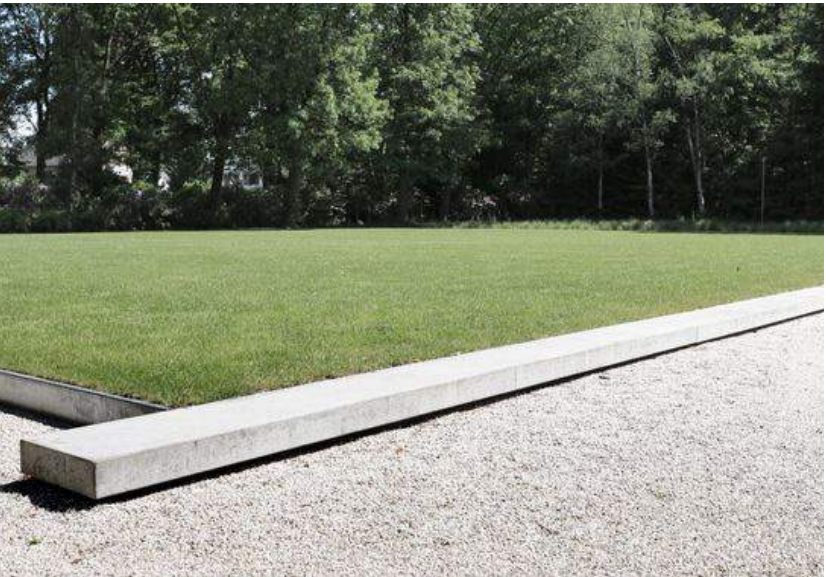
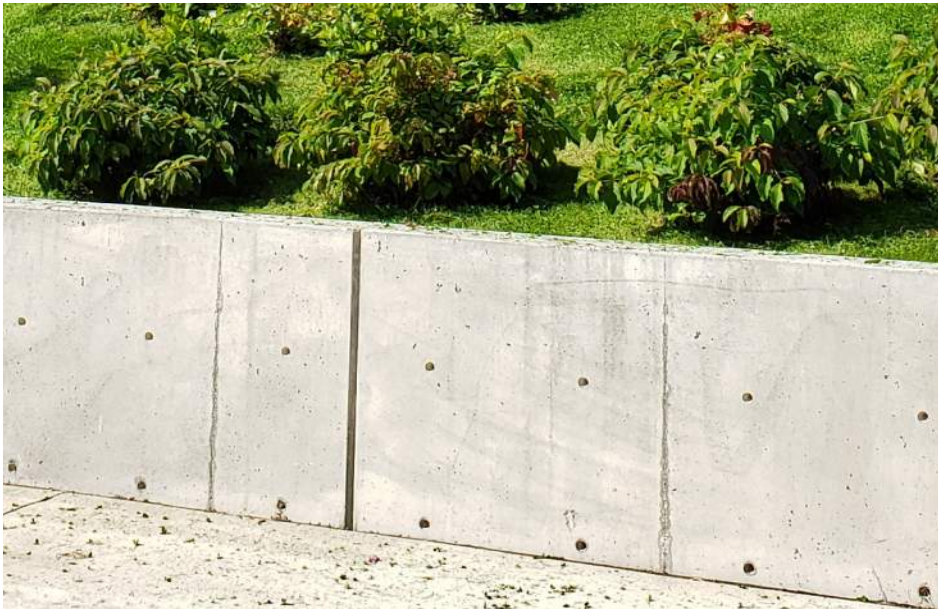
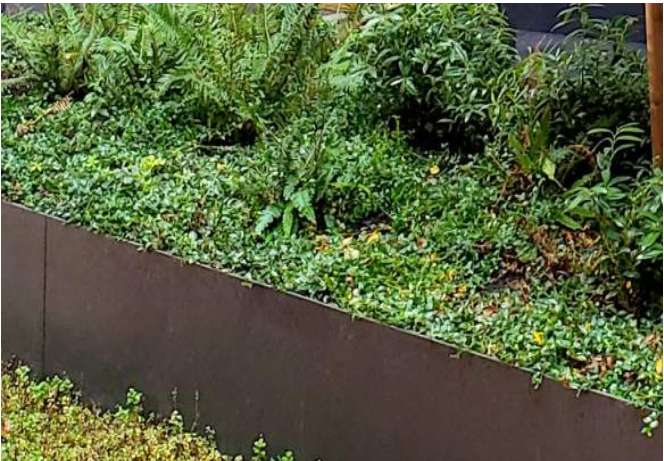
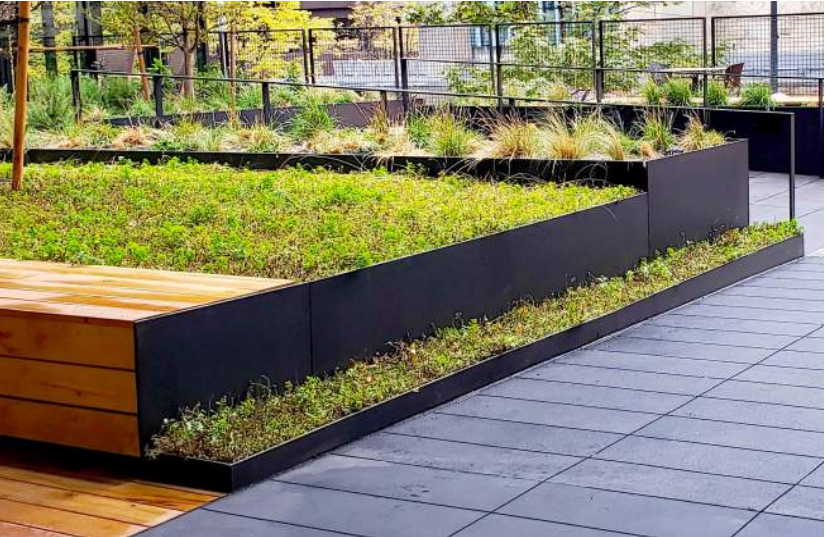
Due to the negotiation of significant grade changes throughout the site, retaining walls will be required in order to provide improved universal accessibility. Retaining walls will be designed to blend as much as possible into the site and be light in their visual impact. Planting will be used in order to minimize visual impact by screening walls where possible.

Concrete walls provide a simple, neutral, solid expression that fits with existing elements.
