Window Condition Assessment for B.F. Day Elementary School

on behalf of Seattle Public Schools

July 16, 2024

Miller Hayashi Architects PLLC

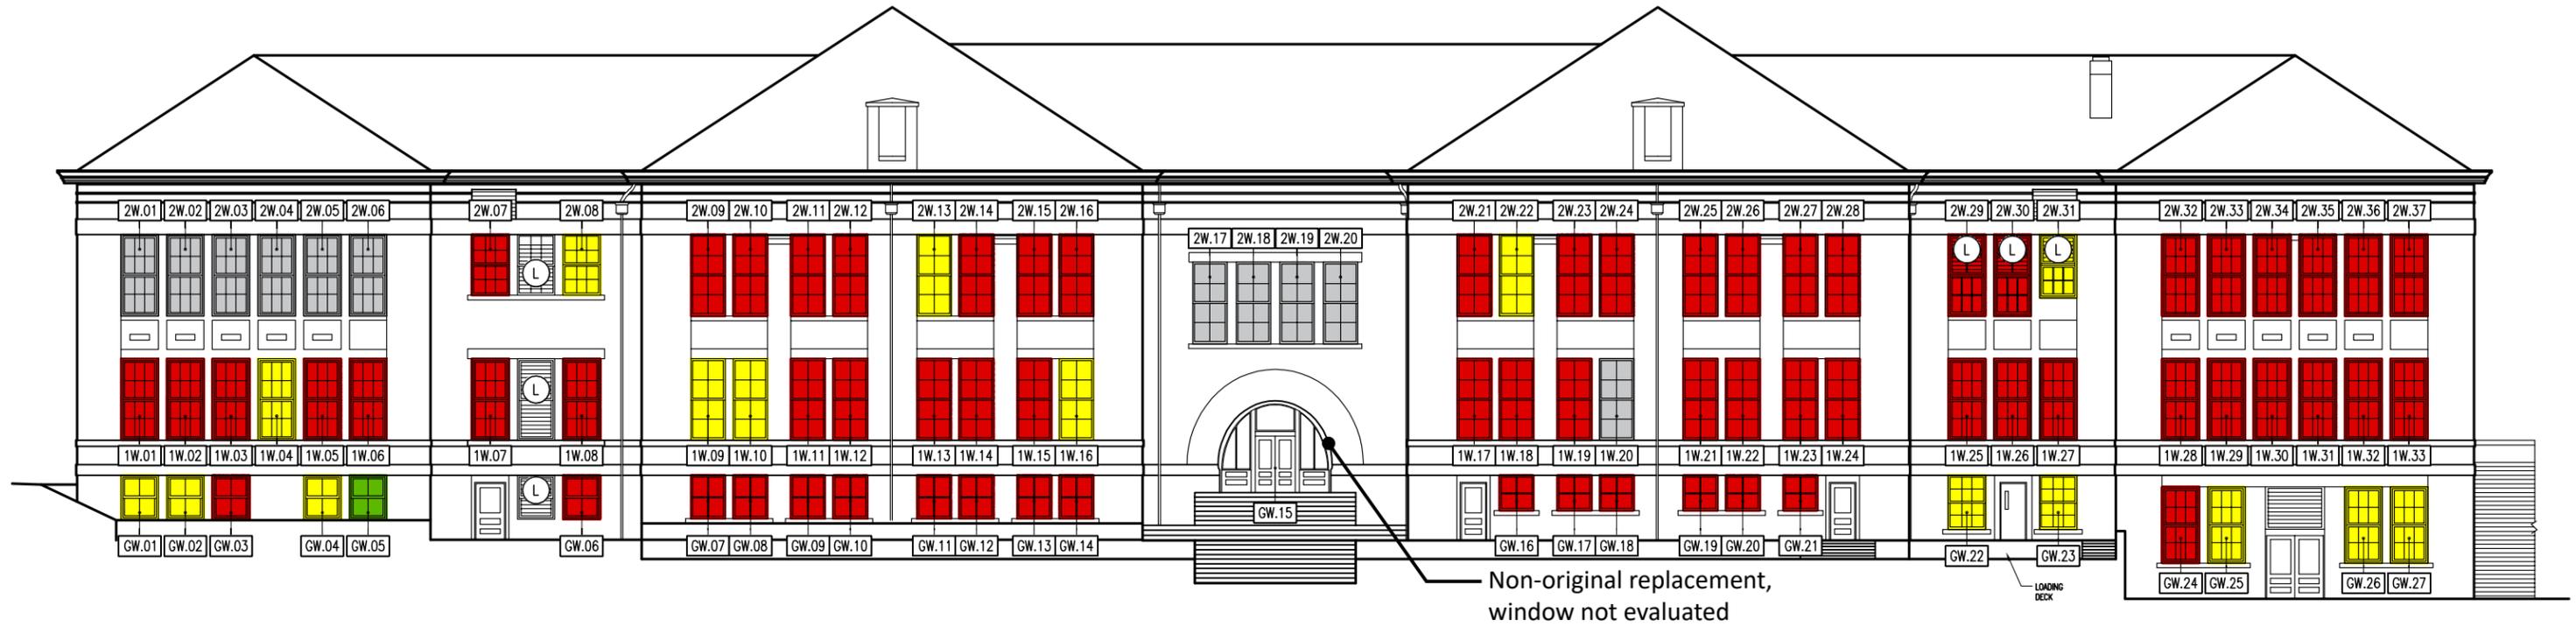
West Elevation

- Surface Defects (operationally sound, routine maintenance required)
- Moderate Condition (operable, physical deterioration requiring stabilization)
- Poor Condition (not operable, advanced deterioration, splices and/or parts replacement required)
- Inaccessible (not evaluated)

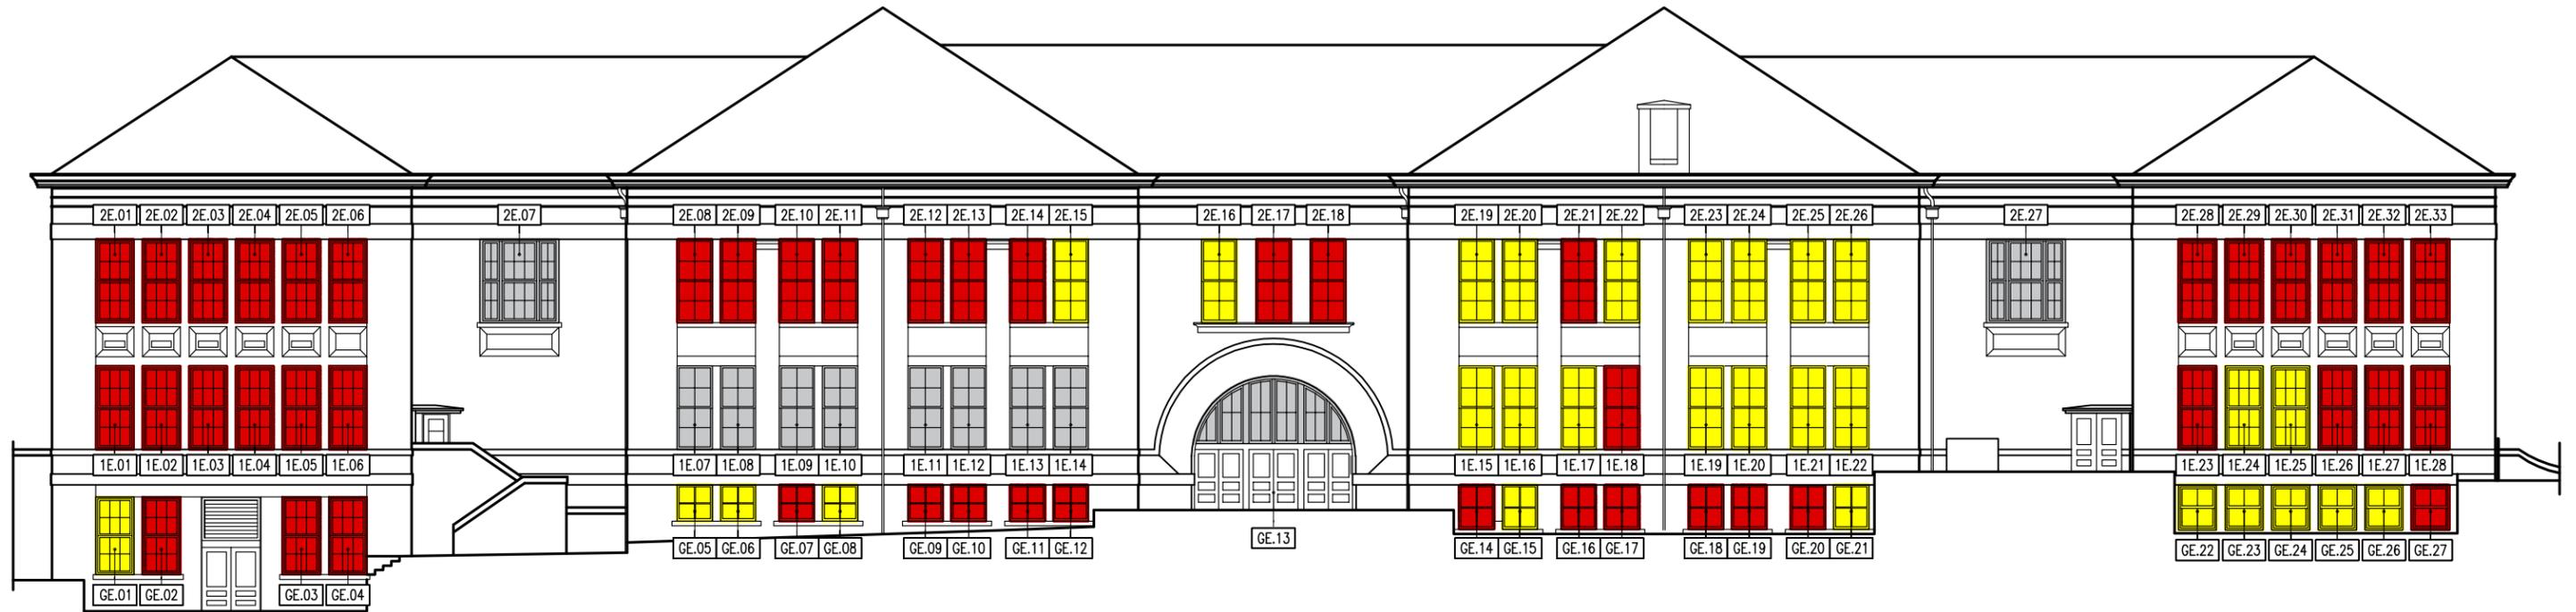
East Elevation

- Surface Defects (operationally sound, routine maintenance required)
- Moderate Condition (operable, physical deterioration requiring stabilization)
- Poor Condition (not operable, advanced deterioration, splices and/or parts replacement required)
- Inaccessible (not evaluated)

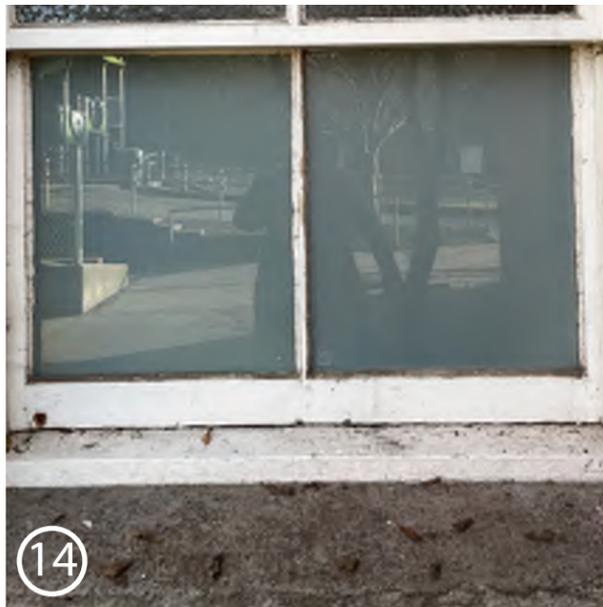
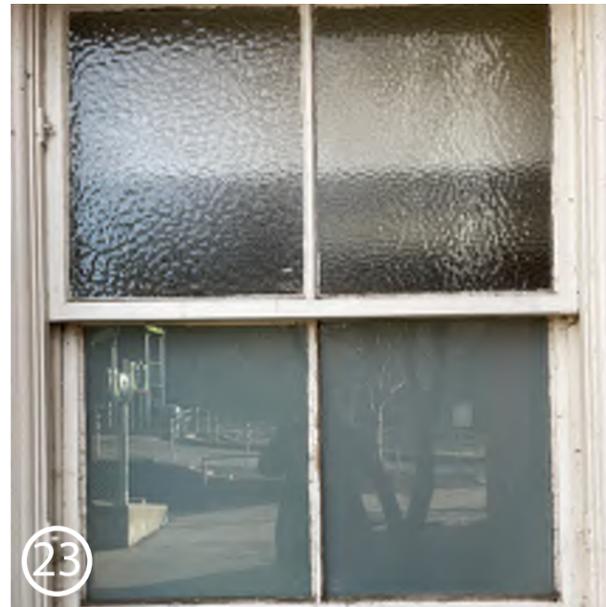
Window ID GW.06 POOR CONDITION

● Sash cords painted over

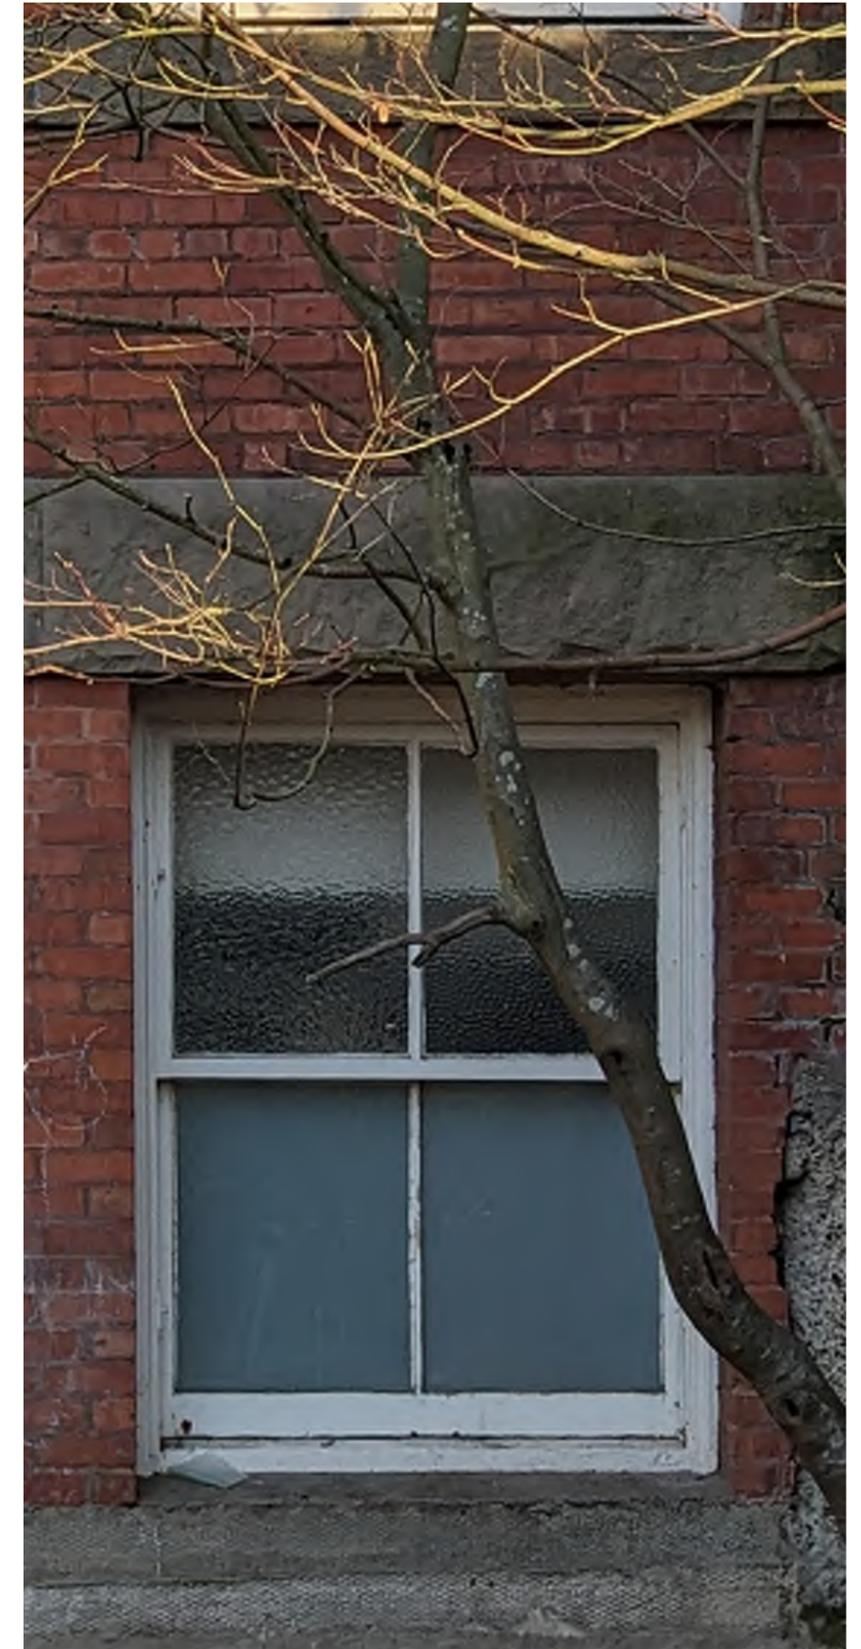
Window ID **GW.07** POOR CONDITION

1. Sash Operation Difficult/Won't Open
- ② Inoperable – Screwed Shut
- ③ Exterior Paint at Sash and Trim Cracked and Peeling at Limited Areas
4. Exterior Paint at Sash and Trim Heavily Deteriorated

5. Checked Sash/Muntin
- ⑥ Deteriorated Sash
7. Checked/Split Frame
8. Deteriorated Frame
9. Parting Bead Lightly Deteriorated
10. Parting Bead Missing or Heavily Deteriorated

11. Sill 20% or Less Deteriorated
- ⑫ Sill Heavily Deteriorated, Wood Consolidation Necessary for More Than 20% of the Sill
13. Reinforced Sash (non-original)

- ⑭ Section Loss
15. Missing Window Stop
16. Sealant Deteriorated
17. Weatherstrip Deteriorated/Missing
18. Deteriorated Glazing Compound/Setting Bead/Glazing Putty

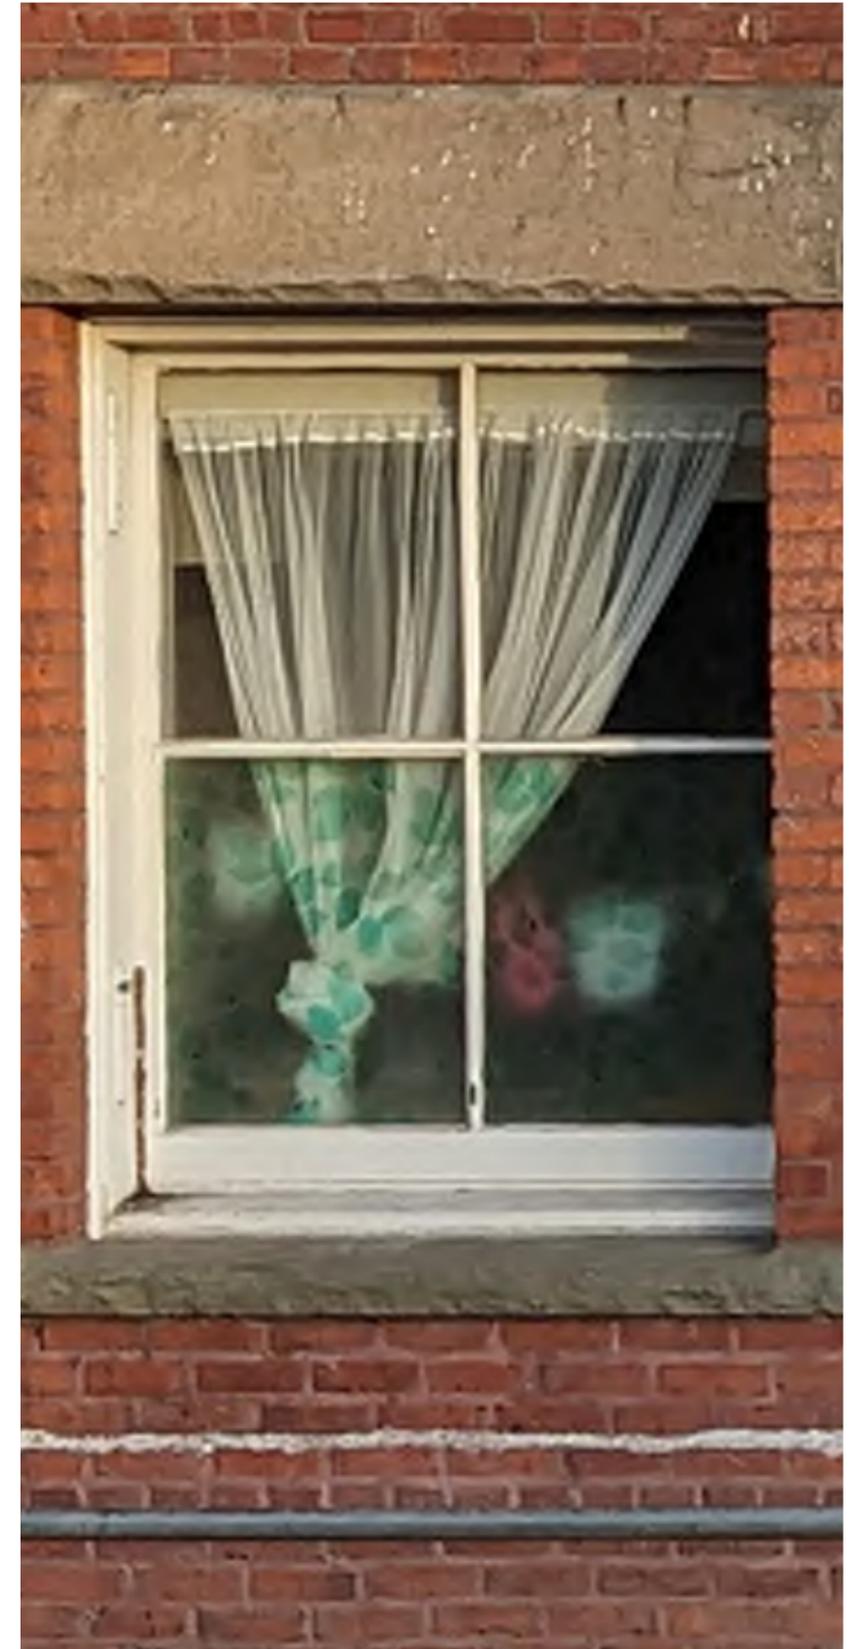
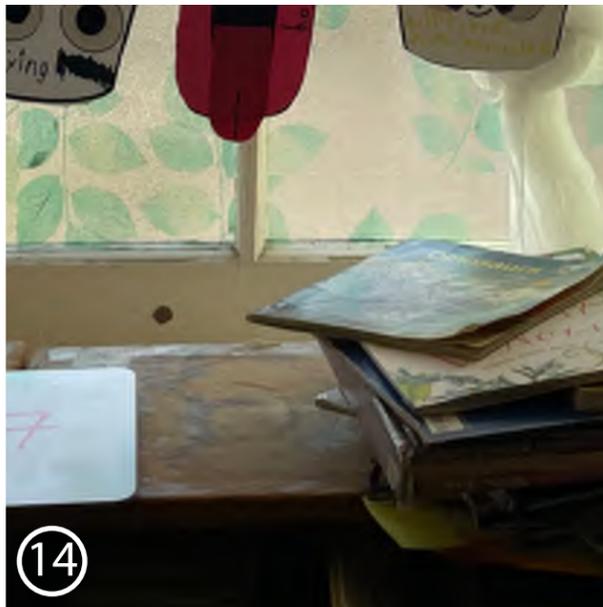
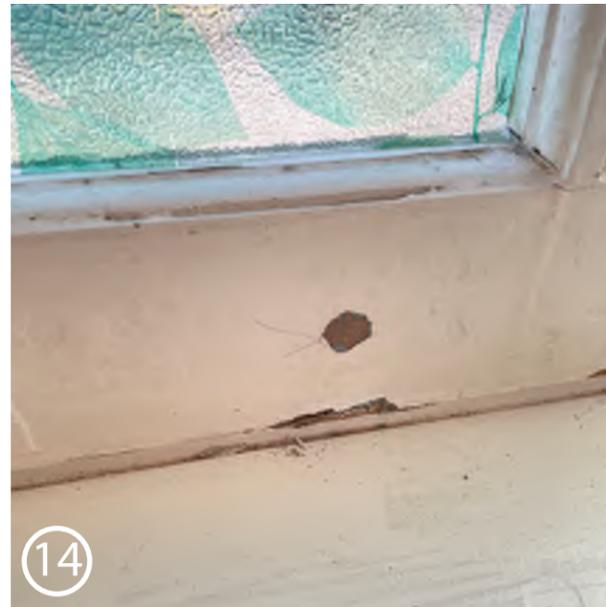
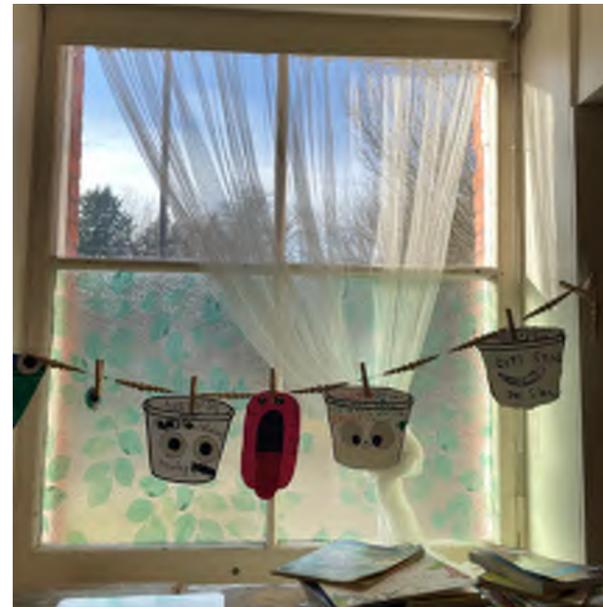
- Sash is misaligned in frame
- Non-original hinges

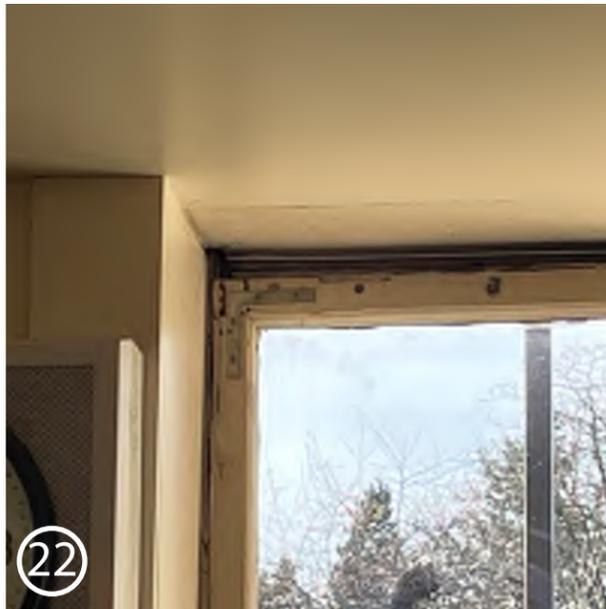
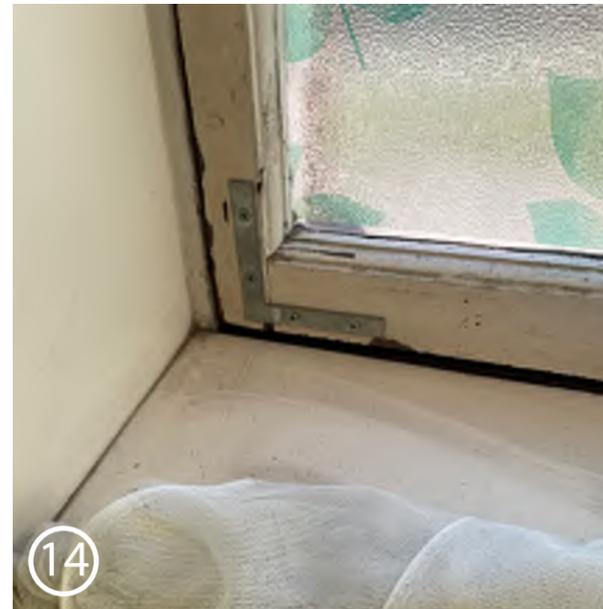
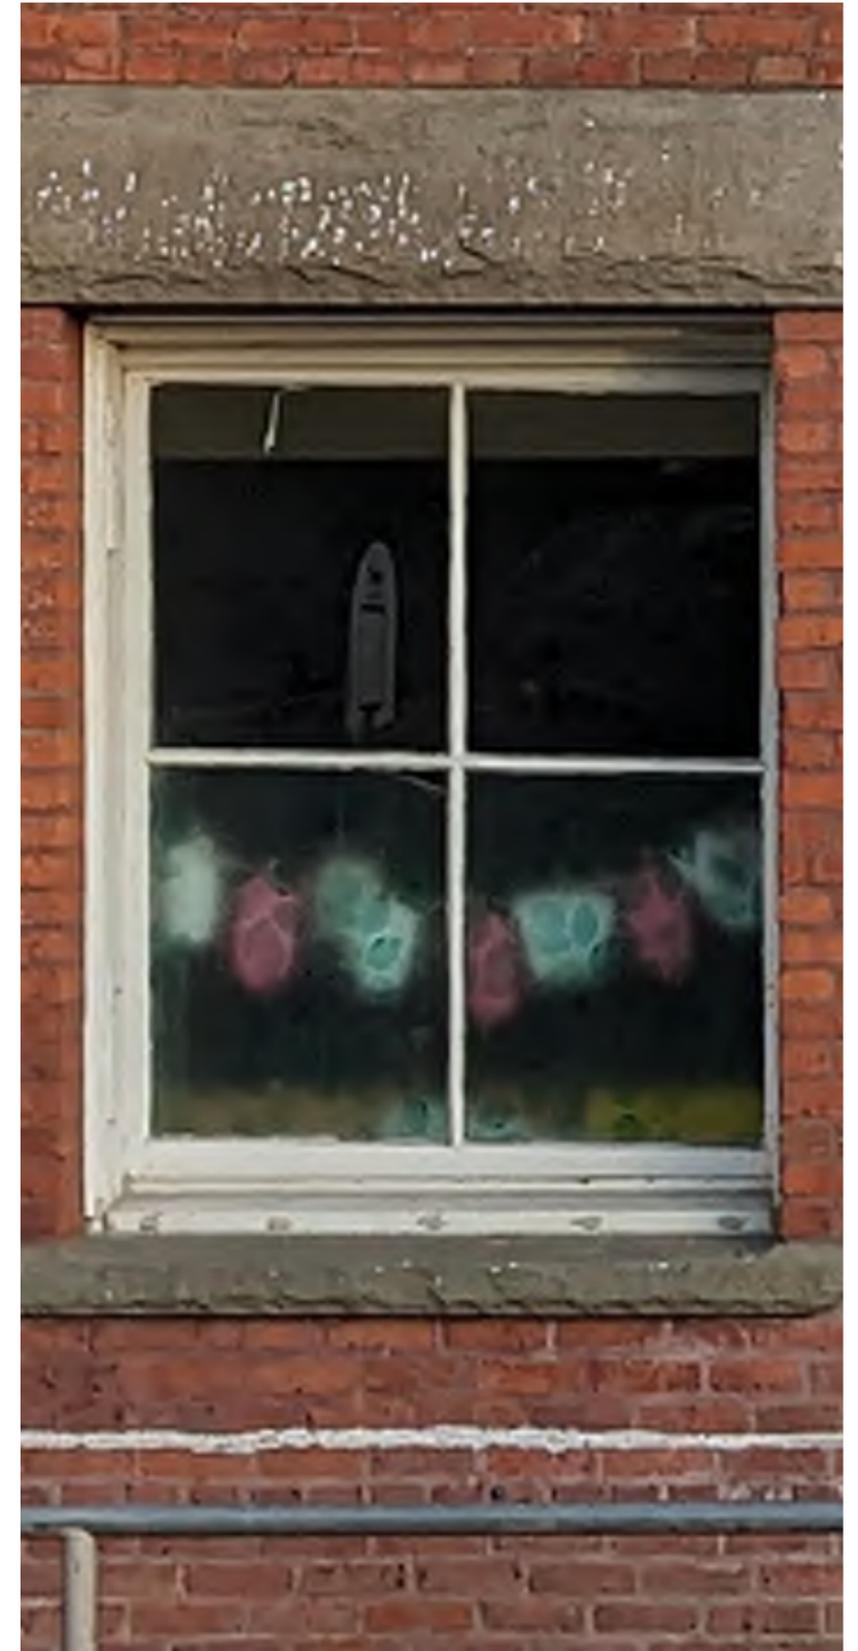
Window ID **GW.08** POOR CONDITION

Metal reinforcement at corners of sash

- Sash is misaligned in frame
- Metal sill cover

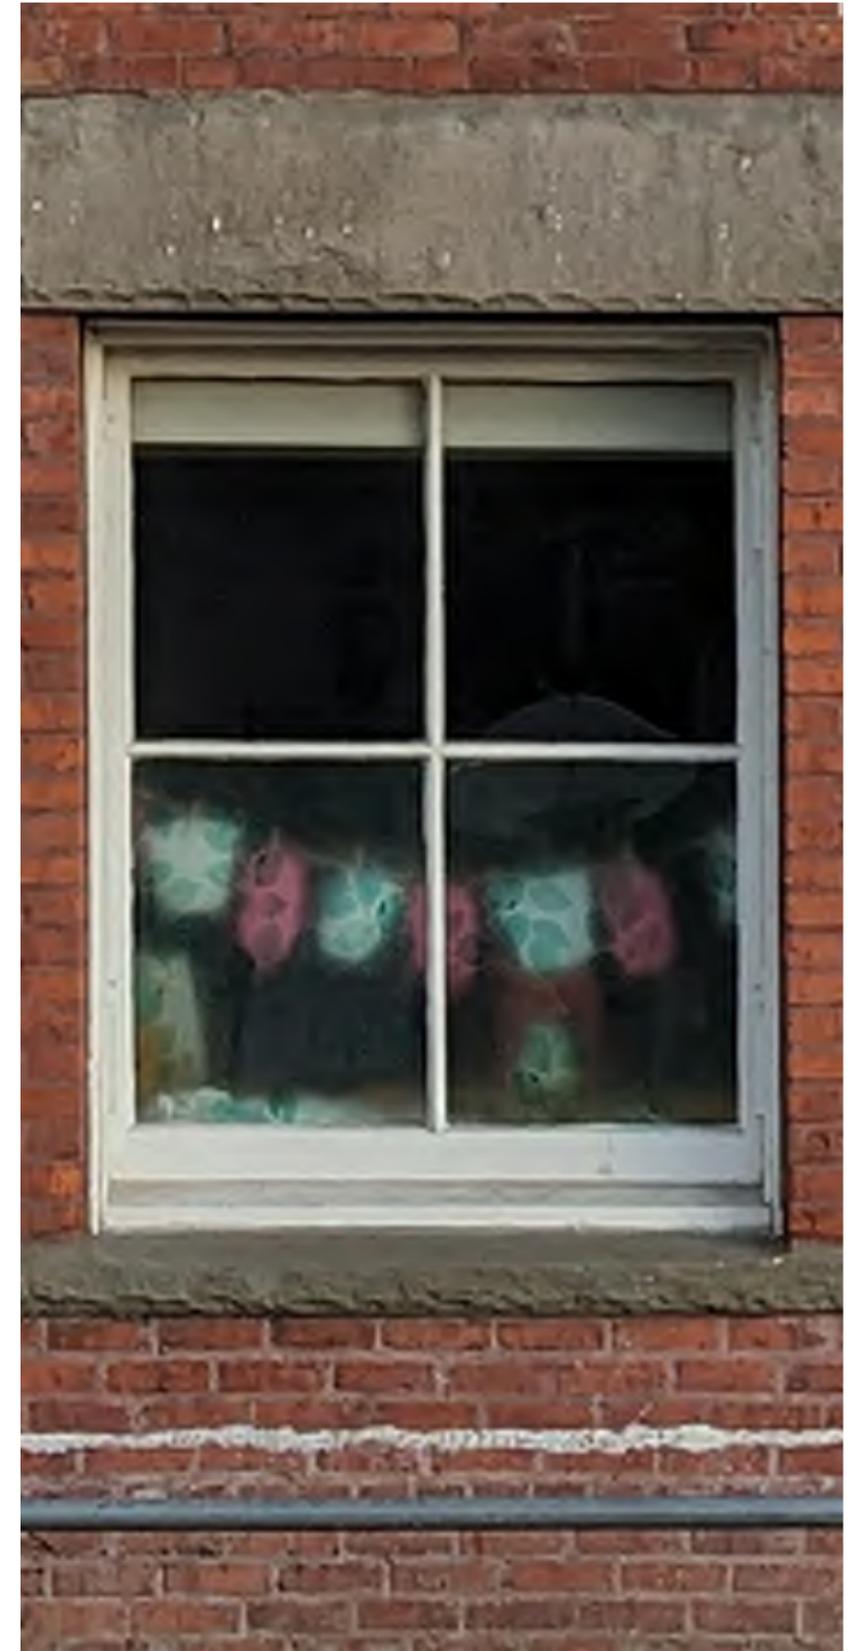
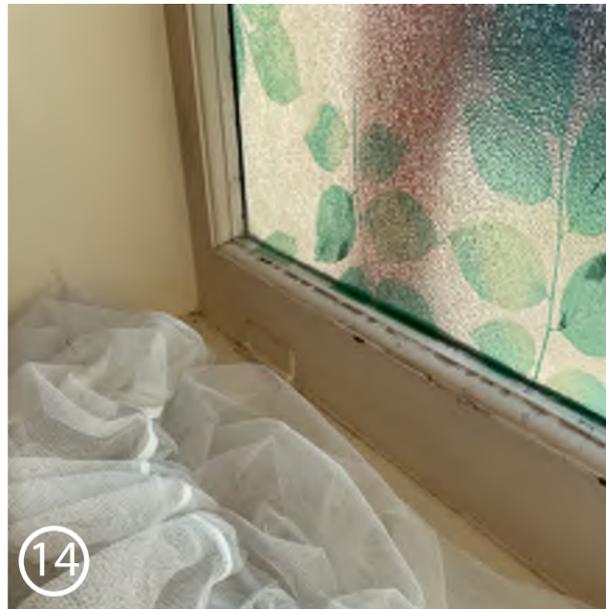
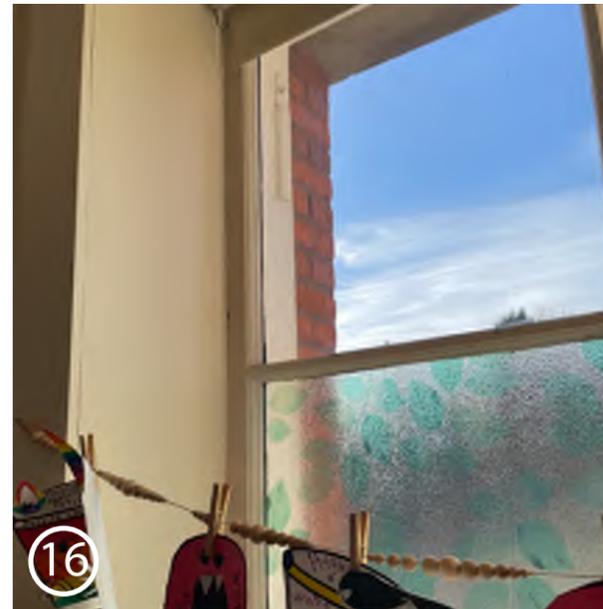
Window ID **GW.09** POOR CONDITION

● Non-original hinges

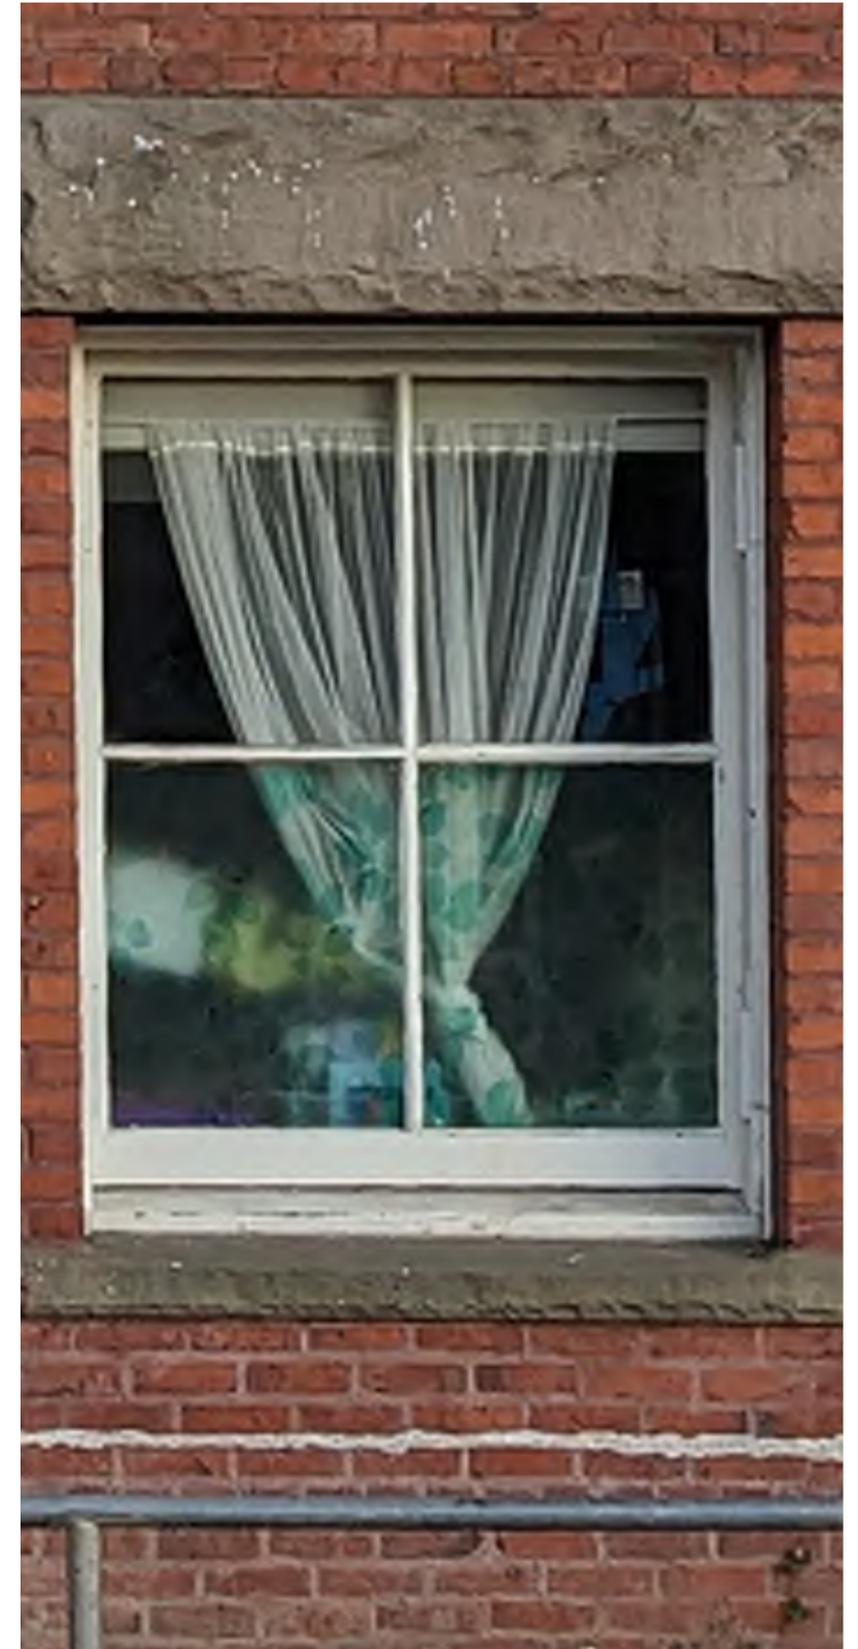
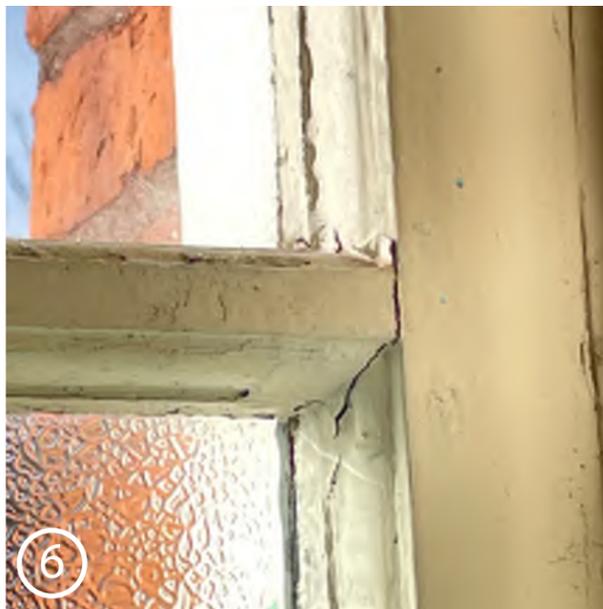
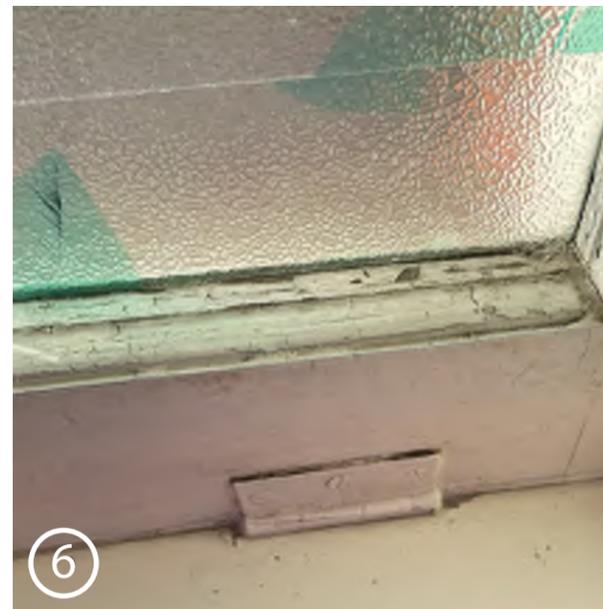
Window ID **GW.10** POOR CONDITION

● Non-original hinges

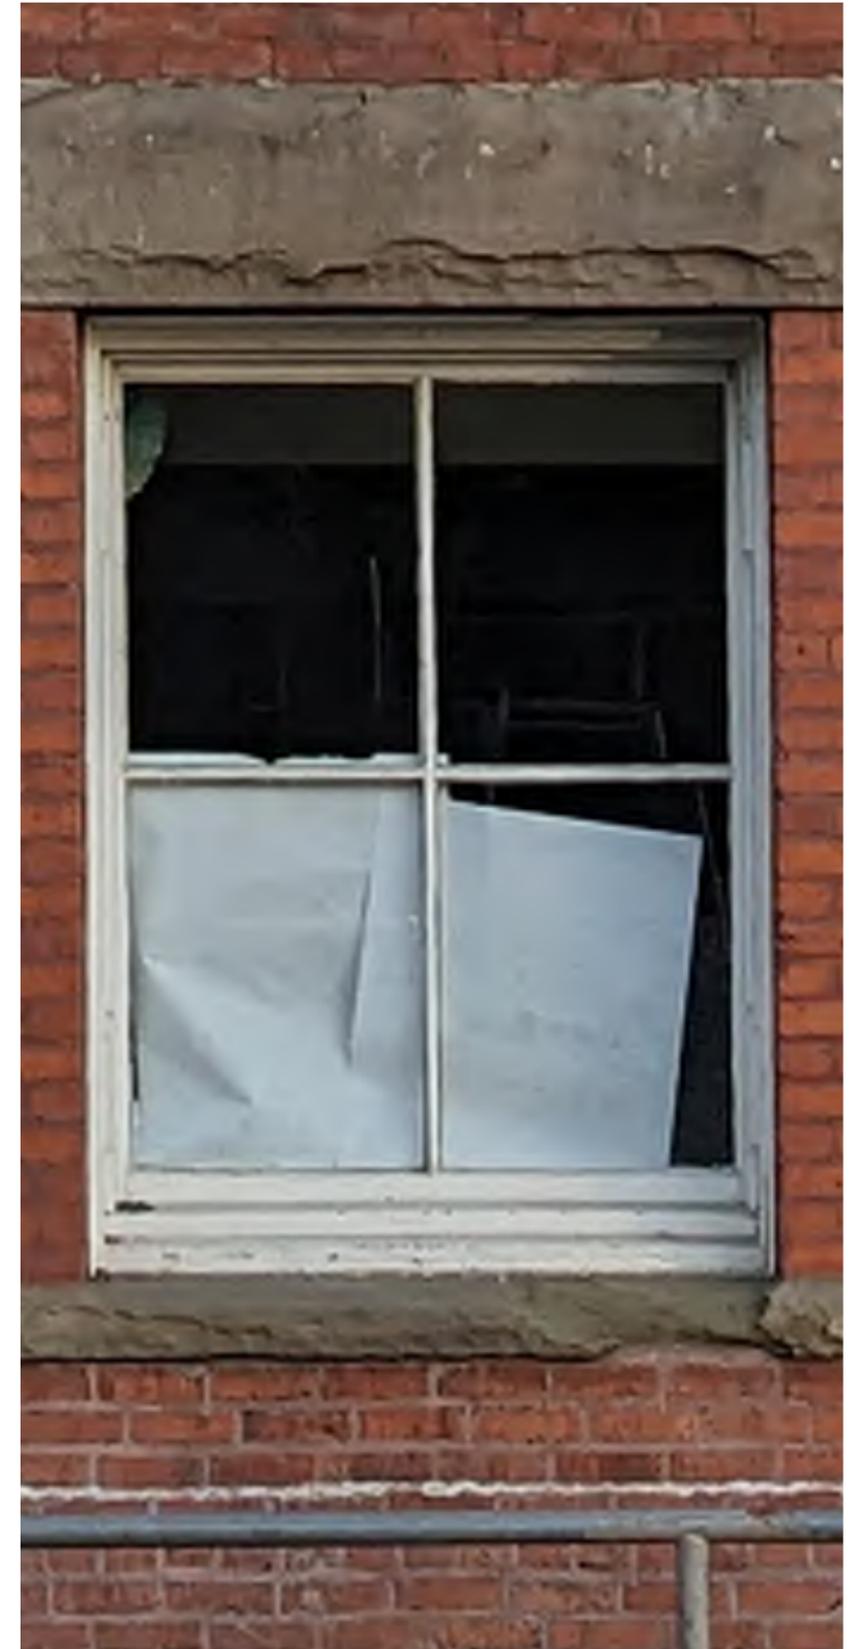
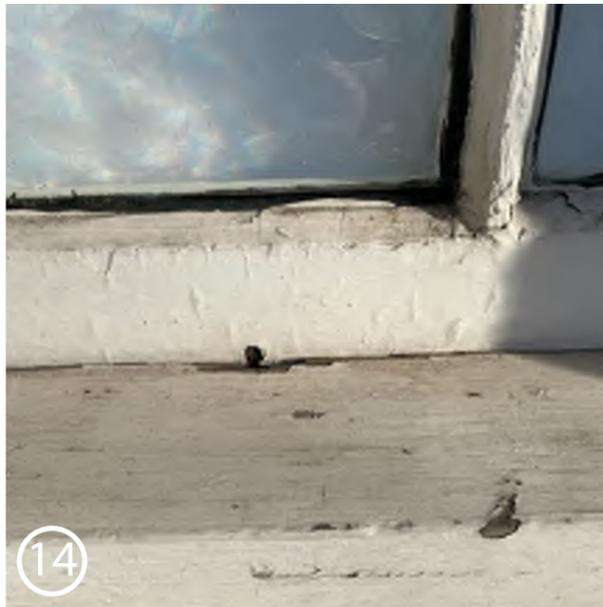
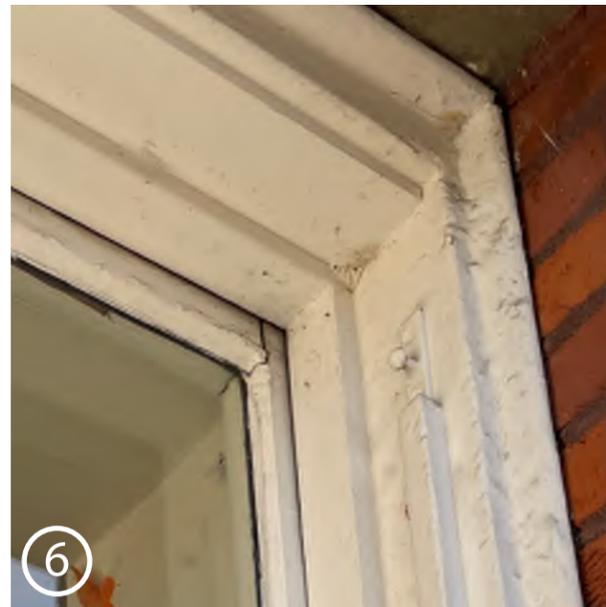
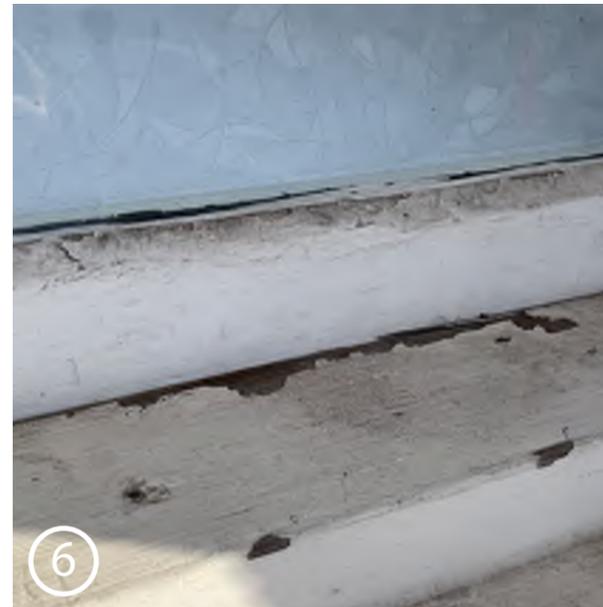
Window ID GW.12 POOR CONDITION

- Non-original hinges
- Stone sill is badly damaged

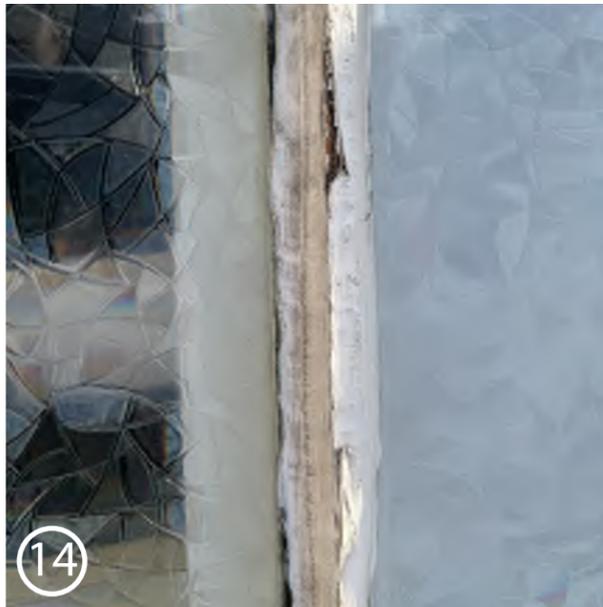
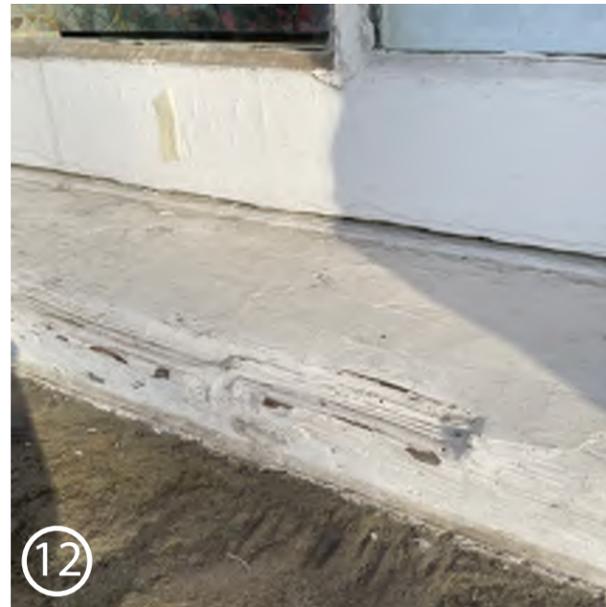
Window ID GW.13 POOR CONDITION

- Original hinges at bottom sash
- Stone sill is badly damaged

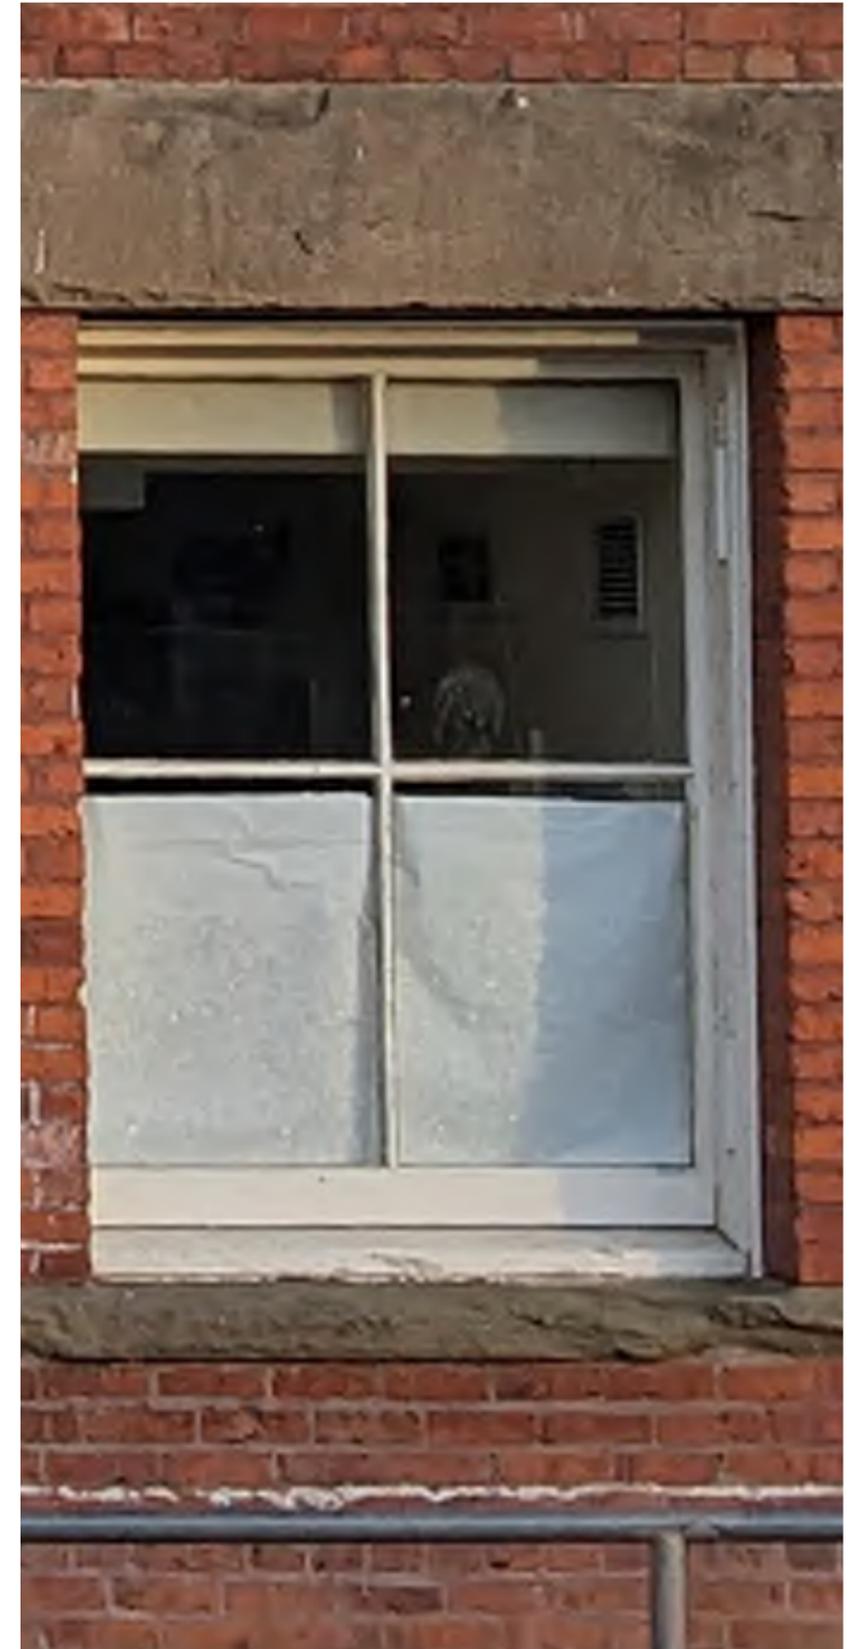
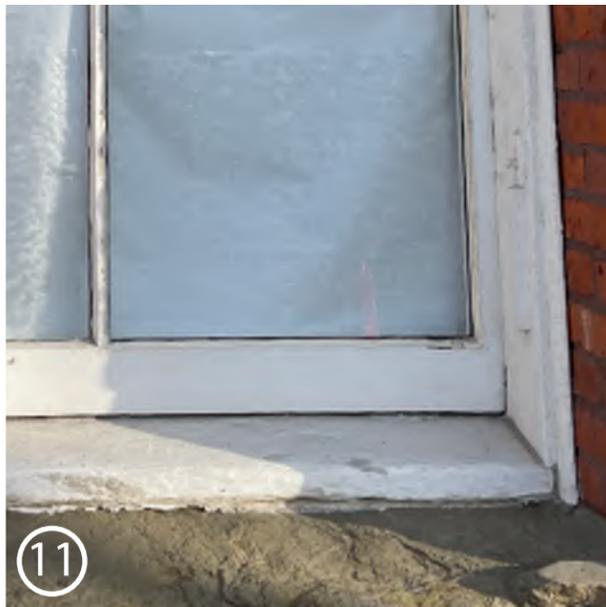
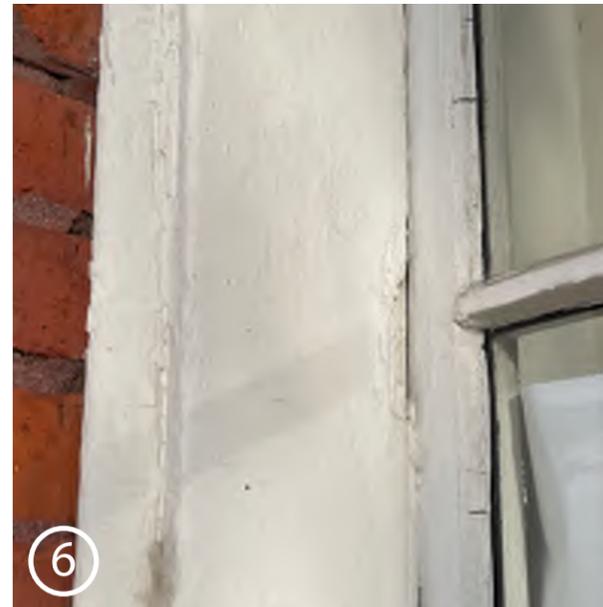
Window ID GW.15 OPENING NOT ASSESSED

Window and door assembly was previously replaced not in-kind. Opening not assessed.

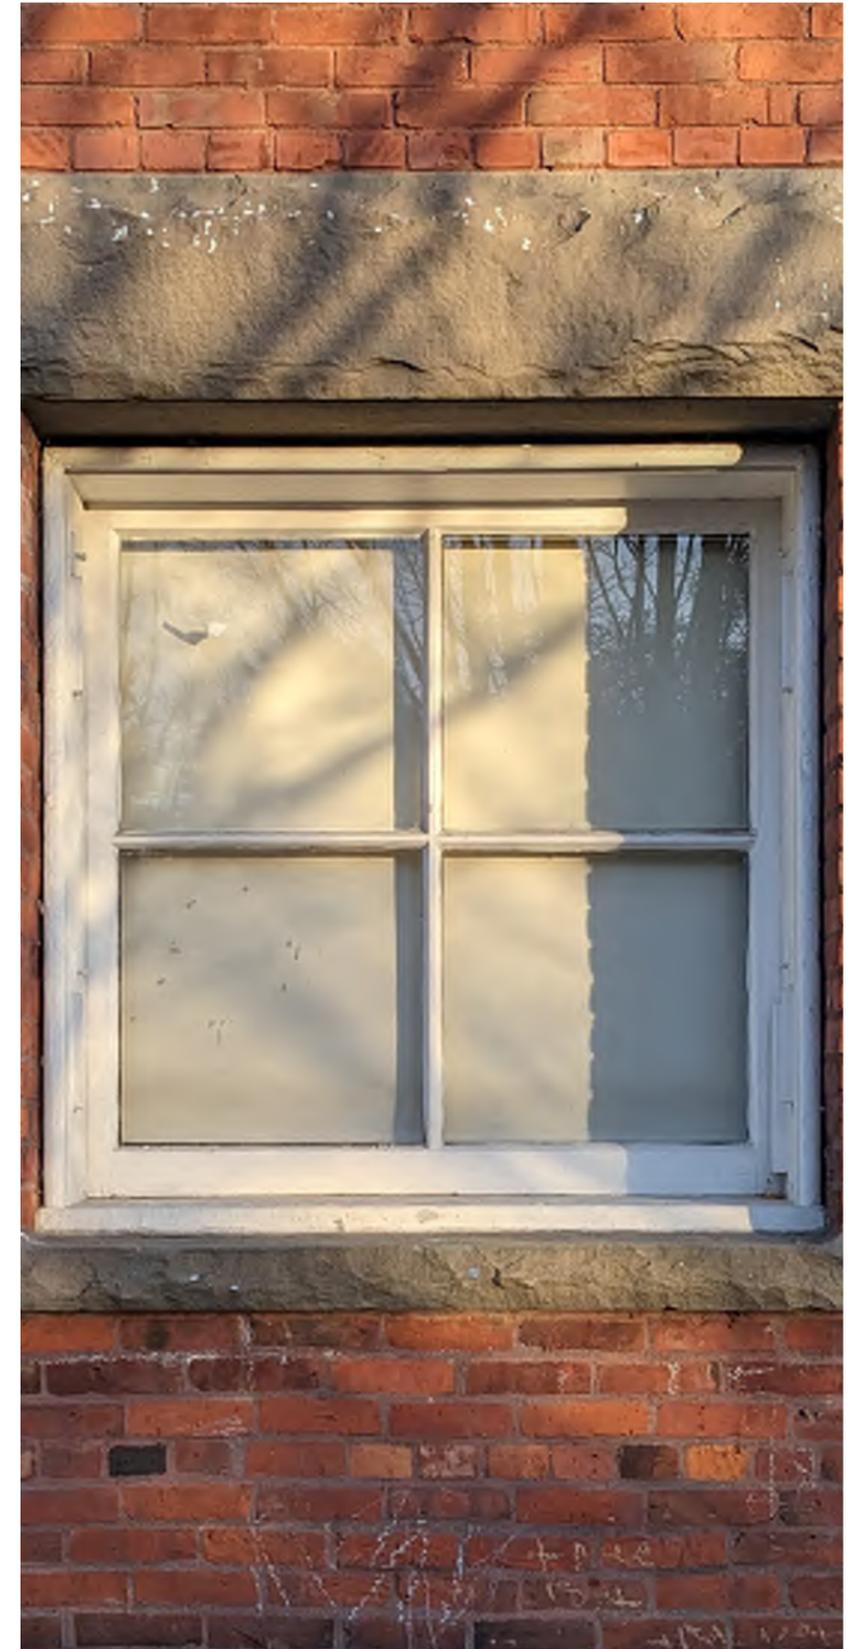
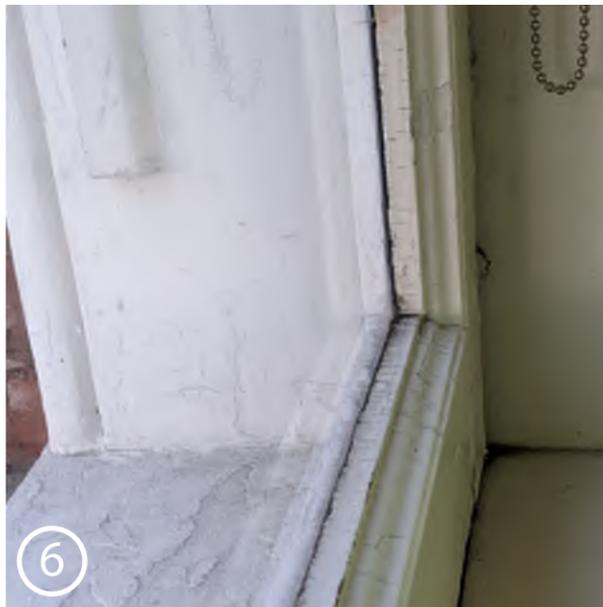
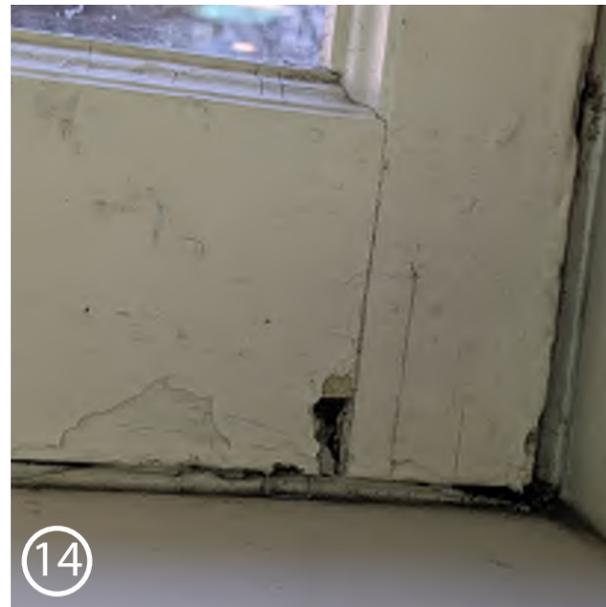
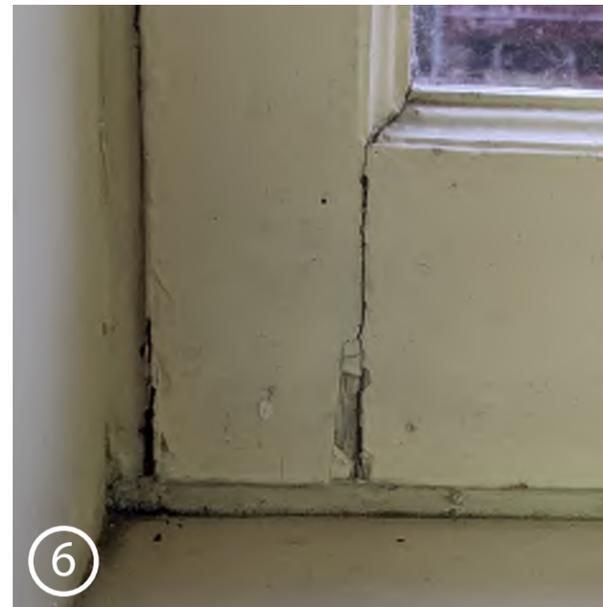
Window ID **GW.16** POOR CONDITION

- ① Sash Operation Difficult/Won't Open
- 2. Inoperable – Screwed Shut
- 3. Exterior Paint at Sash and Trim Cracked and Peeling at Limited Areas
- 4. Exterior Paint at Sash and Trim Heavily Deteriorated

- 5. Checked Sash/Muntin
- ⑥ Deteriorated Sash
- 7. Checked/Split Frame
- 8. Deteriorated Frame
- 9. Parting Bead Lightly Deteriorated
- 10. Parting Bead Missing or Heavily Deteriorated

- ⑭ Section Loss
- 15. Missing Window Stop
- 16. Sealant Deteriorated
- 17. Weatherstrip Deteriorated/Missing
- 18. Deteriorated Glazing Compound/Setting Bead/Glazing Putty

- 19. Sash Pull Hardware Missing
- 20. Sash Lock Damaged/Missing/Not Engaging/No Lock
- 21. Retrofitted Window Limiter
- ⑳ Leaking or Visible Gap to Exterior When Closed
