Window Condition Assessment for B.F. Day Elementary School

on behalf of Seattle Public Schools

July 16, 2024

Miller Hayashi Architects PLLC

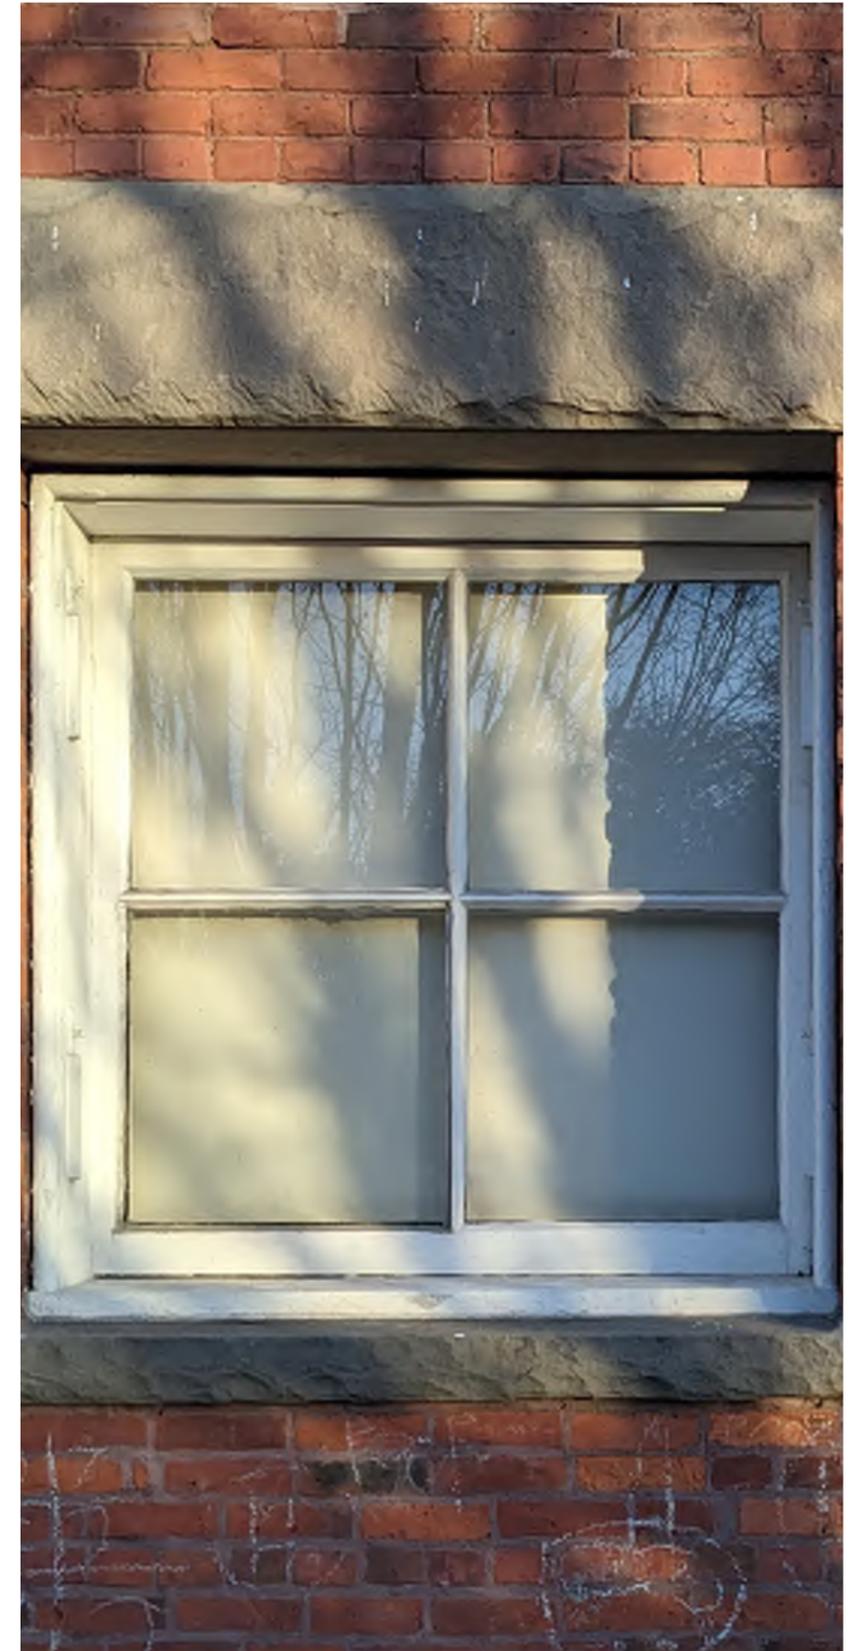
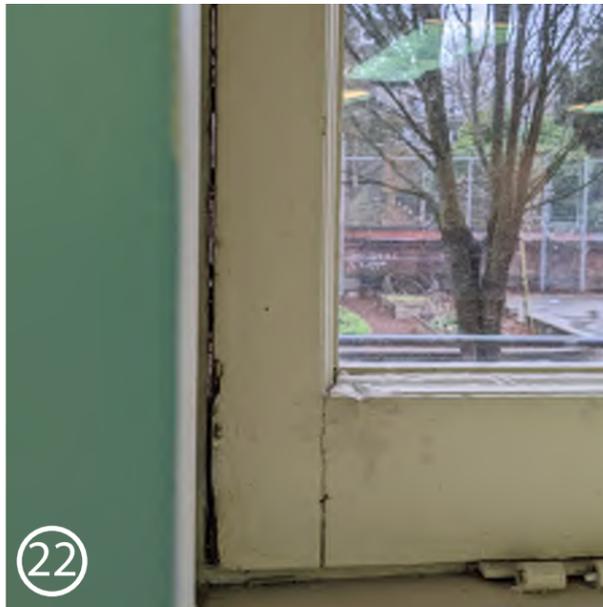
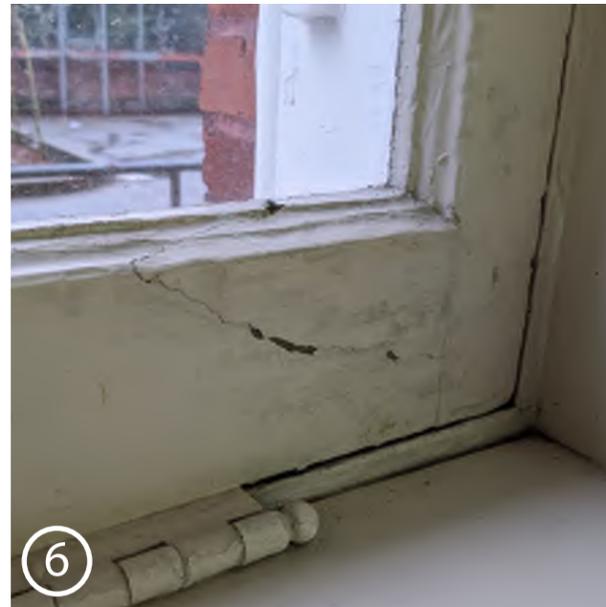
Window ID GW.17 POOR CONDITION

19. Sash Pull Hardware Missing **Hinge is partially missing**
20. Sash Lock Damaged/Missing/Not Engaging/No Lock
21. Retrofitted Window Limiter
22. Leaking or Visible Gap to Exterior When Closed

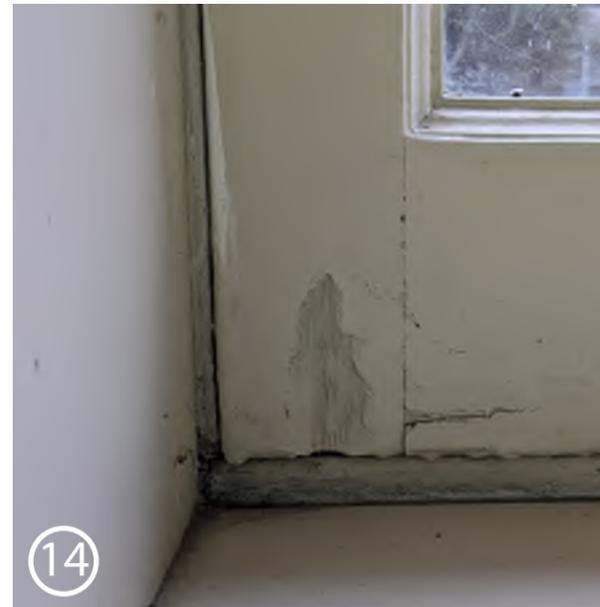
Window ID GW.18 POOR CONDITION

1. Sash Operation Difficult/Won't Open
- ② Inoperable – Screwed Shut **Painted shut**
3. Exterior Paint at Sash and Trim Cracked and Peeling at Limited Areas

4. Exterior Paint at Sash and Trim Heavily Deteriorated
5. Checked Sash/Muntin
- ⑥ Deteriorated Sash
7. Checked/Split Frame
8. Deteriorated Frame
9. Parting Bead Lightly Deteriorated

10. Parting Bead Missing or Heavily Deteriorated
- ⑪ Sill 20% or Less Deteriorated
12. Sill Heavily Deteriorated, Wood Consolidation Necessary for More Than 20% of the Sill

13. Reinforced Sash (non-original)
- ⑭ Section Loss
15. Missing Window Stop
16. Sealant Deteriorated
17. Weatherstrip Deteriorated/Missing
18. Deteriorated Glazing Compound/Setting Bead/Glazing Putty

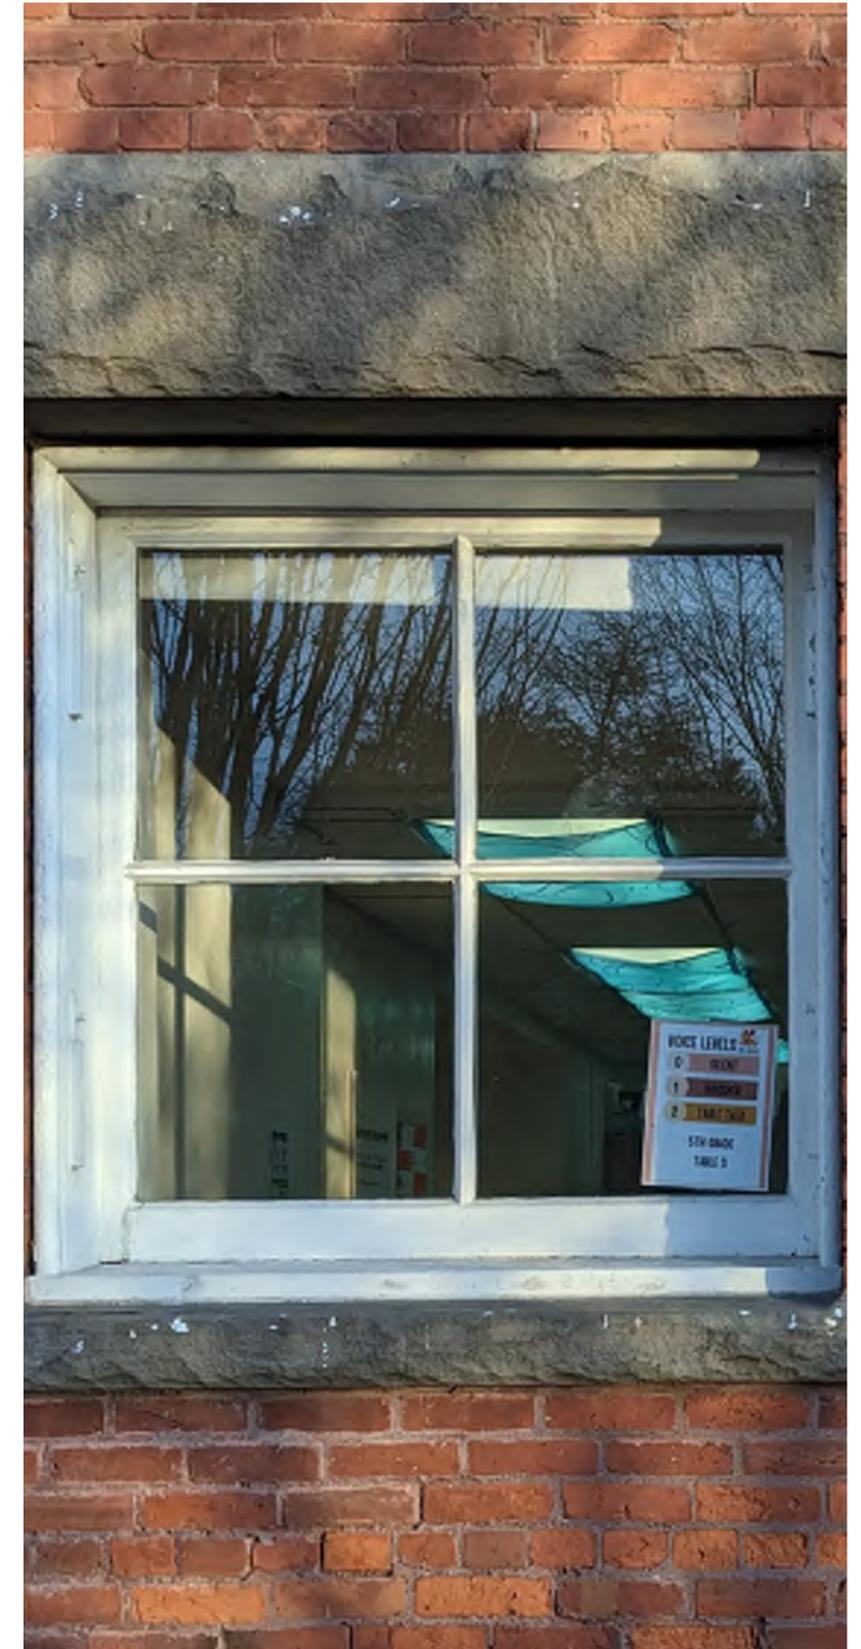
Window ID GW.20 POOR CONDITION

19. Sash Pull Hardware Missing
- ⑳ Sash Lock Damaged/Missing/Not Engaging/No Lock
21. Retrofitted Window Limiter
- ⑳ Leaking or Visible Gap to Exterior When Closed

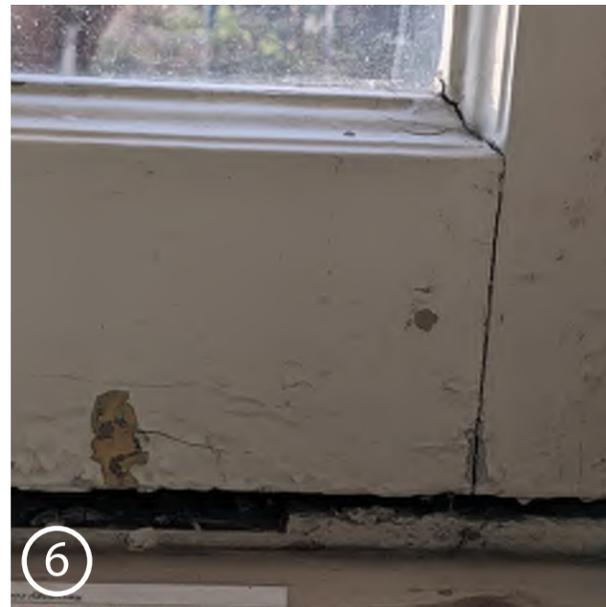
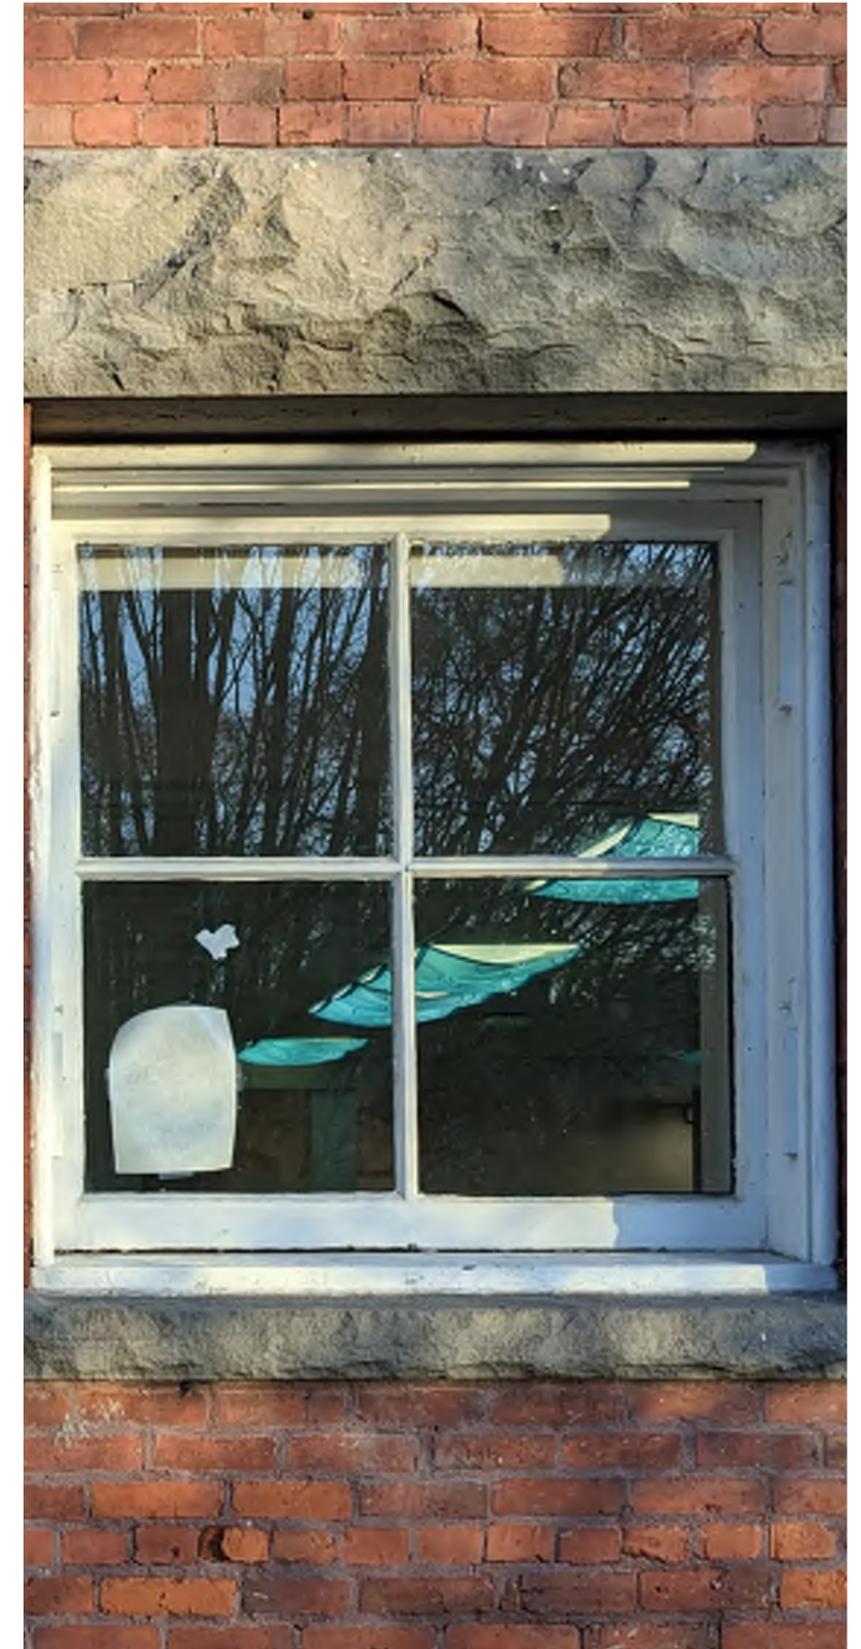
1. Sash Operation Difficult/Won't Open
- ② Inoperable – Screwed Shut
3. Exterior Paint at Sash and Trim Cracked and Peeling at Limited Areas
4. Exterior Paint at Sash and Trim Heavily Deteriorated

5. Checked Sash/Muntin
- ⑥ Deteriorated Sash
7. Checked/Split Frame
8. Deteriorated Frame
9. Parting Bead Lightly Deteriorated
10. Parting Bead Missing or Heavily Deteriorated

11. Sill 20% or Less Deteriorated
- ⑫ Sill Heavily Deteriorated, Wood Consolidation Necessary for More Than 20% of the Sill
13. Reinforced Sash (non-original)

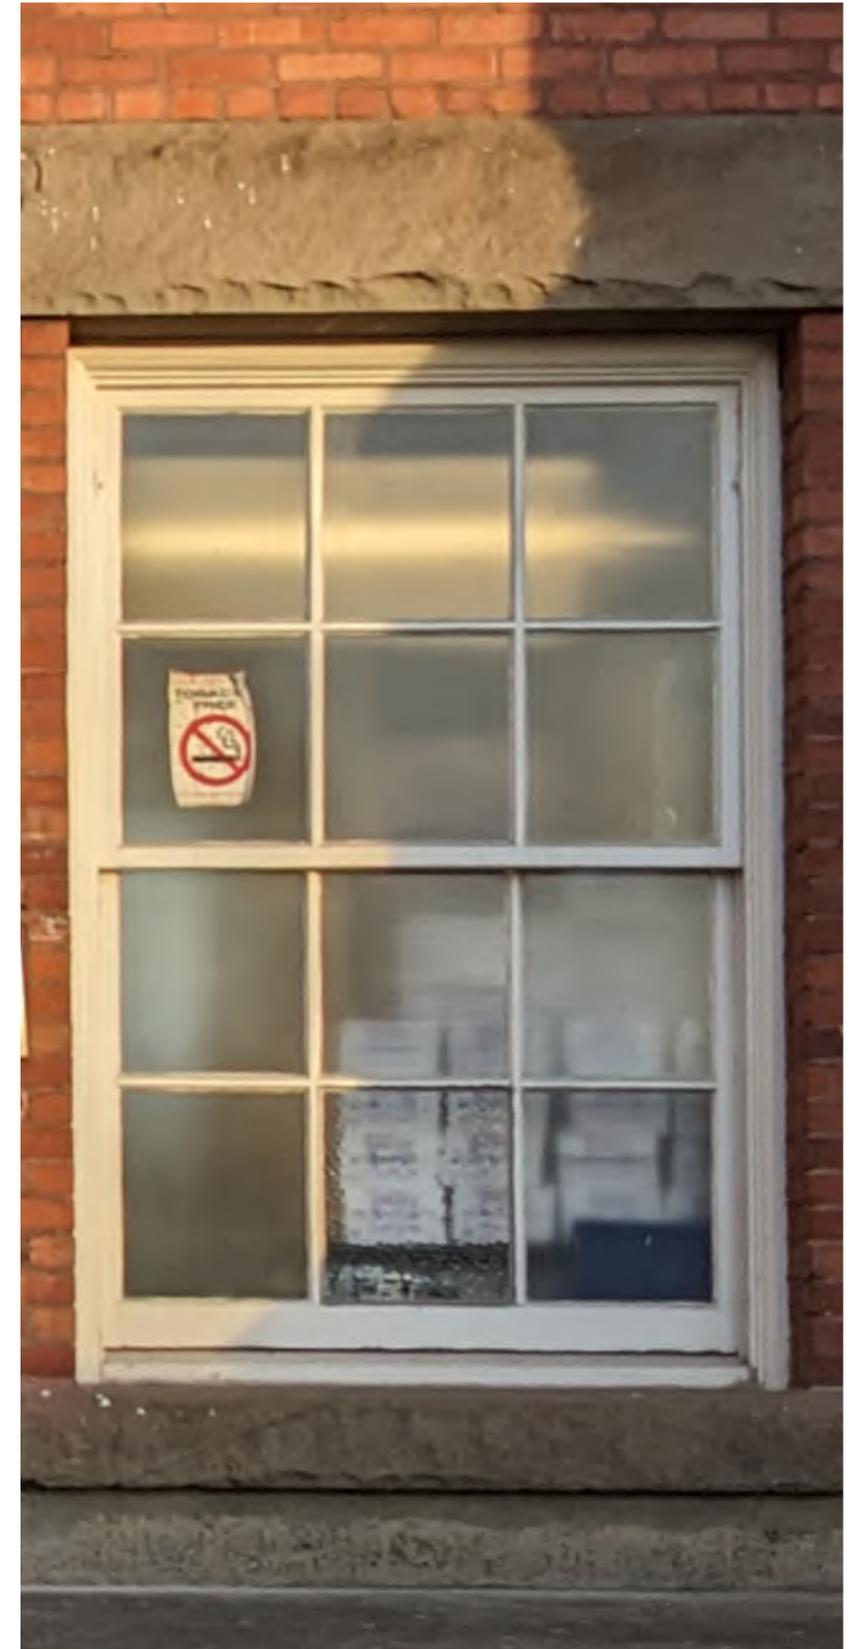
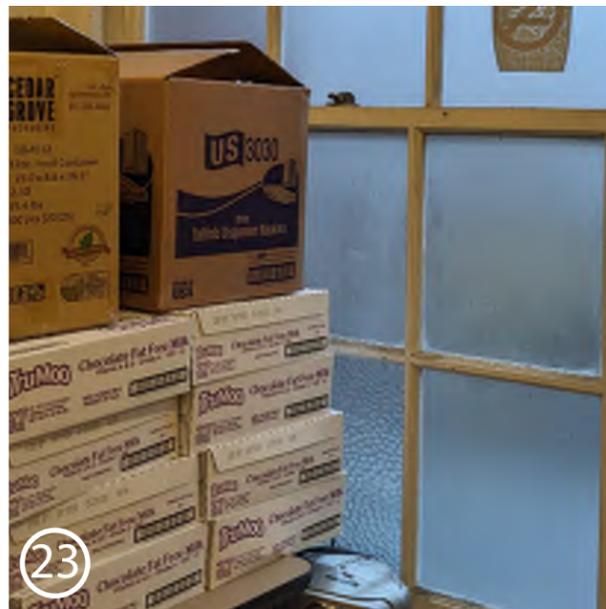
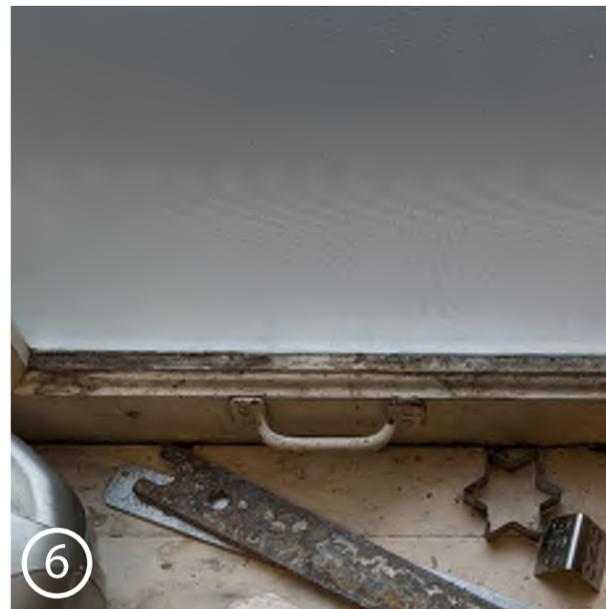
Window ID **GW.23** MODERATE CONDITION

● Screw holes in sash and frame

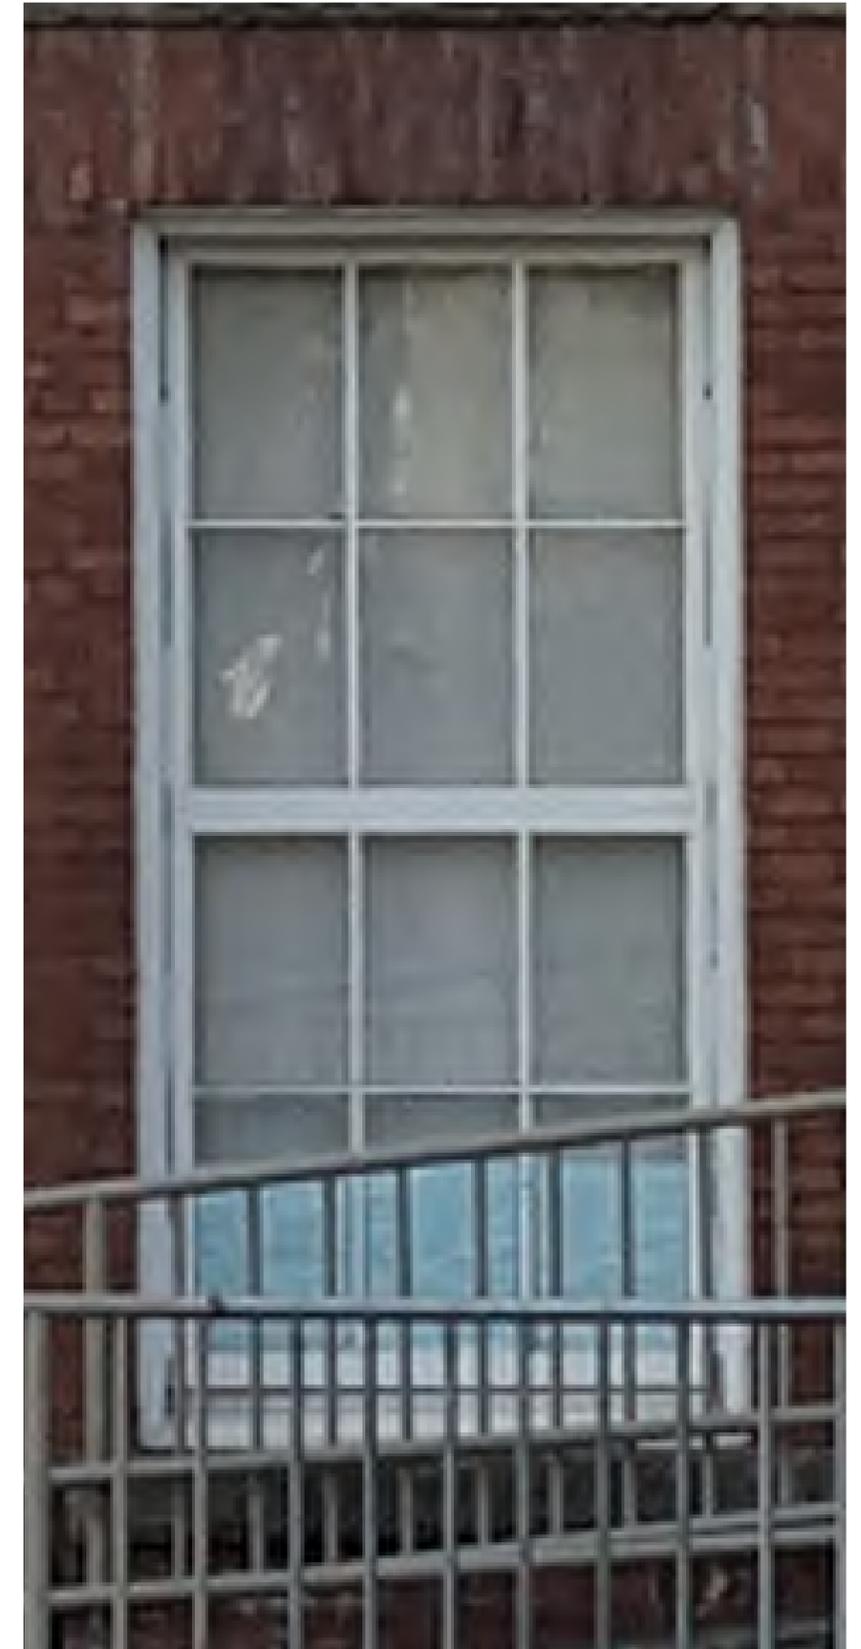
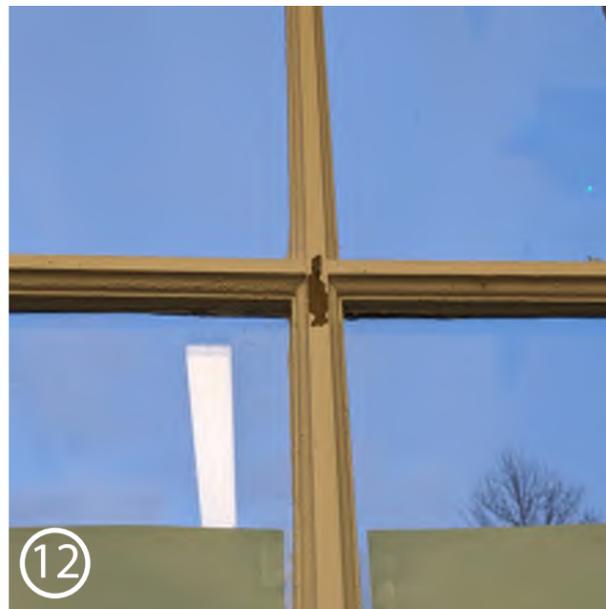
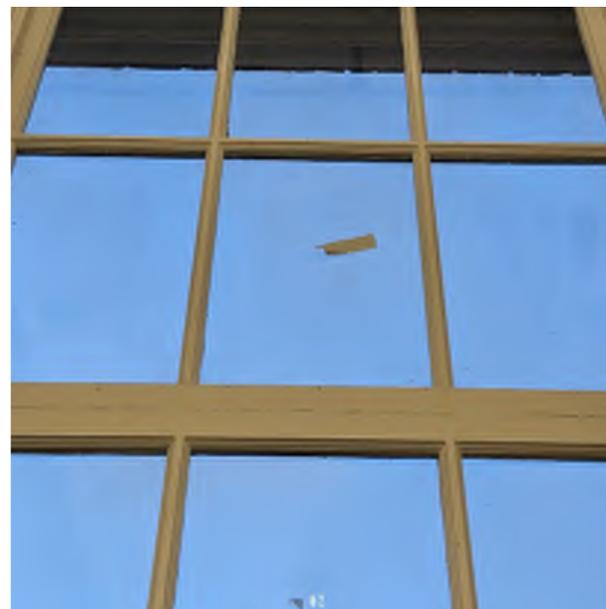
Window ID **GE.04** POOR CONDITION

- ① Sash Operation Difficult/Won't Open
- 2. Inoperable – Screwed Shut
- 3. Exterior Paint at Sash and Trim Cracked and Peeling at Limited Areas
- 4. Exterior Paint at Sash and Trim Heavily Deteriorated

- 5. Checked Sash/Muntin
- ⑥ Deteriorated Sash
- 7. Checked/Split Frame
- 8. Deteriorated Frame
- 9. Parting Bead Lightly Deteriorated
- 10. Parting Bead Missing or Heavily Deteriorated

- ⑭ Section Loss
- 15. Missing Window Stop
- 16. Sealant Deteriorated
- 17. Weatherstrip Deteriorated/Missing
- 18. Deteriorated Glazing Compound/Setting Bead/Glazing Putty

- ⑲ Sash Pull Hardware Missing
- 20. Sash Lock Damaged/Missing/Not Engaging/No Lock
- 21. Retrofitted Window Limiter
- ⑳ Leaking or Visible Gap to Exterior When Closed

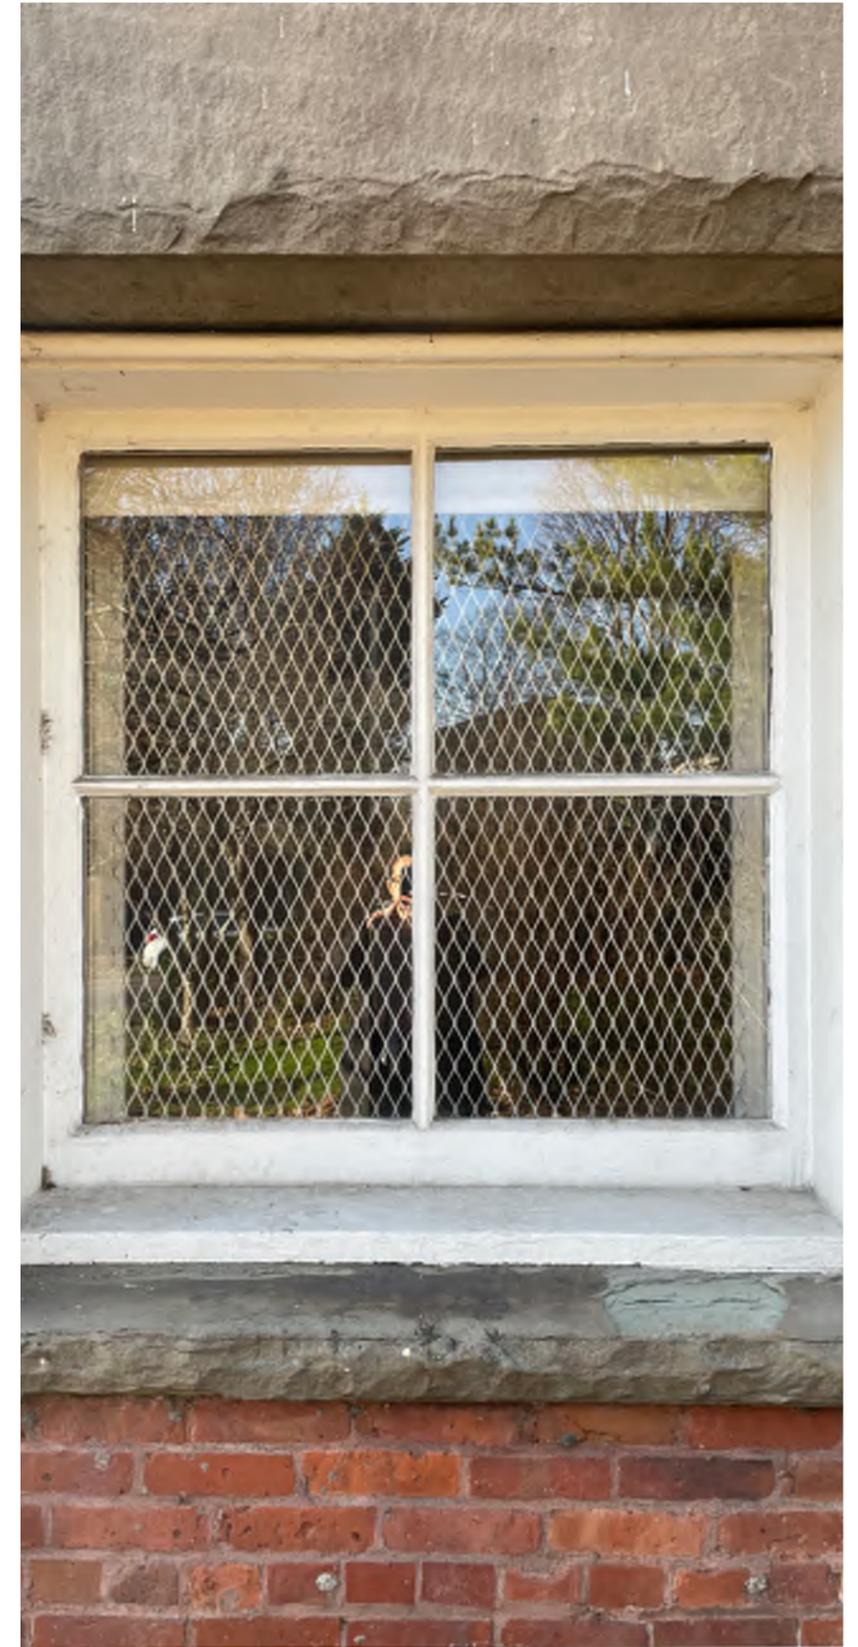
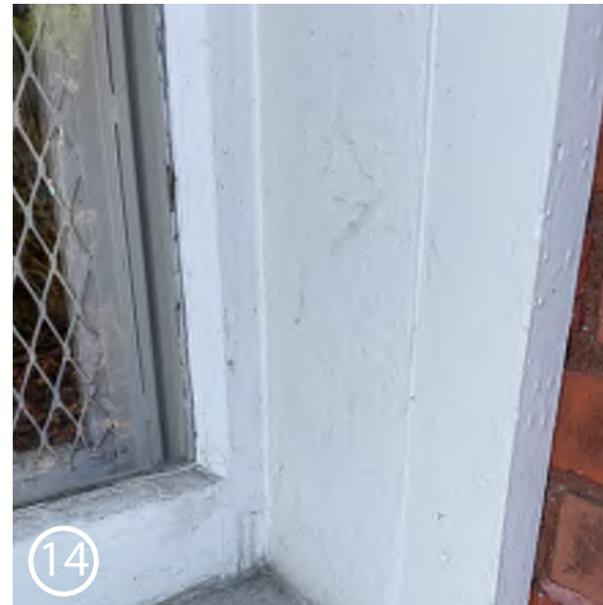
Window ID **GE.06** MODERATE CONDITION

- Stone sill is badly damaged
- Hinged interior security grate, typical at Gym

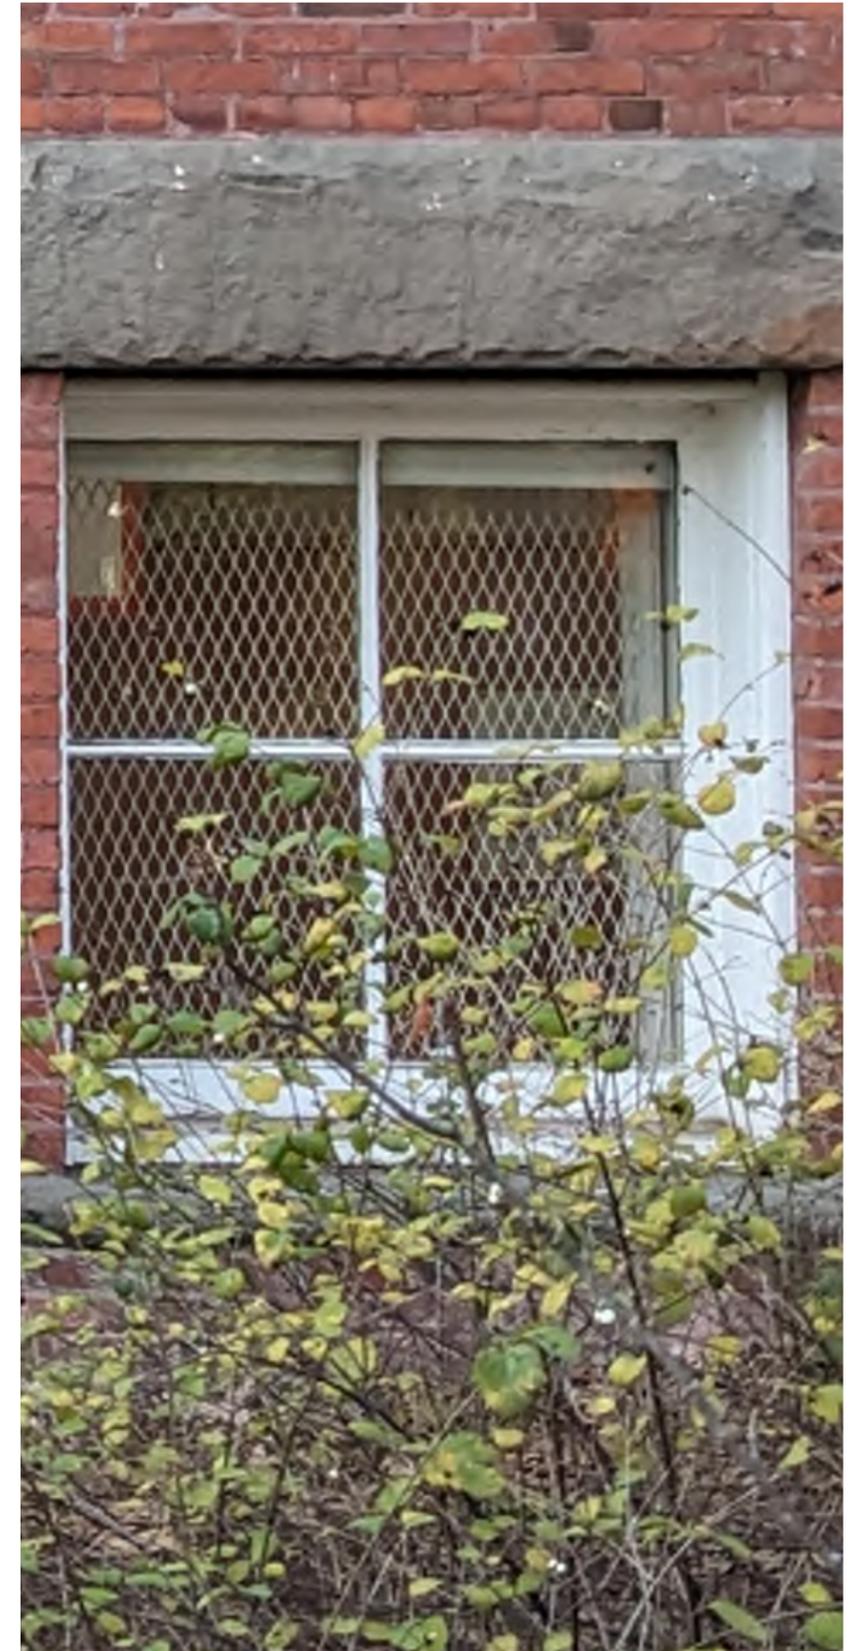
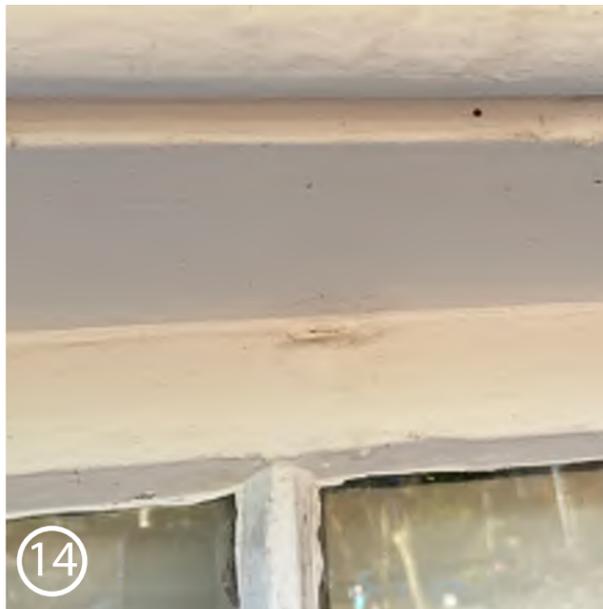
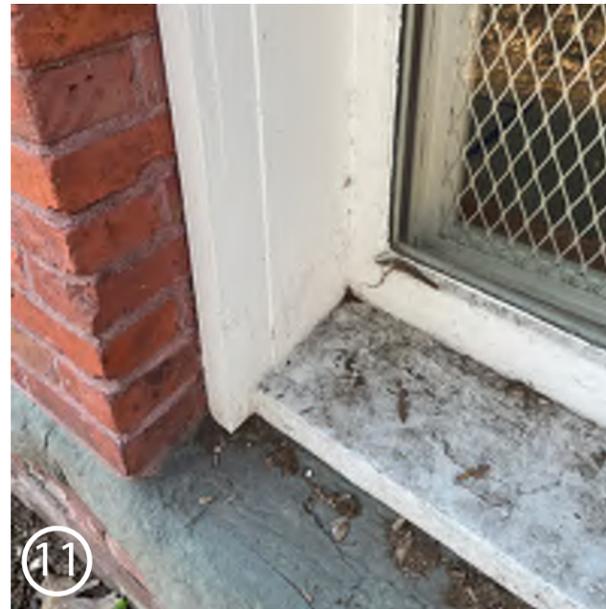
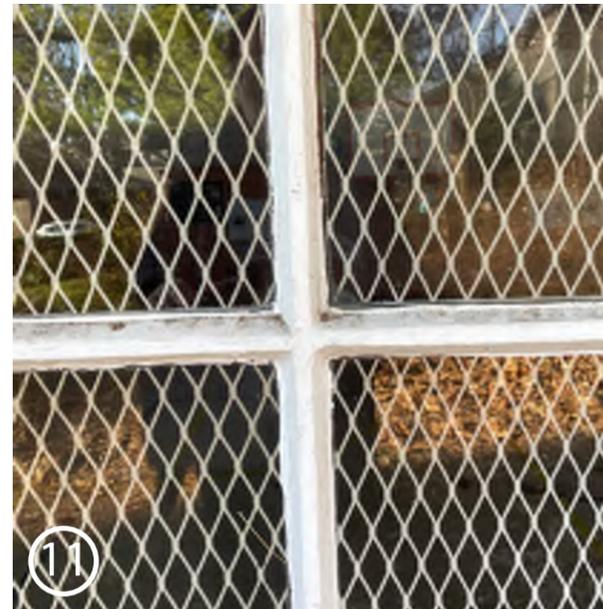
Window ID **GE.09** POOR CONDITION

- ① Sash Operation Difficult/Won't Open
- 2. Inoperable – Screwed Shut
- 3. Exterior Paint at Sash and Trim Cracked and Peeling at Limited Areas
- 4. Exterior Paint at Sash and Trim Heavily Deteriorated

- 5. Checked Sash/Muntin
- ⑥ Deteriorated Sash
- 7. Checked/Split Frame
- 8. Deteriorated Frame
- 9. Parting Bead Lightly Deteriorated
- 10. Parting Bead Missing or Heavily Deteriorated

- ⑪ Sill 20% or Less Deteriorated
- 12. Sill Heavily Deteriorated, Wood Consolidation Necessary for More Than 20% of the Sill
- 13. Reinforced Sash (non-original)

- ⑭ Section Loss
- 15. Missing Window Stop
- 16. Sealant Deteriorated
- 17. Weatherstrip Deteriorated/Missing
- 18. Deteriorated Glazing Compound/Setting Bead/Glazing Putty

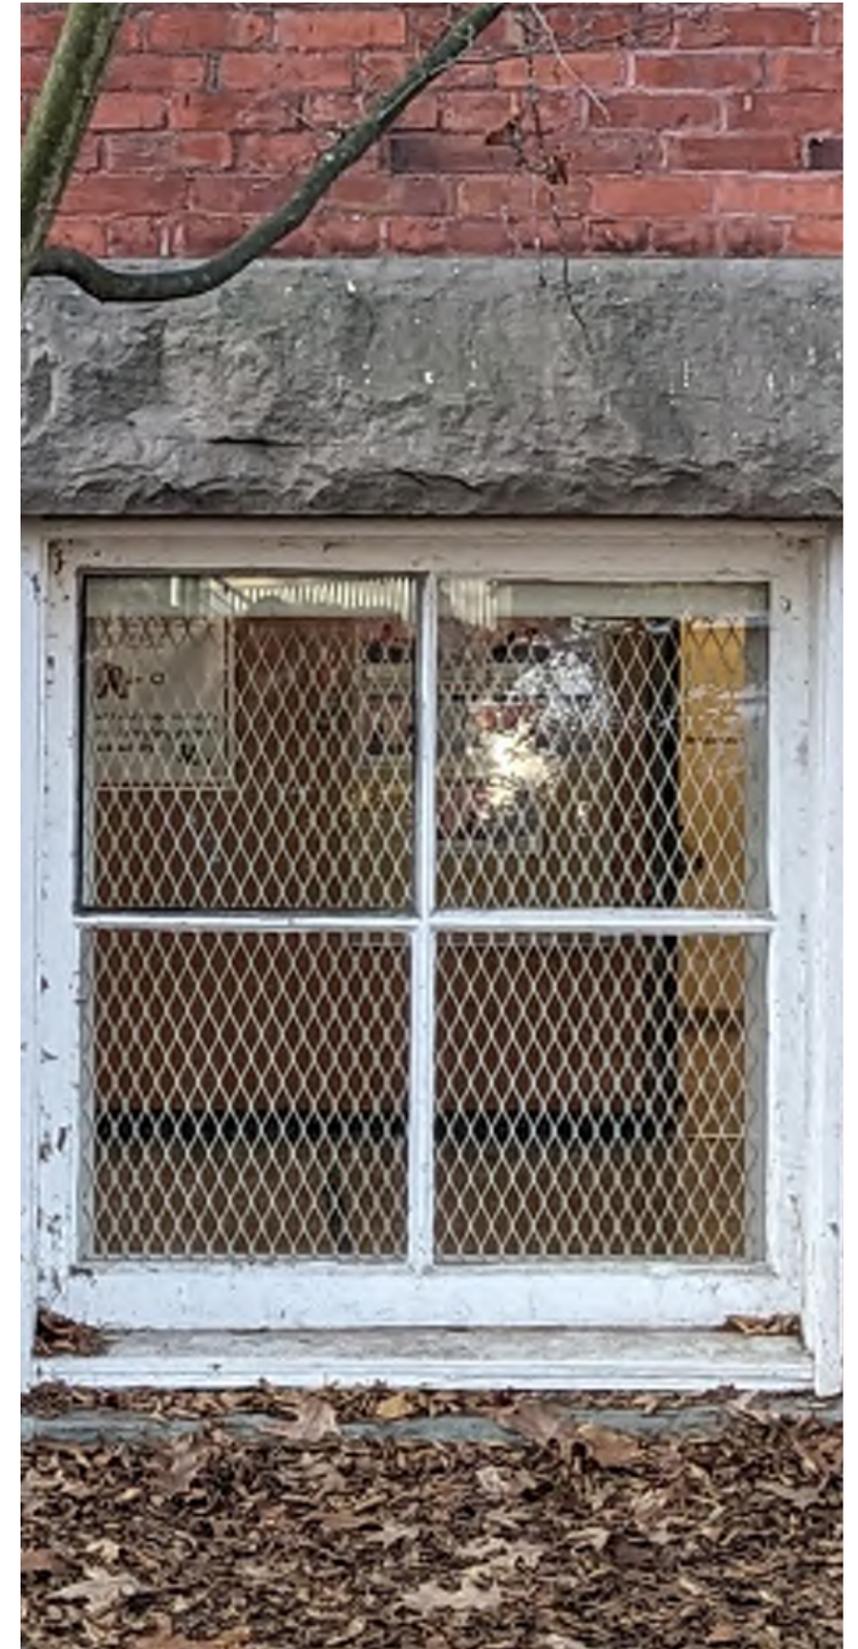
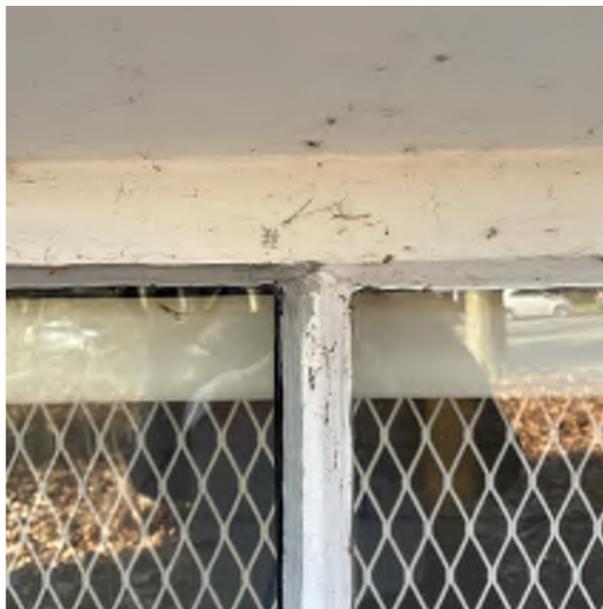
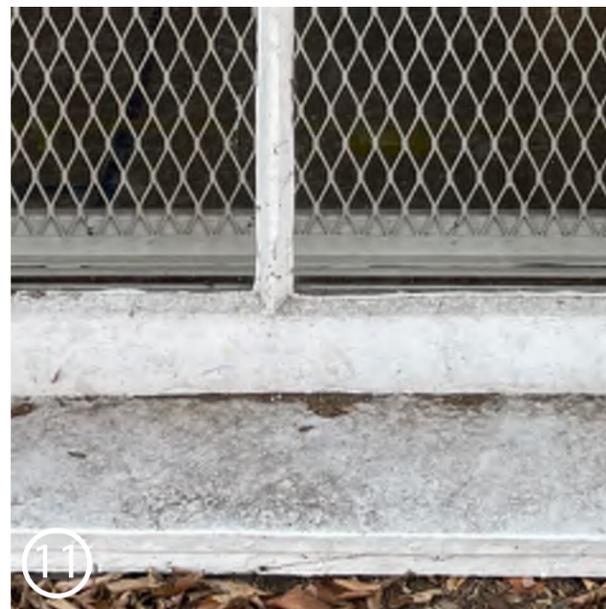
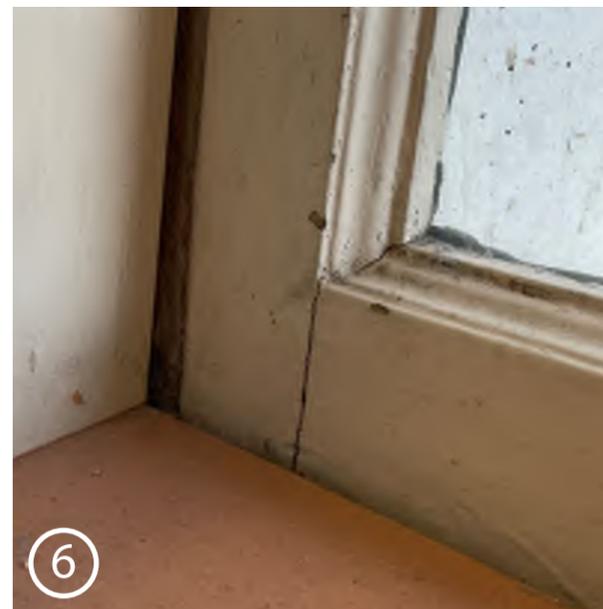
Window ID **GE.12** POOR CONDITION

● Metal sill cover

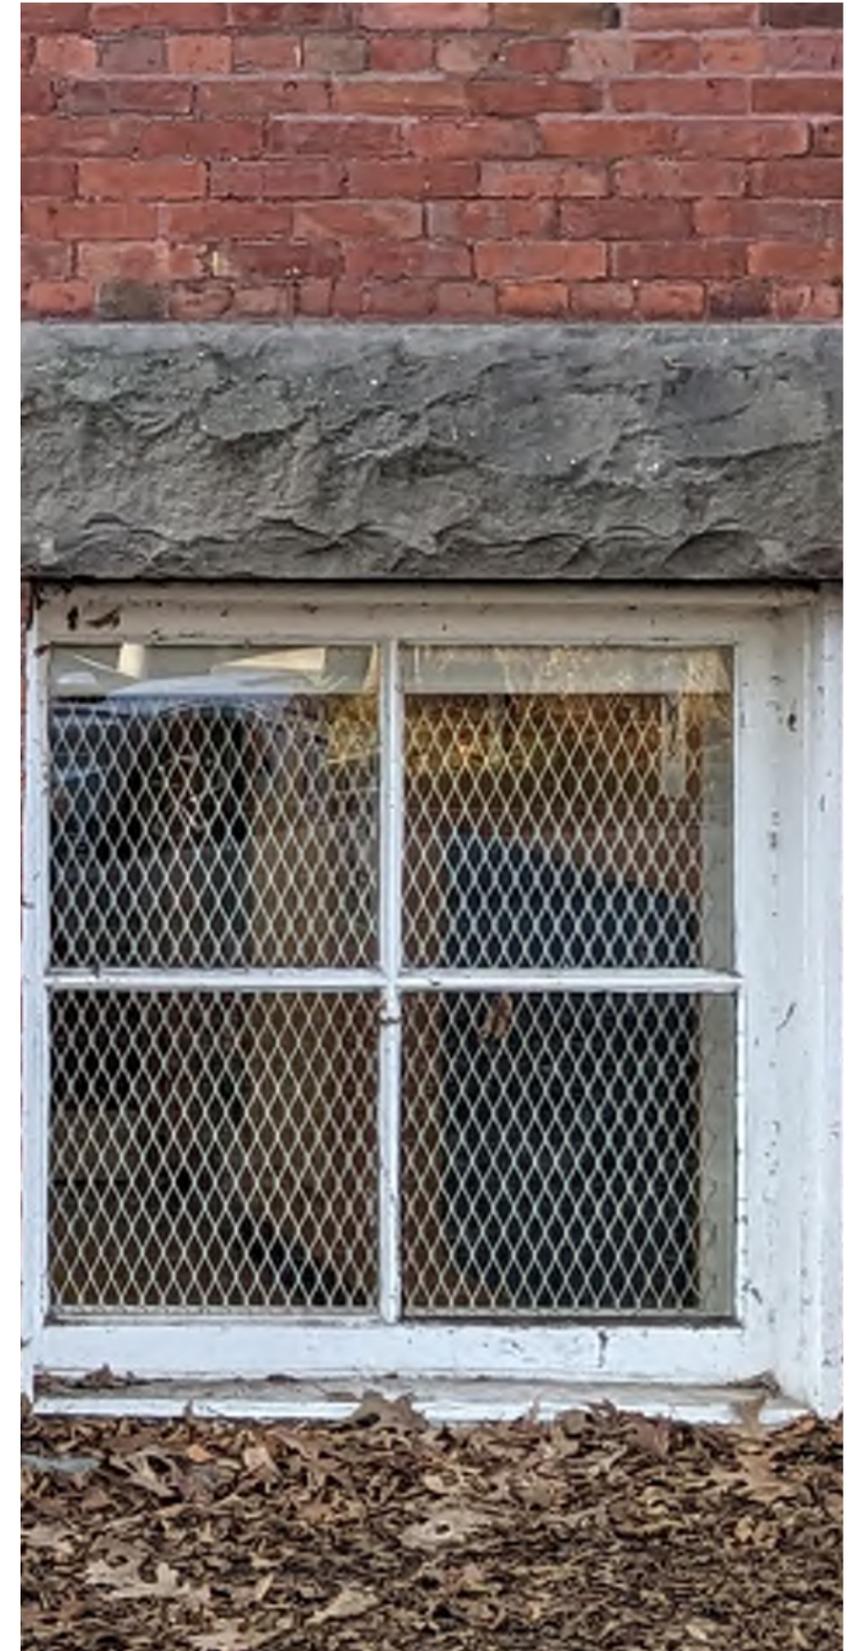
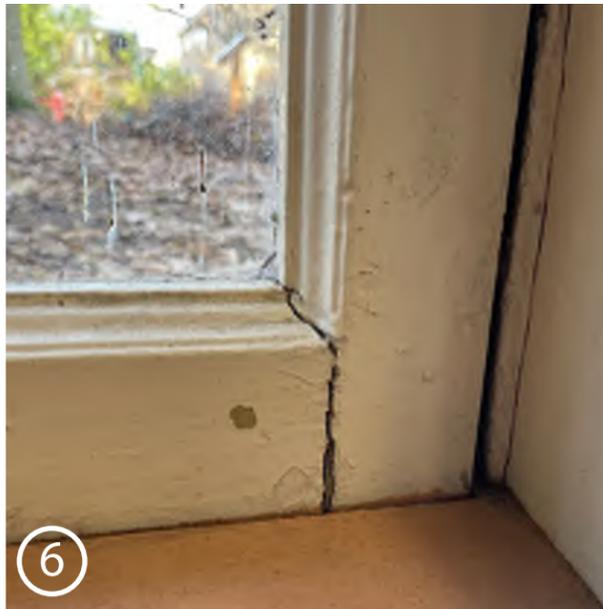
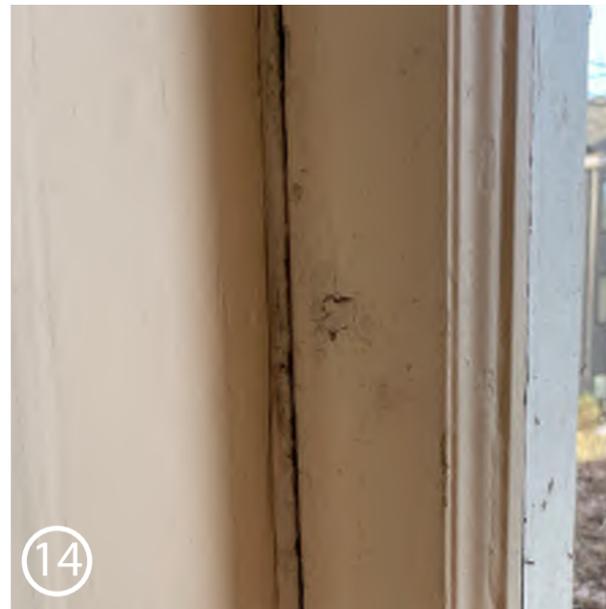
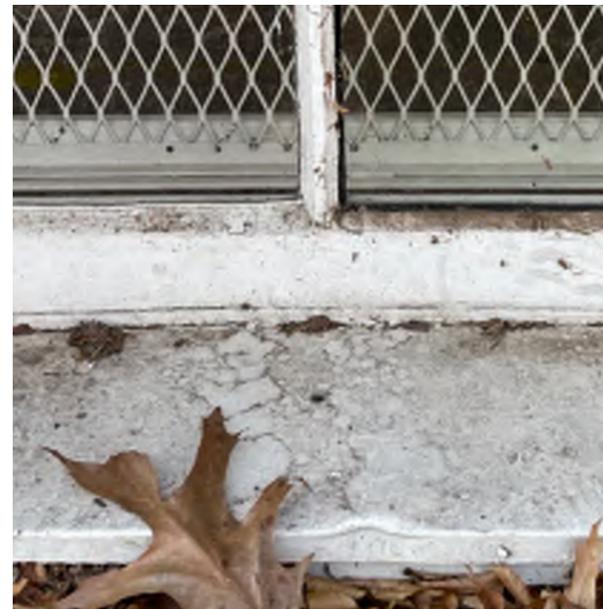
Window ID GE.13 INACCESSIBLE

● Metal sill cover

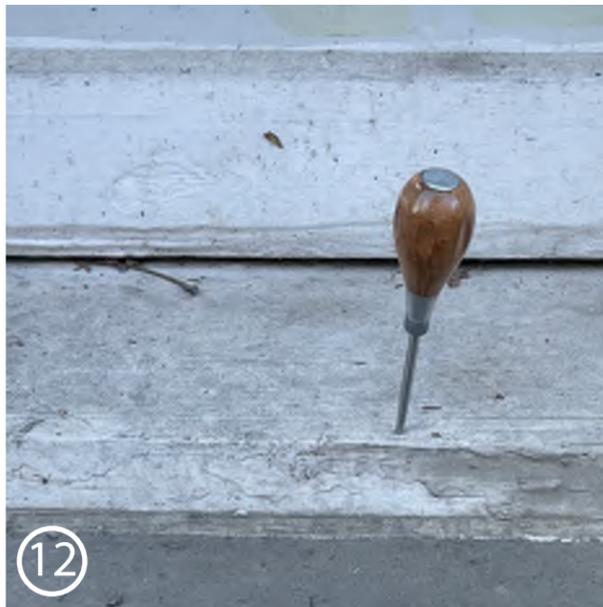
⑫

11. Sill 20% or Less Deteriorated
12. Sill Heavily Deteriorated, Wood Consolidation Necessary for More Than 20% of the Sill
13. Reinforced Sash (non-original)

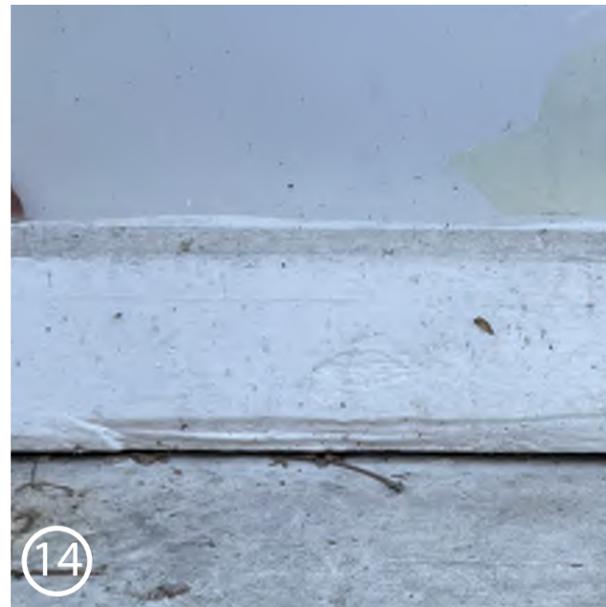
⑭

14. Section Loss
15. Missing Window Stop
16. Sealant Deteriorated
17. Weatherstrip Deteriorated/Missing
18. Deteriorated Glazing Compound/Setting Bead/Glazing Putty **Typical**
