Window Condition Assessment for B.F. Day Elementary School

on behalf of Seattle Public Schools

July 16, 2024

Miller Hayashi Architects PLLC

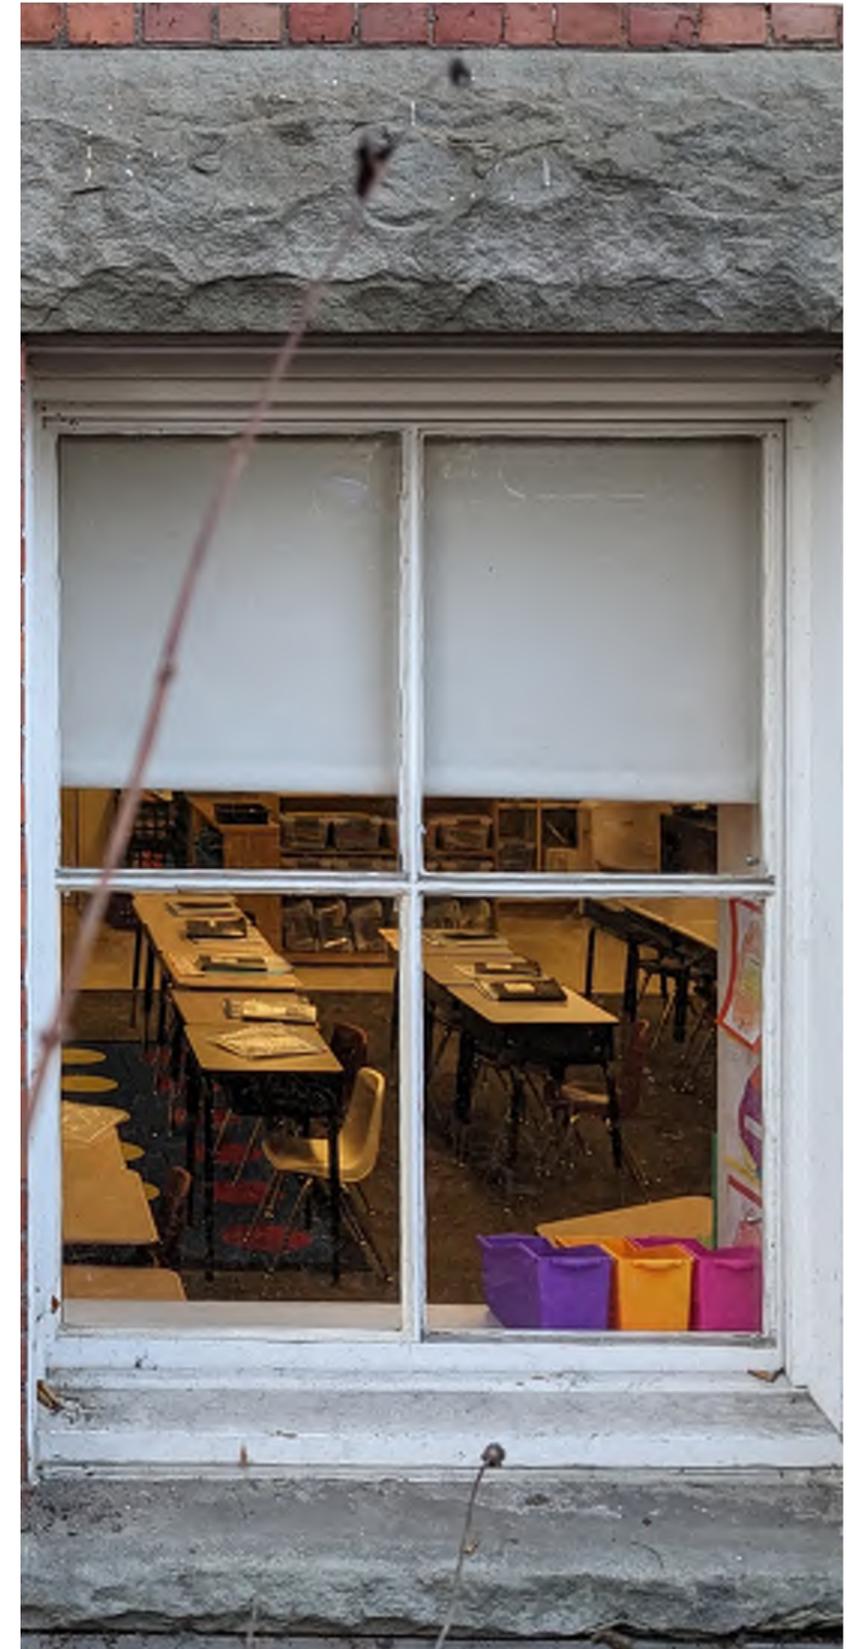
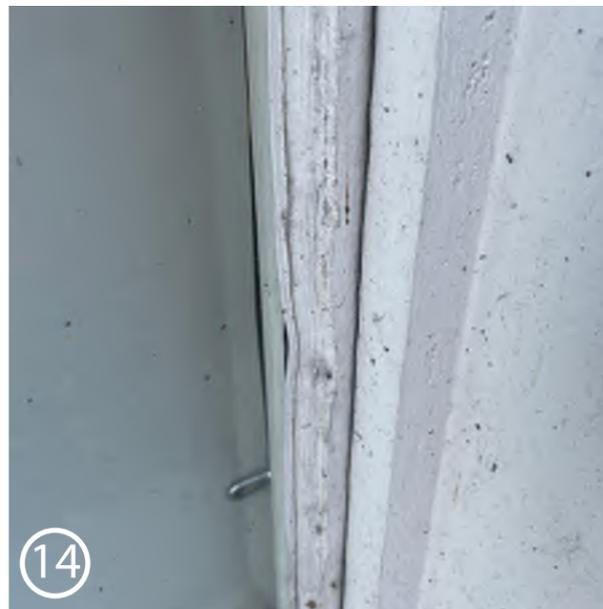
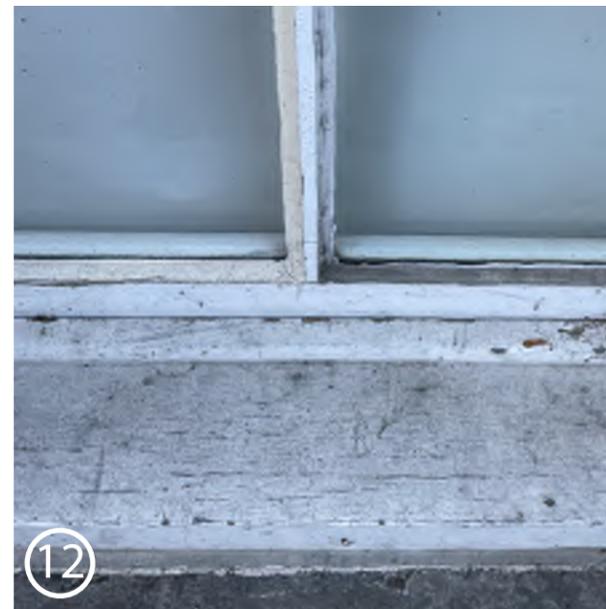
Window ID **GE.20** POOR CONDITION

1. Sash Operation Difficult/Won't Open
2. Inoperable – Screwed Shut
3. Exterior Paint at Sash and Trim Cracked and Peeling at Limited Areas
4. Exterior Paint at Sash and Trim Heavily Deteriorated

5. Checked Sash/Muntin
6. Deteriorated Sash
7. Checked/Split Frame
8. Deteriorated Frame
9. Parting Bead Lightly Deteriorated
10. Parting Bead Missing or Heavily Deteriorated

11. Sill 20% or Less Deteriorated
12. Sill Heavily Deteriorated, Wood Consolidation Necessary for More Than 20% of the Sill
13. Reinforced Sash (non-original)

14. Section Loss
15. Missing Window Stop
16. Sealant Deteriorated
17. Weatherstrip Deteriorated/Missing
18. Deteriorated Glazing Compound/Setting Bead/Glazing Putty **Typical**

19. Sash Pull Hardware Missing
20. Sash Lock Damaged/Missing/Not Engaging/No Lock **Non-original locking hardware**
21. Retrofitted Window Limiter
22. Leaking or Visible Gap to Exterior When Closed

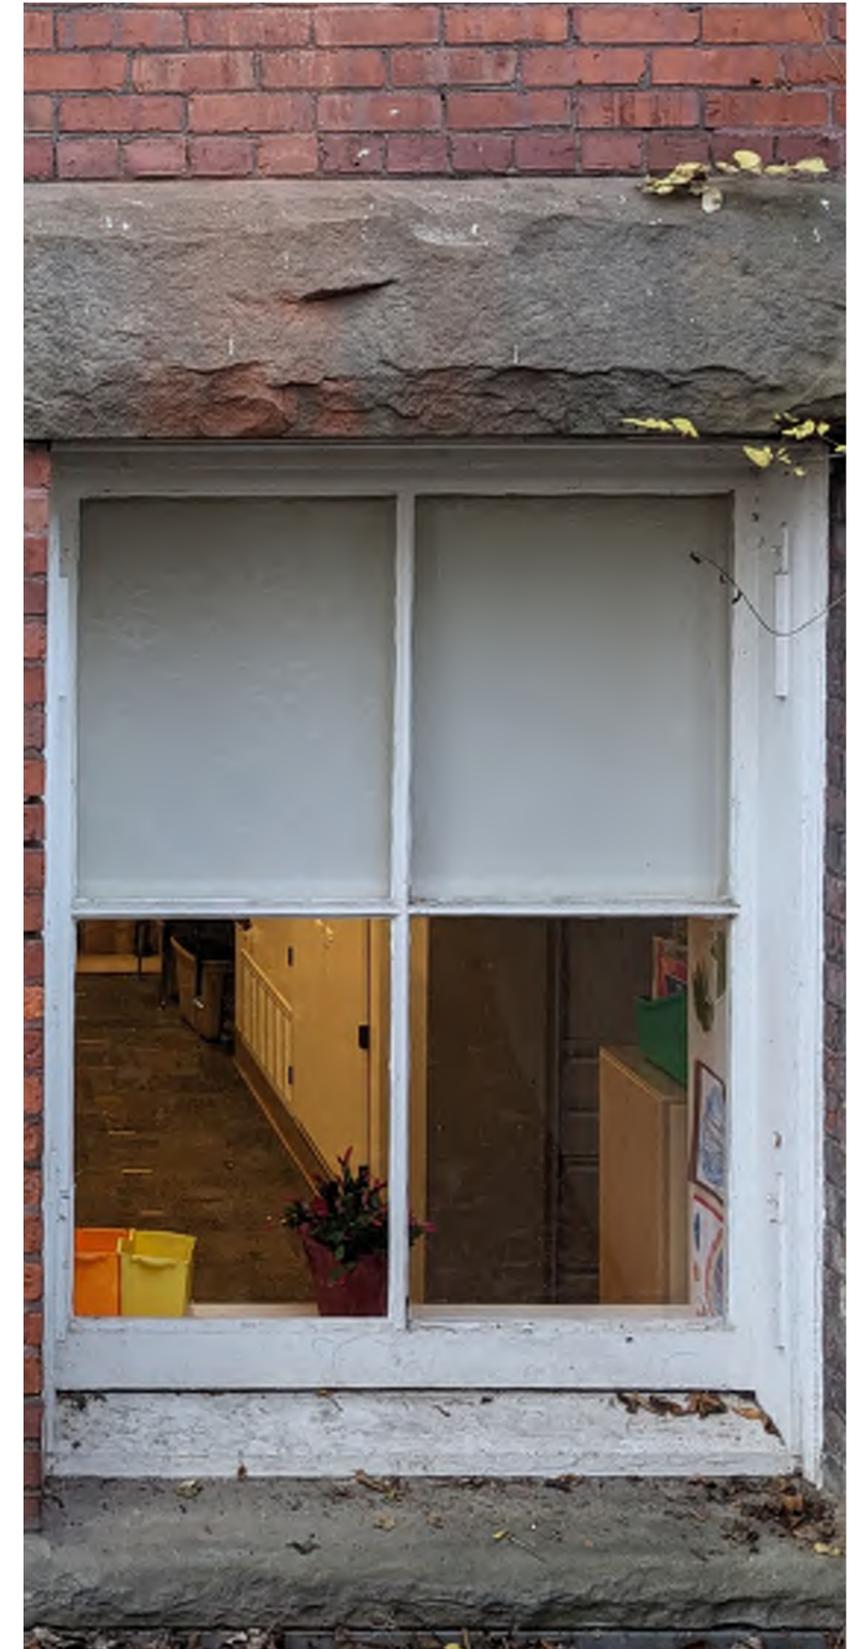
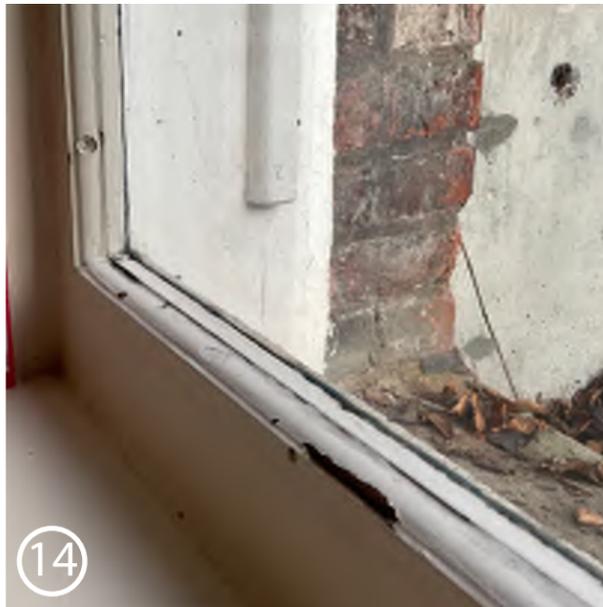
Window ID **GE.22** MODERATE CONDITION

- 1. Sash Operation Difficult/Won't Open
- 2. Inoperable – Screwed Shut **Painted shut**
- 3. Exterior Paint at Sash and Trim Cracked and Peeling at Limited Areas

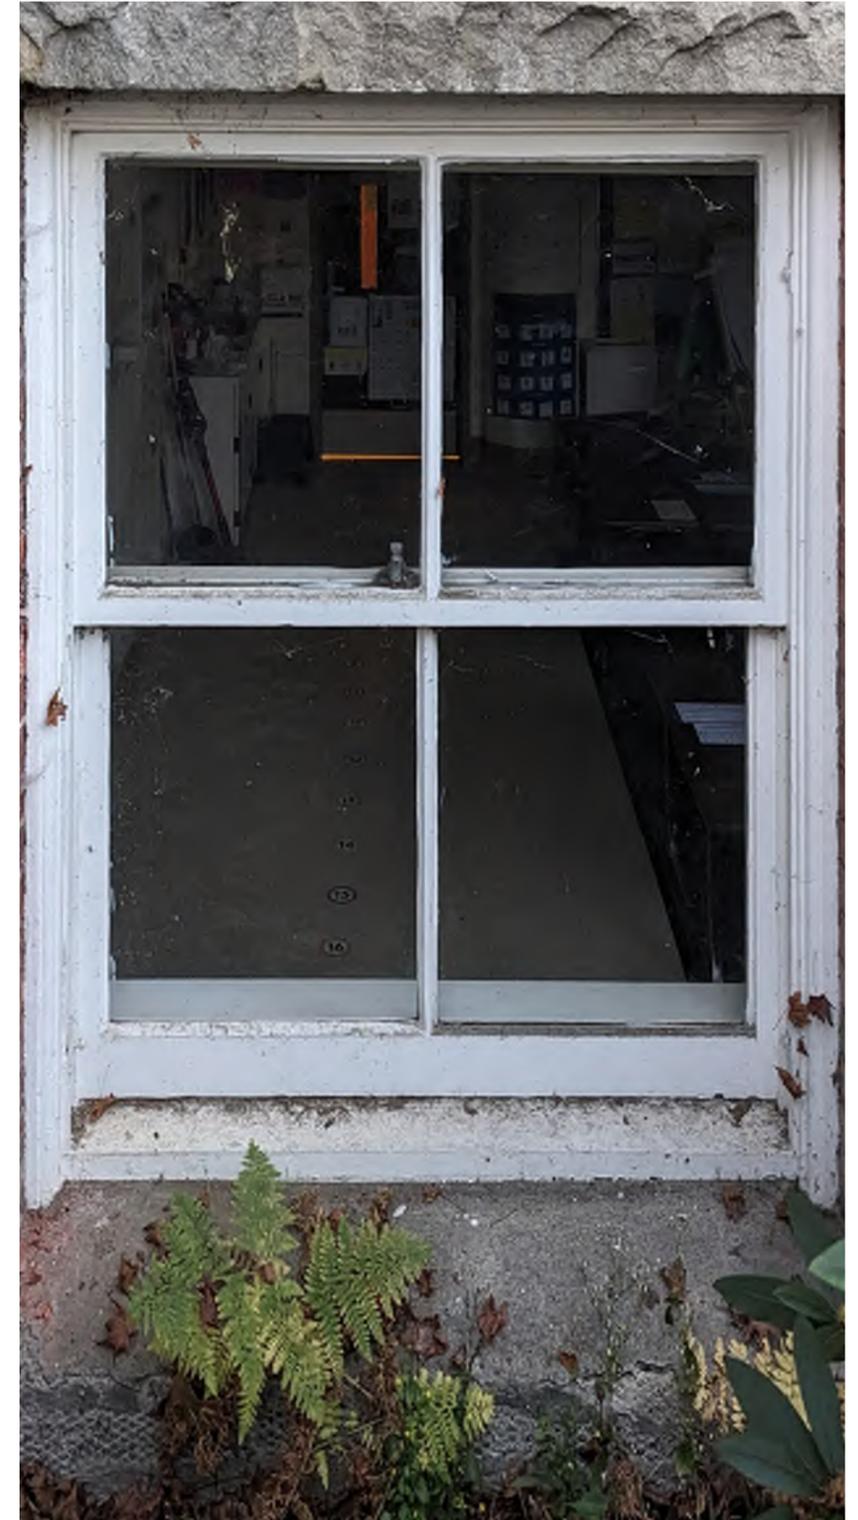
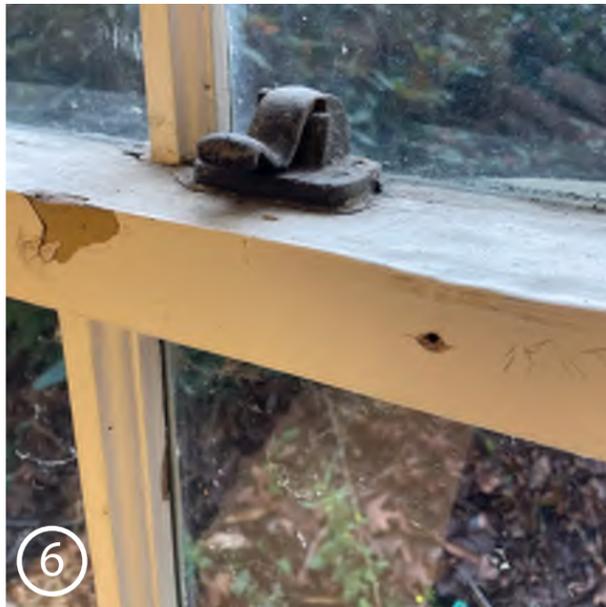
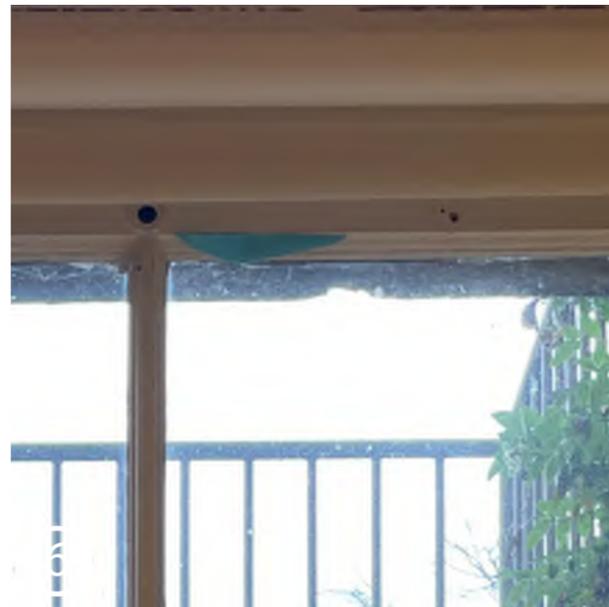
Window ID **GE.23** MODERATE CONDITION

- ① Sash Operation Difficult/Won't Open
- 2. Inoperable – Screwed Shut
- ③ Exterior Paint at Sash and Trim Cracked and Peeling at Limited Areas
- 4. Exterior Paint at Sash and Trim Heavily Deteriorated

- 5. Checked Sash/Muntin
- ⑥ Deteriorated Sash
- 7. Checked/Split Frame
- 8. Deteriorated Frame
- ⑨ Parting Bead Lightly Deteriorated
- 10. Parting Bead Missing or Heavily Deteriorated

- ⑭ Section Loss
- 15. Missing Window Stop
- 16. Sealant Deteriorated
- 17. Weatherstrip Deteriorated/Missing
- 18. Deteriorated Glazing Compound/Setting Bead/Glazing Putty

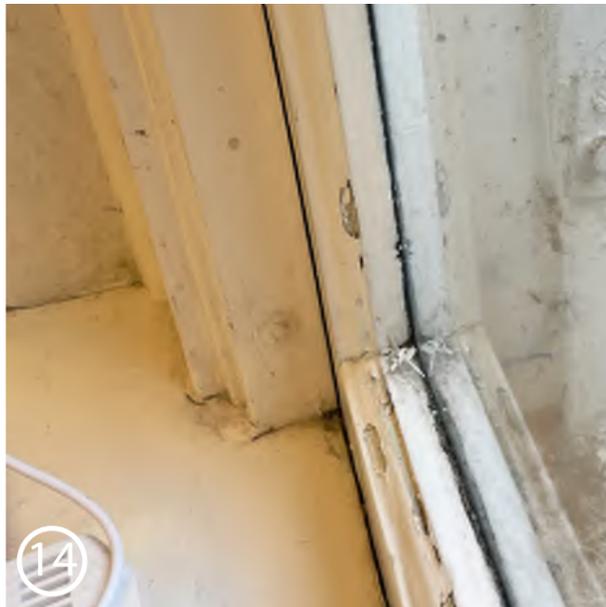
● Sash cord has been painted

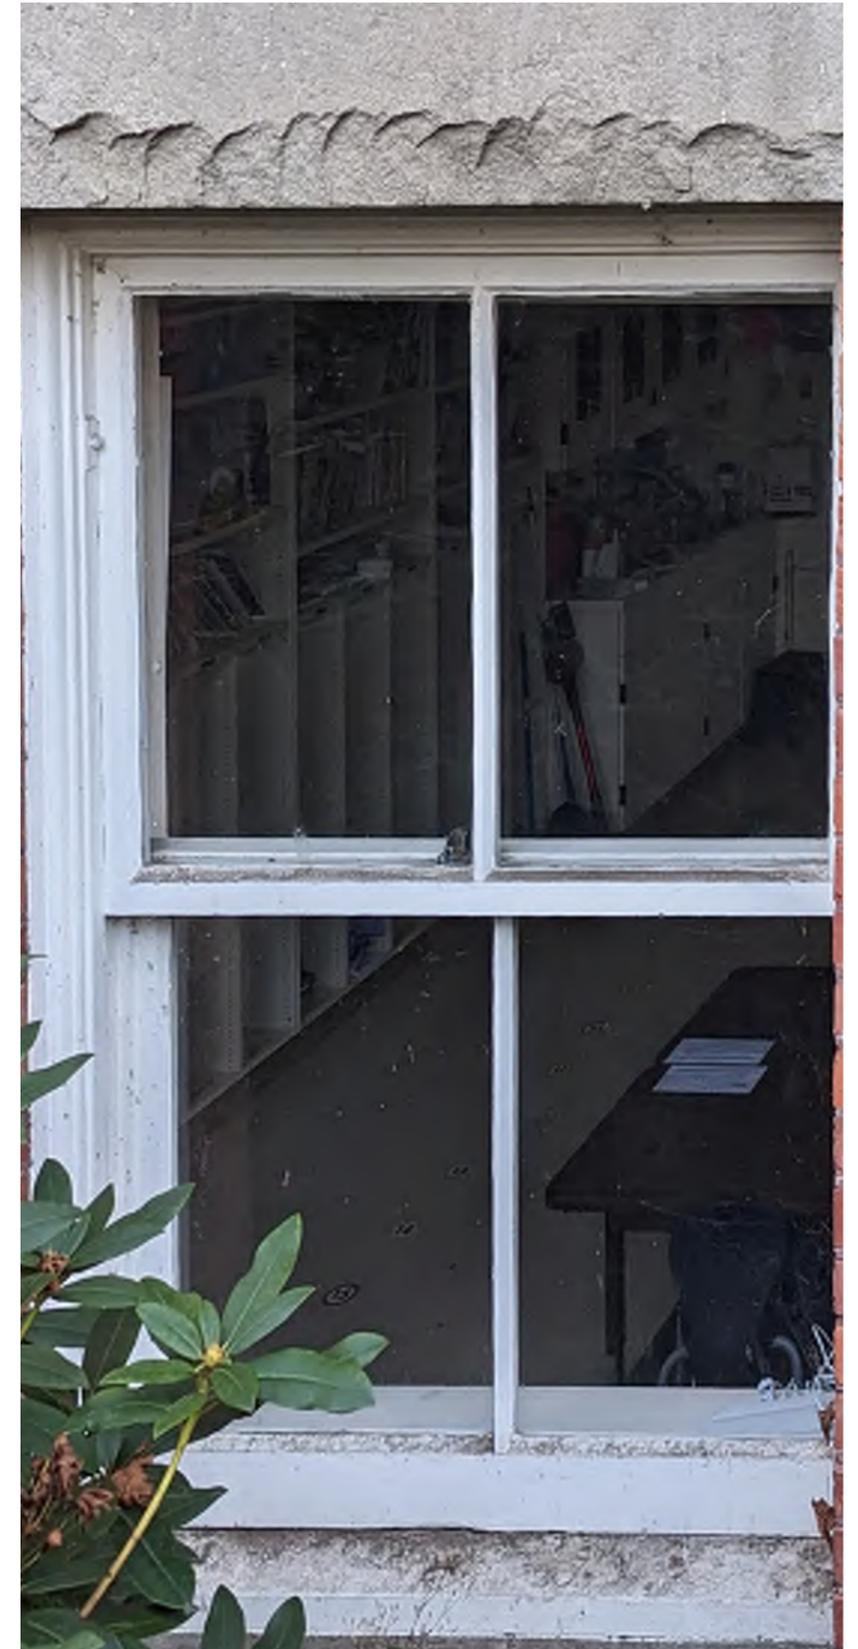
Window ID **GE.24** MODERATE CONDITION

- Upper sash is misaligned within frame
- Sash cord has been painted
- Non-original locking hardware

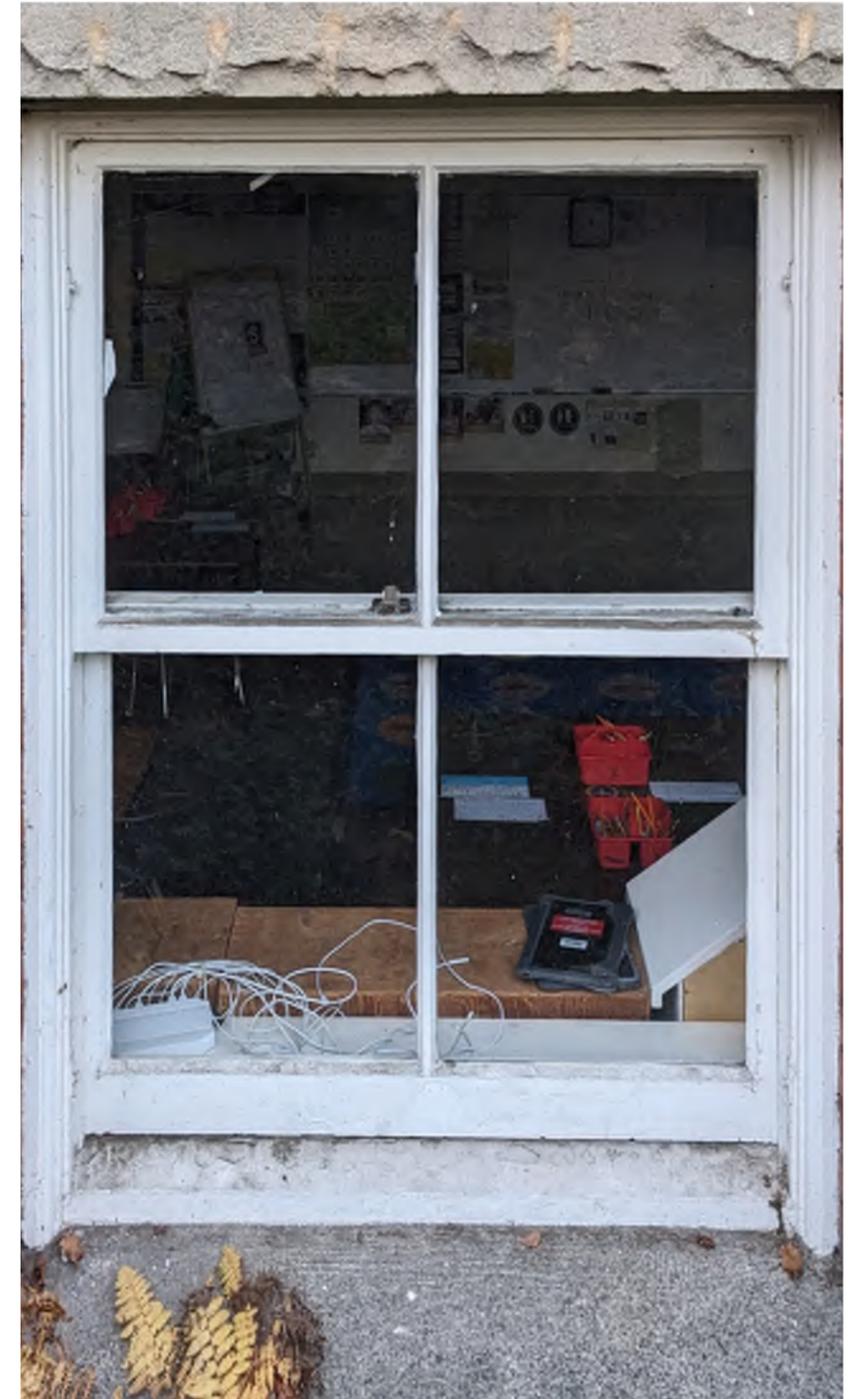
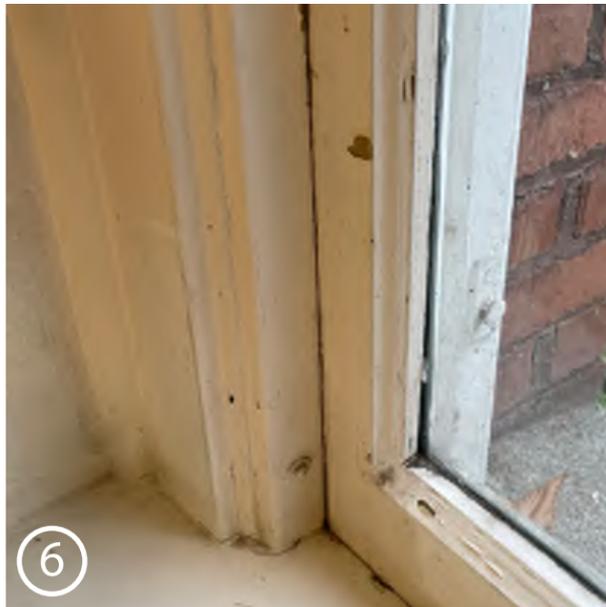
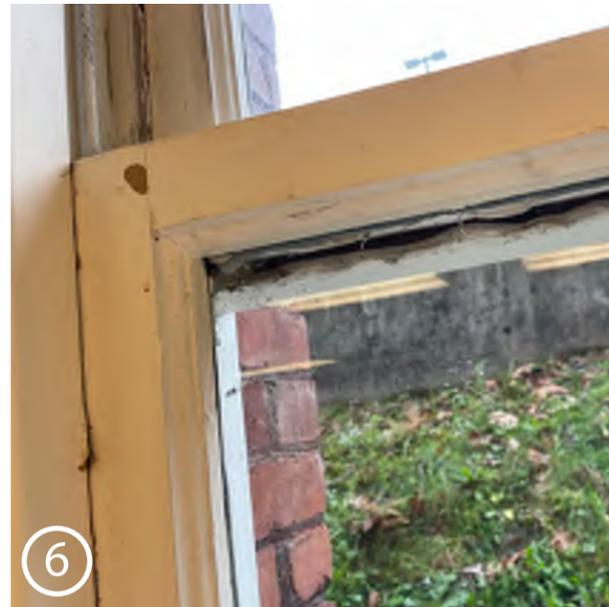
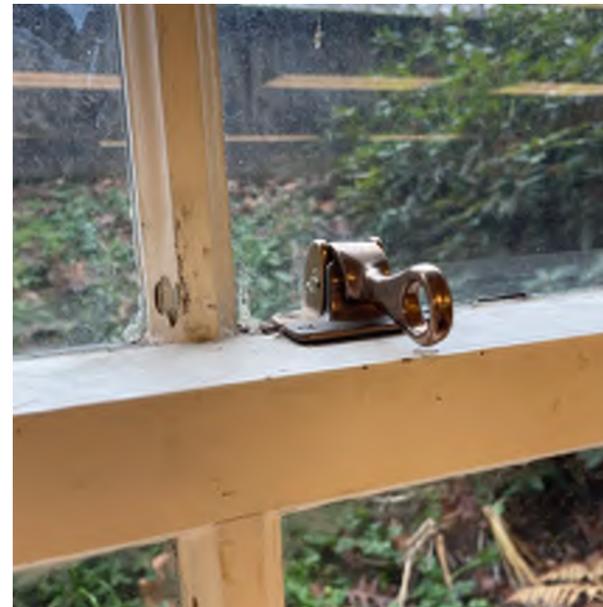
Window ID **GE.25** MODERATE CONDITION

- Sash cord has been painted
- Non-original locking hardware

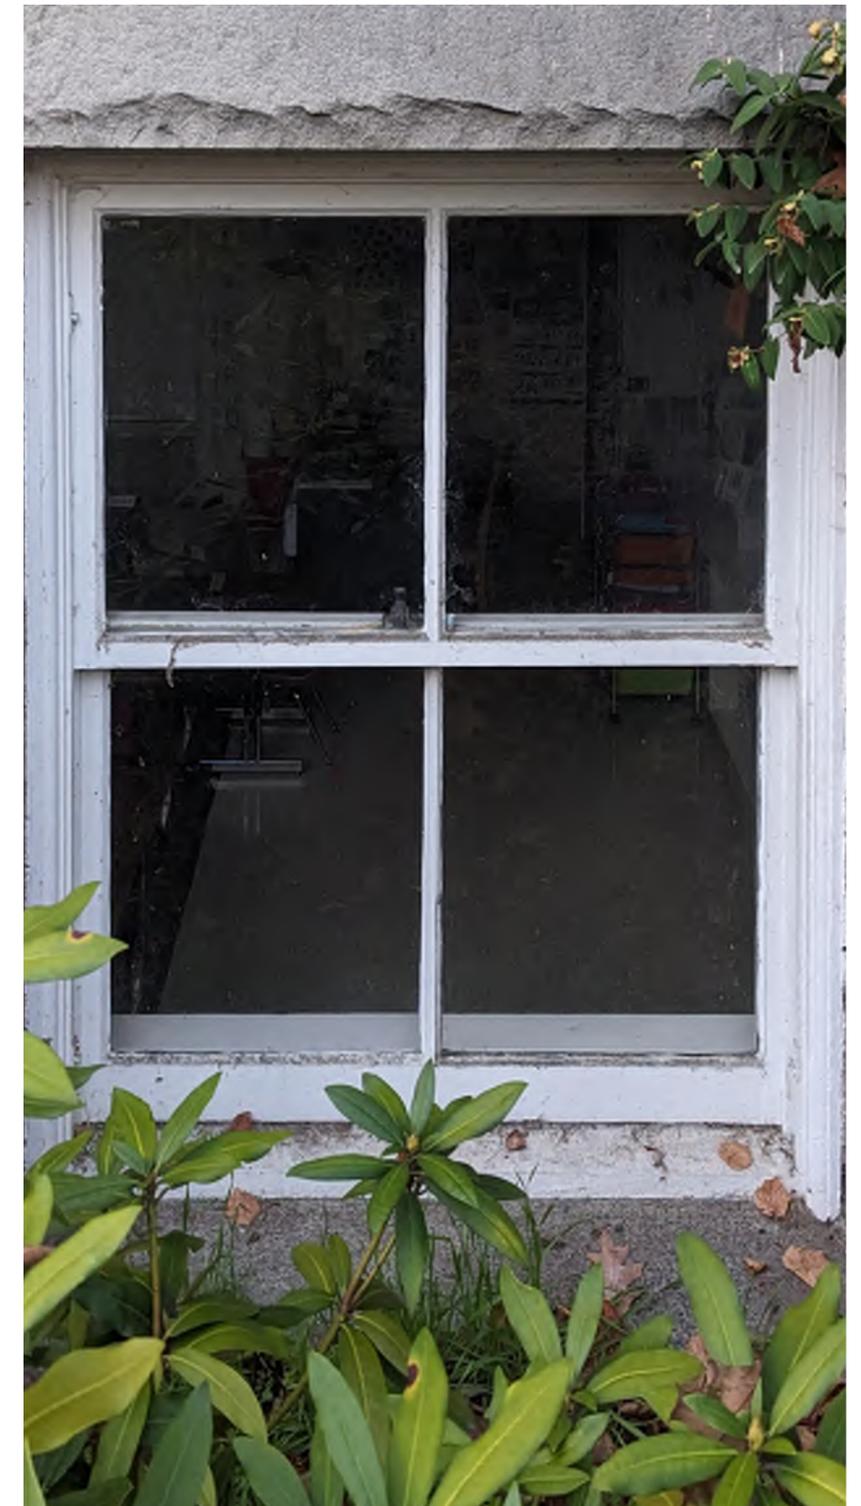
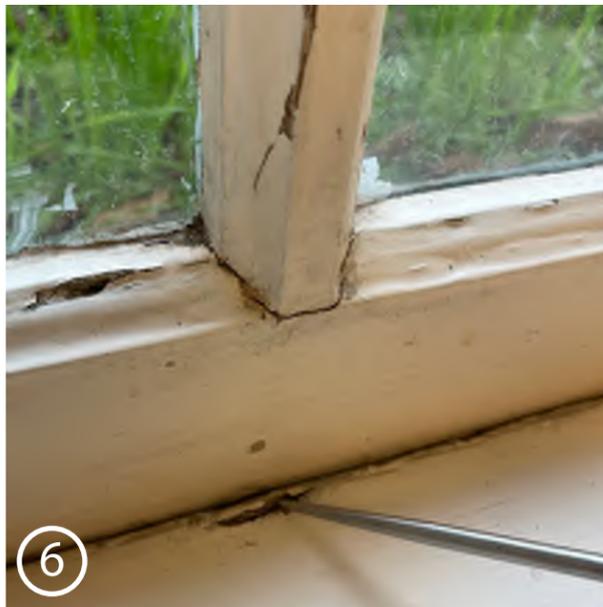
Window ID **GS.01** POOR CONDITION

- 19. Sash Pull Hardware Missing
- ⑳ Sash Lock Damaged/Missing/Not Engaging/No Lock **Window latch is missing**
- 21. Retrofitted Window Limiter
- ㉒ Leaking or Visible Gap to Exterior When Closed

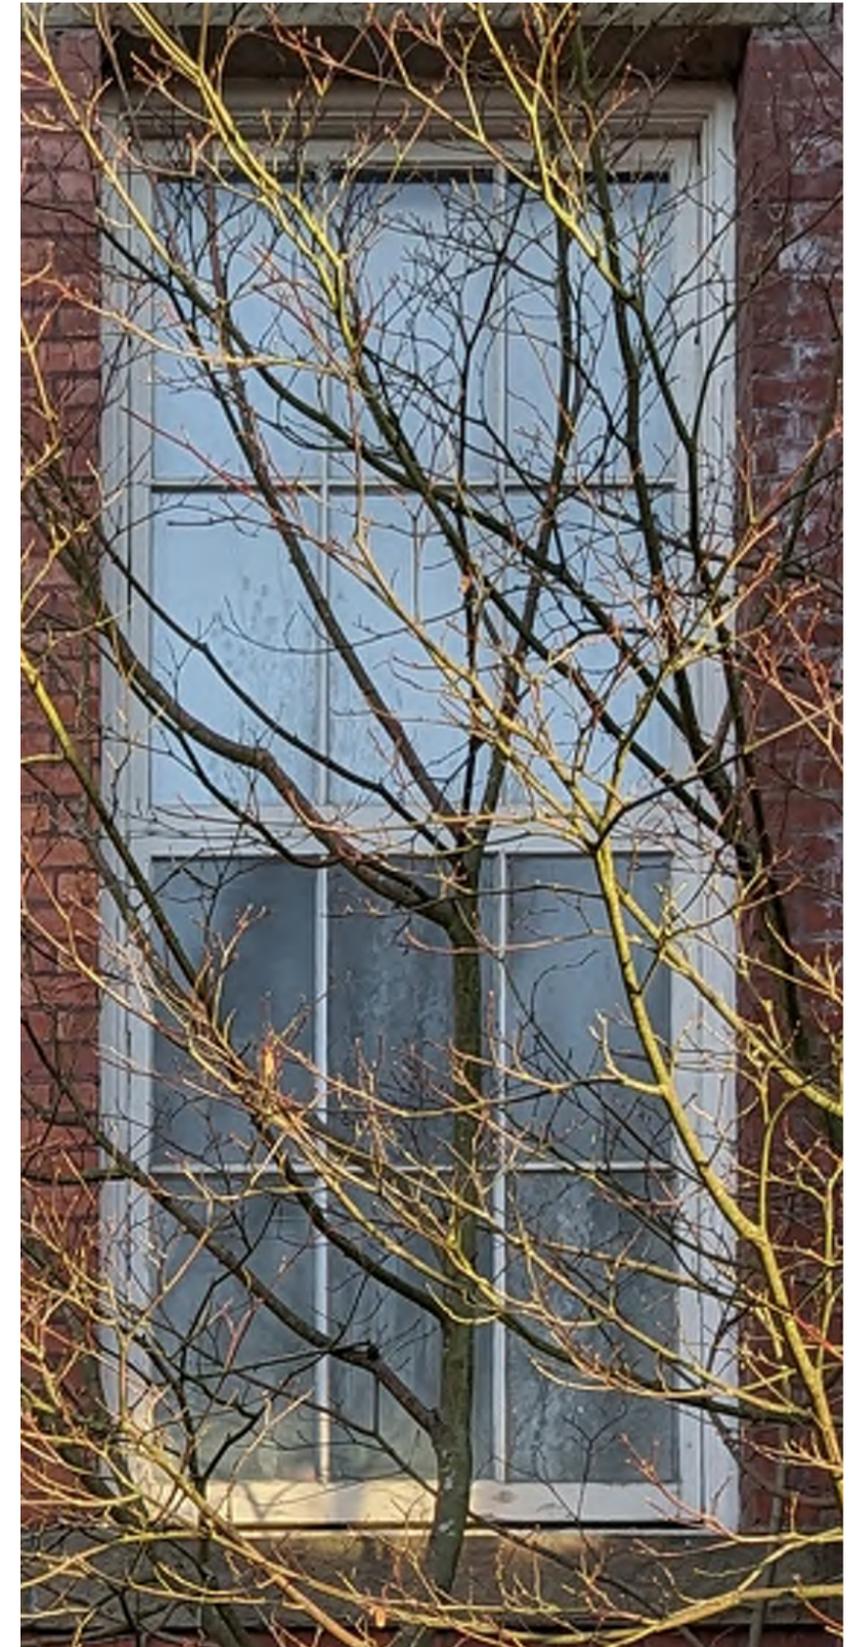
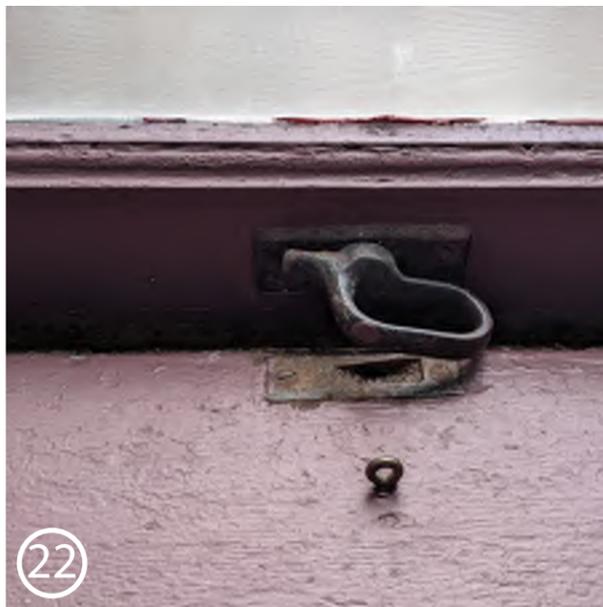
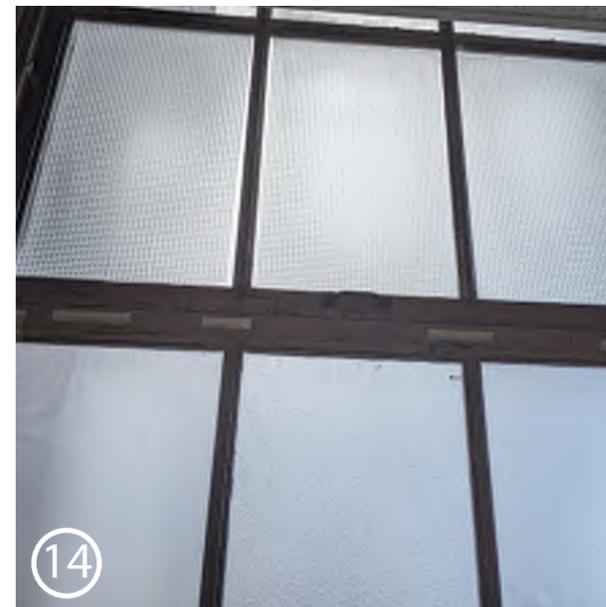
Window ID 1W.09 MODERATE CONDITION

● Upper sash is misaligned within frame

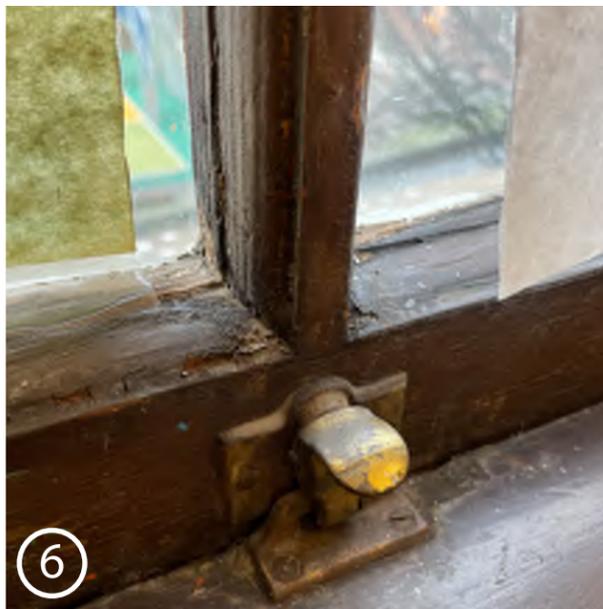
Window ID 1W.11 POOR CONDITION

● Window is loose within frame and rattles with air movement

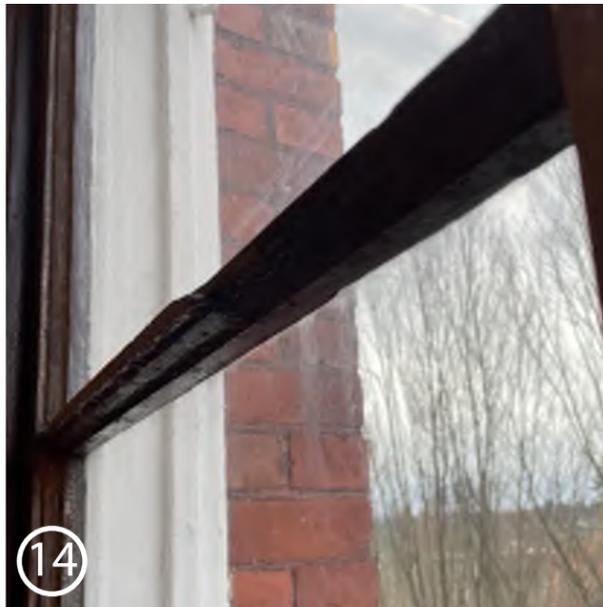
Window ID 1W.19 POOR CONDITION

● Window shows significant structural damage at lower sash

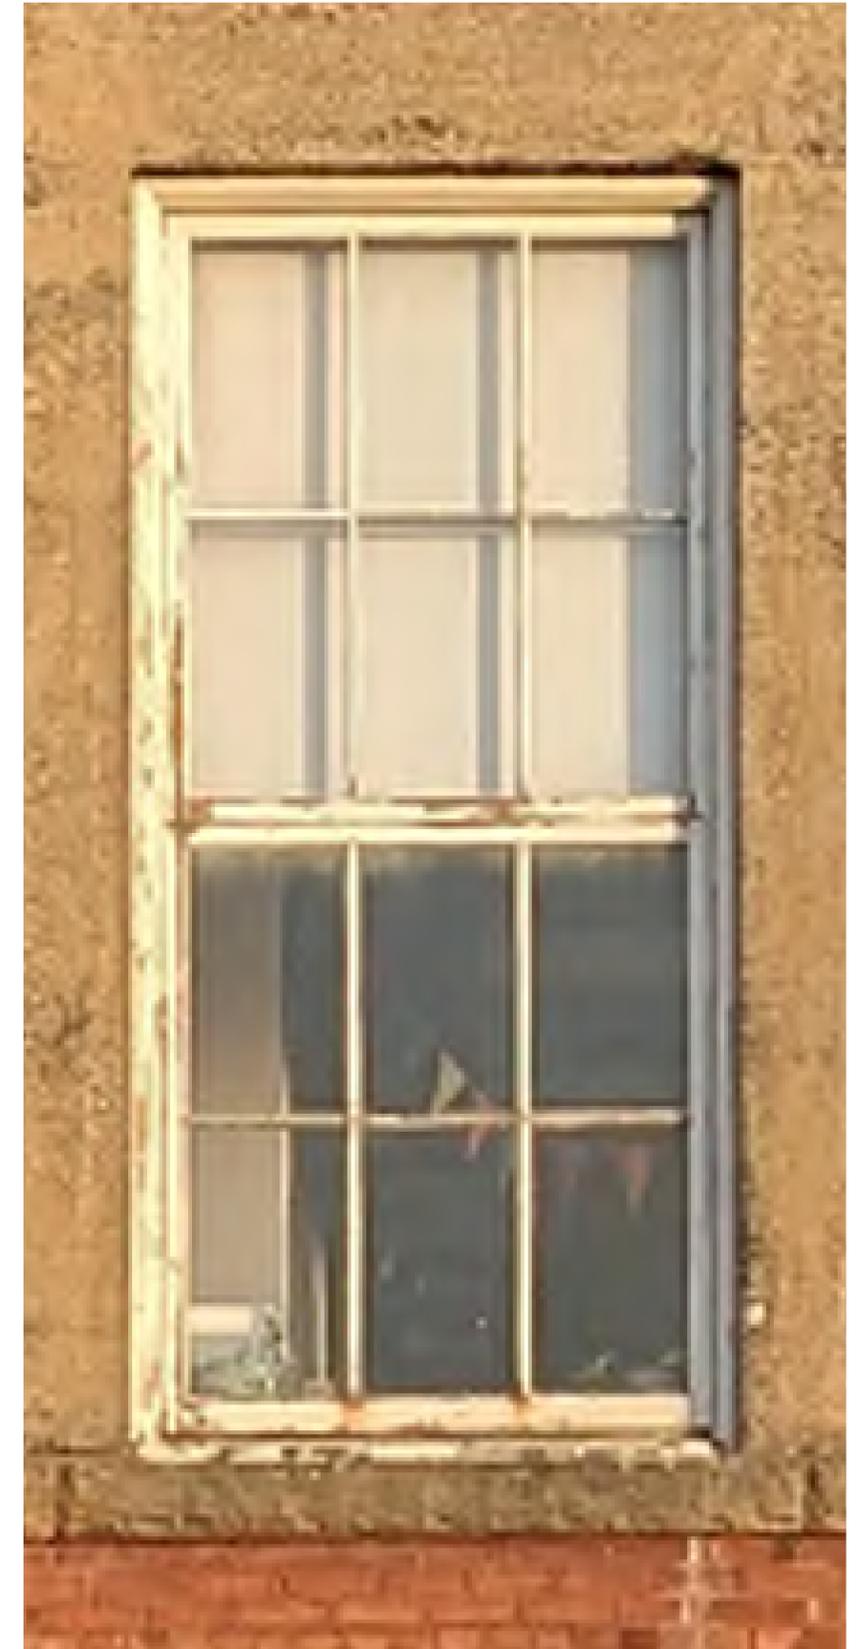
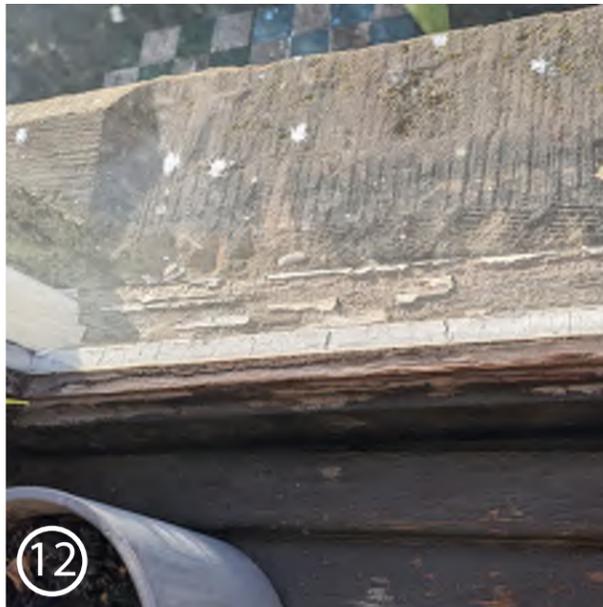
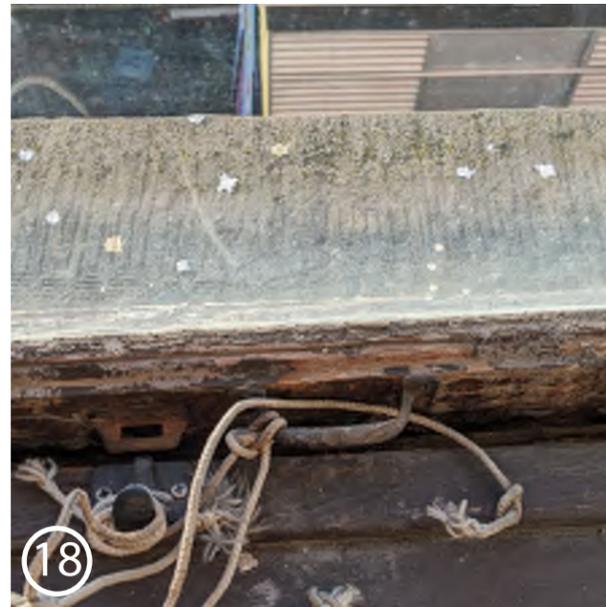
Window ID 1W.30 POOR CONDITION

19. Sash Pull Hardware Missing
20. Sash Lock Damaged/Missing/Not Engaging/No Lock Latches
21. Retrofitted Window Limiter -Missing
22. Leaking or Visible Gap to Exterior When Closed

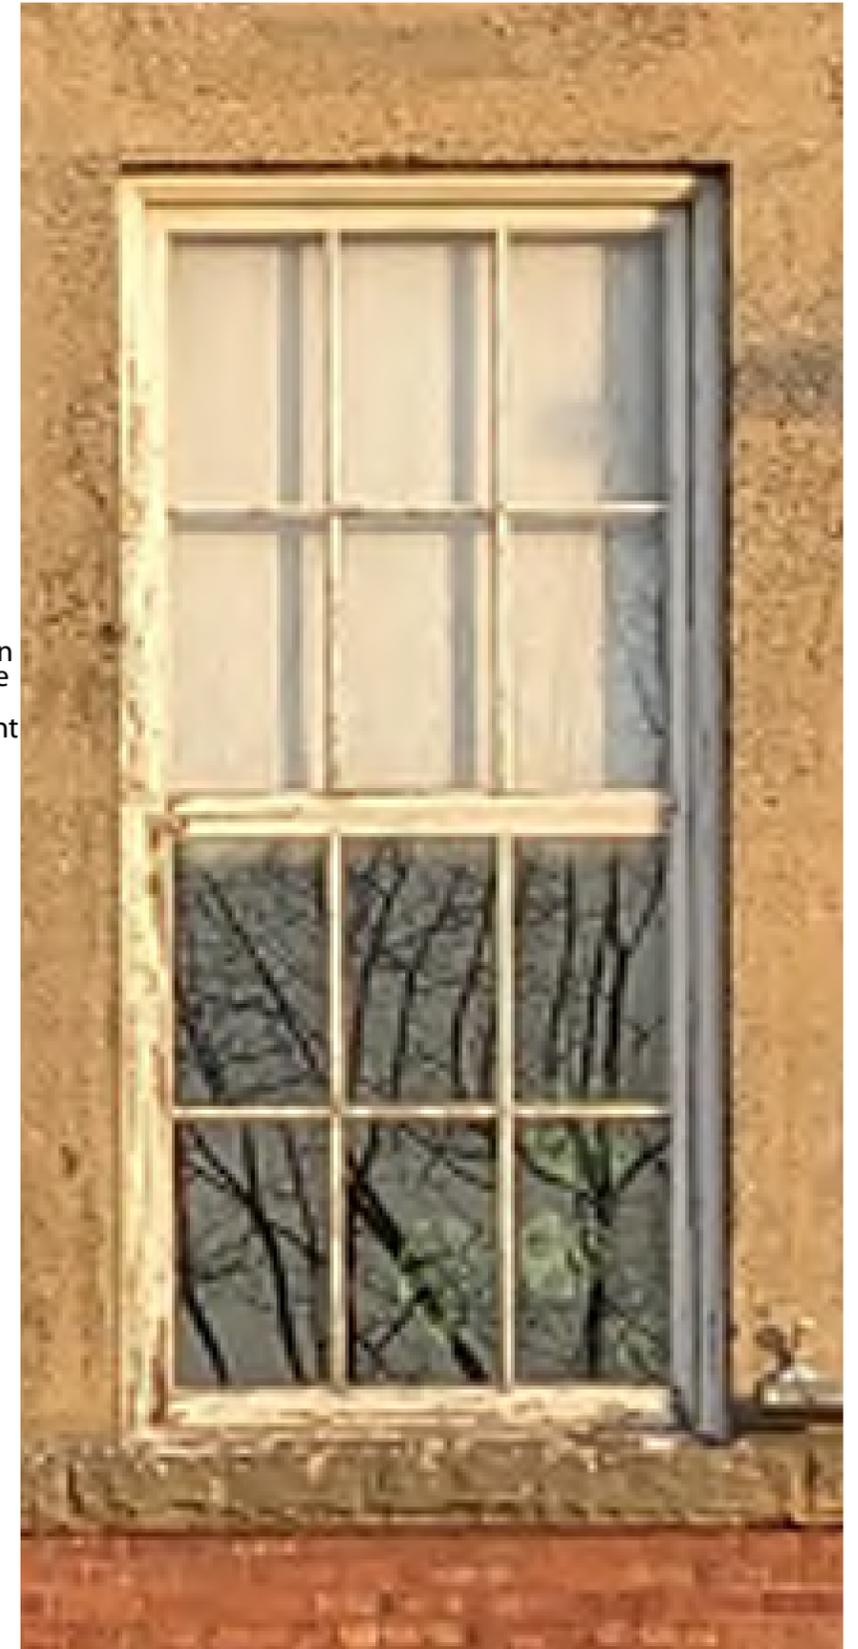
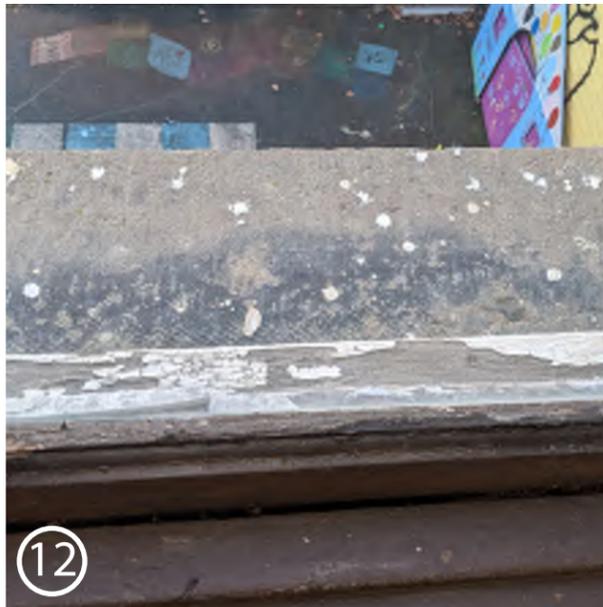
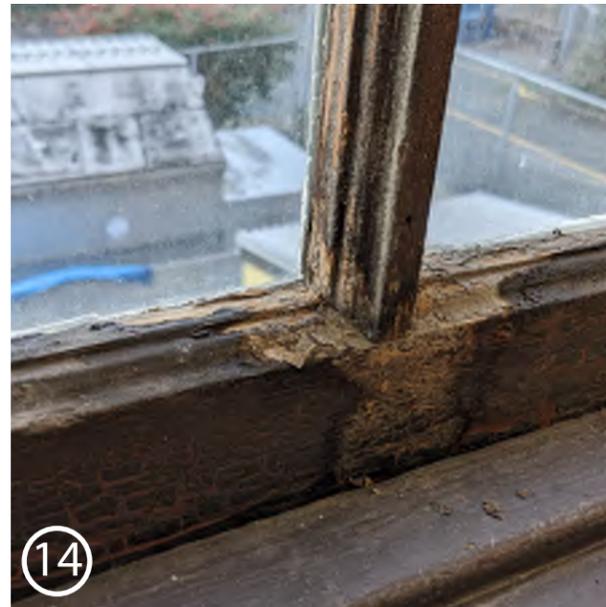
Window ID 1W.32 POOR CONDITION

- 19. Sash Pull Hardware Missing
- 20. Sash Lock Damaged/Missing/Not Engaging/No Lock
- 21. Retrofitted Window Limiter
- ⑳ Leaking or Visible Gap to Exterior When Closed

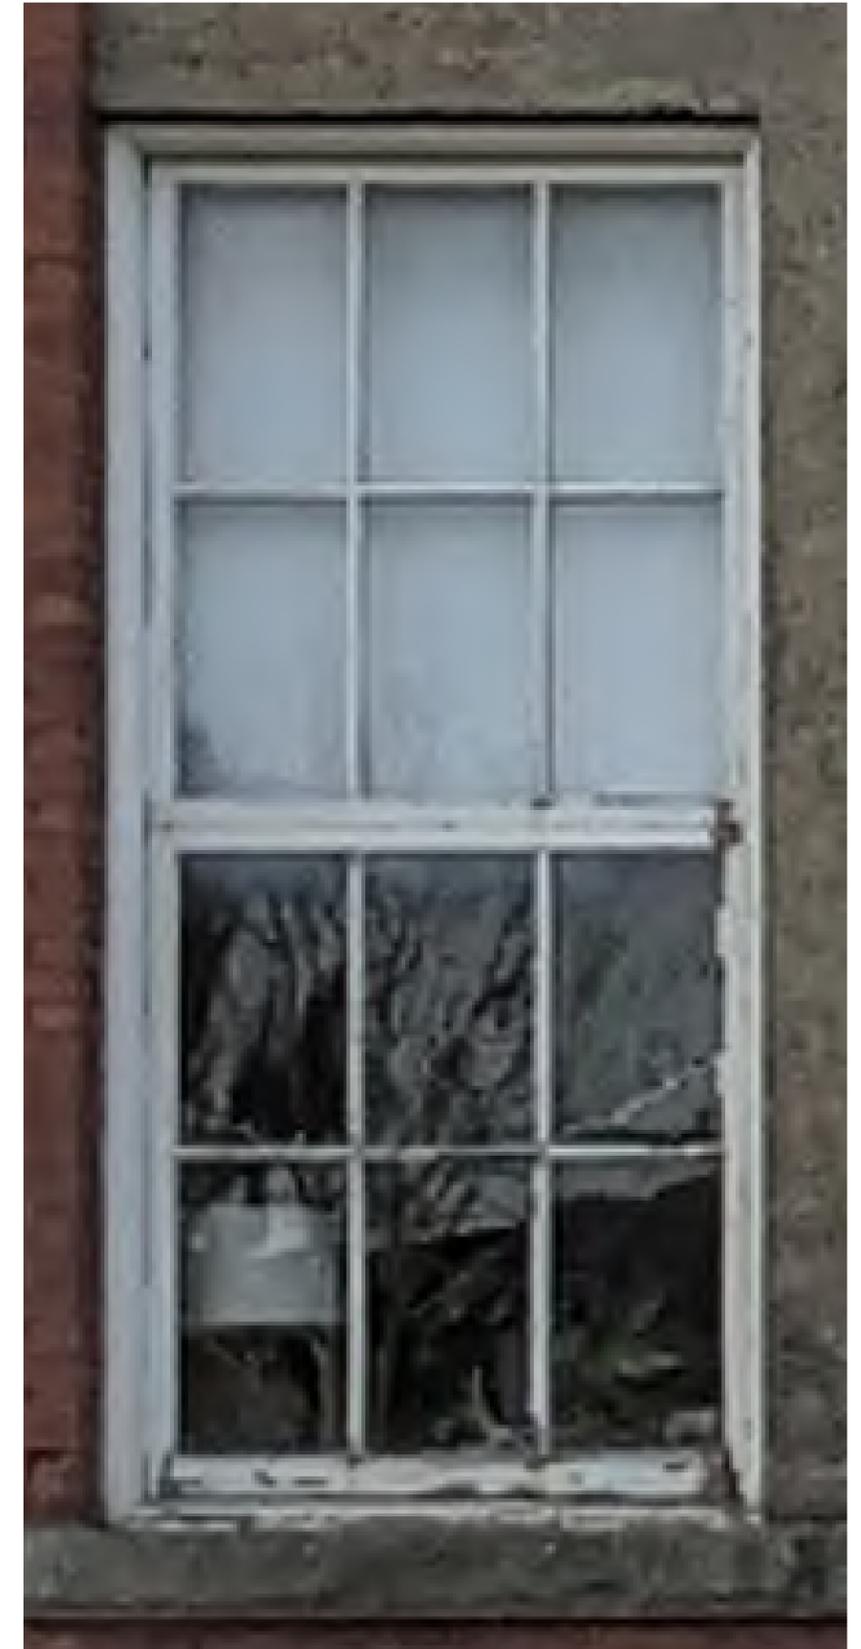
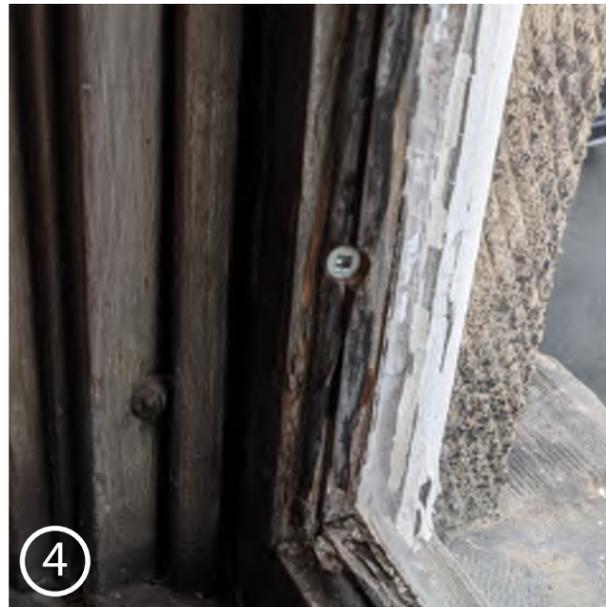
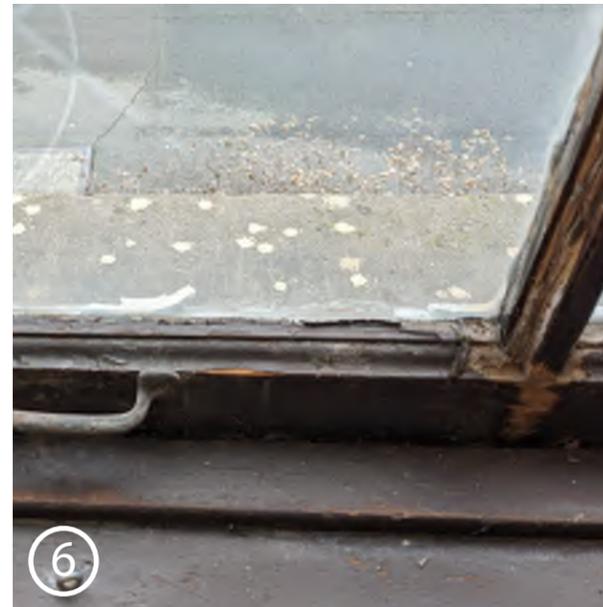
Window ID 1E.02 POOR CONDITION

- 19. Sash Pull Hardware Missing
- ⑳ Sash Lock Damaged/Missing/Not Engaging/No Lock
- ㉑ Retrofitted Window Limiter -Rope
- ㉒ Leaking or Visible Gap to Exterior When Closed

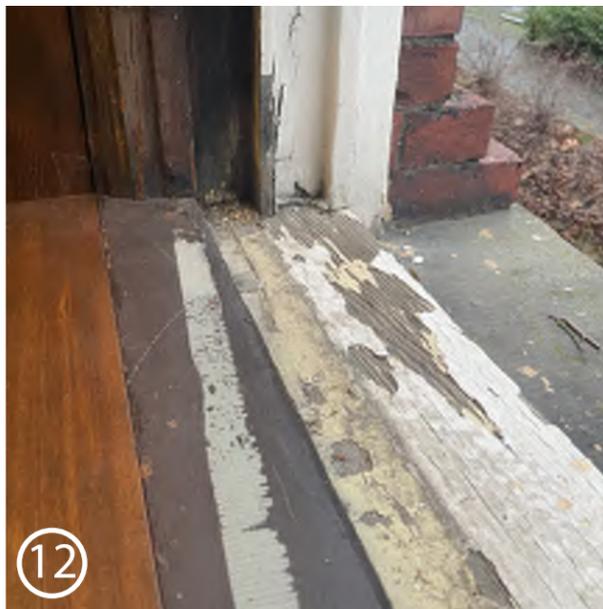
Window ID 1E.18 MODERATE CONDITION

● Lower sash is loose within frame and rattles with air movement
