Window Condition Assessment for B.F. Day Elementary School

on behalf of Seattle Public Schools

July 16, 2024

Miller Hayashi Architects PLLC

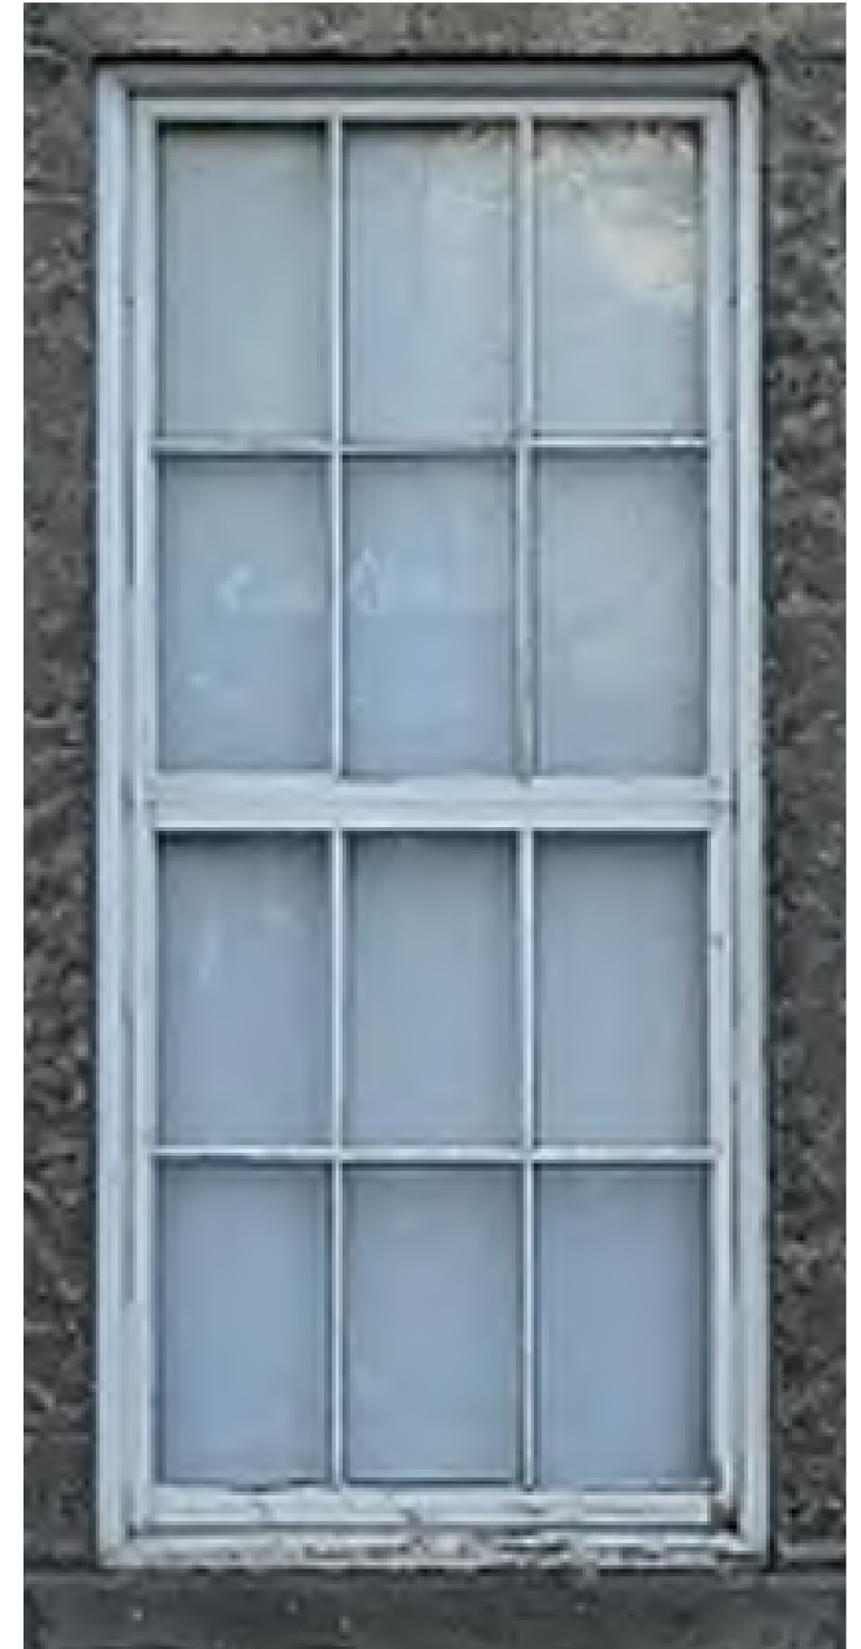
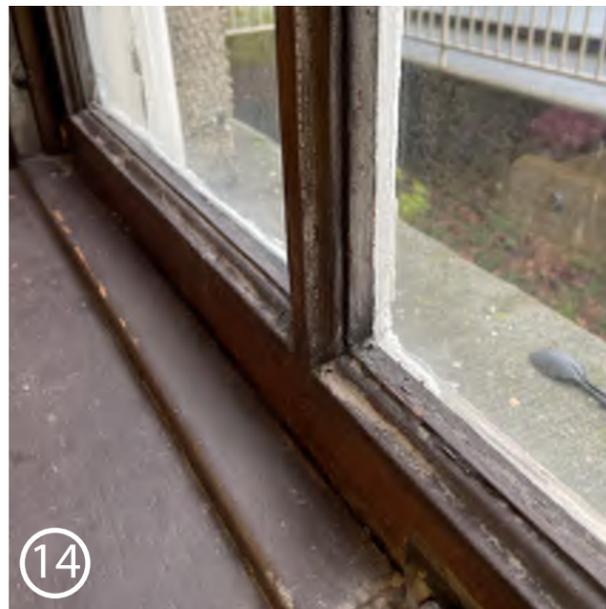
Window ID 1E.26 POOR CONDITION

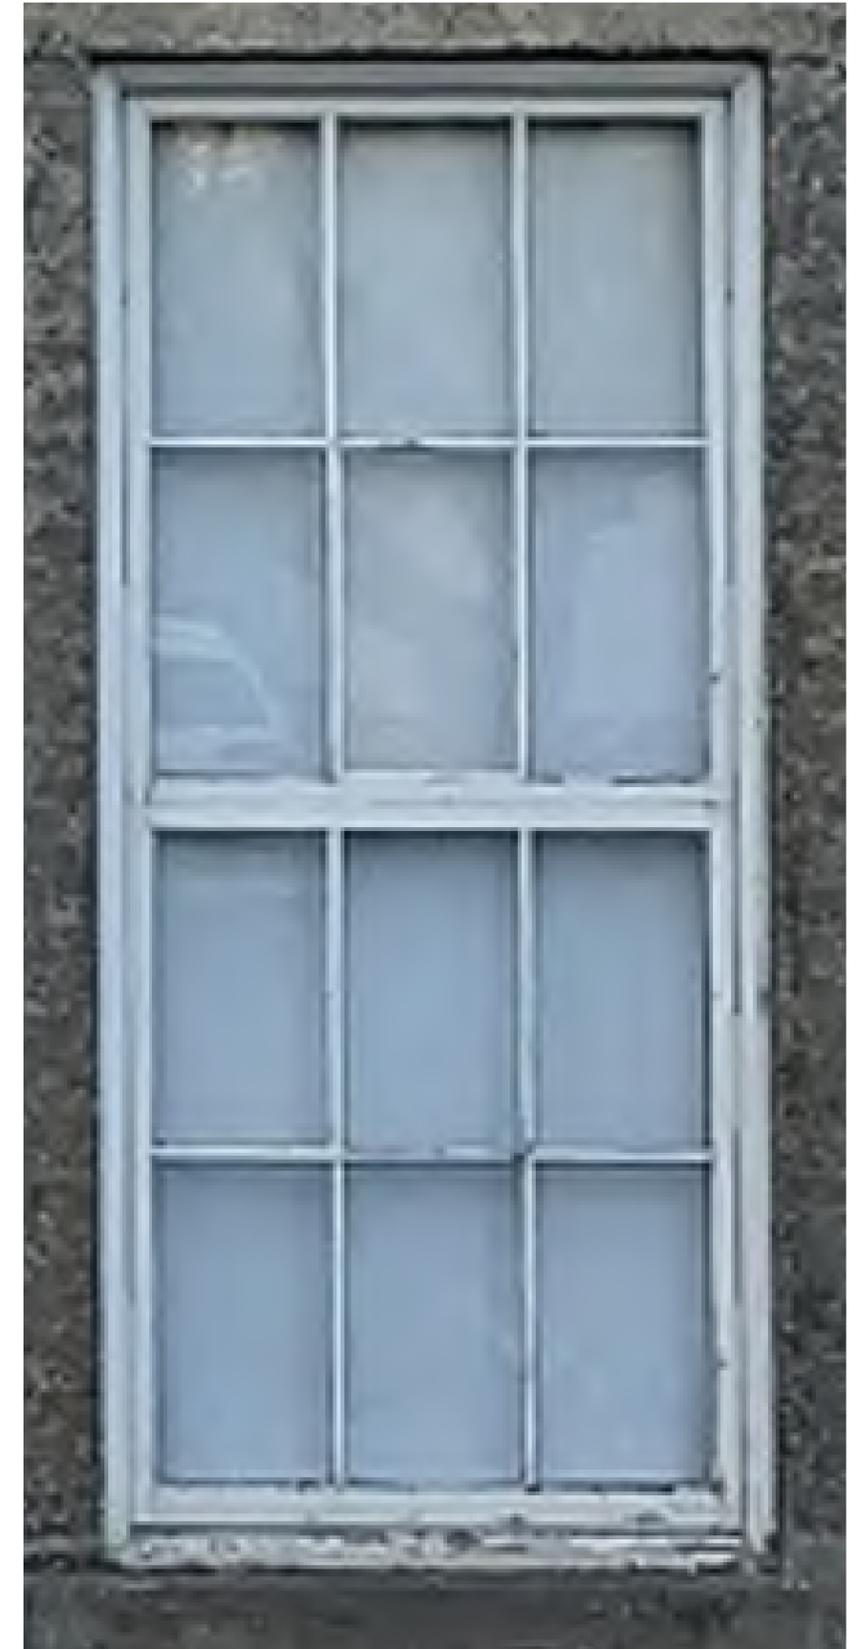
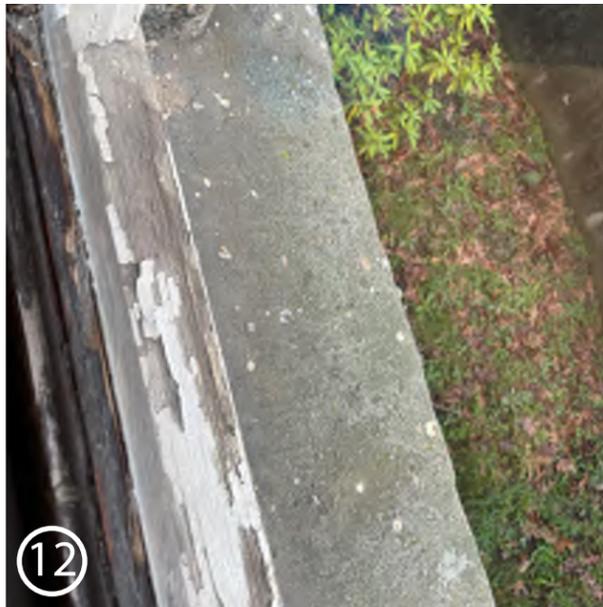
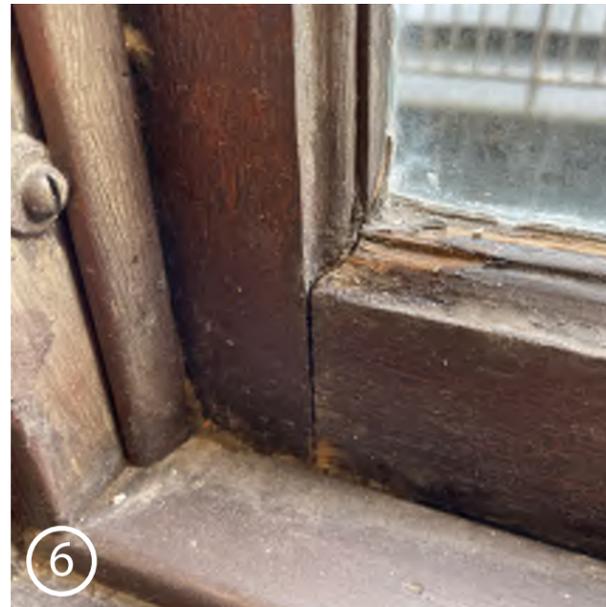
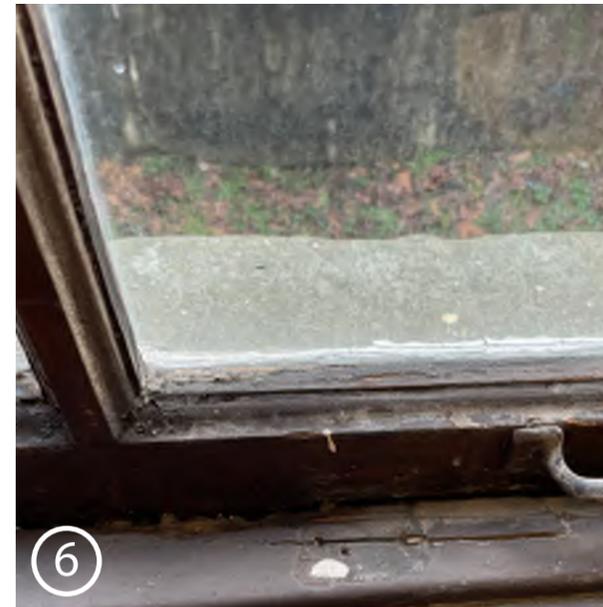
Window ID 1E.27 POOR CONDITION

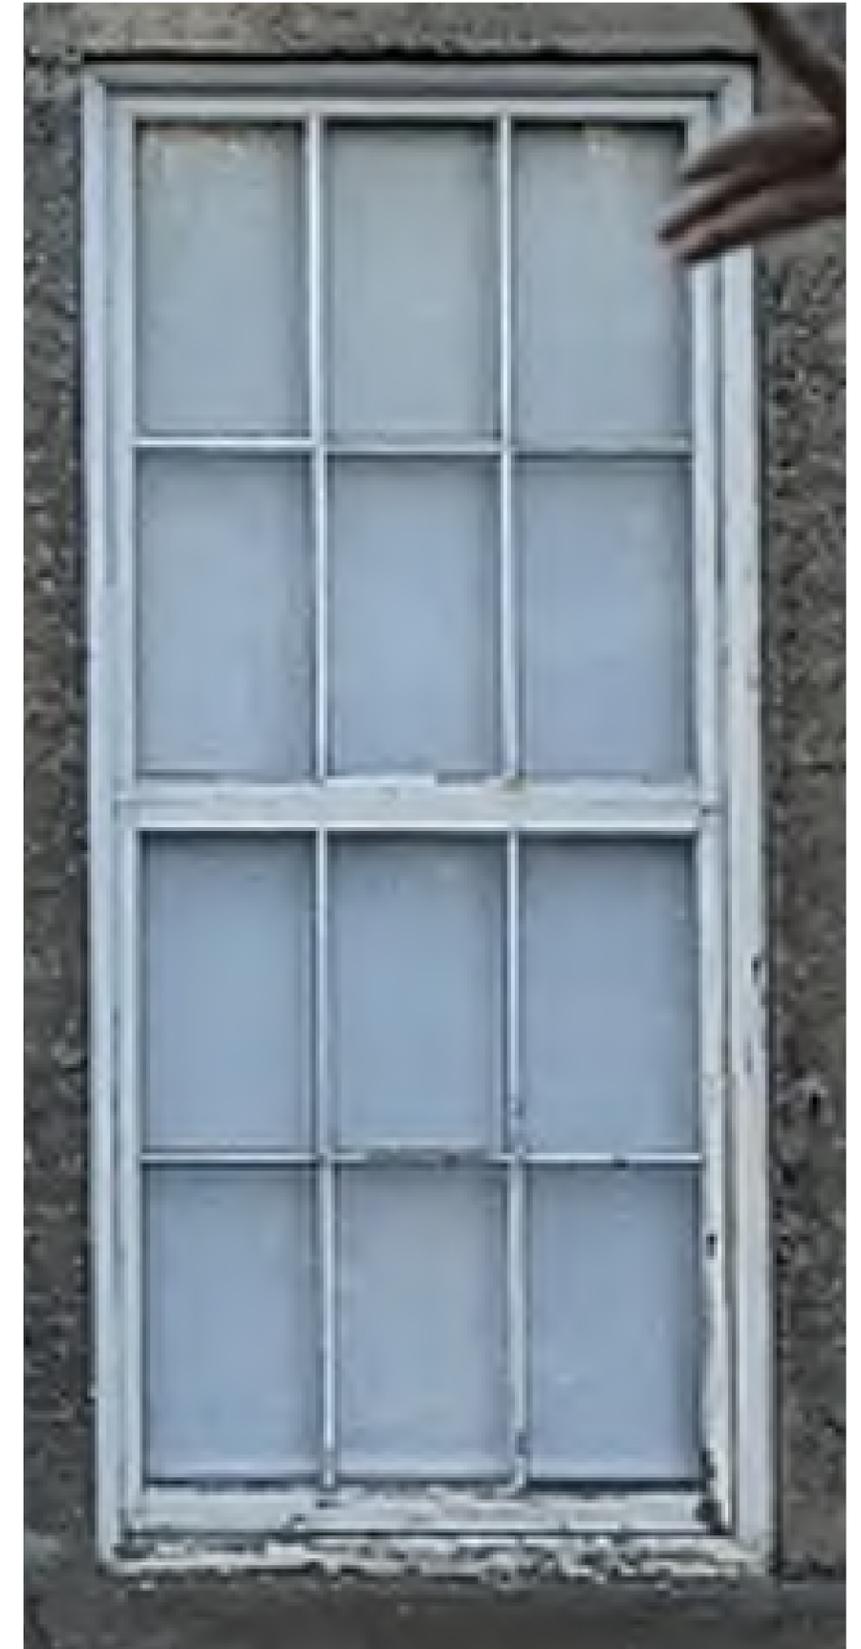
Window ID 1E.28 POOR CONDITION

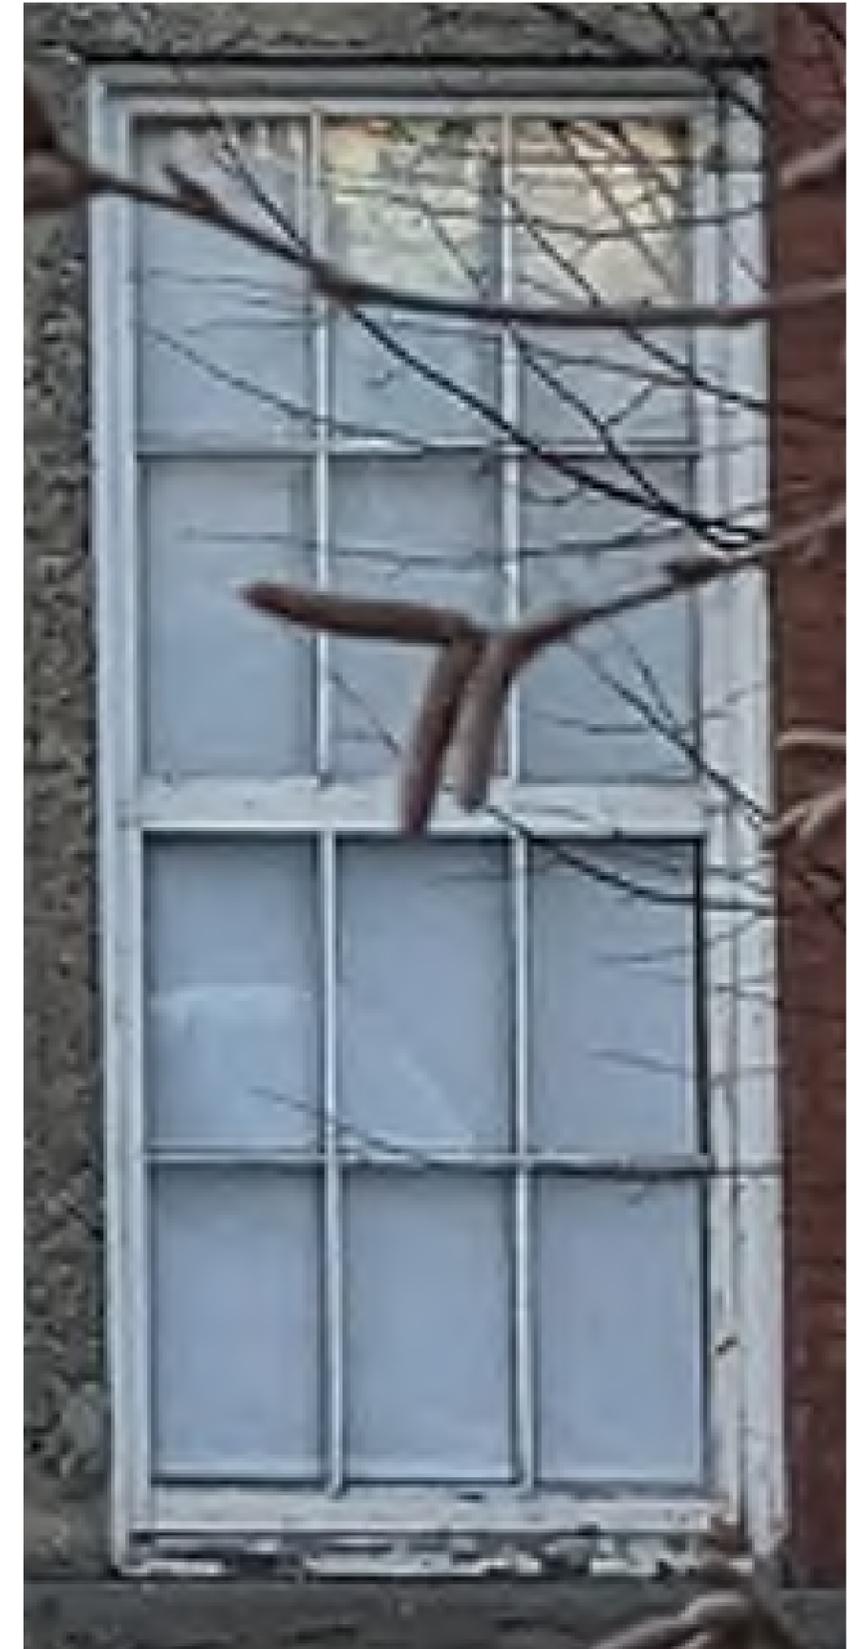
Window ID 1S.01 POOR CONDITION

- ㉓ Replaced Glazing
- ㉔ Cracked Glazing
- ㉕ Missing Glazing

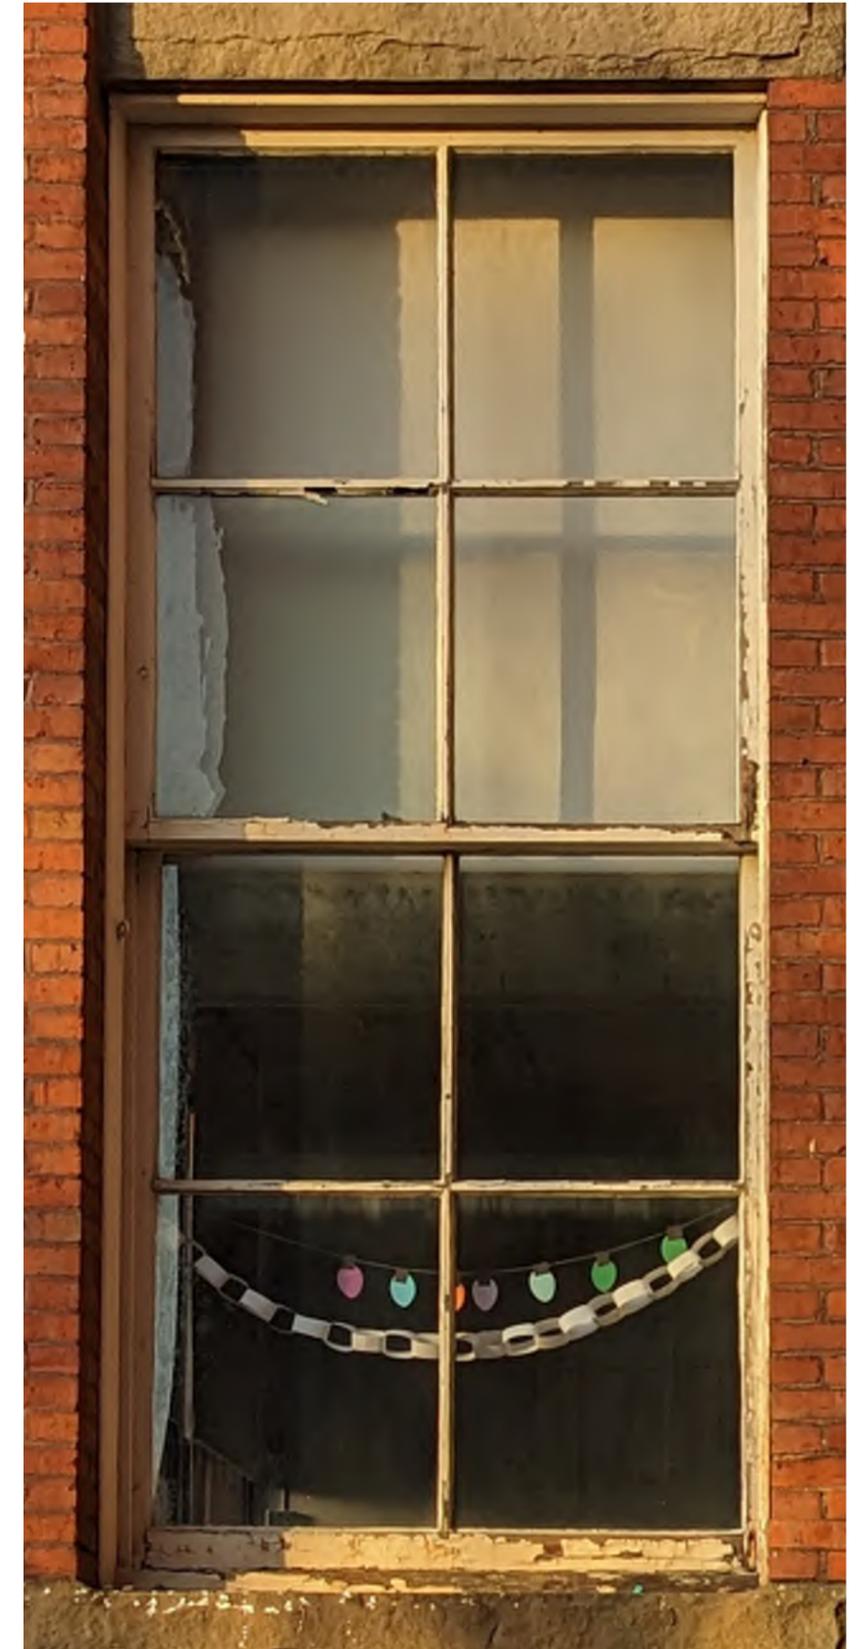
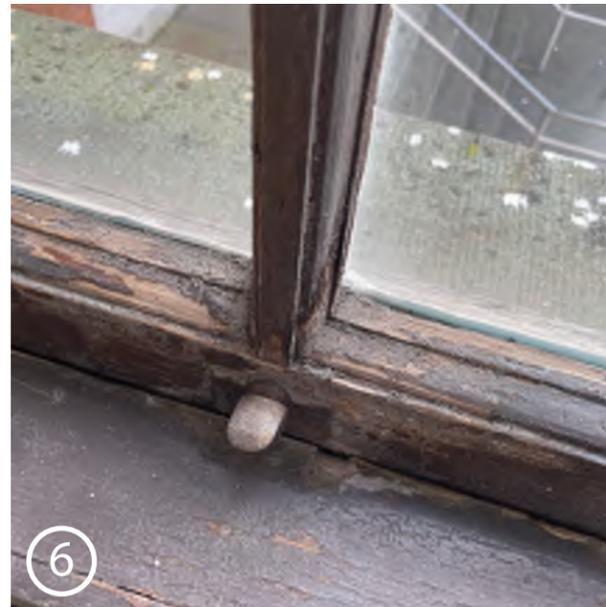
Window ID 1S.02 MODERATE CONDITION

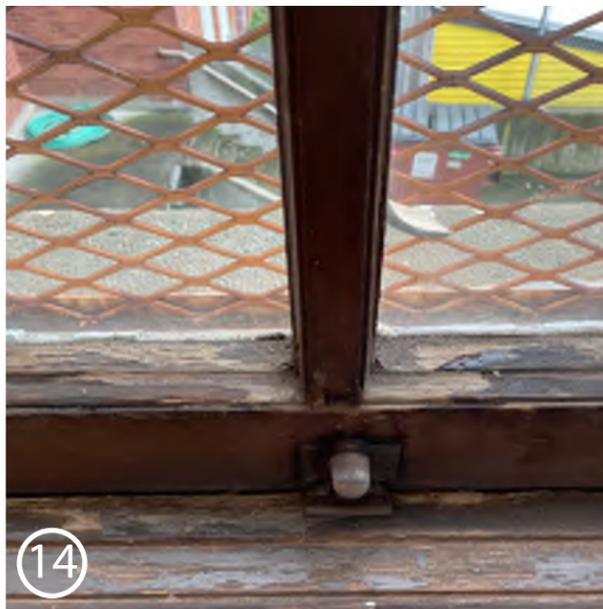
Window ID 1S.03 POOR CONDITION

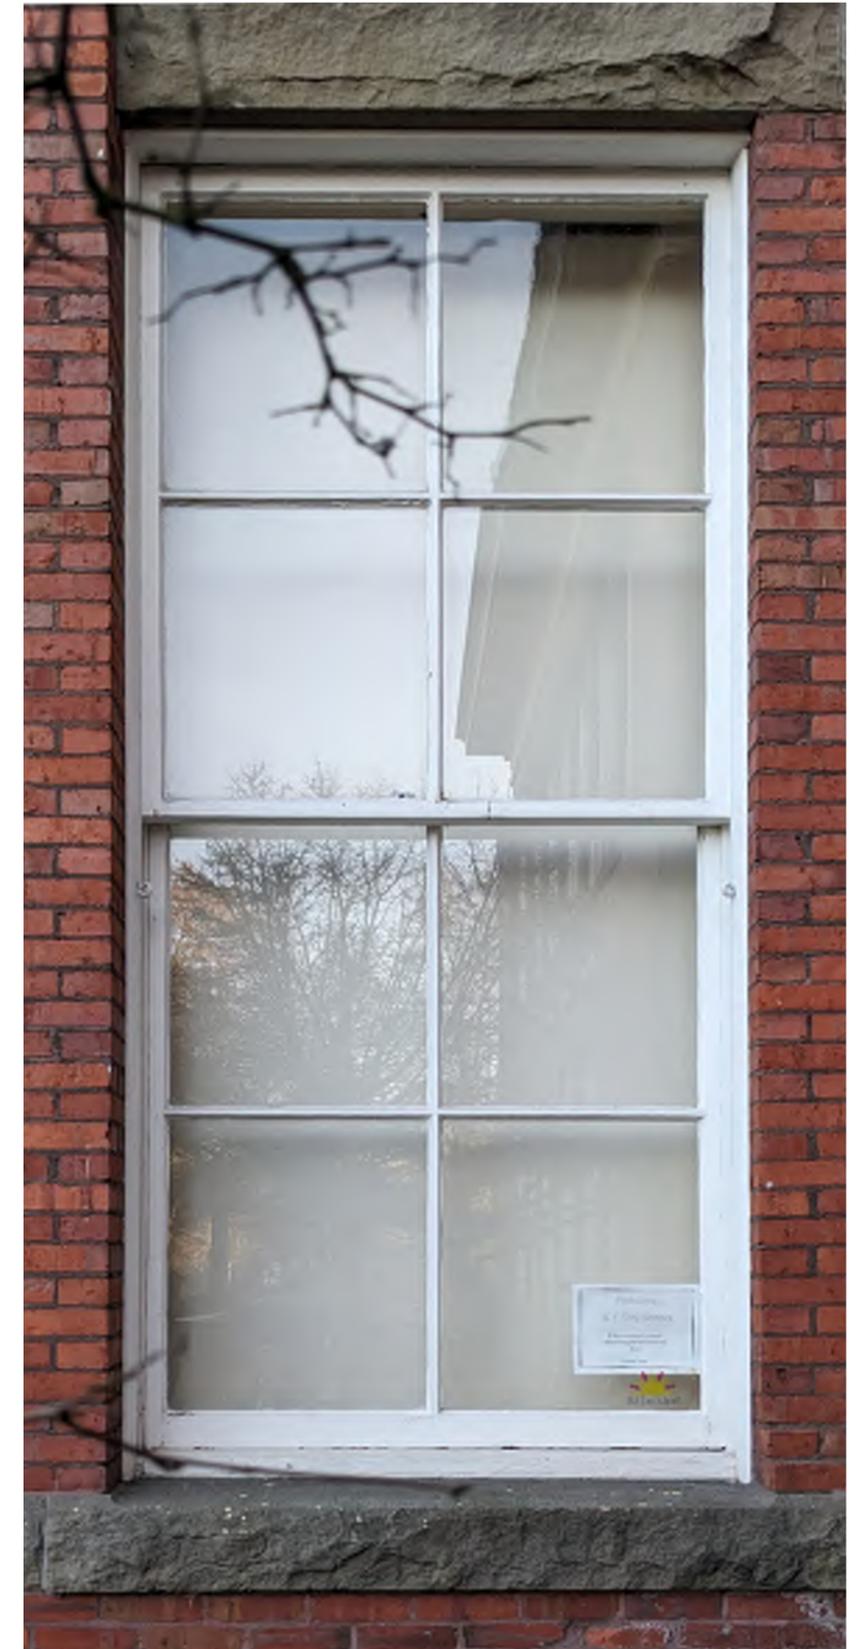
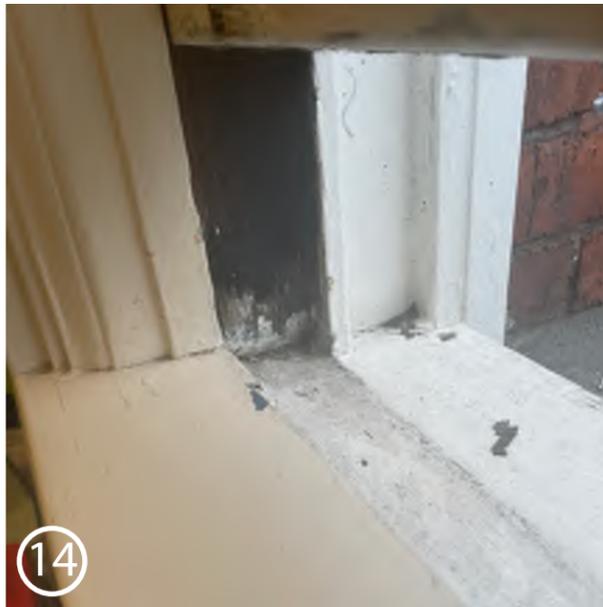
Window ID 1N.04 MODERATE CONDITION

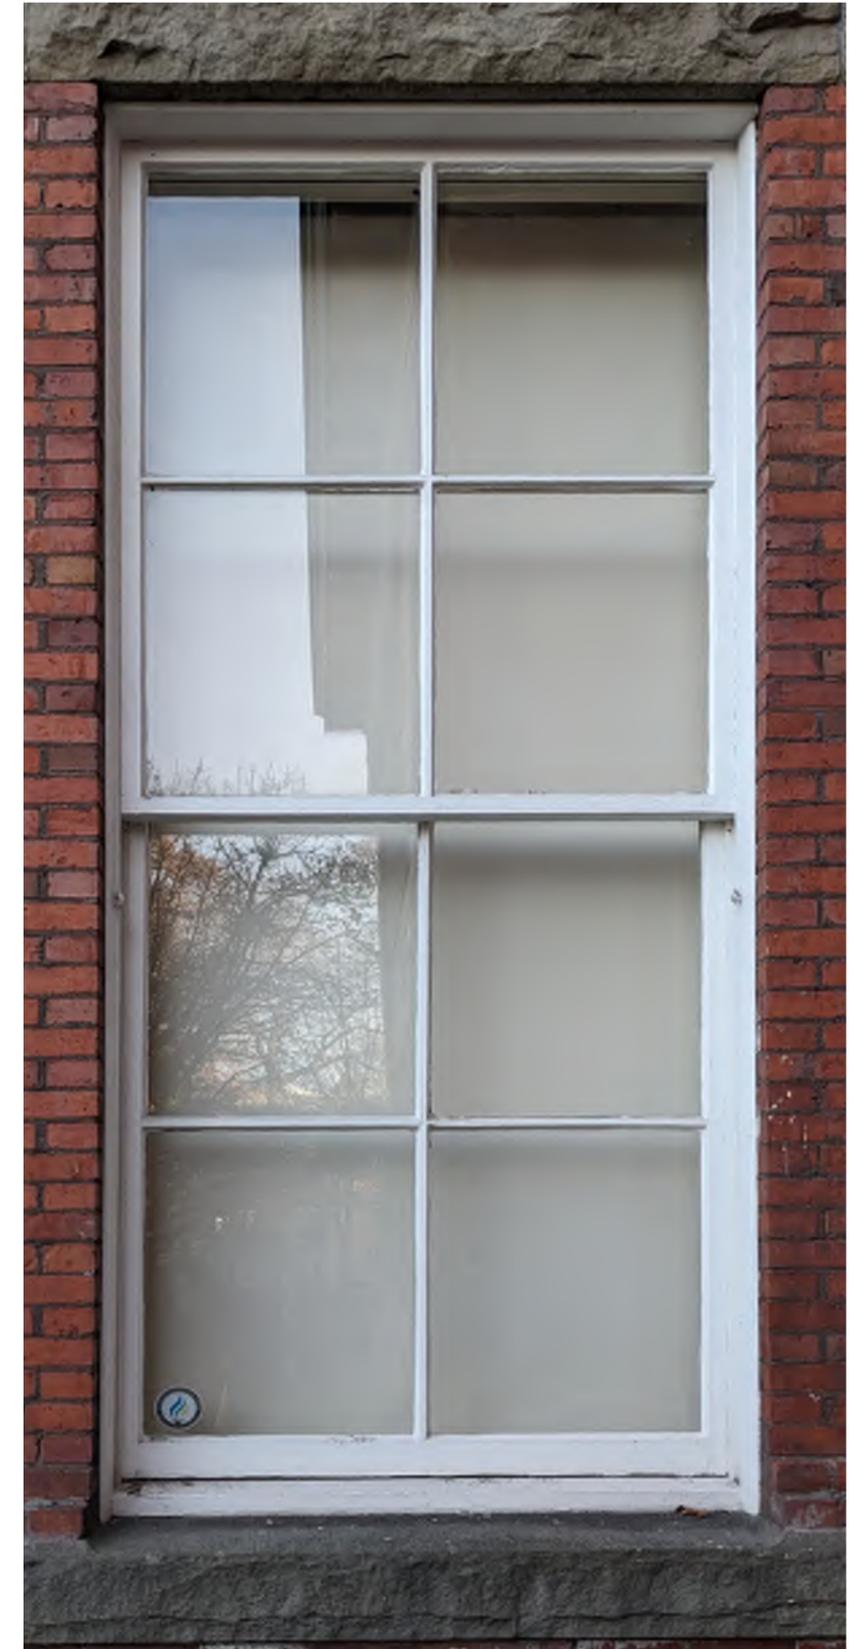
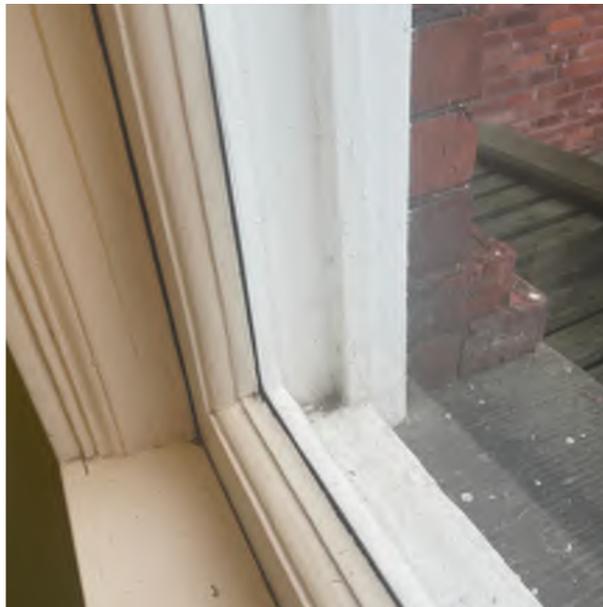
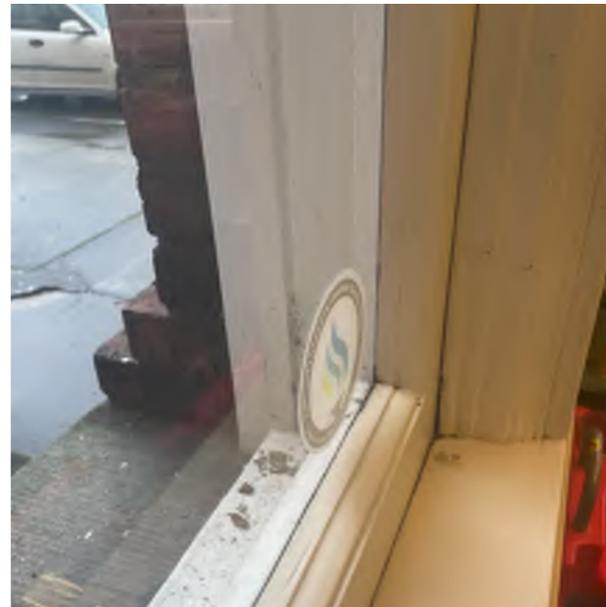
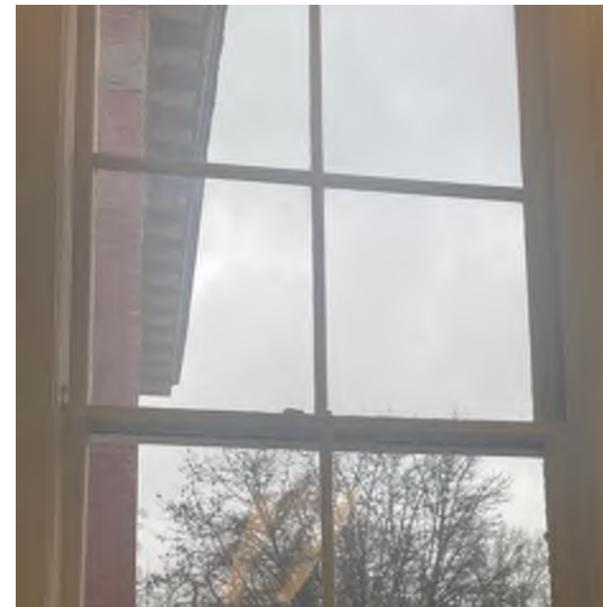
Window ID 1N.05 POOR CONDITION

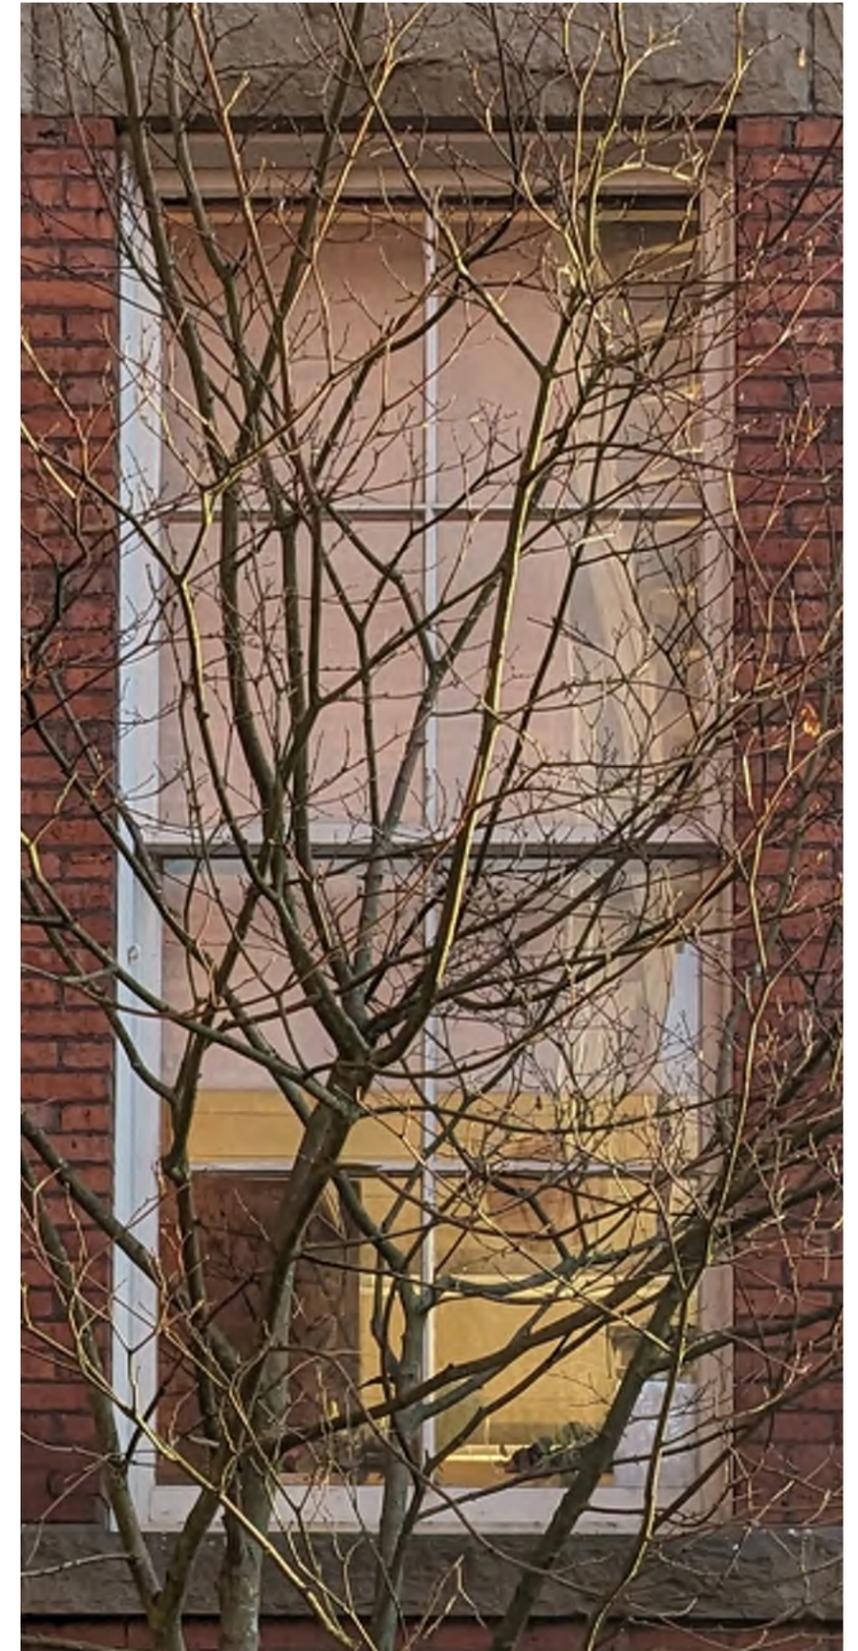
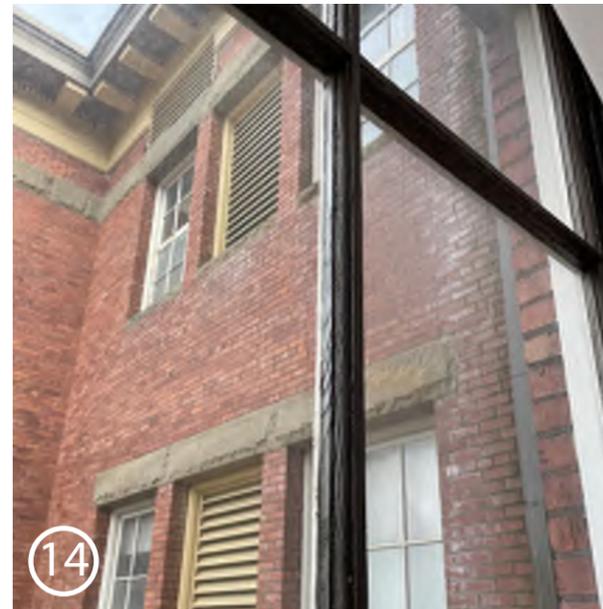
Window ID 1N.06 MODERATE CONDITION

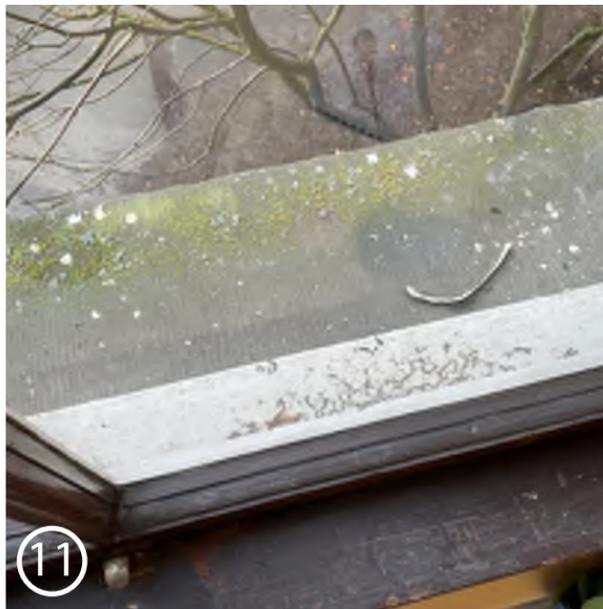
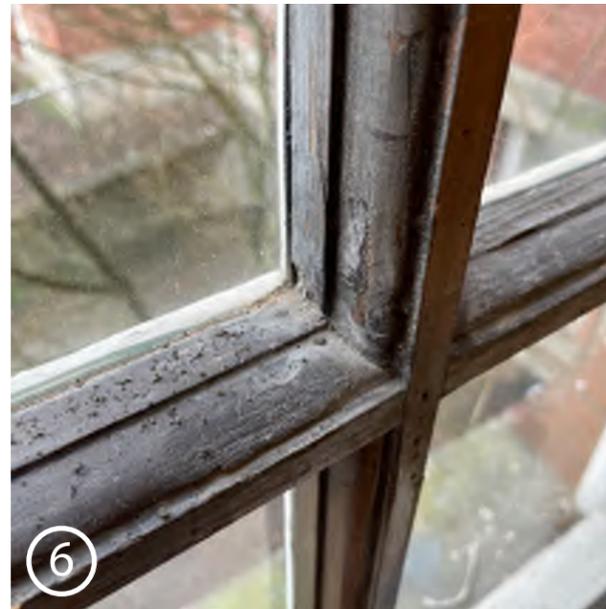
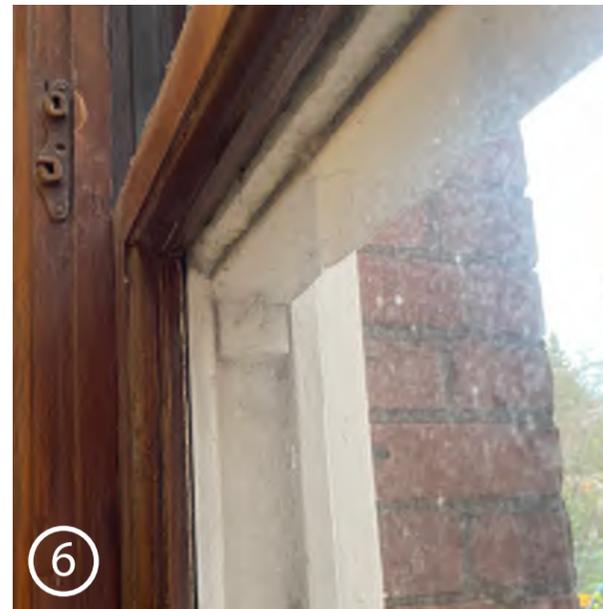
Window ID 1N.07 MODERATE CONDITION

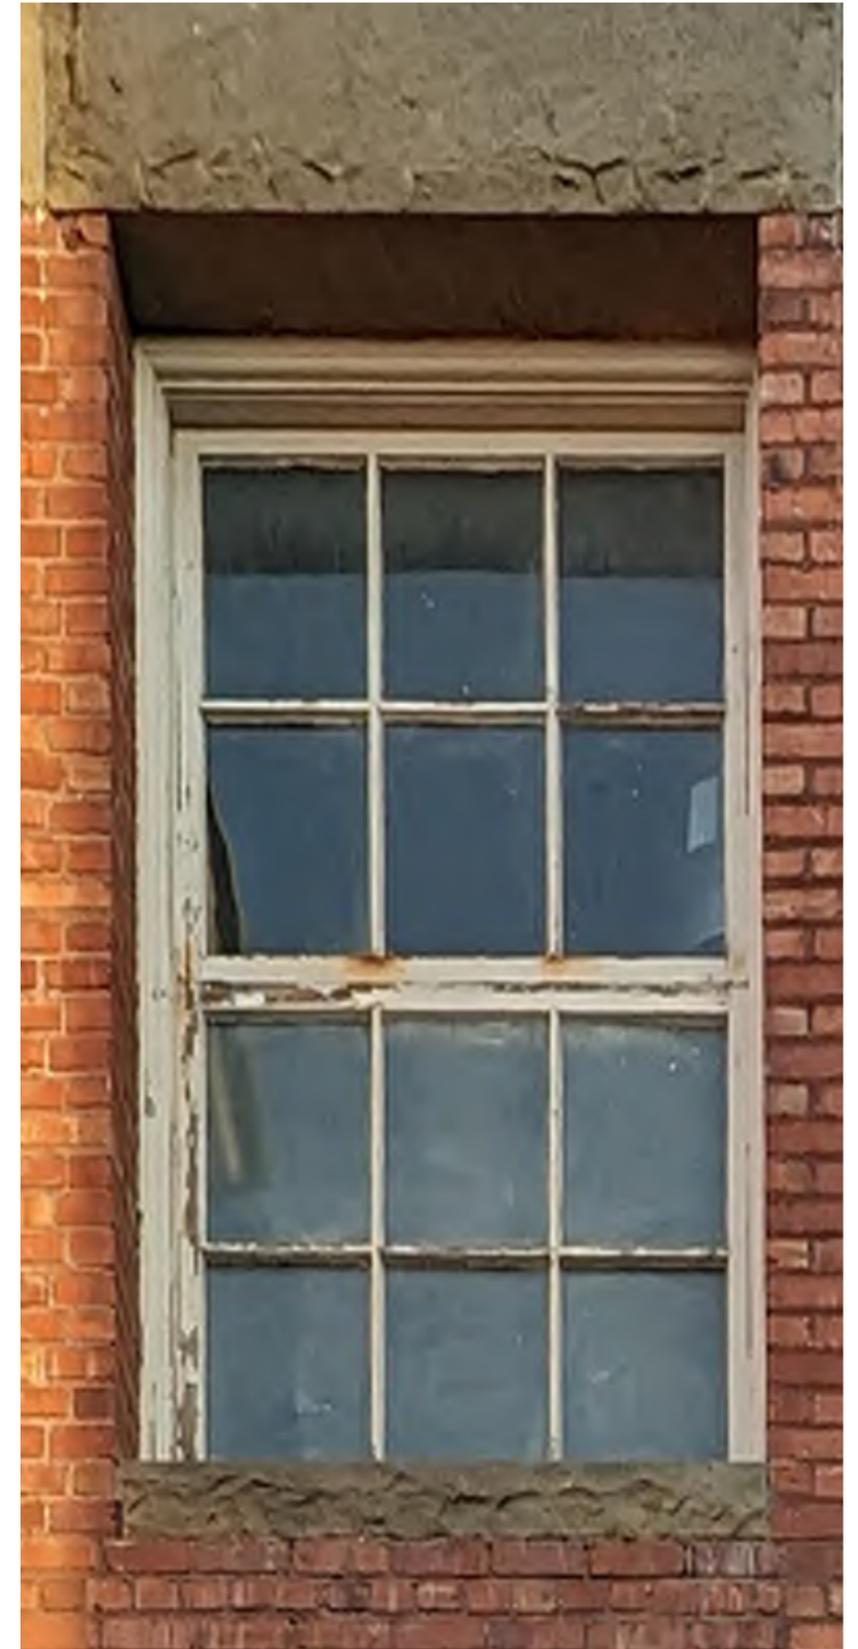
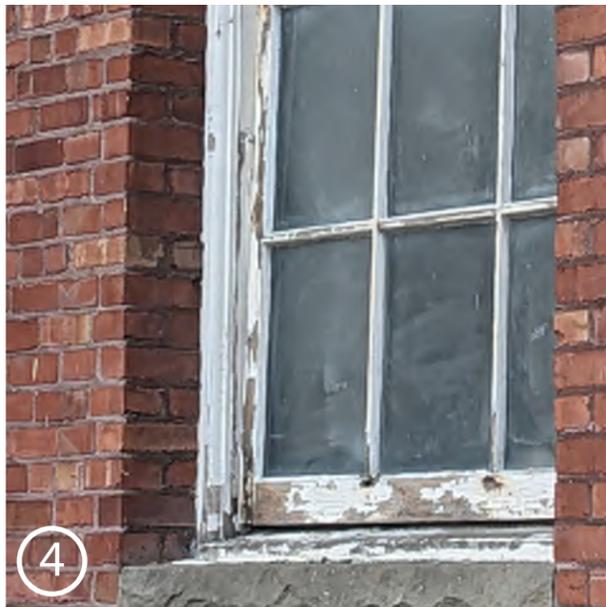
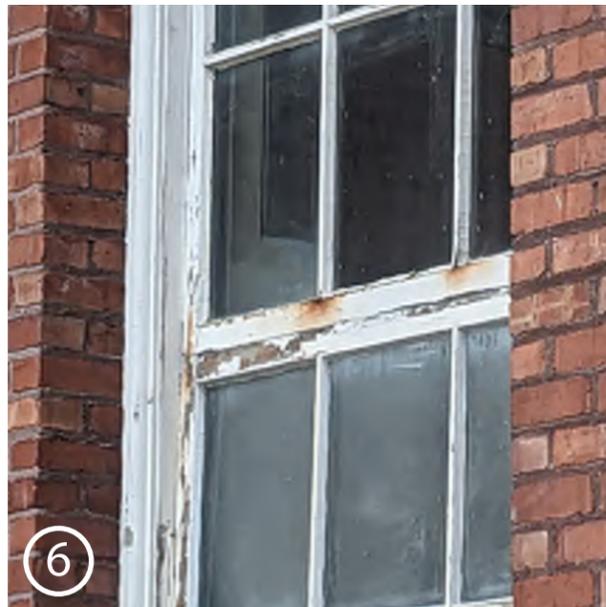
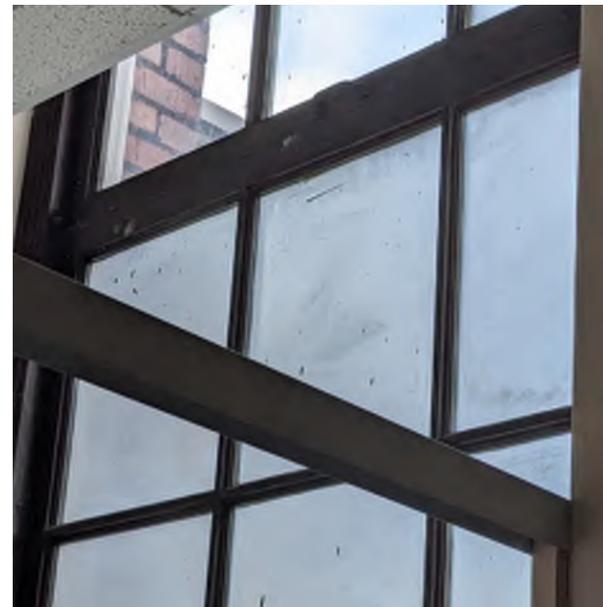
Window ID 2W.08 MODERATE CONDITION

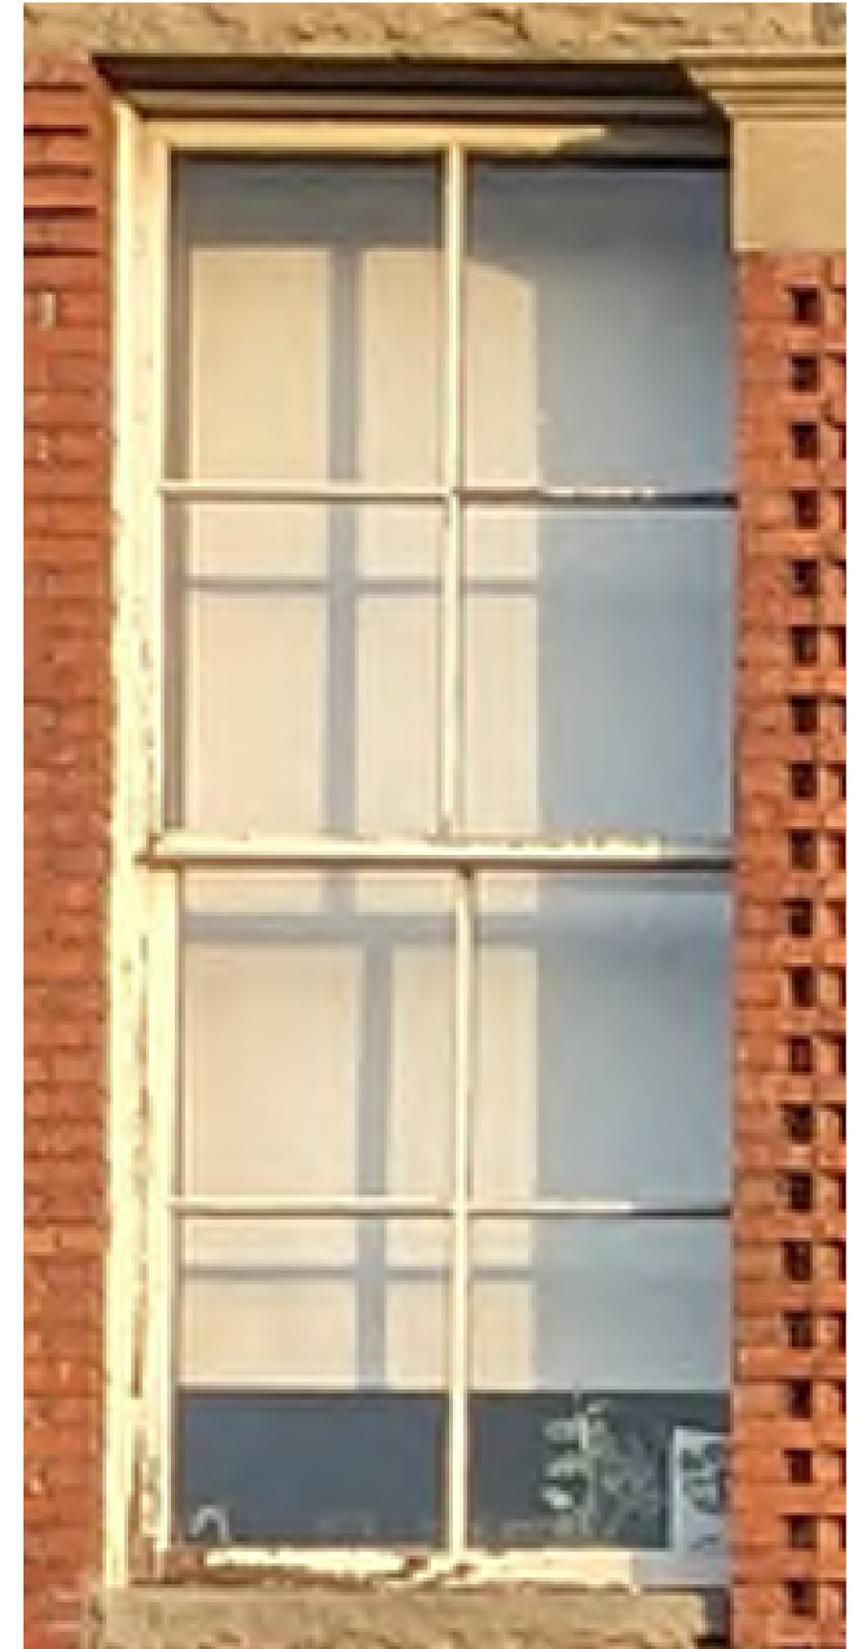
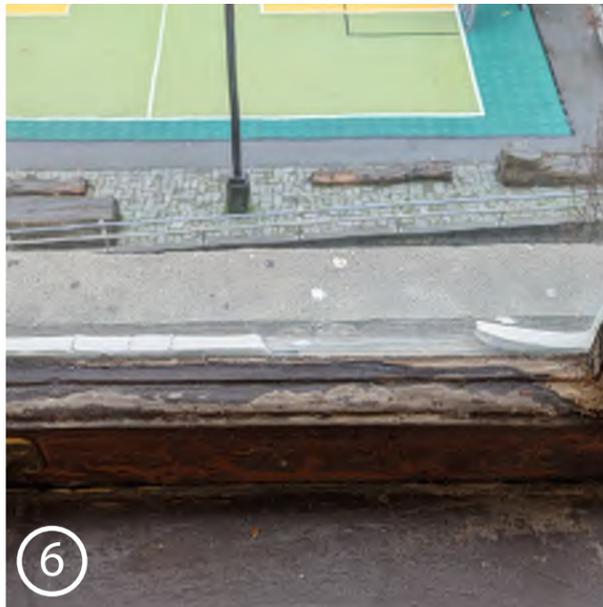
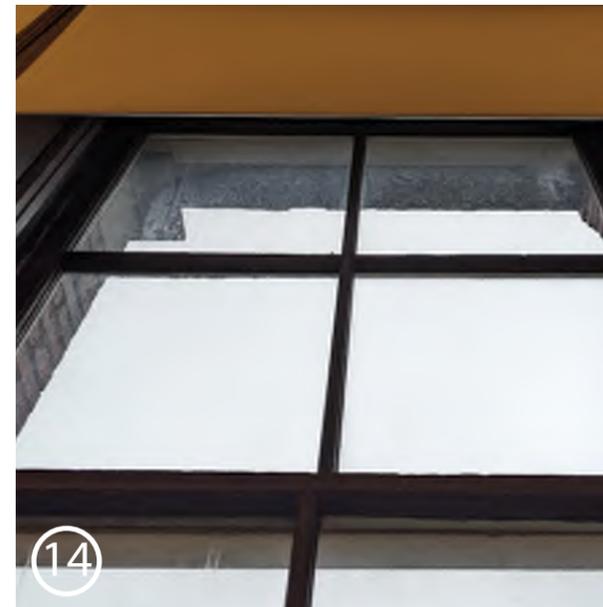
Window ID 2W.11 POOR CONDITION

1. Sash Operation Difficult/Won't Open
2. Inoperable – Screwed Shut **Holes in sash and frame where window was once screwed shut**
3. Exterior Paint at Sash and Trim Cracked and Peeling at Limited Areas

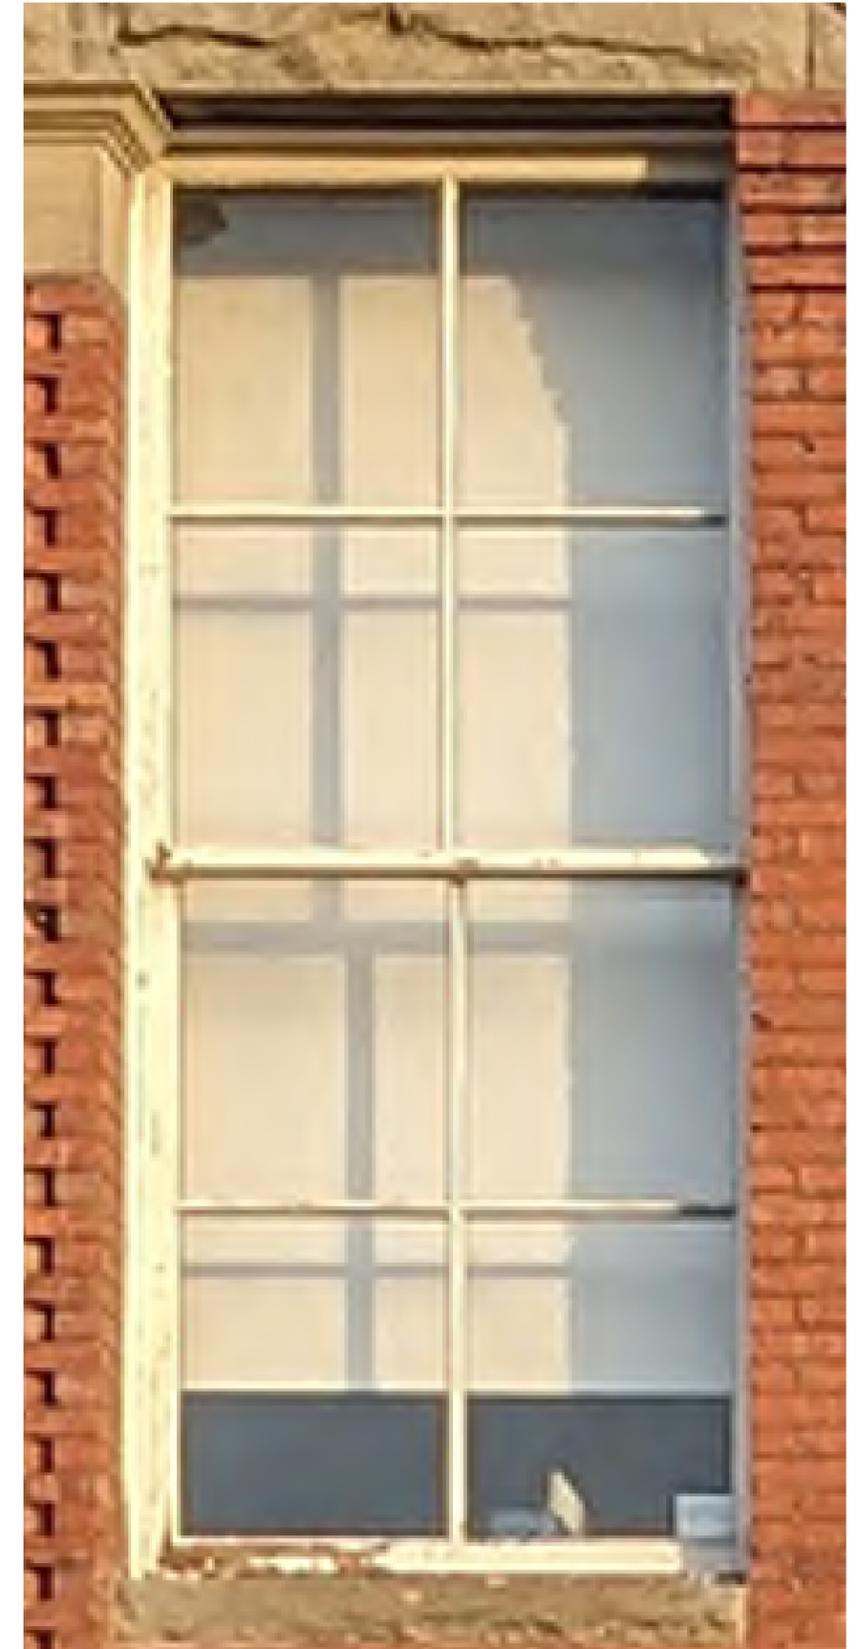
Window ID 2W.12 POOR CONDITION

- ① Sash Operation Difficult/Won't Open **Opens, but is difficult to close**
- 2. Inoperable – Screwed Shut
- ③ Exterior Paint at Sash and Trim Cracked and Peeling at Limited Areas

- 4. Exterior Paint at Sash and Trim Heavily Deteriorated
- 5. Checked Sash/Muntin
- ⑥ Deteriorated Sash
- 7. Checked/Split Frame
- ⑧ Deteriorated Frame **Typical at jamb**

- 13. Reinforced Sash (non-original)
- ⑭ Section Loss **Typical at muntins and jamb**
- 15. Missing Window Stop
- 16. Sealant Deteriorated
- 17. Weatherstrip Deteriorated/Missing
