Window Condition Assessment for B.F. Day Elementary School

on behalf of Seattle Public Schools

July 16, 2024

Miller Hayashi Architects PLLC

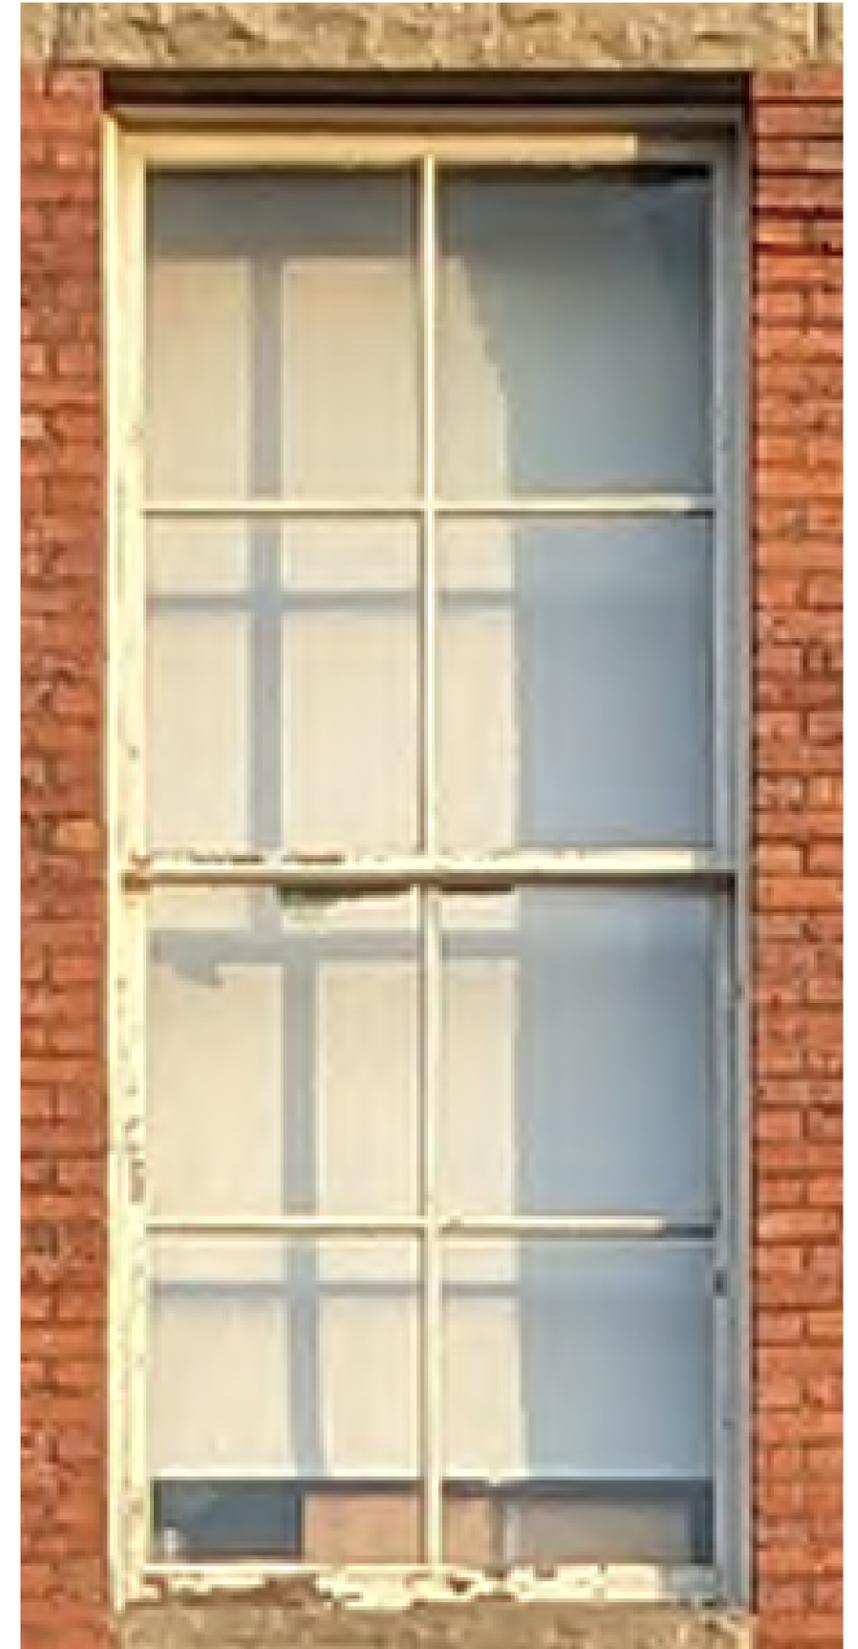
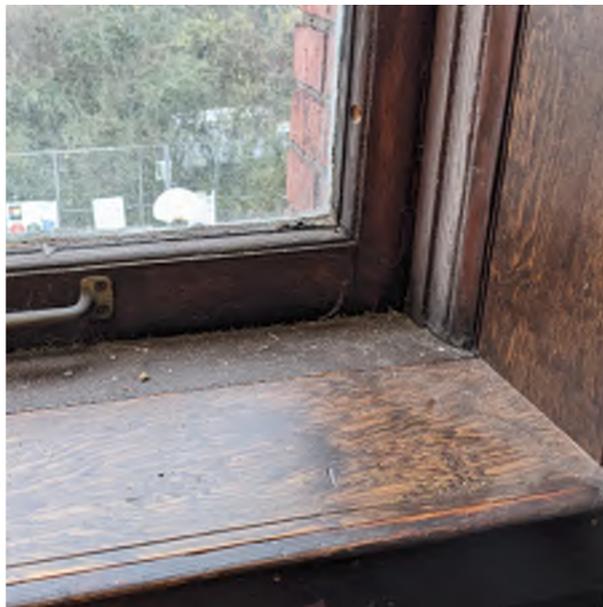
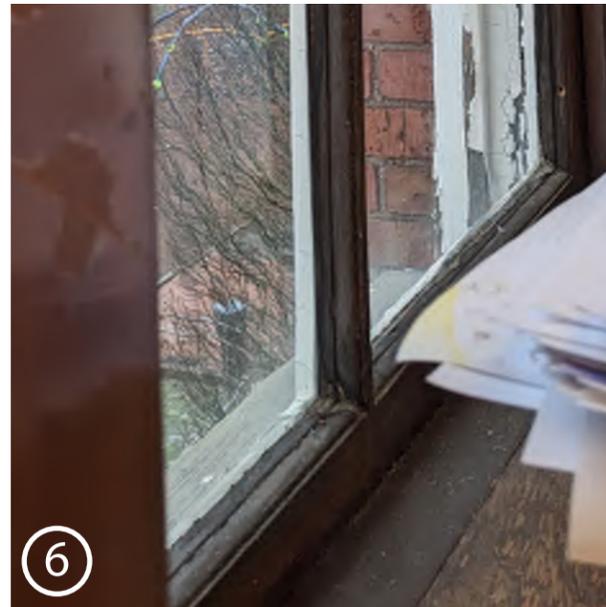
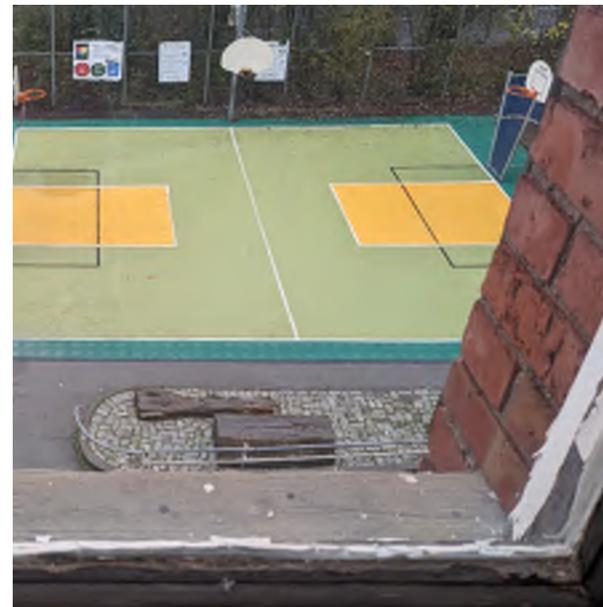
Window ID 2W.14 POOR CONDITION

- ① Sash Operation Difficult/Won't Open **Opens, but is difficult to close**
- ② Inoperable – Screwed Shut
- ③ Exterior Paint at Sash and Trim Cracked and Peeling at Limited Areas

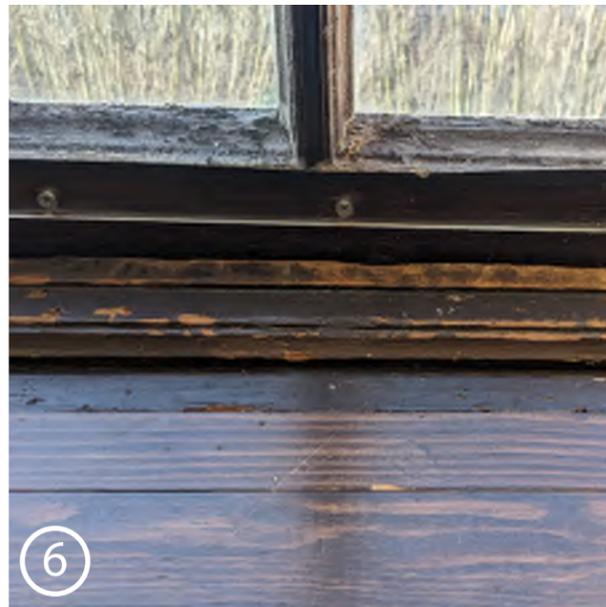
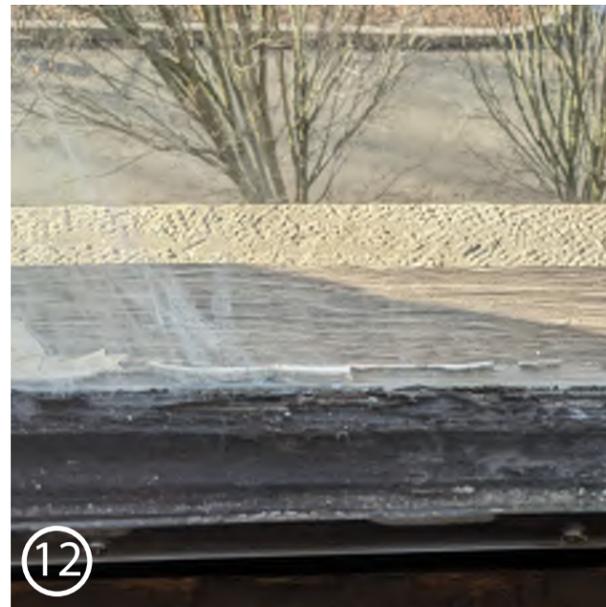
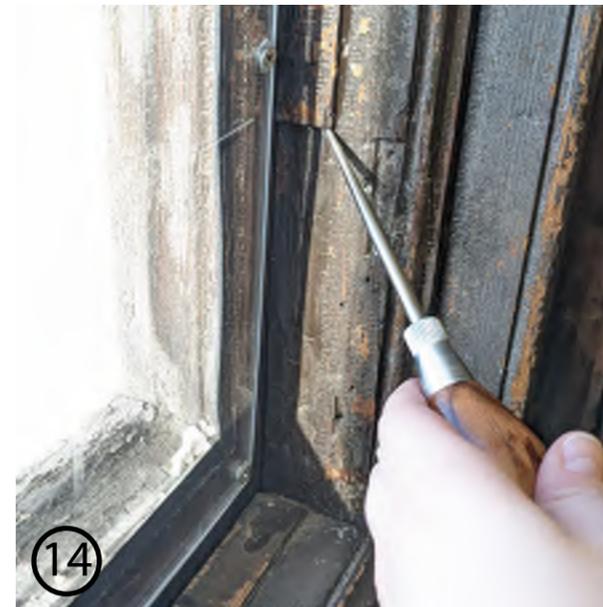
Window ID 2W.22 MODERATE CONDITION

● Interior plexiglass guard fastened to lower sash

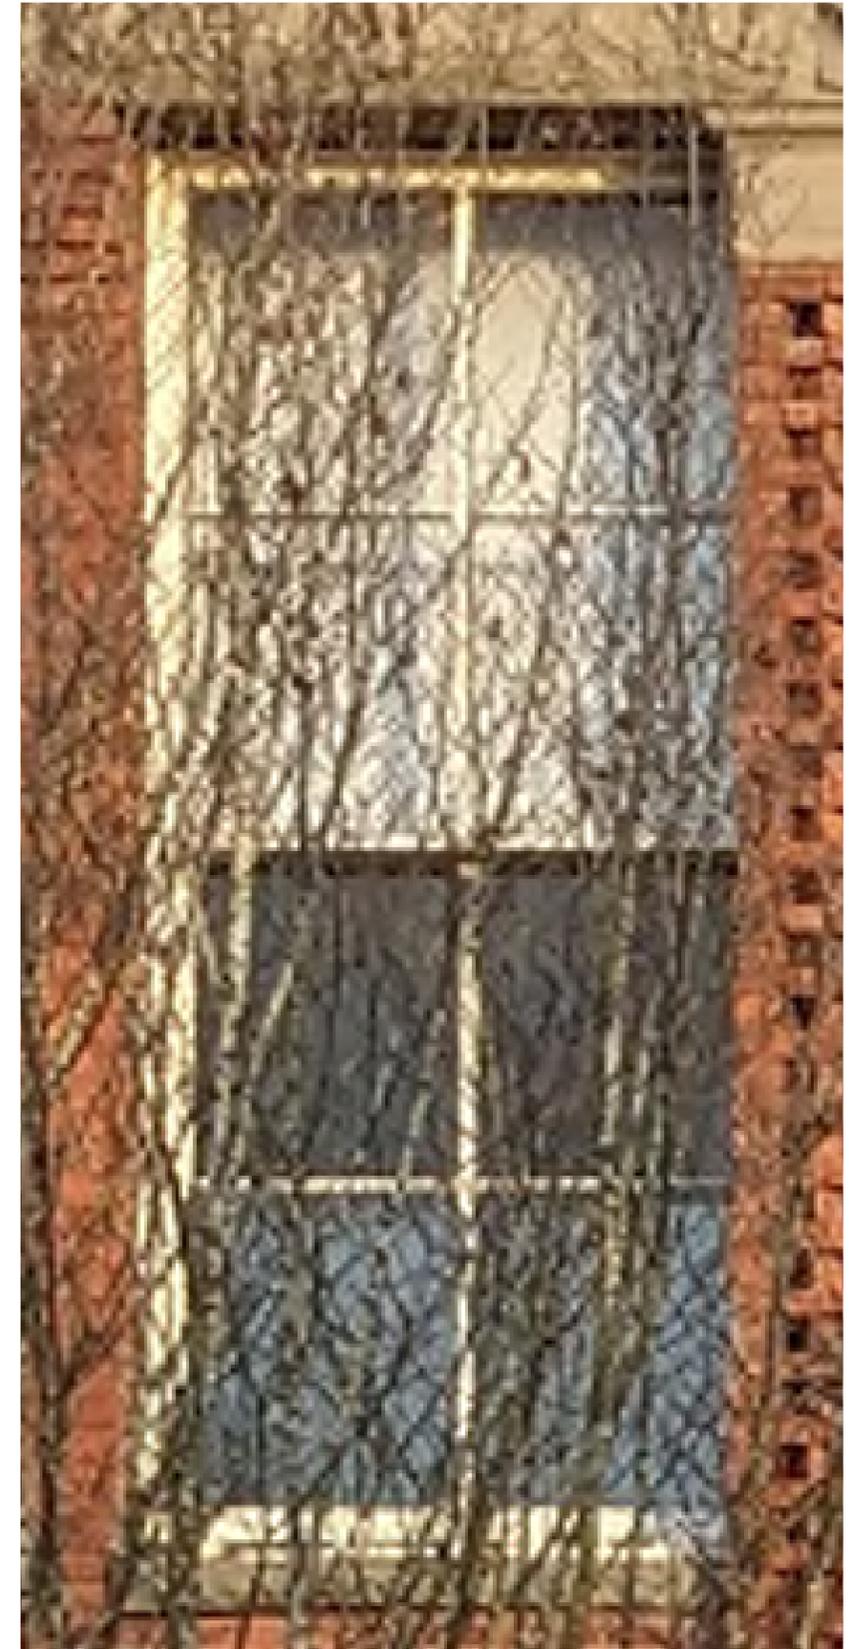
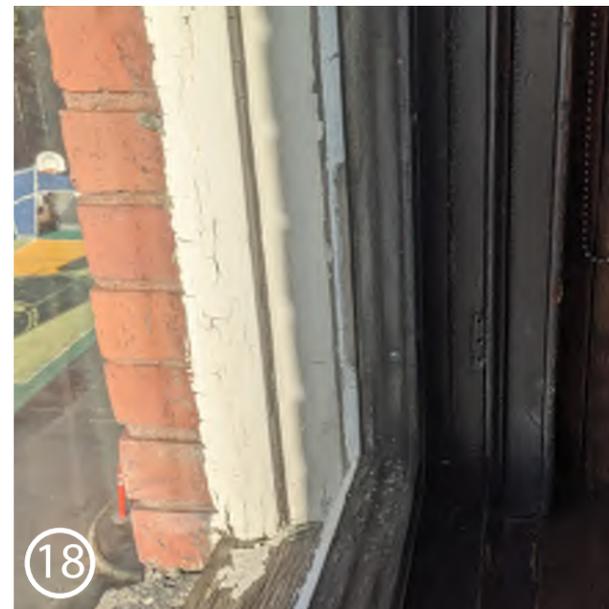
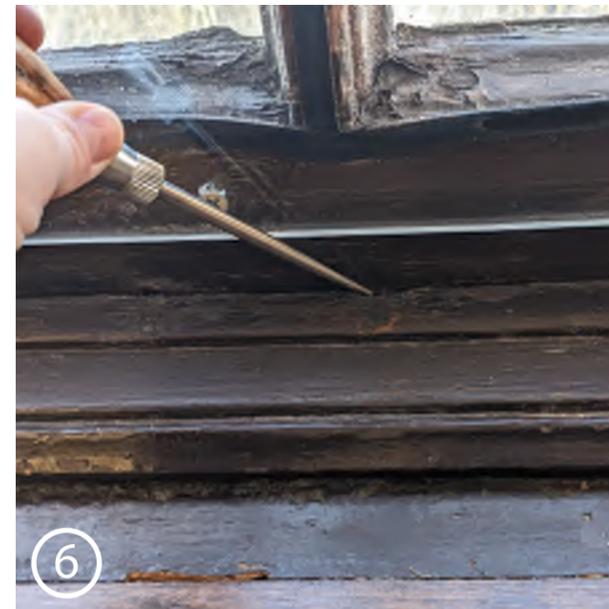
Window ID 2W.23 POOR CONDITION

● Interior plexiglass guard fastened to lower sash

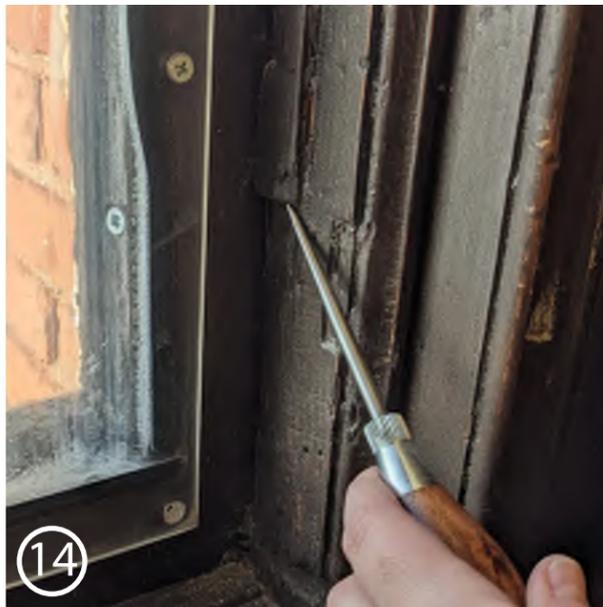
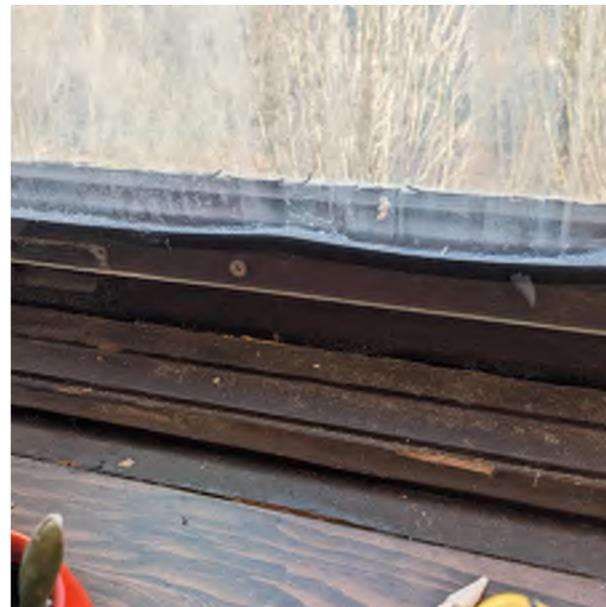
Window ID **2W.24** POOR CONDITION

● Interior plexiglass guard fastened to lower sash

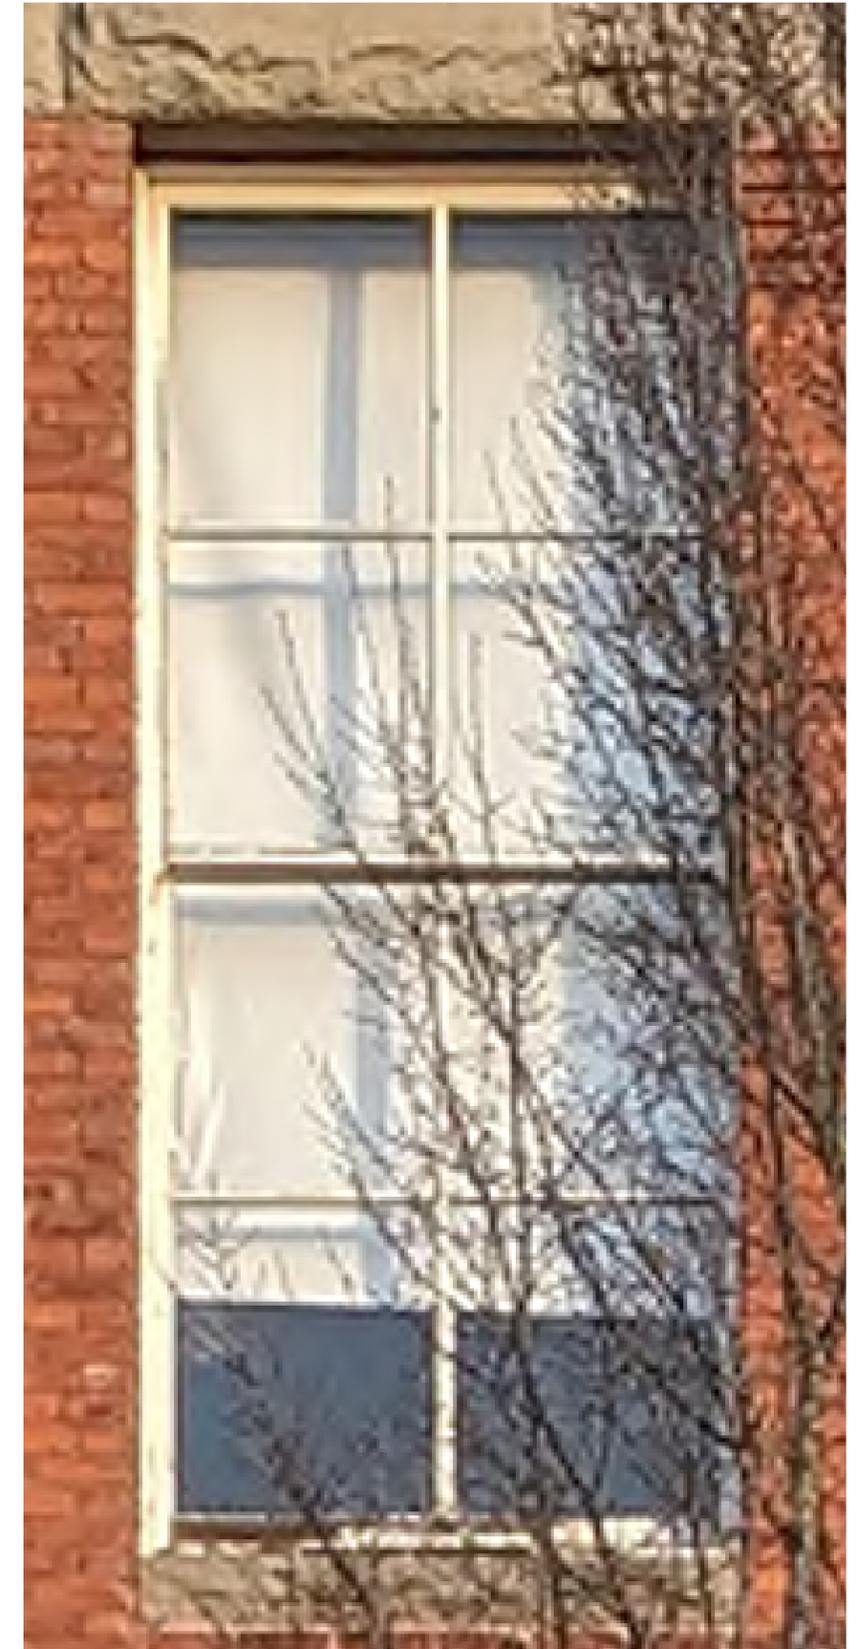
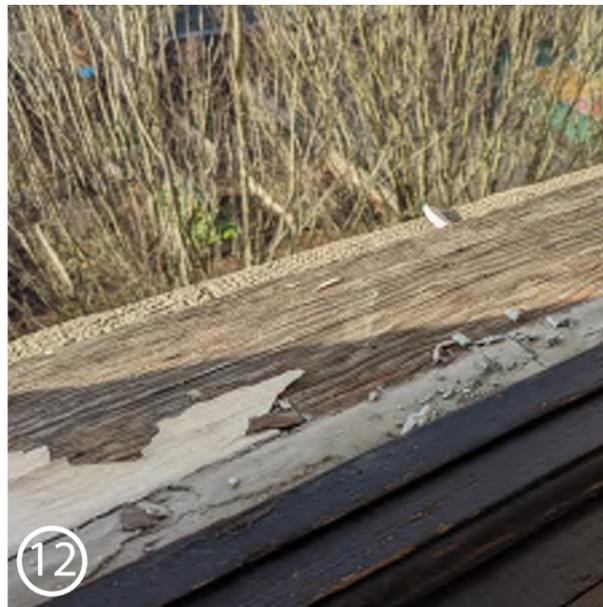
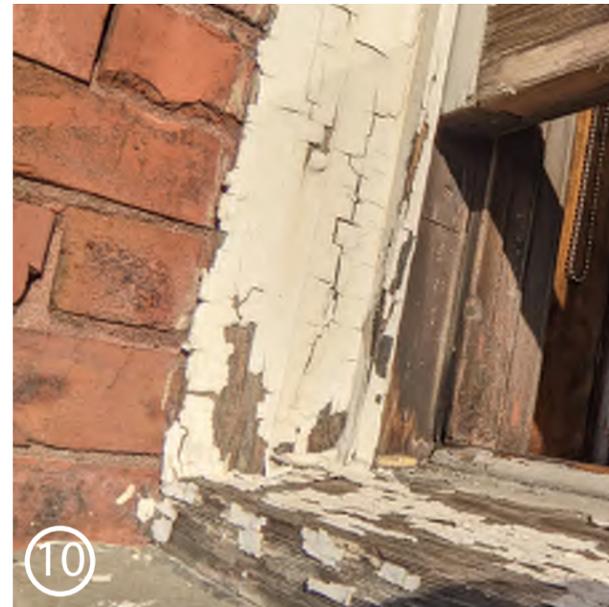
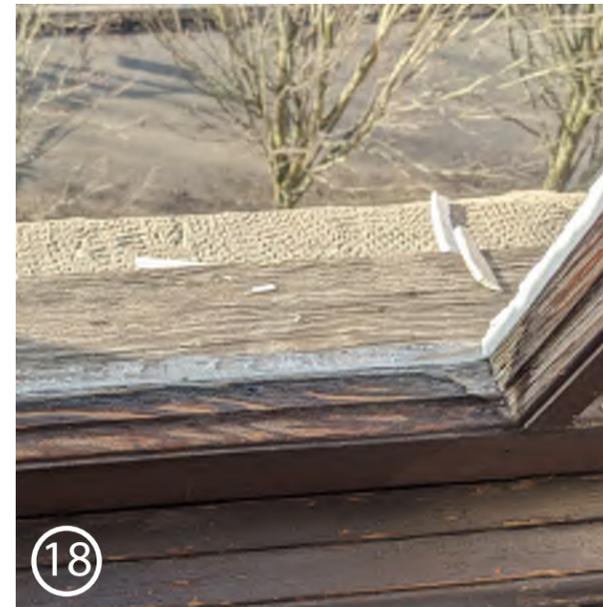
Window ID 2W.26 POOR CONDITION

- 1. Sash Operation Difficult/Won't Open
- 2. Inoperable – Screwed Shut
- 3. Exterior Paint at Sash and Trim Cracked and Peeling at Limited Areas
- 4. Exterior Paint at Sash and Trim Heavily Deteriorated

- 5. Checked Sash/Muntin
- 6. Deteriorated Sash
- 7. Checked/Split Frame
- 8. Deteriorated Frame
- 9. Parting Bead Lightly Deteriorated
- 10. Parting Bead Missing or Heavily Deteriorated

- 11. Sill 20% or Less Deteriorated
- 12. Sill Heavily Deteriorated, Wood Consolidation Necessary for More Than 20% of the Sill
- 13. Reinforced Sash (non-original)

- 14. Section Loss
- 15. Missing Window Stop
- 16. Sealant Deteriorated
- 17. Weatherstrip Deteriorated/Missing
- 18. Deteriorated Glazing Compound/Setting Bead/Glazing Putty

- 19. Sash Pull Hardware Missing
- 20. Sash Lock Damaged/Missing/Not Engaging/No Lock
- 21. Retrofitted Window Limiter
- 22. Leaking or Visible Gap to Exterior When Closed **Top sash is not set in frame**

- 23. Replaced Glazing
- 24. Cracked Glazing
- 25. Missing Glazing

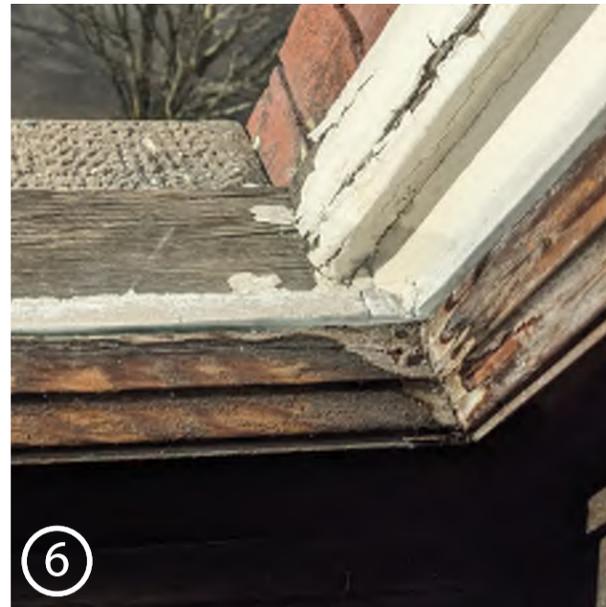
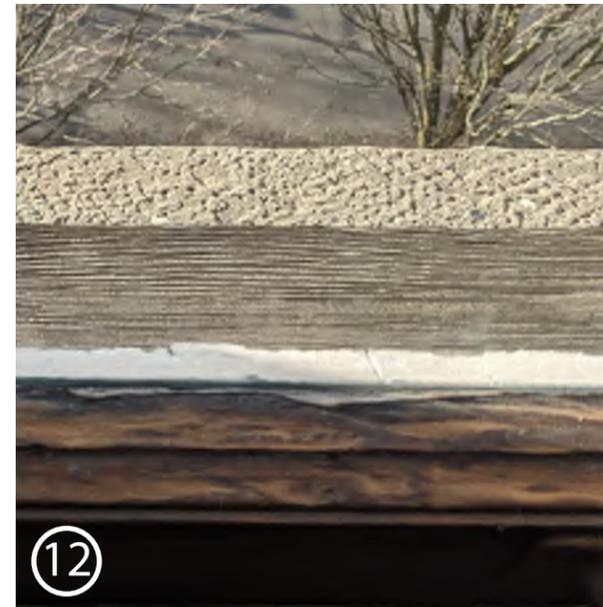
Window ID 2W.27 POOR CONDITION

1. Sash Operation Difficult/Won't Open
2. Inoperable – Screwed Shut
3. Exterior Paint at Sash and Trim Cracked and Peeling at Limited Areas
4. Exterior Paint at Sash and Trim Heavily Deteriorated

5. Checked Sash/Muntin
6. Deteriorated Sash
7. Checked/Split Frame
8. Deteriorated Frame
9. Parting Bead Lightly Deteriorated
10. Parting Bead Missing or Heavily Deteriorated

11. Sill 20% or Less Deteriorated
12. Sill Heavily Deteriorated, Wood Consolidation Necessary for More Than 20% of the Sill
13. Reinforced Sash (non-original)

14. Section Loss
15. Missing Window Stop
16. Sealant Deteriorated
17. Weatherstrip Deteriorated/Missing
18. Deteriorated Glazing Compound/Setting Bead/Glazing Putty

19. Sash Pull Hardware Missing
20. Sash Lock Damaged/Missing/Not Engaging/No Lock
21. Retrofitted Window Limiter
22. Leaking or Visible Gap to Exterior When Closed

23. Replaced Glazing
24. Cracked Glazing
25. Missing Glazing

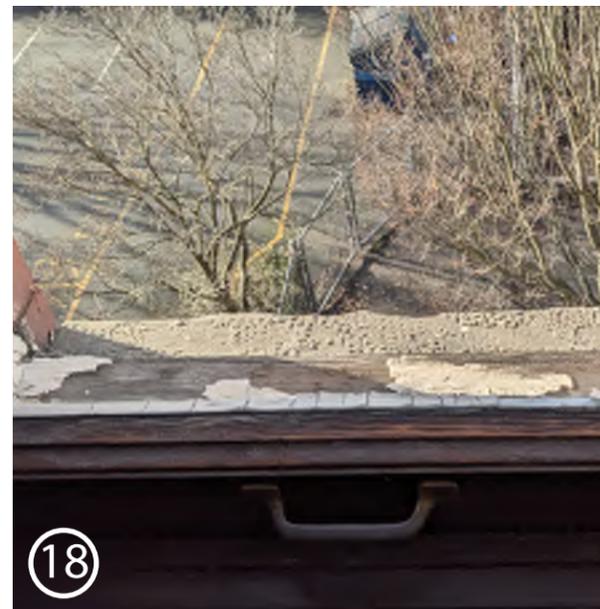
Window ID 2W.28 POOR CONDITION

1. Sash Operation Difficult/Won't Open
2. Inoperable – Screwed Shut
3. Exterior Paint at Sash and Trim Cracked and Peeling at Limited Areas
- ④ Exterior Paint at Sash and Trim Heavily Deteriorated

5. Checked Sash/Muntin
- ⑥ Deteriorated Sash
7. Checked/Split Frame
8. Deteriorated Frame
9. Parting Bead Lightly Deteriorated
- ⑩ Parting Bead Missing or Heavily Deteriorated

11. Sill 20% or Less Deteriorated
- ⑫ Sill Heavily Deteriorated, Wood Consolidation Necessary for More Than 20% of the Sill
13. Reinforced Sash (non-original)

- ⑭ Section Loss
15. Missing Window Stop
16. Sealant Deteriorated
17. Weatherstrip Deteriorated/Missing
- ⑮ Deteriorated Glazing Compound/Setting Bead/Glazing Putty

19. Sash Pull Hardware Missing
20. Sash Lock Damaged/Missing/Not Engaging/No Lock
21. Retrofitted Window Limiter
22. Leaking or Visible Gap to Exterior When Closed

23. Replaced Glazing
24. Cracked Glazing
25. Missing Glazing

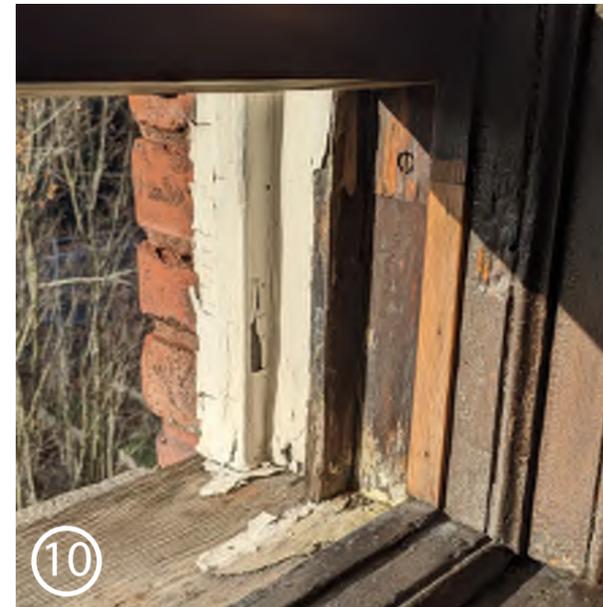
Window ID **2W.29** POOR CONDITION

1. Sash Operation Difficult/Won't Open
2. Inoperable – Screwed Shut
3. Exterior Paint at Sash and Trim Cracked and Peeling at Limited Areas
4. Exterior Paint at Sash and Trim Heavily Deteriorated

5. Checked Sash/Muntin
6. Deteriorated Sash
7. Checked/Split Frame
8. Deteriorated Frame
9. Parting Bead Lightly Deteriorated
10. Parting Bead Missing or Heavily Deteriorated

11. Sill 20% or Less Deteriorated
12. Sill Heavily Deteriorated, Wood Consolidation Necessary for More Than 20% of the Sill
13. Reinforced Sash (non-original)

14. Section Loss
15. Missing Window Stop
16. Sealant Deteriorated
17. Weatherstrip Deteriorated/Missing
18. Deteriorated Glazing Compound/Setting Bead/Glazing Putty

19. Sash Pull Hardware Missing
20. Sash Lock Damaged/Missing/Not Engaging/No Lock
21. Retrofitted Window Limiter
22. Leaking or Visible Gap to Exterior When Closed

23. Replaced Glazing
24. Cracked Glazing
25. Missing Glazing

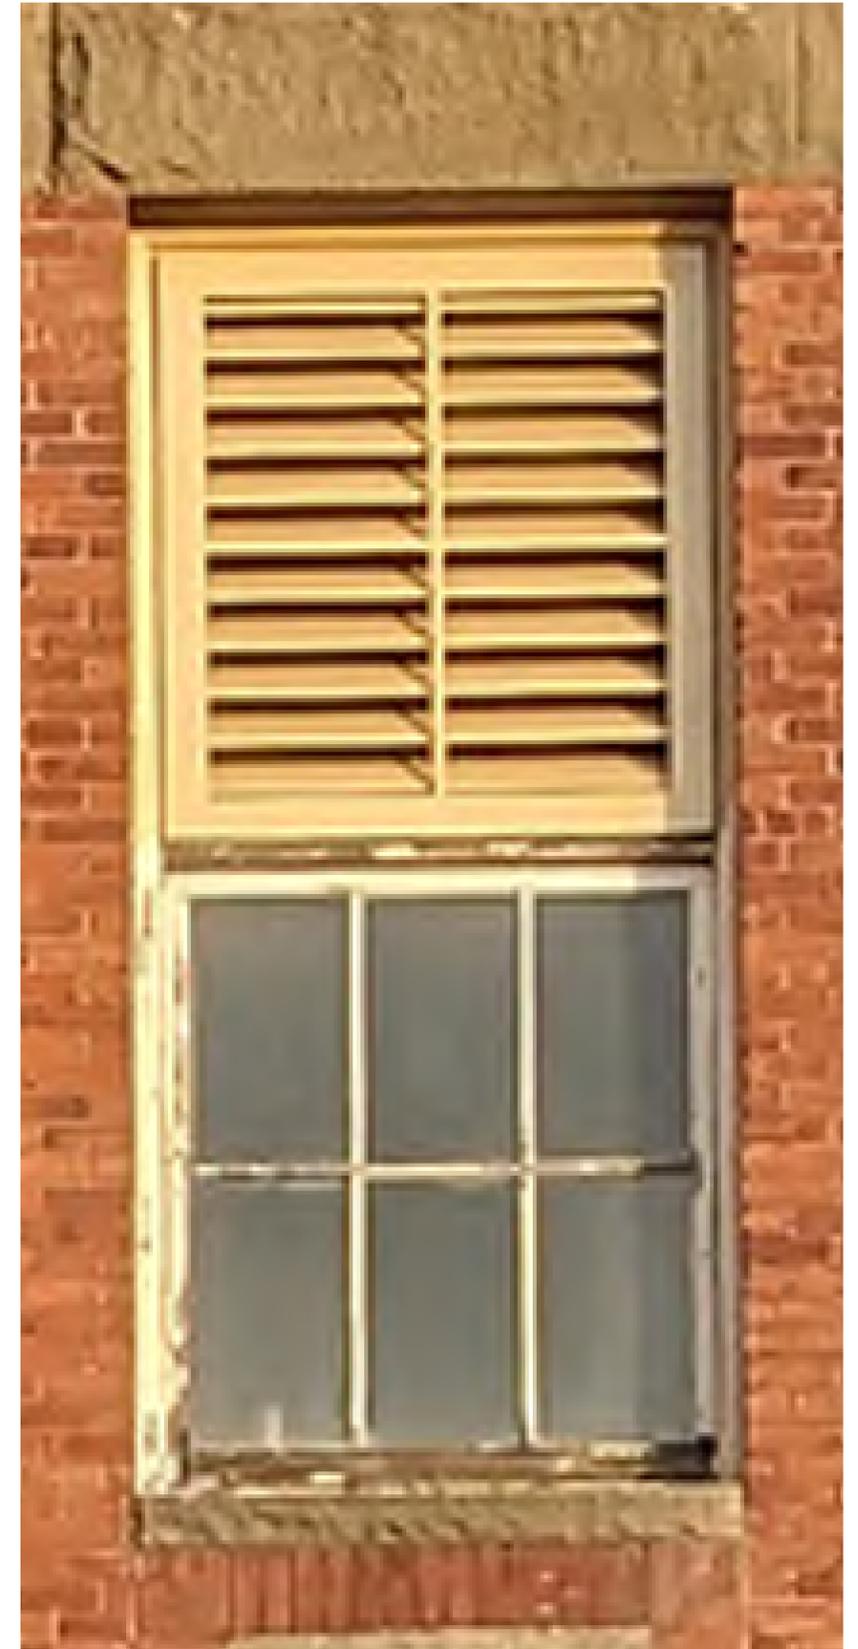
Window ID 2W.30 POOR CONDITION

1. Sash Operation Difficult/Won't Open
2. Inoperable – Screwed Shut
3. Exterior Paint at Sash and Trim Cracked and Peeling at Limited Areas
4. Exterior Paint at Sash and Trim Heavily Deteriorated

5. Checked Sash/Muntin
6. Deteriorated Sash
7. Checked/Split Frame
8. Deteriorated Frame
9. Parting Bead Lightly Deteriorated
10. Parting Bead Missing or Heavily Deteriorated

11. Sill 20% or Less Deteriorated
12. Sill Heavily Deteriorated, Wood Consolidation Necessary for More Than 20% of the Sill
13. Reinforced Sash (non-original)

14. Section Loss
15. Missing Window Stop
16. Sealant Deteriorated
17. Weatherstrip Deteriorated/Missing
18. Deteriorated Glazing Compound/Setting Bead/Glazing Putty

19. Sash Pull Hardware Missing
20. Sash Lock Damaged/Missing/Not Engaging/No Lock
21. Retrofitted Window Limiter
22. Leaking or Visible Gap to Exterior When Closed

23. Replaced Glazing
24. Cracked Glazing
25. Missing Glazing

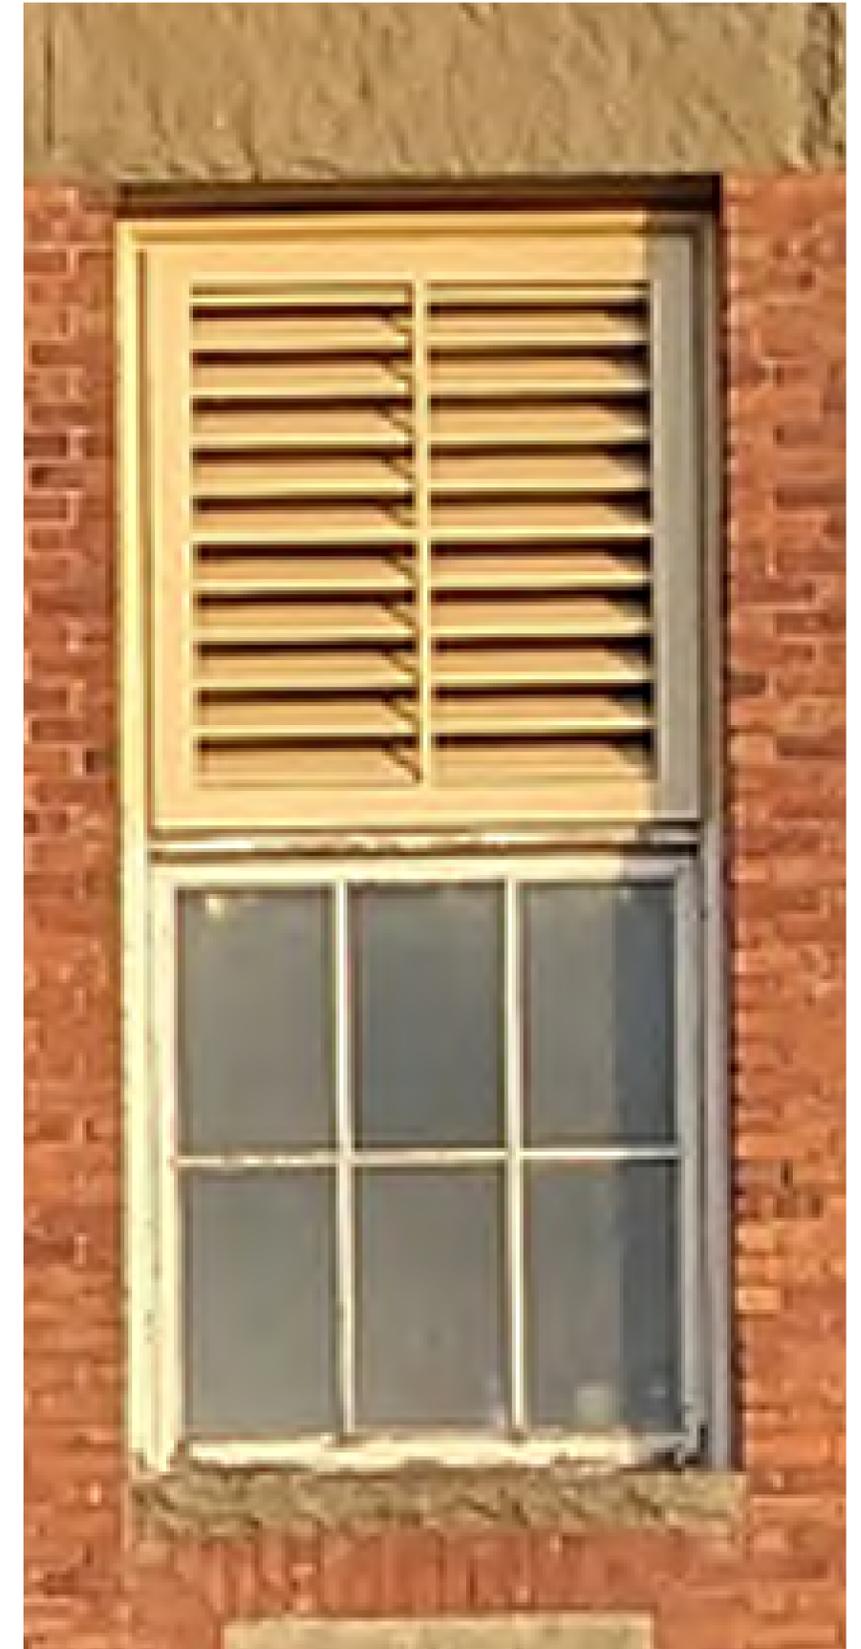
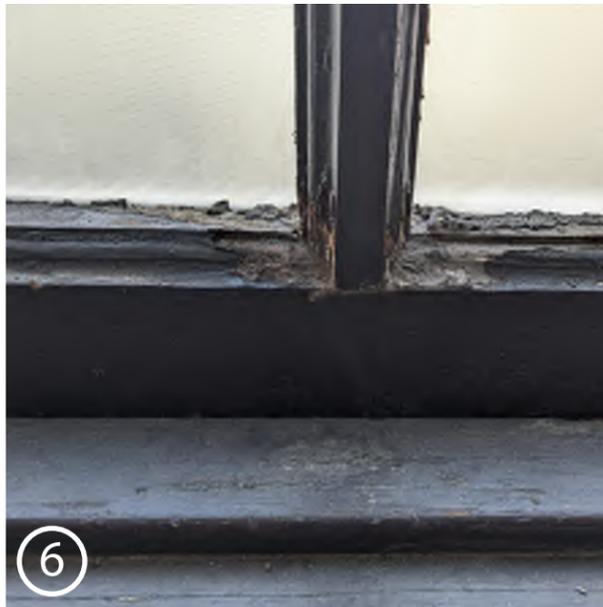
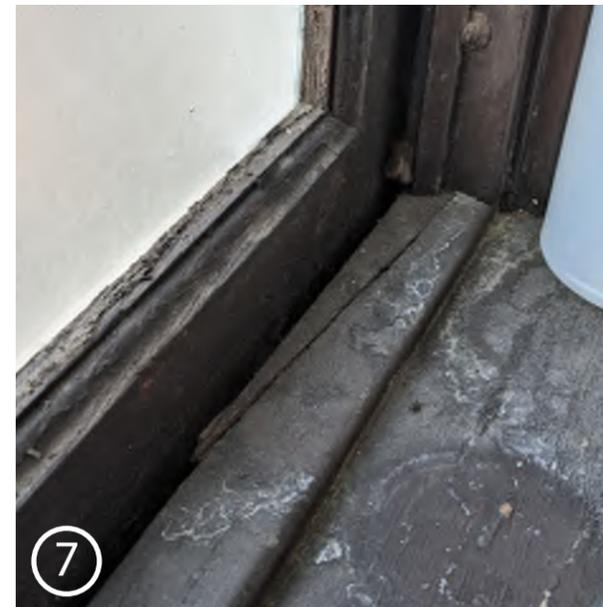
Window ID 2W.31 MODERATE CONDITION

1. Sash Operation Difficult/Won't Open
- ② Inoperable – Screwed Shut
3. Exterior Paint at Sash and Trim Cracked and Peeling at Limited Areas
- ④ Exterior Paint at Sash and Trim Heavily Deteriorated

5. Checked Sash/Muntin
- ⑥ Deteriorated Sash
7. Checked/Split Frame
8. Deteriorated Frame
9. Parting Bead Lightly Deteriorated
10. Parting Bead Missing or Heavily Deteriorated

11. Sill 20% or Less Deteriorated
- ⑫ Sill Heavily Deteriorated, Wood Consolidation Necessary for More Than 20% of the Sill
13. Reinforced Sash (non-original)

- ⑭ Section Loss
15. Missing Window Stop
16. Sealant Deteriorated
17. Weatherstrip Deteriorated/Missing
18. Deteriorated Glazing Compound/Setting Bead/Glazing Putty

19. Sash Pull Hardware Missing
20. Sash Lock Damaged/Missing/Not Engaging/No Lock
21. Retrofitted Window Limiter
- ⑳ Leaking or Visible Gap to Exterior When Closed

23. Replaced Glazing
24. Cracked Glazing
25. Missing Glazing

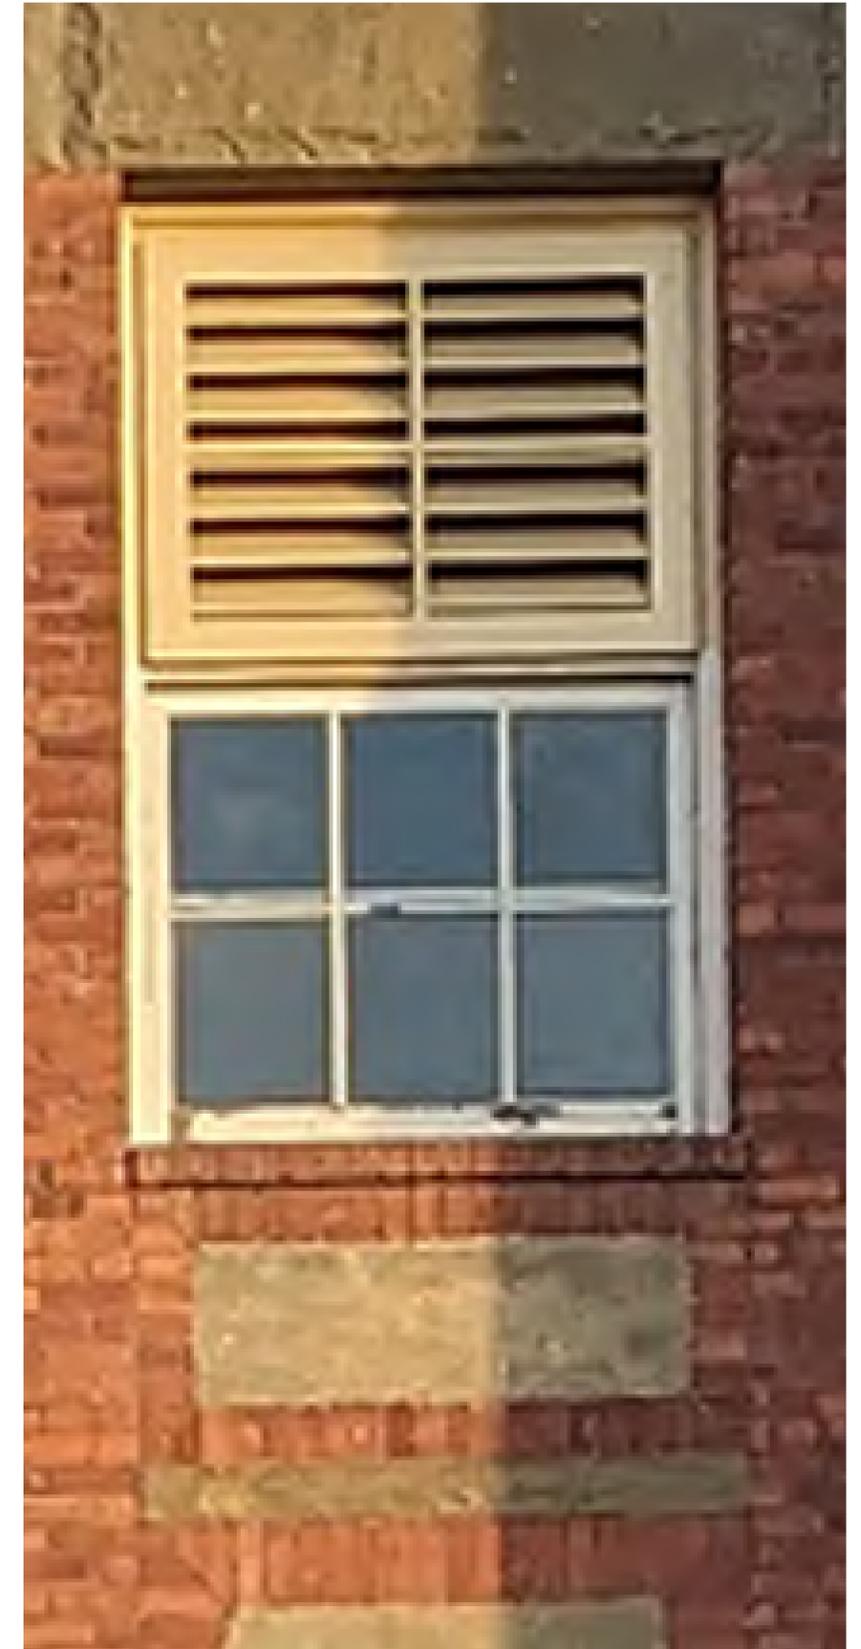
Window ID 2W.32 POOR CONDITION

1. Sash Operation Difficult/Won't Open
2. Inoperable – Screwed Shut
3. Exterior Paint at Sash and Trim Cracked and Peeling at Limited Areas
4. Exterior Paint at Sash and Trim Heavily Deteriorated

5. Checked Sash/Muntin
6. Deteriorated Sash
7. Checked/Split Frame
8. Deteriorated Frame
9. Parting Bead Lightly Deteriorated
10. Parting Bead Missing or Heavily Deteriorated

11. Sill 20% or Less Deteriorated
12. Sill Heavily Deteriorated, Wood Consolidation Necessary for More Than 20% of the Sill
13. Reinforced Sash (non-original)

14. Section Loss
15. Missing Window Stop
16. Sealant Deteriorated
17. Weatherstrip Deteriorated/Missing
18. Deteriorated Glazing Compound/Setting Bead/Glazing Putty

19. Sash Pull Hardware Missing
20. Sash Lock Damaged/Missing/Not Engaging/No Lock
21. Retrofitted Window Limiter
22. Leaking or Visible Gap to Exterior When Closed

23. Replaced Glazing
24. Cracked Glazing
25. Missing Glazing

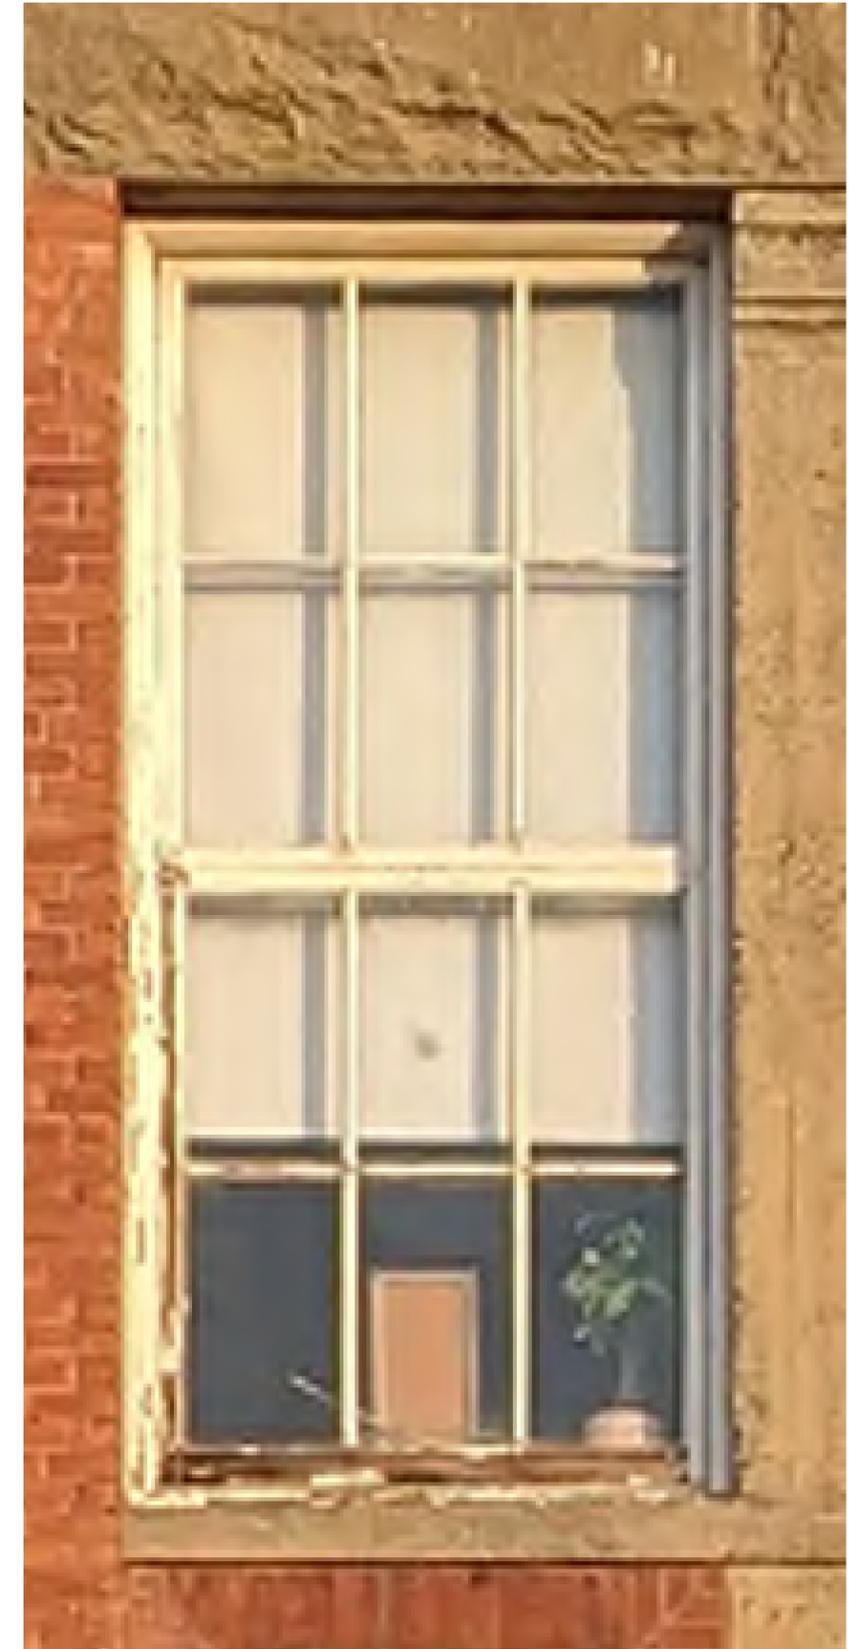
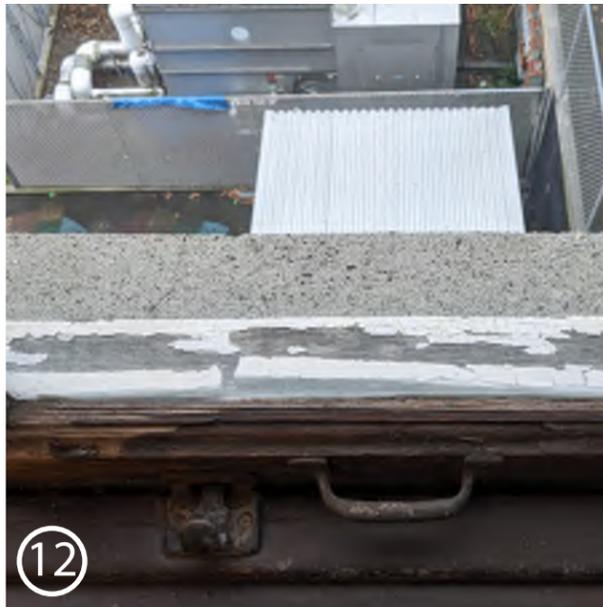
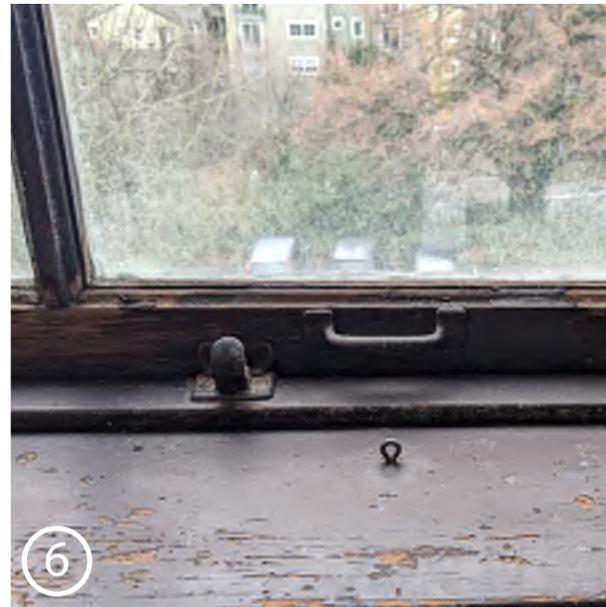
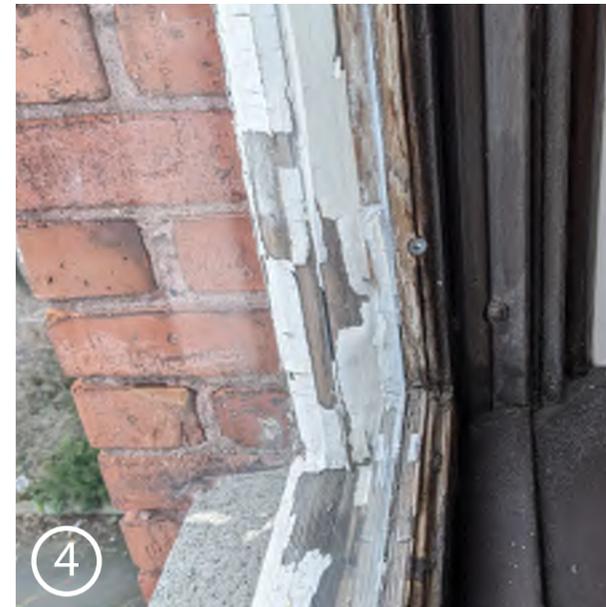
Window ID 2W.33 POOR CONDITION

- ① Sash Operation Difficult/Won't Open
- 2. Inoperable – Screwed Shut
- 3. Exterior Paint at Sash and Trim Cracked and Peeling at Limited Areas
- ④ Exterior Paint at Sash and Trim Heavily Deteriorated

- 5. Checked Sash/Muntin
- ⑥ Deteriorated Sash
- 7. Checked/Split Frame
- ⑧ Deteriorated Frame
- 9. Parting Bead Lightly Deteriorated
- 10. Parting Bead Missing or Heavily Deteriorated

- 11. Sill 20% or Less Deteriorated
- ⑫ Sill Heavily Deteriorated, Wood Consolidation Necessary for More Than 20% of the Sill
- 13. Reinforced Sash (non-original)

- ⑭ Section Loss
- 15. Missing Window Stop
- 16. Sealant Deteriorated
- 17. Weatherstrip Deteriorated/Missing
- ⑮ Deteriorated Glazing Compound/Setting Bead/Glazing Putty

- 19. Sash Pull Hardware Missing
- 20. Sash Lock Damaged/Missing/Not Engaging/No Lock
- ⑰ Retrofitted Window Limiter
- 22. Leaking or Visible Gap to Exterior When Closed

- 23. Replaced Glazing
- 24. Cracked Glazing
- 25. Missing Glazing

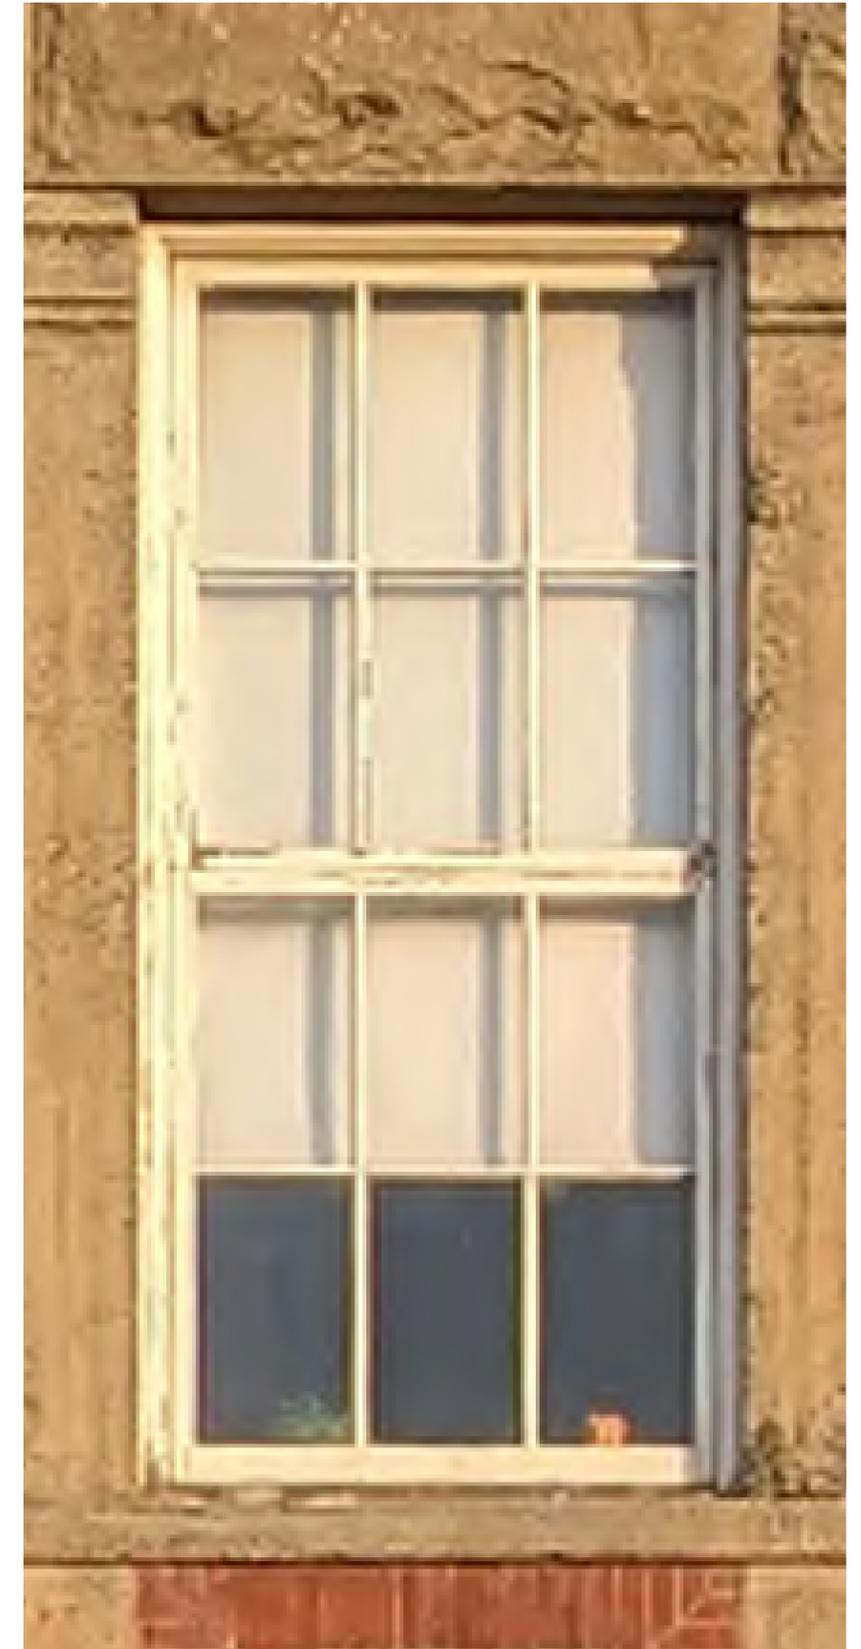
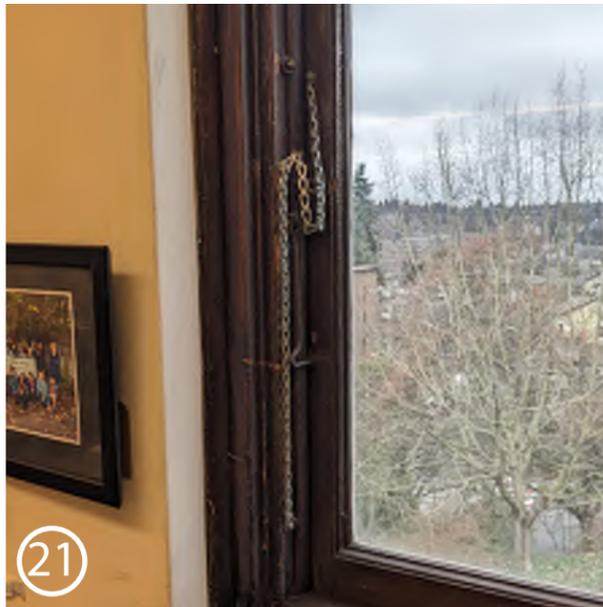
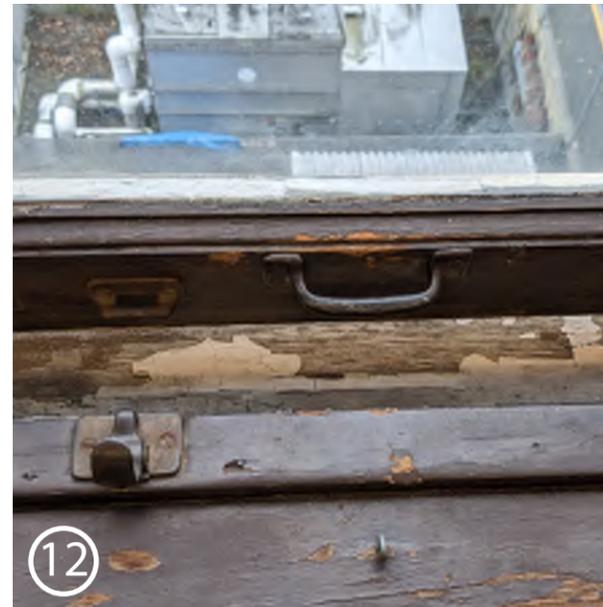
Window ID **2W.34** POOR CONDITION

19. Sash Pull Hardware Missing
20. Sash Lock Damaged/Missing/Not Engaging/No Lock
21. Retrofitted Window Limiter
22. Leaking or Visible Gap to Exterior When Closed

23. Replaced Glazing
24. Cracked Glazing
25. Missing Glazing
