Window Condition Assessment for B.F. Day Elementary School

on behalf of Seattle Public Schools

July 16, 2024

Miller Hayashi Architects PLLC

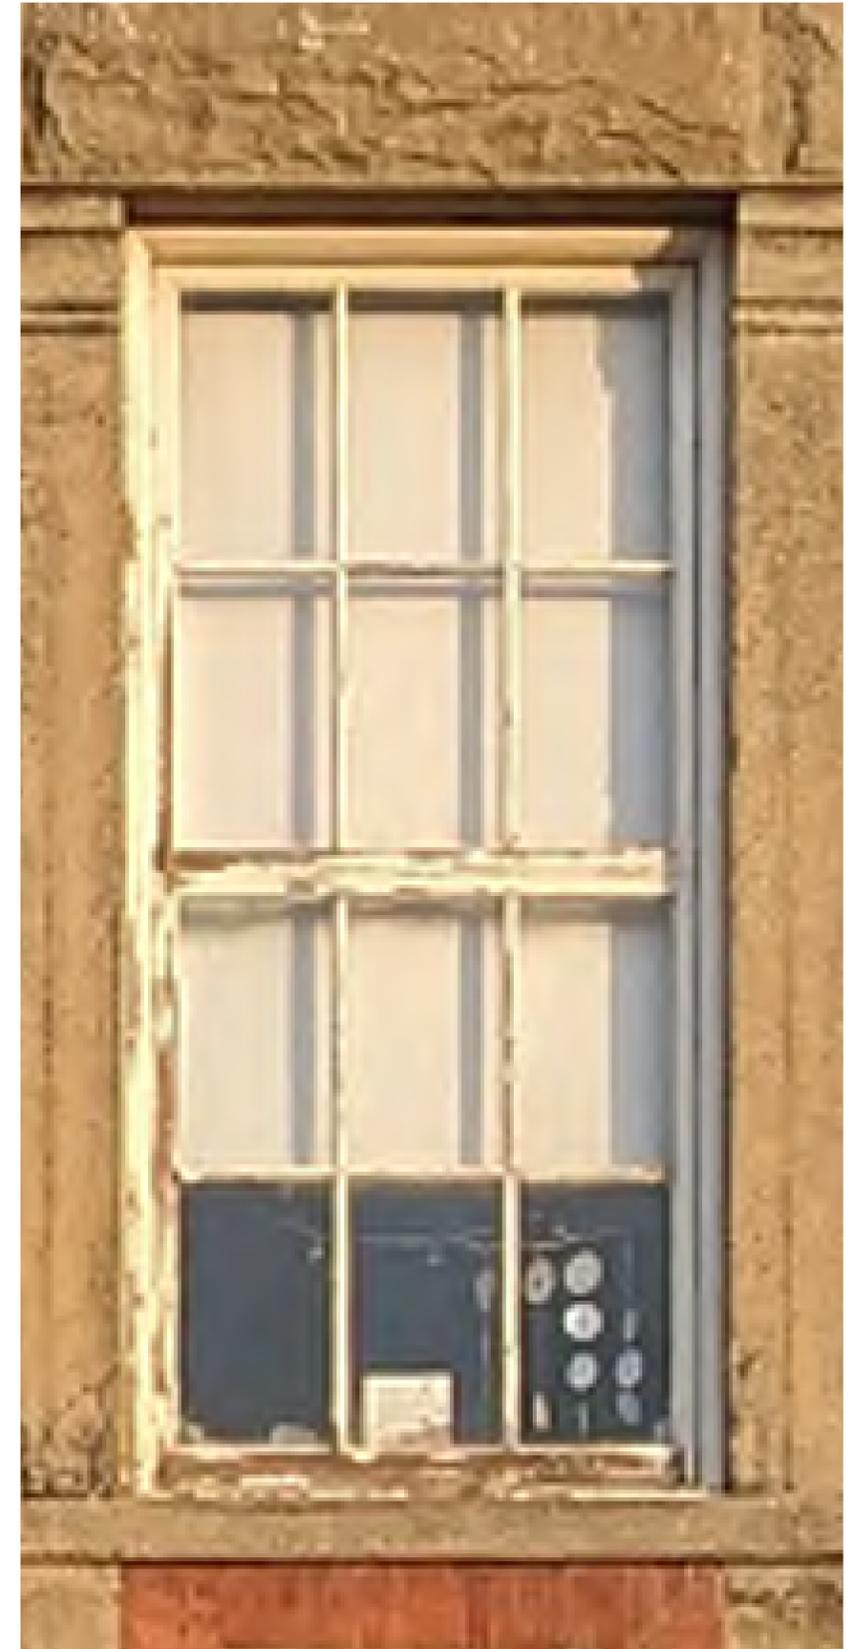
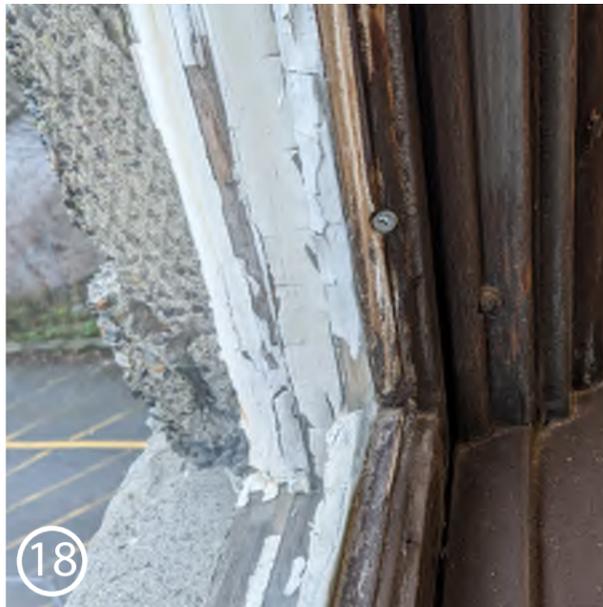
Window ID **2W.35** POOR CONDITION

19. Sash Pull Hardware Missing
20. Sash Lock Damaged/Missing/Not Engaging/No Lock
21. Retrofitted Window Limiter
22. Leaking or Visible Gap to Exterior When Closed

23. Replaced Glazing
24. Cracked Glazing
25. Missing Glazing

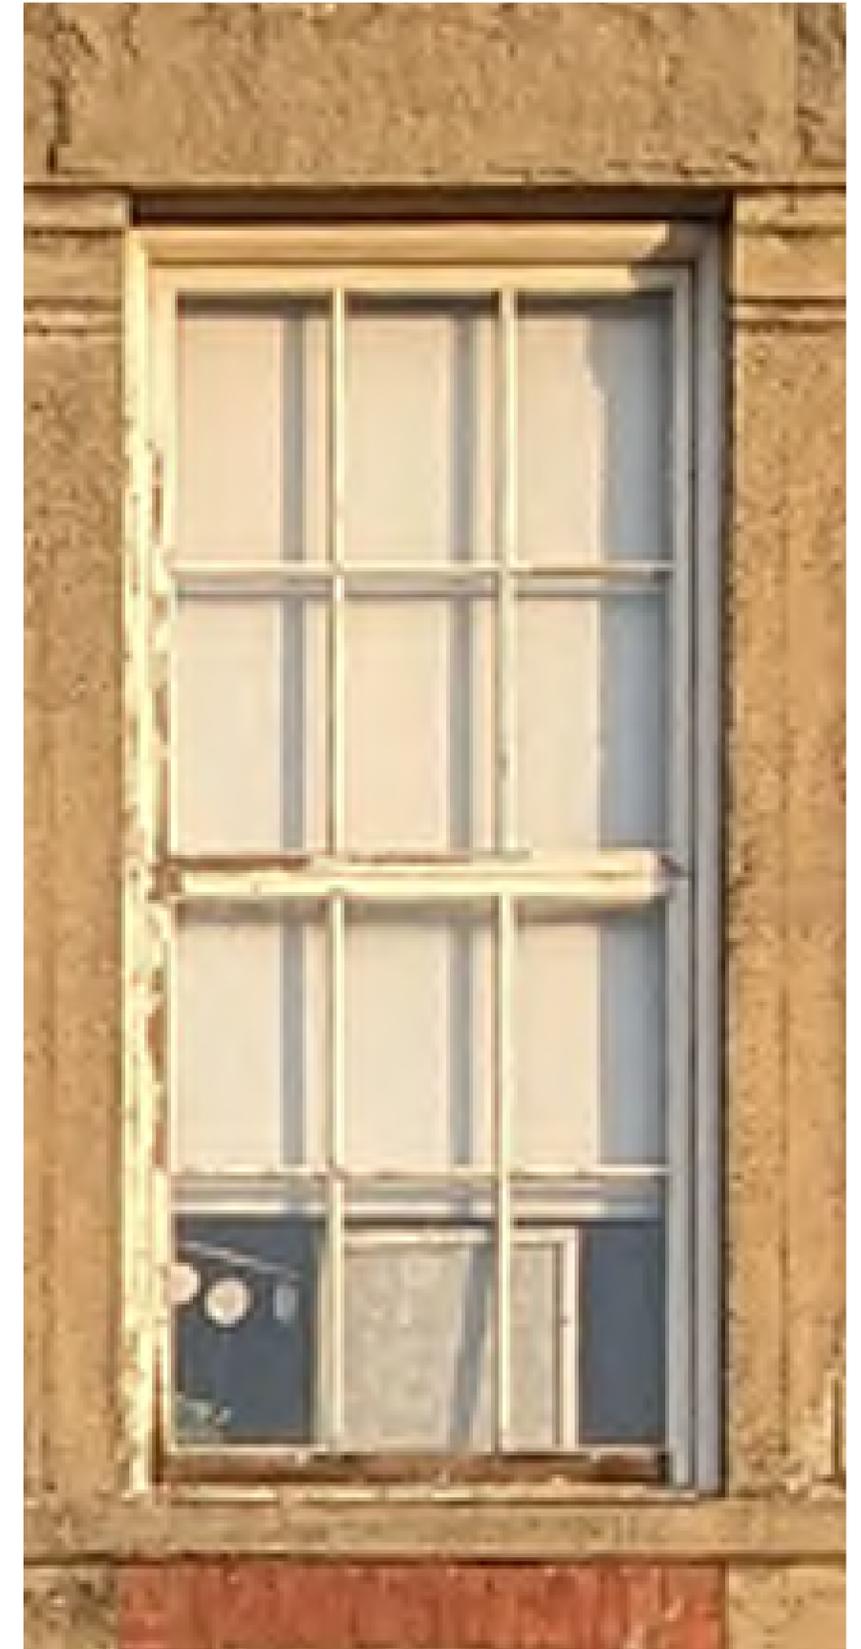
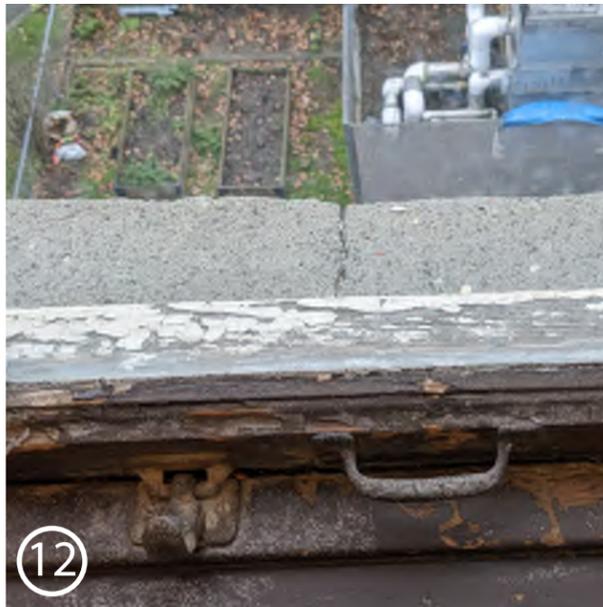
Window ID **2W.36** POOR CONDITION

19. Sash Pull Hardware Missing
20. Sash Lock Damaged/Missing/Not Engaging/No Lock
21. Retrofitted Window Limiter
- ⑳ Leaking or Visible Gap to Exterior When Closed

23. Replaced Glazing
24. Cracked Glazing
25. Missing Glazing

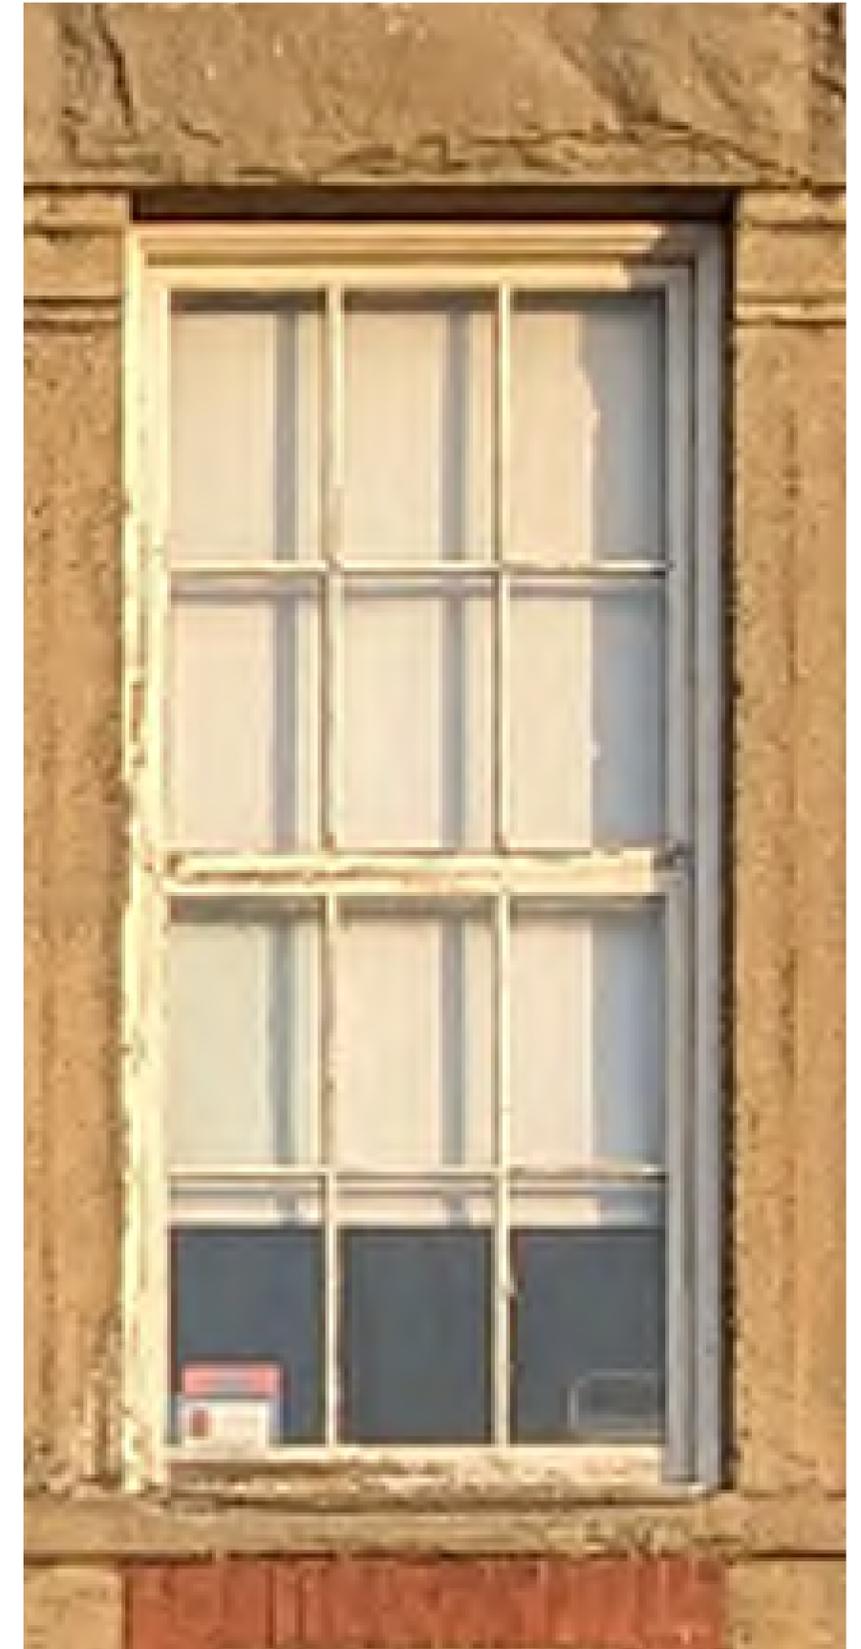
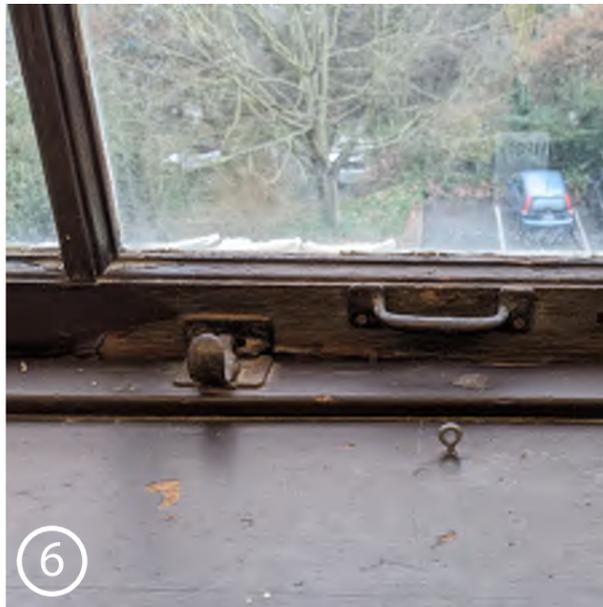
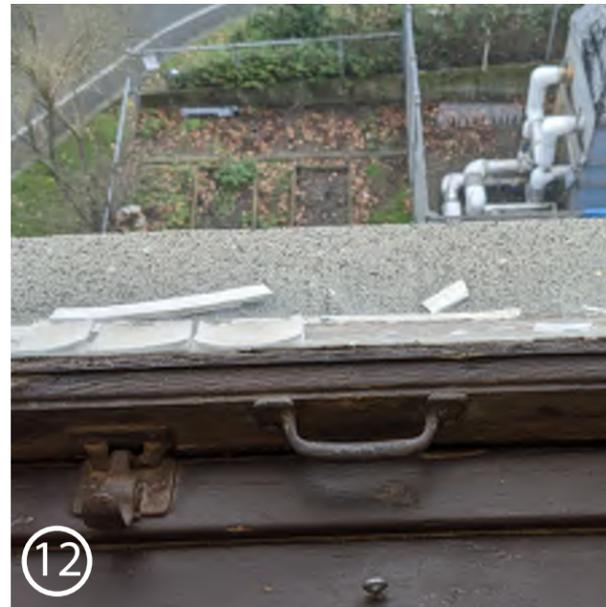
Window ID 2W.37 POOR CONDITION

19. Sash Pull Hardware Missing
20. Sash Lock Damaged/Missing/Not Engaging/No Lock
21. Retrofitted Window Limiter
22. Leaking or Visible Gap to Exterior When Closed

23. Replaced Glazing
24. Cracked Glazing
25. Missing Glazing

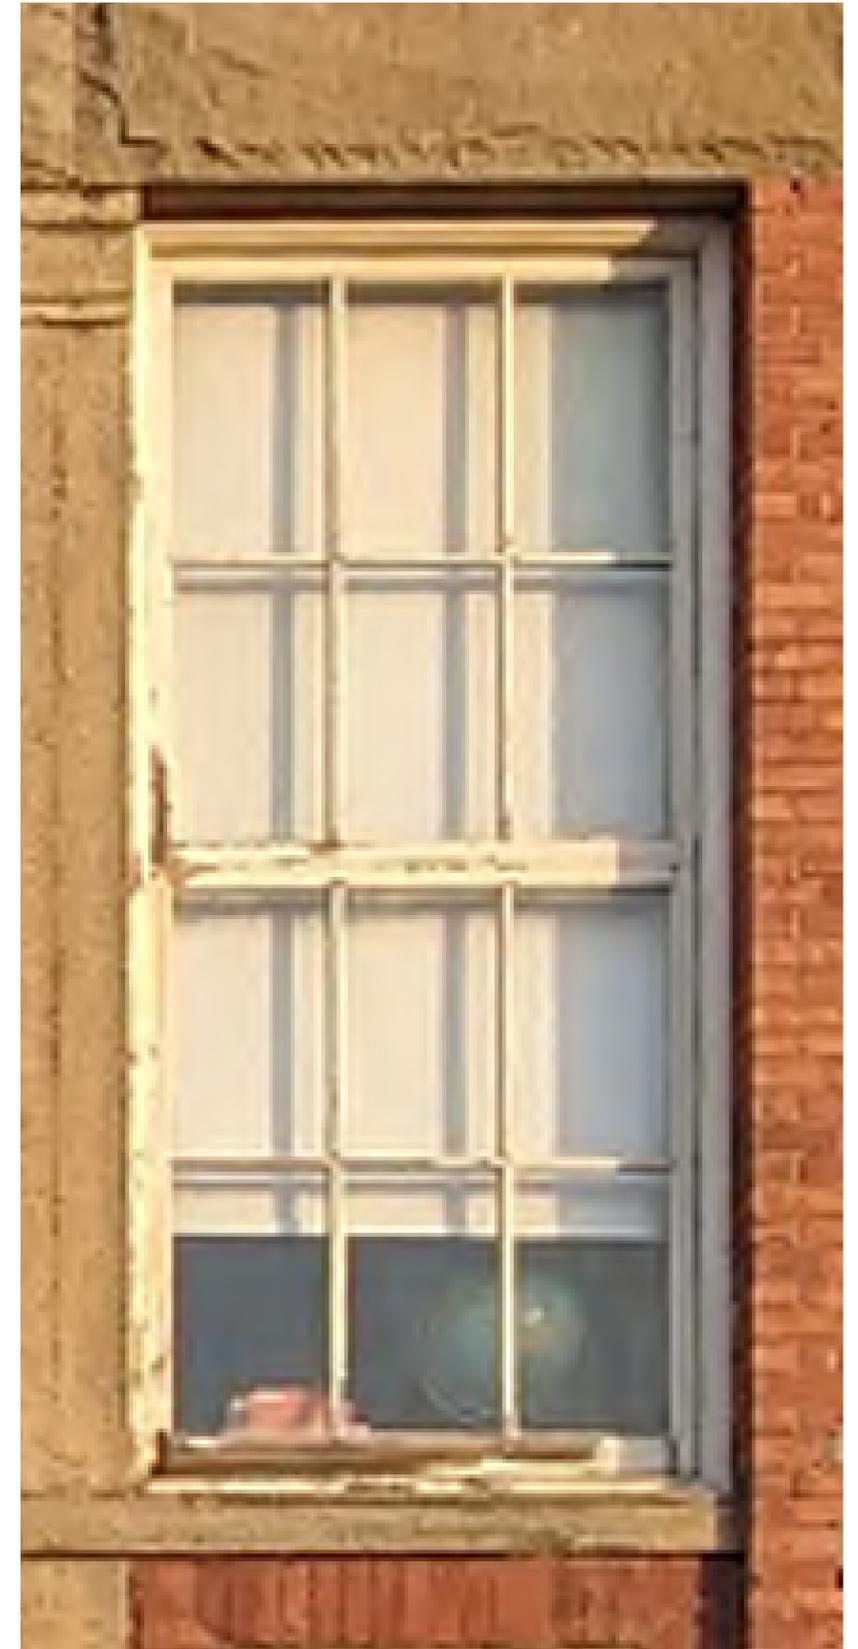
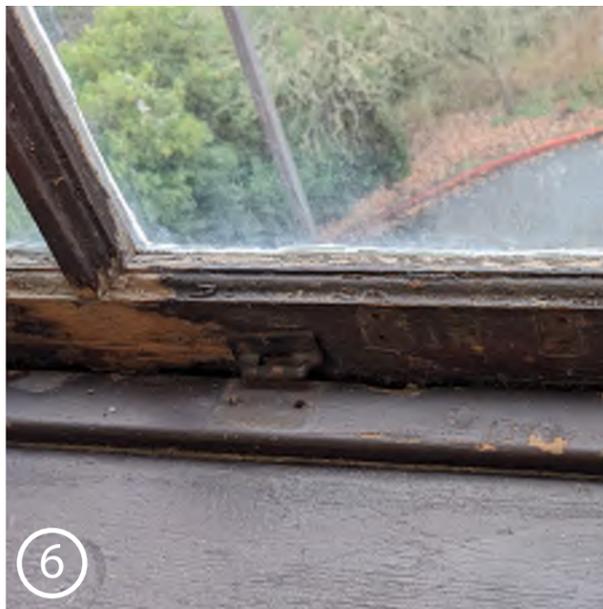
Window ID 2E.01 POOR CONDITION

- 23. Replaced Glazing
- 24. Cracked Glazing
- 25. Missing Glazing

● Interior plexiglass guard fastened to lower sash

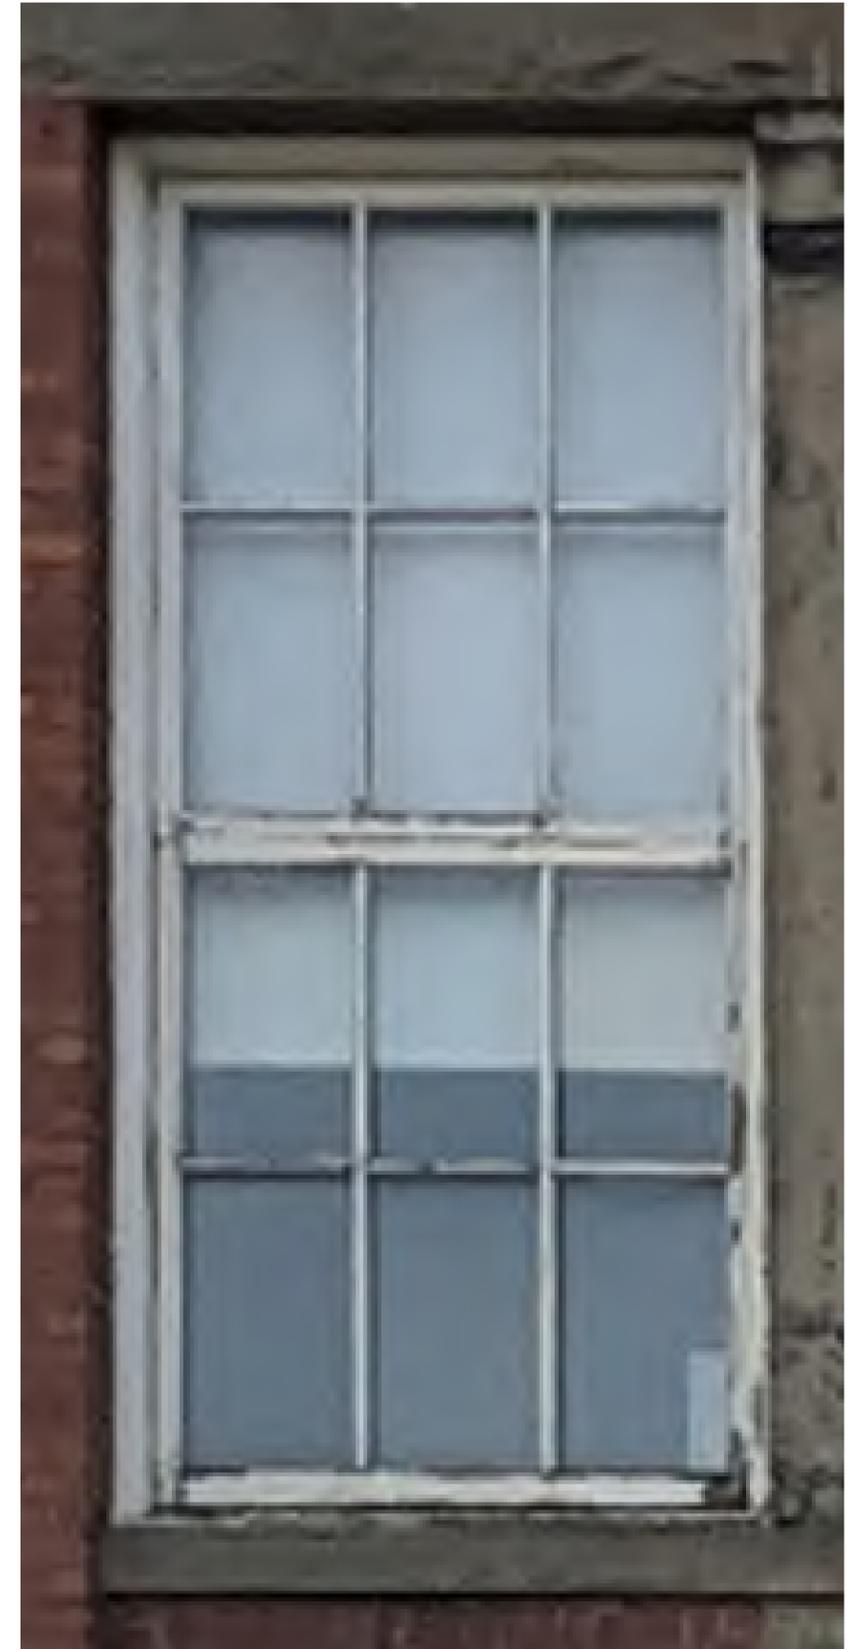
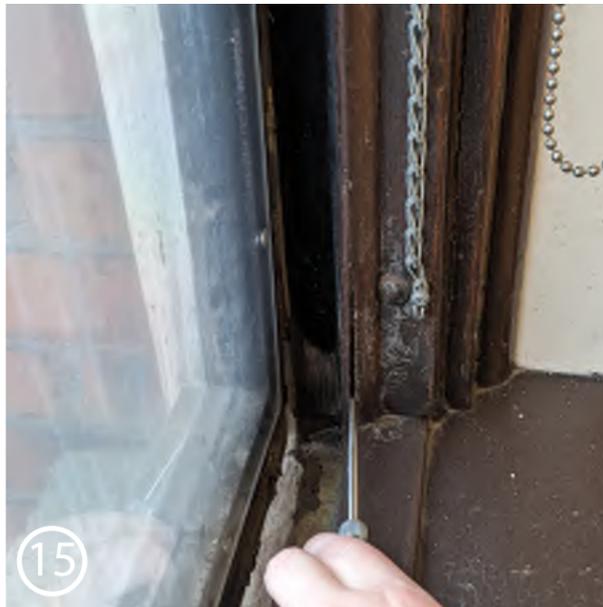
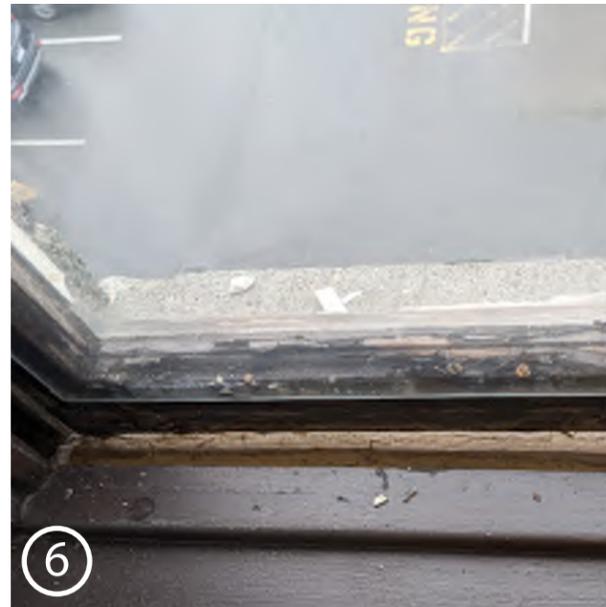
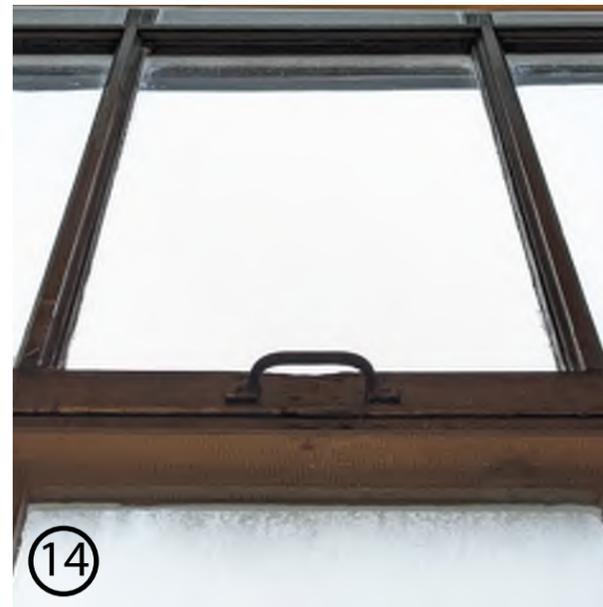
Window ID 2E.02 POOR CONDITION

- 19. Sash Pull Hardware Missing
- 20. Sash Lock Damaged/Missing/Not Engaging/No Lock
- ⑳ Retrofitted Window Limiter
- ㉑ Leaking or Visible Gap to Exterior When Closed

- 23. Replaced Glazing
- 24. Cracked Glazing
- 25. Missing Glazing

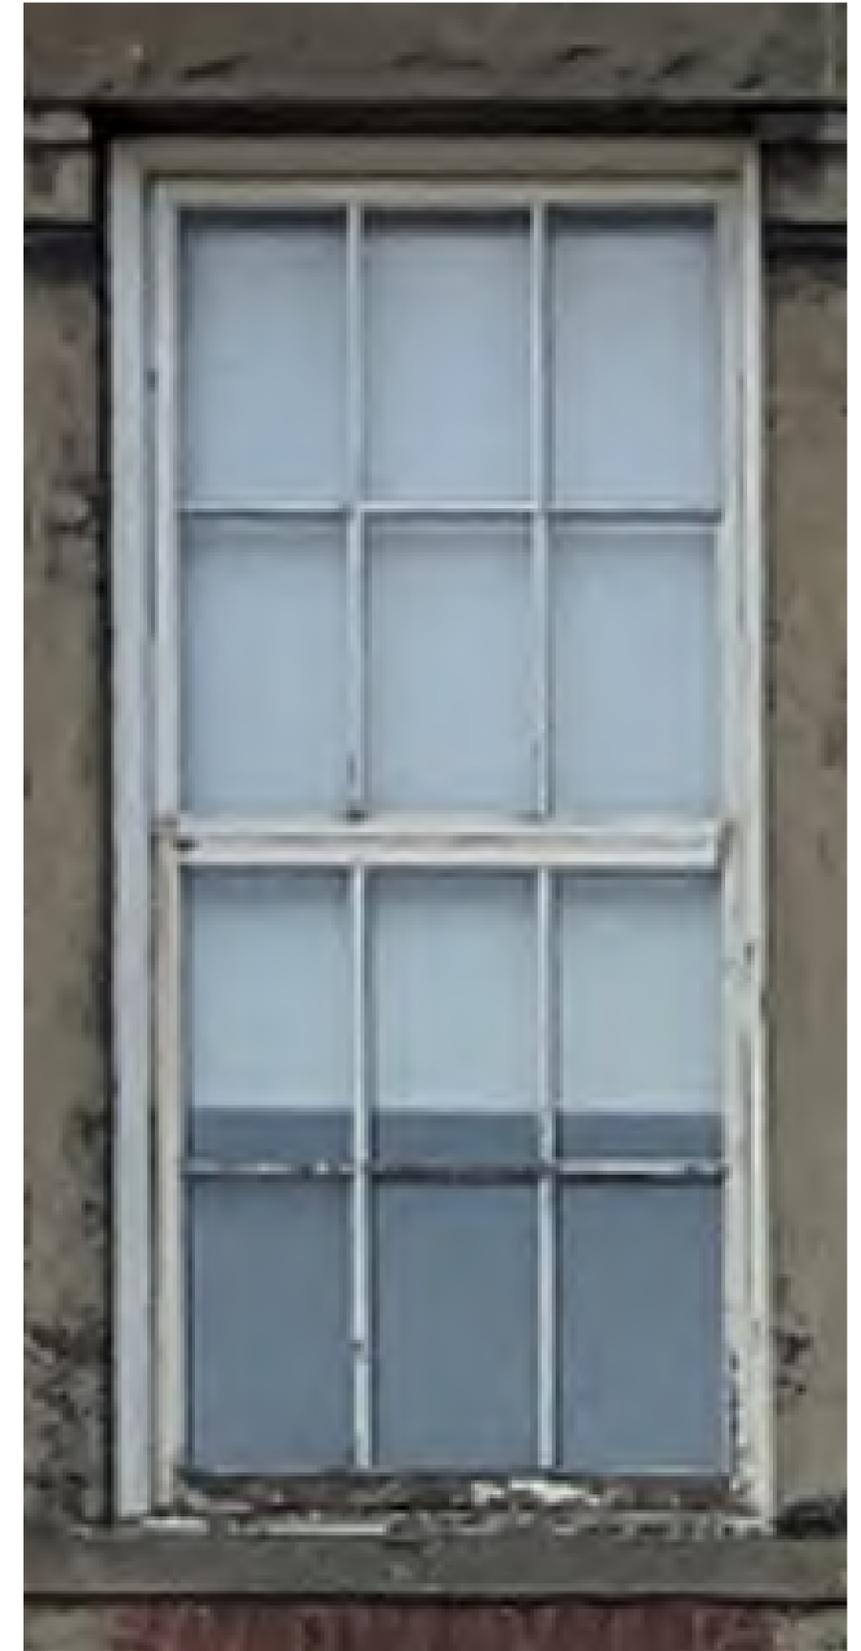
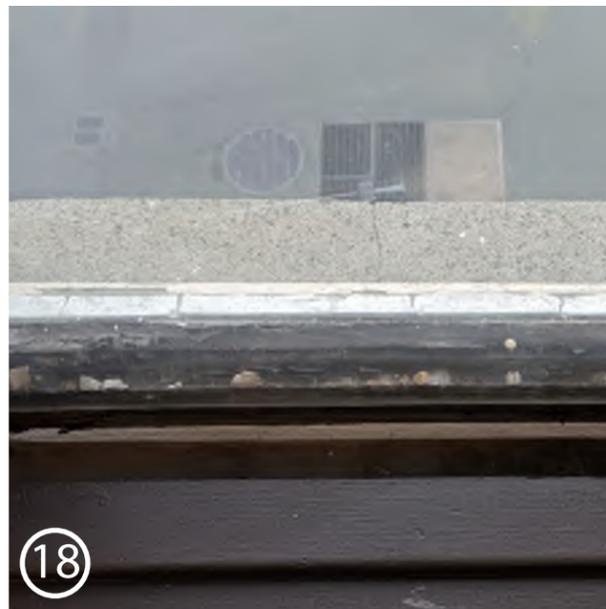
Window ID 2E.03 POOR CONDITION

● Interior plexiglass guard fastened to lower sash

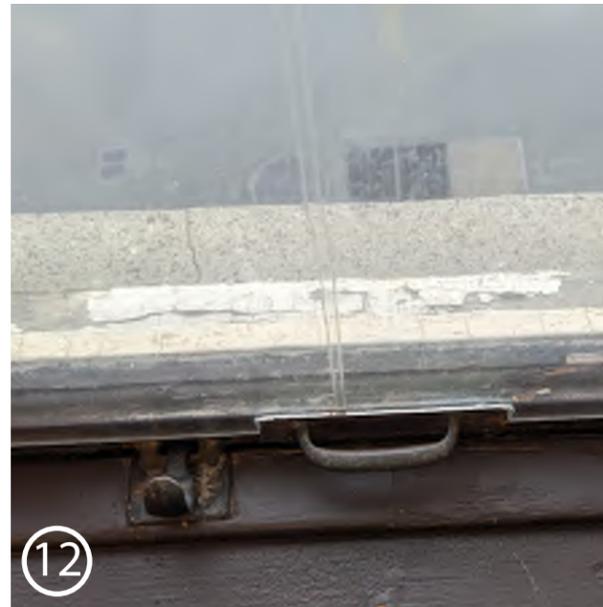
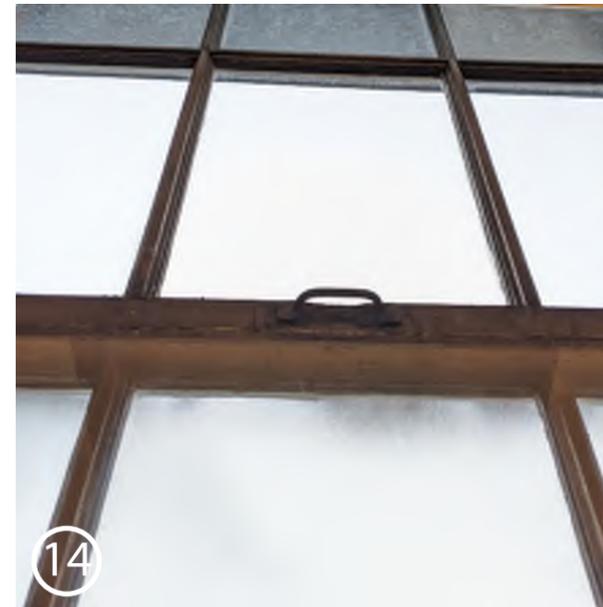
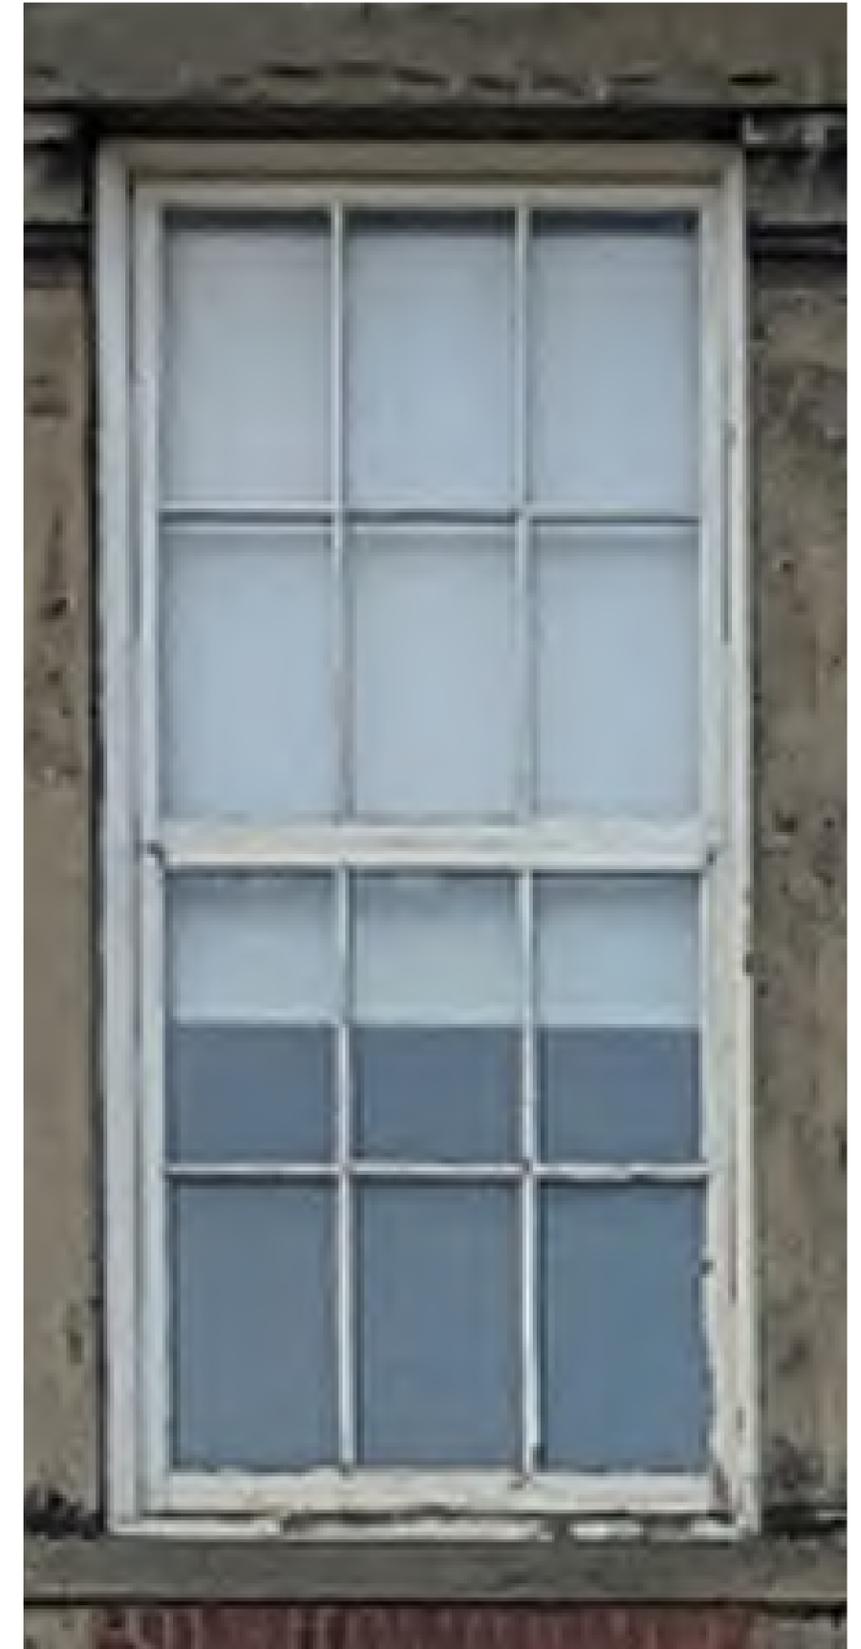
Window ID 2E.04 POOR CONDITION

- 19. Sash Pull Hardware Missing
- ⑳ Sash Lock Damaged/Missing/Not Engaging/No Lock
- 21. Retrofitted Window Limiter
- ㉒ Leaking or Visible Gap to Exterior When Closed

- 23. Replaced Glazing
- 24. Cracked Glazing
- 25. Missing Glazing

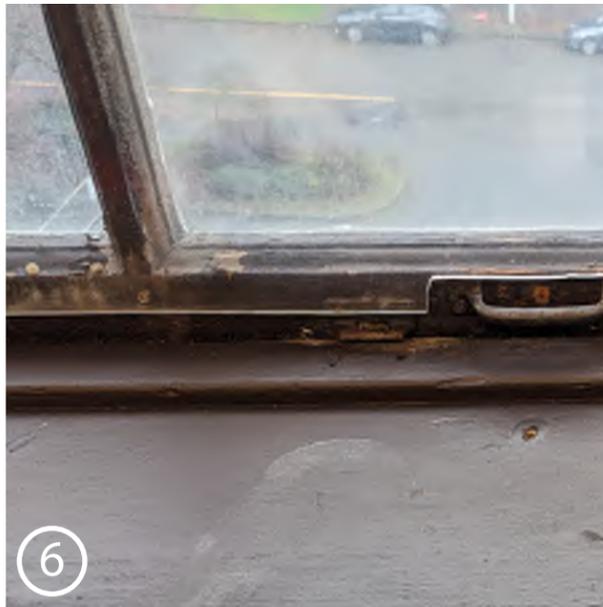
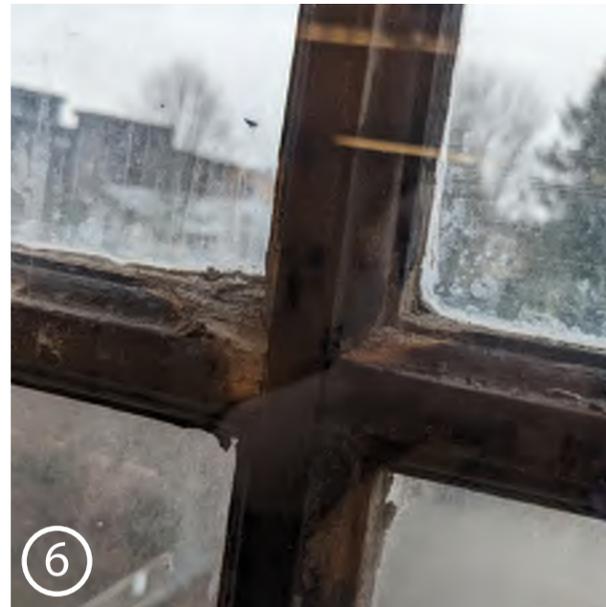
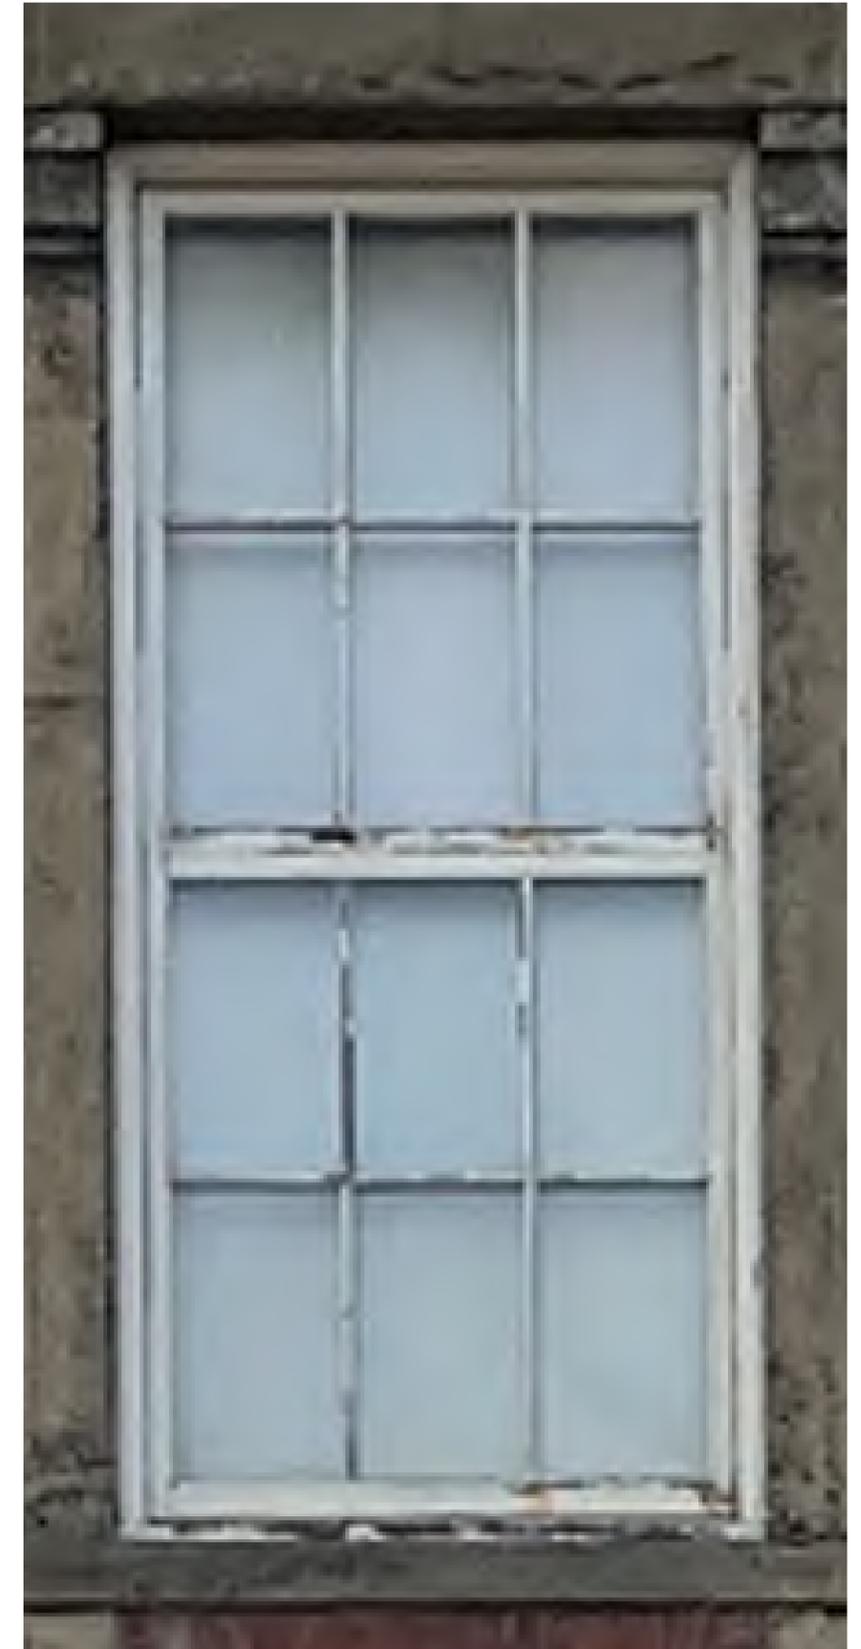
Window ID 2E.06 POOR CONDITION

● Interior plexiglass guard fastened to lower sash

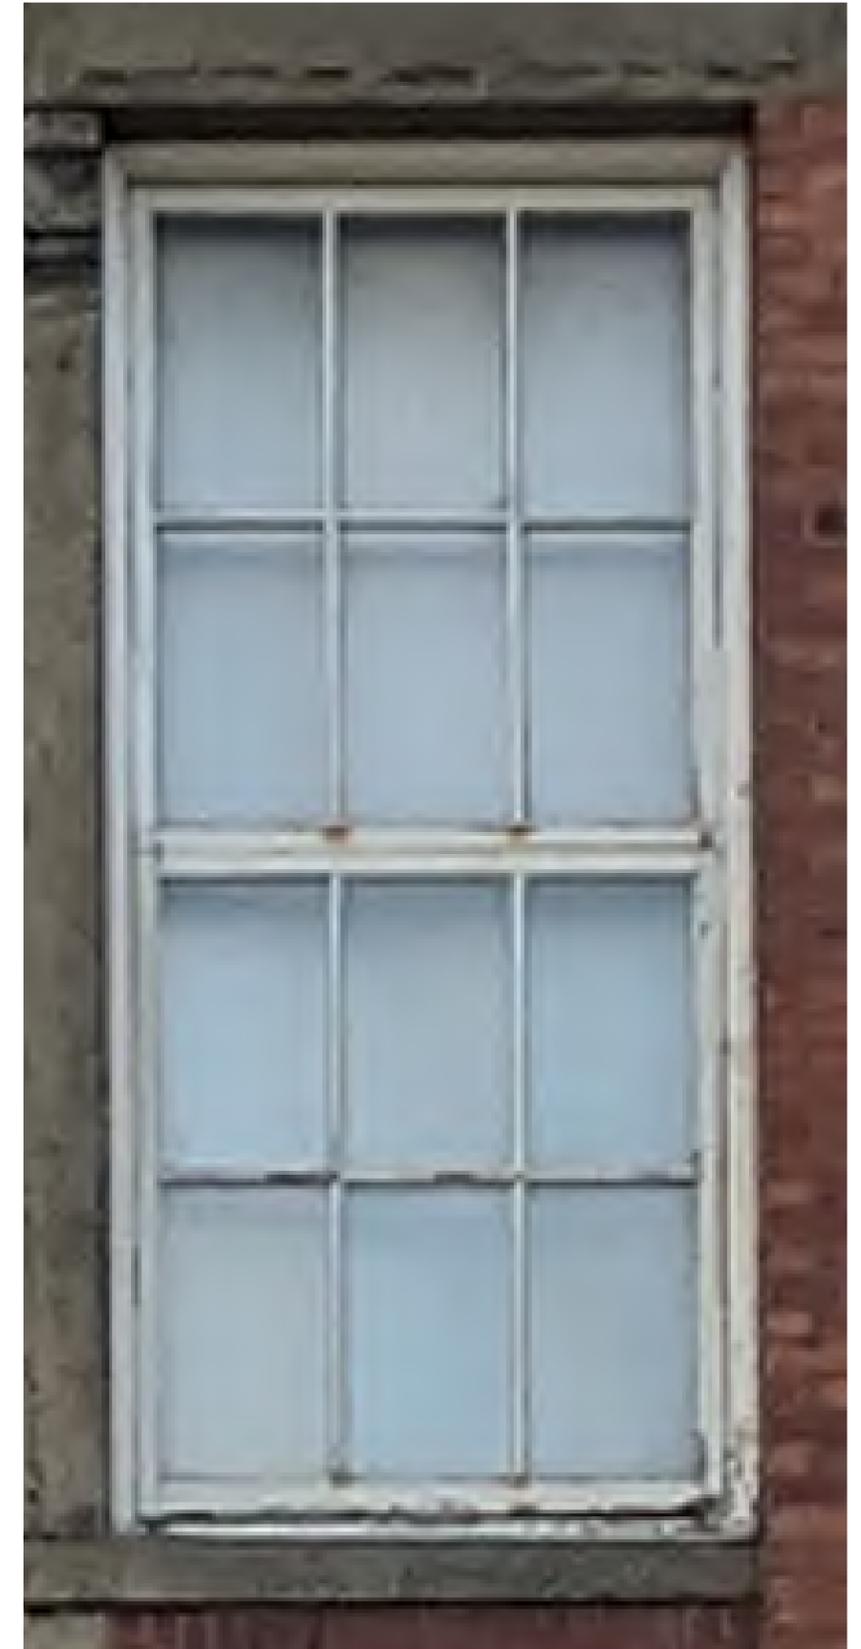
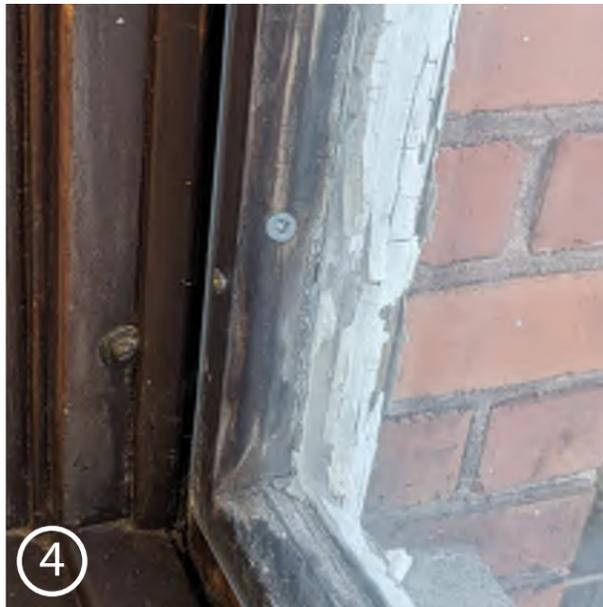
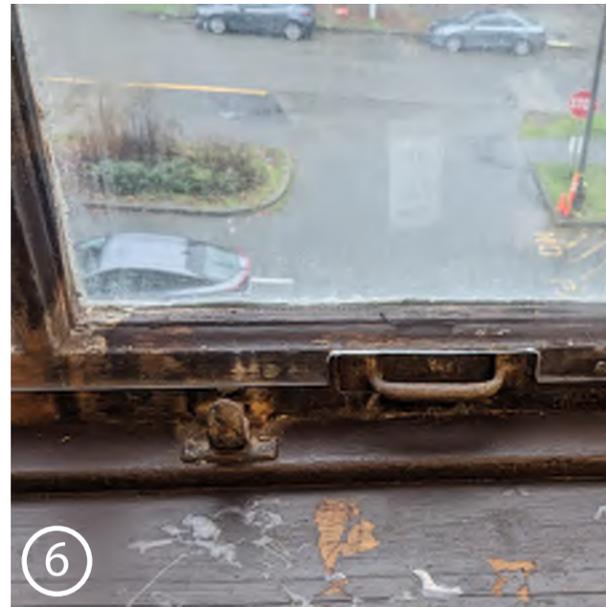
Window ID 2E.07 INACCESSIBLE

● Interior plexiglass guard fastened to lower sash

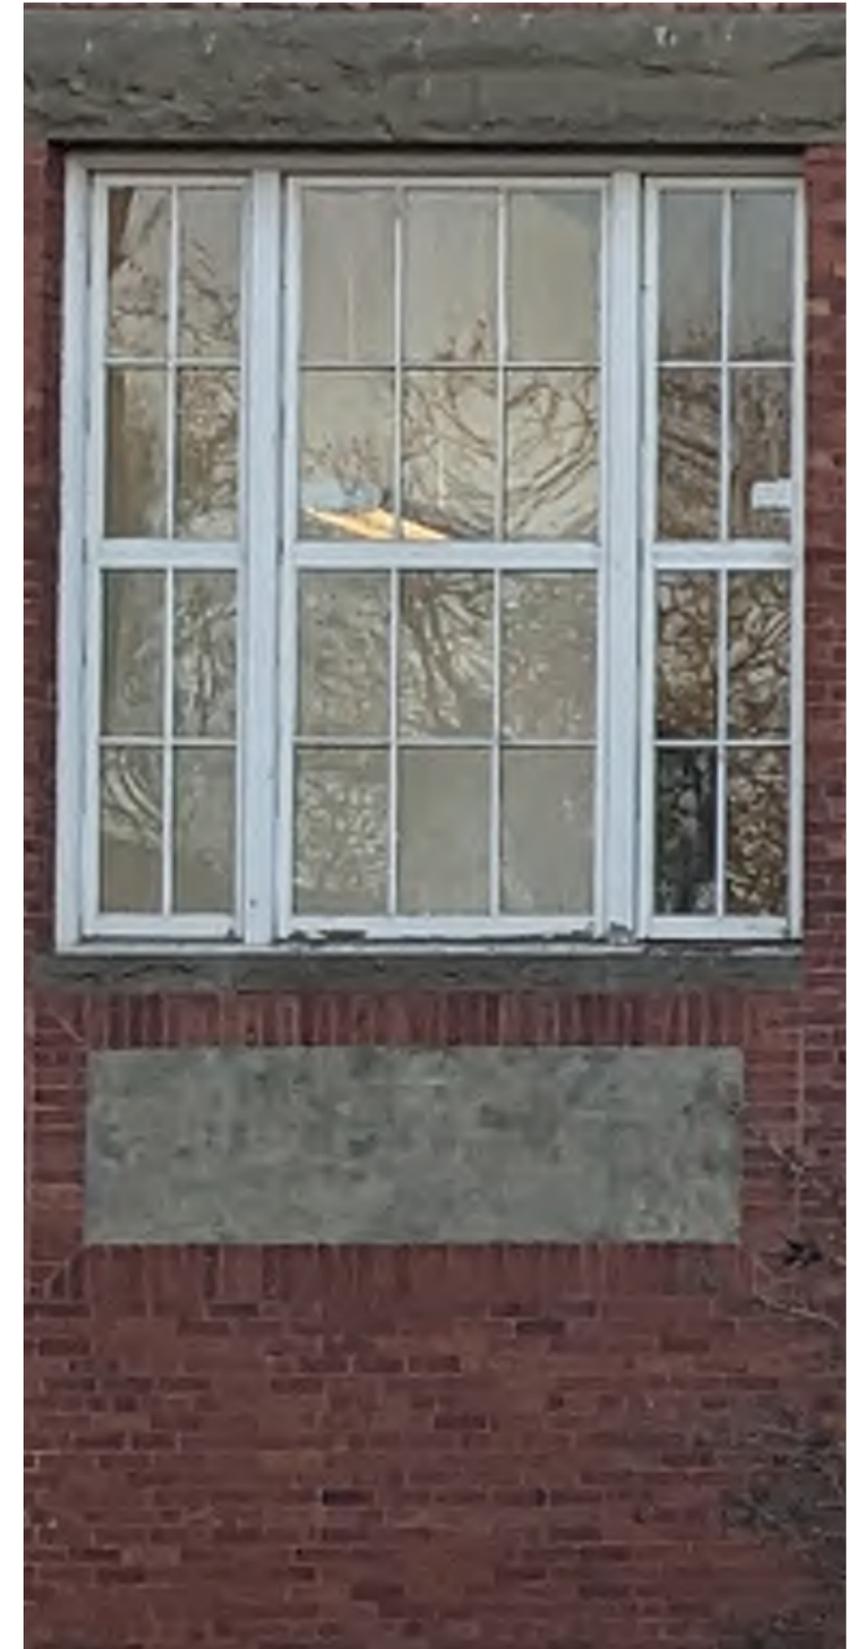
Window ID 2E.08 POOR CONDITION

- ① Sash Operation Difficult/Won't Open
- 2. Inoperable – Screwed Shut
- ③ Exterior Paint at Sash and Trim Cracked and Peeling at Limited Areas
- 4. Exterior Paint at Sash and Trim Heavily Deteriorated

- 5. Checked Sash/Muntin
- ⑥ Deteriorated Sash
- 7. Checked/Split Frame
- 8. Deteriorated Frame
- 9. Parting Bead Lightly Deteriorated
- 10. Parting Bead Missing or Heavily Deteriorated

- 11. Sill 20% or Less Deteriorated
- ⑫ Sill Heavily Deteriorated, Wood Consolidation Necessary for More Than 20% of the Sill
- 13. Reinforced Sash (non-original)

- ⑭ Section Loss
- 15. Missing Window Stop
- 16. Sealant Deteriorated
- 17. Weatherstrip Deteriorated/Missing
- 18. Deteriorated Glazing Compound/Setting Bead/Glazing Putty

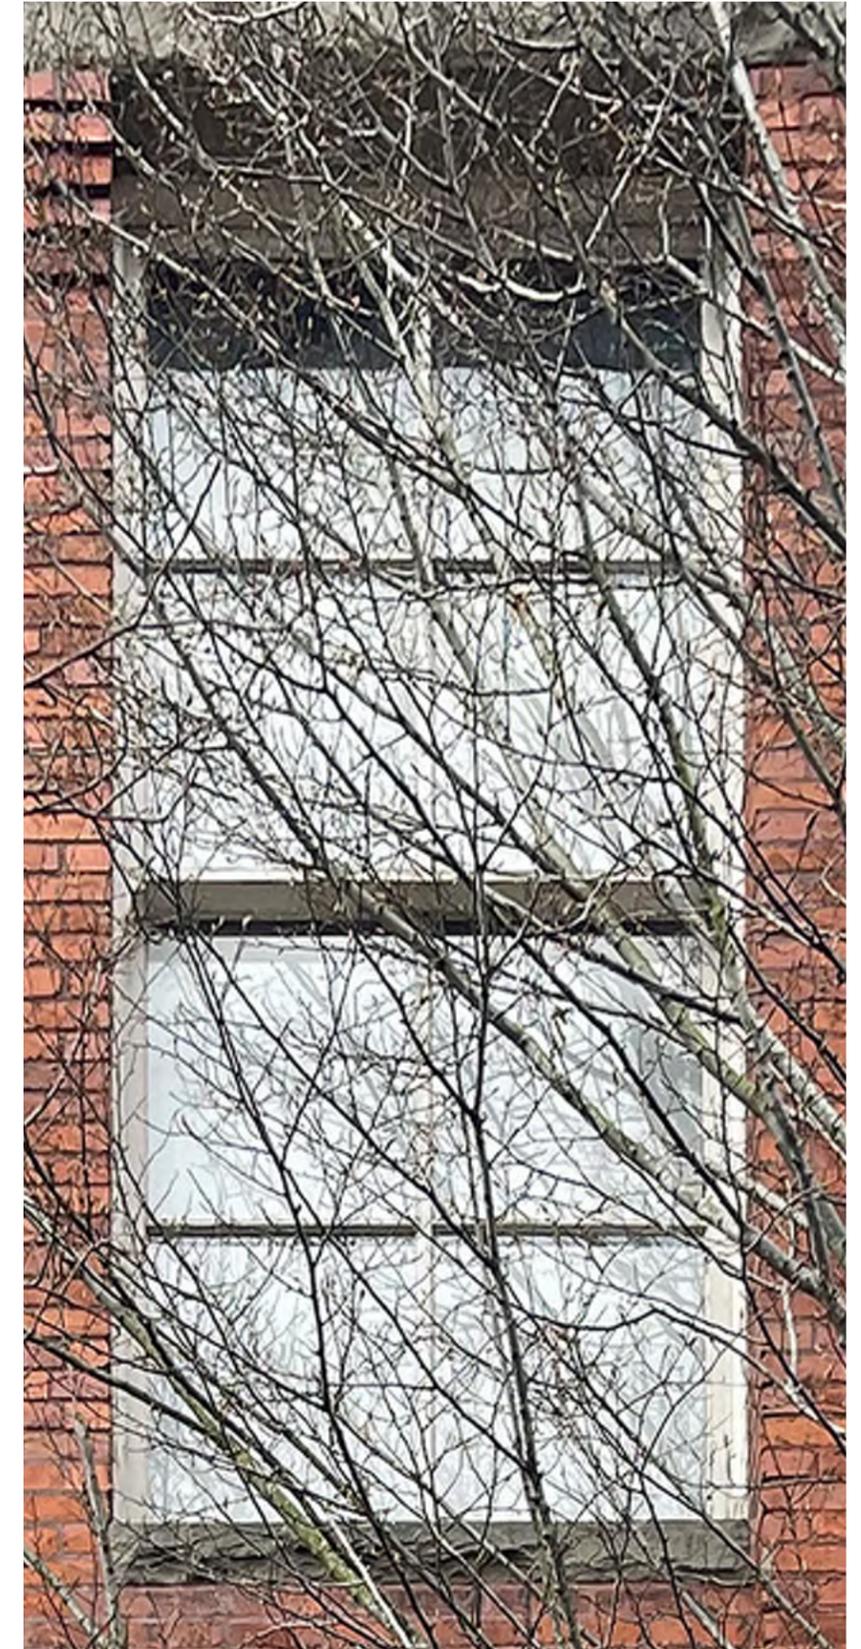
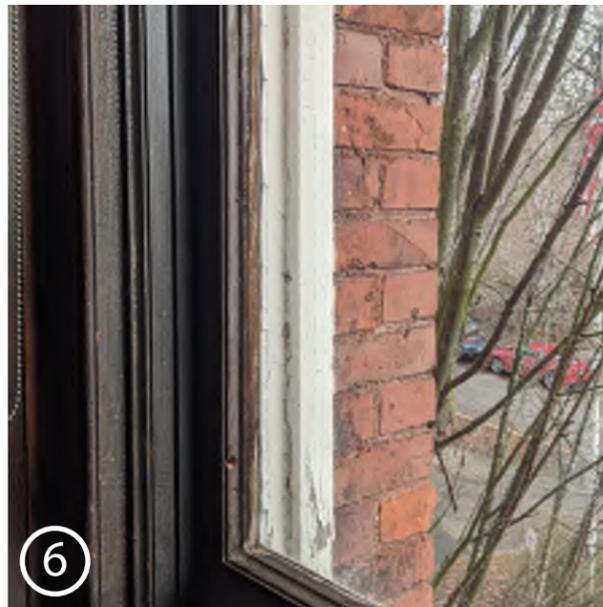
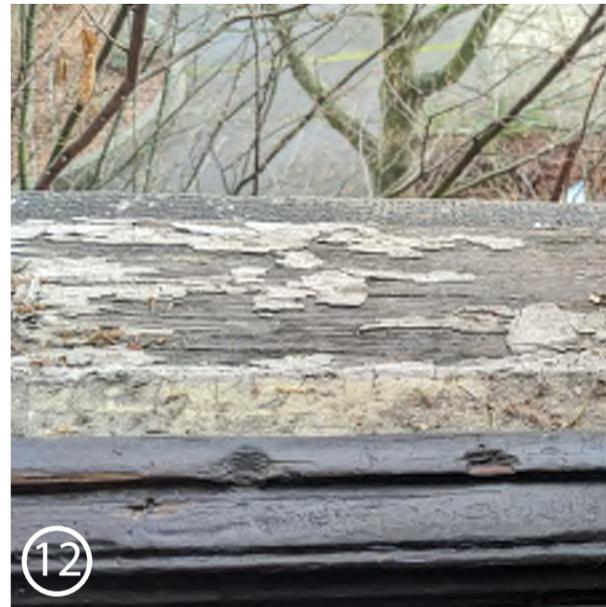
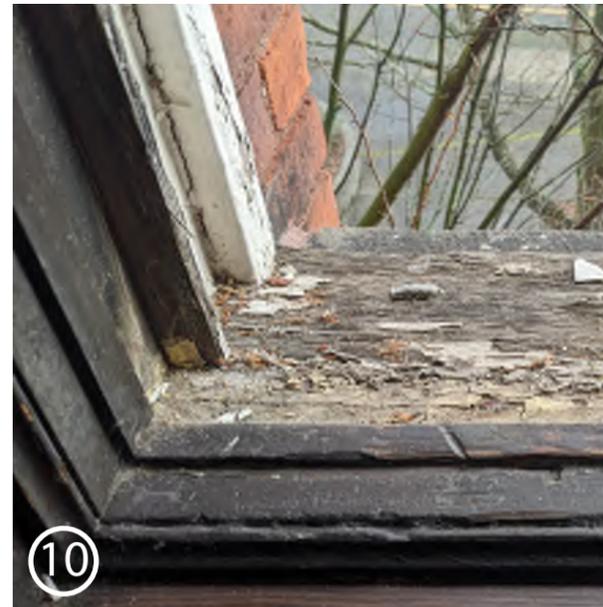
Window ID 2E.16 MODERATE CONDITION

- 19. Sash Pull Hardware Missing
- ⑳ Sash Lock Damaged/Missing/Not Engaging/No Lock
- ㉑ Retrofitted Window Limiter
- 22. Leaking or Visible Gap to Exterior When Closed

- ㉓ Replaced Glazing
- 24. Cracked Glazing
- 25. Missing Glazing
