Window Condition Assessment for B.F. Day Elementary School

on behalf of Seattle Public Schools

July 16, 2024

Miller Hayashi Architects PLLC

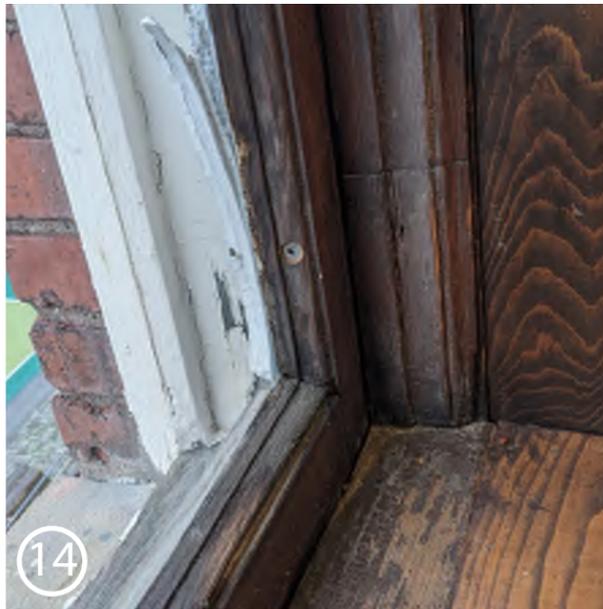
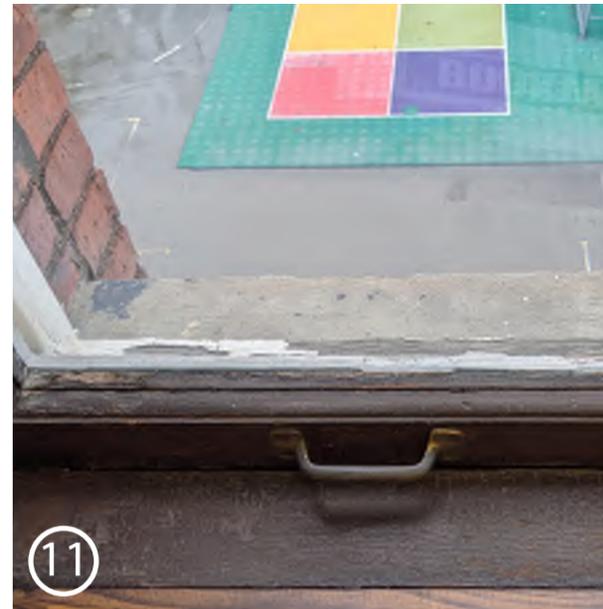
Window ID 2E.17 POOR CONDITION

- ⑲ Sash Pull Hardware Missing
- ⑳ Sash Lock Damaged/Missing/Not Engaging/No Lock
- ㉑ Retrofitted Window Limiter
- ㉒ Leaking or Visible Gap to Exterior When Closed

- ㉓ Replaced Glazing
- ㉔ Cracked Glazing
- ㉕ Missing Glazing

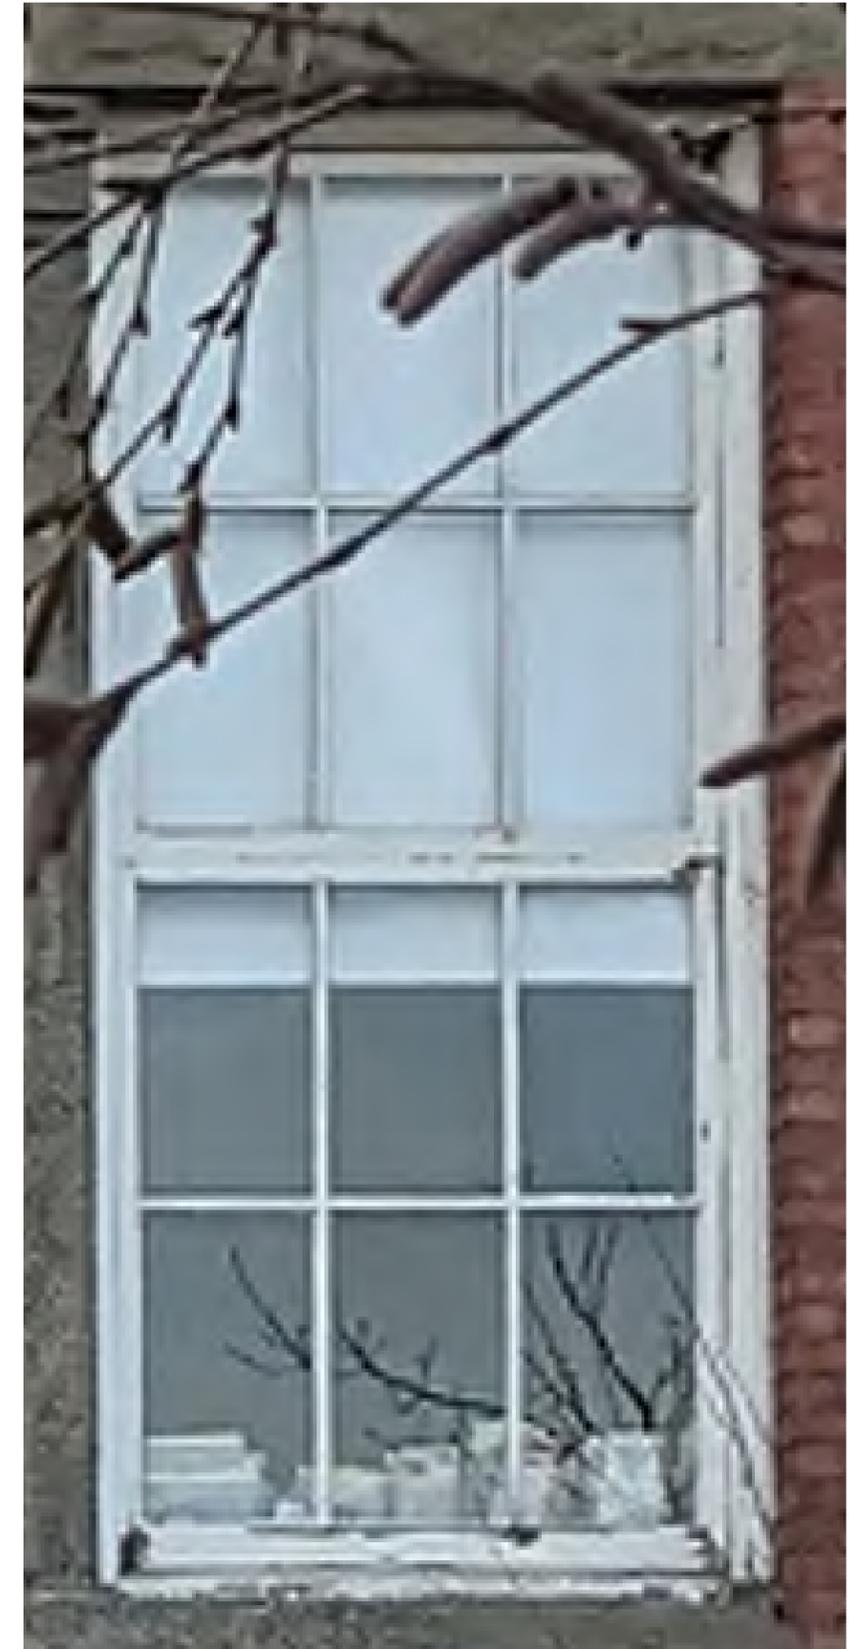
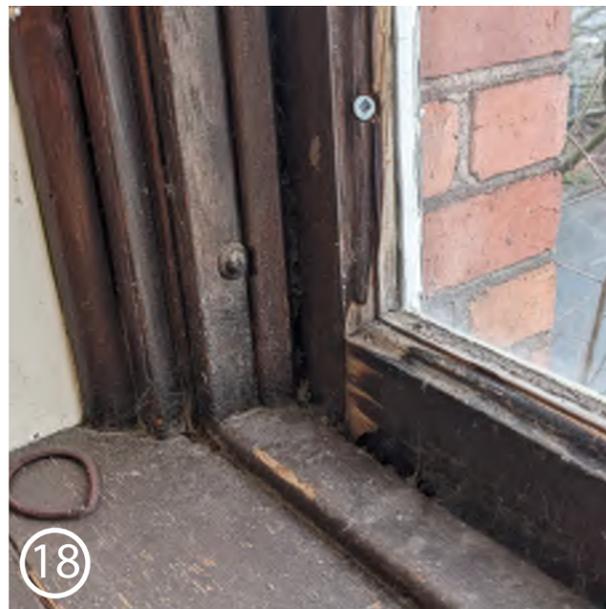
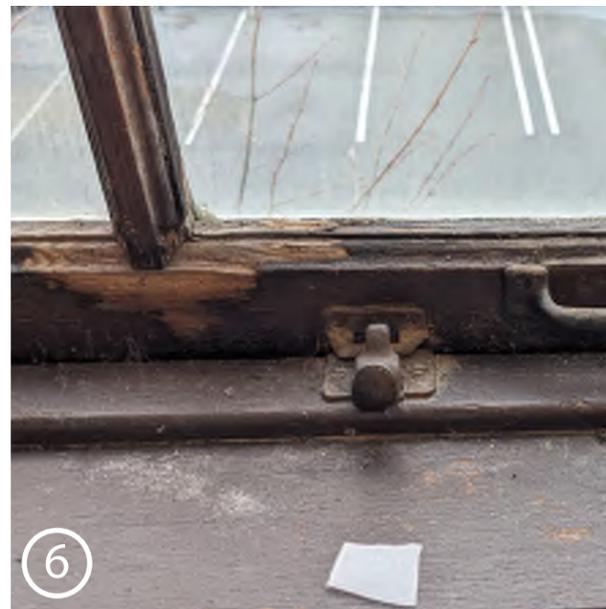
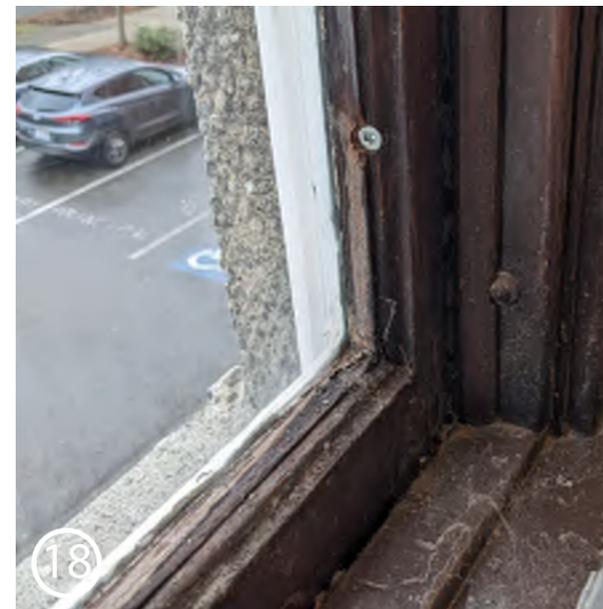
Window ID 2S.01 POOR CONDITION

- ① Sash Operation Difficult/Won't Open **Opens, but lower sash is loose side-to-side**
- 2. Inoperable – Screwed Shut
- 3. Exterior Paint at Sash and Trim Cracked and Peeling at Limited Areas

- ④ Exterior Paint at Sash and Trim Heavily Deteriorated
- 5. Checked Sash/Muntin
- ⑥ Deteriorated Sash
- 7. Checked/Split Frame
- ⑧ Deteriorated Frame
- 9. Parting Bead Lightly Deteriorated

- ⑩ Parting Bead Missing or Heavily Deteriorated
- 11. Sill 20% or Less Deteriorated
- ⑫ Sill Heavily Deteriorated, Wood Consolidation Necessary for More Than 20% of the Sill

- 13. Reinforced Sash (non-original)
- 14. Section Loss
- 15. Missing Window Stop
- 16. Sealant Deteriorated
- 17. Weatherstrip Deteriorated/Missing
- 18. Deteriorated Glazing Compound/Setting Bead/Glazing Putty

- 19. Sash Pull Hardware Missing
- ⑳ Sash Lock Damaged/Missing/Not Engaging/No Lock
- 21. Retrofitted Window Limiter
- 22. Leaking or Visible Gap to Exterior When Closed

- 23. Replaced Glazing
- 24. Cracked Glazing
- 25. Missing Glazing

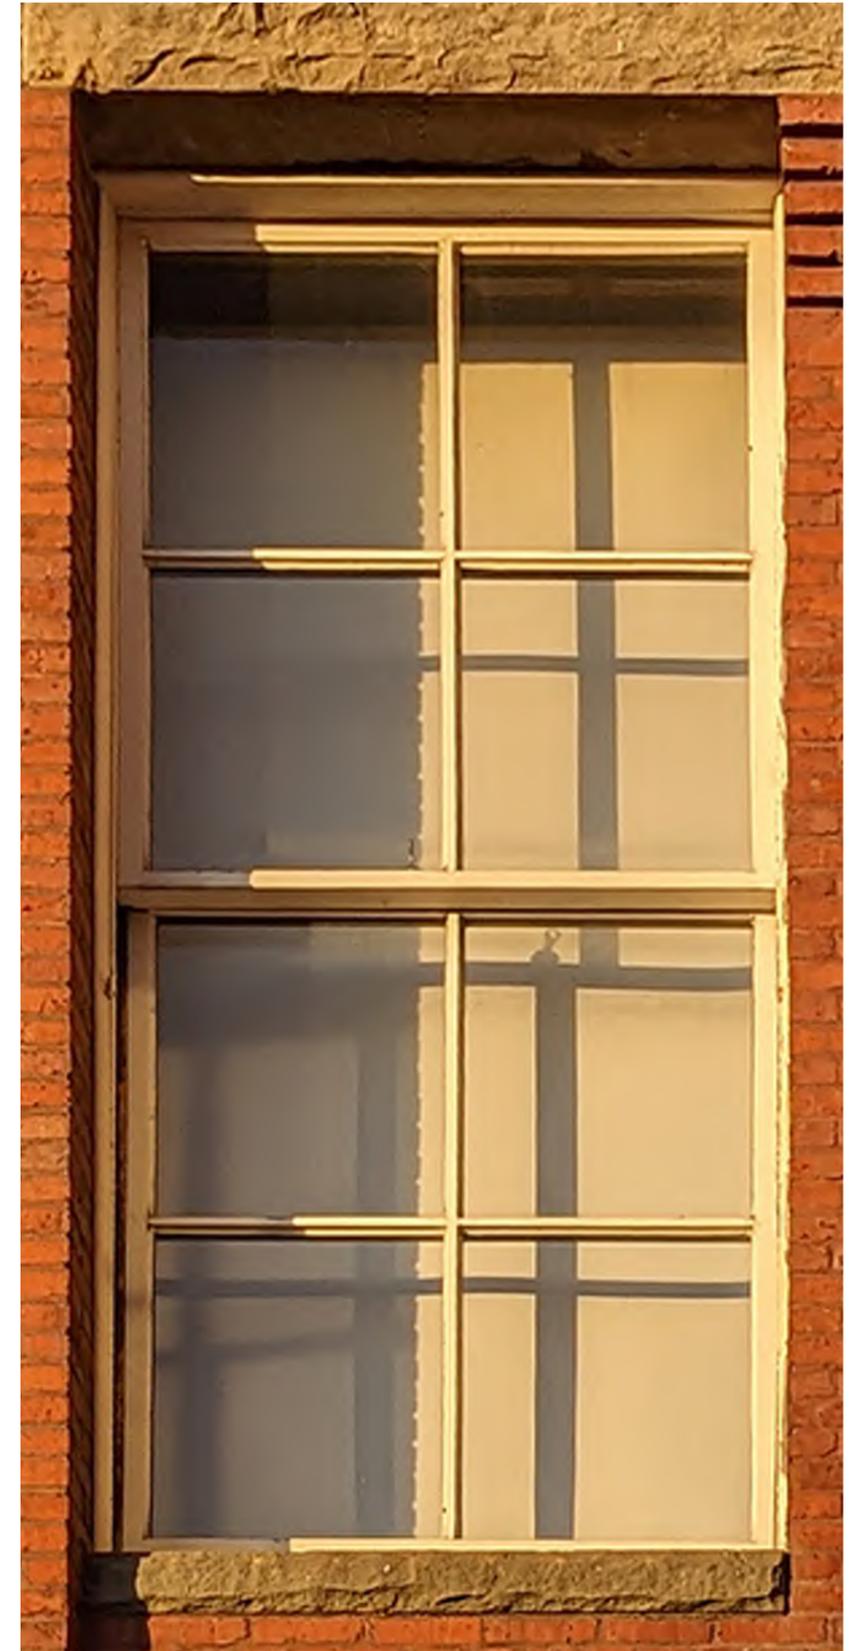
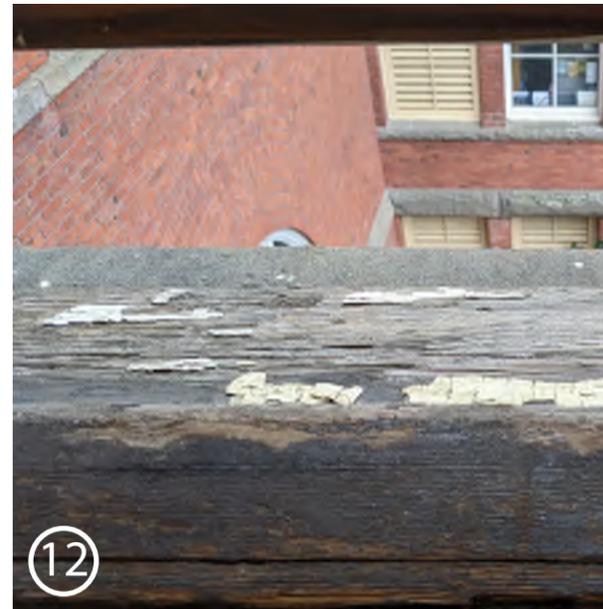
Window ID 2S.02 POOR CONDITION

14. Section Loss
15. Missing Window Stop
16. Sealant Deteriorated
17. Weatherstrip Deteriorated/Missing
18. Deteriorated Glazing Compound/Setting Bead/Glazing Putty **Typical**

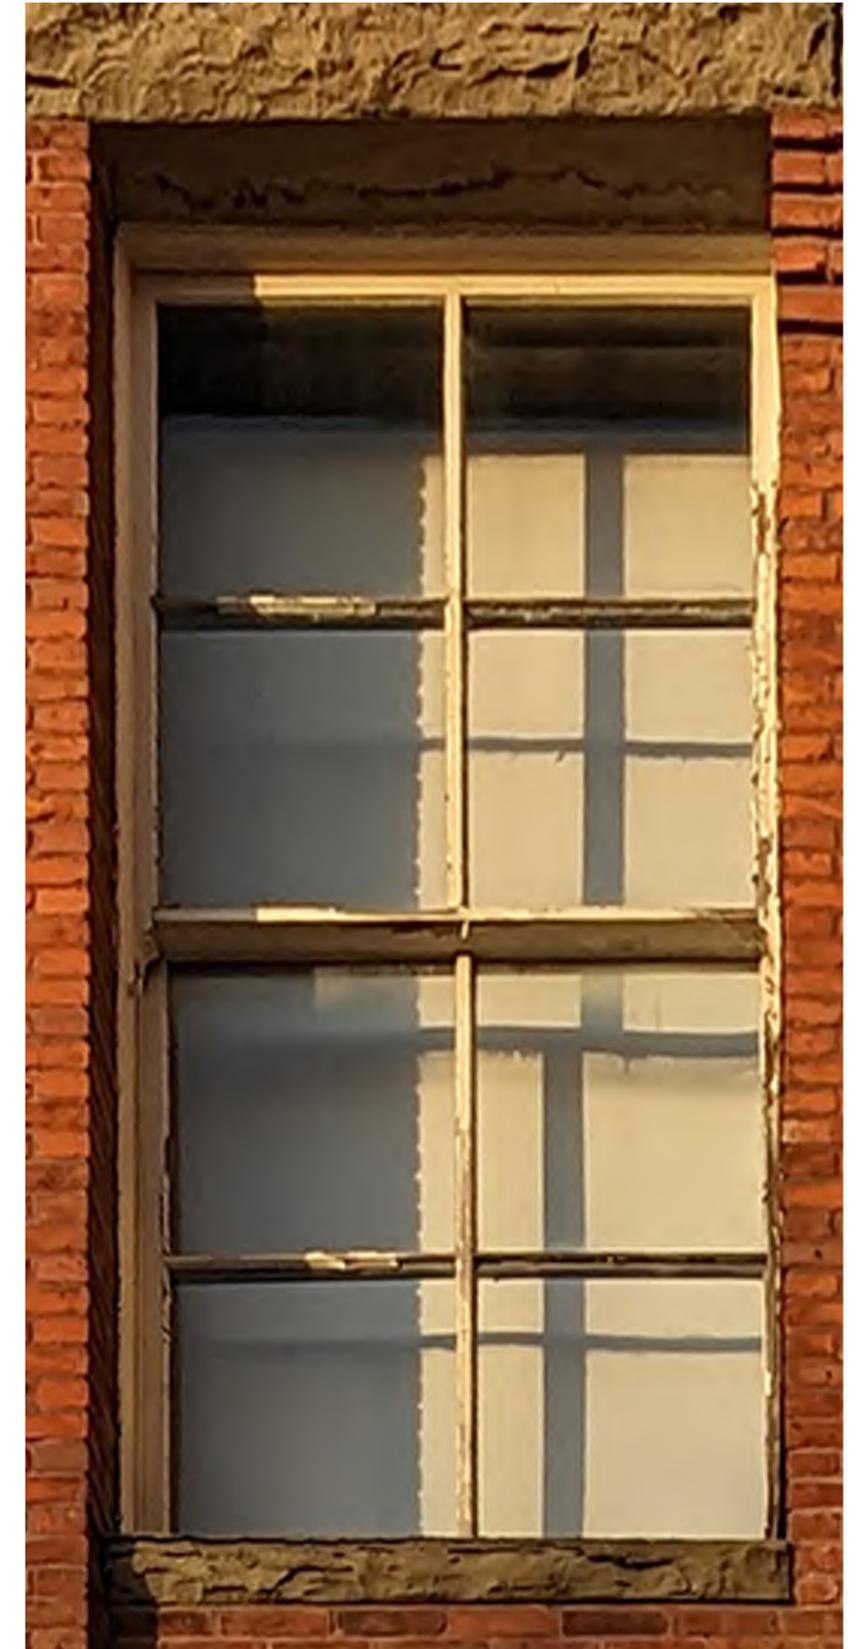
Window ID 2S.03 POOR CONDITION

● Metal sill cover

1. Sash Operation Difficult/Won't Open
2. Inoperable – Screwed Shut
3. Exterior Paint at Sash and Trim Cracked and Peeling at Limited Areas
4. Exterior Paint at Sash and Trim Heavily Deteriorated **Typical**

14. Section Loss
15. Missing Window Stop
16. Sealant Deteriorated
17. Weatherstrip Deteriorated/Missing
18. Deteriorated Glazing Compound/Setting Bead/Glazing Putty **Typical**

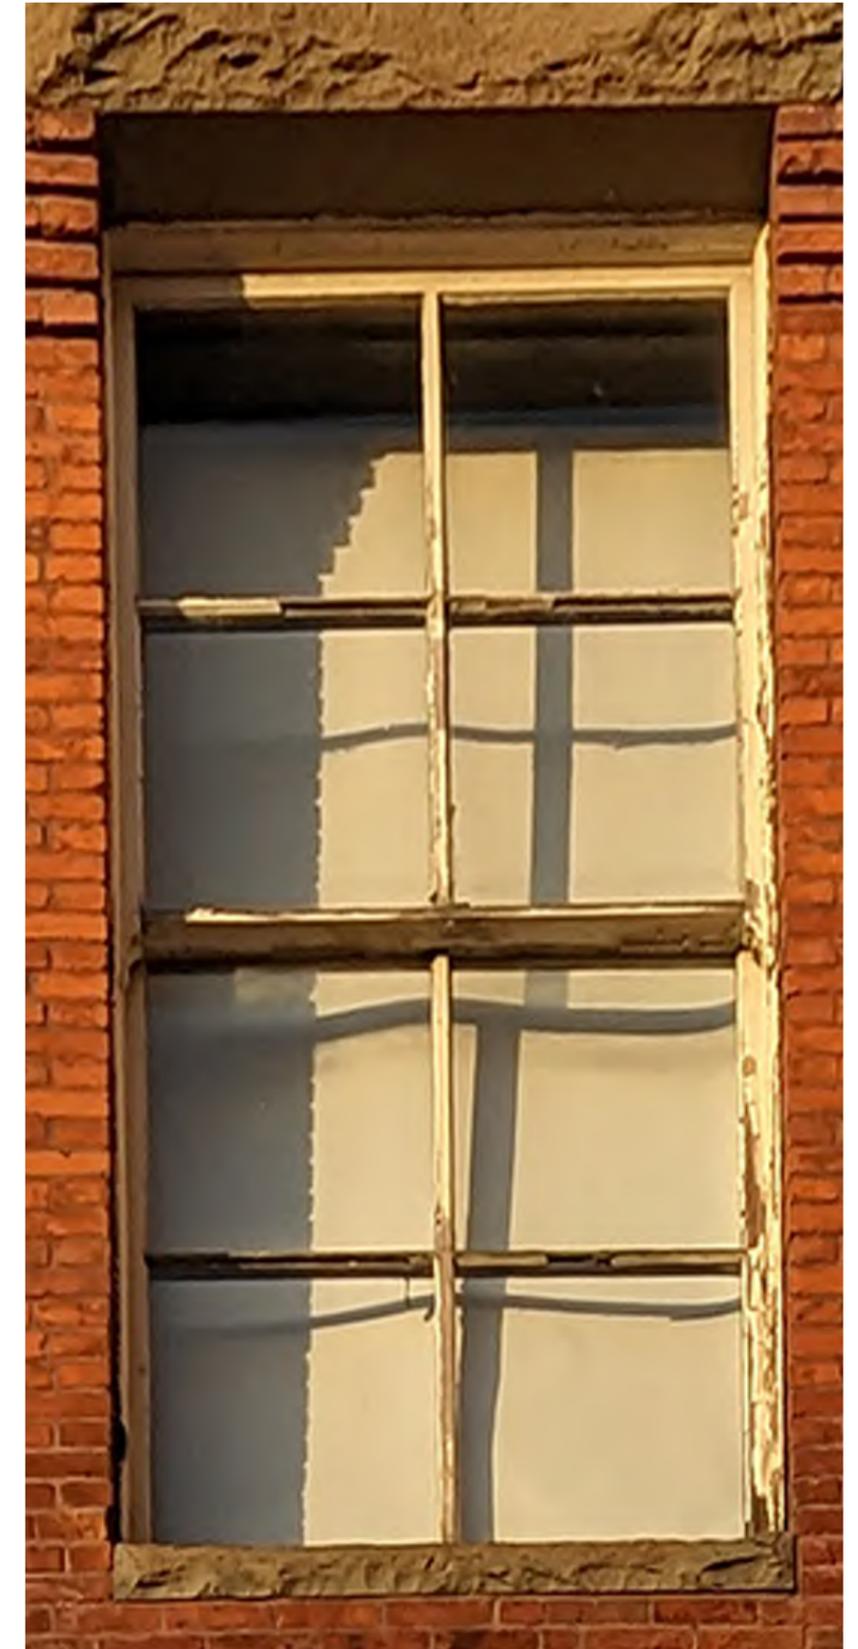
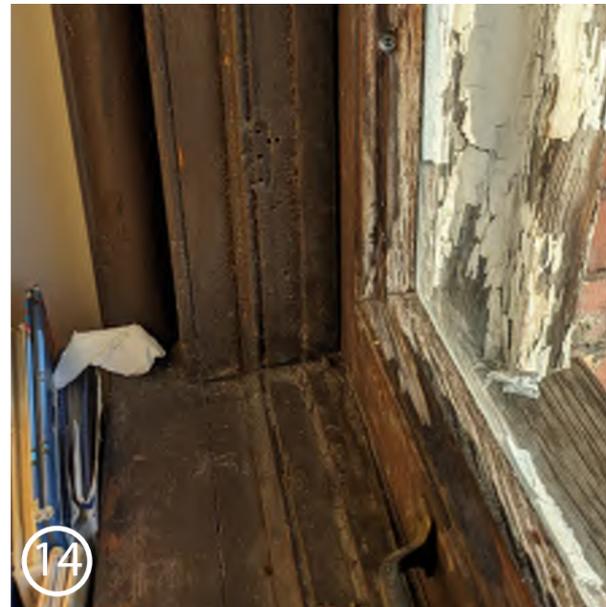
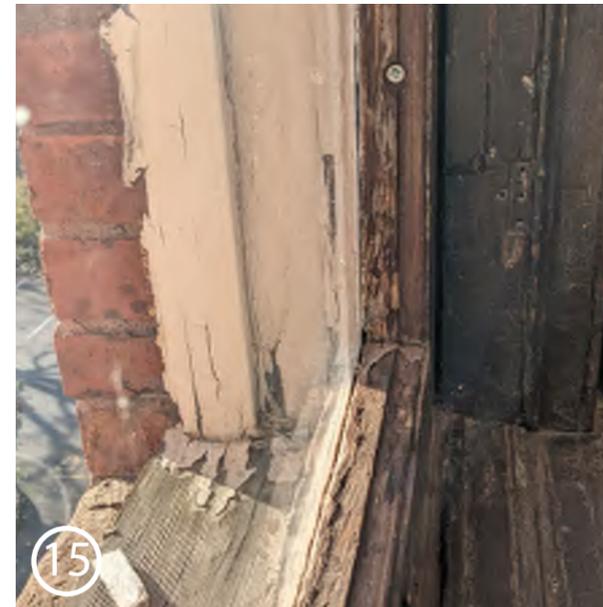
Window ID 2S.04 POOR CONDITION

1. Sash Operation Difficult/Won't Open
2. Inoperable – Screwed Shut
3. Exterior Paint at Sash and Trim Cracked and Peeling at Limited Areas
- ④ Exterior Paint at Sash and Trim Heavily Deteriorated

5. Checked Sash/Muntin
- ⑥ Deteriorated Sash
7. Checked/Split Frame
- ⑧ Deteriorated Frame
9. Parting Bead Lightly Deteriorated
- ⑩ Parting Bead Missing or Heavily Deteriorated

11. Sill 20% or Less Deteriorated
- ⑫ Sill Heavily Deteriorated, Wood Consolidation Necessary for More Than 20% of the Sill
13. Reinforced Sash (non-original)

14. Section Loss
15. Missing Window Stop
16. Sealant Deteriorated
17. Weatherstrip Deteriorated/Missing
- ⑱ Deteriorated Glazing Compound/Setting Bead/Glazing Putty

23. Replaced Glazing
- ⑳ Cracked Glazing
25. Missing Glazing

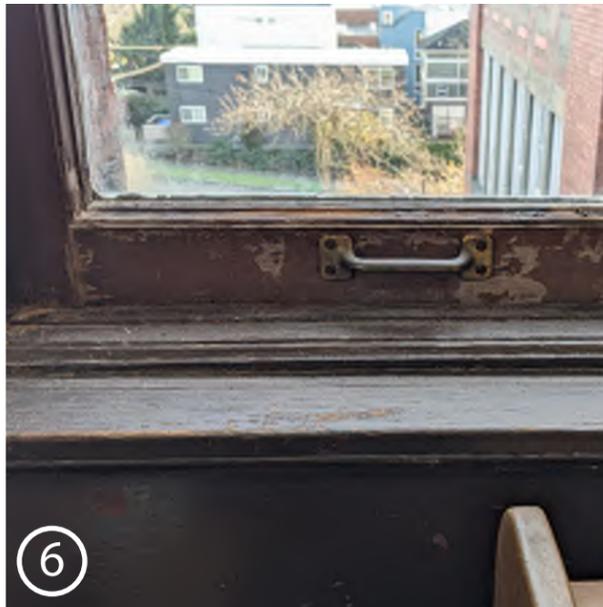
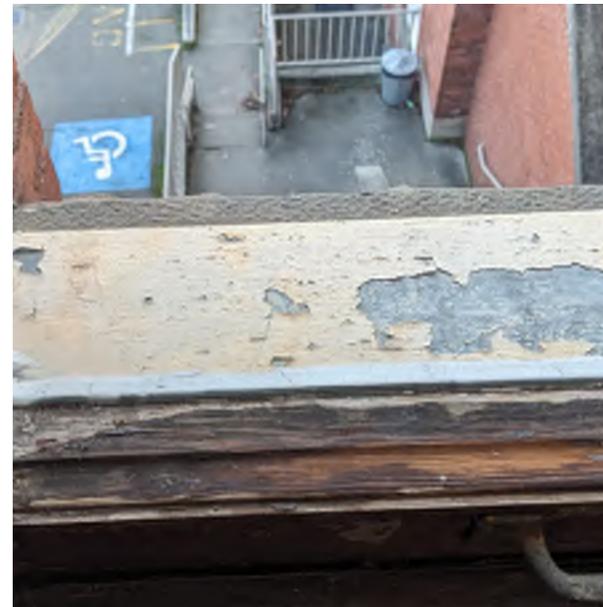
Window ID 2S.06 POOR CONDITION

● Metal sill cover

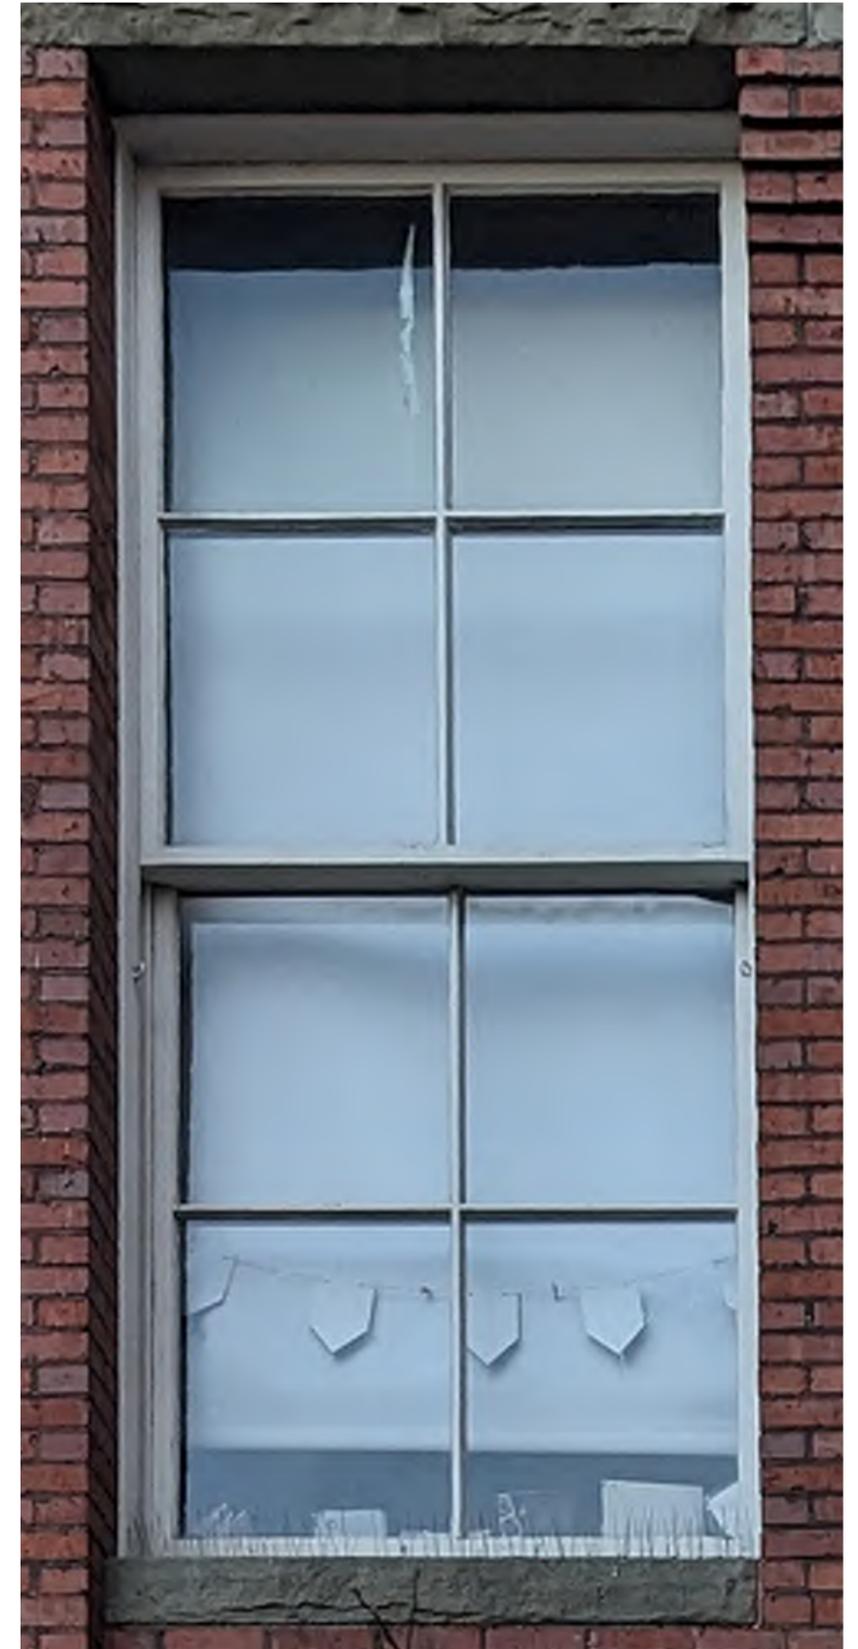
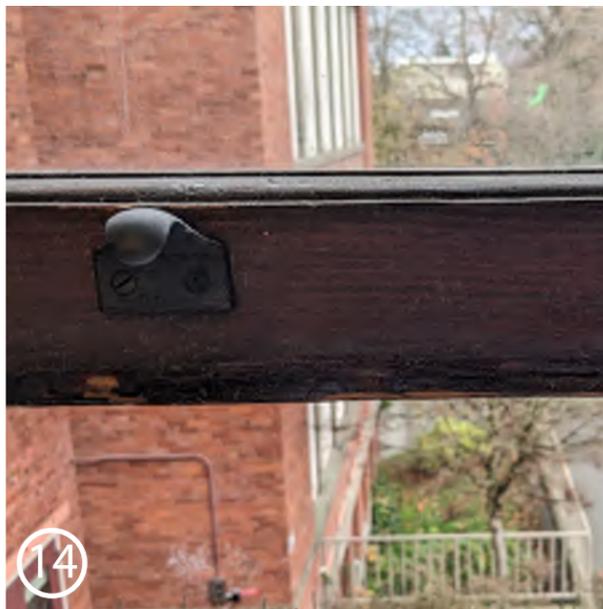
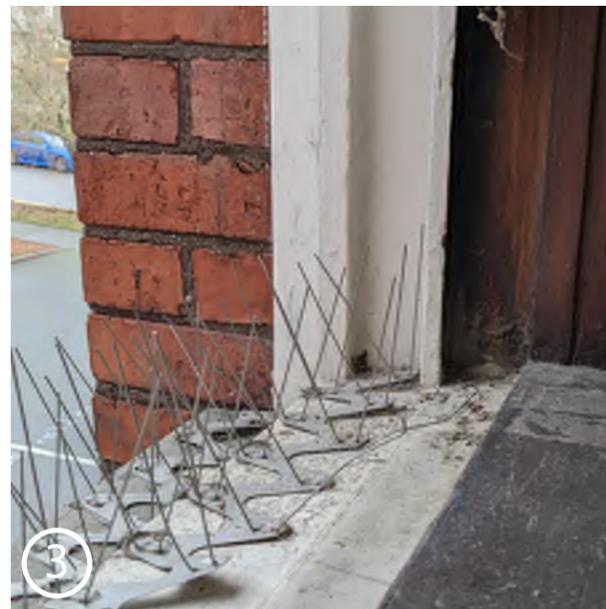
Window ID 2N.03 MODERATE CONDITION

● Window is loose within frame which limits sash operation
