SCOPE OF WORK:

- Replace existing play equipment and meet accessible play area standard
- Provide accessible route to connect play area to restroom and sidewalk
- Improve other accessibility items

ACCESSIBILITY CONSIDERATIONS

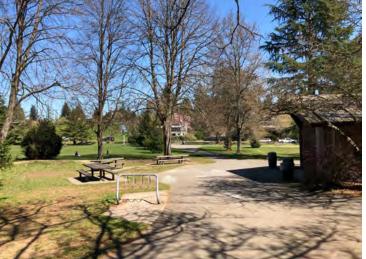
Lack of accessible route to the picnic areas. If budget allows, add concrete paving to picnic area, replace with accessible picnic tables and BBQs.

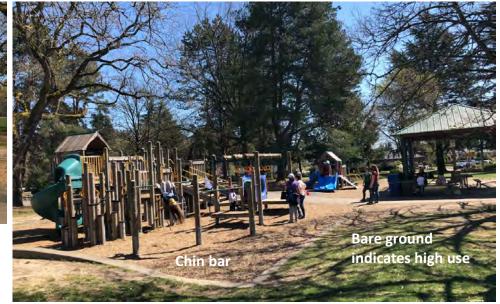
Existing age 2~5 play area echoes the design of bigger play structure.

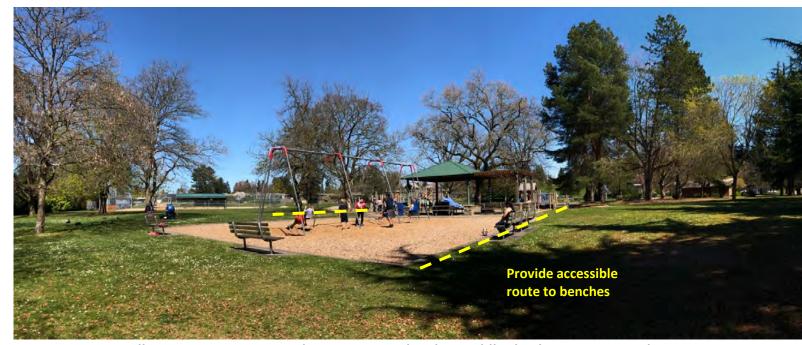
Existing age 5~12 play area

The existing age 5~12 play equipment offers varieties of play events, many access points, and many play routes. Space underneath the deck is well used.

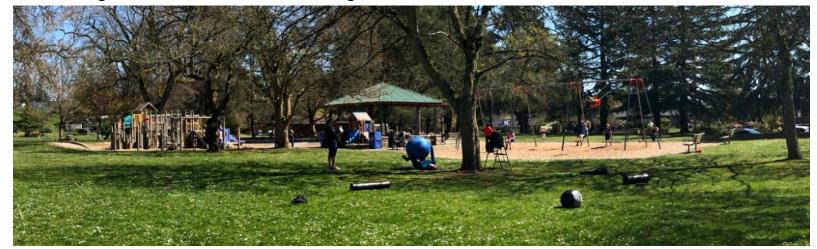
Existing tall swing is aging & exceeds maintenance height. Toddler bucket swing exceed maximum 8' high. Lack of accessible route to existing benches.
