CASE STUDIES IN FINANCING URM RETROFITS

TWO BUILDINGS: TWIN PROJECTS

The Costs of a Seattle URM Retrofit

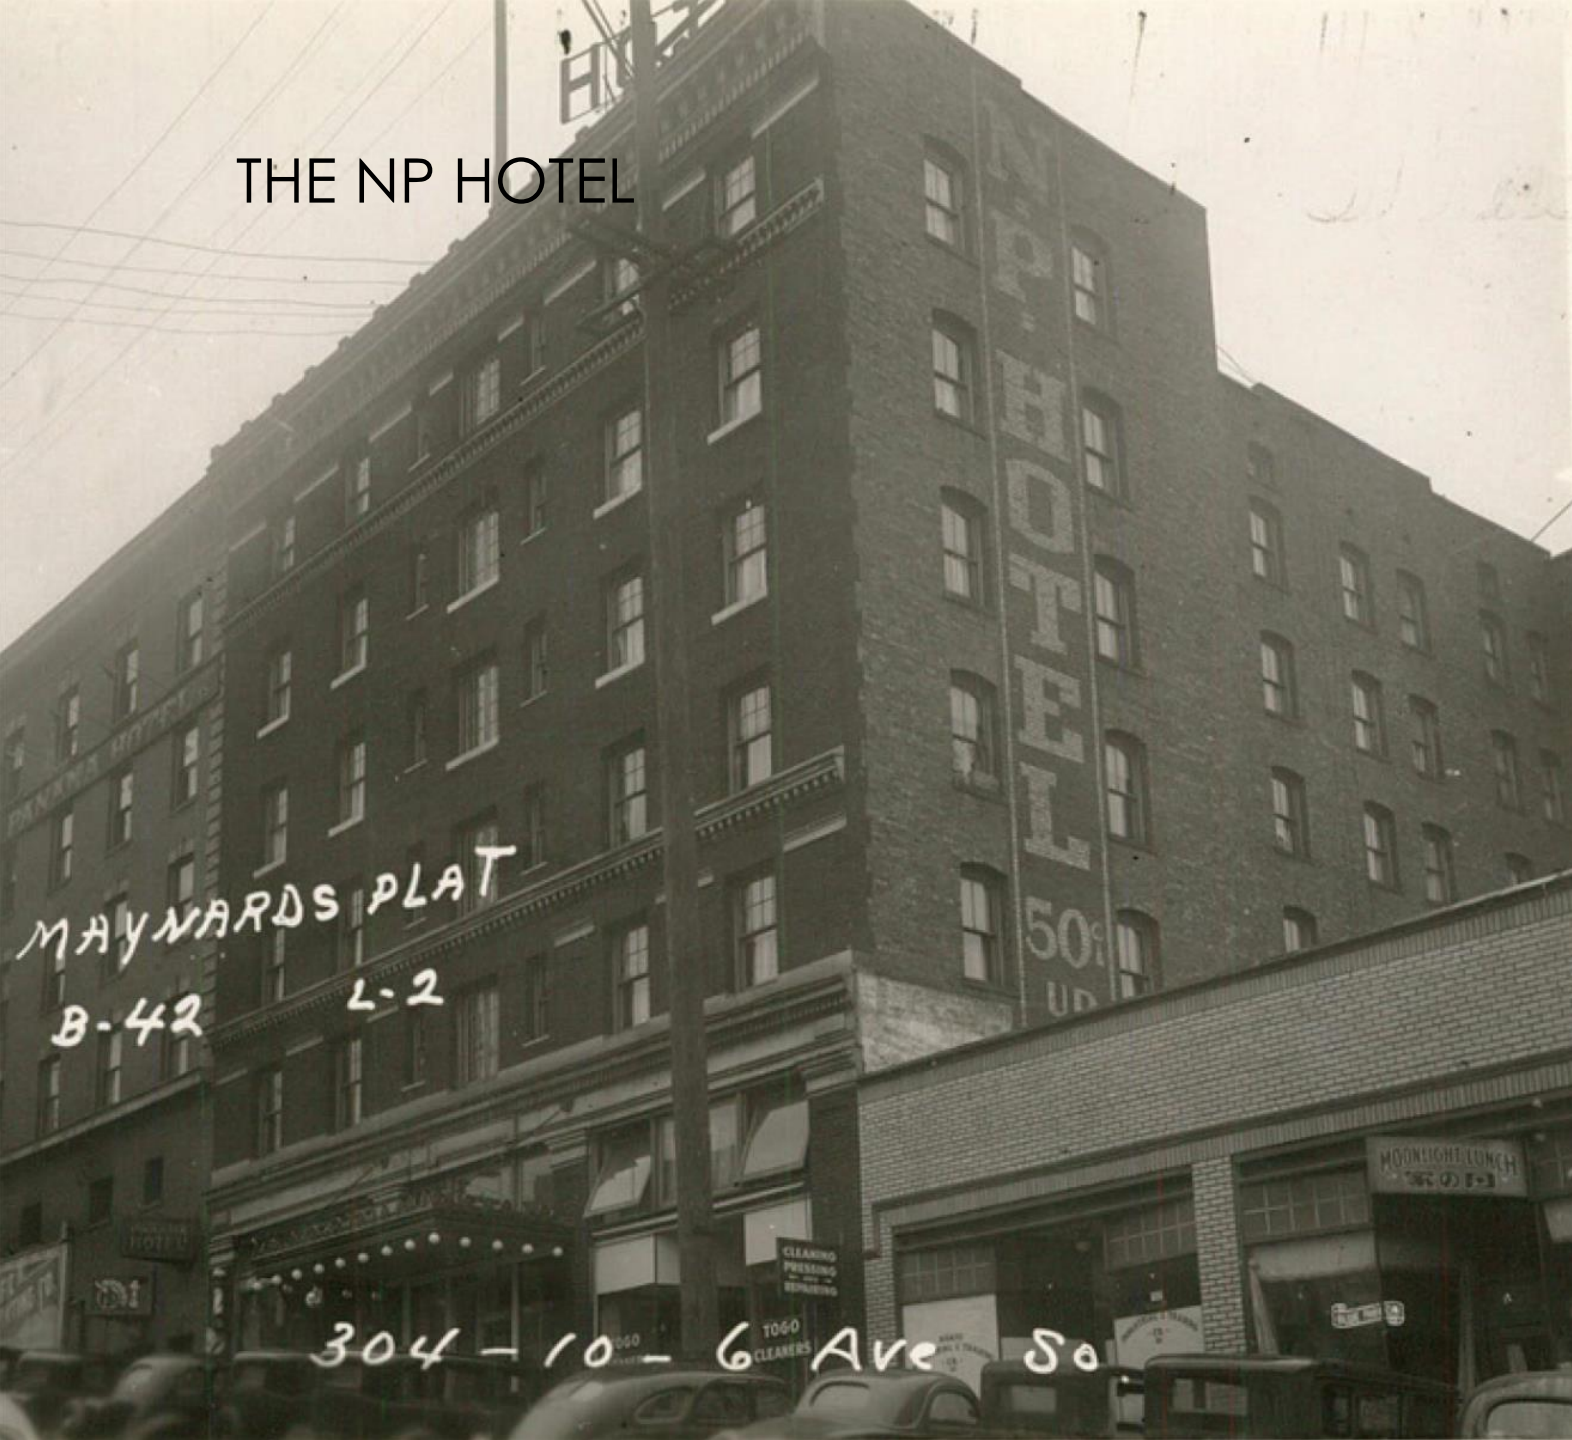
THE NP HOTEL

Seismic retrofits: 1998 & 2023

1998:

Seismic upgrade (COS Administrative Ruling
Informational Bulletin No 2, October 1976)
including steel seismic frames at ground level,
plywood shear walls at upper floors, wood
beam to column ties, roof and floor
diaphragms, wall ties, and parapet bracing.

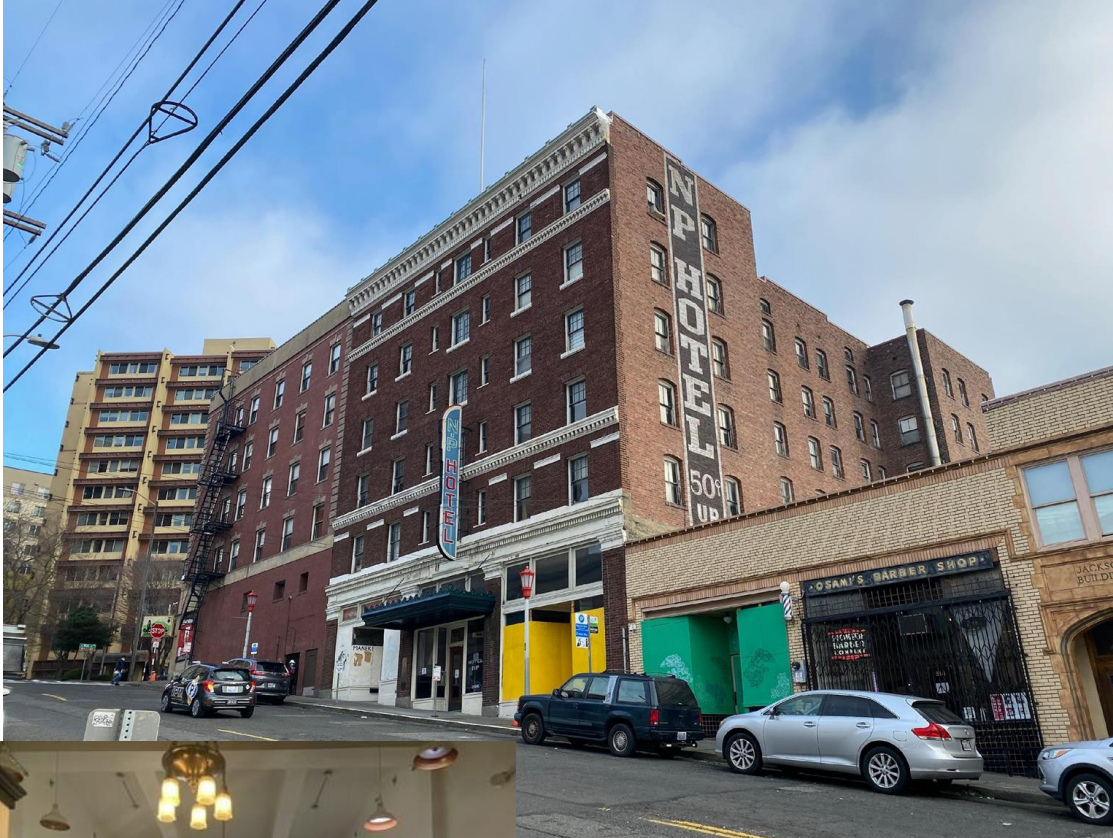
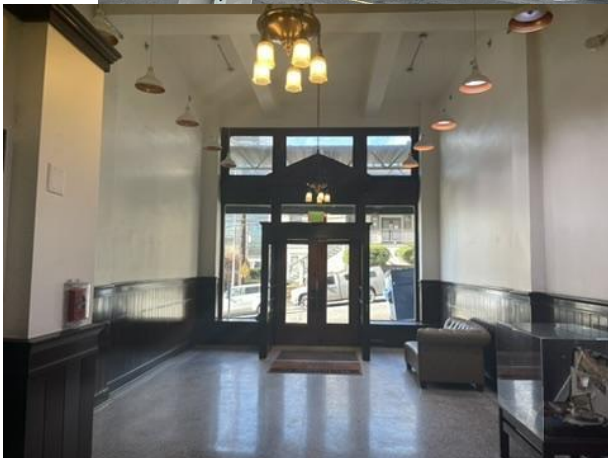
THE NP HOTEL

2023:

- A. Add 1/2" plywood sheathing at floors 2-4. Increase nailing
- B. Add connectors at floor-to-wall connections. Verify 1993 floor-to-wall and add ties where missing or exceed 6' O.C.
- C. Add diaphragm straps near elevator
- D. Add nailing to existing plywood shear walls
- E. Add HSS tube columns at the ends of existing plywood shear walls
- F. Retrofit existing steel moment frames with new bracing
- G. Provide 2 braced frames below discontinuous north and south URM walls
- H. Provide new foundations below the new braced frames, and other bays as noted on plan
- I. Provide let-in concrete strongback beams at the exterior URM walls within the stairwells
- J. Provide HSS tube steel columns below exiting heavy timber beams, for secondary support

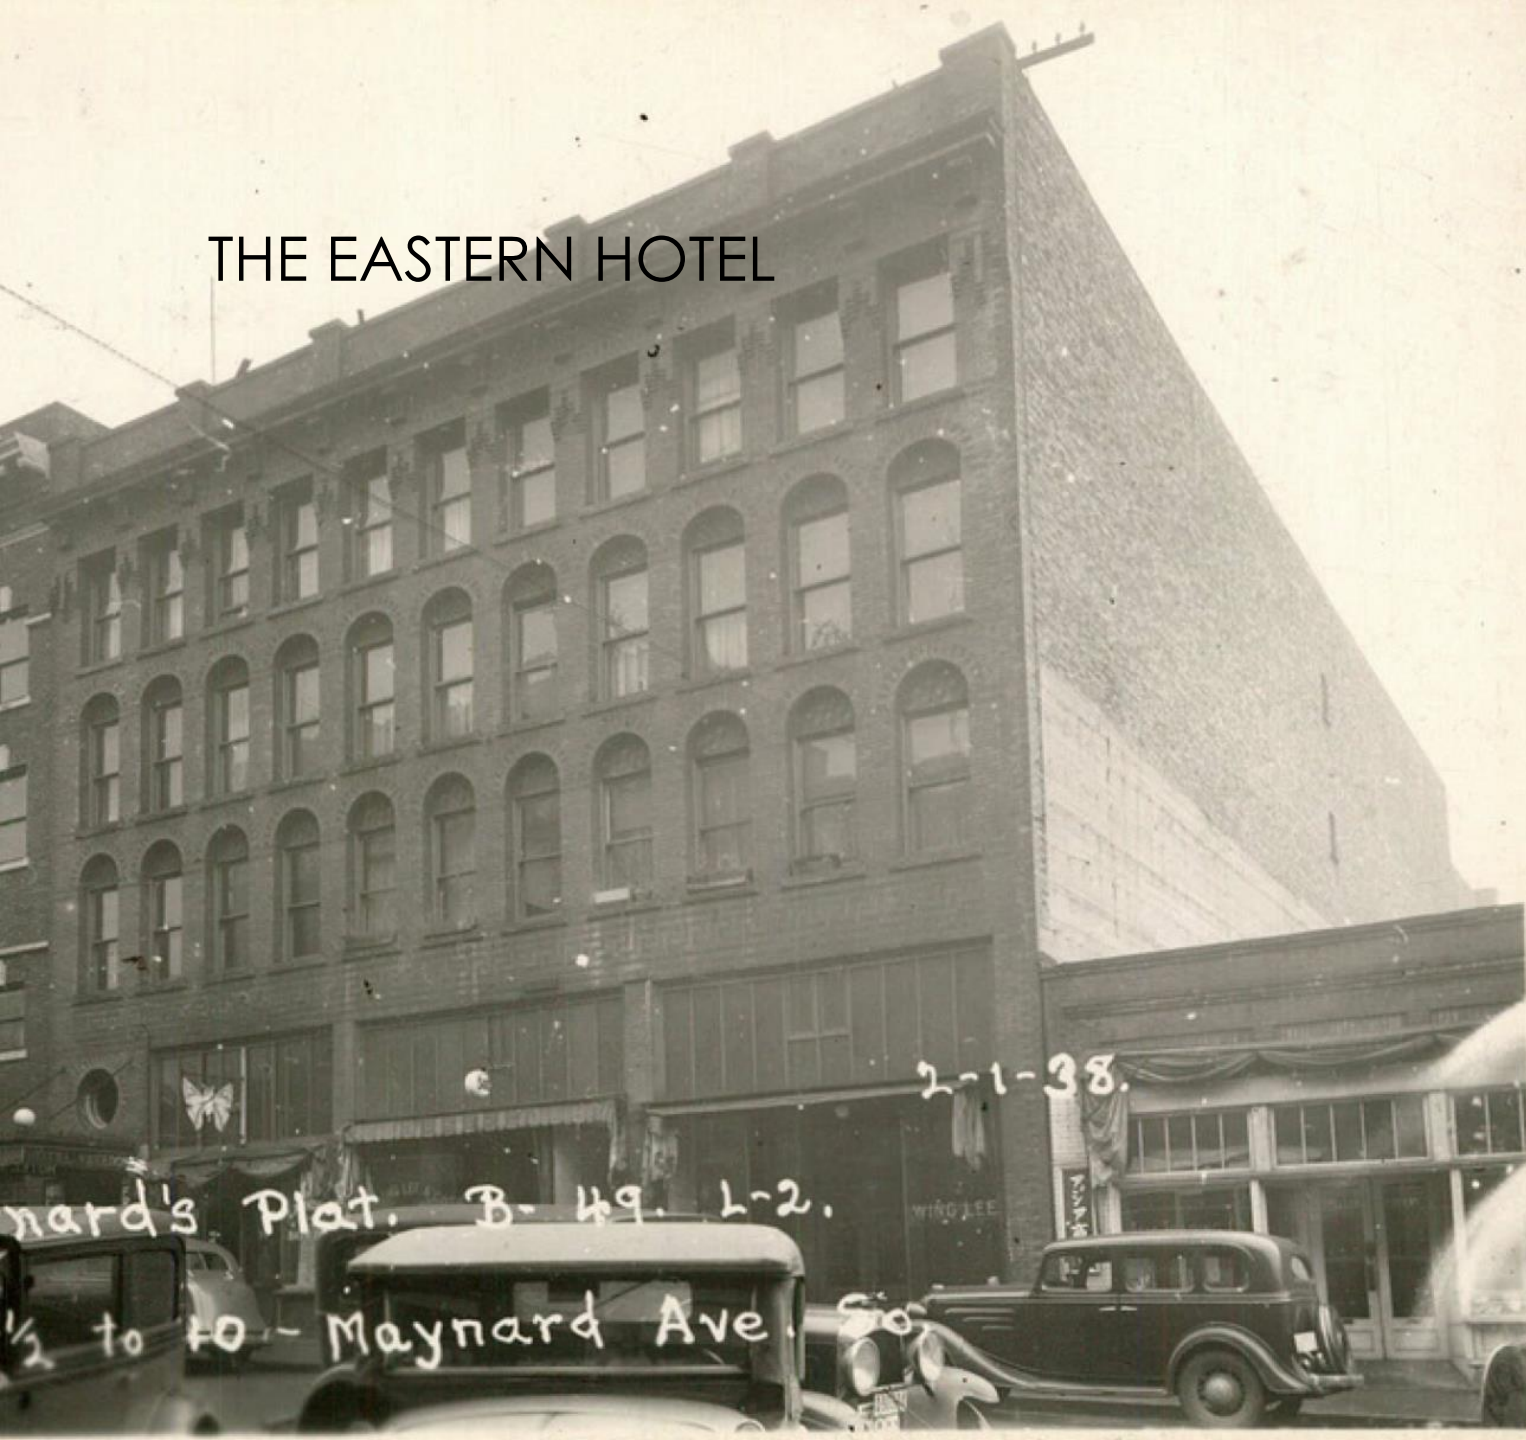
THE EASTERN HOTEL

Seismic retrofits: 1998 & 2023

1998:

Seismic upgrade (FEMA 267 / August 1950) including concrete seismic frames and concrete shear walls at ground level, plywood shear walls at upper floors, wood beam to column ties, roof and floor diaphragms, wall ties, and parapet bracing.

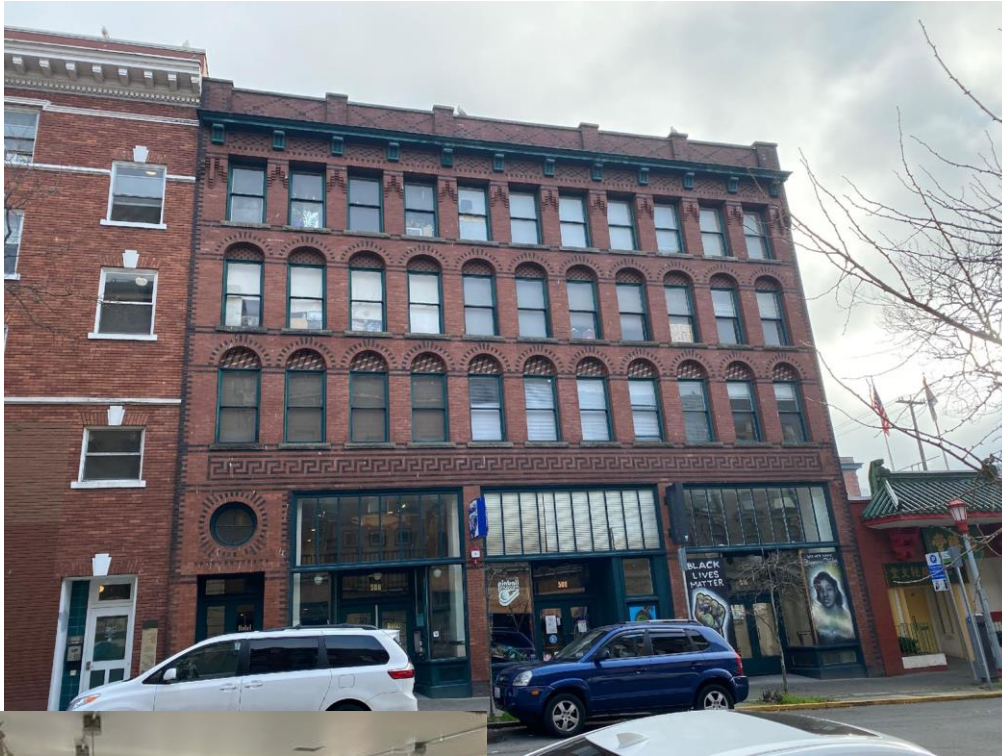
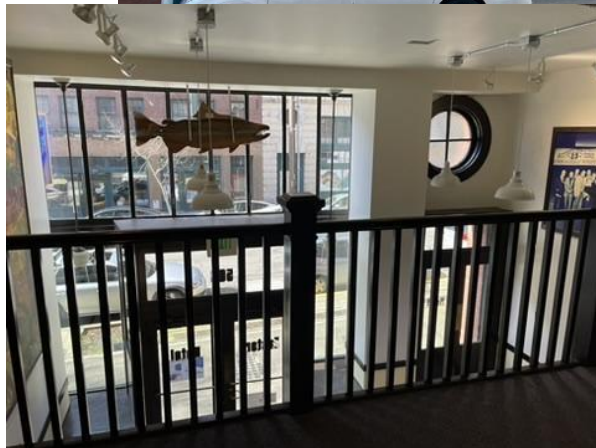
THE EASTERN HOTEL

2023:

A. Add continuous straps or angles at the wood floor / URM walls.

B. Provide 6"-8" concrete wrap at all concrete moment frame columns installed in 1998.

C. Add concrete grade beams tying the base of the wrapped columns to the existing foundations

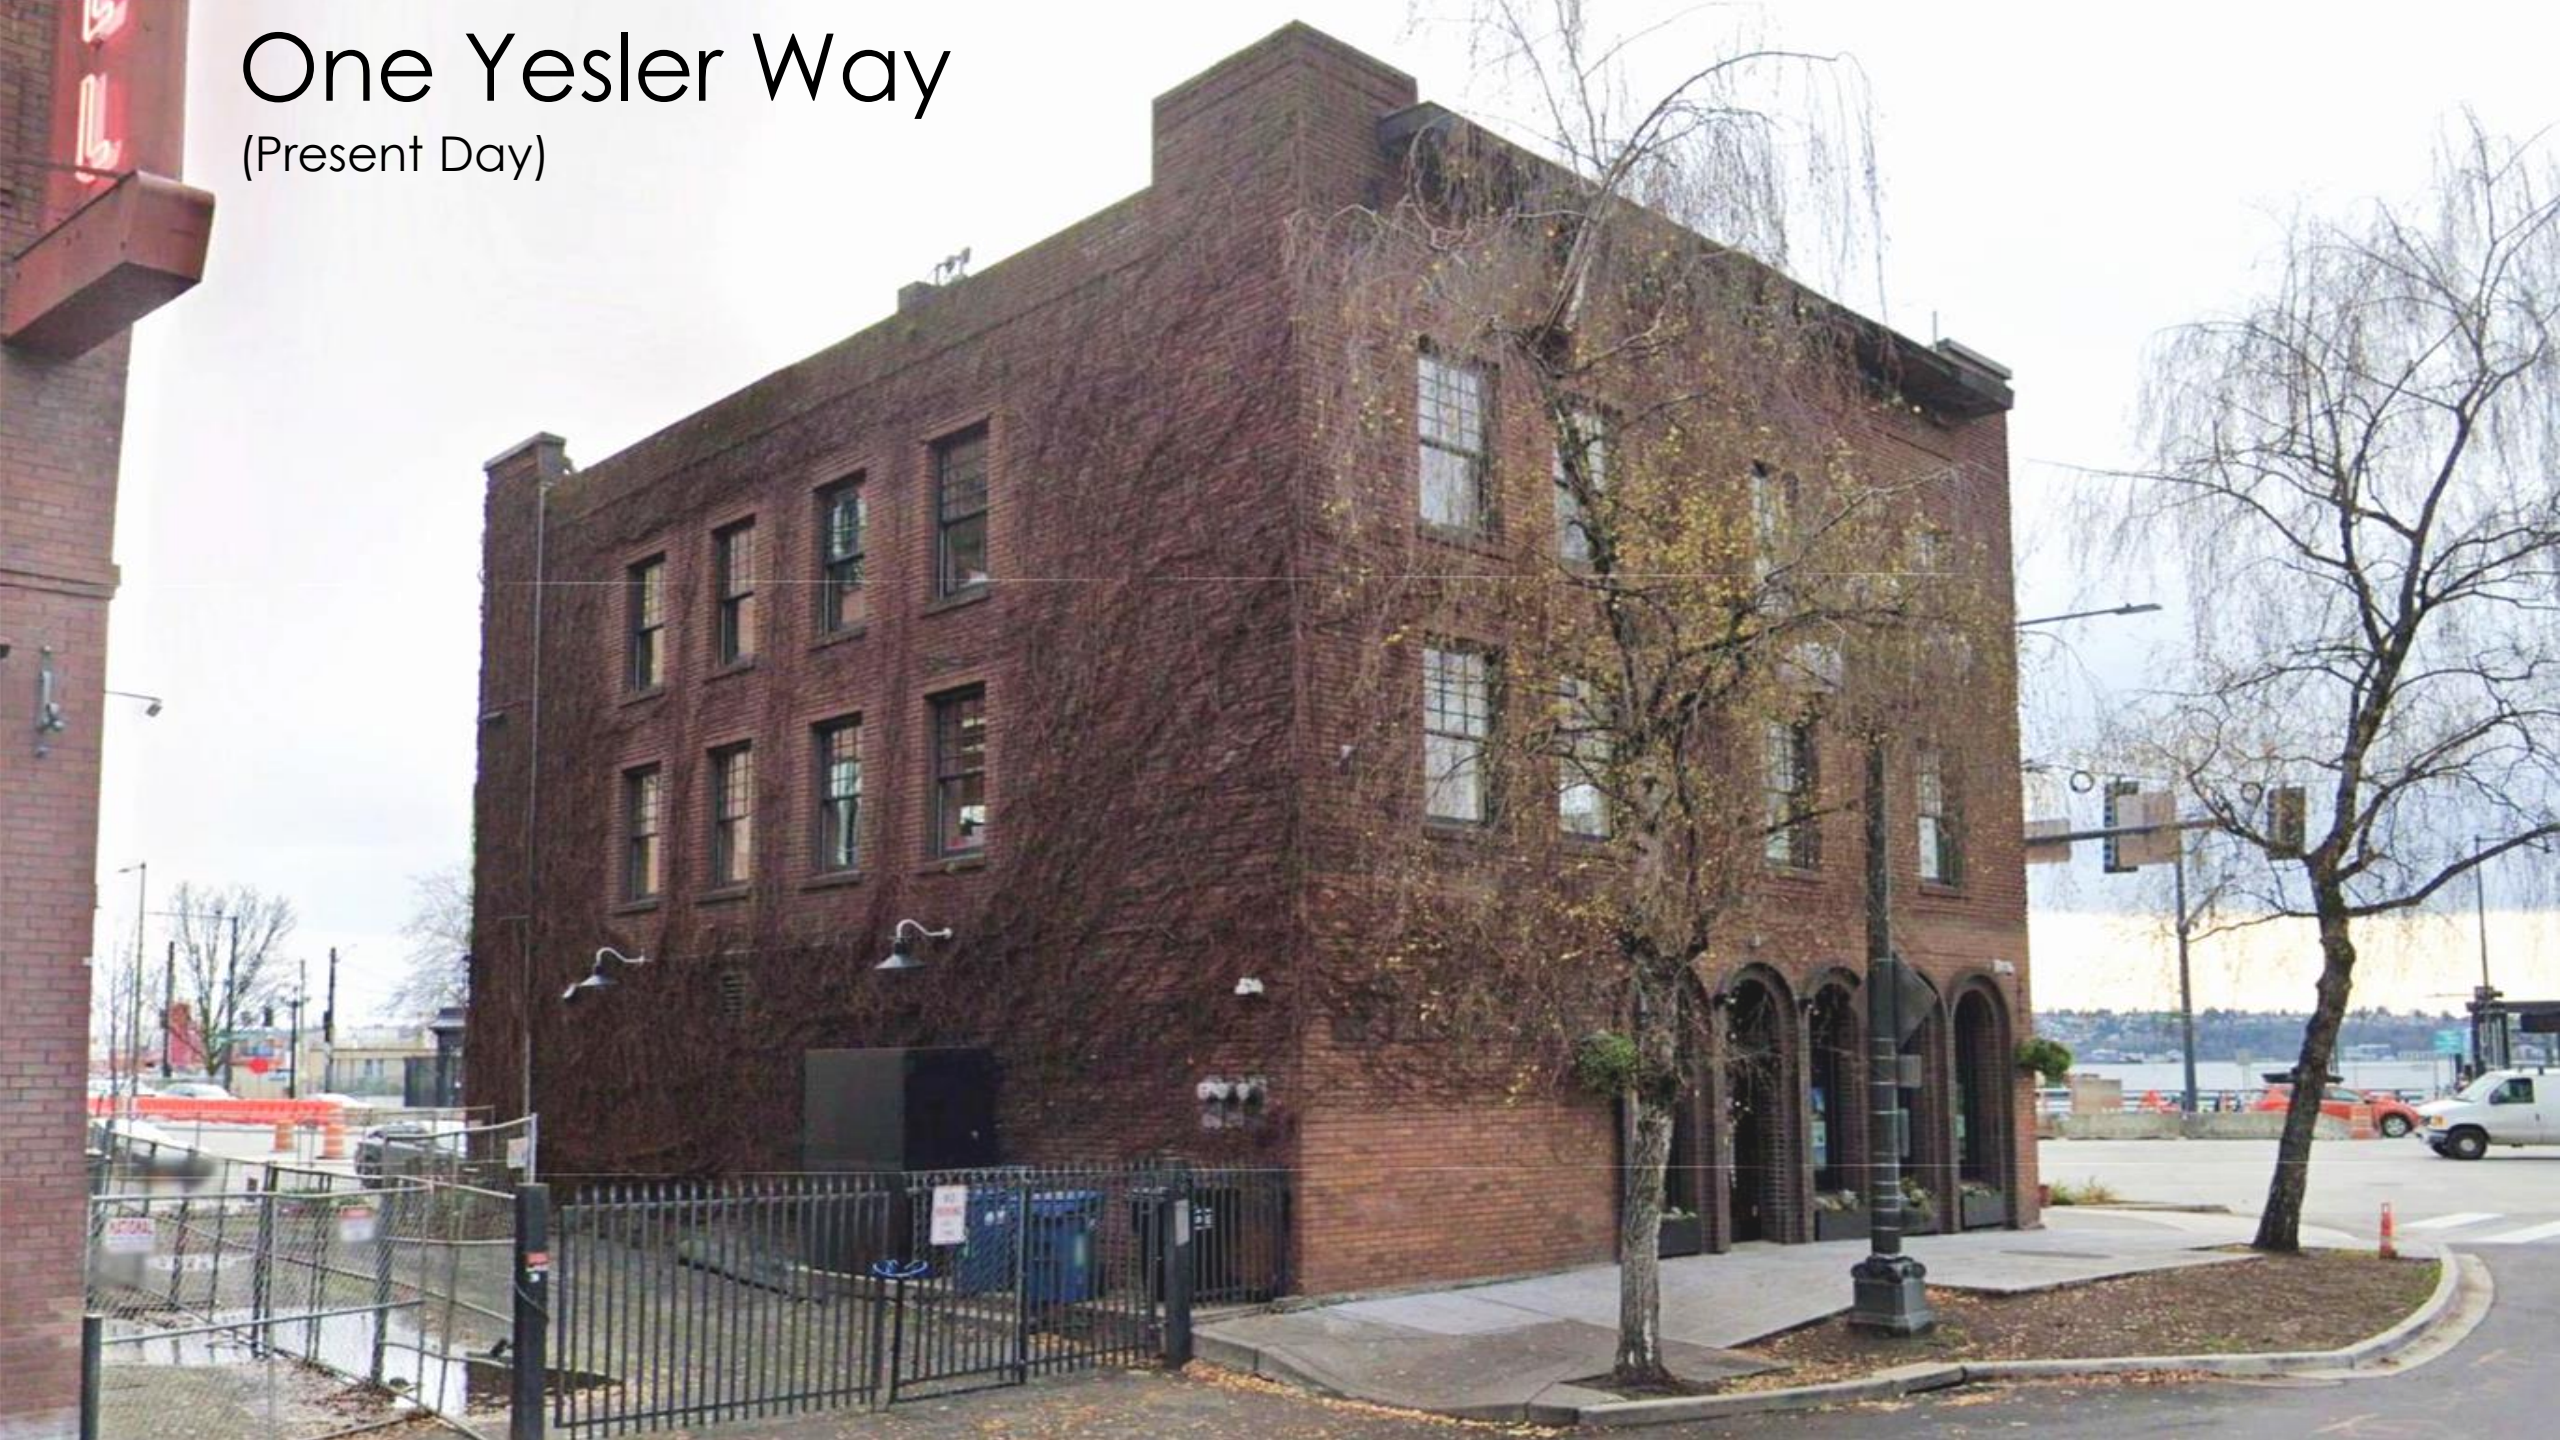
PIONEER SQUARE WATERFRONT

PRE 1860 TIDAL FLATS

1880 PIERS & PILE-SUPPORTED RAILWAYS

1889 GREAT SEATTLE FIRE

1910 ALASKAN WAY SEAWALL

1910 ROAD & RAILWAY OVER BACKFILL

1911 ONE YESLER WAY CONSTRUCTED

1953 ALASKAN WAY VIADUCT (SR 99)

2019 STATE ROUTE 99 TUNNEL

PRESENT WATERFRONT PARK CONSTRUCTION

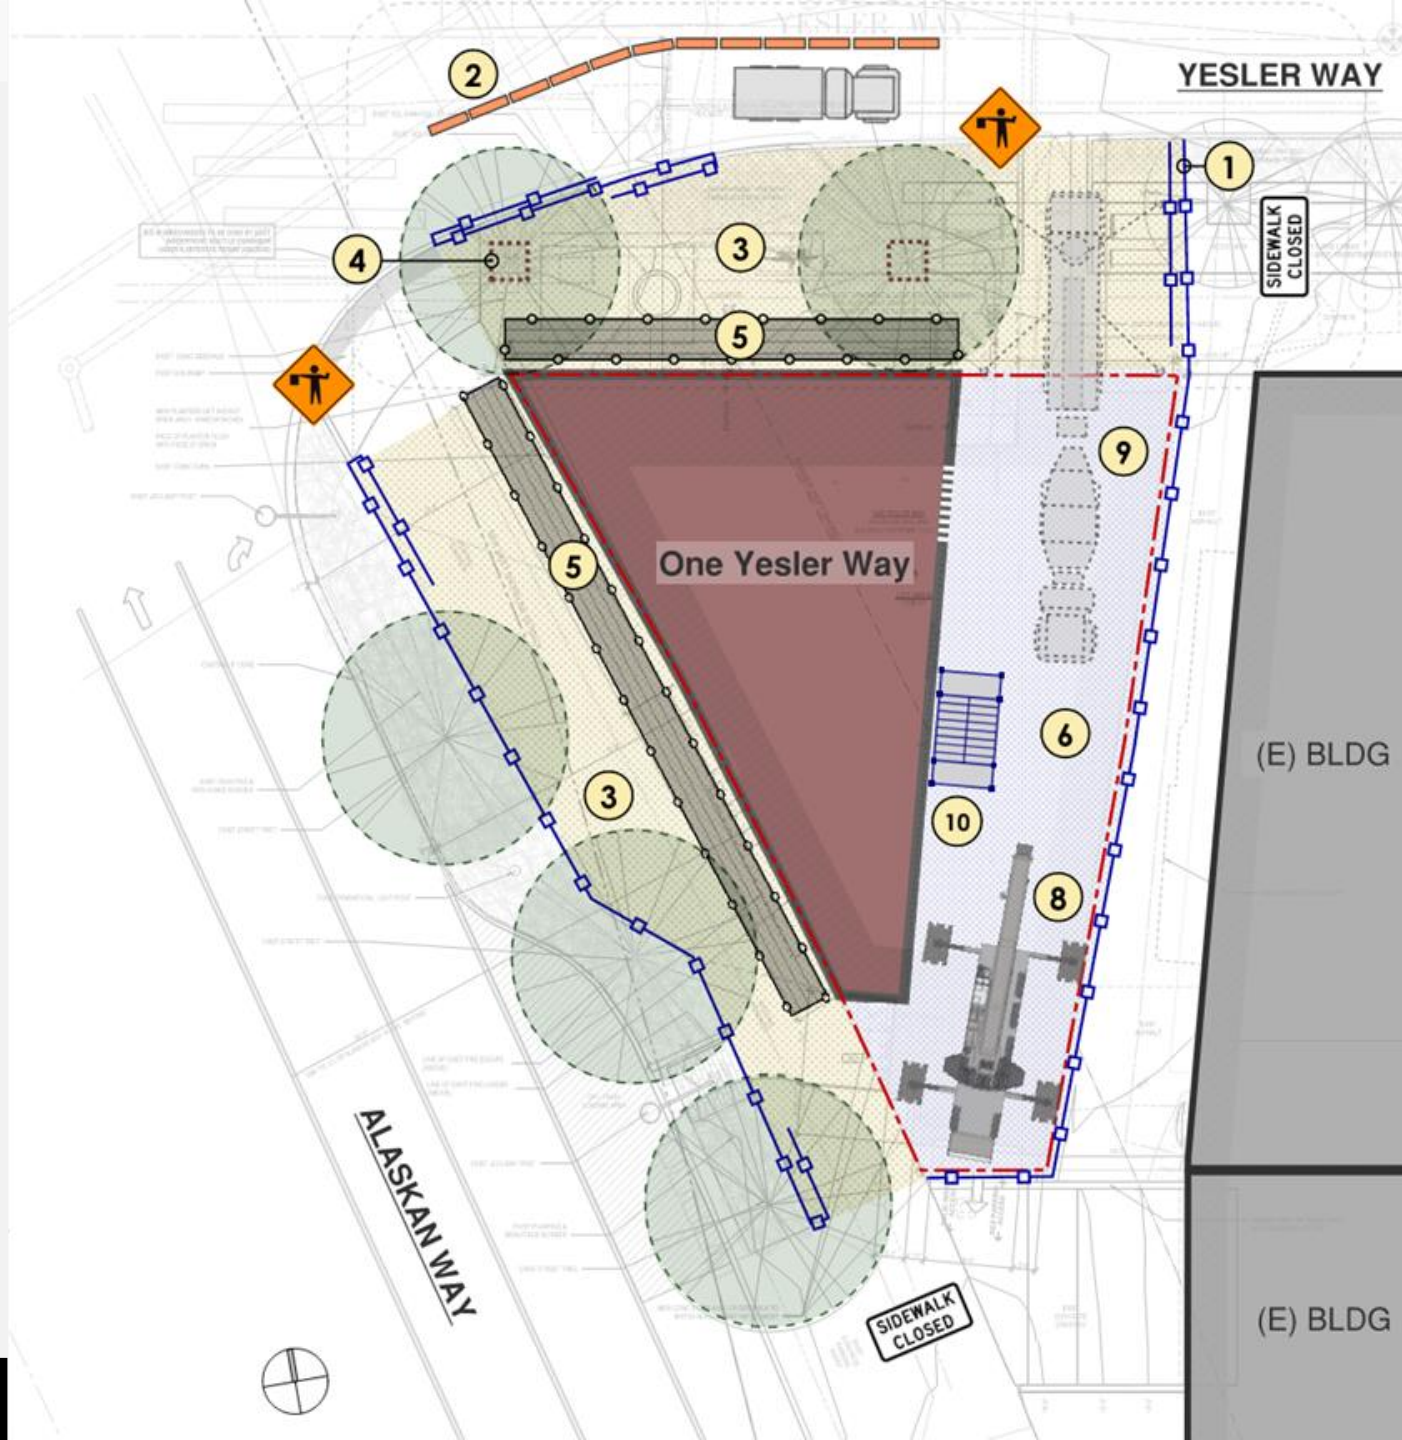
Site Logistics Keynotes

- 1 Perimeter Fencing. Secure at EOD
- 2 Jersey Barriers. Move to Curb at EOD
- 3 Extents of Sidewalk Closure shaded Yellow
- 4 Protect Street Trees within Perimeter
- 5 Scaffolding &/or Boom Lifts for Ext. Access
- 6 Undeveloped Lot = Staging/Hoisting Area
- 7 Temp Opening for Drill Rig Access. Selectively Remove & Preserve Brick.
- 8 Proposed Location for Carry Deck Crane
- 9 Proposed Loading & Pumping Location
- 10 Stair Tower for Upper Level Access

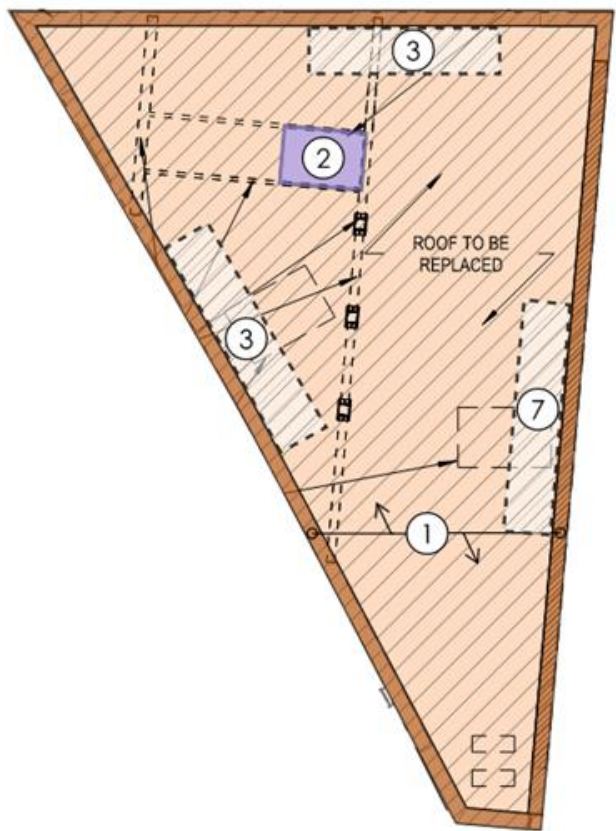
ROOF DEMO SCOPE

1. Remove Roofing & Parapet Cap for Sheathing Installation
2. Remove & Preserve Skylight for Re-installation after New Roofing Installation
3. Create Roof Openings to Place Brace Frame components.

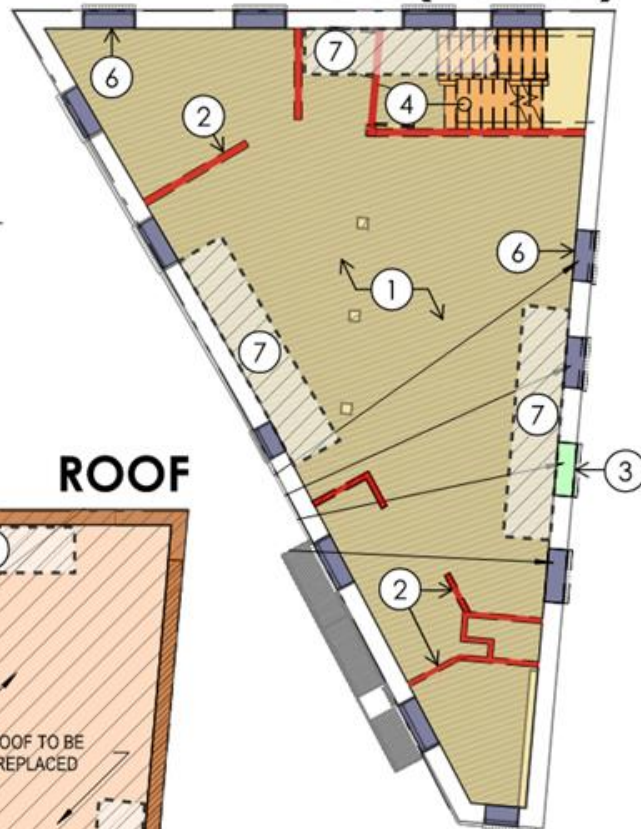
L-2 (L-3 SIM)

LEVEL 2 & 3 DEMOLITION SCOPE

1. Remove Floor Finishes for Sheathing Installation
2. Remove Partitions & Assoc. Doors & MEP Components
3. Remove & Protect Window at Temp Access Opening
4. Remove Stair for Brace Frame Installation
6. Protect Windows & Doors
7. Remove Decking as req'd. for Brace-Frame Installations

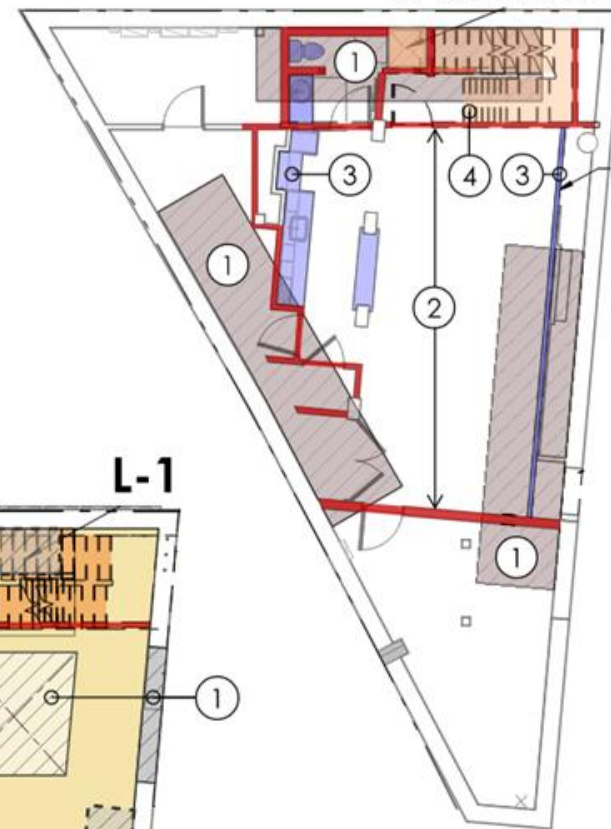
BASEMENT DEMO SCOPE

1. Saw-cut & Remove SOG for Footing Excavation
2. Remove Partitions & Associated Doors & MEP Components
3. Remove, Store, & Protect Casework, Plumbing Fixtures, & Lighting to be Reinstalled
4. Remove Stair & Shower for Footing Excavation

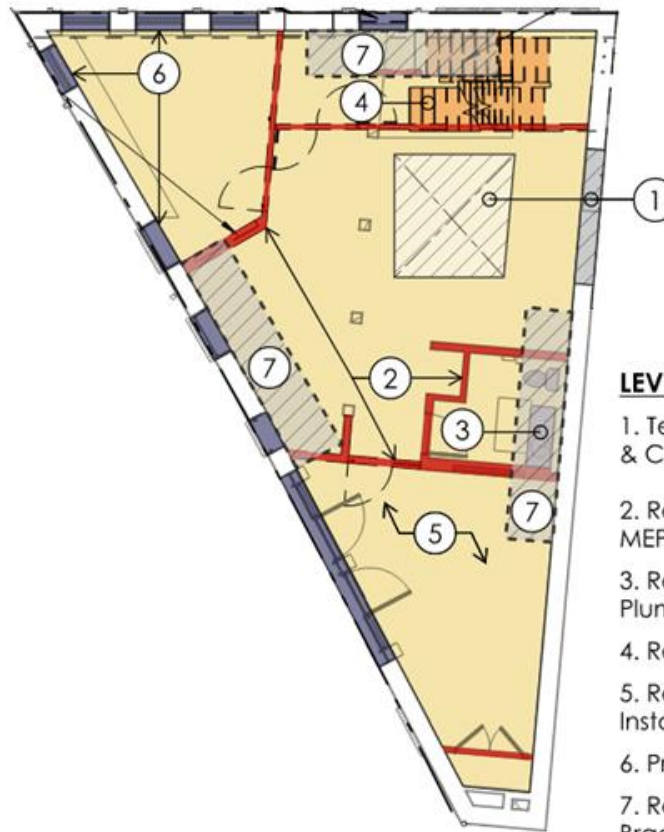
L-1

LEVEL 1 DEMOLITION SCOPE

1. Temp Openings for Shoring Drill Rig & Concrete Slick Line Access
2. Remove Partitions & Assoc. Doors & MEP Components
3. Remove & Protect Casework, Plumbing Fixtures, & Lighting.
4. Remove Stair for Brace Frame Install.
5. Remove Floor Finishes for Sheathing Installation
6. Protect Windows & Doors
7. Remove Decking as req'd. for Brace-Frame Installations

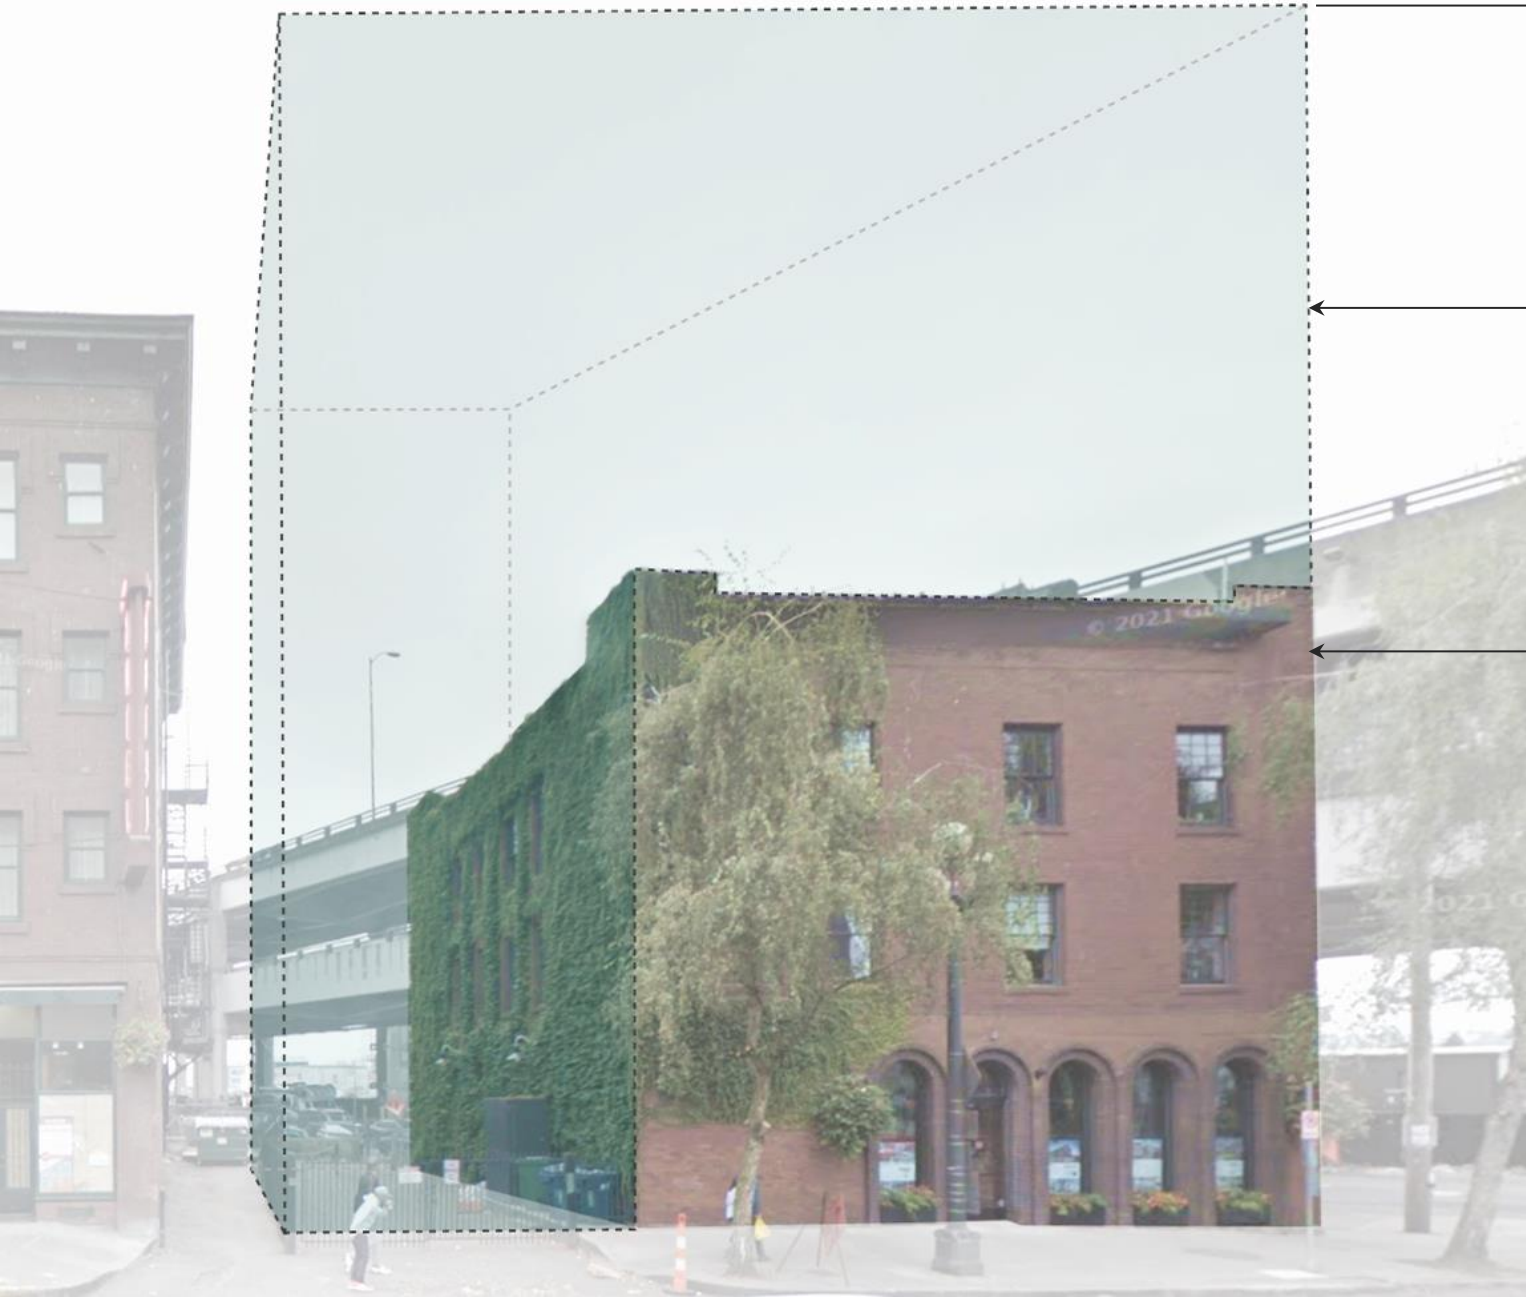
Existing Incentive: Transfer Development Rights

PSM Zone Height Limit Above Average Grade

100' - 0"

Unused Development Area : **21,386 SF**

Chargeable (Existing) Area: **6,181 SF**

Lot Area = 3,063 SF

Total Dev. Area = 3,063 SF x 9 Floors Max = 27,567 SF

Total Dev. Area – Chargeable Area = 21,386 SF
(6,181 SF)

Dev. Rights = 21,386 SF x \$30 Mkt Value = **\$ 641,580**
