Phase 2B

Waiting Room & Upper Floors Construction Updates

November 15, 2012

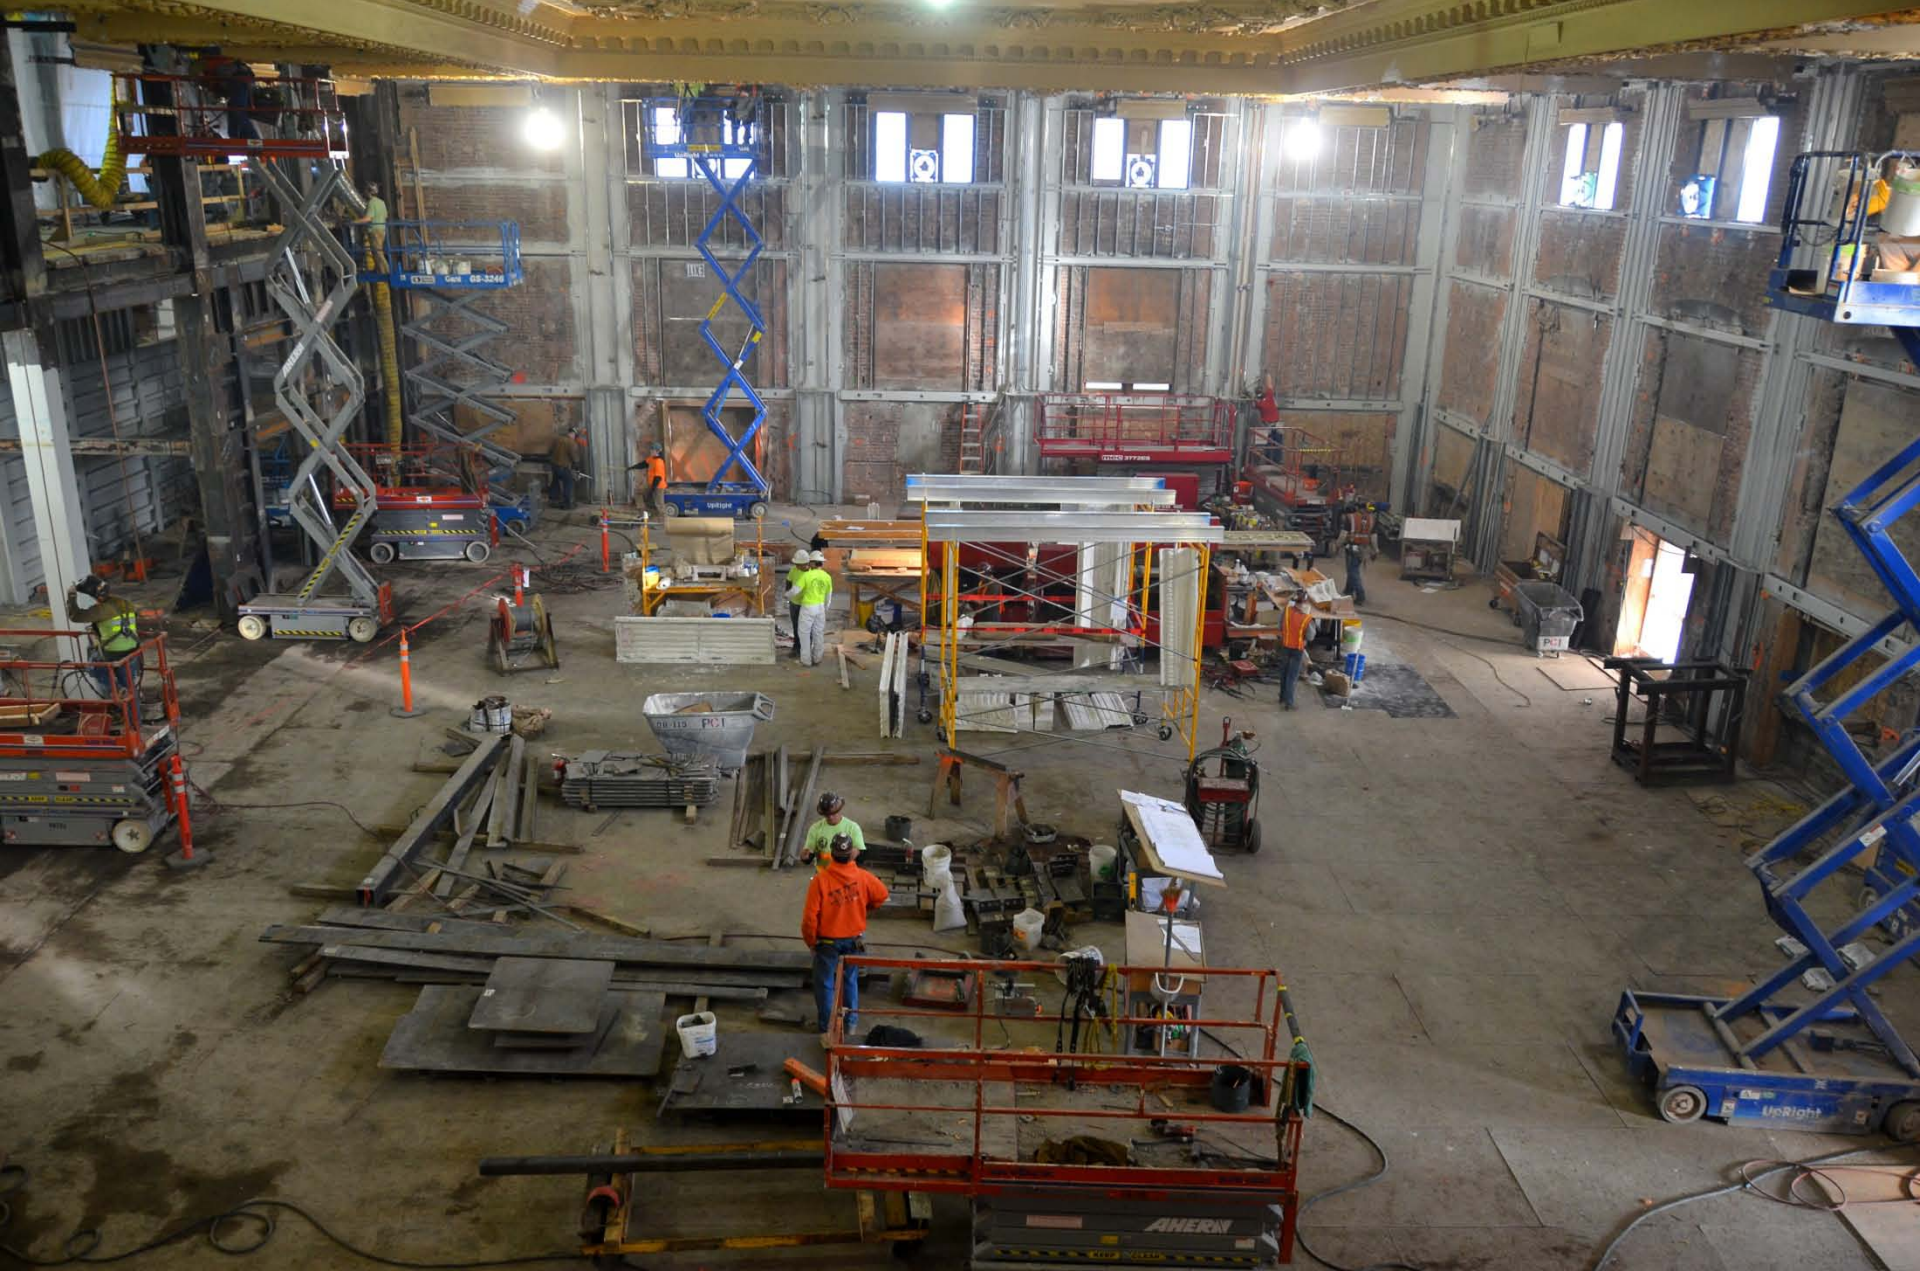
Seismic steel trusses were installed over new white columns for additional load bearings. New ornamental plaster walls will hide these new structural steel reinforcement.

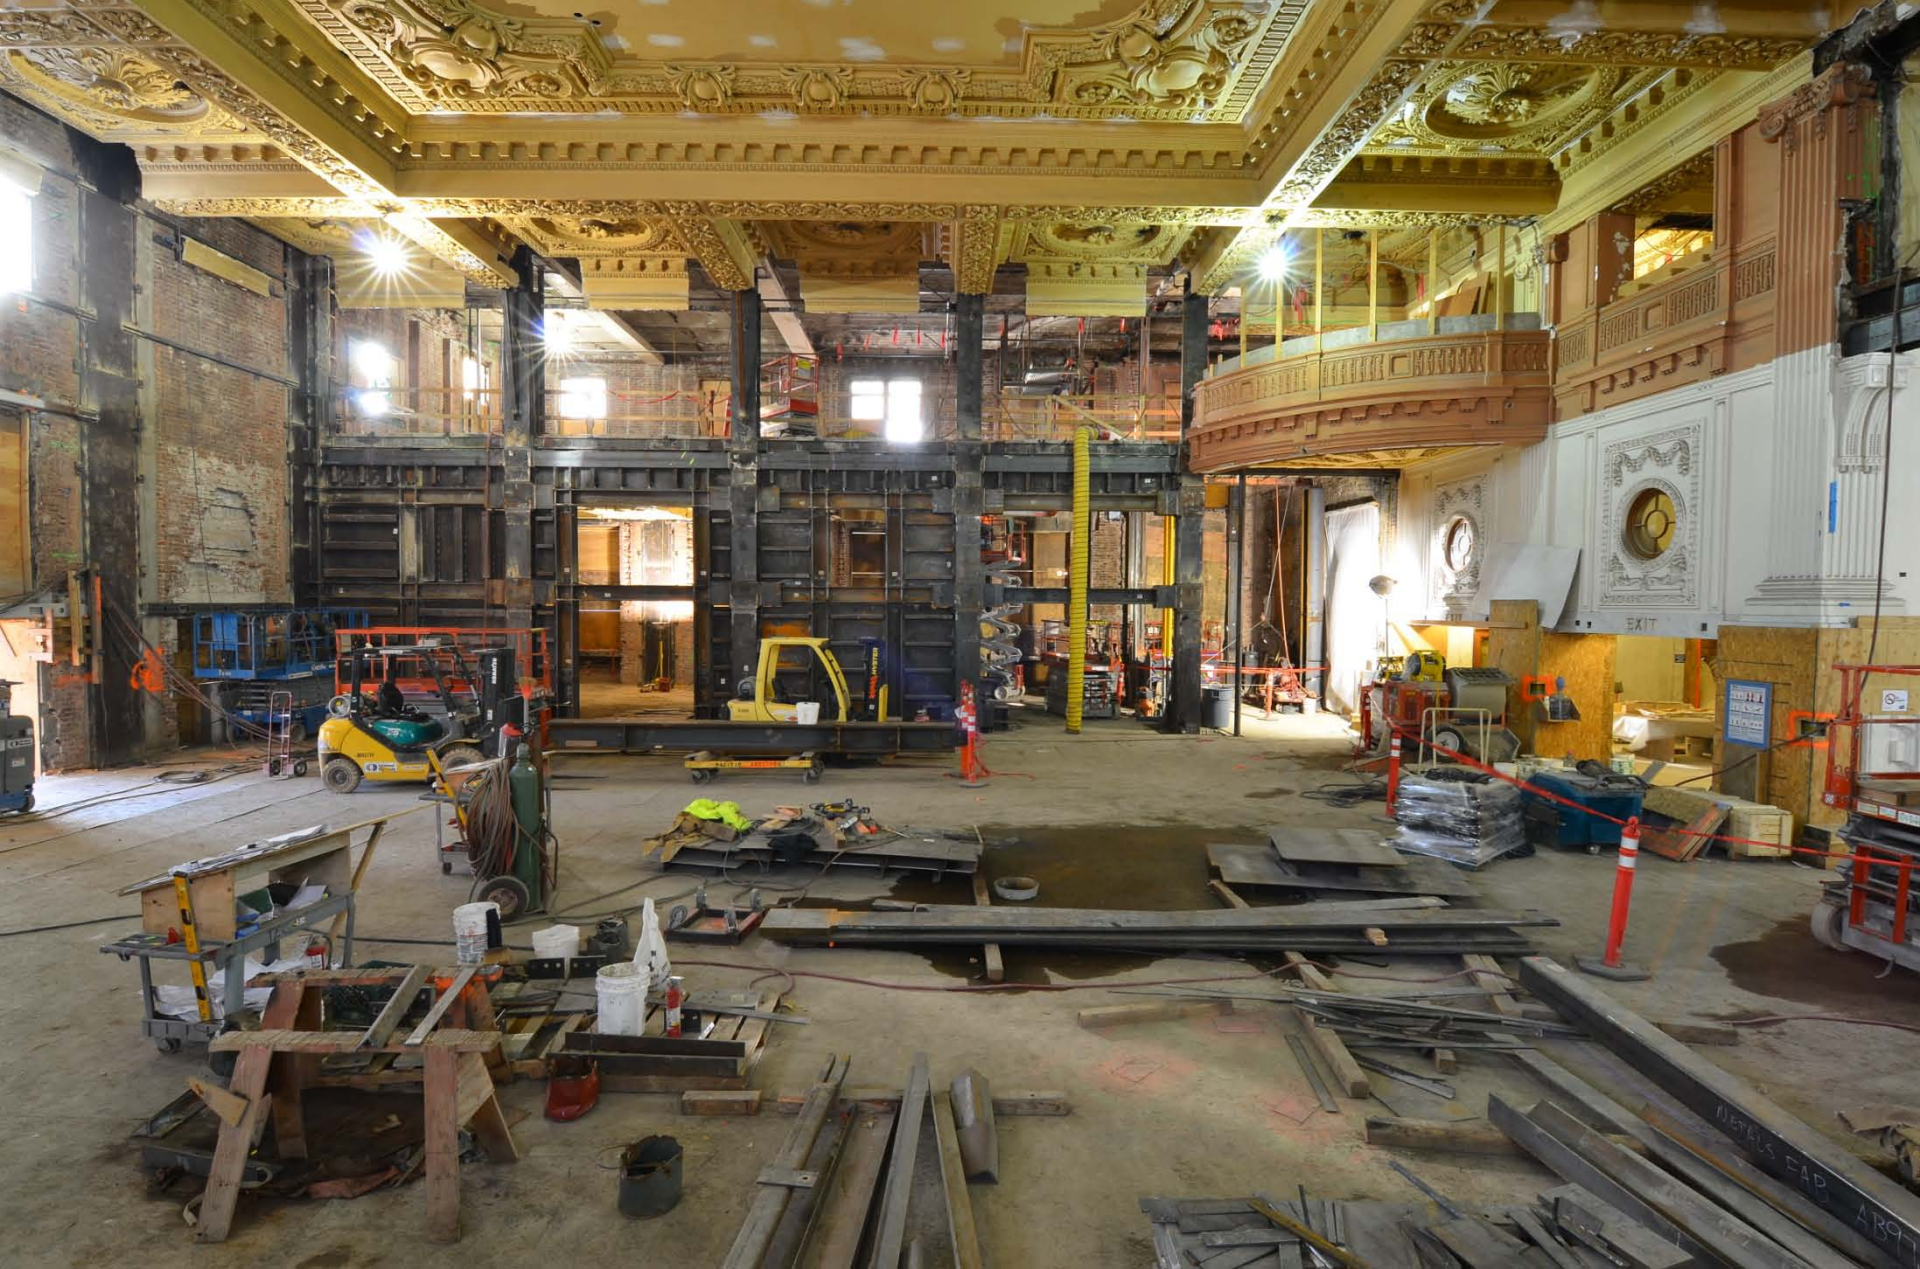
Massive steel shear wall shown is tied to the 30'X30' mat foundation and 46' deep piles below for structural rigidity.

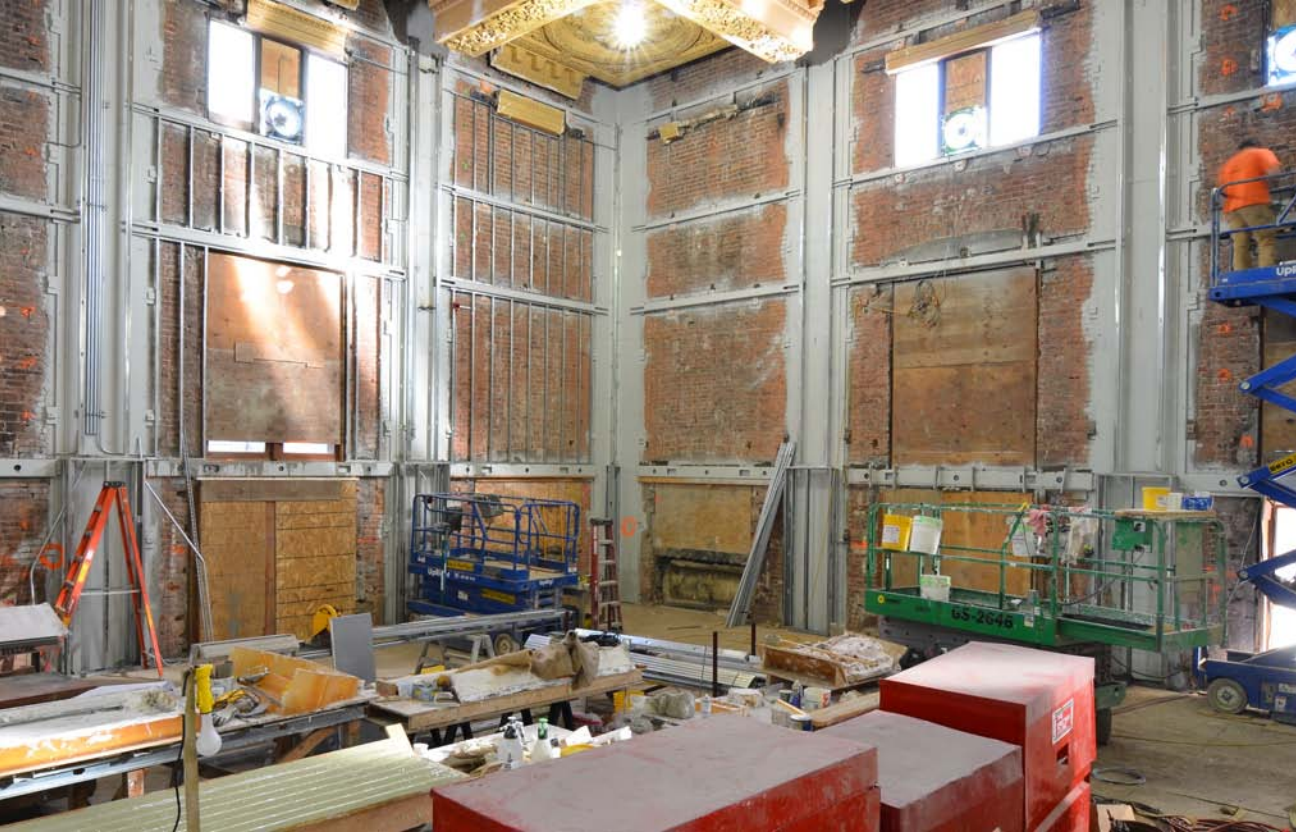
Geothermal heating/cooling works like a car's radiator. Since ground temperature is a stable temperature of 55F year round; It would take less energy to bring that temperature up to a comfortable 65F. The 67 geothermal wells are installed under Jackson Plaza and the west side bus turnaround.

Electrical conduits installed between vertical columns such as one shown in bottom right photo will power future historic lights, fire alarms, unit ventilator power, outlet plugs, PA systems, and security cameras. Geothermal heat/cooling is currently working in Amtrak's operating space. This system will serve the waiting room area once rehabilitation effort completes.

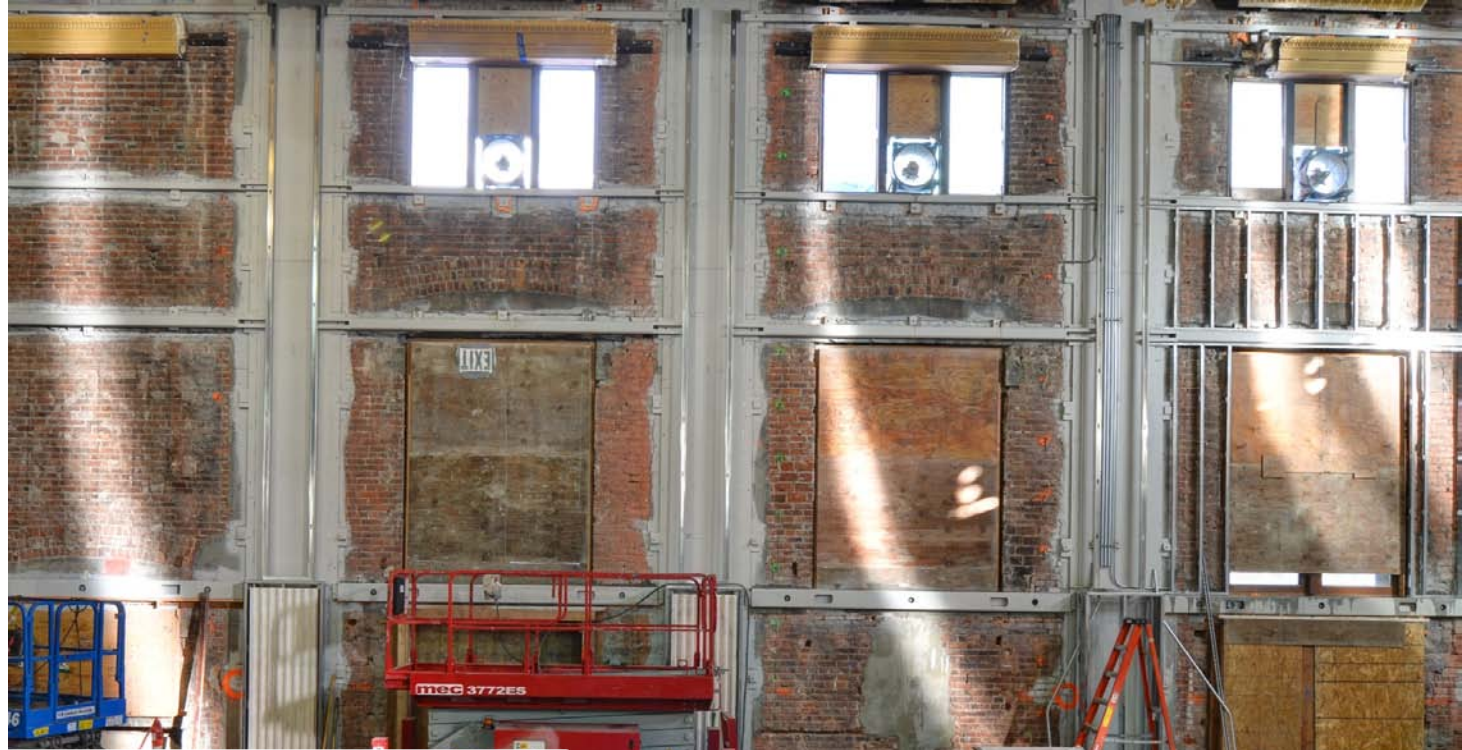
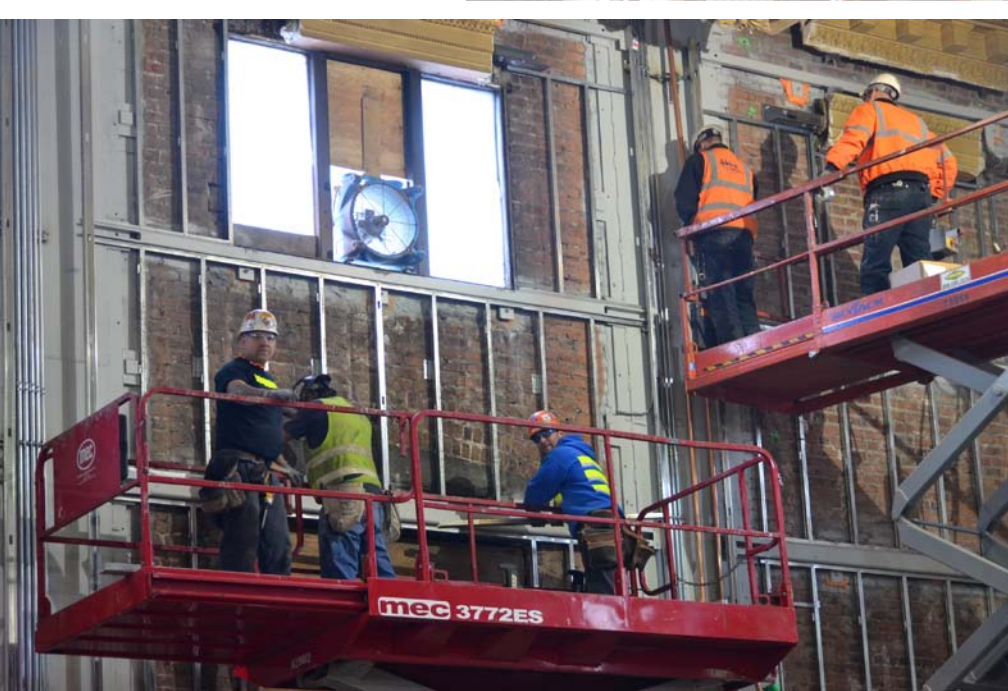
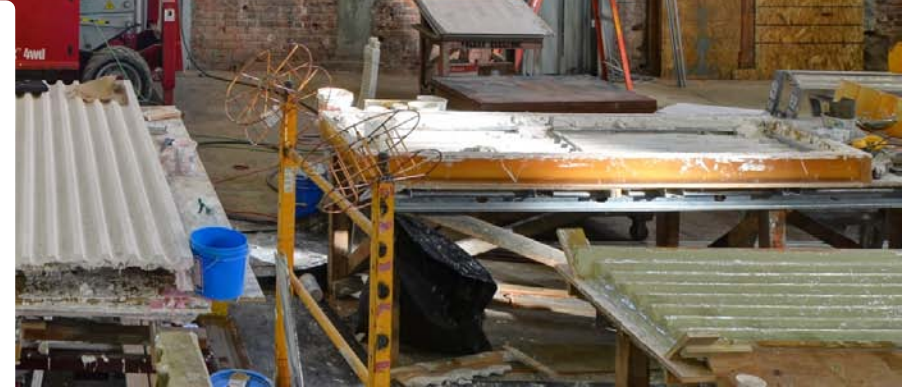
Sometimes several subcontractors work together to troubleshoot an issue that involves installations between multiple parties. On a busy day, up to 75 personnel could be present on site for work.

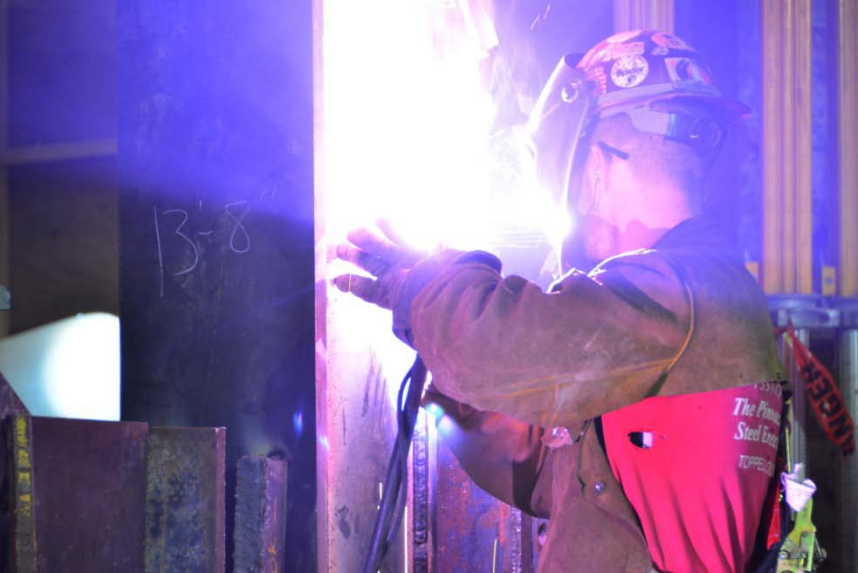
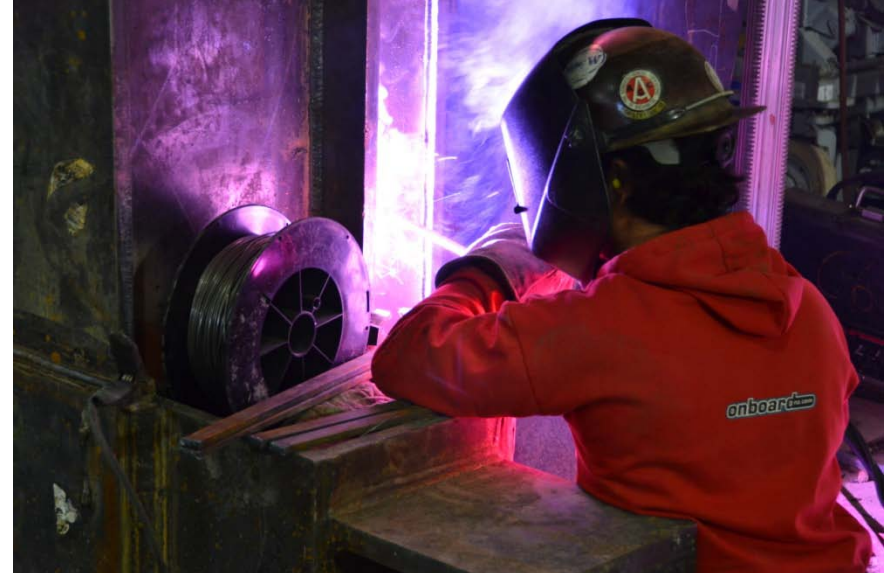
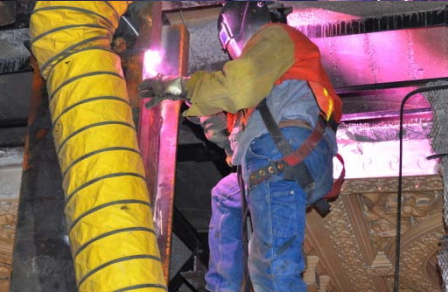
Although construction hours are typically 8 hours a day, sometimes night and/or weekend shifts are demanded to keep the project on schedule.

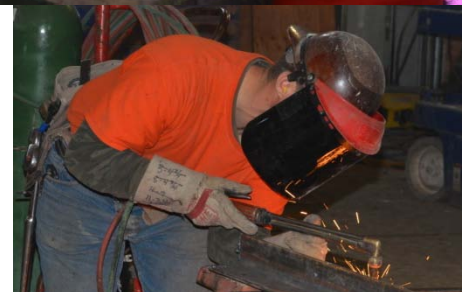
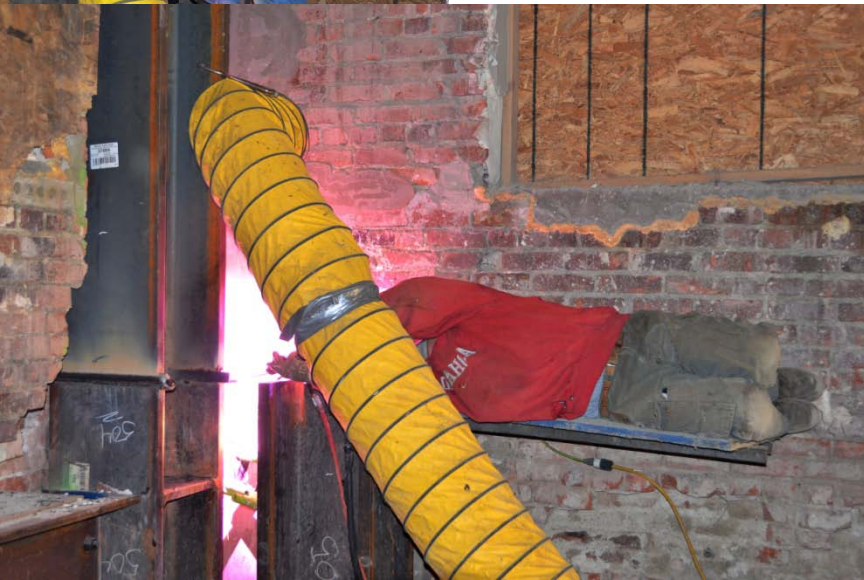
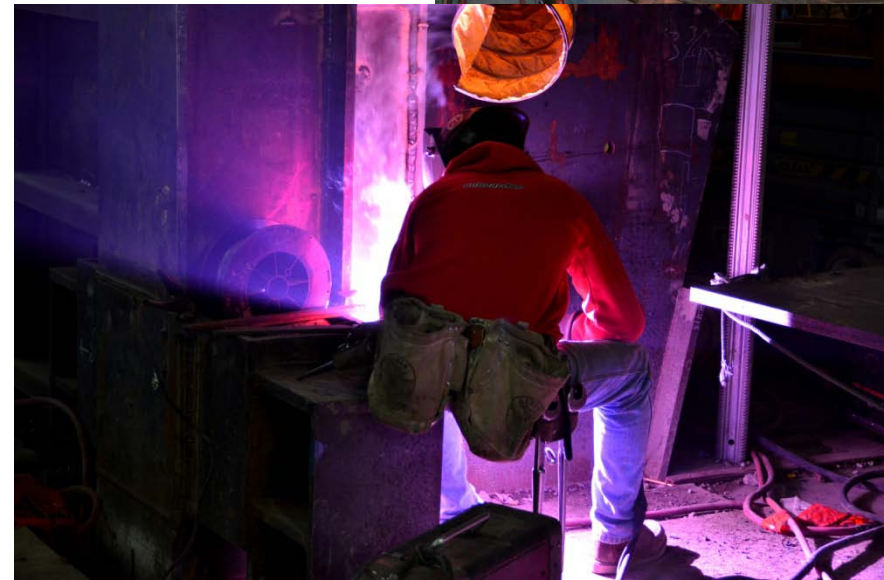
600 tons of seismic steel and 150 tons of rebar have been used for the seismic upgrade to date. Still, another couple hundred tons of steel has yet to be installed. All welding smokes goes through particle filters before exhausted to outside air.

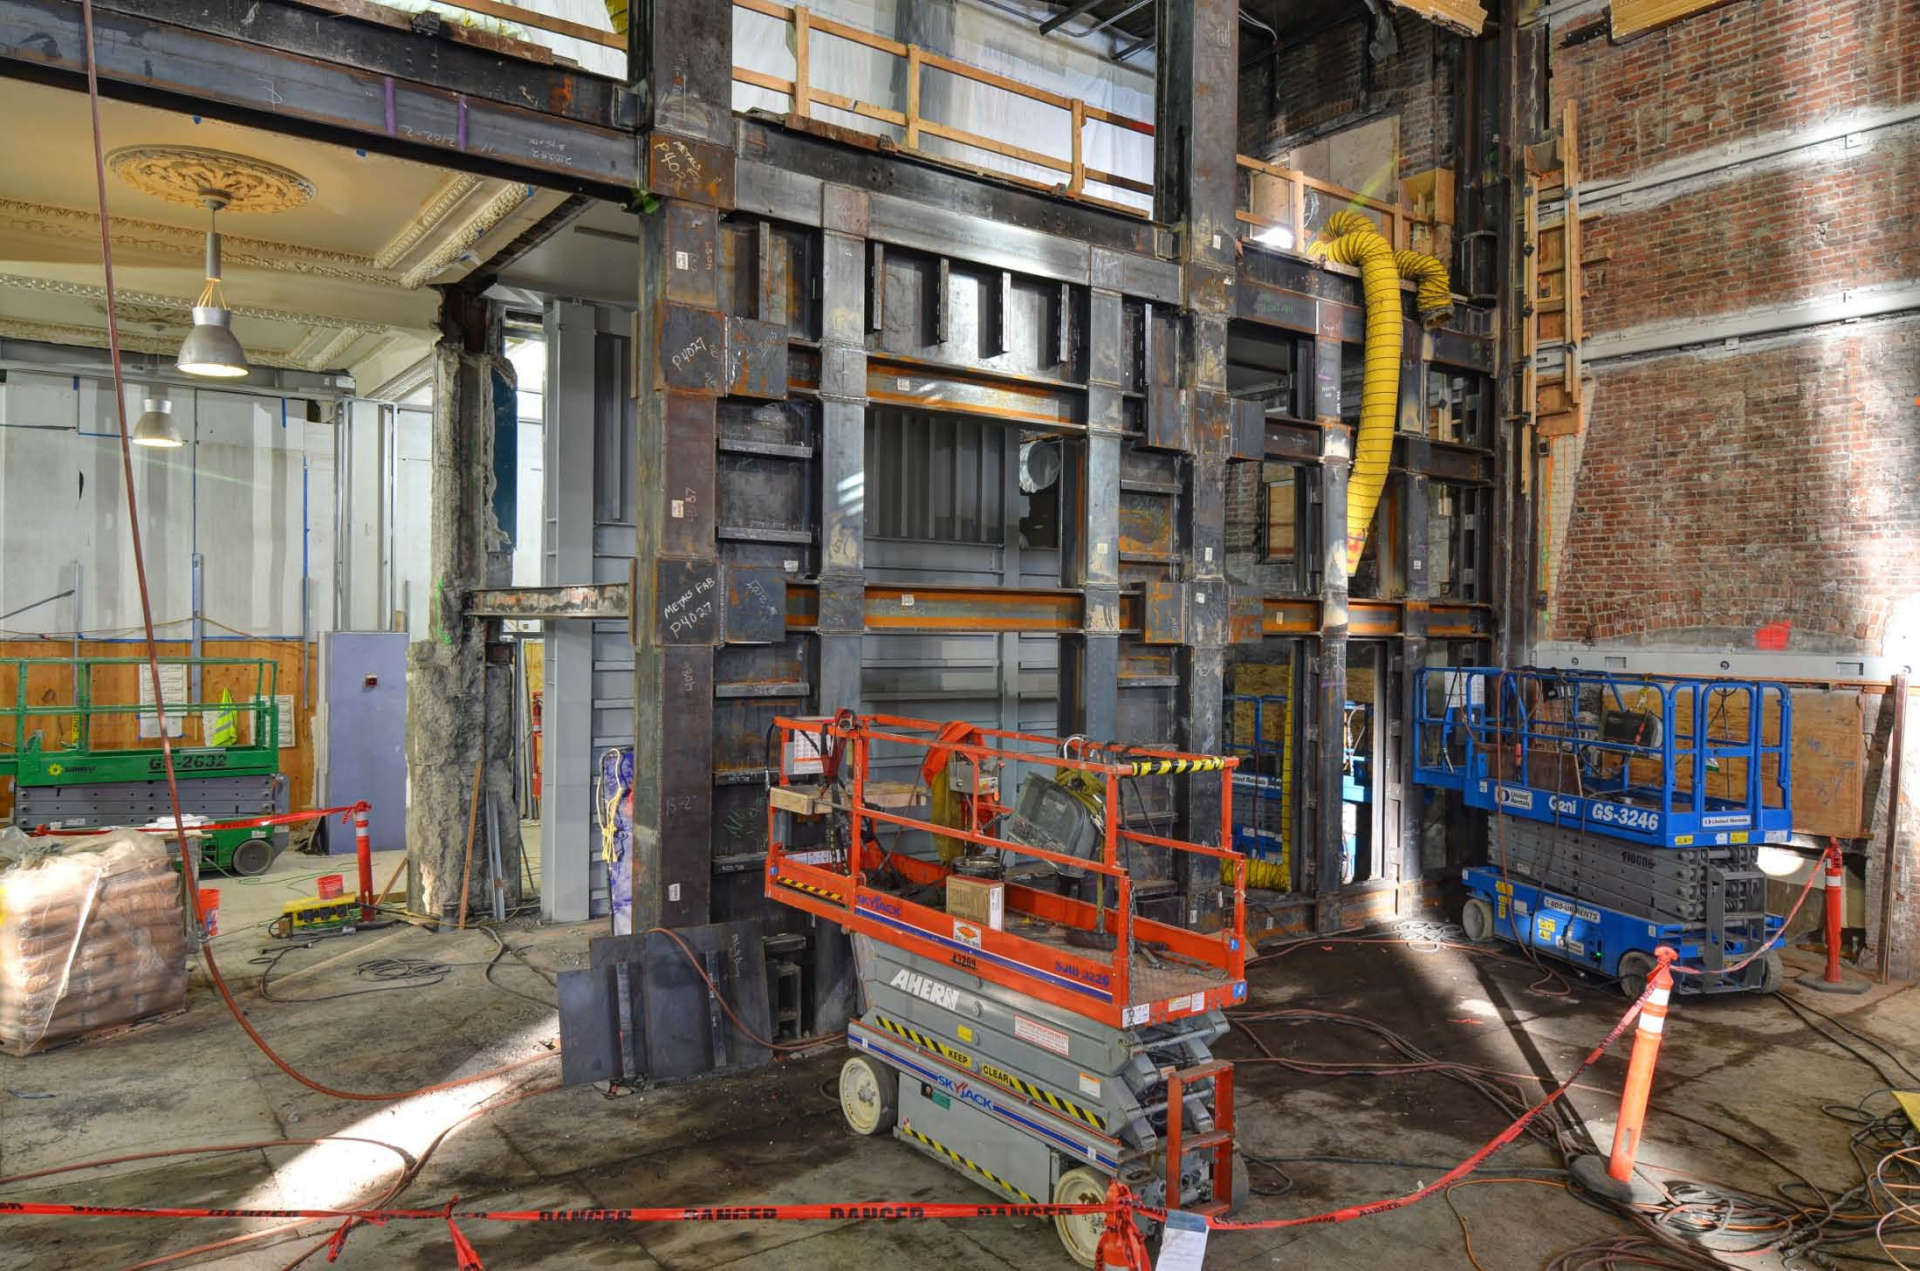
Steel shear wall shown is installed over a 15'X30' mat foundation, deep driven piles and is also tied to the exterior 4'X4' ring beam.

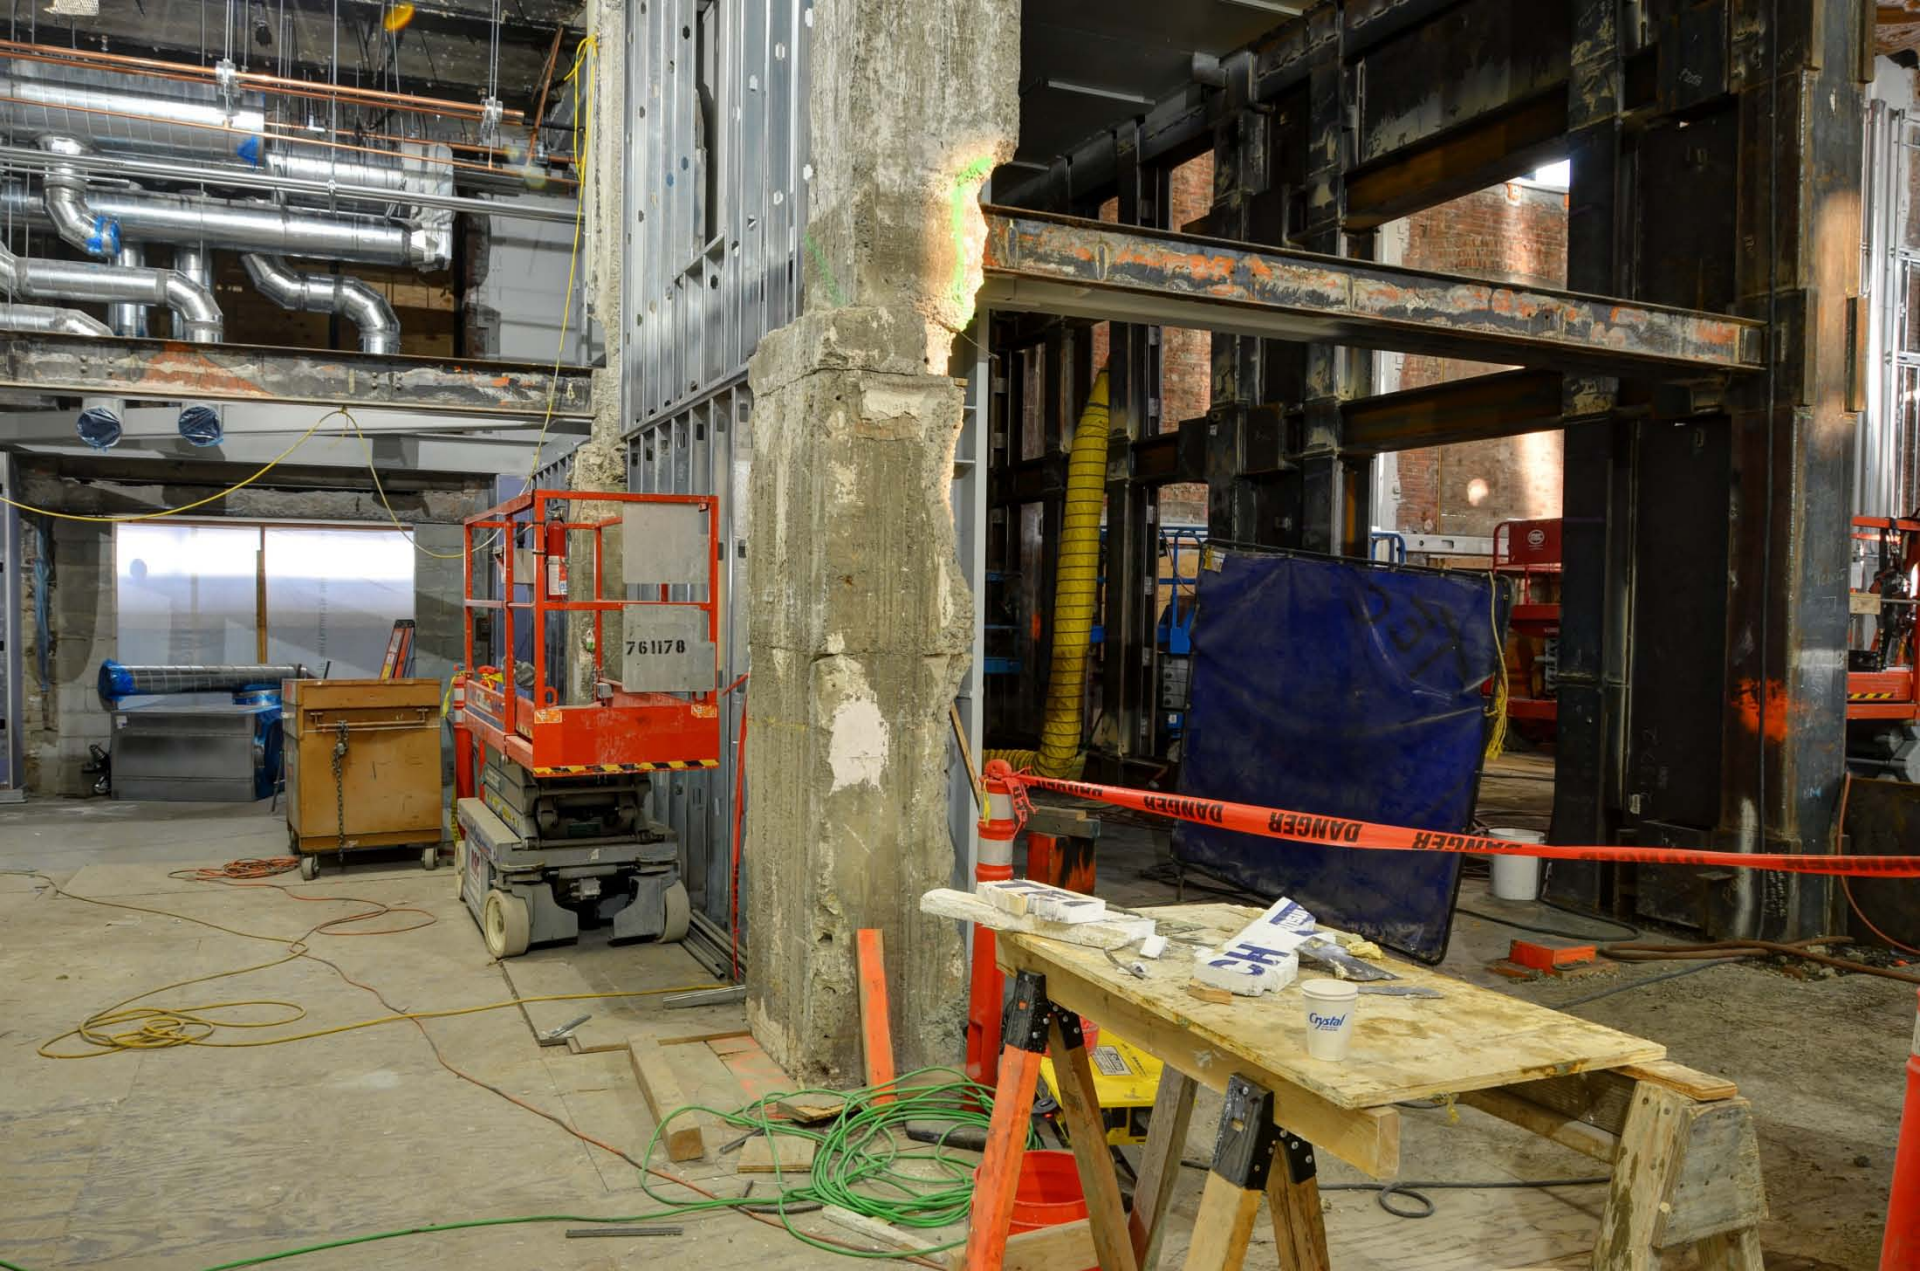
HVAC was installed at the previous electrical room and Amtrak cafeteria located along the east trackside perimeter. This area will be the future Men's restroom. Two new double doors will be installed for access and egress. One of the new double door location is shown in the photo.

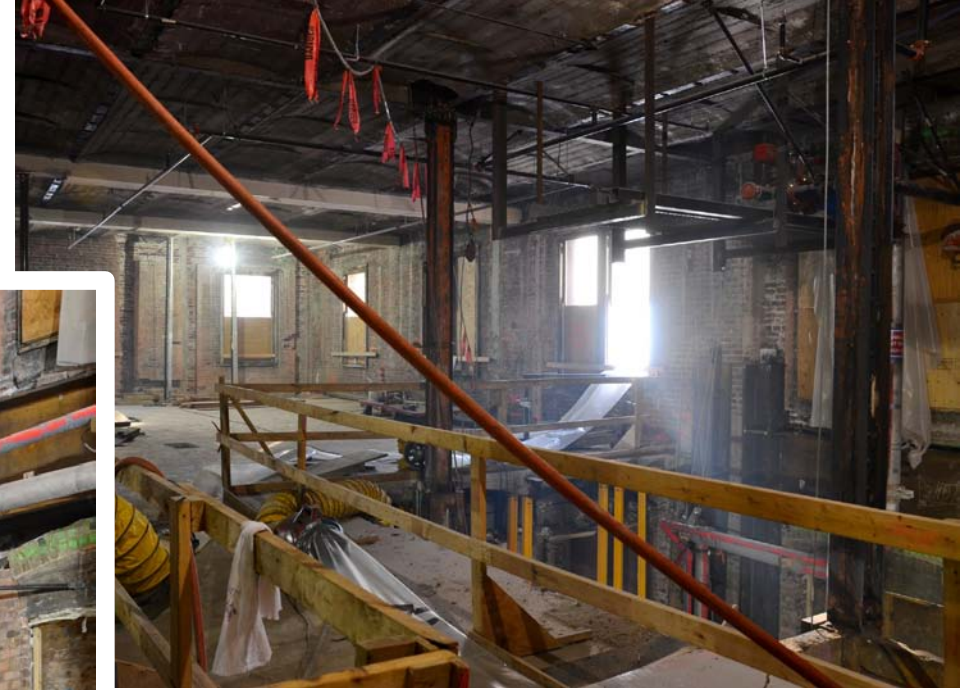
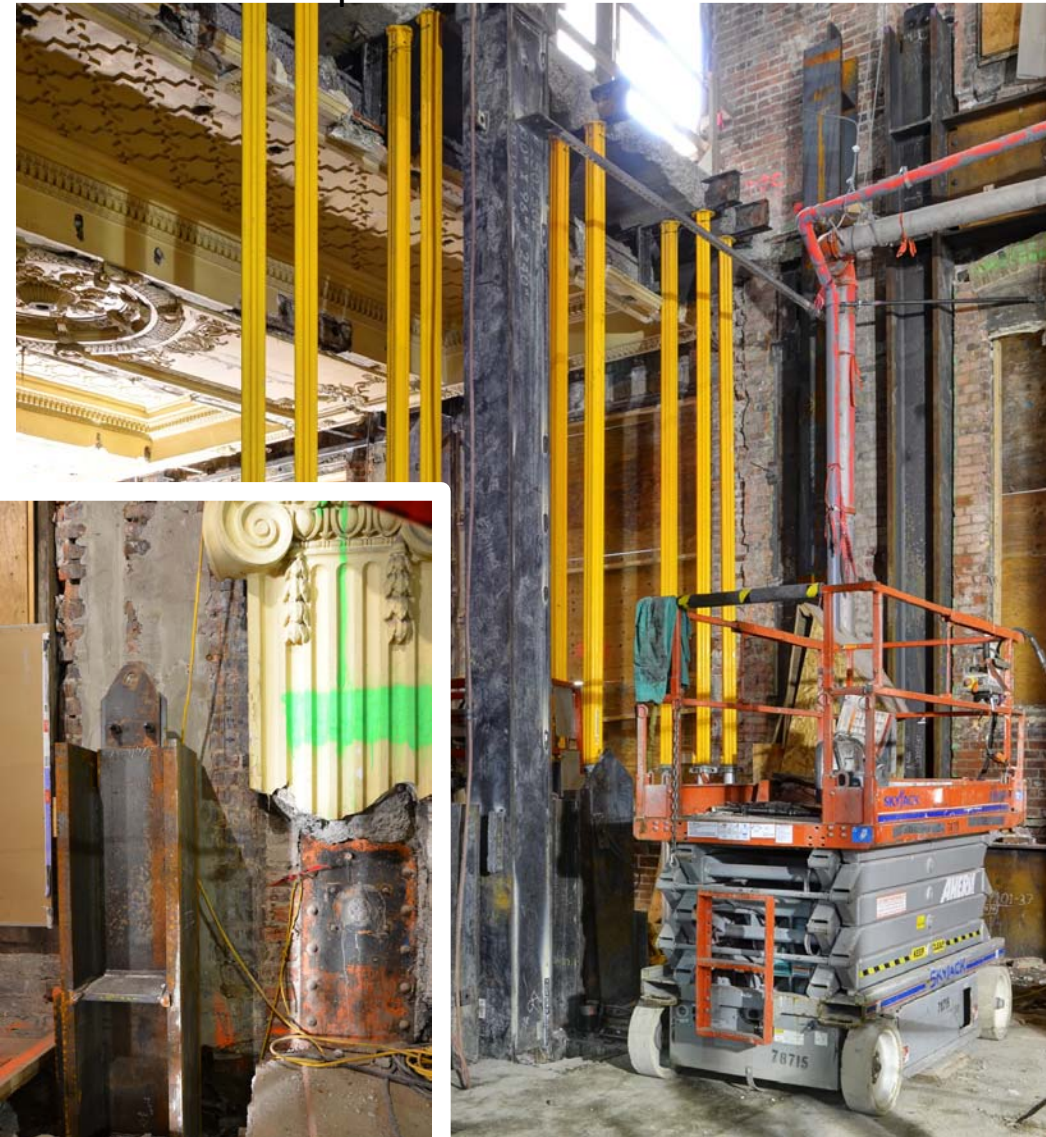
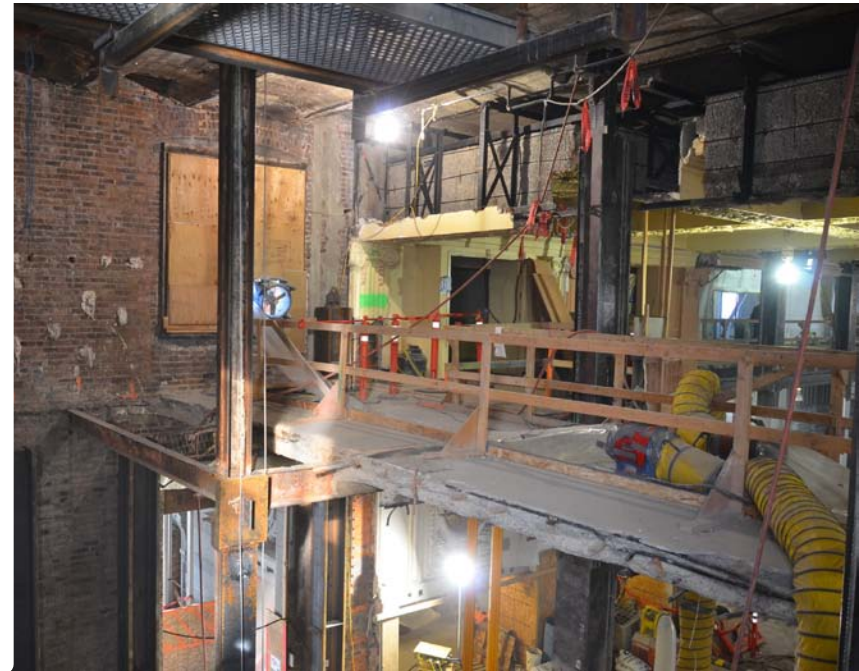
Ceiling in previous men's restroom was opened up for a new stairwell installation that will connect the terminal to the 2nd and 3rd floor. Two stairwells and an elevator are the new interior access options for the station.

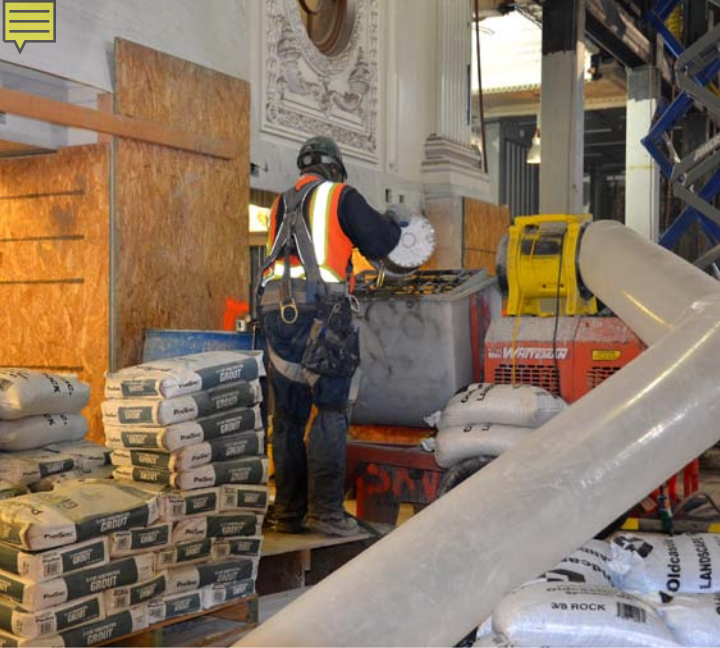
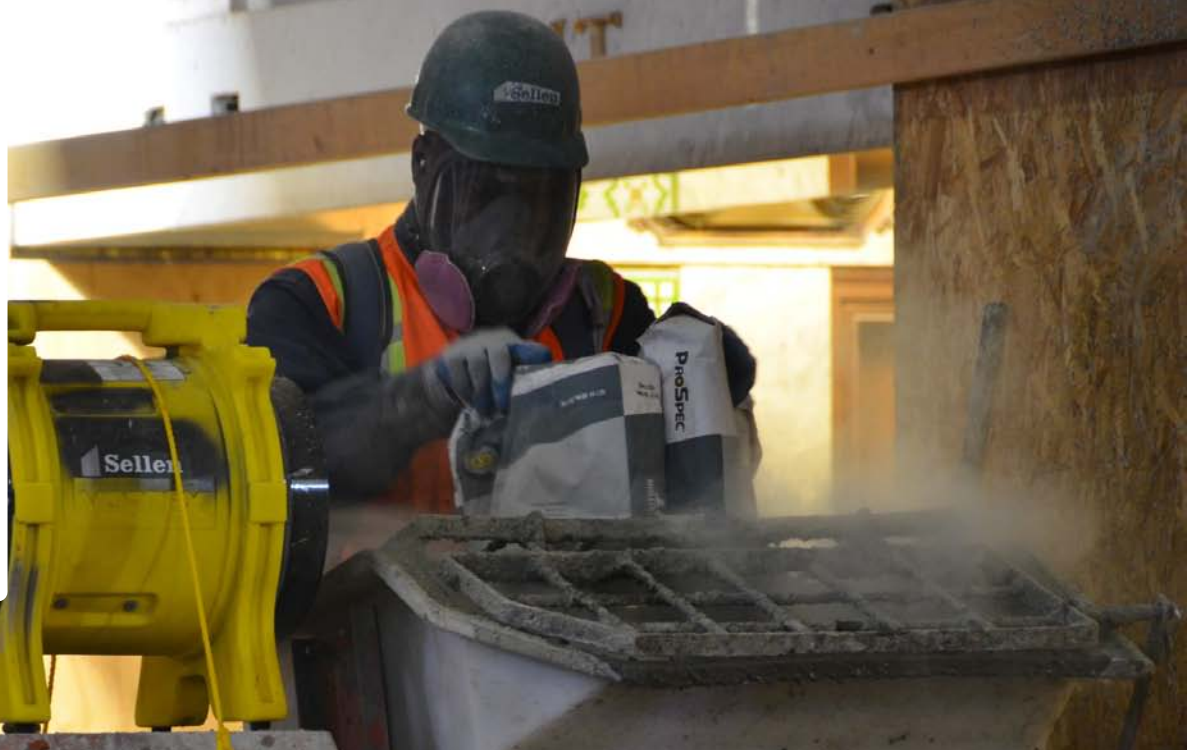
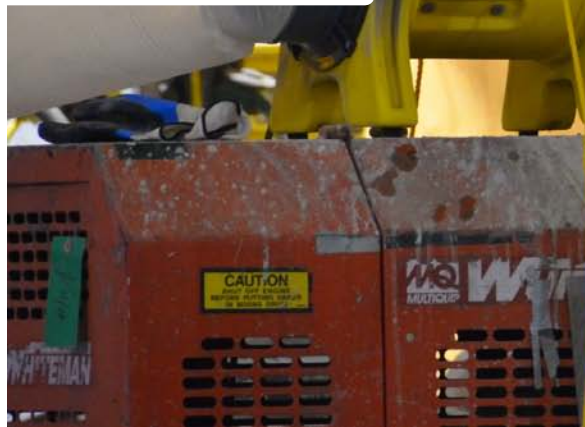
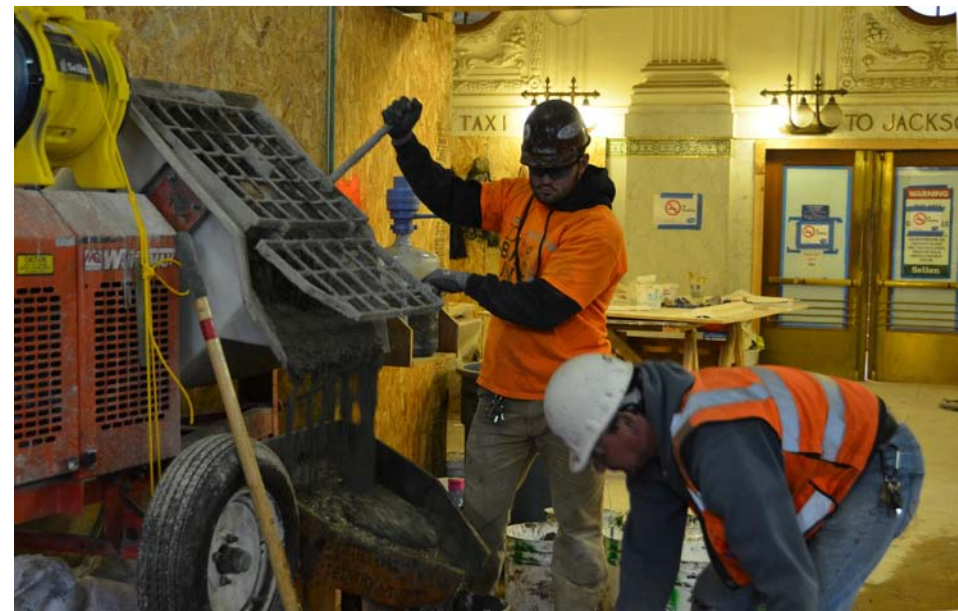
Some concrete are mixed onsite for structural steel embedment and floor pour backs.

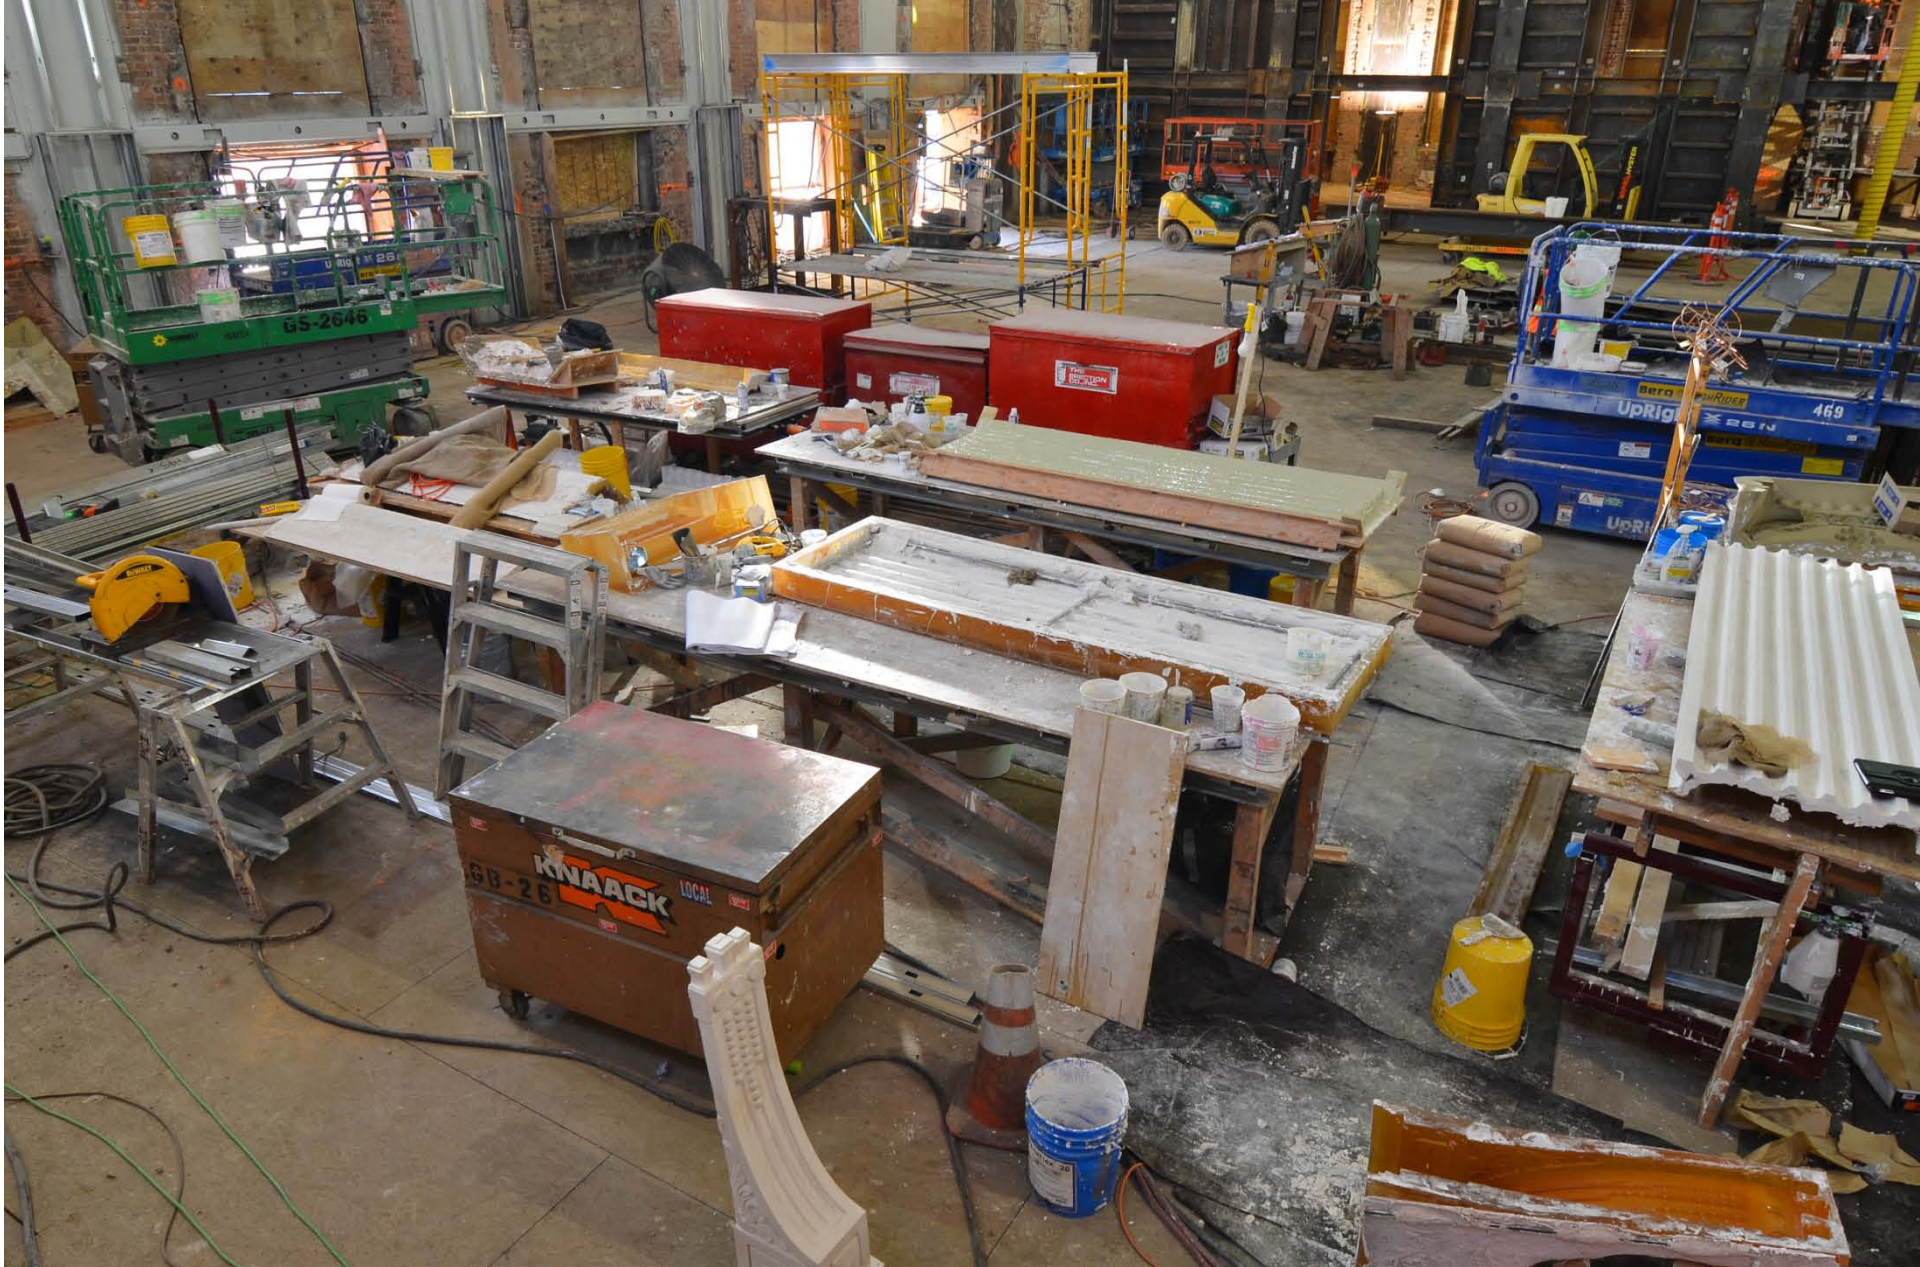
Ornamental plaster casting was relocated to the larger waiting area.
