Phase 2B

Waiting Room & Upper Floors Construction Updates

November 15, 2012

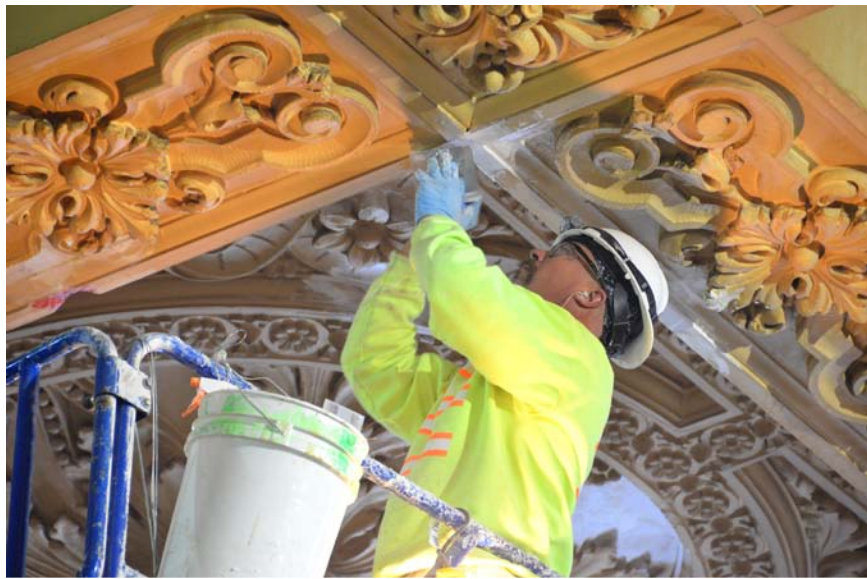
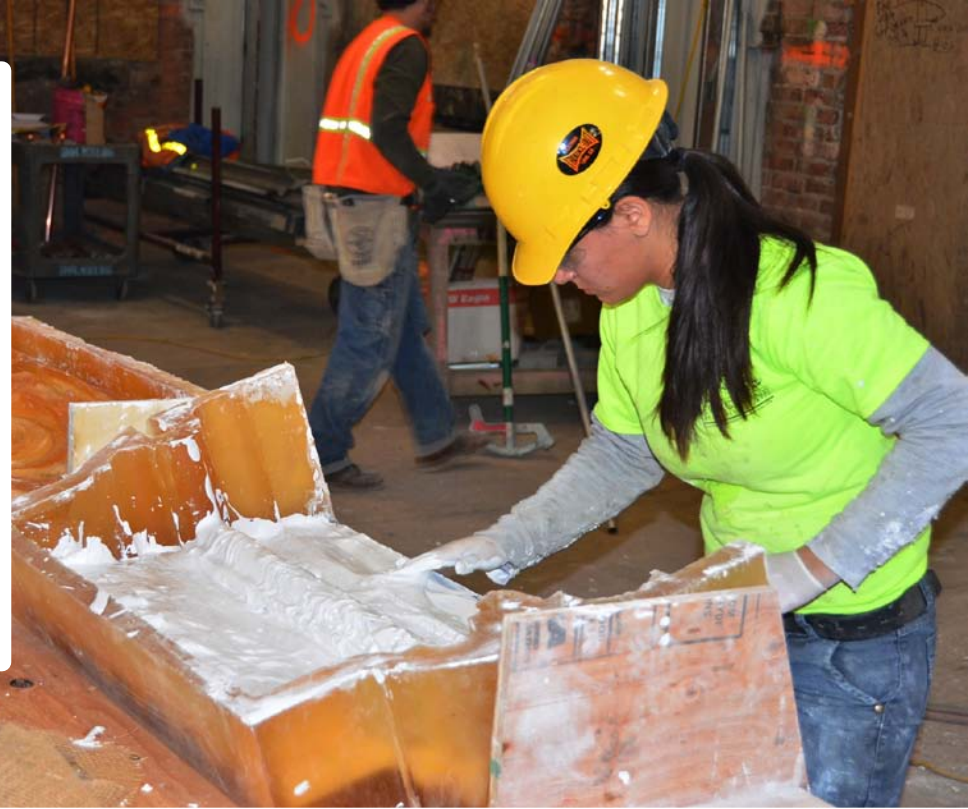
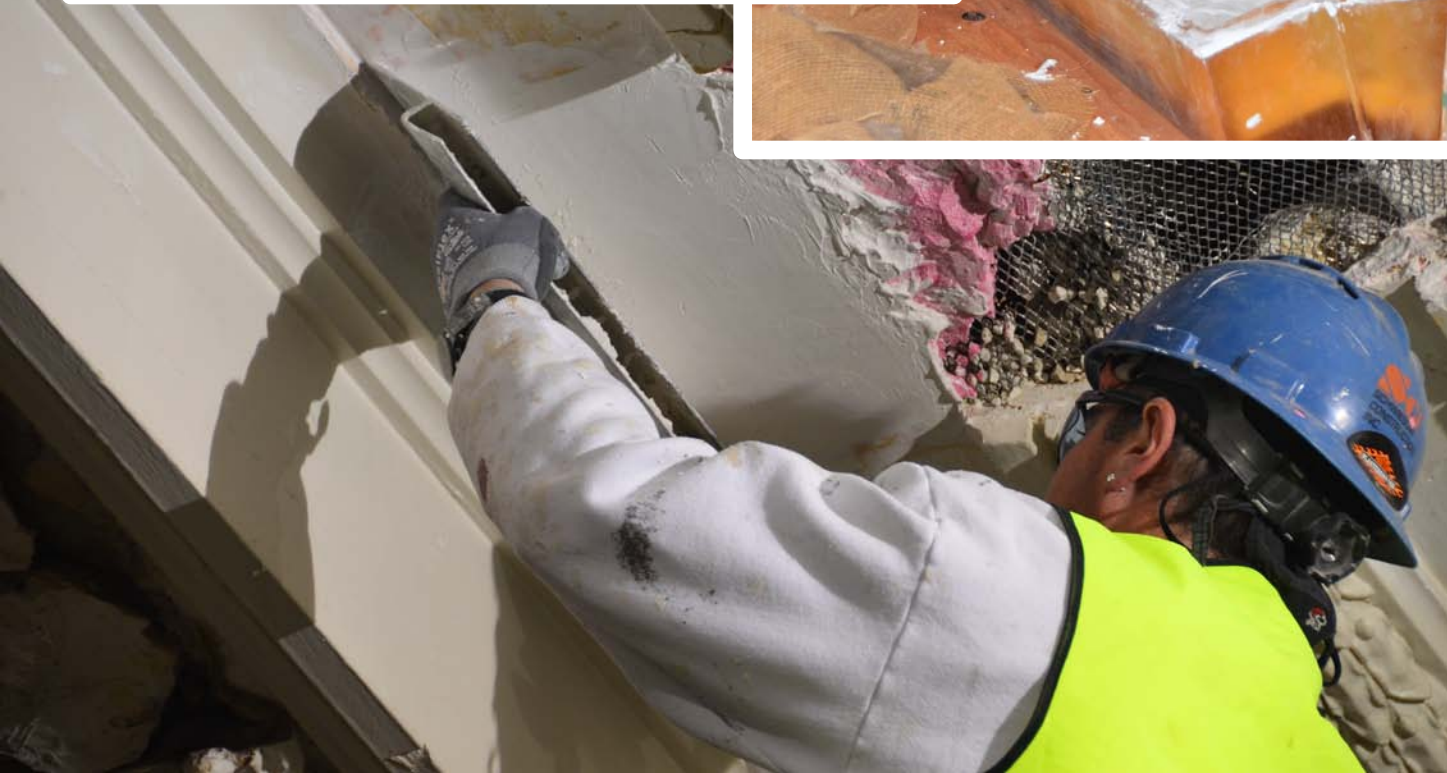
Photos to the left shows craftman repairing original plaster details in place. Another worker is casting plaster from a Vytaflex rubber mold.

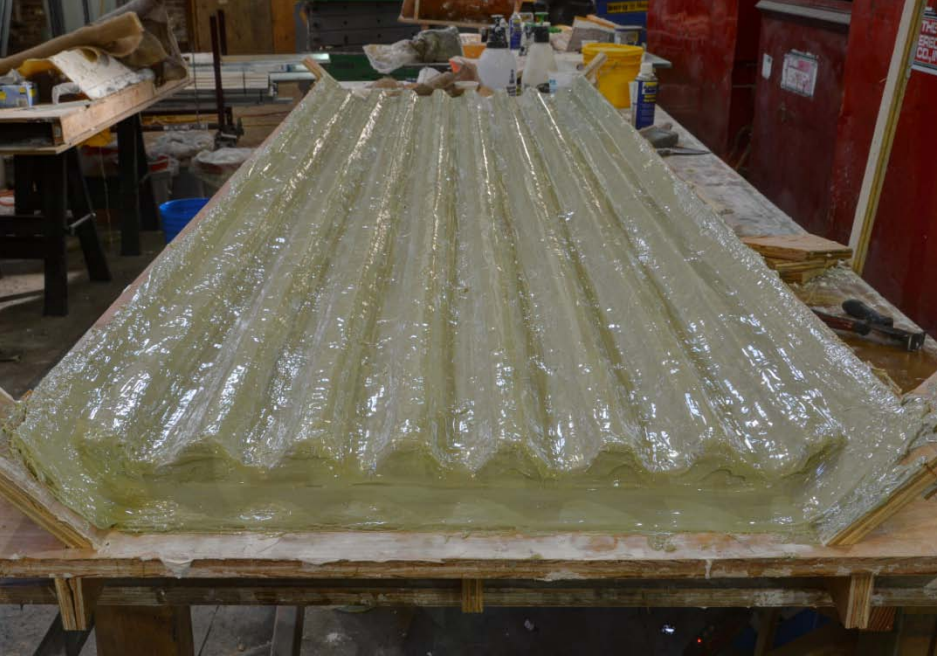
Once a Vytaflex rubber mold is casted, reproduction of new pieces is seamless. Hundreds of pieces can be made from a rubber mold. There are two main type of rubber molds. The green type is usually brushed on while the orange kind gets poured over.

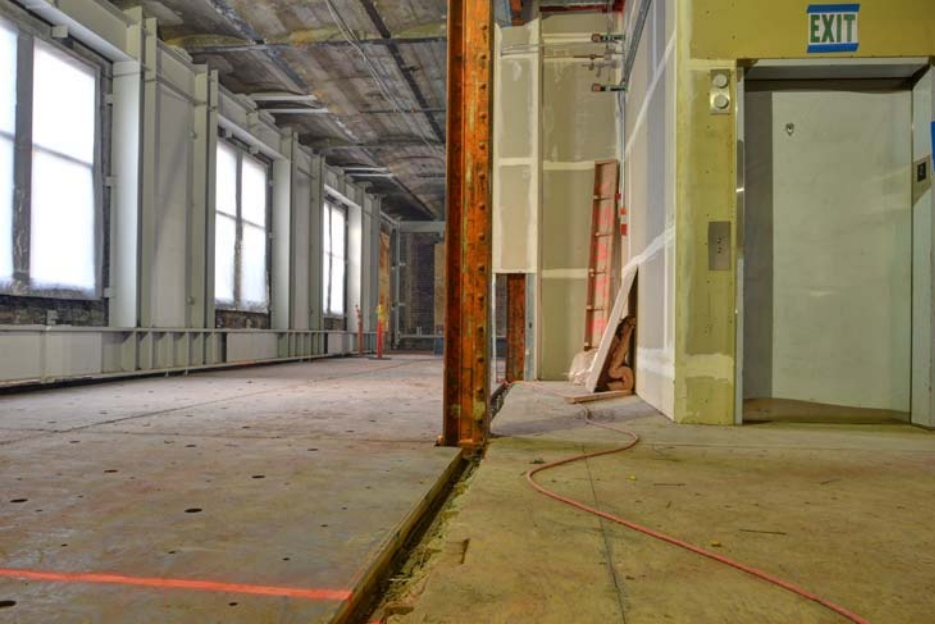
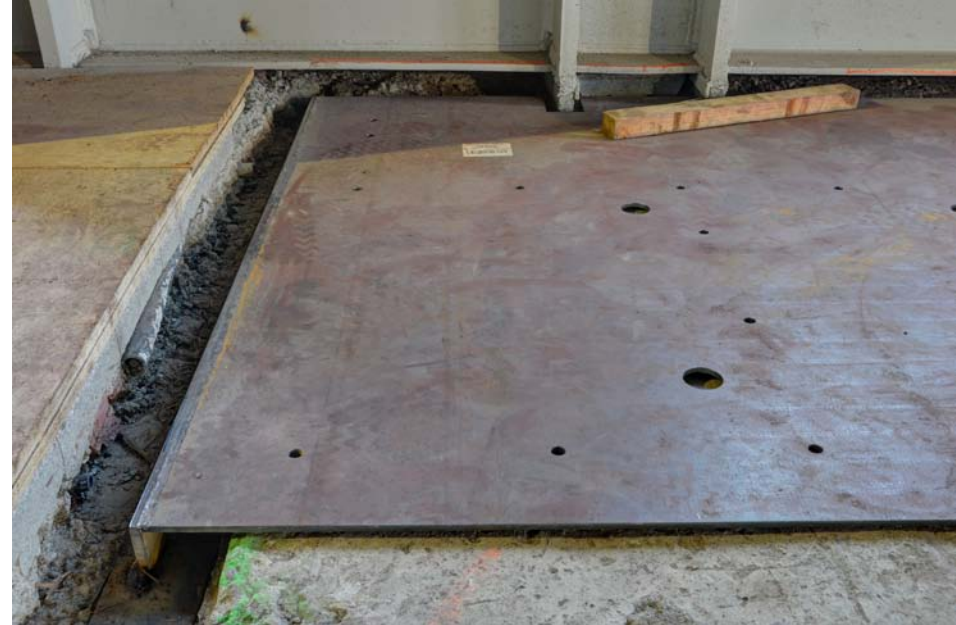
Large structural steel sheets will cover most of the 2nd and 3rd floor. These steel floor sheets will be welded to existing beams and new columns. All seismic upgrades in the building are expected to be complete by February of 2013.

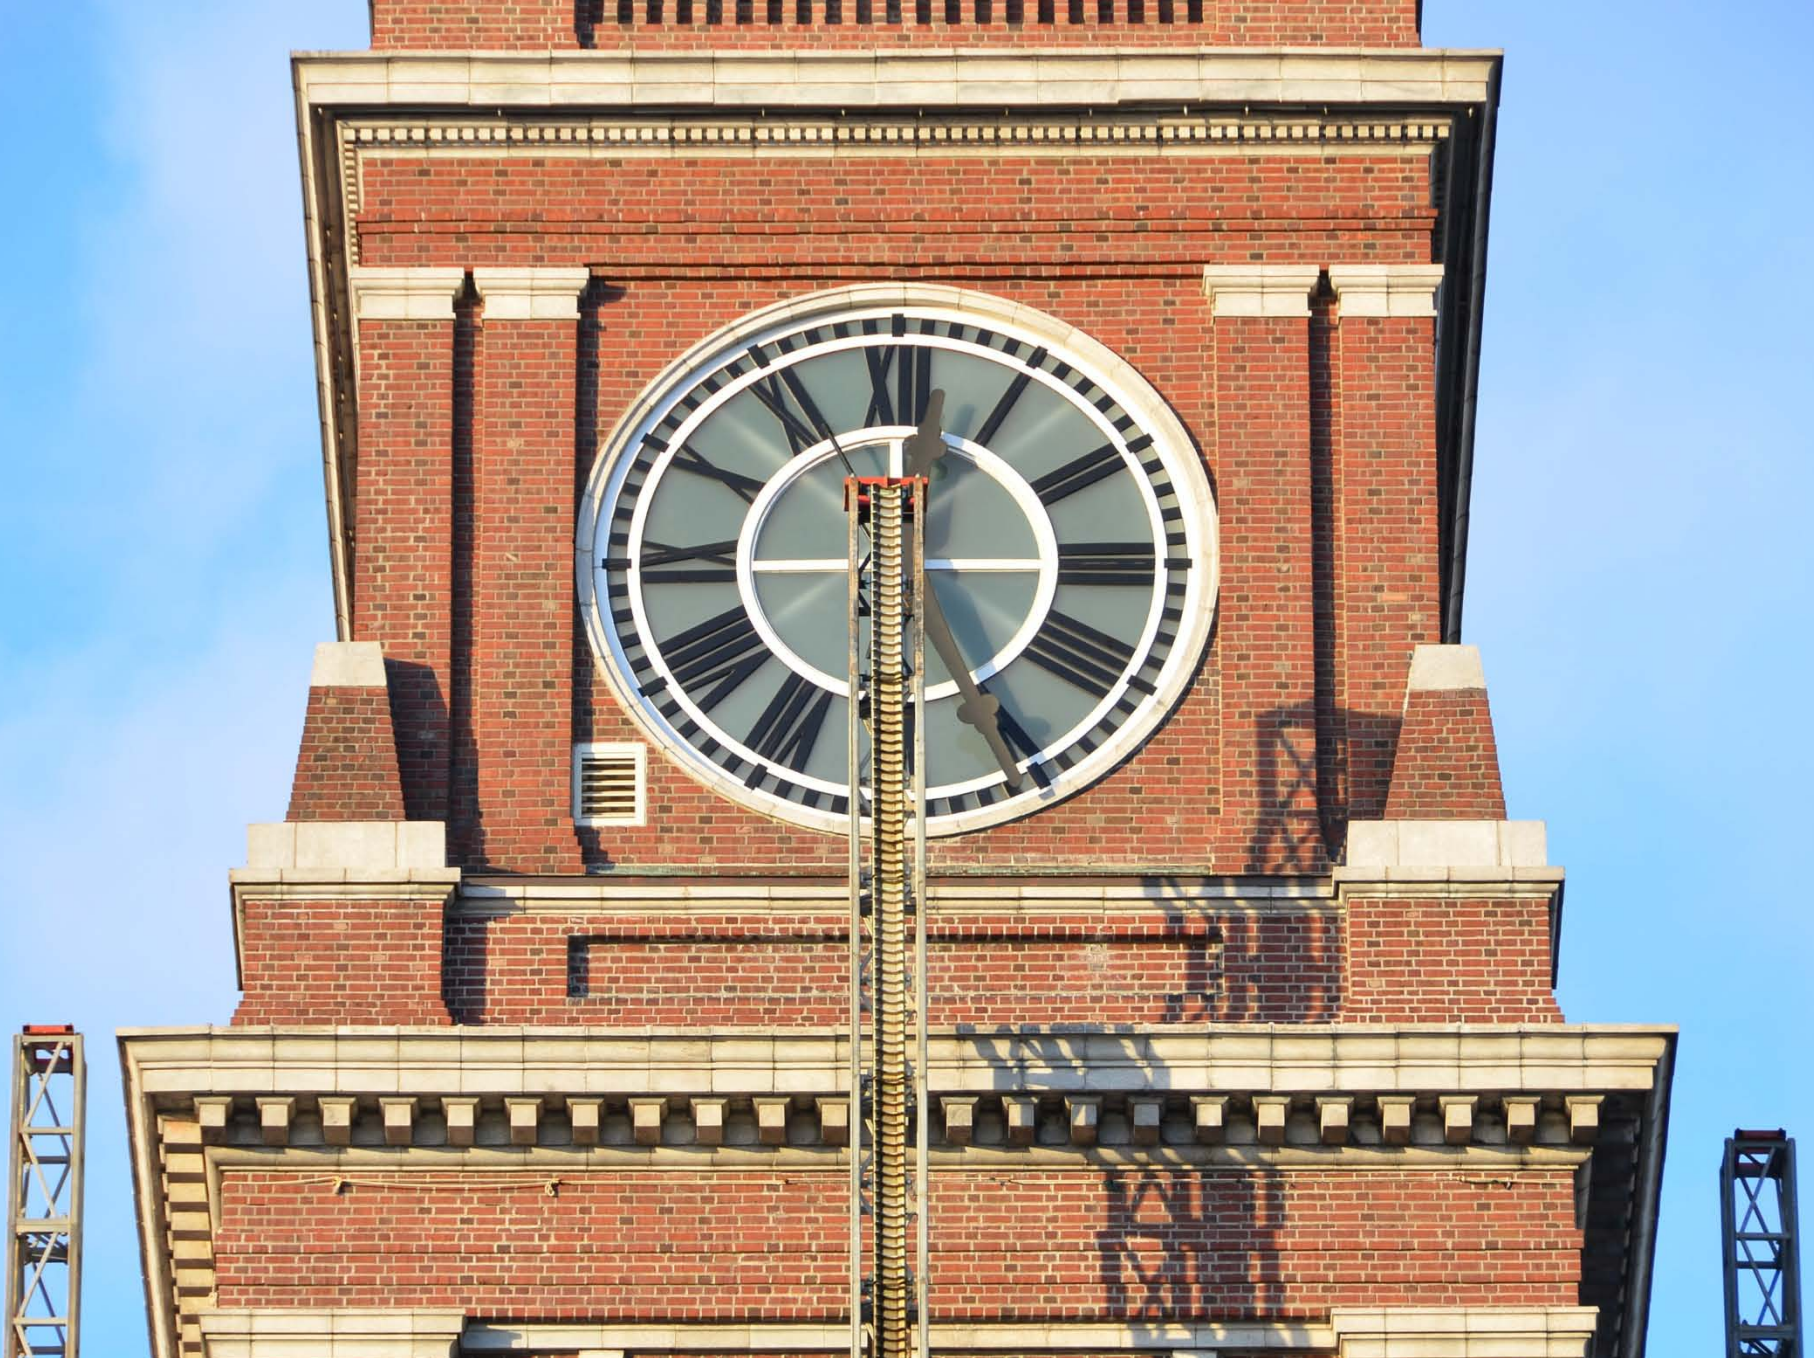
Terracotta dental trim repaired. All new anchorage attachments are stainless steel for longevity.

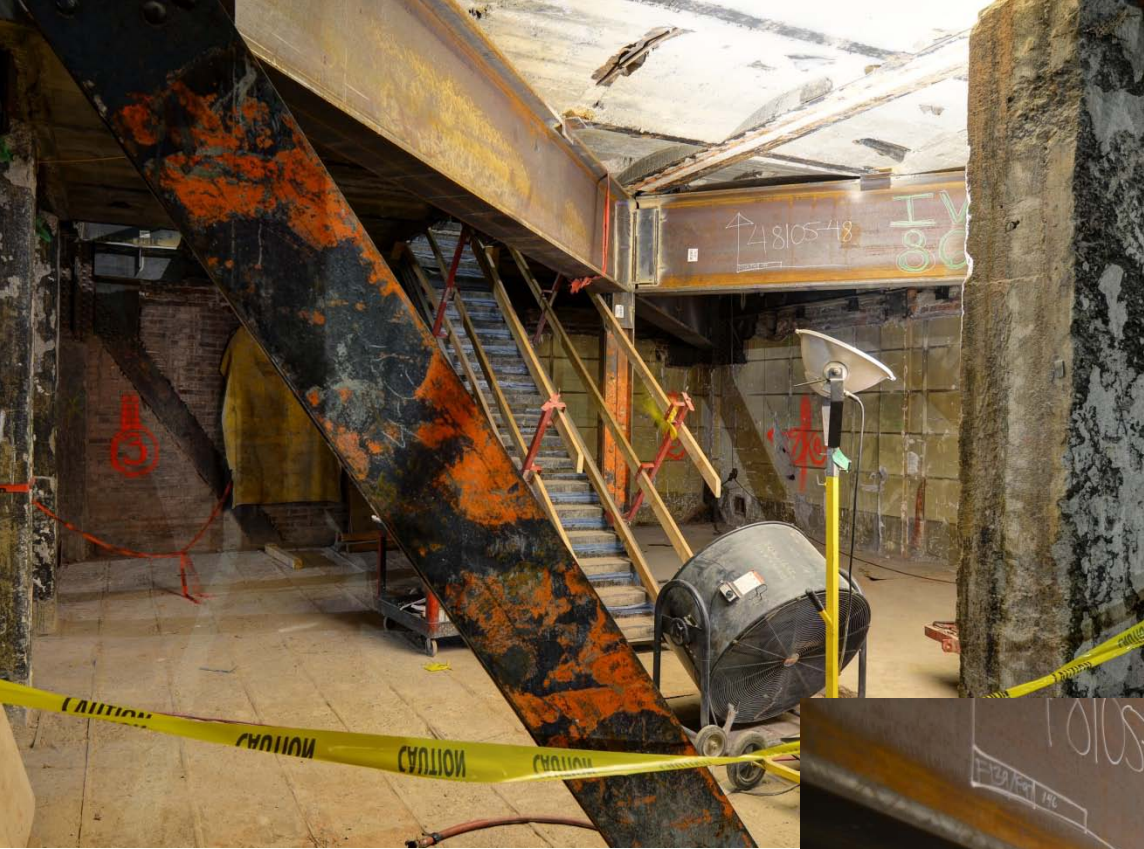
Stairway shown leads up to the tower levels. It has been and will be the only access for the clock tower. Large “I” beam was installed to support the original reinforced concrete slab on the above floor.

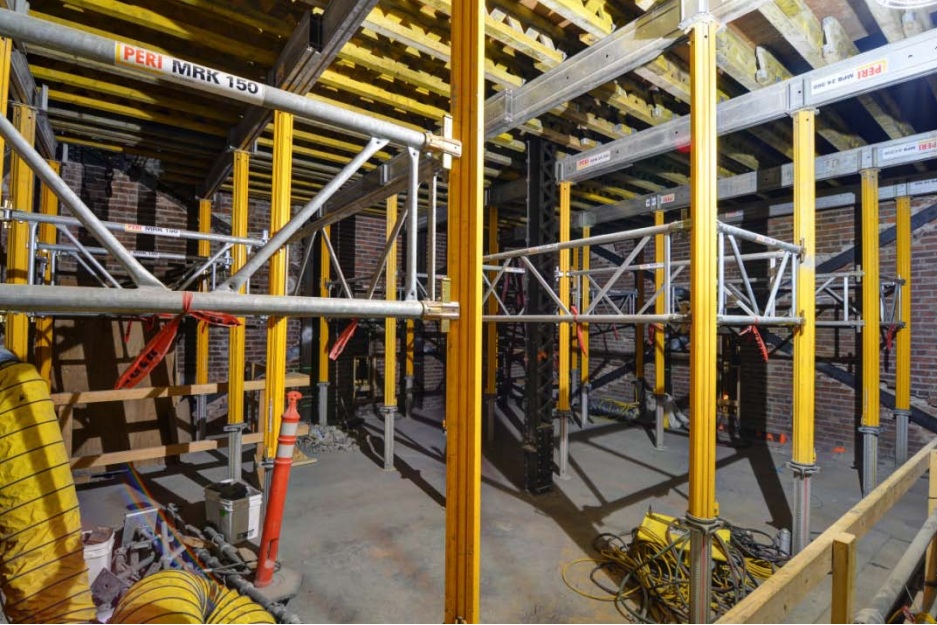
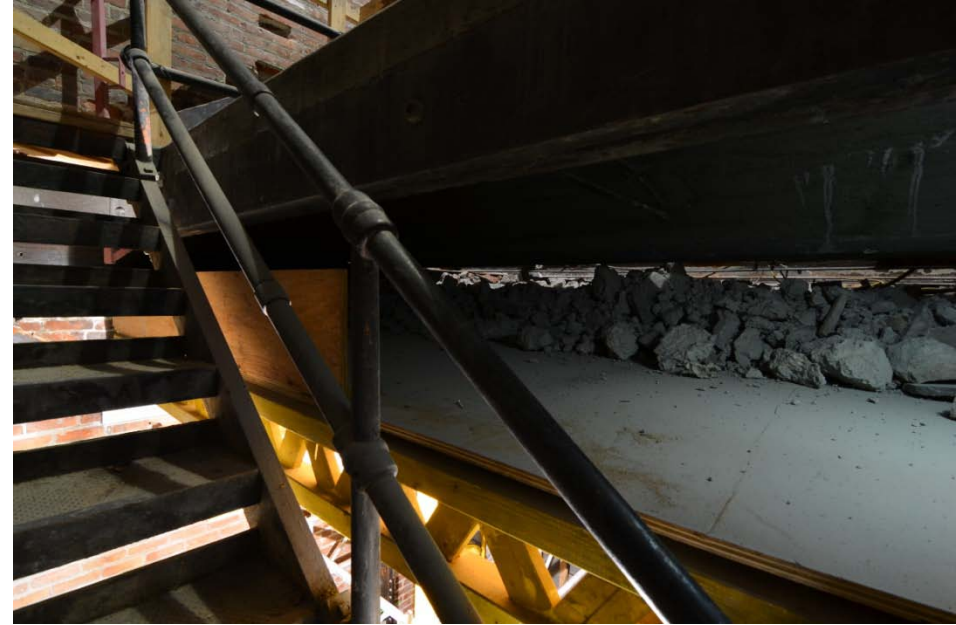
Part of level nine floor was damaged from the Nisqually earthquake. This damaged southwest quadrant is being demolished and replaced. Top left photos shows shoring in place to help support the stacking of demolished flooring debris.
