# PCB DETECTION DOG PILOT STUDY DATA REPORT FINAL

**City of Seattle:  
Seattle Public Utilities**  
700 5th Avenue  
Seattle, WA 98121

**September 15, 2017**

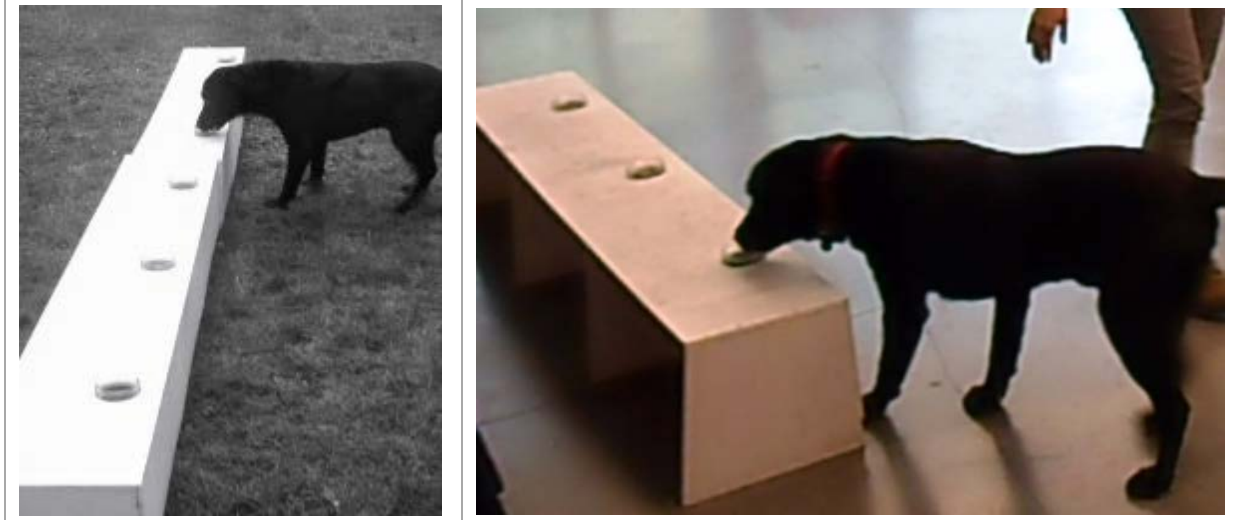
**Figure 2-1. Sampson demonstrating the bench training method**

The bench training technique was used as the first stage of training to introduce Sampson to Aroclor 1254 training samples in June 2016. Each bench held six suspended jars: five control jars (i.e., containing clean material) and one target jar containing sand or soil spiked with PCBs (Figure 2-1). The bench training technique quickly established a positive association between the target odor and the reward. This same technique was used to introduce Sampson to Aroclor 1260 during training conducted in September 2016.

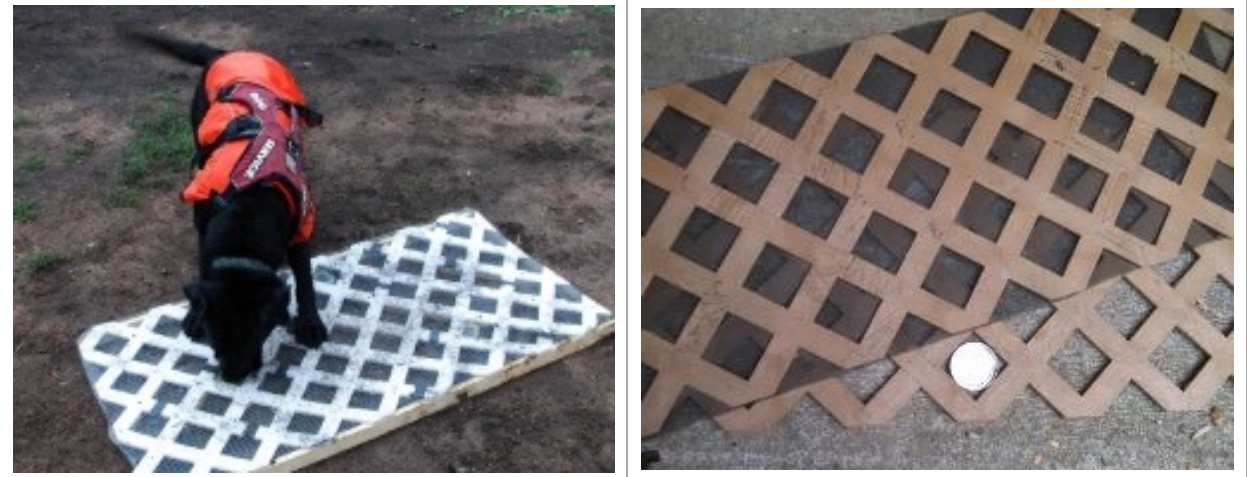
**Figure 2-2. Sampson demonstrating the screen training method (left) and the layers of the screen training apparatus (right)**

The screen apparatus technique was used as a training reinforcement method, and was designed to develop pinpointing skills on a horizontal, ground-level plane (Figure 2-2). For this method, the training apparatus included two layers of wood lattice material. The lower lattice layer was placed on the ground, container lids (some containing sample material and some empty) were placed in the spaces between the wood slats, and the top lattice layer (to which a sheet of screen mesh was attached) was placed over the first lattice layer and samples. The screen training method provides the dog a slightly different experience than the bench training method. This method was used during weekly training sessions from July to September 2016 to maintain and develop Sampson's familiarity with the PCB target. This technique was sustained throughout the project using a variety of materials (i.e., sand, soil, cotton, and wood) spiked with Aroclors 1254 or 1260 at high and low concentration levels. This was done to help Sampson become familiar with PCBs in various media (as would be encountered in the field), and to ensure that Sampson was not inadvertently trained to a specific media type (rather than to the PCBs).

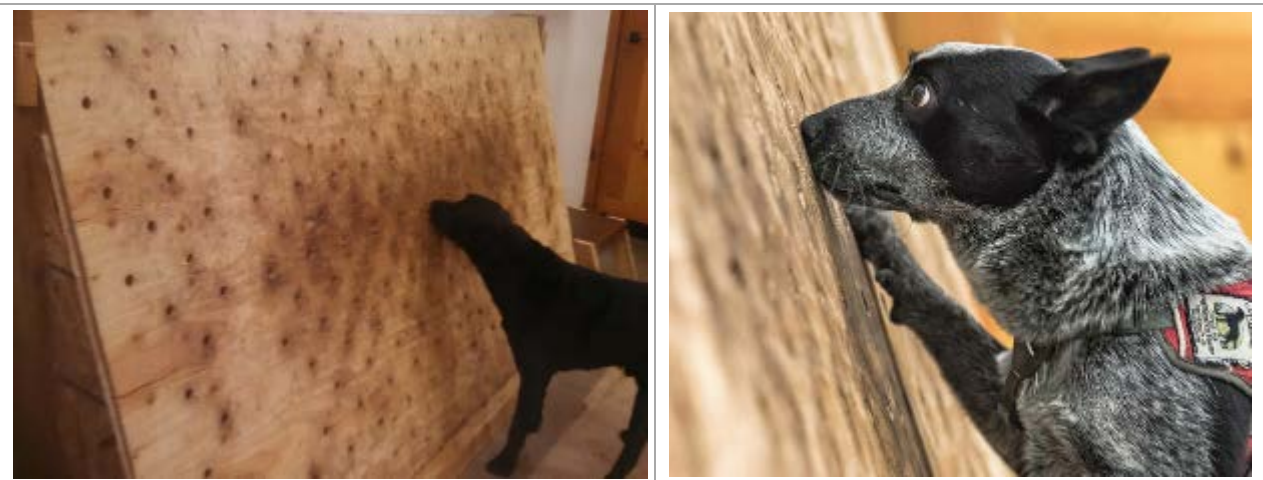
**Figure 2-3. Sampson (left) and Pips (right) demonstrating the wall training method**

The wall training technique was used to further develop Sampson’s scent detection skills by increasing the level of difficulty in PCB detection (Figure 2-3). The wall provided a vertical plane that contained holes leading to either 1) an open environment, 2) jars with control material, or 3) a jar containing the target chemical. A large wall (220 holes) and a portable wall (15 holes) were used between September 2016 and January 2017. All training samples (including Aroclor 1254, Aroclor 1260, and SPU archived samples) were utilized separately in this training method (i.e., only one type of training sample was used at a given time).

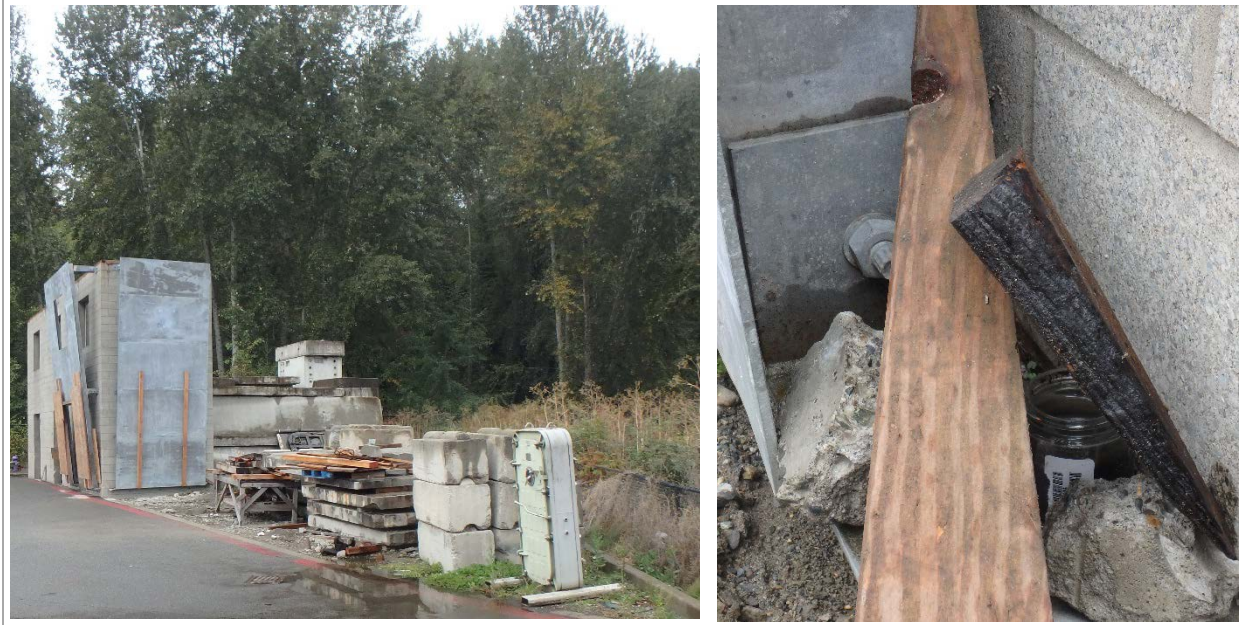
**Figure 3-2. Hidden PCB test area (left) and close-up of hidden sample (right)**

Hidden-PCB tests were conducted outside at the JTF facility, as described in the test plan and Phase 1 sampling memorandum (Windward 2016a, b) (Appendix D). A portion of the facility was designated for each test, and the project team placed one to three PCB targets (typically the SPU archived samples that were also used during training) in each area. Julianne and Sampson would then enter the test area and conduct their search for the PCB targets. Figure 3-2 presents an example of a test area at the JTF that was used for the hidden PCB tests, and shows an example of how archived samples were hidden at these sites.
