Surface volume changes for landslide areas between 2003 and 2020 in Dead Horse Canyon.

Sediment Management Strategy

Taylor Creek Restoration Project Draft Art Renderings

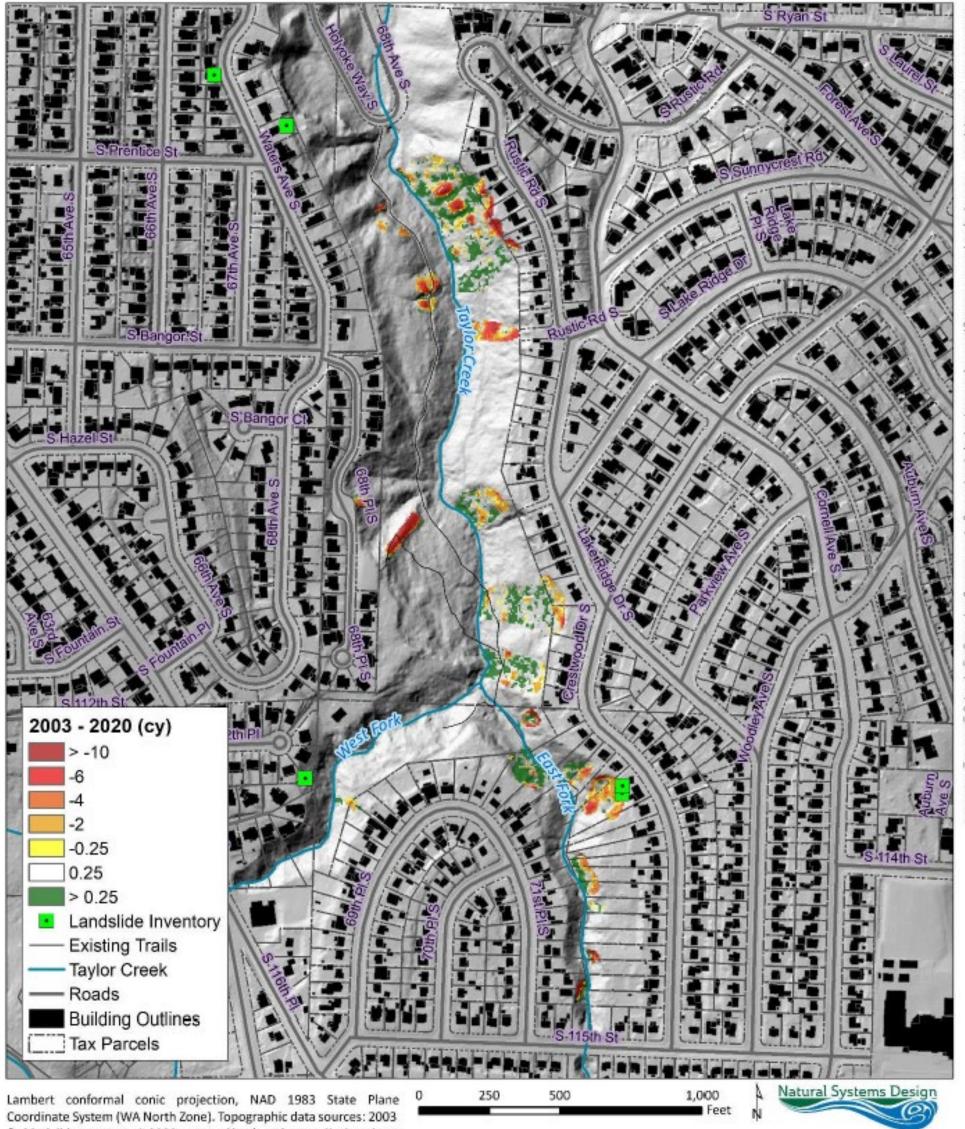
Coordinate System (WA North Zone). Topographic data sources: 2003 & 2016 lidar DEM and 2020 survey (SPU). Volumes displayed are based on vertical differences greater than 1 ft to account for lidar vertical error. Parcels, roads, and buildings from City of Seattle GIS. Surface volumes derived as difference between 2003 - 2020.

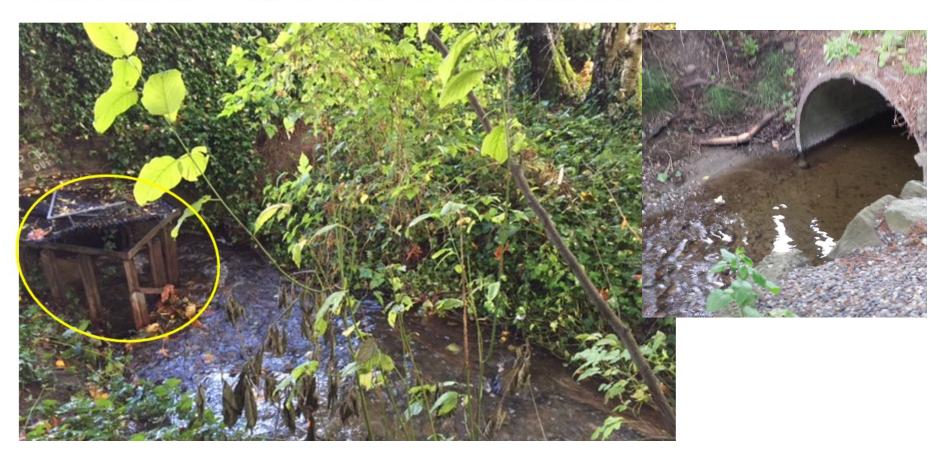
New Culvert / Bridge

Culvert under roadway, example from Thornton Creek Improvement

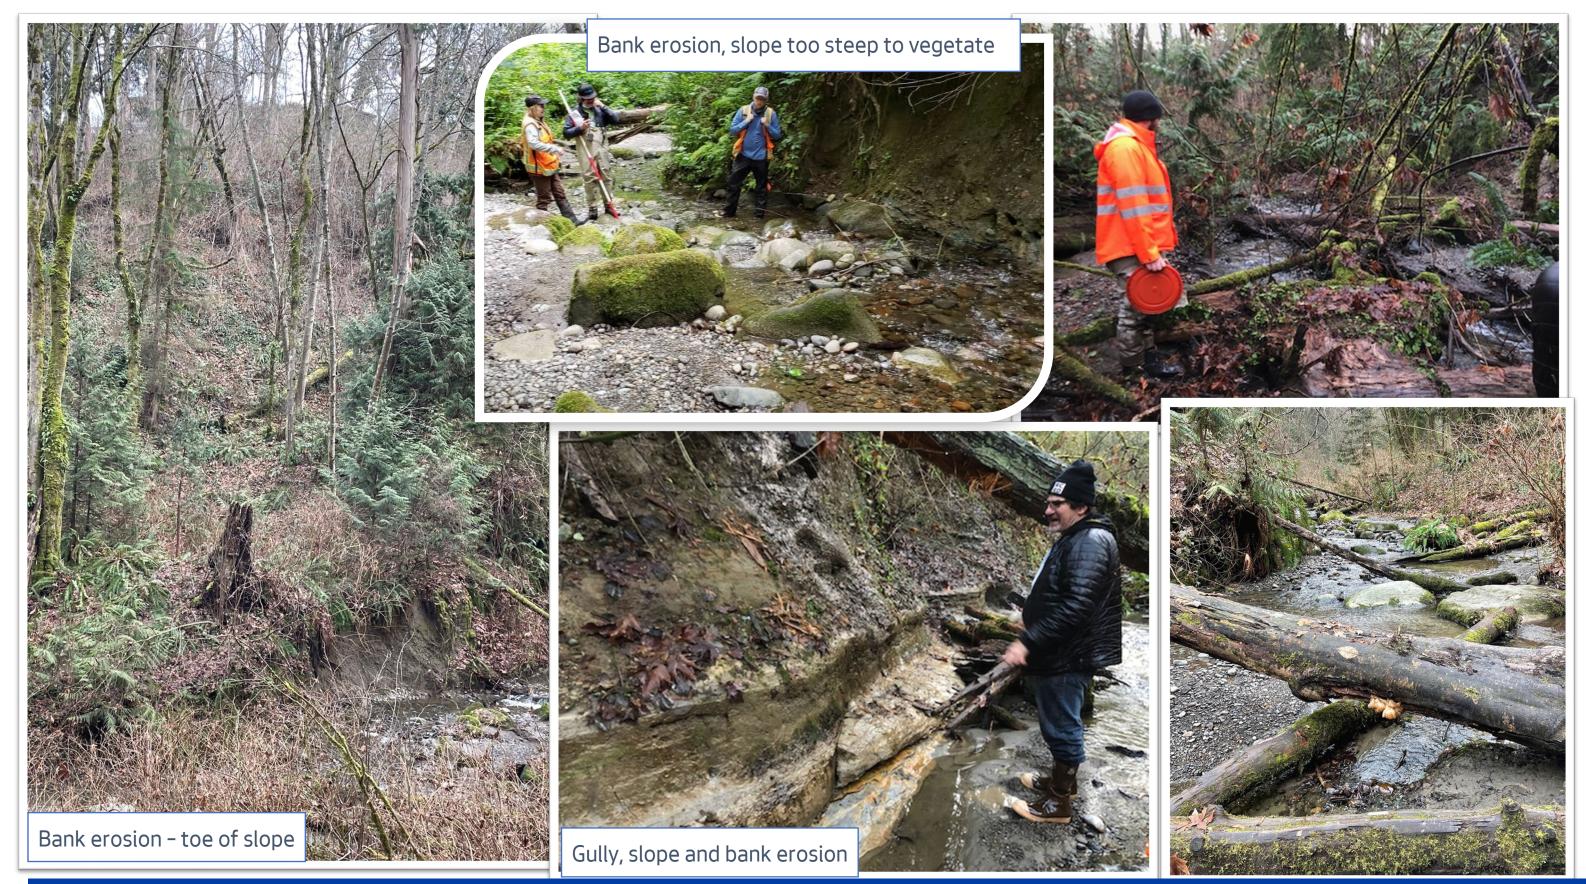
Reduce input Tightline outfall

Streambank stabilization & revegetation

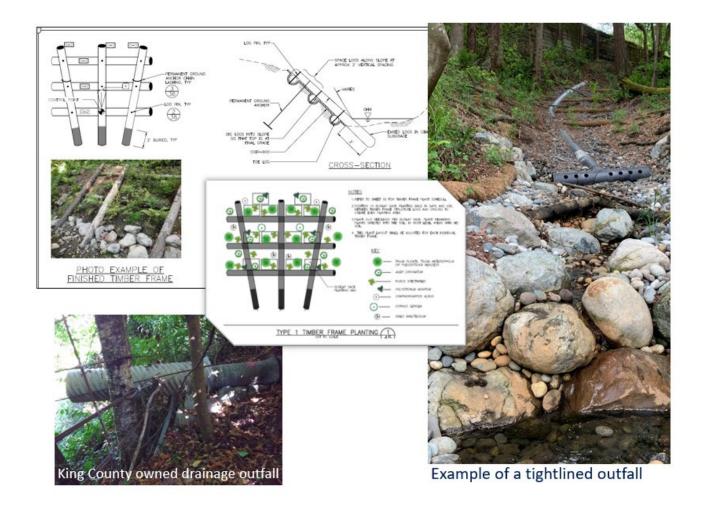
Storage in canyon

Large wood

Streambank stabilization & revegetation

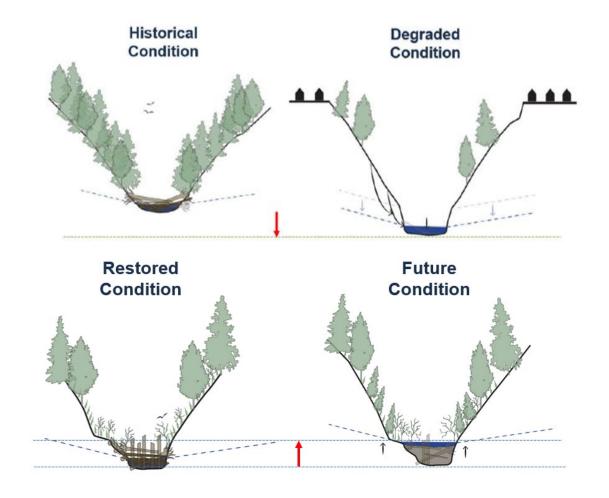
Floodplain storage

Increasing natural floodplain

Expanded future floodplain

Sediment Pond

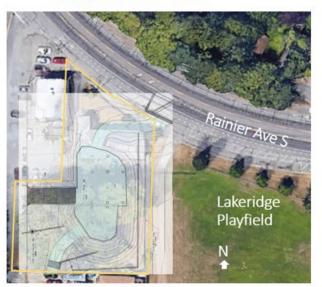
Old Design

Natural Creek Channel

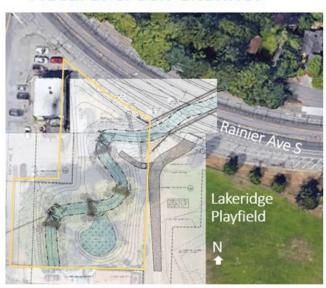
Updated Design
