Campus Trees Briefing

Seattle Urban Forestry Commission

May 11, 2016

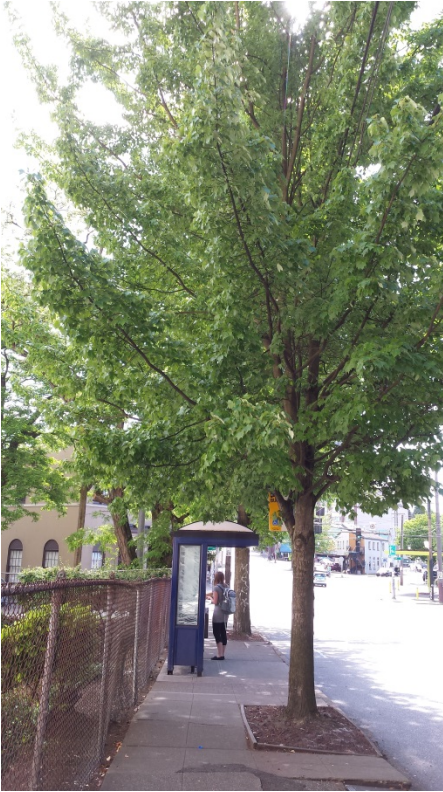
Street Trees

Two maples - *Acer rubrum* 'Doric'

One Norwegian Sunset Maple - *Acer truncatum* x *A. platanoides* 'keithsform'

Per Bill Ames site visit all are healthy; some pruning is recommended.

Power lines do run through the canopies so it is possible SCL may perform extensive pruning in the future.

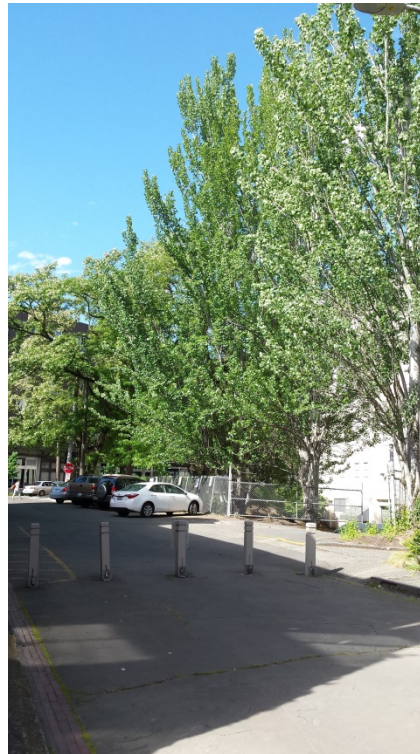
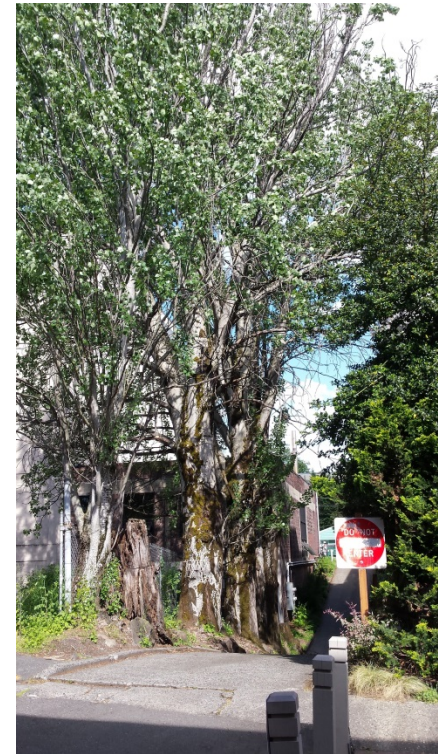
Arborist's Report
Commissioned April
2016
Identified nine
significant trees on site:

six grey poplars -
Populus Canescens

three black locust -
Robinia pseudoacacia

Poplars: usual longevity is 50-70 years
Trees 1-3 are estimated at 80 years
Trees 4-6 are estimated at 40-50 years

Observed crown die-back, embedded bark, and internal decay

Recommendation: trees are not “high retention value” trees and are in or nearing end-of-life “mortality spiral.”

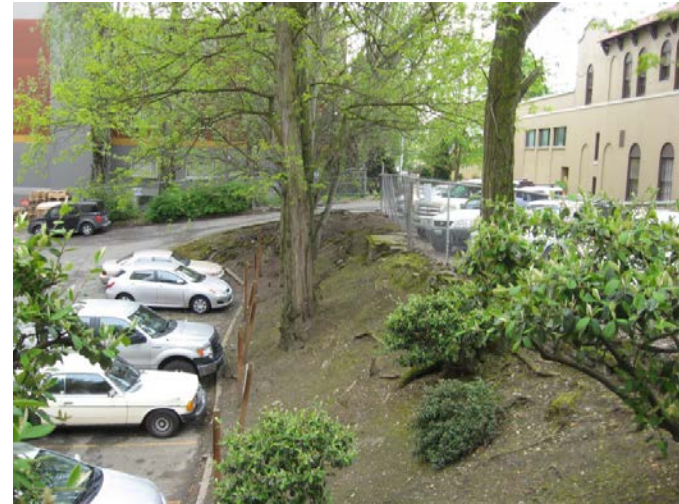
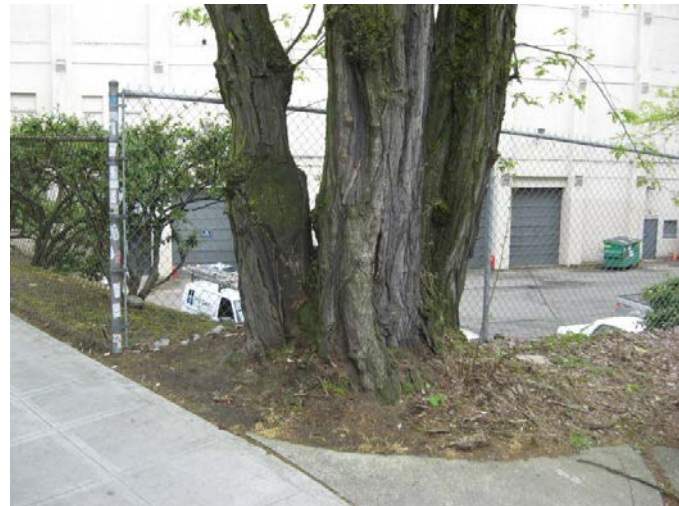
Tree Condition

Black Locust:

Trees 7-9 mature, multiple trunks

Tree 9 has been heavily pruned

Observed leaning trunks “over over-extended lateral branches”

Recommendation: trees are not “high retention value” trees

Bill Ames noted “numerous point of decay” on tree 9 adjacent to the ROW and asked that it be removed.
