## 5021, 5015 & 5001 RAINIER AVENUE S

SEPTEMBER 2022

# 5001, 5015 & 5021 RAINIER AVENUE SOUTH HISTORIC RESOURCES REPORT

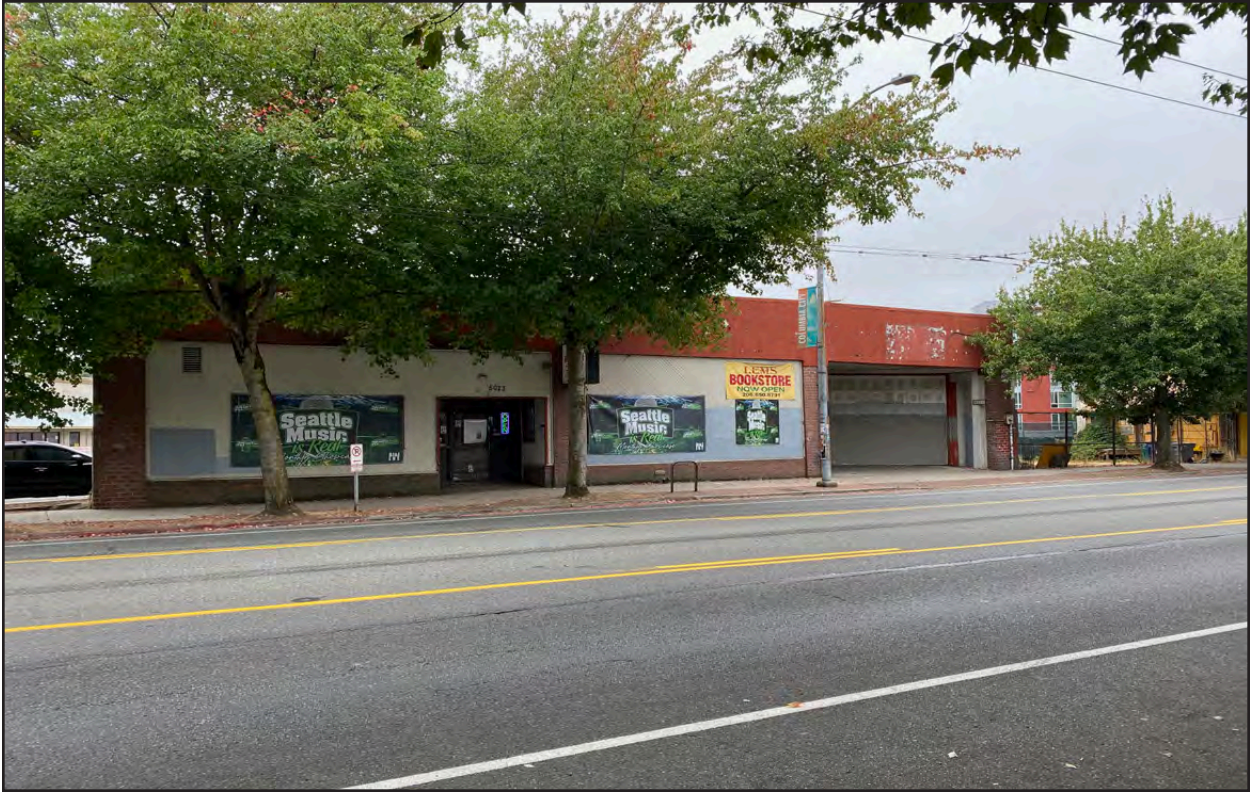
Figure 10 • 5021 Rainier Avenue S, eastern façade

Cladding: The existing cladding consists of the unreinforced masonry walls, including brick veneer at the storefront bulkhead, hollow clay tile walls, and painted stucco at the top of the street front wall. These materials exhibit a range of conditions from fair to poor.

The brick at the street front is in fair condition. Cracking in the mortar indicates settlement.

The stucco at the upper portion of the eastern wall is in poor condition, with evidence of moisture

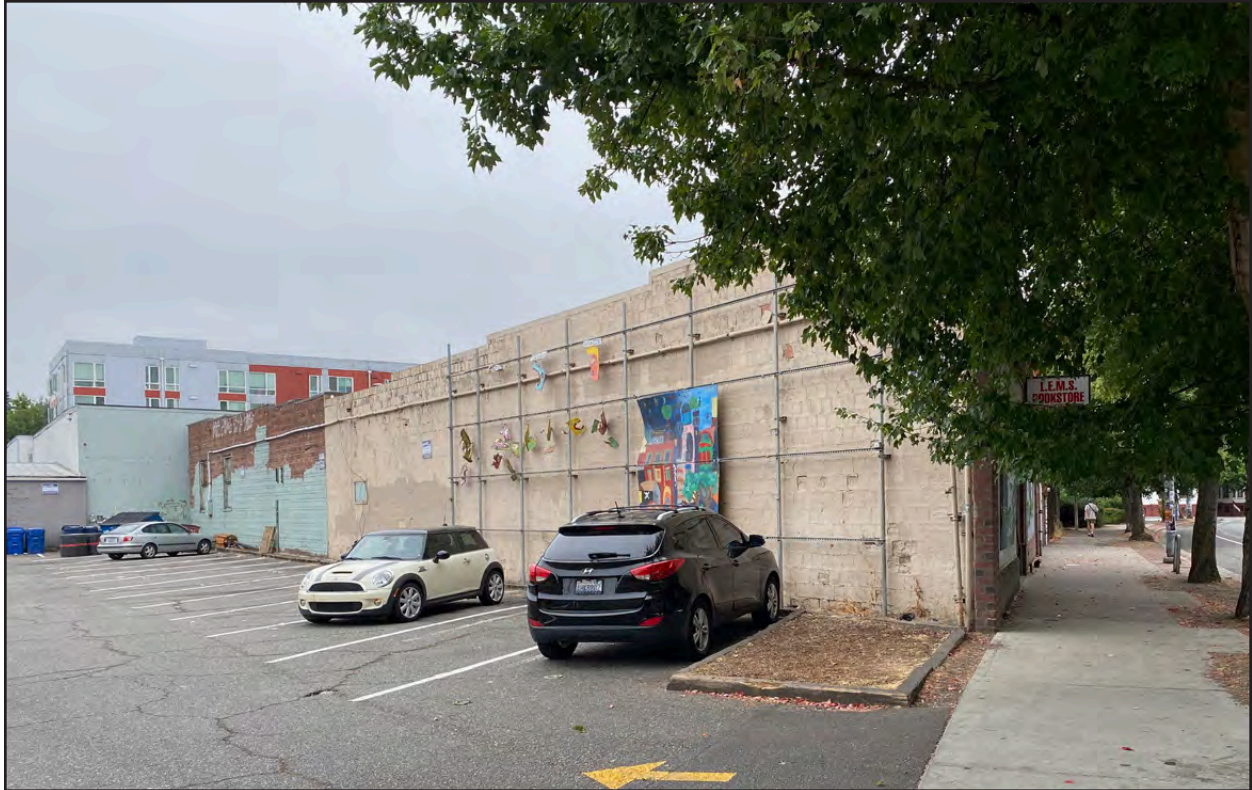
Figure 12 • 5021 Rainier Avenue S, southern façade, viewing northwest

The condition of the hollow clay tile at the northern and southern façades is remarkably poor, with the terra cotta spalling either from moisture intrusion and spalling, gravity load crushing, or settlement of the foundation. Graffiti on the sidewalls has been painted over.

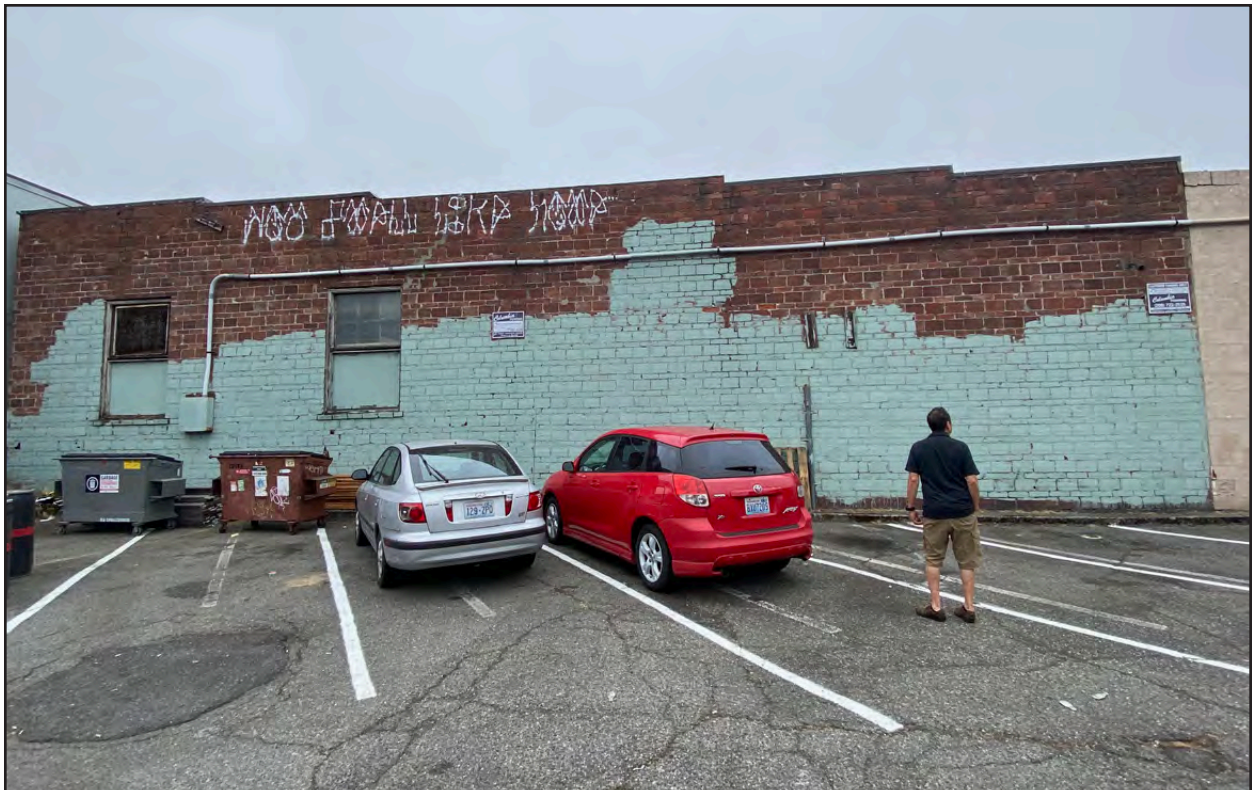
Figure 13 • 5021 Rainier Avenue S, southern façade, western end

The non-original street-front storefront windows systems are single glazed but exhibit no obvious cracks or issues with the wooden frames. The original wood-sash windows at the western end of the building are in poor condition, with missing glazing and evidence of wood deterioration.

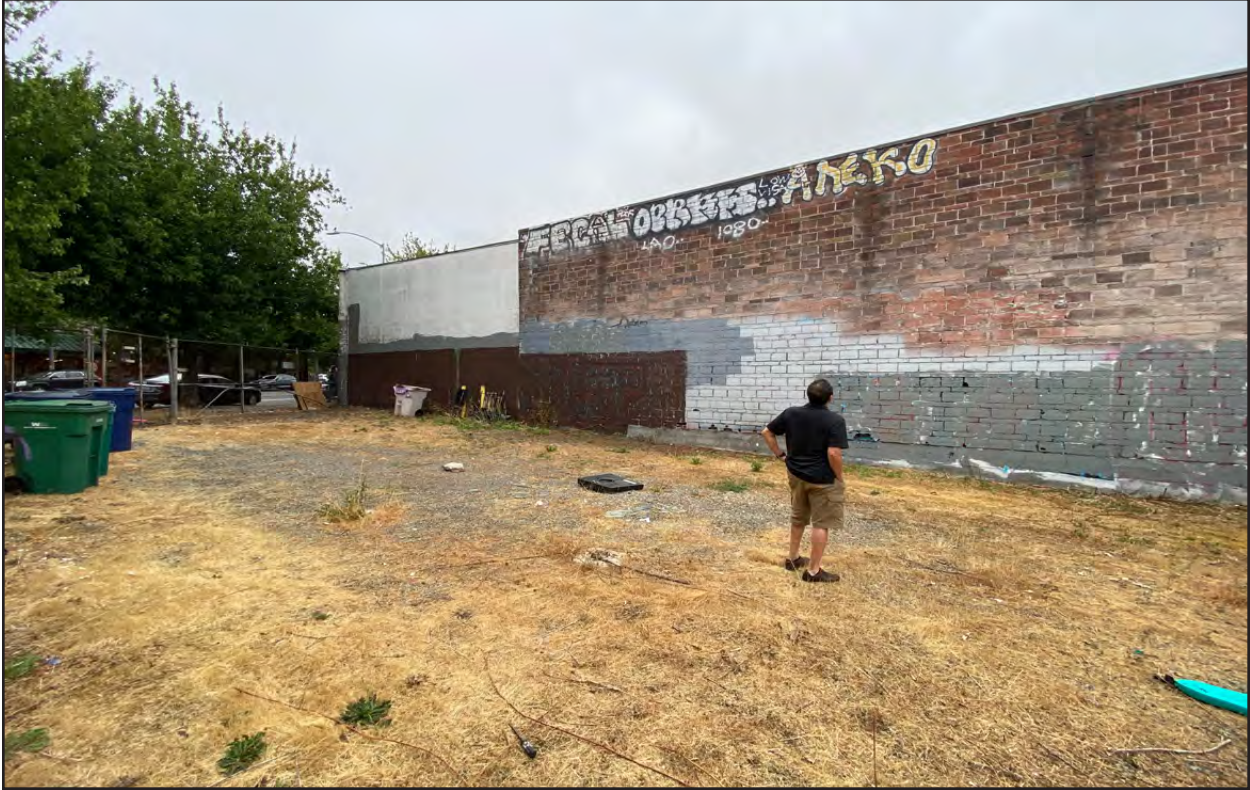
Figure 14 • 5021 Rainier Avenue S, northern façade, viewing southeast

The painted textured panels at the eastern end of the northern façade are in fair condition.

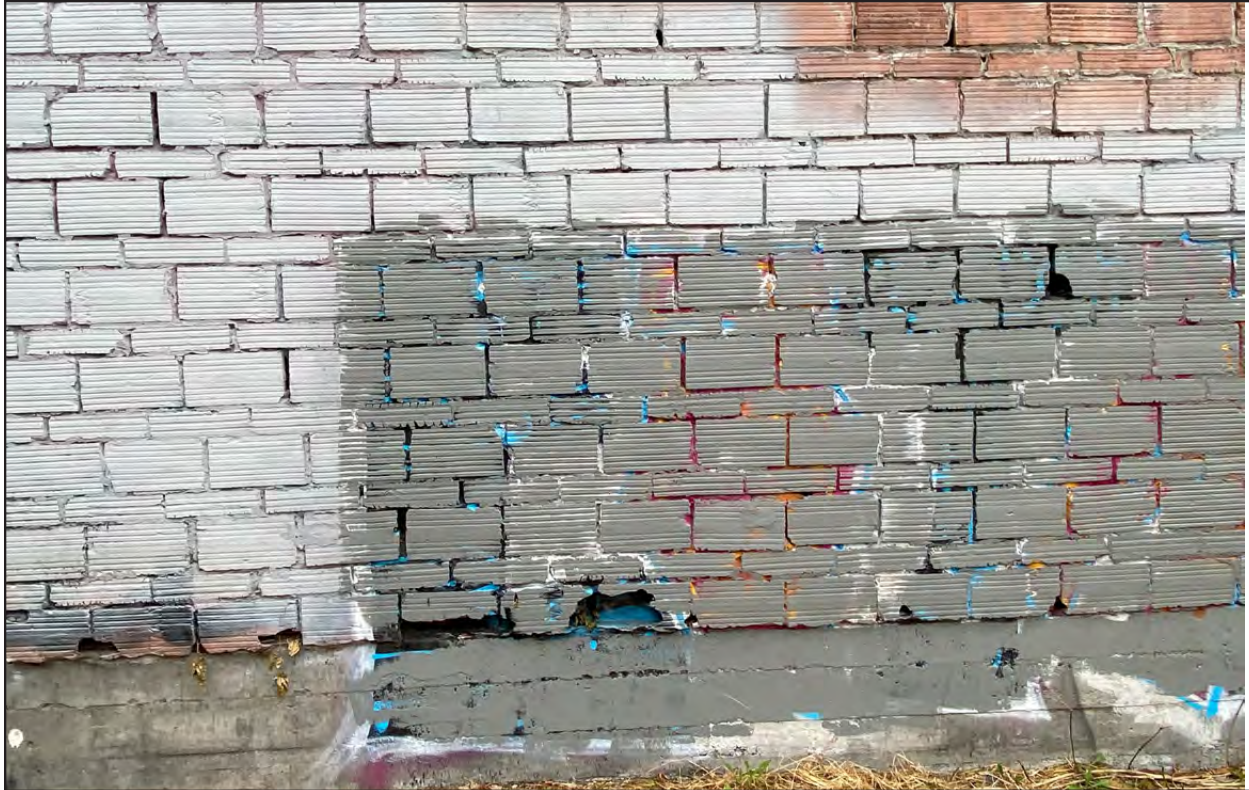
Figure 27 • 5021 Rainier Avenue S, condition of clay tile sidewalls, graffiti and evidence of settlement

Foundation: The poured-in-place foundation seems to be in fair condition except on the eastern side, where settlement of the structure was observed. However, the crushing of the terra cotta walls at the north and south may indicate more extensive foundation issues.

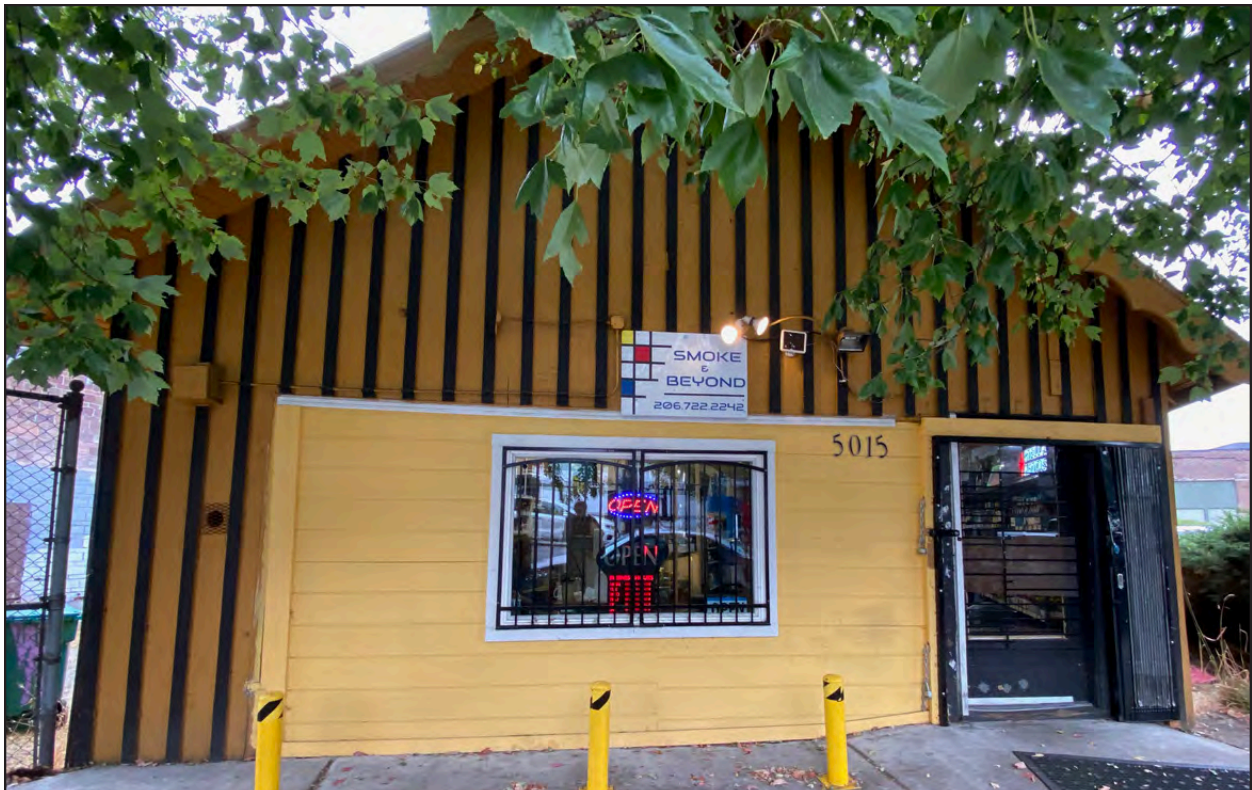
Figure 35 • 5015 Rainier Avenue S, eastern façade

Subsequent alterations include approved applications for signs and paint colors, and approvals for tree removals, landscaping, and right-of-way improvements. In 2022, an automobile accident caused extensive damage to the streetfront facade. The subsequent emergency repairs, replacing diagonal siding with horizontal

The new horizontal siding on the eastern façade, installed in 2022, is in good condition.

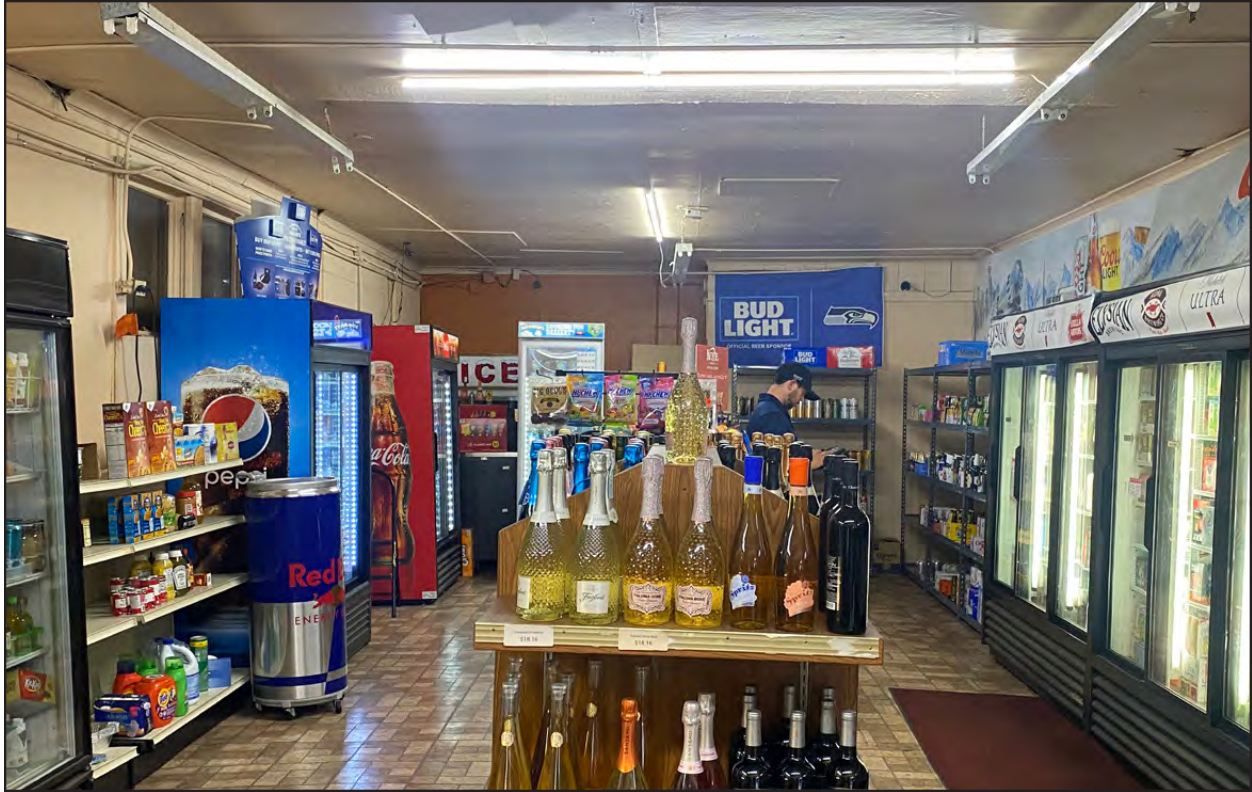
Figure 40 • 5015 Rainier Avenue S, interior viewing west

material, as they have been patched over time. The interior finish materials are in poor condition. *See figures 40-41.*

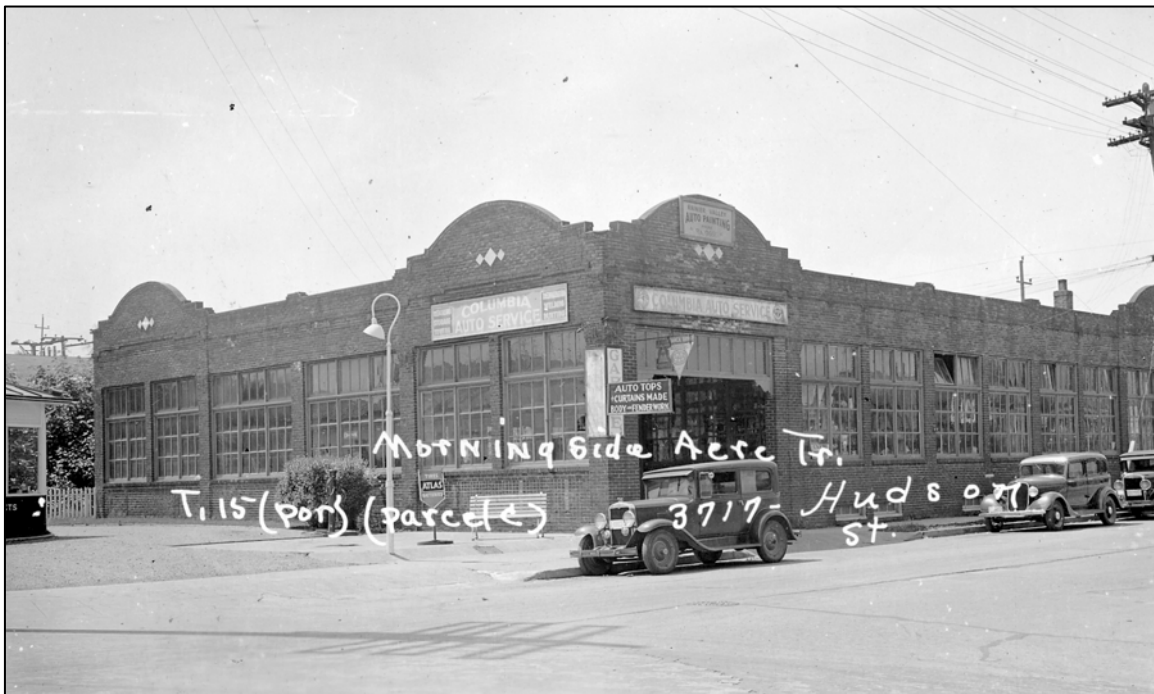
The garage was constructed of wood framing with concrete foundations and floor slab and bearing brick masonry exterior walls on the primary north and east facades. Poured-in-place concrete walls were exposed on the secondary south and west facades. It had a flat roof and a rectangular footprint of 70 by 100 feet. Interiors were finished with a laminated 2x6 fir floor (car-decking). The original basement had an unfinished dirt floor, but a concrete slab was added in 1947. The ceiling heights were noted in the tax record card 9 feet at the basement and 14 at the first floor, and the mean roof level at 16 feet.

The original building had raised brick masonry parapets that projected at least 6 feet above the roof on the north, east and west sides. The outer corners on the north and west facades featured curvilinear parapet walls. These low arched forms were finished with terra cotta decorative tiles at their centers. The raised parapets are stylistic elements taken from classical and baroque design. They once provided embellishment to the relatively utilitarian and vernacular design, and emphasized the buildings height and sense of mass.

*Above, the primary east and partial north facade of the garage at 3711 - 3717 South Hudson Street as shown in a 1937 historic tax assessor's property record card. (Puget Sound Regional Archives)*

Primary piers rising from grade to brick corbelling on the parapets demarked the structural grid on the exterior walls. Secondary piers and large window openings were placed between the primary structural grid, and provided a secondary scale, along with ample natural light to the building's interior space. Industrial steel sash windows were placed between the piers. These were composed in horizontal groups of two or three, each with 3:3 divided panels. Multi-paned transoms provided a similar pattern above the windows on the primary north and east facades, and on portions of the west and south secondary facades. Window openings on these secondary facades were smaller, but contained industrial steel sash windows. The building originally featured a large vehicle opening in the easternmost bay of the north facade, and another on the basement level west facade. Brick masonry was laid in a stacked pattern in bulkhead areas below some of the windows on the primary facades. Painted signage was provided in wood panels above the transoms at the northeast corner and on a projecting blade sign.

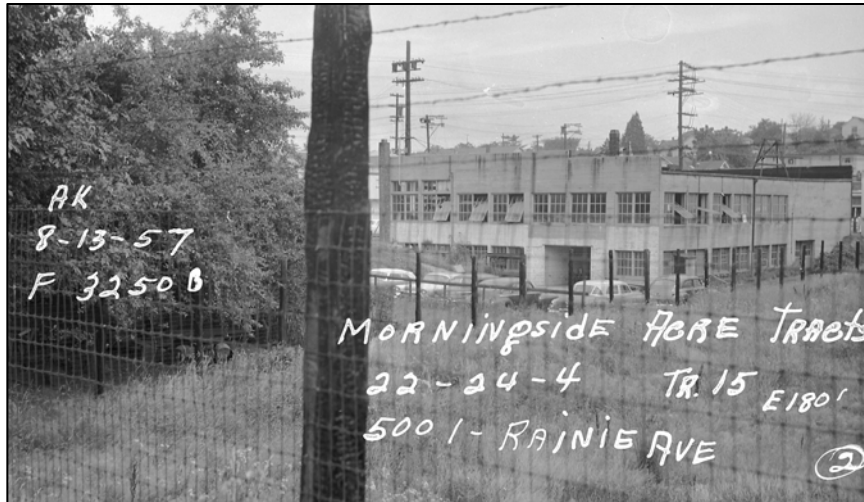
*Left, this later tax assessor's photo, from 1957, shows the secondary facades and the slope that exposes the basement walls on the south and west. (Puget Sound Regional Archives)*

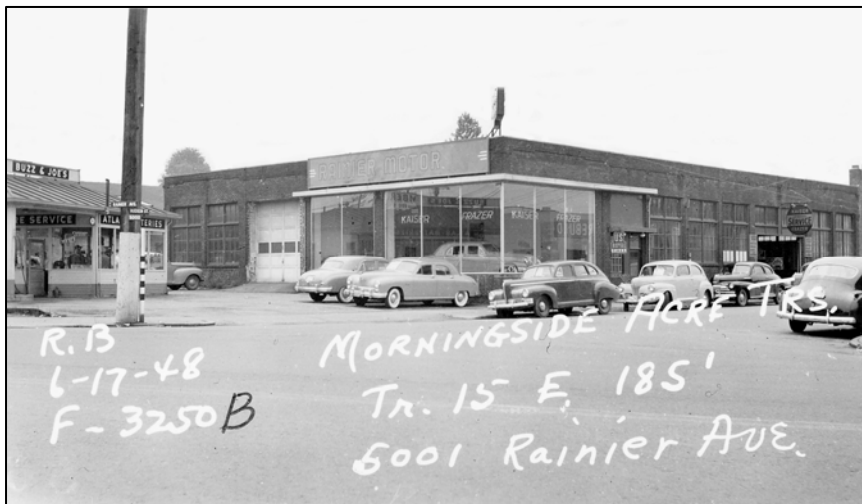
*Left, a 1948 tax assessor's photo showing changes to the northeast corner of the building when it was "modernized" for use as a small auto showroom. (Puget Sound Regional Archives)*

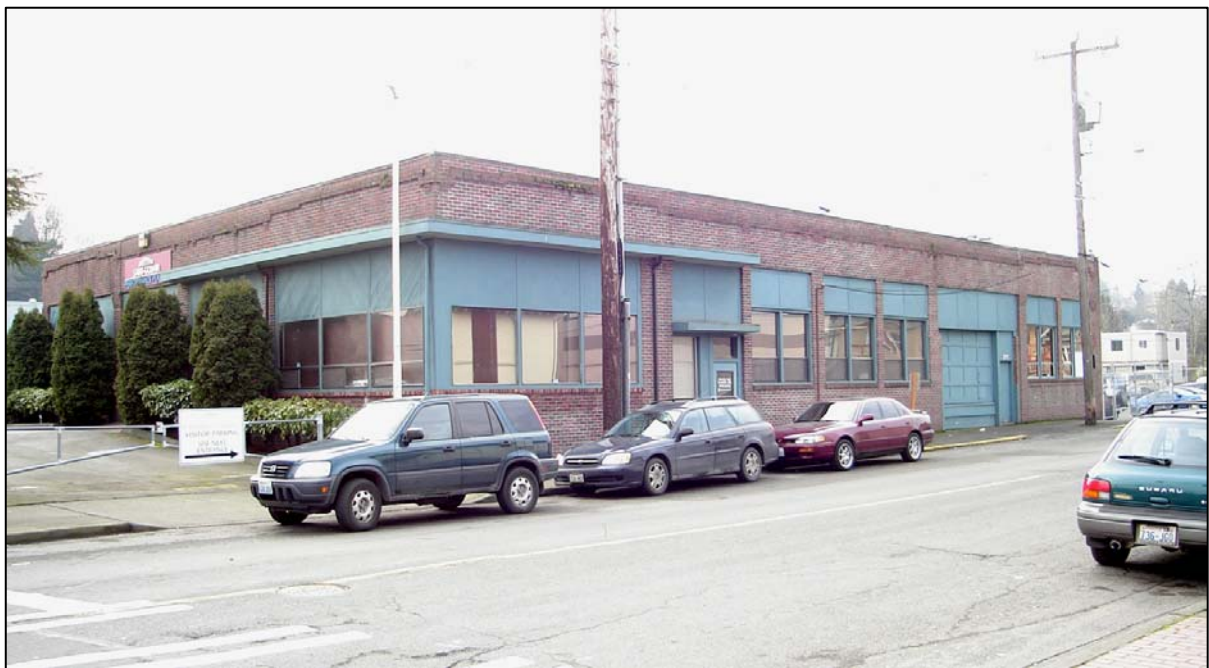
Physical changes to the building that occurred since the 1960s include replacement of all of the original remaining industrial sash windows with plate glass, some with reflective coating. The original window sills, made up by soldier courses of the brick masonry remain as do some areas of stacked brick patterned panels below the windows, some corbelled rows in the masonry near the top of the walls and parapet, and small areas of decorative brick patterning on the piers that demark the bays. Transom windows appear to have been removed or covered with painted plywood panels, and exterior doors replaced with painted flush types of wood or metal. These changes and removal of the raised parapets, have impacted the building's architectural integrity although it appears to be a sturdy structure with some historic features.

*Above, a contemporary view of the primary north and east facades. This and all other current color photos are by BOLA Architecture + Planning and date from February 2007.*

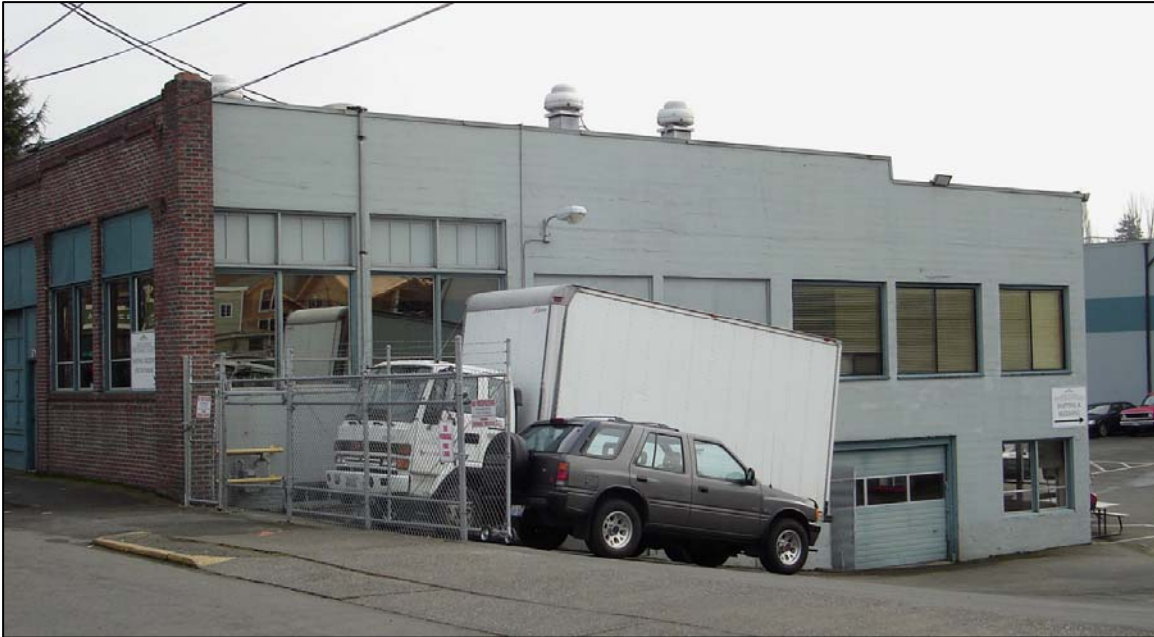
*Above, a view of the secondary west facade. Note the continuation of the original window and transom pattern, which was typical on the north and east facades, along the northern portion of the west facade. Below, a view looking east on South Hudson Street.*

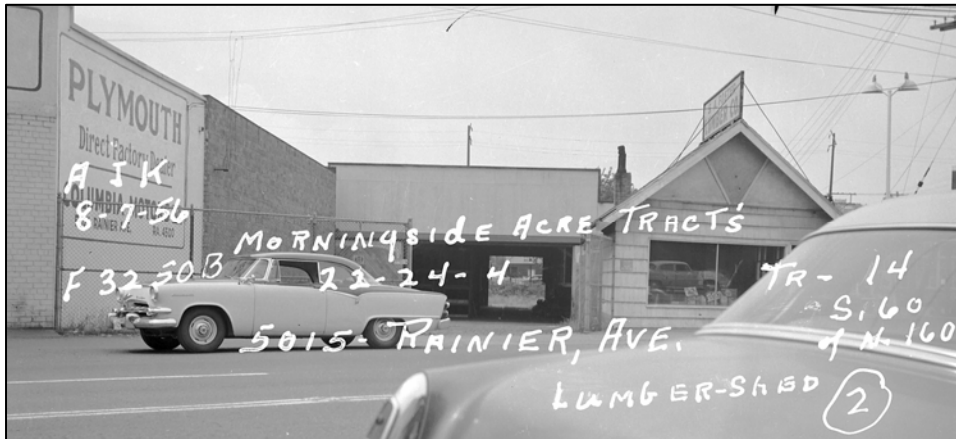
*Above, the building in a tax assessor's record of 1956. Original windows had been replaced by this date. Note the lumber storage building in the back of the lot. (Puget Sound Regional Archives)*

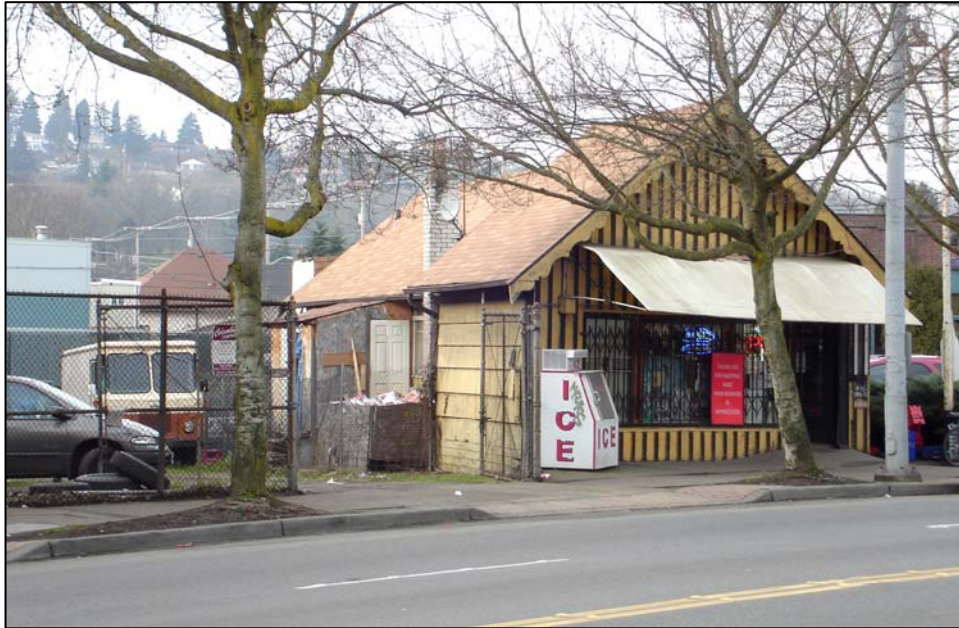
The current siding covers the original timbered treatment in the front gable end. Most of the remaining wall areas are finished with diagonal board siding, and most of the side windows are covered with painted plywood panels, although there are some areas on the north where wood callboards are visible. Original window and door locations on the front facade have been retained but the elements themselves have been changed. The back of the building appears somewhat domestic in nature with a partly enclosed porch on the back end of the south facade. Its condition appears poor.

*Above is current view of the primary east facade and partial view of the south facade of the Busy Bee Mini-Mart. Below, a view looking south across the parking lot of 5001 Rainier Avenue South at its north facade.*

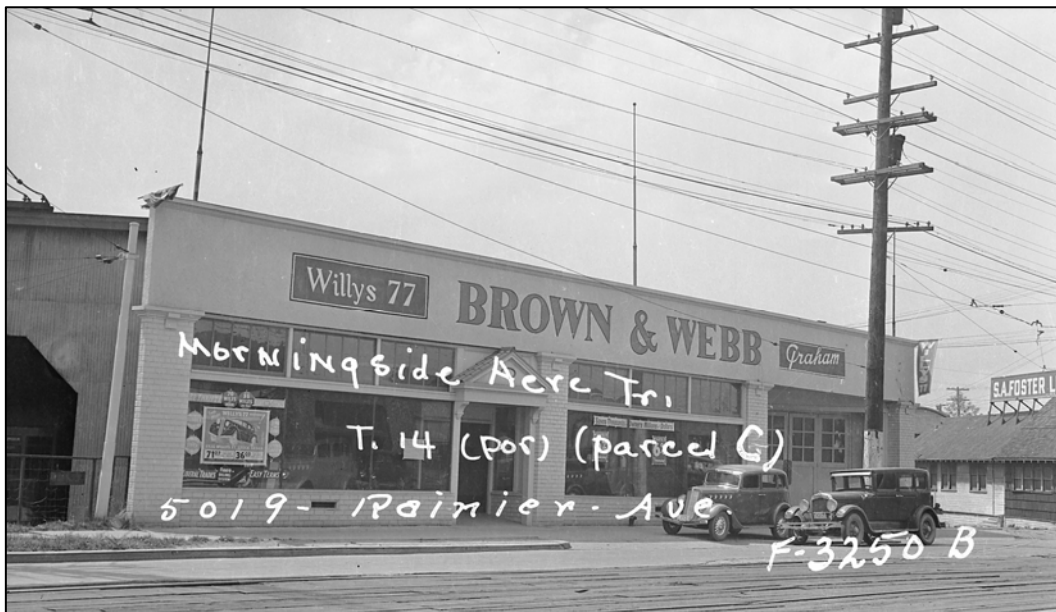
The tax assessor photo, dating from 1936, shows the primary facade was painted by that time, with the tall section above the storefront and transoms serving as signage for the dealership business.

*Above, the building as shown in the historic tax assessor's parcel record card. (Puget Sound Regional Archives)*

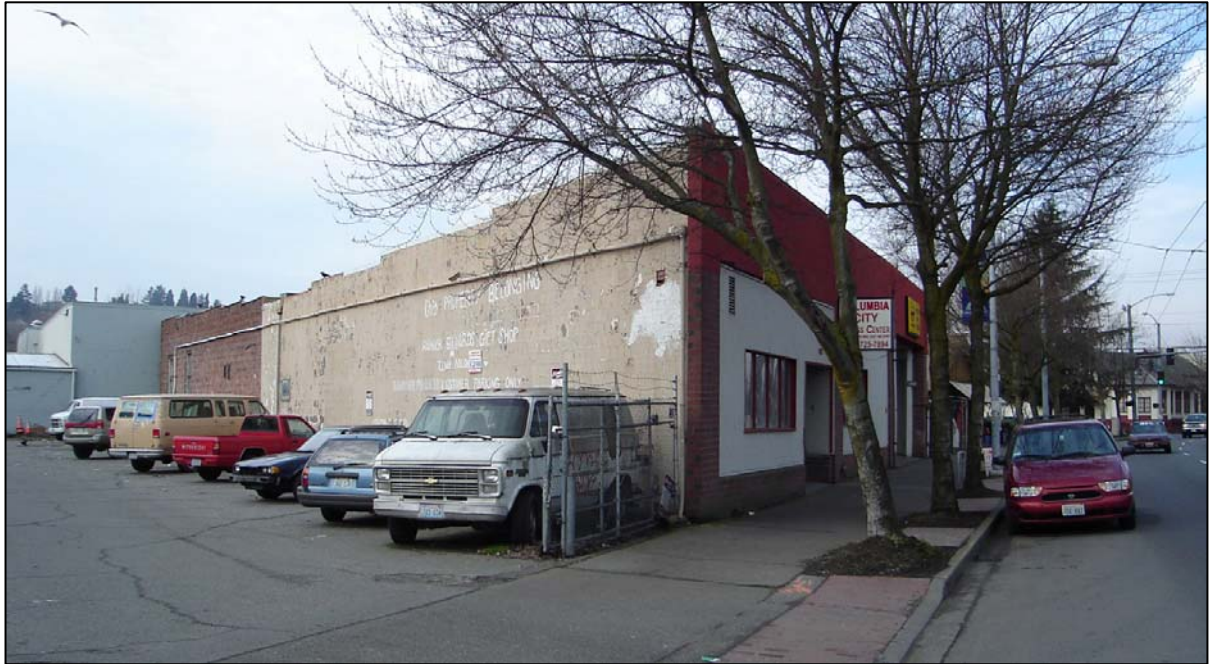
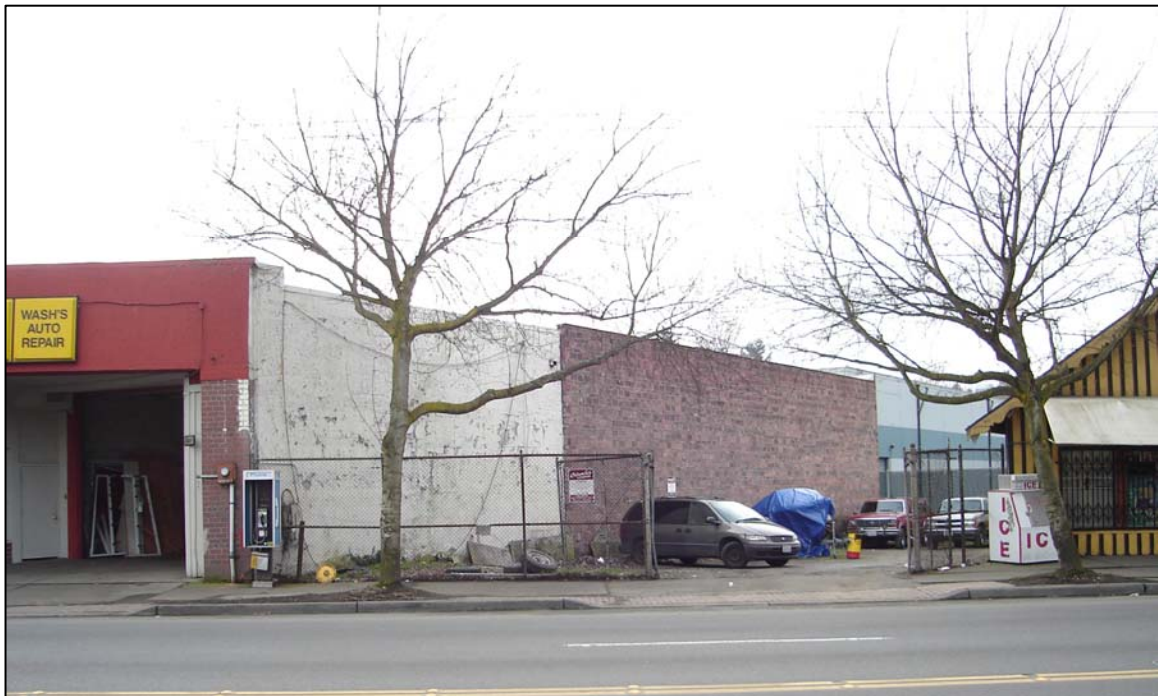
*Above a contemporary view looking northwest from the sidewalk at the secondary south facade and partial east facade of the building. Above a contemporary view of the secondary north facade. Below an oblique view of the north and partial east facades.*

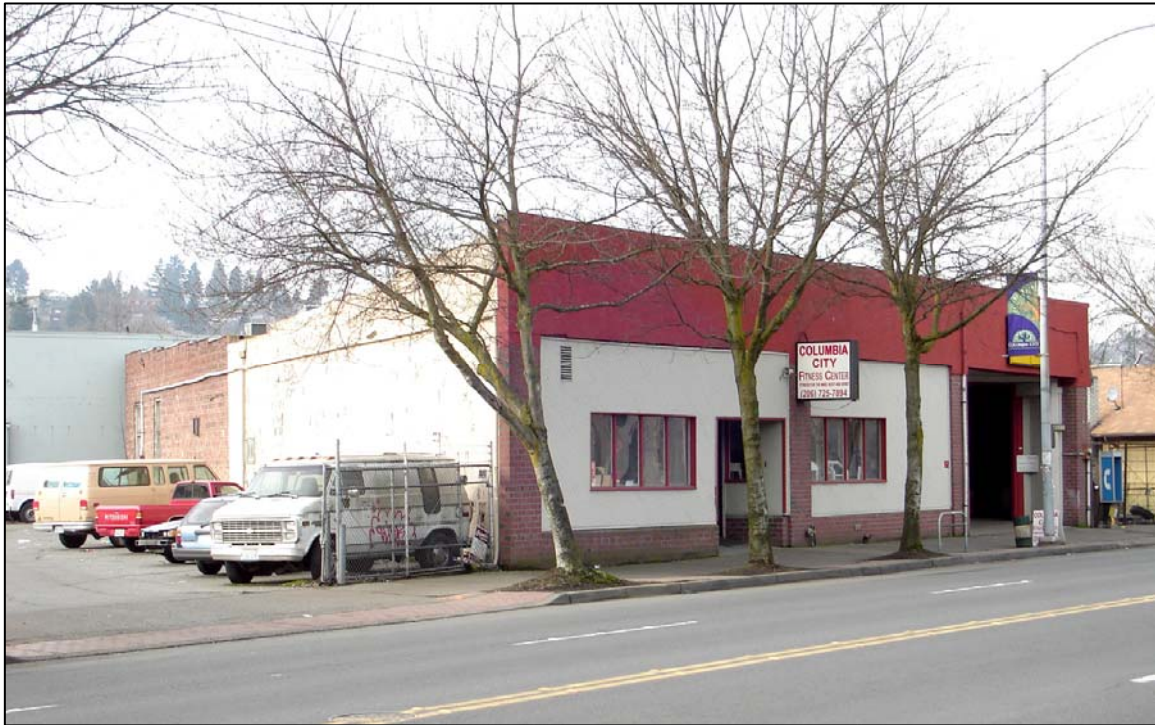
*Above, oblique view of the primary east façade on Rainier Avenue South.*
