## STANDARDS FOR REHABILITATION & GUIDELINES FOR REHABILITATING HISTORIC BUILDINGS

# Rehabilitation

# GUIDELINES FOR REHABILITATING HISTORIC BUILDINGS

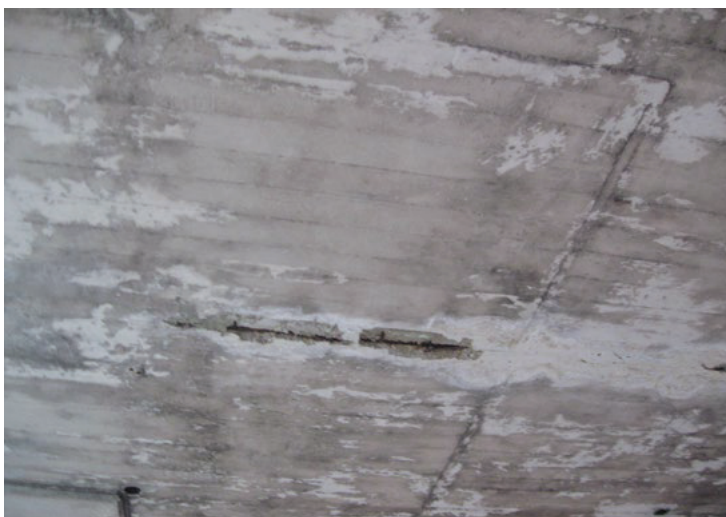
[5] Rebars in the reinforced concrete ceiling have rusted, causing the concrete to spall. The rebars must be cleaned of rust before the concrete can be patched.

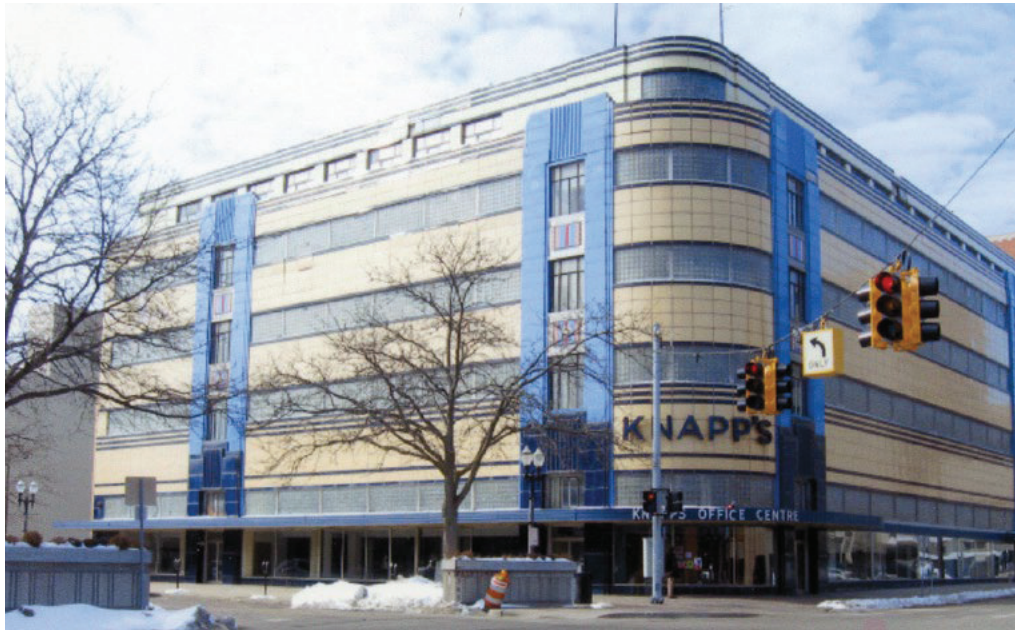
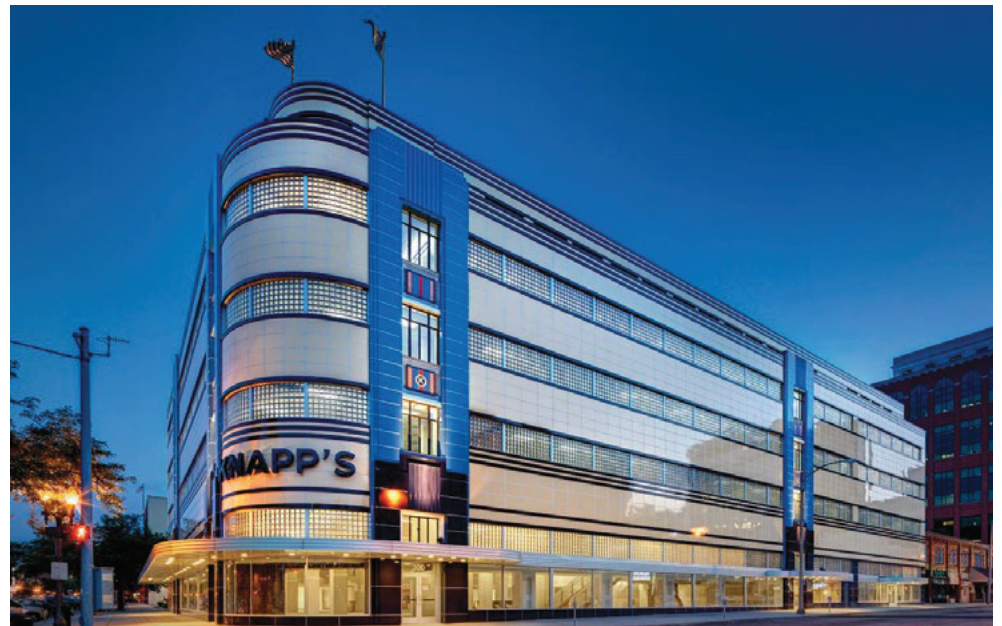
[7] (a) J.W. Knapp's Department Store, built 1937-38, in Lansing, MI, was constructed with a proprietary material named "Maul Macotta" made of enameled steel and cast-in-place concrete panels. Prior to its rehabilitation, a building inspection revealed that, due to a flaw in the original design and construction, the material was deteriorated beyond repair. The architects for the rehabilitation project devised a replacement system (b) consisting of enameled aluminum panels that matched the original colors (c). Photos and drawing (a-b): Quinn Evans Architects; Photo (c): James Haefner Photography.

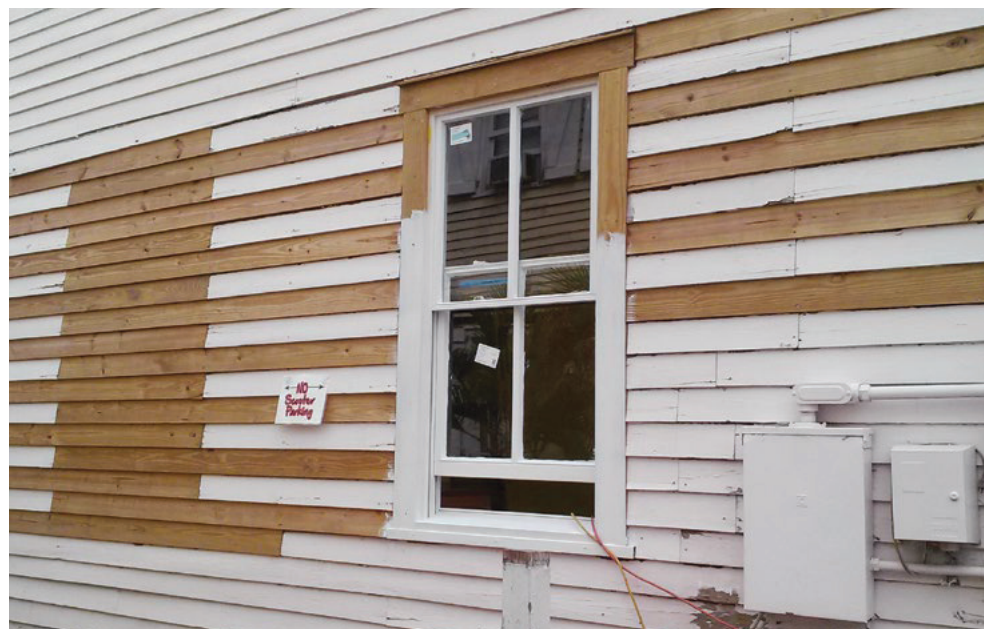
[8] Rotted clapboards have been replaced selectively with new wood siding to match the originals.

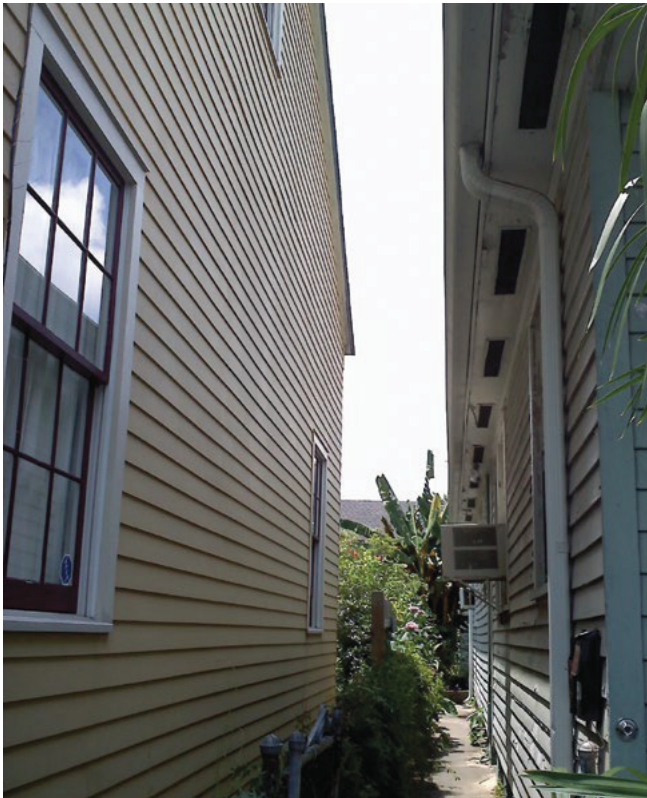
[9] Smooth-surfaced cementitious siding (left) may be used to replace deteriorated wood siding only on secondary elevations that have minimal visibility.

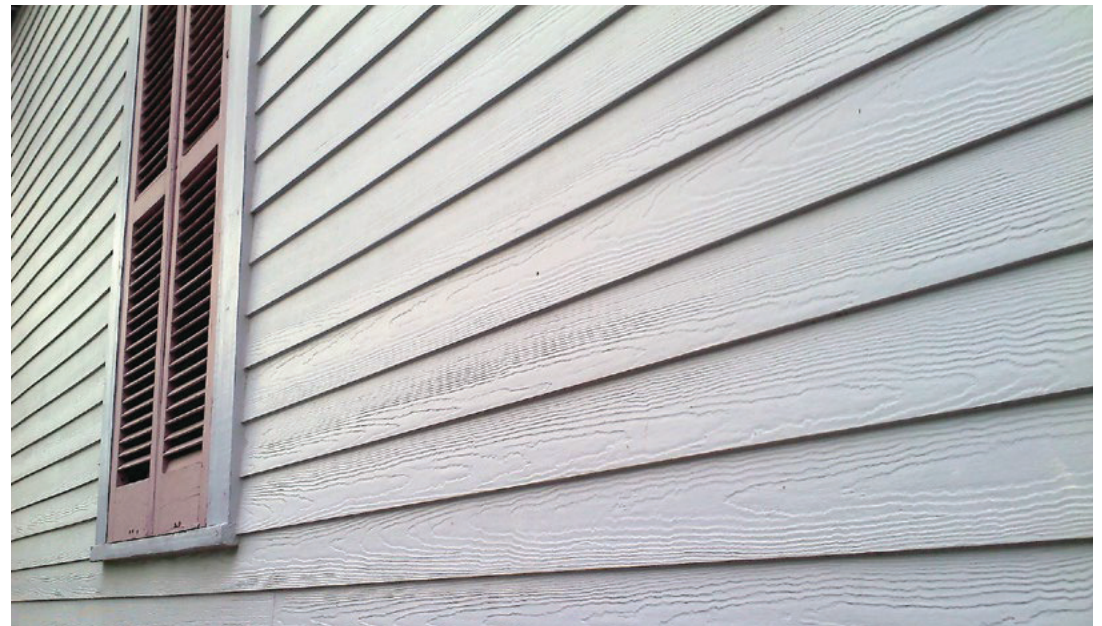
[10] **Not Recommended:** Cementitious siding with a raised wood-grain texture is not an appropriate material to replace historic wood siding, which has a smooth surface when painted.

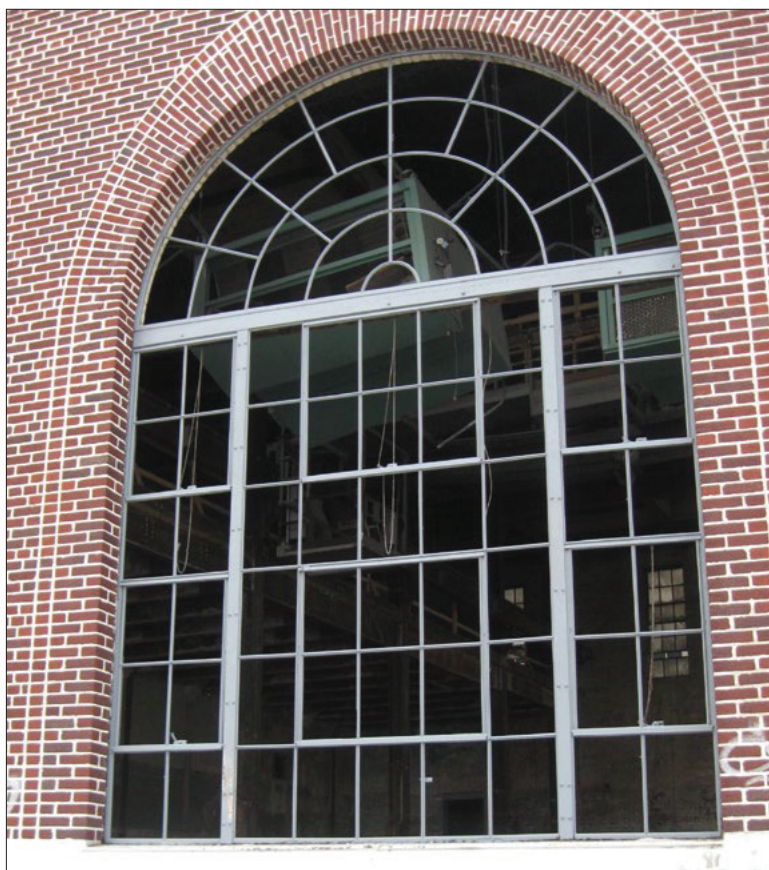
[12] This historic steel window has been cleaned, repaired, and primed in preparation for painting and reglazing.

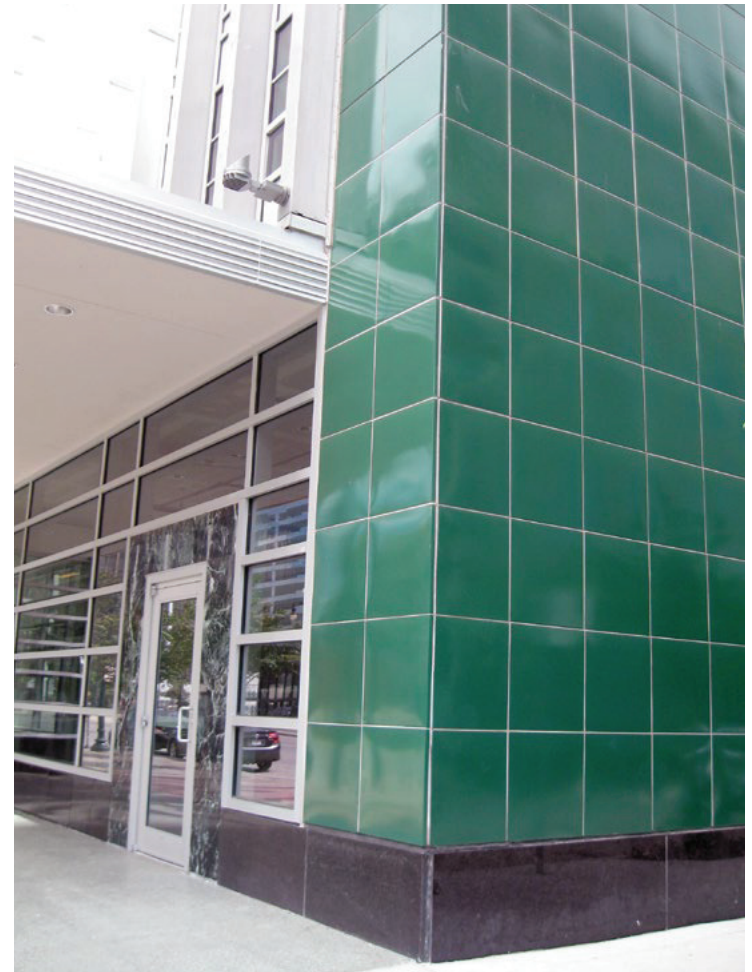
[15] New enameled-metal panels were replicated to replace the original panels, which were too deteriorated to repair, when the storefront of this early 1950s building was recreated.

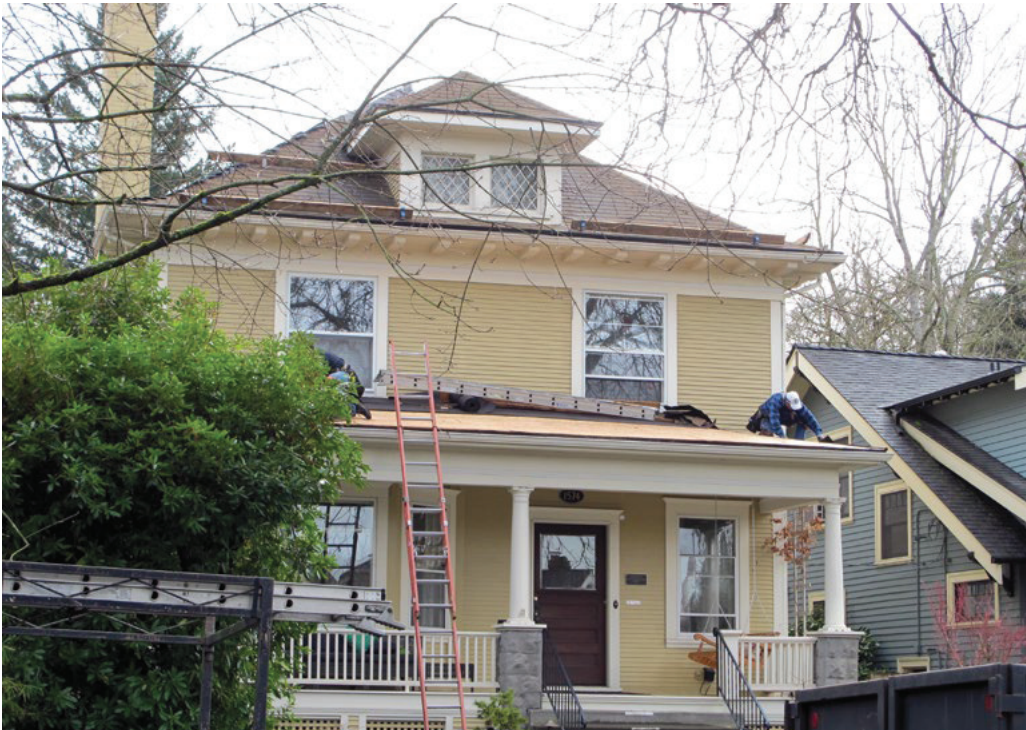
[16] The deteriorated asphalt shingles of this porch roof are being replaced in kind with matching shingles.

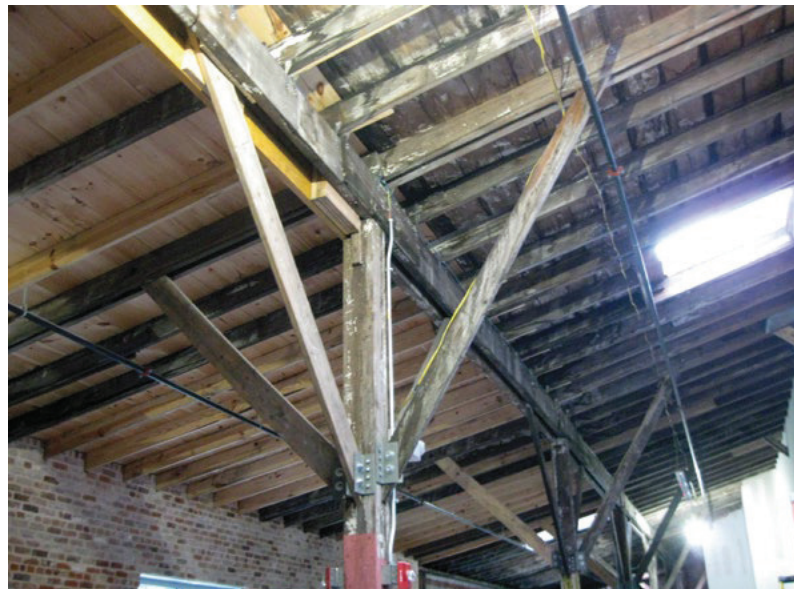
[17] New wood elements have been used selectively to replace rotted wood on the underside of the roof in this historic warehouse.

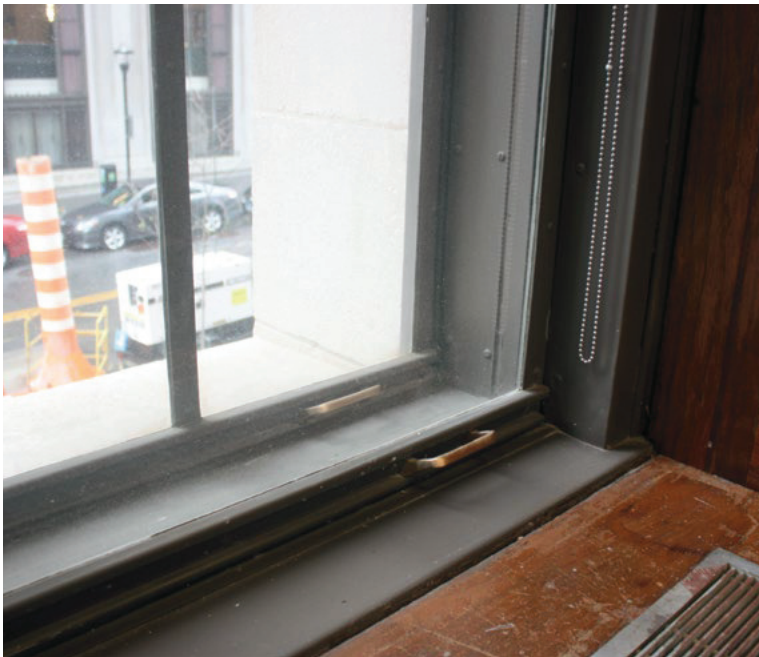
[18] The historic metal storm windows in this 1920s office building were retained and repaired during the rehabilitation project.

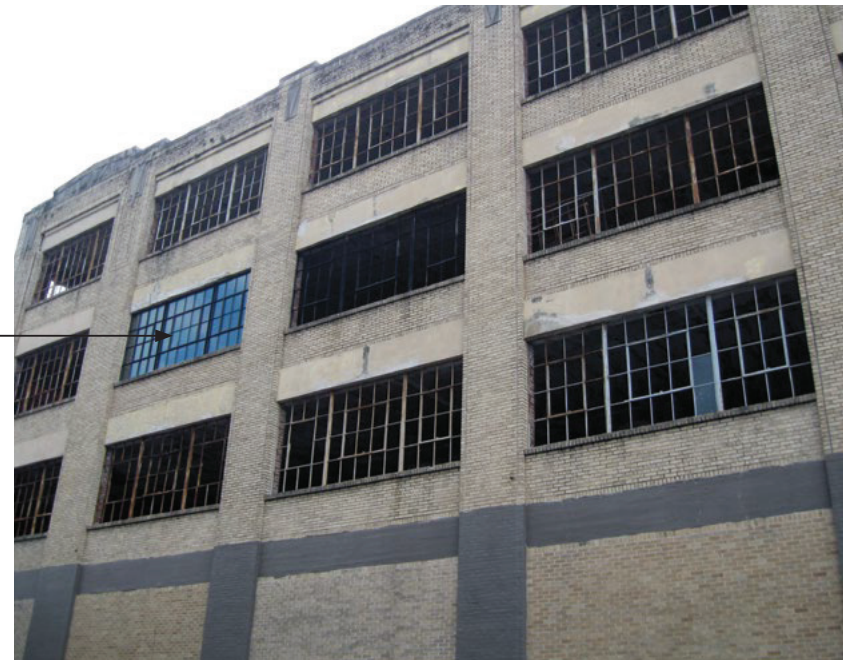
[19] Installing a mockup of a proposed replacement window can be helpful to evaluate how well the new windows will match the historic windows that are missing or too deteriorated to repair.

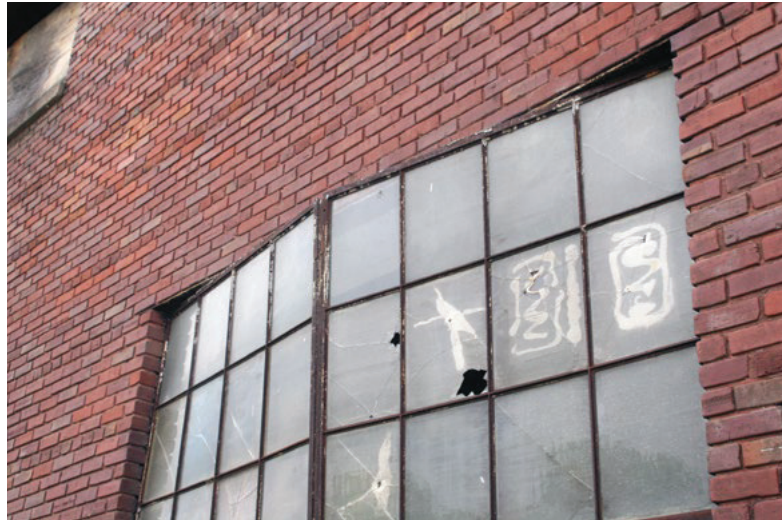
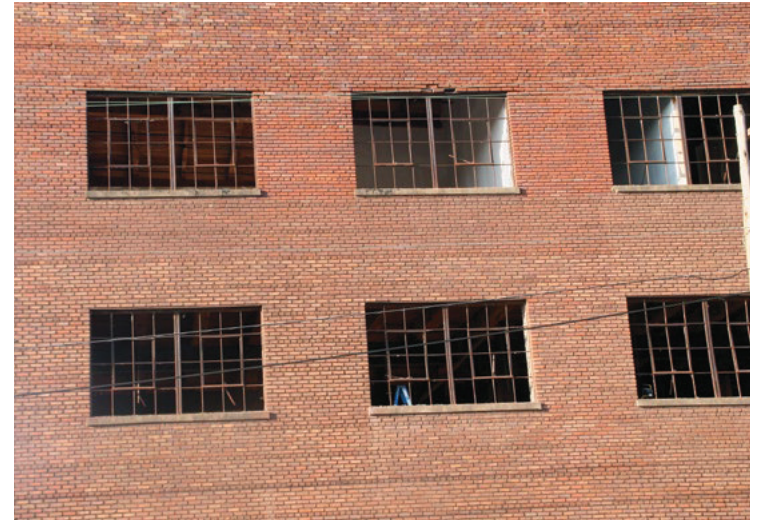
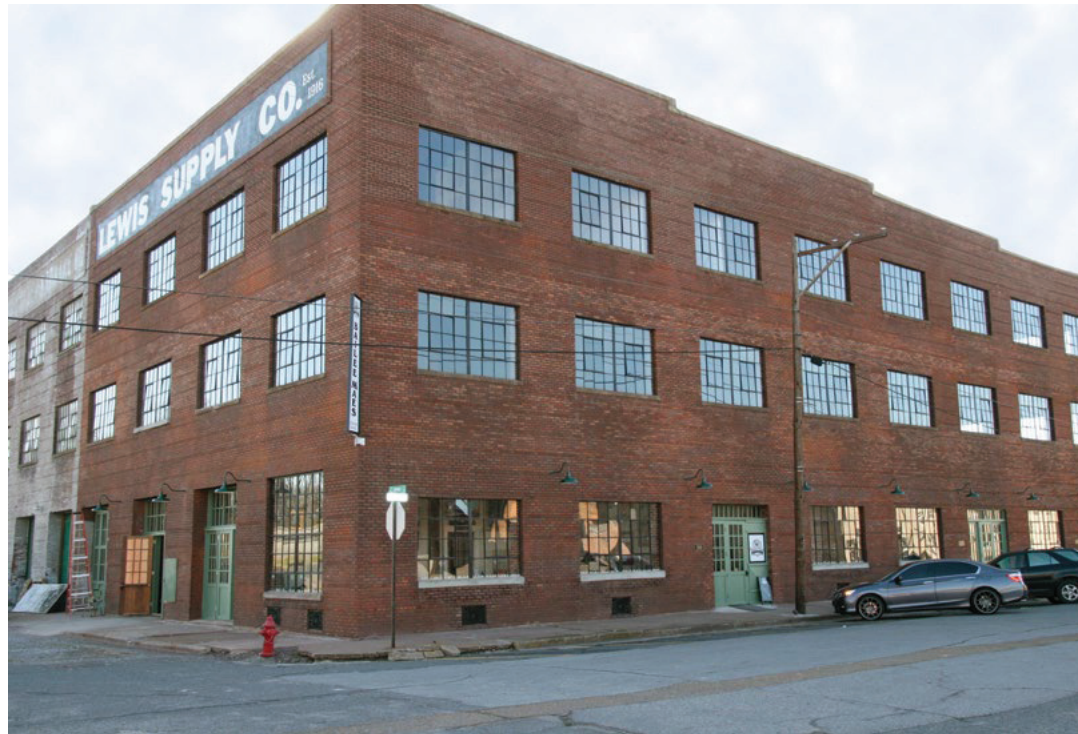
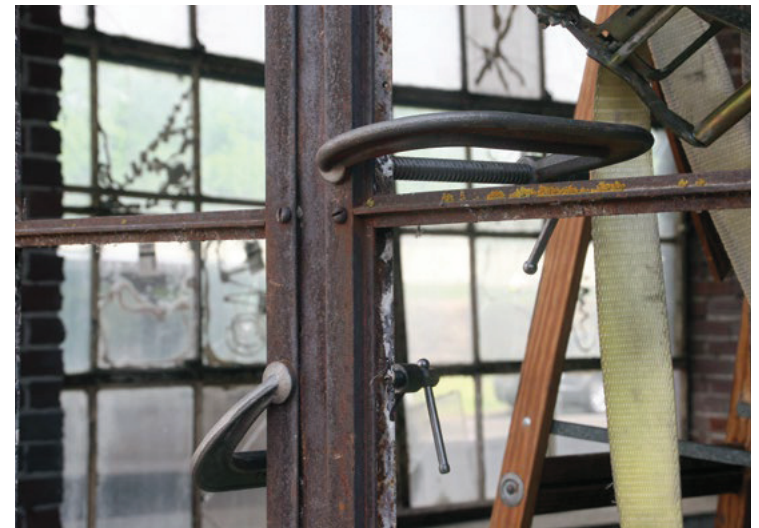
[20 a-d] The original steel windows in this industrial building were successfully repaired as part of the rehabilitation project (left).

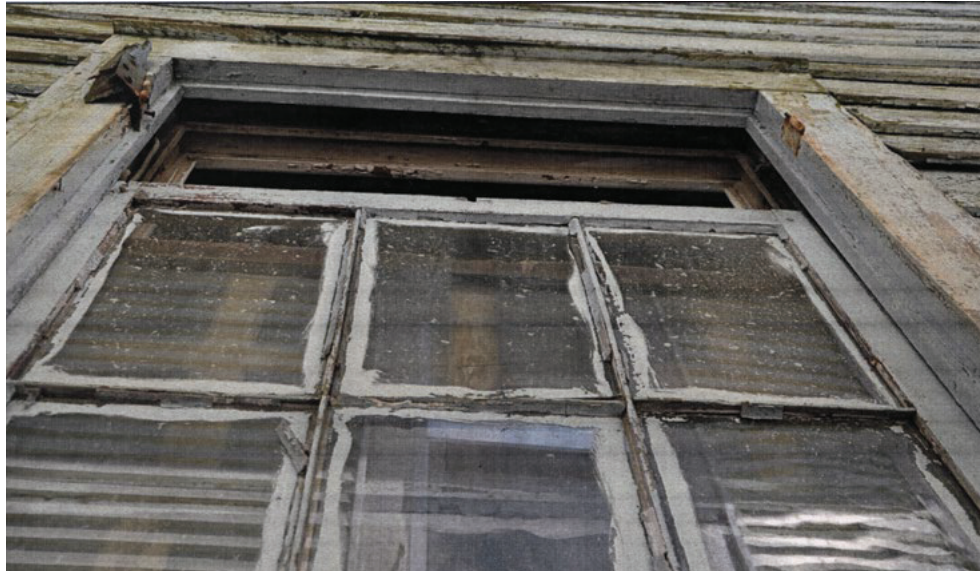
[23] (a) This deteriorated historic wood window was repaired and retained (b) in this rehabilitation project.

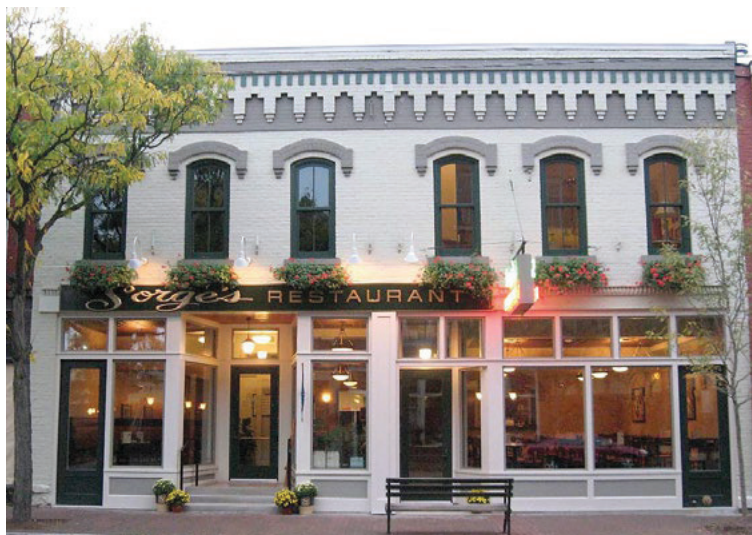
[28] This new storefront, which replaced one that was missing, is compatible with the historic character of the building.

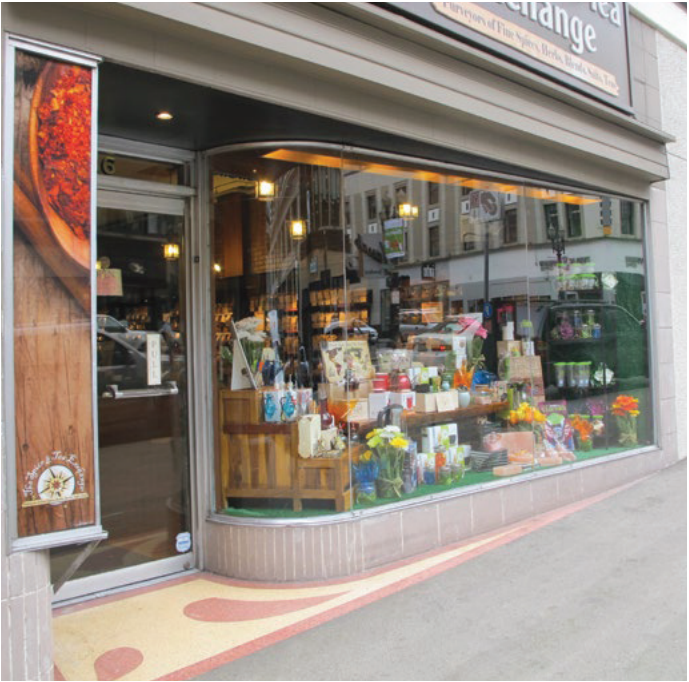
[27] This original c. 1940s storefront, with its character-defining angled and curved glass display window and recessed entrance with a decorative terrazzo paving, is in good condition and should be retained in a rehabilitation project.

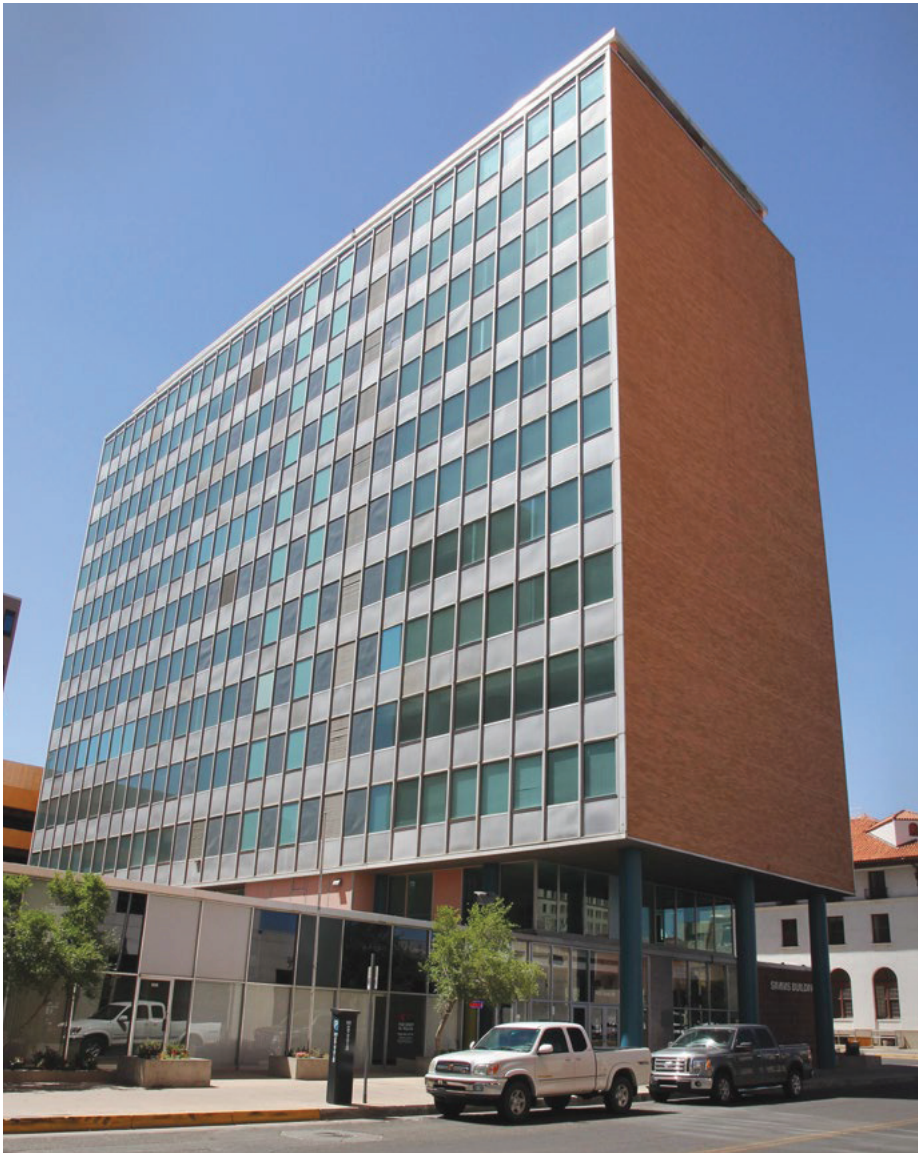
[30] Rather than replace the original curtain wall system of the 1954 Simms Building in Albuquerque, NM, with a different color tinted glass or coat it with a non-historic reflective film, the HVAC system was updated to improve energy efficiency. Photo: Harvey M. Kaplan.

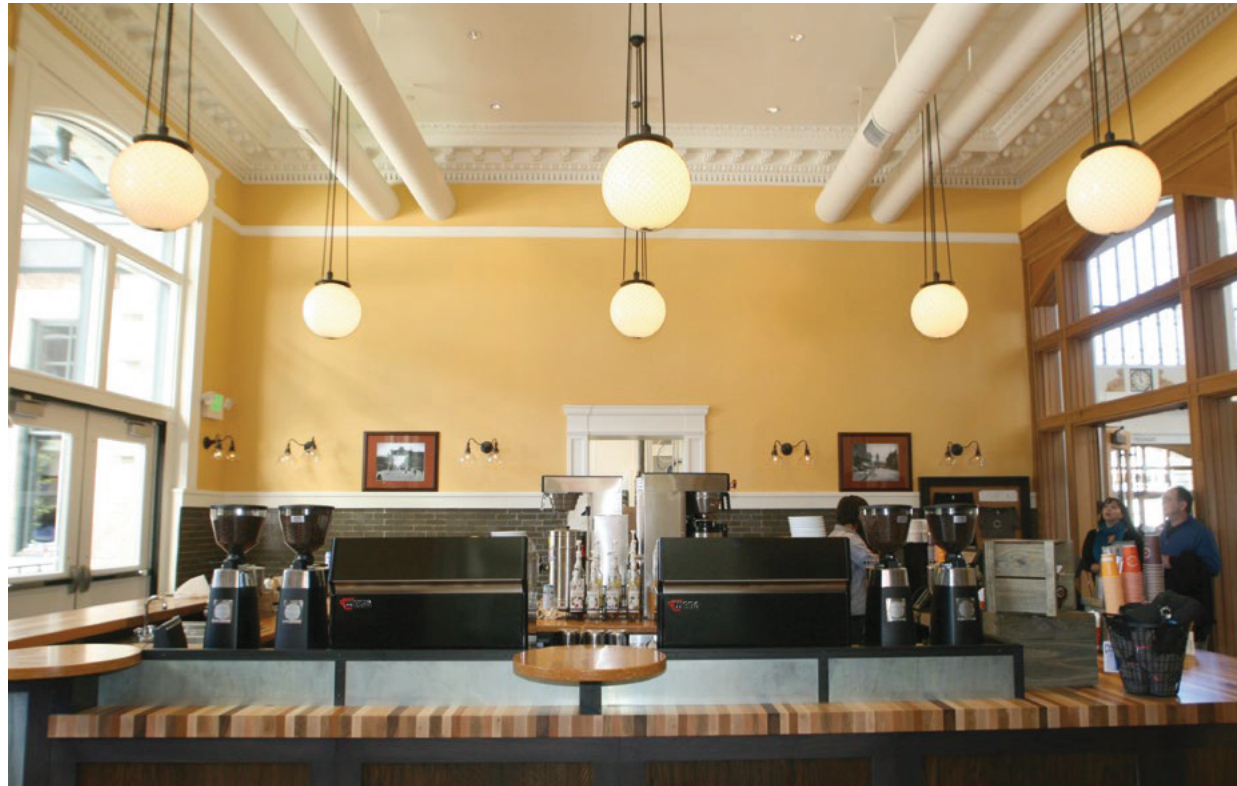
[37] Exposed and painted ducts were appropriately installed here in a retail space in Denver's historic Union Station after considering other options that would have impacted the ceiling height, or damaged or obscured the ornamental plaster crown molding. *Photo: Heritage Consulting Group.*

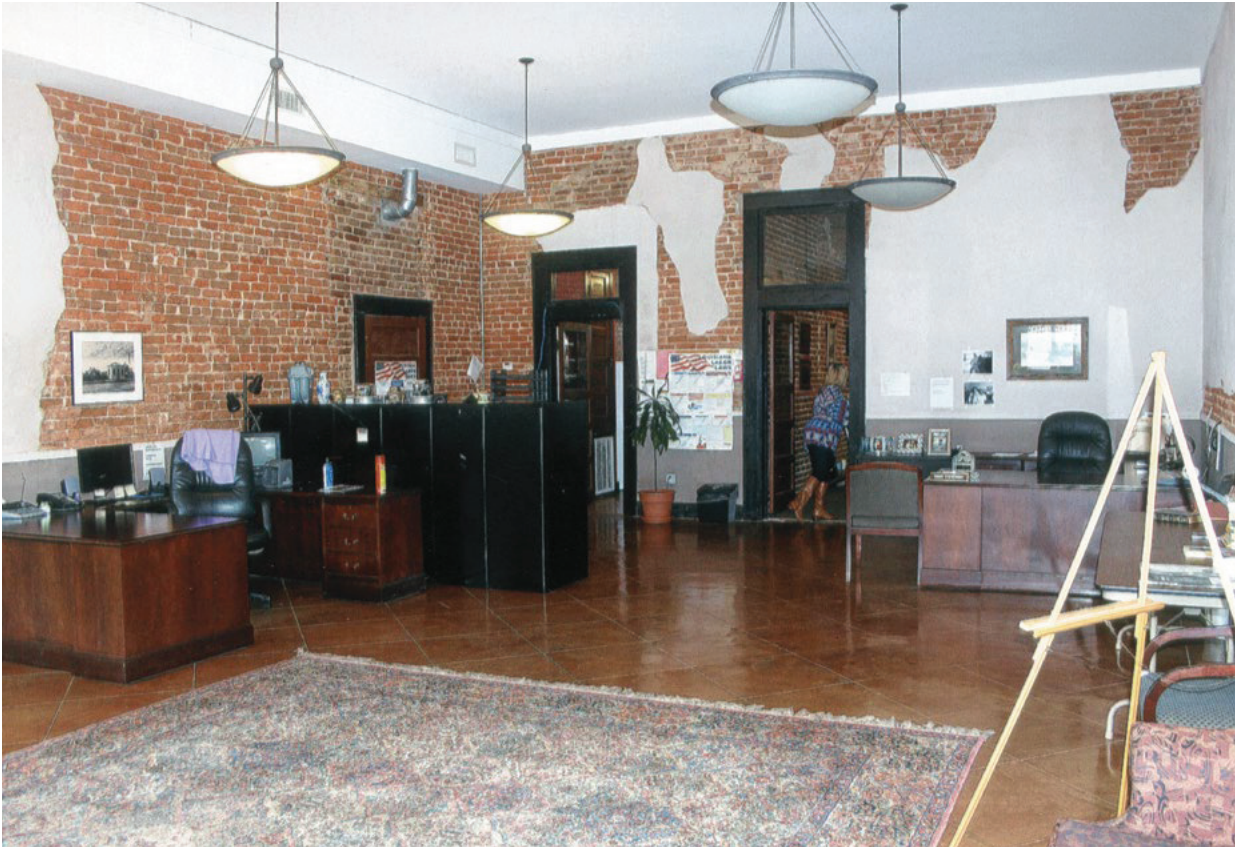
[41] **Not Recommended:** Leaving fragments of deteriorated or “sculpted” plaster is not a compatible treatment for either finished or unfinished interior spaces.

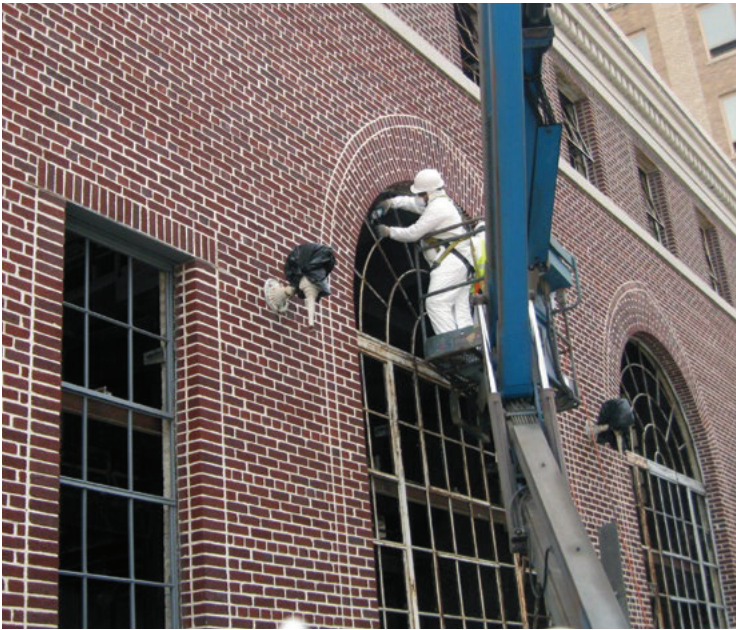
[57] Workers wear protective clothing while removing lead paint from metal features.

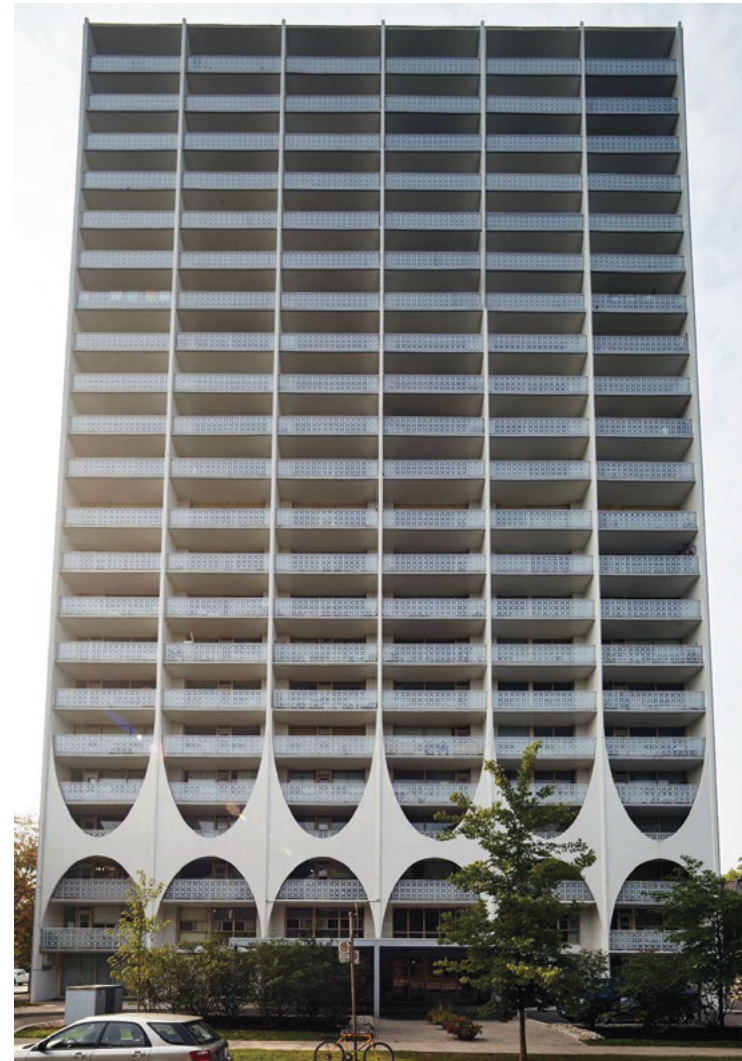
[59] (a-b) The decorative concrete balcony railings on this 1960s building did not meet life-safety code requirements. They were replaced with new glass railings with a fritted glass pattern matching the original design—a creative solution that satisfies codes, while preserving the historic appearance of the building when viewed from the street (c-d). Photos: (a, b, d) ERA Architects, Inc.; (c) Nathan Cyprys, photographer.

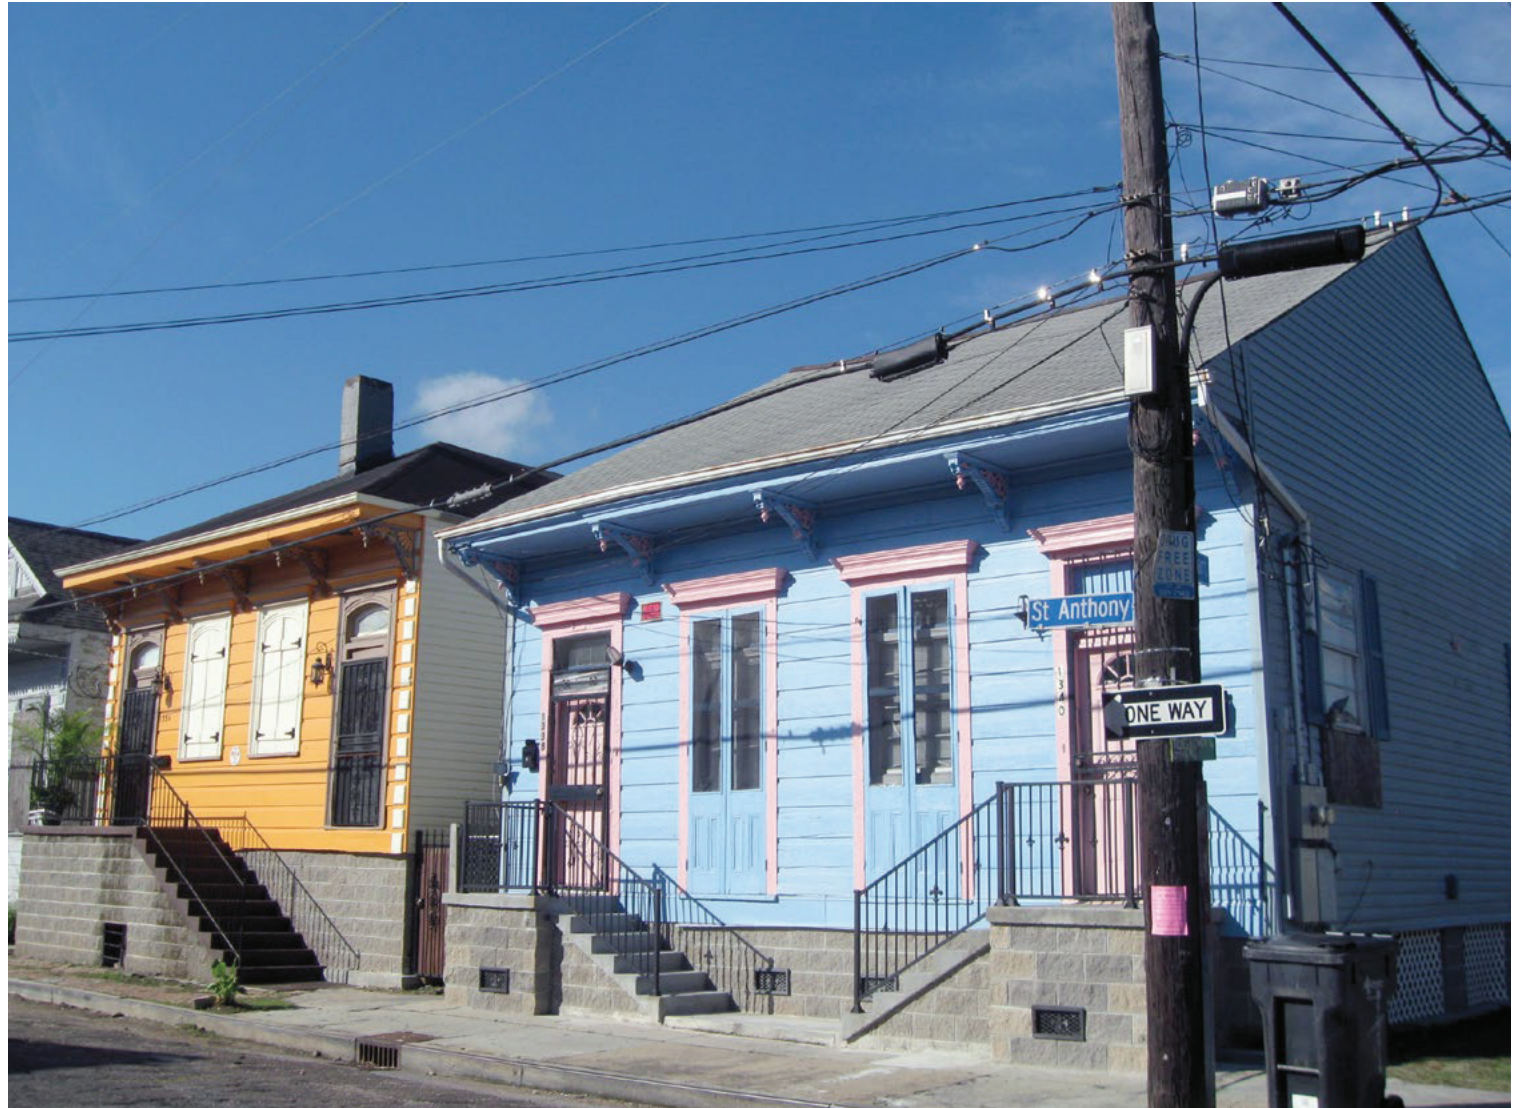
[60] In some instances, it may be necessary to elevate a historic building located in a floodplain to protect it. But this treatment is appropriate only if elevating the building will retain its historic character, including its relationship to the site, and its new height will be compatible with surrounding buildings if in a historic district. The house on the right, which has been raised only slightly, has retained its historic character. The house on the left has been raised several feet higher, resulting in a greater impact on the historic character of the house and the district.

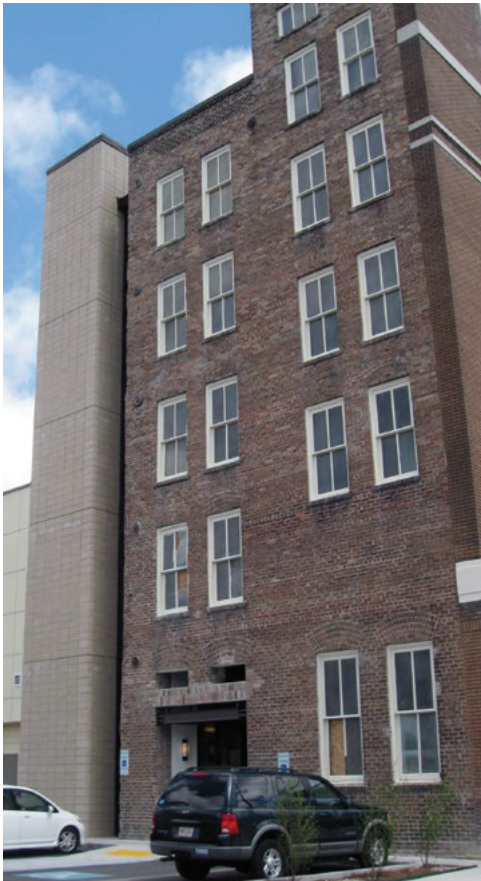
[62] The stair tower at the rear of this commercial building is a compatible new addition.

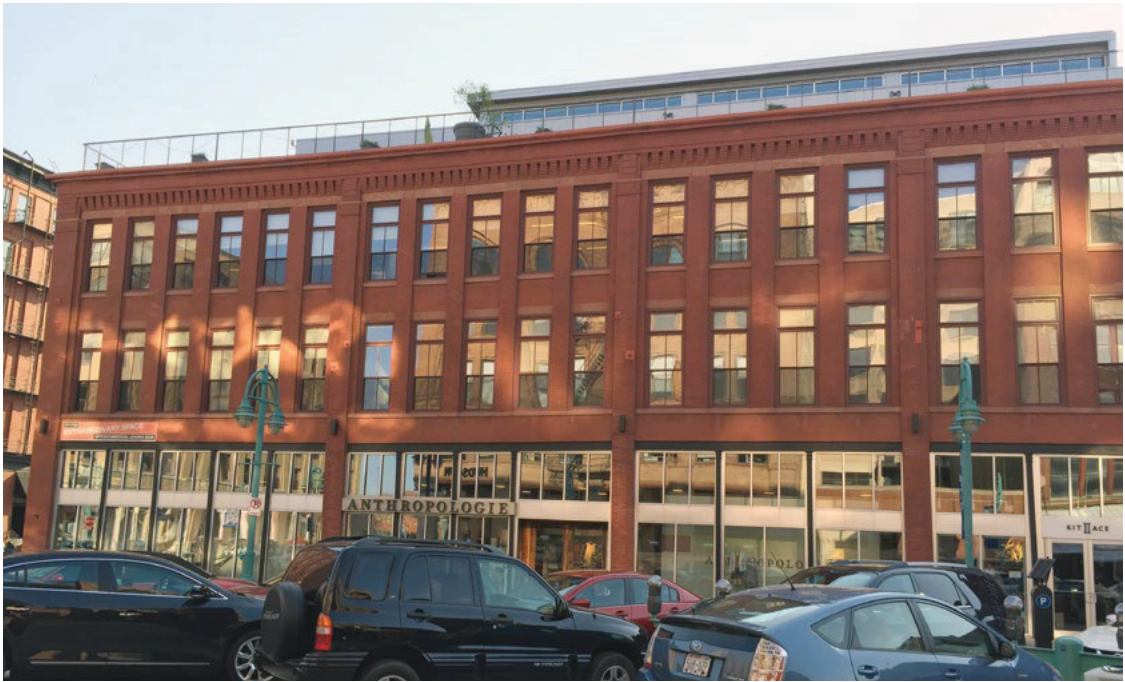
[64] **Not Recommended:**  
It is generally not appropriate to construct a rooftop addition on a low-rise, two- to three-story building such as this, because it negatively affects its historic character.
