Landmark Nomination Report Florence Crittenton Home of Seattle

9236 Renton Avenue S Seattle, Washington King County

August 10, 2020

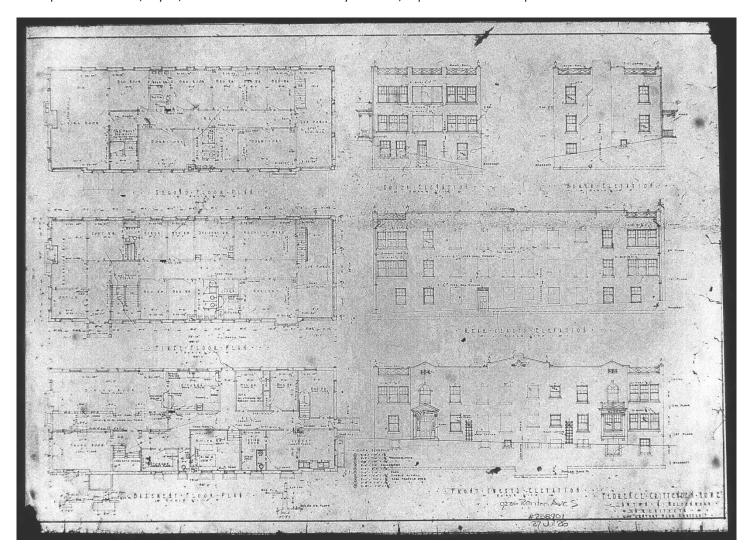
DRAWING 1: Floor plans & elevations, July 27, 1926. Lawton & Moldenhour. City of Seattle, Dept. Construction & Inspections

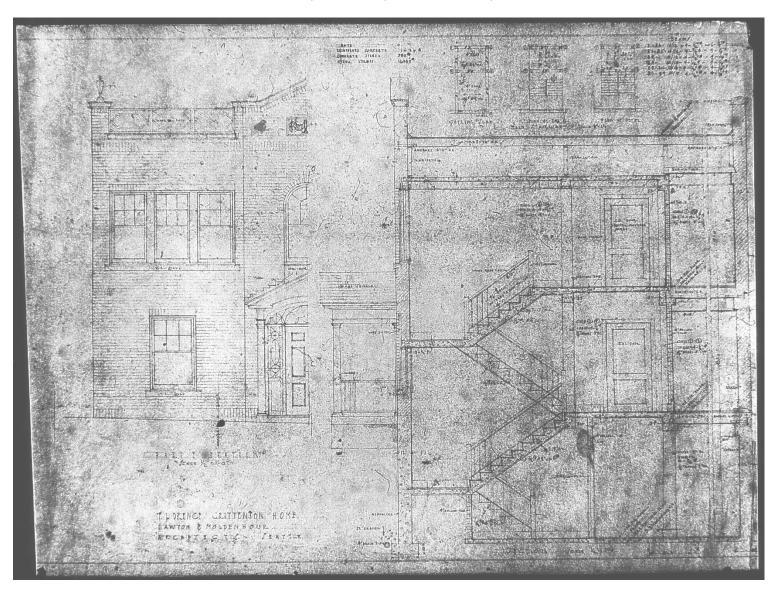
DRAWING 2: Part elevation & section, 1926. Lawton & Moldenhour. City of Seattle, Dept. Construction & Inspections

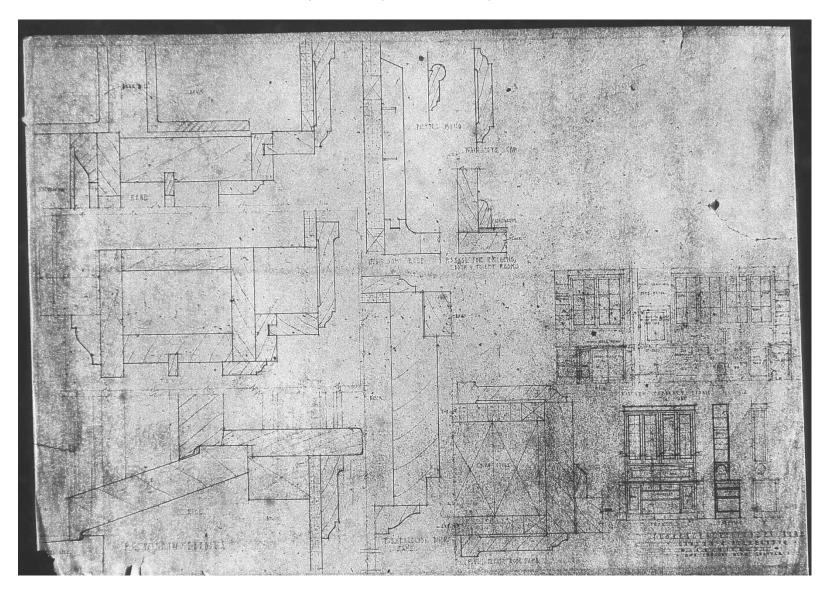
DRAWING 3: Interior trim details, 1926. Lawton & Moldenhour. City of Seattle, Dept. Construction & Inspections

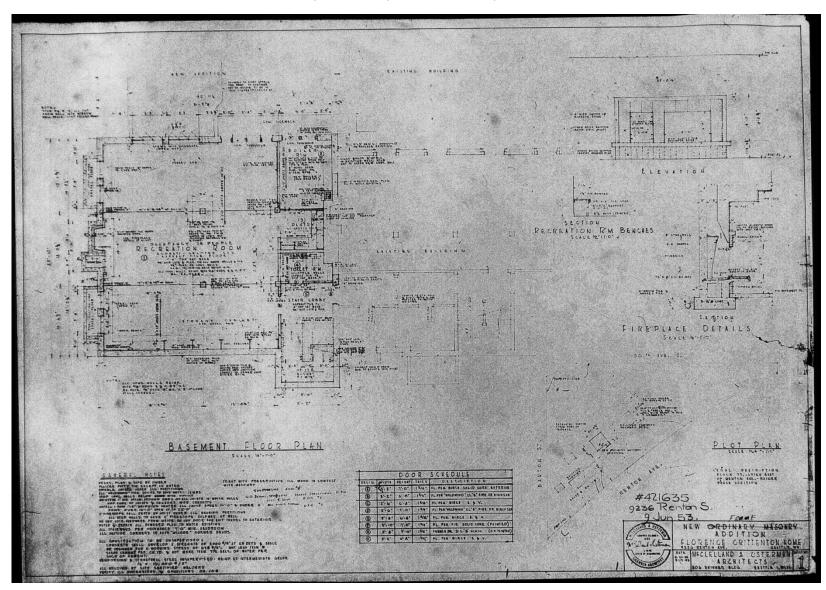
DRAWING 4: Basement Floor Plan, 1953. McClelland & Osterman. City of Seattle, Dept. Construction & Inspections

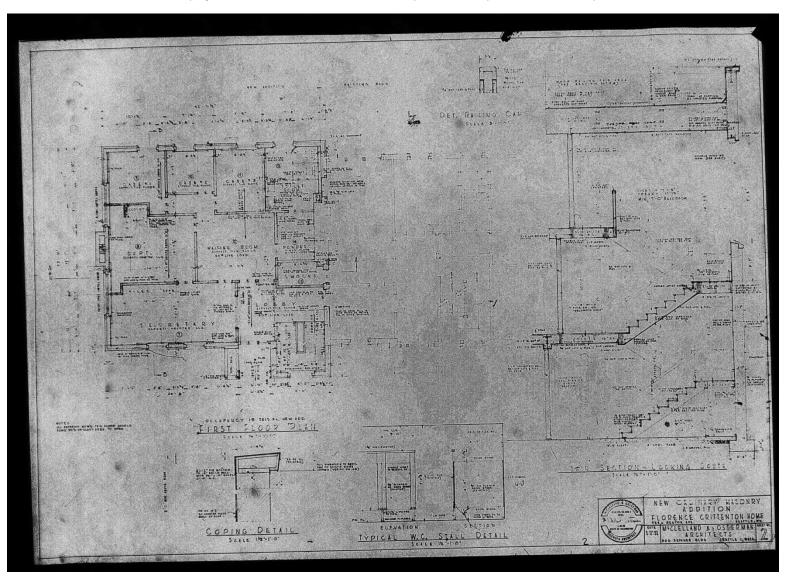
DRAWING 5: First Floor Plan, Stair Section, Coping Detail, 1953. McClelland & Osterman. City of Seattle, Dept. Construction & Inspections

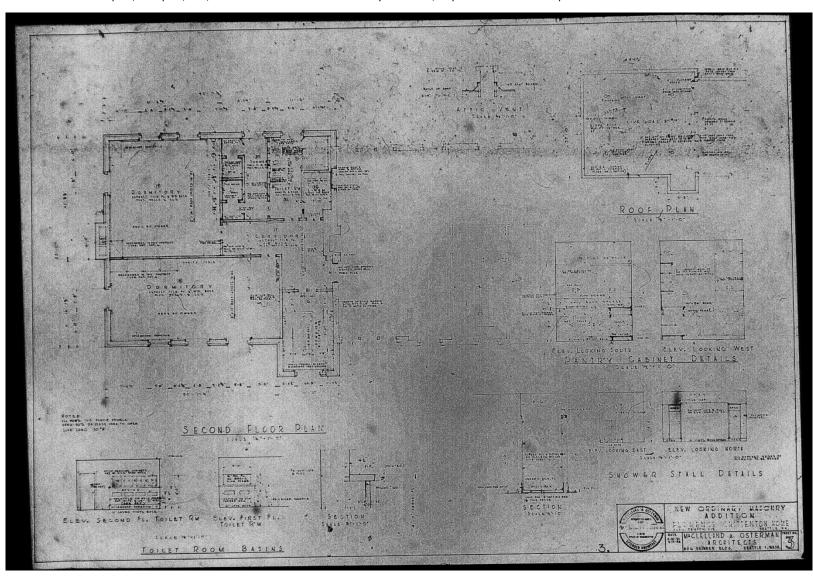
DRAWING 6: Second floor plan, roof plan, etc., 1953. McClelland & Osterman. City of Seattle, Dept. Construction & Inspections

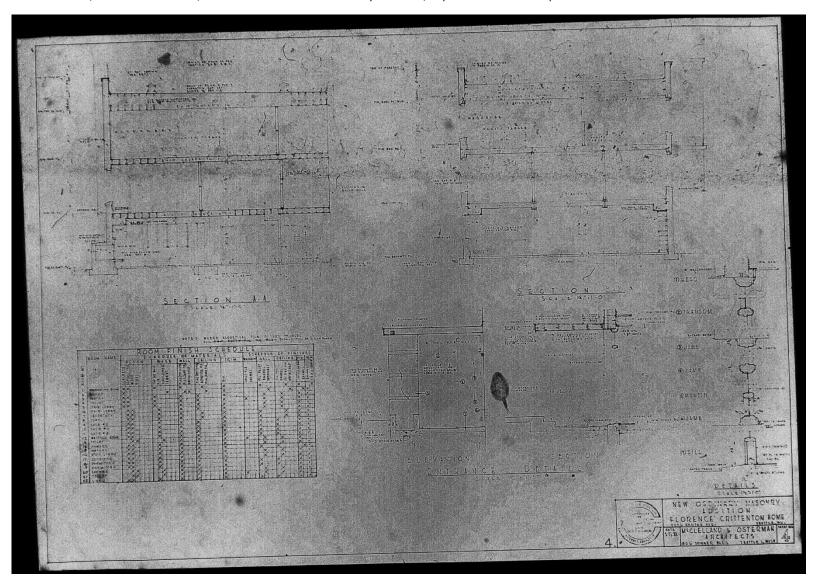
DRAWING 7: Sections, room finish schedule, 1953. McClelland & Osterman. City of Seattle, Dept. Construction & Inspections

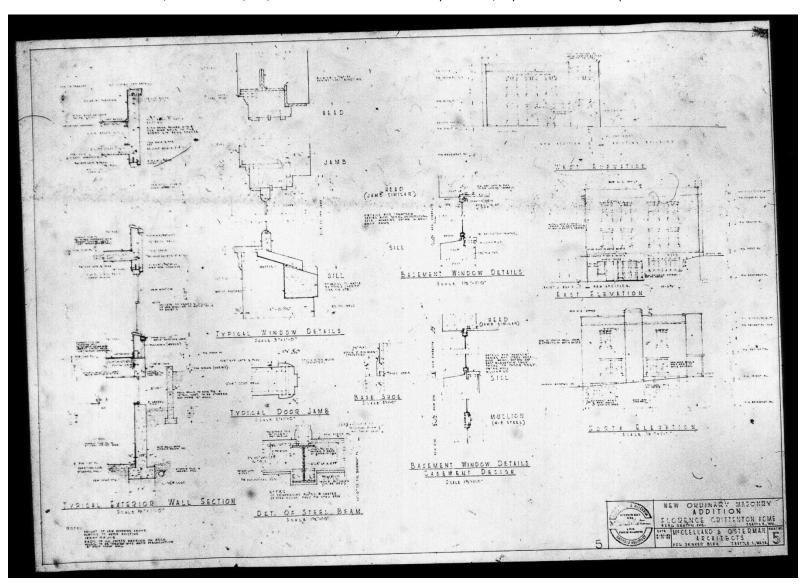
DRAWING 8: North and east elevations, window details, etc., 1953. McClelland & Osterman. City of Seattle, Dept. Construction & Inspections

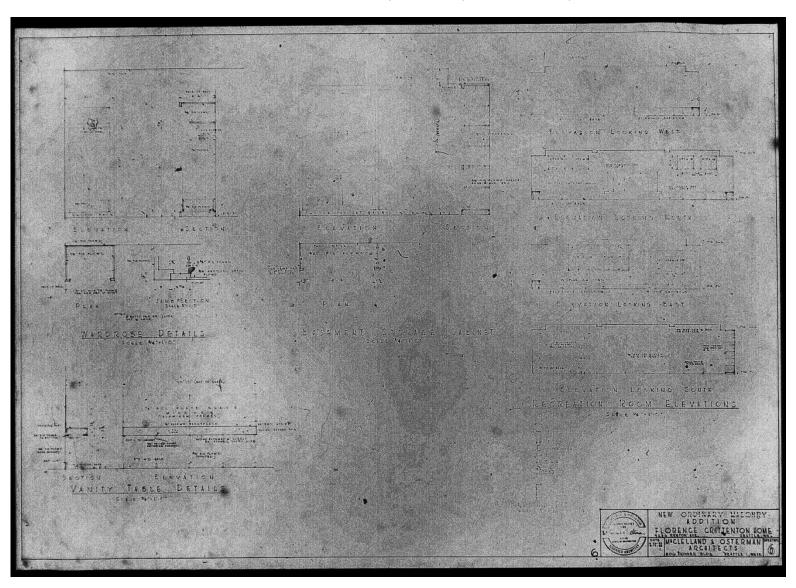
DRAWING 9: Interior room elevations, details, etc., 1953. McClelland & Osterman. City of Seattle, Dept. Construction & Inspections

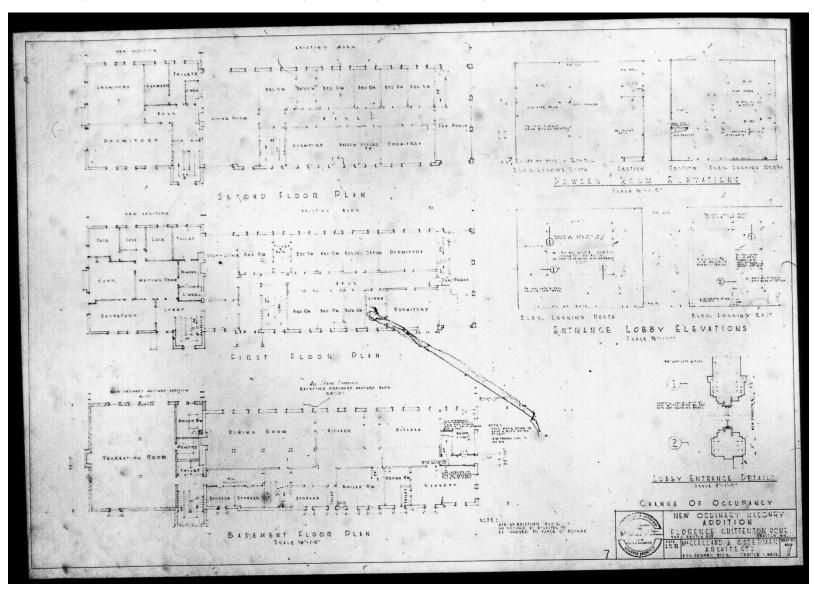
DRAWING 10: Floor plans, etc., 1953. McClelland & Osterman. City of Seattle, Dept. Construction & Inspections

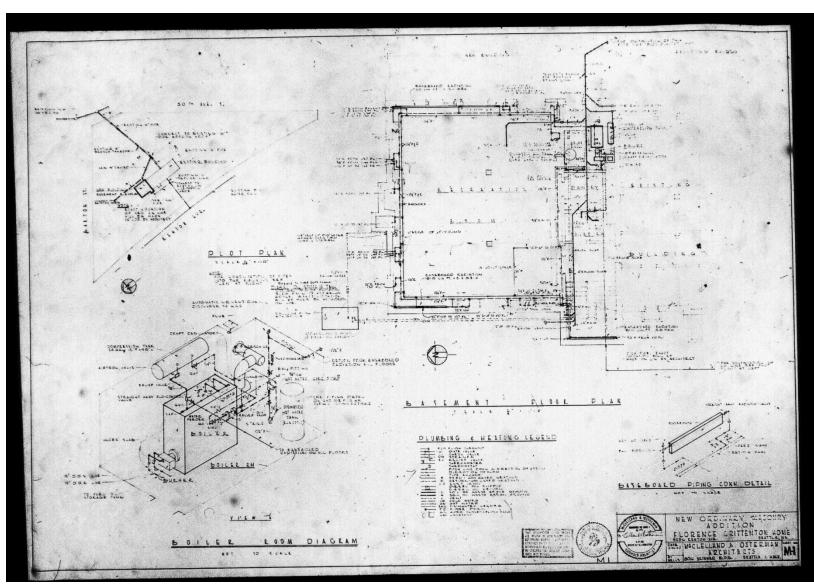
DRAWING 11: Basement floor plan, plot plan, etc., 1953. McClelland & Osterman. City of Seattle, Dept. Construction & Inspections

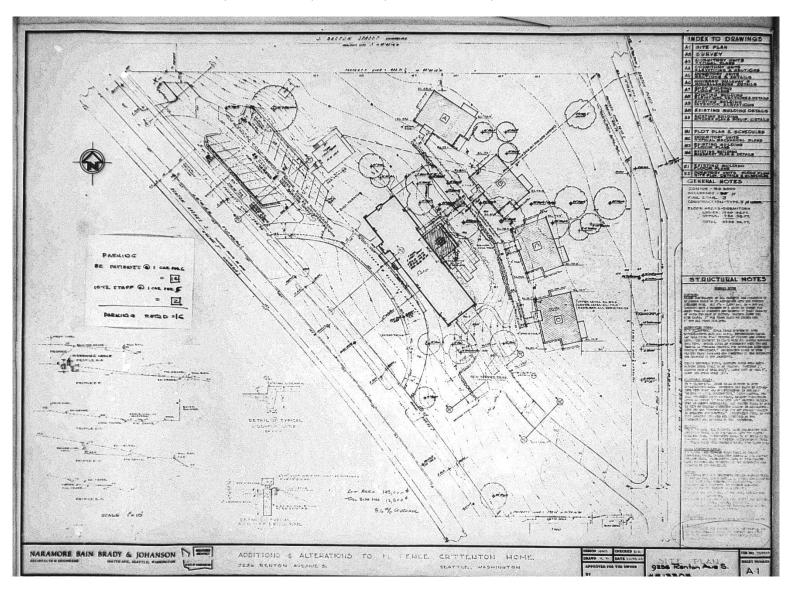
DRAWING 12: Site Plan, 1965. Naramore, Bain, Brady, & Johanson. City of Seattle, Dept. Construction & Inspections

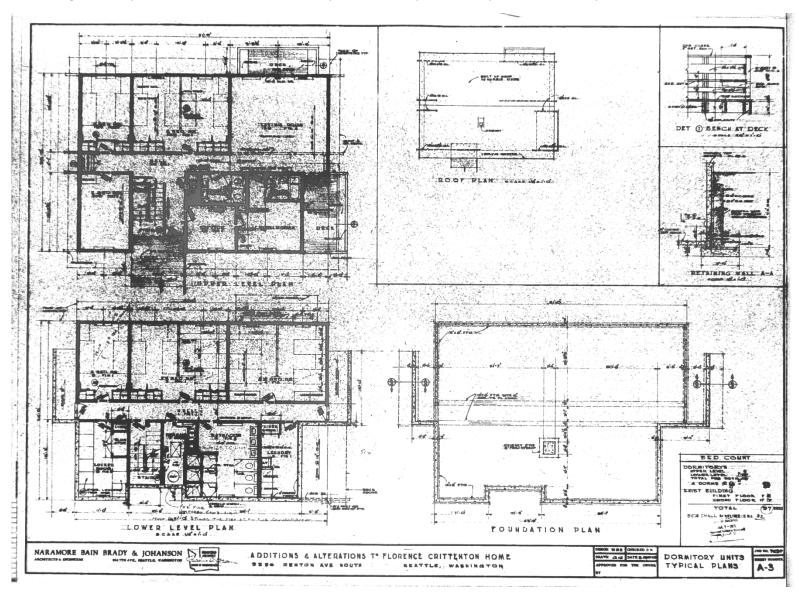
DRAWING 13: Cottage/Dormitory Unit Plans, 1965. Naramore, Bain, Brady, & Johanson. City of Seattle, Dept. Construction & Inspections

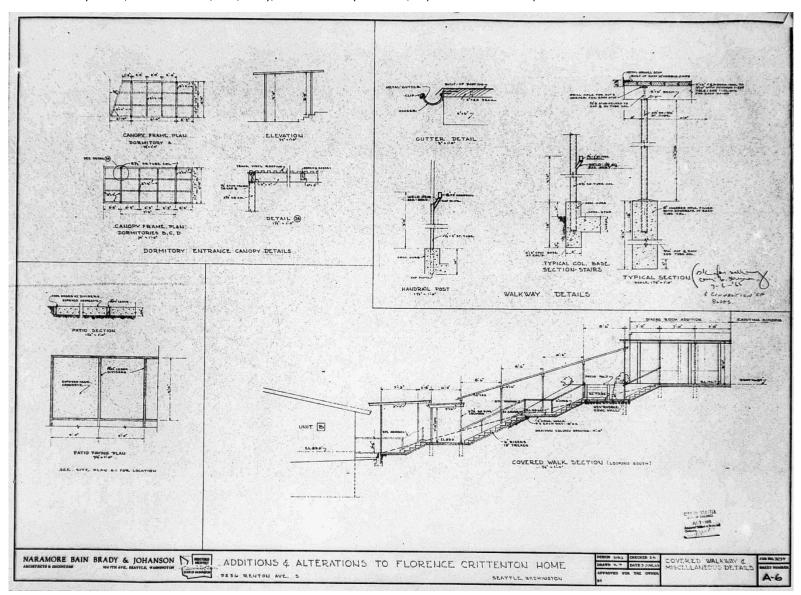
DRAWING 14: Walkway details, 1965. Naramore, Bain, Brady, & Johanson. City of Seattle, Dept. Construction & Inspections

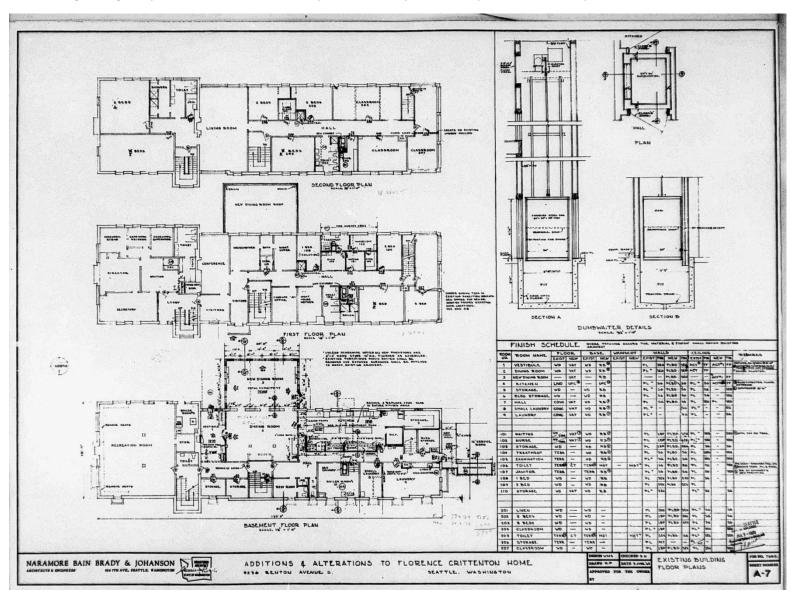
DRAWING 15: Existing building floor plans, 1965. Naramore, Bain, Brady, & Johanson. City of Seattle, Dept. Construction & Inspections

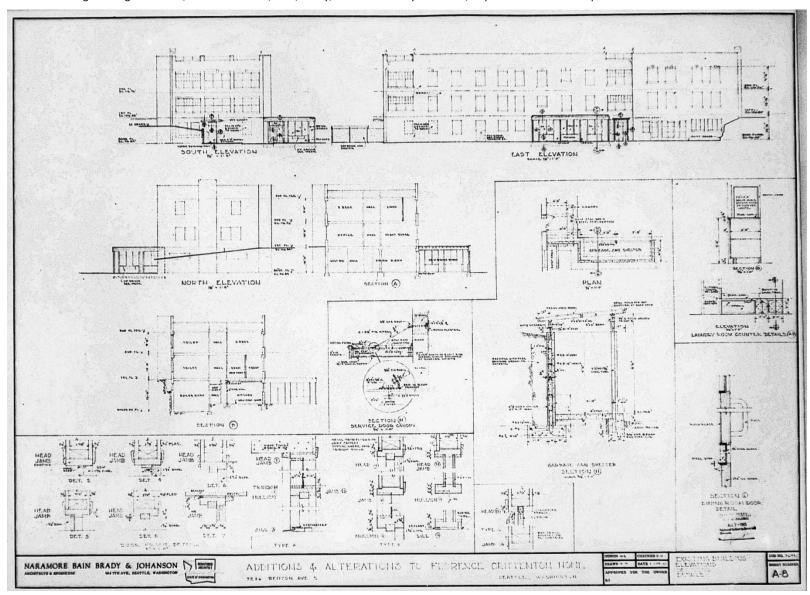
DRAWING 16: Existing building elevations, 1965. Naramore, Bain, Brady, & Johanson. City of Seattle, Dept. Construction & Inspections

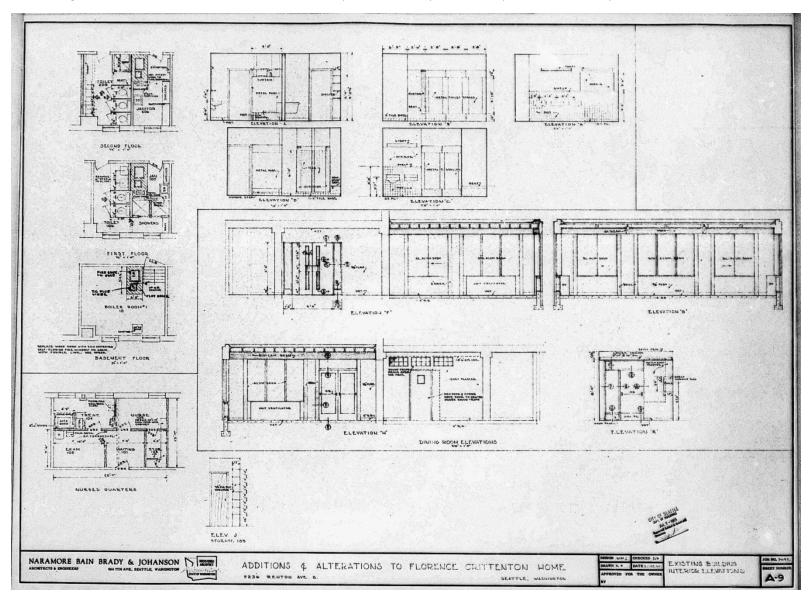
DRAWING 17: Dining room addition elevations, 1965. Naramore, Bain, Brady, & Johanson. City of Seattle, Dept. Construction & Inspections

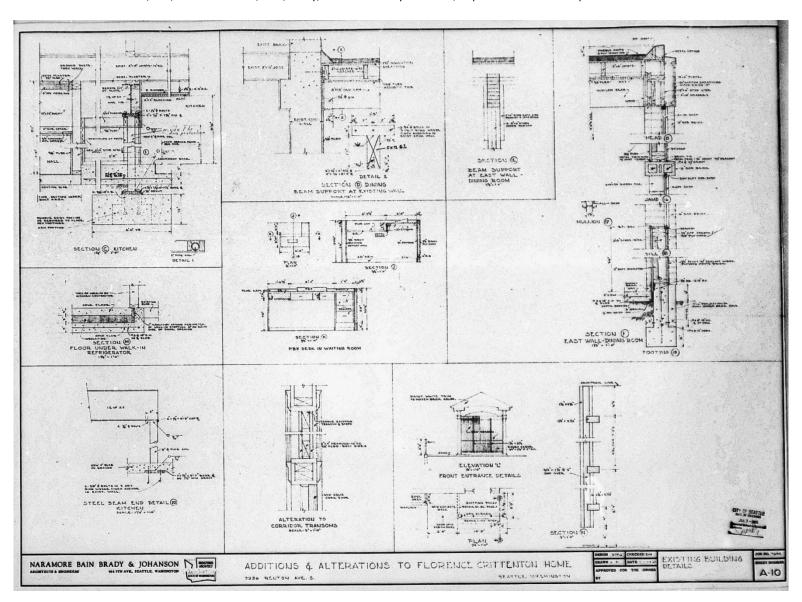
DRAWING 18: Front entrance details, etc., 1965. Naramore, Bain, Brady, & Johanson. City of Seattle, Dept. Construction & Inspections

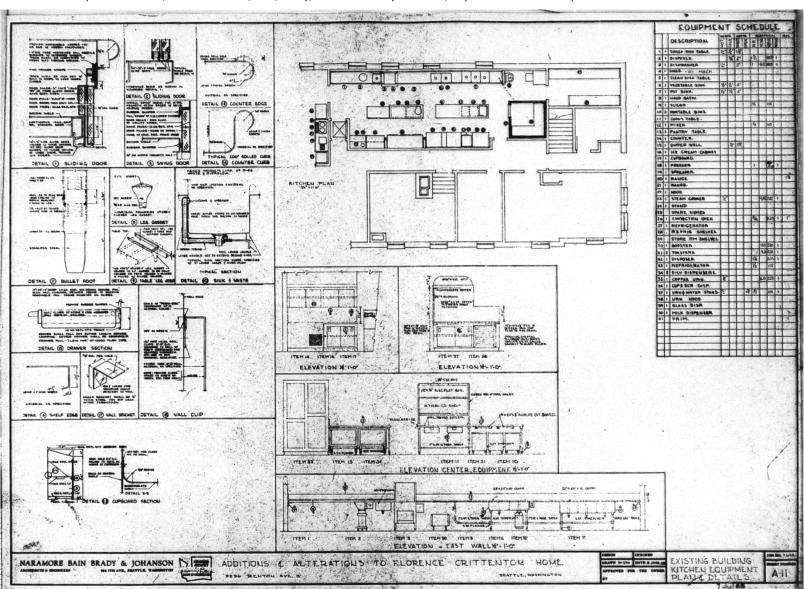
DRAWING 19: Kitchen plan and details, 1965. Naramore, Bain, Brady, & Johanson. City of Seattle, Dept. Construction & Inspections

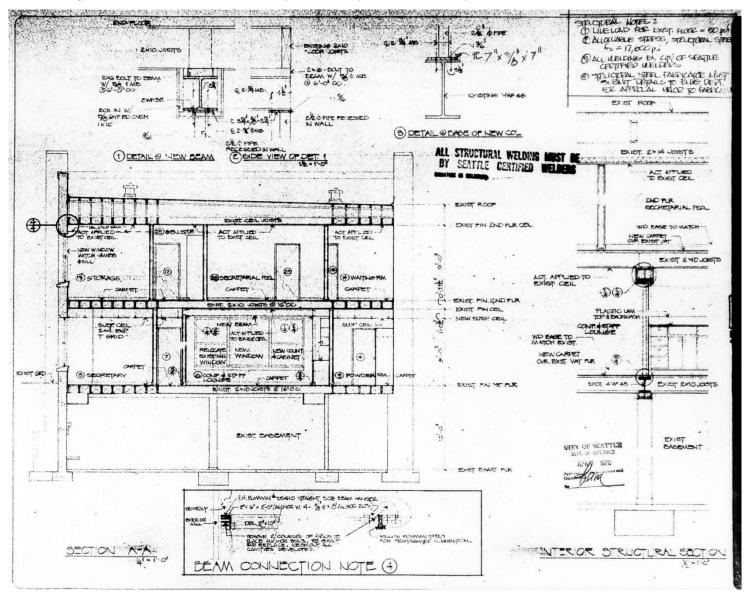
DRAWING 20: Plans showing modifications to 1953 addition, 1970. City of Seattle, Dept. Construction & Inspections

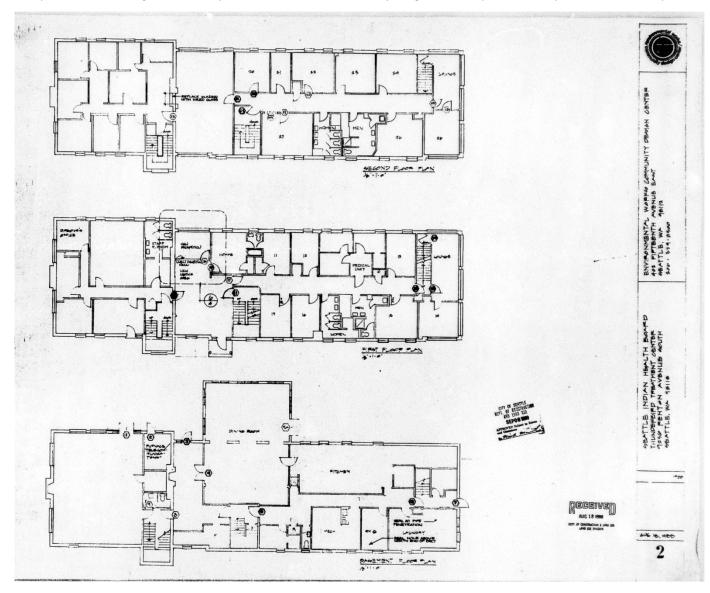
DRAWING 23: Floor plan for main building, 1988. Plans by Environmental Works Community Design Center. City of Seattle, Dept. Construction & Inspections

Shortly after opening the new treatment center, the SIHB made modifications to the property. According to plans drafted September 22, 1988, by the Environmental Works Community Design Center, the SIHB divided the 4-person rooms in the cottages into two 2-person rooms and also made unspecified fire code improvements throughout the property. In 1989 and 1990, the SIHB completed bathroom modifications in cottages B and C, including new sinks, counters, shower heads, handrails, tile floors, and door removals, and repairs new construction of barrier-free ramps, walkways, and railings around cottages B and C.

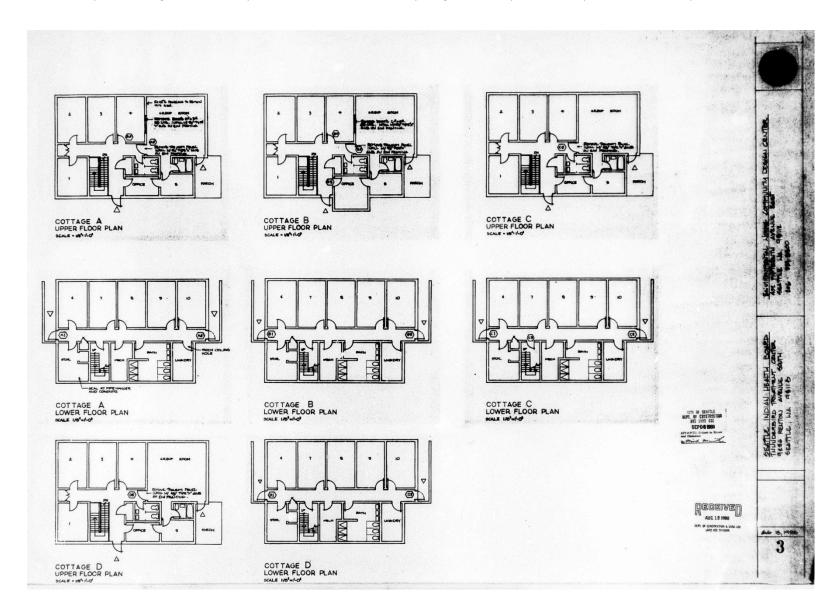
DRAWING 24: Floor plan for cottages, 1988. Plans by Environmental Works Community Design Center. City of Seattle, Dept. Construction & Inspections

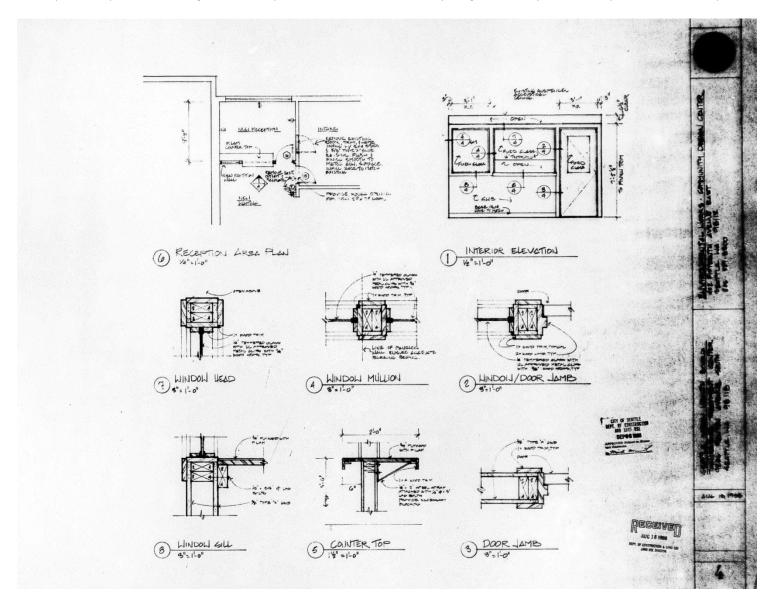
DRAWING 25: Reception Area plan, main building, 1988. Plans by Environmental Works Community Design Center. City of Seattle, Dept. Construction & Inspections

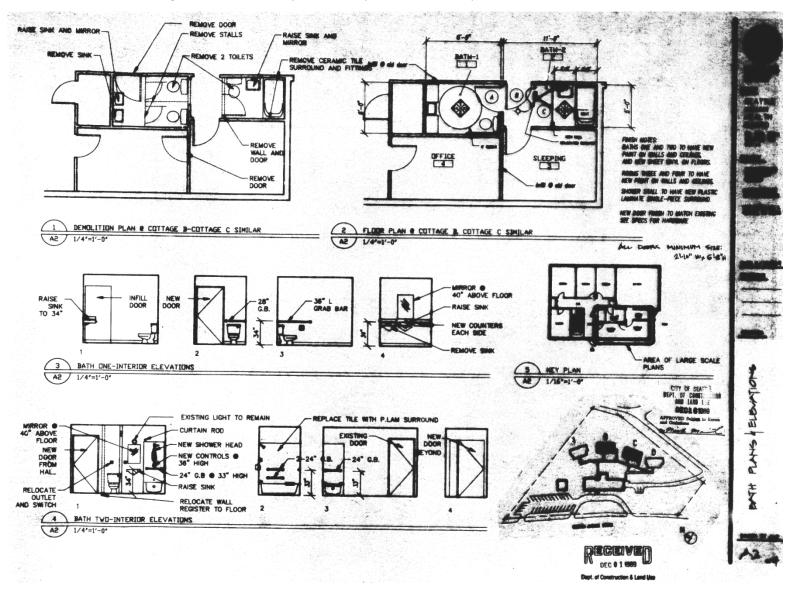
DRAWING 26: Bathroom alterations, Cottages B and C, 1989-90. City of Seattle, Dept. Construction & Inspections

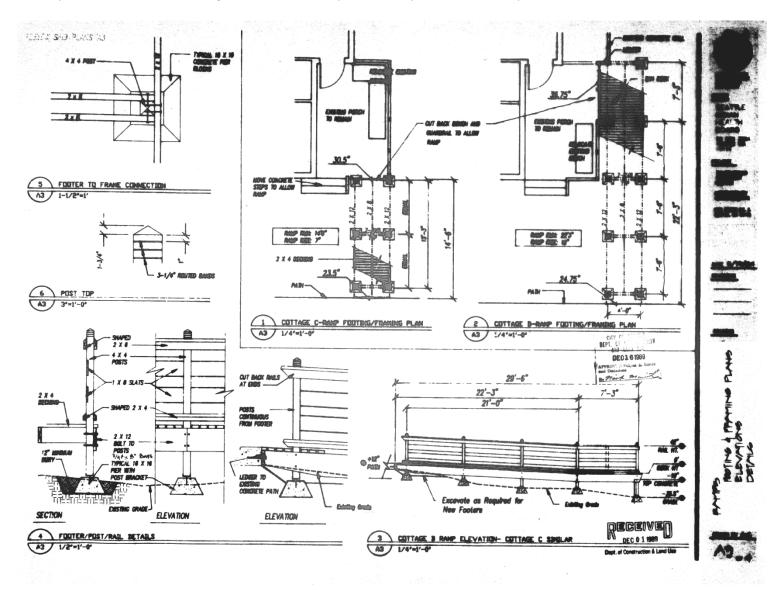
DRAWING 27: Ramp and handrail alterations, Cottages B and C, 1989-90. City of Seattle, Dept. Construction & Inspections
