Rodia-Elliott House

Property Address (Location): 4757 36th Ave S Seattle, WA 98118

Representative photographs of rehabilitation work and photographs of the building (interior and exterior) prior to and after rehabilitation. Photographs should be affixed to 8 ½ x 11 white paper with a label identifying the image and whether the photograph was taken before, during or after construction

Rodia-Elliott House - Addendum

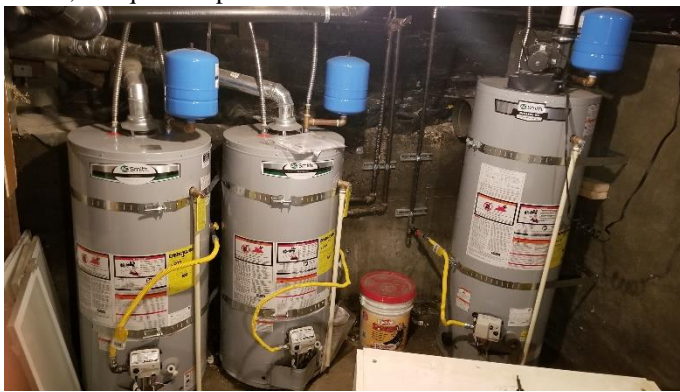
Hot water heaters added in basement (Previously had 1 old in basement and 1 old in attic), new piping and ducting added, 1 required a powered vent
