From: Nathan Rimmer on behalf of 4000 Property LLC (Applicant)

To: Seattle Landmarks Board, Architectural Review Committee

Date: 5-17-20, initial ARC submittal

Re: Certificate of Approval, Talaris Campus temporary security fencing

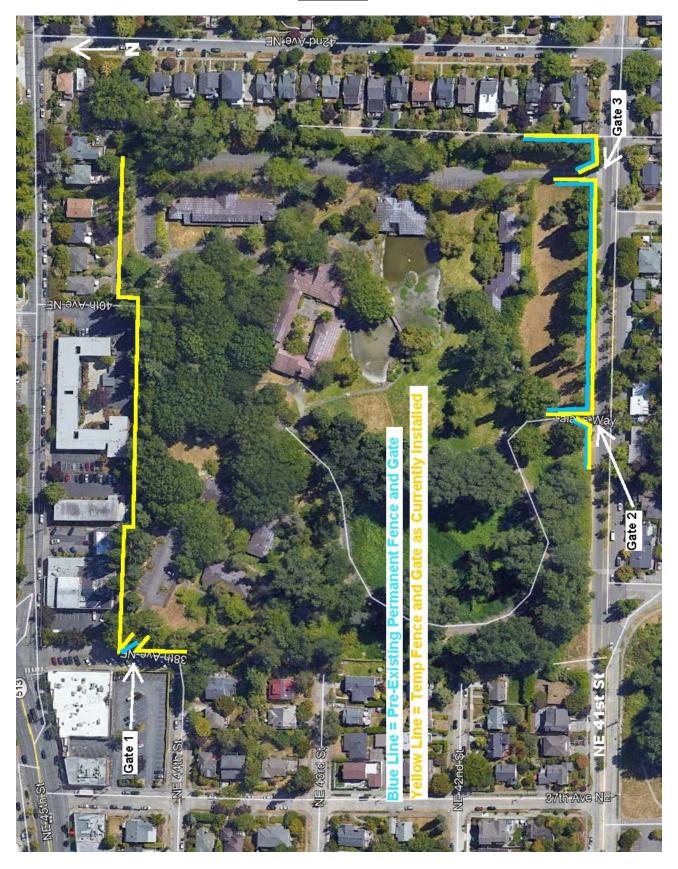
Exhibit A

Prior to landmarking, the only perimeter fencing on the property was a permanent 4′ black vinyl coated chain link fence at the south and southeast perimeter, and three matching vehicle gates (see Exhibit A). That 4′ fence is easily scalable and was only designed to deter casual trespassing while the site when the site was fully operational. When regular conference and hospitality operations ceased in late 2019 there was a need to provide enhanced security measures. A security plan was provided to Erin Doherty in January 2020, which outlines the various security measures that were put in place by the property manager in order to protect the asset.

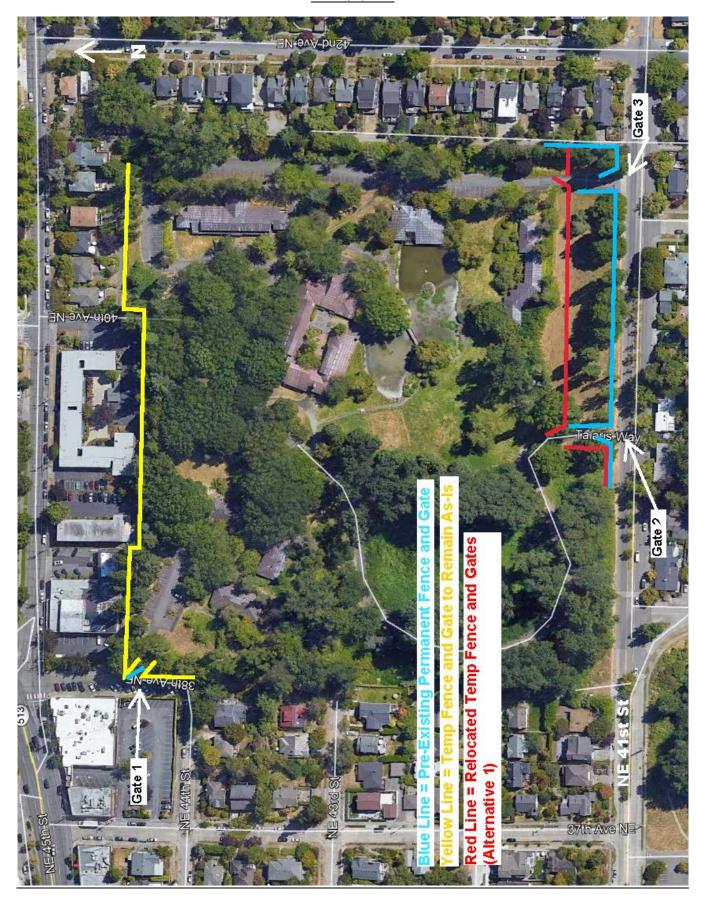
Exhibit A-1

Alternative 1, relocate portions of temp fence, (Exhibit A1):

All pre-existing 4' black fencing will remain as-is. The south section of 6' temp fencing and vehicle gates would be moved north approximately 100' to the north side of the field located along NE 41st St. Placement of the fence farther north would leave the site generally protected, except the upper field area would remain exposed except for the permanent 4' fence.

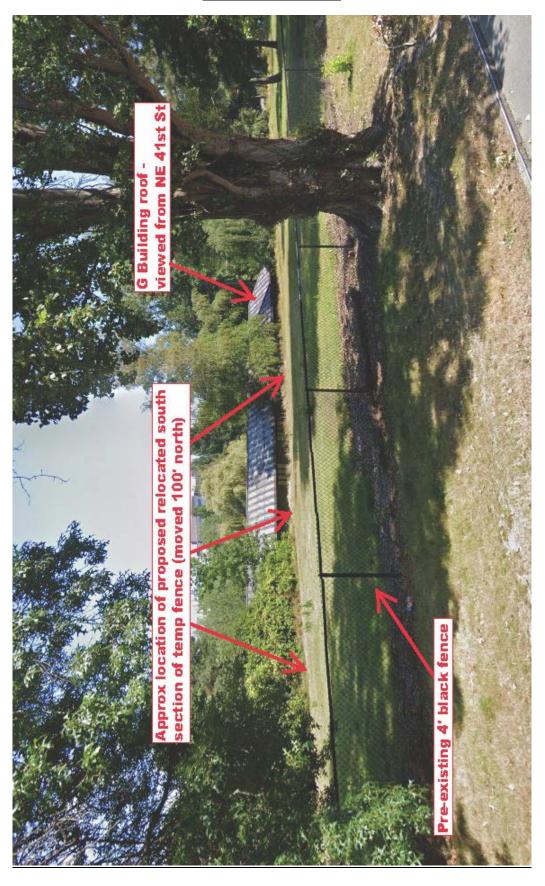
Exhibit A-1, cont...

Alternative 1 perspective view of relocated temp fence as viewed from NE $41^{\rm st}$ St

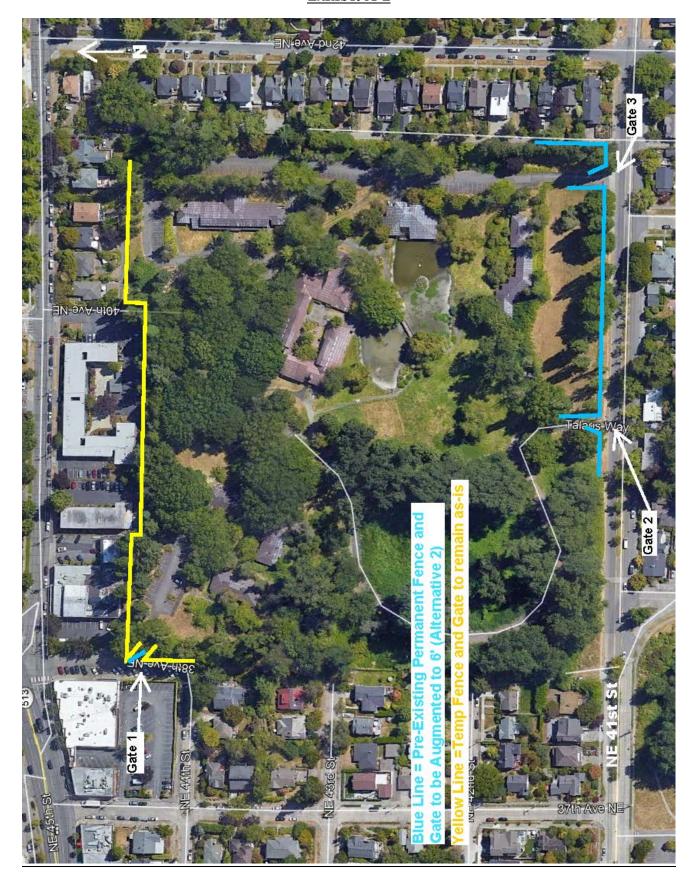
Exhibit A-2

Alternative 2, modify all previously existing fence, (Exhibit A2):

All pre-existing 4' black fencing would be augmented 2' using post risers (see exhibit F). Post risers would either be coated with black vinyl or and painted black to closely match the post it is placed upon. Existing 4' black fence mesh would be replaced with 6' black fence mesh. Cross bars would also be raised so that the finished work closely resembles the second picture in Exhibit F.

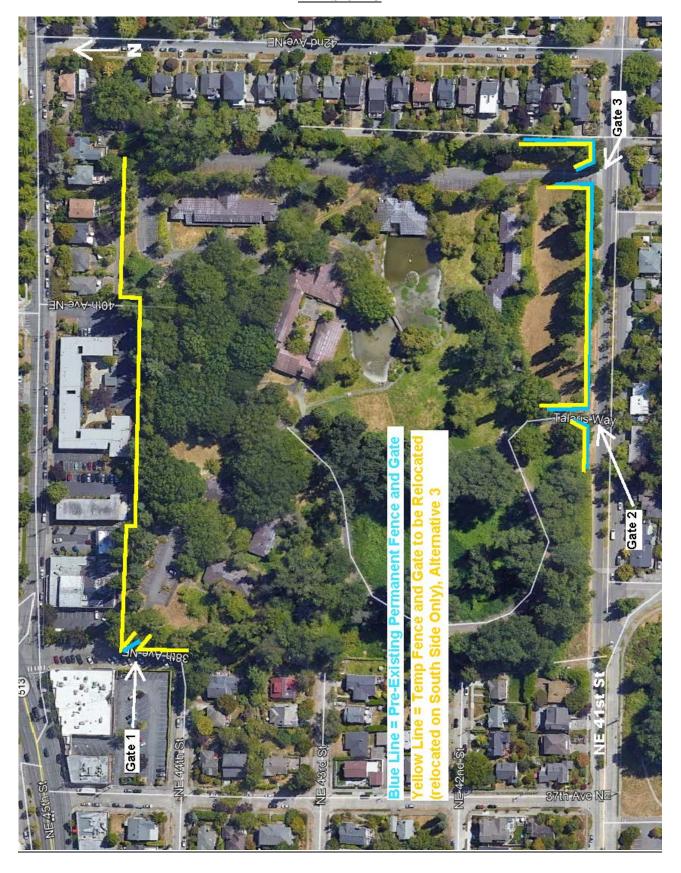
Exhibit A-3

Alternative 3, move temp fencing behind previously existing fencing (Exhibit A3):

Currently the south section of 6' temp fencing is placed immediately outside of the preexisting 4' black fencing. The temp fencing could be moved behind the black fencing which would enhance the visual appearance from NE 4st St while providing the same level of site security.

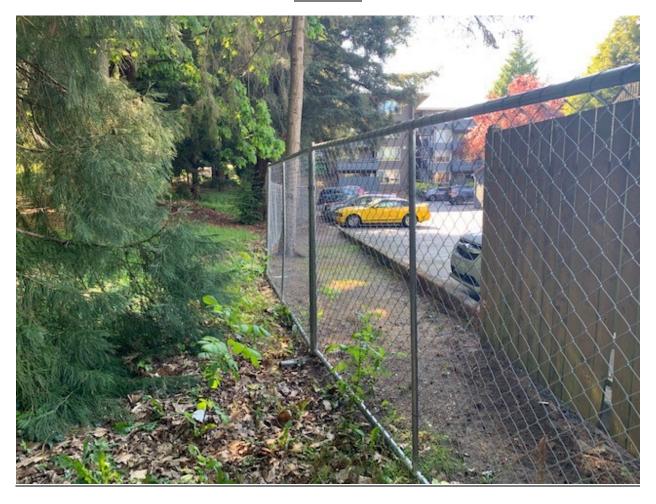
Exhibit B

Typical temporary security fencing panels as installed.

Photo taken at north property line.

The security fence installed is a series of panelized 6′ galvanized chain link fencing that was placed at grade (see Exhibit B). This is industry-standard temporary security/construction fence and is distinguished as temporary by way of using galvanized base-units that are placed on the surface to support the posts (see Exhibit C). A permanent-style fence would have the posts set 12-24″ below the surface and are typically backfilled with concrete. A Google search of "temporary security fence" yields a primary search return showing the same type of fencing that was installed at the Talaris Campus (see Exhibit D).

buildings (see Exhibit B). It is generally unseen from the public right of way except a small section at the NW corner, which is located at an intersection of both public and private parking areas next to two commercial buildings (see Exhibit H). This was previously a common entry point for trespassers and there is no practical alternative location for the fencing here that will also protect the asset. It is proposed that these sections of temporary fencing remain as-is.

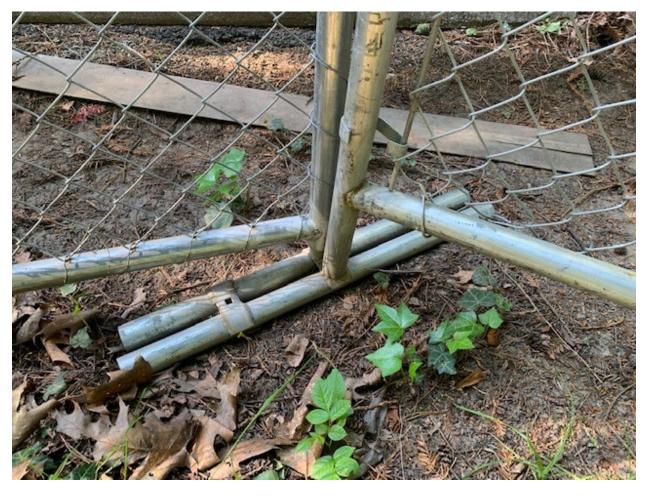
Exhibit C

Temporary security fence footings as installed.

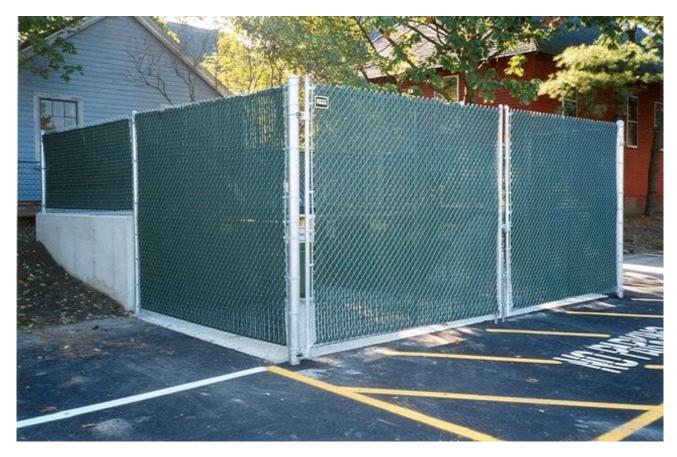
Exhibit E

Example vinyl screening planks installed in chain link fence

Another Board concern was the style of fencing. Being a temporary fence, aesthetic options are limited to the style of fencing that was installed. All other temporary fencing options are low barricade style used to keep out vehicles. The only other aesthetic option for an effective temporary security fence would be one that is installed with vinyl slats (see Exhibit E). That is both a more expensive solution and is far less aesthetically pleasing than what is currently in-place. Vinyl slats are typically used to provide privacy screening from the outside, which is not the objective here.

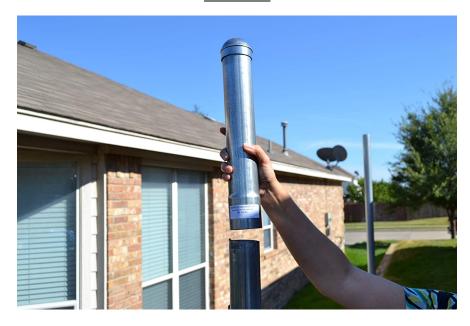
Exhibit F

Example galvanized fence post risers that could be used to augment existing fence posts

Where the pre-existing permanent 4′ black vinyl chain link fencing is installed along the south property perimeter, it would be possible to install 2′ post-risers (See Exhibit F) and then replace the permanent 4′ black vinyl chain link sections with 6′ black vinyl chain link sections to turn a formerly 4′ fence into a 6′ fence (see Exhibit F). This would achieve the same level of security as the temporary fencing. This option would result in a more permanent style fence but would be more aesthetically pleasing than the temporary fencing currently installed. This option is only available along NE 41st where existing permanent fencing was previously in place.

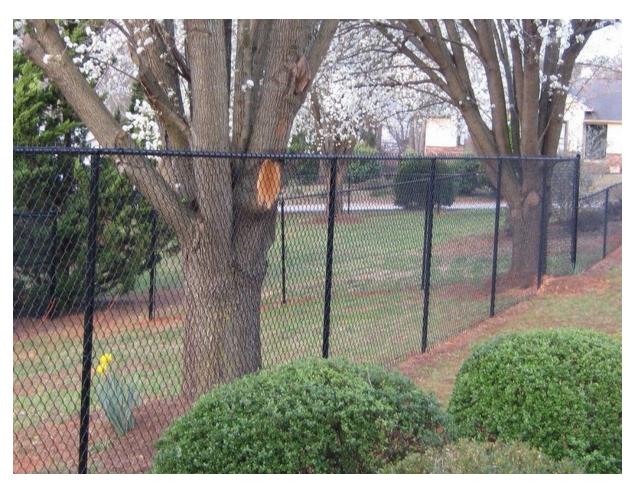
Example 6' black chain link fence. Representative of what fencing would look like if raised from 4' to 6'. Note the shorter 4' fence at far right for comparison.

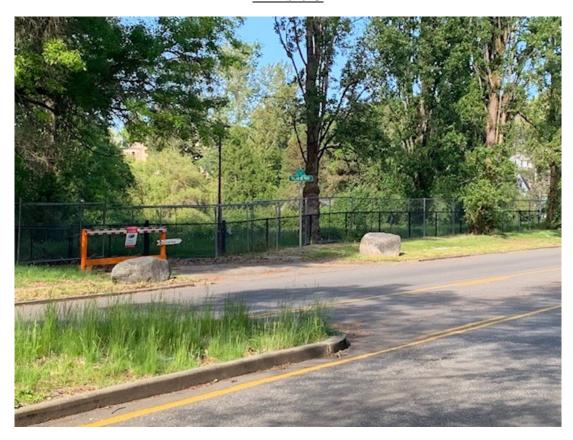
Exhibit G

Temp fencing augmenting permanent fencing as viewed from NE 41st Street.

The Board's primary aesthetic concern seemed to focus along the south perimeter of the property where the fencing is more visible from NE 41st St (see Exhibit G). The specific location was chosen in because it augments the pre-existing permanent 4' black vinyl chain link fence and is a logical place to also put a temporary fence in order to protect both the grounds and buildings (see Exhibit G).

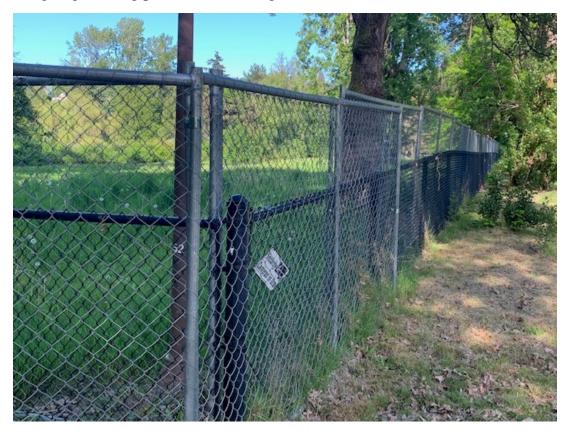
Close up, temp fencing augmenting permanent fencing along NE $41^{\rm st}$ Street

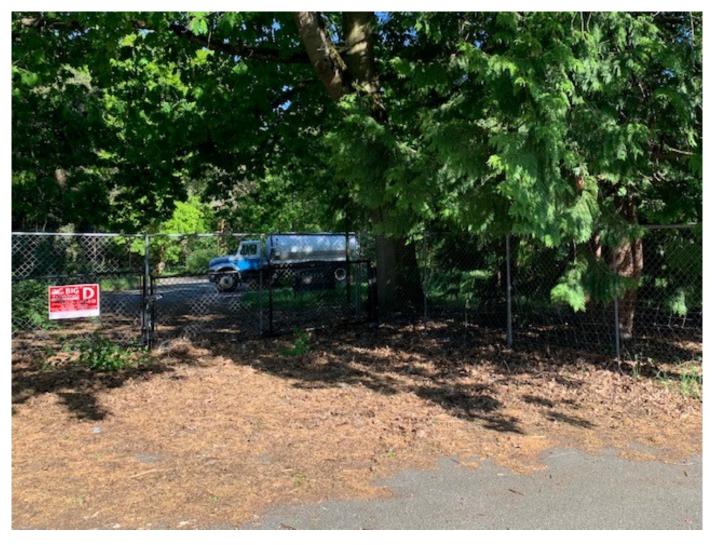
Exhibit H

Temp fencing augmenting permanent gate (at Gate 1 location, NW corner)

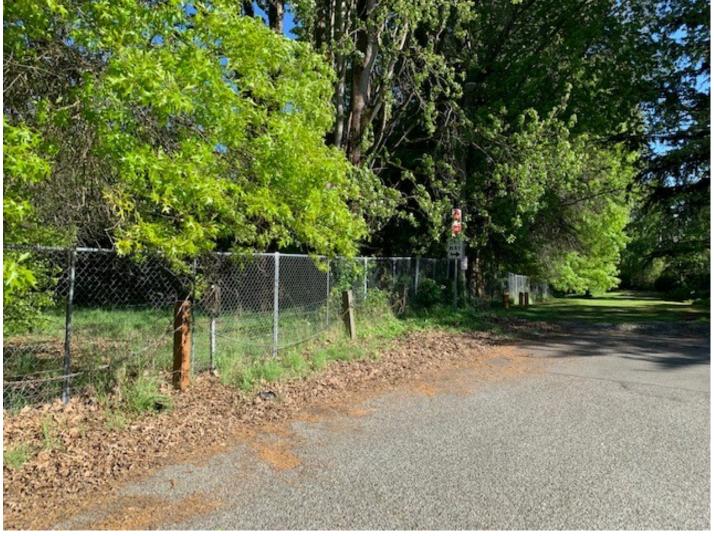
Exhibit H, cont.

Temp fencing at NW corner of site, south of Gate 1 along west property line
