Name Florence Crittenton Home of Seattle Year Built 1926, 1953, 1965
(Common, present or historic)

Street and Number 9236 Renton Avenue S, Seattle, WA

Landmark Nomination Report

Florence Crittenton Home of Seattle

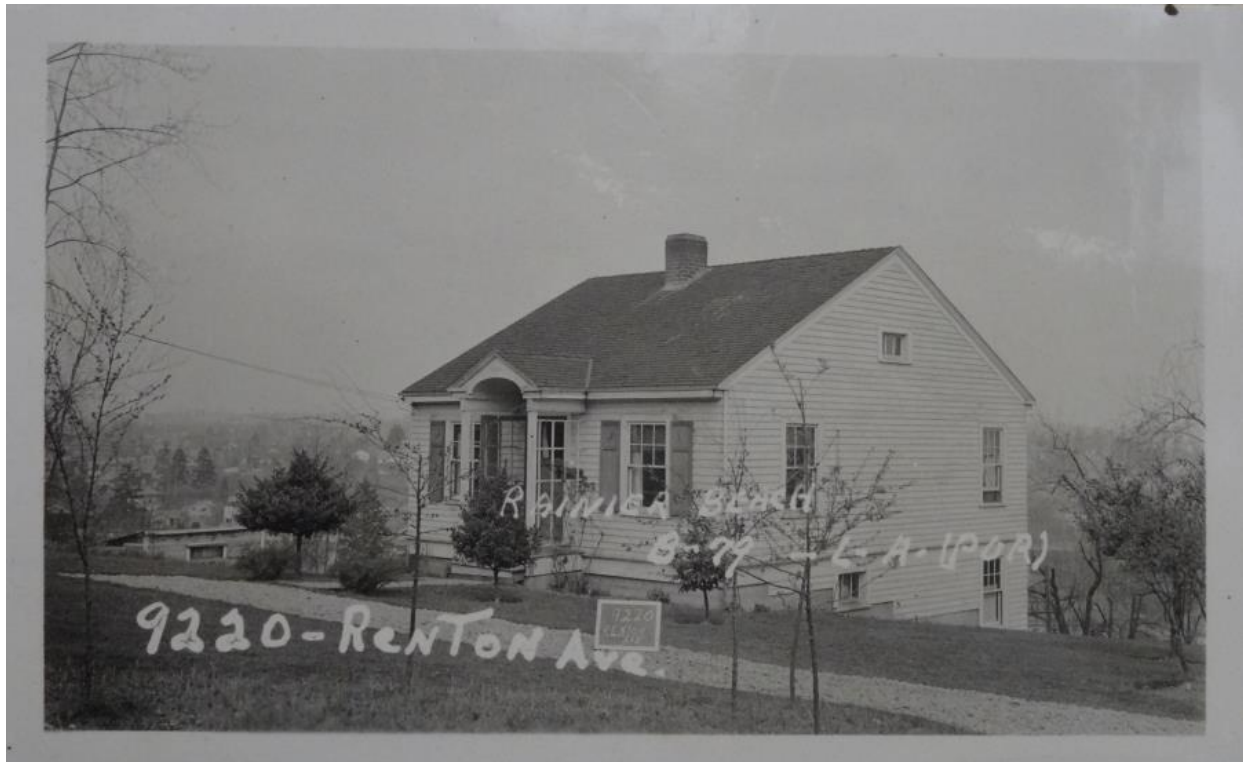
B4. Florence Crittenton Home – caretaker's residence. Property Record Card, King County Assessor, 1938. Washington State Archives, Puget Sound Regional Branch, Bellevue, WA.

The Colonial Revival-style caretaker's residence was built in 1921, according to King County Assessor records, making it the oldest surviving building on the property (see images B4-B5, C3, C31-C35). The modest, wood-frame house is clad in lapped-wood siding that extends around the entire house, with mitered joints at each corner. It has a full basement and a concrete foundation and is built into a hillside, resulting in a one-story primary elevation and a two-story rear elevation. It has a rectangular plan measuring approximately 27' by 30', with a 3' by 5' front (west) porch and a 4' by 5' side (north) porch. The building has double-hung and fixed wood windows, with six of the 20 units having replacement wood sashes. The window and door openings have modest, square-edge, back band trim. There are four exterior doors, three of which are six-panel metal replacements. The side-gable roof is clad in asphalt shingles and has eaves with minimal overhang. A brick chimney pierces the roof's center ridgeline.

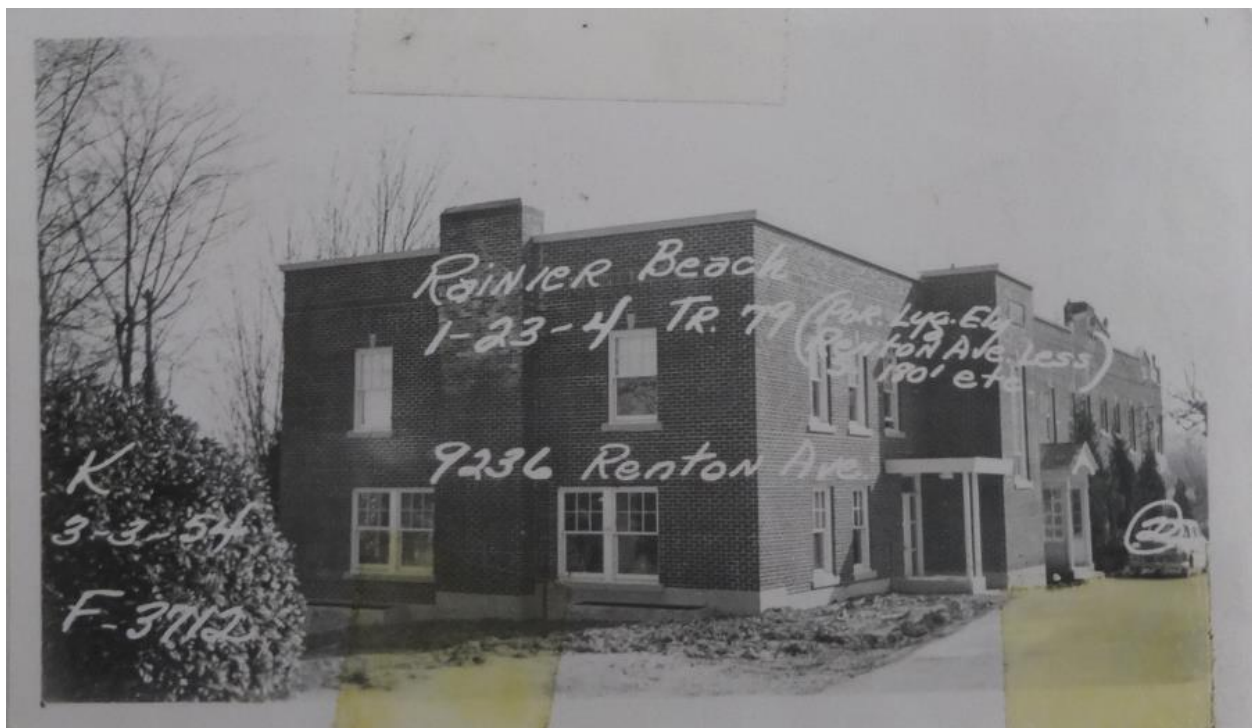
B7. Florence Crittenton Home – main building, showing north addition. Property Record Card, King County Assessor, 1954. Washington State Archives, Puget Sound Regional Branch, Bellevue, WA.

Architects McClelland & Osterman designed the 1953 north addition to blend with the original building, and thus it reflects many of the same characteristics (see images B-7, C4, C6, D4-D11). It measures approximately 42' by 39' and has a red-brick-clad exterior with running bond patterns and soldier courses at the roofline and above windows. Roughly half of the original wood windows remain intact, and they have a multi-light-over-single-light configuration. Aluminum replacement units have been installed in some of the window openings. A brick-clad stair tower that measures 11' wide projects forward approximately 6' from the primary (west) façade (see image C4). It has a tall, multi-light window. Set into the north side of the L formed by the stair tower is a modest, Modern-style entry with flat-roof porch supported by wood posts arranged in a basic rectilinear pattern that resembles a ladder (see image C12). The single-leaf door has a transom and a sidelight, both with textured glass.

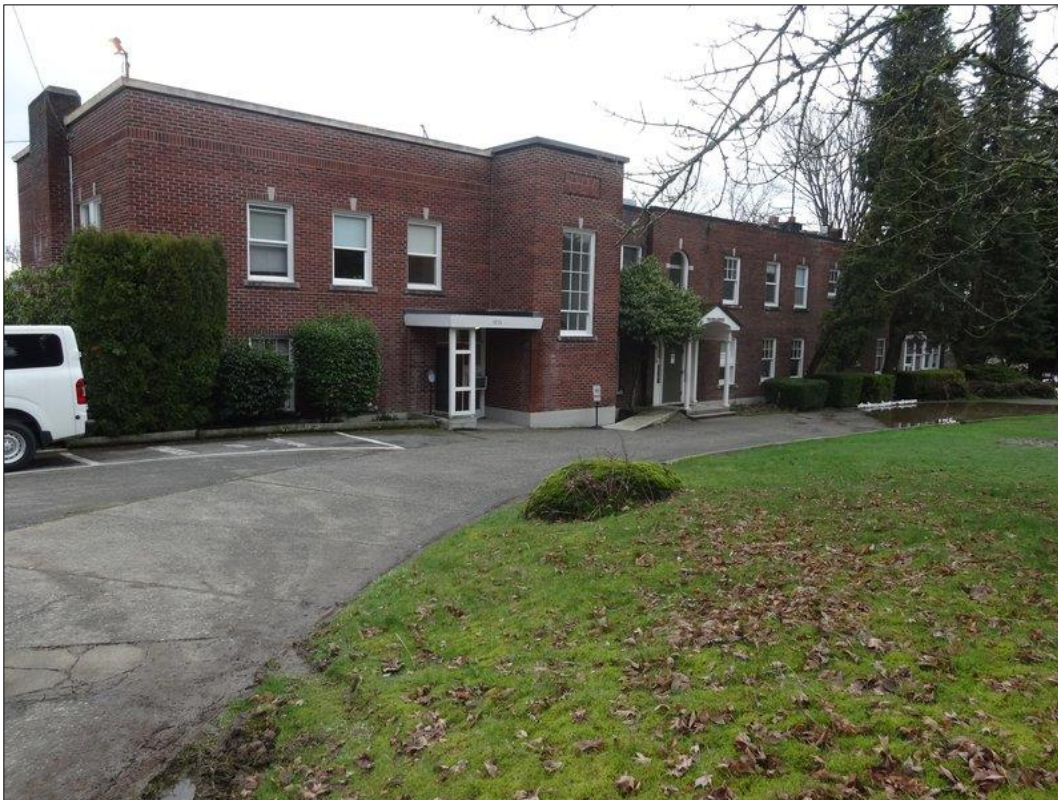
C4. Main building, view of 1953 addition at left and original 1926 building at right, camera facing southeast

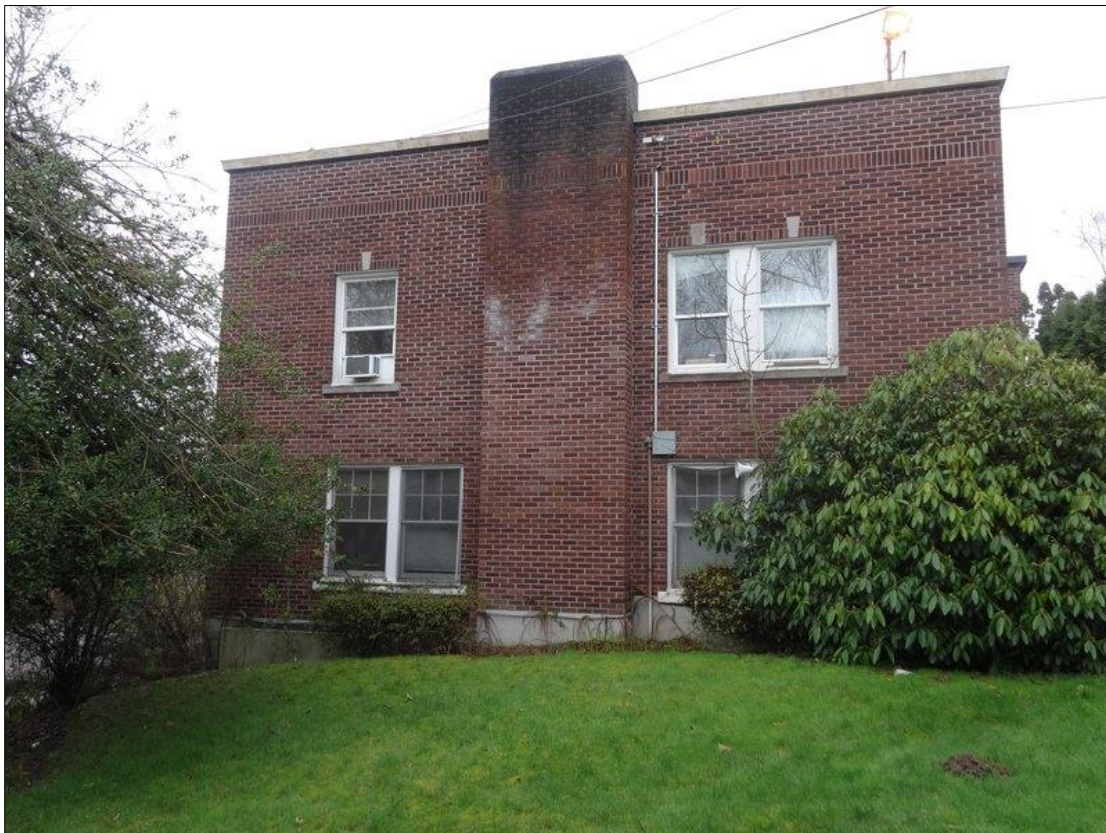
C6. Main building, view of north elevation (1953 addition), camera facing south

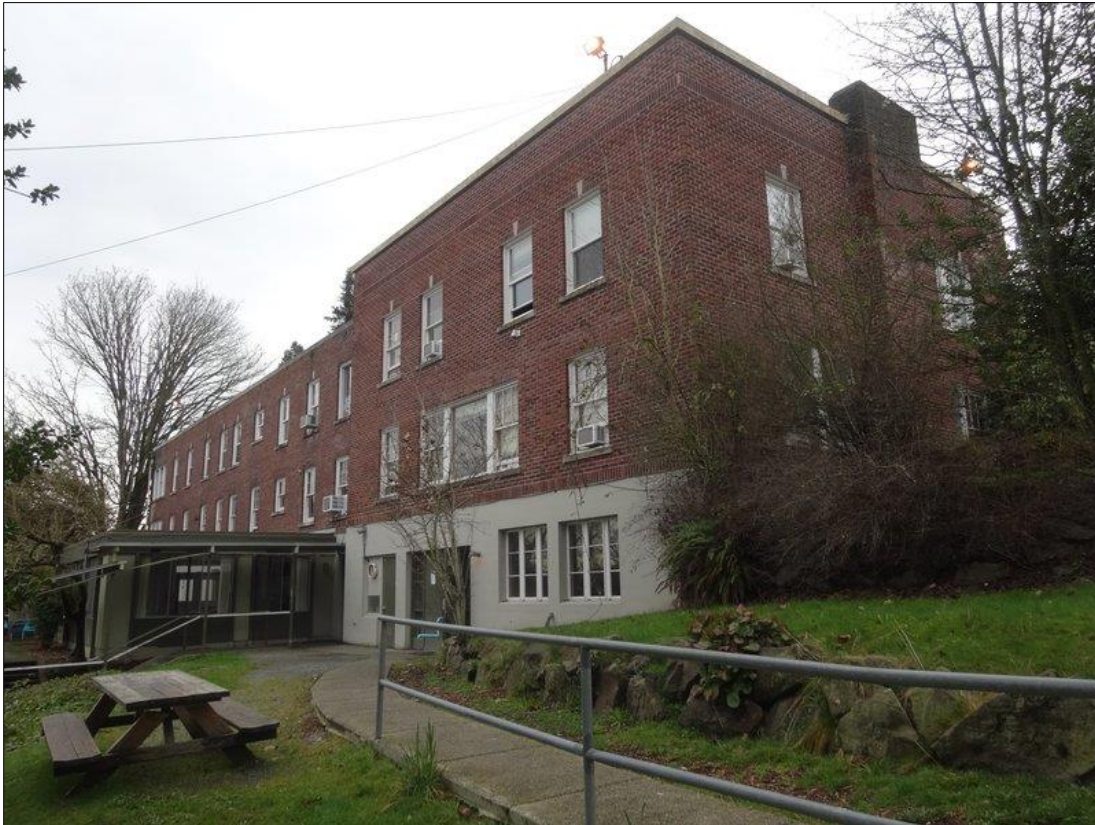
C7. Main building, view of 1953 addition in foreground and 1965 dining hall addition at left, camera facing southwest

The 1965 dining hall addition extends from the rear of the building (see images C7-C8, D14, D16-D17). It is one story and has a rectangular plan that measures approximately 30' by 20'. It has a concrete foundation and is wood construction with horizontal glulam header beams and aluminum window and door systems. The addition was part of a bigger project that included the construction of four residential cottages east of the main building and a freestanding concrete garbage can shelter located alongside the driveway south of the main building.

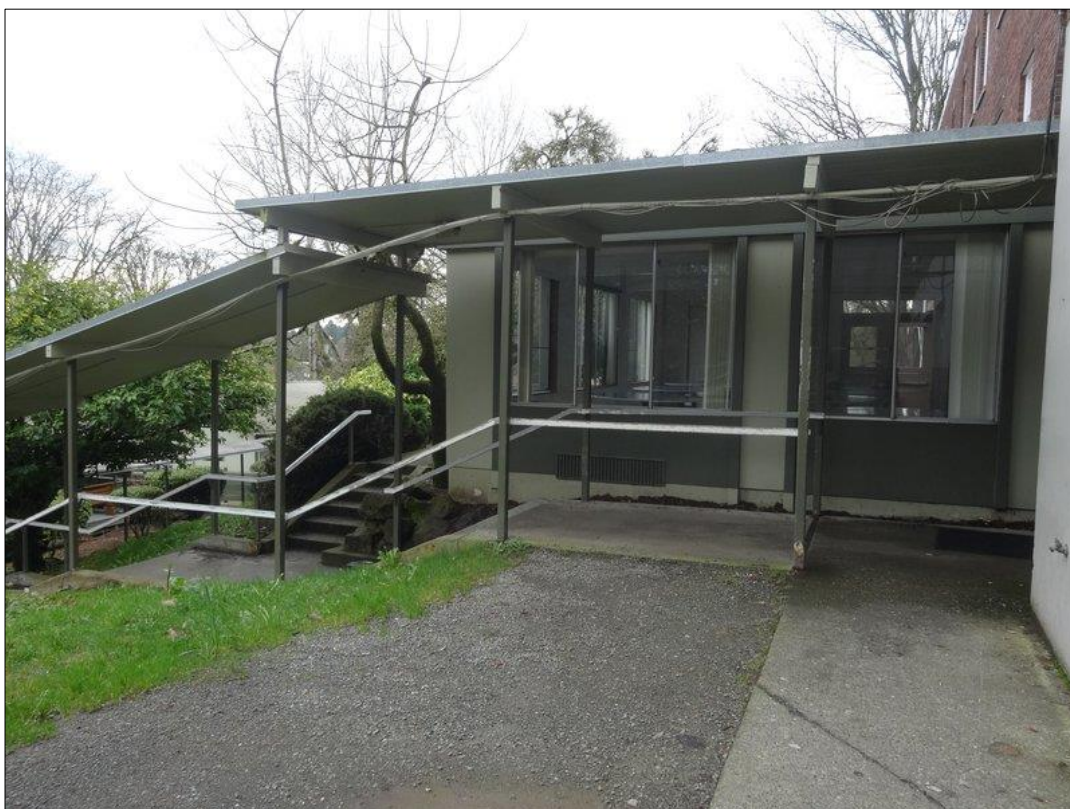
C8. North (side) elevation of the 1965 dining hall, camera facing south

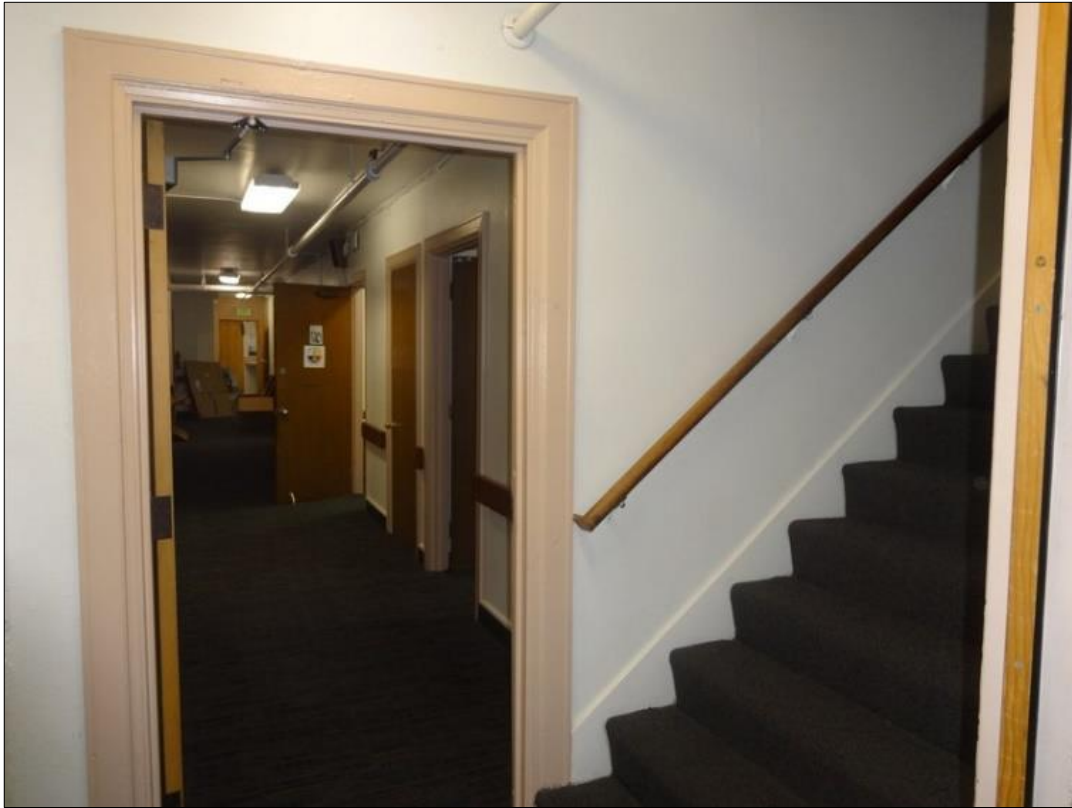
C18. Main building interior, first floor corridor, south stair at right, camera facing north

The lobby area connects to a long, double-loaded corridor via a door on the south wall. The corridor has been enclosed with fire-rated doors at each end. The staircases at each end of the corridor allow for vertical movement between all three floors. The north staircase is the original building's primary stair (see image C20). It is U-shaped, with half-landings and retains more historic features than the south one, including concrete risers and landings and metal newel posts and balusters. The narrower, straight-run staircase at the south end is enclosed and has carpeted risers and replacement wood-handrails attached to each flanking wall (see image C18).

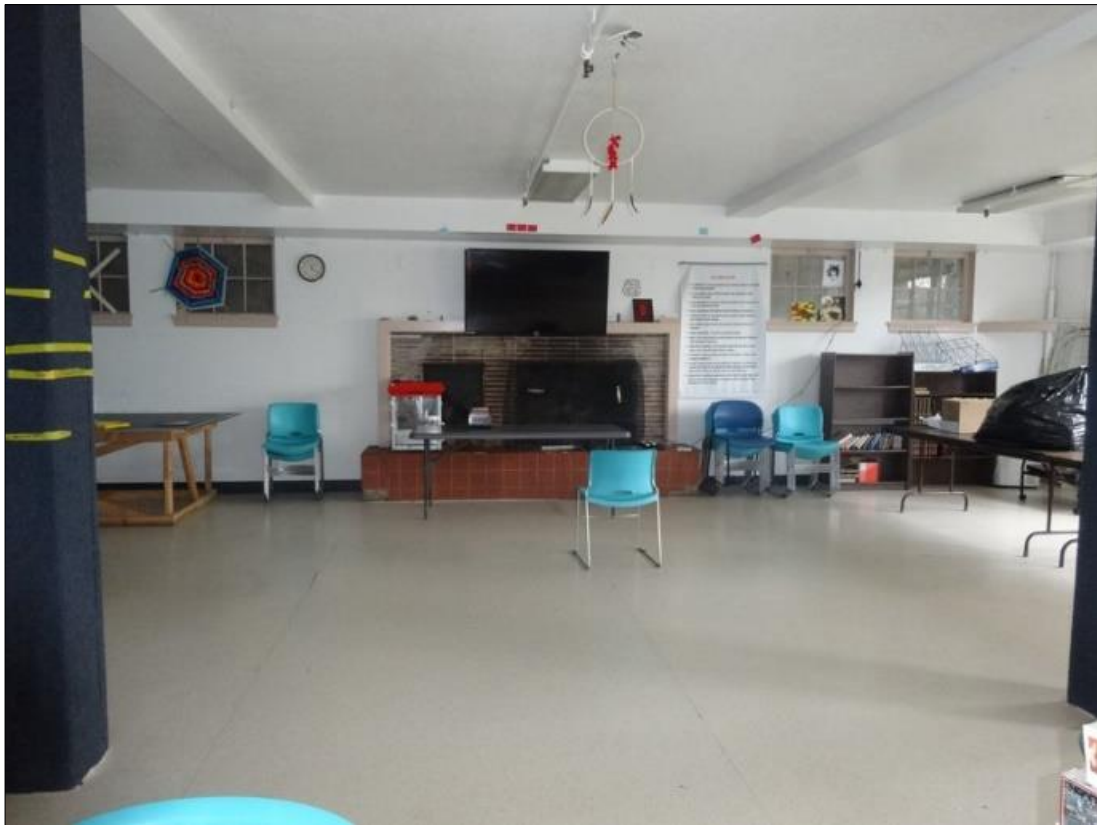
C27. Main building interior, basement level recreation/multipurpose room, camera facing north

steel counters and industrial-size sinks and appliances (see image C29). The basemen corridor terminates at the south end at a door that leads to the secondary driveway. At the north end, it terminates at the base of the north stairs, which also connects with the 1953 recreation room. The recreation room is a large, open space with a beamed ceiling, an asphalt-tile floor with vinyl bases, metal-frame casement windows, and an acoustical-tile ceiling with replacement, flush ceiling-mounted fluorescent lights (see images C27-C28).

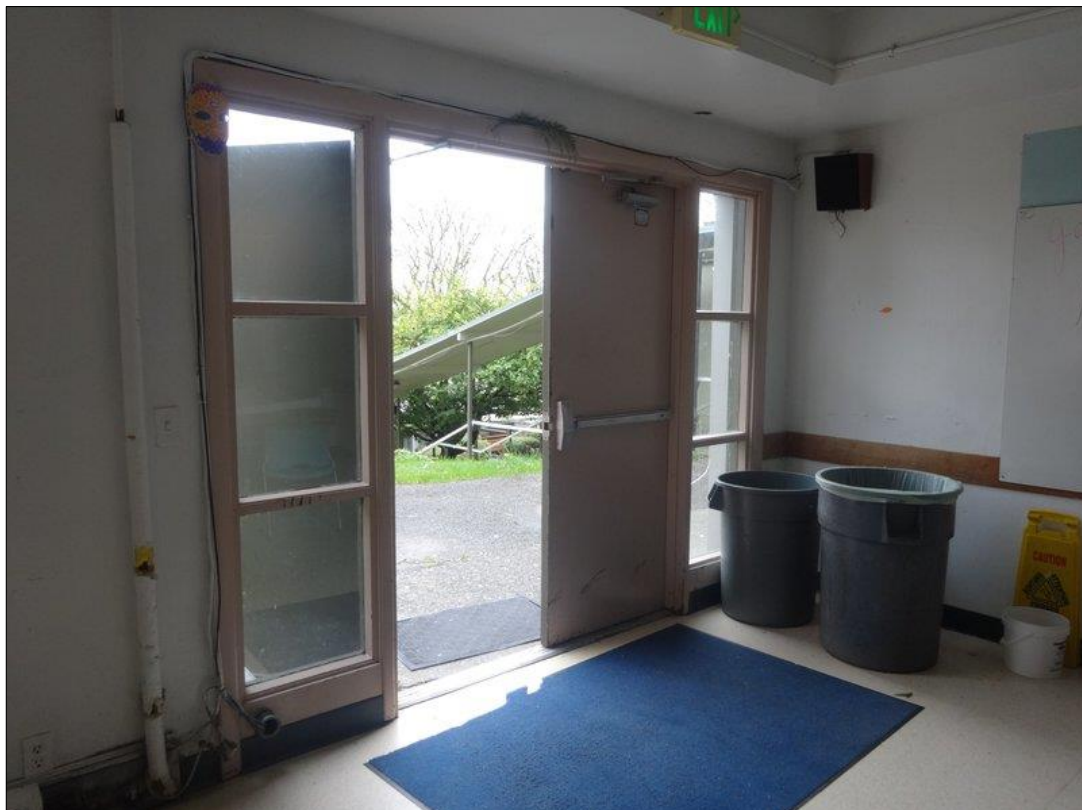
C28. Main building interior, basement level multipurpose room, entry on east wall, camera facing southeast

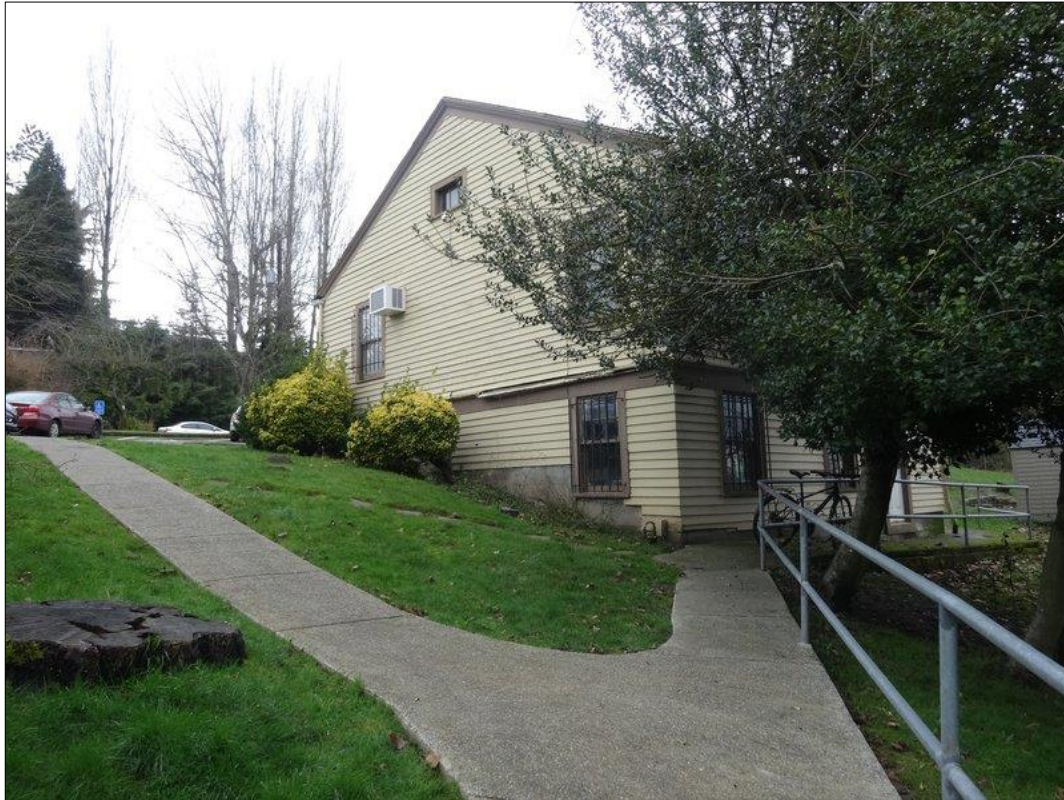
C33. Caretaker's Residence, southeast corner, camera facing northwest

The south (side) elevation is largely unadorned (see images C32-C33). It has two single windows on the main level – a one-over-one replacement window and a six-over-one original window. There are two openings at the basement level – a small, single-sash replacement window and a six-over-one original window. There is an original, three-light window at attic level.

The full two stories are visible on the building's east (rear) elevation. The main level has four windows: a pair of six-over-one units; a single six-over-one unit; and a smaller single one-over-one unit in the center. The basement level has two six-over-one units and a metal six-panel replacement door. A concrete sidewalk with a metal-pipe railing passes alongside the rear wall (see images C33, C35).

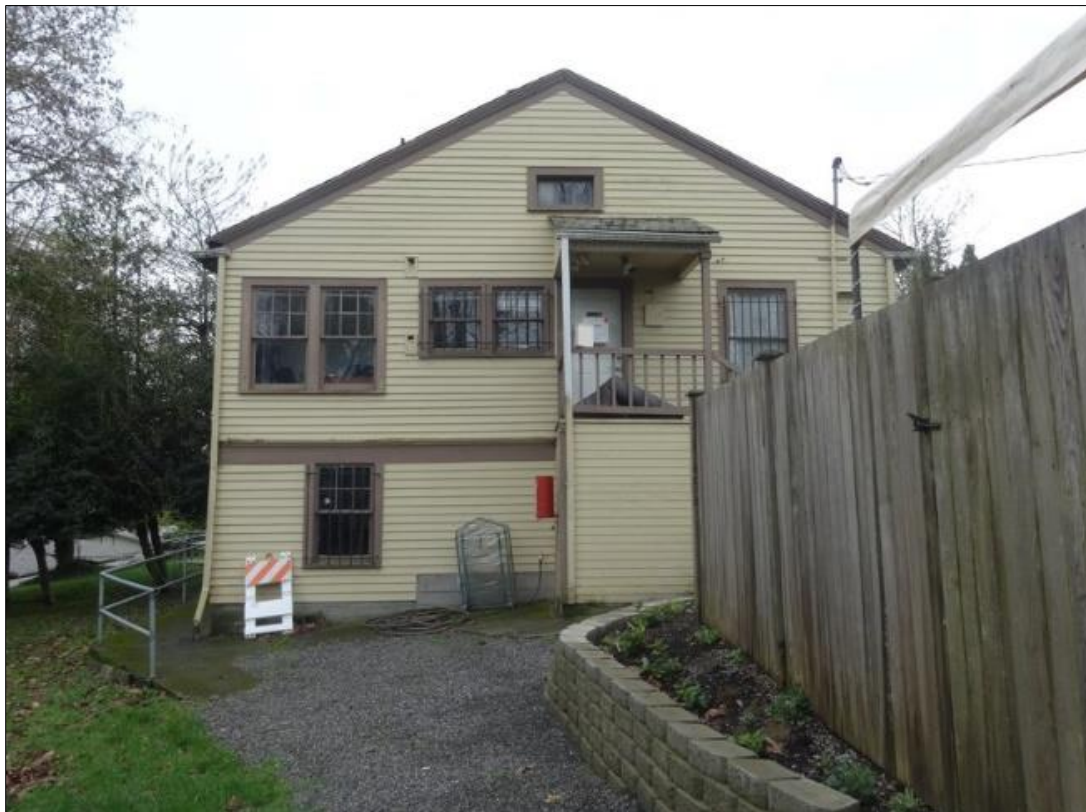
C34. Caretaker's Residence, north (side) elevation, camera facing south

Attached to the north (side) elevation is a straight-run wood staircase that leads up to a main-floor, secondary entrance (into the former kitchen). A shed roof supported by two unadorned square columns covers the entry. The base of the staircase is enclosed, with an older four-panel door that opens to the east. On the main level, there are two pairs of double-hung windows, all with original sashes, and a single window with replacement sashes. There is a single, six-over-one window at the basement level and a single-sash, three-light window at attic level (see image C34).

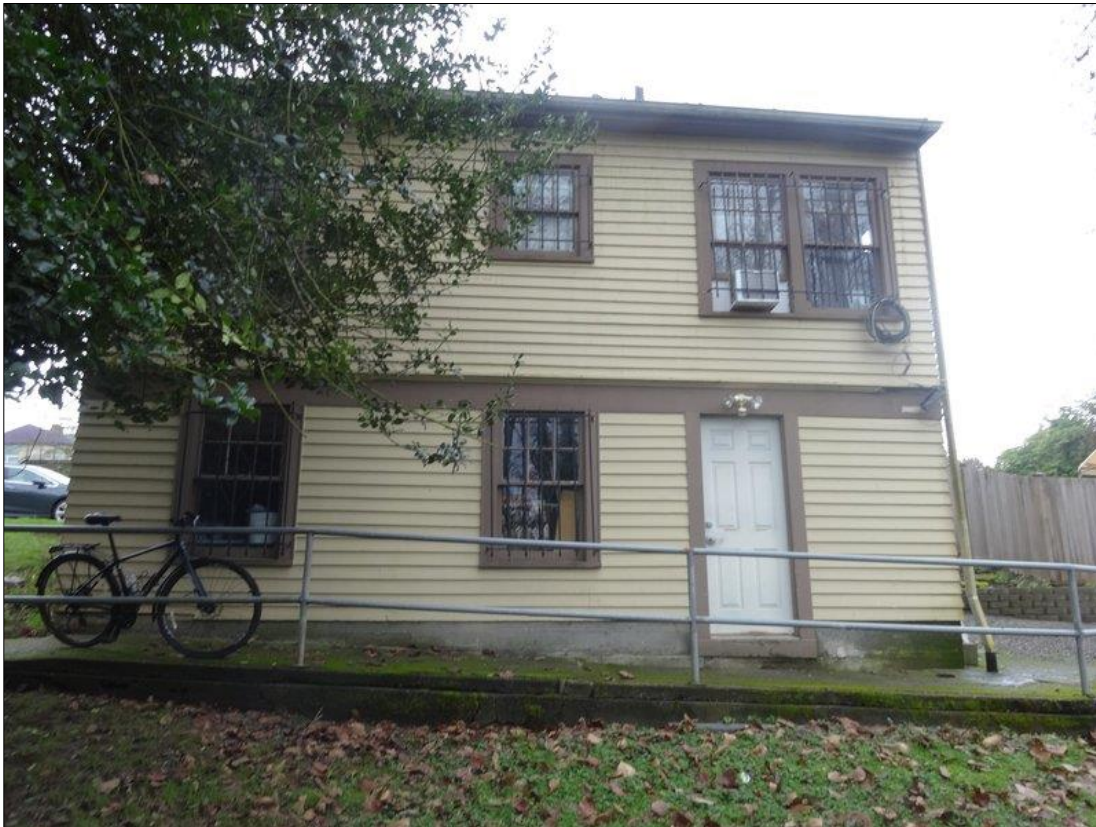
C35. Caretaker's Residence, east (rear) elevation, camera facing west
