Colman Park Vegetation Management Plan Draft

DRAFT

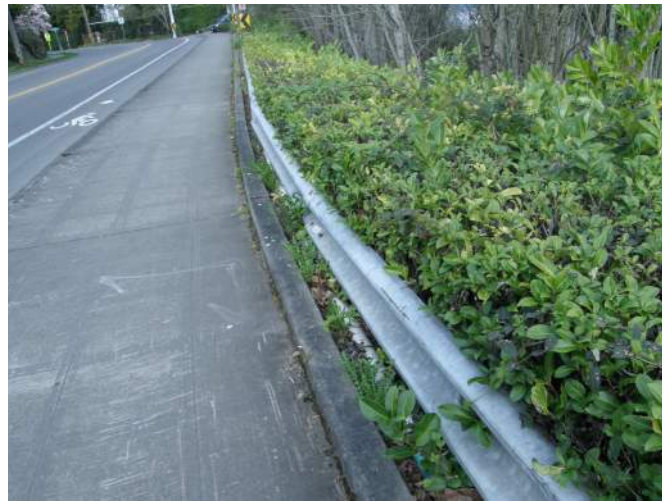
F GUARD RAIL DETAIL

Along 31st Avenue South, the western edge of Colman Park, stands an existing guard rail with a well-maintained, short, dense laurel hedge running along the sidewalk for the entire length of the park's boundary. The sidewalk is bordered by a curb that would prevent major storm water runoff from the street above. Power and communication lines are limited to the sidewalk and street area. Two steep staircases at the southwestern and northwestern corners of the park appear to be in good shape with sides covered in moss but no obvious cracks or apparent uplift by tree roots. An unpaved path (approximately an average of 35 to 45 feet from the street level) runs in a north-south direction, perpendicular to the street, and is a natural terrace between the steep upper slope and lower slope areas.

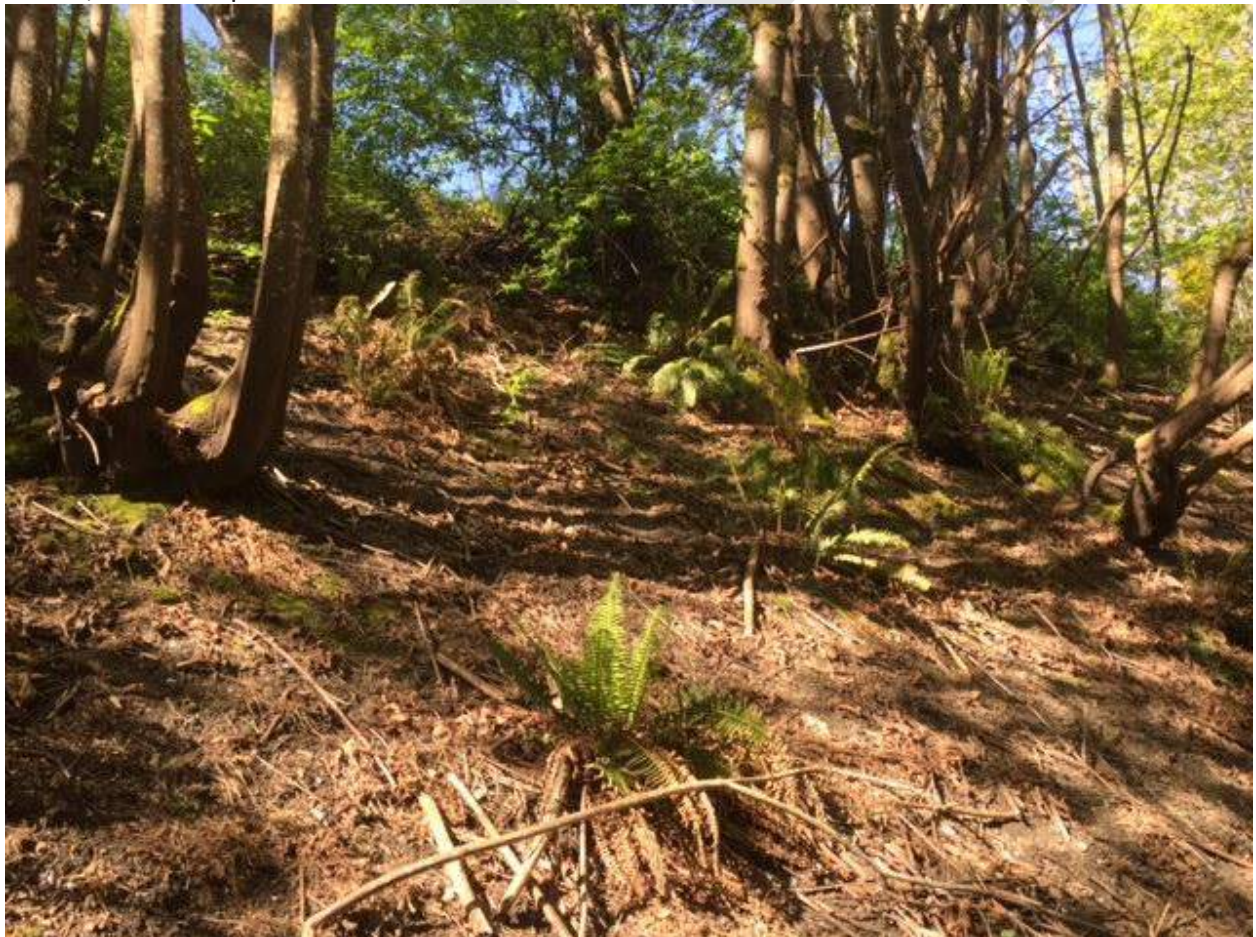
Colman Park Existing Slope Conditions:

Existing ferns and other desirable slope vegetation could be retained if selective staged removal of the maples is done. Additional sword fern and companion groundcovers, possibly other shrubs, would be planted at the same time.

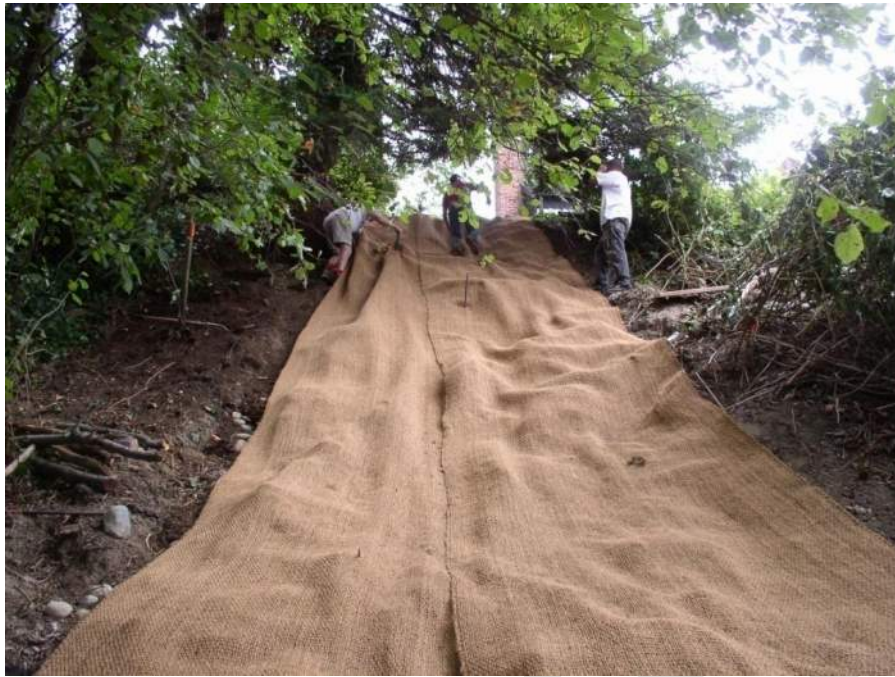
1. Coir fiber erosion blanket placed over bare soil after a slide event.

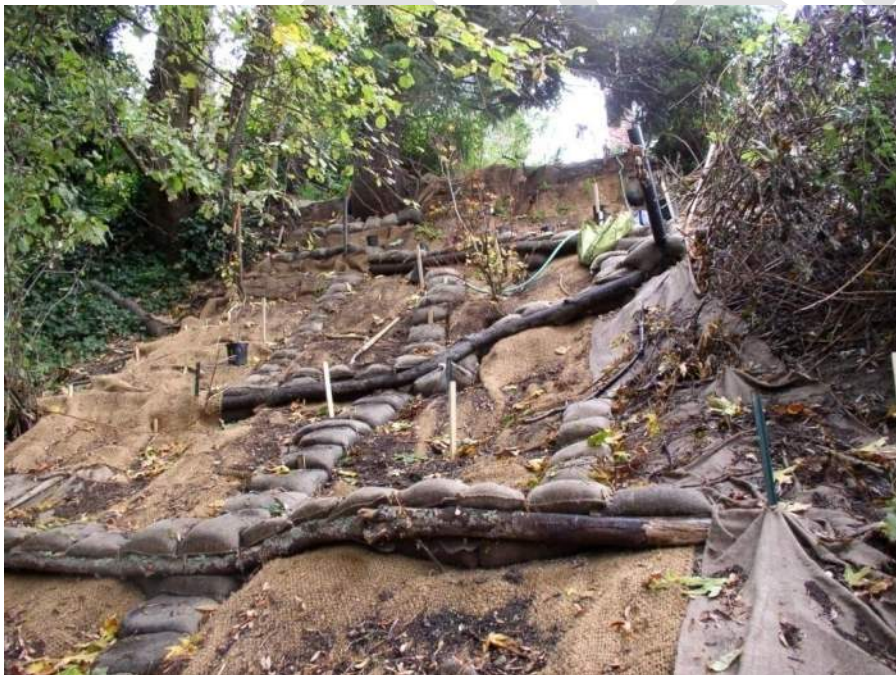
2. The same slope with the addition of sand bags and new plant installation. Large woody debris was added over much of the coir blanket. Natural leaf fall from adjacent trees covered the surface over the following years.

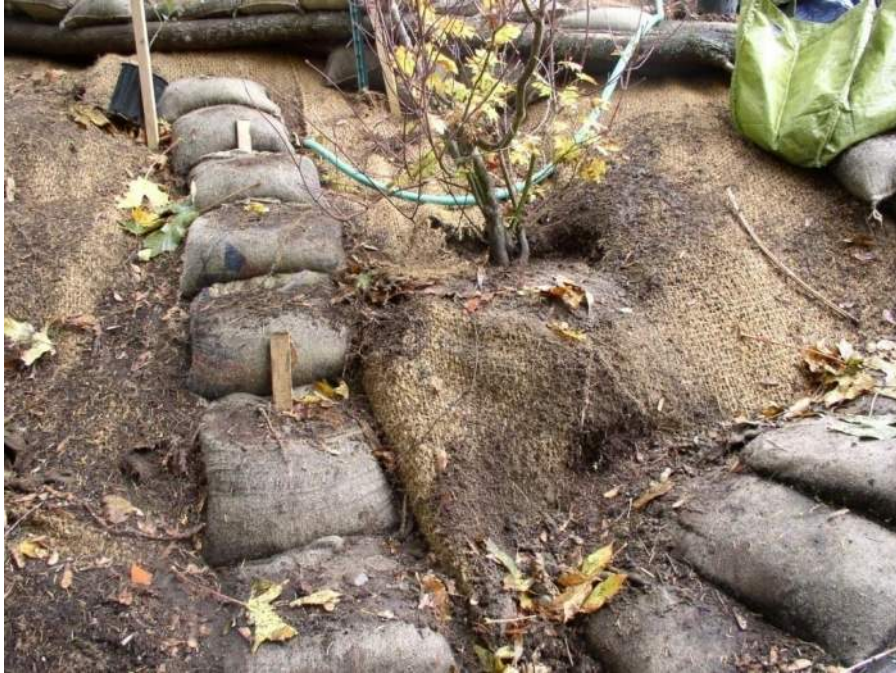
3. Close up of newly planted vine maple with coir fiber and sand-bags. For the Colman project, retaining larger woody debris from the maple removals would take the place of sand bags used in this example.

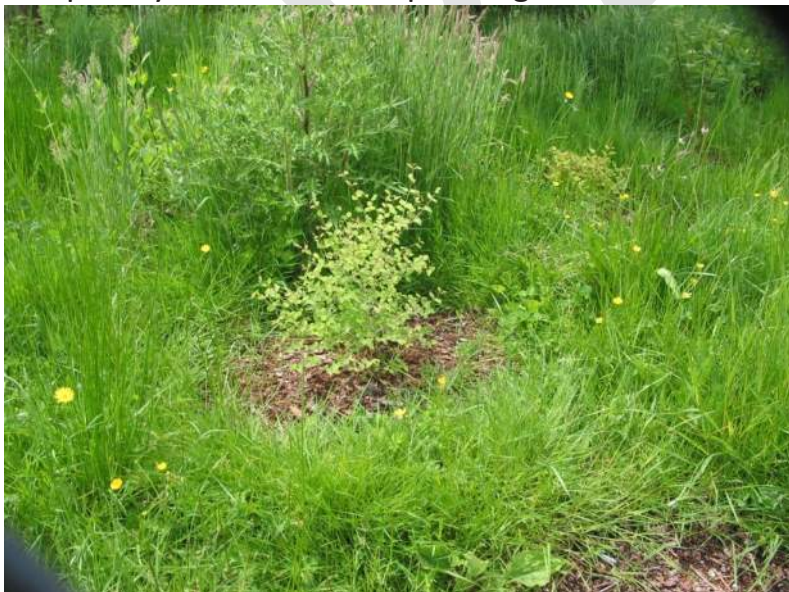
1. Weed control should be provided several times during the growing season to suppress rapidly growing grasses, blackberry, and brush that can quickly overcome new plantings.

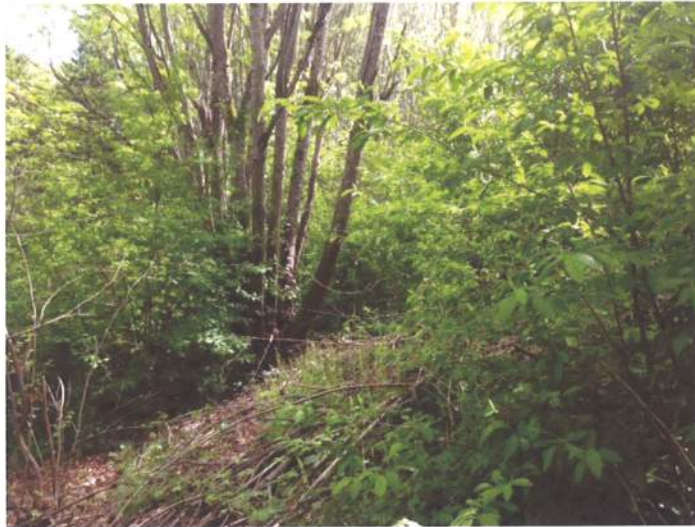
Photo 3A: TYPICAL HILLSLOPE VIEW LOOKING SOUTH

We gave particular attention to the shape and orientation of the tree trunks, because this can provide information about the behavior of hillslope soils. Most tree trunks appear to be fairly straight or, in the case of clump maples, curved outward. Some trunks exhibit a downslope curvature, which typically results from "soil creep" (a very slow, downslope migration of surficial soils). We did not observe a consistent occurrence of upslope-leaning trunks, which often indicates "slumping" (a relatively sudden rotational failure of the deeper soils).

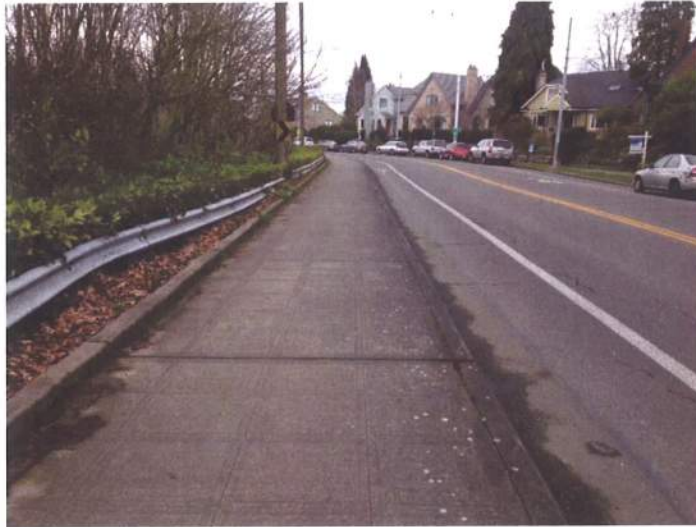
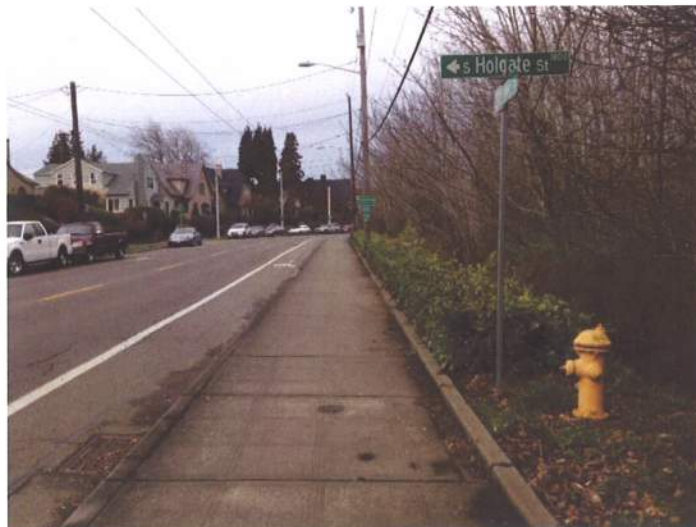
Photo 4A: 31ST AVENUE SIDEWALK VIEW LOOKING SOUTH

A municipal sidewalk and raised curb extend around the western (upper) edge of the site, adjacent to 31st Avenue South. These concrete features, which are shown in Site Photographs 4A and 4B (Figure 4), appear to be in very good condition. We did not observe any cracking, warping, settlement of the sidewalk or curb, nor any other evidence of soil movement along the top of the hillslope. A 6-inch-diameter plastic pipe is visible immediately behind the curb in several locations, but we could not determine the purpose of this pipe.

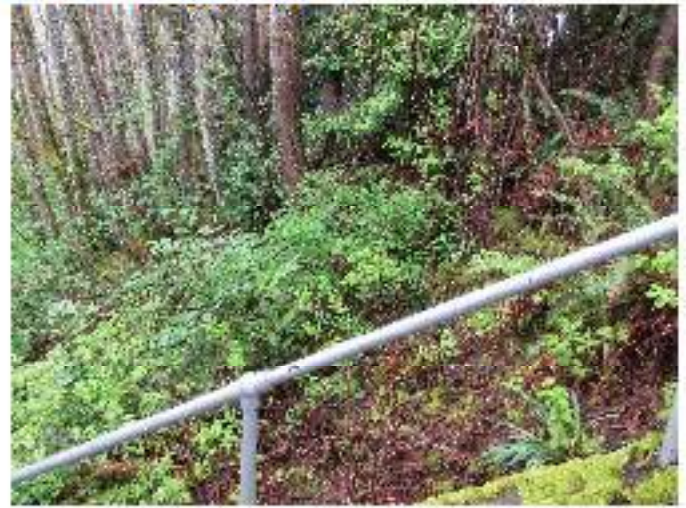
6) Steep upper slope area

From the southwest corner looking down the southern side of the upper slope; residences are to the right up a steep slope of the southern end of the park. Upper slope cross-section of established and dense understory with various tree and plant species showing no sign of slope erosion. Trees in this area appear to be upright and not falling over.

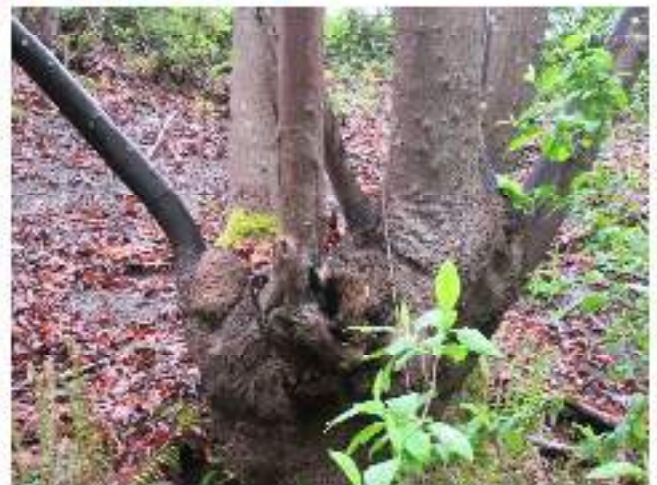
8) Steep upper slope area

Close-up of big leaf maple cluster with no obvious slumping of soil or slope around the base.

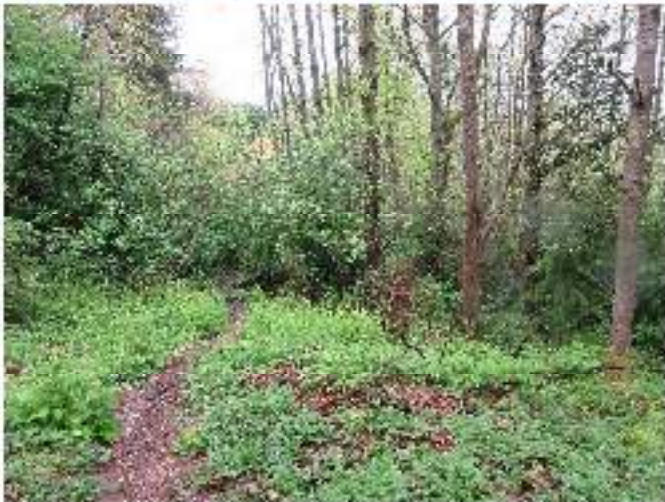
15) Unpaved trail between upper and lower slope

Facing north. An unpaved path runs in a north-south direction, perpendicular to the road and is a natural terrace between the steep upper slope and lower slope areas.

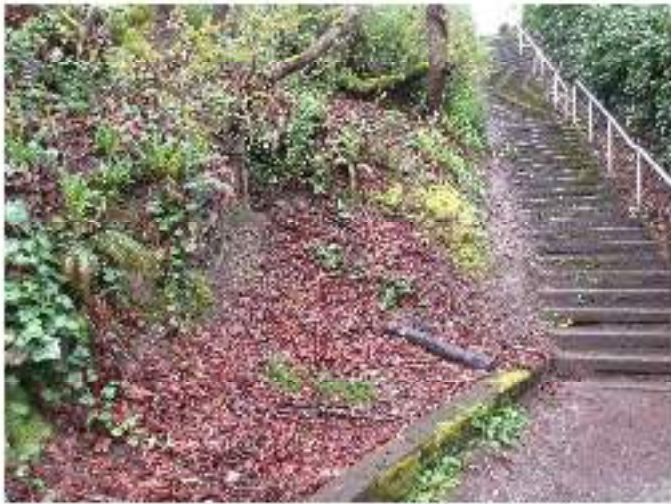
17) Upper steep slope area

Wide angle of southern side of steep upper slope area to the left of the southwest staircase. Invasive English ivy noted.

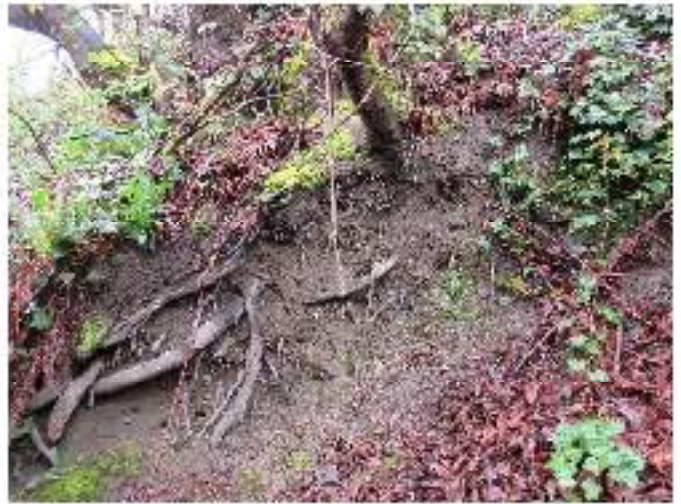
18) Upper steep slope area

Exposed roots along the southern side of the steep upper slope area to the left of the southwest staircase.

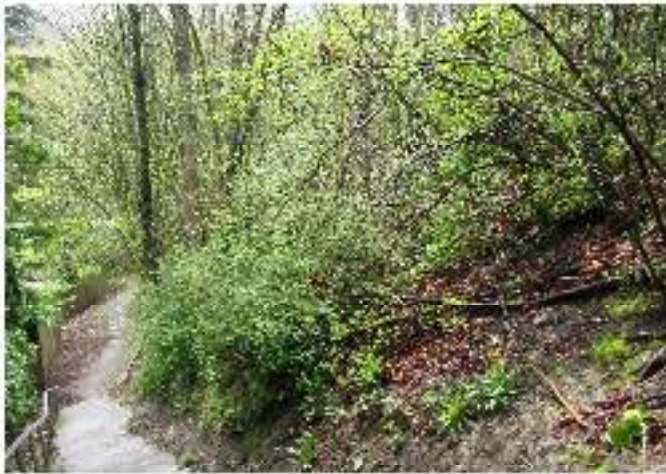
23) Steep upper slope area

Northwest staircase on the upper steep slope. Bushes and low lying plants and ferns are holding soil. A few smaller big leaf maples are leaning here but most are upright.

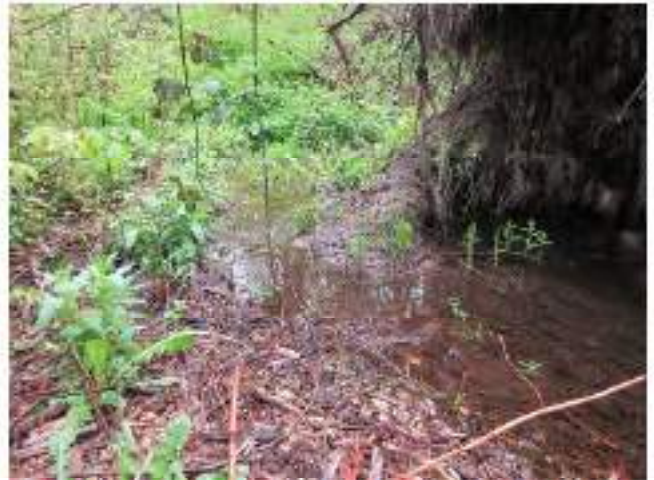
42) Wet area south of P-Patch

Large downed tree, complete uprooted with several inches of water where tree roots used to be. This location is approximately 12 feet east of the frog pond.
