Seattle Stormwater Manual Figure Redlines–

July 2025 Review Draft

Figure Redlines for Volume 1 – Project Minimum Requirements July 2025 Review Draft

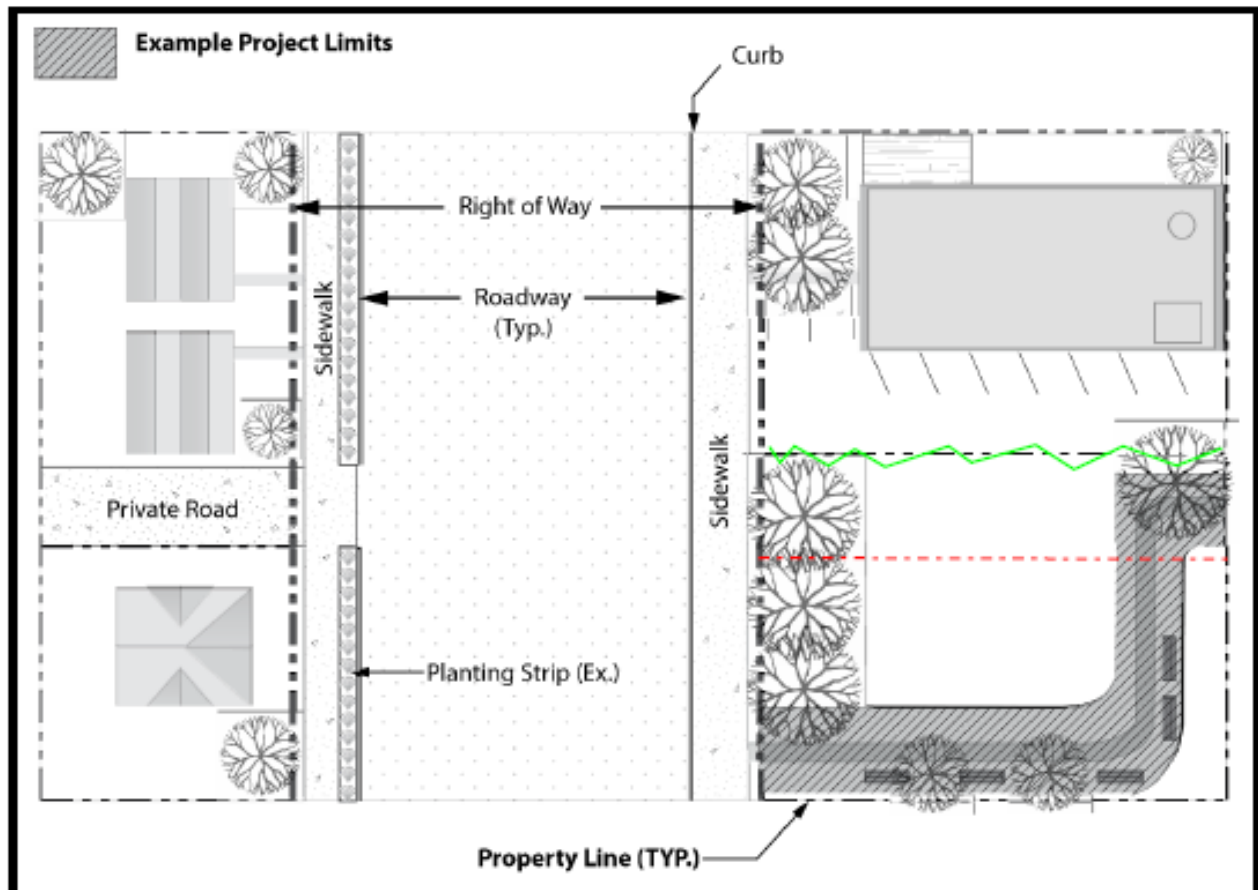
Figure 2.3. Trail Project Definition.

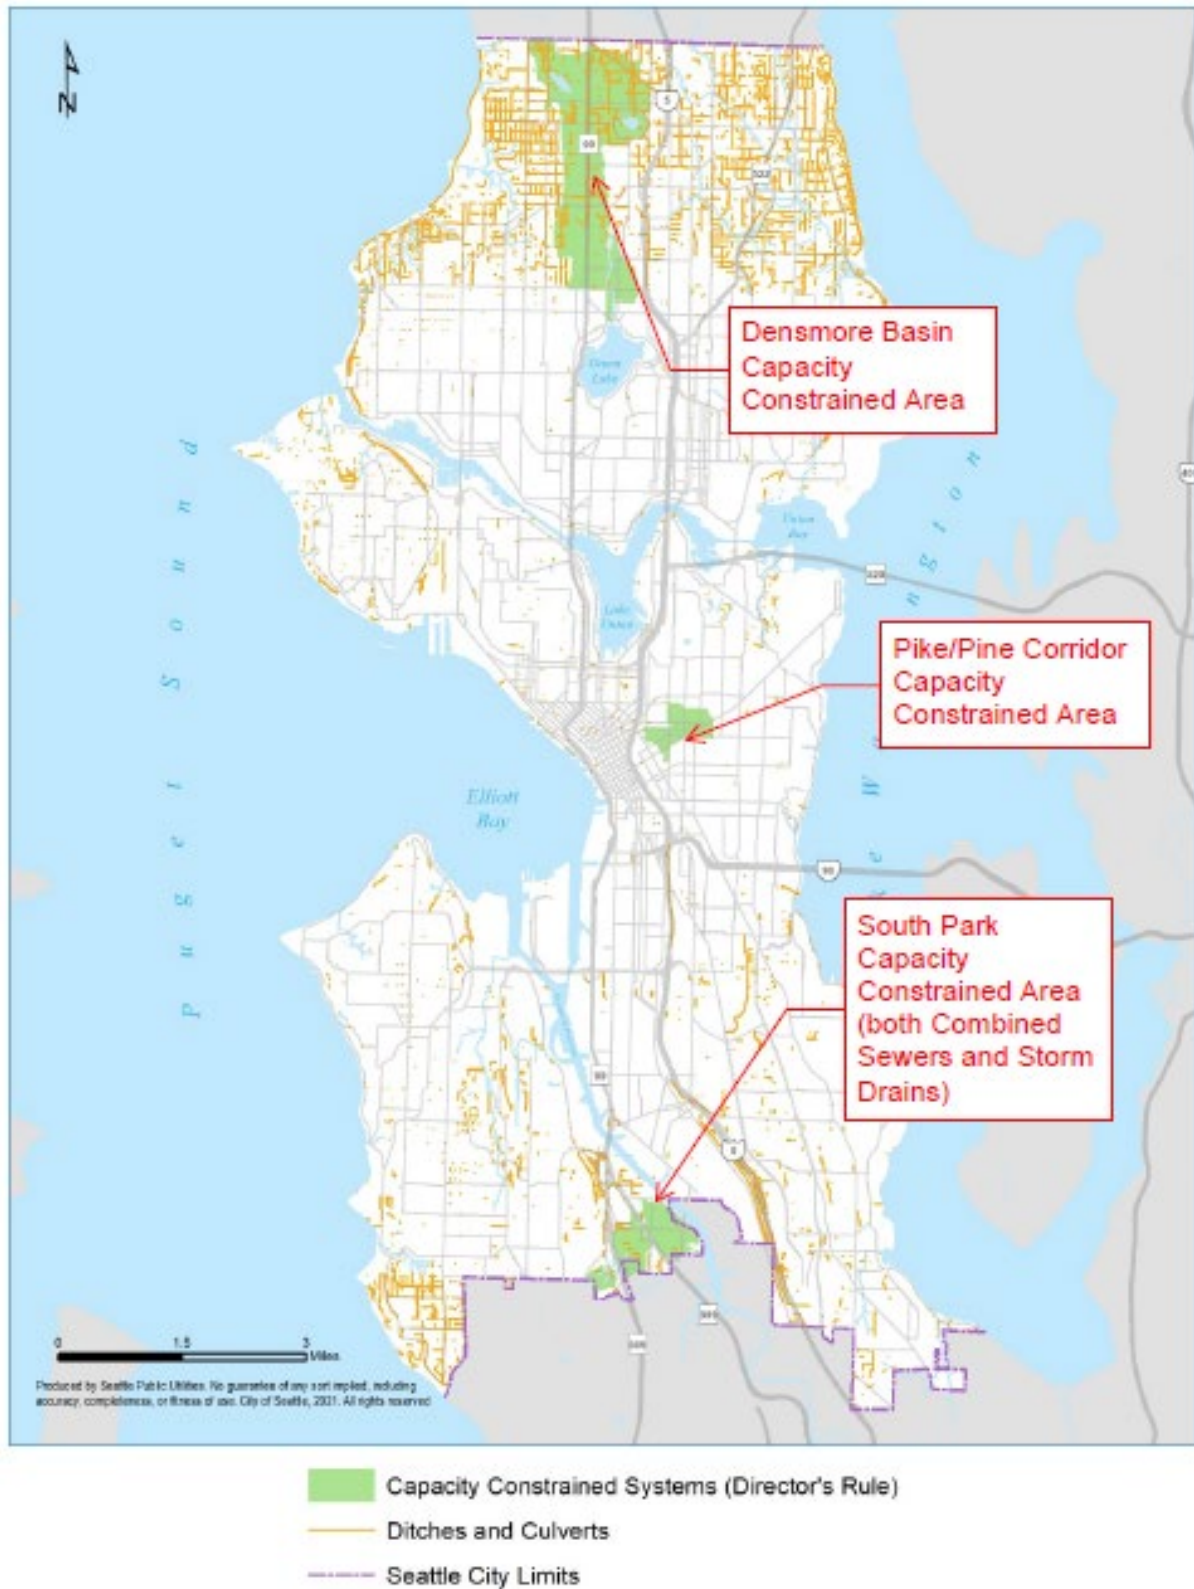
Note: All ditches and culverts are considered to be capacity constrained.

Figure 2.11. Capacity Constrained Systems.

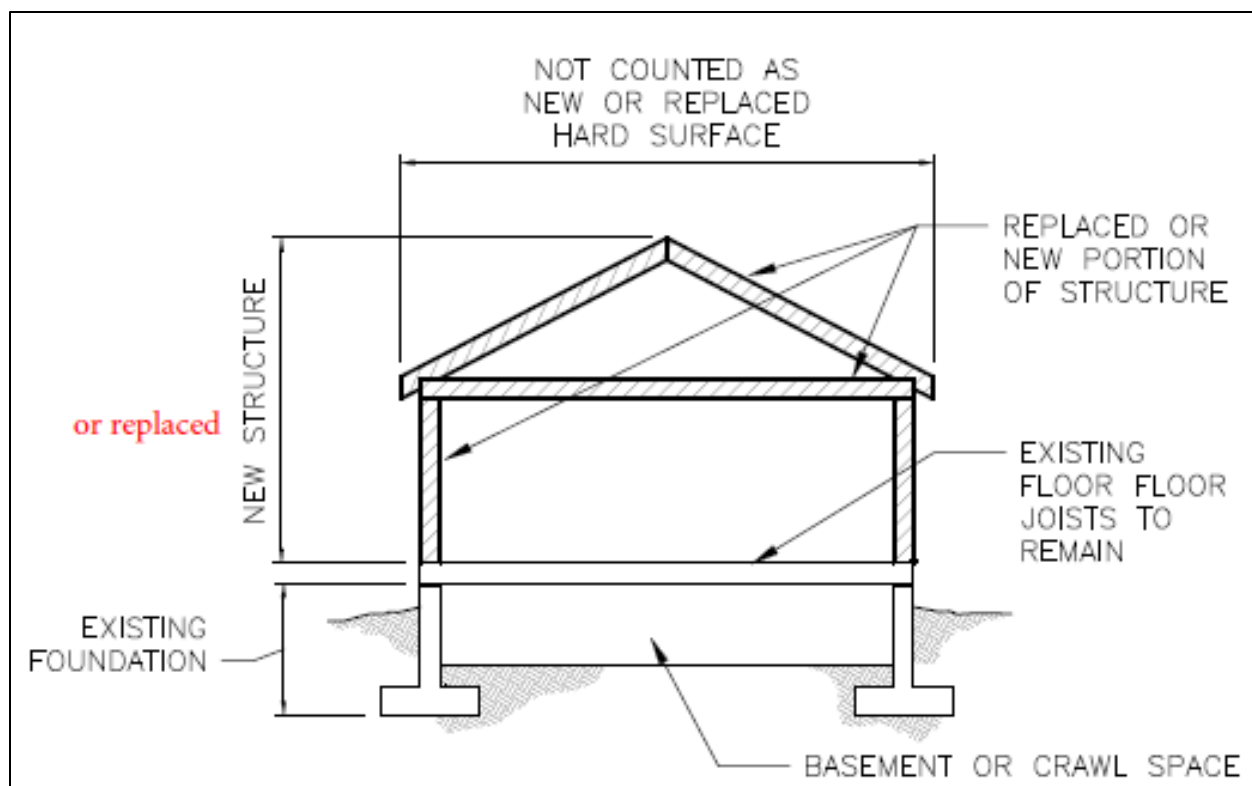
Figure 2.12. Example of Existing Hard Surface to Remain – Existing Floor Joists to Remain. (New Figure)

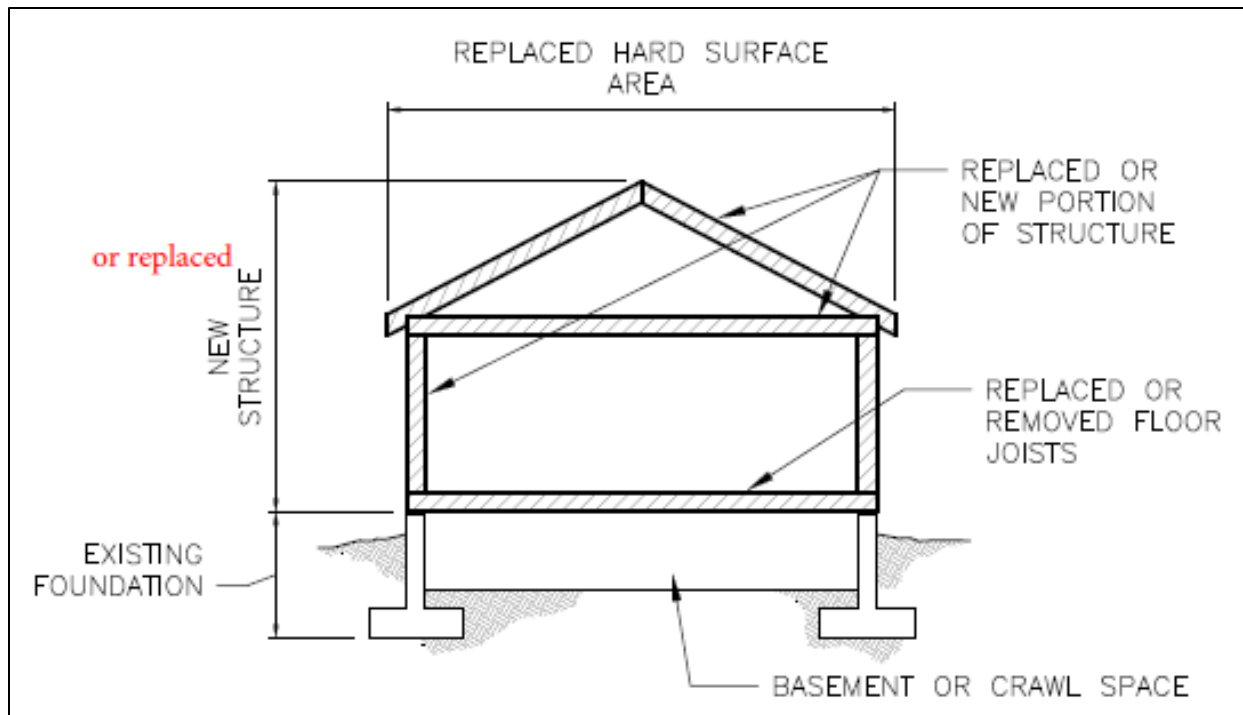
Figure 2.13. Example of Replaced Hard Surface – Flow Joists Removed or Replaced. (New Figure)

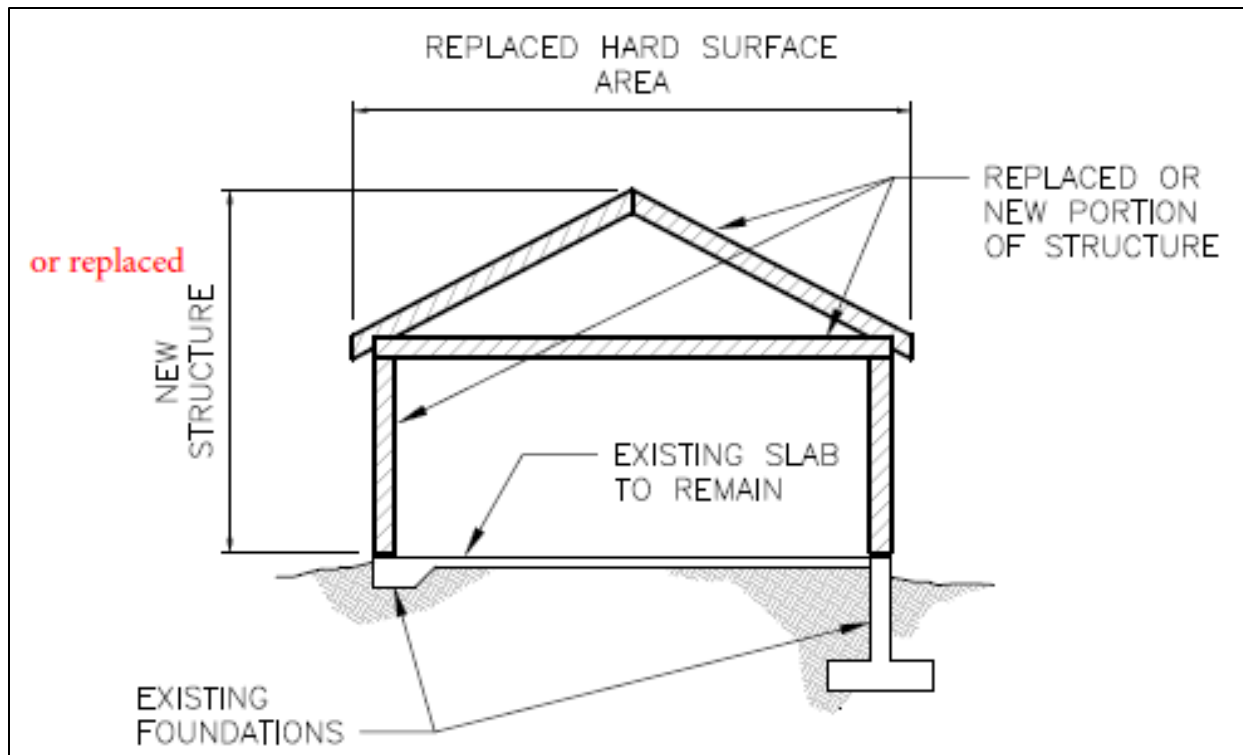
Figure 2.14. Example of Replaced Hard Surface – Structure Removed Down to Slab on Grade/Footings. (New Figure)

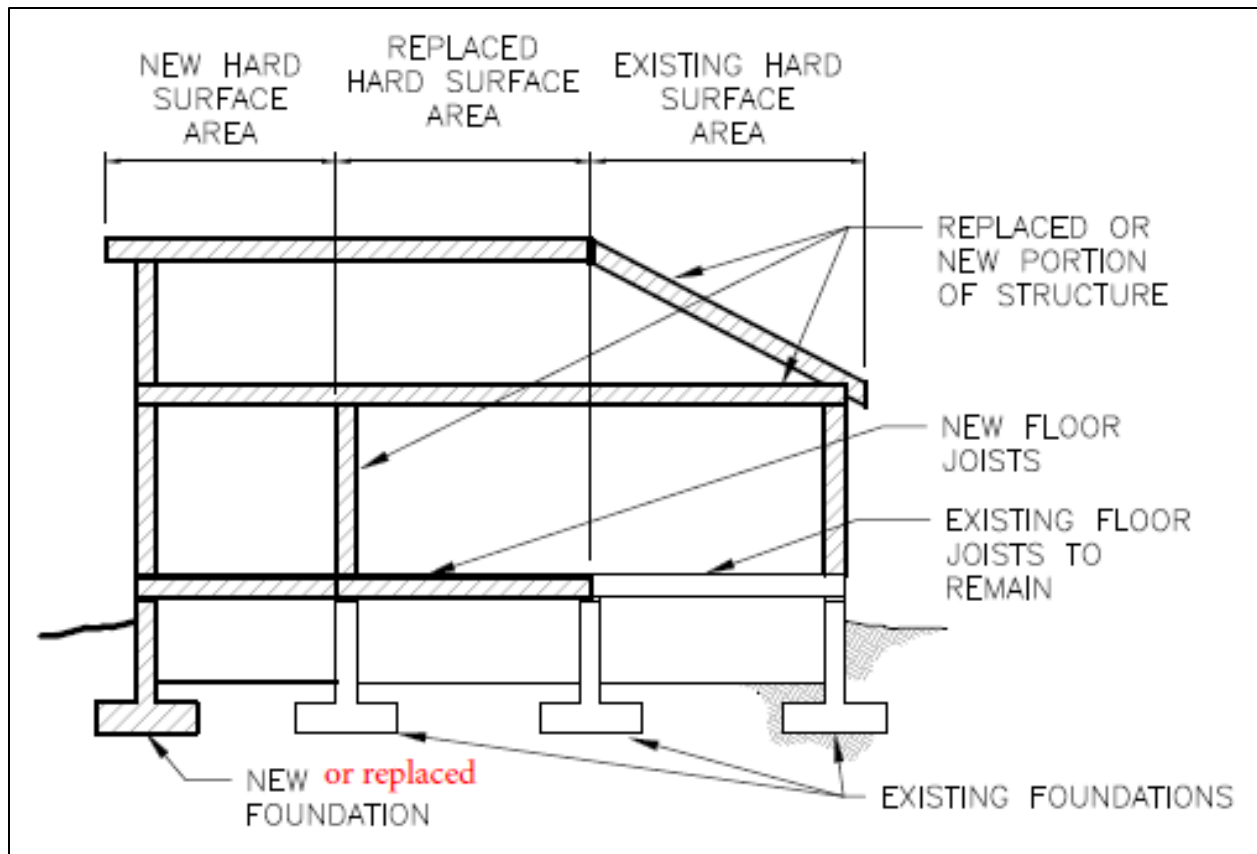
Figure 2.15. Example with New, Replaced and Existing Hard Surfaces. (New Figure)

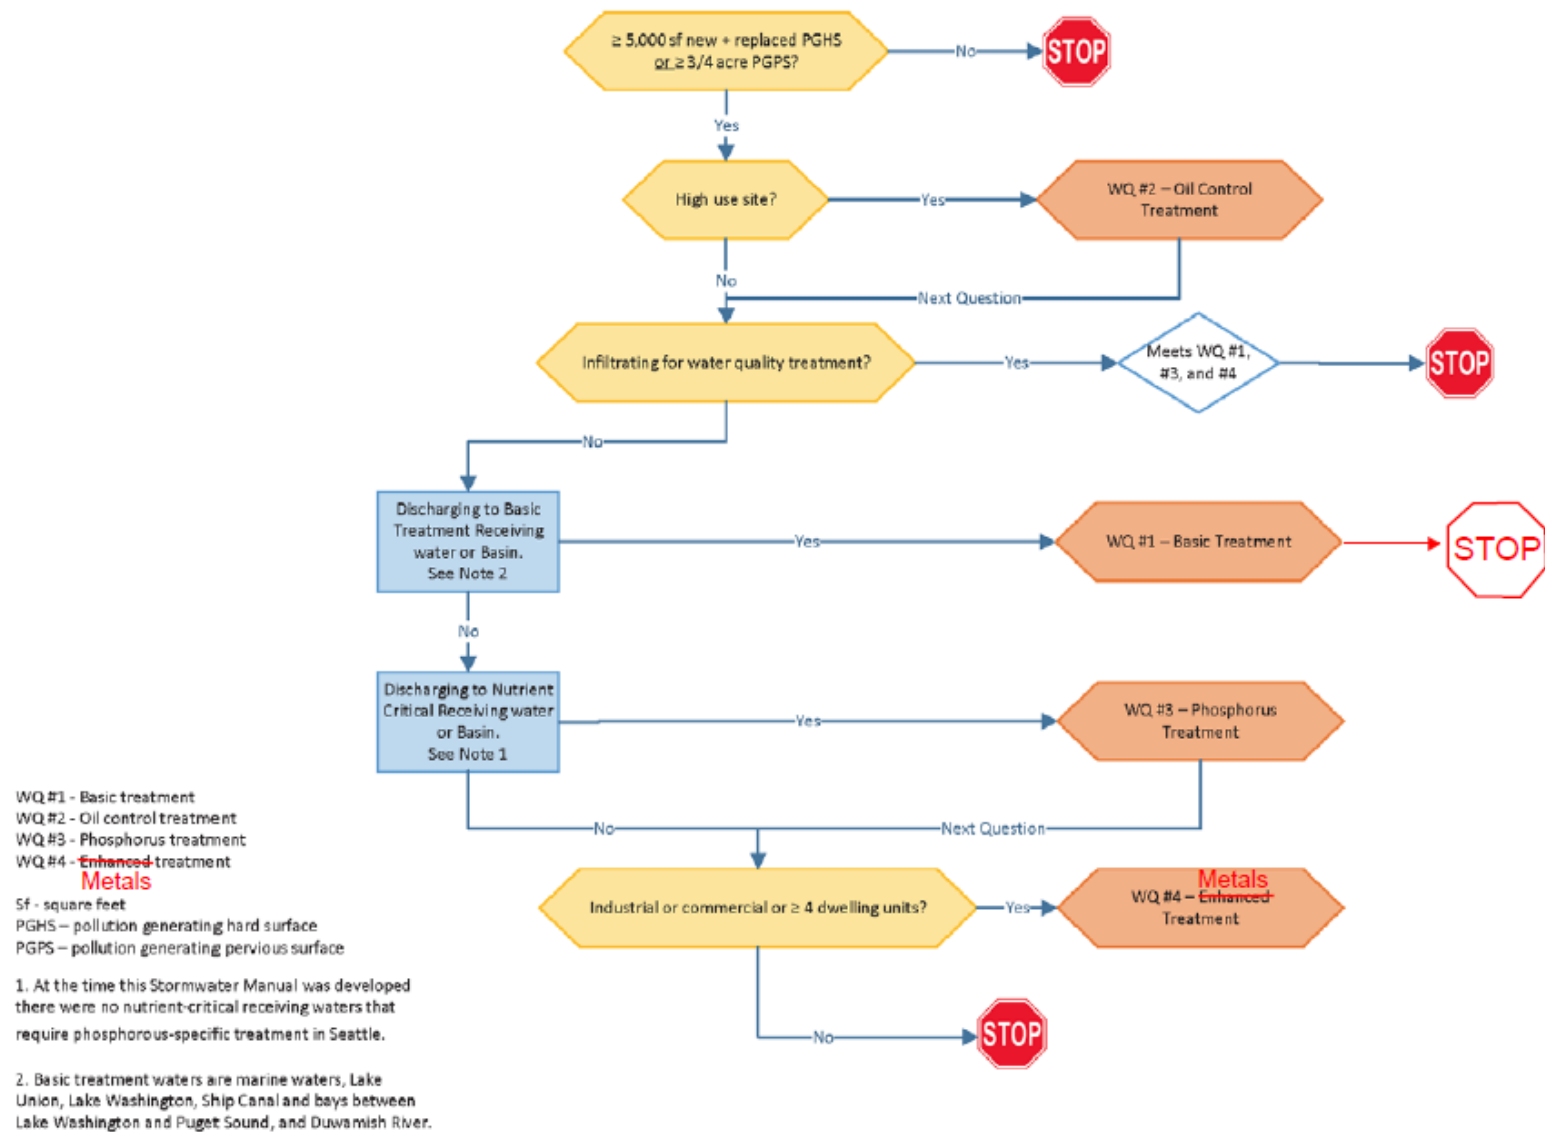
Figure 4.2C. Project Minimum Requirements for Parcel-Based Projects (continued).

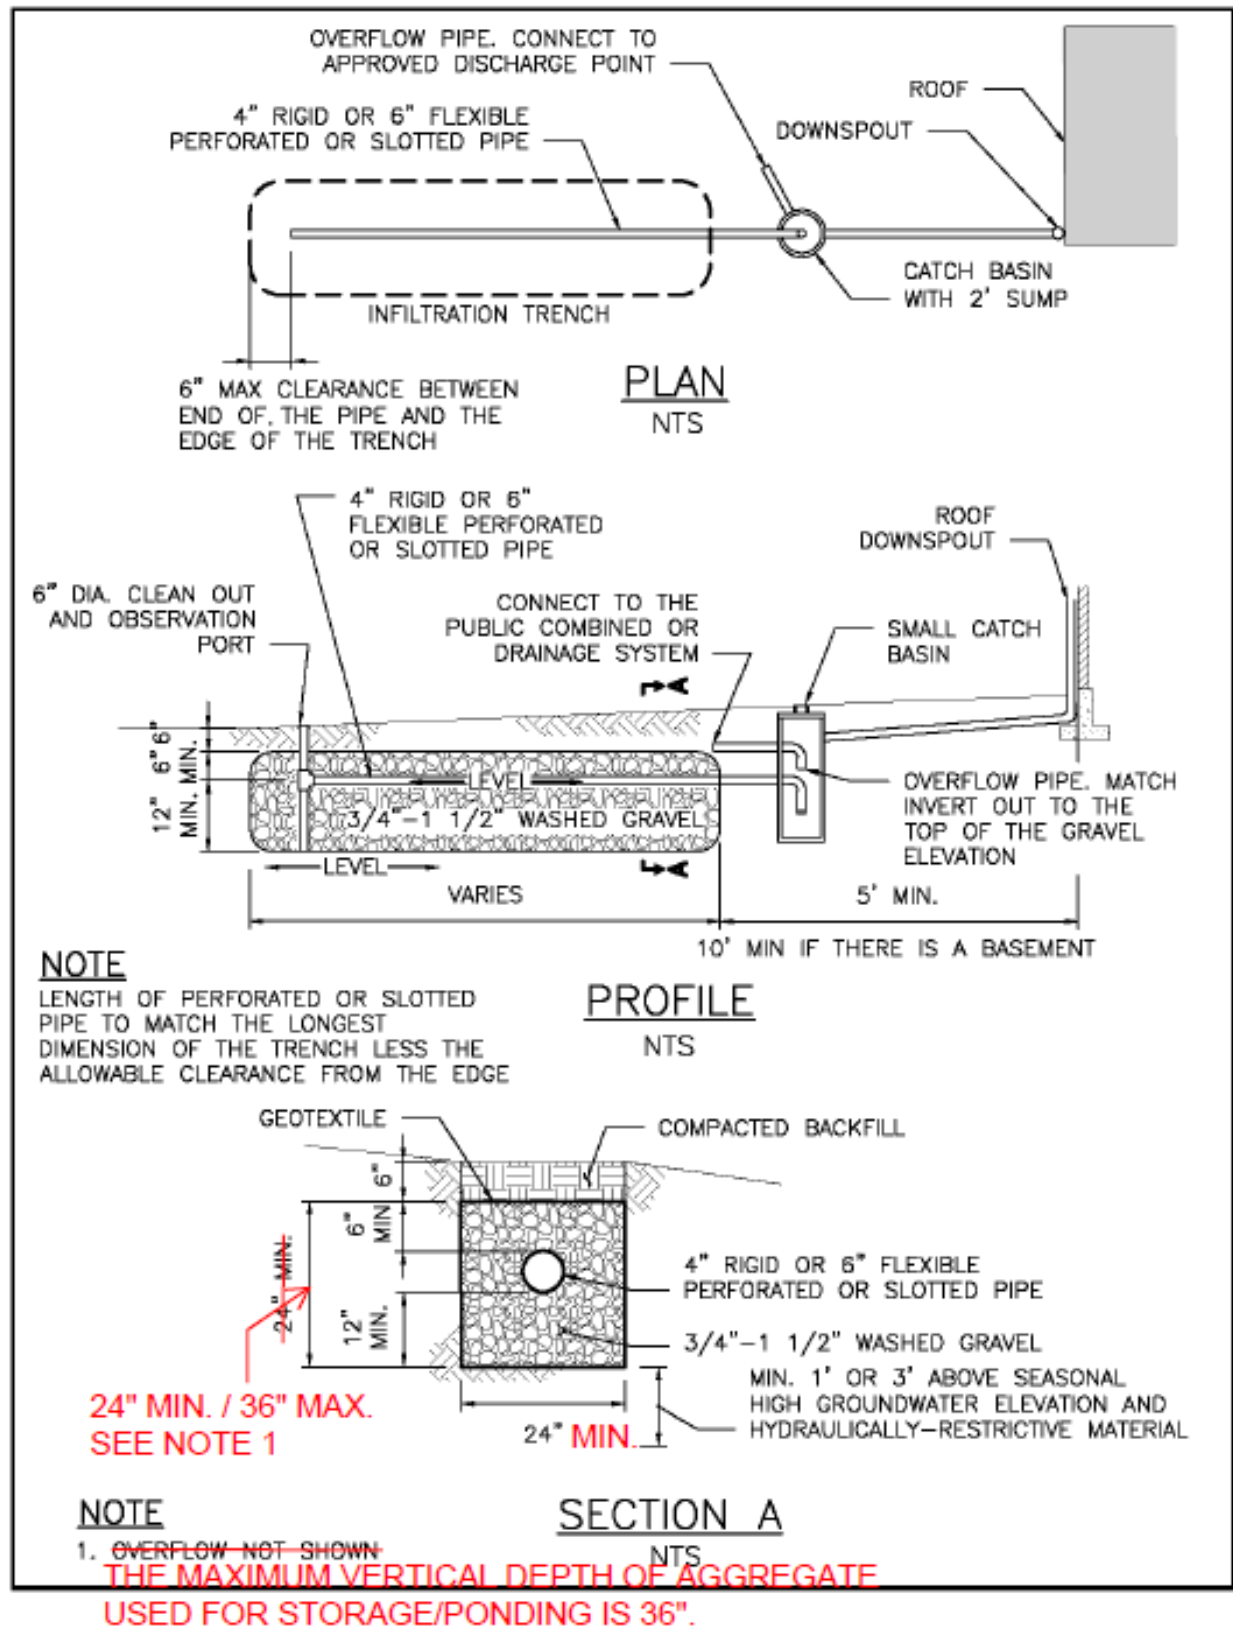
Figure 5.8. Typical Infiltration Trench Receiving Concentrated Flow.

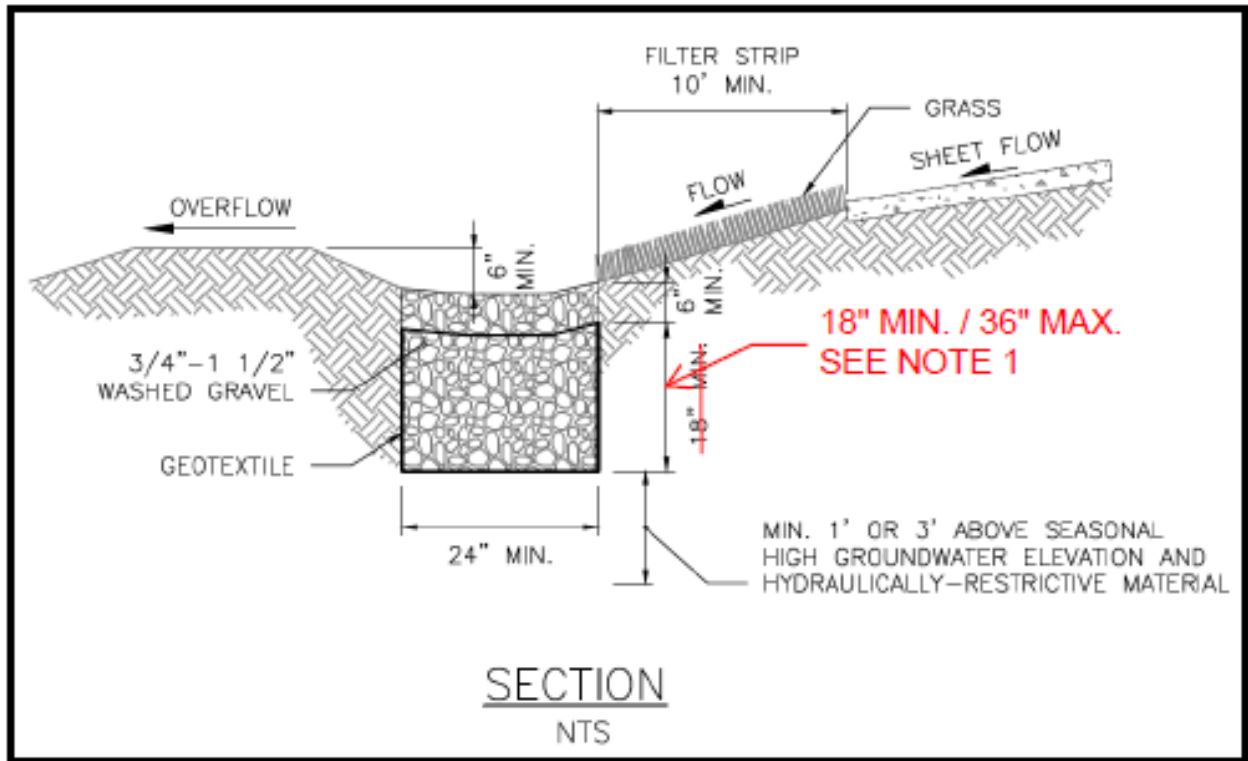
Figure 5.9. Typical Infiltration Trench Receiving Sheet Flow.

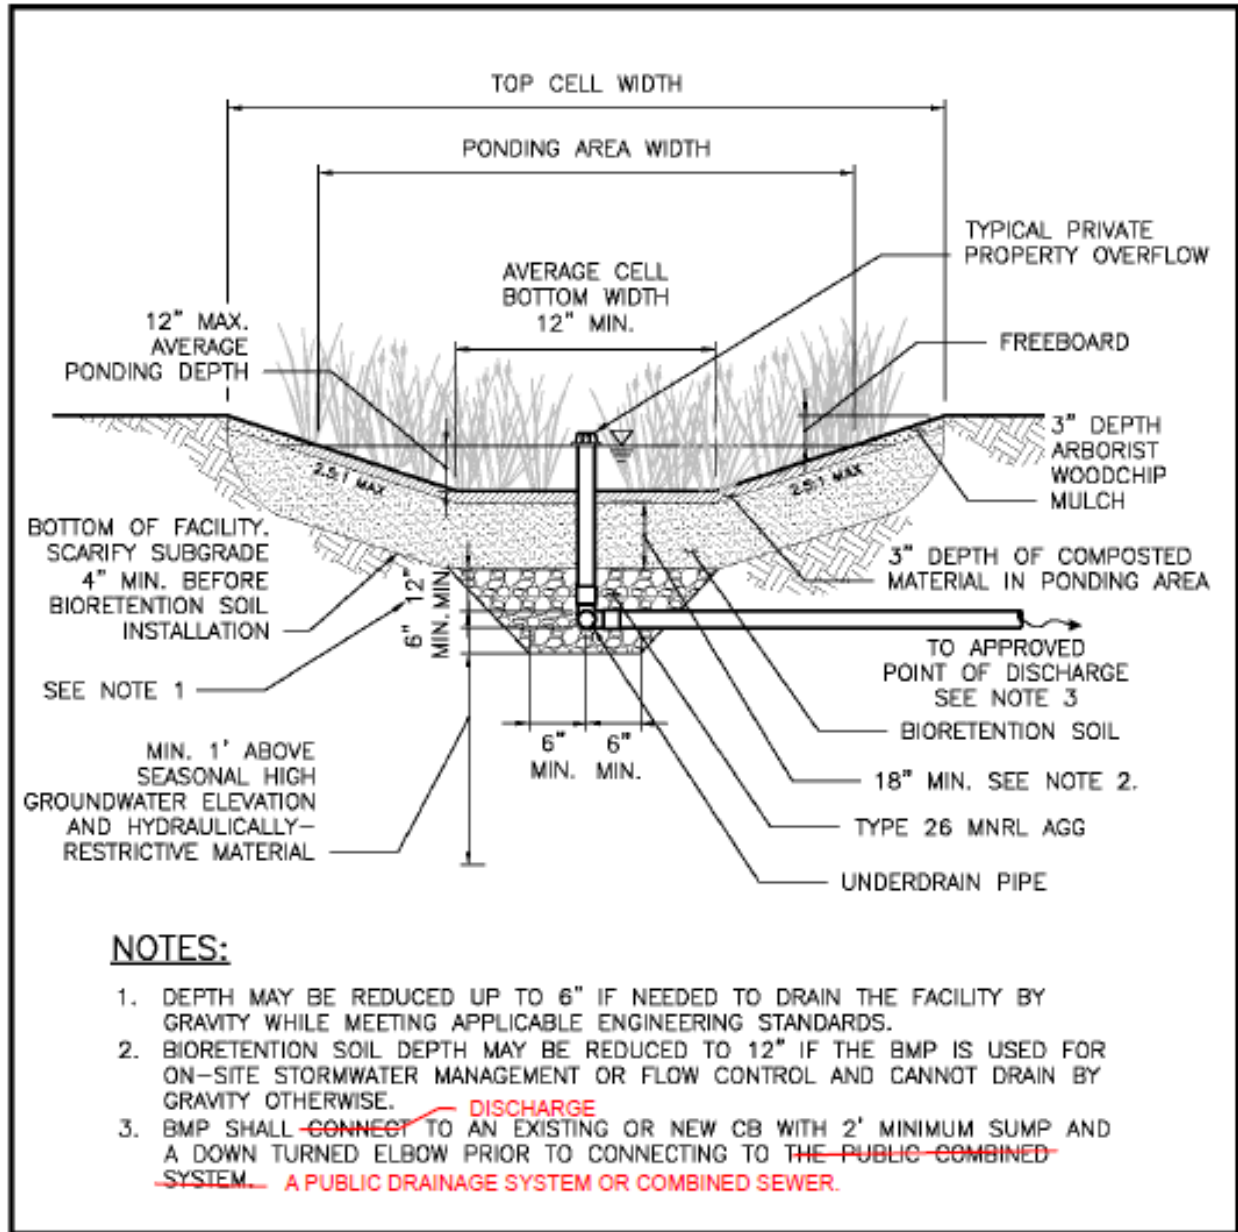
Figure 5.13. Infiltrating Bioretention Facility with Sloped Sides (with Underdrain).

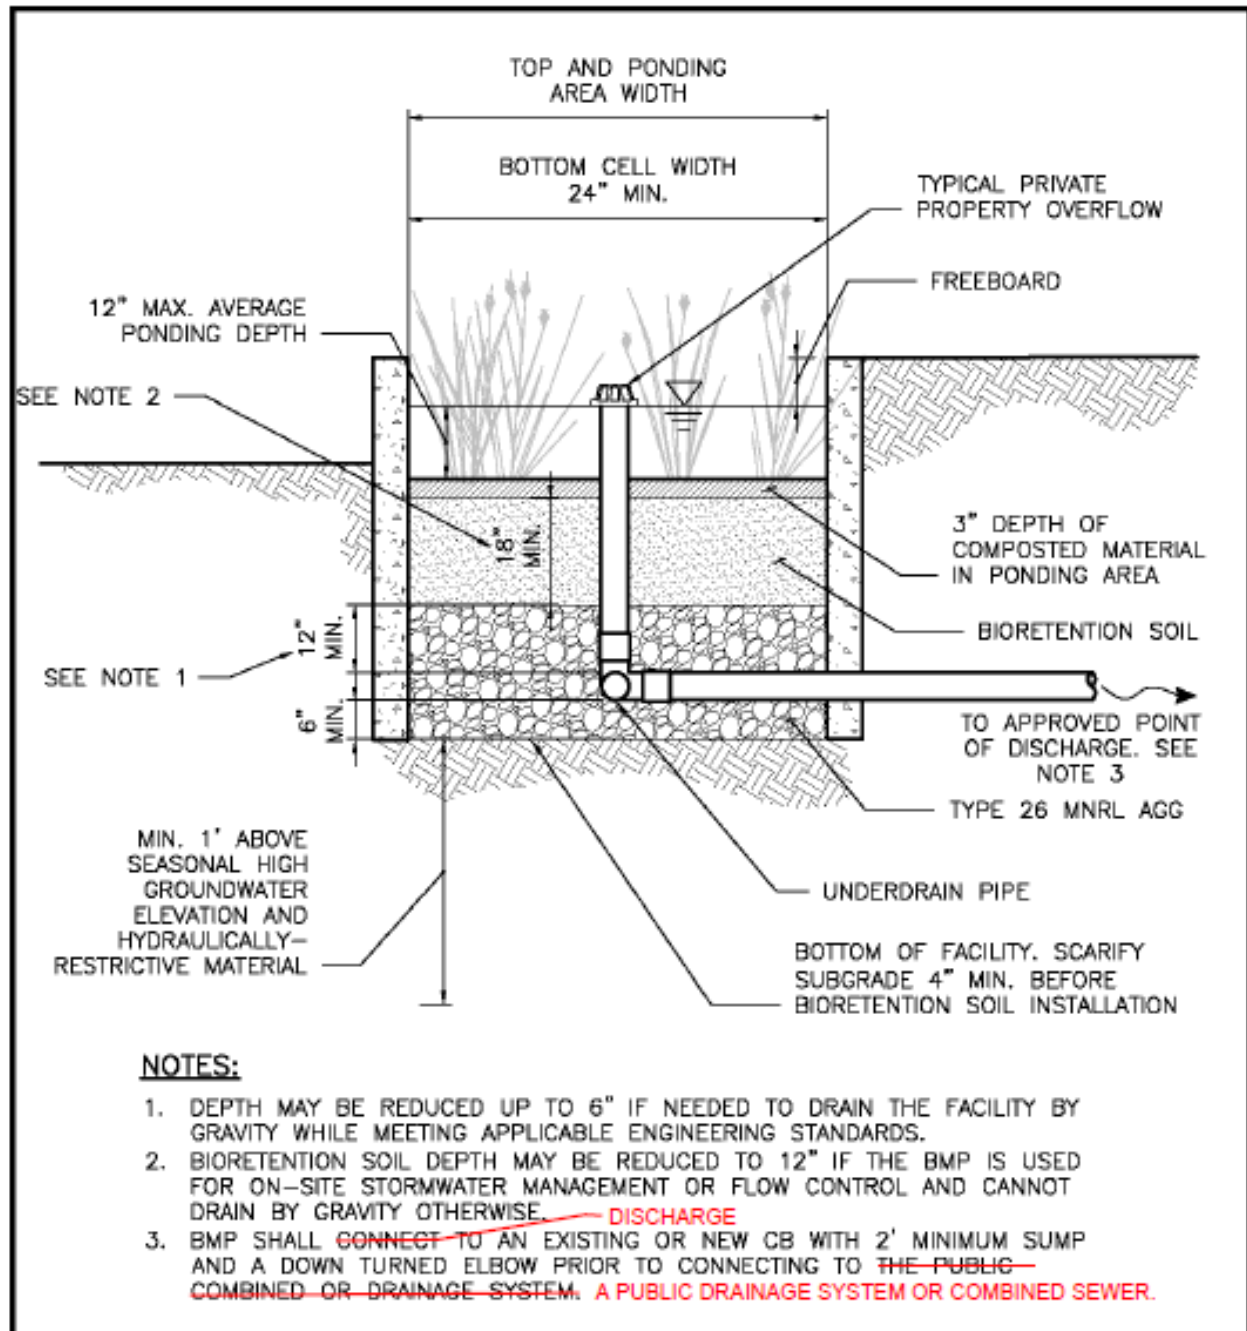
Figure 5.14. Infiltrating Bioretention Facility with Vertical Sides (with Underdrain).

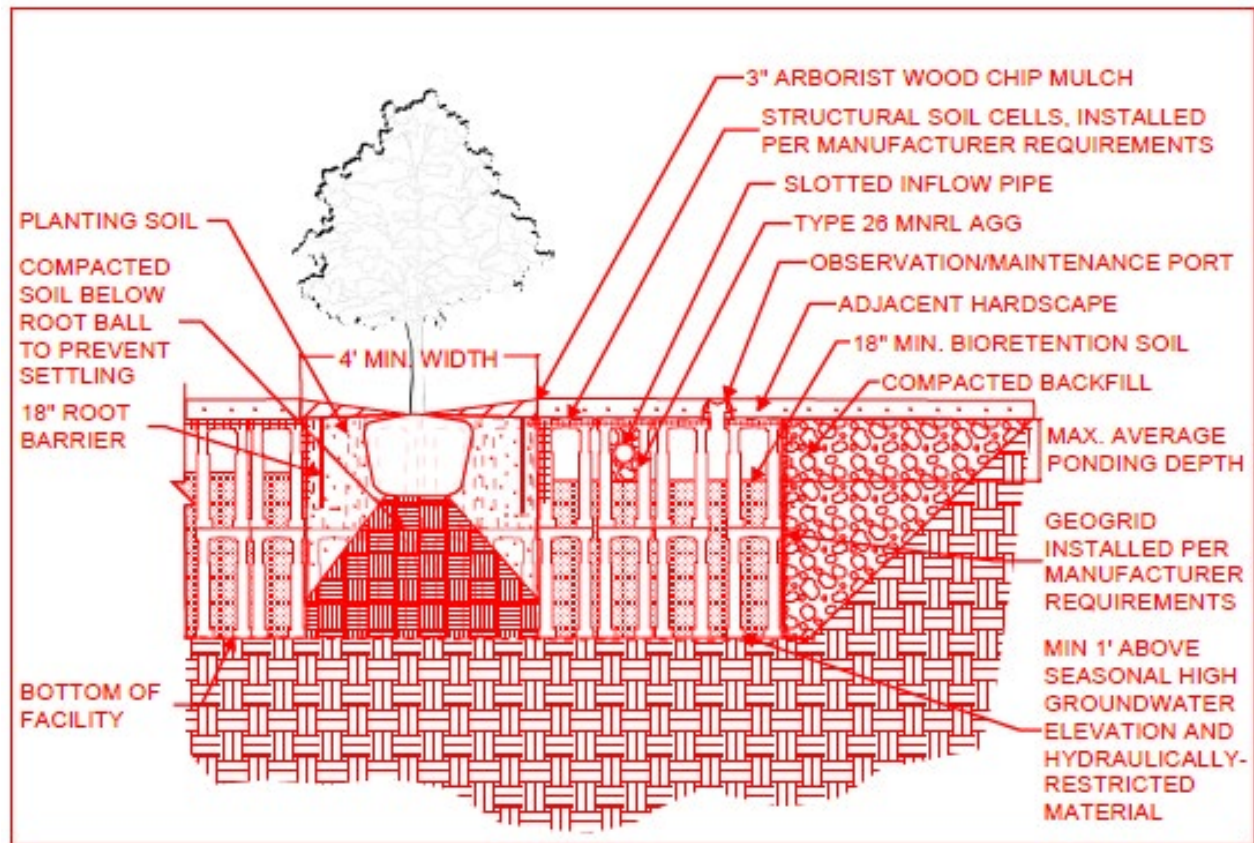
Figure 5.23. Infiltrating Structural Soil Cell BMP without Underdrain. (New Figure)

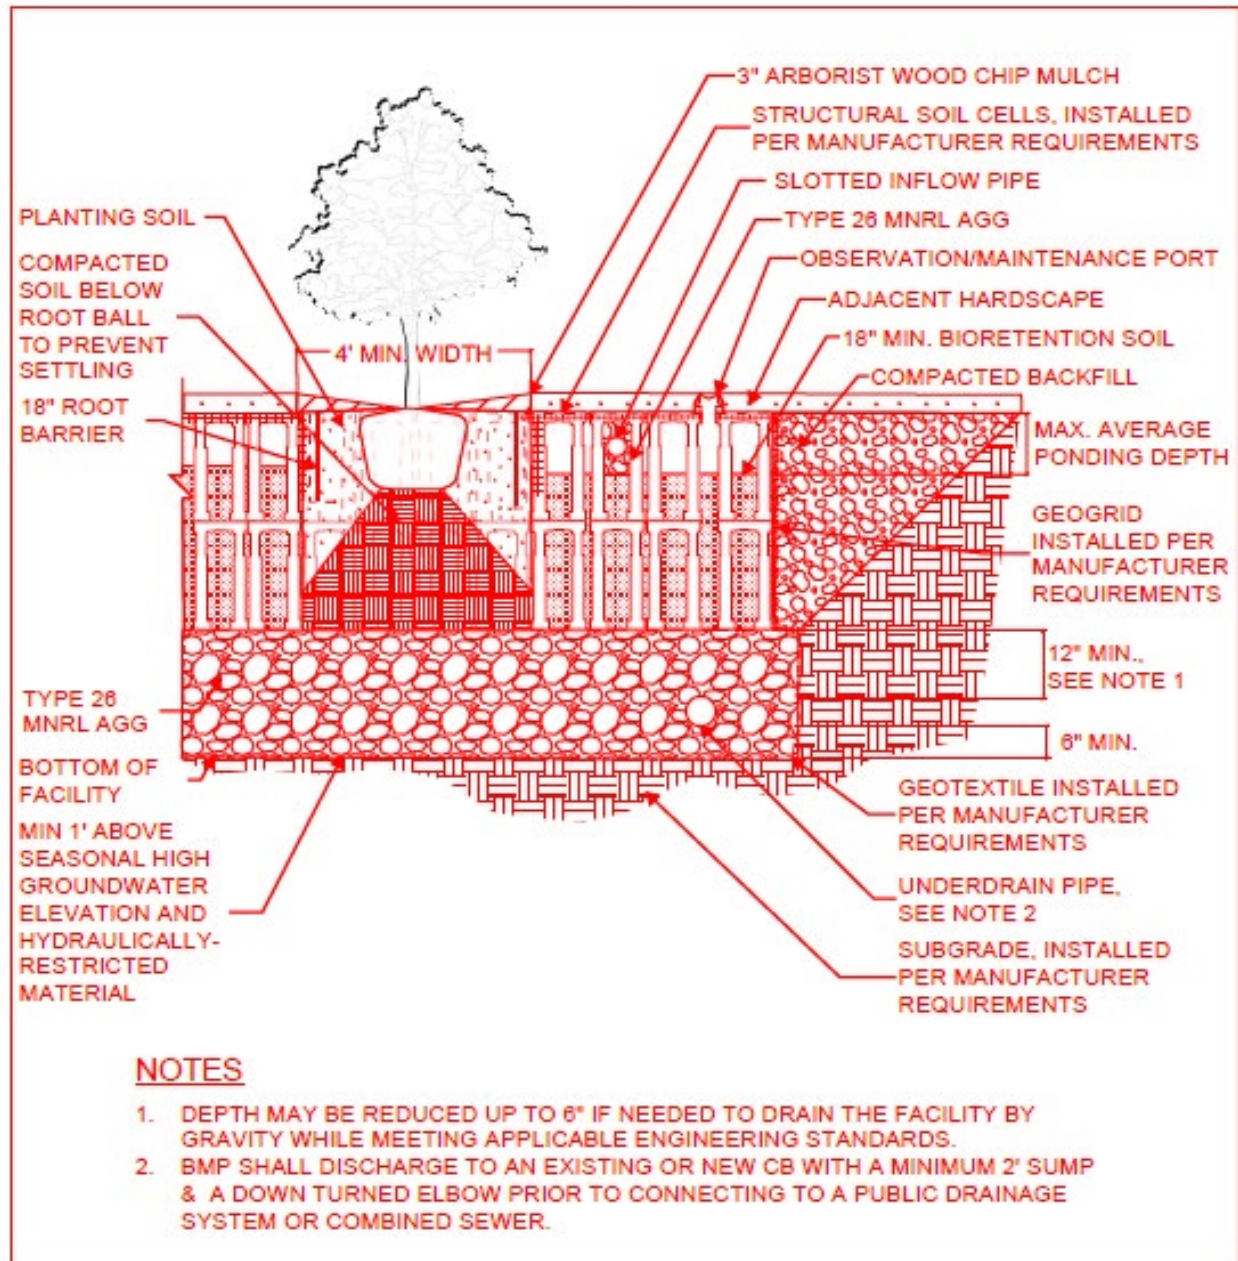
Figure 5.24. Infiltrating Structural Soil Cell BMP with Underdrain. (New Figure)

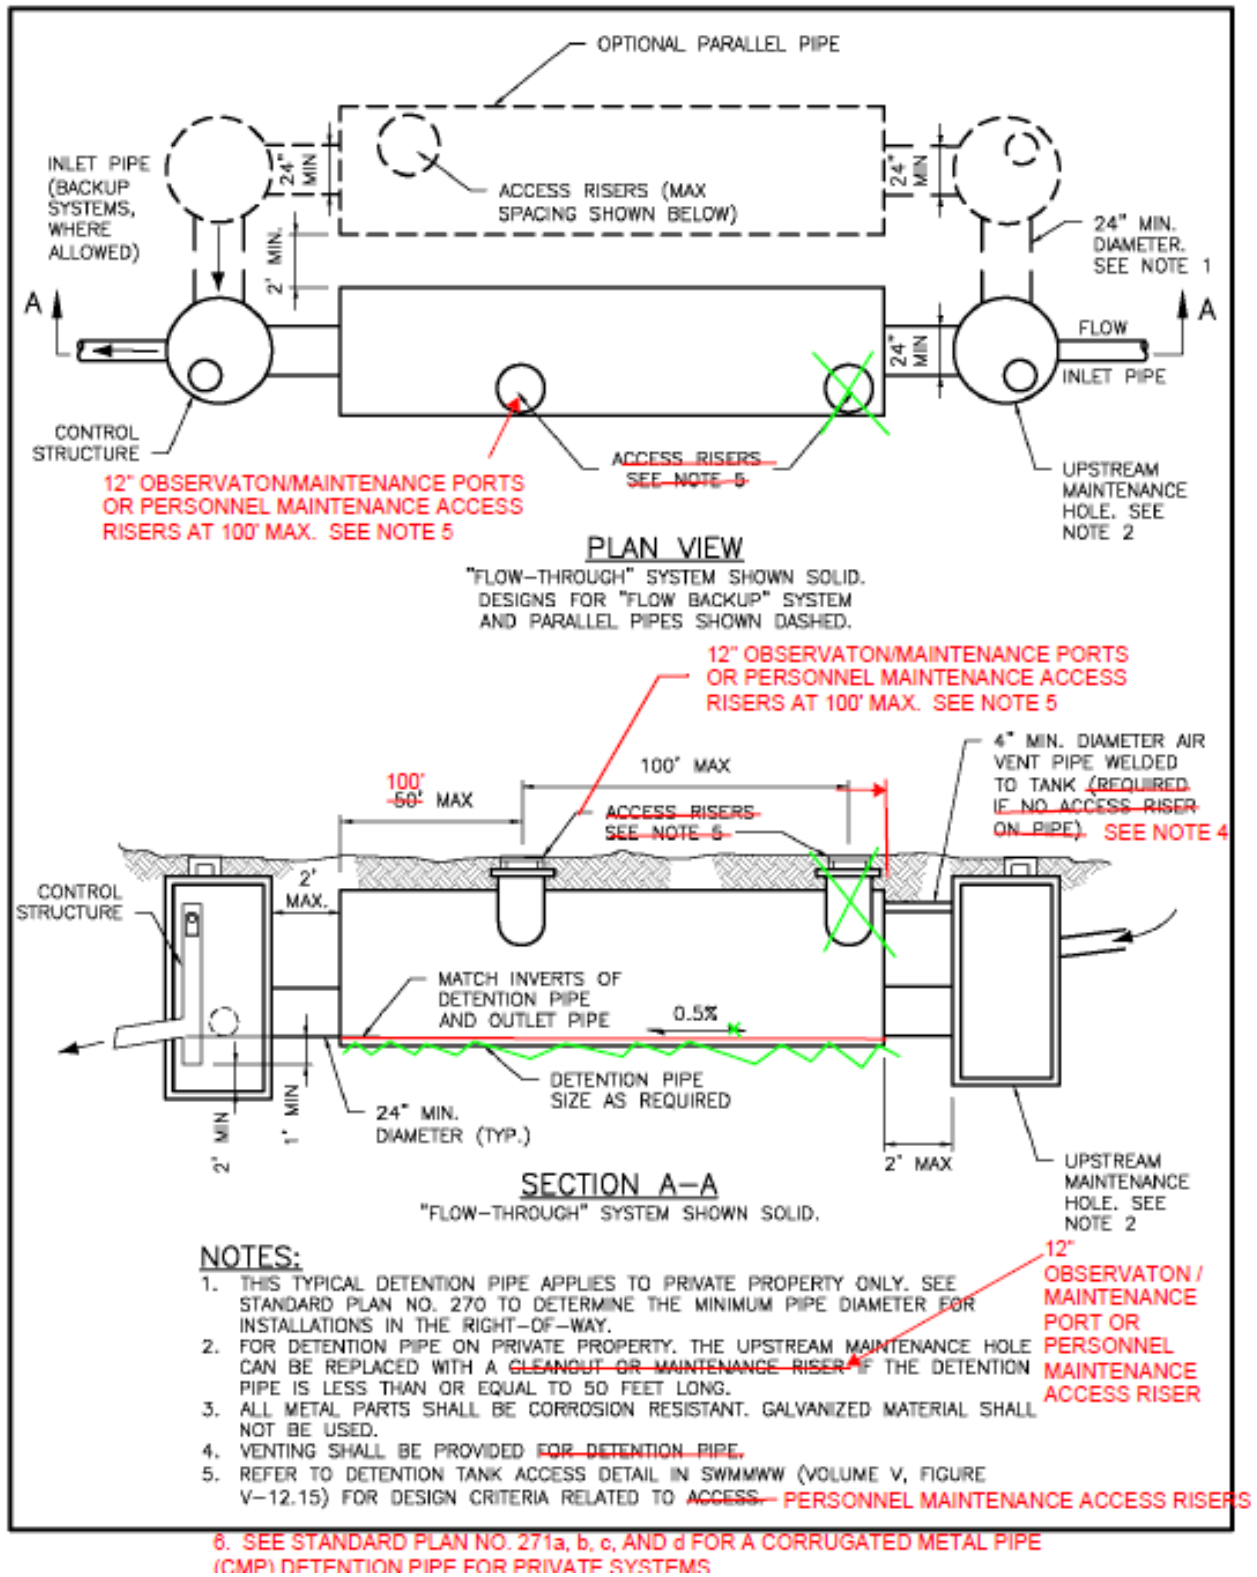
Figure 5.2628. Typical Private Property Detention Pipe.

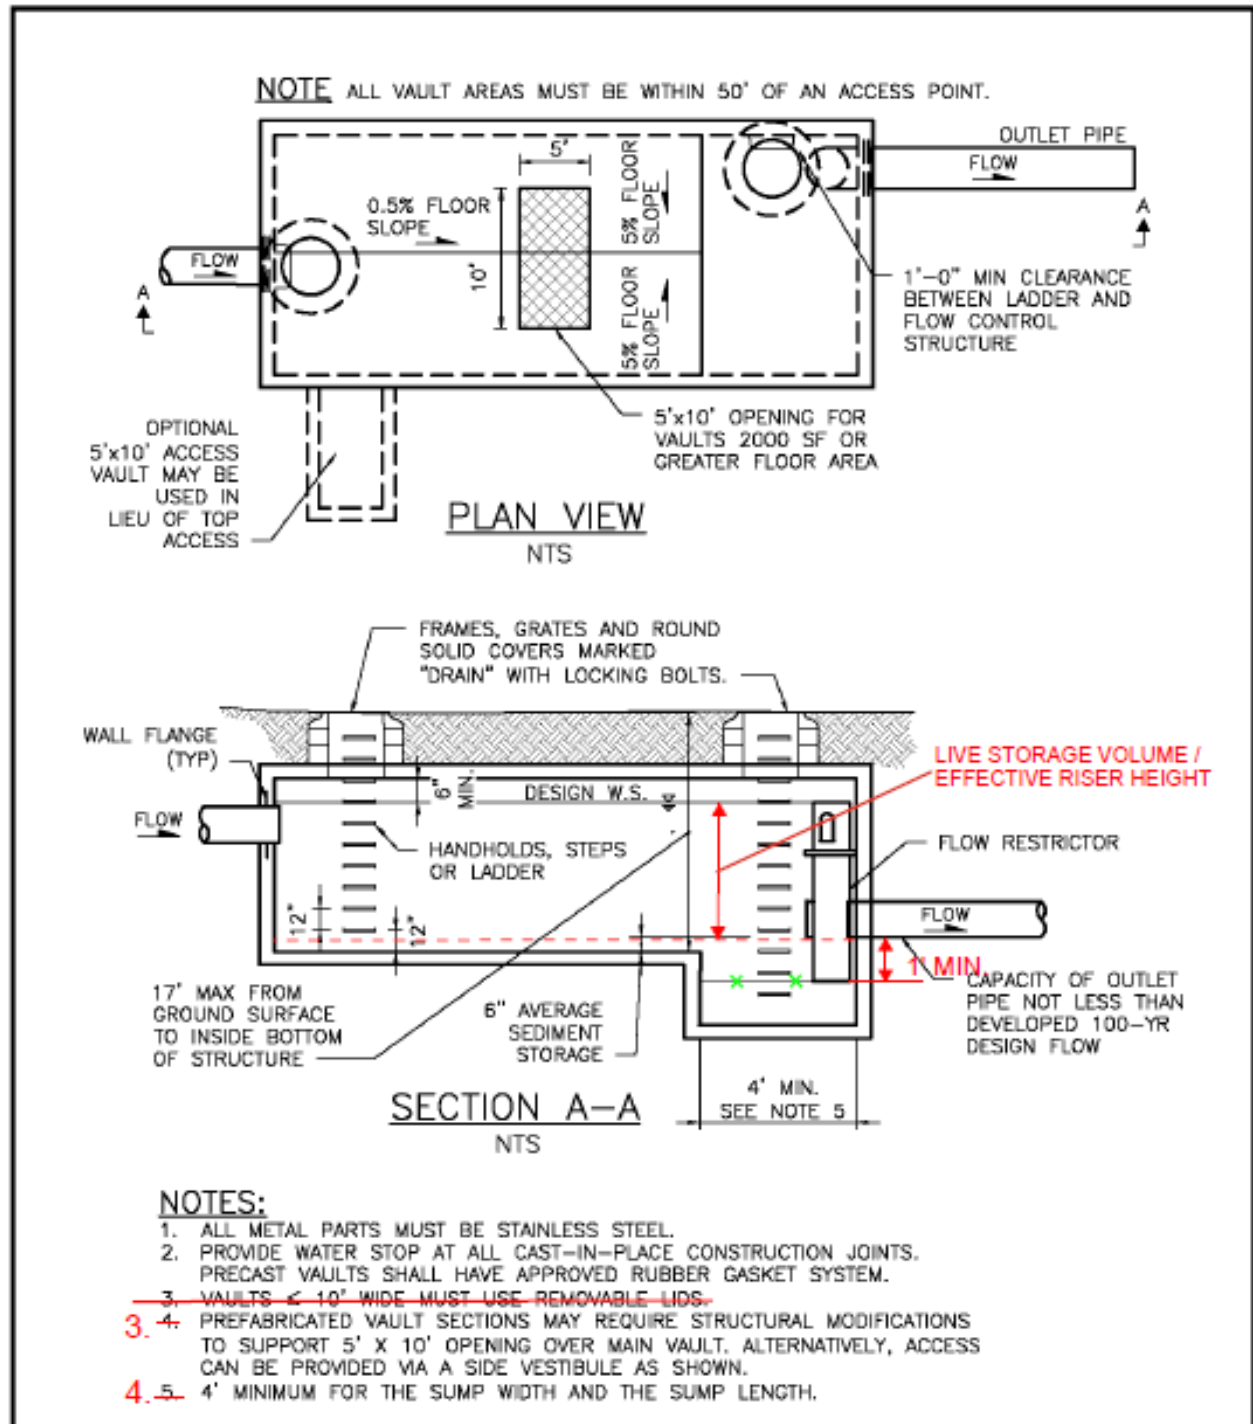
Figure 5.2729. Typical Detention Vault.

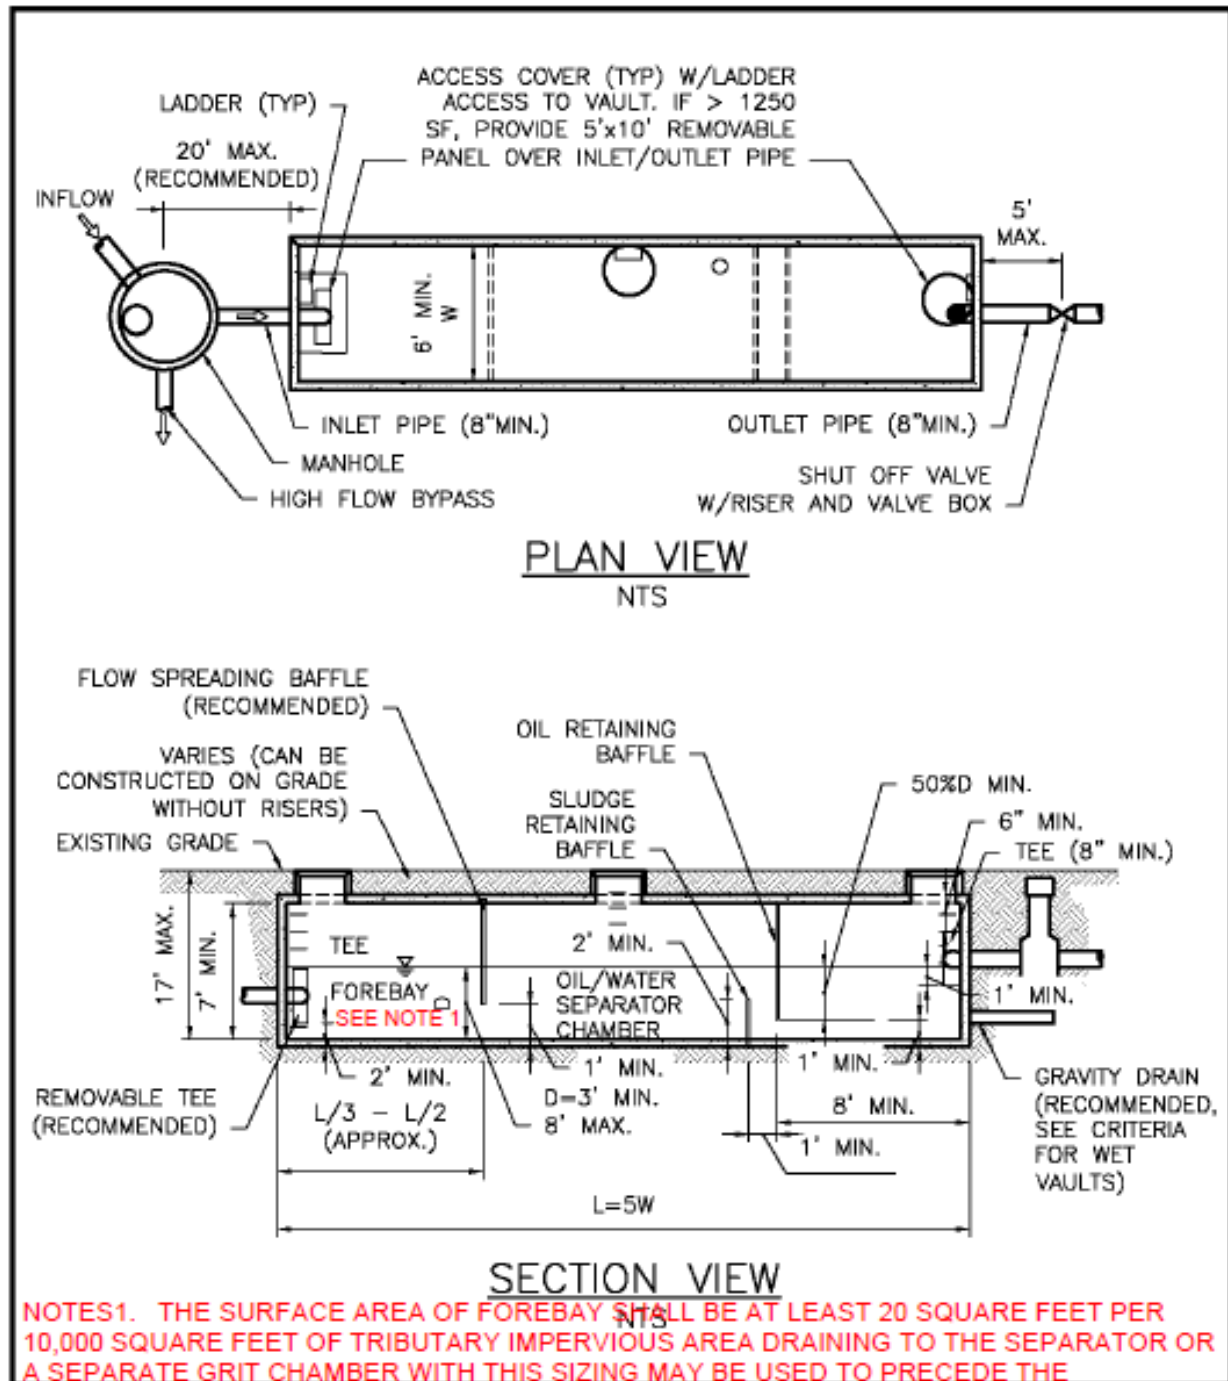
Figure 5.3335. Typical API (Baffle Type) Separator.
