Seattle Stormwater Manual Figure Redlines–

July 2025 Review Draft

Figure Redlines for Volume 1 – Project Minimum Requirements July 2025 Review Draft

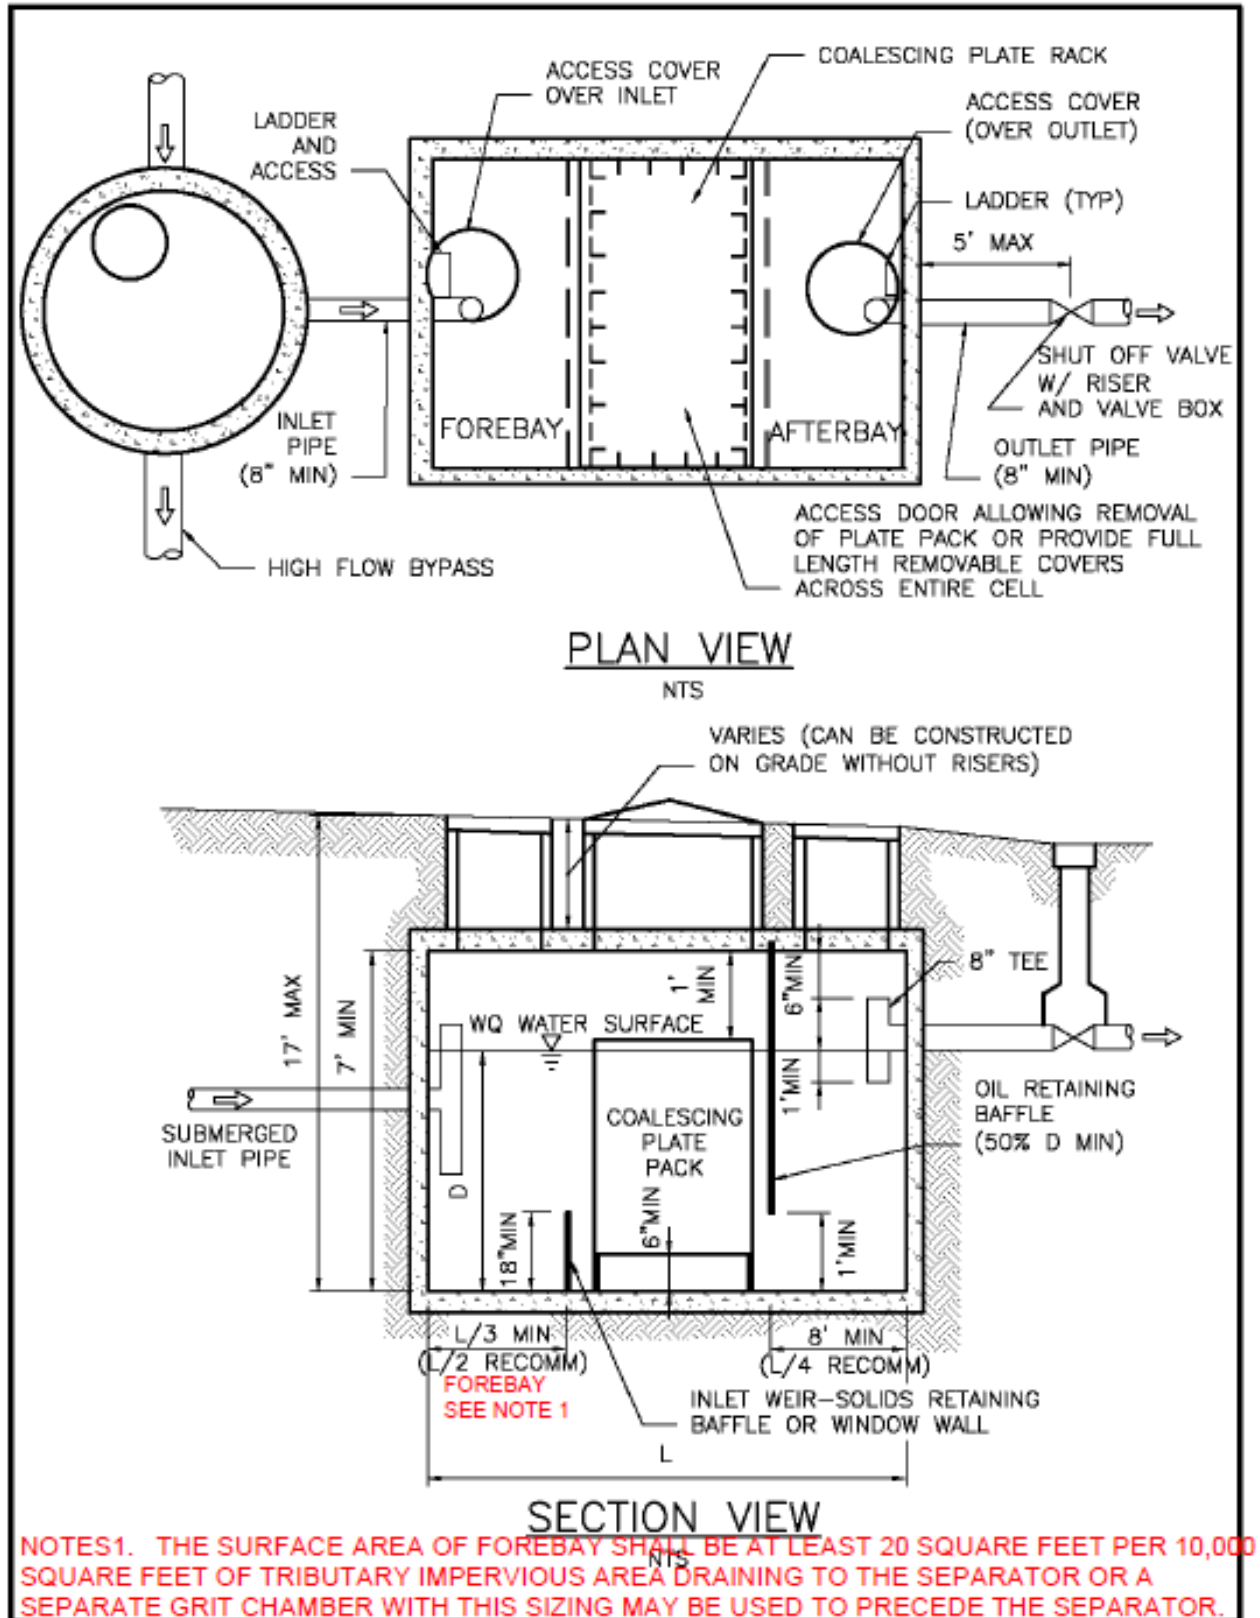
Figure 5.3436. Typical Coalescing Place Separator.

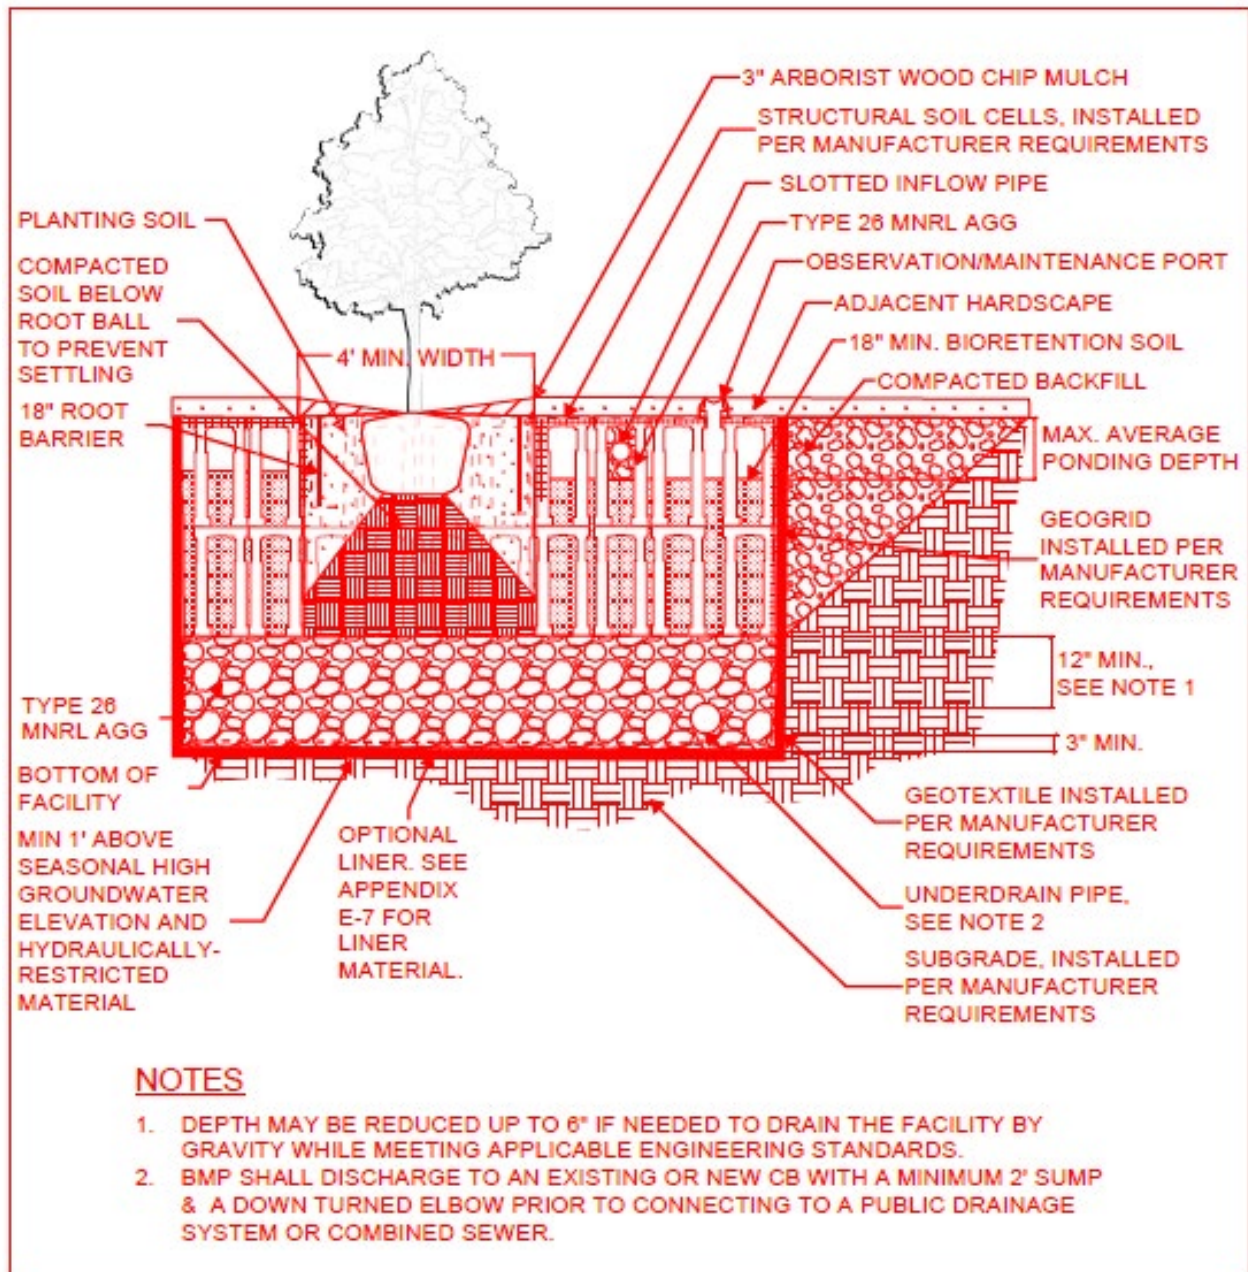
Figure 5.37. Non-infiltrating Structural Soil Cell BMP. (New Figure)

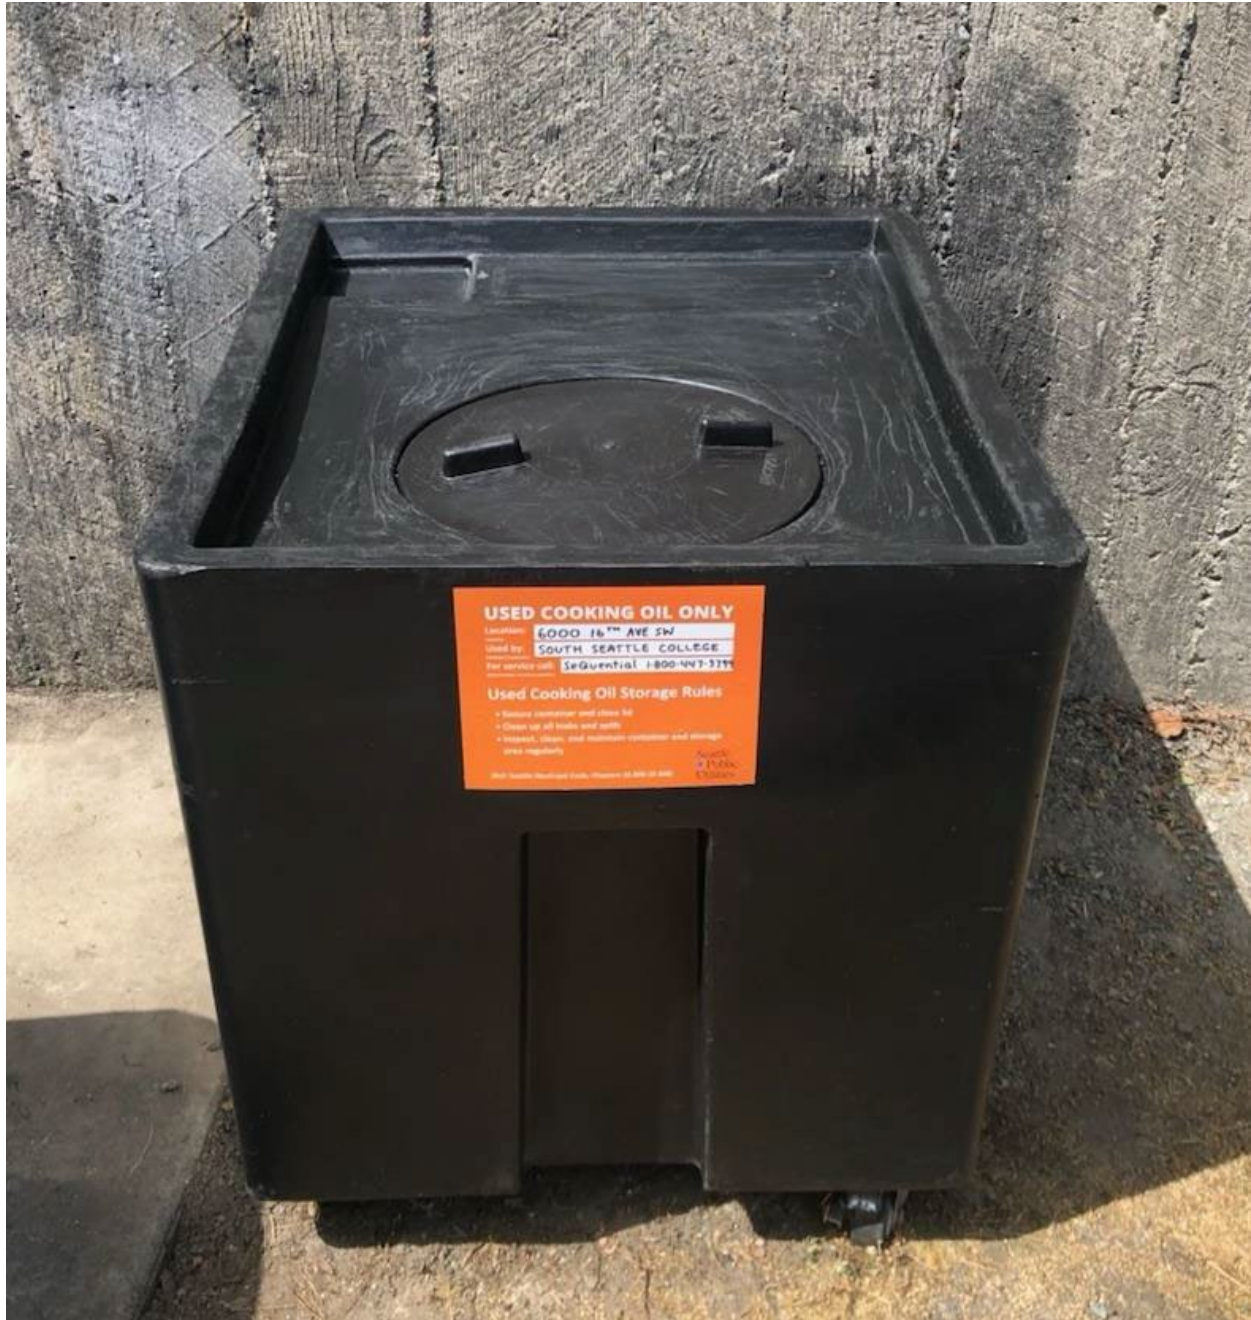
Figure 2. Example of a labeled used cooking oil tote located on a level surface with a secure lid.
(New Figure)

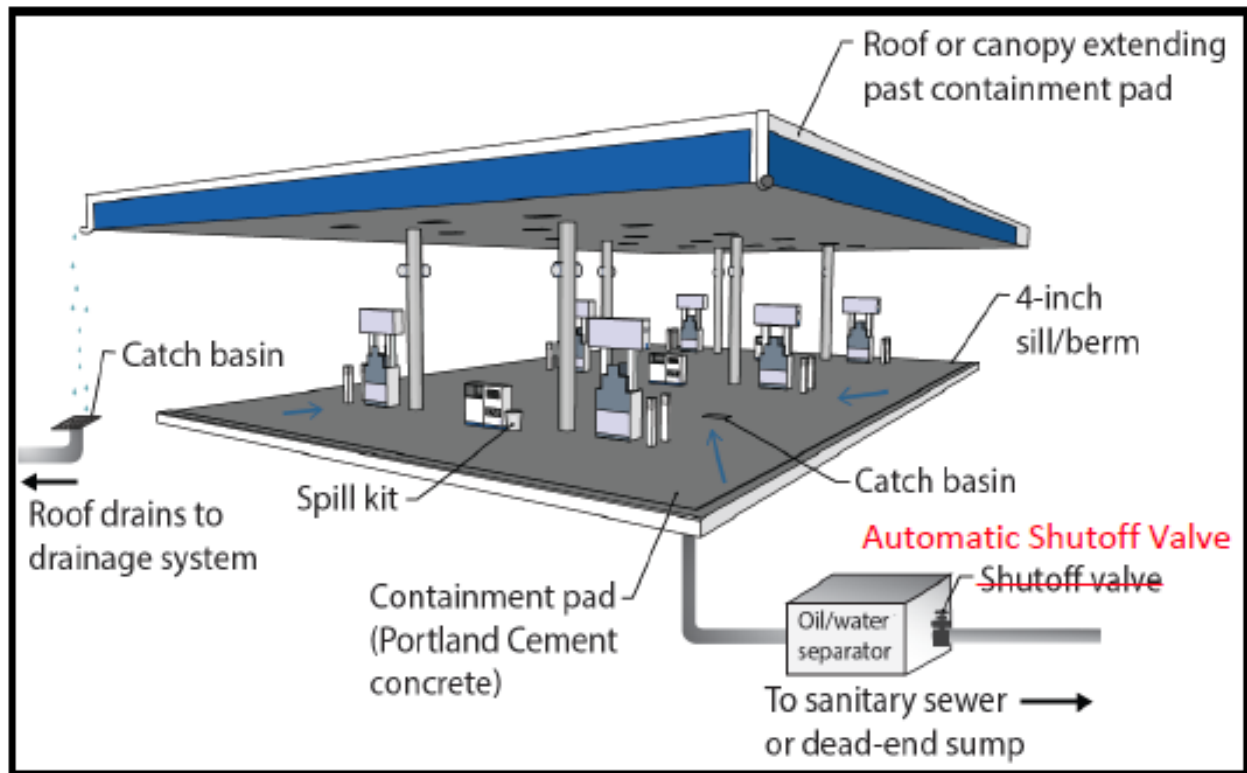
Figure 34. Fueling Island Schematic.
