Cultural Resources Assessment of the Proposed Burke-Gilman Trail Extension Project, Segment 4, Seattle, King County, Washington

Washington Department of Archaeology and Historic Preservation Reference No. 070308-02-FHWA

September 2010

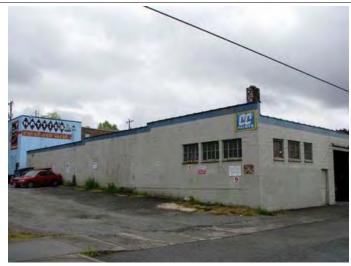
Description of Physical Appearance	flat roof with parapet. The parapet has standing-seam metal flas	hing and asphalt roofing material. The buildi	nstructed of concrete masonry units (CMU, concrete block), and has a ing maintains three banks of original eight-light metal sash windows on parn-style door on a track. The building is attached on the southeast and
Major Bibliographic References

View of west oblique, viewing east

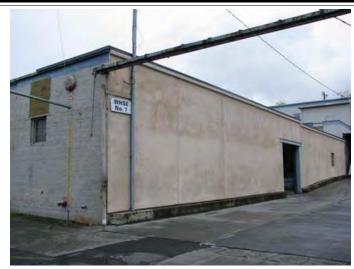
Description of Physical Appearance	southwest elevation is clad in hollow clay tiles and has a roll-up ga	arage door and a large pedestrian entr	constructed of hollow clay tiles and has a flat roof clad in asphalt. The rance door, as well as two twelve-light wood-sash windows. The southeast ding is attached to adjacent buildings on the northeast and northwest
Major Bibliographic References

View of south oblique, viewing north

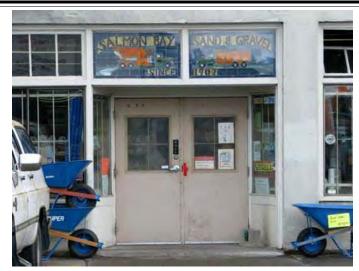
The building appears to retain poor integrity of design, materials, workmanship, feeling, and association and good integrity of setting and location. The building is recommended ineligible to the National Register of Historic Places, the Washington Heritage Register, King County Landmarks designation and the Seattle Landmarks Register due to an inability to meet any of the eligibility criteria.					
Description of Physical Appearance	This tax parcel contains two buildings which are attached. The first building, located on the north side, was constructed in 1920; the second, located on the south side, was constructed in 1940. Both segments are two story and rectangular in plan, on poured concrete foundations with flat roofs. Both buildings are clad in stucco and T1-11 siding. Both have vinyl windows and storefronts that have either been significantly altered and/or boarded over.					
Major Bibliographic References

View of main entry taken 5/18/2010

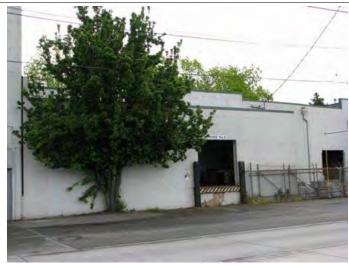
Description of Physical Appearance			north and a corner "flat-iron" section. Both segment has vinyl windows on the first floor and four-ligh	ents are two-story, with exposed concrete block cladding and flat roofs. It wood sash windows on the second floor.
Major Bibliographic References

View of southwest elevation

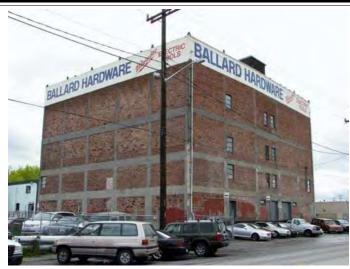
Description of Physical Appearance	the large warel windows. The	house to the southwest has a flat roof with an elevator I warehouse is clad in a combination of poured concrete an assortment of metal doors and roll-up doors. A warel	house. The storefront-side is , brick, and hollow clay tile. T	ry rectangular building on the southwest elevation. Both segments have flat roofs; clad in a combination of structural brick and plywood with a series of wood the building has metal sash windows on the second, third and fourth floors. The side of the building was constructed in 1928, but is currently being expanded and
Major Bibliographic References

View of west oblique, viewing east

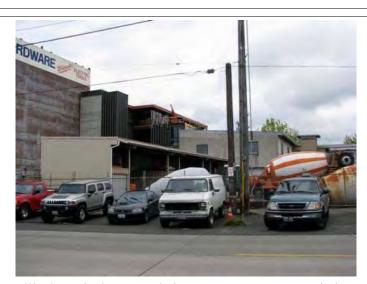
View of Warehouse (under construction)

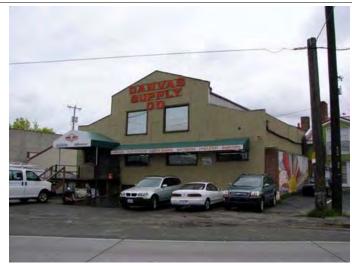
Description of Physical Appearance	vertical wood boards. Th		tal sash windows and a metal entryway	outh. The building is clad in a combination of brick, corrugated metal siding and door, as does the opposite (southwest) elevation. A detached warehouse
Major Bibliographic References

View of west oblique, viewing east taken 5/18/2010

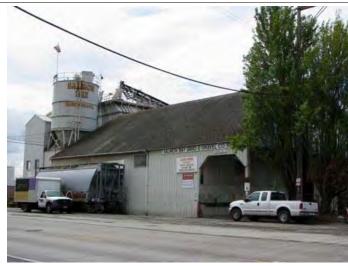
Description of Physical Appearance		the south is a large addition, built in 1960	al 1916 warehouse. The building is clad in standing seam metal and has an 0, with an irregular plan which houses gravel and sand crushing and loading
Major Bibliographic References

View of northeast oblique, viewing southwest
