# Seattle's Source Control Plan for the Lower Duwamish Waterway (2021 – 2026) December 2020 Update

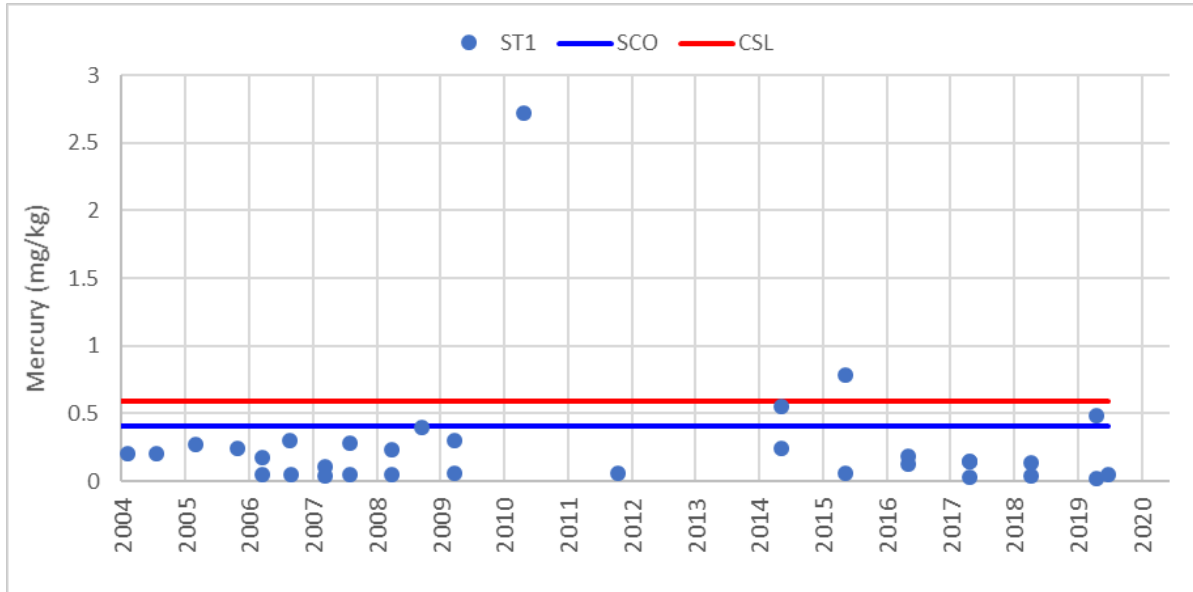
**Figure 1: Mercury in Diagonal Ave S CSO/SD near end-of-pipe samples.**

Mercury concentrations were also elevated (3.3-7.6 mg/kg) in inline samples collected from a small sub-basin of the Diagonal Ave CSO/SD drainage basin, located near Airport Wy S and 7th Ave S. SPU has cleaned the storm drain lines and conducted extensive source tracing efforts in this area but has not yet identified a source. However, as shown in Figure 1, mercury concentrations in the near end-of-pipe samples collected from the Diagonal Ave S CSO/SD have been below SCO in 28 out of 32 samples. King County has found that mercury concentrations can be quite variable in field replicate samples, due to matrix effects. SPU intends to continue tracking mercury in the Diagonal Ave S CSO/SD system.

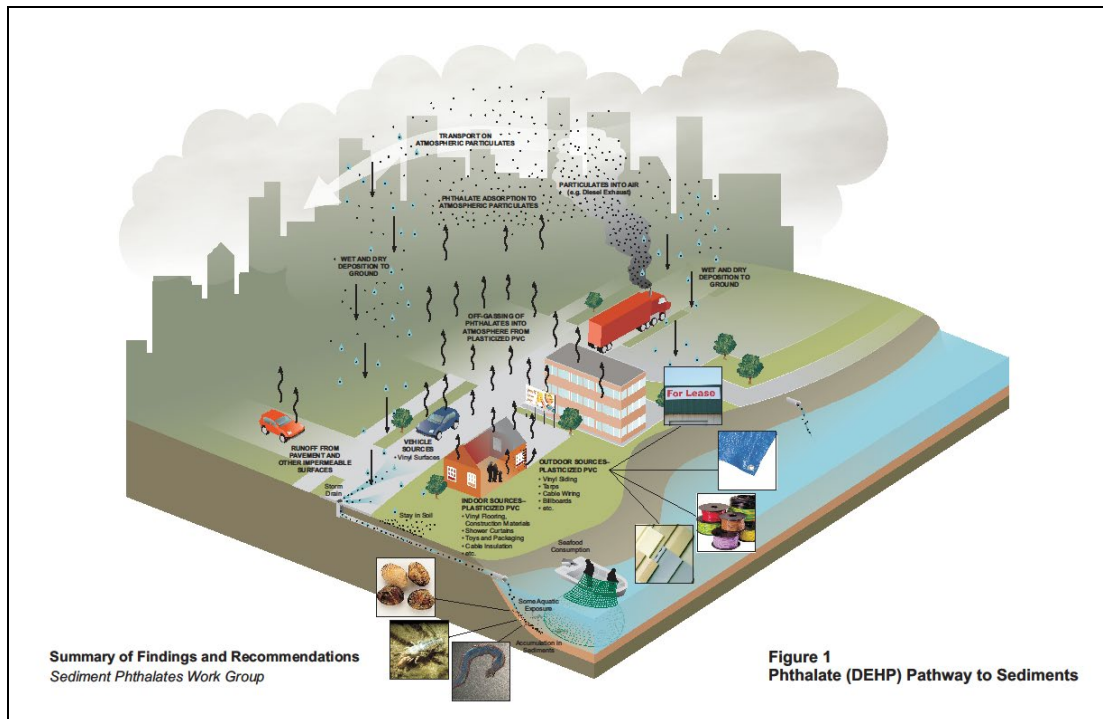
Figure 3: BEHP pathways.

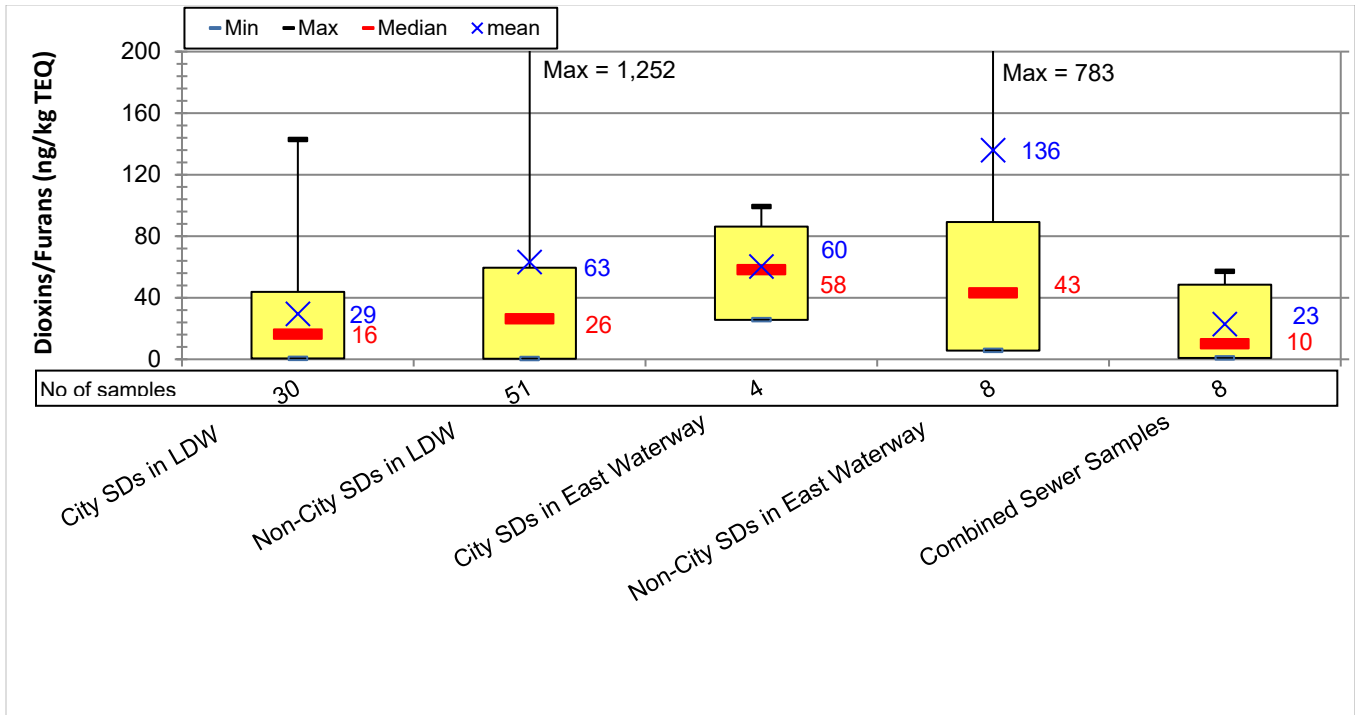
**Figure 4: Comparison of dioxins/furans in City and non-City storm drains and combined sewers in the LDW and East Waterway.**

SPU has analyzed dioxins/furans in 30 source samples collected in 2011 from City storm drains in the LDW. Concentrations ranged from 0.51 to 143 ng/kg TEQ, with an average of 29.5 ng/kg TEQ. The highest concentration (143 ng/kg TEQ) was found in a sample of sediment that had accumulated in the temporary stormwater storage tanks at the Terminal 117 Adjacent Streets site. The tanks receive runoff from the streets adjacent to Terminal 117. The remaining samples contained less than 90 ng/kg TEQ. As shown in Figure 4, dioxin/furan concentrations in samples collected from City-owned storm drains in the LDW are generally lower than most other samples collected from storm drains in the LDW and East Waterway, but are comparable to the concentrations found in samples collected from combined sewers.

The data from the samples indicated widespread, but low concentrations of dioxins/furans throughout the storm drains within the LDW. There was no discernable pattern to concentrations found in the sample results and their proximity to possible sources. Source tracing efforts for dioxins/furans was not effective, as concentrations were generally low and sources of these chemicals are not fully understood. Additionally, the costs associated with analyzing sediment data for Dioxins/Furans is prohibitively expensive, making the source tracing process very difficult and ineffective.

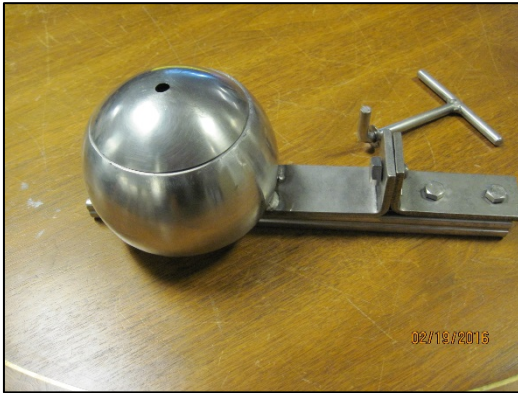
**Figure 5: Field prototype #1.**

In 2013-2017, Ecology funded SPU to develop a new sediment trap that could be easily installed and serviced in a wide range of pipe sizes, particularly in small diameter pipes where the trap that SPU currently uses (modified-Norton) cannot be used due to its high (approximately 9 inches tall) profile. Work involved designing and testing the sediment capture ability of a new trap, followed by side by side testing of the new trap with others (i.e., modified-Norton, SIFT, Fuller, and Hamlin traps) to compare both capture efficiency and chemical quality of the material captured. SPU completed bench testing of several designs in 2015 (SPU 2016). Based on the flume test results, a bowl-style design was selected for field testing. Two versions of the design were fabricated (Figure 5 and Figure 6) and installed at two test locations in early 2016, a 72-inch diameter pipe (Diagonal Ave CSO/SD) and a 24-inch diameter pipe (S Myrtle St SD).

Test results for the 2016 and 2017 seasons were provided to Ecology (SPU 2019). Although not all the traps were able to capture enough sample quantity for both grain size and chemistry testing, the results indicated that the new trap design performed similarly to the other styles currently in use for source tracing.

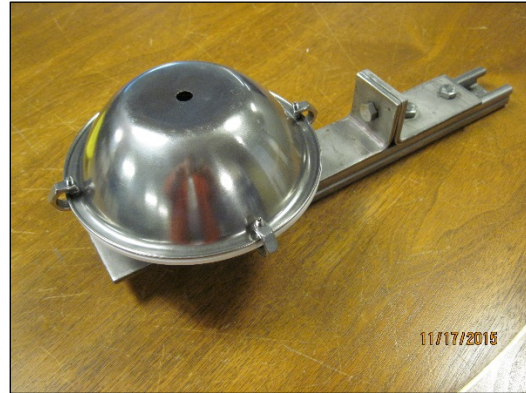
**Figure 6: Field prototype #2.**

Prototype #2, which was fabricated from two stainless steel bowls, experienced rust problems within one year of installation. SPU eliminated this model and in 2019, developed a third model fabricated from a stainless-steel 3¼-inch pipe cap (Figure 7). SPU intends to install Prototypes 1 and 3 in new locations where a lower profile trap is needed. Because these new traps will be installed in small diameter pipes which serve small drainage basins (5-25 acres), the primary concern will be the ability to capture enough material for chemical analyses. SPU routinely installs two traps at each location but may need to install additional traps to ensure enough material is collected.

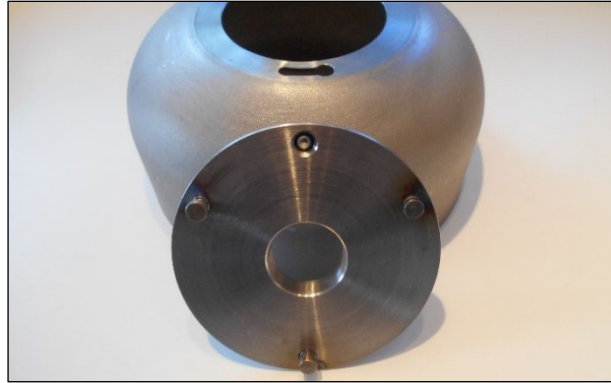
**Figure 7: Field prototype #3.**

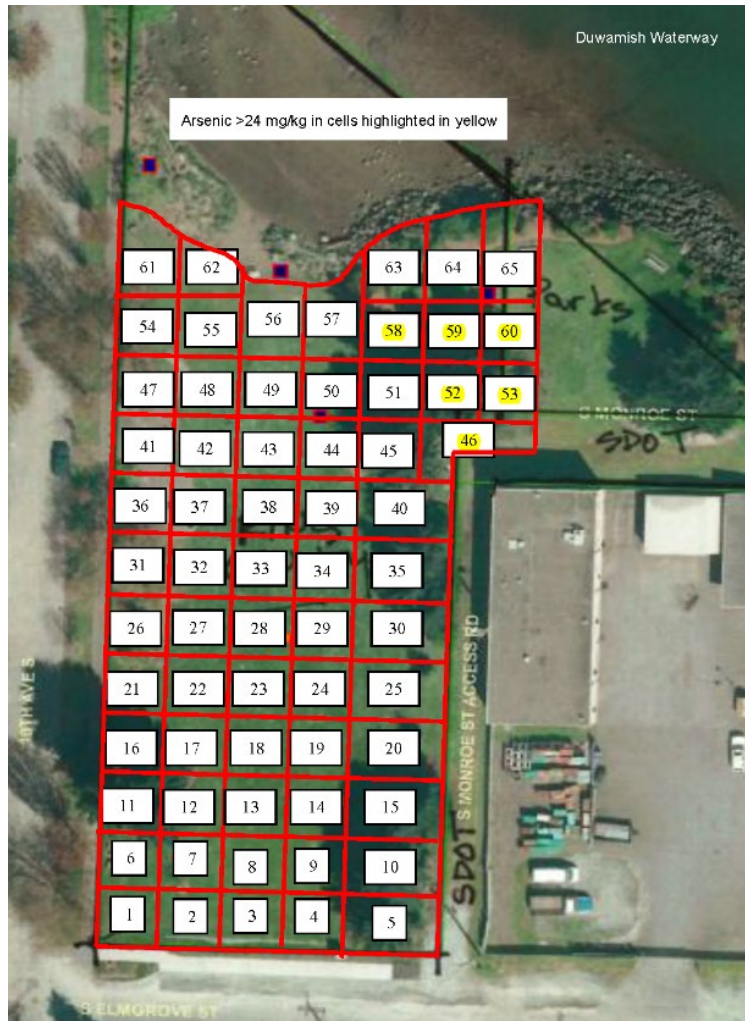
**Figure 8: Soil sample locations at Duwamish Waterfront Park.**

Seattle Parks and Recreation Department (Parks) investigated soil contamination at the Duwamish Waterway Park located at 10<sup>th</sup> Ave S and S Elmgrove St in 2014-2019 (Eco Compliance Corporation, 2019). Soil samples were collected from depths of 1-6 inches and 7-12 inches at approximately 61 locations on the site and were analyzed for arsenic and lead. Arsenic ranged from 4.1 to 104 mg/kg. The highest concentrations (41.7 – 104 mg/kg) were found in six samples located in the northeast corner of the site (Figure 8). Parks is undertaking the following steps to address contamination on this site:
