# **WATER YEAR 2007 DATA REPORT**

# High Point Phase I Block Scale Monitoring

Seattle Public Utilities

Herrera Environmental Consultants, Inc. 2200 Sixth Avenue, Suite 1100 Seattle, Washington 98121

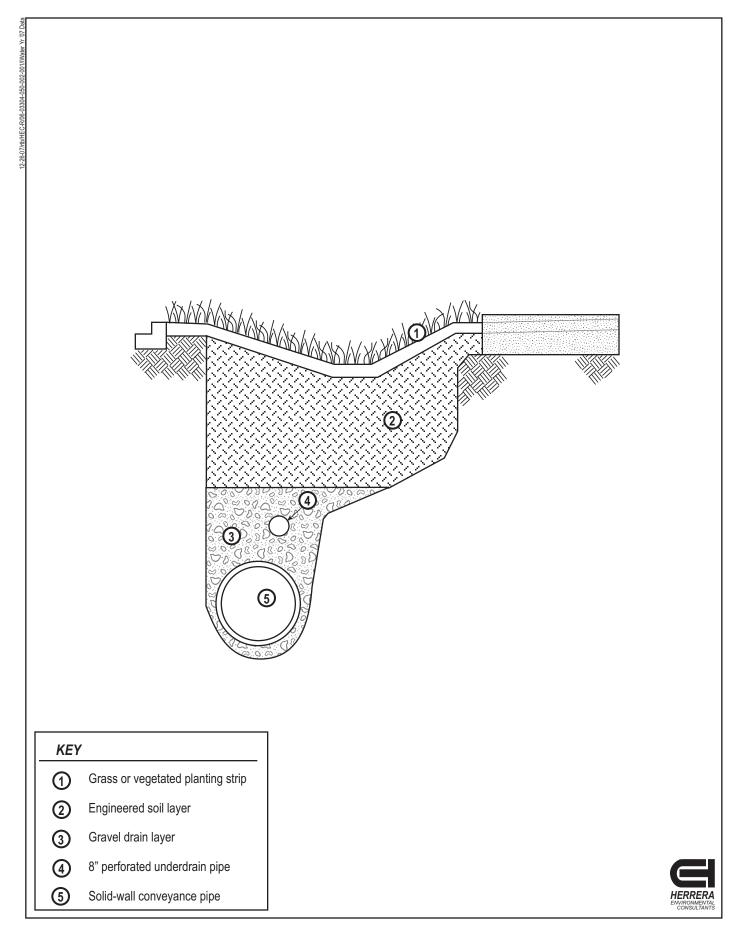
Figure 2. Schematic diagram of a typical NDS swale cross-section.

During operation, stormwater runoff from the surrounding drainage basin enters the planting strip via sheetflow where it is retained for a sufficient period of time to allow for infiltration to the underlying engineered soil layer. Absorption and filtration processes within the engineered soil layer then provide water quality treatment. Storage within the engineered soil layer also serves to attenuate stormwater runoff flow rates and volumes. Under saturated conditions, stormwater will infiltrate from the engineered soil layer down to the gravel drain layer. The gravel drain layer provides additional storage for attenuating stormwater runoff flow rates and volumes. Overflow from the gravel drain layer is first collected in the 8-inch perforated underdrain pipe and then discharged to the solid-walled pipe (via a public storm drain manhole [PSDMH]) for conveyance out of the NDS swale.

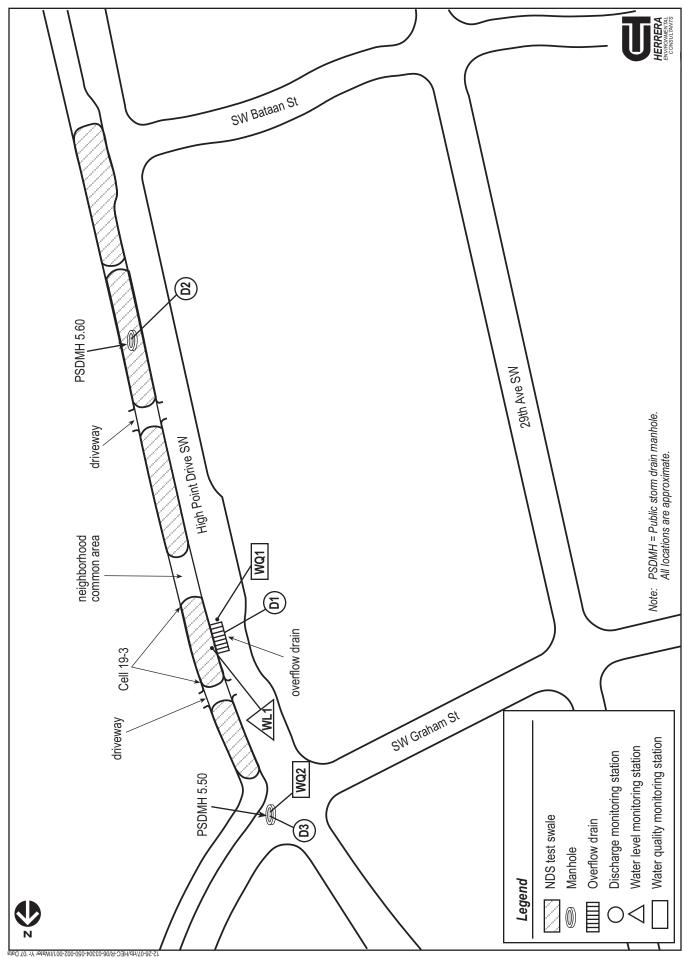
Plan view of NDS test swale and monitoring station locations for the High Point Phase I Block Scale monitoring. Figure 4.

The purpose and general location of the monitoring stations associated with these study components also are summarized in Table 1. The specific location of the monitoring stations is also shown in Figure 4.

Water quality samples are being collected during six separate storm events at the monitoring stations depicted in Figure 4 (i.e., WQ1 and WQ2). The following conditions serve as guidelines for defining the acceptability of specific storm events for sampling:

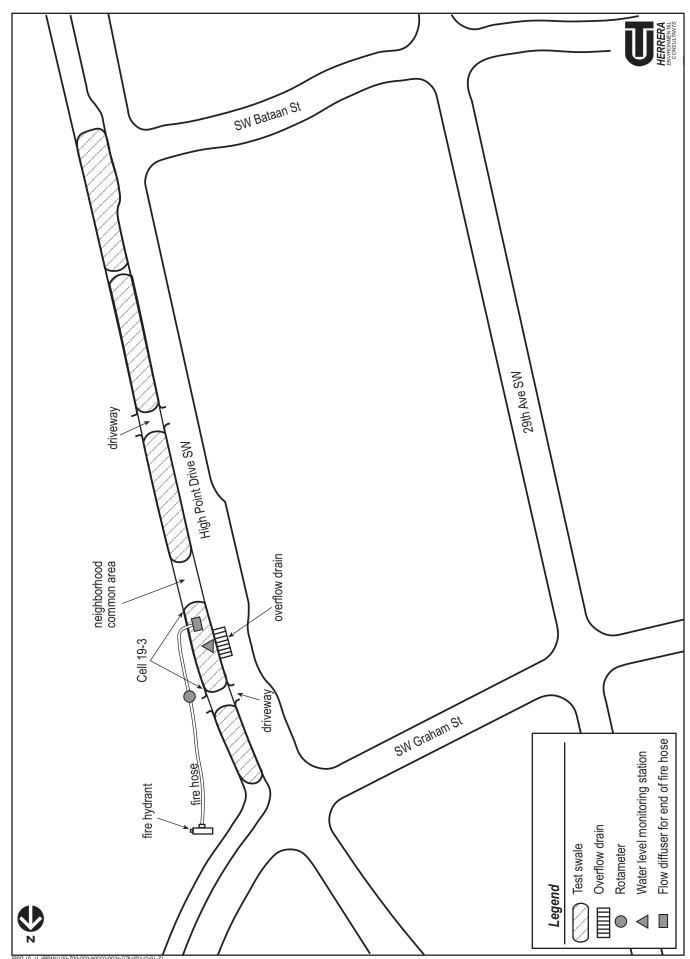
Plan view of natural drainage system test swale and controlled infiltration test monitoring station location for the High Point Phase I Block Scale Monitoring project. Figure 5.

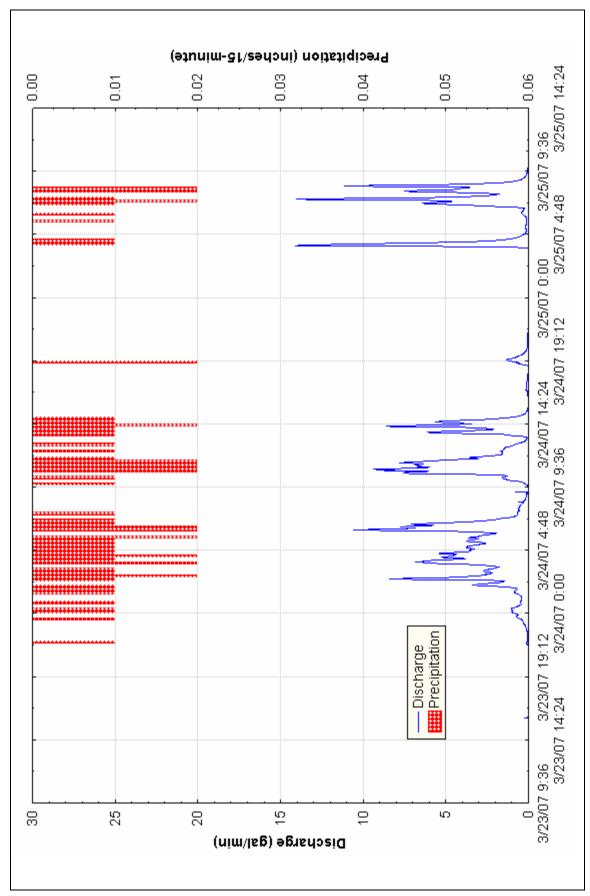
Precipitation and discharge data collected during the March 23, 2007 storm event for HSPF calibration monitoring related to the High Point Phase I Block Scale Monitoring project. Figure 7.

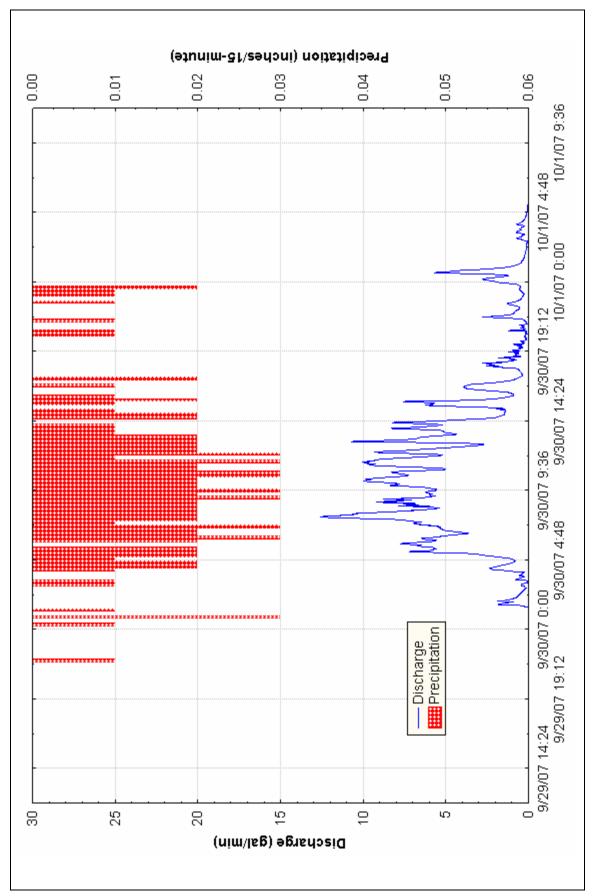
Precipitation and discharge data collected during the September 29, 2007 storm event for HSPF calibration monitoring related to the High Point Phase I Block Scale Monitoring project. Figure 8.

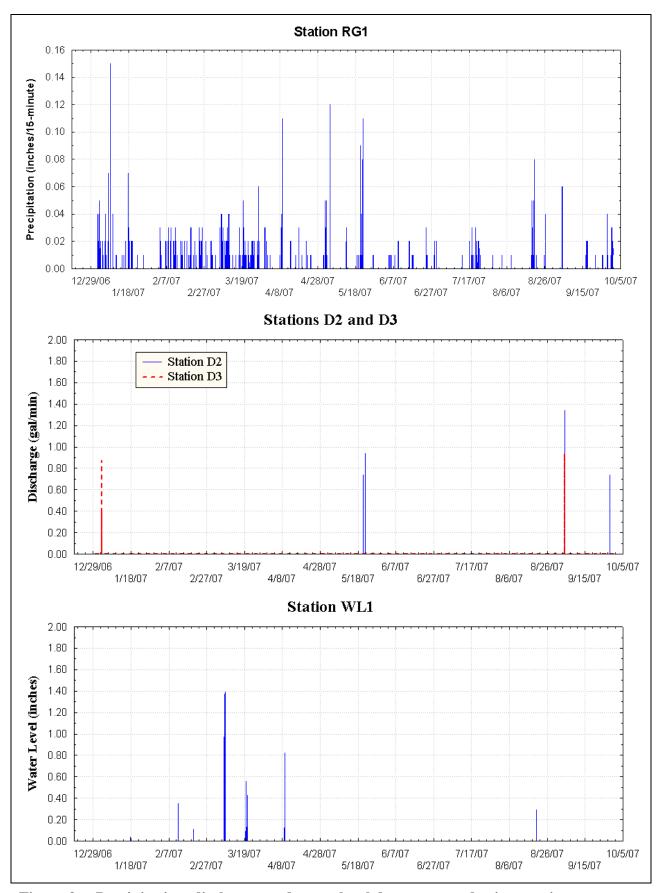
Figure 9. Precipitation, discharge, and water level data measured using continuous hydrologic monitoring for the High Point Phase I Block Scale Monitoring project.

Substantial quantities of stormwater were observed at station D3 during only two storm events that began on January 1 and September 3 (see Figure 9 and Appendix D, Table D2). As noted

previously, the January 1 storm had the second highest precipitation total (1.15 inches) out of all the storms in the current monitoring period and lasted 42.0 hours. (Note that station D2 was not installed until January 17; therefore, no data are available from this station for the January 1 storm.) Characteristics of the September 3 storm event are described above in conjunction with the station D2 data. Similar to station D2, the flow volumes measured at station D3 during these storms were relatively low (60.3 and 77.4 gallons, respectively). Likewise, the maximum discharge rate for both storms (0.9 gal/min) was barely above levels that can be accurately quantified using the equipment employed for this study.

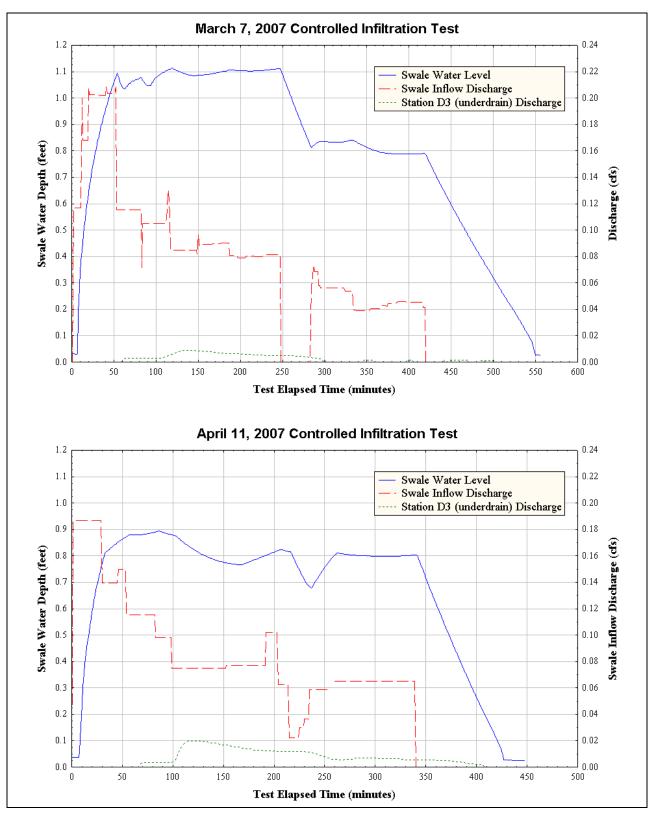
Figure 10. NDS test swale water depth and discharge data from the March 7 and April 11, 2007 controlled infiltration tests.

Graphs summarizing the water depth and discharge data collected during the March 7 and April 11 infiltration tests are presented in Figure 10. These graphs show the water level increase that occurred with the initial introduction of water into the NDS test swale at the onset of each test, the period of steady state water level and discharge towards the end of each test, and the final period of draw down after the inflow of water has been cut off.

Based on these data, the calculated infiltration rate for the NDS test swale from the March 7 test was 4.22 inches/hour. Similarly, the calculated infiltration rate for NDS test swale from the April 11 test was 6.11 inches/hour. To provide some perspective for interpreting these results, an infiltration rate of 2 inches/hour was assumed for the surface of the High Point NDS swales during the design phase of the project (Herrera and R.W. Beck 2004).

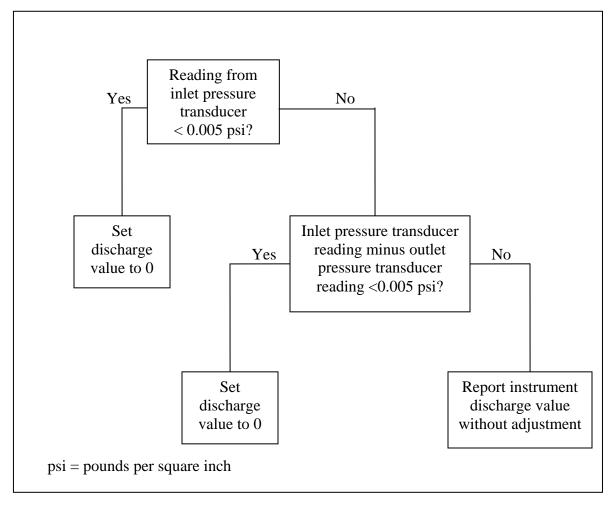
Figure A1. Data processing procedures for DataGator flow metering systems installed at stations D2 and D3 for the High Point Phase I Block Scale monitoring project.

Based on manufacturer recommendations, post processing of the data from the DataGator flow metering systems at stations D2 and D3 is also performed to eliminate noise from sensor readings that are below lower thresholds for accuracy. Specifically, the DataGator flow metering systems are constructed with three separate pressure transducers that are positioned at the inlet, throat, and outlet of a Venturi flow tube. Data from the inlet and outlet pressure transducers are processed according to the flow chart in Appendix A to remove spurious values in the flow data record relating to pressure readings that are below the manufacturer's recommended threshold of 0.005 pounds per square for accuracy.

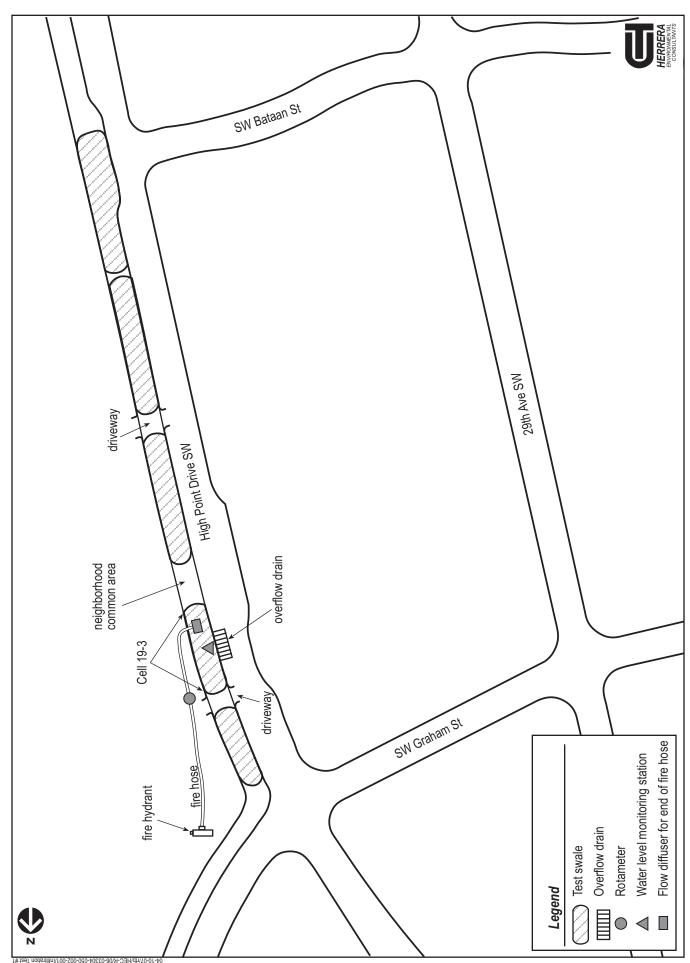
Plan view of natural drainage system test swale and controlled infiltration test monitoring station location for the High Point Phase I Block-scale Monitoring project. Figure 2.

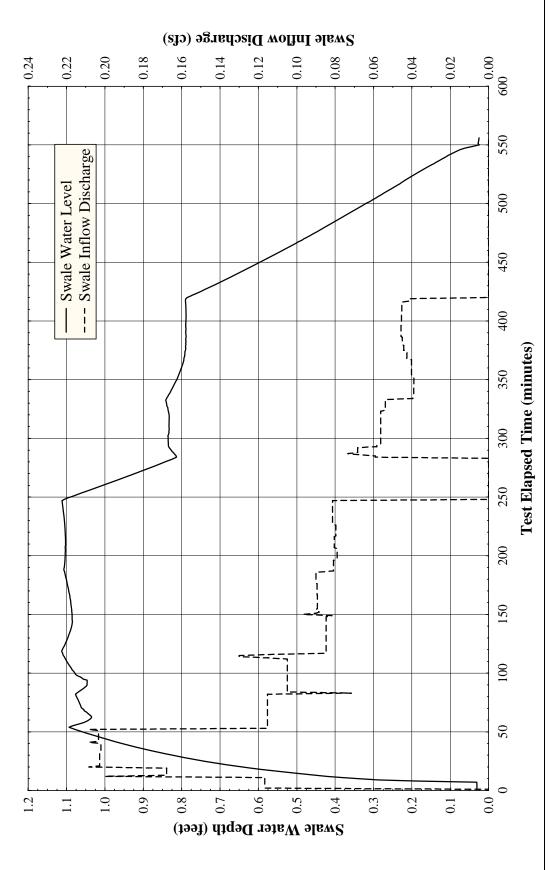
Inflow discharge rates and water depths measured during the controlled infiltration test on March 7, 2007, for the High Point Phase I Block-Scale Monitoring project. Figure 3.

At the beginning of the test, the discharge rate for water entering the swale was initially ramped up to approximately 0.2 cubic feet per second (cfs) (Figure 3). After approximately 60 minutes of elapsed time, the ponding depth in the swale reached 1.1 feet, a level just below the invert for the swale's overflow drain. However, as noted above, at this water depth, water was observed discharging into the overflow drain for the swale through a joint in the associated concrete casing. Therefore, after 248 minutes of elapsed test time, the water discharge to the swale was

turned off for approximately 30 minutes to allow the water depth to decrease to the new target of 0.79 feet. The inflow rate was then adjusted (primarily reduced) to maintain this water depth for the next 73 minutes (Figure 3).

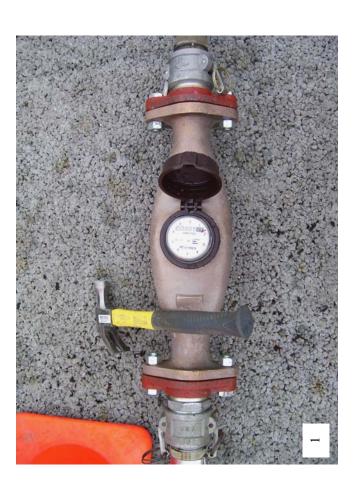
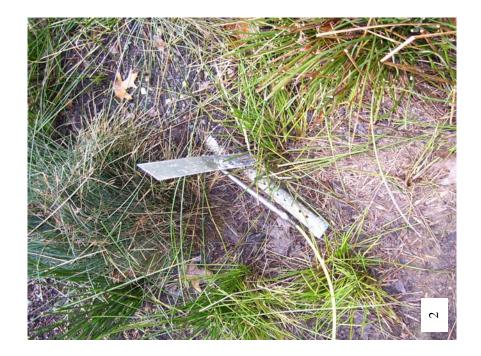
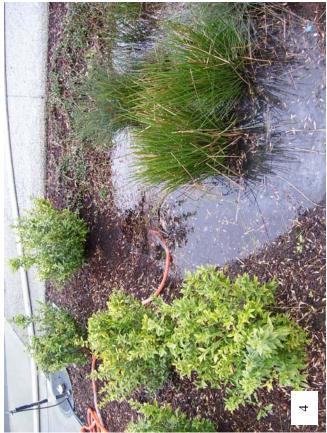
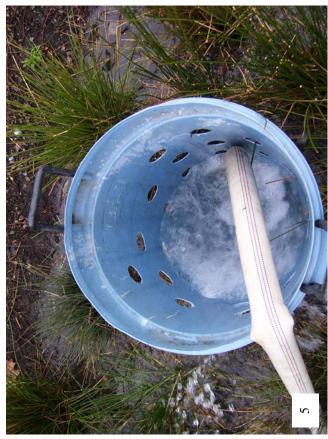
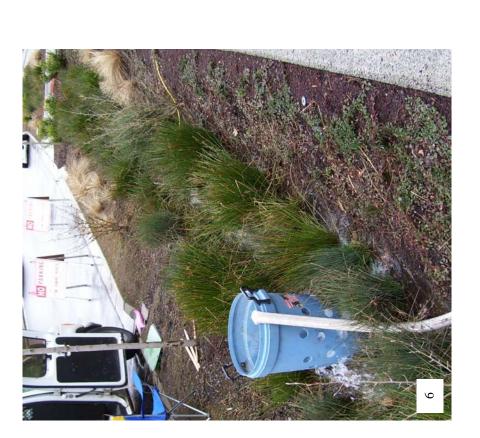
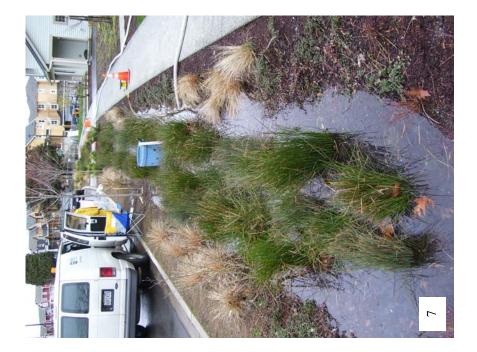
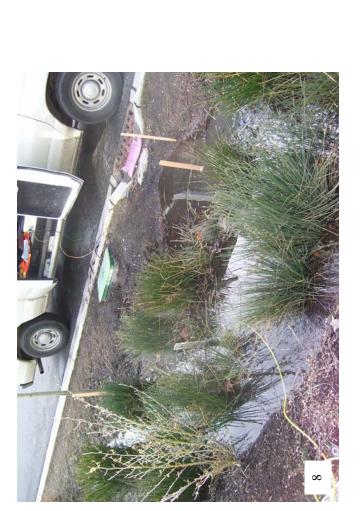
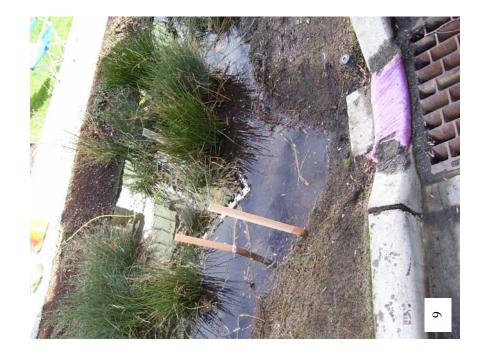
#### Controlled Infiltration Test on March 7, 2007 High Point Block-Scale Monitoring Program Photographic Log

Photo Number	Photo Description
1	Rotameter used to measure inflow discharge rates to the natural drainage system test swale
2	Pressure transducer used to measure water level in the natural drainage system test swale
3	Downgradient inflatable plug used to isolate Cell 19-3 of the natural drainage system test swale
4	Upgradient inflatable plug used to isolate Cell 19-3 of the natural drainage system test swale
5	Flow diffuser used for water entering the natural drainage system test swale
6	Flow diffuser used for water entering the natural drainage system test swale
7	Ponding in natural drainage system test swale during infiltration test
8	Ponding in natural drainage system test swale during infiltration test
9	Ponding near overflow drain for natural drainage system test swale during infiltration test

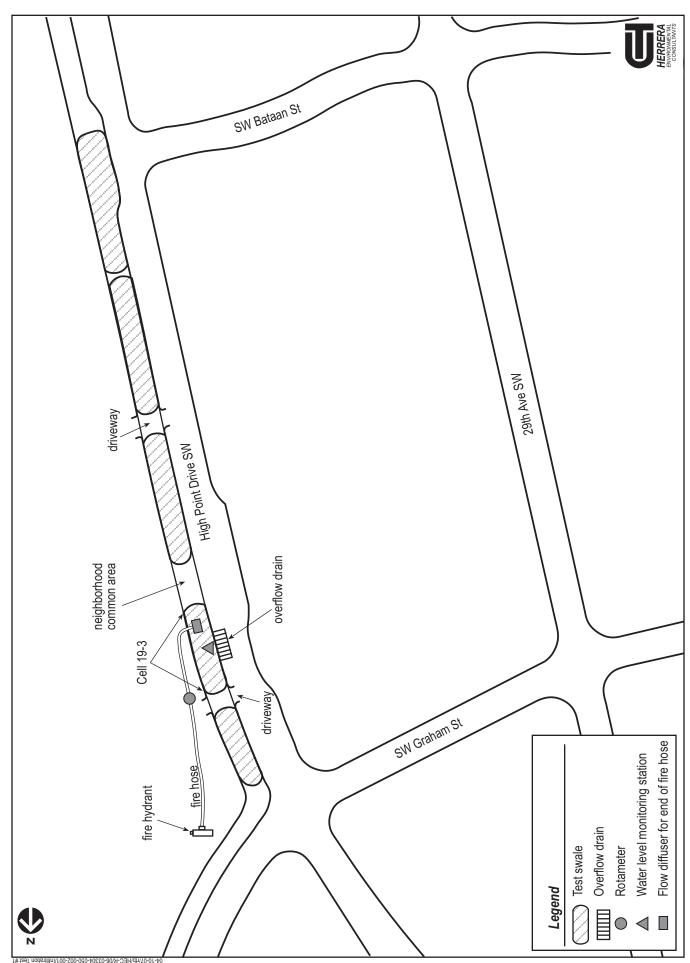
Plan view of natural drainage system test swale and controlled infiltration test monitoring station location for the High Point Phase I Block-scale Monitoring project. Figure 2.

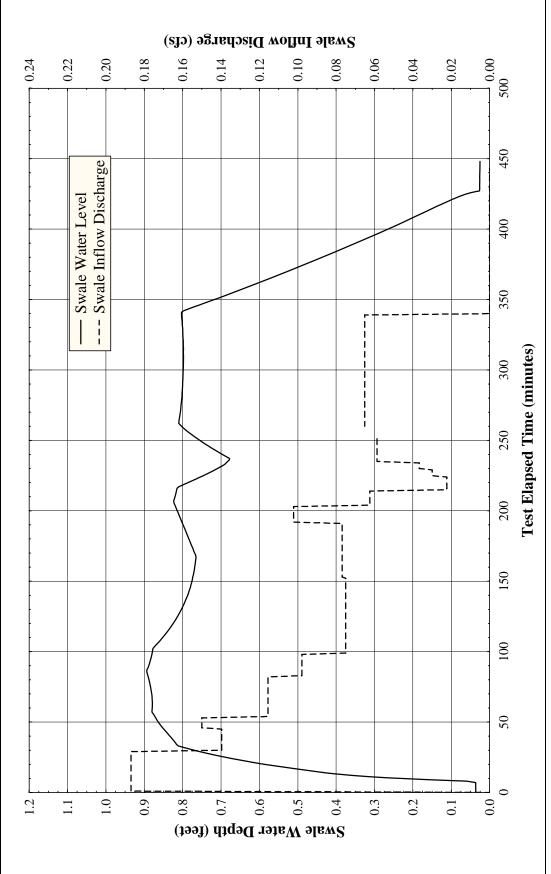
Inflow discharge rates and water depths measured during the controlled infiltration test on April 11, 2007, for the High Point Phase I Block-Scale Monitoring project. Figure 3.

At the beginning of the test, the discharge rate for water entering the swale was initially ramped up to approximately 0.19 cubic feet per second (cfs) (Figure 3). After approximately 33 minutes of elapsed time, the ponding depth in the swale reached the target depth of 0.80 feet. The inflow rate was then adjusted (primarily reduced) to maintain a water depth greater than or equal to 0.80 feet until 279 minutes of elapsed time in the test, at which point the discharge rate required to maintain this depth stabilized at 0.065 cfs (Figure 3). This discharge rate was maintained for approximately 60 minutes, or until 339 minutes of elapsed test time, at which point the water input to the swale was turned off. The water depth then dropped steadily over the next 91 minutes (1.52 hours) from the target depth of 0.80 feet until there was no appreciable standing

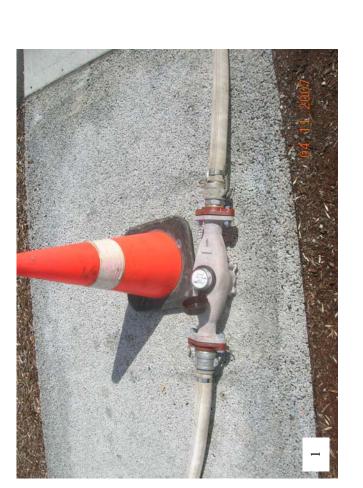
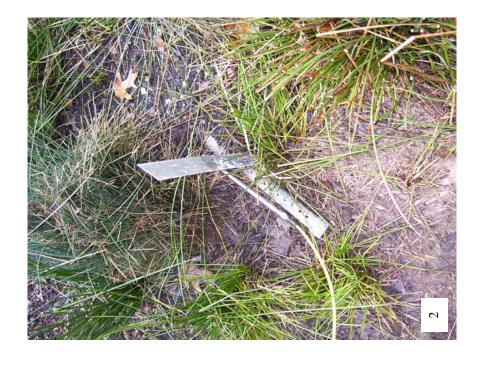
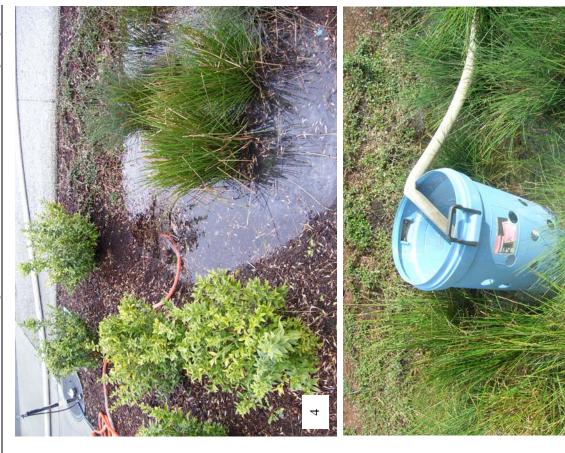
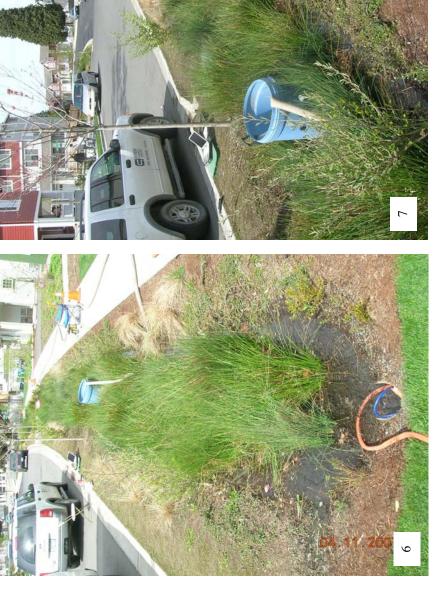
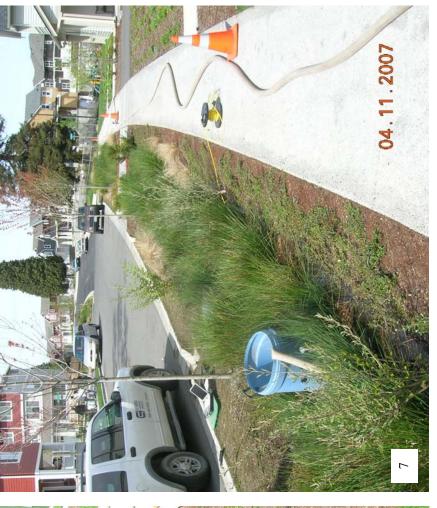
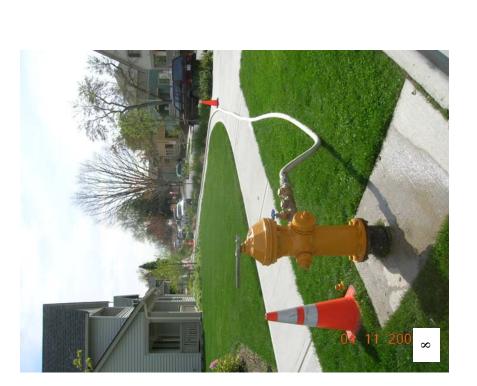
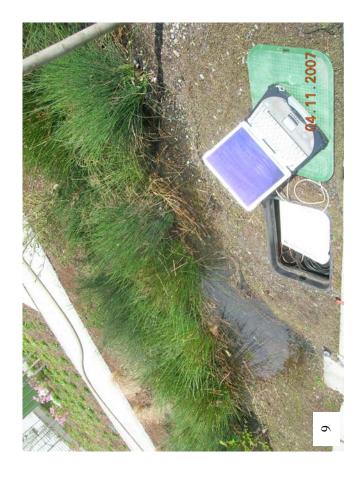
### Controlled Infiltration Test on April 11, 2007 High Point Block-Scale Monitoring Program Photographic Log

Photo Number	Photo Description
1	Rotameter used to measure inflow discharge rates to the natural drainage system test swale
2	Pressure transducer used to measure water level in the natural drainage system test swale
3	Upgradient inflatable plug used to isolate Cell 19-3 of the natural drainage system test swale
4	Downgradient inflatable plug used to isolate Cell 19-3 of the natural drainage system test swale
5	Flow diffuser used for water entering the natural drainage system test swale
6	Ponding in natural drainage system test swale during infiltration test
7	Ponding in natural drainage system test swale during infiltration test
8	Fire hydrant and 4" hose used to deliver water to the natural drainage system test swale
9	Field book and datalogger near natural drainage system test swale overflow drain
