WATER YEAR 2008 DATA REPORT

High Point Phase I Block-Scale Monitoring

Seattle Public Utilities

Herrera Environmental Consultants, Inc.
2200 Sixth Avenue, Suite 1100
Seattle, Washington 98121
Telephone: 206/441-9080

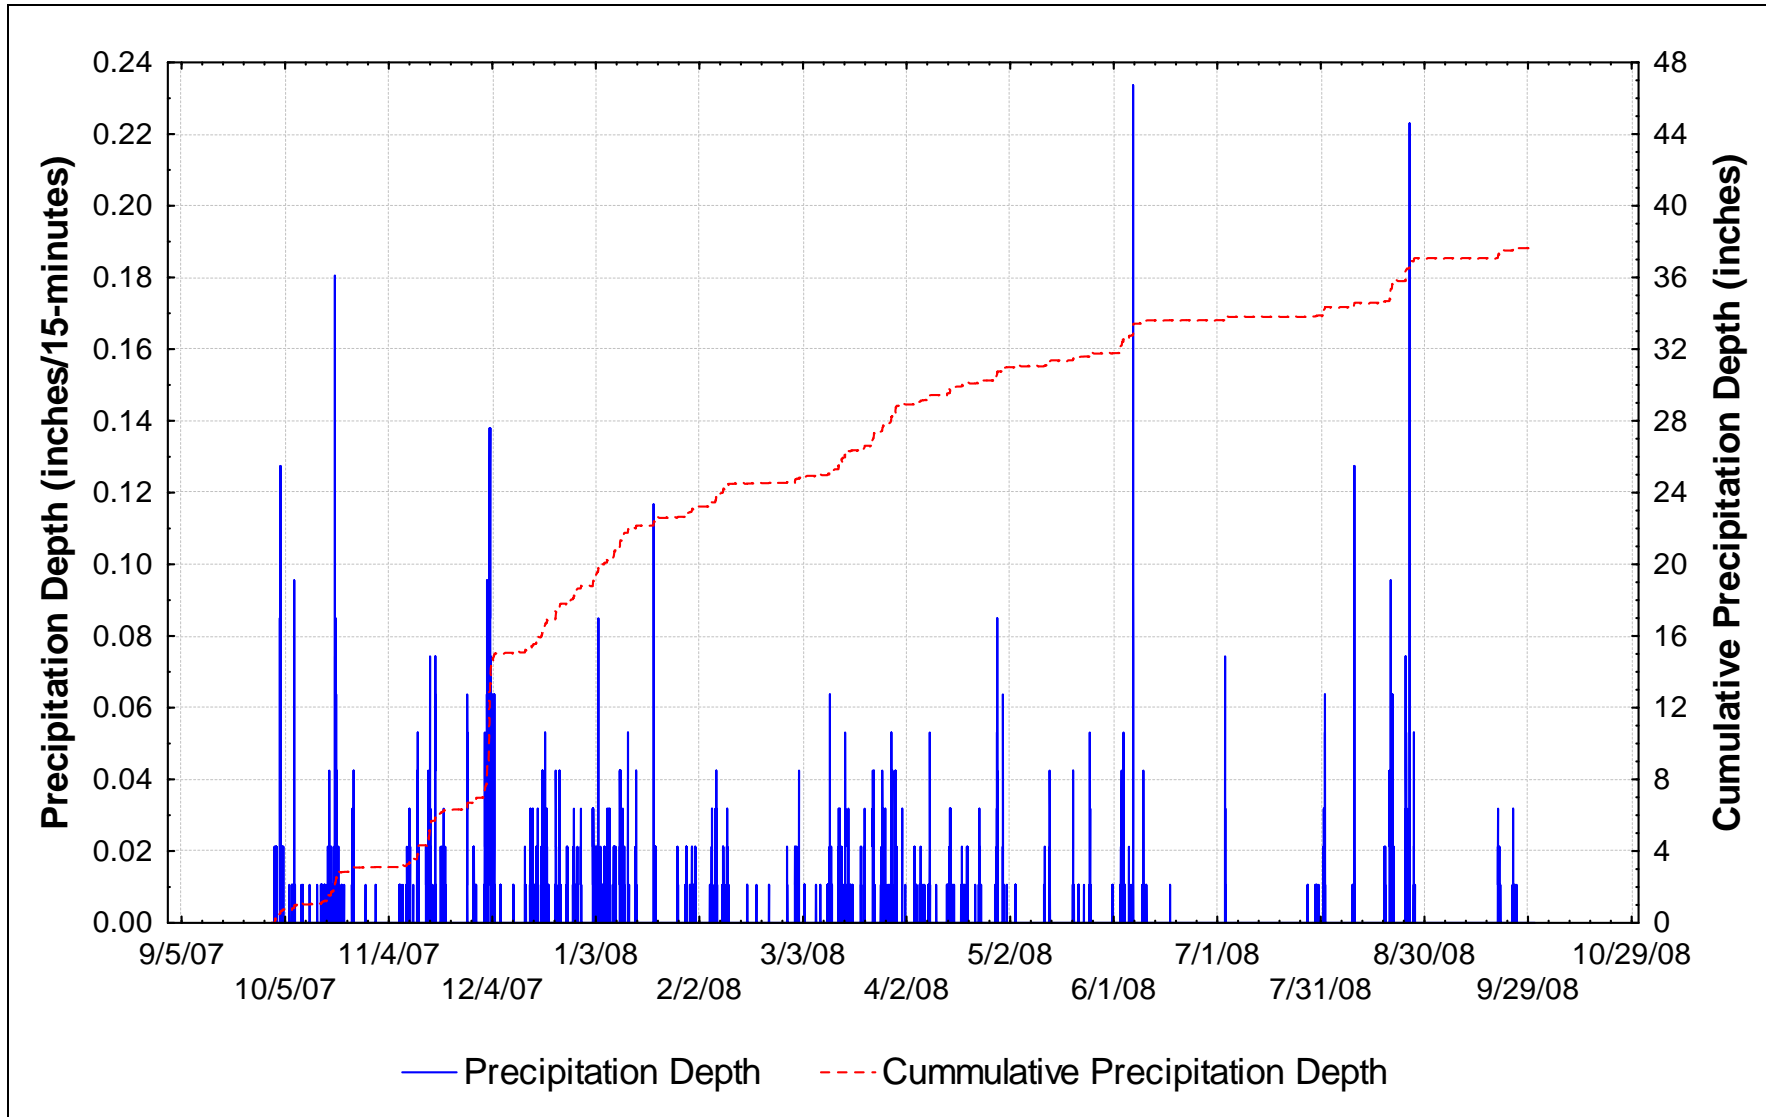
Figure 5. Precipitation depth measured at station RG1 for the High Point Phase I Block-Scale Monitoring project during water year 2008.

The raw precipitation data from station RG1 during water year 2008 are summarized graphically in Figure 5. A detailed summary of the data from individual storm events (including the date and time for the storm beginning and end, storm duration, antecedent dry period, precipitation total, maximum intensity, and average intensity) is provided in Appendix D (Table D-1). More general summary statistics computed from these data are provided in Table 2. The forms that were completed in conjunction with routine quality assurance audits of the data from station RG1 are provided in Appendix E, and the results of the formal verification and validation review of these data are summarized in Appendix B.

A total of 99 storm events occurred during water year 2008. (Storm events are defined by a precipitation depth of at least 0.01 inches and a period of at least 12 hours with no precipitation separating each event.) For 18 of these storms, the precipitation totals exceeded 0.50 inches; 23 storms had totals between 0.50 and 0.25 inches, and 58 storms had totals that were less than 0.25 inches. The median precipitation total across all the storms was 0.22 inches. The five highest precipitation totals (8.05, 1.57, 1.36, 1.32 and 1.12 inches) occurred during storm events that began on December 1, 2007, and October 17, November 14, January 1, and August 19,

2008, respectively. These five storms were the only storms with precipitation totals exceeding the threshold corresponding to the 6-month, 24-hour design storm (1.08 inches). The precipitation total for the storm that began on December 1, 2007, also exceeded the threshold corresponding to the 2-year, 24-hour design storm (1.68 inches). However, the total duration of this storm (74.5 hours) was much longer than 24 hours. The NDS test swale was severely damaged by runoff from a nearby construction site during this storm.

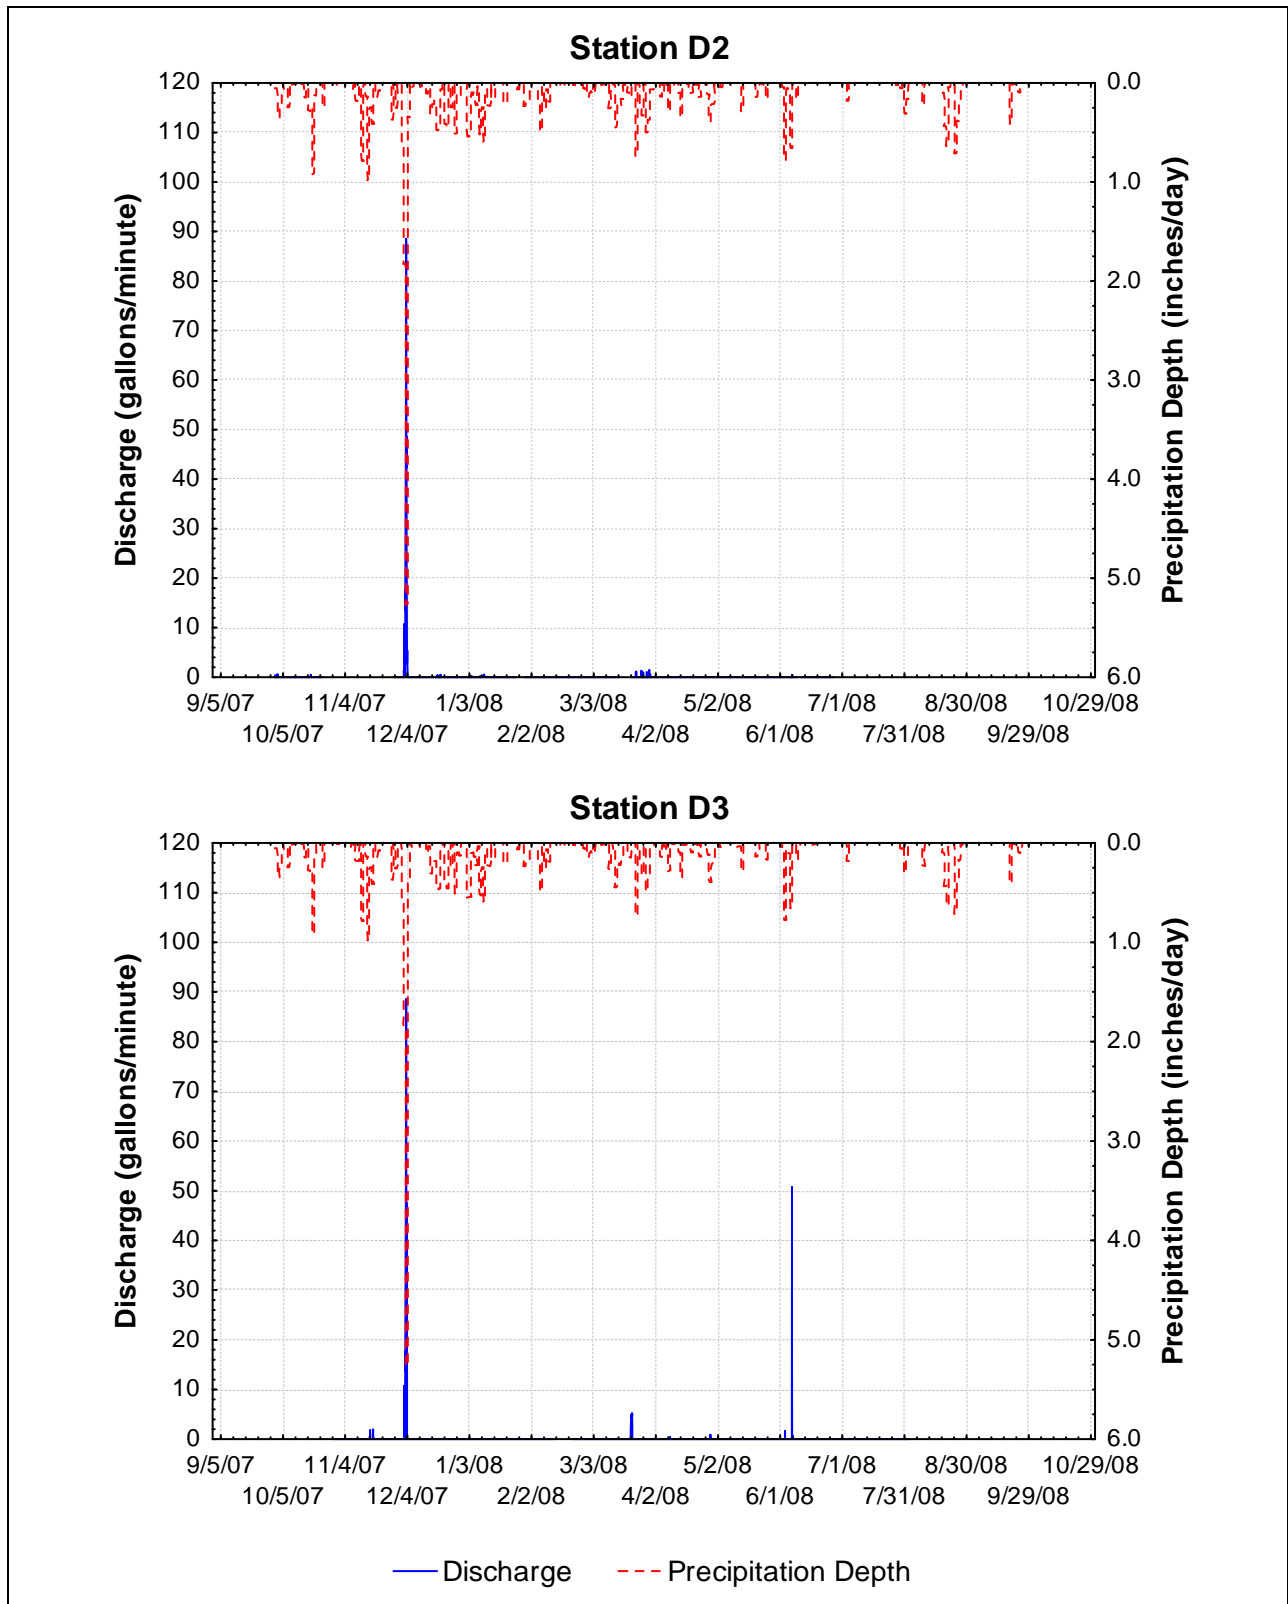
Figure 6. Discharge measured at stations D2 and D3 for the High Point Phase I Block-Scale Monitoring project during water year 2008.

Discharge monitoring at stations D2 and D3 was suspended on June 26, and August 2, 2008, respectively. The available raw discharge data that were collected from each station during water year 2008 are provided in Figure 6. (To aid in the interpretation of these data, Figure 6 also presents daily precipitation totals from station RG1.) Data from these two stations for individual storm events (including total flow volume, maximum discharge rate, and flow duration) are summarized in Appendix D (Table D-2). More general summary statistics computed from these data are provided in Table 3. The forms that were completed in conjunction with routine quality assurance audits of these data are provided in Appendix E, and the results from the formal verification and validation review of these data are summarized in Appendix B.

Excluding periods when no data were collected due to equipment malfunction or the suspension of monitoring, discharge data were collected over 69 storm events at station D2 (Appendix D, Table D-2). However, stormwater discharges from the underdrain pipe associated with station D2 were observed only during 17 of these events. The largest discharge was measured during the December 1, 2007, storm event. The peak discharge rate measured at station D2 during this event was 88.6 gallons per minute (gal/min), and the total flow volume was 50,300 gallons. Peak discharge rates measured during the other 16 storm events at station D2 were extremely low in comparison, with a median of 0.51 gal/min and a range from 0.07 to 1.48 gal/min. Discharge rates this low are difficult to measure accurately with the equipment used in this study. Total flow volumes during these 16 events were also relatively insignificant (median = 76.4 gallons; range = 6.3 to 239 gallons).

Discharge data were collected over 81 storm events at station D3 (Appendix D, Table D-2). However, stormwater discharges from the underdrain pipe associated with station D3 were only observed during seven of these events. Similar to station D2, the largest discharge was measured during the December 1, 2007, storm event. The peak discharge rate measured at station D3 during this event was 88.6 gal/min, and the total flow volume was 42,300 gallons. A relatively high peak discharges rate (50.7 gal/min) was also measured during a storm event that began on June 6, 2008, and produced 0.66 inches of precipitation in a 9-hour period. The flow volume measured at station D3 during this event was 3,254 gallons. Peak discharge rates measured during the other five storm events at station D3 were near the lower threshold (i.e., 1 gal/min) for accurate measurement using the equipment used in this study. For example, peak discharge rates for these five storm events ranged from 0.89 to 5.16 gal/min, with a median of 0.51 gal/min. Total flow volumes during these five events were also relatively small (median = 231 gallons; range = 42.5 to 4,600 gallons).

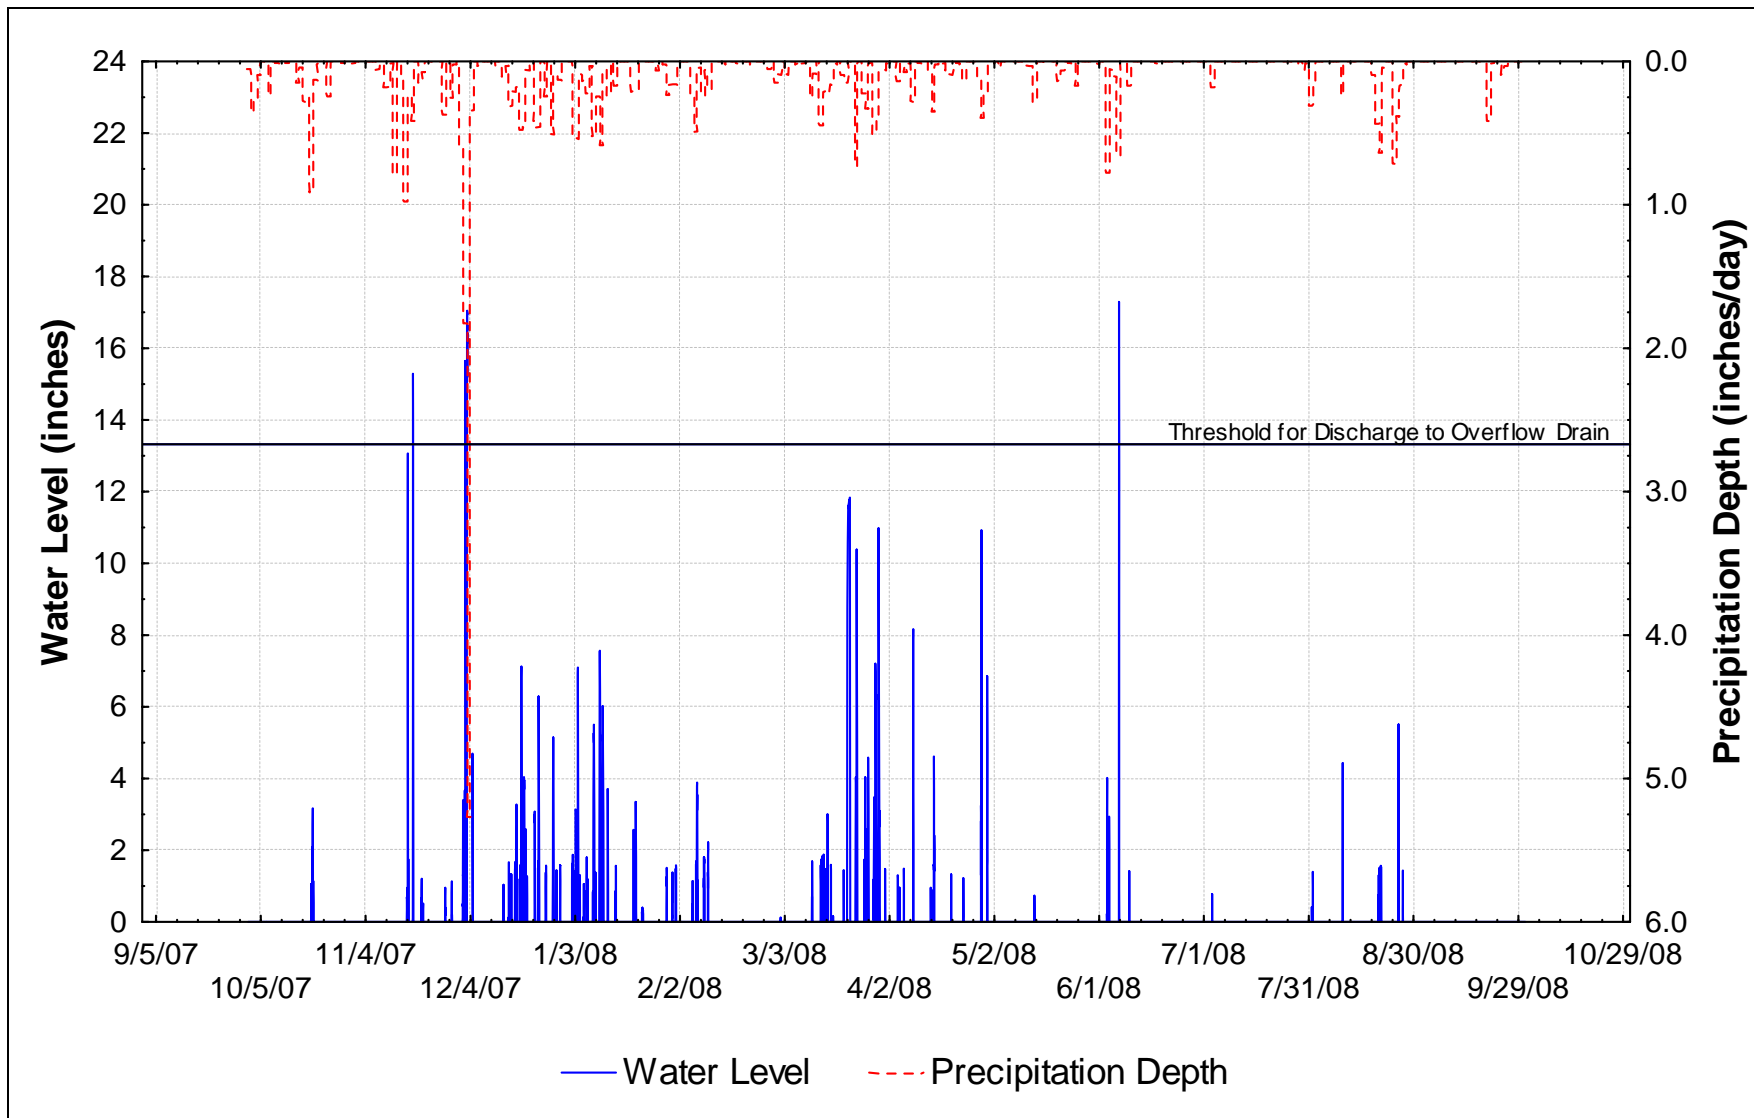
Figure 7. Water level measured at station WL1 for the High Point Phase I Block-Scale Monitoring project during water year 2008.

Despite the increased frequency of ponding during water year 2008, water levels within the NDS test swale exceeded the depth threshold (13.32 inches) that results in a discharge to the overflow drain on only three occasions. The first occasion was during a storm event that began on November 17, 2007, and produced 0.41 inches of precipitation over a 6-hour period. The second

occasion was during the December 1, 2007, storm event. Due to heavy flooding during this event, the data logger associated with station WL1 was severely damaged; therefore, only a partial record of water levels is available. Based on this incomplete data record, water levels measured at station WL1 reached a depth of at least 17.3 inches during this event. The third occasion of a discharge to the overflow drain occurred was during a storm event that began on June 6, 2008, and produced 0.66 inches of precipitation over a 9-hour period. The highest measured water level at station WL1 during this event was 17.3 inches.

Excluding periods when no data were collected due to equipment malfunctions, water level data were collected at station WL1 over 96 storm events (see Appendix D, Table D-3). Ponding occurred during 58 of these events, with substantial ponding (i.e., more than 2 inches) during 29 of these events. This represents a substantial increase in the frequency of ponding within the swale relative to water year 2007. For example, out of the 83 storm events that were monitored during water year 2007 at station WL1, ponding was observed during only 7 events, with substantial ponding during only one of these events (Herrera 2008).

As noted above, two factors likely contributed to this pattern in the data. First, field observations indicated severe damage to the NDS test swale due to construction-related runoff during the December 1, 2007, storm event. Sediment deposited with this runoff likely decreased surface infiltration rates and contributed to increased ponding in the NDS test swale during water year 2008 relative to water year 2007. Second, the drainage basin that contributes to the NDS test swale expanded by 15 to 30 percent over the spring and summer of 2007 due to new roadway and housing construction for Phase II of the High Point redevelopment project. Runoff from these areas subsequently increased the amount of stormwater entering the NDS test swale during any given storm event relative to conditions in water year 2007. This change likely also contributed to the increased ponding observed in the NDS test swale during water year 2008.

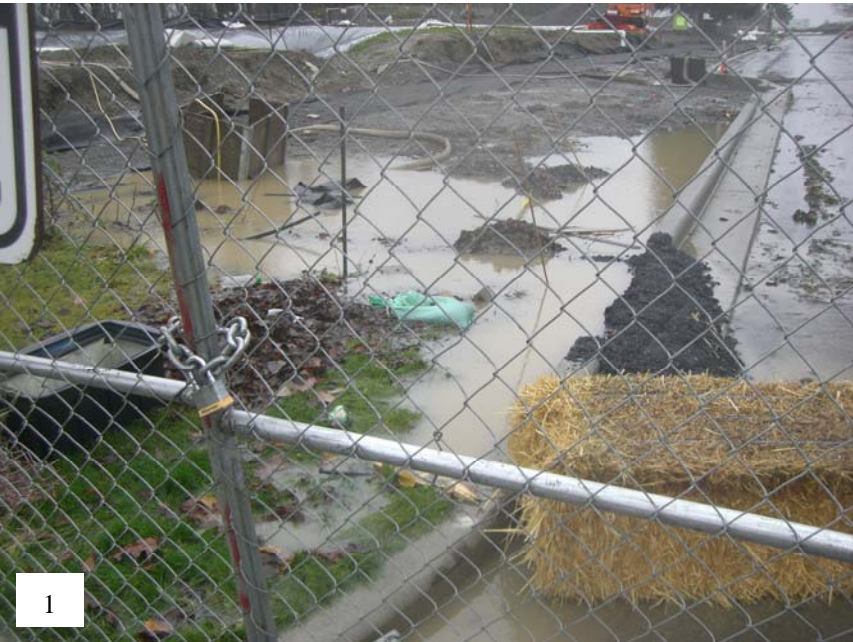
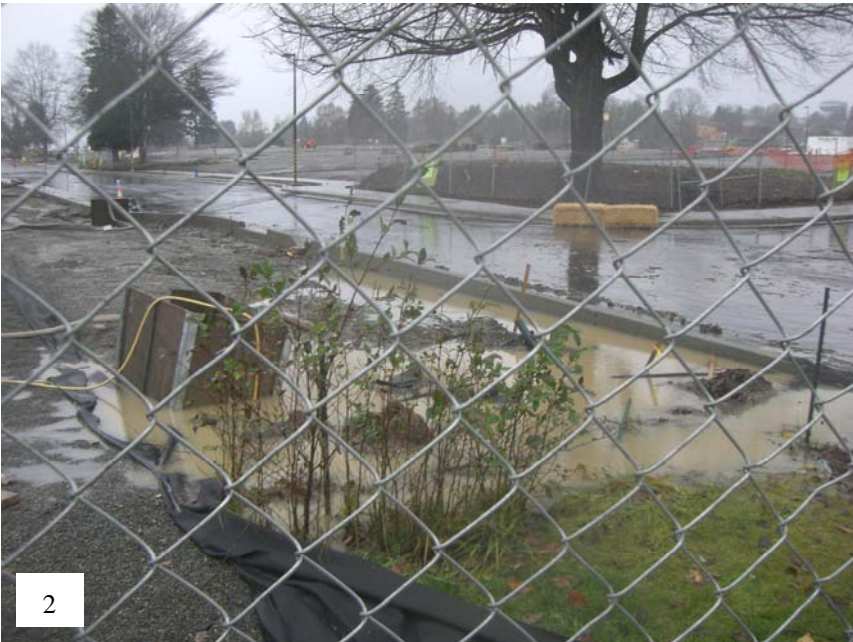
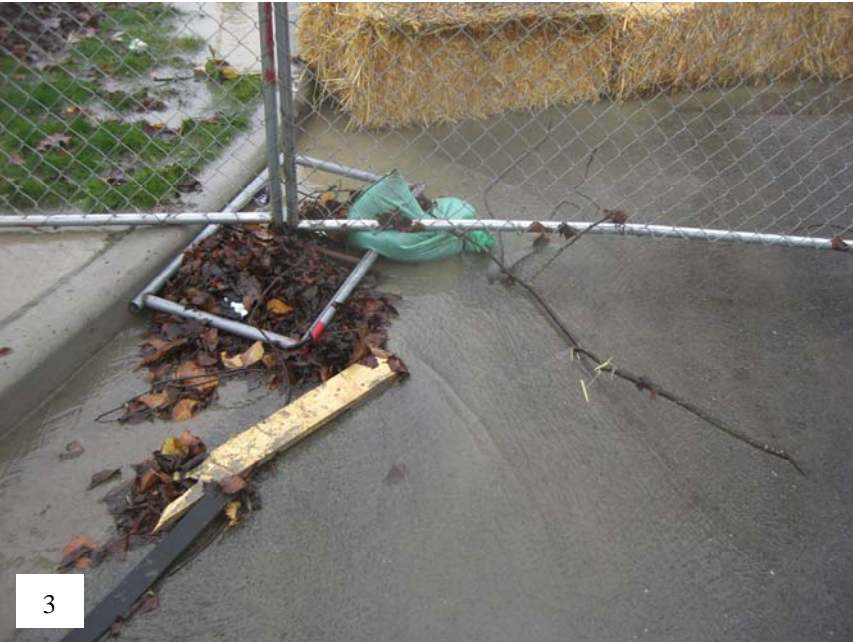
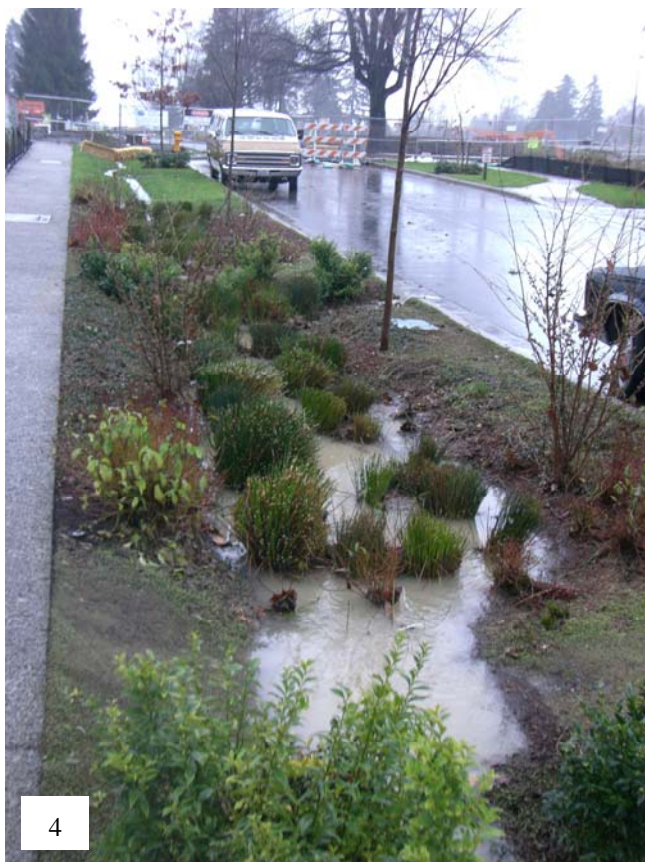
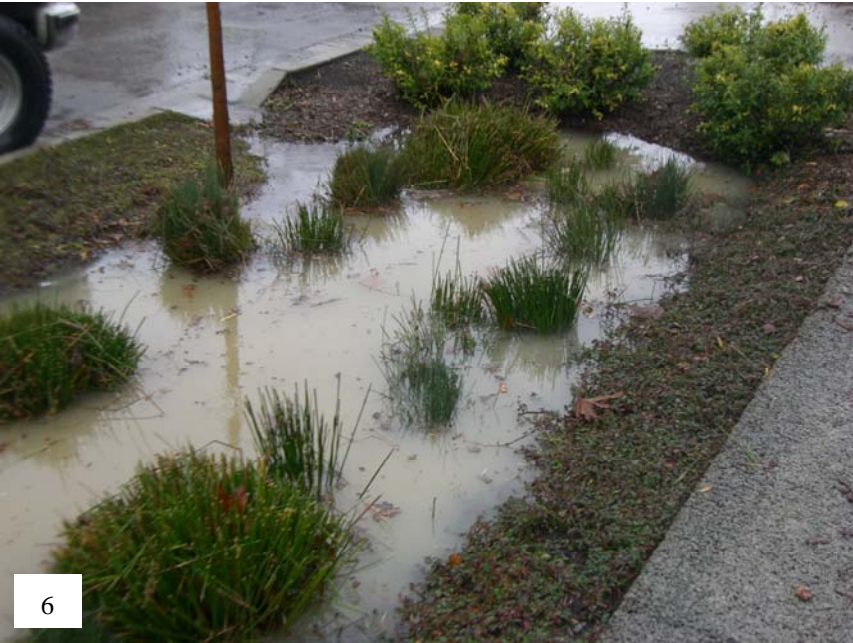
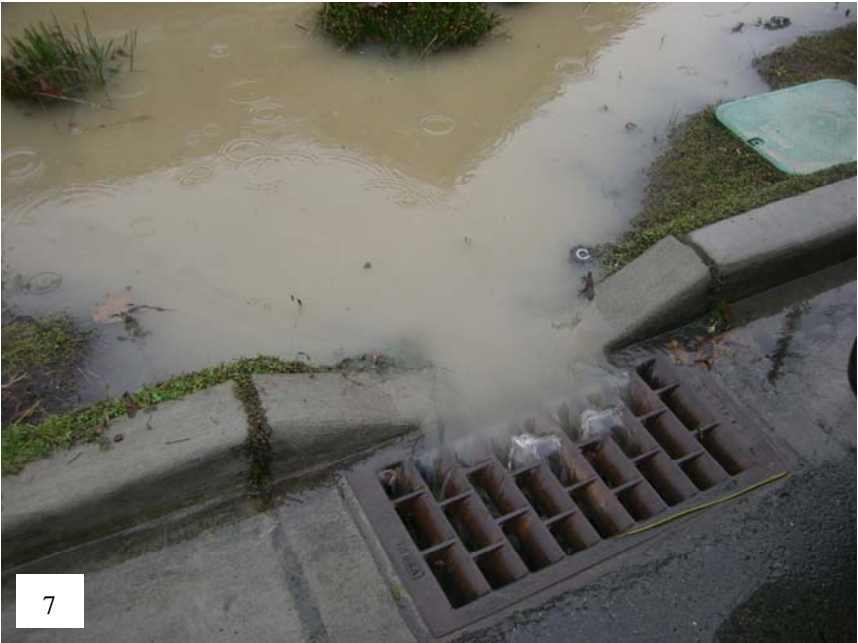
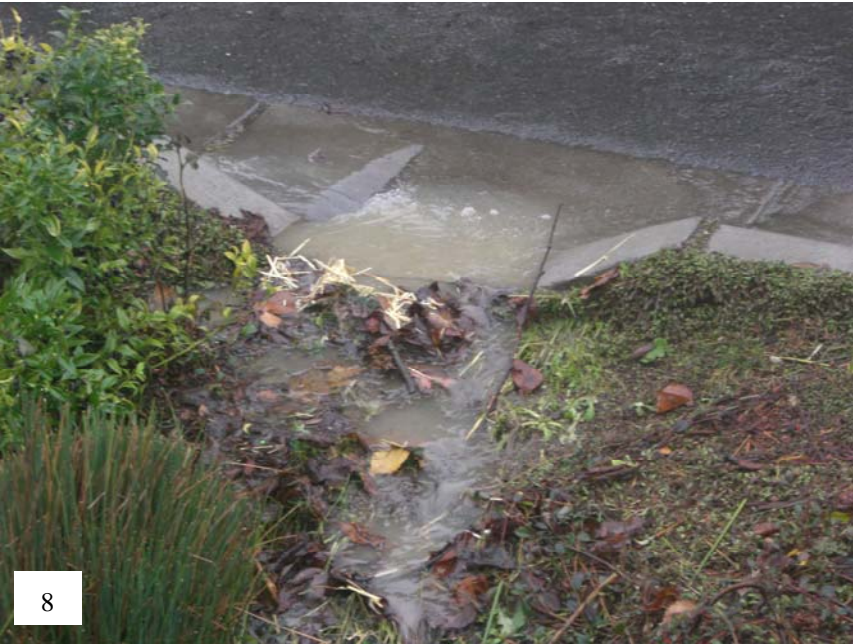
**High Point Phase I Block-Scale Monitoring
Flooding Observed during the December 1, 2007, Storm Event
Photographic Log**

Photo Number	Photo Description
1	Runoff from construction site adjacent to NDS test swale.
2	Runoff from construction site adjacent to NDS test swale.
3	Runoff from construction site adjacent to NDS test swale.
4	Construction related runoff in NDS test swale.
5	Construction related runoff in NDS test swale.
6	Construction related runoff in NDS test swale.
7	Overflow from the NDS test swale.
8	Runoff from construction site entering the NDS test swale.

However, during a large storm event in December 2007, the NDS test swale for this monitoring project received substantial quantities of untreated runoff from a nearby construction site. Field observations made after this event indicated severe damage to the NDS test swale by sediment deposits from this runoff. Consequently, SPU suspended monitoring of this NDS test swale at the end of water year 2008 and identified two new NDS test swales for monitoring in water year 2009. The specific monitoring procedures that will be used in connection with these new swales are detailed in a separate QAPP (SPU 2008) that was prepared to meet the project monitoring goal and the monitoring requirements identified in the Seattle's Phase I Municipal Stormwater Permit (Phase I Permit). Monitoring of these new swales will continue through water year 2011, with annual data reports to be prepared at the end of each water year.
