Seattle's Source Control Plan for the Lower Duwamish Waterway (2026 – 2031)

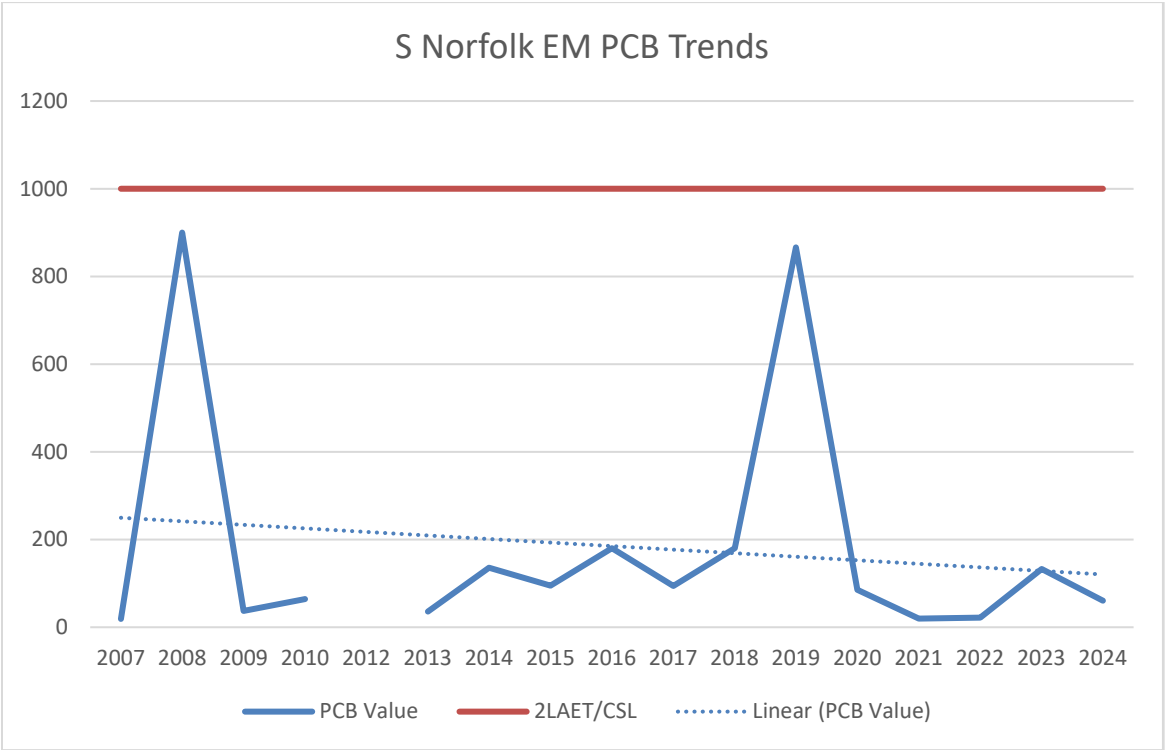
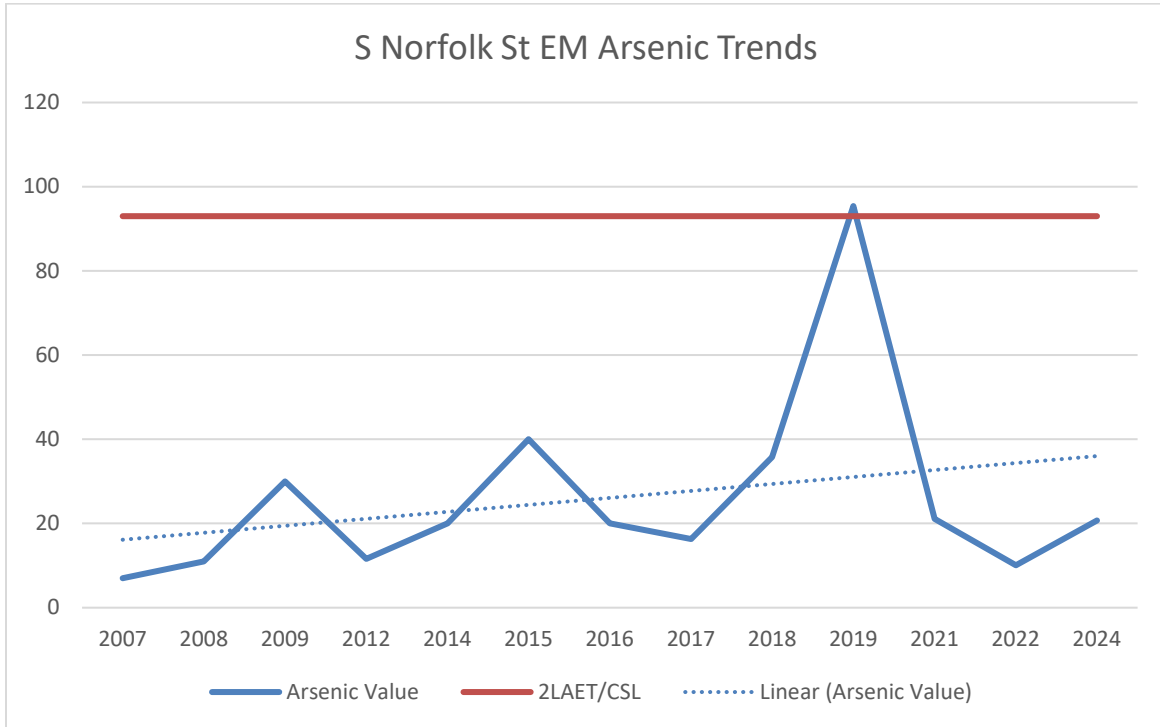
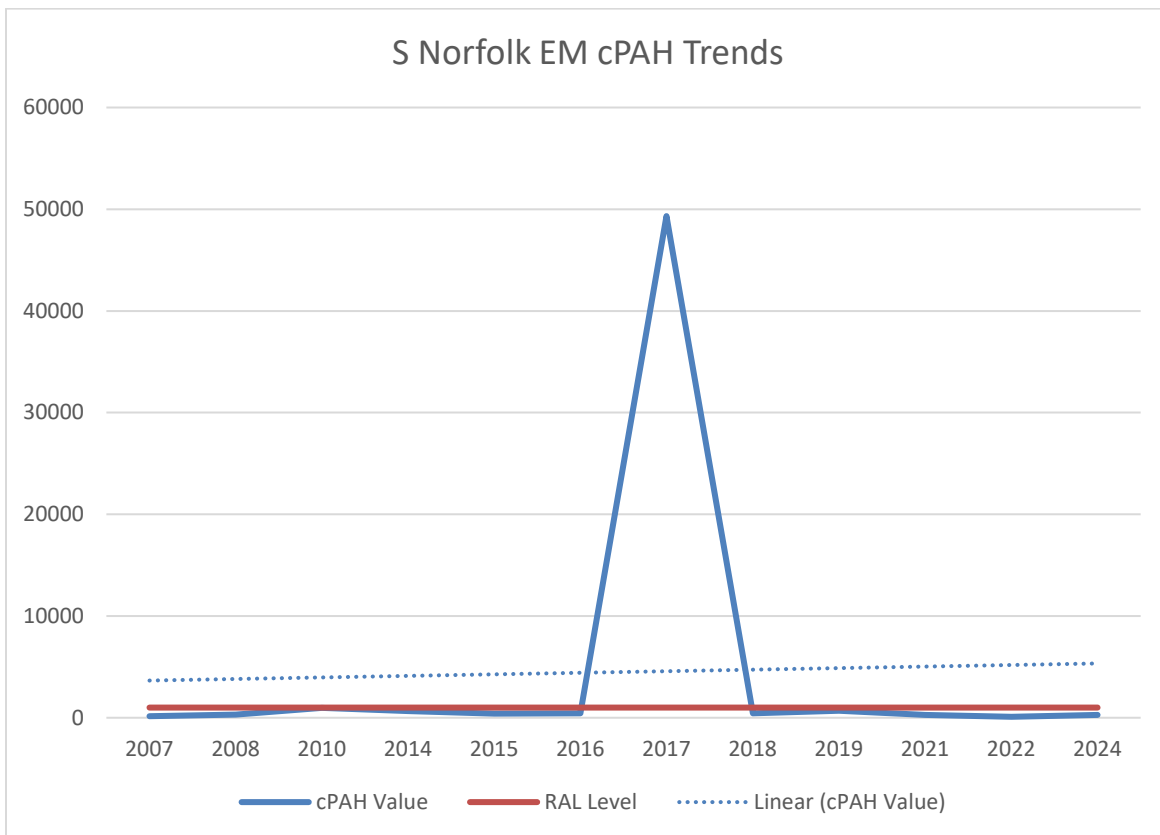
Figure 14: Effectiveness Monitoring Location data trends for chemicals of concern in S Norfolk St CSO/PS17 EOF/SD

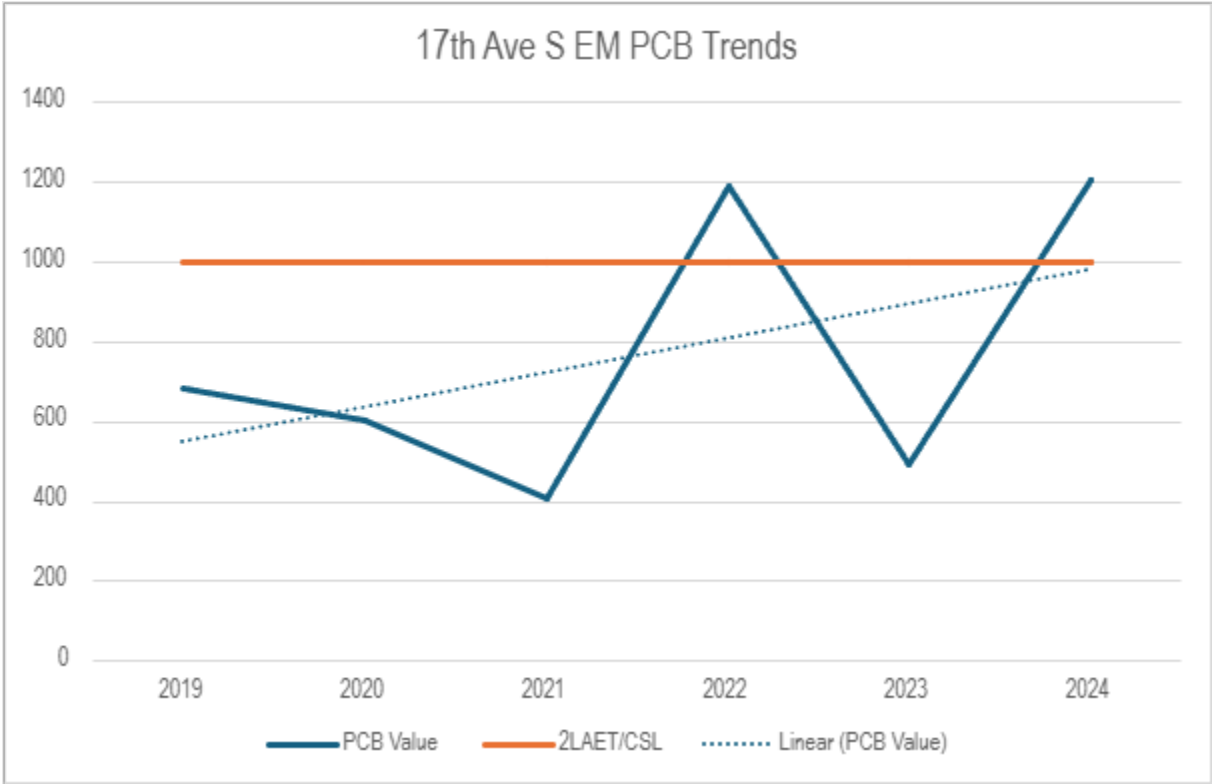
Figure 15: Effectiveness monitoring data trend for PCBs within the 17th Ave S SD

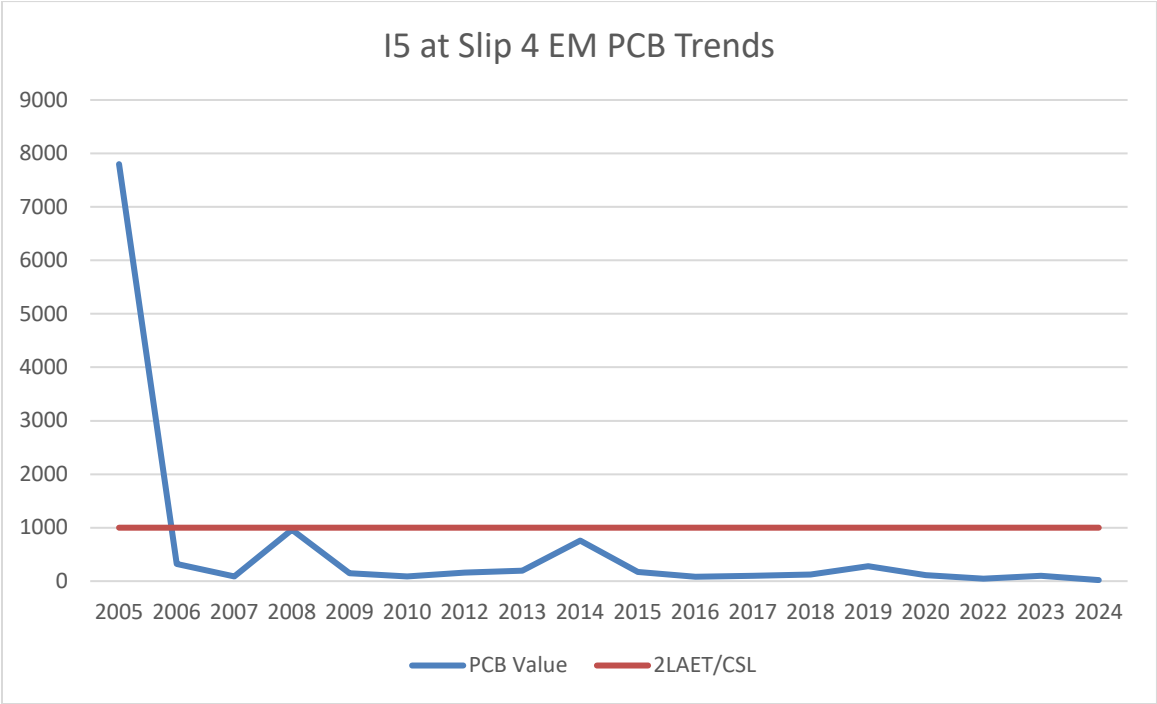
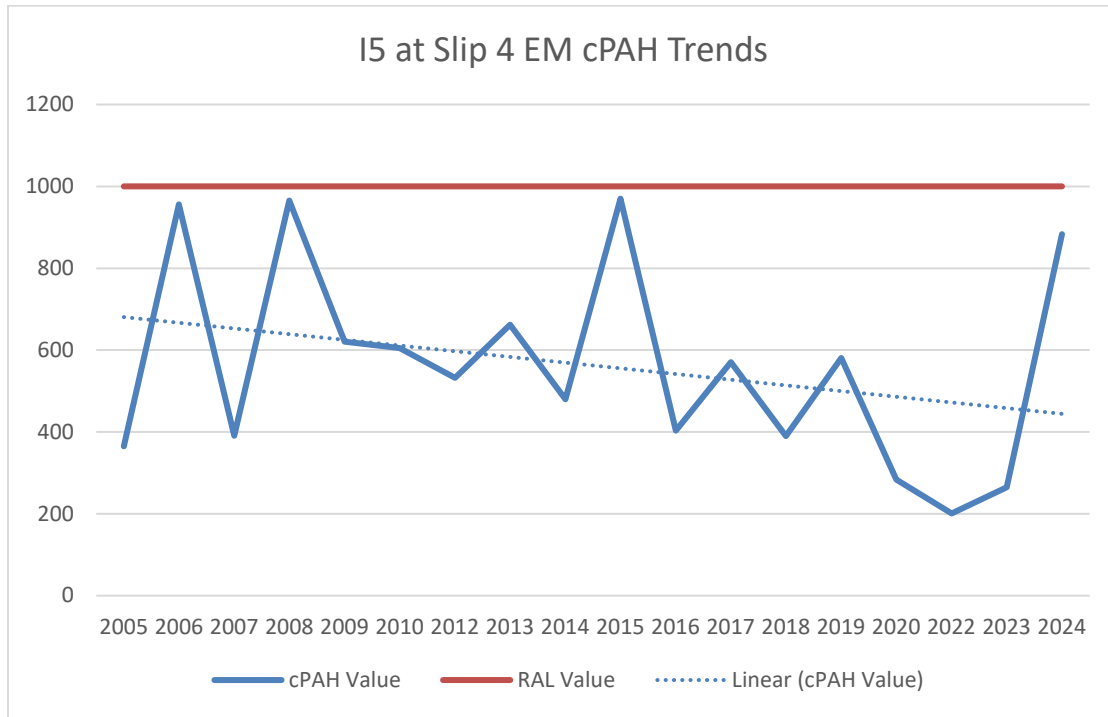
Figure 16: Effectiveness Monitoring Data Trends for the I5 SD at Slip 4

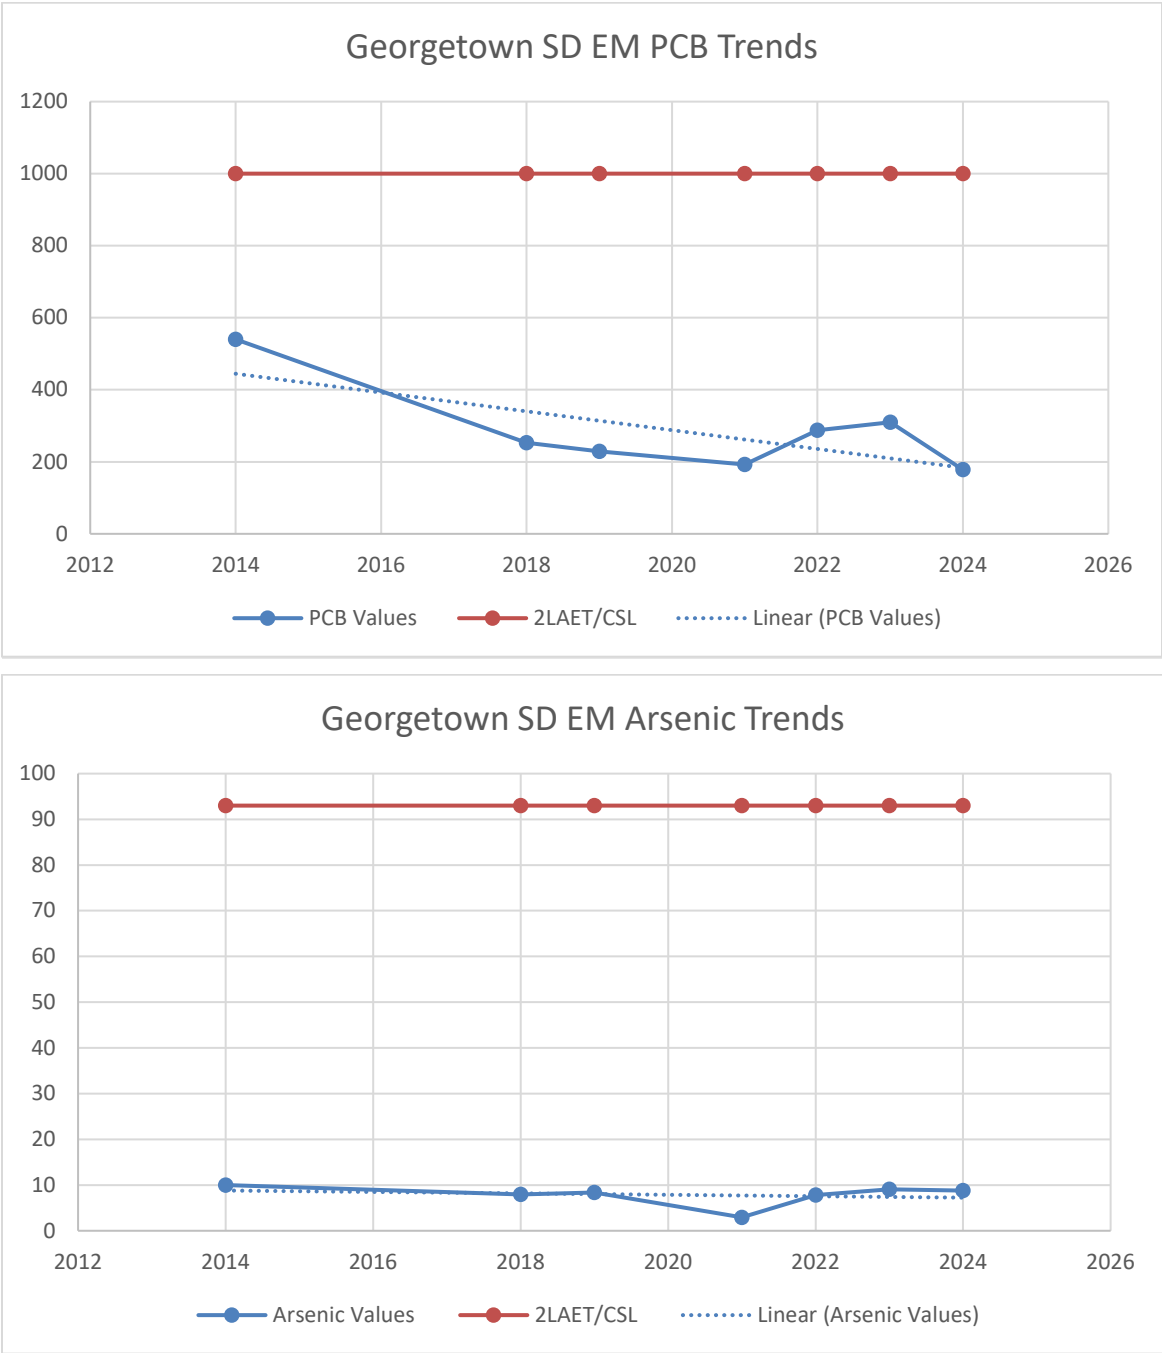
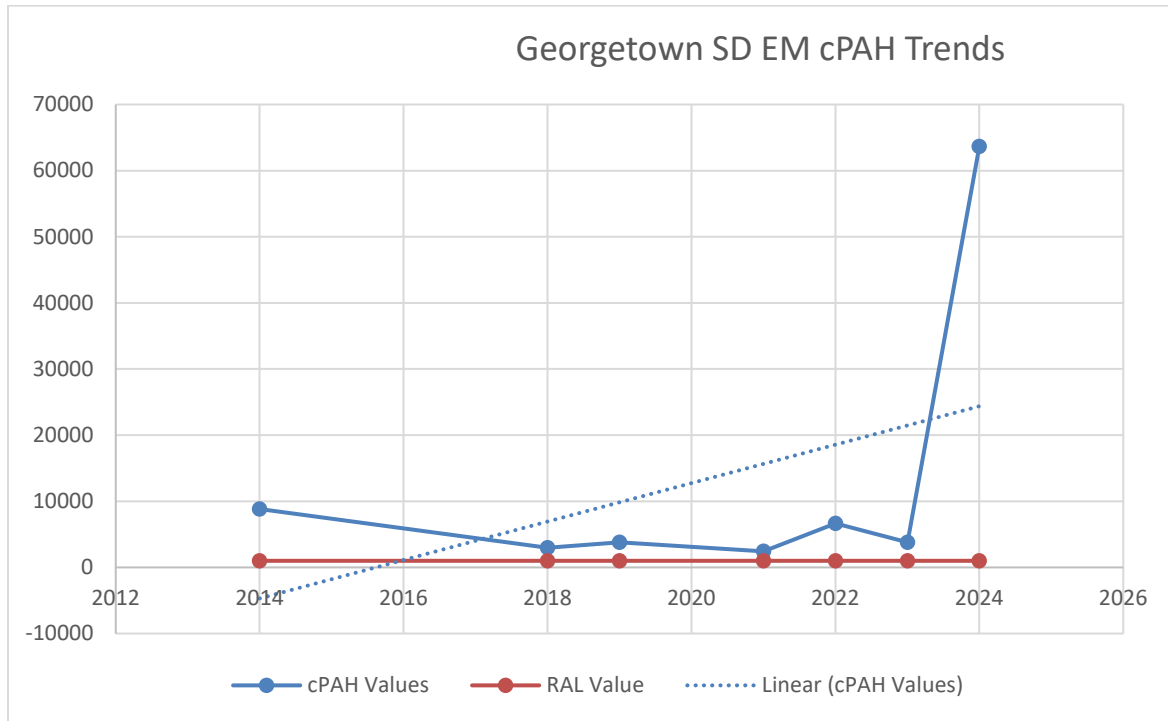
Figure 17: Effectiveness Monitoring Data Trends for the Georgetown SD.

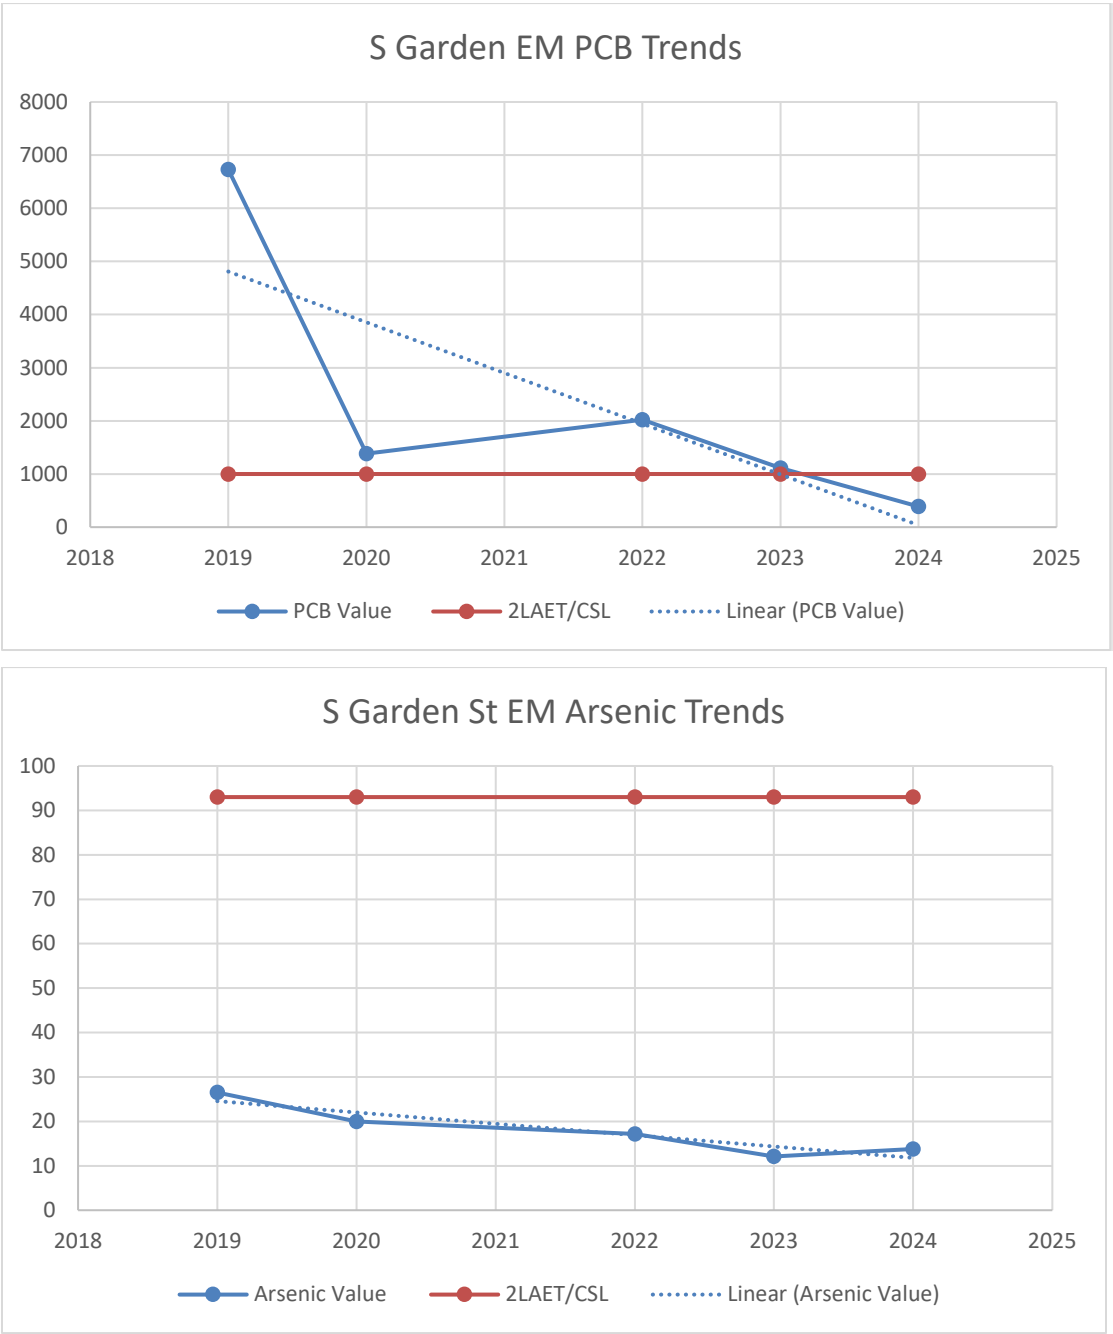
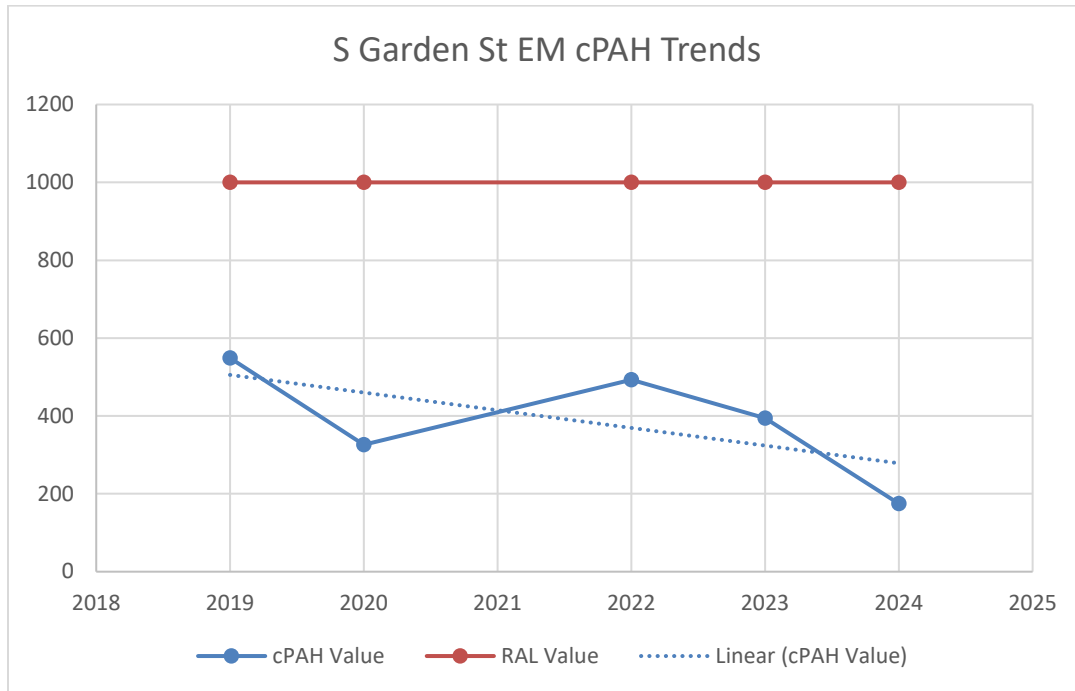
Figure 18: Effectiveness Monitoring Data Trends for the S Garden St SD.

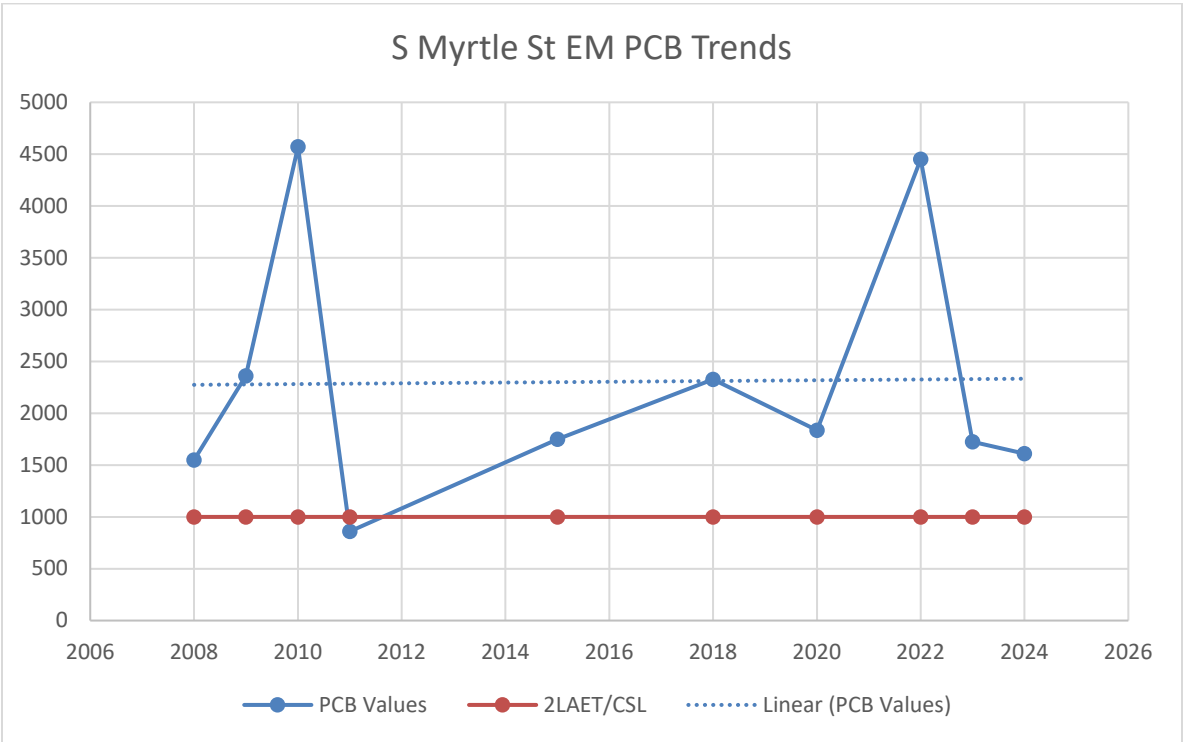
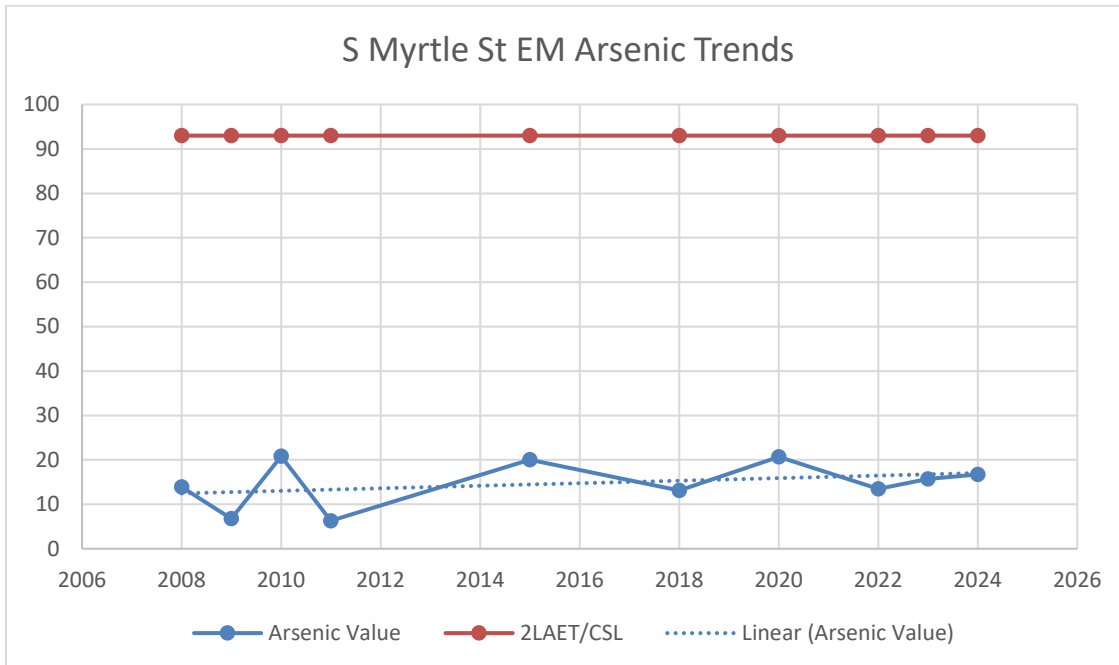
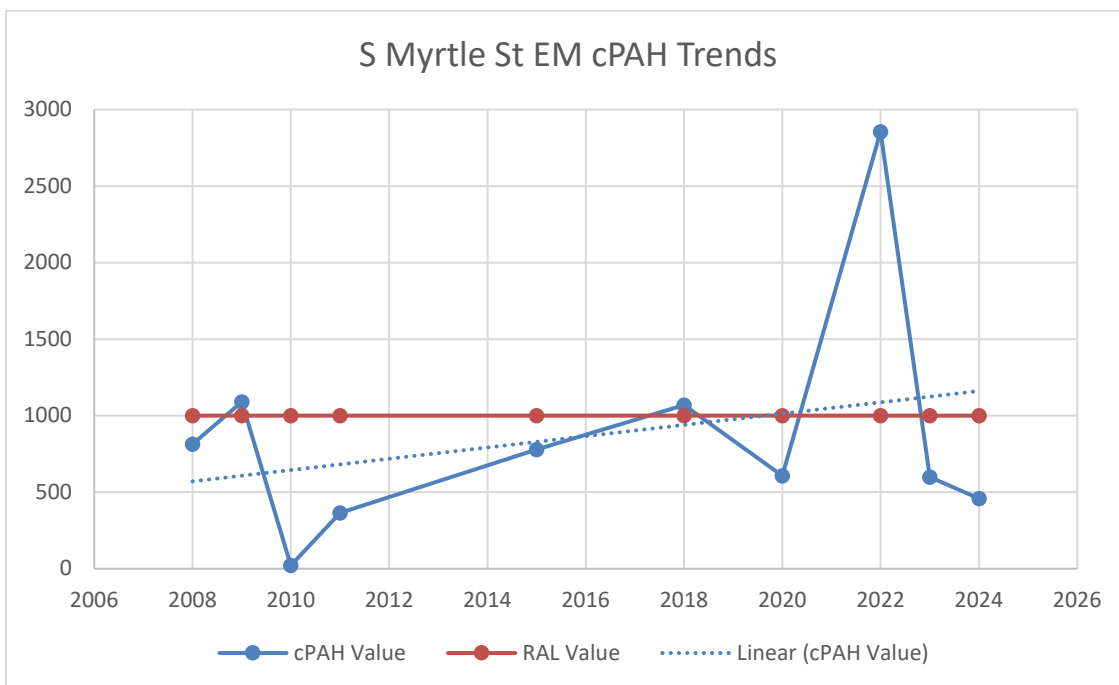
Figure 19: Effectiveness Monitoring Data Trends for the S Myrtle St SD.

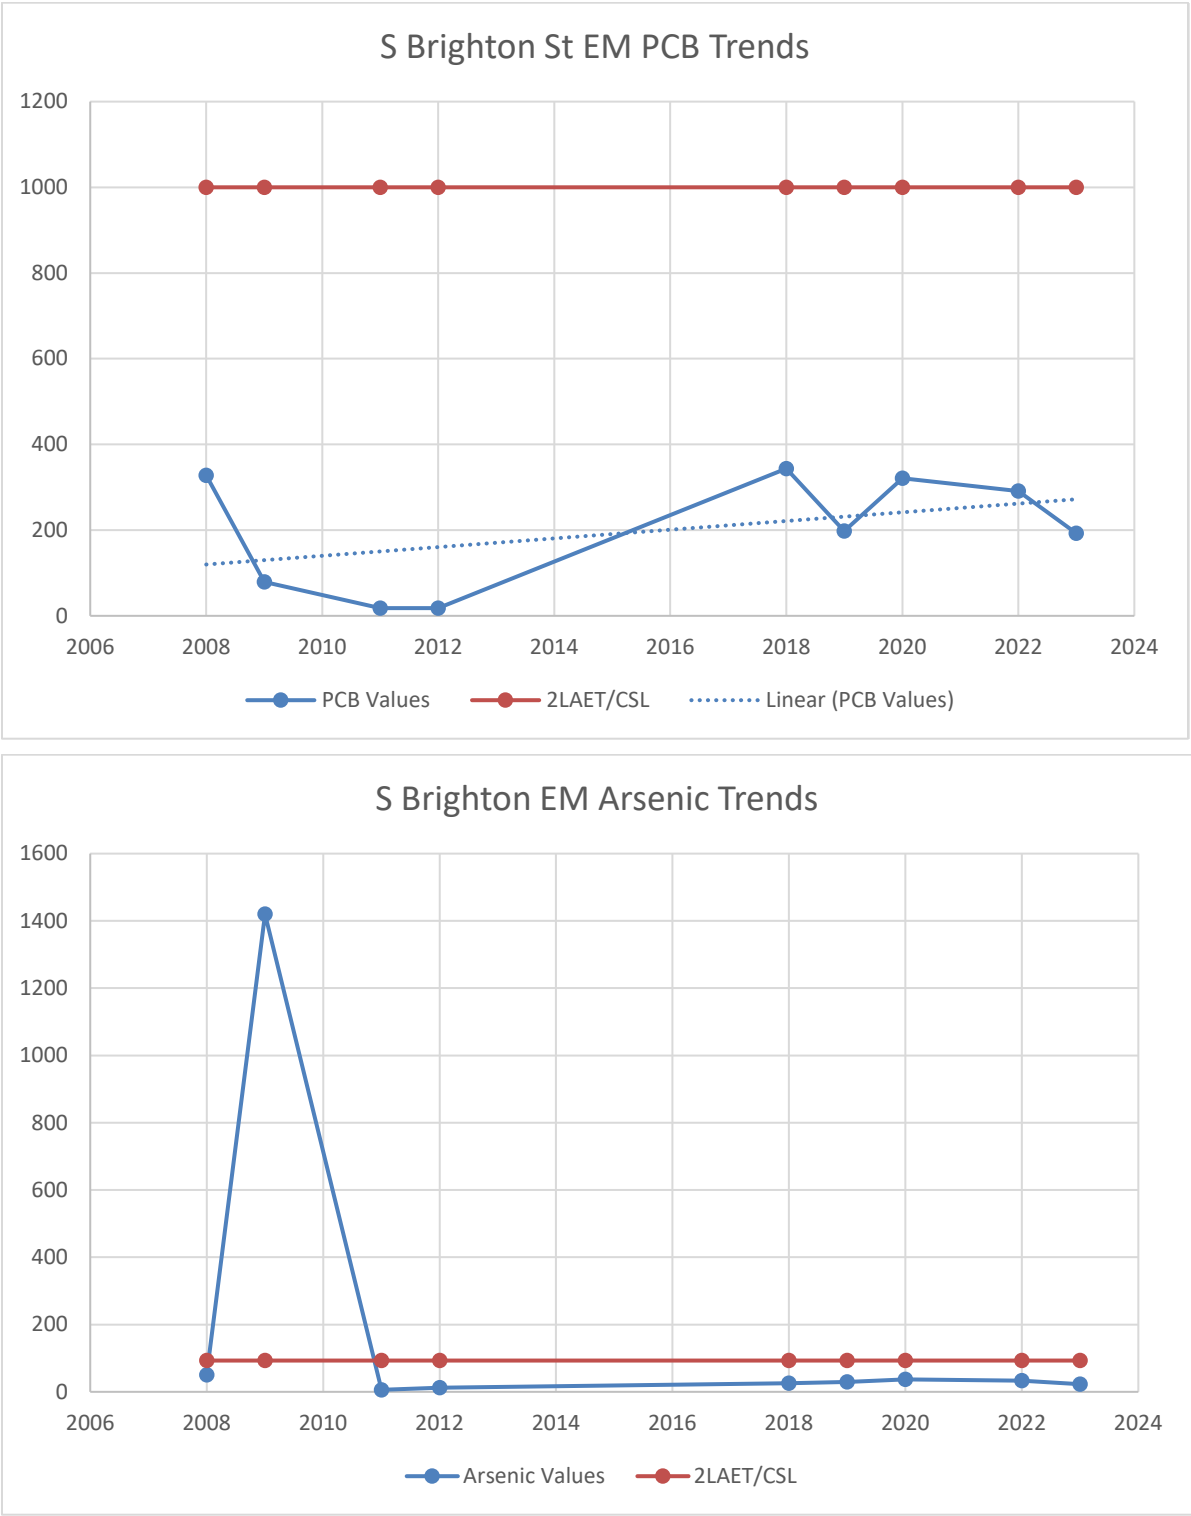
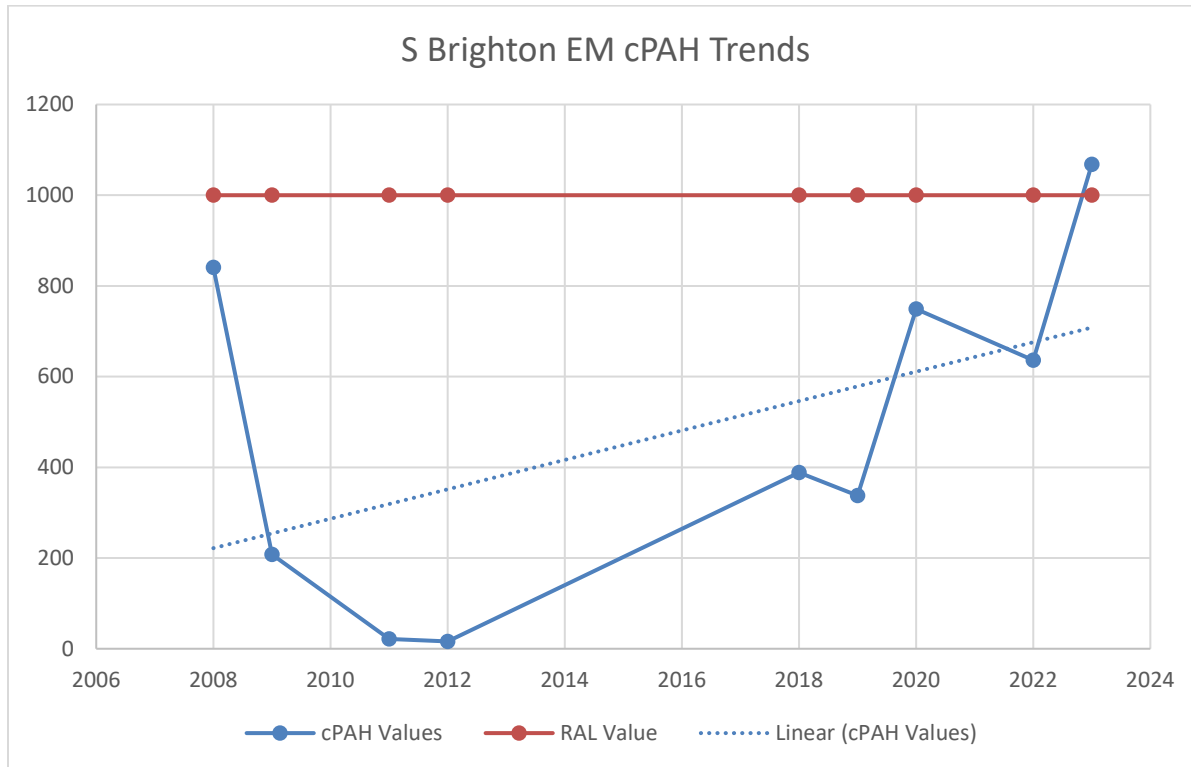
Figure 20: Effectiveness Monitoring Data Trends for the S Brighton St SD.

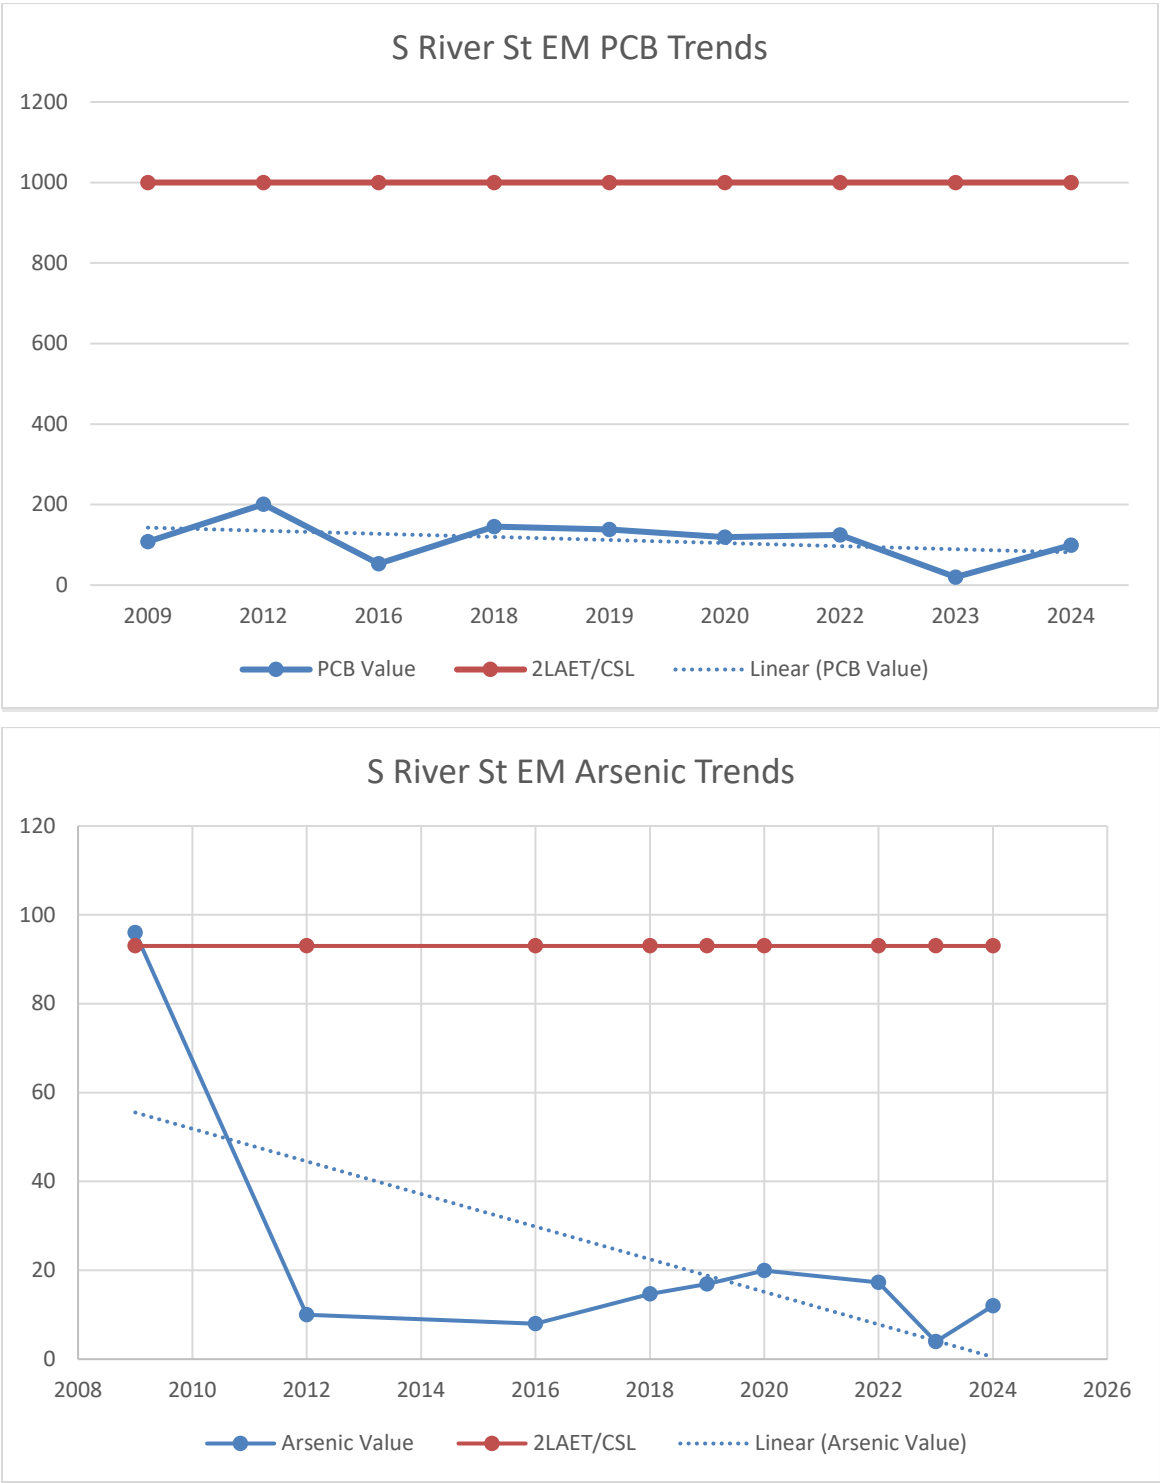
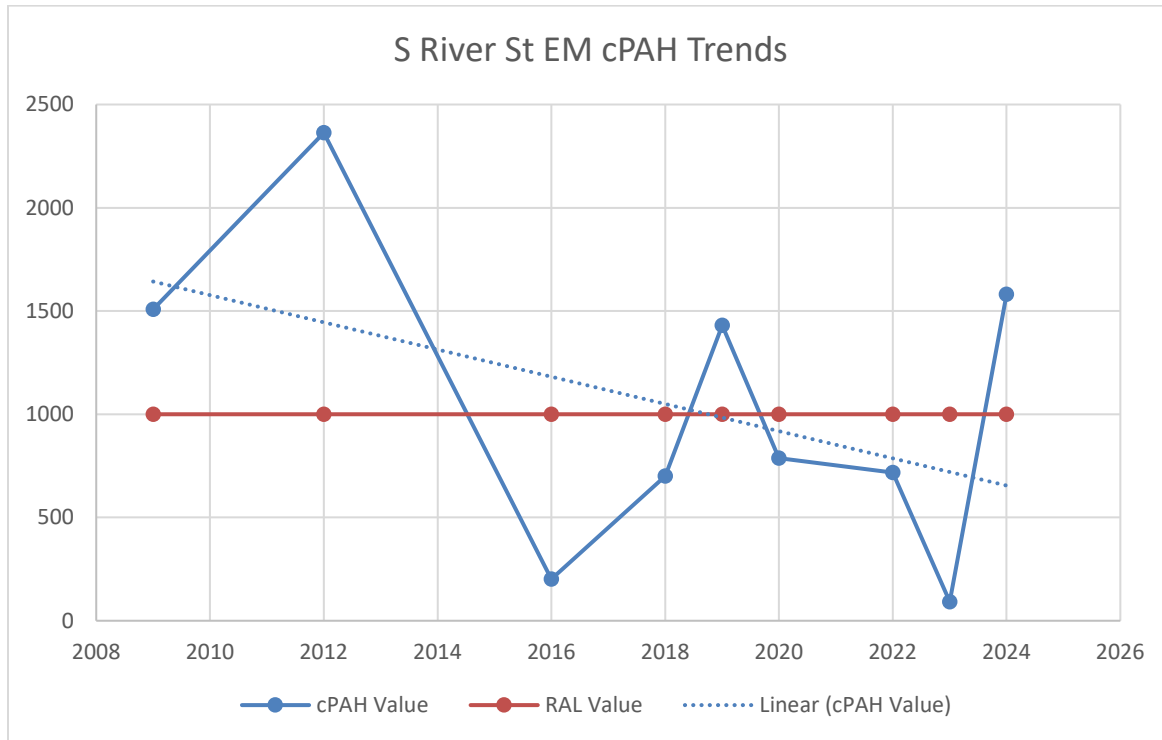
Figure 21: Effectiveness Monitoring Data Trends for the S River St SD.

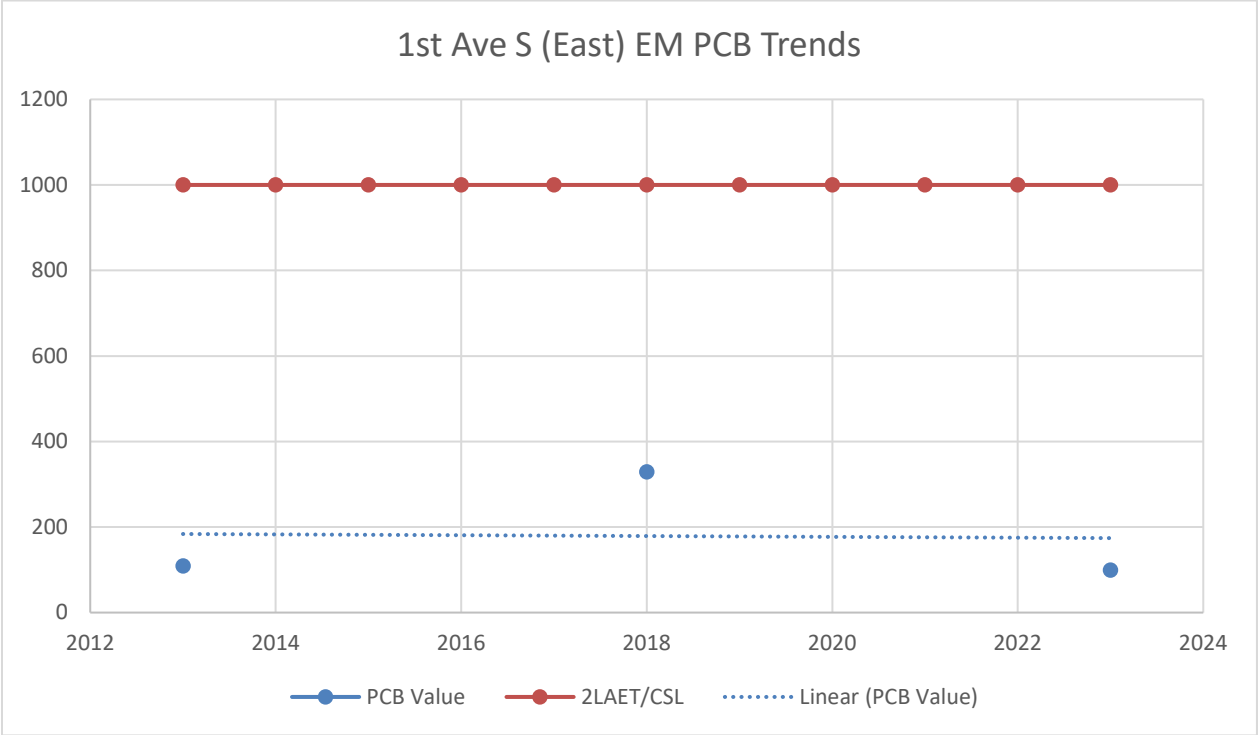
Figure 22: Effectiveness Monitoring Data Trends for the 1st Ave S SD (East).

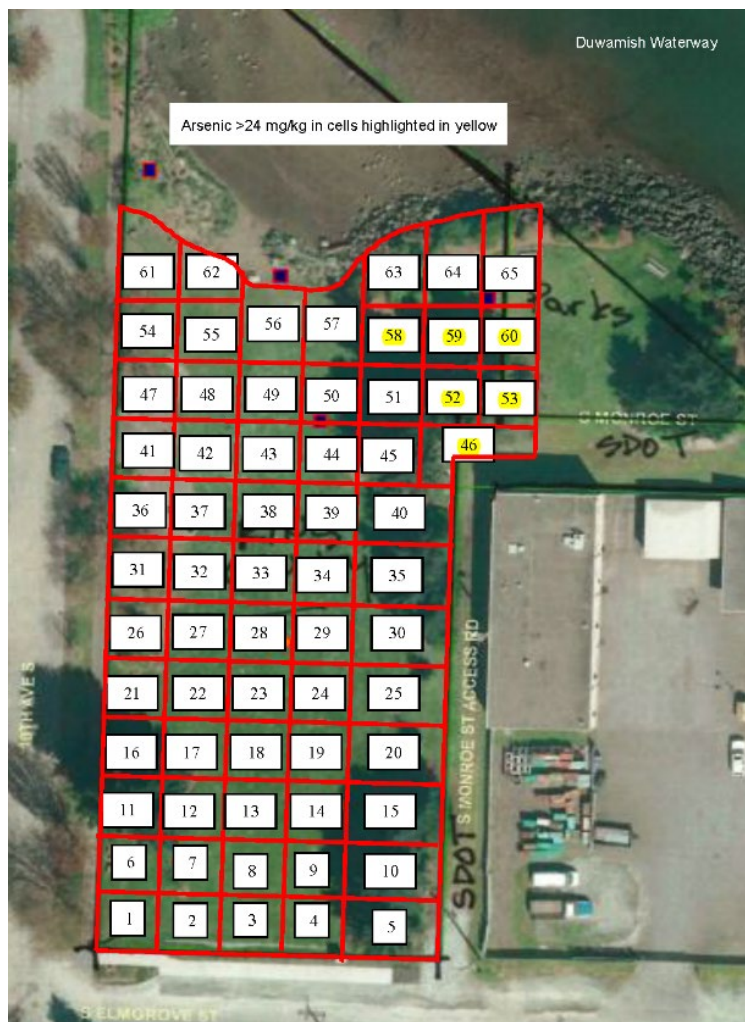
Figure 31: Soil sample locations at Duwamish Waterfront Park.

Seattle Parks and Recreation (SPR) investigated soil contamination at the Duwamish Waterway Park located at 10th Ave S and S Elmgrove St from 2014-2019 (Eco Compliance Corporation, 2019). Soil samples were collected from depths of 1-6 inches and 7-12 inches at approximately 61 locations on the site. Sample results for arsenic ranged from 4.1 to 104 mg/kg with the highest concentrations (41.7 – 104 mg/kg) found in six samples located in the northeast corner of the site (Figure 8). SPR pursued a voluntary cleanup of the property initially and is now working to clean up the site under an Agreed Order with Ecology. The site cleanup has been expanded to include the parcel to the east of the park site, which will eventually be incorporated into the park complex. More information is available in section 7.6.3 below.
