# **Seattle's Source Control Plan for the Lower Duwamish Waterway (2026 – 2031)**

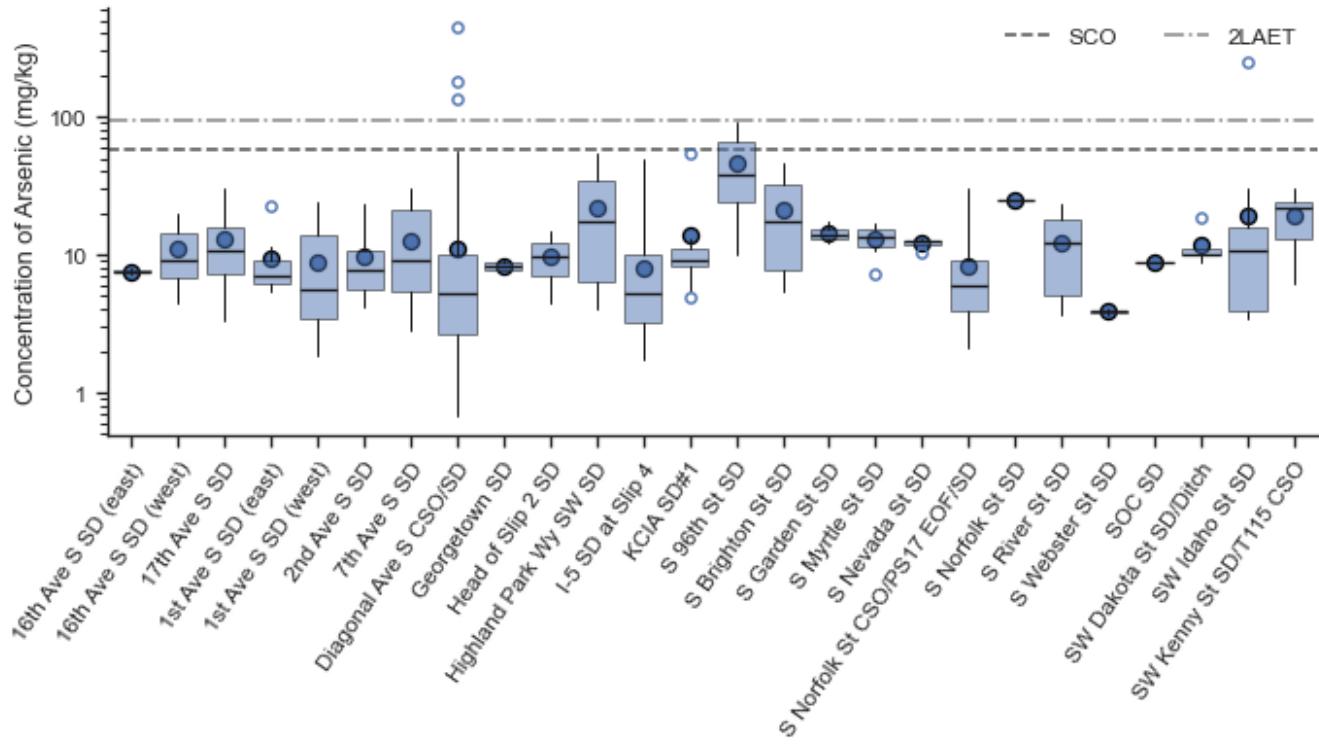
**Figure 1: Arsenic box plots by drainage basin**

The highest concentration (452 mg/kg) was found in an inline grab sample collected in 2019 at the sediment trap pilot test station in the Diagonal Ave S CSO/SD. None of the three sediment trap samples collected at this location in 2019 (7.42-15.4 mg/kg) exceeded the SCO. Other samples that exceeded the SCO screening level (57 mg/kg) include:

- The 2019 NST4 sediment trap location within the S Norfolk St CSO/PS EOF/SD. The sample contained 95.4 mg/kg, and was collected during redevelopment activities at an adjacent warehouse property. Samples collected prior to and after 2019 did not exceed the SCO screening level. Redevelopment activities replaced a large portion of the drainage system flowing into the sample location. Subsequent samples from this location have had substantially lower arsenic levels.

- Diagonal Ave S CSO/SD (3 inline grab samples collected at various locations in the drainage system). Two of these samples were near the 2019 sediment trap pilot test station and may have had the same source. The other sample was collected from a maintenance hole adjacent to a play field in a residential neighborhood. None of the 35 inline samples collected near the downstream end of the Diagonal Ave S CSO/SD system have exceeded the SCO, which indicates that this outfall is not a significant contributor of arsenic to the waterway.

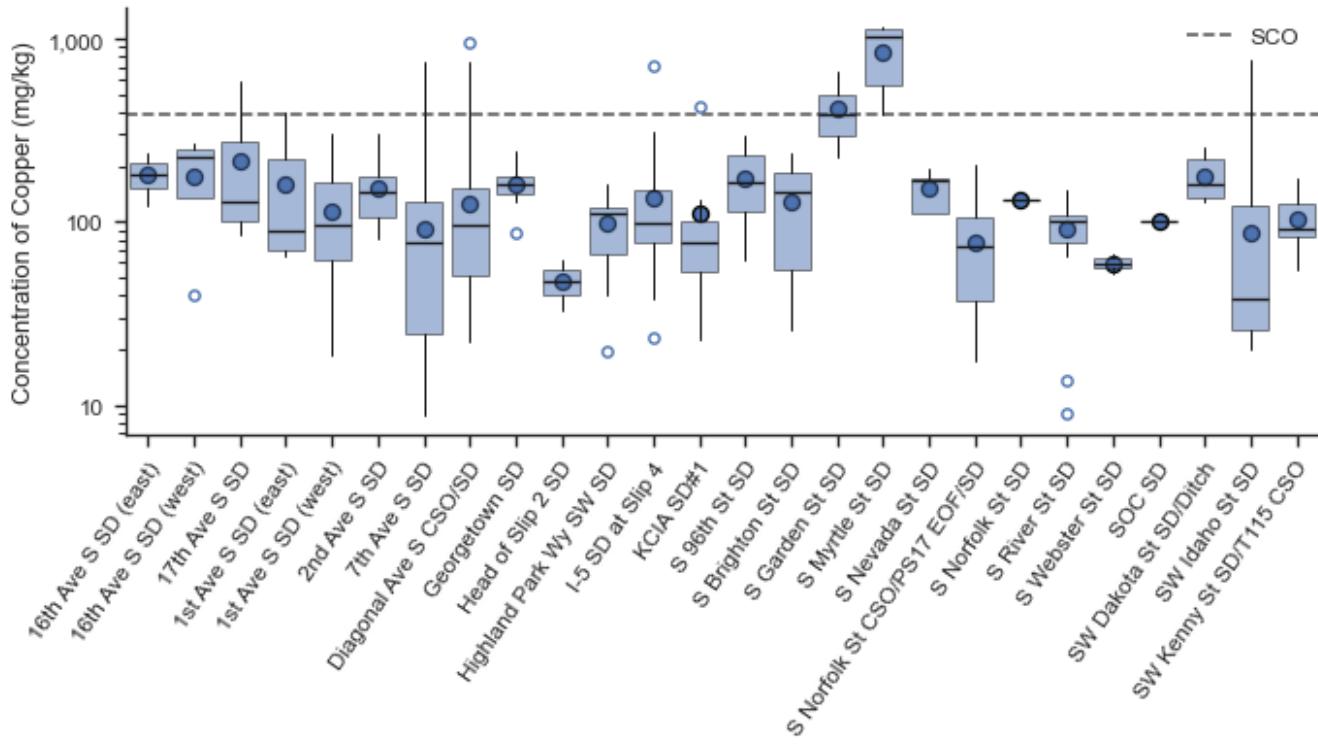
Figure 2: Copper box plots by drainage basin

Copper has exceeded the SCO/CSL in near end-of-pipe samples collected from five outfalls, including S Myrtle St SD, S Garden St SD, 17<sup>th</sup> Ave S SD, a grab from the 7<sup>th</sup> Ave S SD, and the KCIA SD#1. Five of the 19 exceedances occurred in the S Myrtle St SD and one occurred in the S Garden St SD, adjacent to a metals recycling facility. A lawsuit completed in 2019 required the metal recycling facility to make modifications to their operation to help to control contaminants leaving the site. The drainage samples from the basin have seen a reduction in copper levels since the implementation of these changes, which coincided with increased drainage system maintenance and sweeping conducted by SPU. Several locations that had previously been found to have elevated copper within source trace samples have not exceeded the copper SCO/CSL since their most recent cleaning, including the Highland Park Wy SW SD near-end-of-pipe samples.

Copper exceeded the SCO in only about one percent of the 1,994 surface sediment samples collected from the waterway (Windward 2019) and, with the exception of one sample collected 100 feet upstream of the 2<sup>nd</sup> Ave S SD, none of these sampling locations is located within 200 feet of an outfall that is owned by the City or that receives stormwater and/or wastewater from a City-owned system (Windward 2010). See Appendix J for a detailed description of SMS exceedances in waterway samples collected near outfalls.

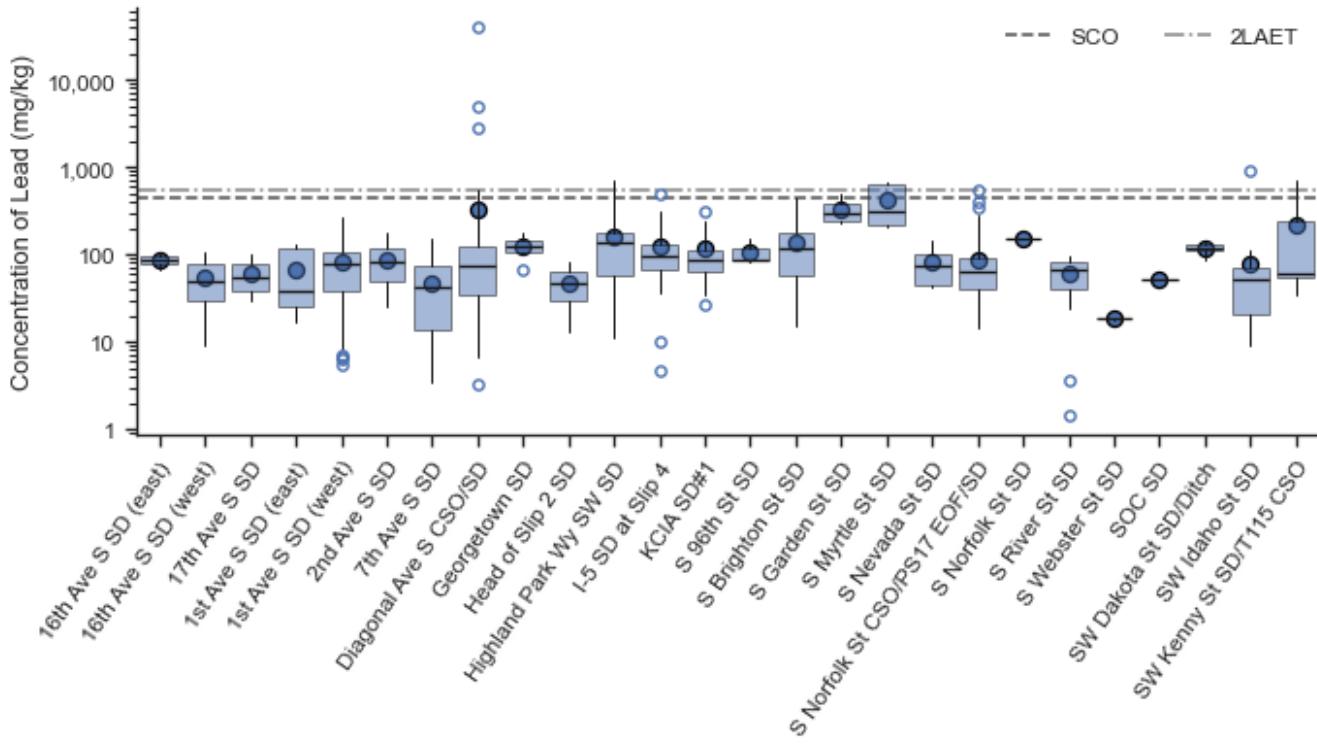
**Figure 3: Lead box plots by drainage basin**

Lead exceeded the SCO in only about two percent of the 2,124 surface sediment samples collected from the waterway (Windward 2019). The 2<sup>nd</sup> Ave S SD (Trotsky Inlet), which is a private outfall, is the only outfall that receives stormwater and/or wastewater from a City-owned system where lead exceeded the SCO within 200 feet of the outfall (AECOM 2012a). Samples from within the 2<sup>nd</sup> Ave S SD in proximity to SPU's inputs have not indicated lead is present above the SCO within the SPU operated portion of this system. Based on these data, it does not appear that the City MS4 is a significant contributor of lead to waterway sediment.

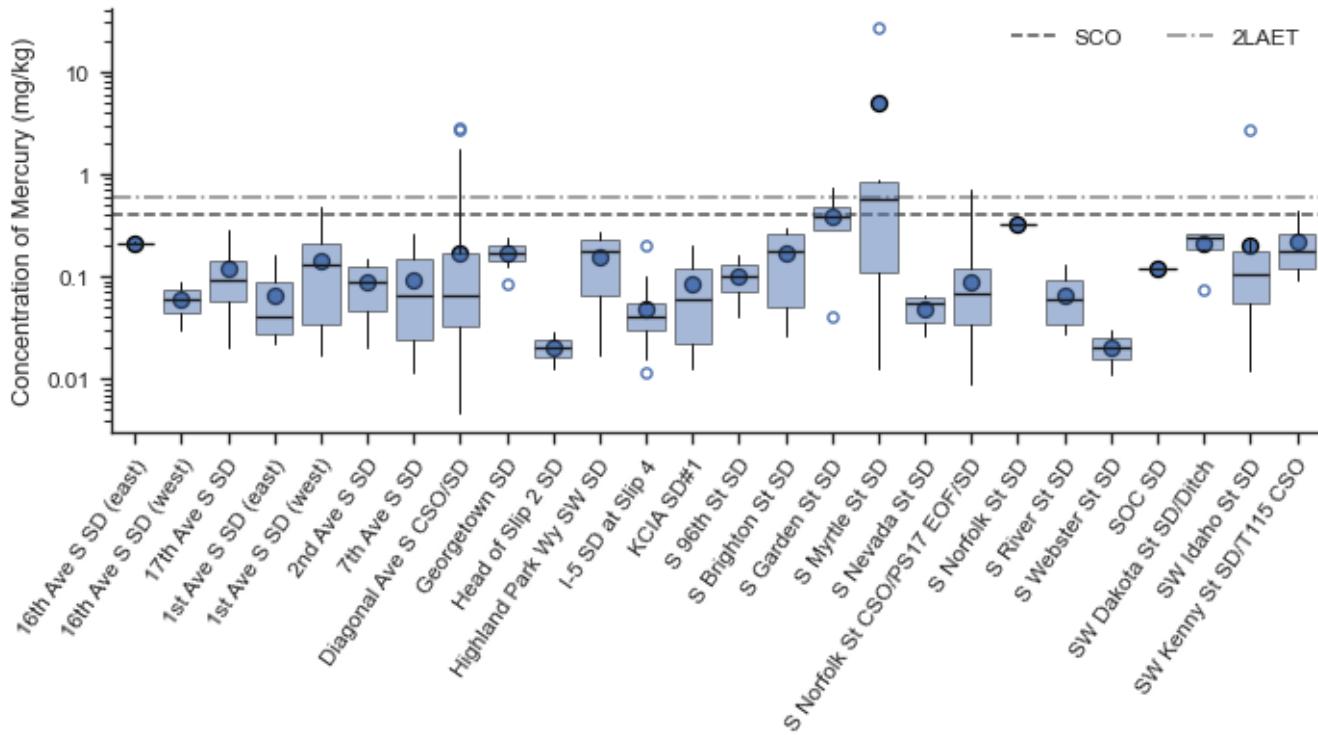
Figure 4: Mercury box plots by drainage basin

Only 4 percent of the 1,958 surface sediment samples collected in the LDW were greater than the SCO and less than the CSL, while 3 percent of the samples were greater than the CSL (Windward 2019). Slip 4, Trotsky inlet, S Myrtle St SD, and 7<sup>th</sup> Ave SD are the only sampling locations where SMS exceedances occurred near an outfall that either is owned by the City or that receives stormwater and/or wastewater from a City-owned system. One sample collected 165 feet offshore of the Diagonal Ave S CSO/SD outfall exceeded the SCO for mercury, but

none of the samples collected within 100 feet of the outfall exceeded the SCO. In addition, none of the samples collected since the 2004-2005 Diagonal Duwamish Early Action Area cleanup have exceeded the SCO for mercury. See Appendix J for a detailed description of SMS exceedances in waterway samples collected near outfalls.

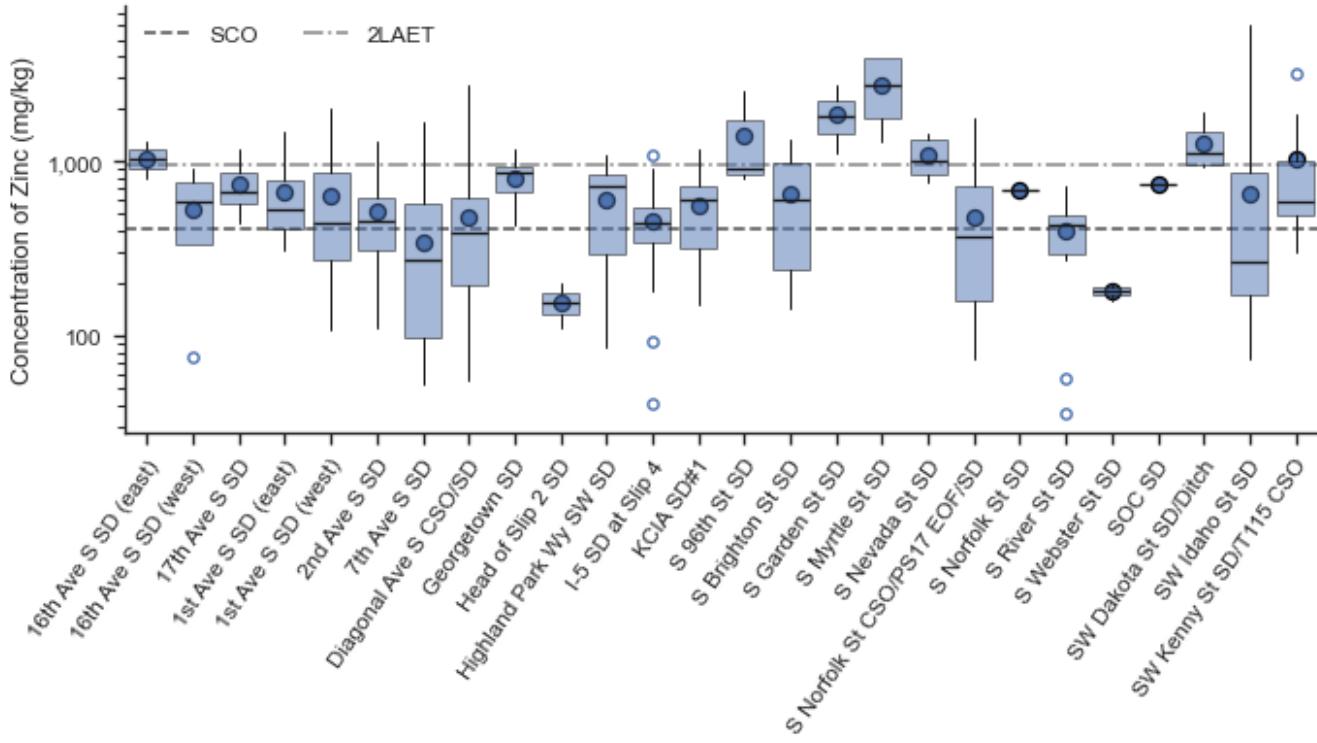
Figure 5: Zinc box plots by drainage basin

Zinc is a common component of galvanized materials (e.g., fences, roofs, flashing, pipe, and heating and ventilation equipment), automobile and equipment tires, motor and hydraulic oils, and chemical treatments for moss control. The widespread use of the metal has resulted in elevated levels of zinc being found in roadside catch basins and inline grabs. Zinc is frequently found in private catch basins in parking lots as well as in areas used to store metals, tires, and other zinc containing materials. Zinc was detected in all 576 samples collected in the MS4. Fifty-one (51) percent of the samples exceeded the SCO screening level and 14 percent exceeded the CSL screening level. However, zinc was not often found above SCO in waterway sediment. Only 3.1 percent of the surface sediment samples collected in the LDW were greater than the SCO and less than the CSL, while 1.9 percent of the samples were greater than the CSL (AECOM 2012a). One of these samples is located within 200 feet of an outfall owned by the City (Diagonal Ave S CSO/SD)<sup>10</sup>. Two are located near an outfall that receives stormwater and/or wastewater from a City-owned system (16<sup>th</sup> Ave S SD and 2<sup>nd</sup> Ave S SD). See Appendix J for a detailed description of SMS exceedances in waterway samples collected near outfalls. Because of the widespread use of zinc and the low frequency of zinc in waterway sediment, SPU has not focused source tracing efforts on zinc.

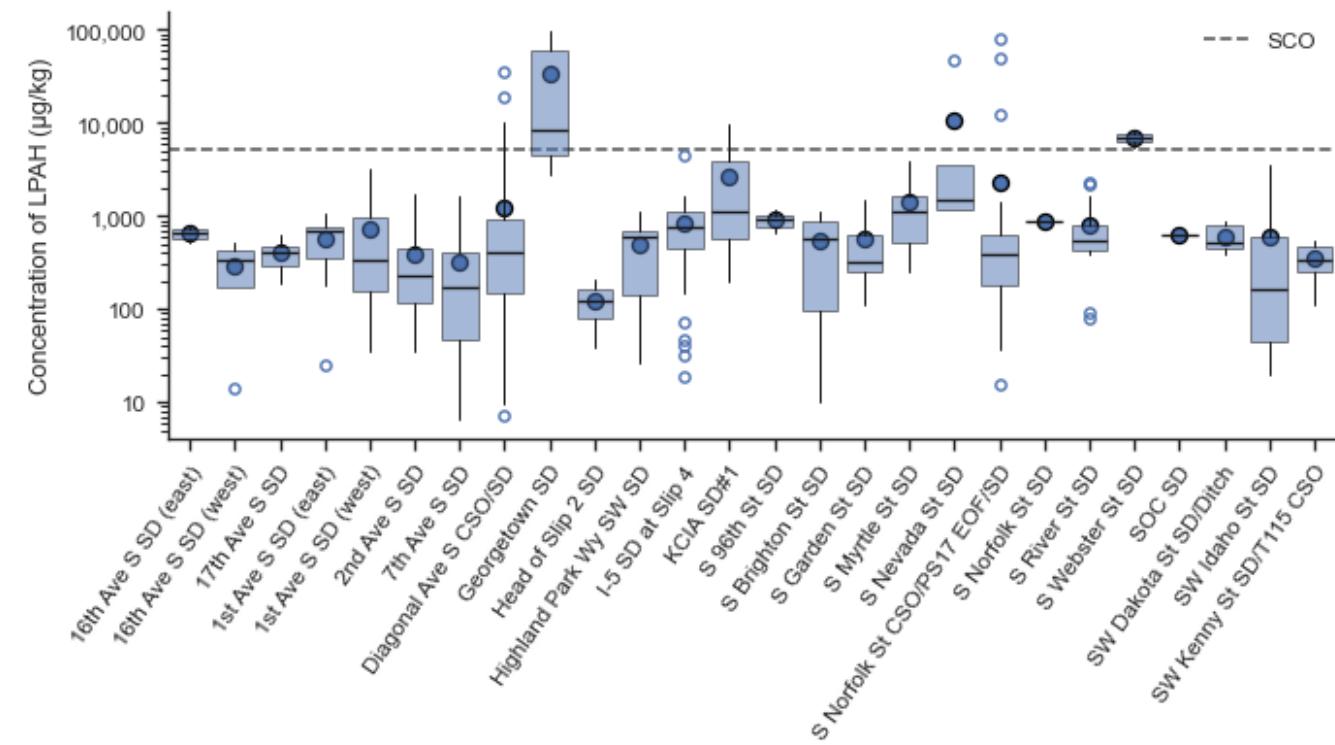
**Figure 6: LPAH box plots by drainage basin**

LPAH exceeded the SCO in less than 1 percent of the surface sediment samples collected from the waterway and only one of these sampling locations is near an outfall (7<sup>th</sup> Ave S SD) that is owned by the City or that receives stormwater and/or wastewater from a City-owned system (AECOM 2012a).<sup>11</sup> See Appendix J for a detailed description of SMS exceedances in waterway samples collected near outfalls.

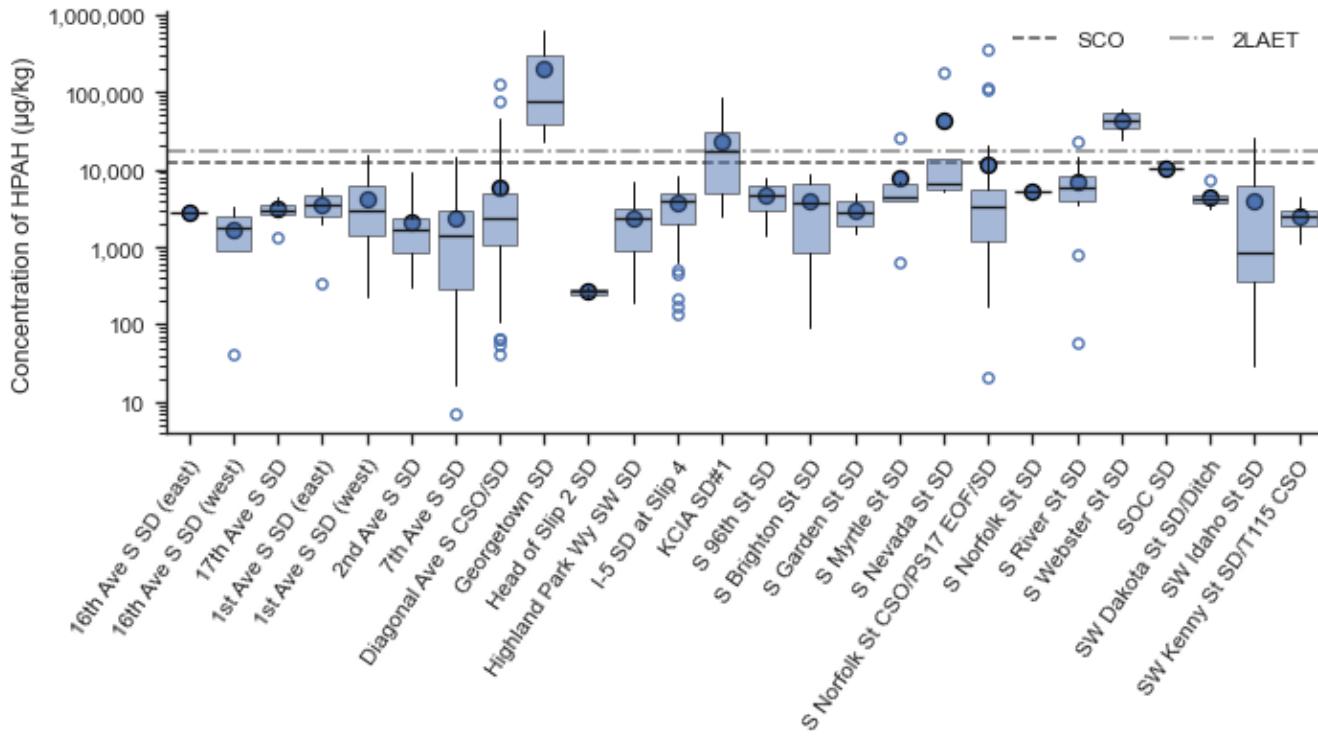
Figure 7: HPAH box plots by drainage basin.

HPAH exceeded the SCO in 2.9 percent and the CSL in 0.48 percent of the surface sediment samples collected from the waterway (AECOM 2012a). SCO exceedances occurred in samples located within 200 feet of outfalls in Slip 4 (prior to the 2012 Early Action Area cleanup), offshore of the Diagonal Ave S CSO/SD (prior to the 2004-2005 Early Action Area cleanup), 16<sup>th</sup> Ave S SD (east), KCIA SD #2/PS78 EOF, SW Dakota St SD, 2<sup>nd</sup> Ave S SD, and 7<sup>th</sup> Ave S SD outfalls. See Appendix J in SCIP 2 for a detailed description of SMS exceedances in waterway samples collected near outfalls.

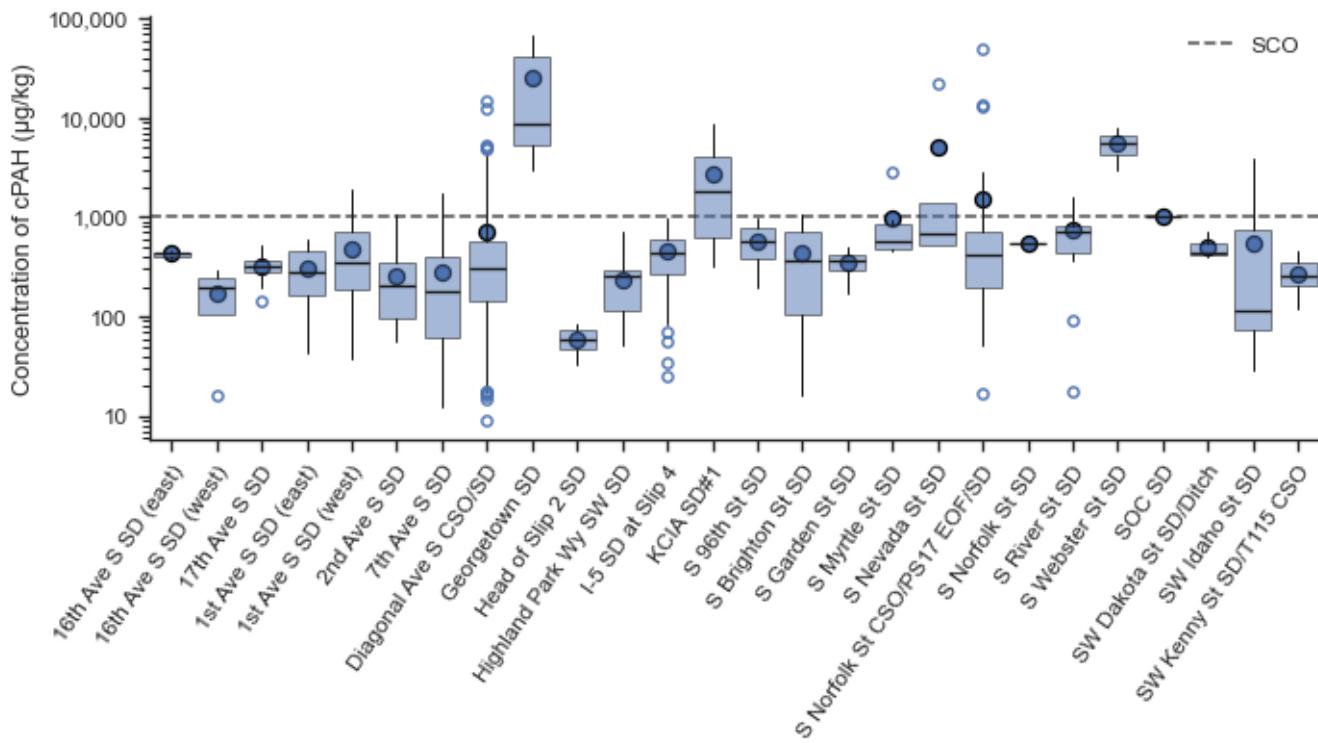
**Figure 8: cPAH box plots by drainage basin**

and HPAHs, these concentrations may increase shortly after the line cleaning occurs but are then expected to decrease as the cPAHs are diluted and active sources are eliminated.

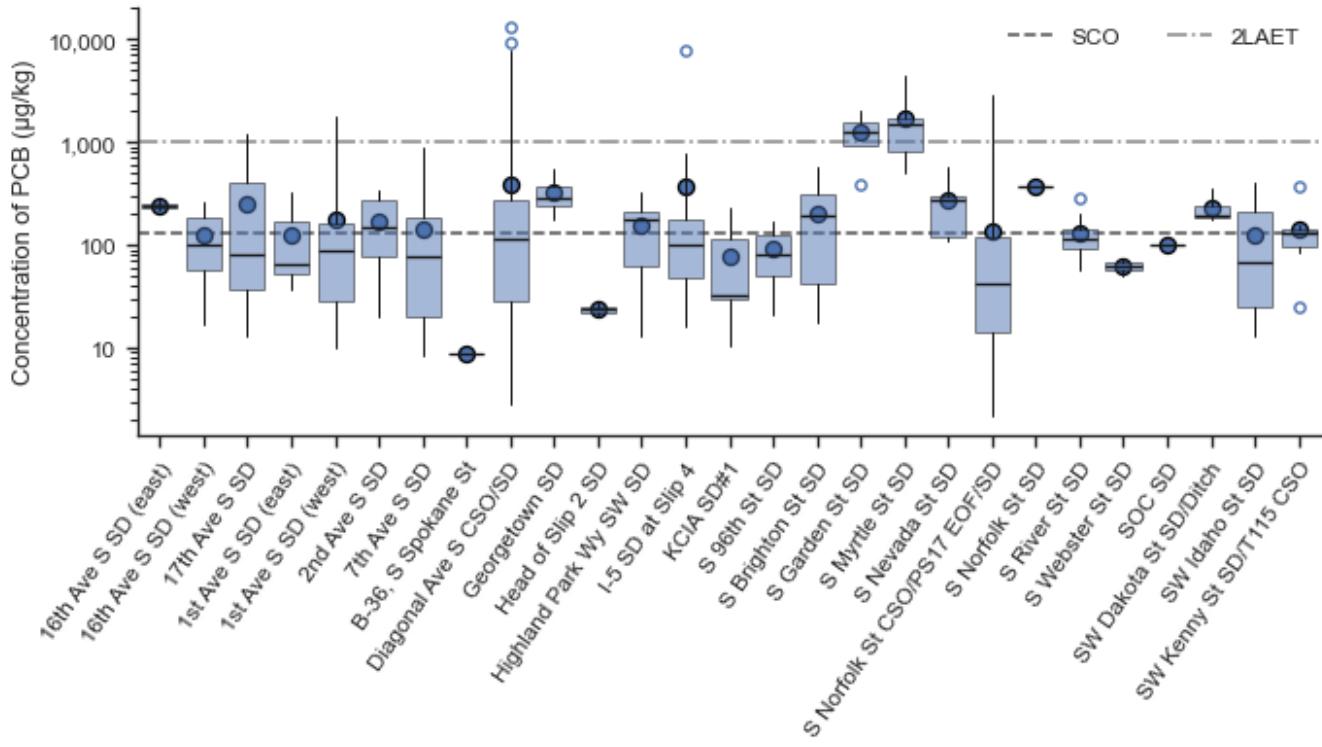
Figure 9: PCB box plots by drainage basin

SPU plans to sub-divide larger drainage basins into sub-basins and conduct targeted source tracing within these sub areas. While this approach has been used before, annual sub-basin “end-of-pipe” sampling will be implemented in areas with ongoing PCB detections to expand the data available to analyze trends and facilitate more targeted source tracing at lower PCB concentrations. This will allow SPU to identify discrete sources that may be contributing PCBs to our drainage system that exceed the cleanup and near end of pipe targets for basins but fall below our traditional source tracing values. SPU has conducted this type of source tracing in the past but will formalize this source tracing process moving forward.

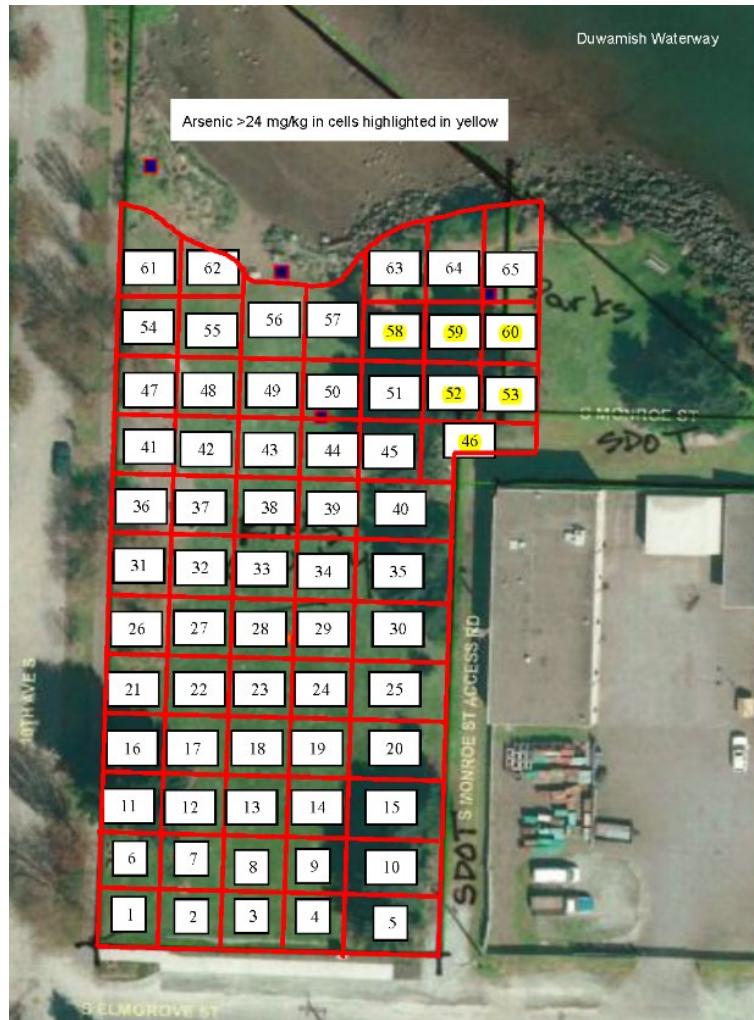
Figure 31: Soil sample locations at Duwamish Waterfront Park.

Seattle Parks and Recreation (SPR) investigated soil contamination at the Duwamish Waterway Park located at 10<sup>th</sup> Ave S and S Elmgrove St from 2014-2019 (Eco Compliance Corporation, 2019). Soil samples were collected from depths of 1-6 inches and 7-12 inches at approximately 61 locations on the site. Sample results for arsenic ranged from 4.1 to 104 mg/kg with the highest concentrations (41.7 – 104 mg/kg) found in six samples located in the northeast corner of the site (Figure 8). SPR pursued a voluntary cleanup of the property initially and is now working to clean up the site under an Agreed Order with Ecology. The site cleanup has been expanded to include the parcel to the east of the park site, which will eventually be incorporated into the park complex. More information is available in section 7.6.3 below.
