SKAGIT - FERC PROJECT #553
EROSION CONTROL PROGRAM
2004 COMPLETION REPORT

North Cascades National Park and Seattle City Light

May, 2005

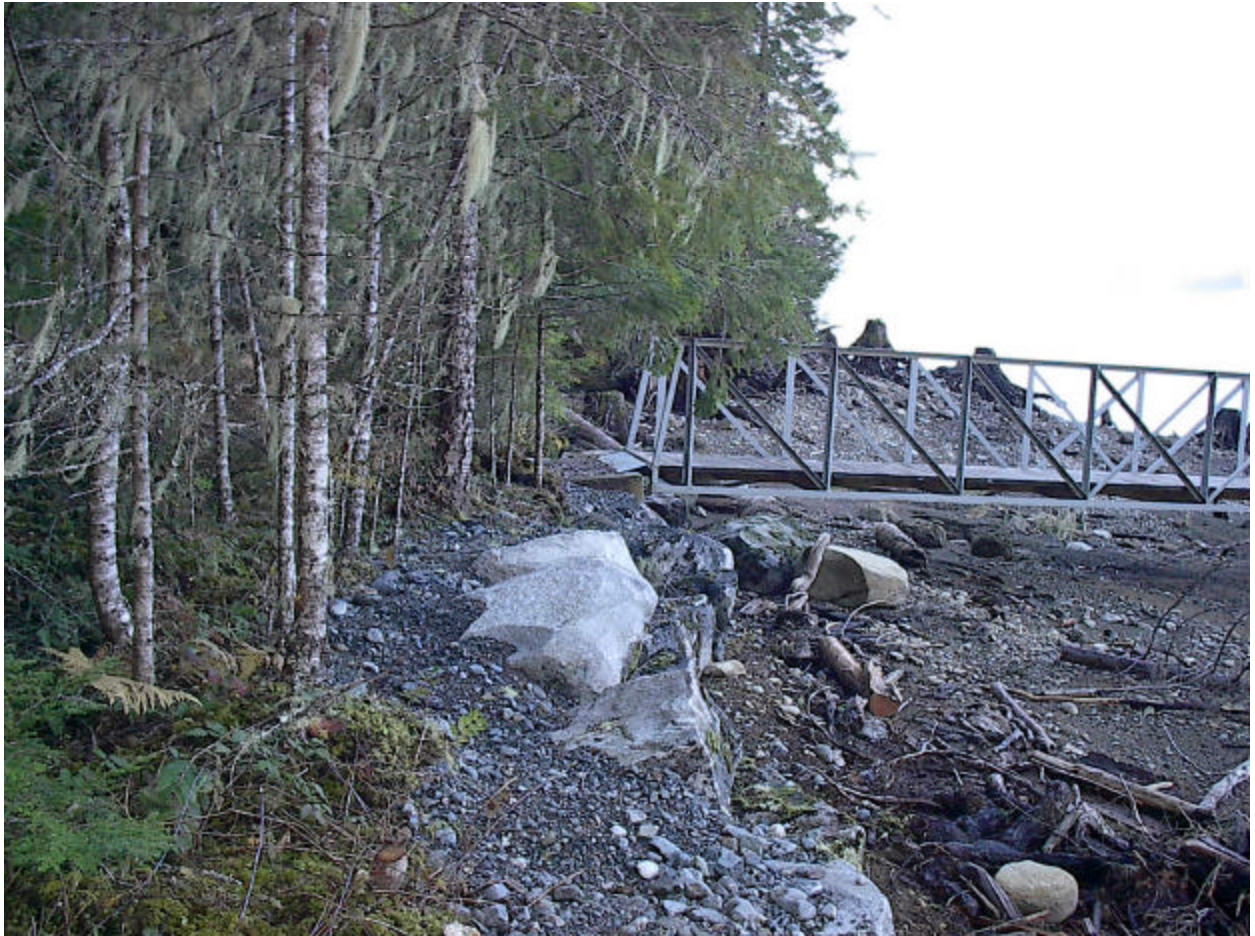
Photo 1. E-40, McMillan Campground.

SITE E-40: McMillan Campground. A new bulkhead and dock were installed here in 2002. On either side of the new bulkhead, scouring from wave activity had created a cut bank approximately 8'-12" H. Large (2'-4' square) boulders were placed along 60' of the shoreline around the bulkhead to prevent erosion creeping in behind the bulkhead. Gravel and fines placed behind the boulders to fill voids along the linear footage of boulder placement. (Photo 1).

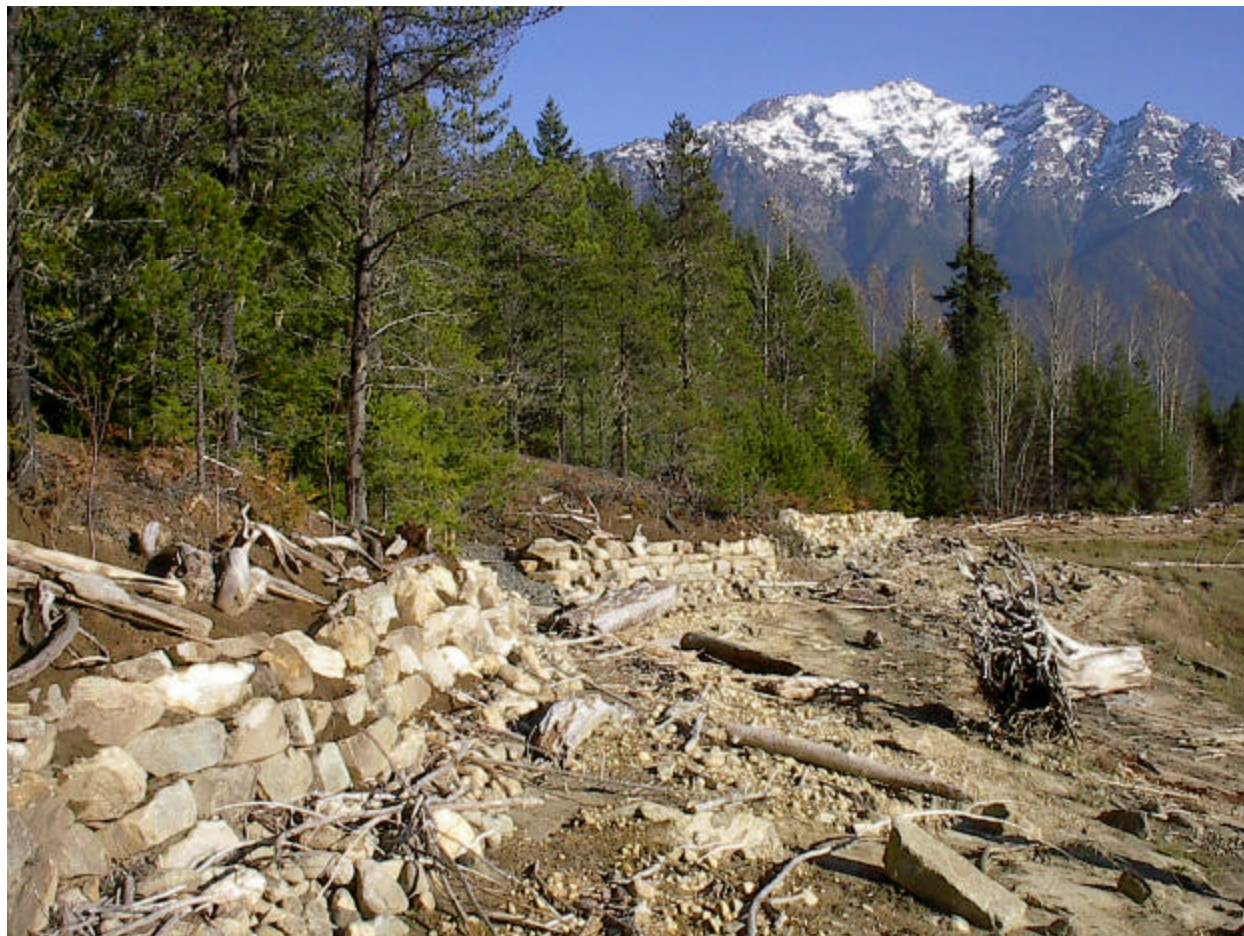
Photo 2. W-34, Big Beaver spur trail

SITE W-34: Big Beaver Spur Trail. Continuation and completion of a dry lay rock wall, 5' tall per erosion control design, 100' linear (Photo 2).

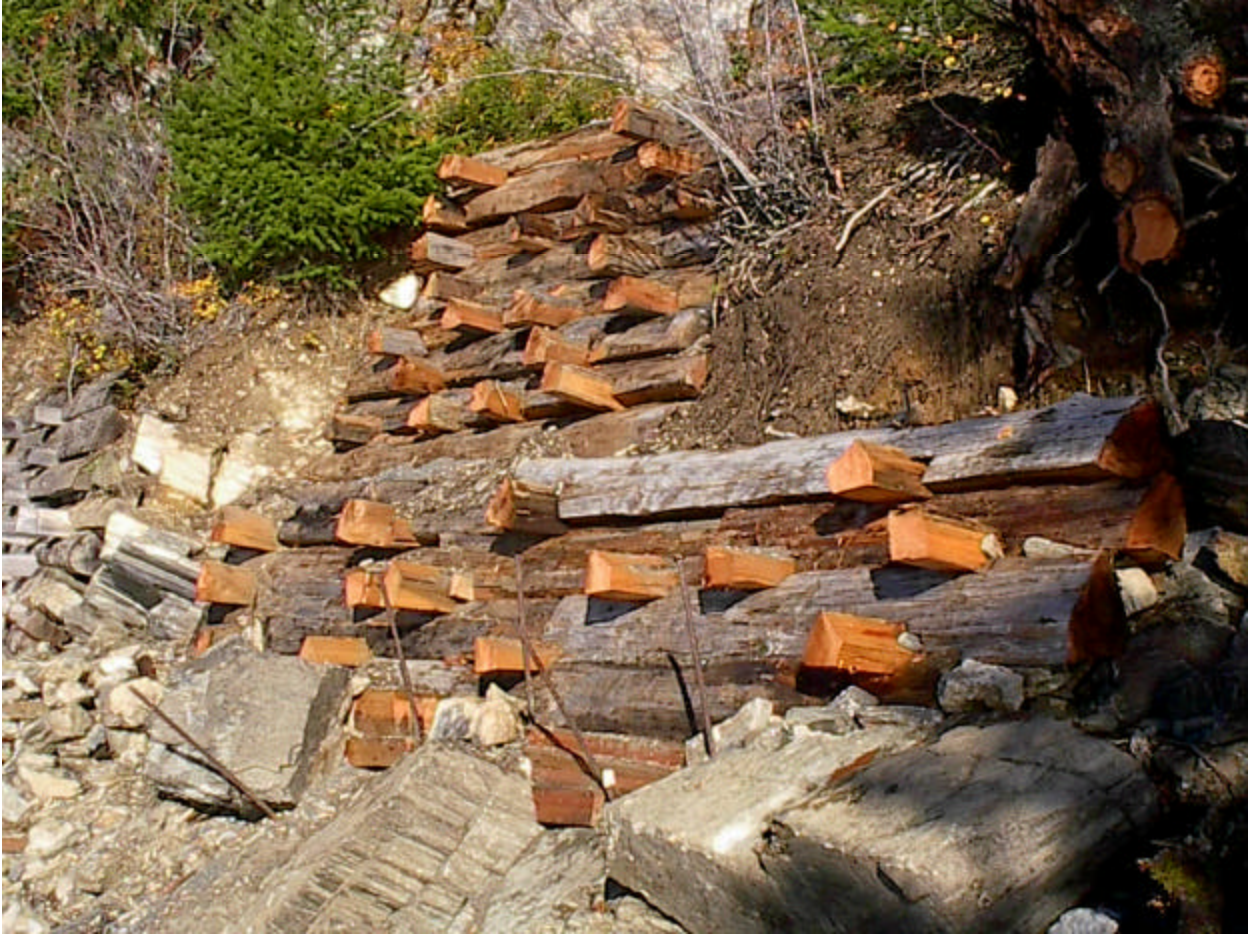
Photo 3. E-70A-5B, East Bank Trail, contingency cribbing site.

CONTINGENCY CRIBBING SITE East Bank Trail (E-70A-5B): (not identified in original Erosion Control site plan. Site completed located between E-70A-5 and E-70A-6). Erosion mitigation work done at this site in the early 1970s, had been deteriorating and had reached a point very close to complete failure. Failure at this particular site would have closed the East Bank Trail to hikers and stock. Corrective measures were initiated by installing terraced cedar cribbing as per cribbing design at other designated erosion control sites along the East Bank Trail. 30 linear feet of shoreline protected to a height of 18' (Photo 3)

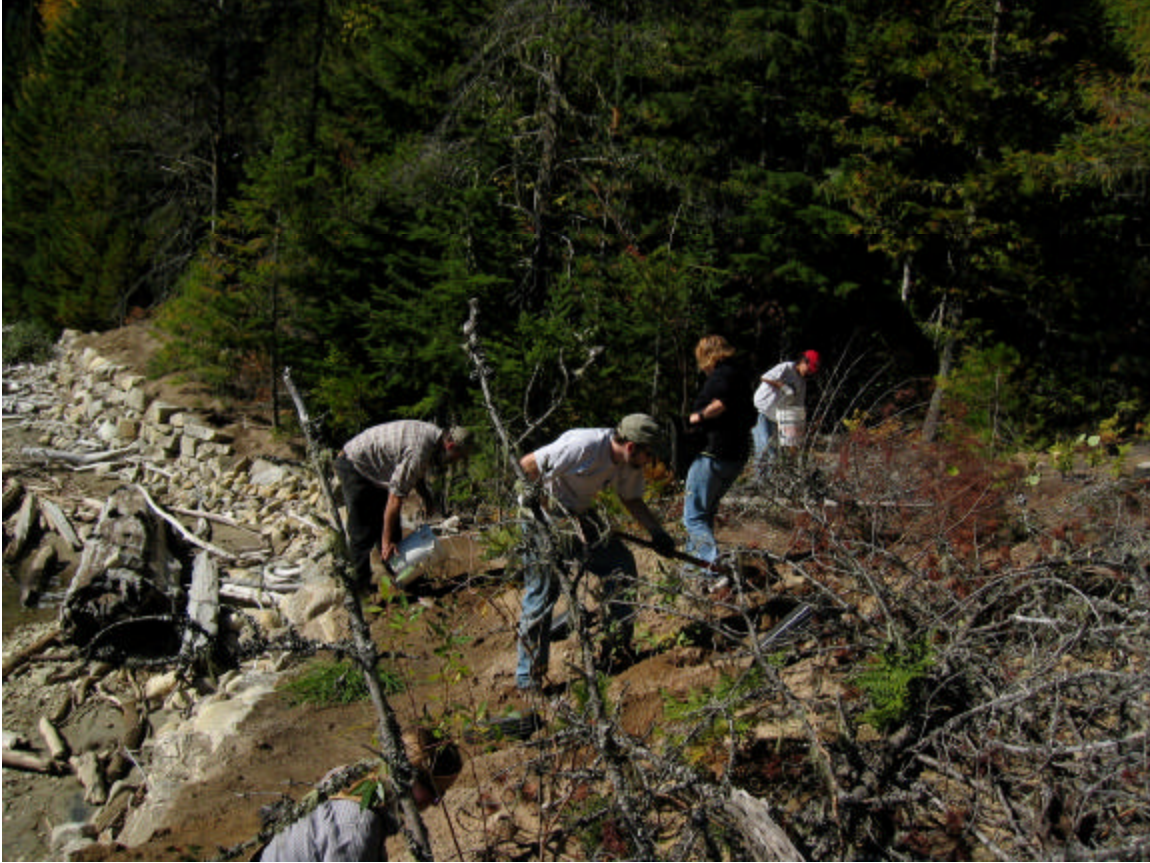
Photo 4. Revegetation at site W-34

NPS Greenhouse and Plant Propagation: : The Ross Lake Plant Propagation Crew installed 1315 new plants at 1 new site and 3 previously planted sites during September and October of 2004. The new site was site W-34: Big Beaver Spur Trail (Photo 4). Additional planting occurred at W-122, Little Beaver Cove; E-112, Dry Creek; and E-70A4, East Bank Trail. Propagation work, including seed and cutting collection and growing was continued in preparation for planting at two erosion control sites on Diablo Lake in 2005.
