Newhalem Riparian Restoration Project Seattle City Light

Prepared by
Michelle Murphy
Stewardship Manager
Skagit Fisheries Enhancement Group
September 30th, 2015

PROJECT BACKGROUND

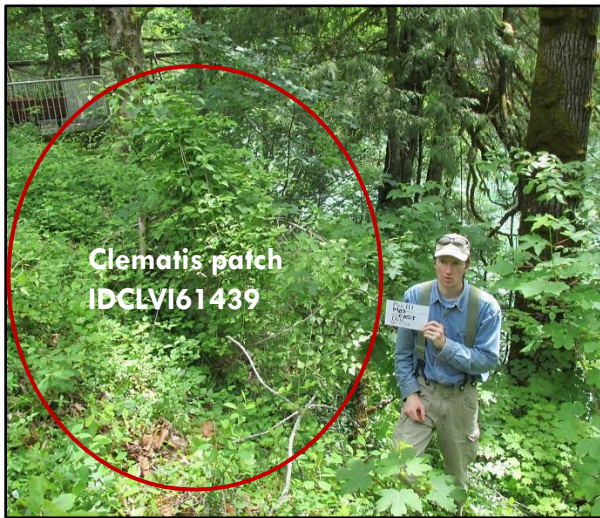
Figure 2. plot 1403 prior to treatment, photo shows extensive clematis infestation.

Vegetation monitoring data collected for plots in Newhalem show substantial clematis control was achieved but that follow up work is needed. Plot 1402 was set up in a clematis control area adjacent across from the Gorge Powerhouse. Baseline data in this plot showed that clematis covered 10% of the plot area in 2014 prior to project implementation. Follow up monitoring in September 2015 recorded <1% clematis present in the area. Plot 1403 which was set up adjacent to the trail of cedars bridge, showed 15% coverage of clematis in 2014 prior to project work and <1% in post project monitoring in September 2015. These monitoring results show the progress that has been made in control, but that small areas of clematis still remain, supporting the need for follow work is still needed (figure 2-3).

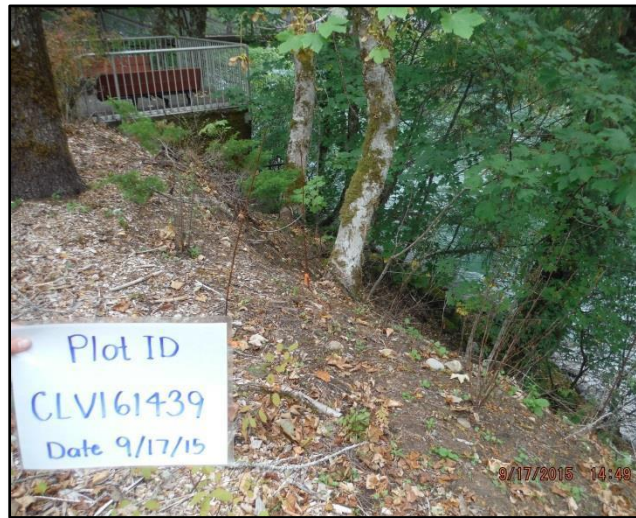
Figure 3. plot 1403, patch CLVI61439 was dead in 2015, <1% clematis remains in this area.

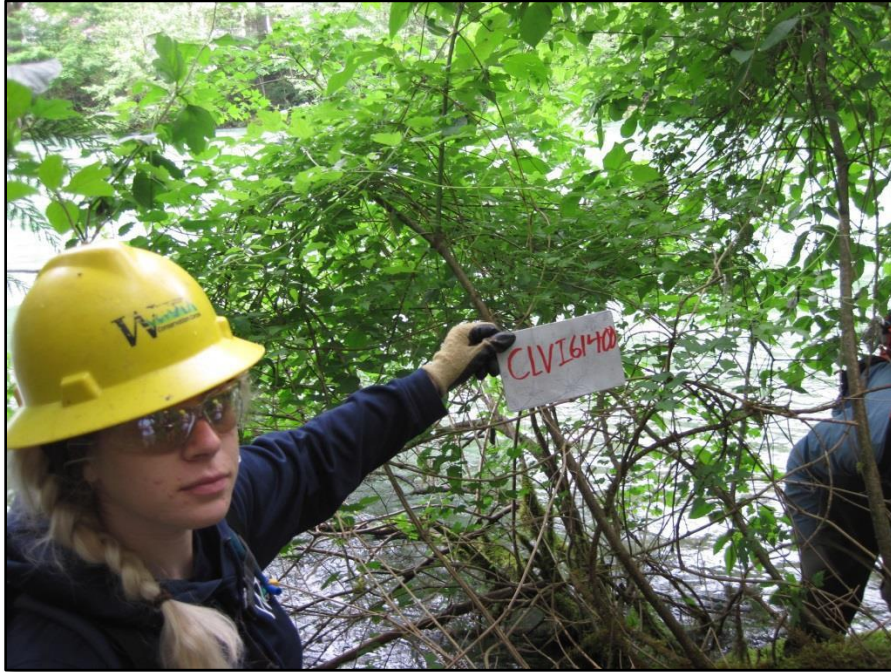
The treatment segment on the Skagit River right from the gorge powerhouse bridge to ladder creek, was the worst infestation of clematis in the Newhalem riparian area when the project began in 2014. When work began clematis had climbed up the gorge bridge and had covered approximately .4 acre of ground below the bridge with additional infestations throughout the native vegetation in the area. Where clematis had not overtaken native vegetation, it had interwoven itself into native vegetation. Treatment of this section was difficult because of the volume of clematis and the way it had interwoven into native plants. Crews worked to remove clematis from native plants prior to treatment. As of the fall of 2015 only small clematis resprouts were found in this area.

Figure 5. photo spring of 2014, clematis patch was in the river and strangling adjacent tree.

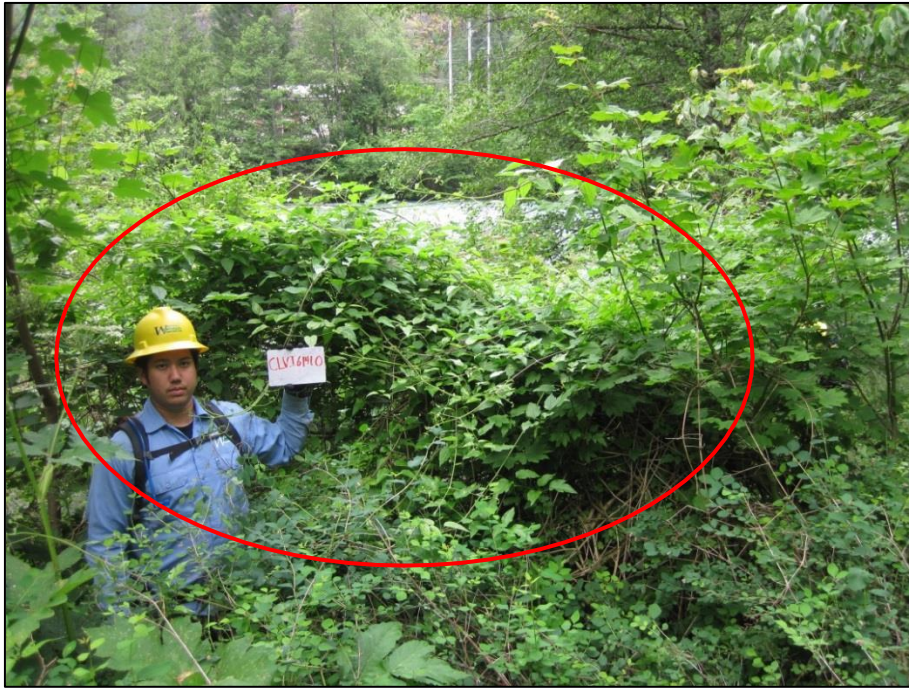
Figure 6. Clematis patch adjacent to Skagit River, beginning to strangle native vegetation.

The treatment segment on the Skagit River right from Newhalem Mainstreet to the NPS bridge, began in 2014. Clematis infestations were found throughout this area, with one patch covering a 15 by 30ft area (figure 6).

The treatment of the section on the Skagit River right from ladder creek to Mainstreet, began in 2014. Clematis infestations were found throughout this area, clematis in this section had also climbed many of the mature trees. Clematis patches were also found in the floodplain area on the Skagit River left and especially along Newhalem Creek and the gravel bars of the river. Most of the river left patches were small and appeared to have recently established. Because of the fires in the summer, there was no access to the trail of the cedars and retreatment of clematis patches on the river left was not done in the fall of 2015. However, clematis was spot sprayed on river left in the spring of 2015. Transect surveys of this section are recommended for 2016. This is because of the small resprouts that can be found. Survey is also recommended to be conducted during low flows as there will likely be many small resprouts along the river margin.

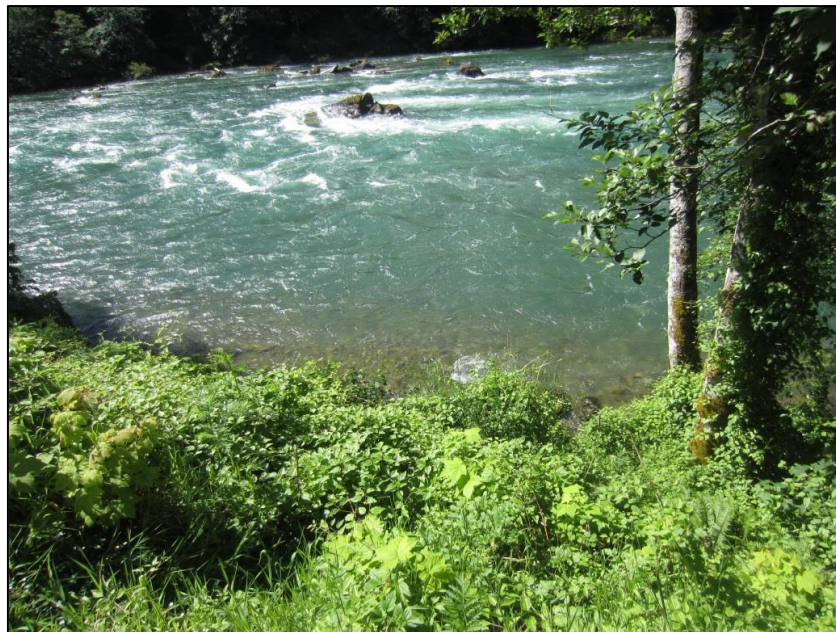
Figure 7. Slope covered in clematis, found below the Newhalem housing in 2014.

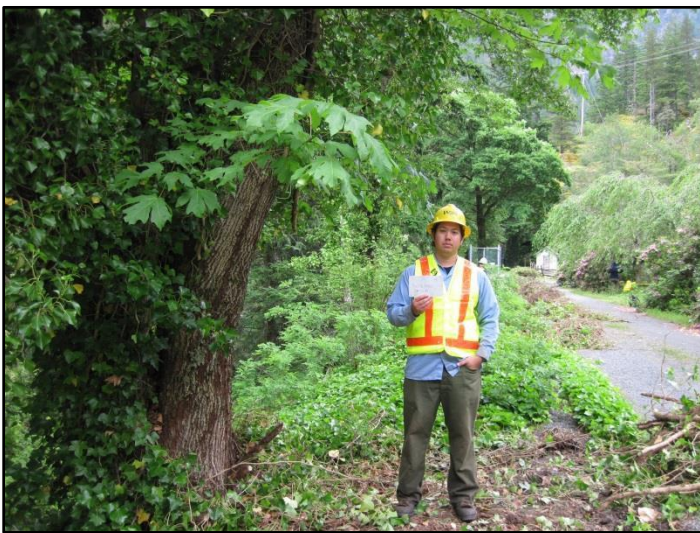
Prior to treatment of ivy in this area was very dense, extending over a foot in depth in many section in continuous coverage. Ivy in this area extended from east of the greenhouse to the gorge powerhouse actively covering at least 8 mature trees. Extensive treatment of the ivy in this section has been done since the summer of 2014. All ivy girdling the trees has been cut down (figure 1 and 2) and approximately 70% of ivy has been controlled.

Figure 8. Greenhouse drive ivy control area during spring 2014 work, removal of ivy being removed shown here.

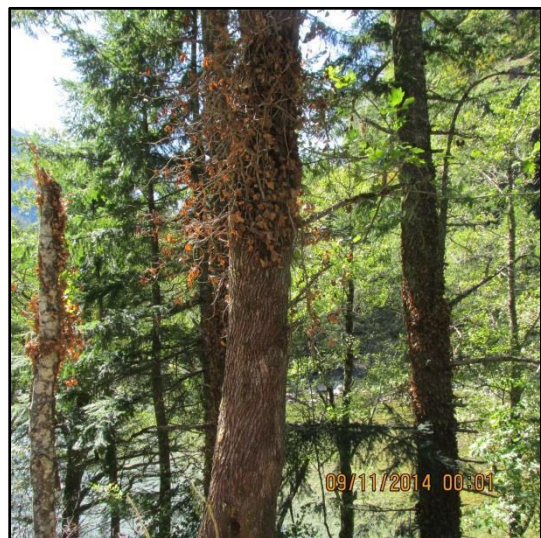
Figure 9. Ivy climbing trees was girdled in the spring of 2014, shown in this photo ivy dying on large trees in the fall of 2014 as a result of this work.

Beginning in the spring of 2014 ivy was foliar treated with 2.5% glyphosate, trade name AquaNet, treatment occurred in the fall of 2014 and again in the spring of 2015. Treatment of ivy in this area has been challenging due to the depth of the infestation and some sections of ivy are still actively growing. As illustrated in figure 2, significant progress has been made and ivy has been controlled in many sections. After two seasons of chemical treatment the remaining patches are recommended for hand removal.

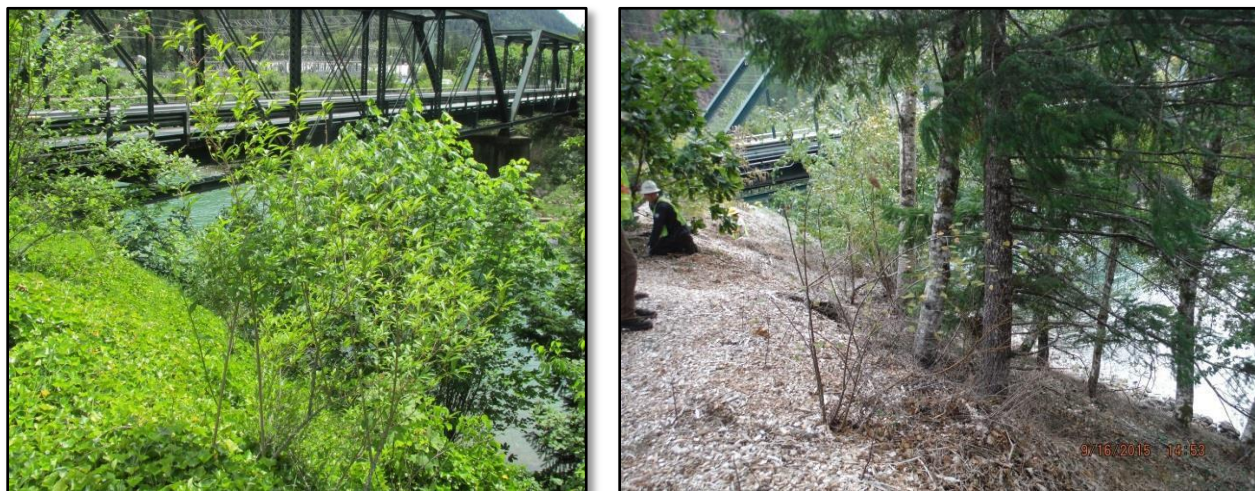
Figure 10. Before, 2014 ivy below Gorge Powerhouse bridge (left) and after (right) September 2015 absence of ivy below the bridge.

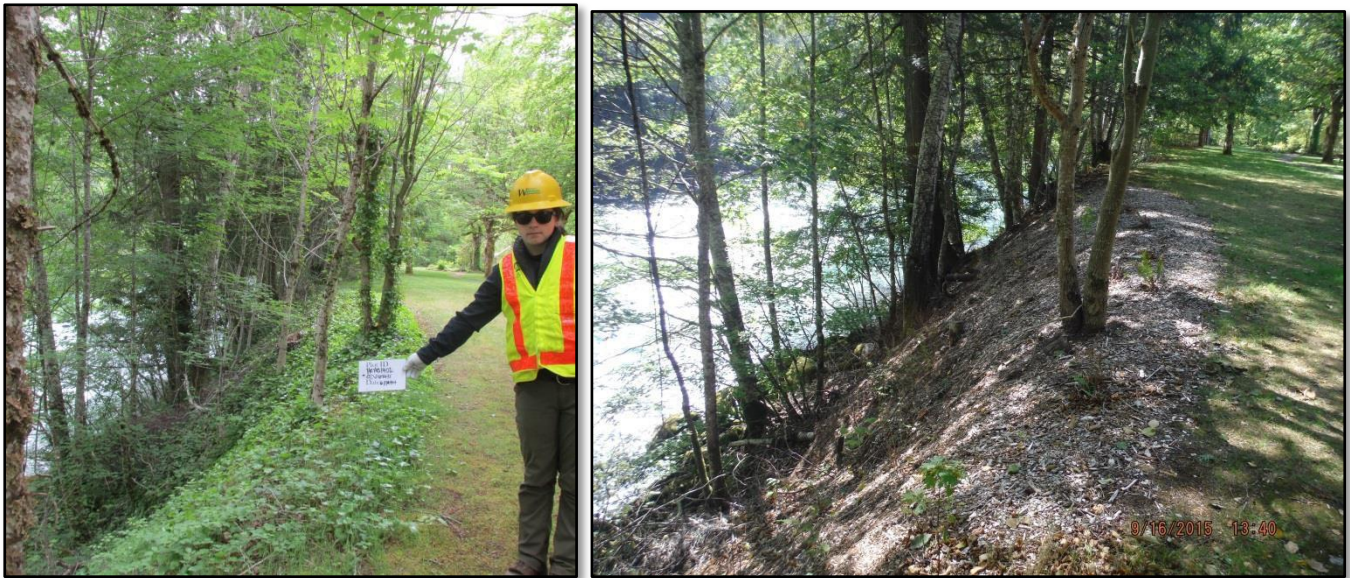
The baseline vegetation monitoring plot 1401 was set up below the green house drive in an area of dense ivy. Baseline plot data recorded prior to project work showed a 90% cover of ivy. In the fall of 2015 post treatment, percent cover was reduced to 23%. As described in the section below ivy control below the greenhouse drive (plot 1401) was especially difficult due to the density of the coverage, however significant progress has been made as shown by the 67% reduction in percent cover. Other areas that had similar ivy coverage prior to treatment now appear to have less than 1% coverage, such as the section of adjacent to Newhalem mainstreet (figure 11).

Figure 11. Before, 2014 ivy near Newhalem Mainstreet (left) and after (right) September 2015 absence of ivy and new plantings in the area.

After two years of focused treatment and removal very few small sprouts of ivy remain in this section. However, follow up hand removal will be needed for at least several years to make sure small resprouts do not re-establish.

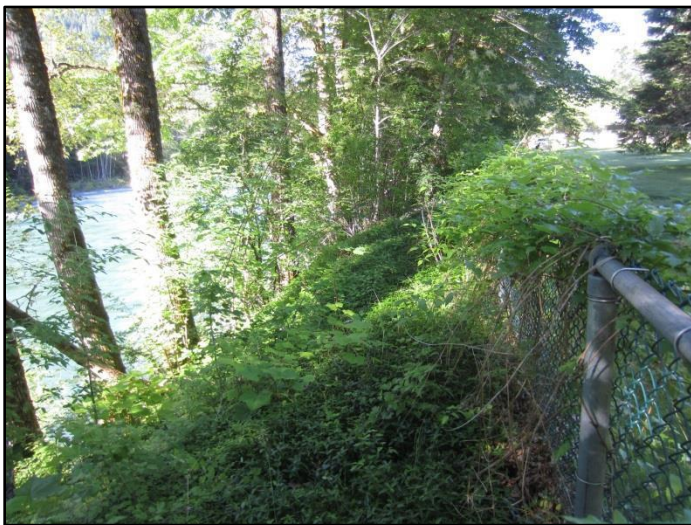
Ivy is established in dense coverage from Newhalem Mainstreet to the pump house and tennis courts. This area was treated with herbicide from 2014 -2015. Many trees in this section were also being strangled by ivy. The WCC uncovered most trees in this section by girdling ivy at the tree base and cutting and painting large roots or ez-jecting them. Herbicide treatment in this section has knocked the ivy back significantly, however this area needs follow up treatment with herbicide.

Figure 12. Prior to treatment in 2014 ivy, clematis and vinca near Newhalem Mainstreet at the beginning of the Newhalem houses.

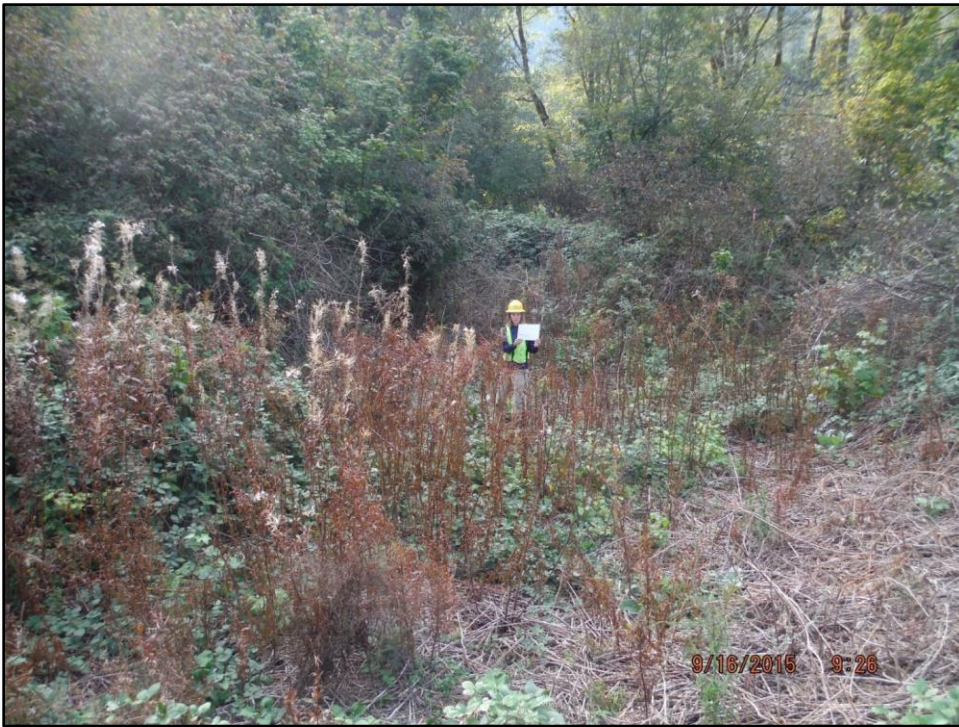
Treatment of blackberry in 2014 did not significantly control blackberry based on visual assessment and the baseline vegetation plot monitoring data collected for the site. Based on data from Plot 1404 which is in the center of the project site, blackberry coverage was 17% in 2014 prior to treatment and up to 30% in the fall of 2015. This increase in blackberry coverage is likely due to the mowing of vegetation and subsequent reduction of native cover, increasing the visibility of the blackberry. These results also confirm that continued treatment is needed at this site. Important to note is that 2015 blackberry treatment occurred at the time of monitoring and therefore results of this second round of treatment are not represented in the data.

Figure 13. Plot 1404, Babcock creek blackberry treatment.

Control of blackberry began in 2014. In the spring of 2014, SFEG and WCC mowed down blackberry patches and returned to treat blackberry in the fall of 2014. This process was repeated in 2015. Retreatment of blackberry was completed in early September of 2015. Blackberry was only found in the area of creek between HWY 20 and the Skagit River. However, blackberry was found and treated on both forks of the creek. This area is directly below the SCL powerlines.

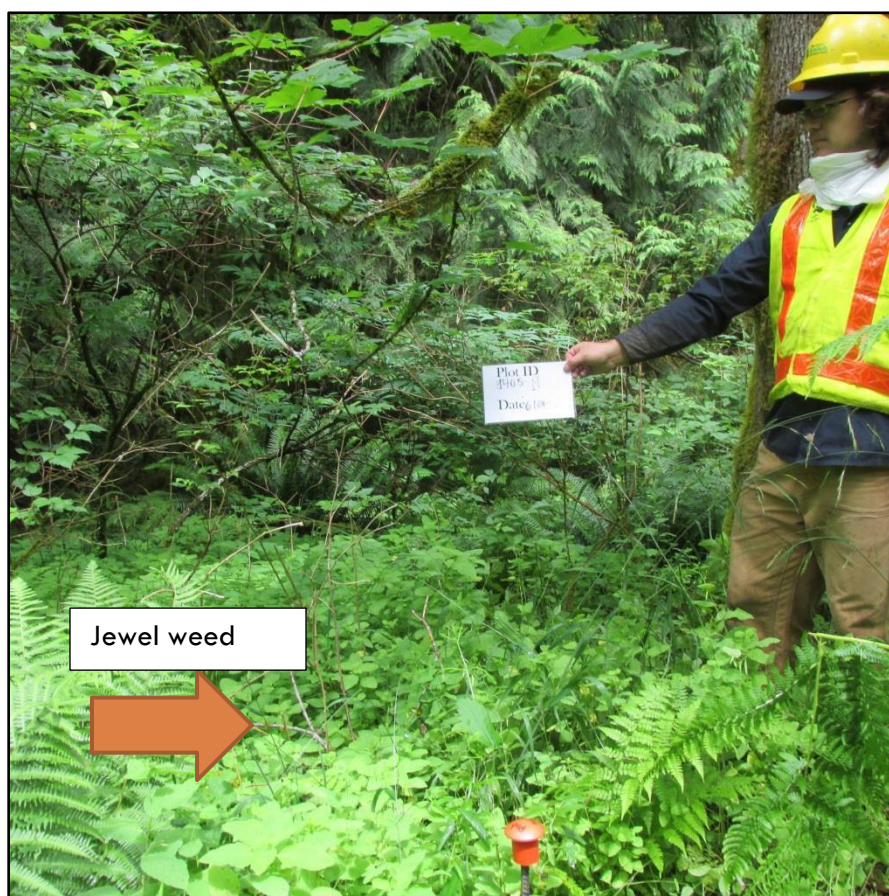
Vegetation monitoring data from the site (plot 1405) show significant results for jewel weed control. Plot 1405 was set up at one of the most densely infested sites on Babcock Creek. Initial monitoring data in the spring of 2014 showed that jewel covered 85% of the site. Follow up monitoring in the fall of 2015 found 0% jewel weed in this area. This is likely because the area was treated with herbicide in June and the plant does tend to die back by September. Treatment areas were also clear in areas dominated by badge moss which was not present in the baseline monitoring data. Also of note in the data, the presence of salmon berry, sword fern, and fringe cup all increased at the site. This site also has a healthy composition of native plants and canopy cover.

Figure 14. Plot 1405, Babcock creek jewel weed prior to treatment in the spring of 2014.

Again, prioritized surveys and foliar treatment of jewel weed is recommended for this creek. Significant steps have been made towards its control and follow up is needed to insure this weed does not continue to infest new areas. It is also recommended to survey and treat jewel weed more than once during the year, its phenology is such that it will grow and flower over the course of the entire summer.

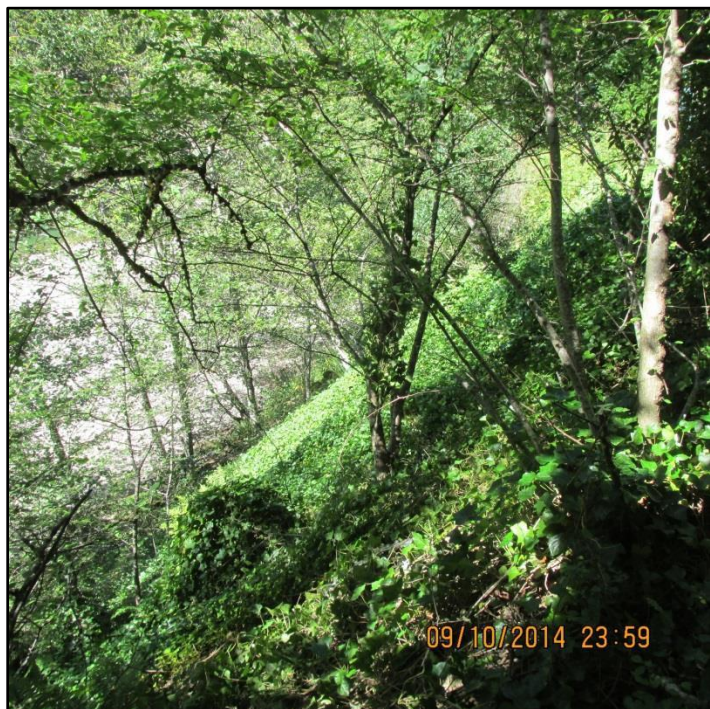
In addition to blackberry being present on Babcock Creek, it was also found below the gorge powerhouse bridge and the greenhouse drive and near the pump house at the end of newhalem. Blackberry was treated with 2.5% glyphosate solution in all of these areas, achieving substantial control. Follow up treatment is recommended for 2016.

Figure 15. Area below green house, blackberry and ivy shown in photo covered this area in 2014.

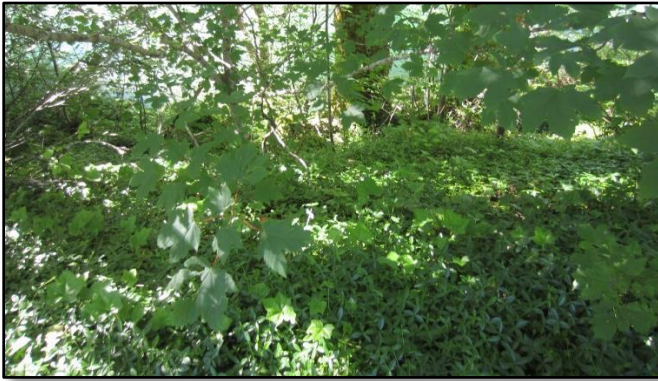
Common periwinkle (*Vinca minor*) was densely present from the Trail of the Cedars Bridge to the Newhalem tennis courts. Baseline monitoring results at plot 1403 adjacent to trail of cedars show that vinca covered 55% of the area in 2014 and by 2015 only 1% remained. This 54% reduction in percent cover is representative of control at all sites, herbicide treatment in 2014 was very effective on the vinca patches. In 2015 vinca coverage was so low that vinca was not treated with herbicide but re-sprouts were removed by hand. Based on field observation, the control of vinca was one of the most effective in the project area. Herbicide used to treat vinca was 2.5% glyphosate. In 2016 monitoring of vinca removal areas is recommended. Small re-sprouts are recommended for hand removal.

Figure 16. Vinca cover adjacent to Trail of Cedars Bridge in 2014 prior to treatment, also shown in photo sycamore maple.

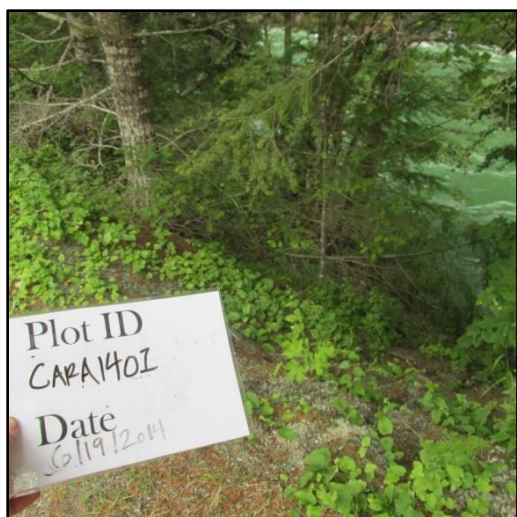
Creeping blue bells (*Campanula rapunculoides*), where another species that was discovered during treatment. Like Robinia this species is not listed as a noxious weed by the Washington State Noxious Weed Board, but is listed in other states as a noxious weed. The blue bells seem to have spread from landscaping in Newhalem and are present along the top edge of the banks from the gorge bridge to Newhalem mainstreet (blue bells shown in figure 15). Unfortunately, treatment of this species was not very successful. It does not seem to respond well to glyphosate herbicide treatment. Continued control is recommended with an alternate herbicide.

Figure 17. Creeping blue bells in 2014, patch CARA1401.

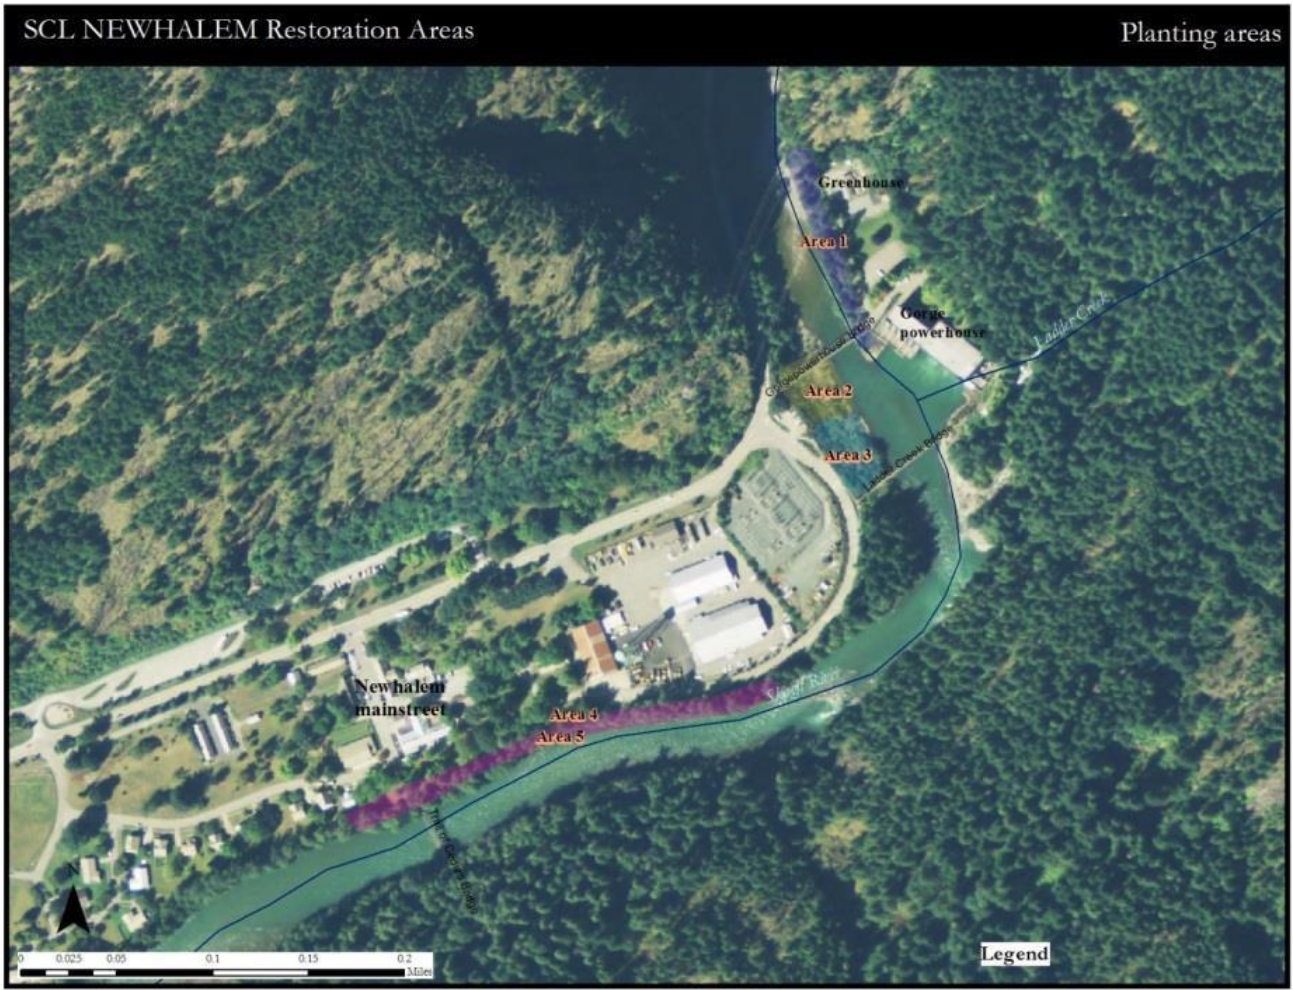
After successful treatment of target weed species, 4 areas that did not have adequate native plant cover after invasive weed treatment were planted with appropriate native species. This action promoted slope stability, and will help to prevent re-infestation by non-native species. Areas replanted were deemed as needing re-vegetation by mutual agreement of both SFEG and SCL as were planting specifications for each site (Figure 18).

Figure 18. This map shows the geographic locations of planting areas in Newhalem.
