# **FISH HABITAT ASSESSMENT AND CHAR UTILIZATION FOR THE UPPER SKAGIT RIVER WATERSHED, BC**

**Ministry of Water, Land and Air Protection  
Lower Mainland Region**

**August 2005**

**LGL Limited  
environmental research associates  
9768 Second Street  
Sidney, BC V8L 3Y8**

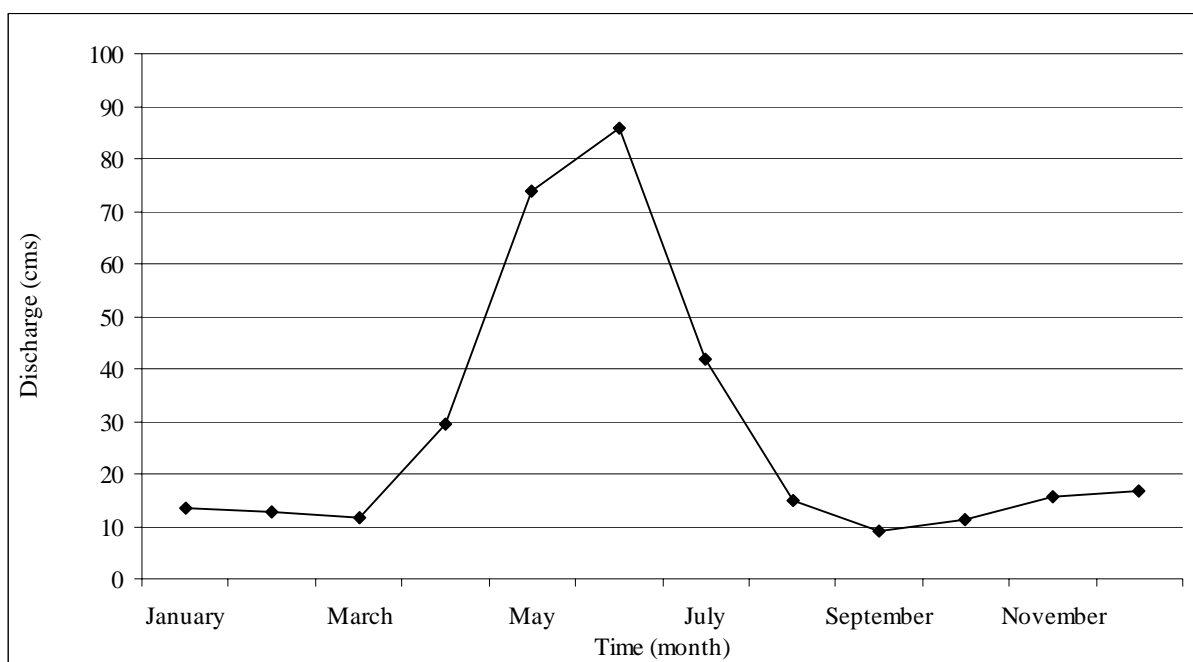
Figure 3. Annual hydrograph of mean monthly flows in Skagit River near Hope, BC.  
Discharges based on Water Survey of Canada Station 08PA001, 1915-1955.

Mean monthly flows in this watershed begin to rise in April in response to snowmelt, peak in June, and steadily decline through summer with the lowest discharges occurring typically in September (Figure 3). The mean annual flow at Ross Lake was estimated at 32 m<sup>3</sup>/s (Table 1). 2-year and 50-year maximum daily flows were estimated at 179 and 312 m<sup>3</sup>/s, respectively. The unit flood discharge with a return period of 50 years was calculated at 299 l/s/km<sup>2</sup>.

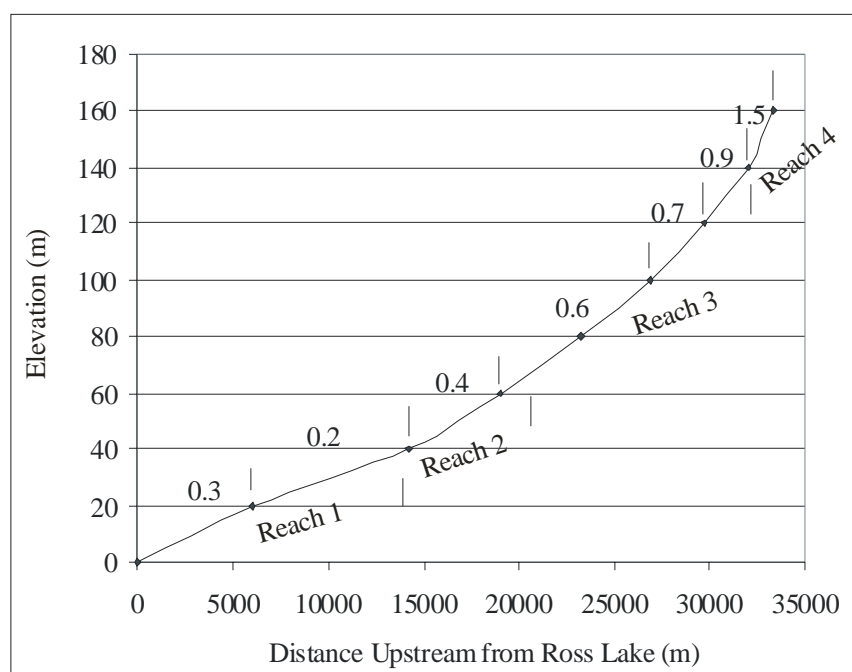
Figure 4. Long profile, gradient (%) and reach boundaries for the mainstem study area of the Skagit River.

Pre-field activities included preparing a gradient profile of the Skagit River mainstem from 1:20,000 TRIM maps. Three reach breaks were established based on this gradient profile and stream pattern (Figures 4 and 5). Reach 1 and Reach 3 have an irregular wandering pattern and are frequently confined; whereas, Reach 2 has a more sinuous pattern and is occasionally confined (Figure 5). Reach 4 is straight and frequently confined.

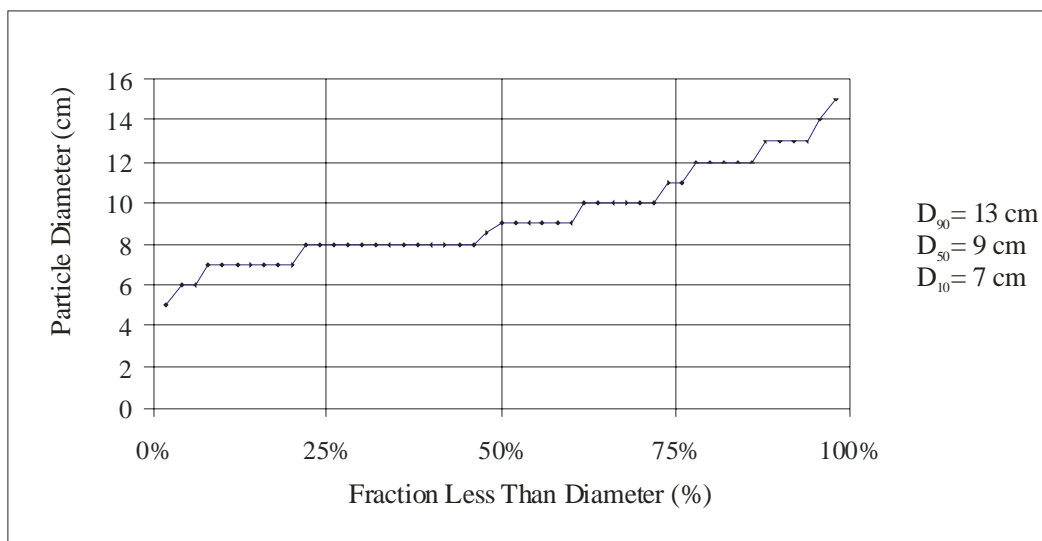
Figure 6. Substrate characteristics from pebble counts on a riffle at chainage 16+782 m in Reach 2 of Skagit River.

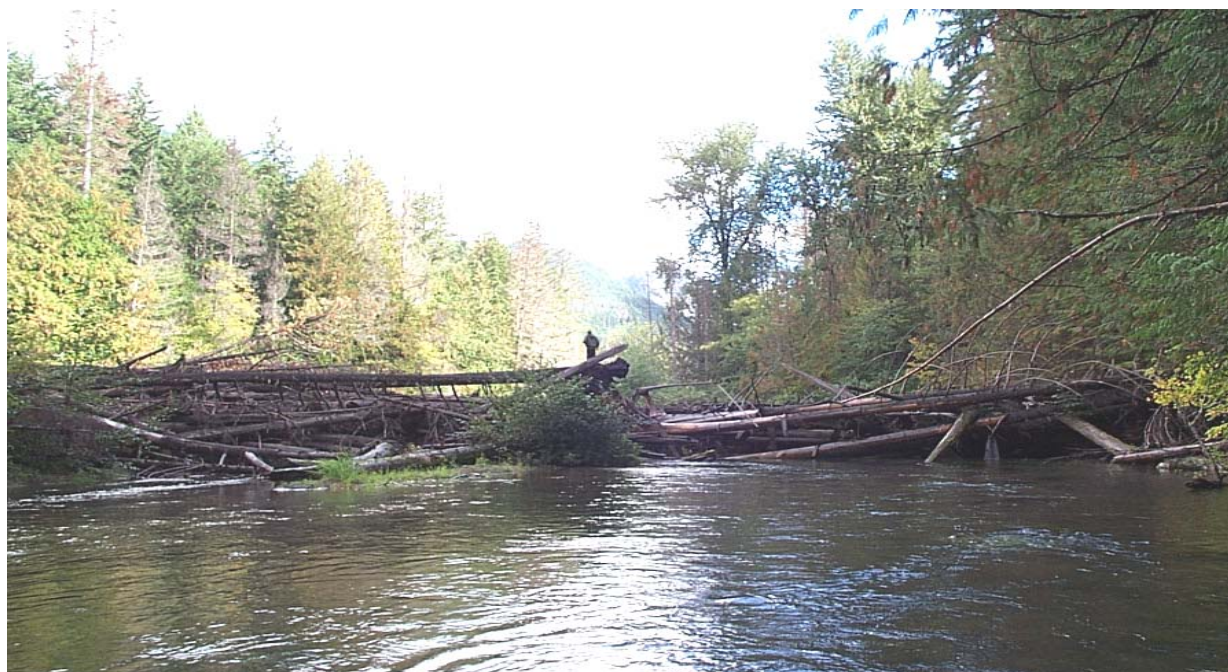
Photo 1. Upstream view of massive logjam and sediment wedge complex (800 m in length) at WP 1030 (chainage 20+900 m), Reach S3.

The diagnostic summary of salmonid habitat condition assigns a good rating for amount of off-channel habitat as well as quantity and quality of spawning habitat; while a fair rating was given for percent overhead pool cover and percent boulder cover in riffles for juvenile rearing. Percent pool area, pool frequency, number of holding pools with adequate cover per km of reach and percent woody cover in pools all received a poor ranking (Table 2). An overall inadequate rating for supply of functional LWD and a poor ranking for percent wood cover in pool habitat suggests that instream rehabilitation opportunities exist and would benefit fish and fish habitats. LWD distribution is presently clumped in two major logjams (Figure 5, Photo 1 and Photo 2).

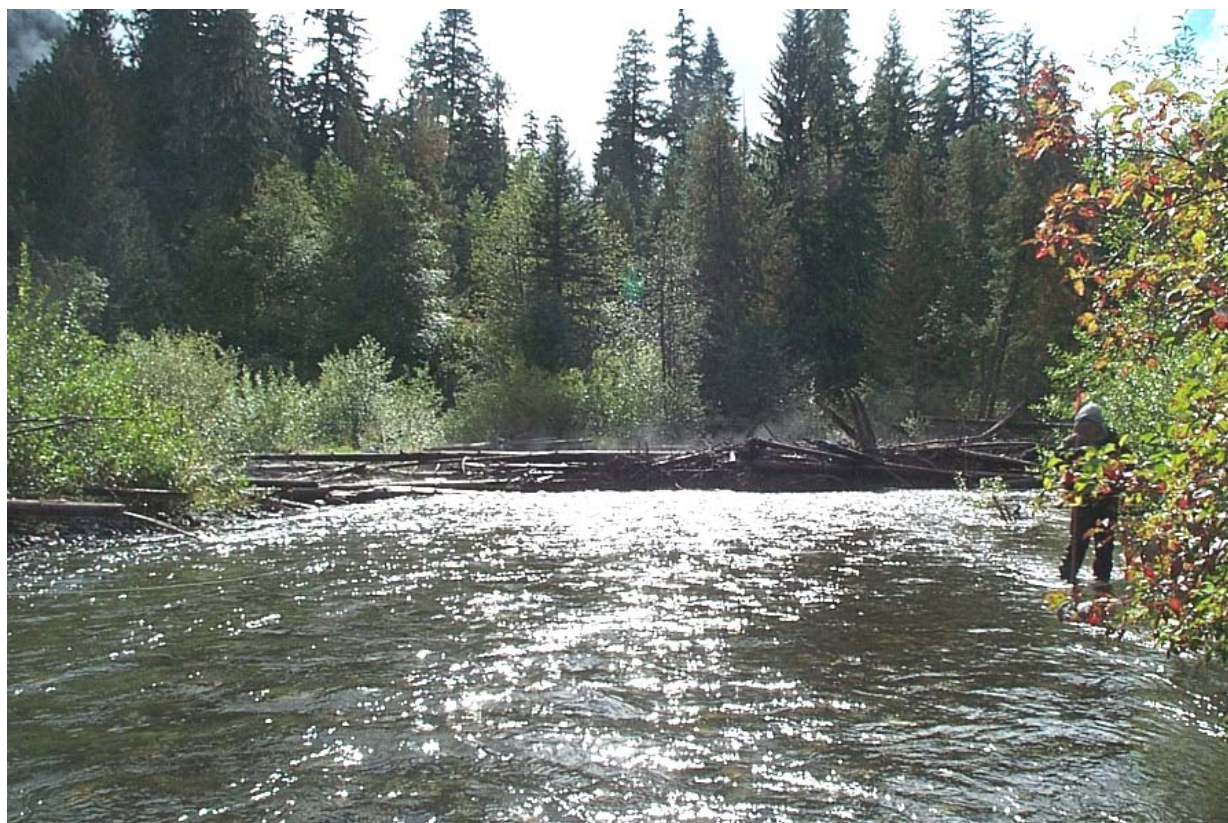
Photo 2. Downstream view of logjam at WP 622 (chainage 31+054 m), Reach S3.

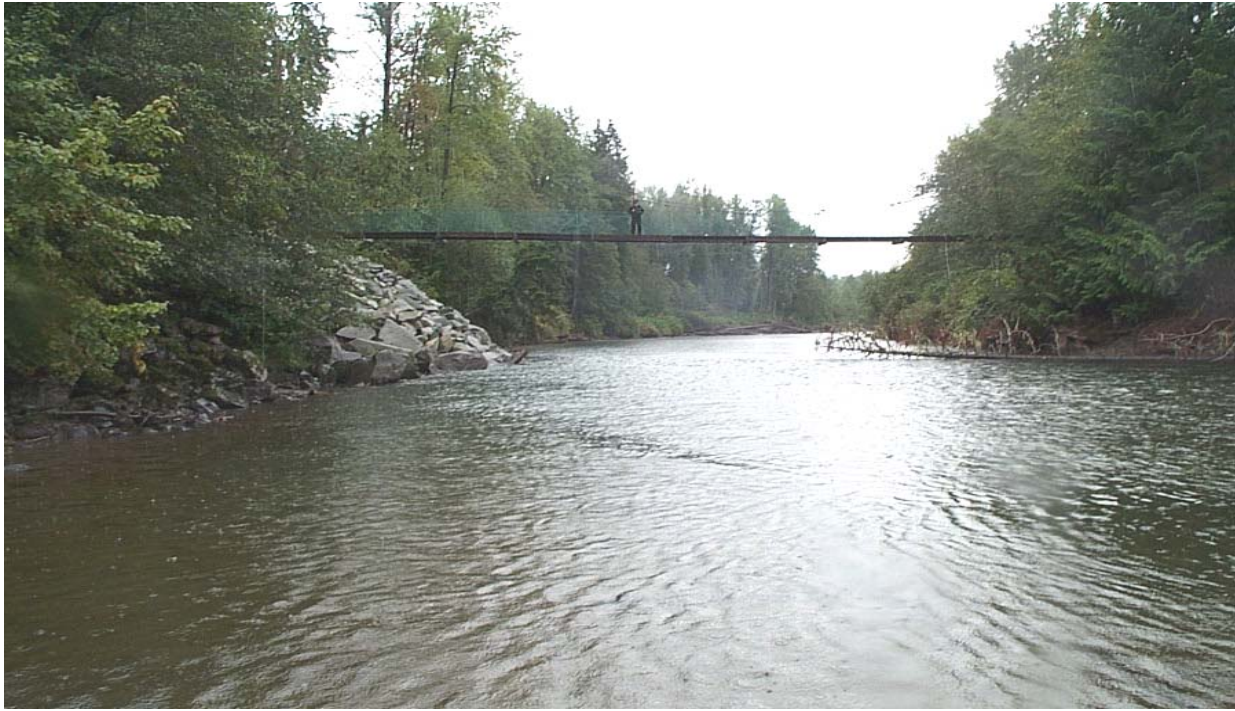
Photo 3. Downstream view from WP 72 at holding pool WP 73, Reach S1. Riprap contributes to boulder cover in pool.

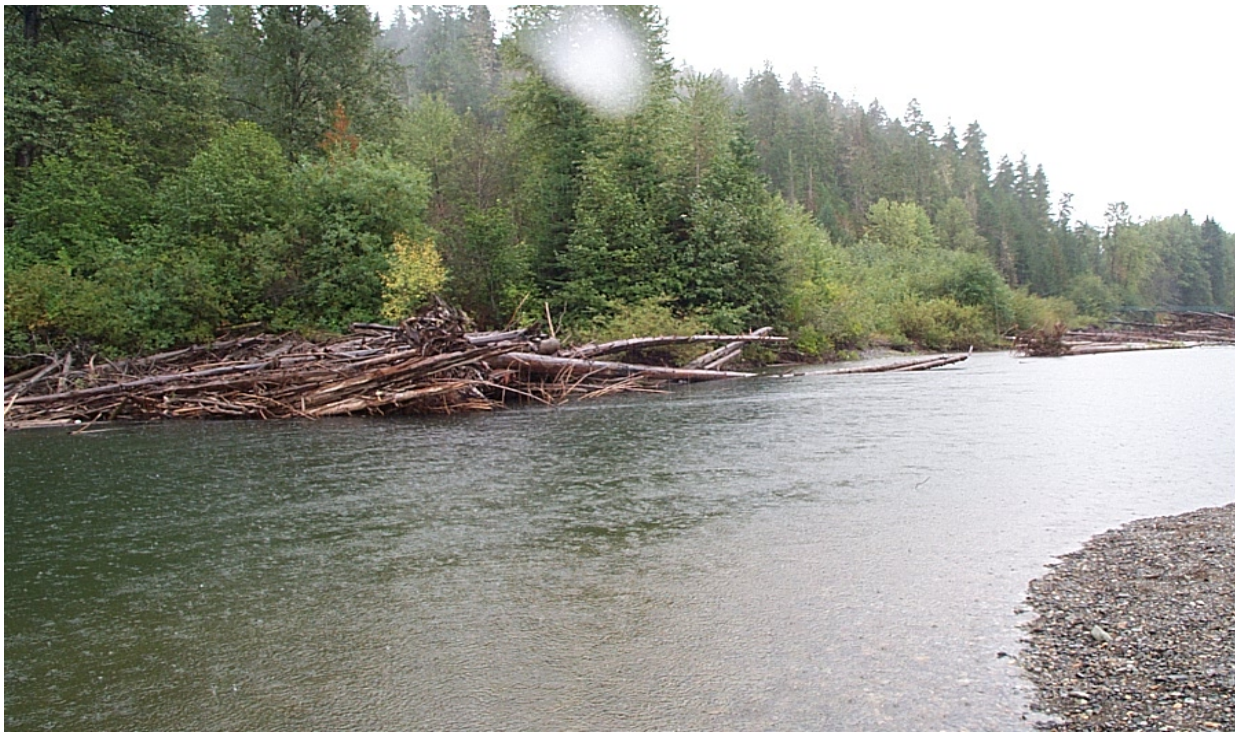
Photo 4. Downstream view from WP 68 at holding pool WP 69, Reach S1. LWD is good overhead escape cover but because of location relative to thalweg, it is questionable cover for feeding purposes.

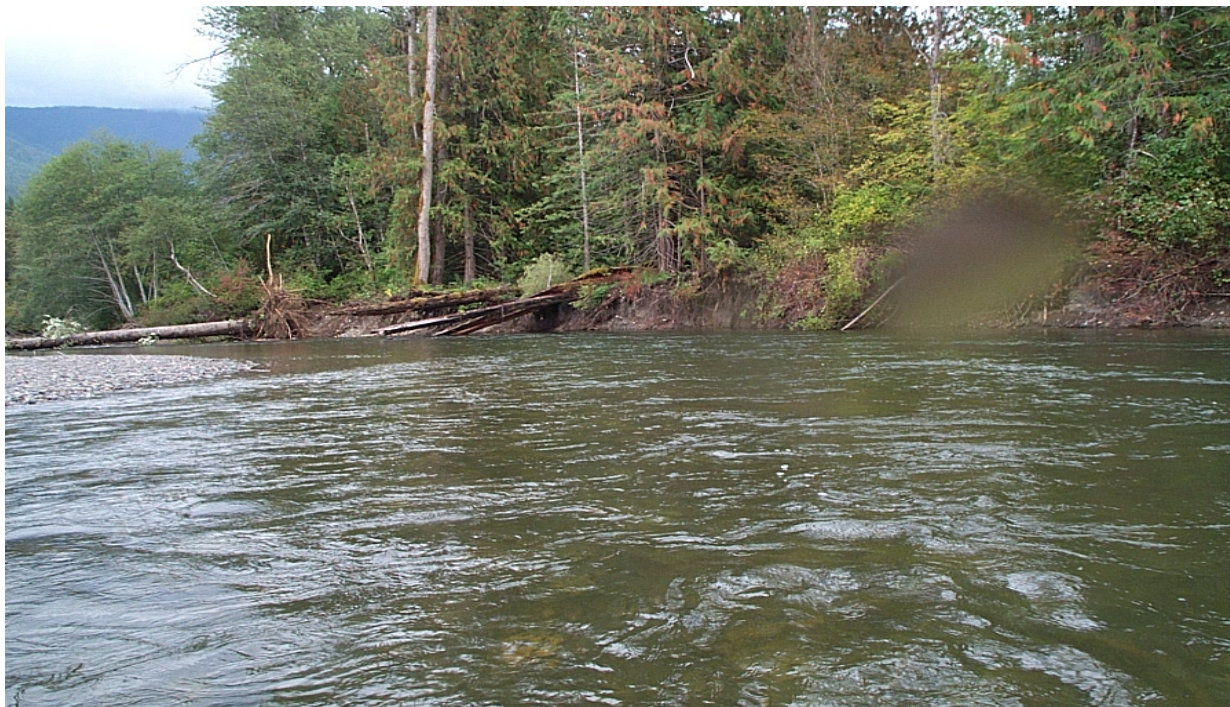
Photo 5. Downstream view from WP 112 at holding pool WP 113, Reach S1. Fish often holding in this pool, which has a combination of LWD and boulder cover.

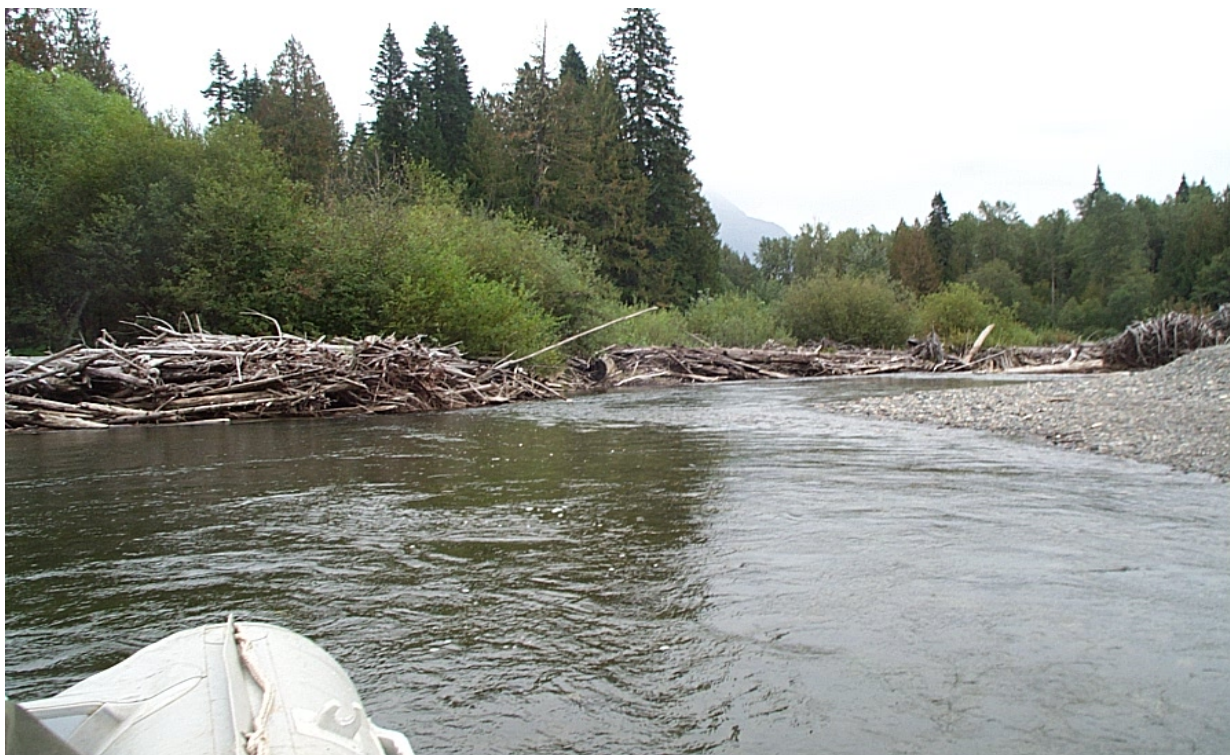
Photo 6. Downstream view from WP 107 at holding pool WP 108, Reach S1. Fish holding occasionally in LWD cover. Pool is in transition, infilling with gravel from upstream sediment wedge formed prior to flood of October 2003; presently no boulder cover.

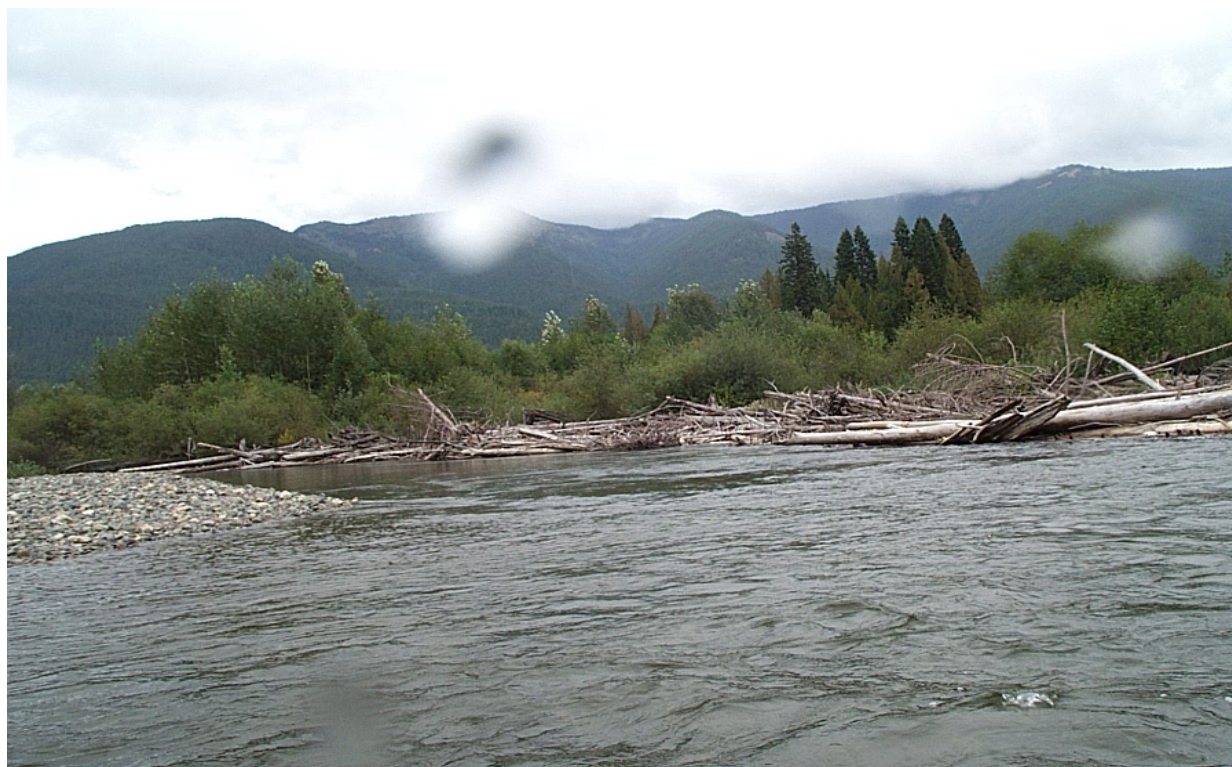
Photo 7. Downstream view from WP 105 at occasionally used holding pool WP 106, Reach S1. This logjam and sediment wedge is remnant of much larger jam formed prior to flood of October 2003.

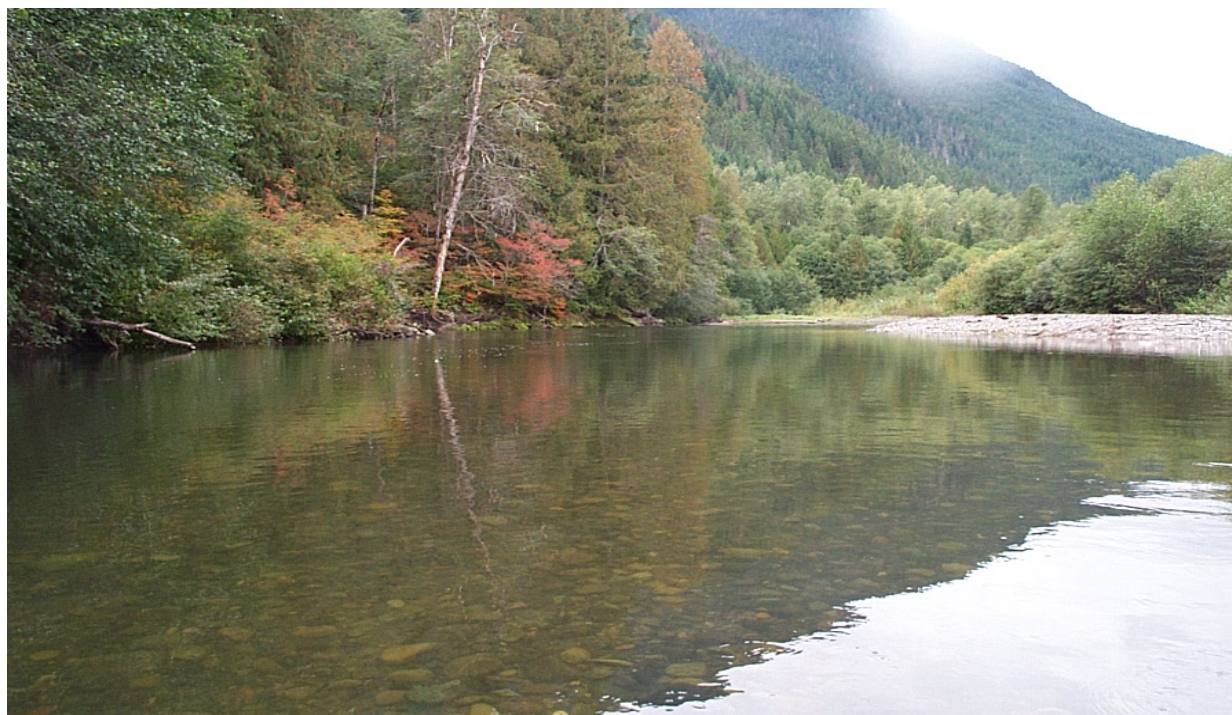
Photo 8. Upstream view from WP 100 at holding pool WP 100, Reach S1. Pool has 35% boulder cover. On three occasions, four or more char were observed holding here.

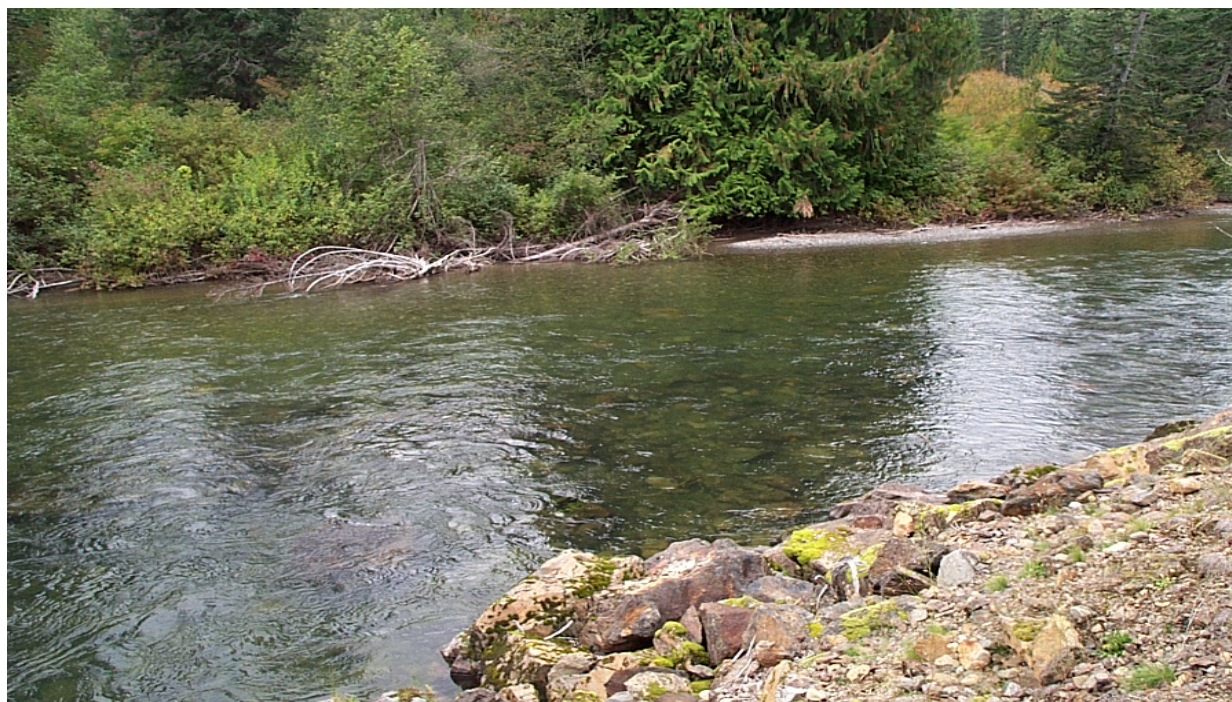
Photo 9. View from road at holding pool WP 58, Reach S1. Char utilize large boulders (riprap from road) for holding and as feeding stations in thalweg.

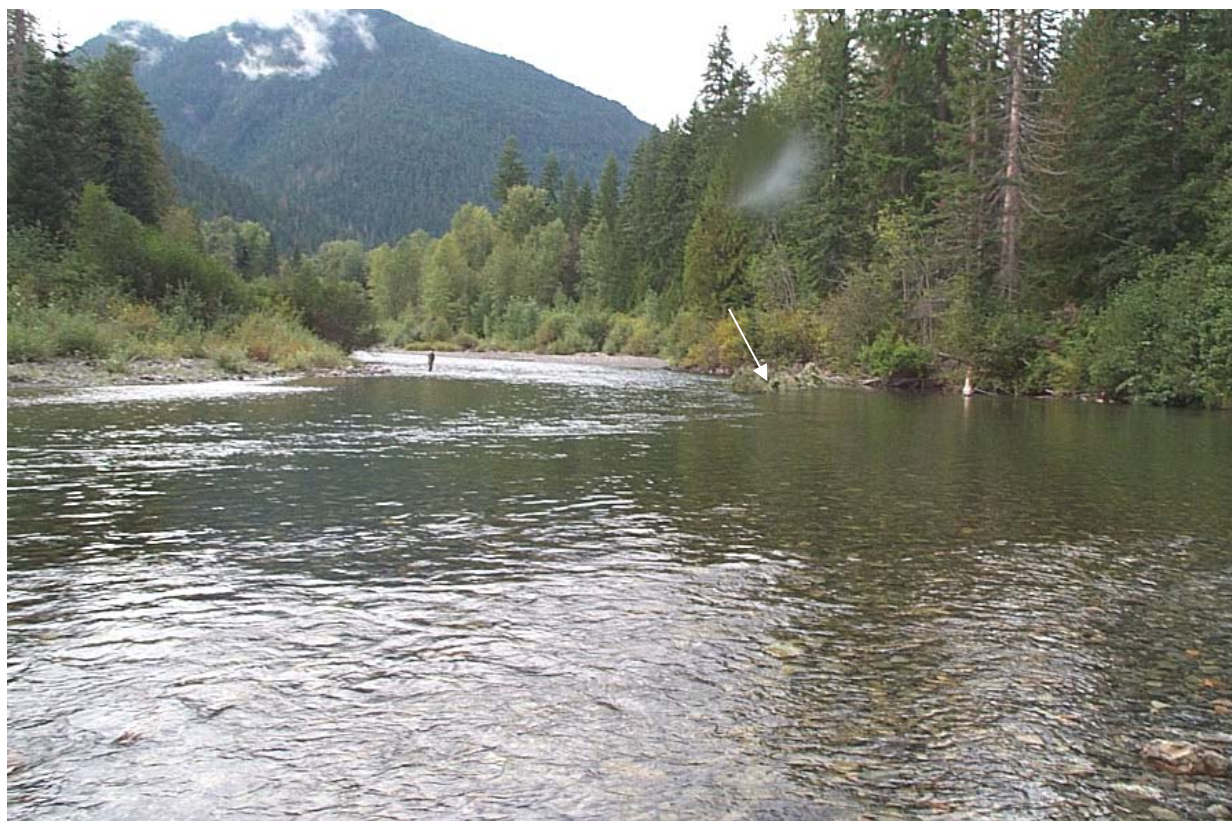
Photo 10. Upstream view from WP 56, Reach S1. Excellent holding and feeding station under fallen fir with branches intact (left bank) in the thalweg at riffle tail-out.

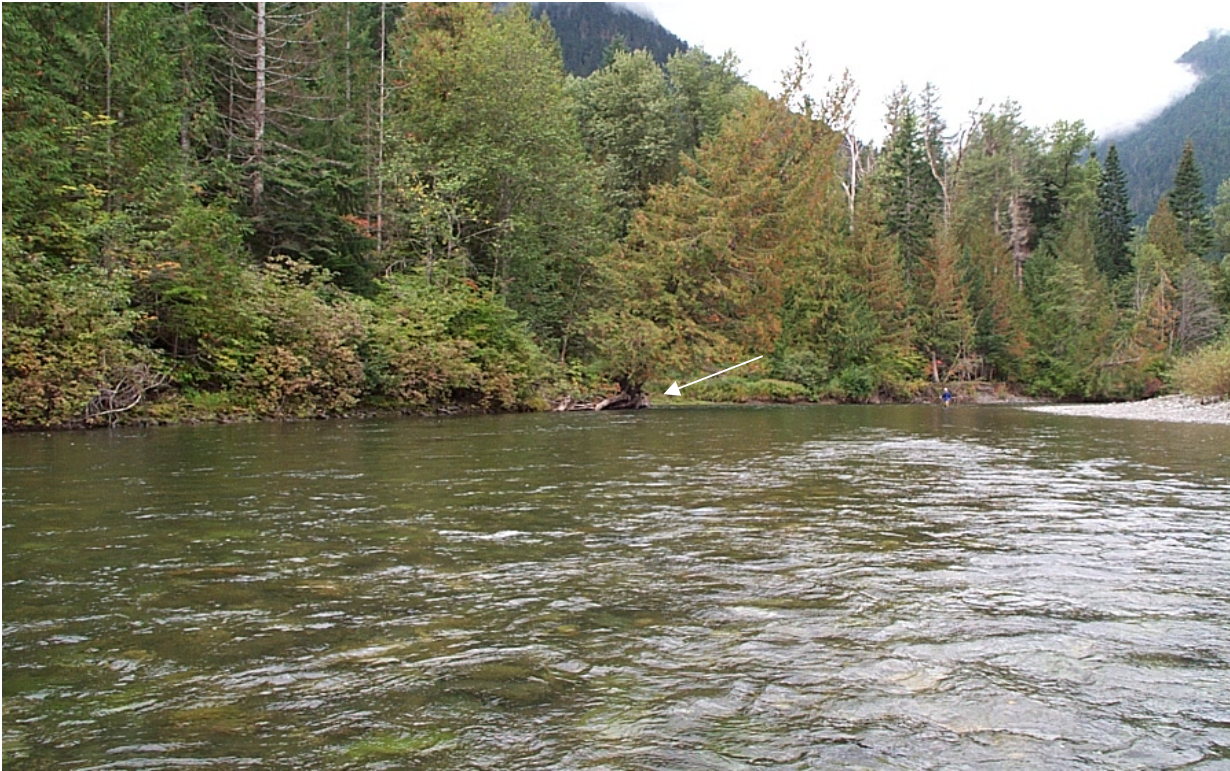
Photo 11. Upstream view at leaning cedar off right bank at WP 53, Reach S1. Char hold under leaning cedar using combination of boulder, undercut bank and overhanging vegetation for cover. It is an excellent feeding station directly in thalweg current.

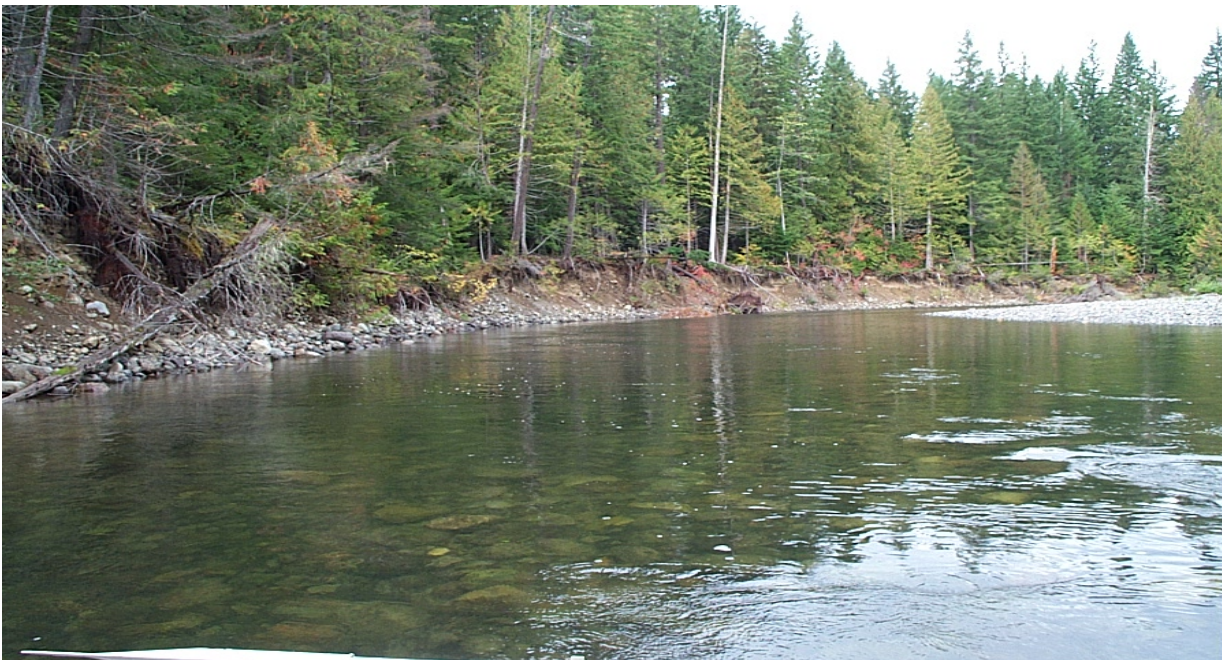
Photo 12. Upstream view from WP 48, Reach S1. Frequently holds less than five char. Boulders are smallish ( $D_{90}=35$  cm) and flat. This site could use LWD-boulder structures for supplemental overhead cover and provide protection to eroding right bank.

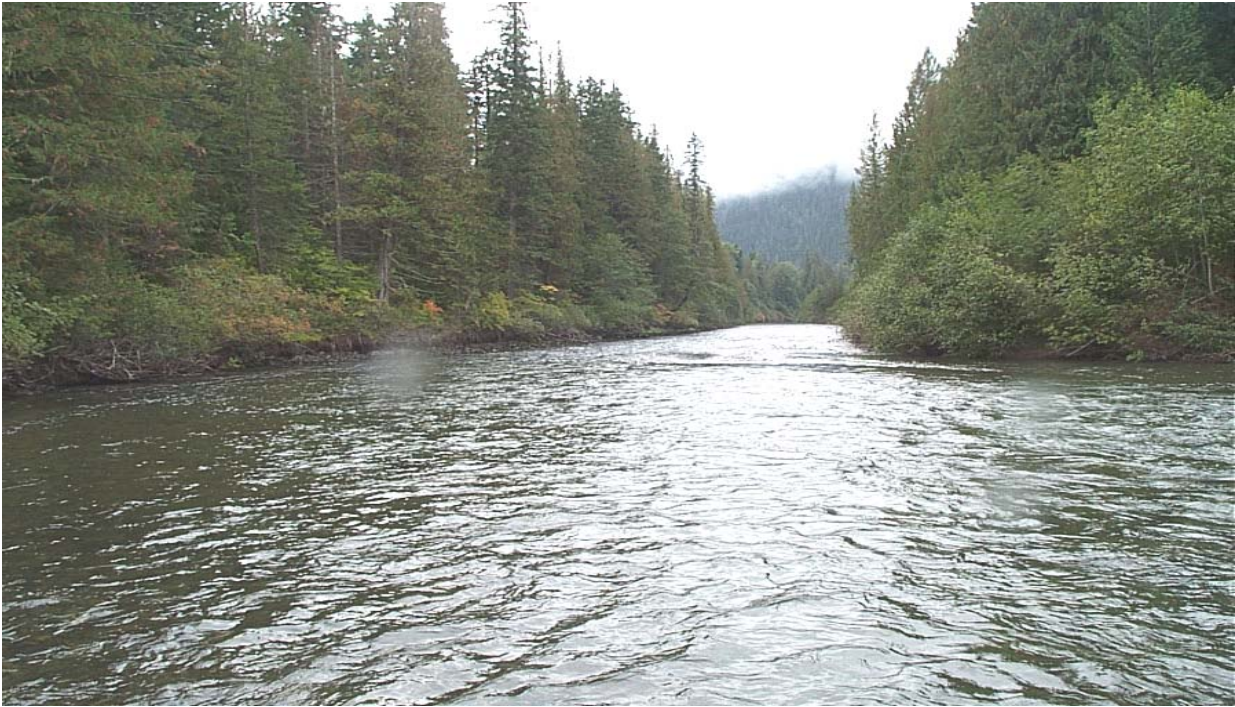
Photo 13. Downstream view of pool WP 44 from WP 43, Reach S1. Good holding pool with 30% boulder cover.

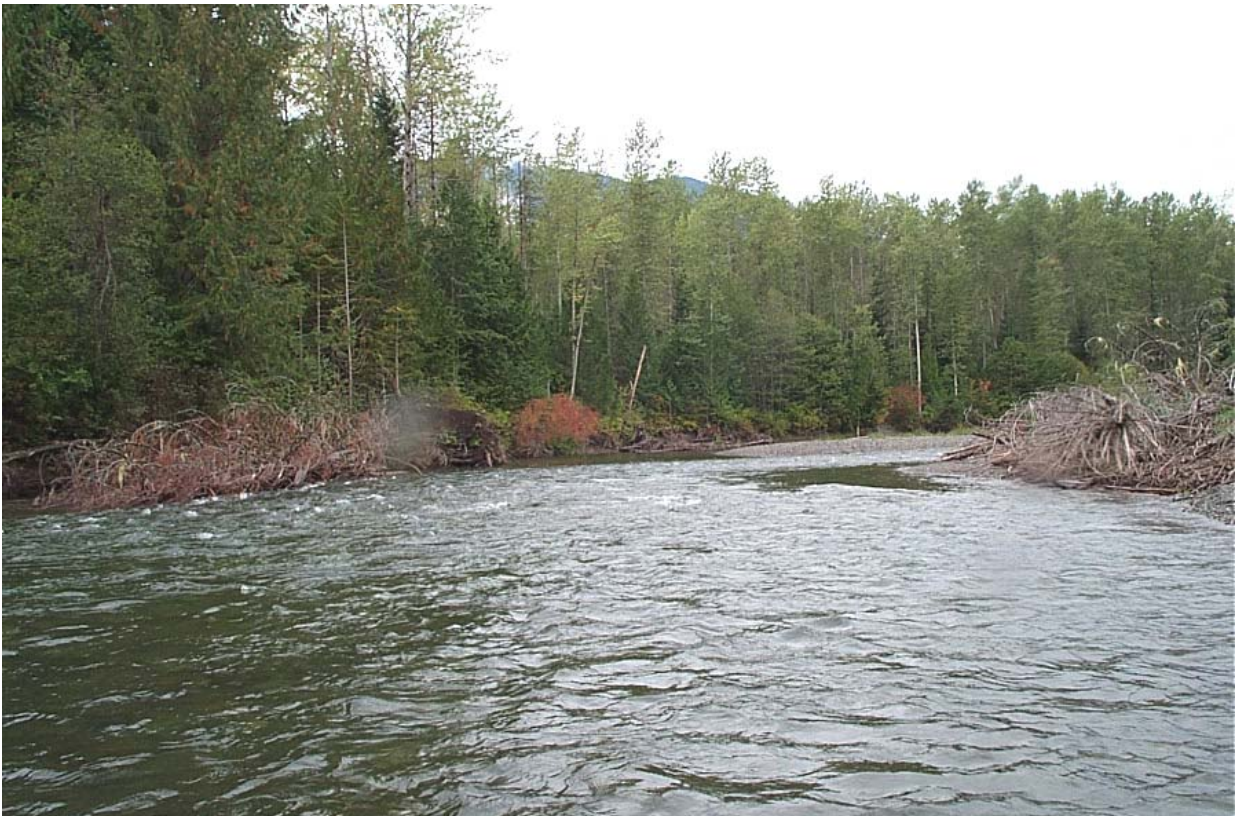
Photo 14. Upstream view of LWD cover (right bank) utilized by small char at riffle tail-out at WP 43, Reach S1.

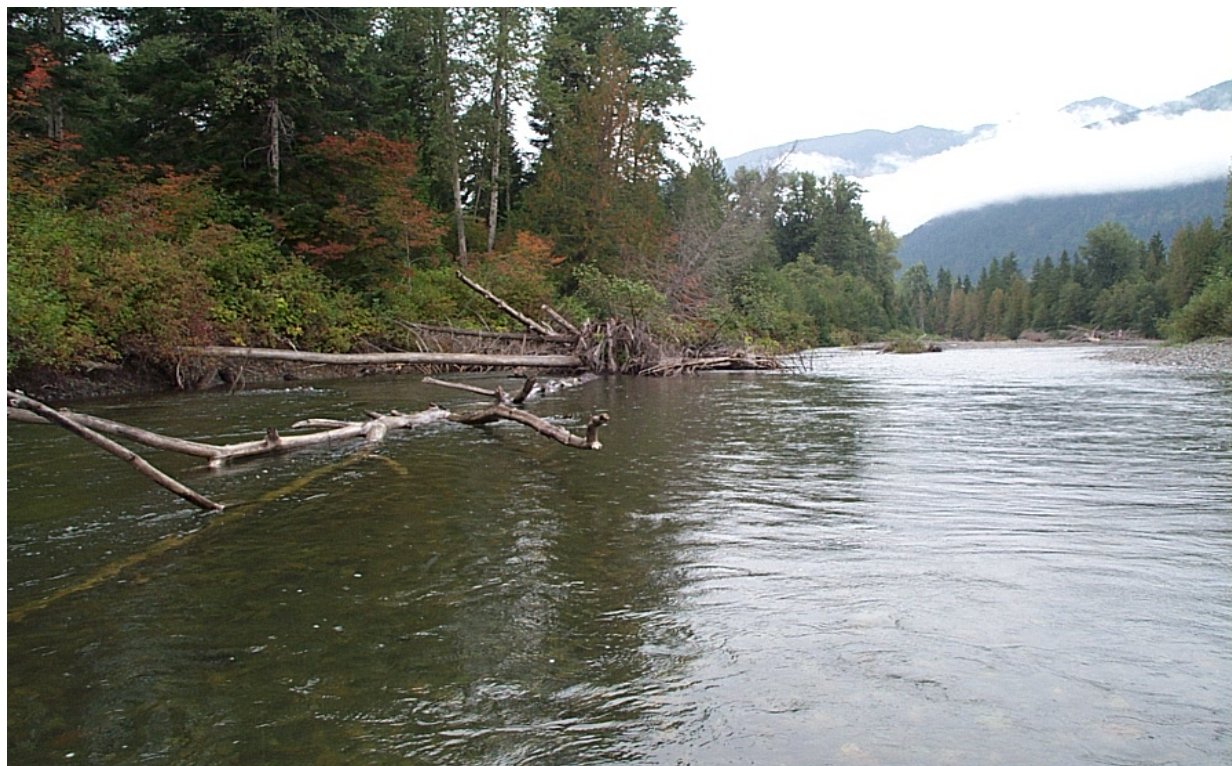
Photo 15. Upstream view from WP 41, Reach S1. Pool now infilling. Prior to October 2003 flood, single char were often holding under LWD.

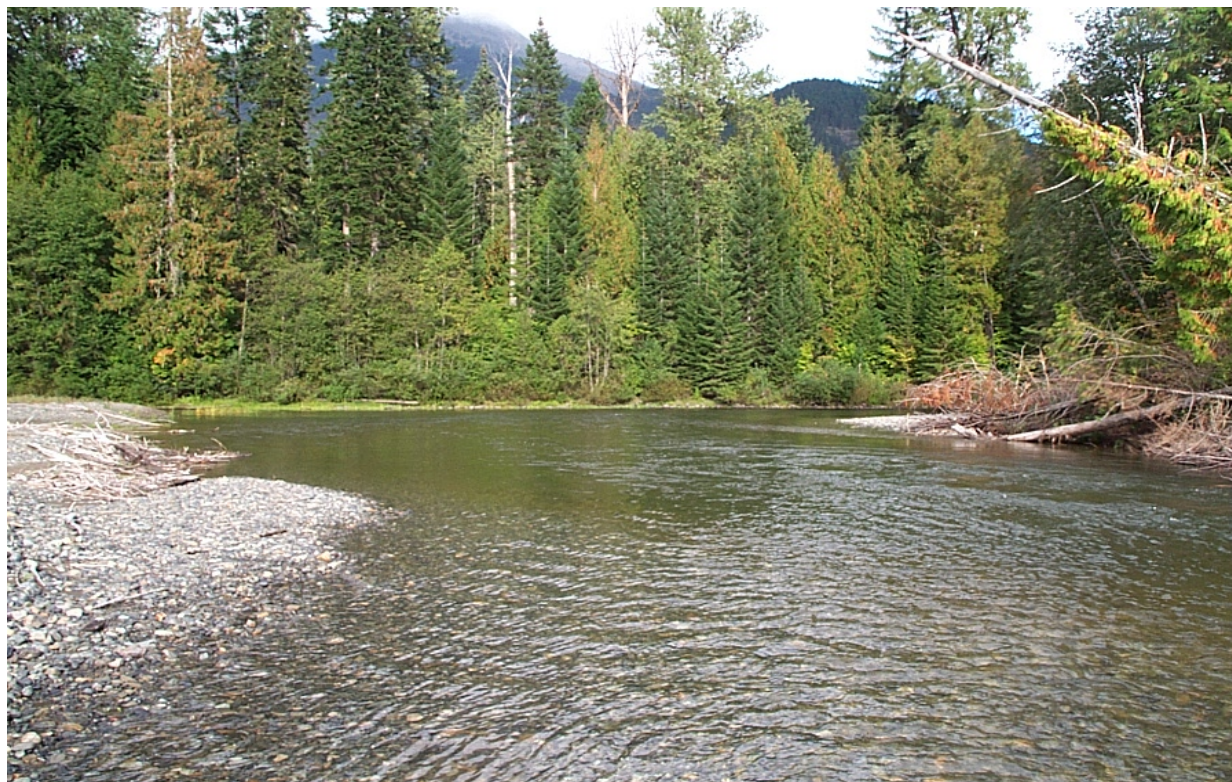
Photo 16. Downstream view from WP 34, Reach S1. Holding pool WP 35 not heavily utilized; few feeding stations, only 15% boulder cover, boulders predominantly small (25 cm).

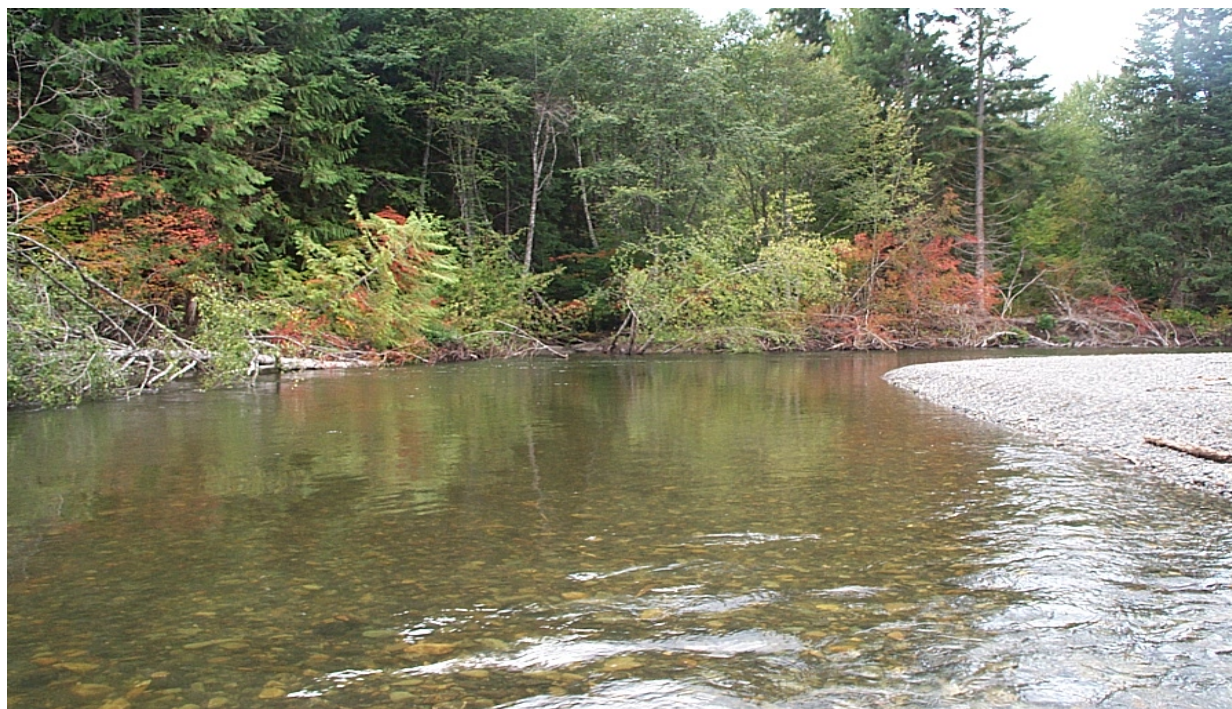
Photo 17. Upstream view from WP 33. This pool was well-utilized by char until a massive log jam across the entire channel width at WP30 washed out in the October 2003 flood (Figure 5).

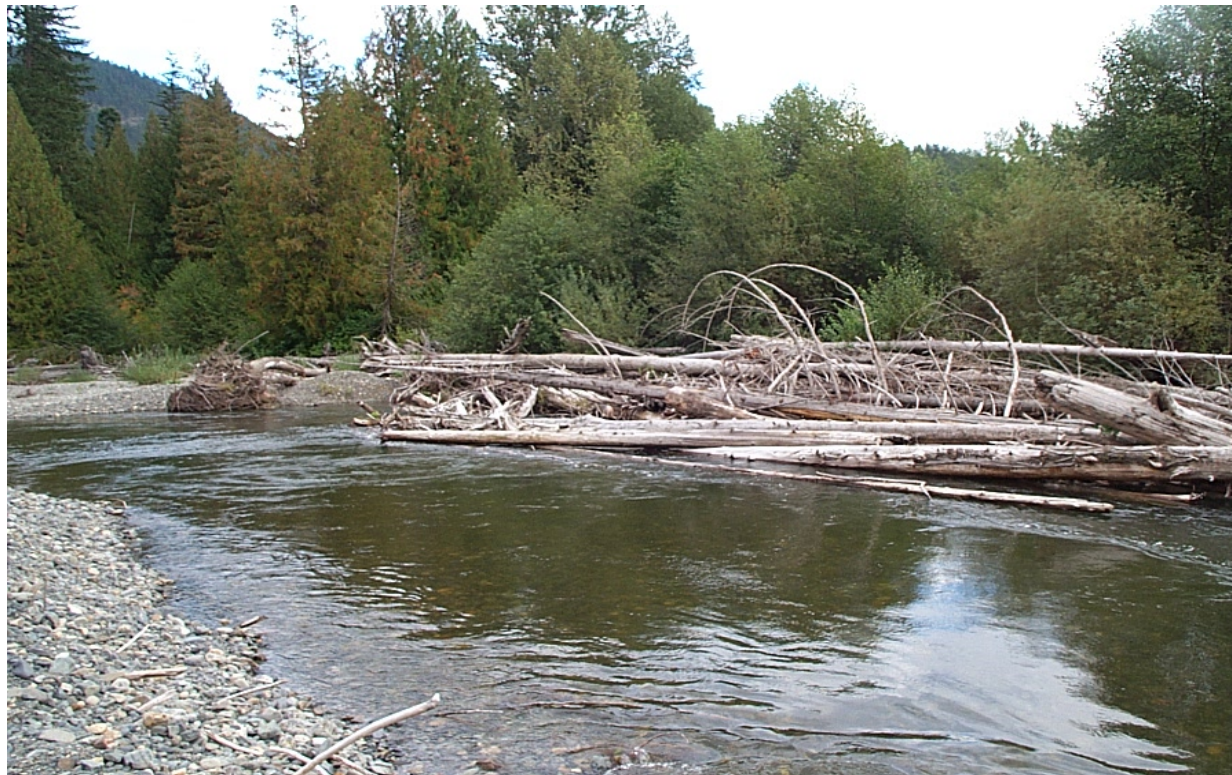
Photo 18. Upstream view from WP 31 at new holding pool with LWD overhead cover. This pool is being used by char since previous logjam and sediment wedge scoured out in 2003 flood.

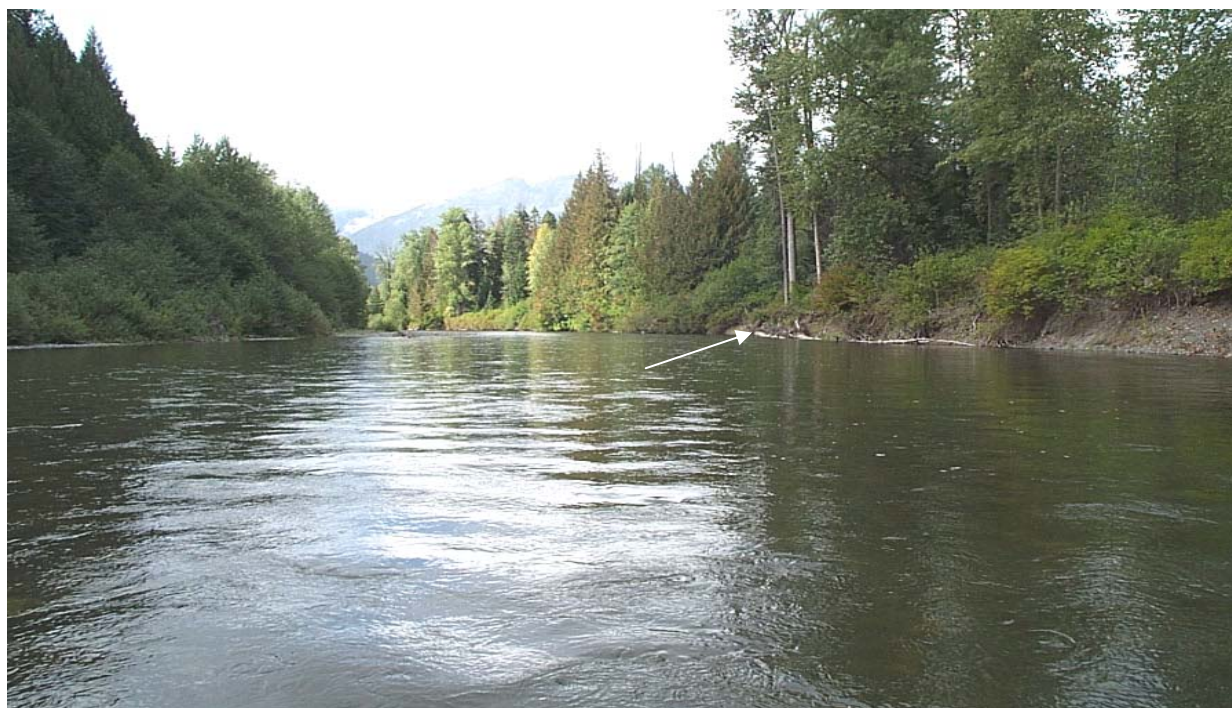
Photo 19. Upstream view from WP 25, Reach S1. Char hold under limited LWD cover off left bank.

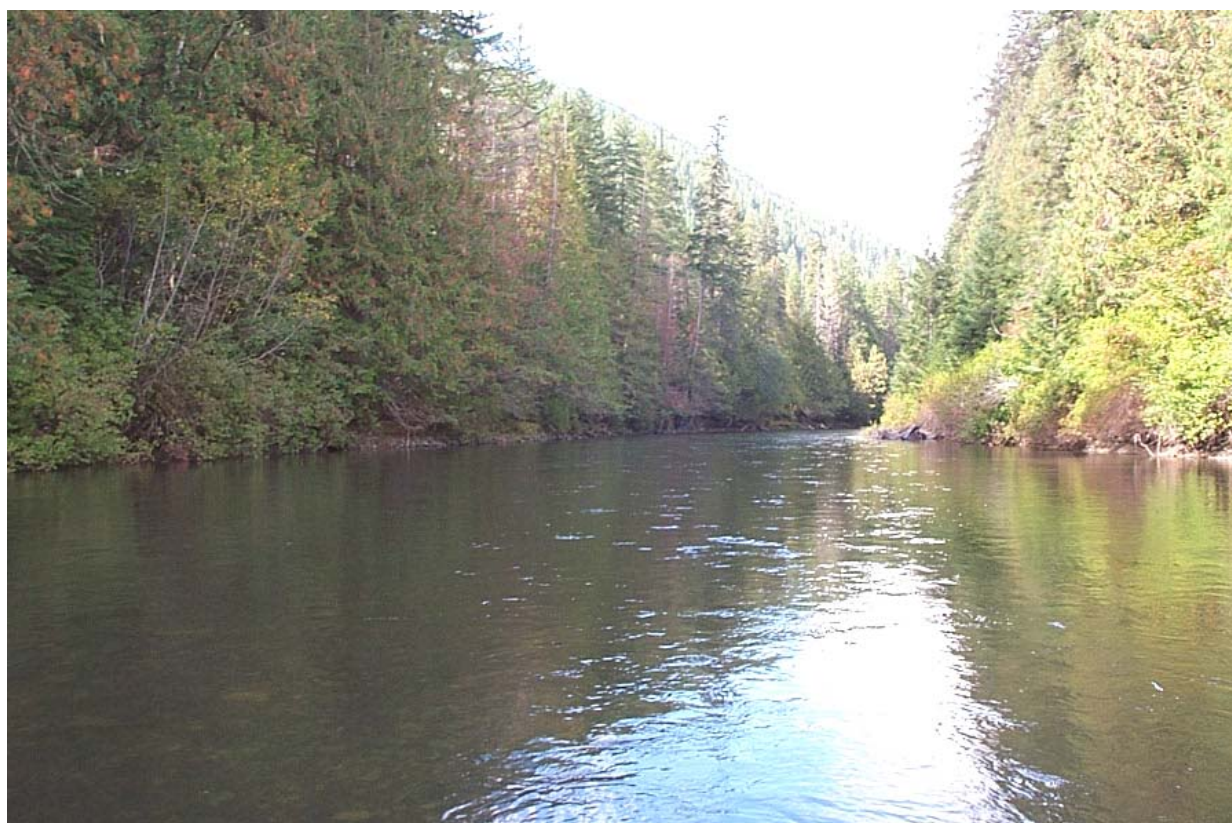
Photo 20. Upstream view from WP 18, Reach S1 of well used holding pool.

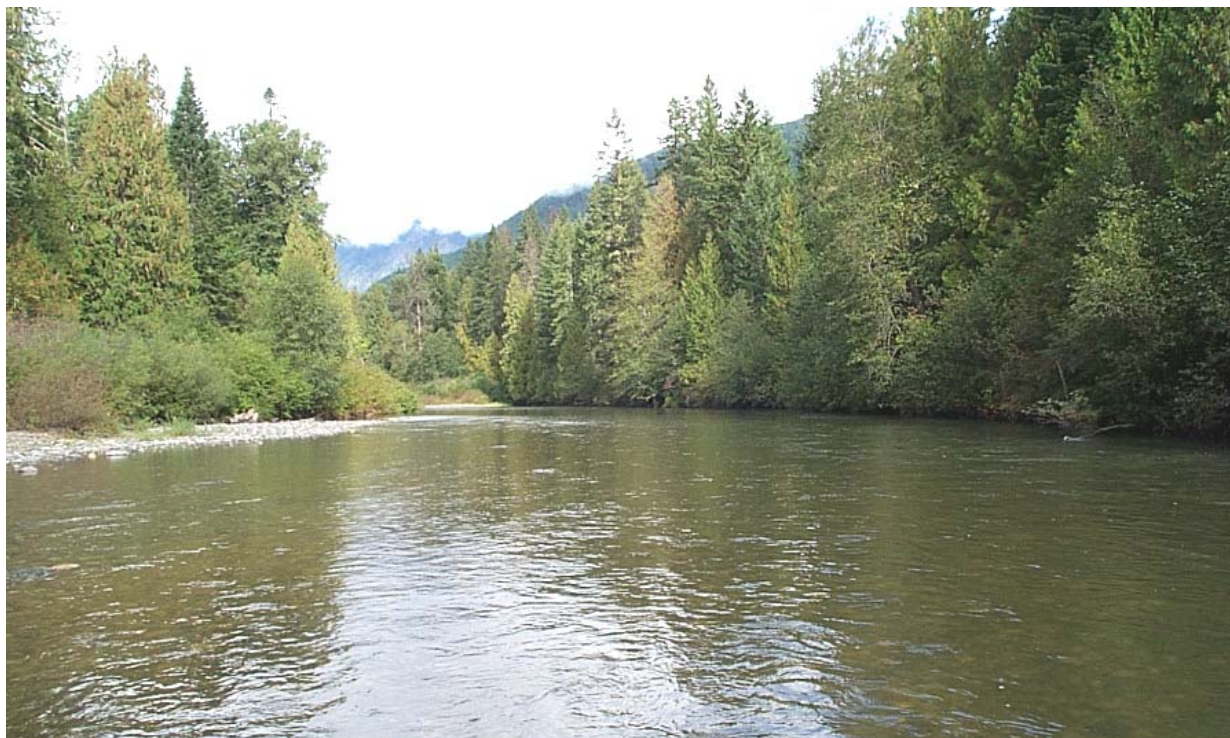
Photo 21. Looking upstream at char holding pool at WP 11, Reach S2.

In Reach S2, char have been observed holding in four pools located at WP 11 (Photo 21), WP 1000 (Photo 22), WP 1006 (Photo 23), WP 1008 (Photo 24) and one glide at WP 1013 (Photo 25). Only the site at WP 1006 (Photo 23) met the criteria for a good holding pool. Furthermore, two other sites at WP 1016 (Photo 26) and WP 1018 (Photo 27) had sufficient overhead cover to be classified as good holding pools. No char were ever found to hold at either of these sites even though in excess of 300 rainbow trout consistently hold at WP 1018 under cover of a log jam (Photo 27).
