# **FISH HABITAT ASSESSMENT AND CHAR UTILIZATION FOR THE UPPER SKAGIT RIVER WATERSHED, BC**

**Ministry of Water, Land and Air Protection  
Lower Mainland Region**

**August 2005**

**LGL Limited  
environmental research associates  
9768 Second Street  
Sidney, BC V8L 3Y8**

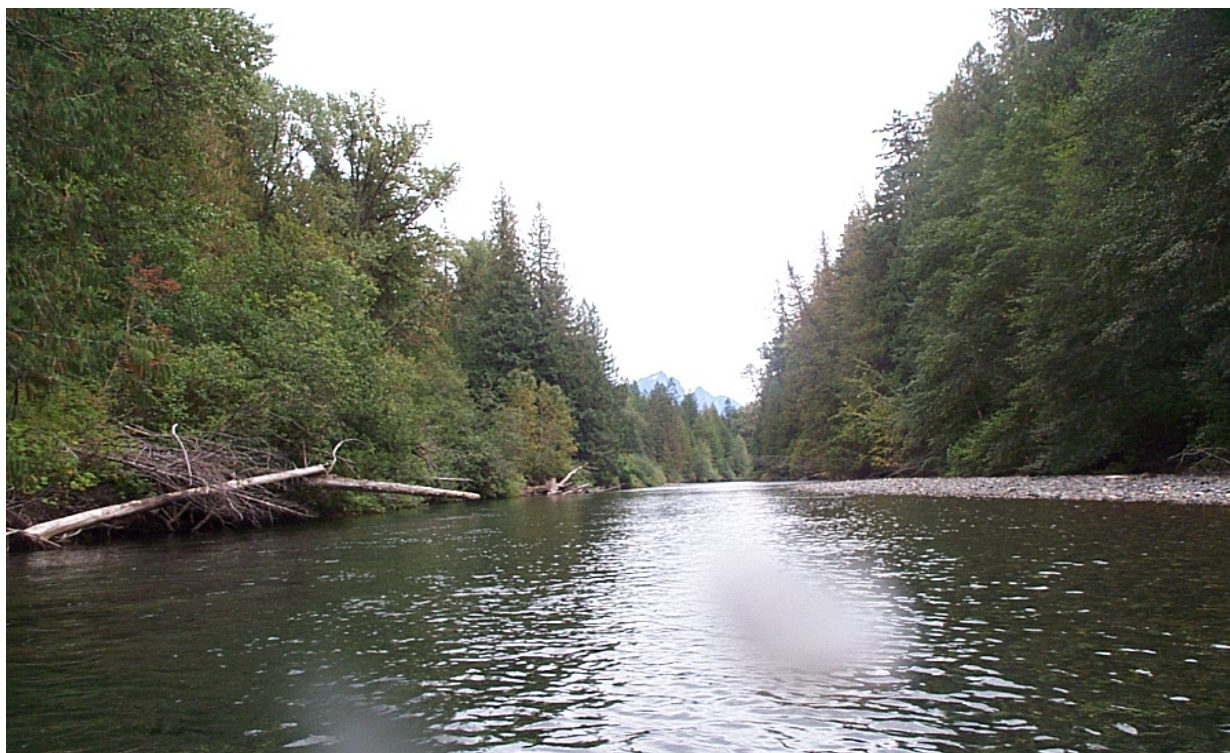
Photo 22. Looking downstream at frequently used char holding pool at WP 1000, Reach S2.

In Reach S2, char have been observed holding in four pools located at WP 11 (Photo 21), WP 1000 (Photo 22), WP 1006 (Photo 23), WP 1008 (Photo 24) and one glide at WP 1013 (Photo 25). Only the site at WP 1006 (Photo 23) met the criteria for a good holding pool. Furthermore, two other sites at WP 1016 (Photo 26) and WP 1018 (Photo 27) had sufficient overhead cover to be classified as good holding pools. No char were ever found to hold at either of these sites even though in excess of 300 rainbow trout consistently hold at WP 1018 under cover of a log jam (Photo 27).

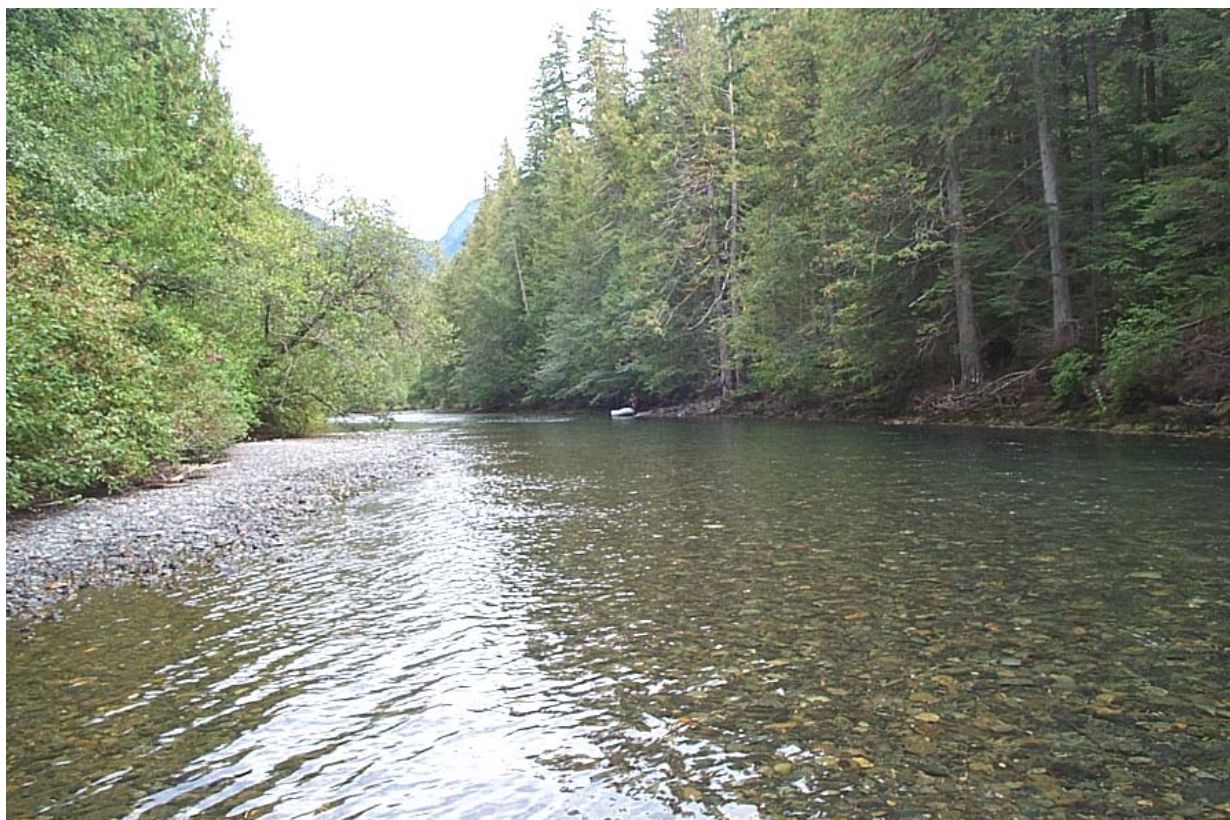
Photo 23. Looking downstream at frequently used char holding pool at WP 1006, Reach S2.

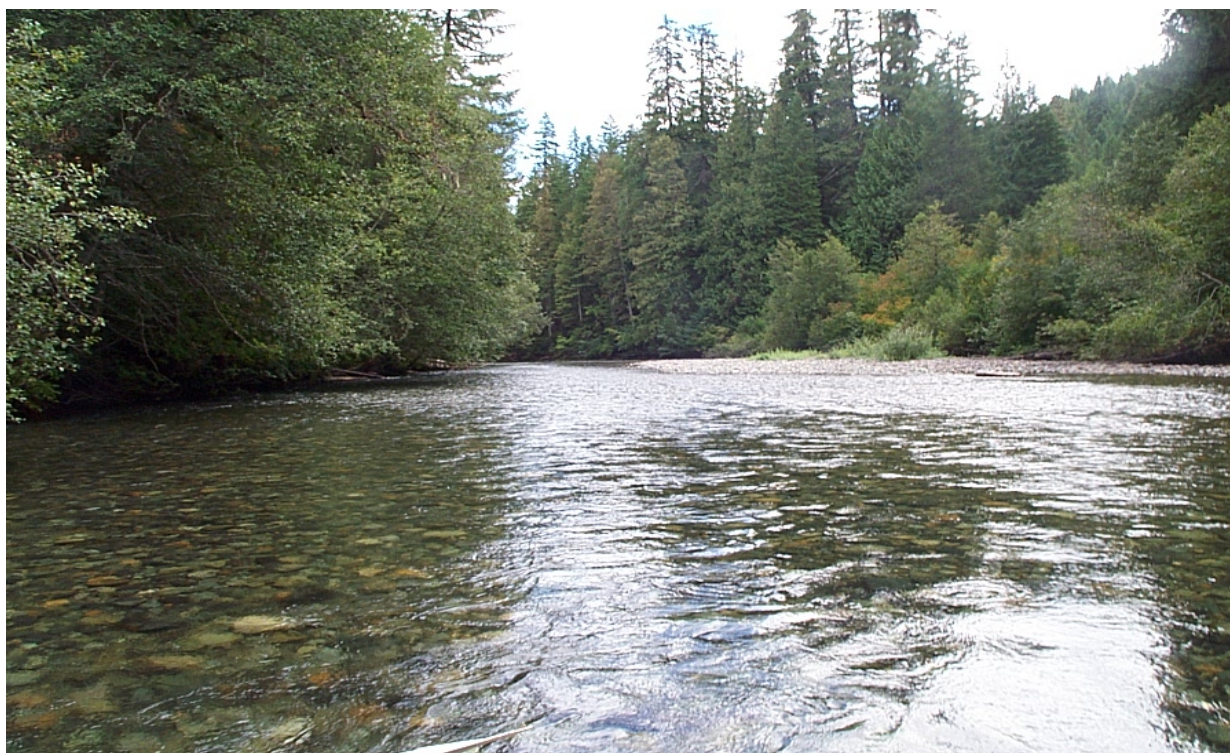
Photo 24. View of char holding pool located at WP 1008, Reach S2.

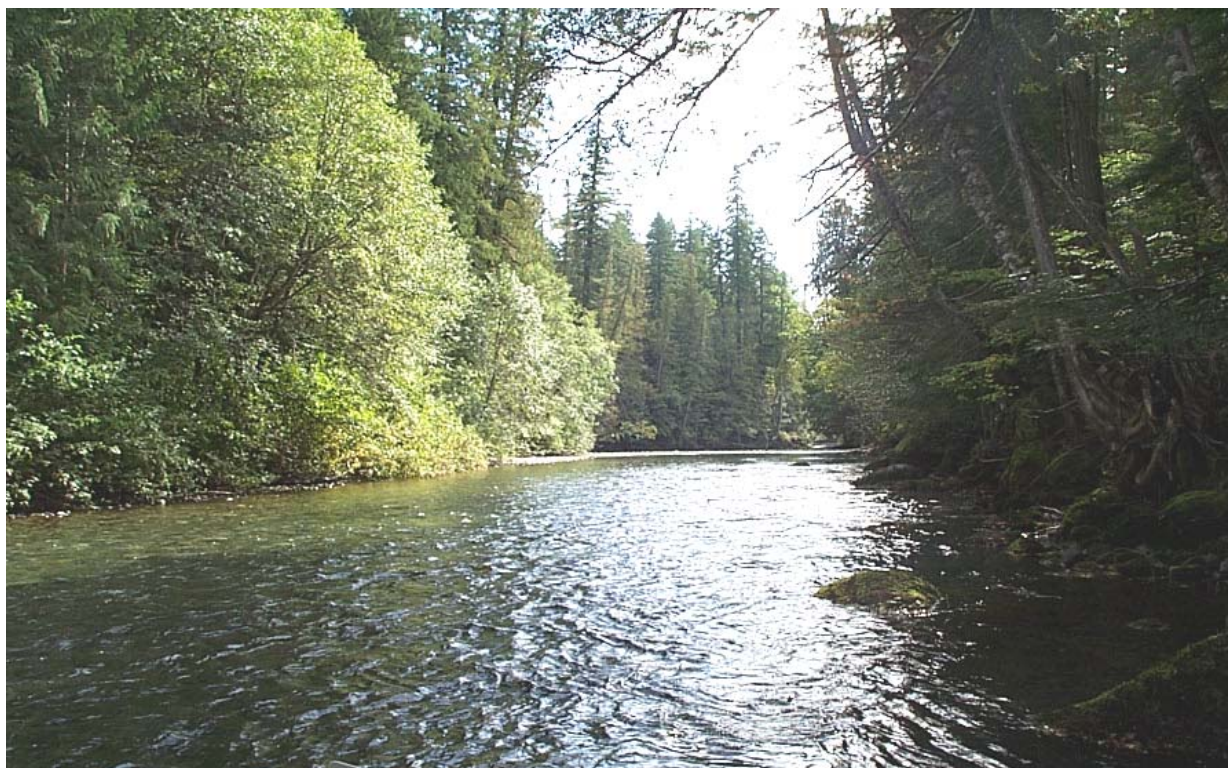
Photo 25. Upstream view in glide frequently used by holding char at WP 1013, Reach S2.

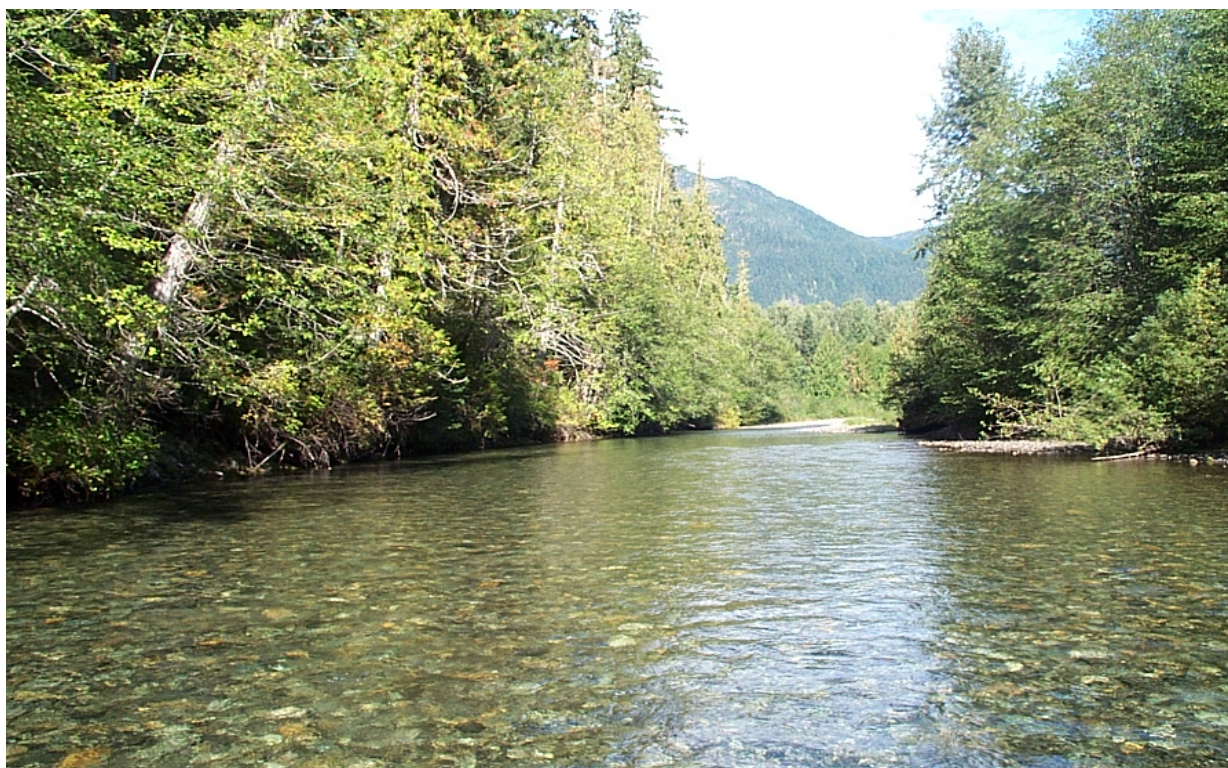
Photo 26. Upstream view of pool (photo background) at WP 1016 that char have never used for holding.

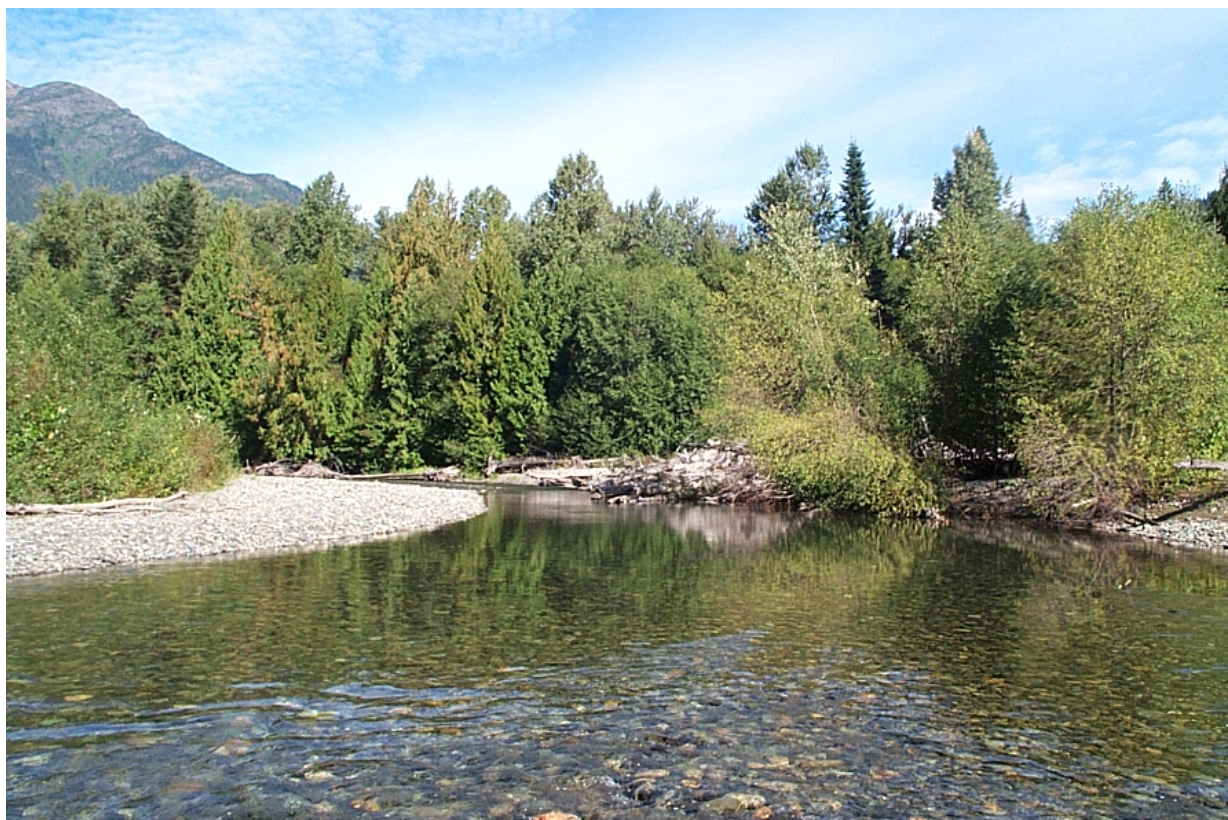
Photo 27. Upstream view of rainbow trout holding pool and logjam at WP 1018, Reach S2.

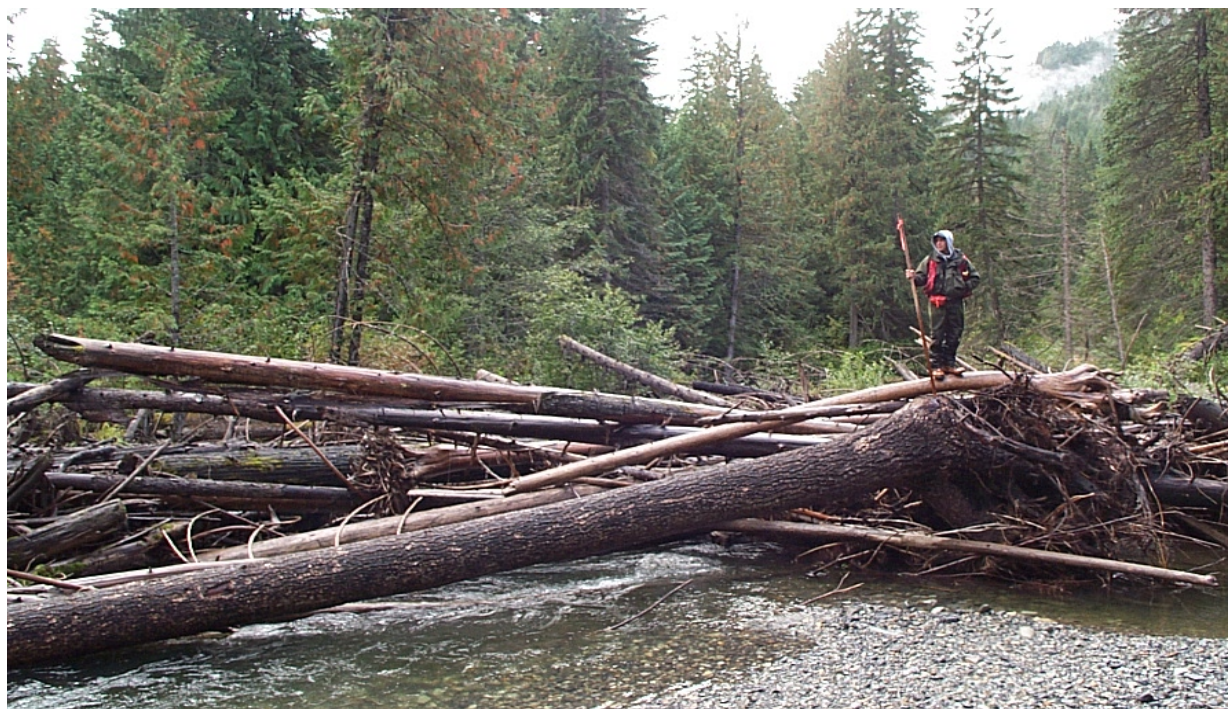
Photo 28. View of log jam at WP 622, Reach S3. No char have been recorded holding at this site.

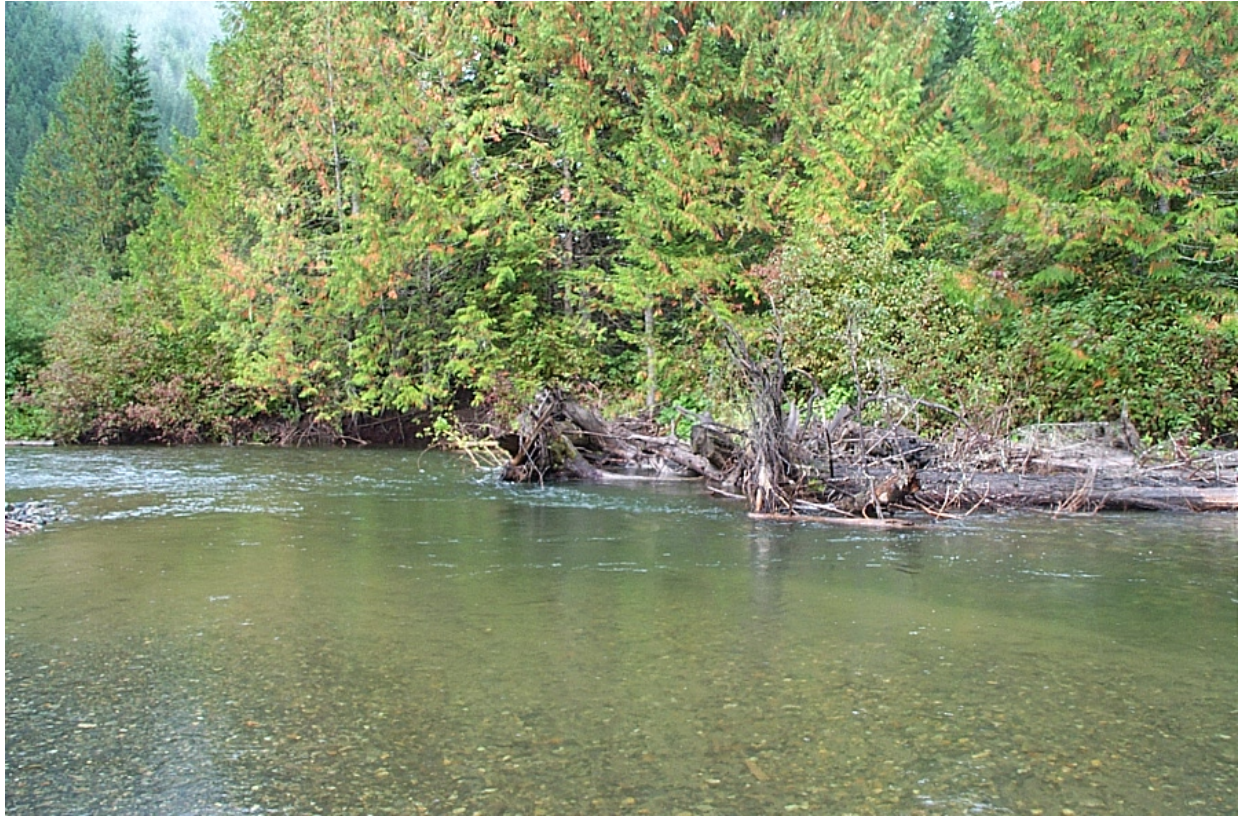
Photo 29. Upstream view of holding pool at WP 1037, Reach S3.

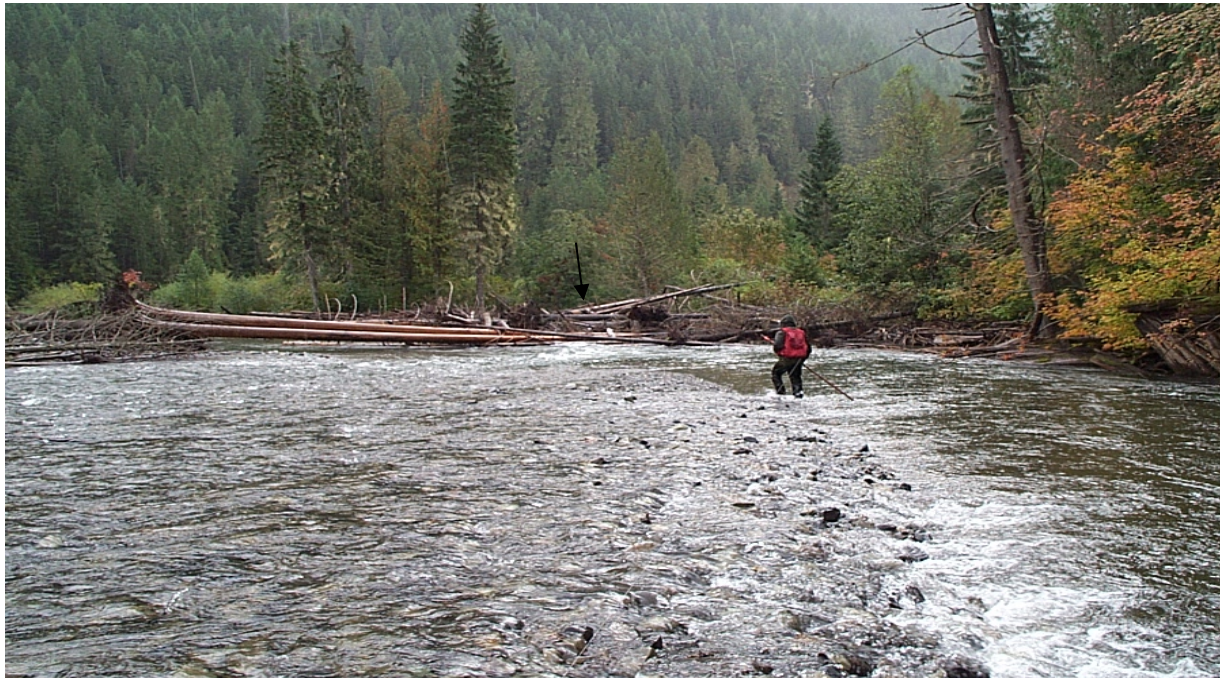
Photo 30. Looking downstream at new avulsion channel that has eroded through massive log jam at WP 1043, Reach S3. This avulsion will eventually cut off holding pools at WP 622 and WP 1037 and WP 1042 located just left (photo left) of avulsion channel.

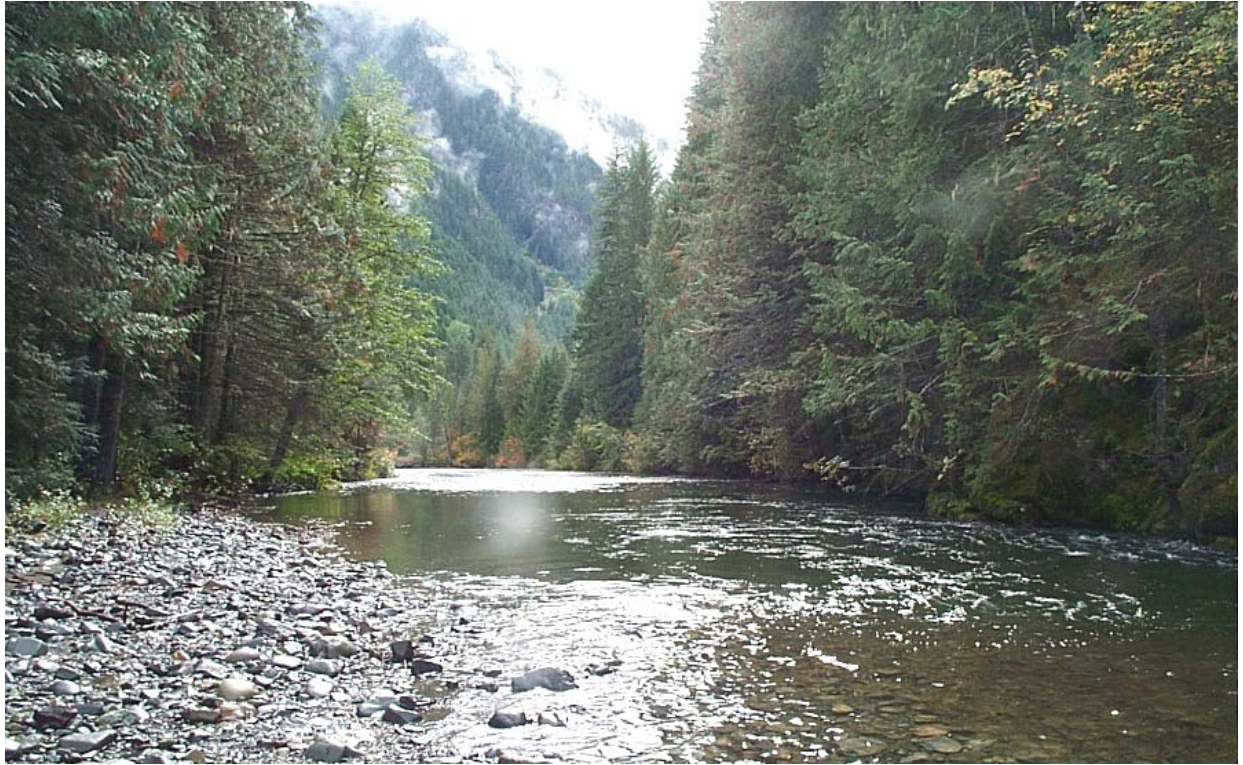
Photo 31. View of holding pool at WP 1047, Reach S3. On two previous floats, this pool held at least four char.

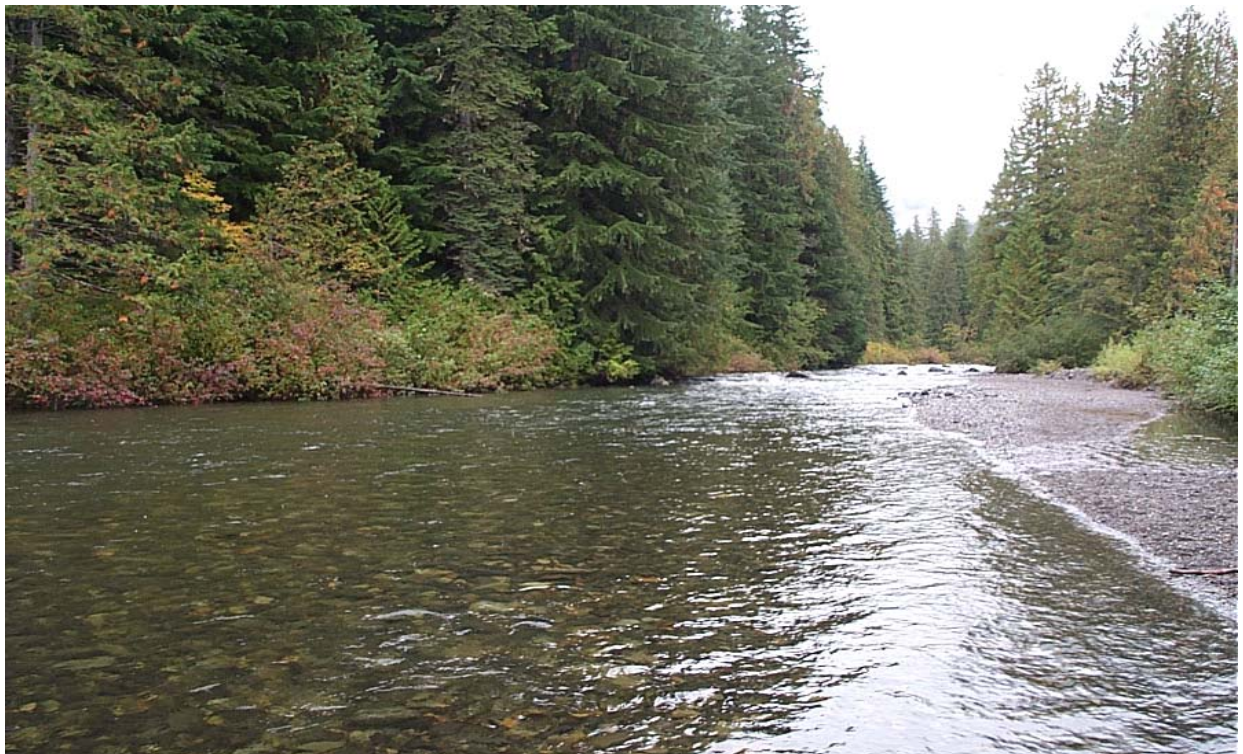
Photo 32. Upstream view of pool at WP 1064, Reach S4. Char occasionally hold here; rainbow trout always hold in this pool.
